# Assessment of Dam Safety Coal Combustion Surface Impoundments (Task 3) Final Report

Georgia Power  
Company

Plant Branch

Milledgeville, GA

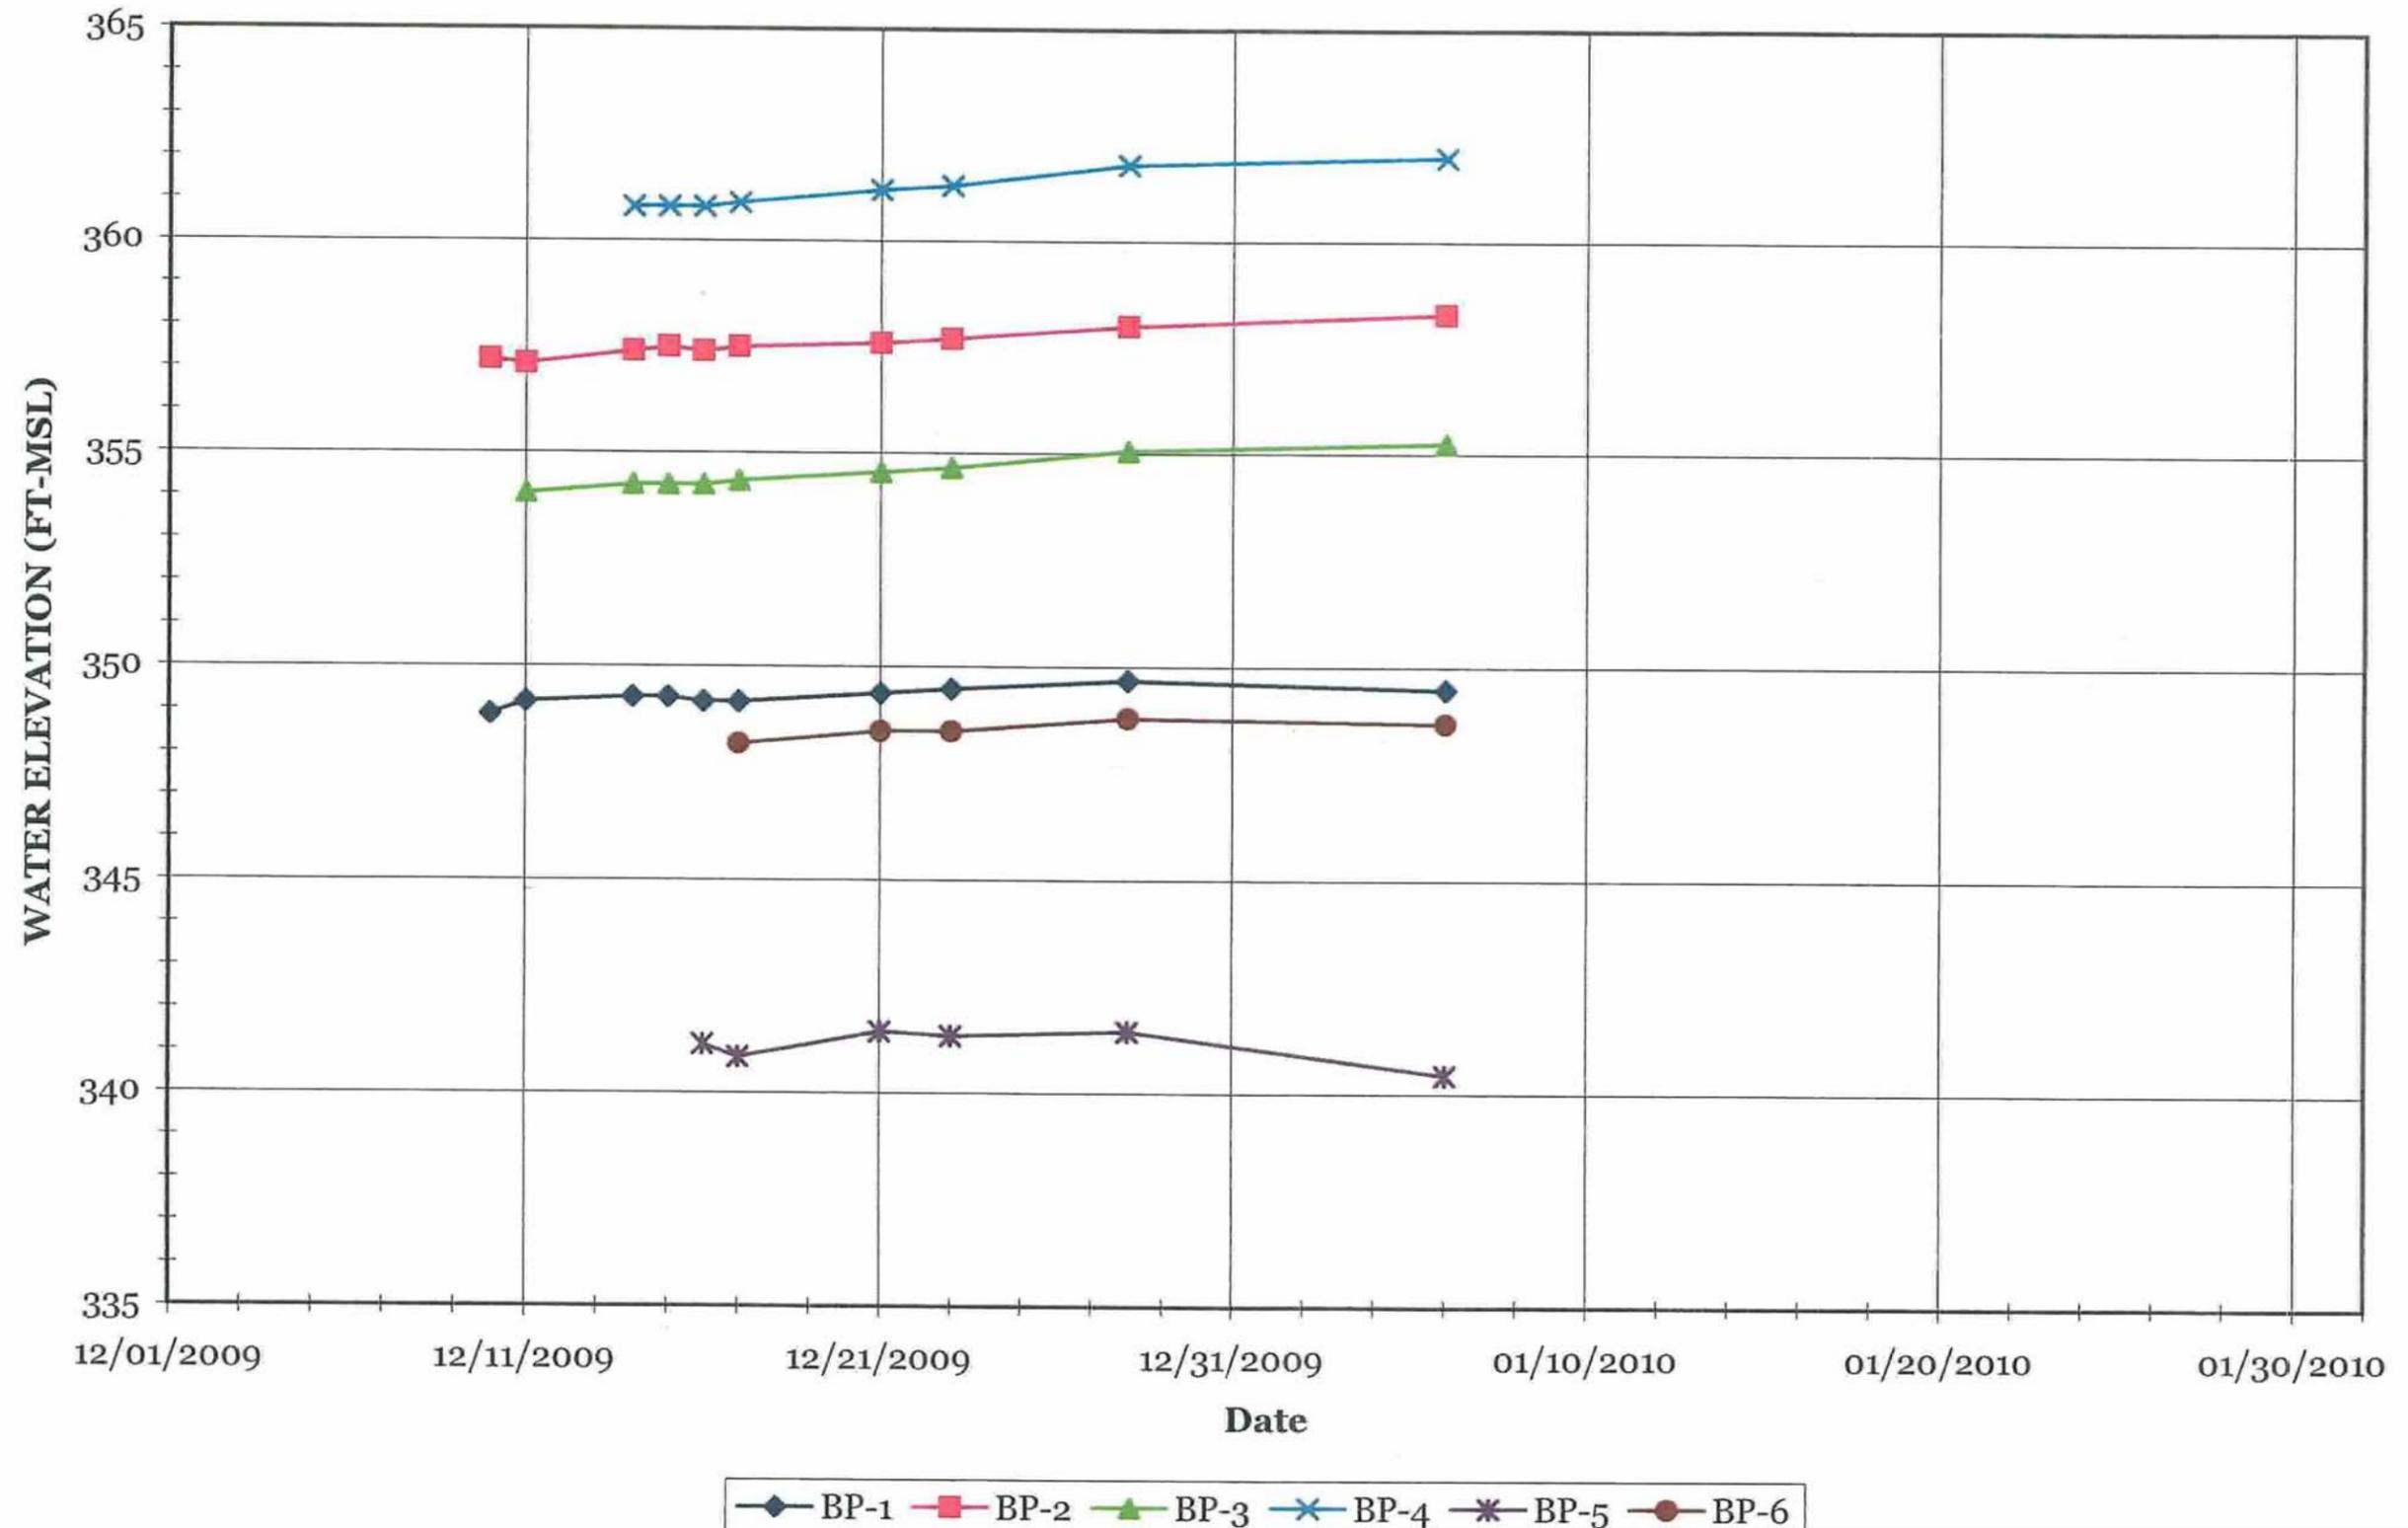
PROJECT NO. 20085.2060
DATE: 03/2010
FIGURE 6A-2

Pursuant to the site assessment of the Ash Pond B, Southern Company/Georgia Power personnel installed six piezometers, BP-1 through BP-6, to determine soil cover thicknesses over the pond area and ascertain the phreatic surface in the ash and dike. Piezometers BP-1 through BP-4 were installed in what is now the dried, capped and vegetated area of Ash Pond B, while piezometers BP-5 and BP-6 were installed through the old dike area. Soil cover thickness above the old ash surface ranged from 0.6 feet to three feet at the piezometer locations. At the time the piezometers were installed, the measured water levels varied from approximately 17 feet deep in the pond area roughly 400 feet from the dike (BP-4) to approximately 42 feet deep at the dike crest (BP-5). Figure 6A-1 shows the location of instrumentation at Ash Pond B. Periodic water level readings were subsequently taken and are summarized in Figure 6A-2.

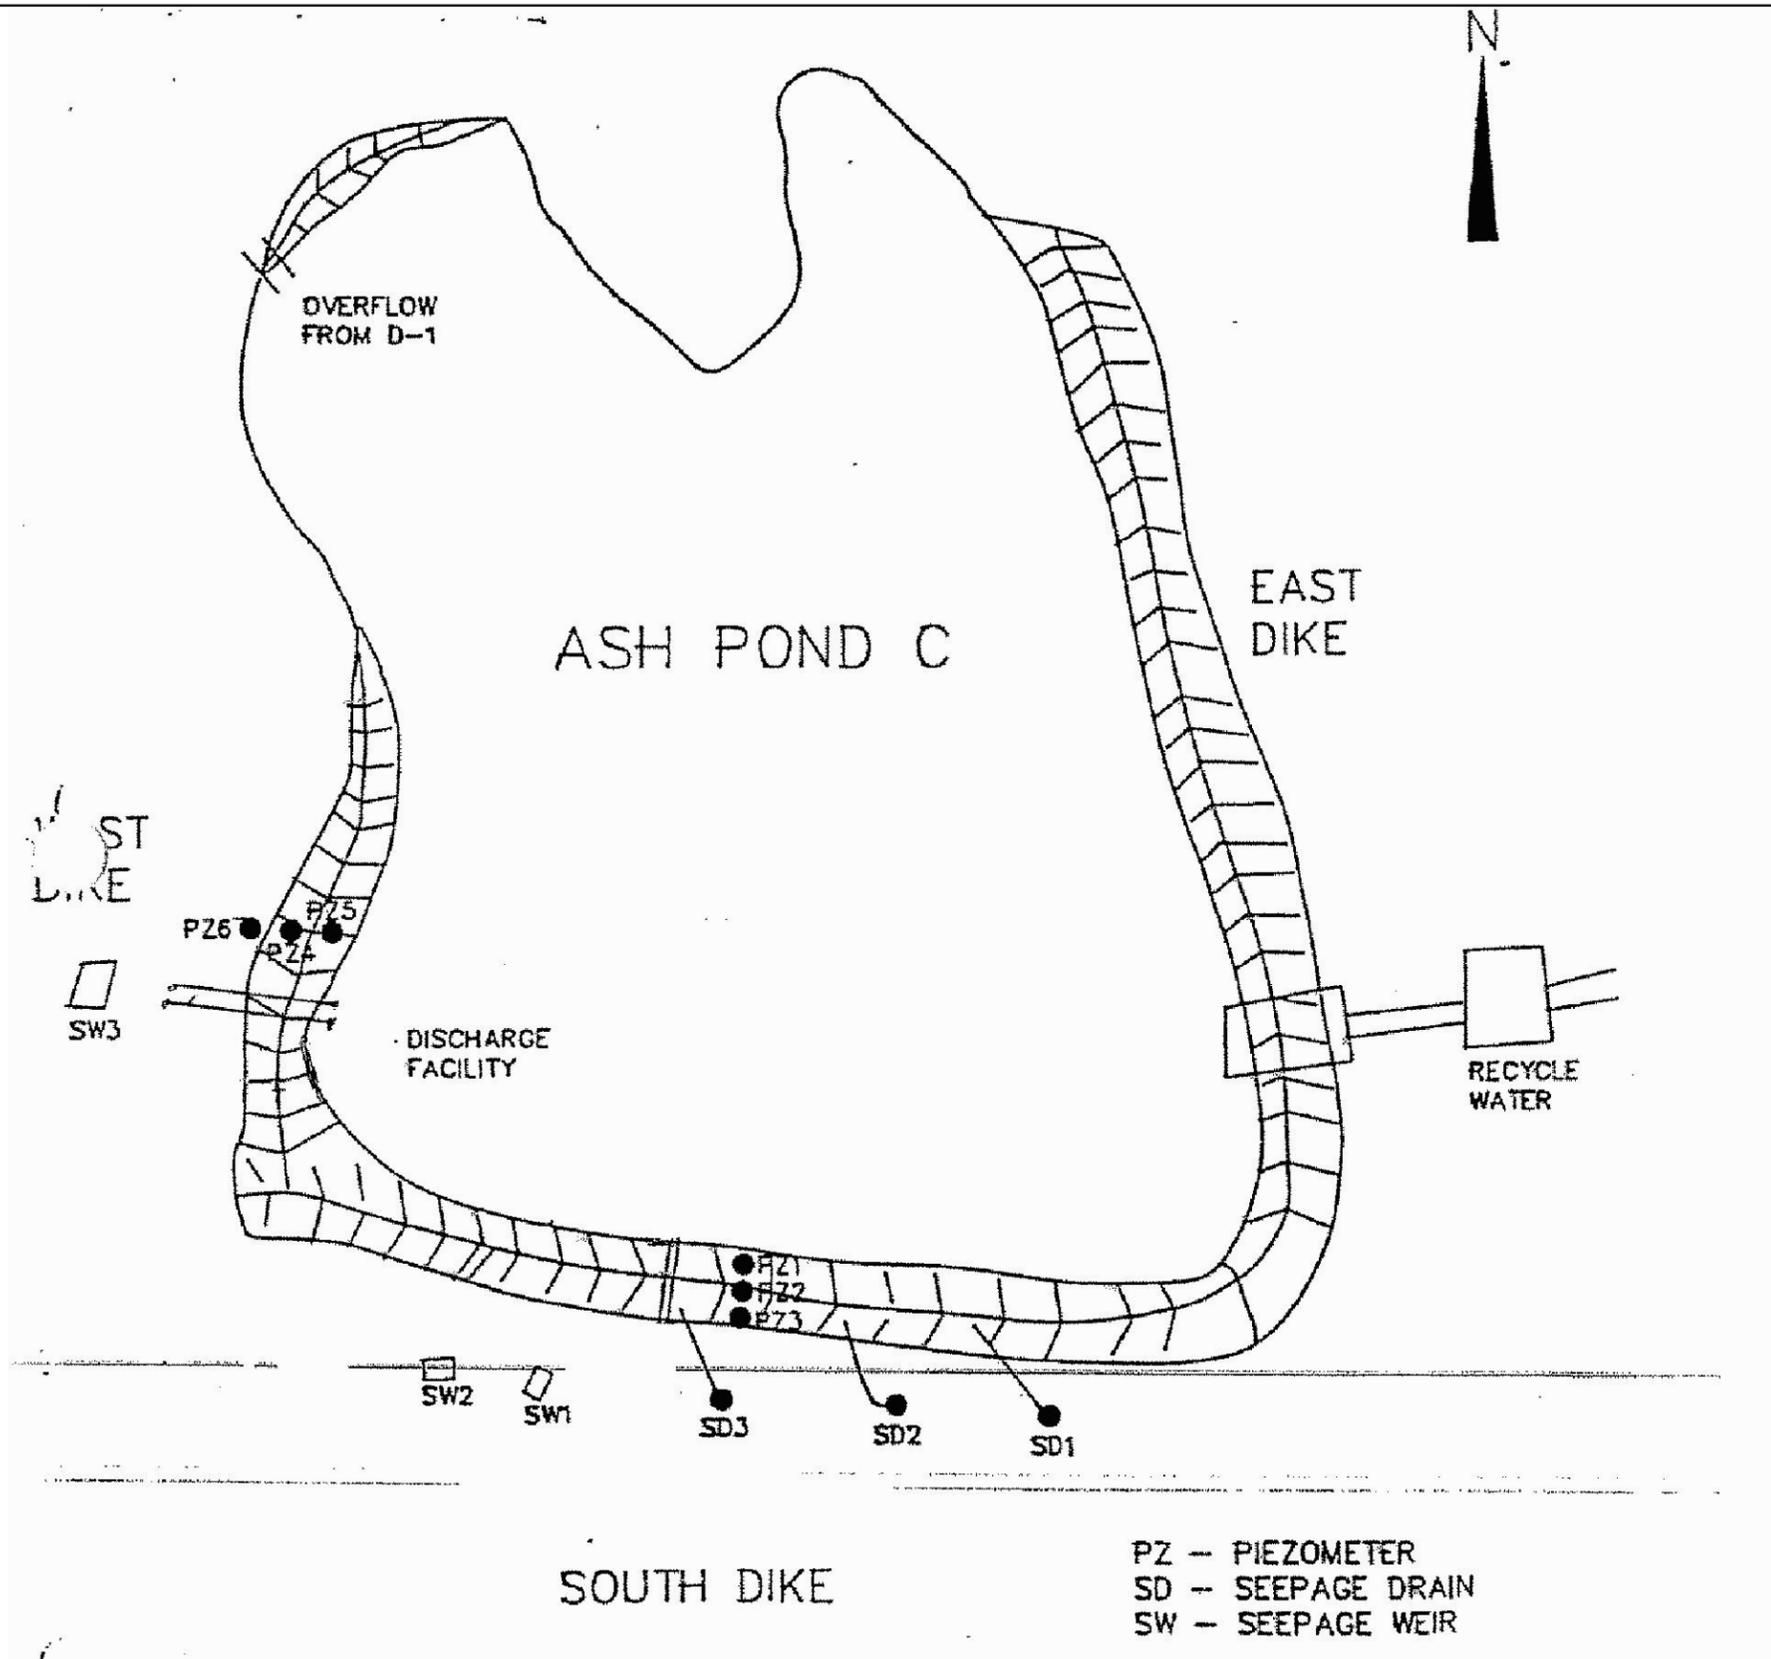
Drawing Copyright © 2010 III Winners Circle, PO Box 5269 · Albany, NY 12205-0269 Main: (518) 453-4500 · www.chacompanies.com	ASH POND C INSTRUMENTATION LOCATION PLAN	PROJECT NO. 20085.2060
	PLANT BRANCH MILLEDGEVILLE, GEORGIA	DATE: 03/2010
	FIGURE 6B

Instrumentation at Ash Pond C includes six piezometers installed along the dikes and three seepage weirs at the approximate locations shown on Figure 6B. Three piezometers (PZ1 through PZ3) are installed near the center of the south dike and three piezometers (PZ4 through PZ6) are installed near the center of the west dike. Figure 6C shows a plot of Ash Pond C piezometer levels and Figure 6D shows a plot of Ash Pond C seepage weir flow rates from January 1998 through October 2009.

At Ash Pond C, arrays consisting of three piezometers have been installed across the approximate center of the south dike and approximate center of the west dike as shown on Figure 6B. Recent water level measurements in piezometers PZ-1, PZ-2, and PZ-3 near the highest section through the south dike (Section A-A/Section C) indicated that the phreatic surface has a slightly different shape than the design surface shown for the original stability cross section depicted in Figure 9C. This revised surface, shown in Figure 9M, was established with data taken after the November site assessment and used in the updated analyses. Instrumentation data is not available for comparison with the design phreatic surfaces at Sections A and B which are located on the west end of the south dike and at the south end of the east dike.

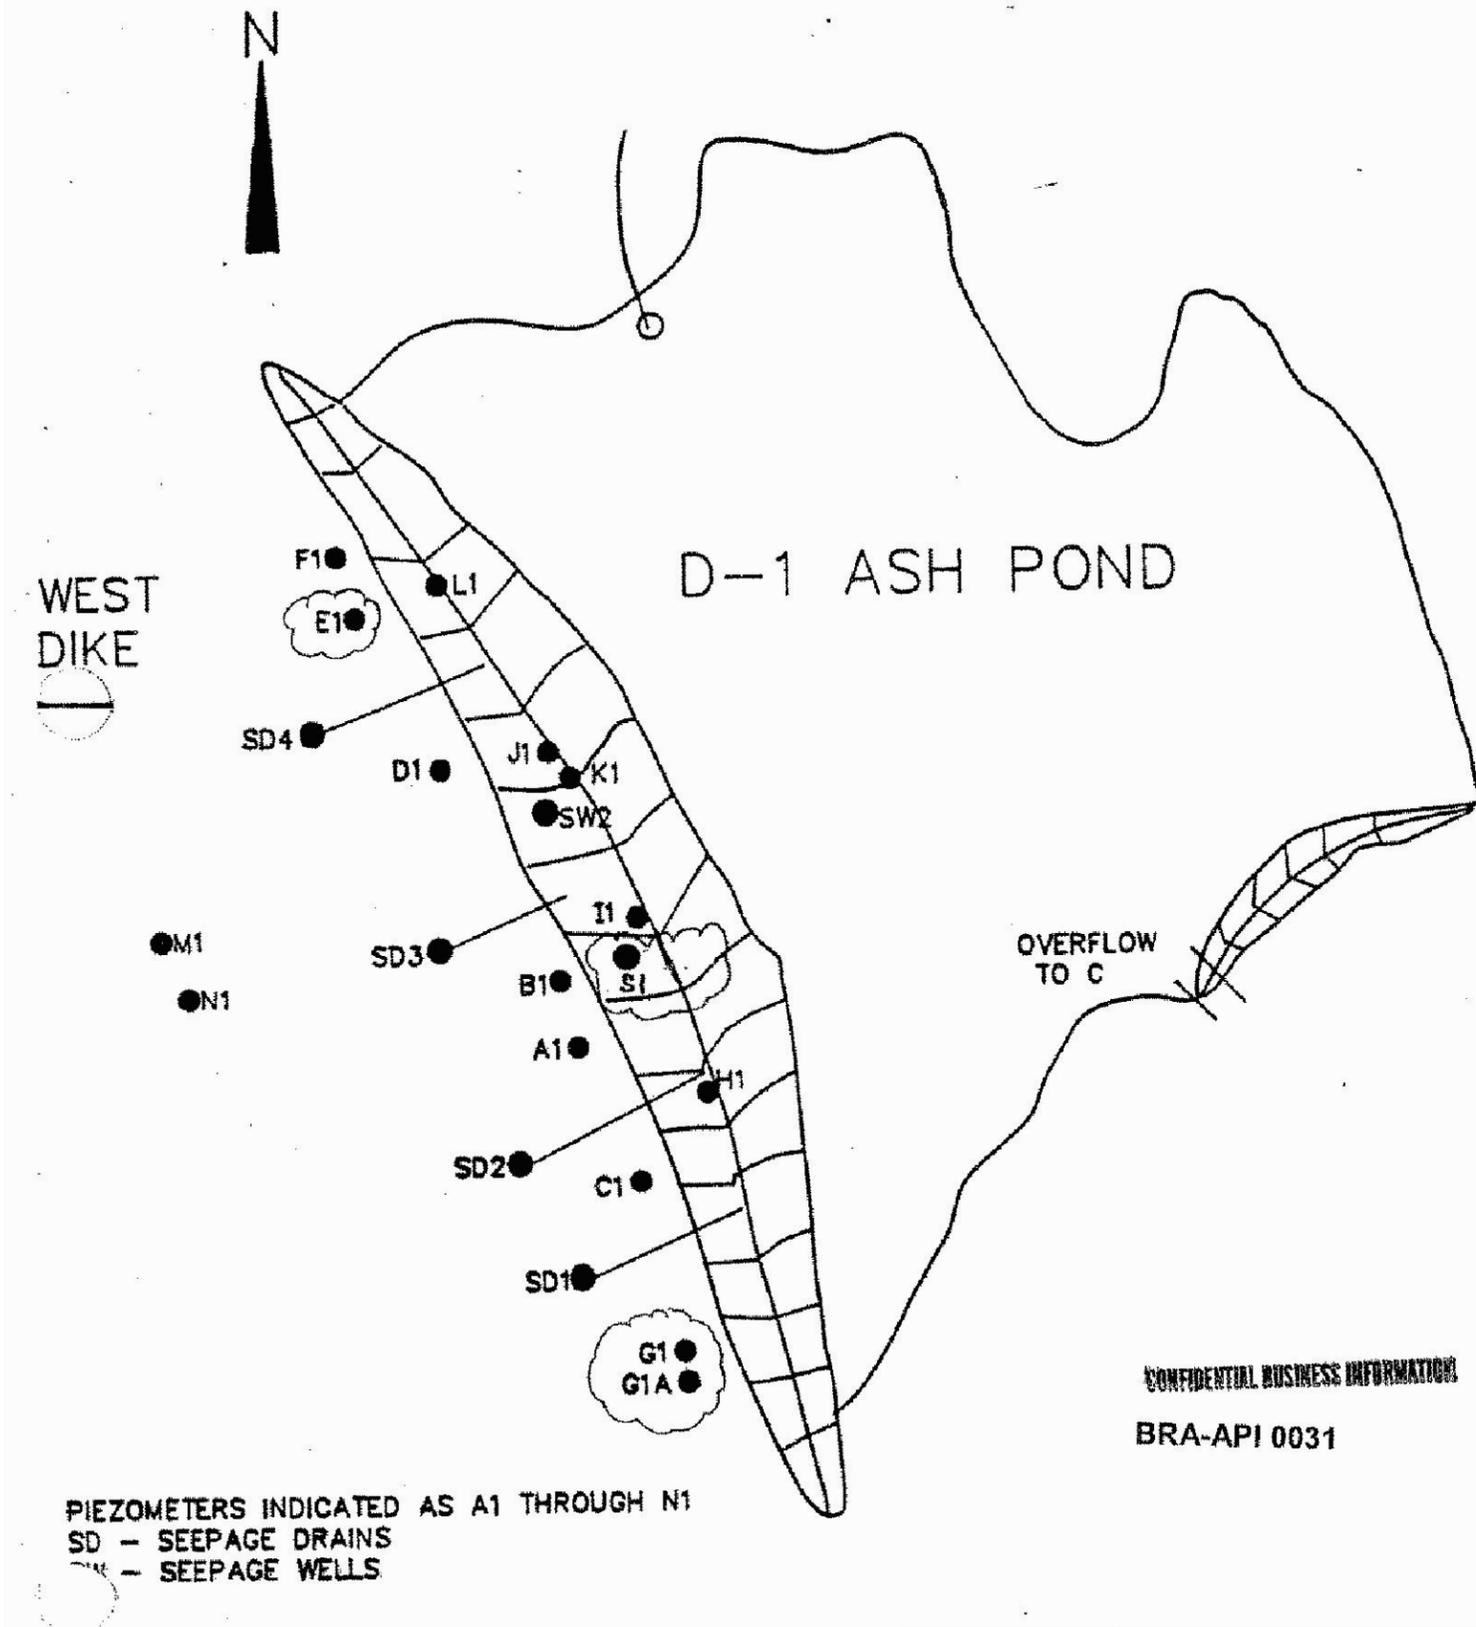
PROJECT NO. 20085.2060
DATE: 03/2010
FIGURE 7A

There are a total of 16 piezometers installed at Ash Pond D at the approximate locations shown on Figure 7A. Eight piezometers (A1 through G1, and G1A) are located at the toe, five piezometers (H1 through L1) are located on the dike crest, and two piezometers (M1 and N1) are located downstream of the dike. The S1 and SW2 piezometers are located halfway up the slope. Information for Piezometer S2 is provided in the plots, and its location is shown as SW2 on the location plan provided. Figures 7B and 7C show plots of the piezometer levels from January 1998 through October 2009.

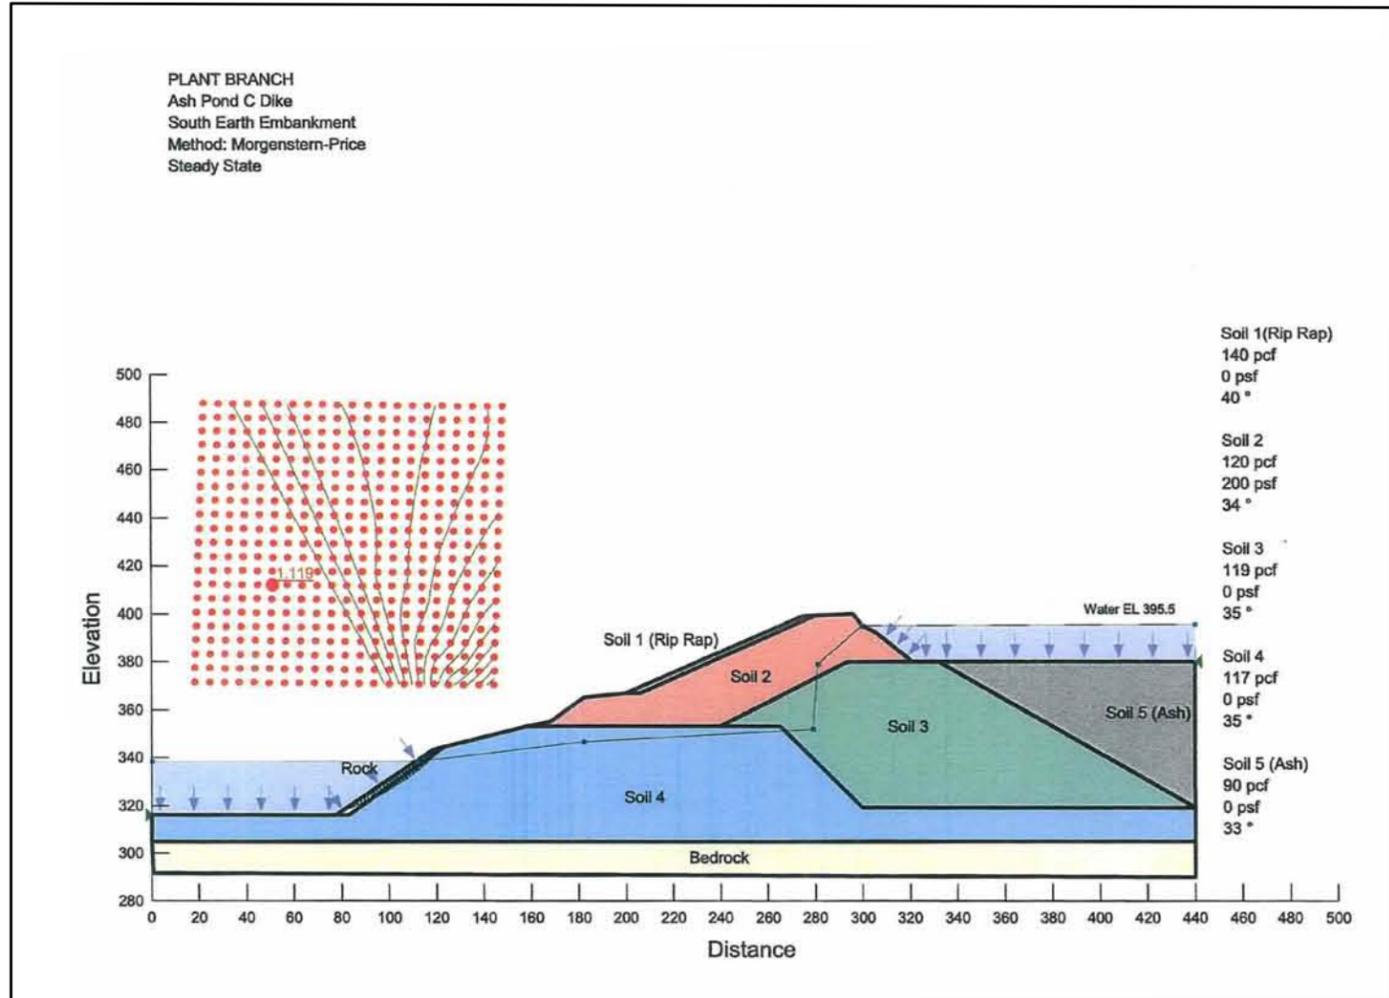
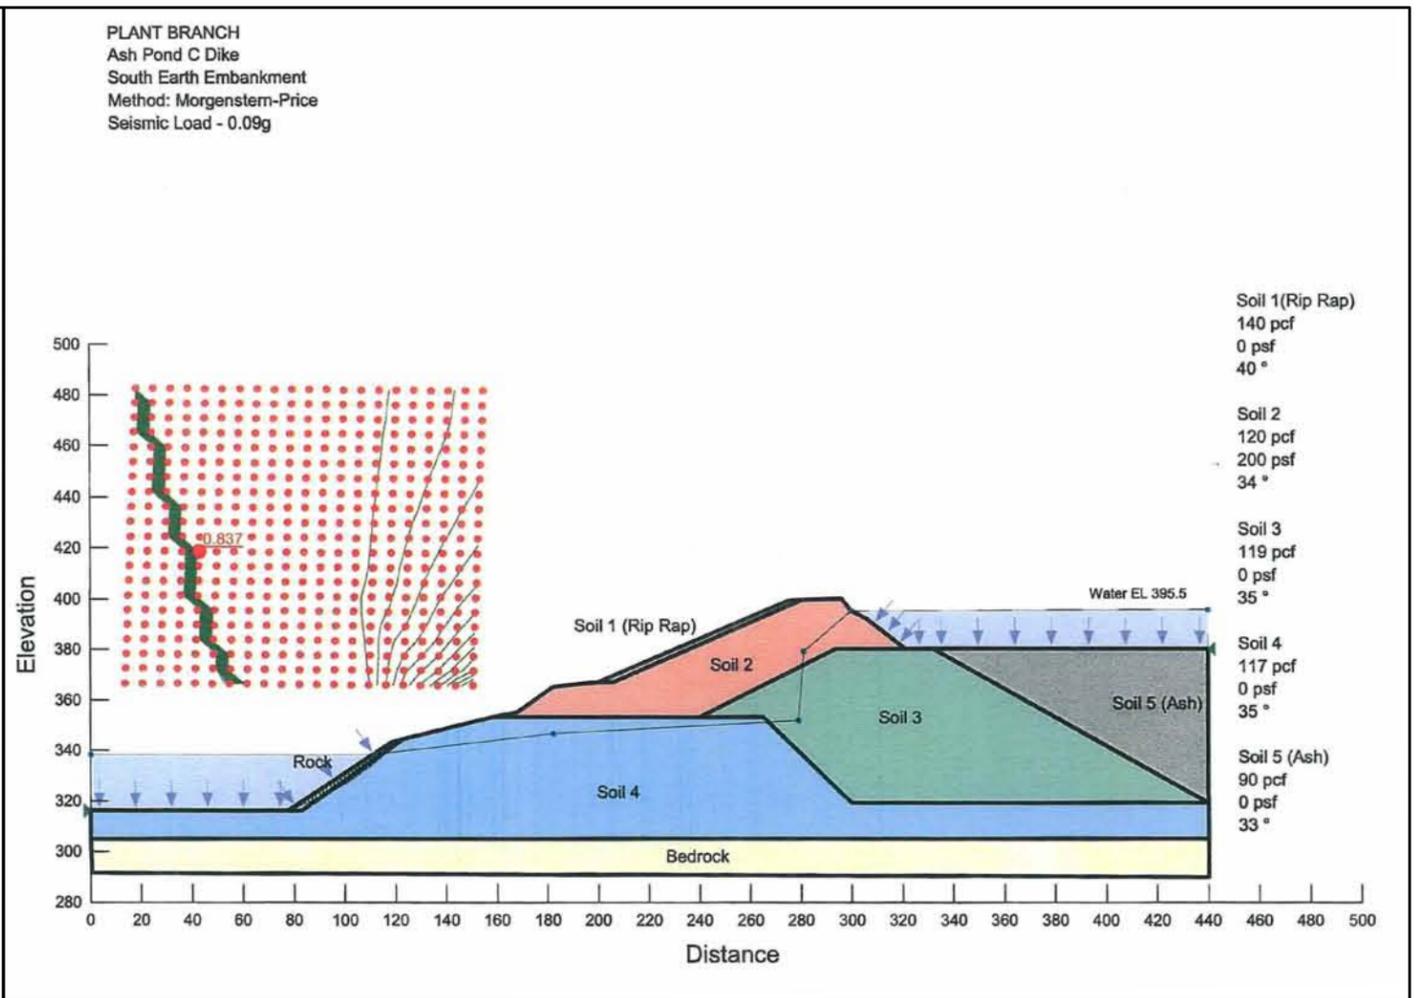
PROJECT NO.  
20085.2060  
DATE: 03/2010  
FIGURE 9J

The original and updated analyses show that the Ash Pond C embankment was generally designed with the required factors of safety for the load cases considered at the time the particular analyses were performed. An exception is the Lake Sinclair shoreline below the toe of the dike, where it has been demonstrated that the minimum factor of safety is associated with a thin, superficial failure plane. Since the failure surface with the minimum factor of safety is below accepted standards, CHA suggests that this area be investigated to determine where the failure surface with an acceptable safety factor lies with respect to the dike geometry. In this way one can ascertain how such a failure would affect gross dike stability.

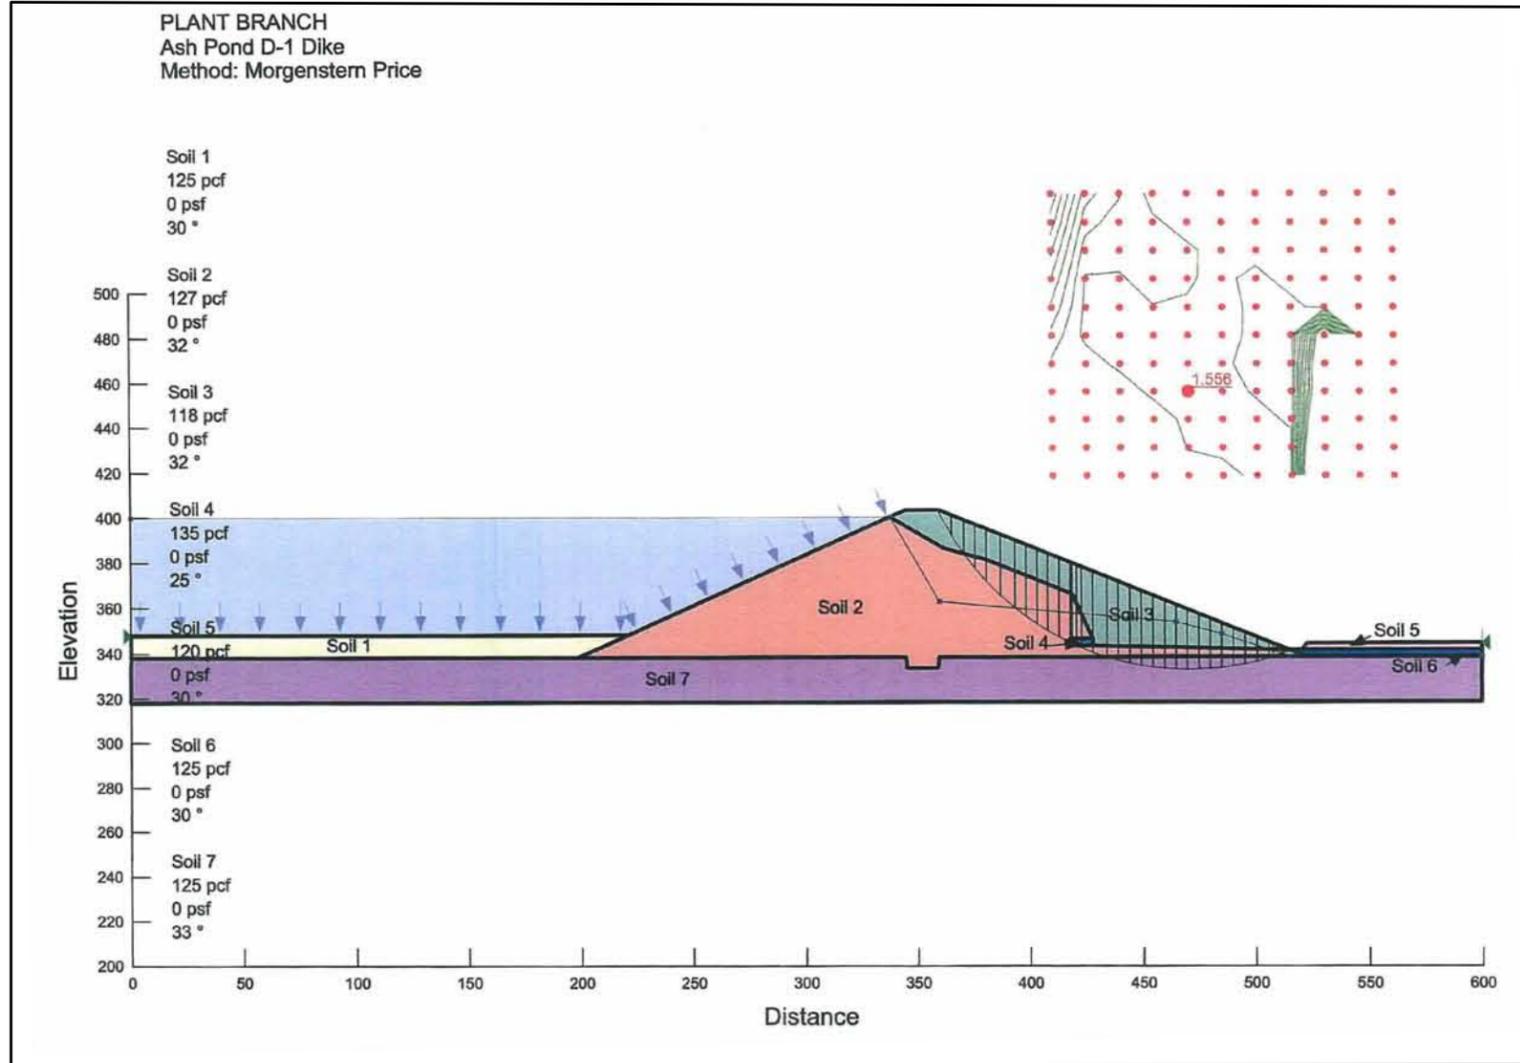
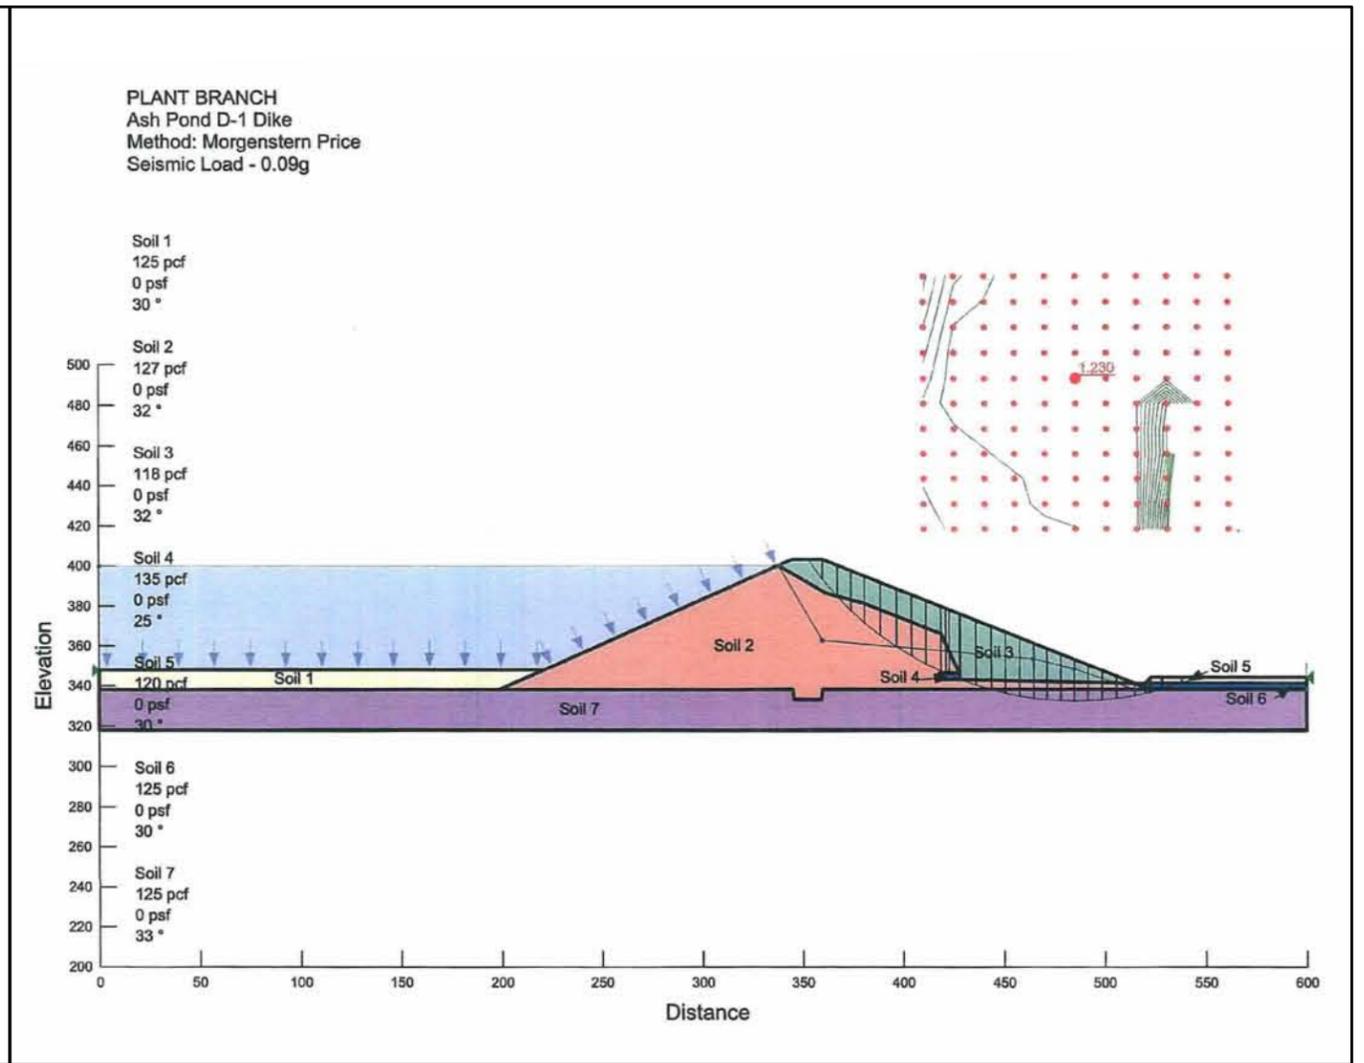
FIGURE 10A

Figures 10A and 10B show the analysis cross section and minimum factor of safety circles for each loading condition for the original design and updated analyses. The computed factor of safety is summarized in the following table.

The original and updated analyses show that the Ash Pond D dike embankment was generally designed with the required factors of safety for the load cases considered at the time the particular analyses were performed. CHA recommends that a stability analysis be performed for rapid drawdown and a surcharge pool or flood condition.
