**Coal Combustion Residue Impoundment
Round 9 - Dam Assessment Report**

Plant Kraft

Ash Dikes

Georgia Power Company
Port Wentworth, Georgia

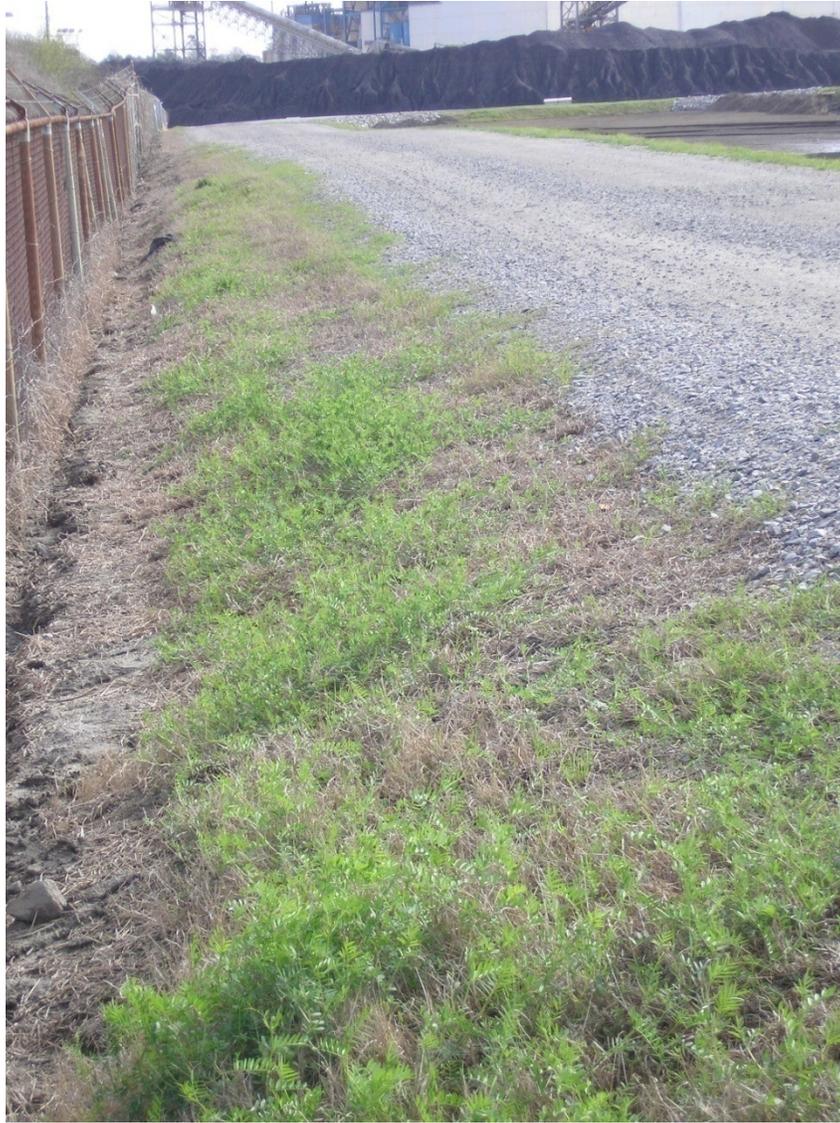
Figure 5.4-1 Outside Slope of Embankment on North Side of Impoundment

Figures 5.4-1 and 5.4-2 show the outside slopes of the embankment on the north and south sides of the impoundment, respectively.

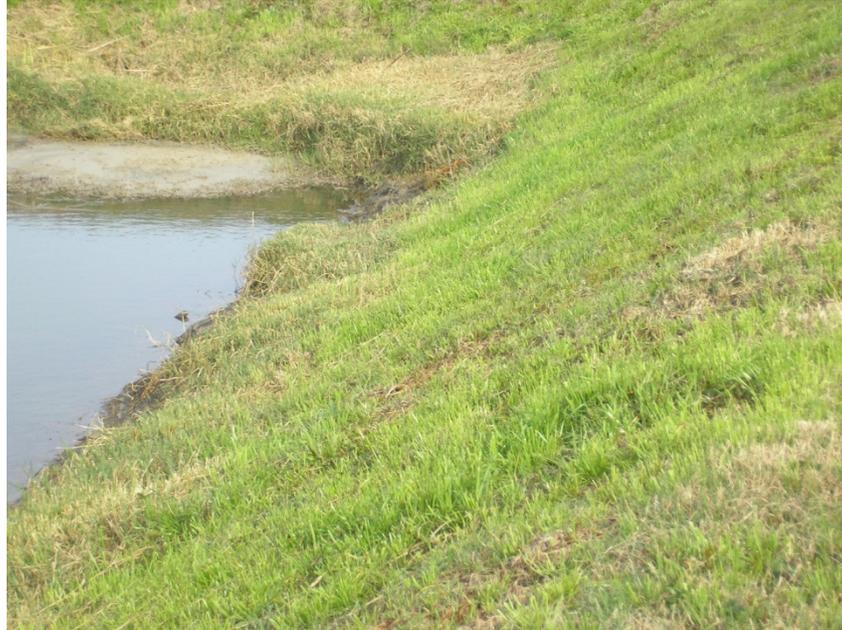
Figure 5.5-2: Groin Area Southeast Corner of Embankment

Erosion or uncontrolled seepage was not observed along embankment groins. Embankment groins on the north side of the CCR impoundment have had riprap added to protect against erosion caused by surface runoff across the embankment crest.

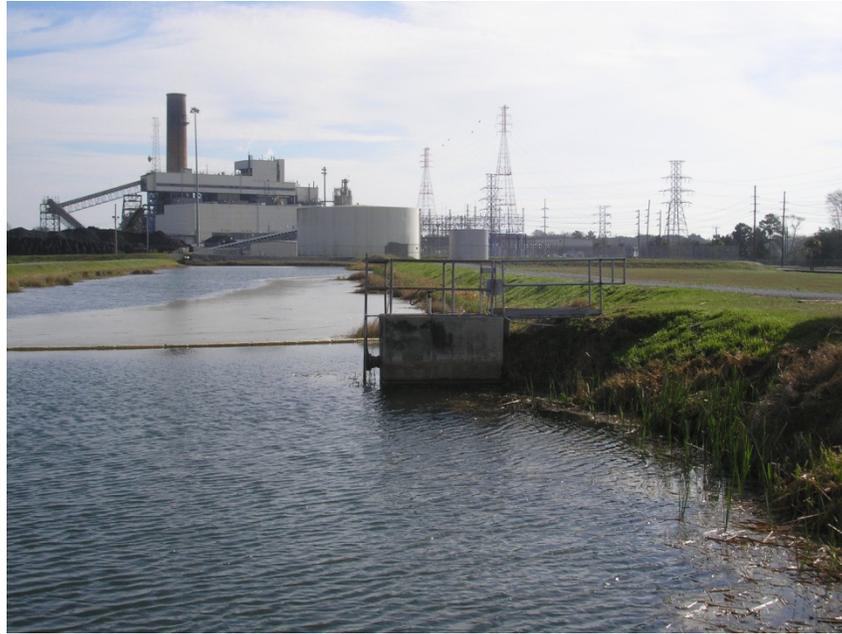
Figure 5.3.2-1 Outlet Structure

The impoundment overflow structure is located in the southwestern corner of the impoundment. The overflow structure consists of a concrete riser in which flow is controlled by a weir and stop logs. Figure 5.6.1-1 shows the riser structure.

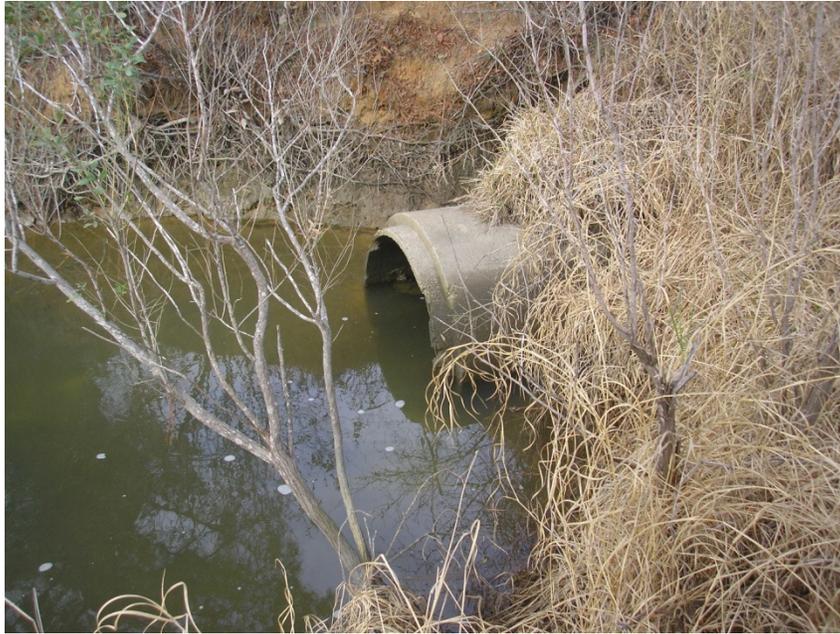
Figure 5.6.2-1 Outlet Conduit Discharge Location

The outlet conduit consists of a 42-inch diameter concrete pipe that discharges to a drainage canal south of the CCR impoundment. The canal flows along the Plant Kraft property line to the Savannah River. At the time of Dewberry's site visit the water level in the drainage canal was above the bottom of the outlet conduit. Figure 5.6.2-1 shows the outlet conduit.

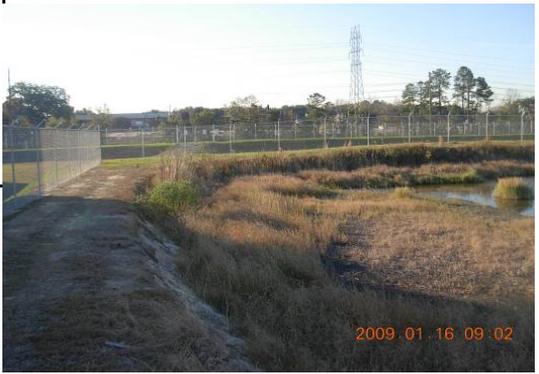
Location No. Photo No.	Description	Photo
285 2834	(looking south) West dike of southernmost ash cell. Slopes need to be grassed and crest needs to be grassed or graveled.

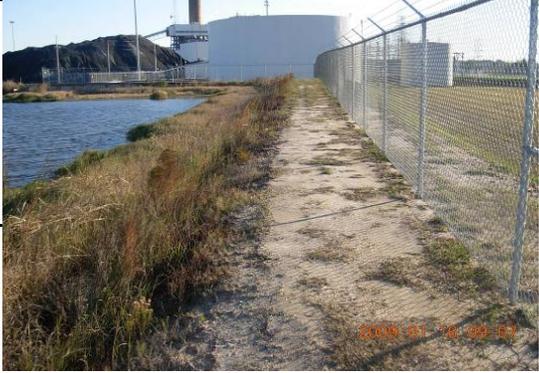
a. Condition	<i>The crest of the ash pond dike and the oil containment dike is bare in many areas. This appears to be due in some areas to four-wheeler traffic. It would be a good idea to either discontinue this traffic and grass the crest or, if the traffic is to continue, to gravel the crest.</i>	286-2835 286-2836
--------------	--	------------------------------

286 2835	South dike (looking east) The crest of the dike needs to be graveled or grassed. The bare spots appear to be the result of four-wheeler traffic. In that case, it would be better to gravel the crest.

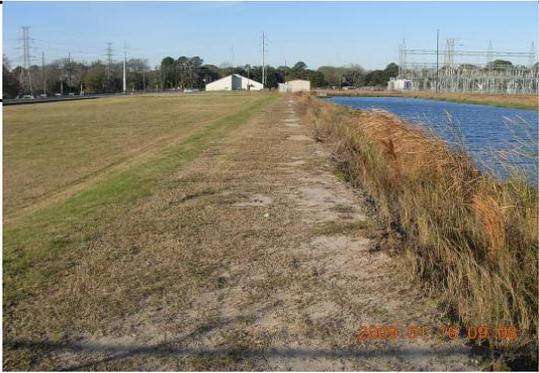
286 2836	South dike (looking west) Crest needs grassing.

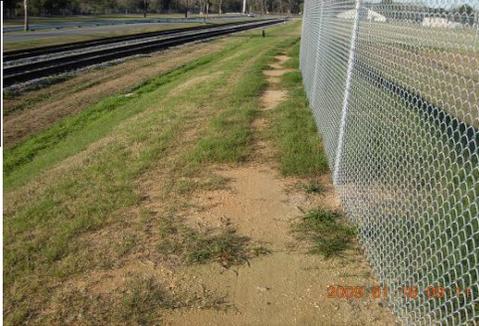
288 2837	Oil tank containment berm (looking west) Loss of grass, probably due to four-wheeler traffic. The crest needs grassing or gravel.

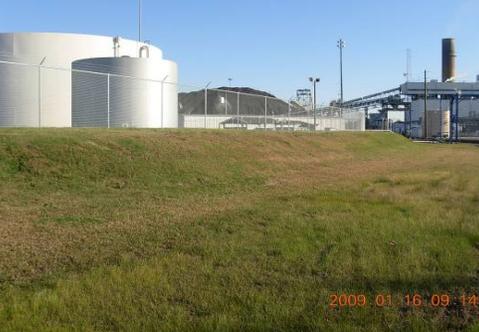
287 2838	South side of oil tank containment (looking northeast) Grass is thin in some spots on outside of containment dike.

No.	Description	Location No.- Photo No.
1	Ash Pond: There are a number of places where the dikes do not have the grass cover they should. This appears to be due to drainage in some locations. The drainage should be corrected and the area grassed.	285-2832 285-2833
2	Ash Pond/Oil containment: The grass cover on some of the dike crests seems to have been worn out by wheeled traffic. These crests should either be graveled to accommodate the traffic, or grassed and the vehicles excluded.	285-2834 286-2835 286-2836 287-2837
3	Ash Pond/Oil Containment: The grass cover on some of the dike slopes and the dikes themselves seem to have been damaged by mower tires rutting the slope and mower blades gouging the slopes. It would be worth investigating different mowing equipment that would be more suitable. Some portions of the dike slopes appear to be steeper than they should be. It would be prudent to cut the grass on these with a weedeater rather than a riding mower.	288-2838 293-2843

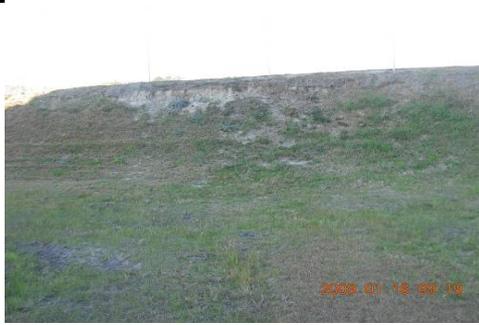
2009.01.16.09.16
290 2840	This segment of the outside of the containment dike is way too steep. This is contributing to the erosion. The best way to fix this would be to import some soil and flatten the slope. Barring that, the next best thing to do would be to mulch, seed, fertilize the slope, then mow it carefully with weed eaters.

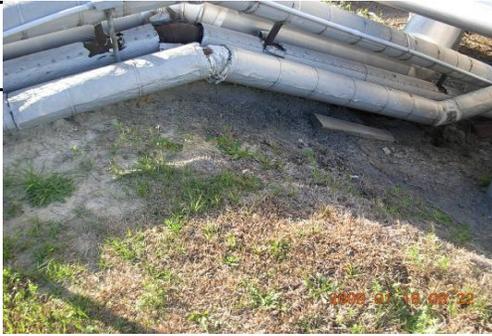
2009.01.16.09.19
291 2841	Minor erosion on inside of oil containment dike. This area could use some gravel.

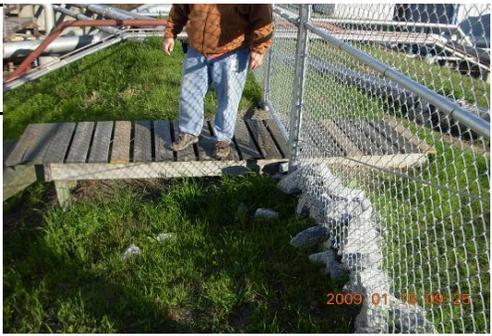
2009.01.16.09.22
292 2842	This may be a low spot on the dike rim. It would be a good idea to shoot this with a level to see if it is.

4	Oil containment: There is a spot on the rim of the containment that appears to be lower than the remainder of the rim. This should be checked with a level to see if it is lower or not, and if there is a particular reason that it is lower.	292-2842
5	Ash Monofill: The whole site could use a general application of fertilizer to invigorate the grass cover.	296-2856 299-2859 300-2860 302-2864
6	Ash Monofill: There are a number of scalped and rutted places on the monofill that are the direct result of mowing activity. The mowing techniques and equipment should be changed to prevent this damage from recurring. This mowing damage will result in higher maintenance costs at best and may result in erosion of the earth cap and release of ash at the worst.	294-2854 300-2860 304-2867

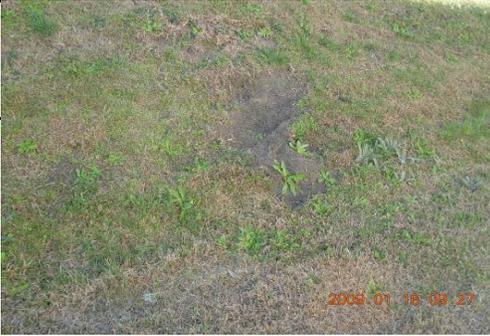
Location No. Photo No.	Description	Photo
293 2843	Mower gouges on slope.

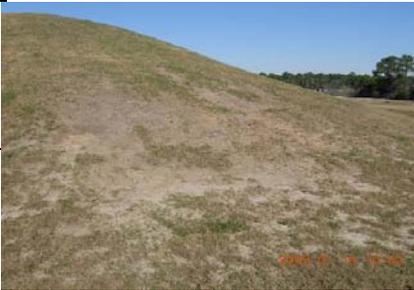
Location No. Photo No.	Description	Photo
294 2854	Bare patch on slope. Areas like this need to be seeded and mulched. The whole monofill could use a general application of fertilizer to strengthen the grass cover as well as special attention to bare spots like this one.

7	Ash Monofill: The bare spots on the monofill should be treated with seed, fertilizer and mulch to replace the grass cover.	294-2854 297-2857 298-2858 304-2867
8	Ash Monofill: The slide on the south side of the detention pond should be monitored to see if it moves any more	306-2870
9	Ash monofill: A splash pad should be constructed at the outlet for the plastic down drain pipe at location 301.	301-2862 301-2863
10	The oversteep slopes and ditches at locations 295, 301 and other locations should be flattened to a 3:1 or flatter slope, then grassed.	295-2855 301-2862

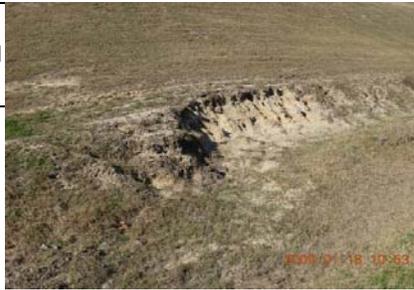
295 2855	Erosion of oversteep slope. This area should be graded to a flatter slope then seeded, fertilized and mulched.

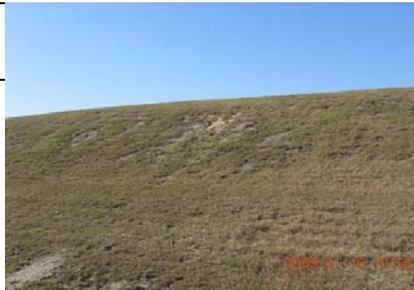
296 2856	Bare patches on slope.

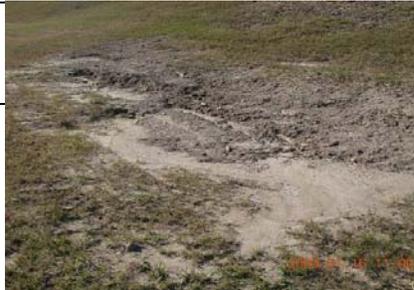
297 2857	Bare spot that has started to erode.

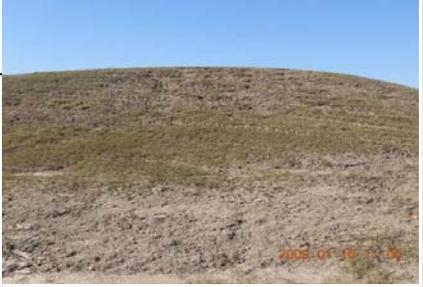
Location No. Photo No.	Description	Photo
298 2858	Bare spot in foreground and thin grass on the slope in the background.

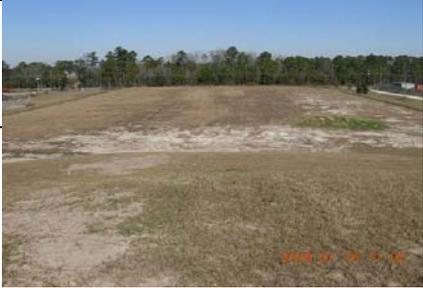
299 2859	View of northern cell from top of southern cell. Note thin grass cover in some areas.

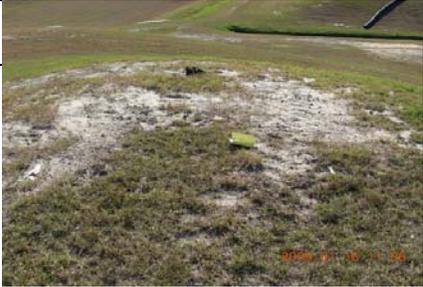
300 2860	Bare patches on crest of cell.

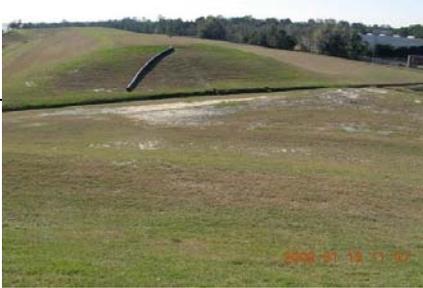
300 2861	View looking south from crest of northern cell toward southern cell. Note displaced black plastic down drain.

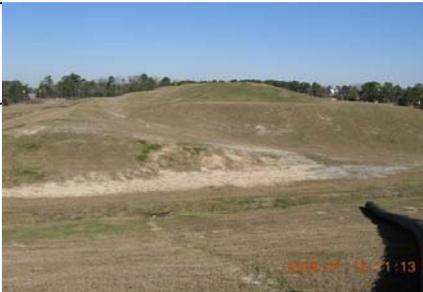
302 2864	View of south cell from north cell.

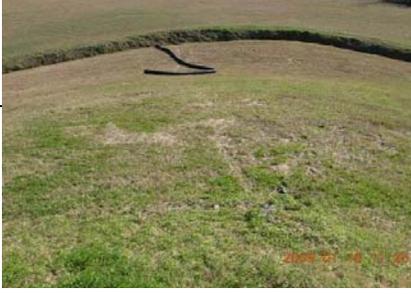
Location No. Photo No.	Description	Photo
305 2869	Displaced black plastic down drain. Probably moved by mowing crew.

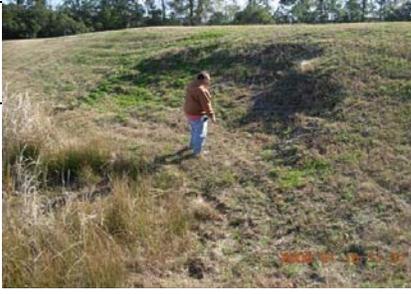
306 2870	Slide on south bank of detention pond. Large compliance specialist inserted for scale.

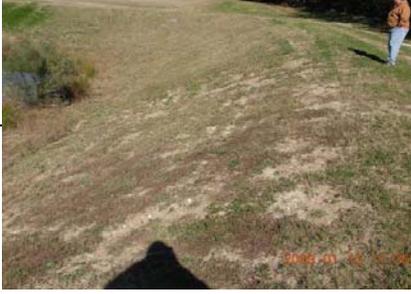
307 2871	East side of detention pond. Vegetation growing through outlet structure has been removed since the inspection. There are some bare spots on the pond slope.

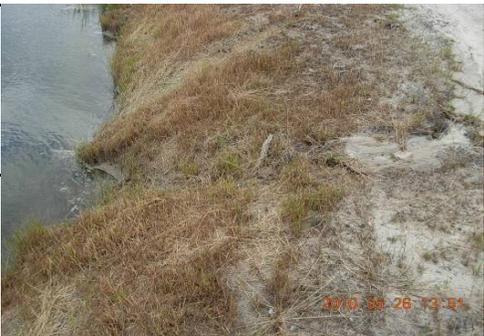
2010.05.26 13:41
3906	Erosion under matting where concentrated storm flow from the crest road enters the pond. This location can be improved with a plastic down drain and earth berm.

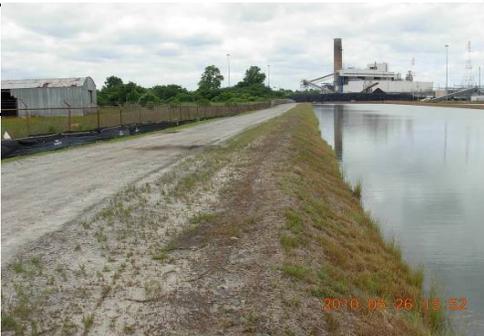
2010.05.26 13:41
3907	North dike showing fair grass cover on upstream slope.

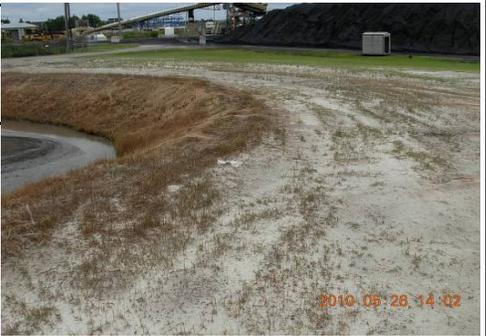
3908	Bare crest of dike. This area would benefit from gravel.

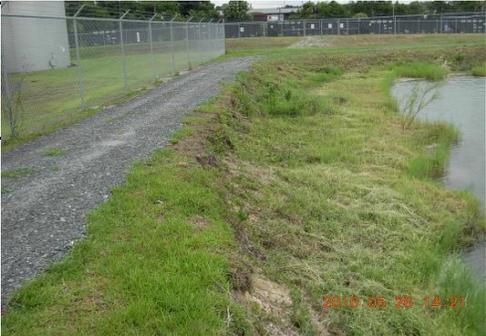
A wide, flat, eroded area of light-colored soil and sand, likely the crest of a dike. There is some sparse, dry vegetation. A timestamp in the bottom right corner reads "2010.05.26.14.02".
3909	The addition of gravel to the crest in this area has worked well. This slope is overly steep and should be flattened with the addition of suitable fill.

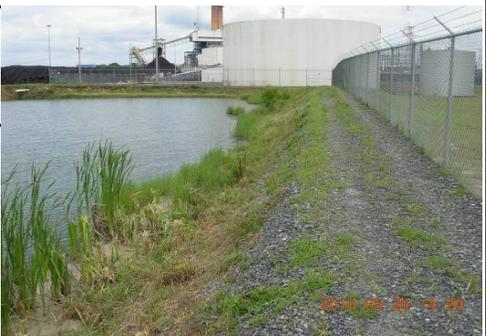
A gravel path runs along a steep, grassy slope. A chain-link fence is visible in the background. A timestamp in the bottom right corner reads "2010.05.26.14.27".
3910	The addition of gravel to the crest in this area has solved the rutting and erosion problems noted in 2009.

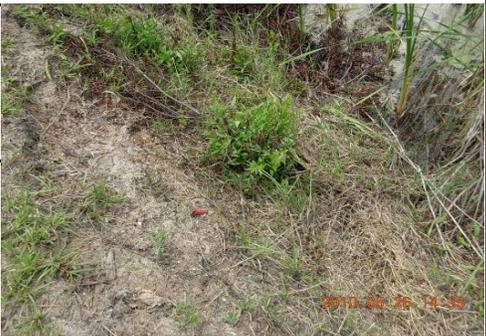
A gravel path runs along the edge of a pond. In the background, there are large white storage tanks and industrial structures. A timestamp in the bottom right corner reads "2010.05.26.14.29".
3912	A number of woody plants were noted around the perimeter of the dike. All woody plants around the dike should be treated with herbicide.

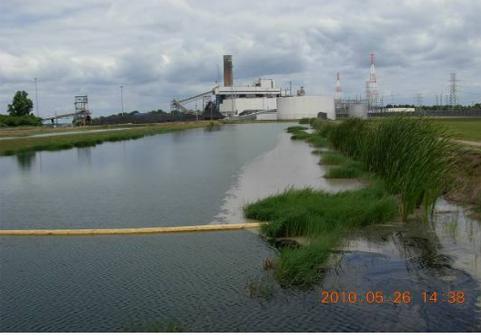
Photo No.	Description	Photo
3913	Cattails growing in ash are not a problem from a dam safety standpoint.

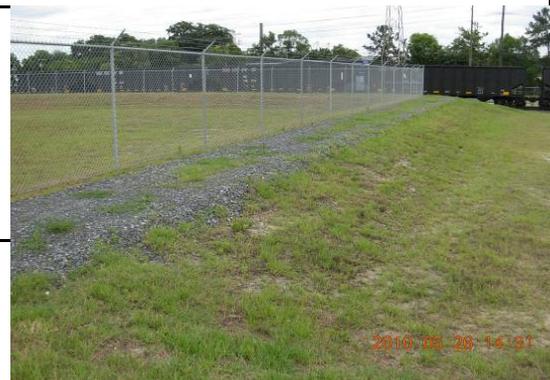
3911	Placing gravel on the crest of the dike has solved the problem of rutting and erosion. The slope has some bare and thin spots that should be treated with seed and fertilizer. It looks like mower tires may be the culprit here.
-------------	--

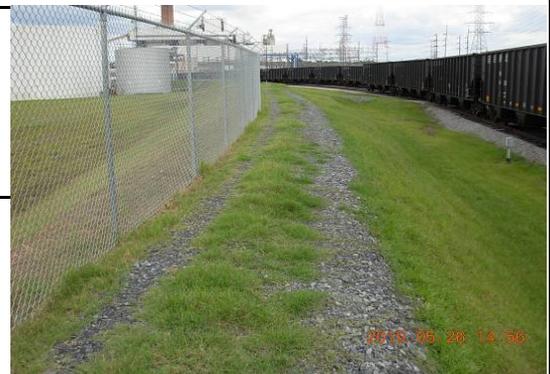
3914	Placing gravel on the crest of the dike has solved the problem of rutting and erosion.
-------------	--

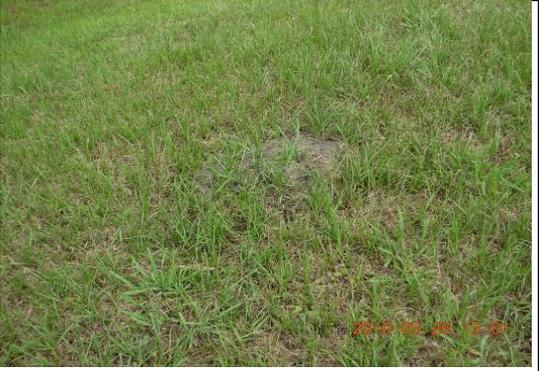
A wide-angle photograph showing a grassy slope next to a chain-link fence. In the background, industrial structures are visible under a cloudy sky. A timestamp '2010.05.26 14:57' is in the bottom right corner.
3916	Some fire ant mounds were noted. Fire ants damage the dike by removing soil. In smaller dikes like these, this can sometimes lead to the loss of the structure. At the least the nest will cave in at some point, leaving a low spot that can lead to mowing problems. It would be a good idea to institute a systematic fire ant control program.

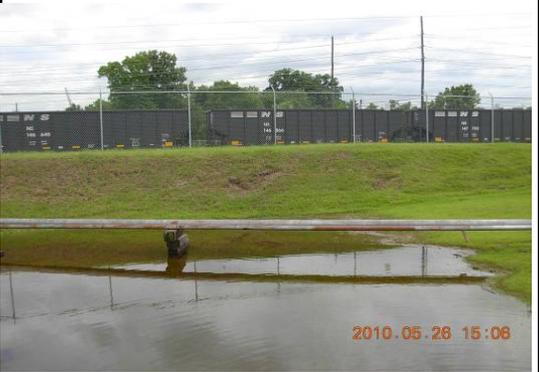
A close-up photograph of a grassy area showing a small, raised mound of soil, which is a fire ant nest. A timestamp '2010.05.26 15:01' is in the bottom right corner.
3917	Ruts on slopes from mower tires.

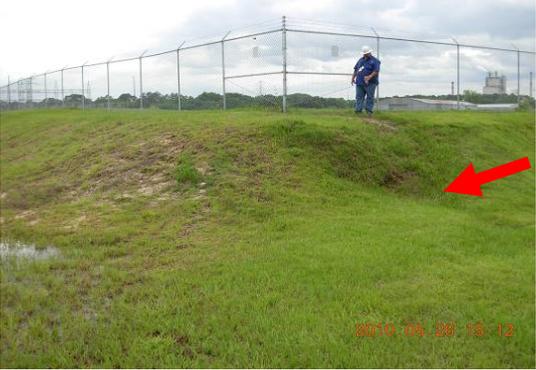
Photo No.	Description	Photo
3918	The slope to the right is very steep, making it very difficult to care for. This slope should be flattened with fill. The bare areas to the left will need treatment with seed and fertilizer and be mowed gently.

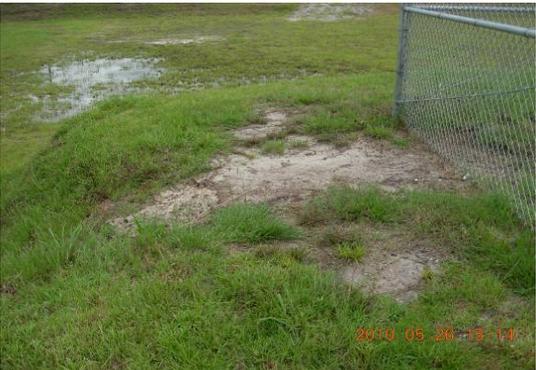
3919	This bare spot is due to erosion from concentrated rainfall runoff. The fix would be to install an earth berm and plastic pipe down drain buried in the slope.

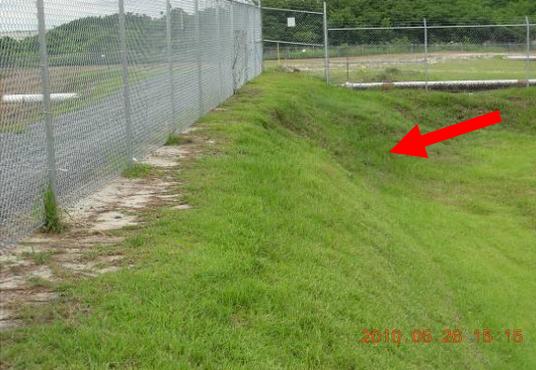
3920	This slope is too steep to maintain and is also a risk for a slide. This area needs to be filled in to a slope matching that of the surrounding slopes (roughly 2:1).

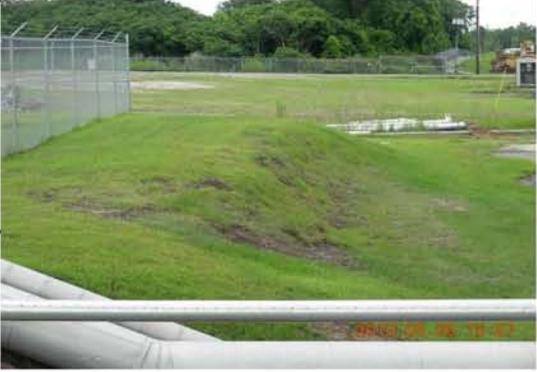
Photo No.	Description	Photo
3921	The dike in this location shows bare spots, some due to rutting and some due to scalping. The slope is too steep. The slope should be flattened and the area regrassed with suitable grass seed, fertilizer and mulch.

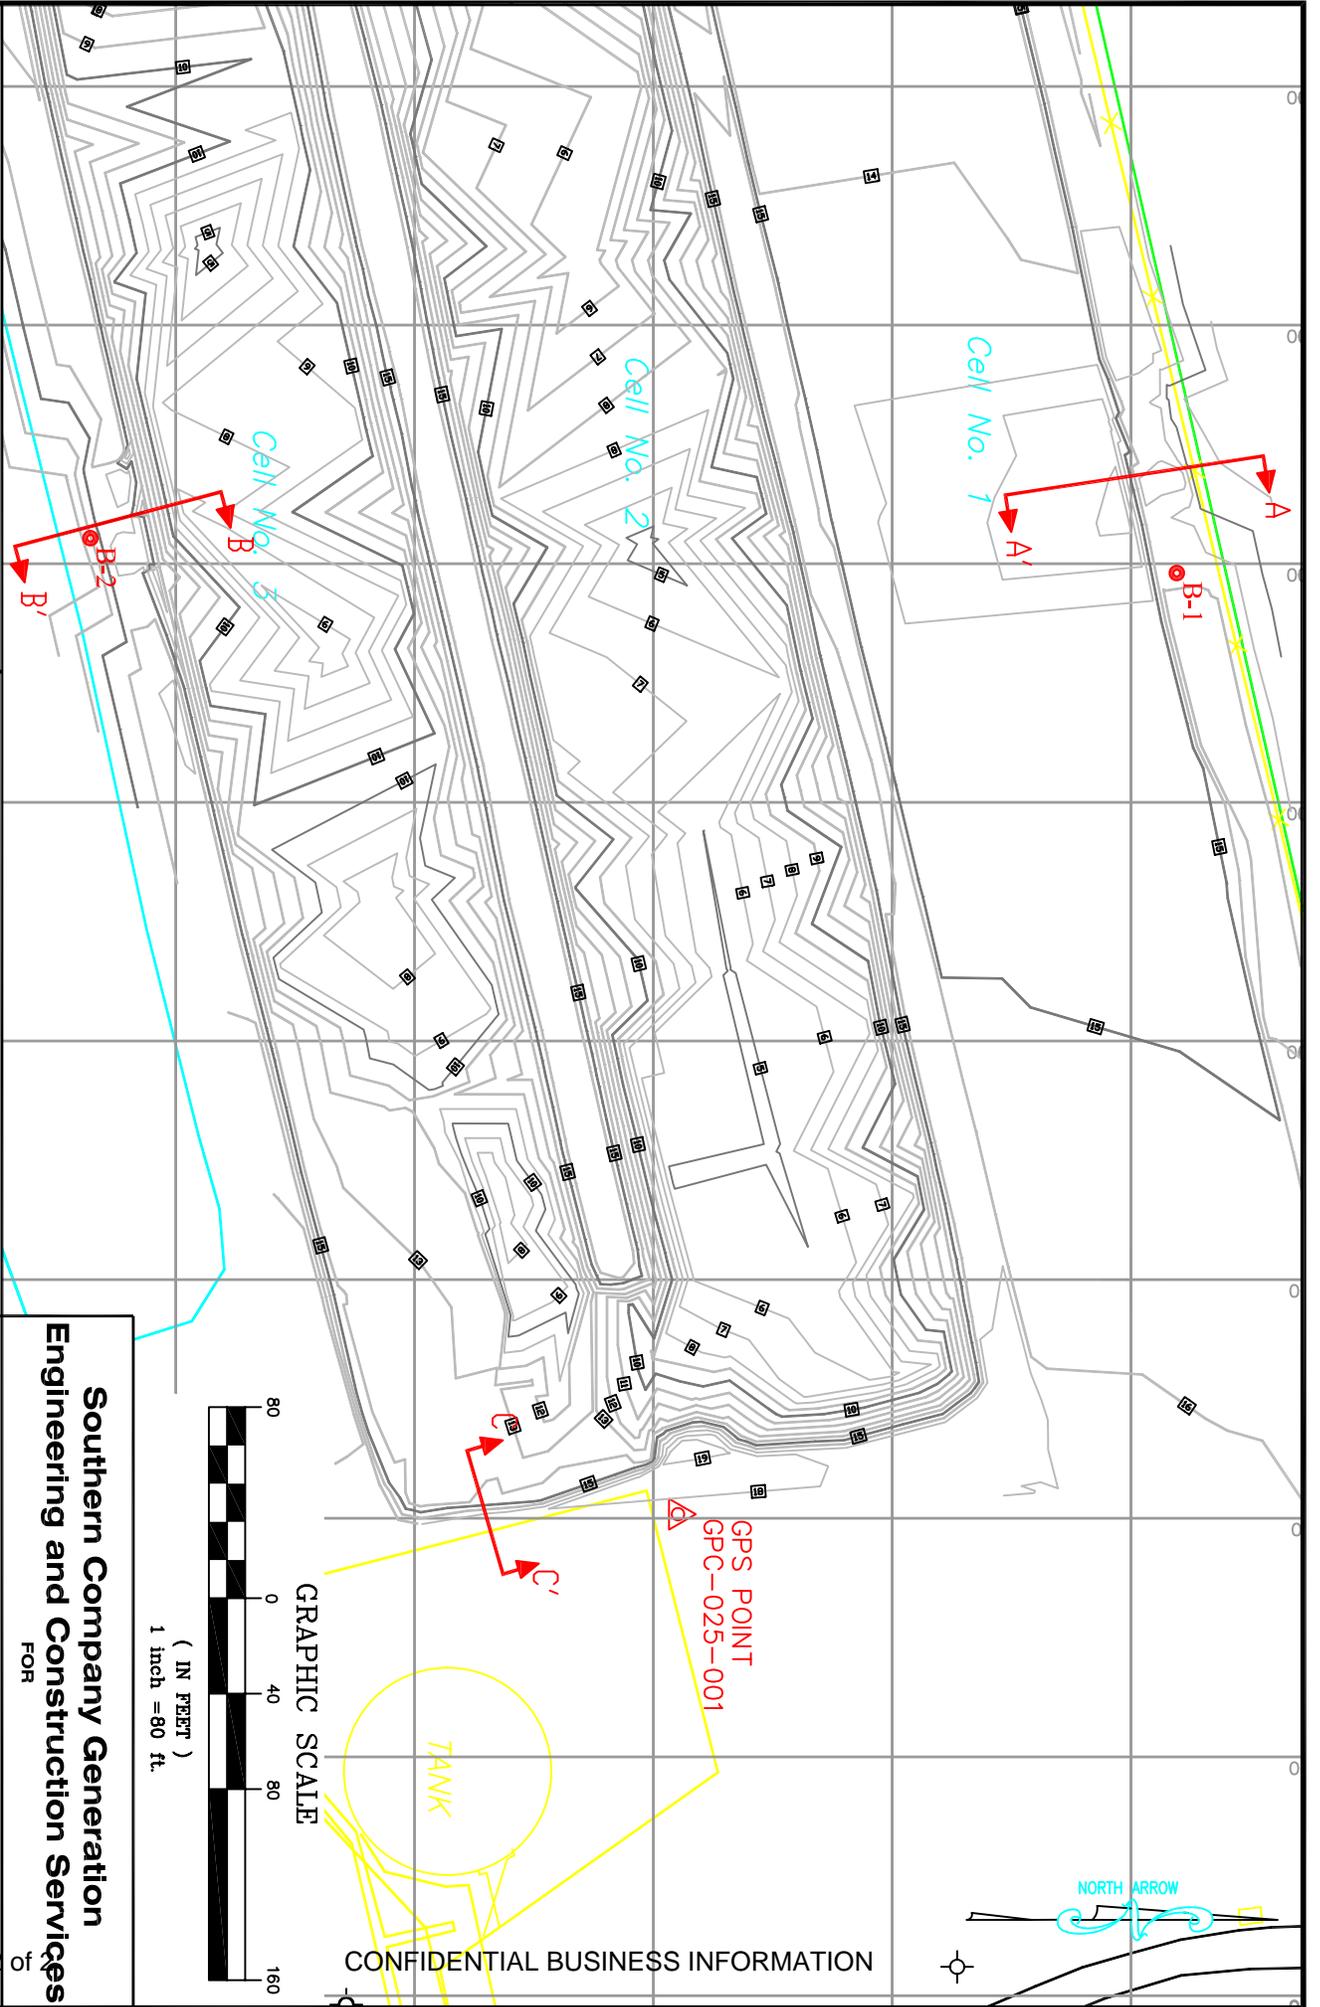
Figure 1

Boring Locations

Cross-Sections A-A' and B-B'
