Report of
Dam Safety Assessment of Coal Combustion
Surface Impoundments
Plant McDonough, Smyrna, GA

AMEC Project No. 3-2106-0174.0100

December 2010

The management units referenced herein: Southern Company, Georgia Power, Plant McDonough: Ash Pond 1, Ash Pond 2, Ash Pond 3, and Ash Pond 4; were assessed on April 28th, 2010.

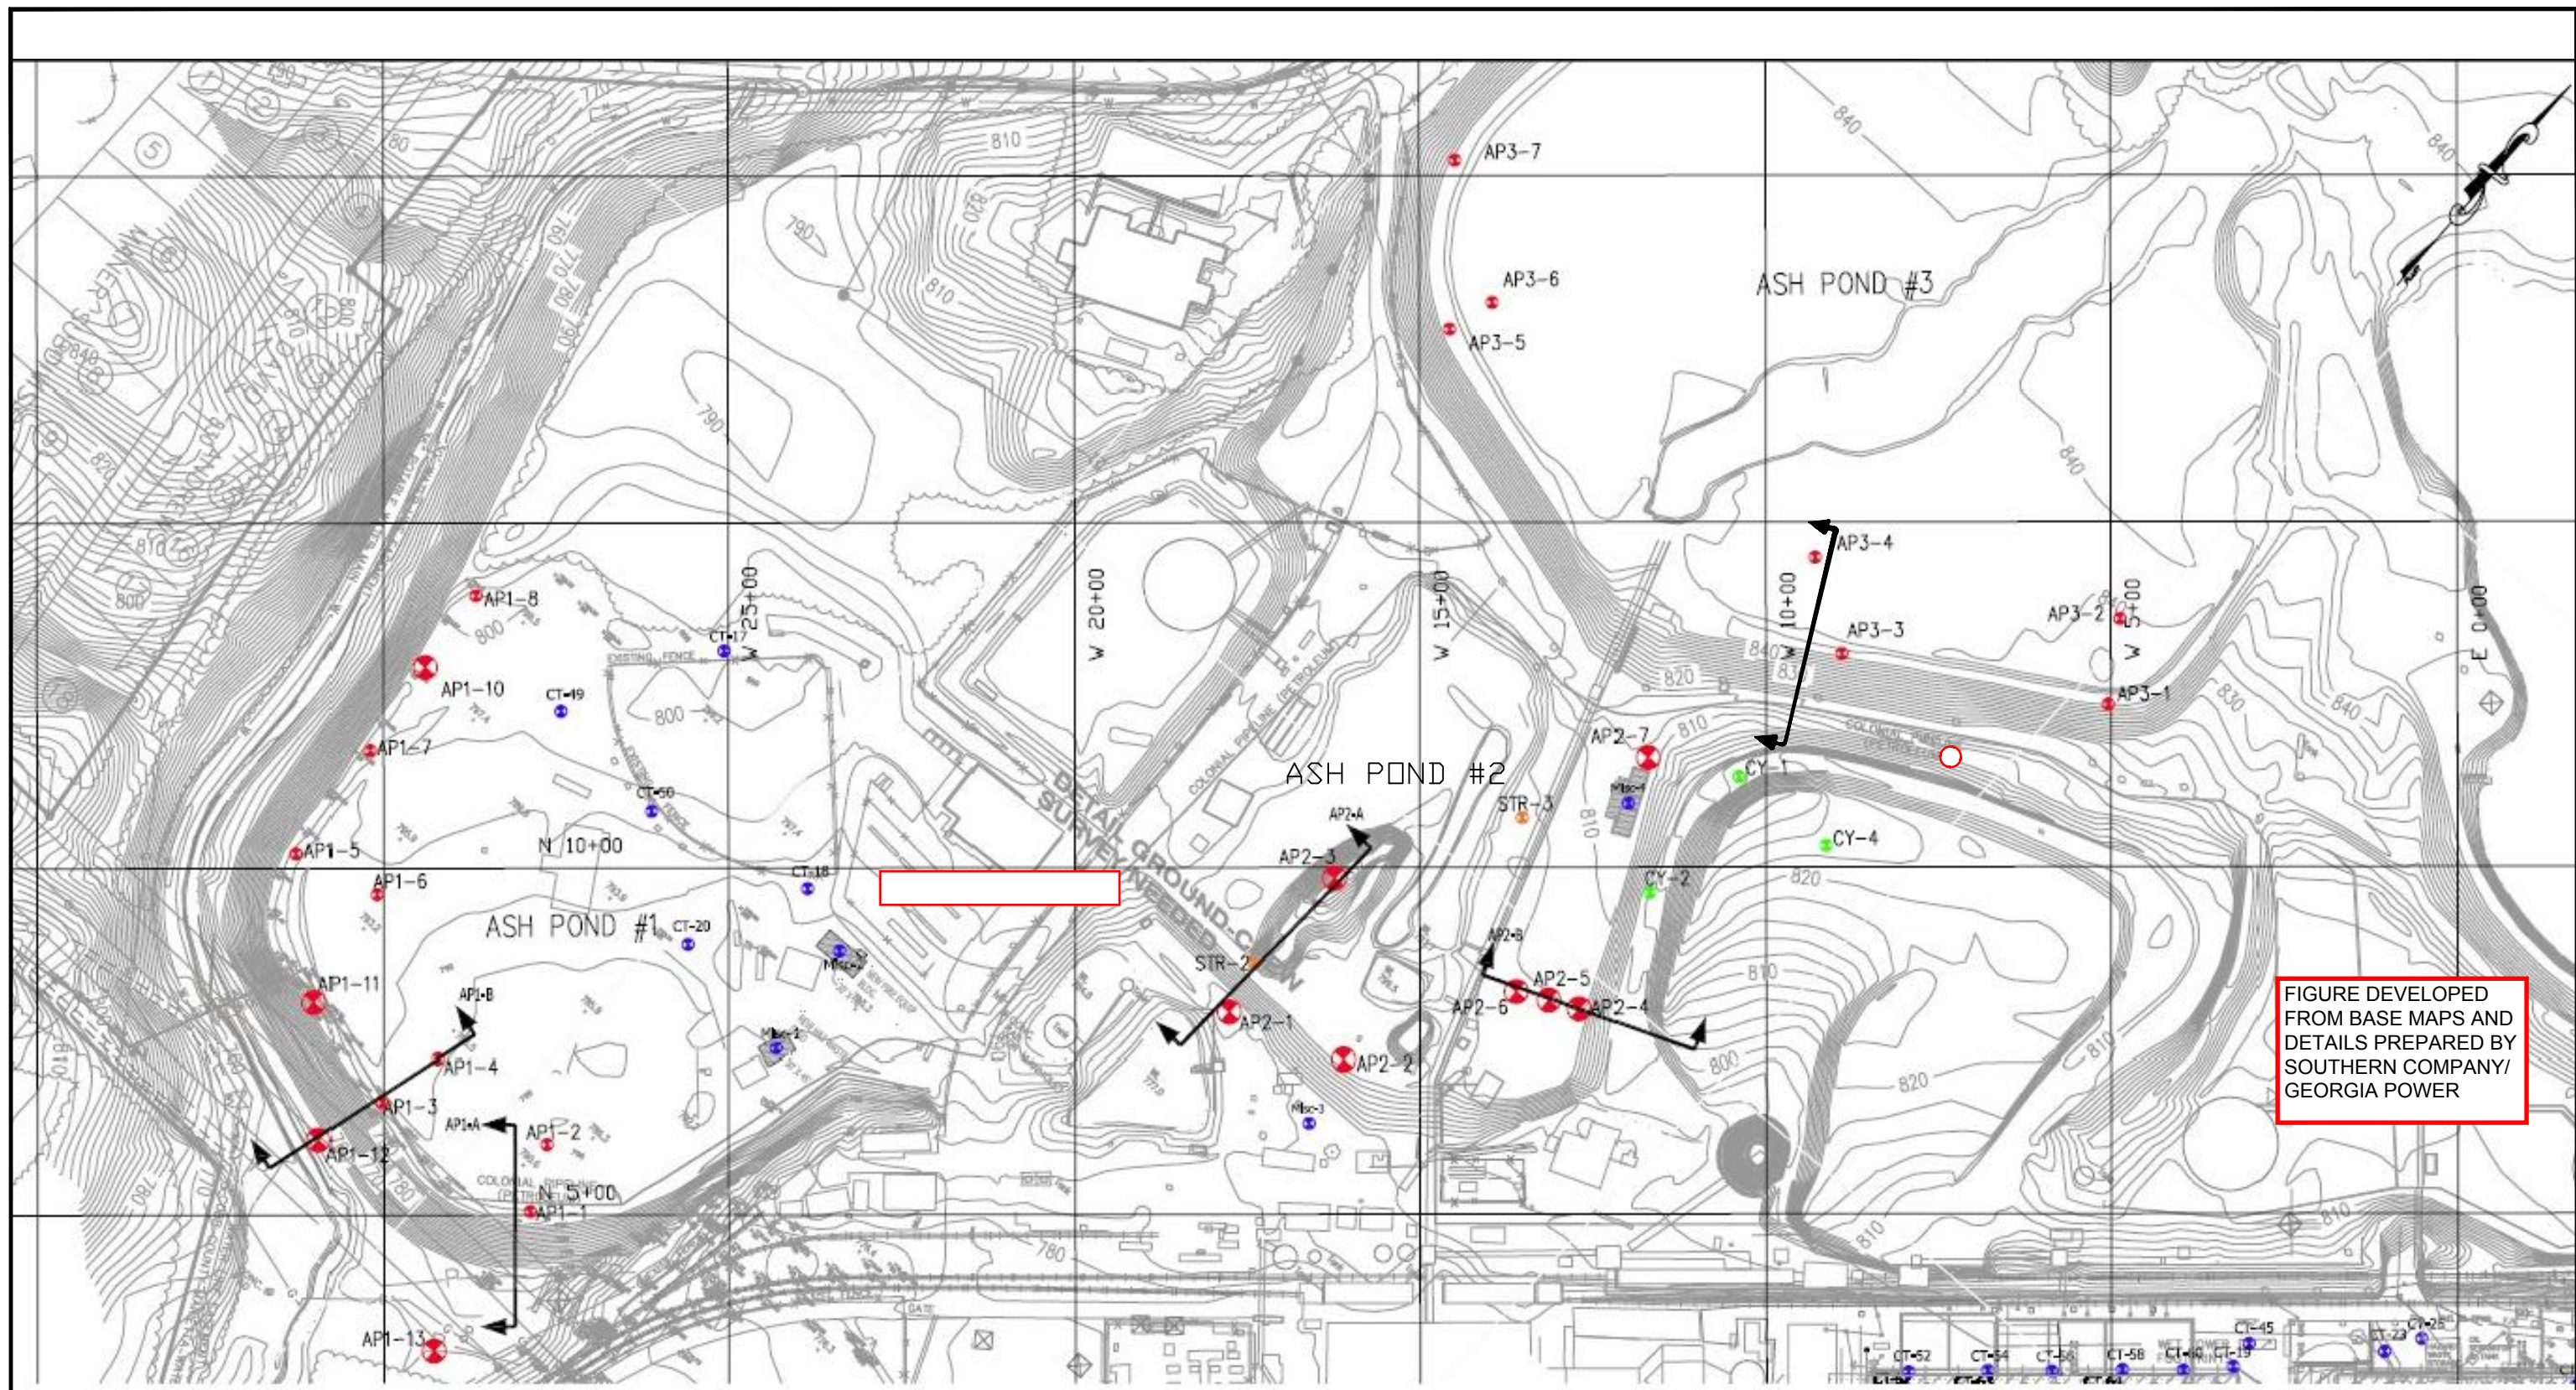
DATE: 6/2/10
 PROJECT NO: 3-2106-0174.0100
 REV. NO:
 FIGURE No: 5

Axial and lateral drains are present in Ash Pond 3; see Figure 5 for drain locations. As illustrated by “Plant McDonough-Atkinson Site Surveillance Map” dated January 4, 1996, four lateral drains (drains 3-2, 3-3, 3-4, and 3-5) are present along the southern and southwestern downstream toe. Station numbers for these drains were not provided. During the site visit, lateral drain 3-3 was noted to be flowing, which was typical according to on-site personnel. It was observed that on drawing “Plant Jack McDonough/Atkinson Ash Pond Details of Underground Drainage” dated May 12, 1969, additional 6 to 8-inch CMP lateral drains are indicated to be present at stations 14+85, 15+85, and 16+85 along the southwestern toe, however these drains do not appear on the later 1996 drawing.

A total of 19 lateral drains are located along the embankment of Ash Pond 4, see Figure 5 for drain locations. During the site inspection Drain 15 was noted to be flowing, which according to on-site personnel, is typical. Additionally, two weirs (east and west weir) are located at the downstream toe of the north end of the embankment. The most current quarterly report provided (dated January 8, 2010) stated that flows for the two weirs has remained close to or slightly below their historical range. In regards to the drains, flow for Drain No. 1 increased significantly during and following slope modifications and road reconstruction along the south dike in June 2009. Drain 1 was rebuilt to capture the additional seepage that resulted from the work on the south dike. Flow for Drain 15 increased close to historic levels, which is expected to be a result of heavy rainfall during the fall months.

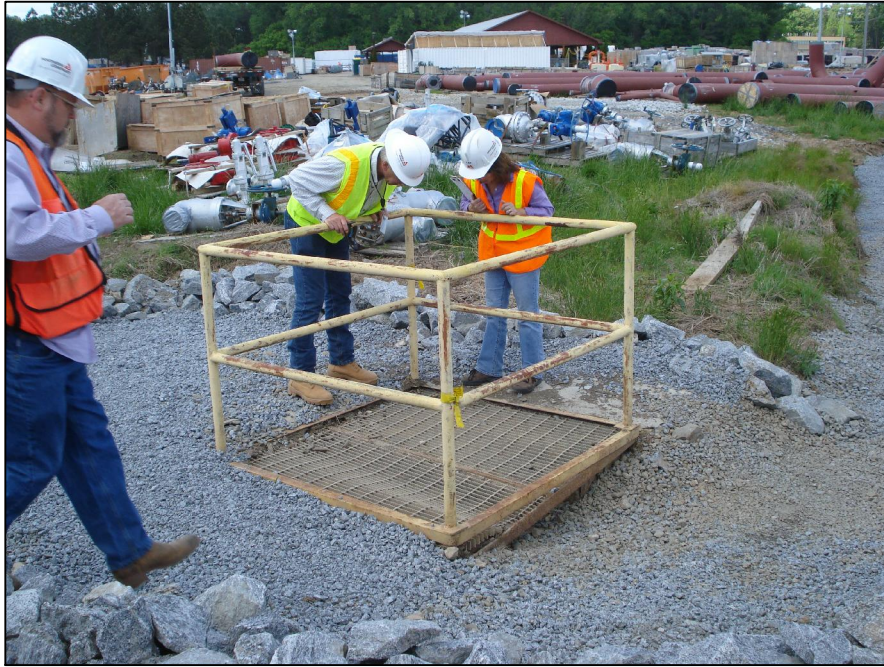
1-1
PRIMARY SPILLWAY INLET

Ash Pond 1 historically received liquid-borne CCW materials. This pond became inactive in the late 1960's when it was filled to capacity with CCW. Currently, Ash Pond 1 is filled and covered, inactive, and used as a lay-down and parking area for the current construction activities. At the time of the site visit, standing liquid was not observed in the pond. Ash Pond 1 has a functional drop inlet decant.

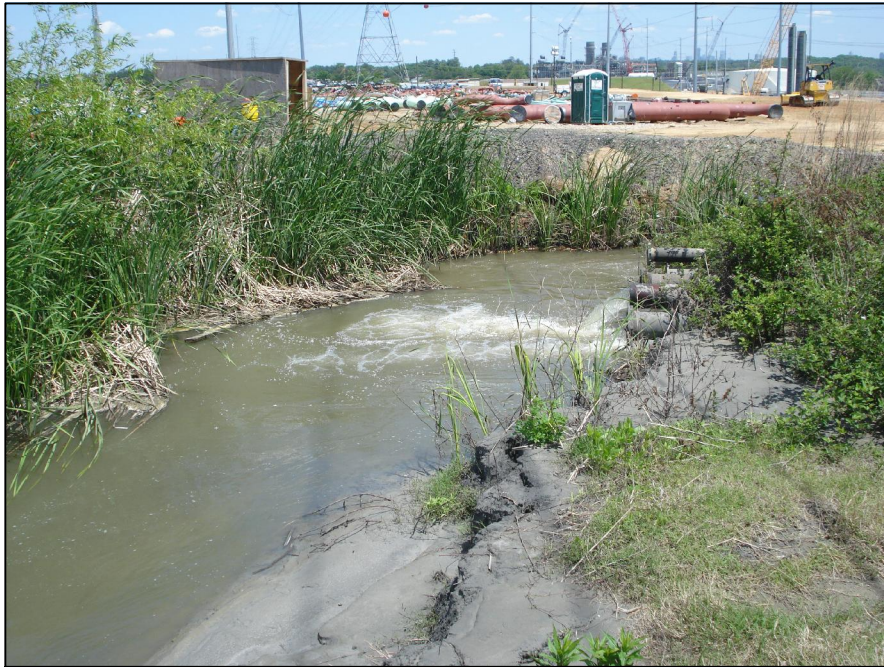
3-2

SLUICE LINE DISCHARGE FROM PLANT
