ASSESSMENT OF DAM SAFETY OF COAL COMBUSTION SURFACE IMPOUNDMENTS – FINAL REPORT

**Gulf Power
Plant Scholz
Sneads, Florida**

May 2014
Revised July 10, 2014

CDM Smith Project No.:
93083.1801.044.SIT.SCHOL

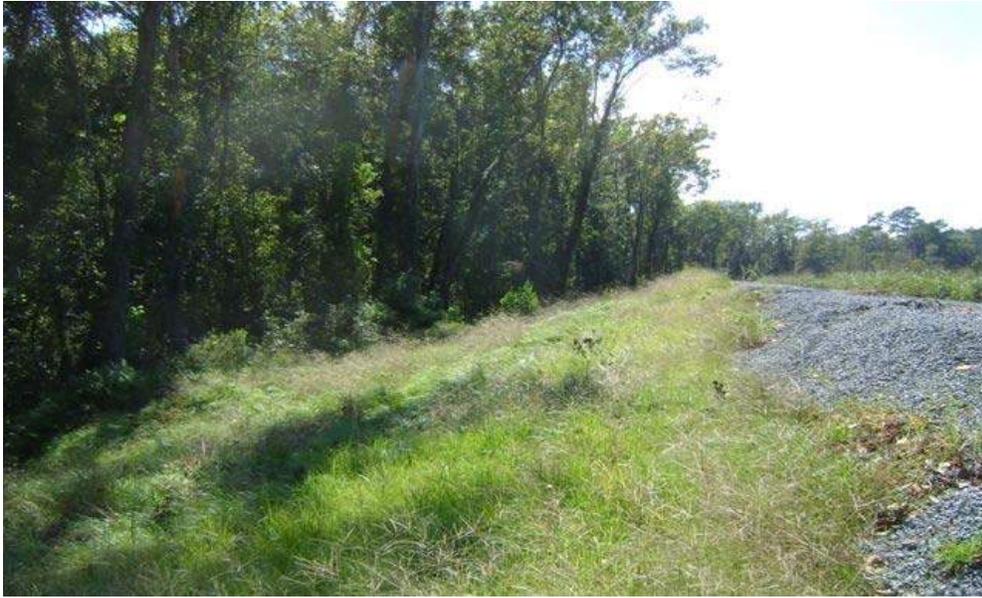
South Dike Where Trees Removed 25 Feet Down From the Crest (View to Southwest)

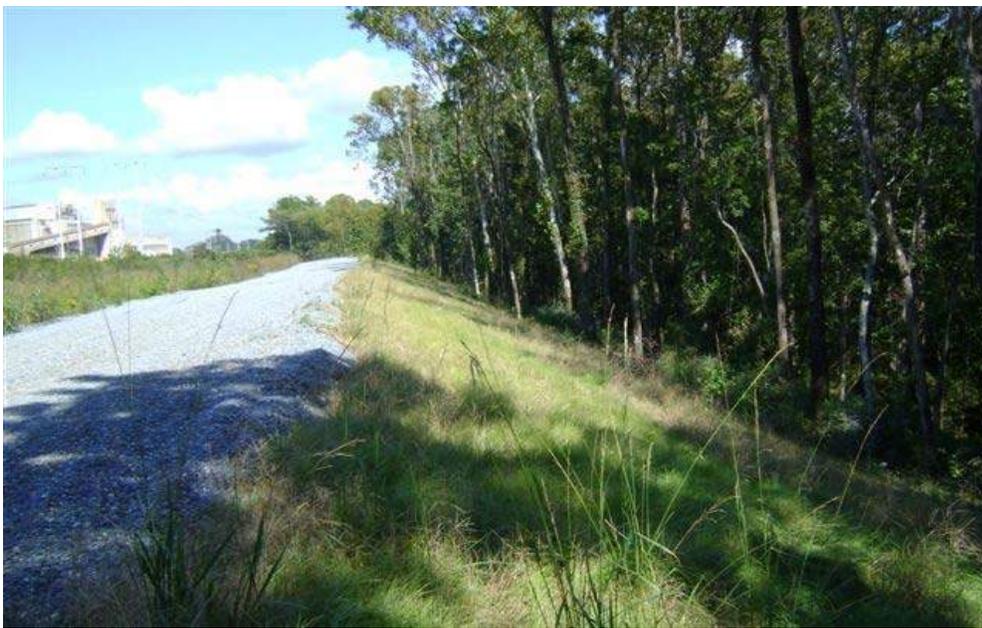
South Dike Where Trees Removed 25 Feet Down From the Crest (View to Northeast)

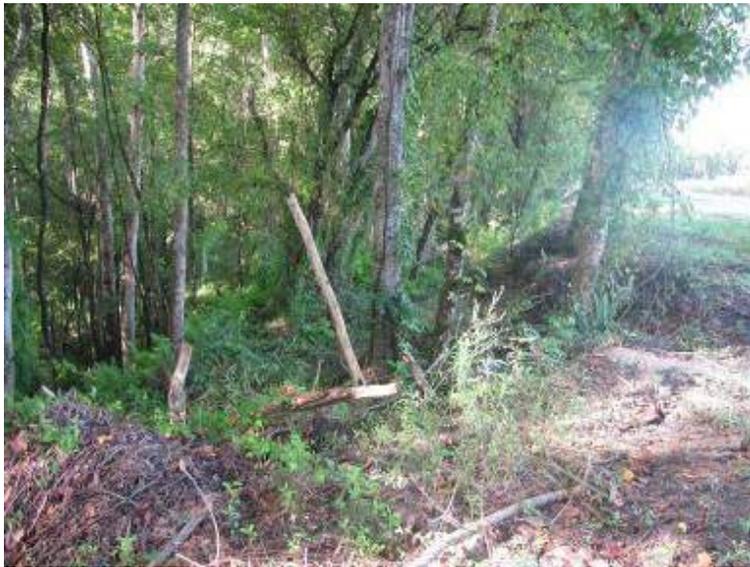
Exterior slopes of the south and southeast embankments appear to be in poor condition. Irregular slope faces are approximately 2H:1V with some areas at 1.5H:1V (Photographs 4, 16 and 17). The exterior slopes of the south and southwest embankments are covered with trees and dense vegetation (Photographs 1, and 3). Erosion rills and scarps were observed on the exterior slope of the southeast embankment within the dense vegetation.

Photo 1: Lower Pond – Southeast embankment exterior slope, looking southwest. Note trees and dense vegetation.

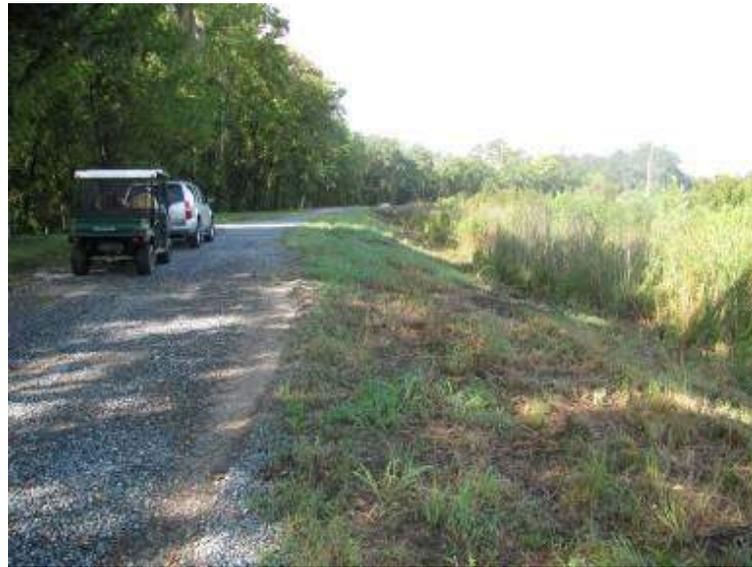
The crests appeared to be in satisfactory condition (Photographs 2 and 6). The average crest width is approximately 30 feet. The crest widens to approximately 40 feet near the south corner near the NPDES discharge area and a chemical storage building (Photograph 8). Crests are gravel-covered without vegetation (Photos 2, 5, 6 and 26). No depressions or evidence of settlement were observed on the crest.

Photo 2: Lower Pond – Southeast embankment interior slope, looking southwest.

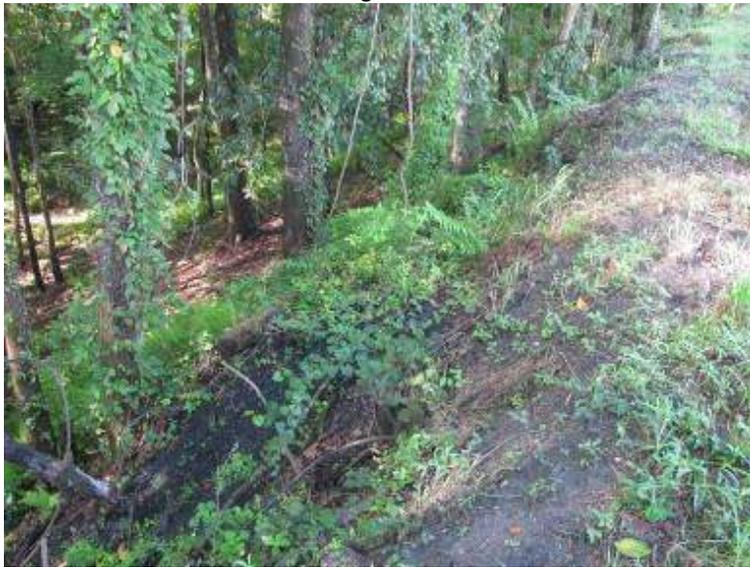
Photo 3: Lower Pond – Southeast embankment exterior slope, looking southwest. Note erosion of crest and trees/dense vegetation on exterior slope.

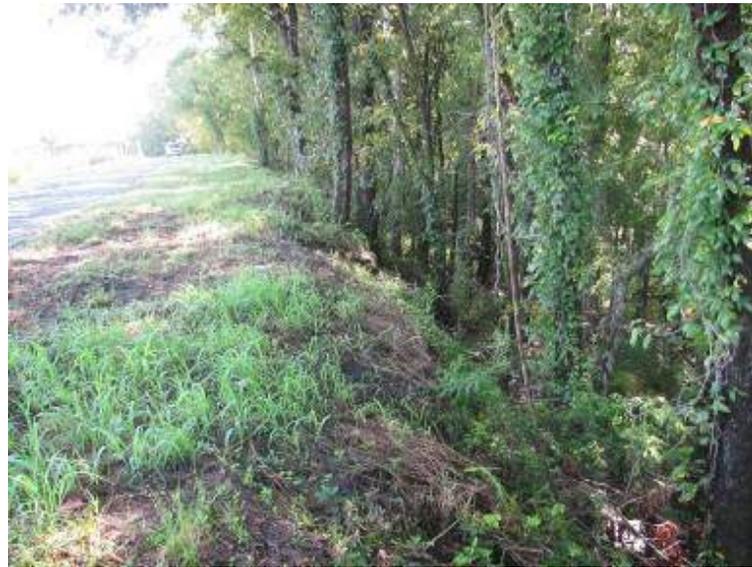
Photo 4: Lower Pond – Southeast embankment exterior slope, looking east. Note steepness, eroded areas along crest, trees, and dense vegetation.

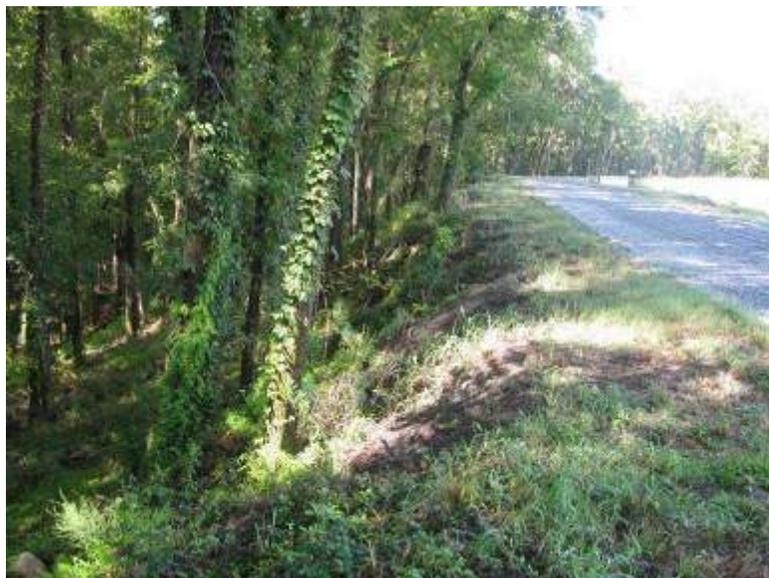
Photo 5: Lower Pond – Southeast embankment exterior slope, looking southwest. Note steepness, eroded areas along crest, trees, and dense vegetation.

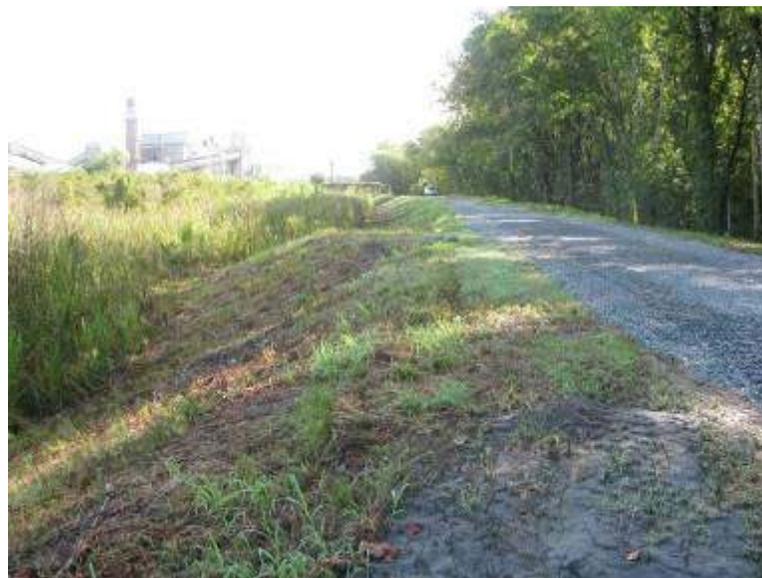
The interior slopes appear to be in satisfactory condition and are approximately 2.5H:1V (Photographs 6, 22 and 26). Some erosion and scarps along the interior slopes (Photograph 7) on the southeast embankment were observed. Erosion rills were also observed on the divider embankment between the Middle Pond and the Lower Pond (Photograph 29).

Photo 6: Lower Pond – Southeast embankment interior slope, looking northeast.

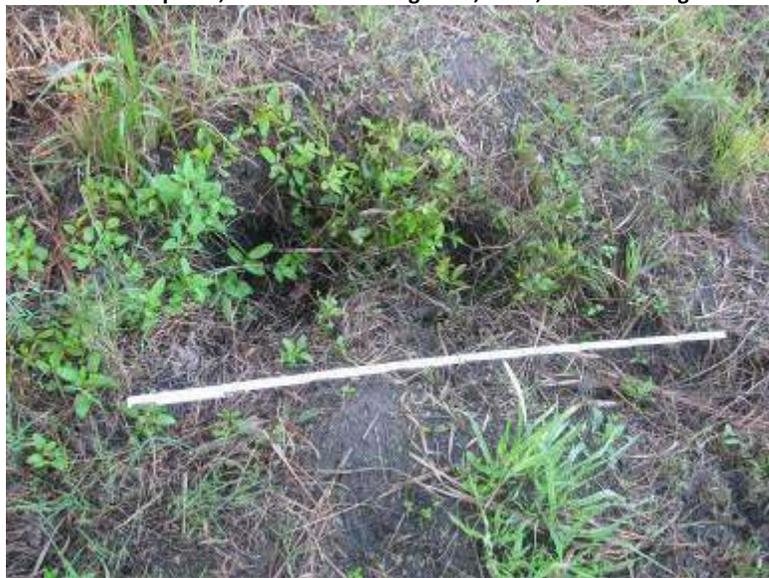
Photo 7: Lower Pond – Southeast embankment interior slope, 5-foot long by 1-foot wide by 16-inches deep scarp, looking southeast.

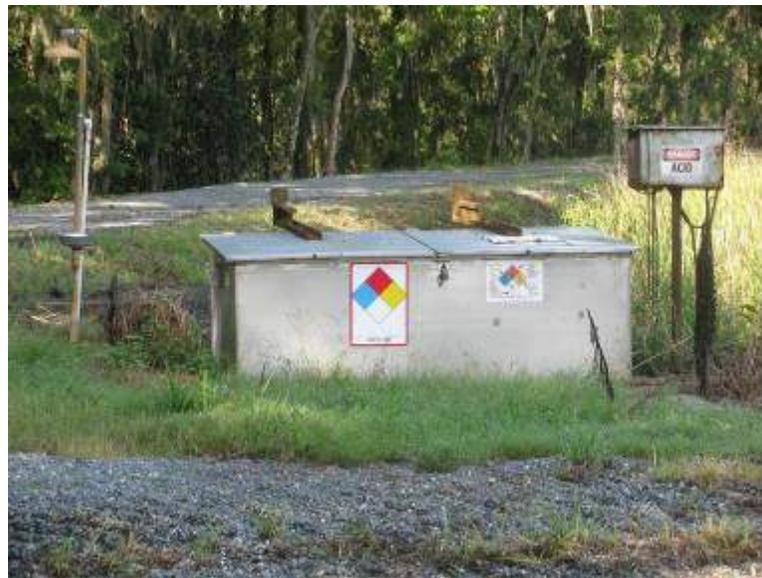
Photo 8: Lower Pond – Southeast embankment exterior slope, chemical storage system looking west.

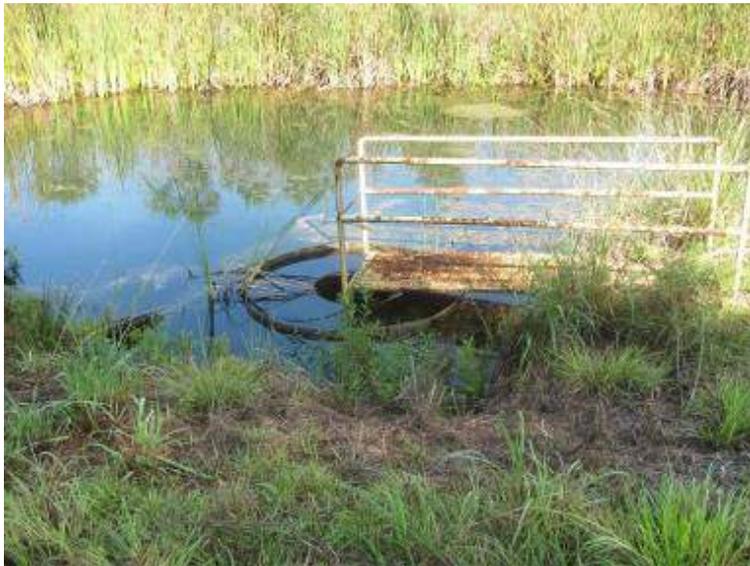
The Lower Pond outlet structure consists of a 24-inch-diameter morning glory-type steel pipe riser with a 48-inch trash rack pipe located near the south corner of the pond (Photograph 9 and 10). The riser appeared to be free of debris and in satisfactory operating condition. A concrete outlet structure located at the toe of the southeast embankment's exterior slope appeared to be in satisfactory condition (Photographs 11 to 15). Discharge flow from a 27-inch-diameter reinforced concrete pipe (RCP), flows through a v-notch weir, to a concrete-lined canal (Photograph 18) that discharges to the

Photo 9: Lower Pond – Southeast embankment interior slope, Morning glory-type drop inlet structure. Pipe is metal, 24-inches in diameter with a trash rack.

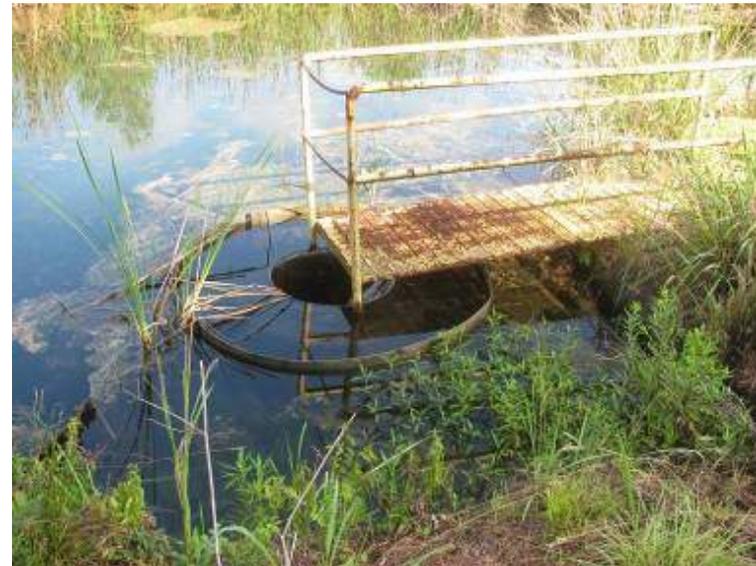
Photo 10: Lower Pond – Southeast embankment interior slope, Morning glory-type drop inlet structure. Pipe is metal, 24-inches in diameter with a trash rack.

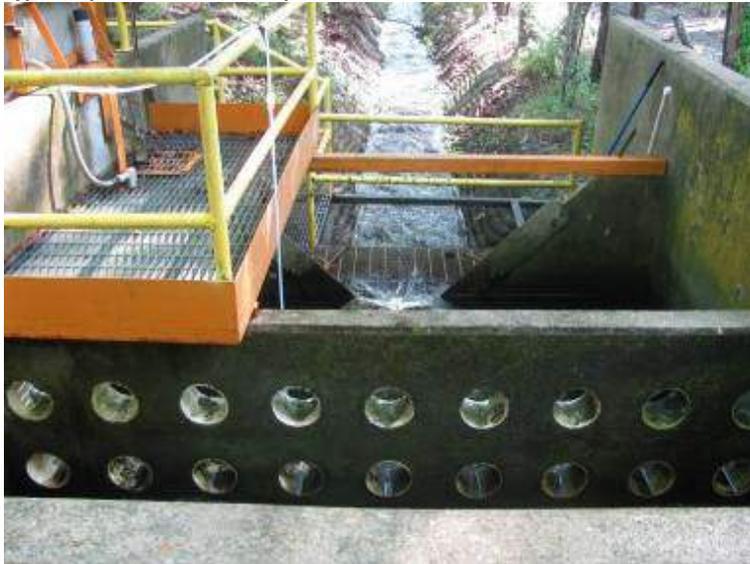
Photo 11: Lower Pond – Outside southeast embankment exterior slope, outlet structure looking northeast. Outflow to lined ditch is through V-notch weir.

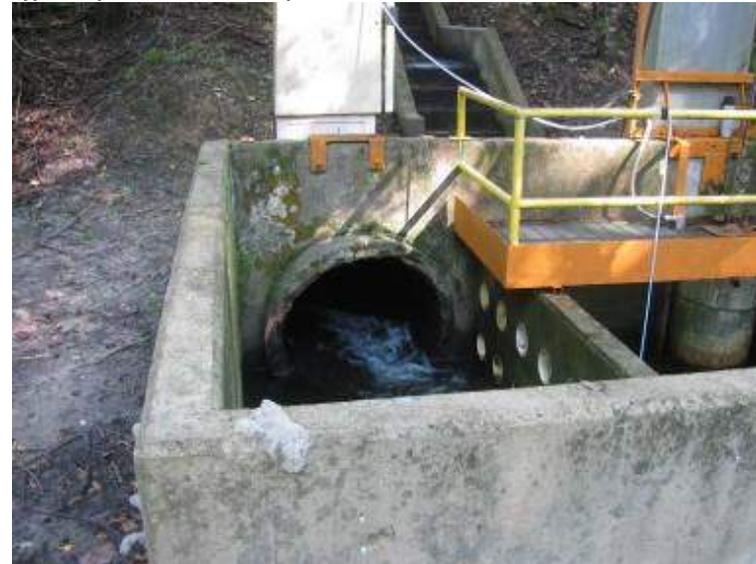
Photo 12: Lower Pond – Outside southeast embankment exterior slope, outlet structure looking northwest. Outlet from pond is via 27-inch diameter Reinforced Concrete Pipe (RCP).

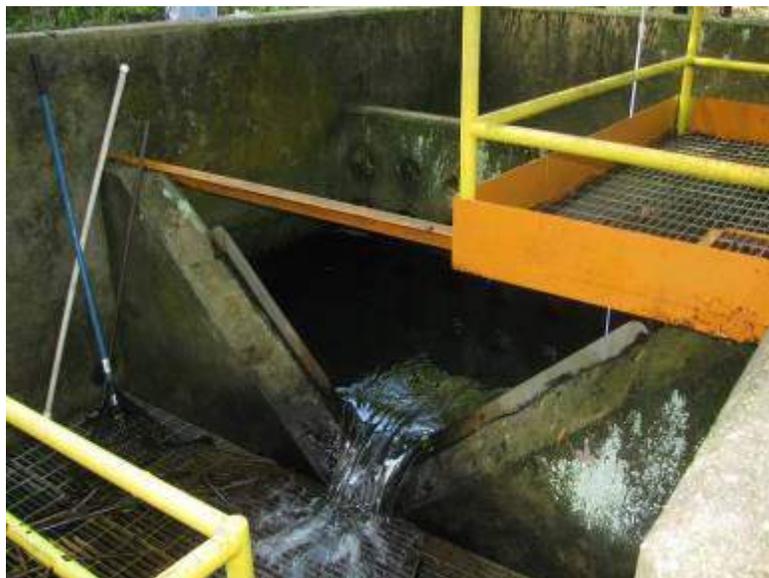
Photo 13: Lower Pond – Outside south embankment exterior slope, outlet structure located at toe of exterior slope, looking southwest.

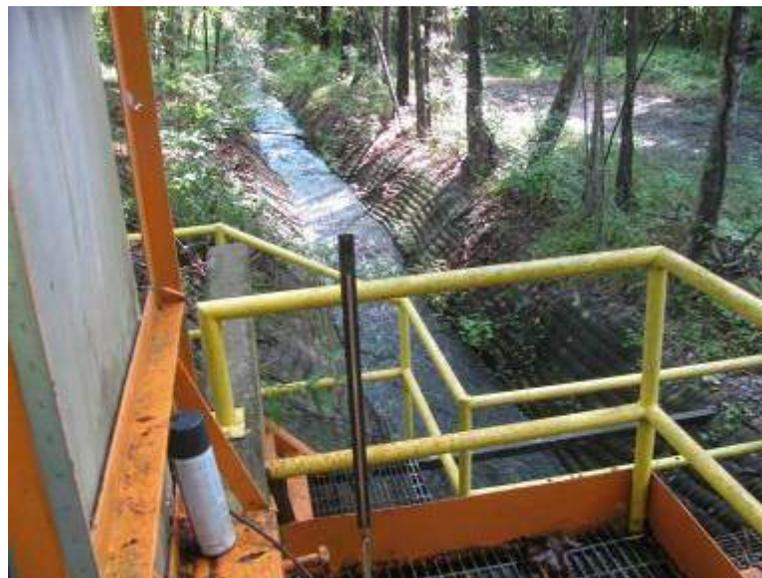
Photo 14: Lower Pond – Outside south embankment exterior slope, outlet structure with discharge from pond area flowing through lined ditch.

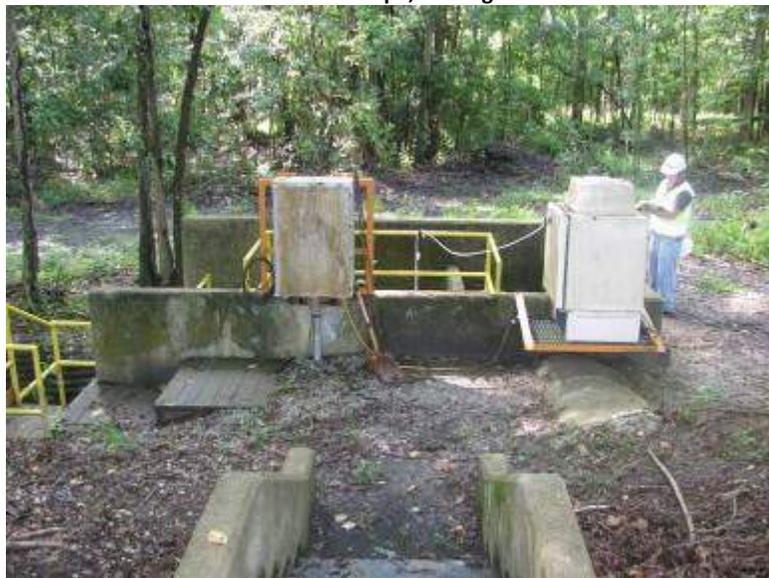
Photo 15: Lower Pond – Outside Southeast embankment exterior slope, general view of outlet structure and flow-meter, looking southeast.

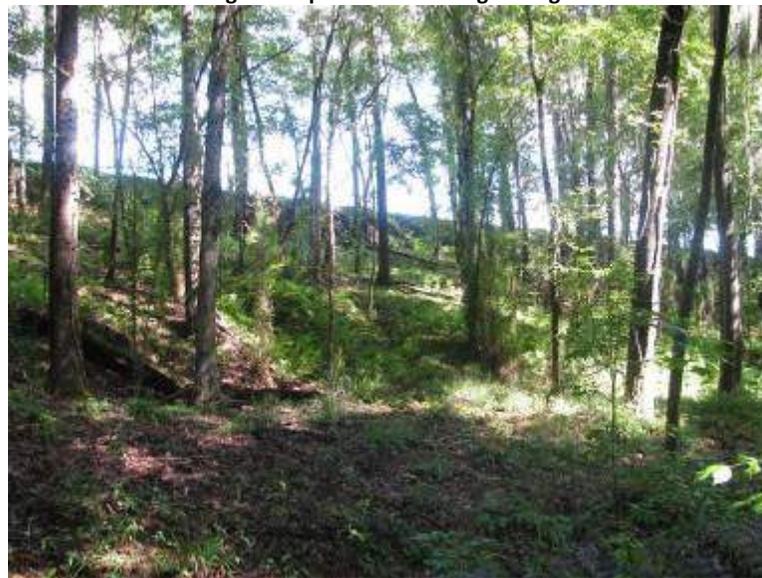
Photo 16: Lower Pond – Southeast embankment exterior slope, looking north from toe. Note steepness, trees, and dense vegetation.

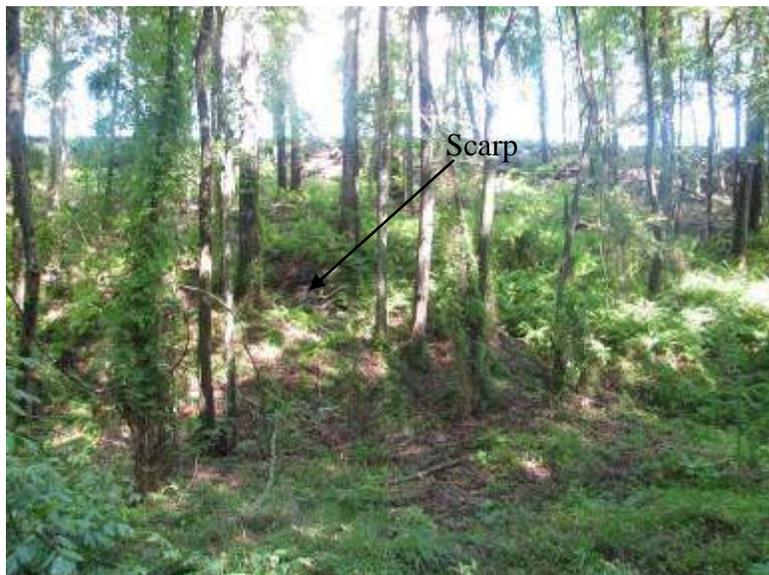
Photo 17: Lower Pond – Southeast embankment exterior slope, looking north from toe. Note scarps, steepness, trees, and dense vegetation.

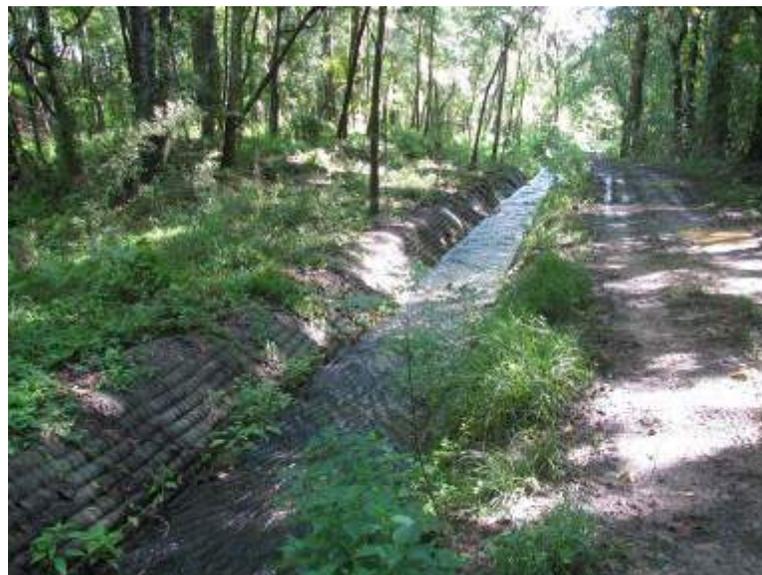
A concrete-lined canal conveying the discharge water from the Lower Pond runs parallel to the toe of slope of the southeast embankment (Photograph 18).

Photo 18: Lower Pond – Outside southeast embankment exterior slope Fabri-Form installation discharge channel located in wooded area beyond toe of exterior slope looking east.

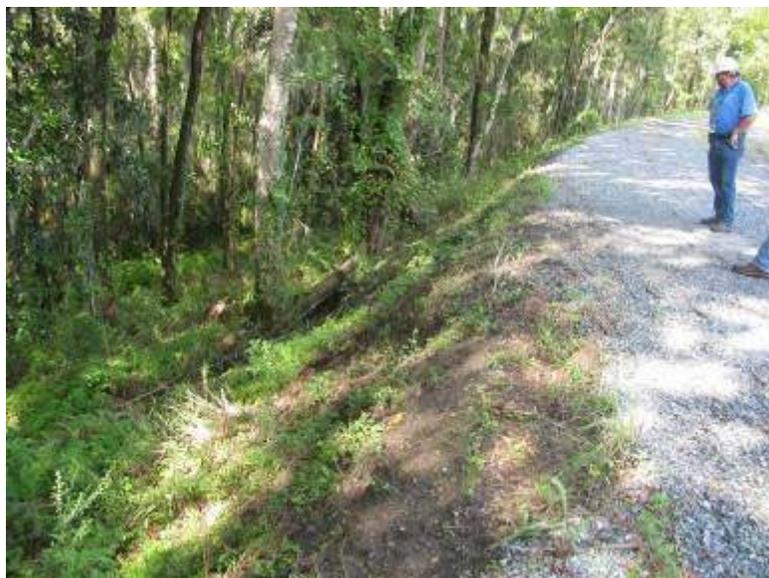
Photo 19: Lower Pond – Southeast embankment exterior slope, looking southwest. Note trees, dense vegetation, and erosion along crest.

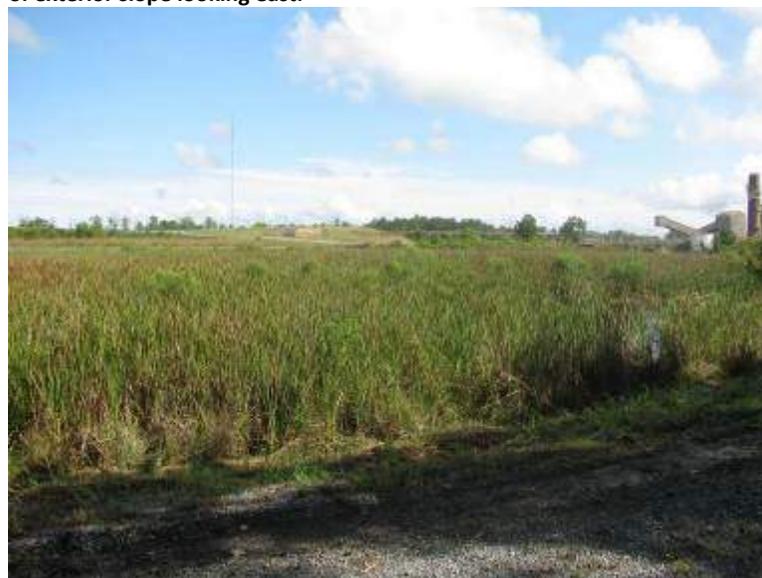
The Lower Pond is located adjacent to and south of the Middle Pond, sharing a common divider embankment with the Middle Pond. The Lower Pond contained standing water during the assessment, with approximately 6 ½ feet of freeboard and an embankment height of about 30 feet on the south and southeast sides. The north and northwest embankment height is about 6 feet. The pond receives water from the Middle Pond near the north corner of the pond. The pond surface is densely vegetated with cattails (Photograph 20).

Photo 20: Lower Pond – Southeast embankment interior slope, looking north.

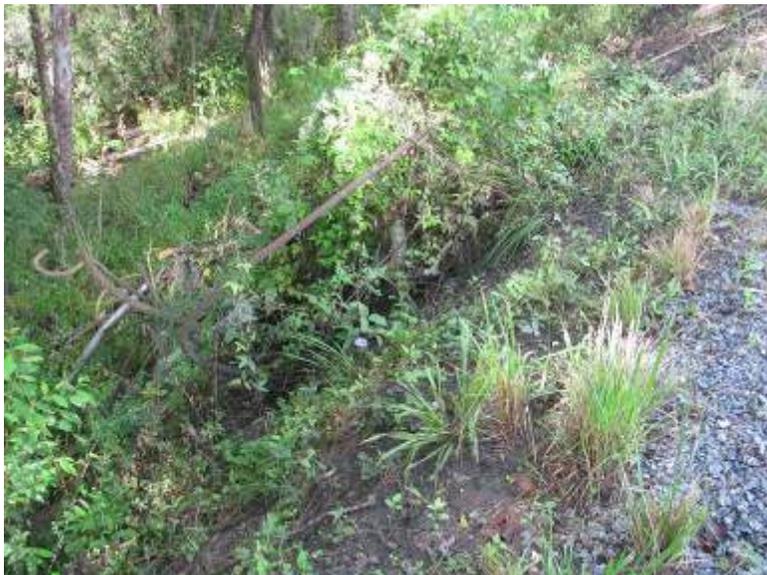
Photo 21: Lower Pond – South embankment exterior slope, Miscellaneous trash and debris.

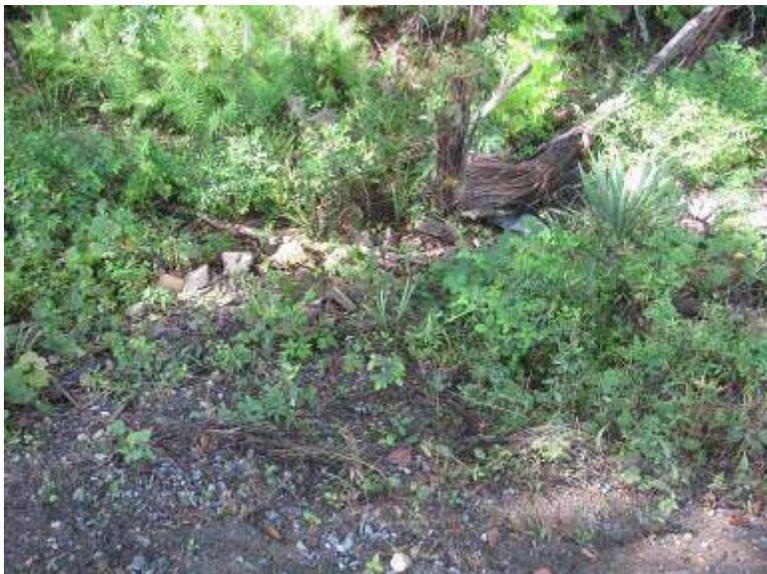
Photo 23: Lower Pond – South embankment exterior slope, Miscellaneous trash and debris looking west.

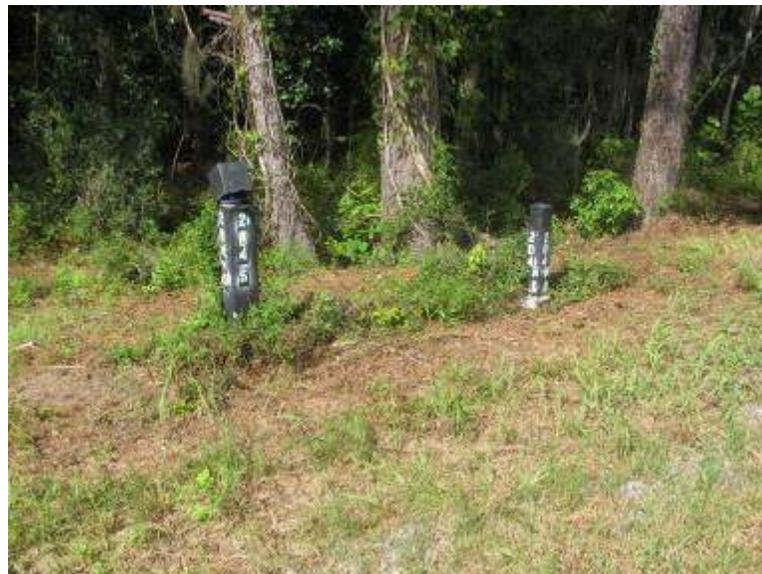
Two monitoring wells were observed beyond the toe of the south embankment (Photograph 24).

Photo 24: Lower Pond – Southwest embankment exterior slope, groundwater monitoring wells looking west.

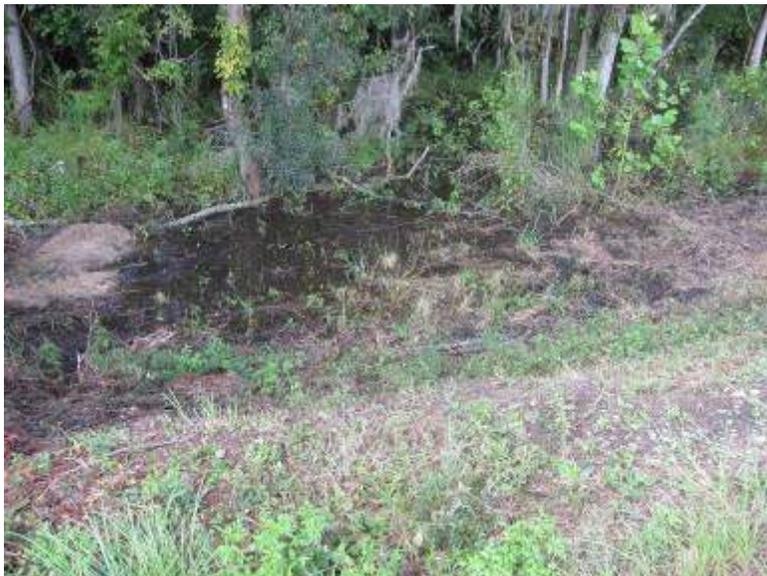
An area of standing water or possible seepage was observed at the toe of the southwest embankment (Photograph 25). Trees and dense vegetation extend beyond the toe of the embankment in this area. Animal burrows were not observed during visual assessment of this area.

Photo 25: Lower Pond – Southwest embankment toe of exterior slope, Area of standing/ponded water looking west.

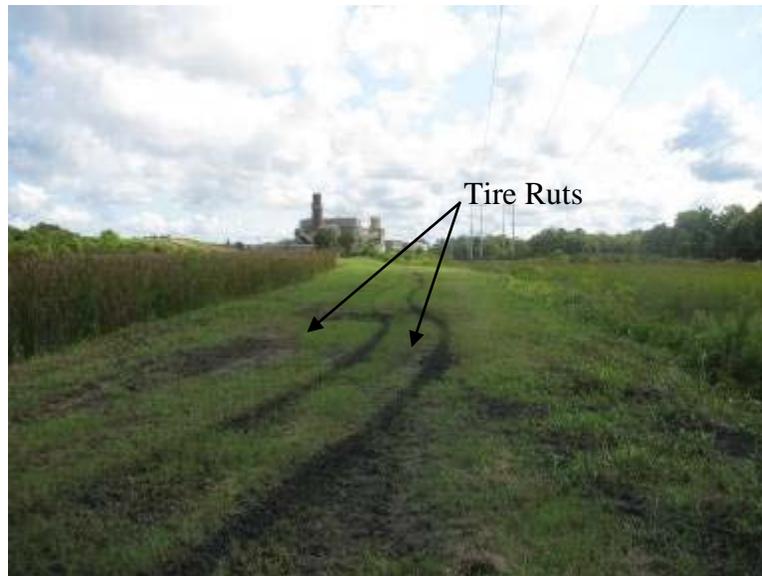
The crest of the Middle Pond appeared to be in satisfactory condition (Photographs 115 and 116). The average crest width is approximately 25 feet. The southwest and west crests are gravel-covered with sparse short grass. The crest of the divider embankment between the Middle Pond and the Lower Pond appeared to be in satisfactory condition. The crest of the west embankment of the pond is nearly level with the natural ground elevation west of the pond area. The crest of the north and southeast divider embankments was surfaced with a soil and ash mix; no gravel was observed on the crests. No depressions or evidence of settlement were observed on the crests. Ruts and tire tracks were observed on the southeast divider embankment crest (Photographs 28, 109 and 110).

Photo 28: Lower and Middle pond – General view of crest of divider embankment looking northeast. Note tire ruts.

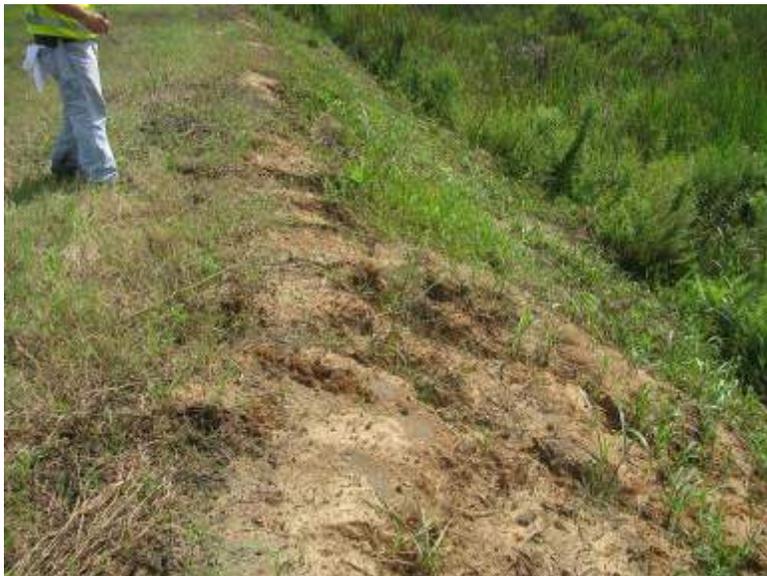
Photo 29: Lower pond – Divider embankment interior slope looking northeast.

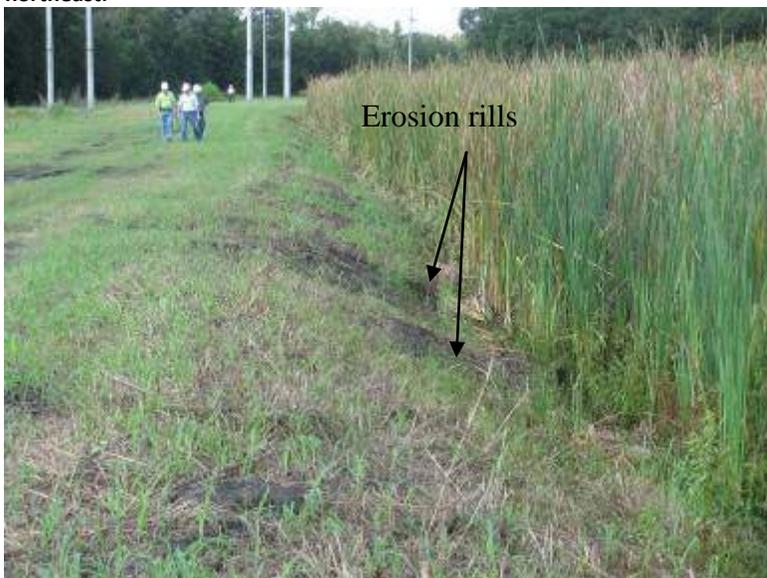
Photo 31: Middle pond – Divider embankment interior slope looking southwest. Note erosion rills on slope.

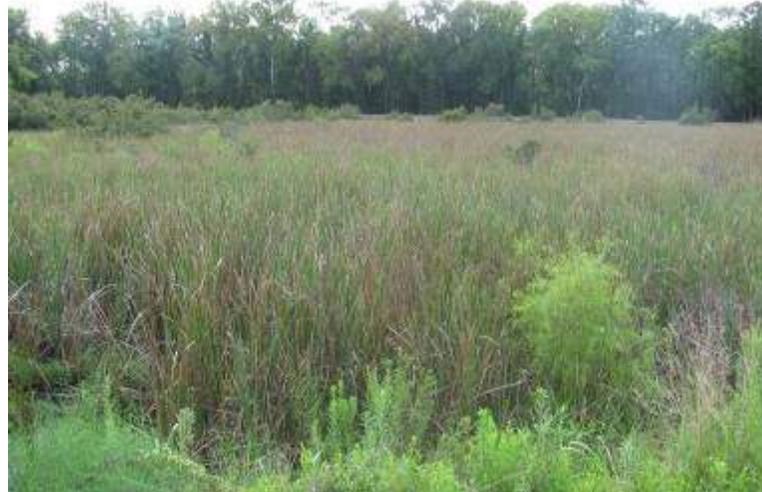
Photo 32: Lower pond – Divider embankment interior slope, general view of pond surface looking south. Note the vegetation (cattails).

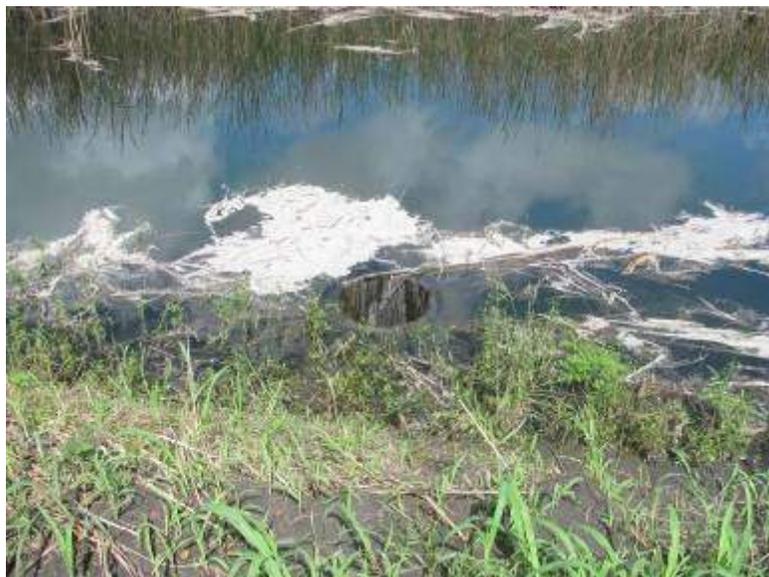
The Middle Pond outlet structure consists of an 18-inch-diameter morning glory-type steel pipe located near the east corner of the pond (Photograph 33). The riser appeared to be free of debris and in satisfactory operating condition.

Photo 33: Middle Pond – Divider embankment interior slope, Morning glory-type drop inlet structure looking northwest. Pipe is 18-inch diameter metal.

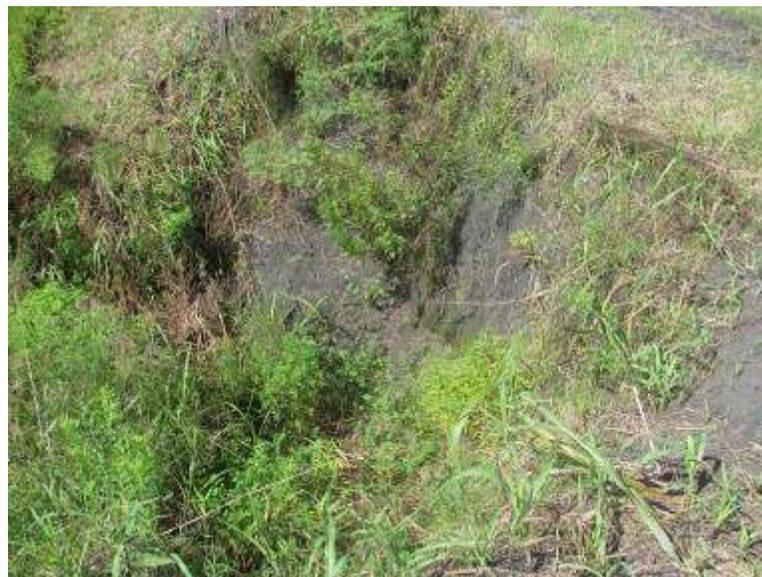
Photo 34: Lower Pond – Divider embankment interior slope looking south. Note scarp.

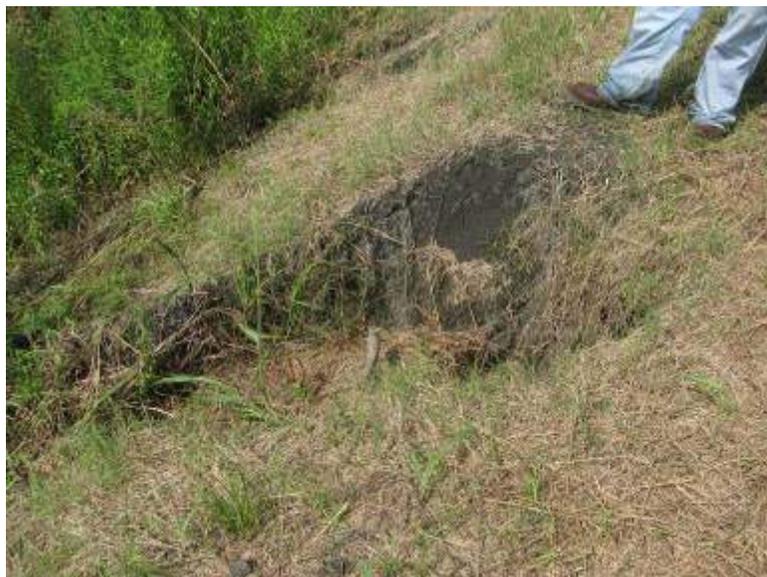
Photo 37: Middle Pond – North embankment interior slope, erosion rill looking west.

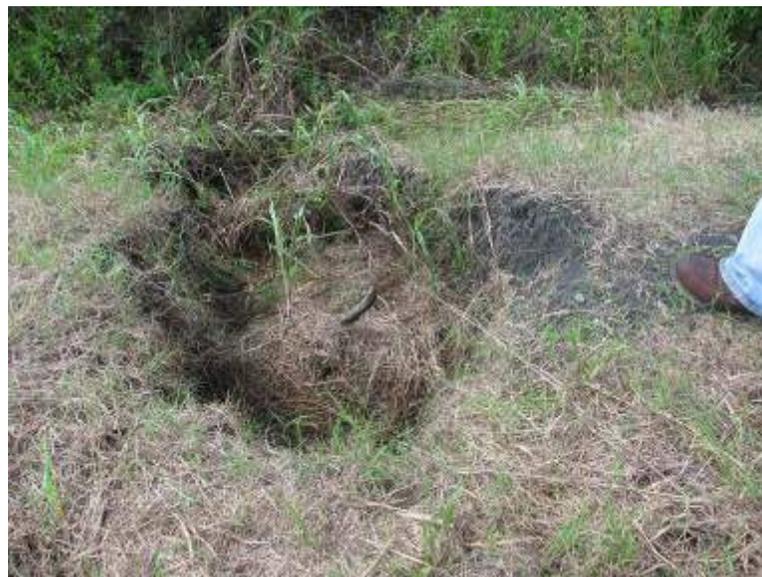
Photo 38: Middle Pond – North embankment interior slope, erosion rill looking south.

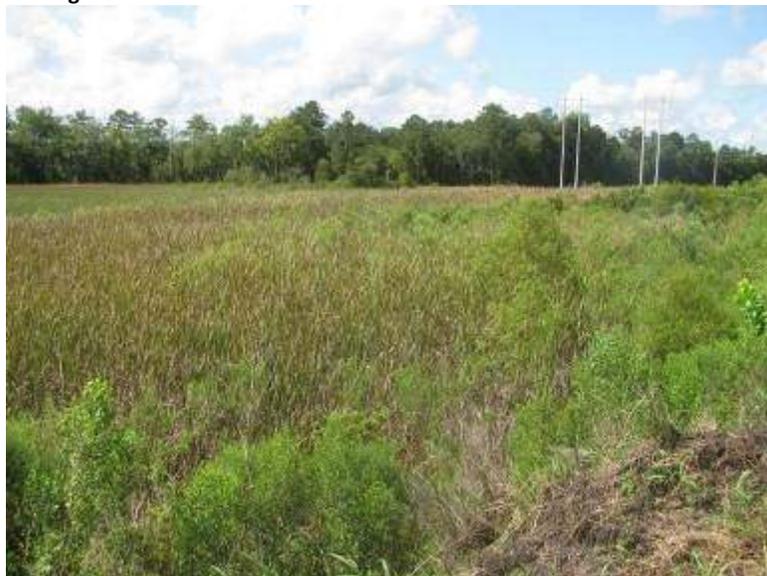
Photo 39: Middle Pond – North embankment interior slope, general view of pond surface looking southwest. Note vegetation (cattails).

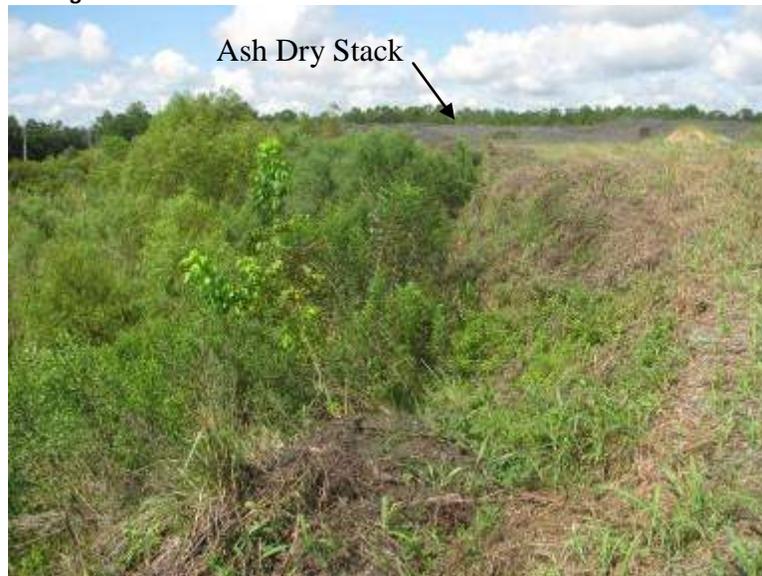
Photo 40: Middle Pond – North embankment interior slope, scarp looking west.

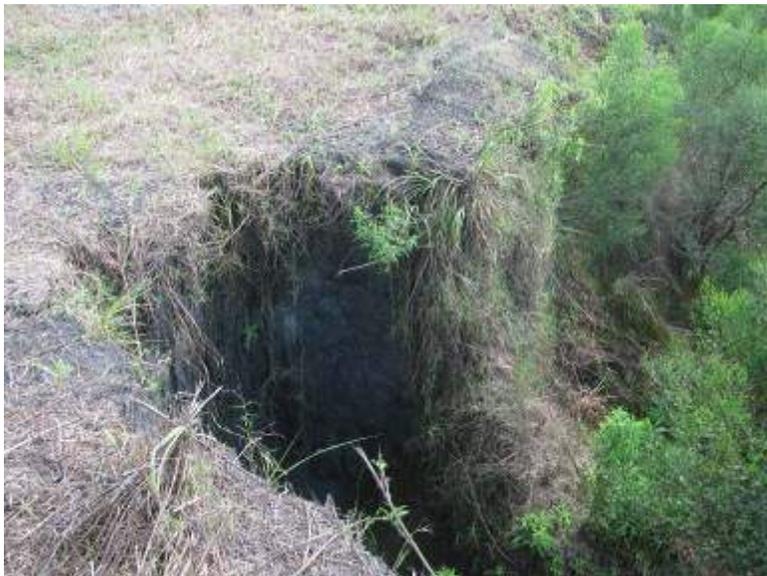
Photo 41: Middle Pond – North embankment interior slope, scarp looking east.

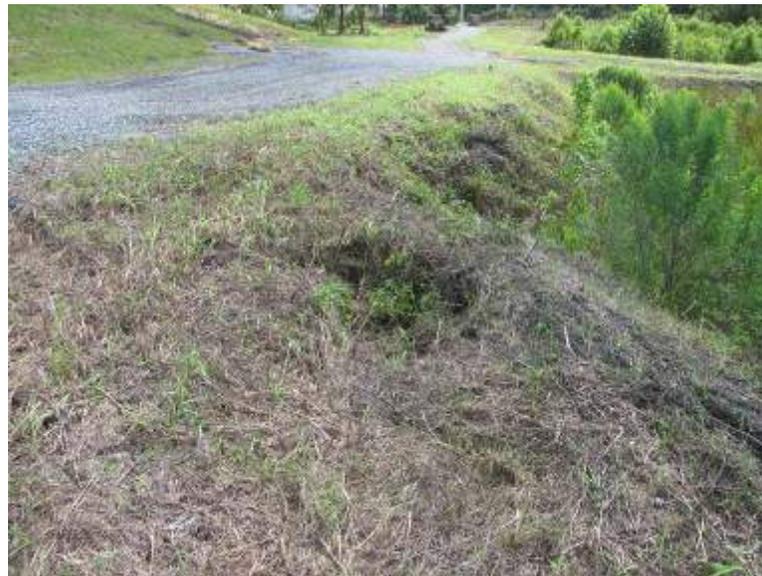
Photo 42: Middle Pond – North embankment interior slope, erosion looking east.

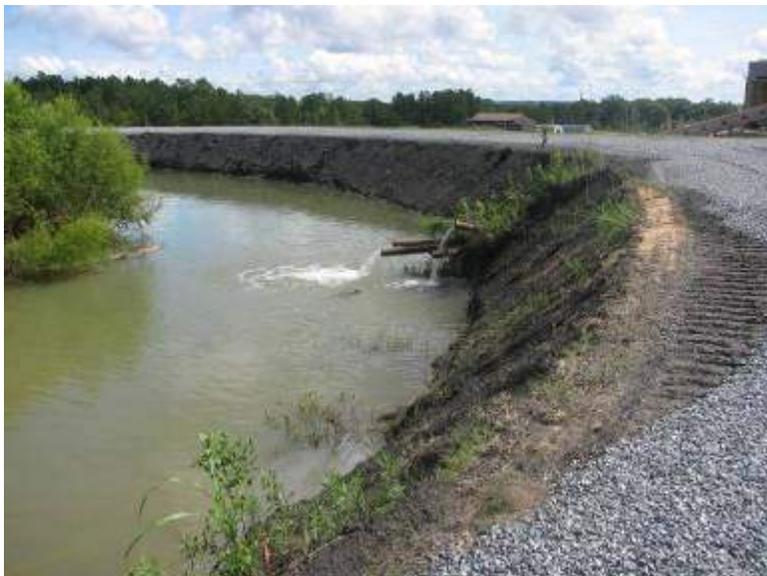
Inlet pipes are located at the south corner of the Upper East Pond (Photograph 43).

Photo 43: Upper East Pond –East embankment interior slope, general view of inflow pipes looking northeast.

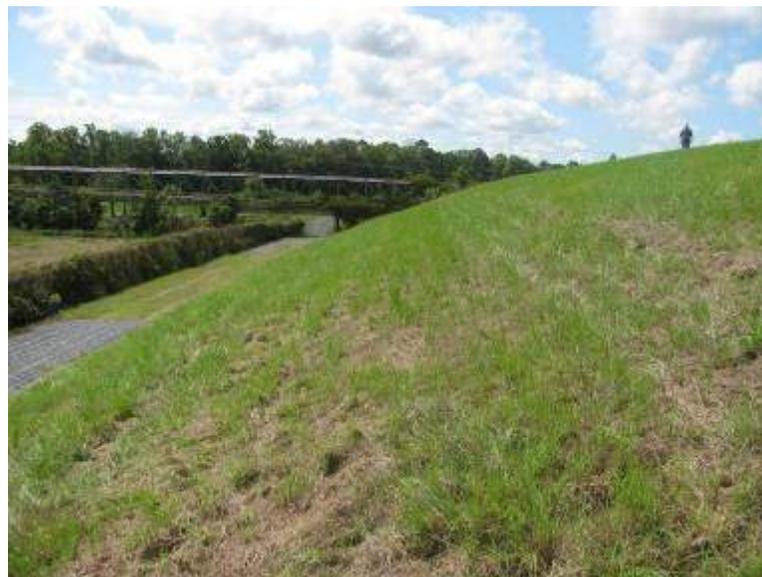
The exterior slopes appear to be in satisfactory condition. The exterior slopes of the embankment are approximately 2.5H:1V. They are covered with short grass, approximately 4 to 6 inches tall at the time of the visual assessment (Photographs 45 to 47). Some areas on the east embankment appear to be recently backfilled and repaired. Based on plant personnel comments, shallow erosion rills have occurred in these areas (Photographs 45 and 48). Some saturation was observed at the toe of slope (Photograph 49 to 51) of the east embankment. It was difficult to determine if these wet areas were caused by seepage or the previous day's rain. Based on the embankment height, these areas have the potential to have seepage.

Photo 46: Upper East Pond – East embankment exterior slope, looking south.

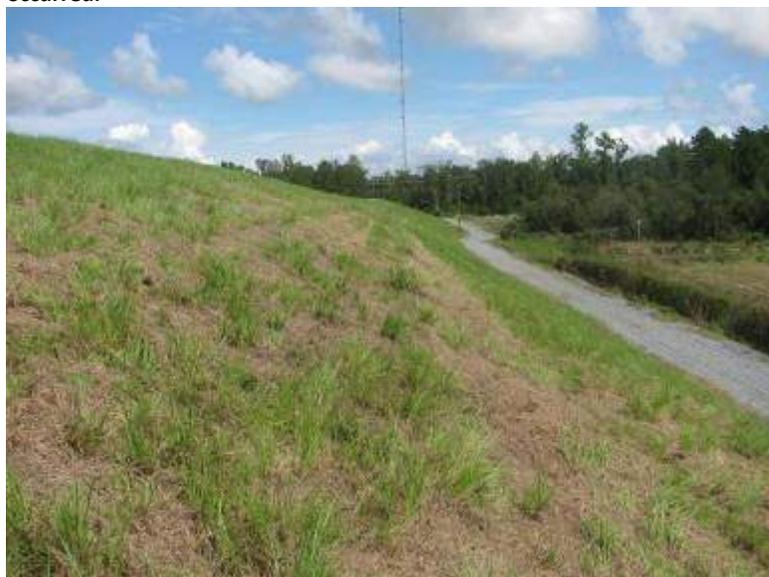
Photo 47: Upper East Pond – East embankment exterior slope, looking north.

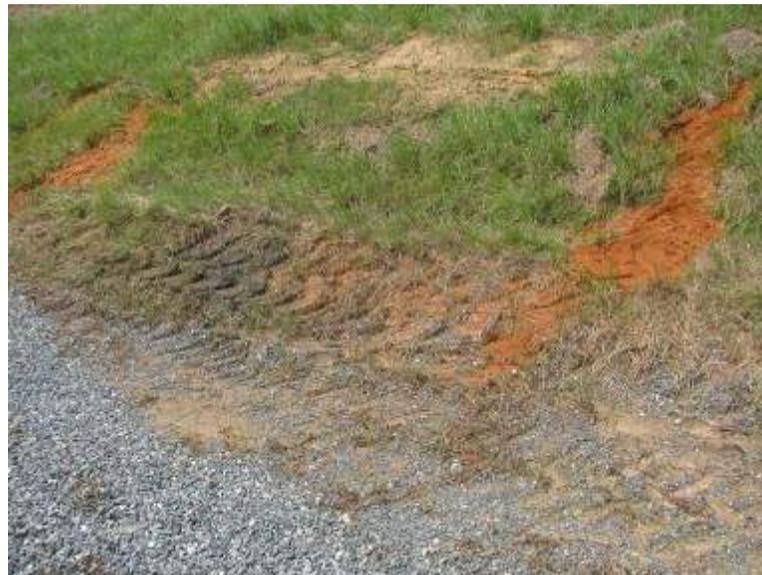
Photo 50: Upper East Pond – East embankment exterior toe of slope looking west. Note saturated area at toe of slope.

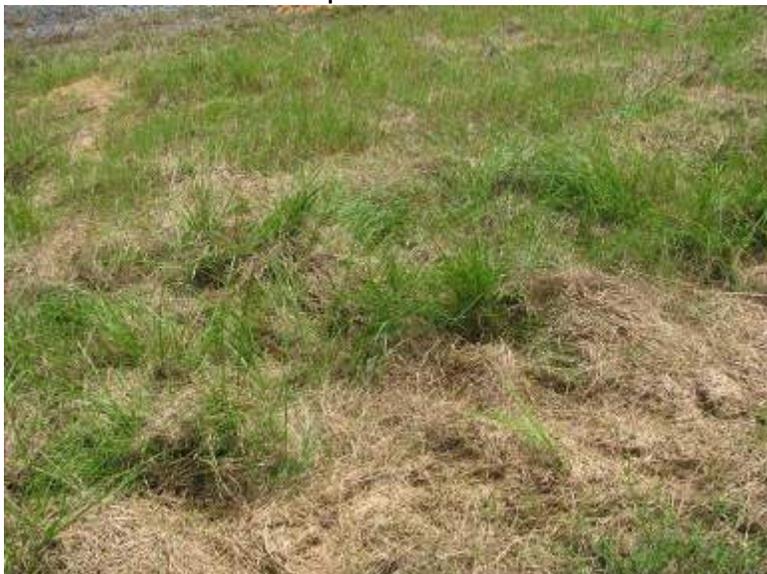
Photo 51: Upper East Pond – East embankment exterior toe of slope, looking west. Note area of possible seepage and depression 3-foot wide by 10-foot long by 6-inches deep.

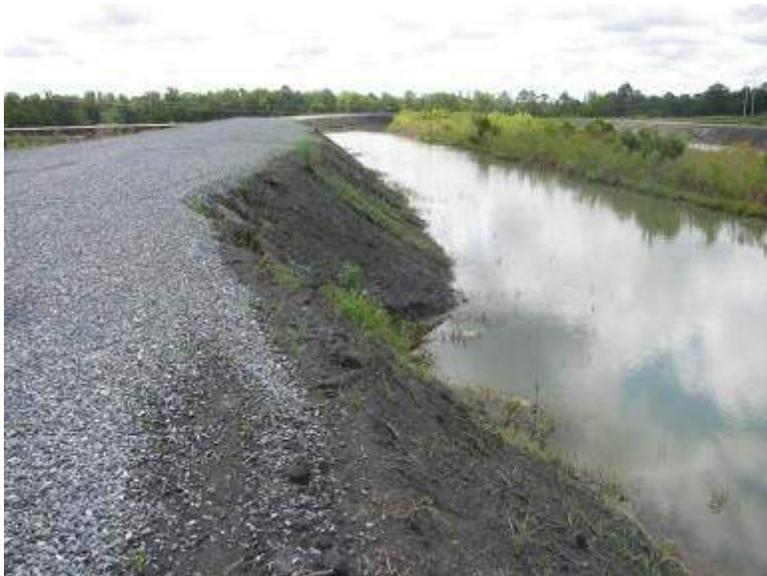
The interior slopes appear to be in fair condition. Reportedly, the interior slopes are 2H:1V, but a portion of the slopes on the east embankment seem to be around 1.5H:1V. Sparse vegetation covers the interior slopes. Discontinuities and eroded areas (Photographs 57, 86, and 91) were observed along the interior slopes.

Photo 57: Upper East Pond, Divider embankment interior slope looking south at embankment erosion.

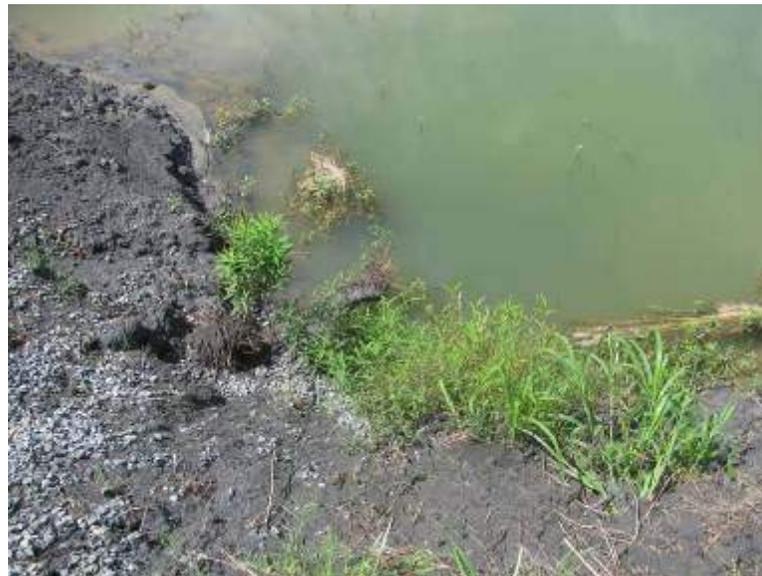
Photo 58: Upper East Pond – Divider embankment interior slope, Inflow pipe looking west. Note eroded areas at discharge of pipe.
