ASSESSMENT OF DAM SAFETY OF COAL COMBUSTION SURFACE IMPOUNDMENTS – FINAL REPORT

**Gulf Power
Plant Scholz
Sneads, Florida**

May 2014
Revised July 10, 2014

CDM Smith Project No.:
93083.1801.044.SIT.SCHOL

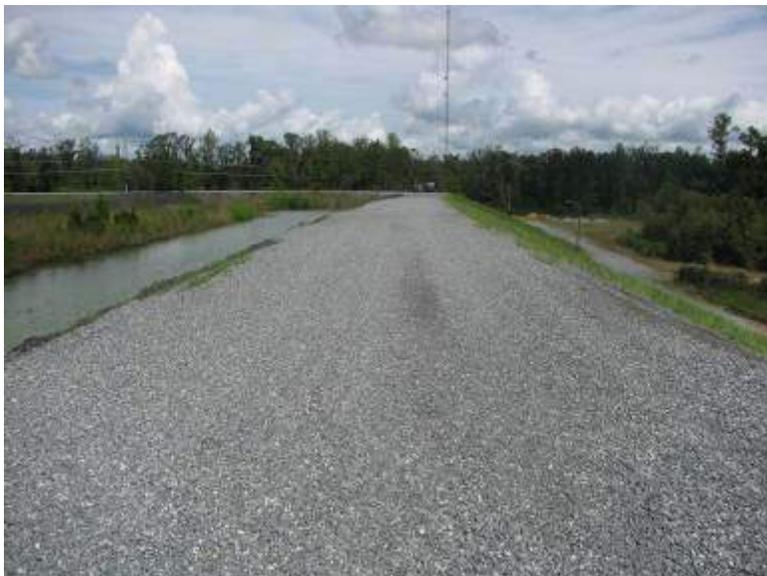
The crest of the Upper East Pond embankments appeared to be in satisfactory condition (Photographs 54, 59 and 60). The crest ranged from 20 to 30 feet wide. The crest of the embankment consists of compacted granular soils and gravel and is exposed to minimal vehicle traffic. No depressions or evidence of settlement were observed on the crest. Minor rutting was observed (Photograph 60).

Photo 59: Upper East Pond – Crest of east embankment looking north.

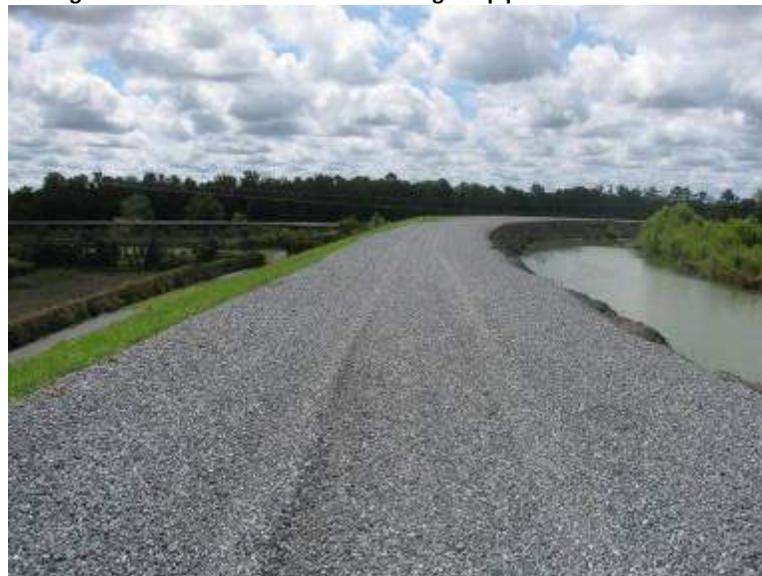
Photo 60: Upper East Pond – Crest of East embankment looking south.

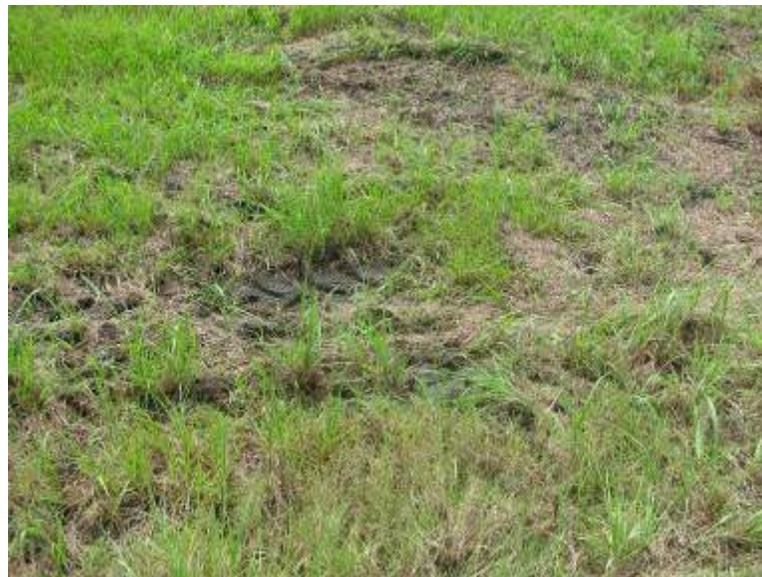
Photo 64: Upper East Pond – North embankment toe of exterior slope looking south. Note saturation at toe of slope.

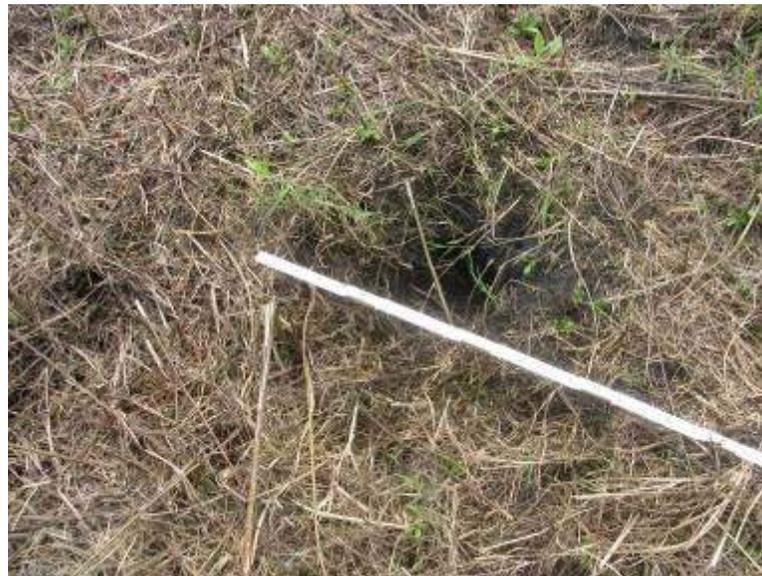
The repaired area, previously described in Section 3 of this report, located on the exterior slope of the north embankment was identified (Photographs 61 and 62). No signs of further seepage were observed in the area. An animal burrow was observed on the north embankment (Photograph 66).

Photo 66: Upper East Pond –North embankment mid-slope, Animal burrow. Note burrow is about 1-foot deep.

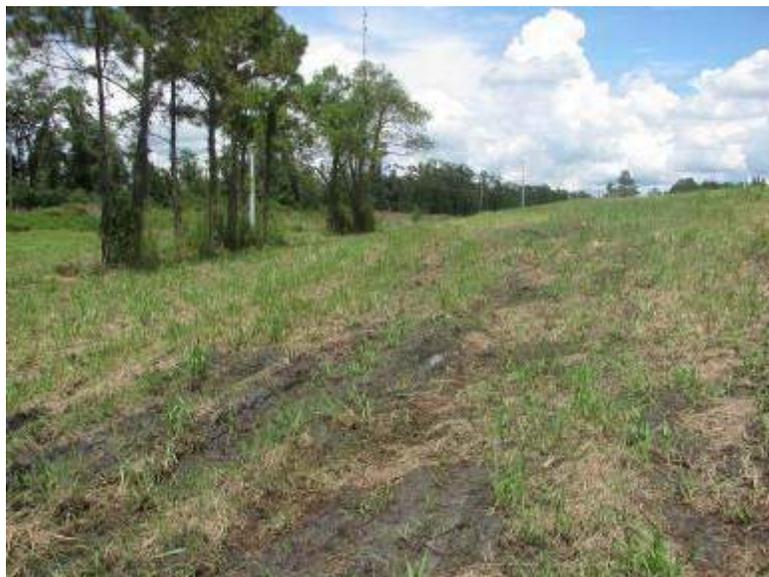
In general, the exterior slopes of the Upper West Pond appear to be in satisfactory condition (Photographs 69 and 70). The embankment slopes are approximately 3H:1V with a flattening tendency towards the southwest corner of the embankment. Exterior slopes are covered with grassy vegetation about 4 to 6 inches tall. The alignment and slopes appear to be relatively uniform and consistent.

Photo 69: Upper West Pond – West embankment exterior slope, general view looking north.

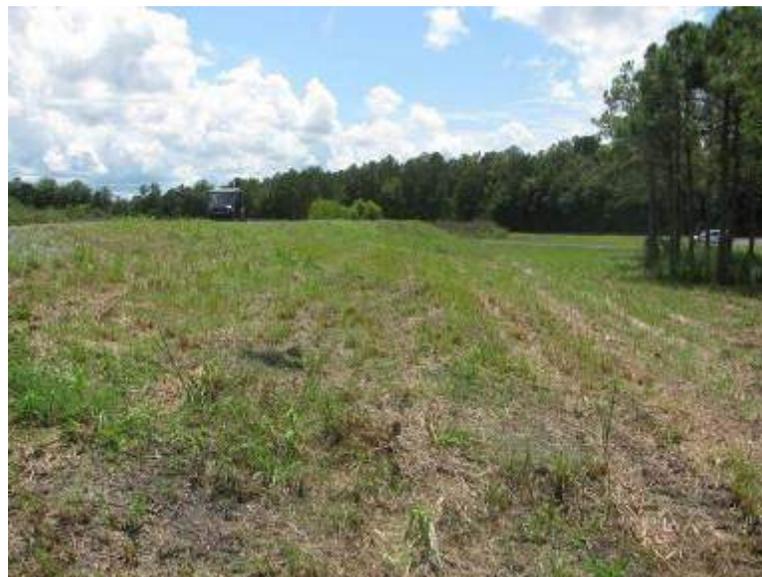
Photo 70: Upper West Pond – West embankment exterior slope, general view looking southwest.

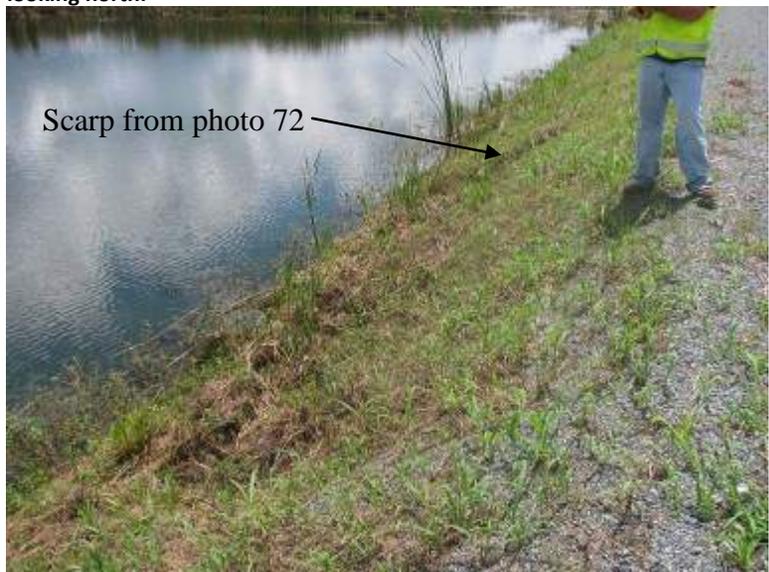
The interior slopes appear to be in fair condition. The interior slopes of the embankments were approximately 2H:1V. The interior slopes were generally covered with grassy vegetation approximately 3 to 6 inches tall. Shallow erosion and scarps were observed on the west interior slope (Photographs 71 and 72). An approximately 30-foot-long erosion/depressed area (Photograph 73) was also observed at the west embankment. An 18-inch-diameter corrugated HDPE inlet pipe is located near the southeast corner of the pond. Water was flowing through the pipe from the Upper Middle Pond.

Photo 71: Upper West Pond – West embankment interior slope, general view looking south. Note shallow scarps over approximate 50-foot length.

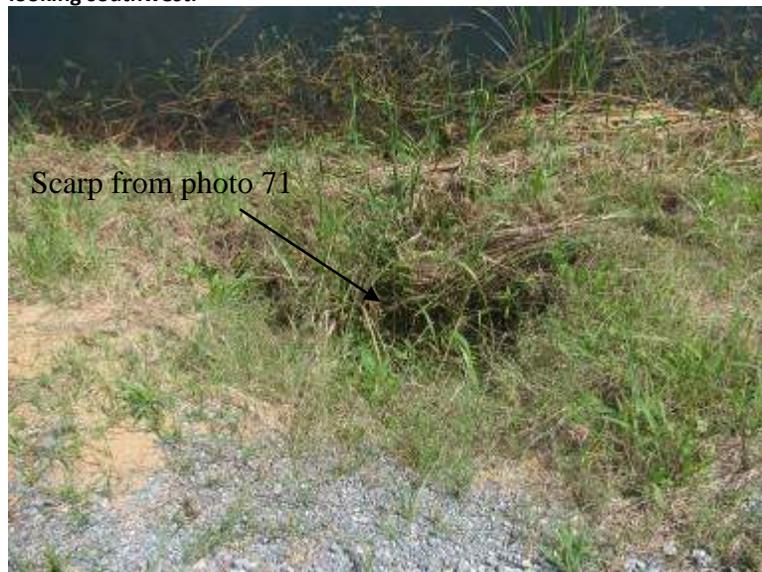
Photo 72: Upper West Pond – West embankment interior slope, scarp looking east.

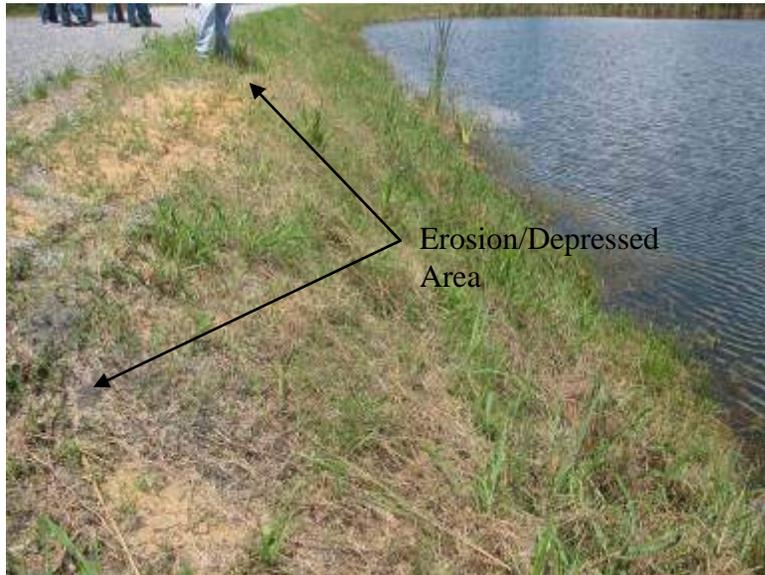
Photo 73: Upper West Pond – West embankment interior slope, showing erosion/depressed area approximately 30-foot long, looking north.

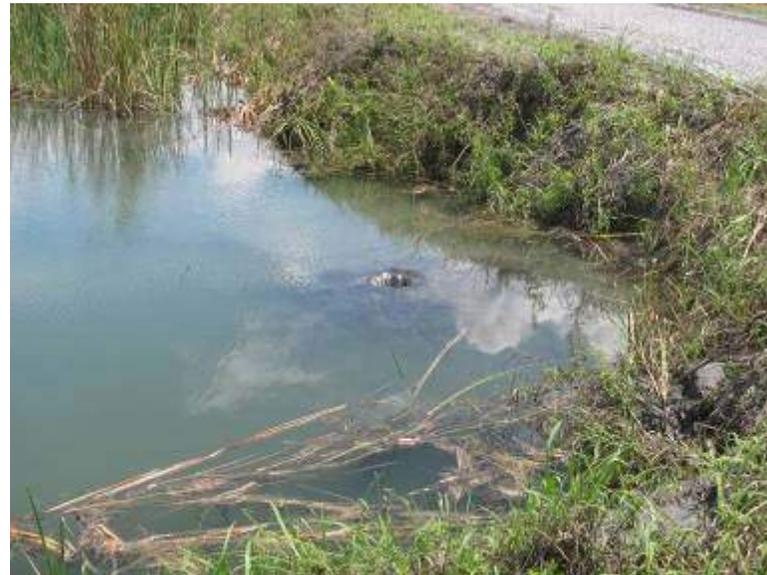
The Upper West Pond outlet structure consists of an 18-inch-diameter morning glory-type steel pipe located at the southwest corner of the pond (Photograph 74). The riser appeared to be free of debris and in satisfactory operating condition.

Photo 74: Upper West Pond – Southwest embankment interior slope, morning glory-type drop inlet structure looking southeast.

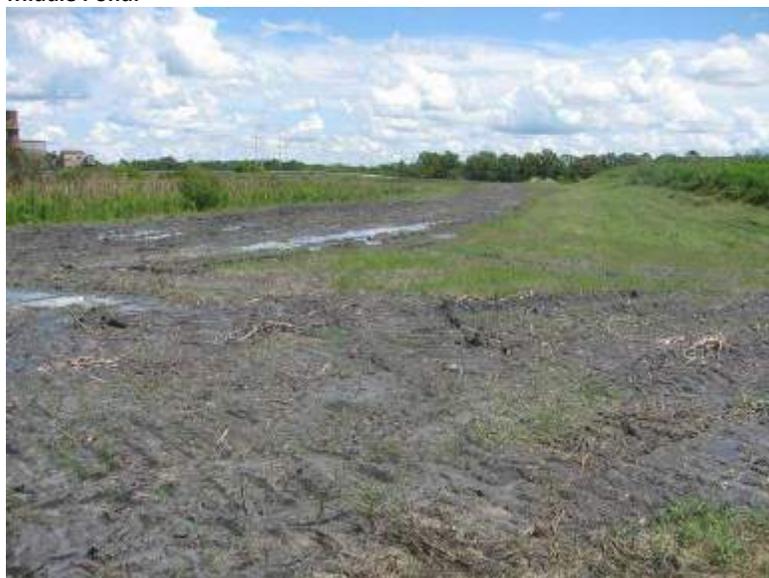
The crests of the Upper Middle Pond embankments appear to be in satisfactory condition. The average crest width is approximately 22 feet. Slight depressions and ruts with standing water (Photographs 79, 80, 83 and 85) were observed on the crest of the west divider embankment between the Upper Middle Pond and the Upper West Pond. No evidence of settlement or cracks was observed on the crests. Signs of heavy equipment traffic were present on the crest of the east divider embankment (Photographs 93 to 95 and 104).

The crest of the Upper West Pond appears to be in fair condition, with some areas of rutting and signs of heavy equipment traffic on the west divider embankment between the Upper Middle Pond and the Upper West Pond (Photographs 79 and 80). The average crest width is approximately 25 feet. The crest of the west embankment is gravel-covered without vegetation. The east divider embankment crest is surfaced with compacted gravel and is used as an access road. Sparse vegetation was growing in the middle and on both sides of the roadway (photo 88).

Photo 79: Crest of divider embankment between Middle Pond and Upper West Pond, looking southeast at excavator tracks.

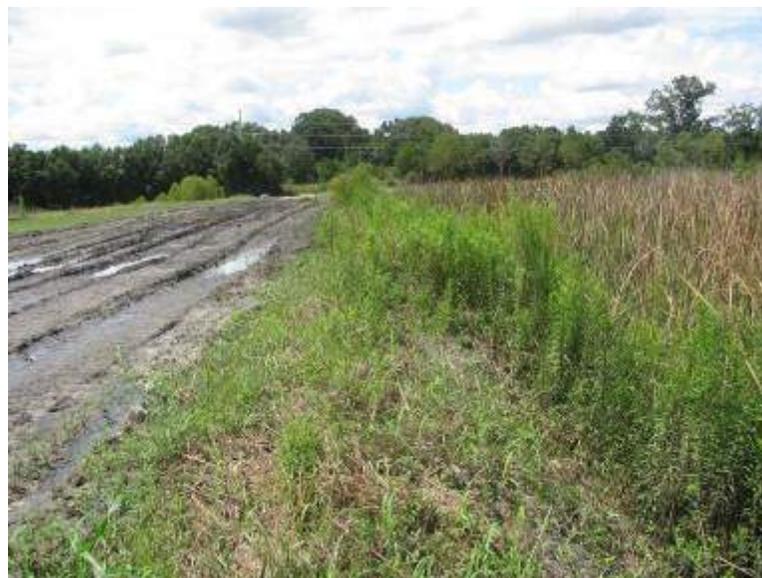
Photo 80: Crest and interior slope of divider embankment between Middle Pond and Upper West Pond, looking northwest.

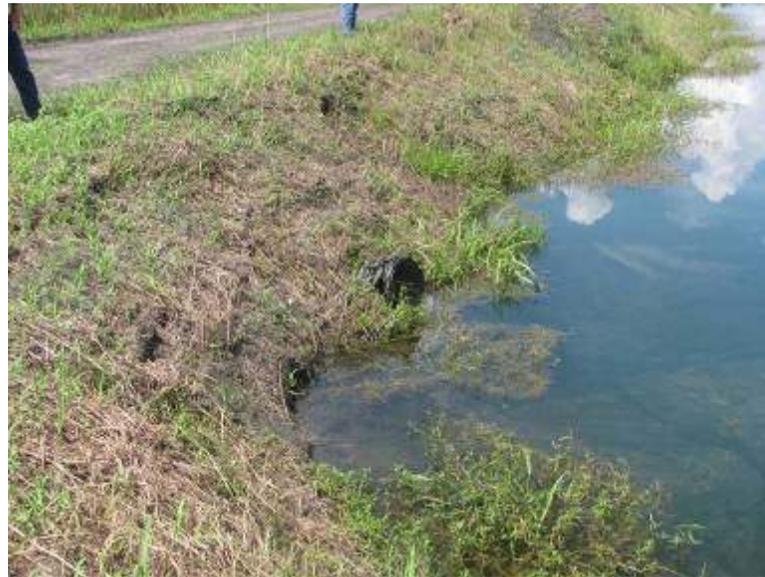
The outlet from the Upper Middle Pond consists of an 18-inch-diameter corrugated HDPE pipe located near the southwest corner of the pond (Photograph 82). The pipe appears to be in satisfactory condition.

Photo 82: Upper Middle Pond – Divider embankment interior slope, 18-inch diameter corrugated HDPE outlet pipe looking northwest.

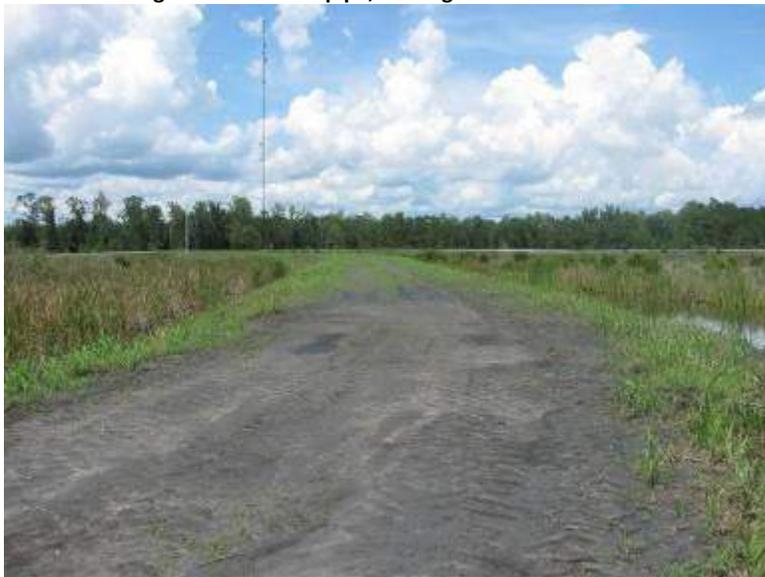
Photo 83: Crest of divider embankment between Upper West Pond and Upper Middle Pond, looking north.

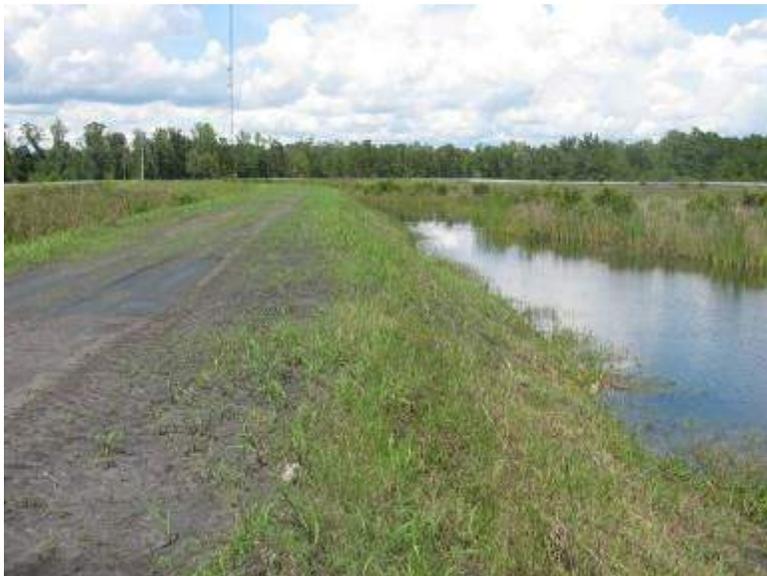
Photo 85: Upper Middle Pond – Divider embankment interior slope and crest, looking north.

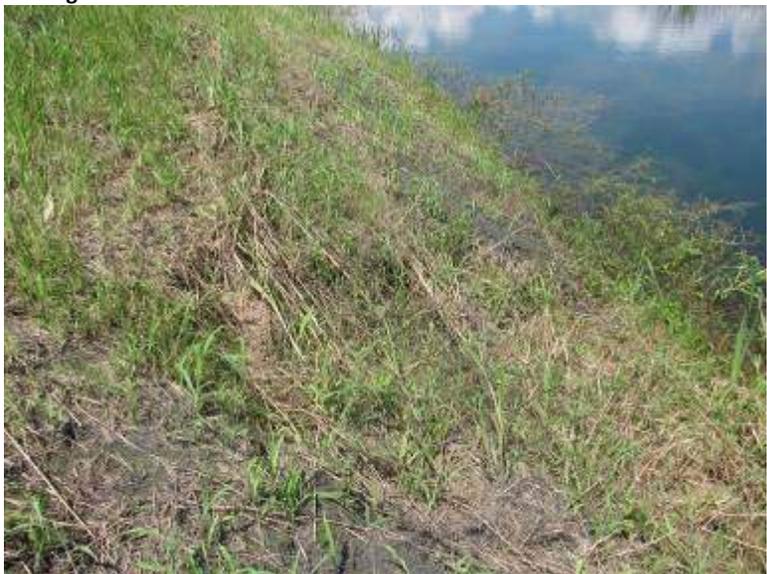
Photo 87: Upper Middle Pond – Divider embankment interior slope scarp looking northwest.

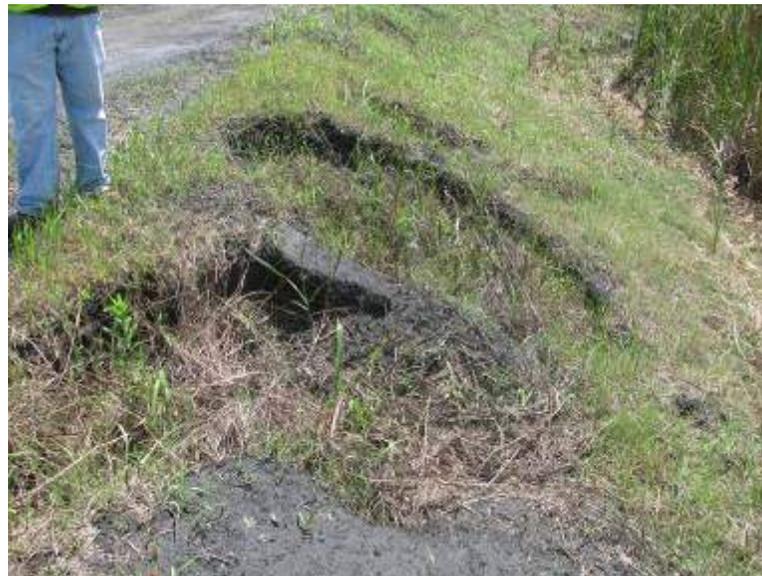
The interior slopes appear to be in fair condition. Reportedly, the interior slopes are 2H:1V, but a portion of the slopes on the east embankment seem to be around 1.5H:1V. Sparse vegetation covers the interior slopes. Discontinuities and eroded areas (Photographs 57, 86, and 91) were observed along the interior slopes.

Photo 86: Upper Middle Pond – Divider embankment interior slope looking north. Typical of four scarps along approximate 50-foot length of slope.

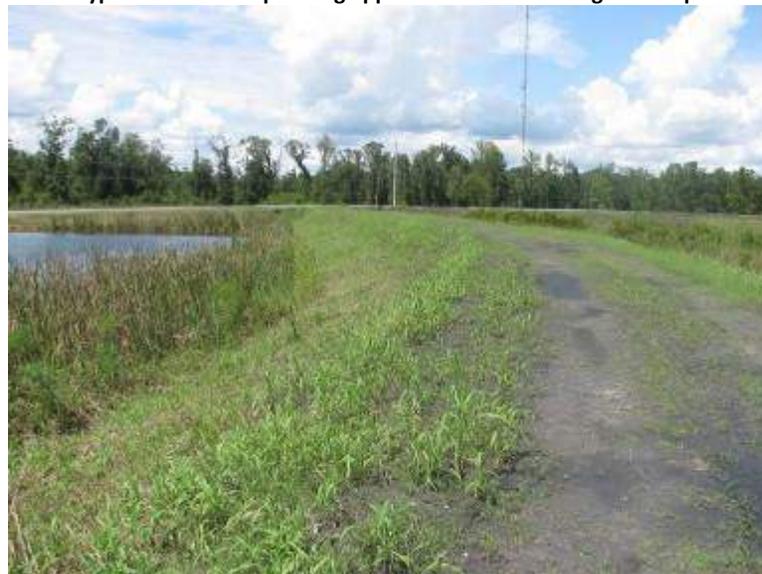
Photo 88: Upper West Pond – Divider embankment interior slope and crest, looking north.

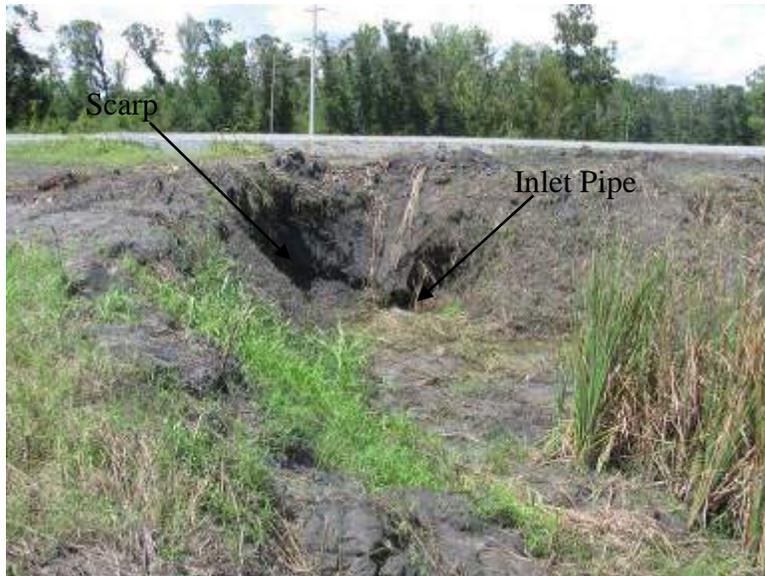
Photo 89: Upper Middle Pond – Divider embankment interior slope, 18-inch diameter corrugated HDPE inlet pipe, looking north. Note scarp adjacent to pipe.

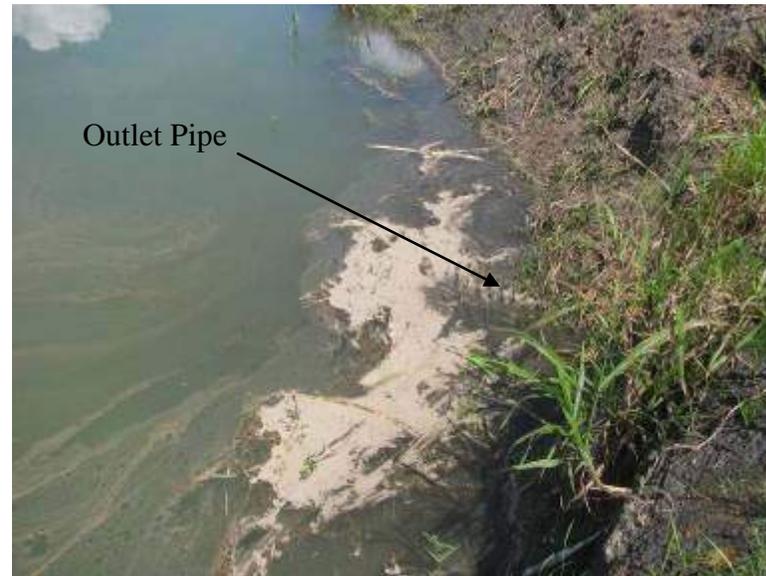
The outlet pipe consists of an 18-inch-diameter corrugated HDPE pipe (Photograph 90). The pipe was submerged at the time of visual assessment and is located near the northwest corner of the Upper East Pond. The pipe appears to be functioning satisfactorily.

Photo 90: Upper East Pond – Divider embankment interior slope, 18-inch diameter corrugated HDPE outlet pipe, looking east. Pipe is submerged.

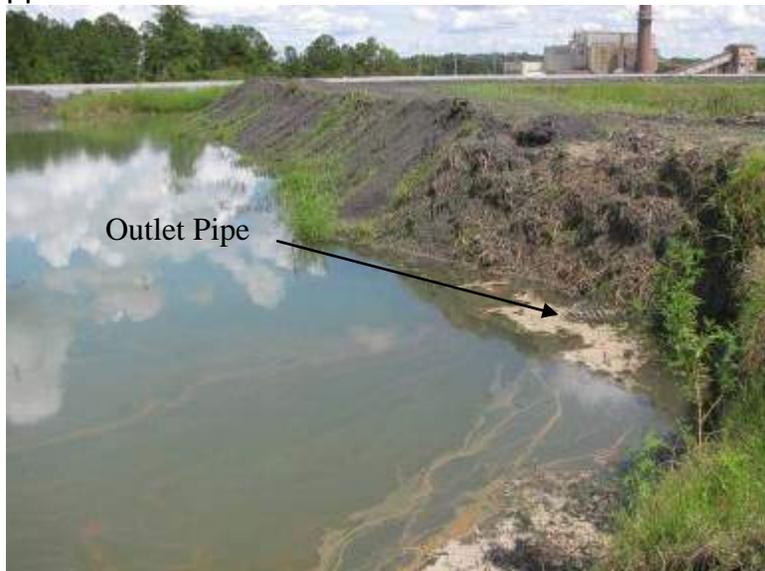
Photo 91: Upper East Pond – Divider embankment interior slope, general view of pond surface, looking east.

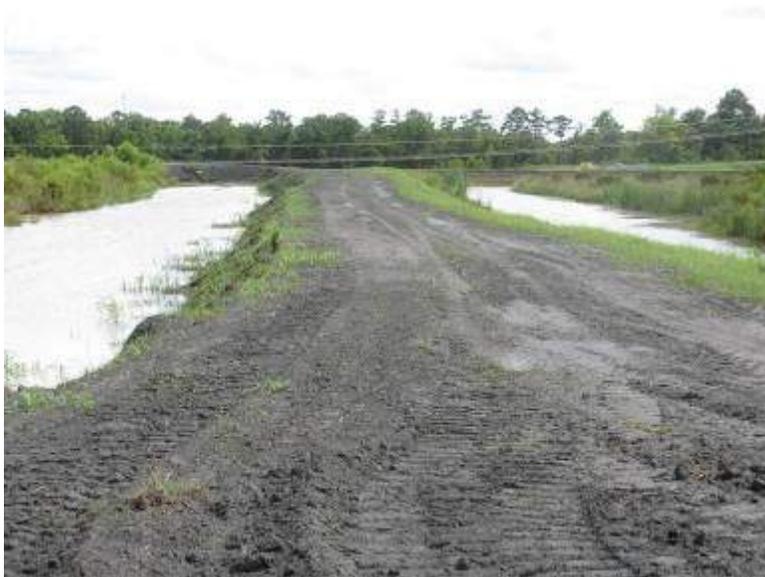
Photo 93: Crest of divider embankment between Upper East Pond and Upper Middle Pond, looking south.

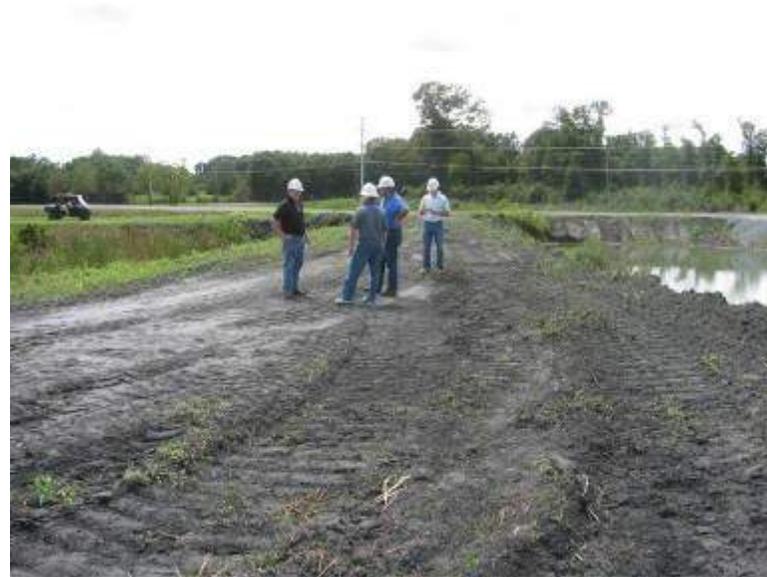
Photo 94: Crest of divider embankment between Upper East Pond and Upper Middle Pond, looking west.

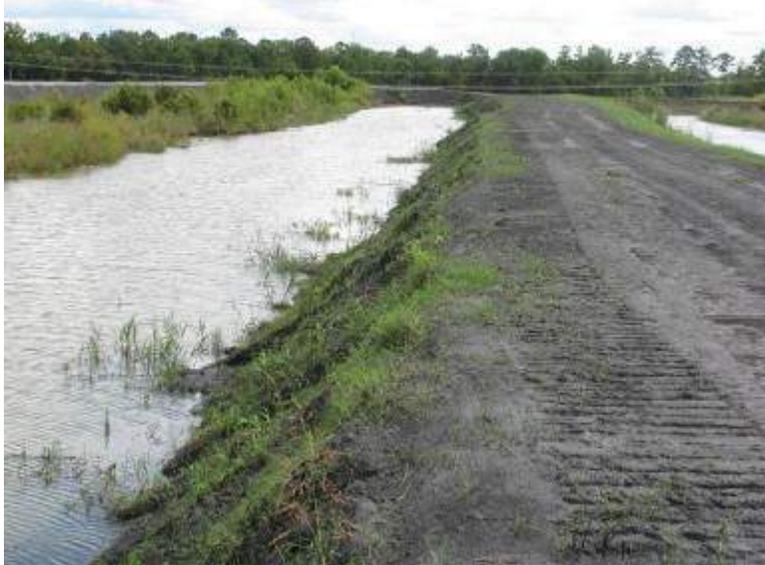
Photo 95: Upper East Pond – Divider embankment interior slope, general view of pond surface, looking south.

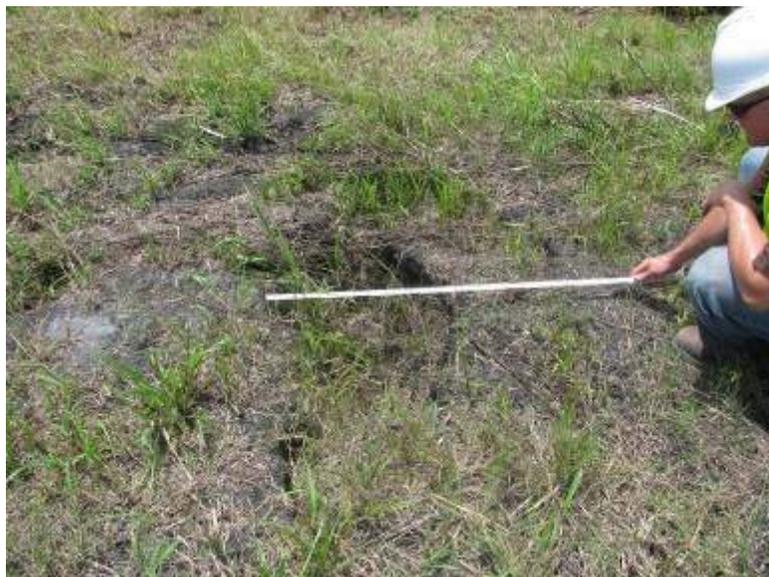
The interior slopes appear to be in fair condition. The interior slopes appear to be approximately 2H:1V. Short grass covers the interior slopes. Shallow erosion rills (Photographs 101 and 102) were observed along the interior slope of the west divider embankment with an approximate frequency of one every 50 feet. Areas of surface erosion were observed on the west divider embankment (Photograph 86 and 87) and also were observed at the northwest corner of the pond (Photograph 89) around the 18-inch-diameter corrugated HDPE inlet pipe. Water was flowing through the pipe from the Upper East Pond.

Photo 101: Upper Middle Pond – Divider embankment interior slope, 2-foot x 2-foot x 6-foot long erosion rill, looking west.

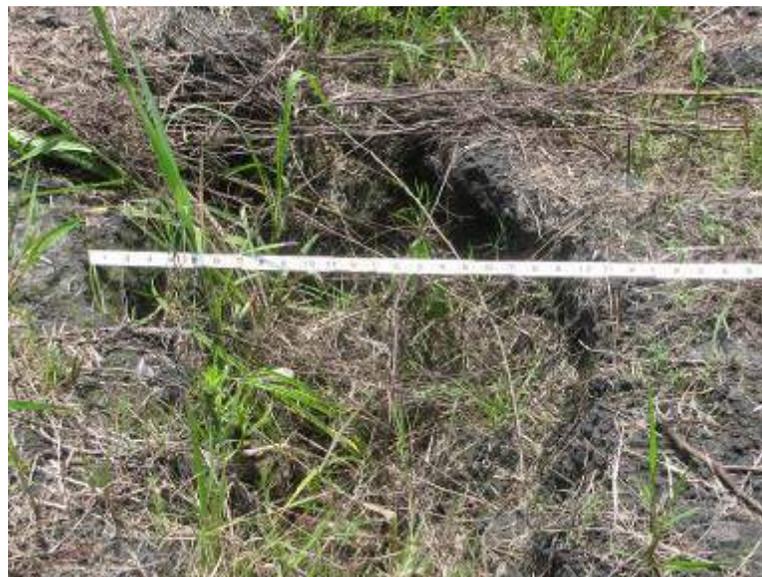
Photo 102: Upper Middle Pond – Divider embankment interior slope, close up of erosion rill, looking west.

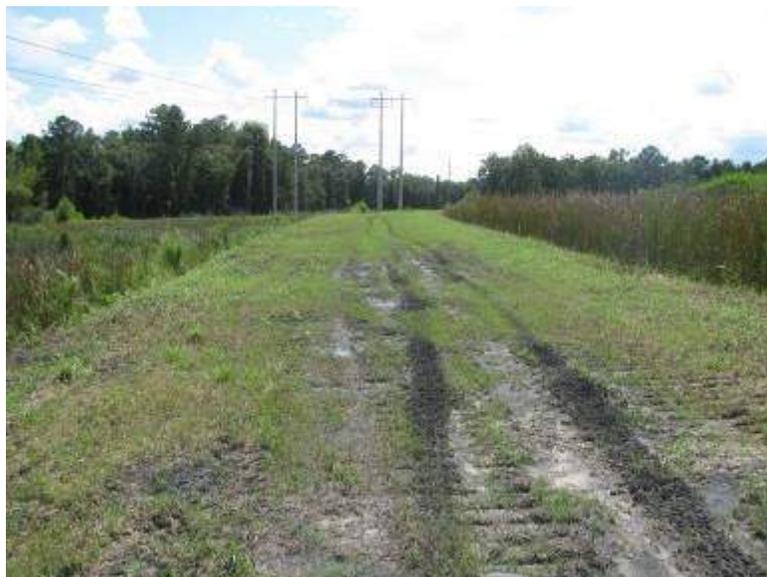
The crest of the Middle Pond appeared to be in satisfactory condition (Photographs 115 and 116). The average crest width is approximately 25 feet. The southwest and west crests are gravel-covered with sparse short grass. The crest of the divider embankment between the Middle Pond and the Lower Pond appeared to be in satisfactory condition. The crest of the west embankment of the pond is nearly level with the natural ground elevation west of the pond area. The crest of the north and southeast divider embankments was surfaced with a soil and ash mix; no gravel was observed on the crests. No depressions or evidence of settlement were observed on the crests. Ruts and tire tracks were observed on the southeast divider embankment crest (Photographs 28, 109 and 110).

Photo 109: Crest of divider embankment between Middle Pond and Lower Pond, looking southwest.

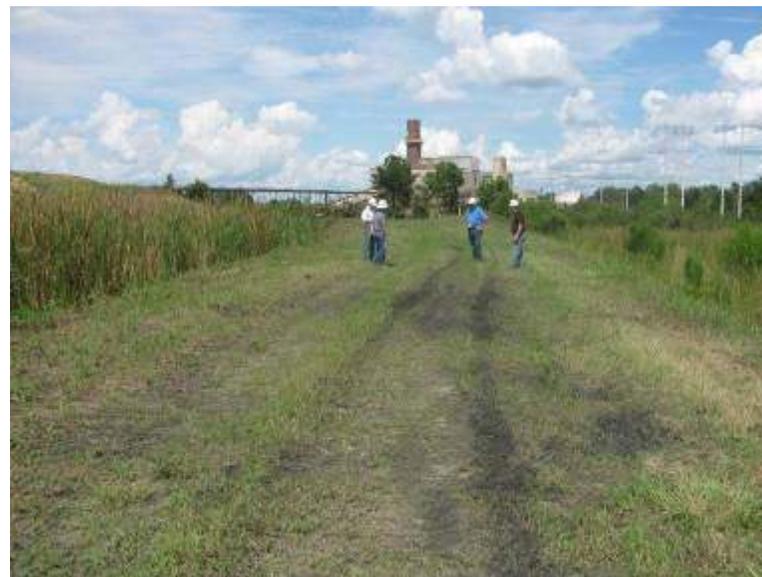
Photo 110: Crest of divider embankment between Middle Pond and Lower Pond, looking northeast.

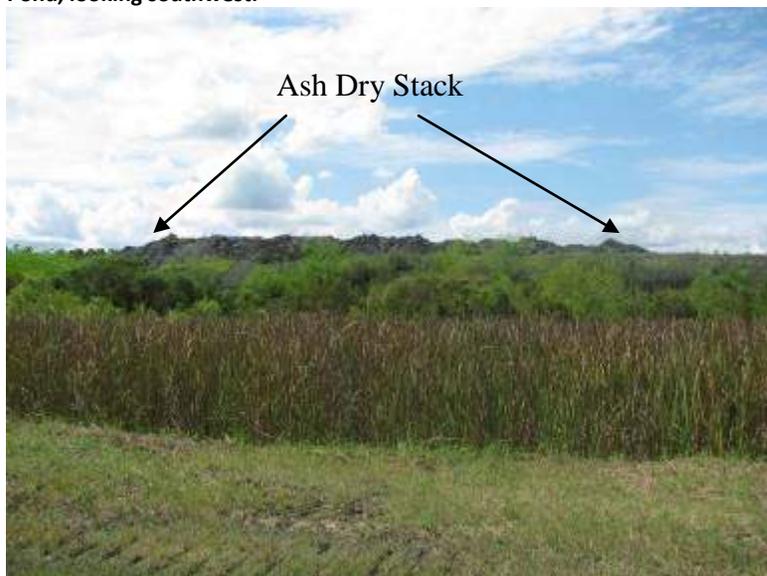
Photo 111: Middle Pond - Southside of Ash Dry stack area, looking northwest. Slope along South side of Ash Dry Stack area is nearly vertical and inaccessible.

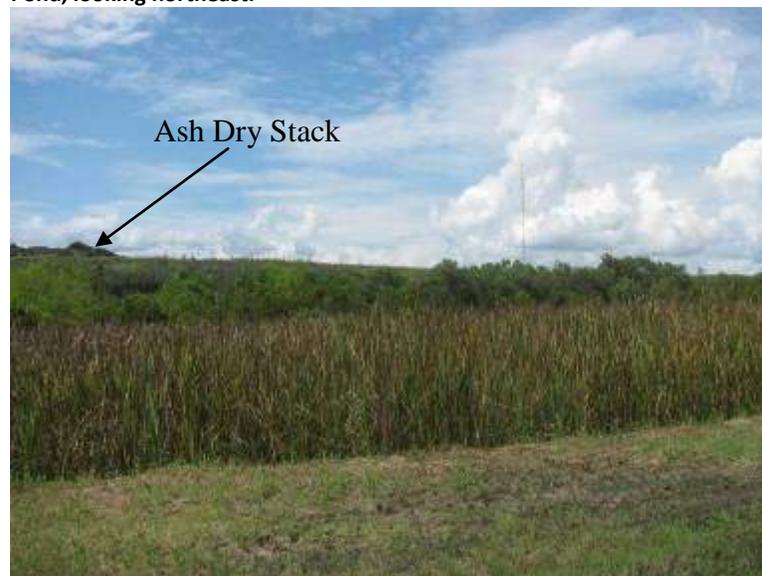
Photo 112: Southside of Ash Dry Stack area, looking northeast. Slope along South side of Ash Dry Stack area is nearly vertical and inaccessible.

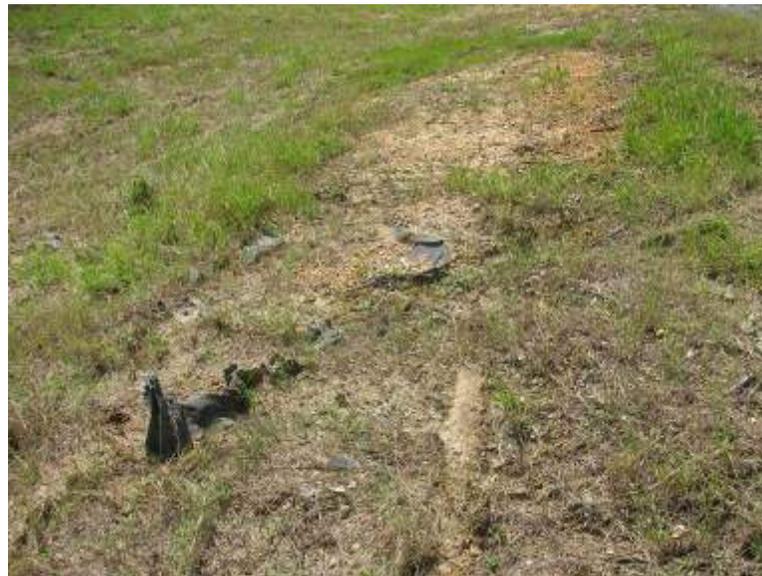
Photo 114: Middle Pond – West embankment exterior slope, trash and miscellaneous debris looking northwest.

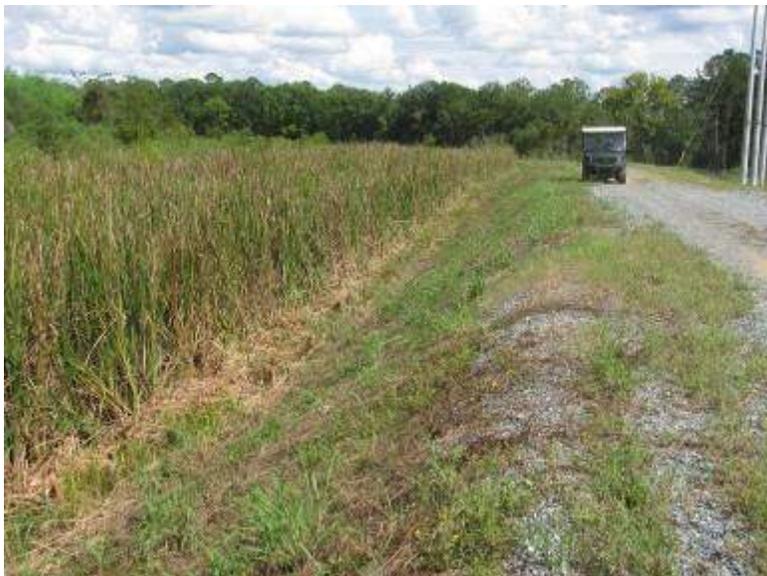
The interior slopes of the pond appear to be in fair condition. Portions of the north and northeast interior slope were not visible due to the presence of ash fill placed for an access/haul road. Erosion rills observed along the north embankment interior slope appeared to only extend into the haul road fill materials (Photographs 40, 41 and 42). Erosion rills and scarps (Photographs 37 and 38) were observed on the northeast embankment, adjacent to the Ash Dry Stack. Grass on the inside of the embankment was approximately 8 to 12 inches tall (Photographs 31, 76 and 78) and was recently mowed. The west embankment interior slope appeared to be in satisfactory condition, well vegetated with grass, typically less than 6 inches in height (Photographs 115 and 117).

Photo 115: Middle Pond – West embankment interior slope, crest looking southeast.

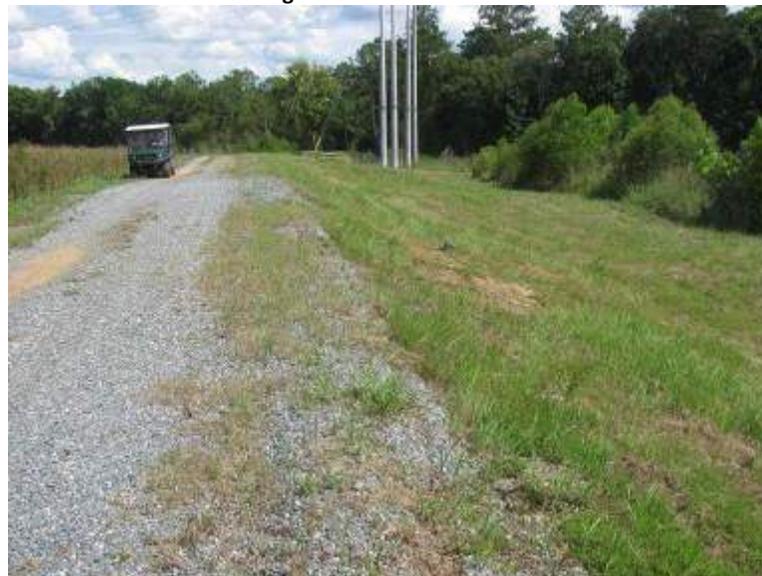
Exterior slopes of the Middle Pond appear to be in satisfactory condition. Slopes are approximately 4H:1V. Exterior slopes are covered with grassy vegetation about 4 to 6 inches tall (Photograph 116).

Photo 116: Middle Pond – West embankment exterior slope, crest looking southeast.

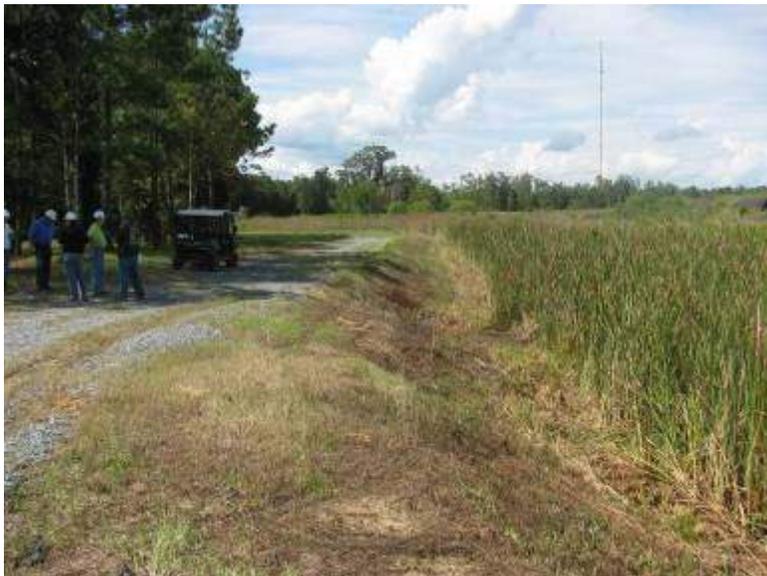
Photo 117: Middle Pond – West embankment interior slope, crest looking north.

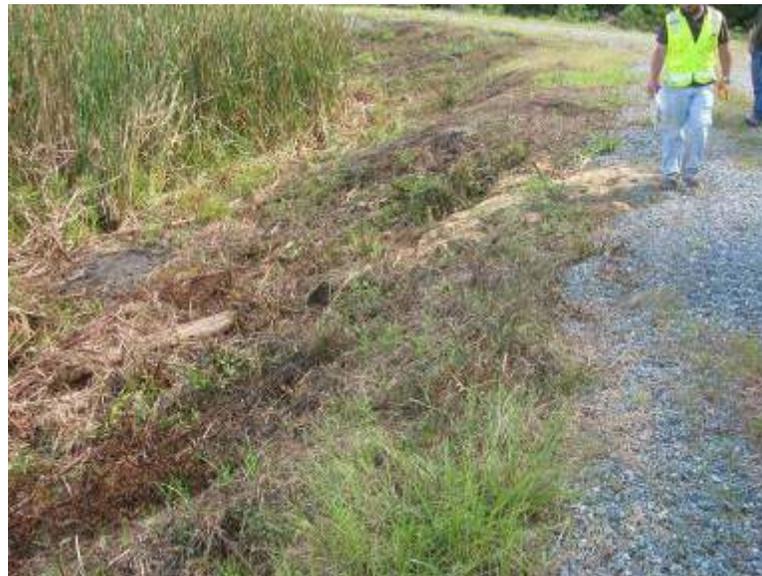
Photo 118: Middle Pond – West embankment interior slope scarp, looking south.
