COAL ASH IMPOUNDMENT SITE ASSESSMENT FINAL REPORT

**Stanton Station
Great River Energy**

KLEINFELDER PROJECT NUMBER 118953-2

October 26, 2012

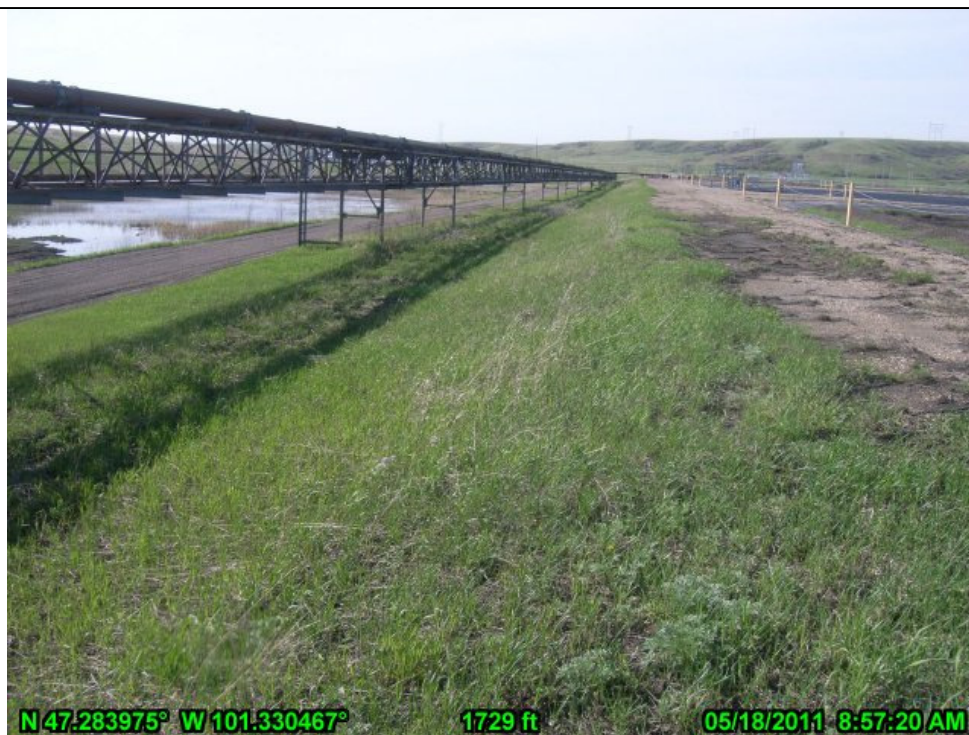
- No major depressions, erosion, or rutting was noted on the impoundment crest.
- Transecting the crest near the northeast corner with minimal cover are two bottom ash sluice lines. Photo 1 shows these sluice lines.
- Sluice pipe structure support columns for the pipeline that runs along the east lower bench of the North Ash Pond and the Center Drainage Pond rest on small concrete foundation pads that penetrate the crest in multiple locations, as shown in Photo 2.

2-Landside View of East Embankment Modification and Sluice Pipes (looking south)

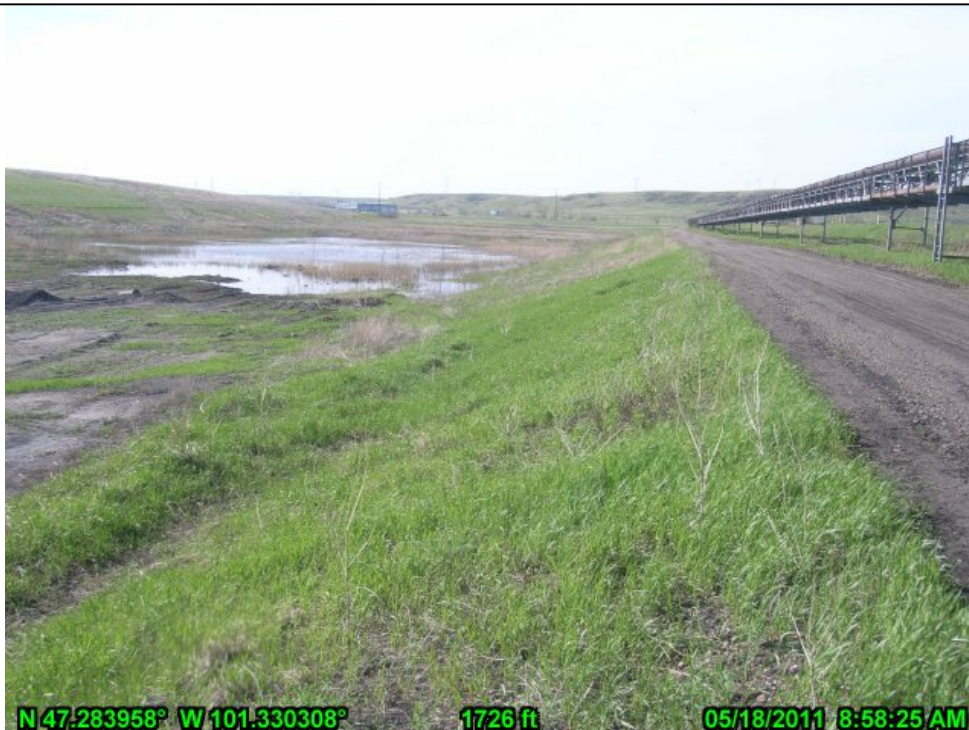
Overall, the downstream slope was in Fair condition. Photos 3, 4, 31, and 32 show the conditions of the downstream slope. Specific observations include:

The toe areas of the embankment were in Fair condition. See Photos 3, 32, and 33 for the condition of these areas. Key features and observations of these areas include:

3-Landside View of Original (Lower) East Embankment (looking south)

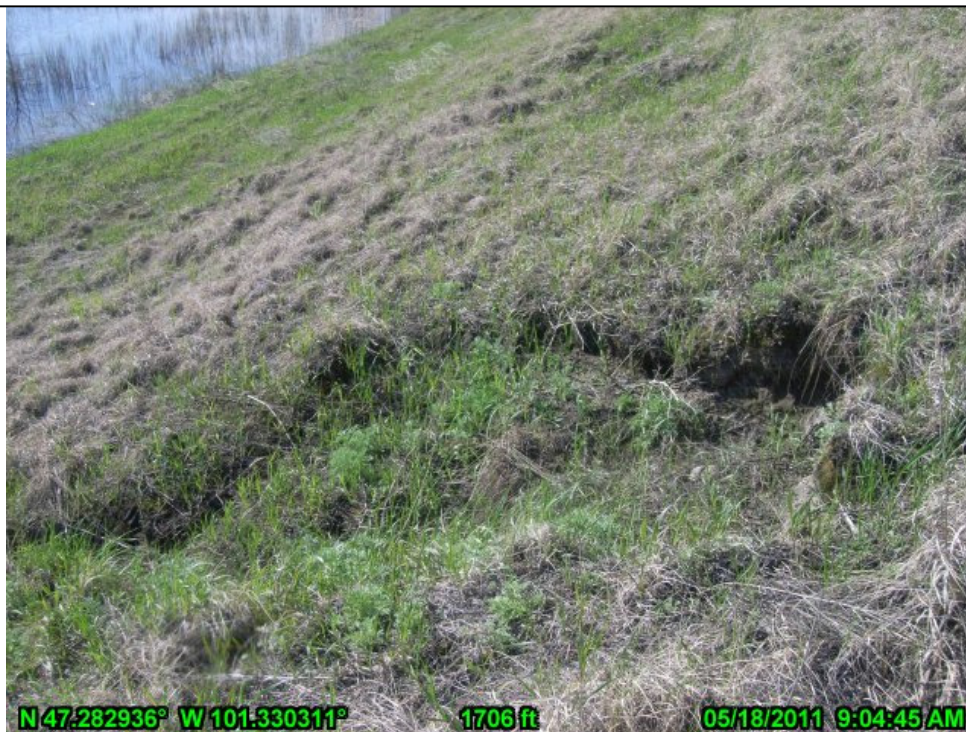
5-Scarp on Original Landside East Embankment (looking southwest)

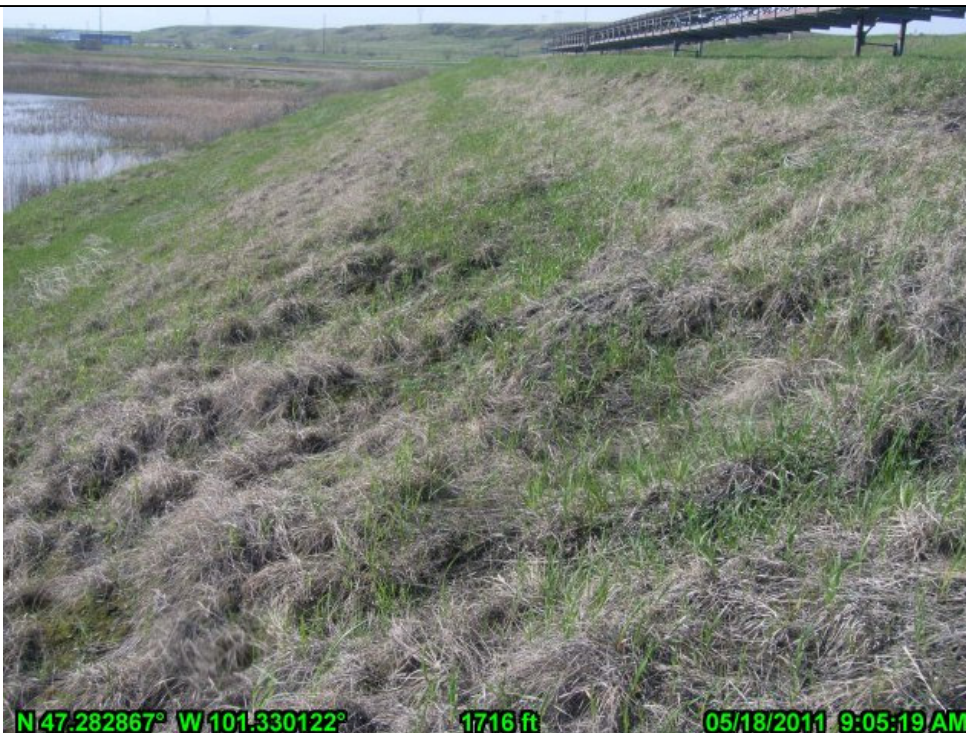
6-Surface Erosion on Original Landside East Embankment (looking south)

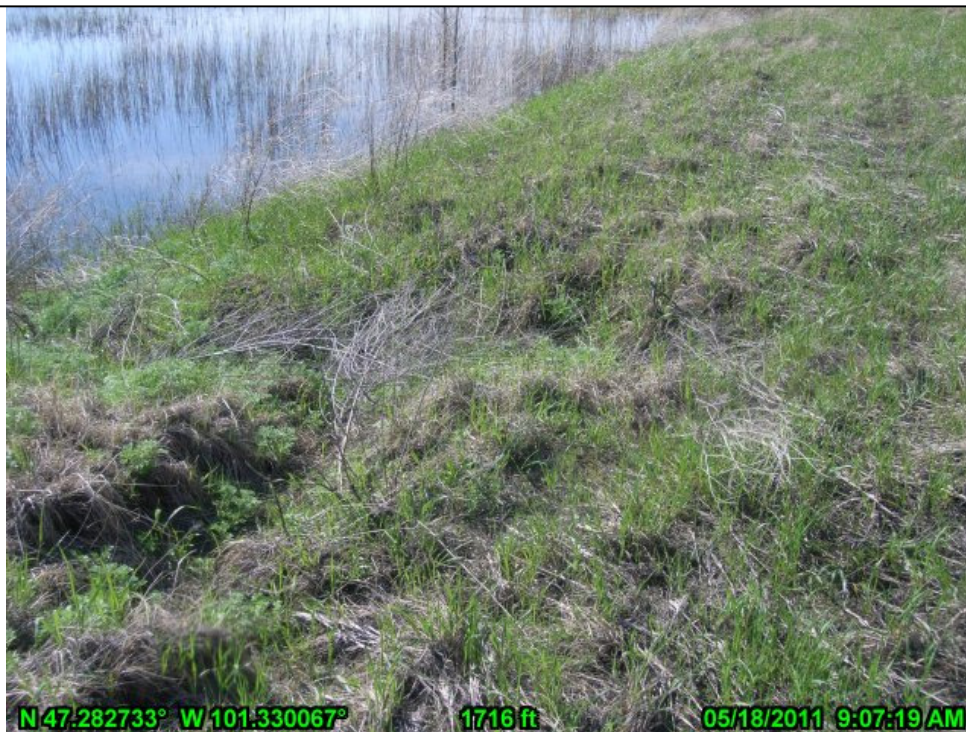
7-Erosion on Original Landside East Embankment (looking southeast)

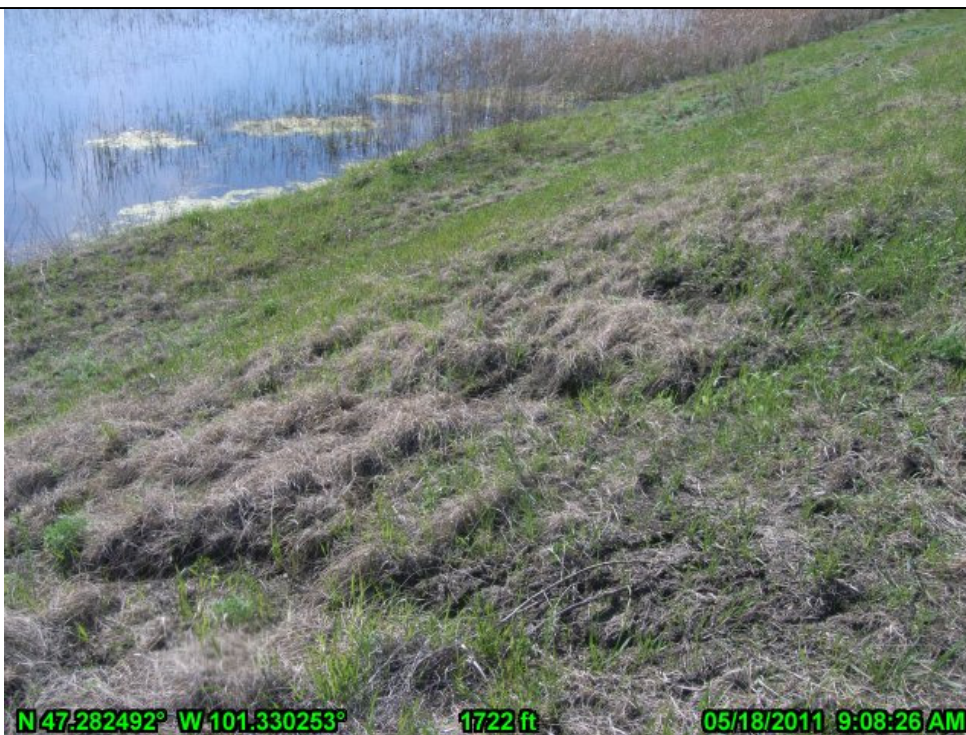
8-Erosion Rills on Original Landside East Embankment (looking southeast)

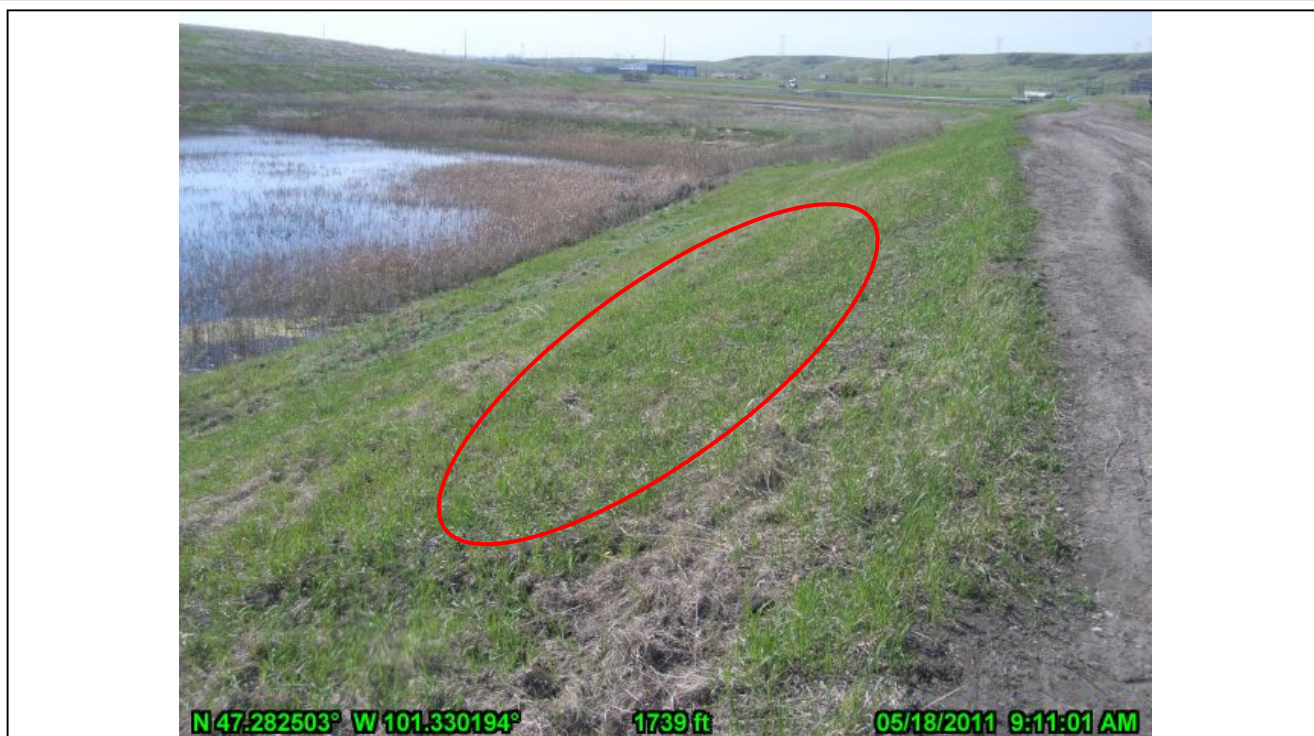
9-Bulging of Original Landside East Embankment (looking south)

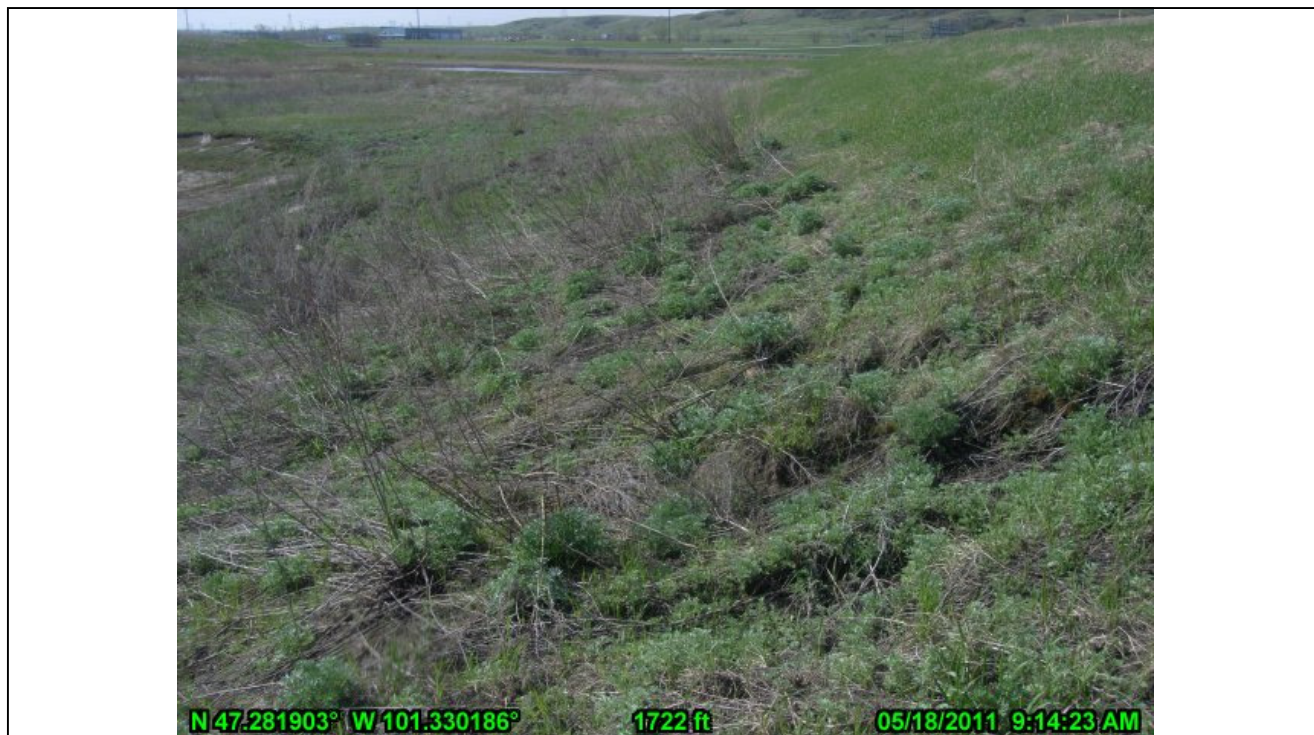
10-Erosion and Vegetation on Slope of Original Landside East Embankment (looking south)

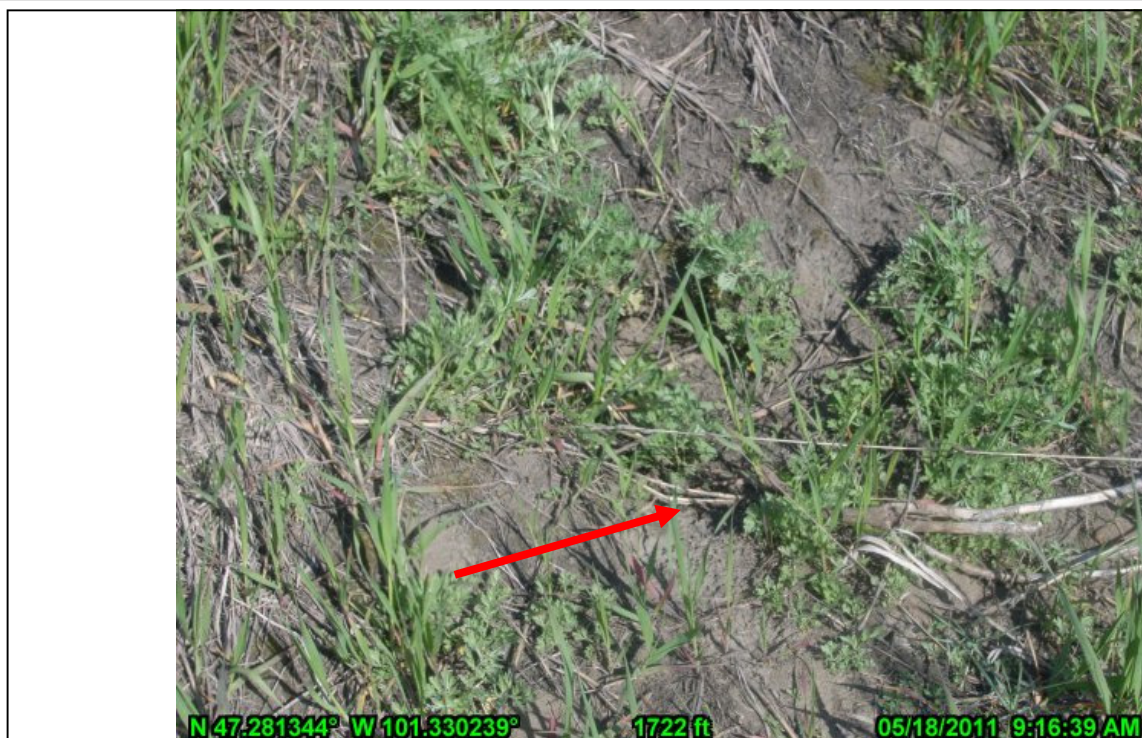
11-Animal Burrow on Landside East Embankment

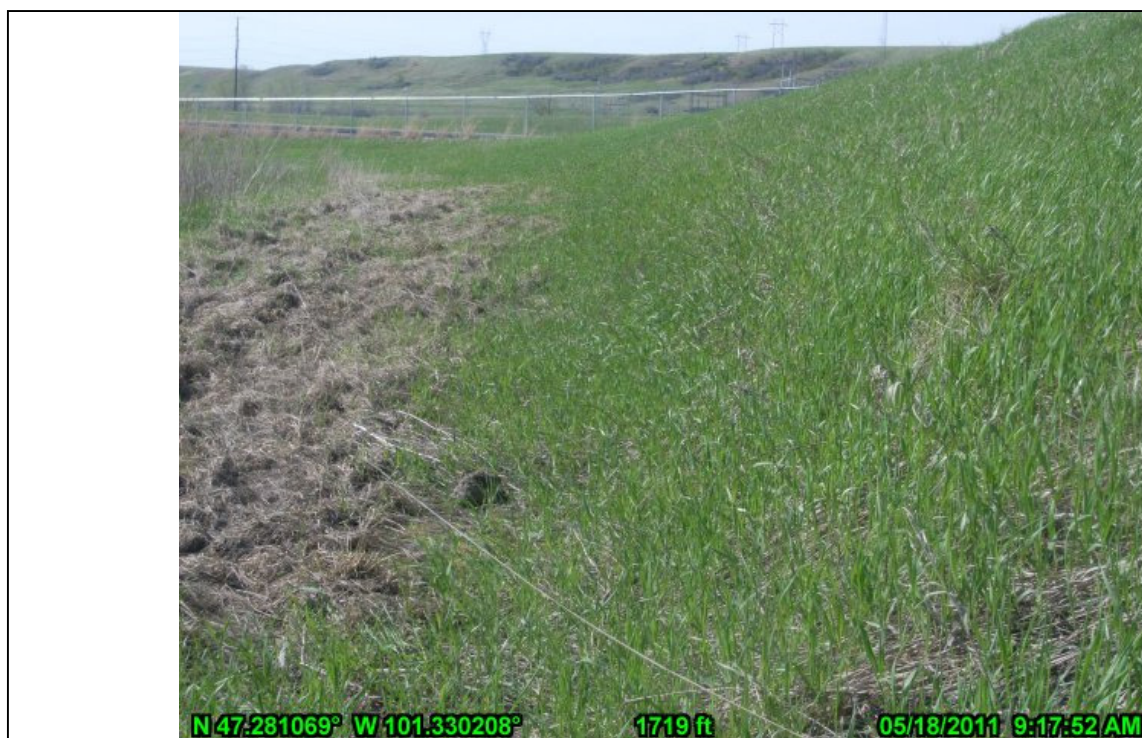
12-Toe of Original East Embankment Over Steepened (looking south)

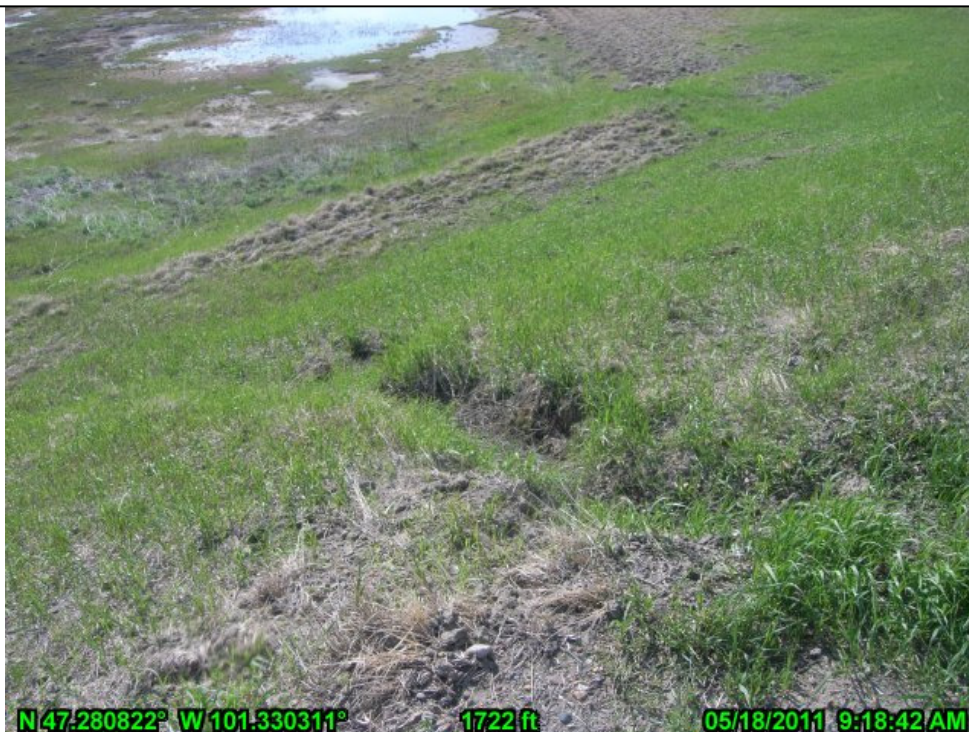
13-Erosion Channel on Original Landside East Embankment (looking east)

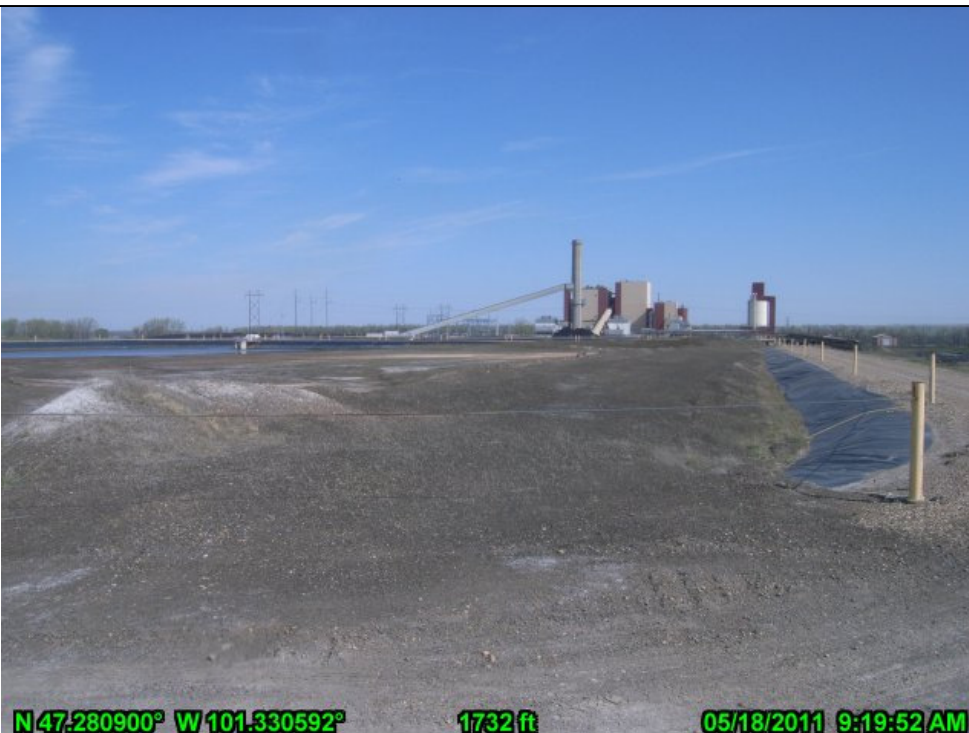
14-South Ash Pond Waterside East Embankment, Not in Use (looking north)

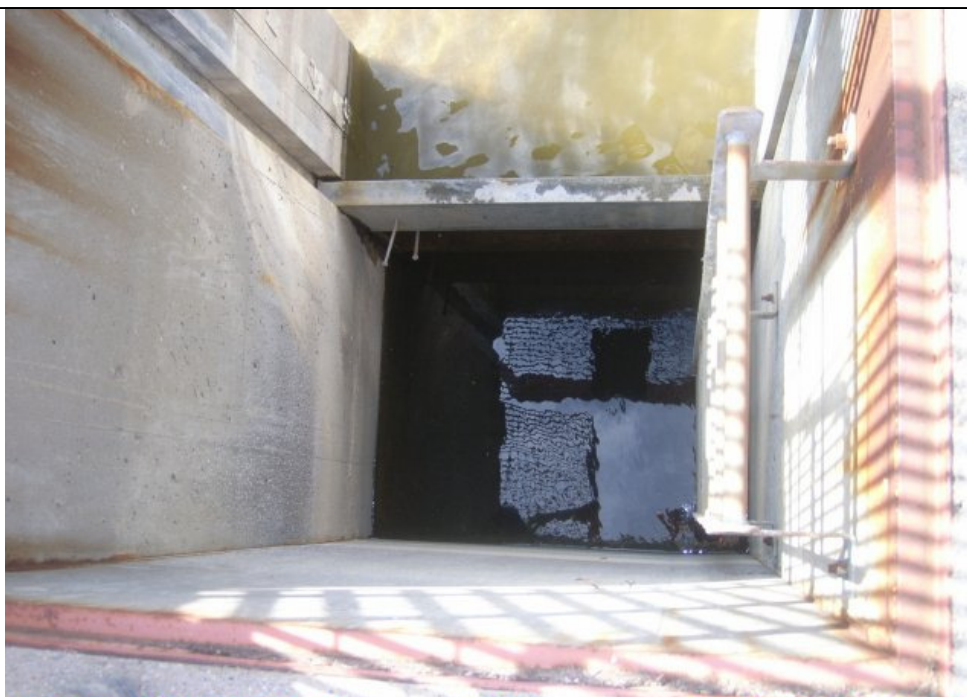
18-South Pond Decant Inlet Structure, Not in Use

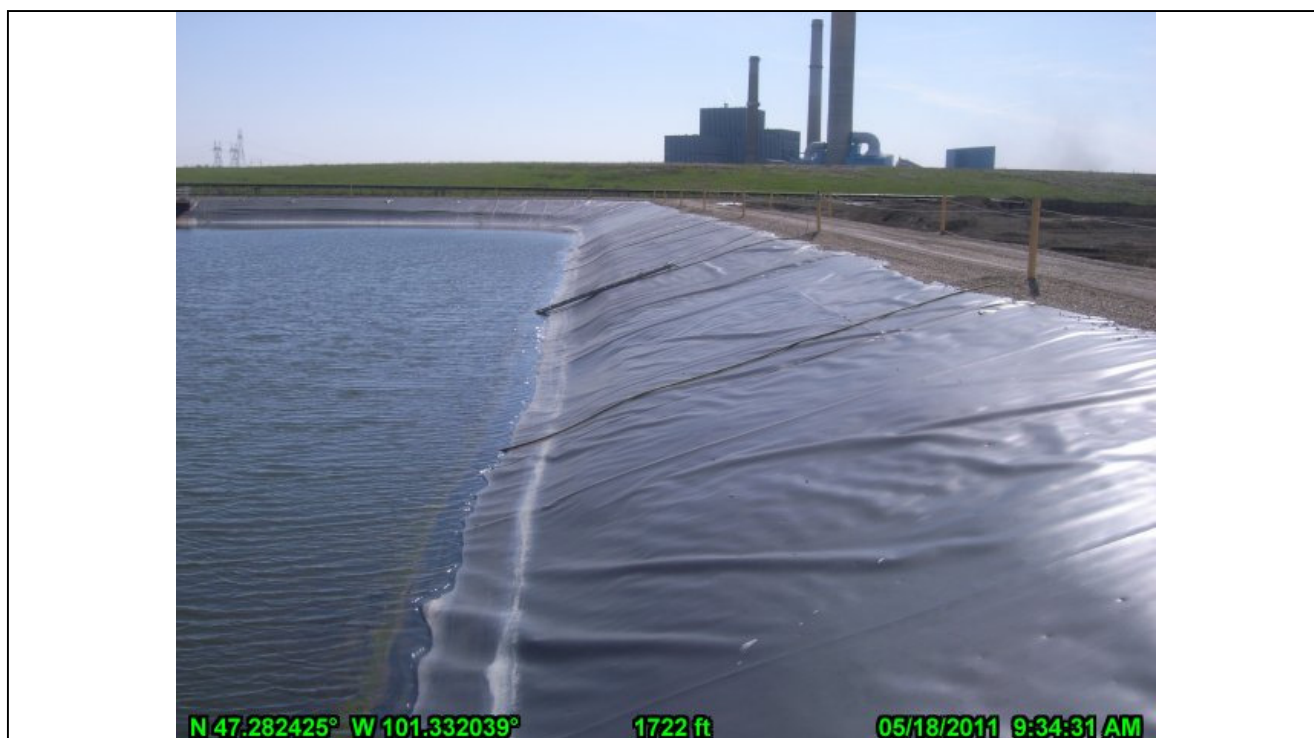
Overall, the upstream slope of the impoundment was in satisfactory condition. Photos 20, 22, and 24 show the conditions of the upstream slope. Specific observations include:

20-Divider Dike Liner on South Side of Center Pond (looking east)

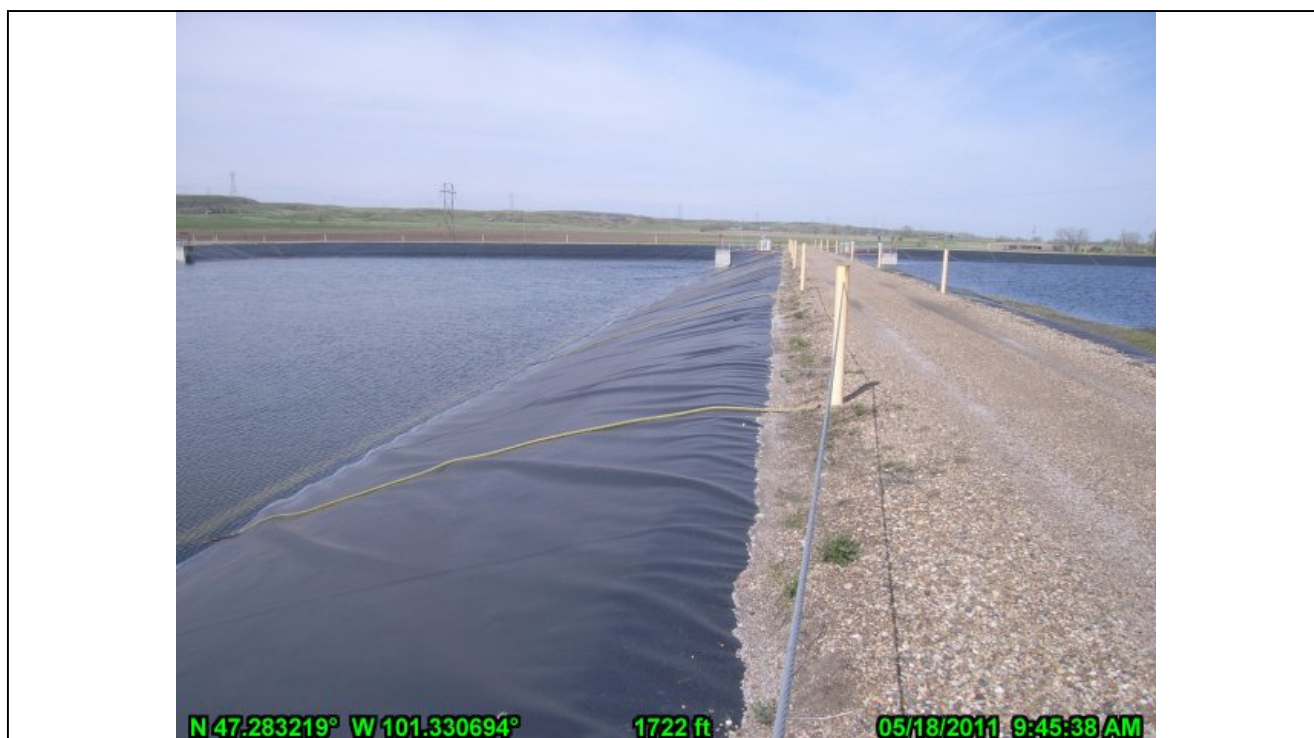
24-Divider Dike Liner on North Side of Center Pond (looking west)

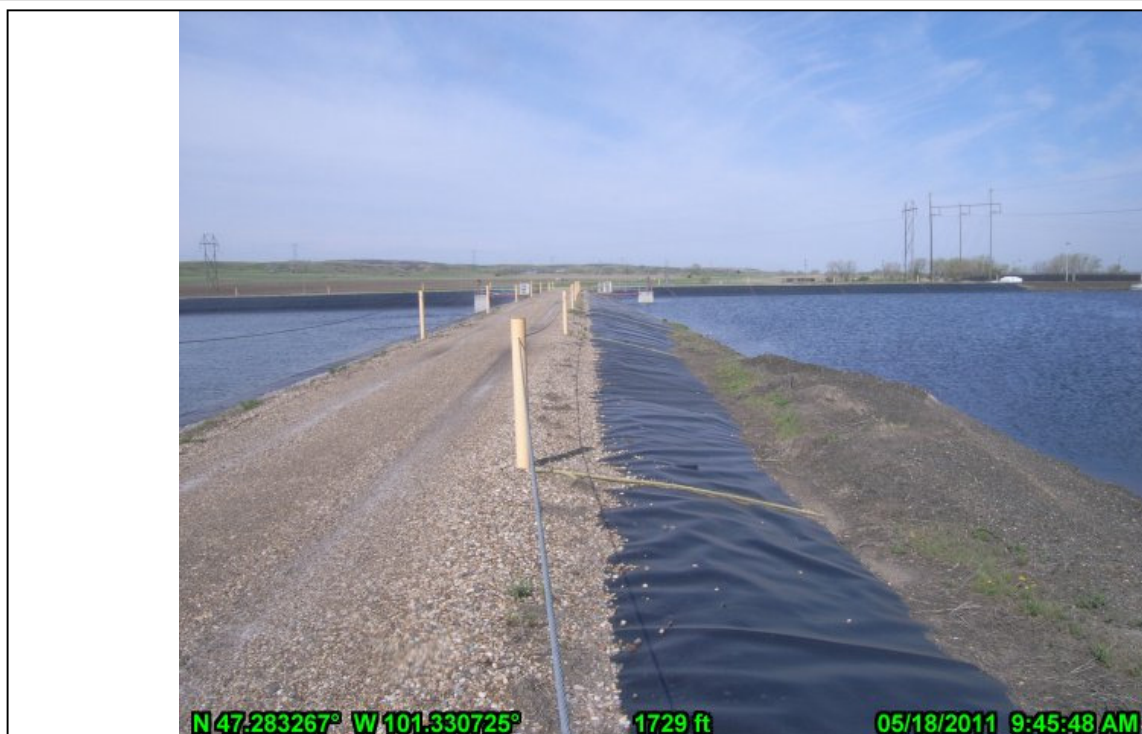
Overall, the upstream slope of the impoundment was in satisfactory condition. Photos 1, 25, 29, and 30 show the conditions of the upstream slope. Specific observations include:

25-Divider Dike Liner on South Side of North Pond (looking west)

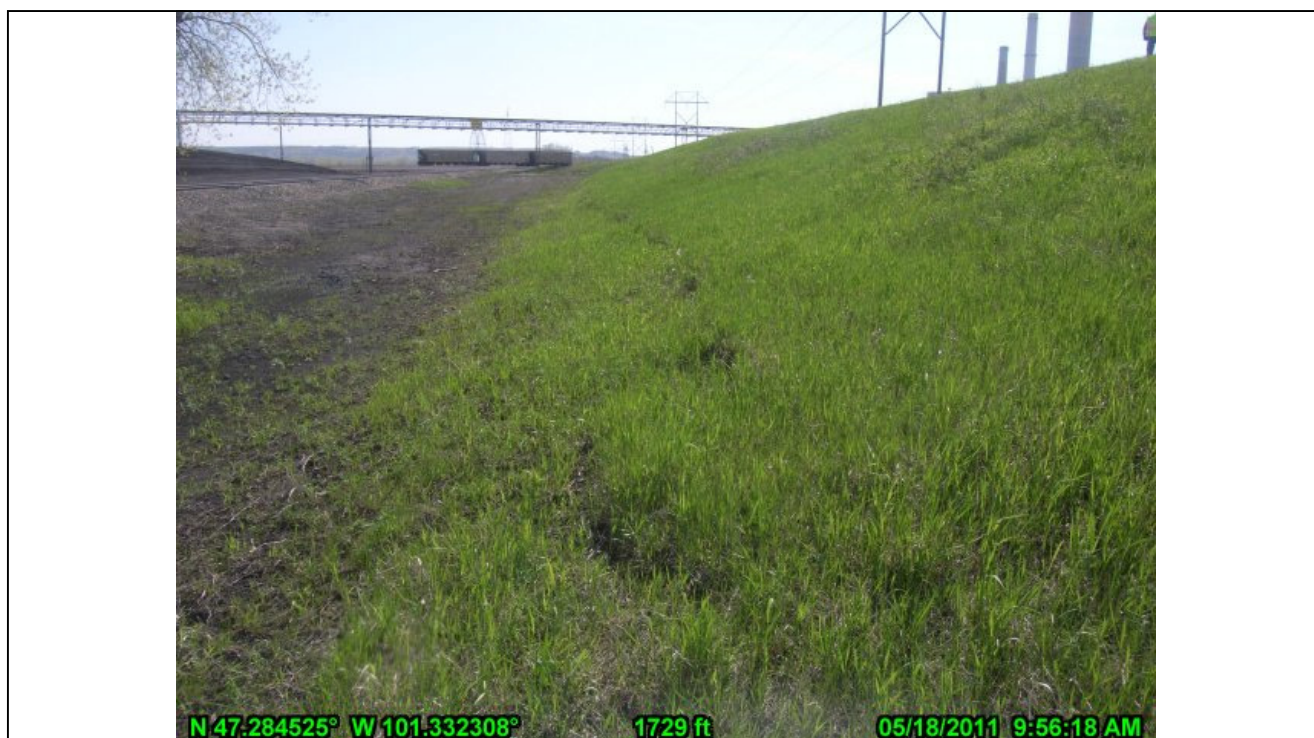
32-Approximately 100' Long Scarp Along Toe of North Embankment (looking east)

1. Repair embankment scarps and sloughs by July 1, 2013.
2. Maintain a log of maintenance and other activities at the impoundments and supporting facilities by July 1, 2013.
3. Update the Operation and Maintenance (O&M) Manual for the impoundments and the facility by July 1, 2013.

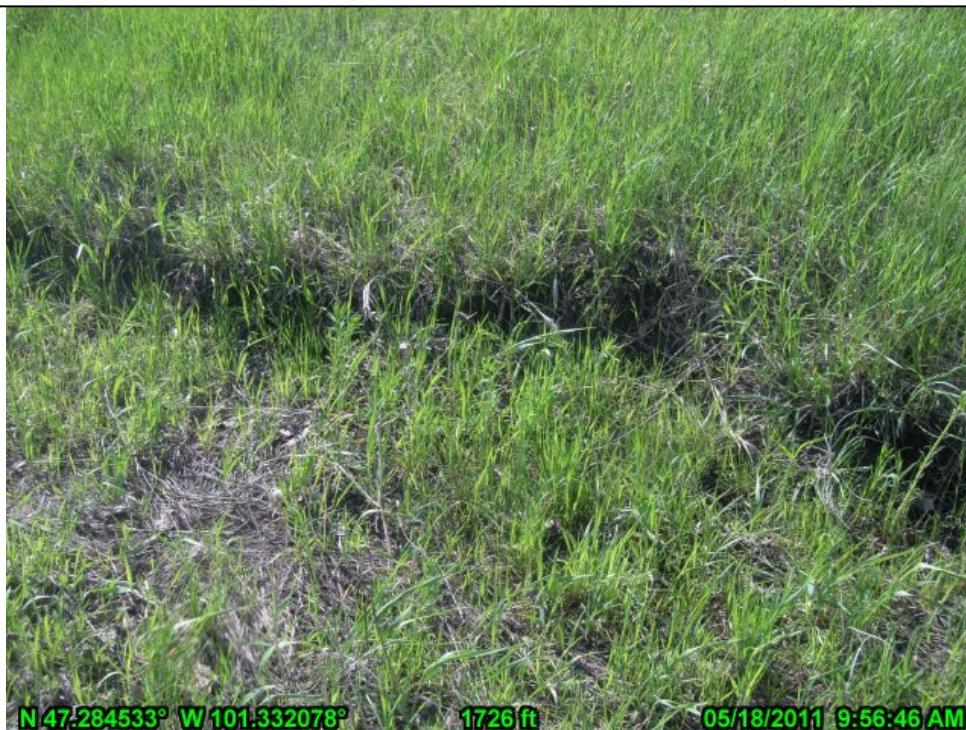
33-Scarp at Toe of North Embankment Approximately 8" Deep

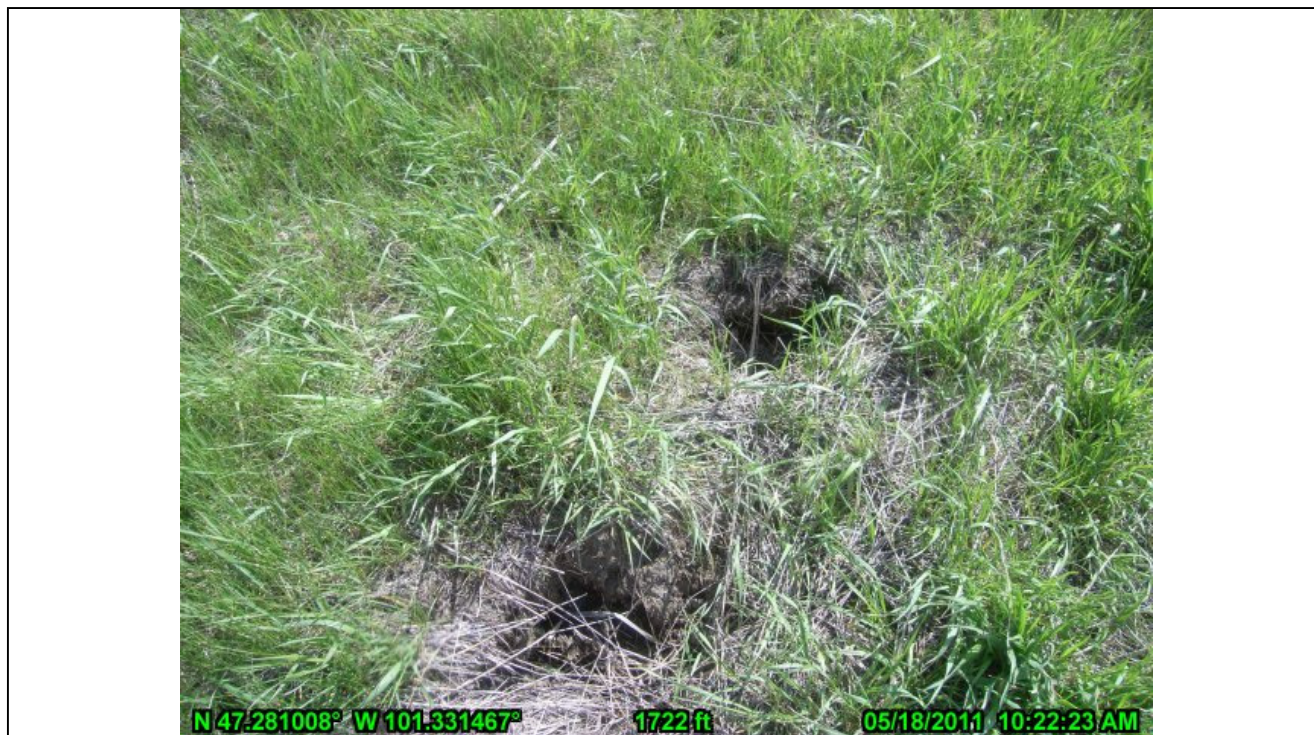
- A few animal burrows were noted.

36-Animal Burrows Approximately 6" to 12" Diameter

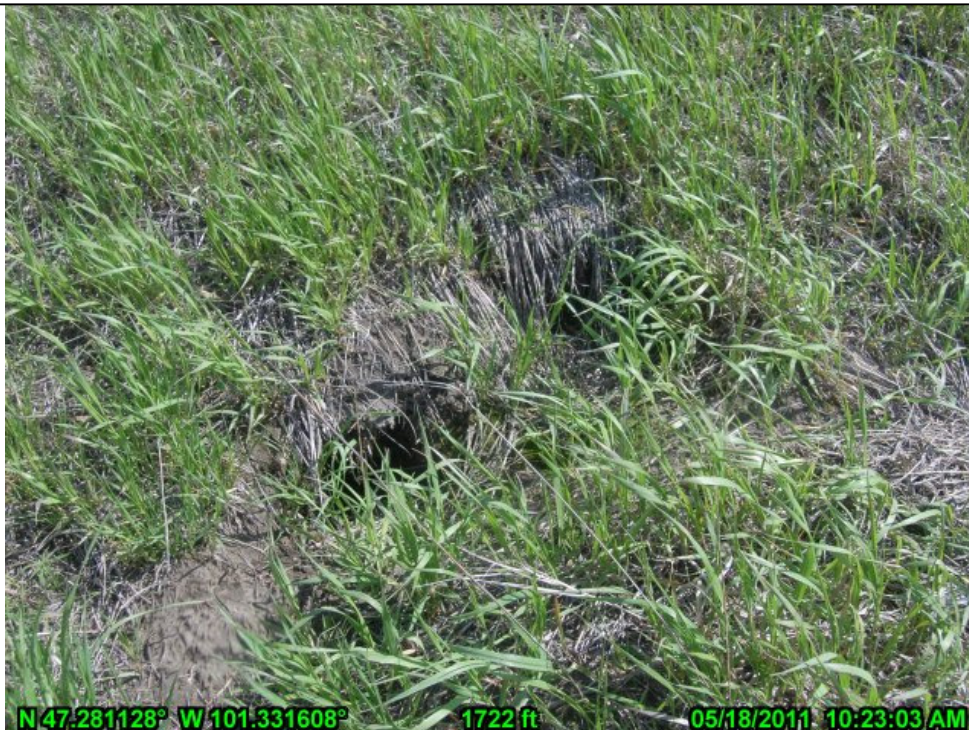
37-Animal Burrows Approximately 6" to 12" Diameter

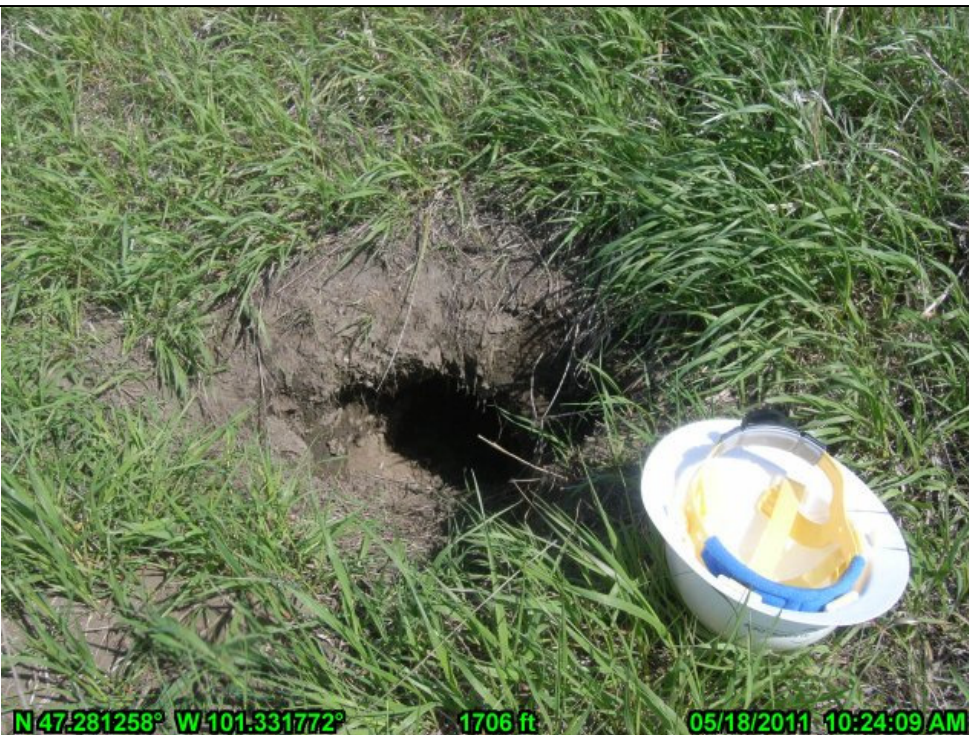
38-Animal Burrows Approximately 6" to 12" Diameter

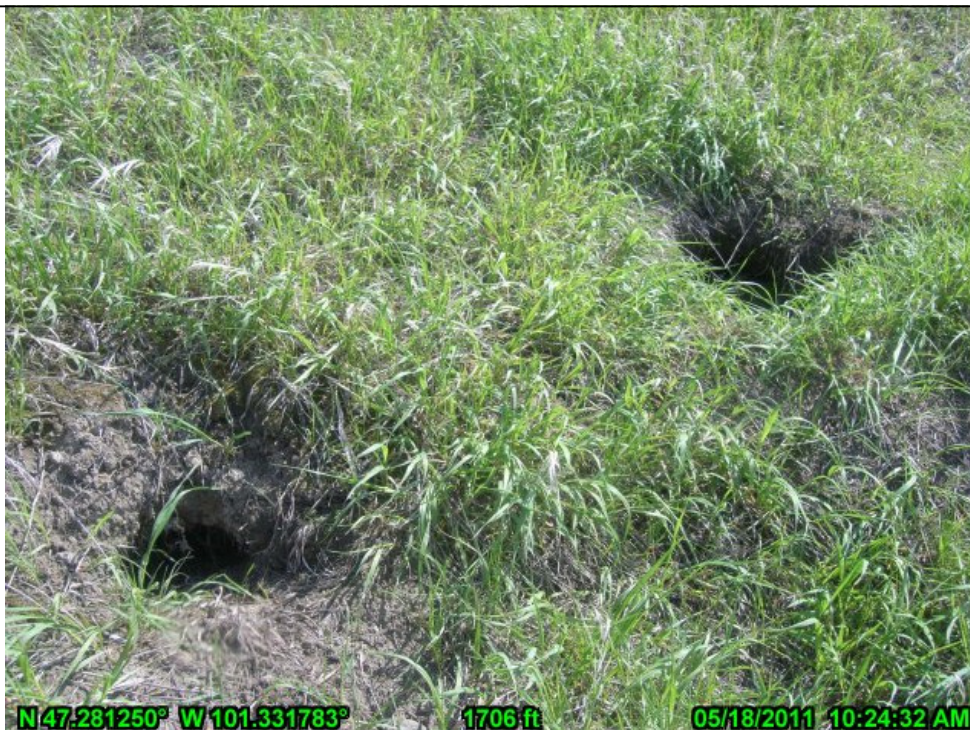
Overall, the downstream slope was in reasonably Fair condition. Photos 10, 35, 38, and 39 show the conditions of the downstream slope. Specific observations include:

39-Animal Burrows Approximately 6" to 12" Diameter

- Several animal burrows were observed. Some of the burrows were quite large – up to a 10-inch diameter opening. This condition should be remedied with a more aggressive animal control program, as the entire pond complex is

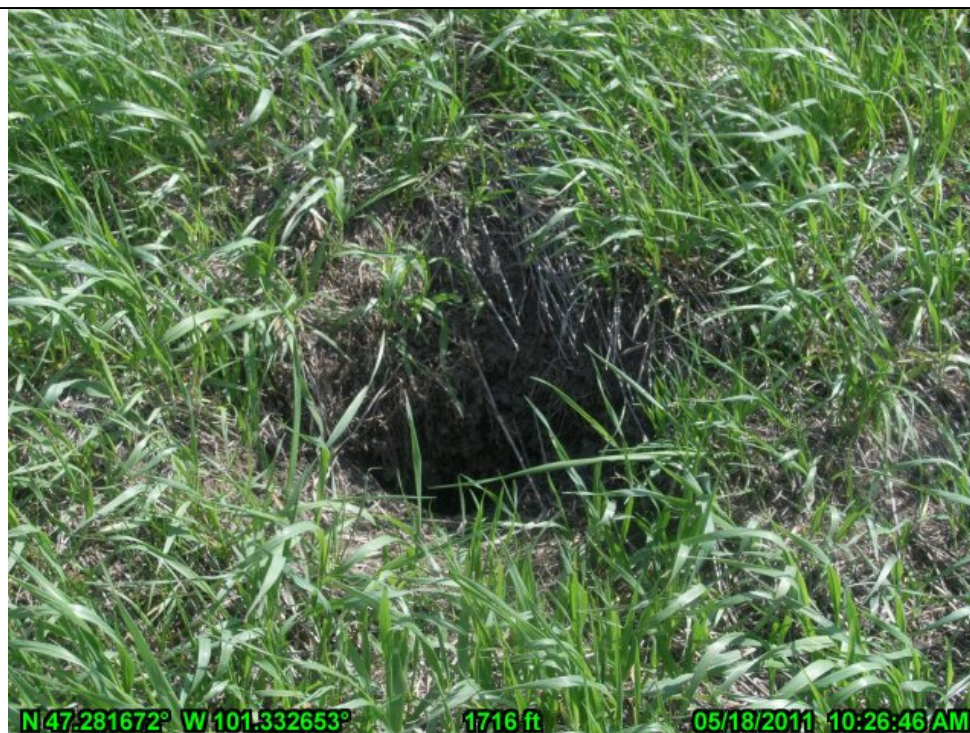
40-Animal Burrows Approximately 6" to 12" Diameter

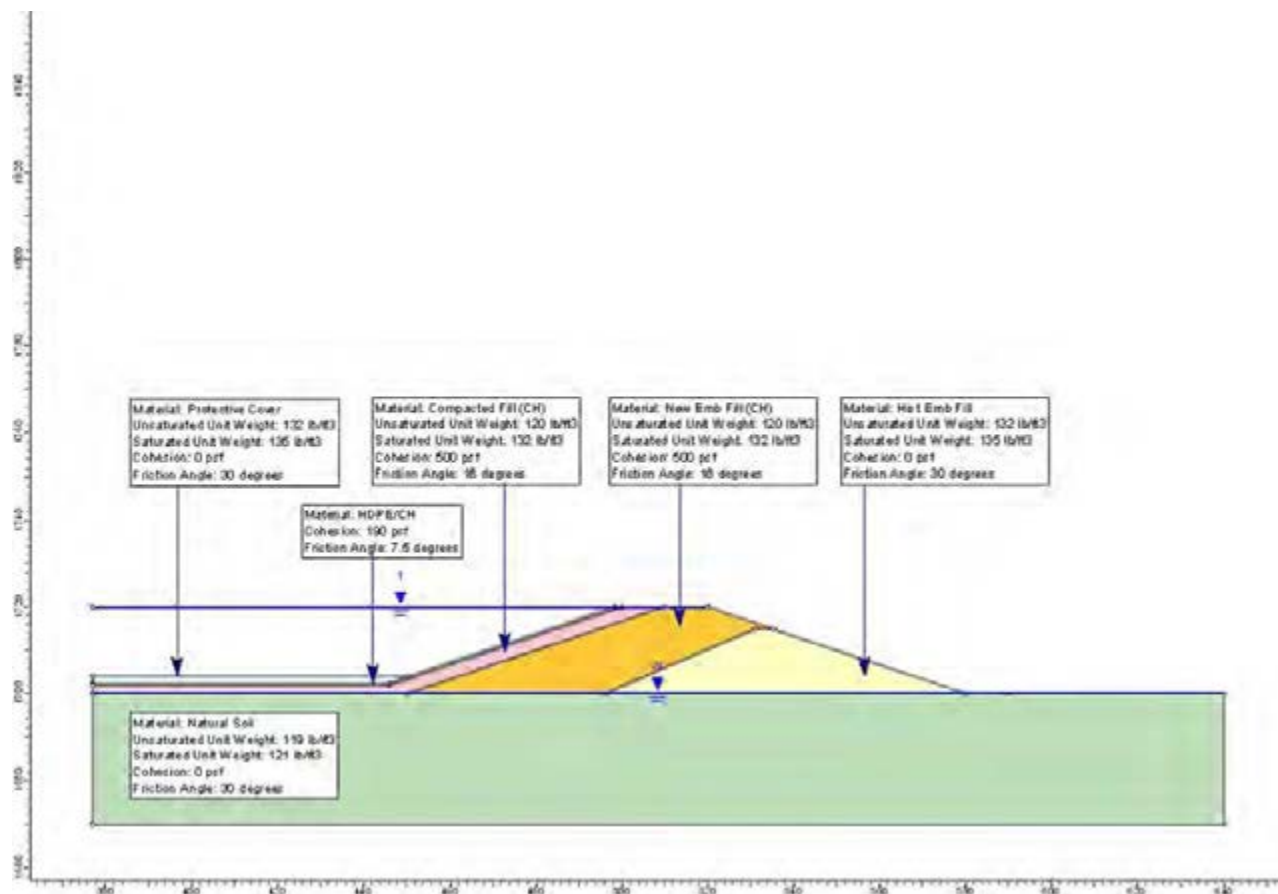
FIGURE 3

The geometry of the north and south downstream slopes are the same; therefore, one stability analysis was performed to examine both downstream slopes. The stability of the downstream slopes was examined according to design grades. The design indicates a 20-foot wide crest at an elevation of 1720 feet with 3:1 side slopes to approximately 1700 feet. Grades from a 2001 aerial survey were used to confirm the design slope geometry. The cross section for the north and south downstream slope is shown on Figure 3.

NORTH AND SOUTH BERMS
CROSS SECTION

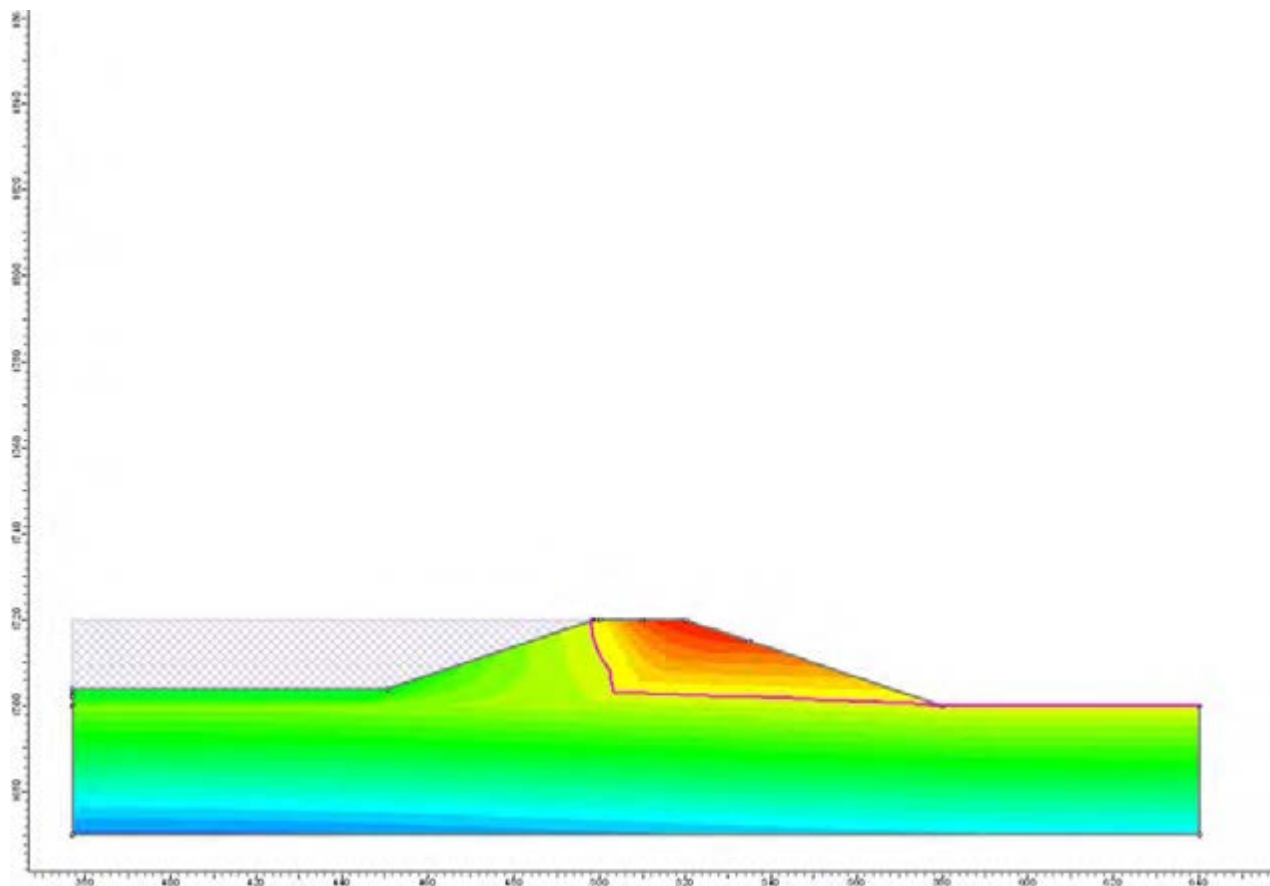
FIGURE 5

For the north/south, east and west downstream sections, the stability of each cross section was analyzed for the condition of an intact geomembrane and if no geomembrane is present reflective of a severely compromised geomembrane liner. For both analyses, the water level in the impoundment was set at elevation 1720 feet to represent maximum conditions. With an intact geomembrane, there was no flux assumed between the impoundment and the groundwater. The stability analysis for the condition of no geomembrane required the development of a phreatic surface through the berm. The phreatic surface was determined using groundwater finite element modeling within SLIDE. This surface was then modeled in the slope stability analysis as a piezometric surface through the berm. The finite element model for the phreatic surface through the north/south, west and east cross sections is shown on Figures 5, 9, and 13, respectively.

NORTH AND SOUTH BERMS WITH NO GEOMEMBRANE WATER TABLE ANALYSIS RESULTS

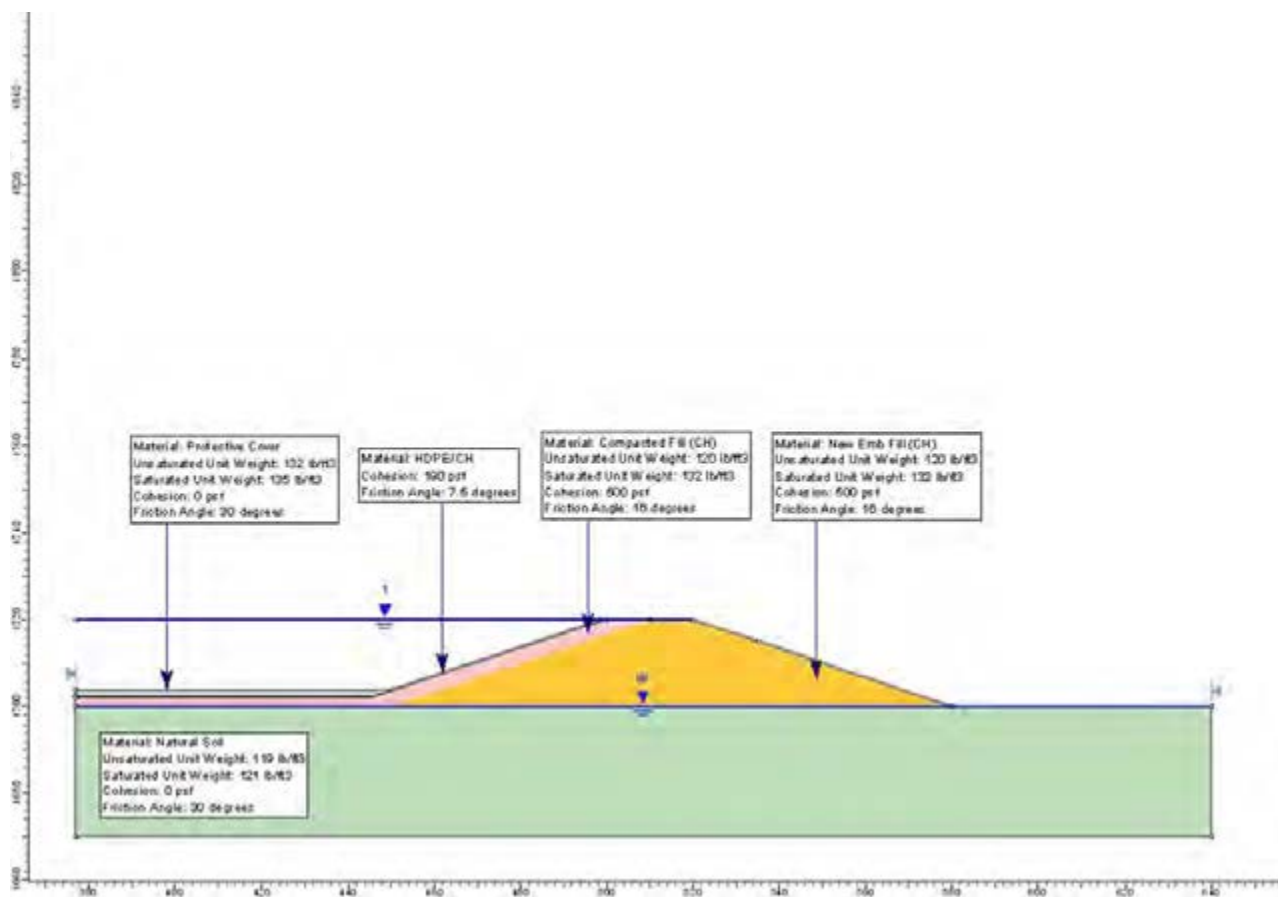
FIGURE 7

The west downstream slope has a design crest width of 20 feet at an elevation of 1720 feet and extends at an approximate 3:1 slope down to an elevation of 1700 feet (approximately). This section geometry was also verified with grades from the 2001 aerial survey. The cross section for the west downstream slope is shown on Figure 7.

WEST BERM CROSS SECTION
