COAL ASH IMPOUNDMENT SITE ASSESSMENT FINAL REPORT

**Stanton Station
Great River Energy**

KLEINFELDER PROJECT NUMBER 118953-2

October 26, 2012

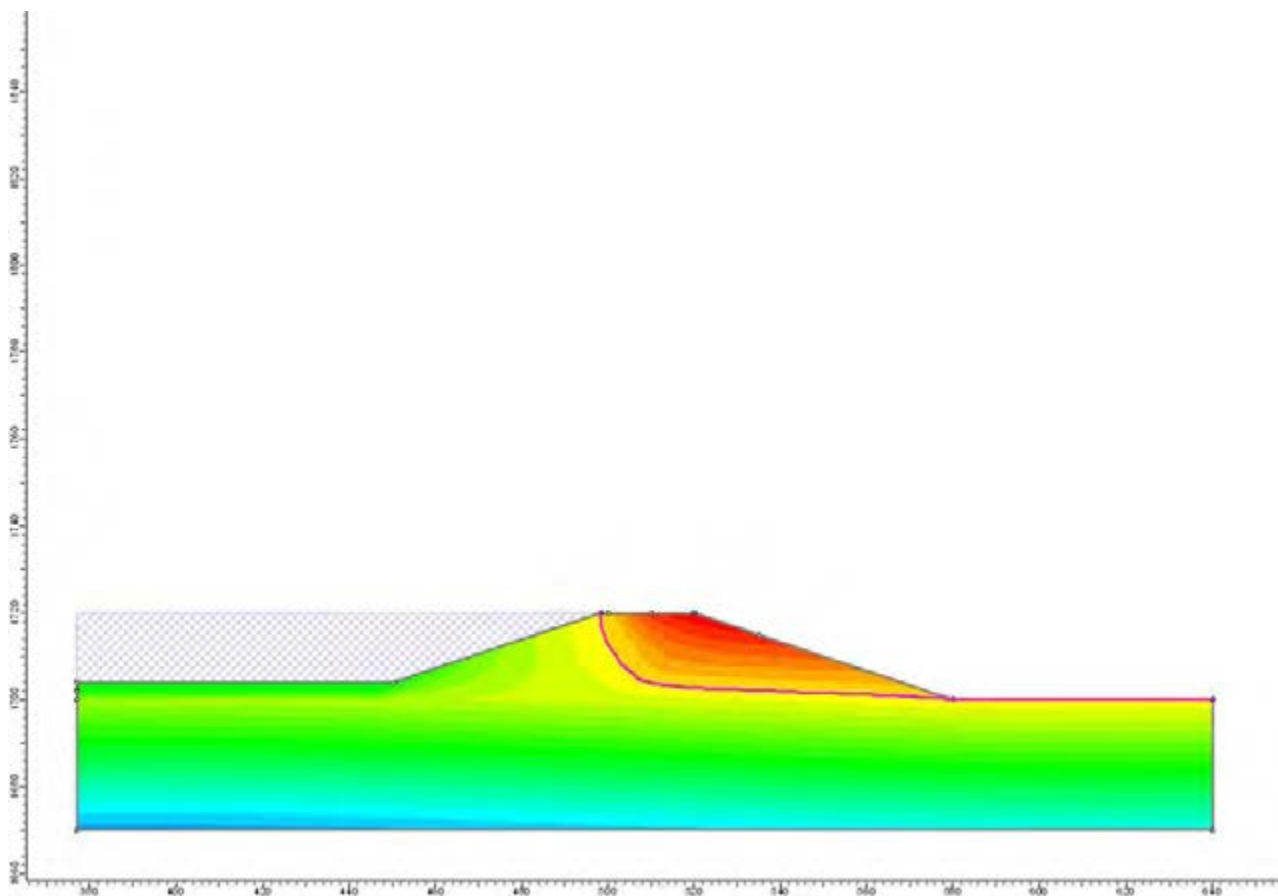
FIGURE 9

For the north/south, east and west downstream sections, the stability of each cross section was analyzed for the condition of an intact geomembrane and if no geomembrane is present reflective of a severely compromised geomembrane liner. For both analyses, the water level in the impoundment was set at elevation 1720 feet to represent maximum conditions. With an intact geomembrane, there was no flux assumed between the impoundment and the groundwater. The stability analysis for the condition of no geomembrane required the development of a phreatic surface through the berm. The phreatic surface was determined using groundwater finite element modeling within SLIDE. This surface was then modeled in the slope stability analysis as a piezometric surface through the berm. The finite element model for the phreatic surface through the north/south, west and east cross sections is shown on Figures 5, 9, and 13, respectively.

**WEST BERM WITH NO GEOMEMBRANE
WATER TABLE ANALYSIS RESULT**

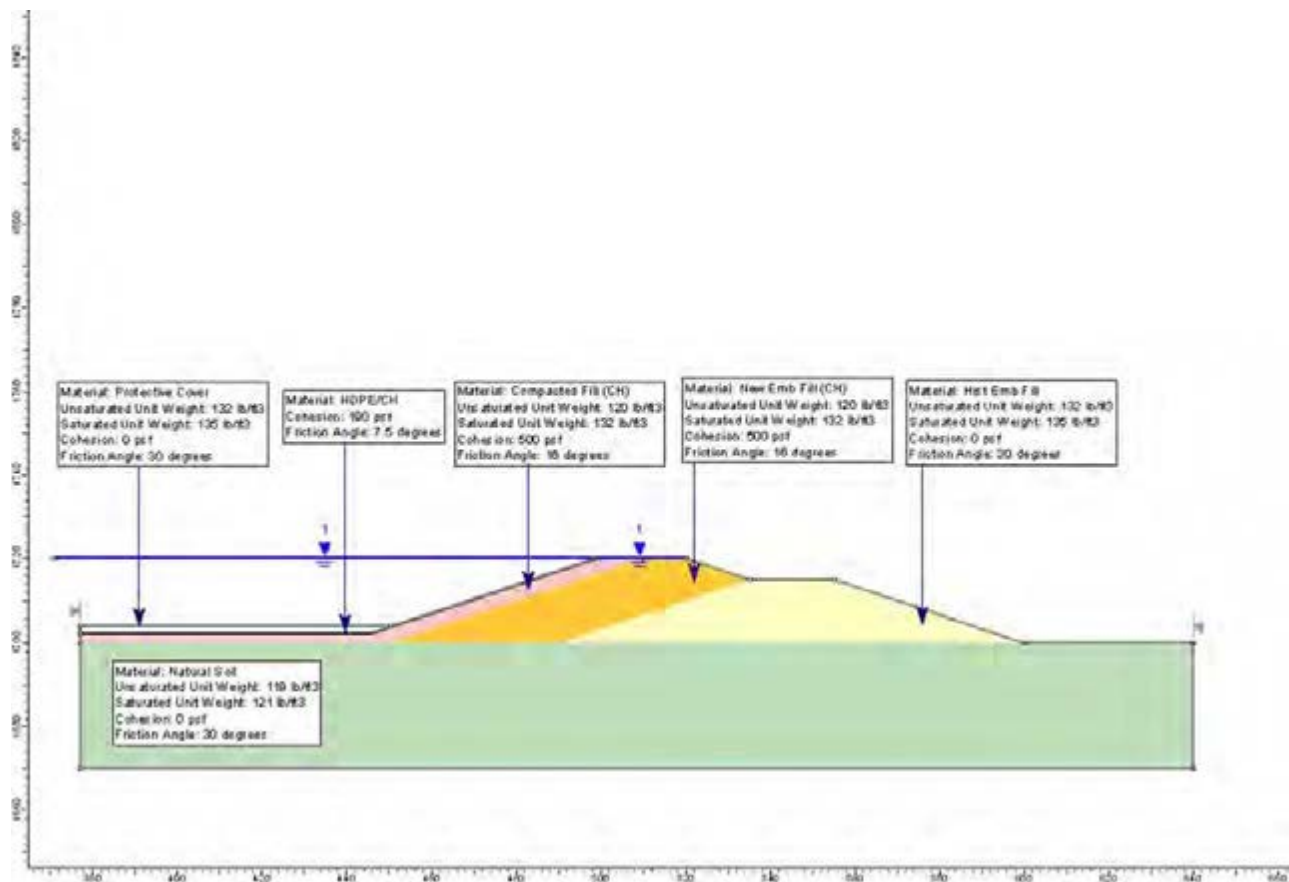
FIGURE 11

The east downstream slope has a design crest width of 20 feet at an elevation of 1720 feet and extends at an approximate 3:1 slope down to an elevation of 1715 feet. There is a 4-foot wide bench at elevation 1715 then 3:1 slope down to an elevation of 1700 feet (approximately). Site observations, as-built drawings and sections developed using the 2001 aerial survey do not match the design geometry. The bench at elevation 1715 is substantially wider than the design and was modeled as 20 feet. The cross section for the east downstream slope is shown on Figure 11.

**EAST BERM
CROSS SECTION**

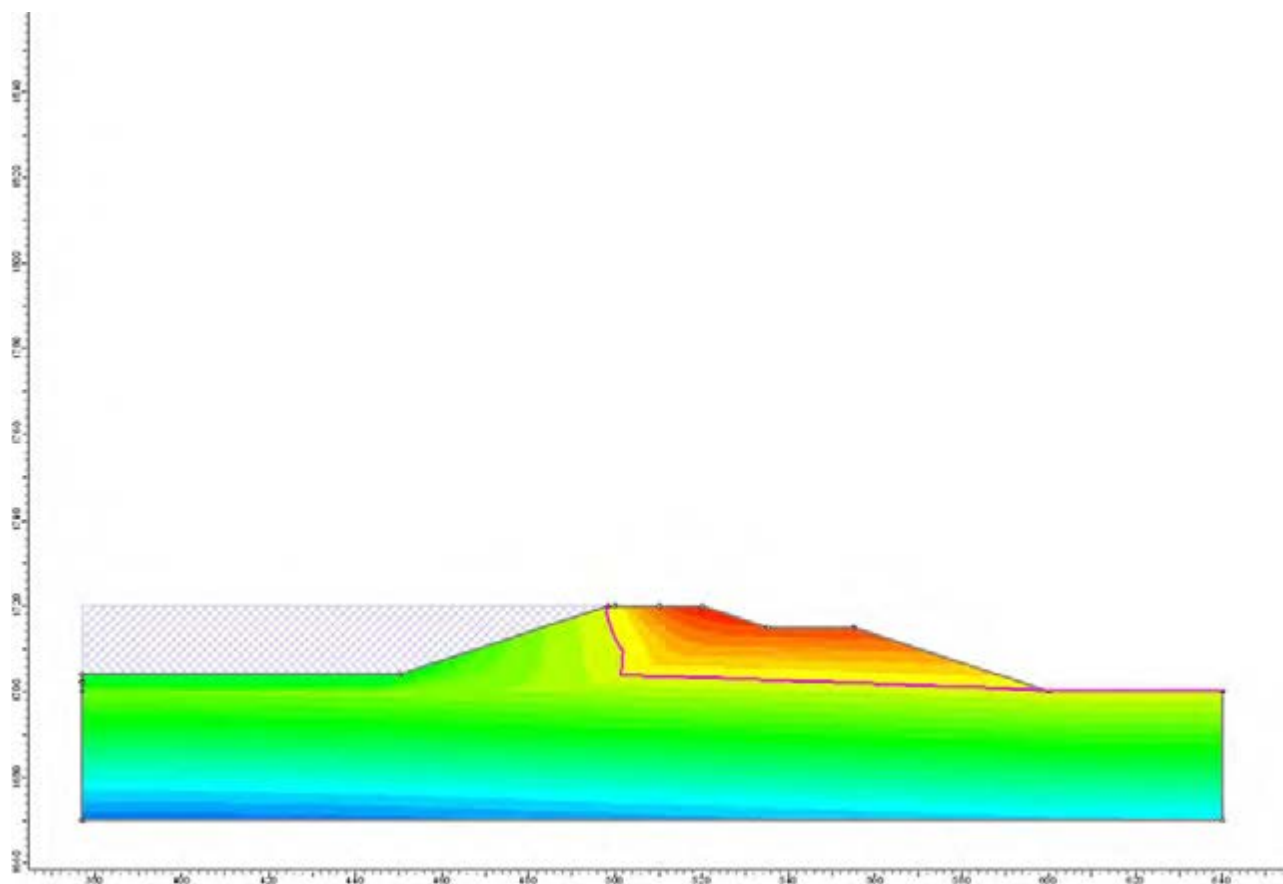
FIGURE 13

**EAST BERM WITH NO GEOMEMBRANE
WATER TABLE ANALYSIS RESULT**

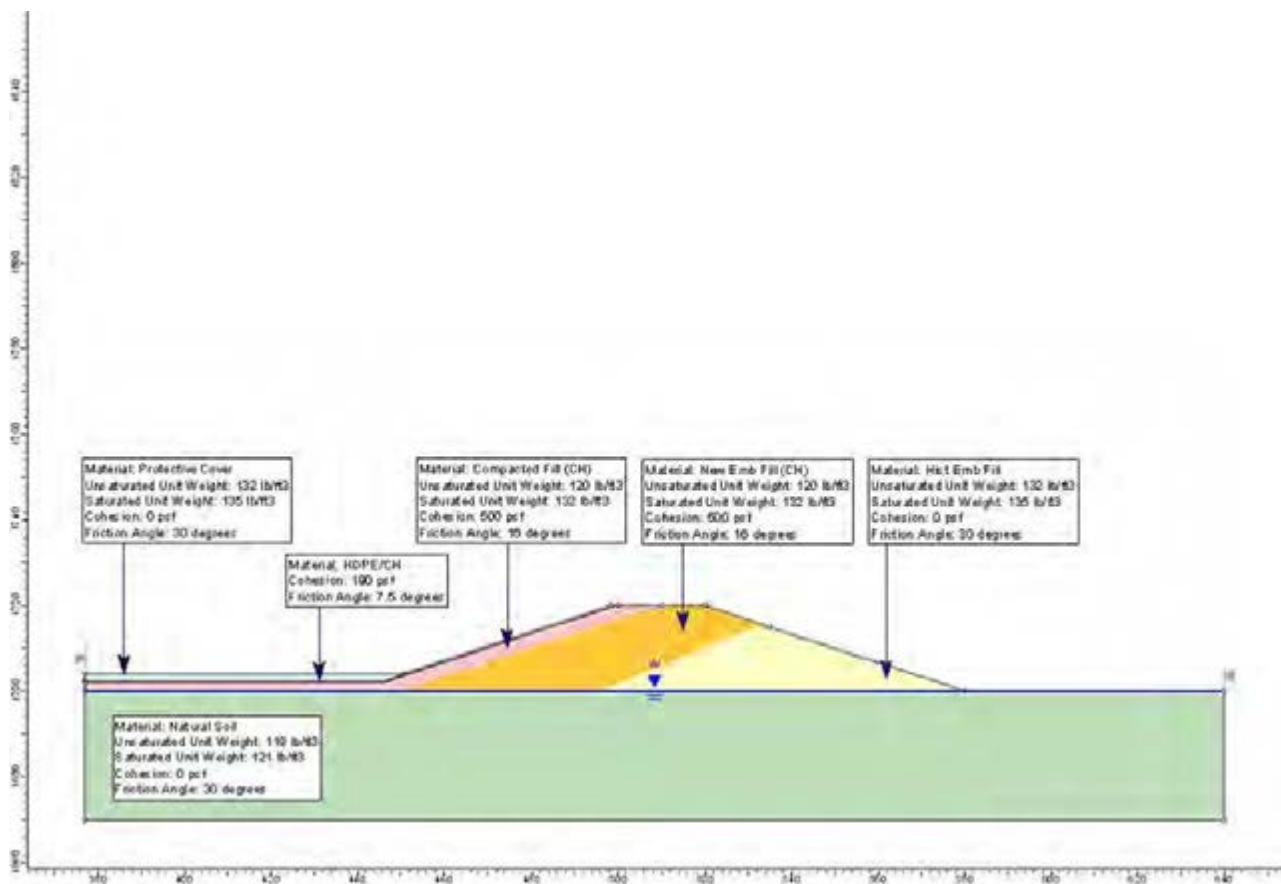
FIGURE 15

The upstream slope has an approximate 3:1 slope from elevation 1720 feet down to elevation 1702 feet. This section geometry was verified with the as-built drawings and grades from the 2001 aerial survey. The cross section for the upstream slope is shown on Figure 15. The analysis of the upstream slope did not look at bottom ash on the smooth geomembrane but focused on the underlying clay liner and berm.

UPSTREAM CROSS SECTION

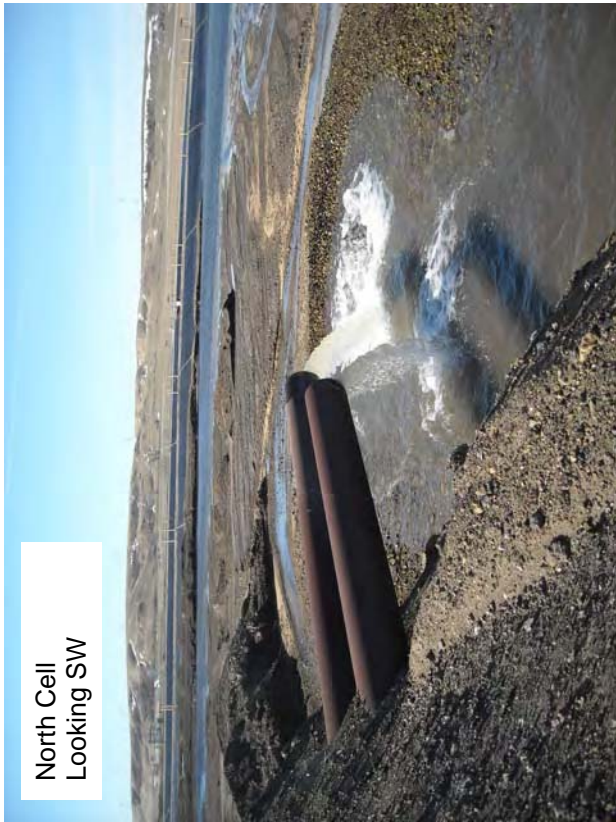
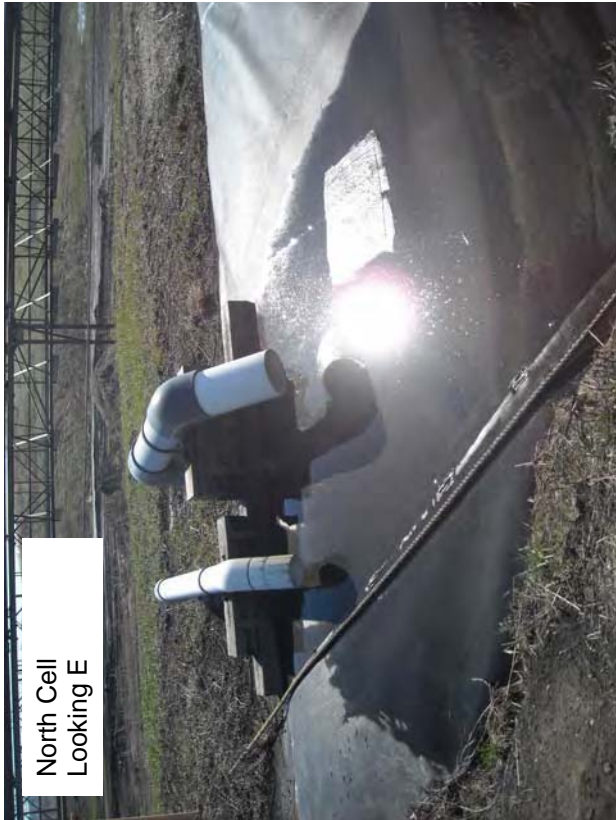
| <div>North Cell Looking SW</div> <div></div> | <div>Bottom Ash Inlet Pipes (001)</div> | <div>North Cell Looking E</div> <div></div> | <div>Coal Pit and Retention Ponds Inlets (002)</div> |

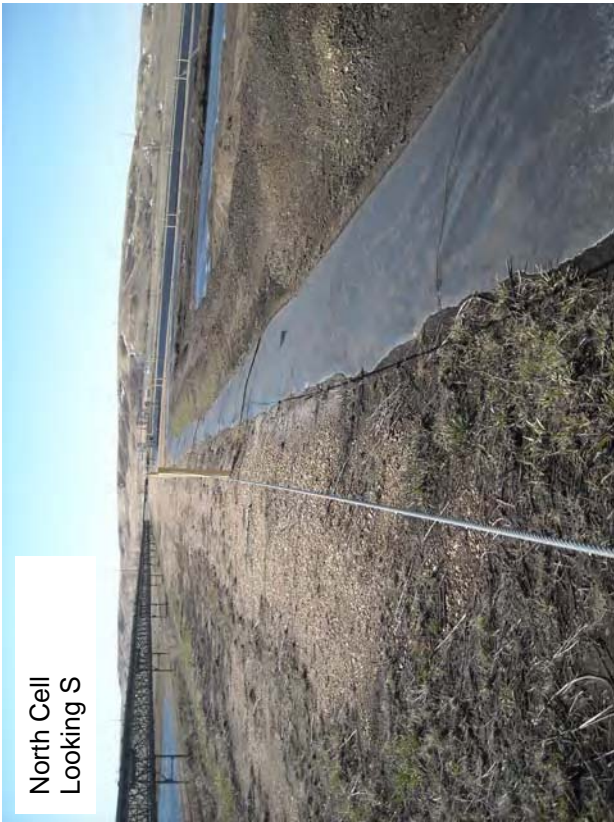
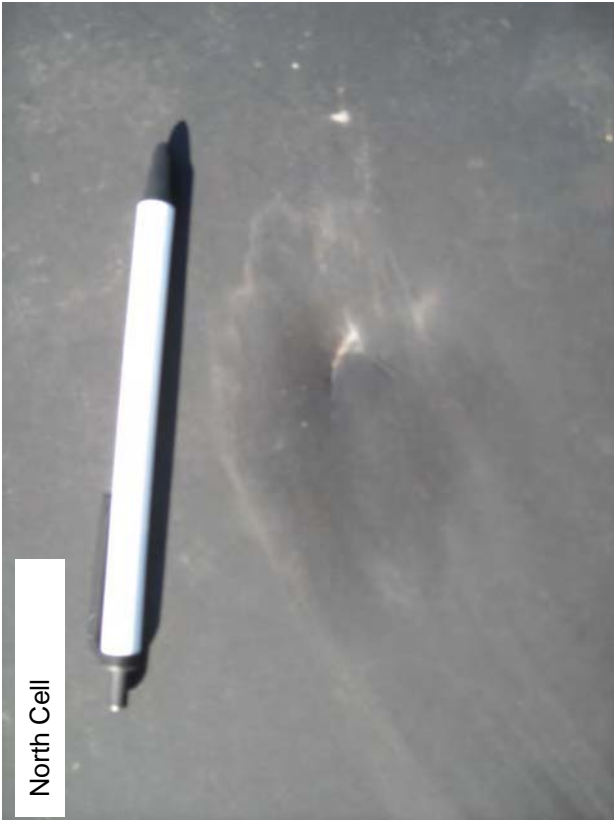
| <div>North Cell Looking S</div> <div></div> | <div>North Cell</div> <div></div> | <div>Small Puncture in Geomembrane Liner (006)</div> | |
| <div>Exposed Geomembrane on East Upstream Slope (004)</div> | | | |

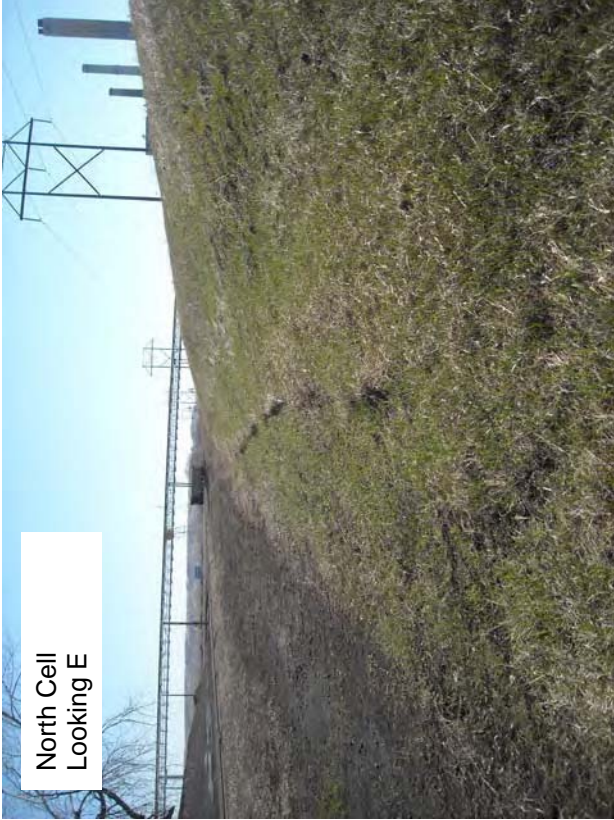
| <div>Crack in Shallow Cover over Anchor Trench (021)</div> <div>A close-up photograph of a concrete surface, likely a dam or outlet structure, showing a significant crack running horizontally across the frame. The surface is covered with small, dark, irregular patches, possibly mold or debris.</div> | <div>Steepened Toe of North Downstream Slope (023)</div> <div>A photograph showing a steep, grassy slope. In the background, there are industrial structures, including a tall chimney and a power line tower, under a clear blue sky.</div> |

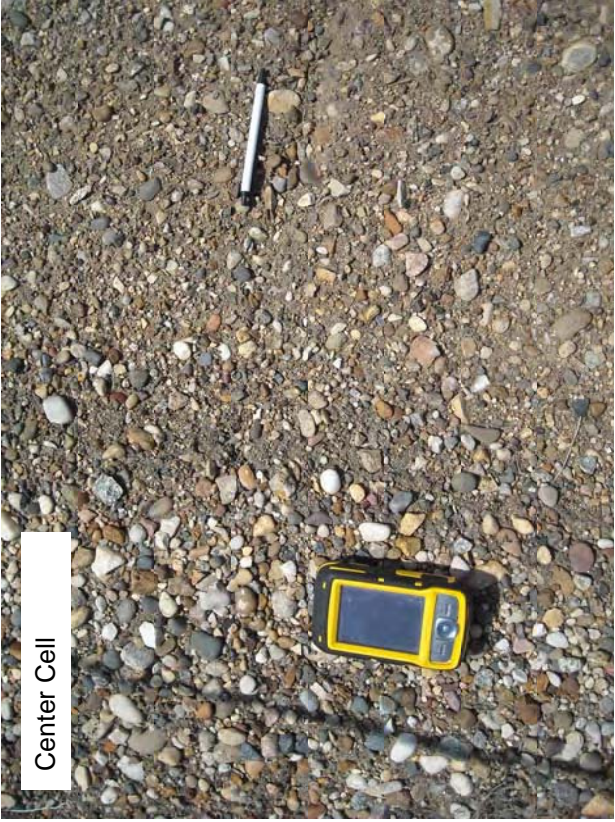
| <div>Inlet Structure from North Cell (042)</div> <div> </div> | <div>Center Cell</div> <div></div> |
| <div>Damaged/Broken Egress Safety Rope (045)</div> | <div>Slight Crack Across West Berm (046)</div> |

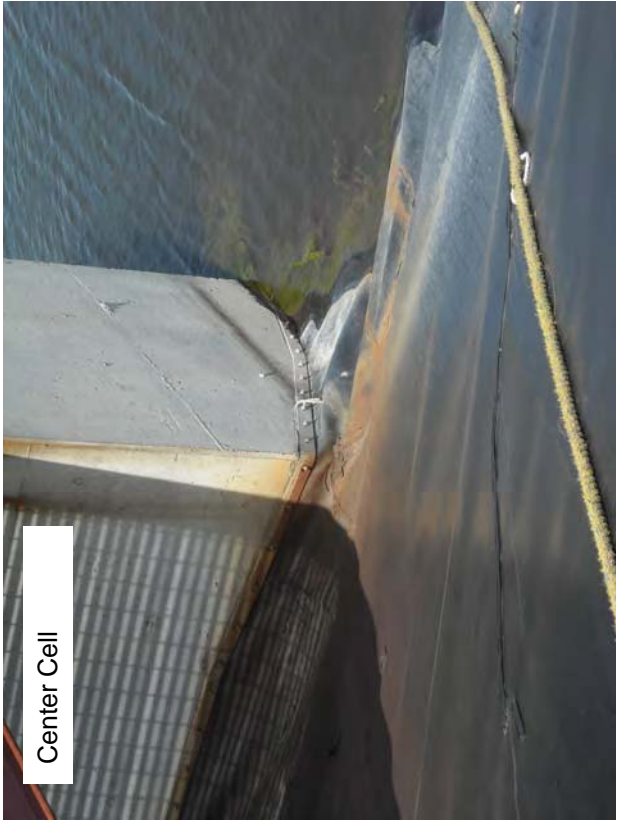
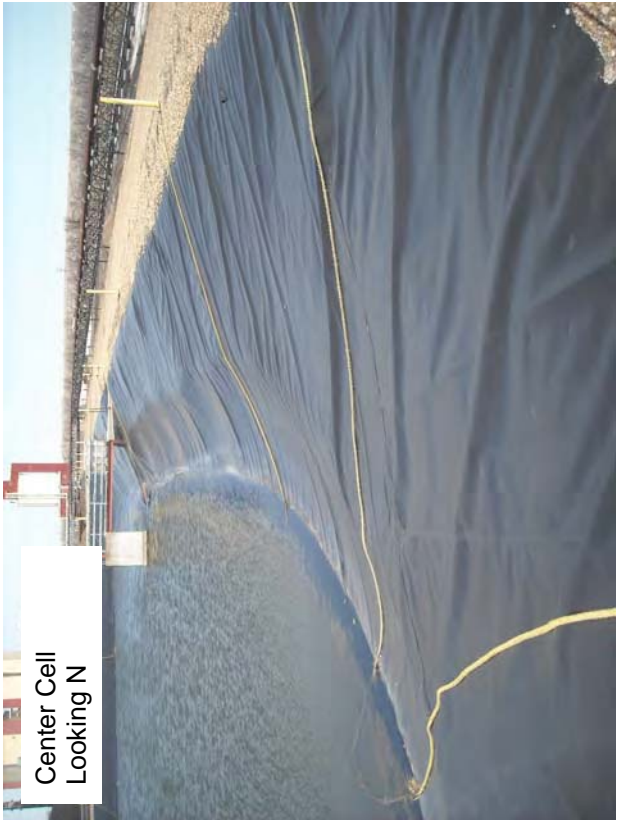
| Geomembrane Attachment to Inlet Structure (052) | Displacement of Lower Upstream Slope, East Berm (054) |

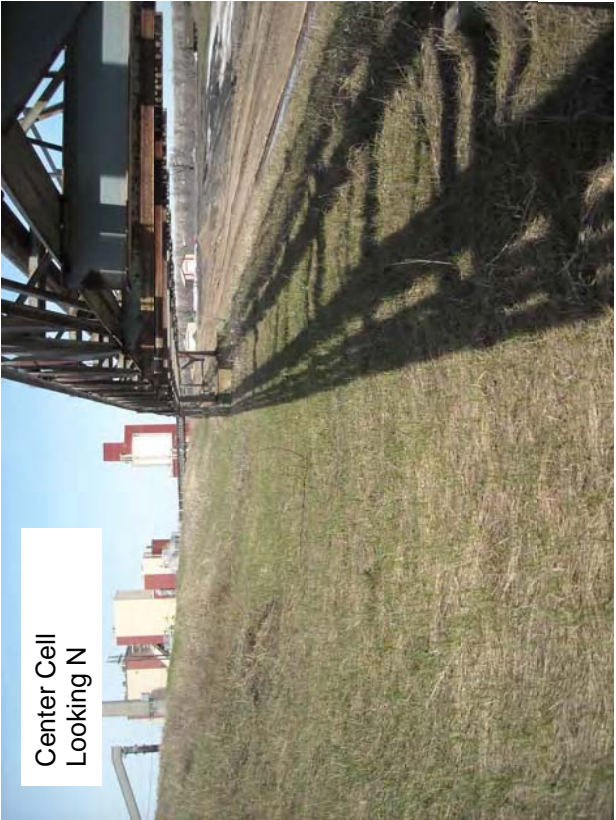
| East Berm Downstream Slope (055) | Displacement of Lower Upstream Slope, East Berm (056) |

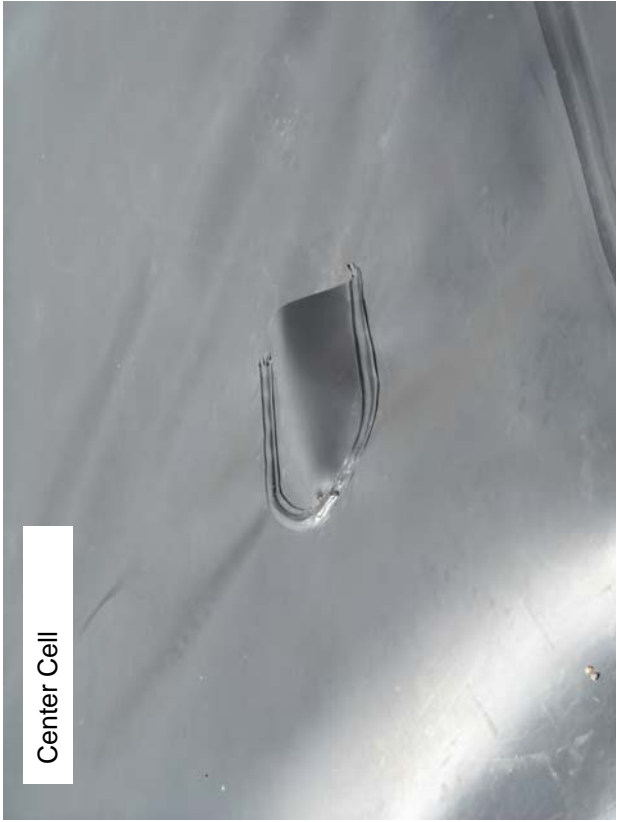
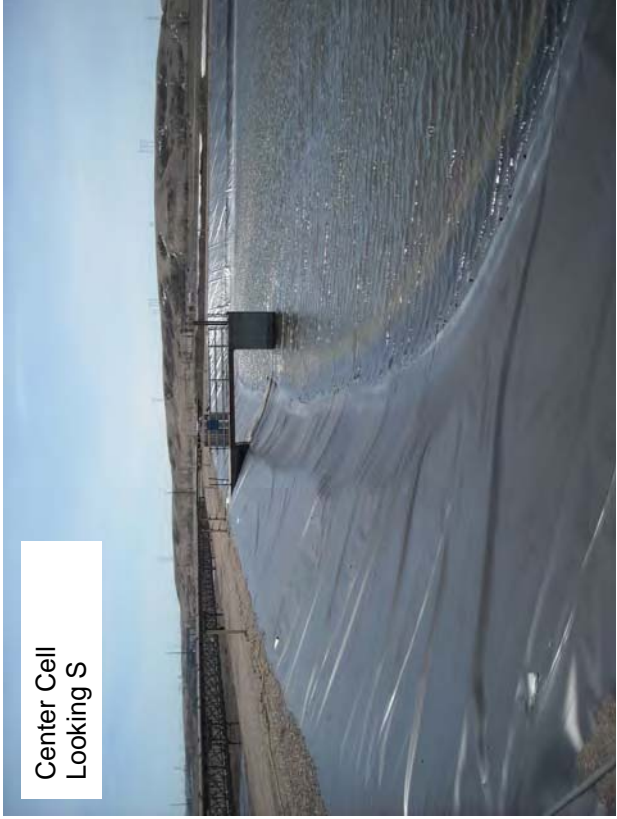
| Vent in Geomembrane Liner (057) | Center Cell from NE Corner, 1 of 3 (058) |

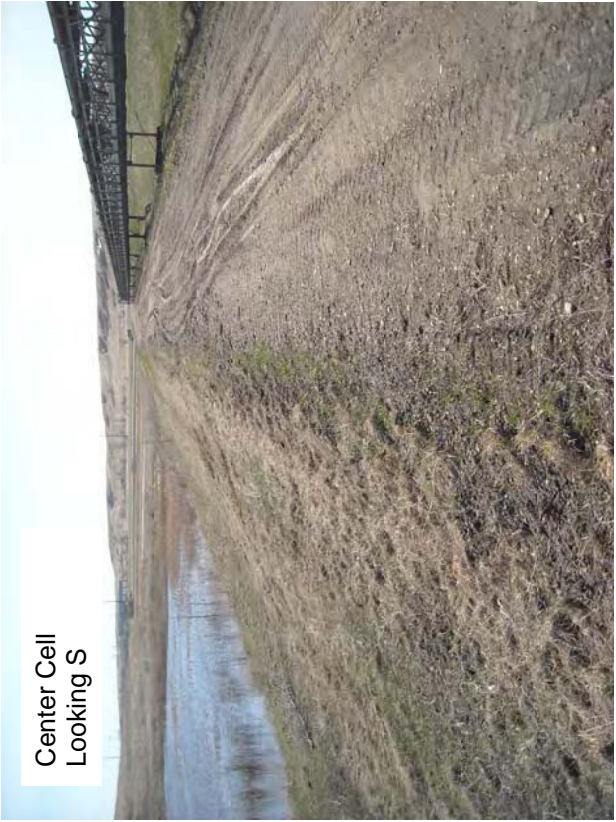
| <div>East Downstream Slope, Road at 1715 (063)</div> | <div>Erosion Rill/Slough/Scarp on East Downstream Slope (064)</div> |

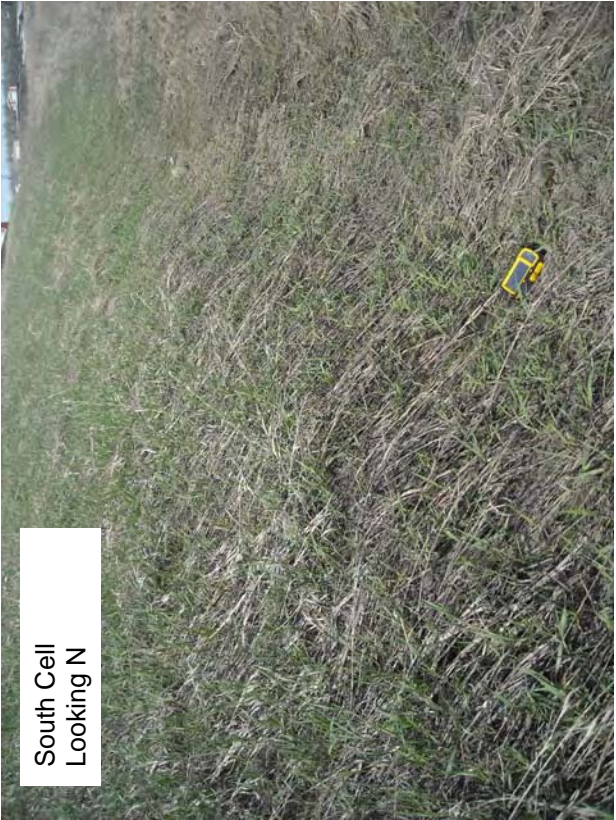
| <div>Downstream Slope of East Berm, Road at 1715 (097)</div> | <div>Erosion Rill/Slough/Scarp on East Downstream Slope (098)</div> |
| <div>Steepened Toe of East Downstream Slope (099)</div> | <div>Erosion Rill/Slough/Scarp on East Downstream Slope (101)</div> |

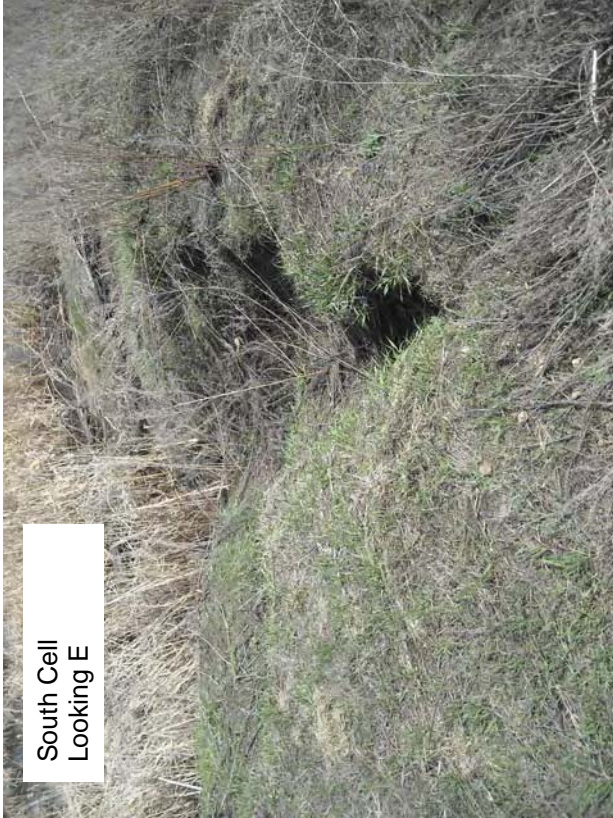
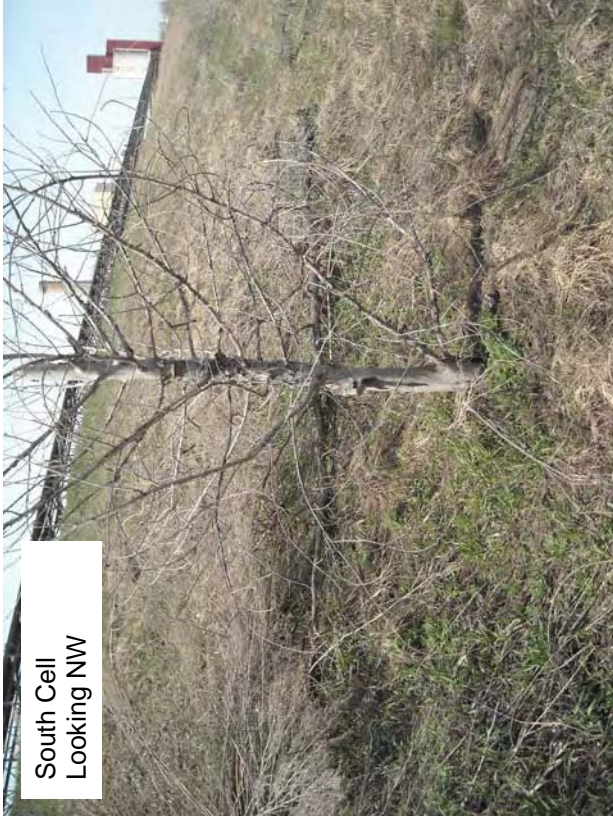
| <p>Erosion Rill/Slough/Scarp on East Downstream Slope (103)</p> | <p>Dead Tree at East Downstream Toe (104)</p> |

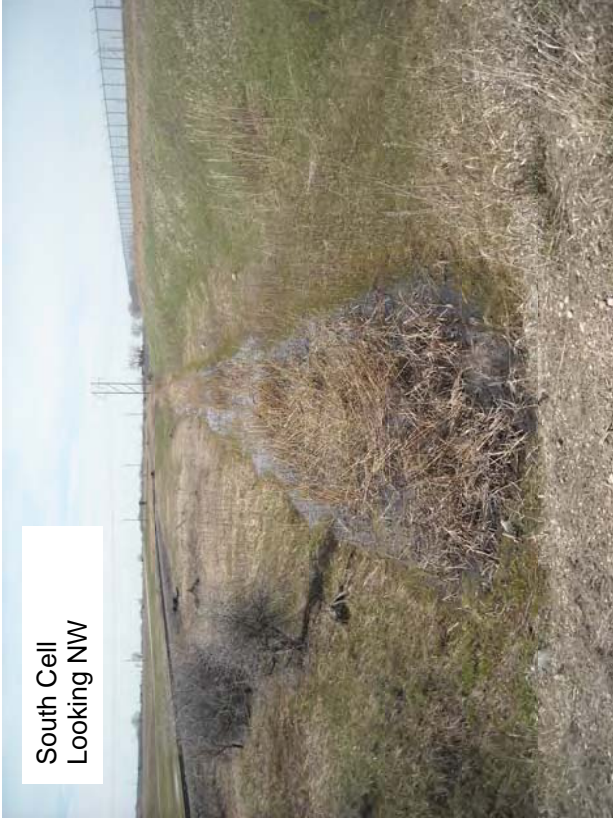
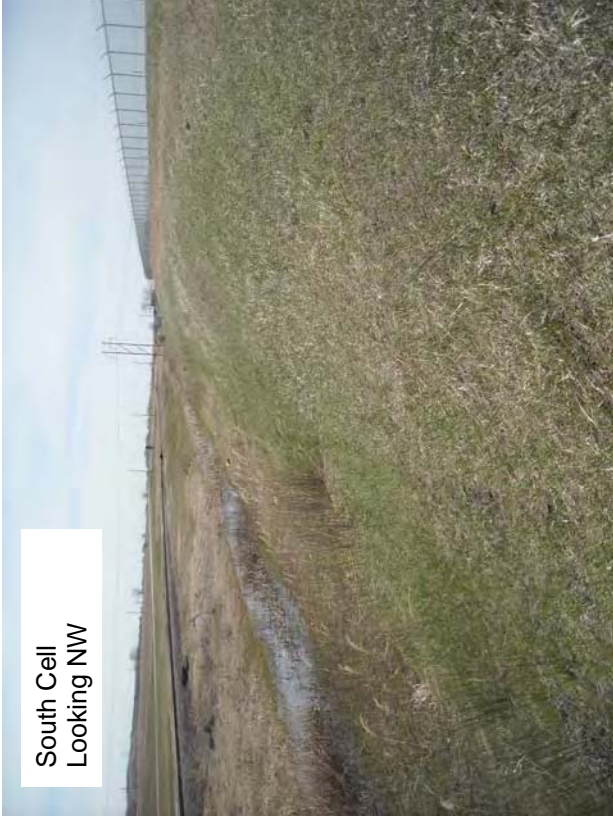
| <p>Ditch at Toe of South Downstream Slope (108)</p> | <p>South Downstream Slope (109)</p> |

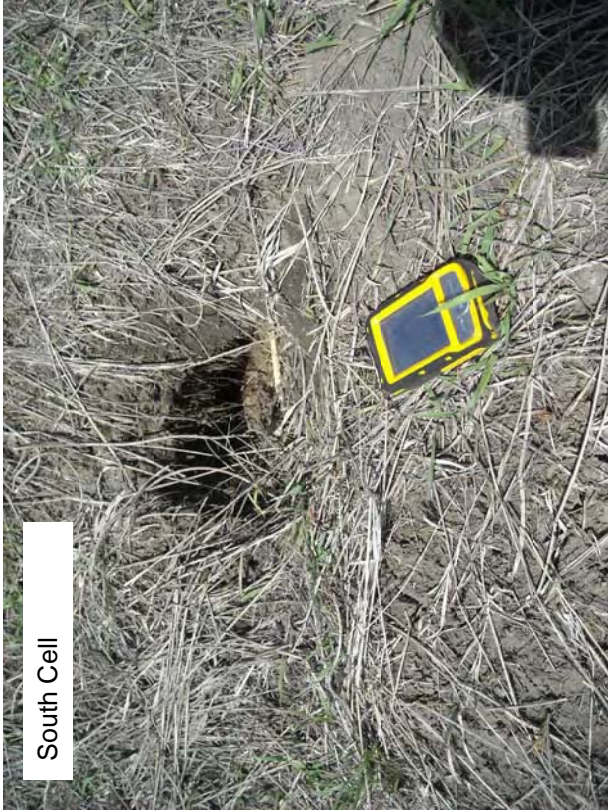
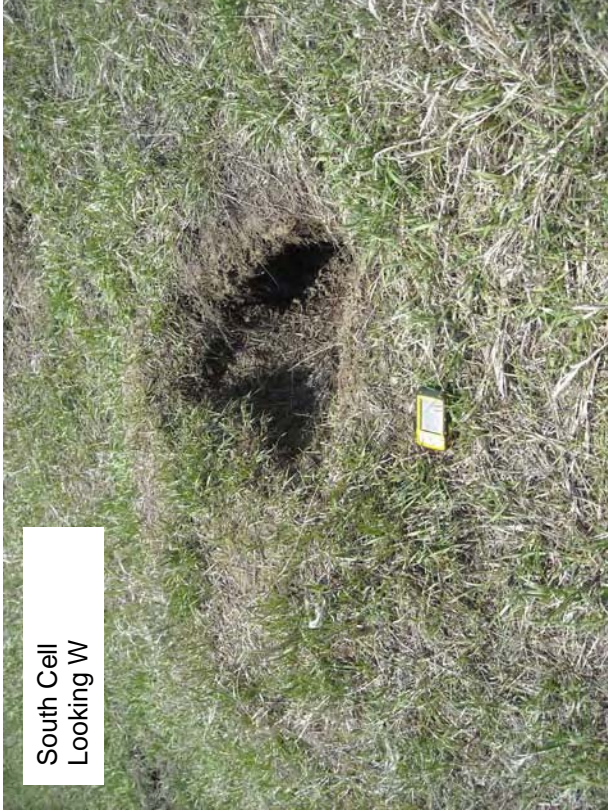
| <p>South Cell Looking W</p> | <p>South Cell Looking W</p> | Larger Animal Burrow on South Downstream Slope (110) | Larger Animal Burrow on South Downstream Slope (112) |

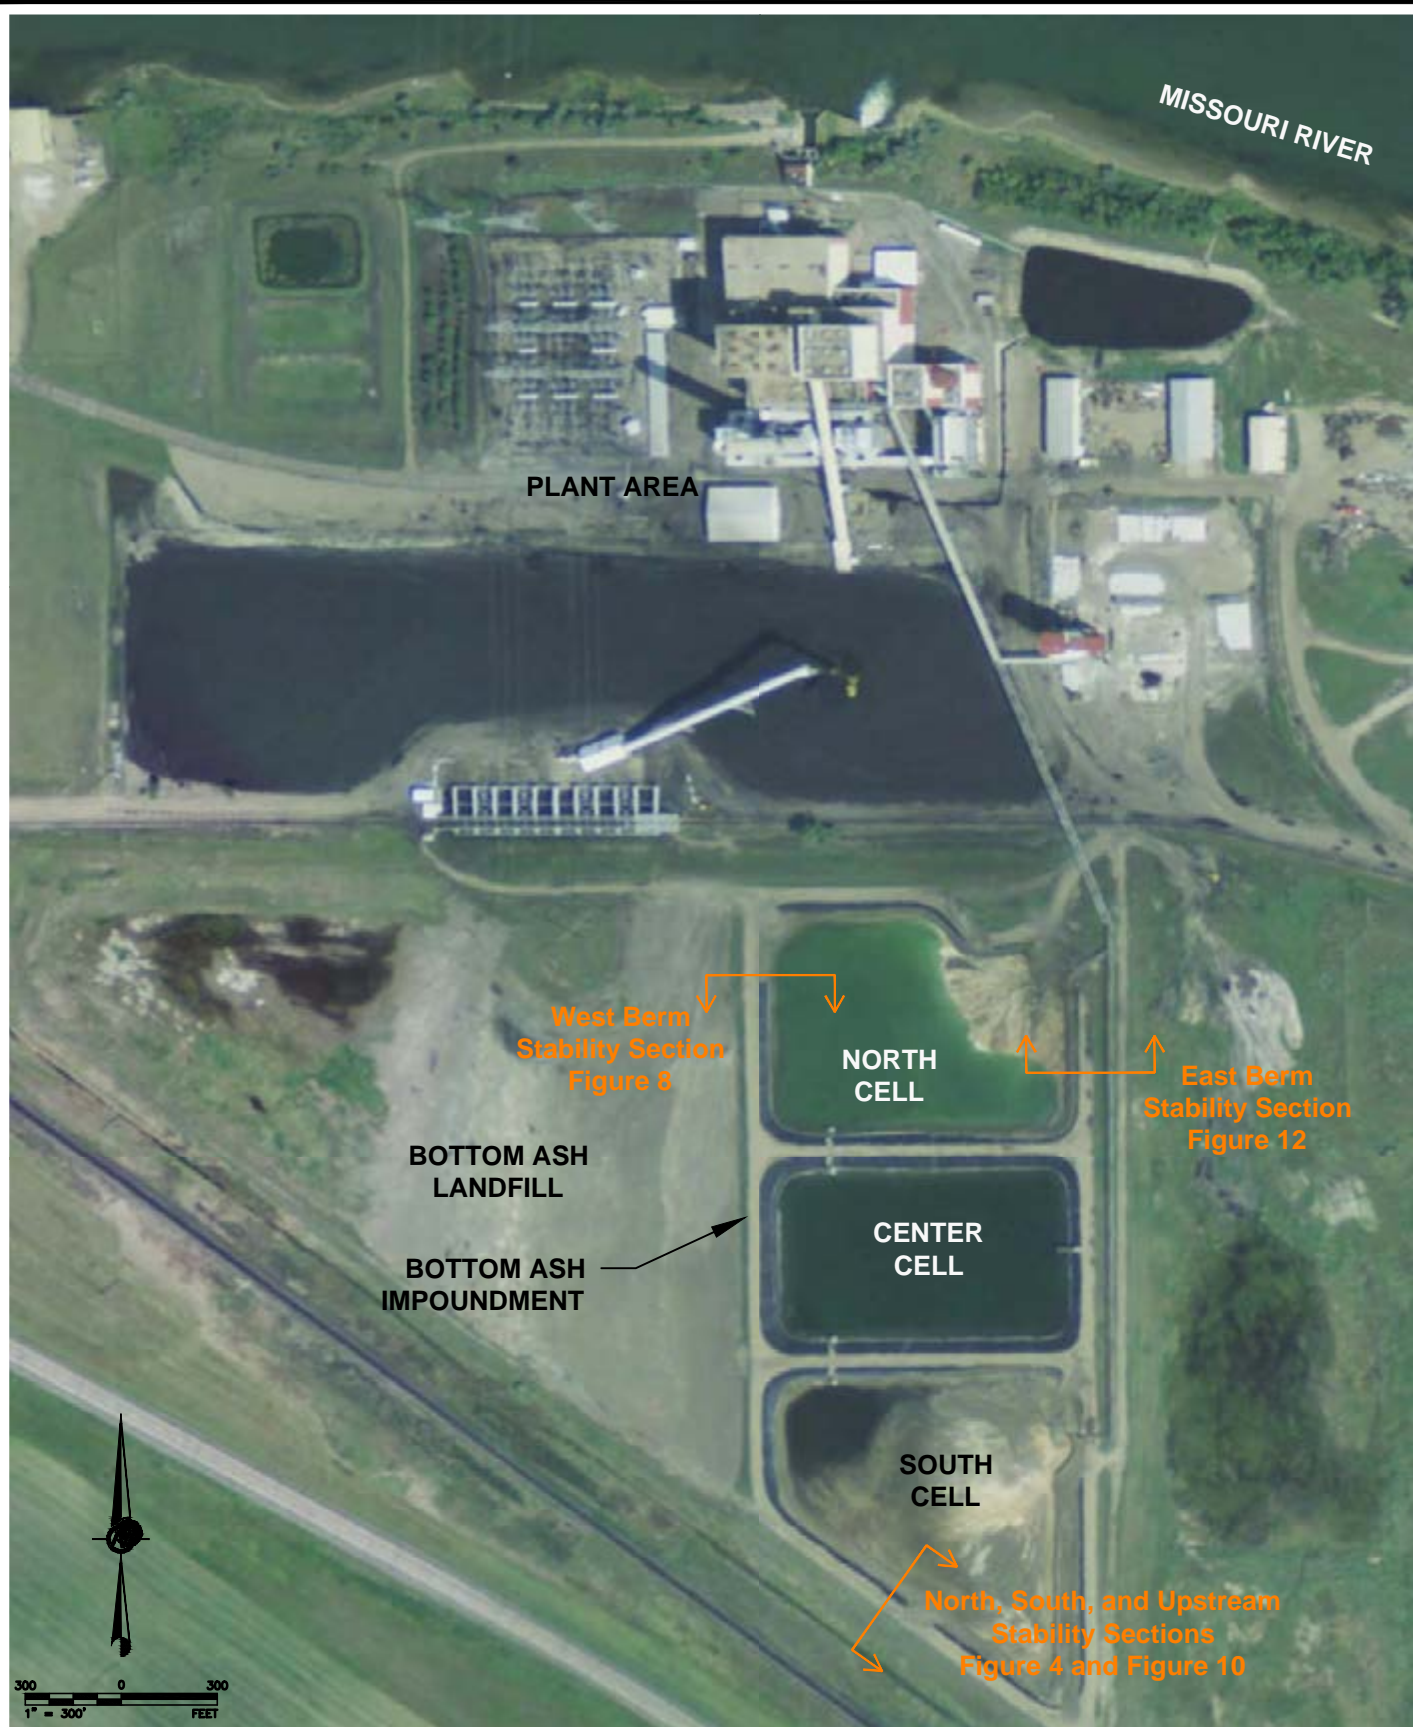
FIGURE 3

The cross sections that were evaluated for stability are the north/south, west, and east downstream (outside) slopes, and the upstream (interior) slope (Figure 3). Two scenarios for each cross section were evaluated. The first scenario examined the stability for an intact geomembrane and the second analysis

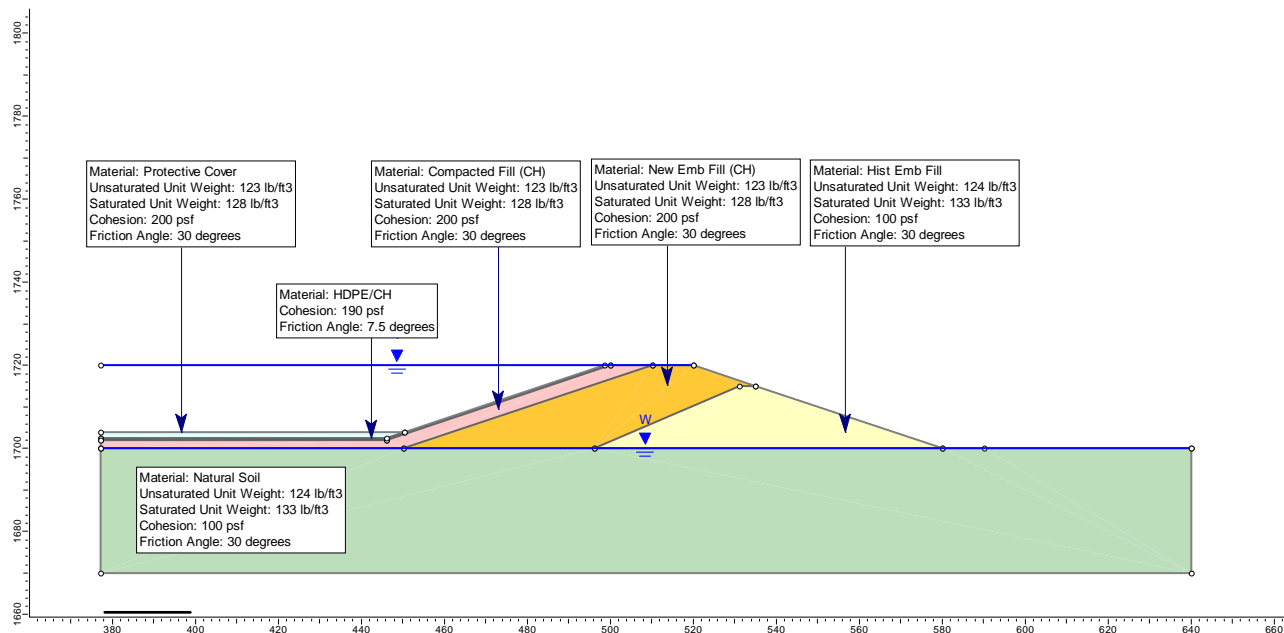
FIGURE 4

The geometry of the north and south downstream slopes are the same; therefore, one stability analysis was performed to examine both downstream slopes. The stability of the downstream slopes was examined according to design grades. The design indicates a 20-foot wide crest at an elevation of 1720 feet with 3:1 side slopes to approximately 1700 feet. Grades from a 2001 aerial survey were used to confirm the design slope geometry. The cross section for the north and south downstream slope is shown on Figure 4.

NORTH AND SOUTH BERMS CROSS SECTION

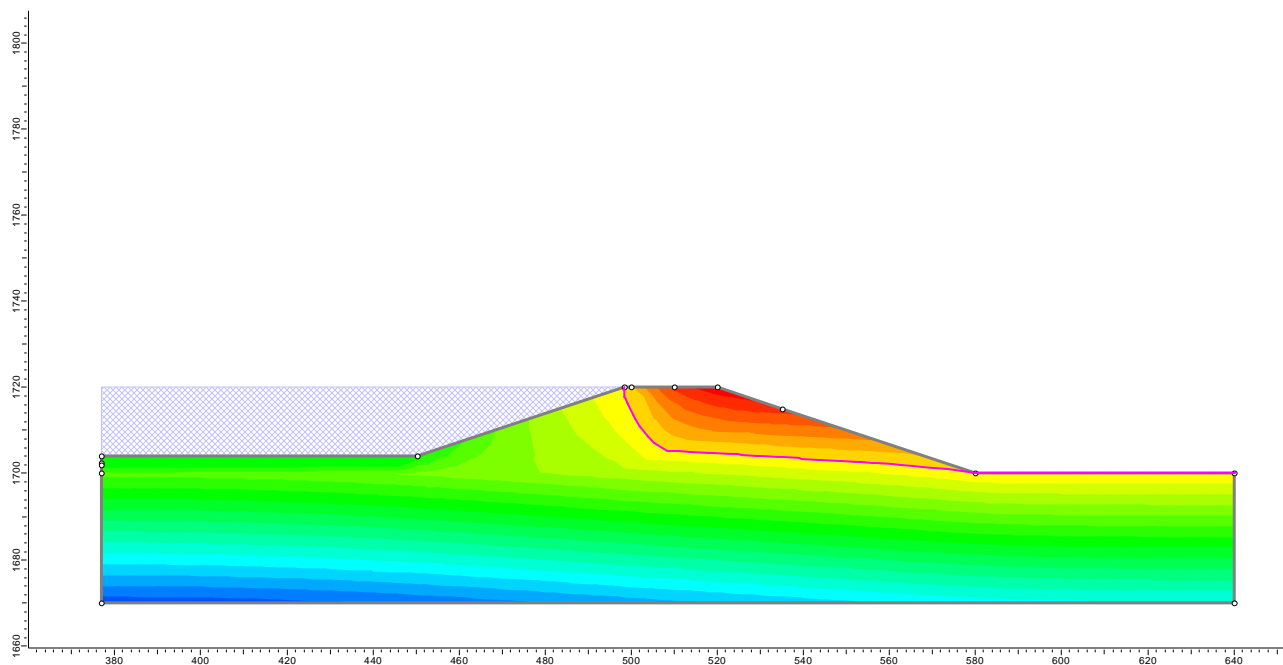
FIGURE 6

For the north/south, east and west downstream sections, the stability of each cross section was analyzed for the condition of an intact geomembrane and if no geomembrane is present reflective of a severely compromised geomembrane liner. For both analyses, the water level in the impoundment was set at elevation 1720 feet to represent maximum conditions. With an intact geomembrane, there was no flux assumed between the impoundment and the groundwater. The stability analysis for the condition of no geomembrane required the development of a phreatic surface through the berm. The phreatic surface was determined using groundwater finite element modeling within SLIDE. This surface was then modeled in the slope stability analysis as a piezometric surface through the berm. The finite element model for the phreatic surface through the north/south, west and east cross sections is shown on Figures 6, 10, and 14, respectively.

NORTH AND SOUTH BERMS WITH NO GEOMEMBRANE WATER TABLE ANALYSIS RESULTS

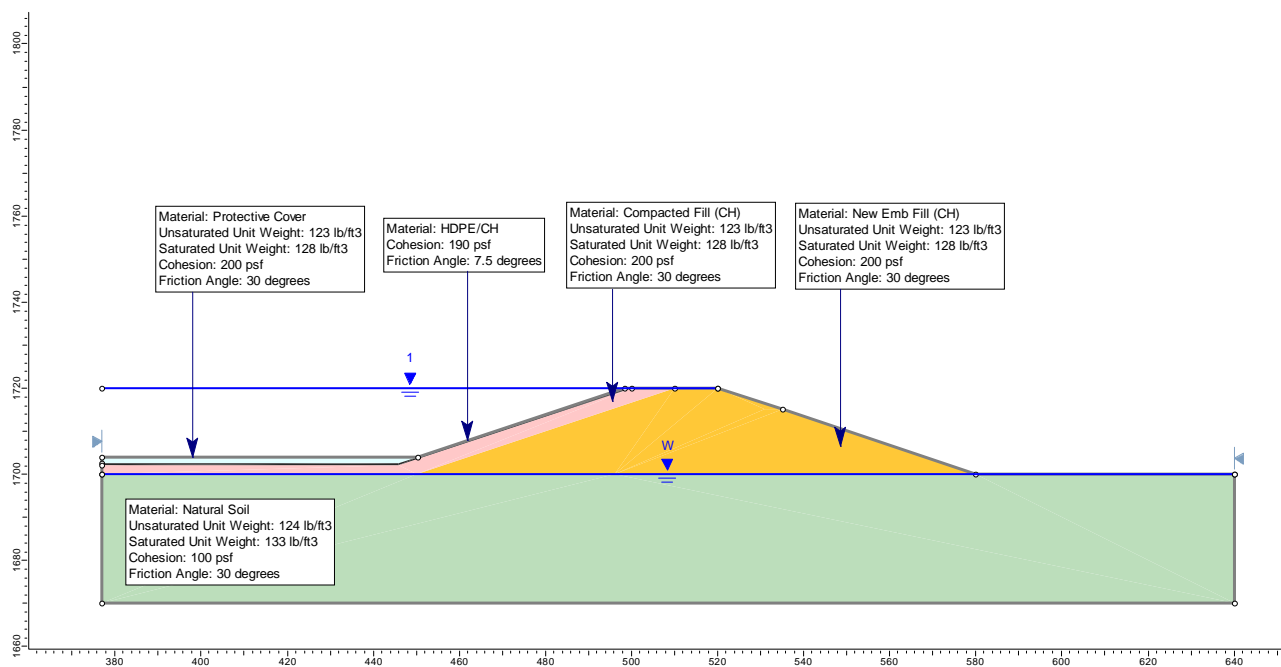
FIGURE 8

The west downstream slope has a design crest width of 20 feet at an elevation of 1720 feet and extends at an approximate 3:1 slope down to an elevation of 1700 feet (approximately). This section geometry was also verified with grades from the 2001 aerial survey. The cross section for the west downstream slope is shown on Figure 8.

WEST BERM CROSS SECTION

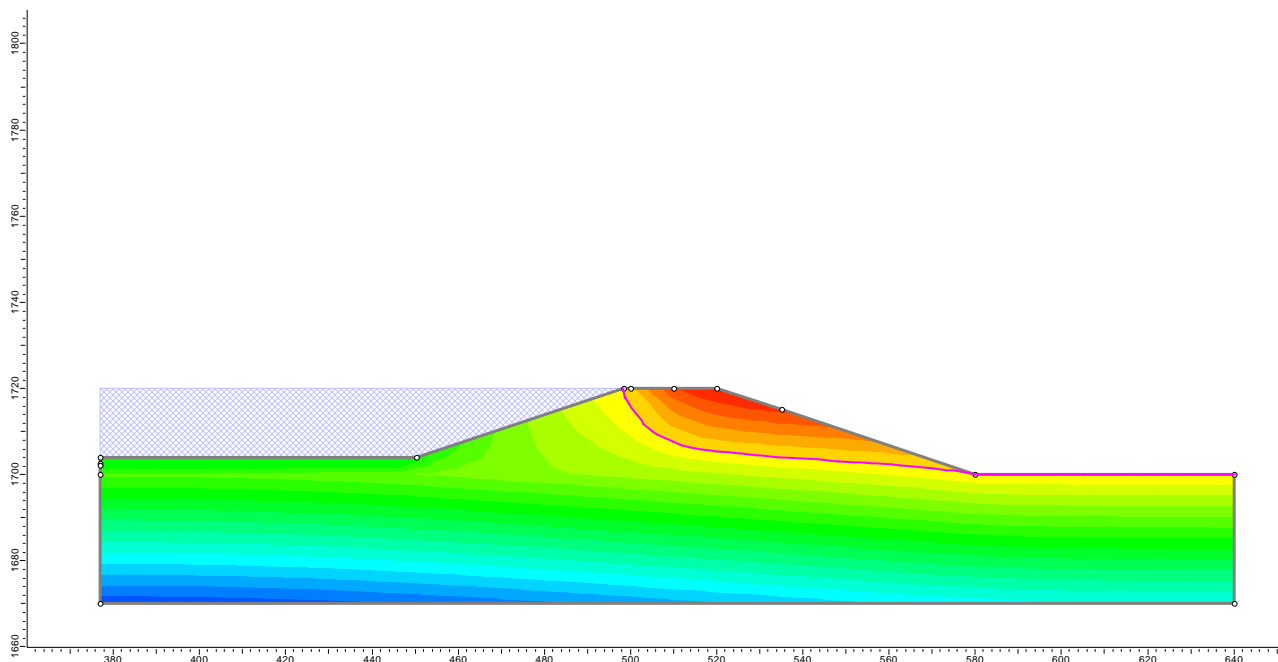
FIGURE 10

**WEST BERM WITH NO GEOMEMBRANE
WATER TABLE ANALYSIS RESULT**

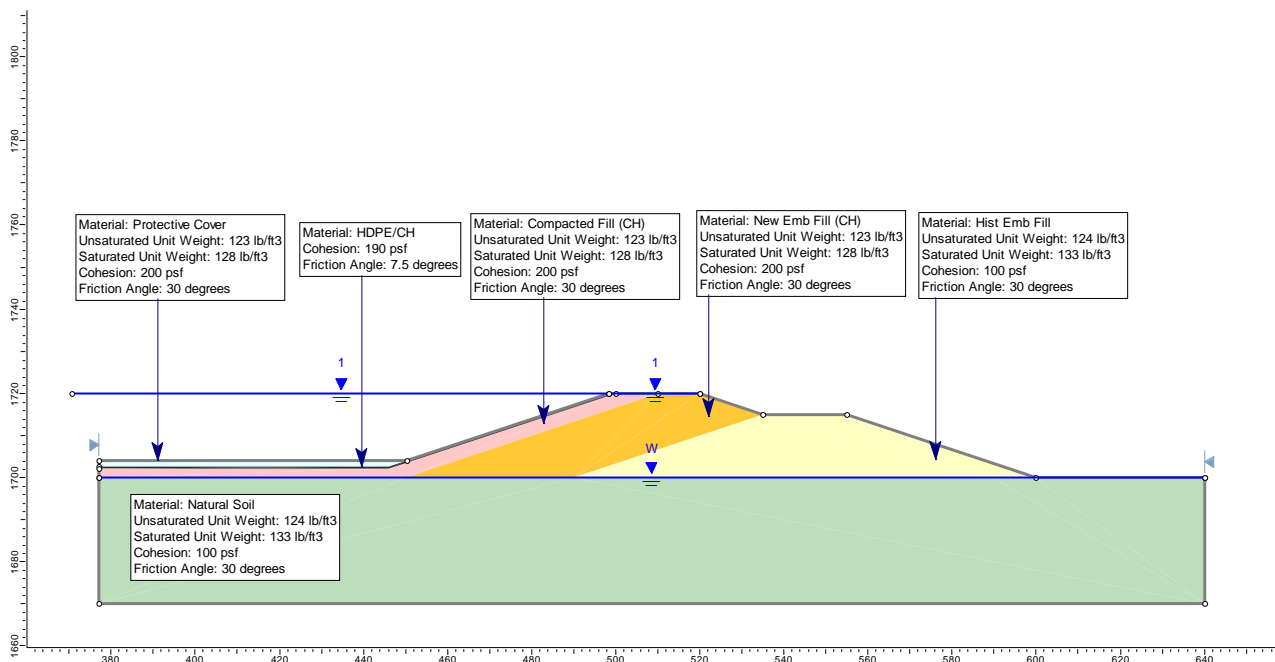
FIGURE 12

The east downstream slope has a design crest width of 20 feet at an elevation of 1720 feet and extends at an approximate 3:1 slope down to an elevation of 1715 feet. There is a 4-foot wide bench at elevation 1715 then a 3:1 slope down to an elevation of 1700 feet (approximately). Site observations, as-built drawings and sections developed using the 2001 aerial survey do not match the design geometry. The bench at elevation 1715 is substantially wider than the design and was modeled as 20 feet. The cross section for the east downstream slope is shown on Figure 12.

EAST BERM CROSS SECTION
