COAL ASH IMPOUNDMENT SITE ASSESSMENT FINAL REPORT

**Stanton Station
Great River Energy**

KLEINFELDER PROJECT NUMBER 118953-2

October 26, 2012

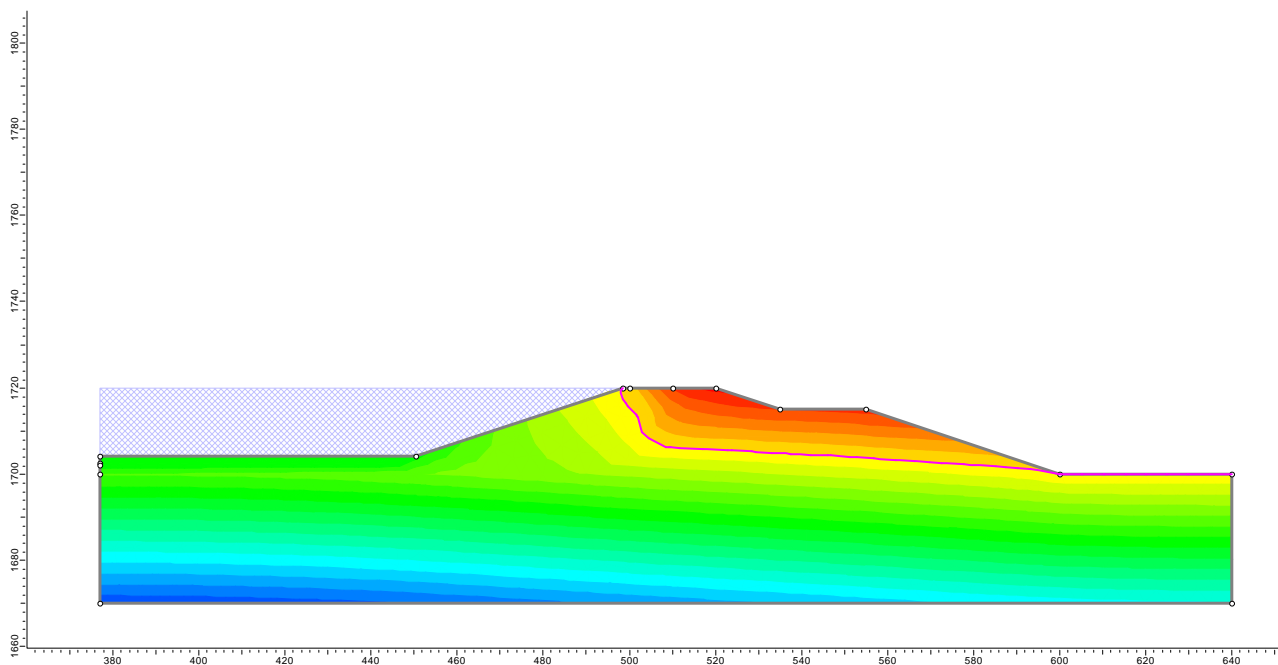
FIGURE 14

For the north/south, east and west downstream sections, the stability of each cross section was analyzed for the condition of an intact geomembrane and if no geomembrane is present reflective of a severely compromised geomembrane liner. For both analyses, the water level in the impoundment was set at elevation 1720 feet to represent maximum conditions. With an intact geomembrane, there was no flux assumed between the impoundment and the groundwater. The stability analysis for the condition of no geomembrane required the development of a phreatic surface through the berm. The phreatic surface was determined using groundwater finite element modeling within SLIDE. This surface was then modeled in the slope stability analysis as a piezometric surface through the berm. The finite element model for the phreatic surface through the north/south, west and east cross sections is shown on Figures 6, 10, and 14, respectively.

**EAST BERM WITH NO GEOMEMBRANE
WATER TABLE ANALYSIS RESULT**

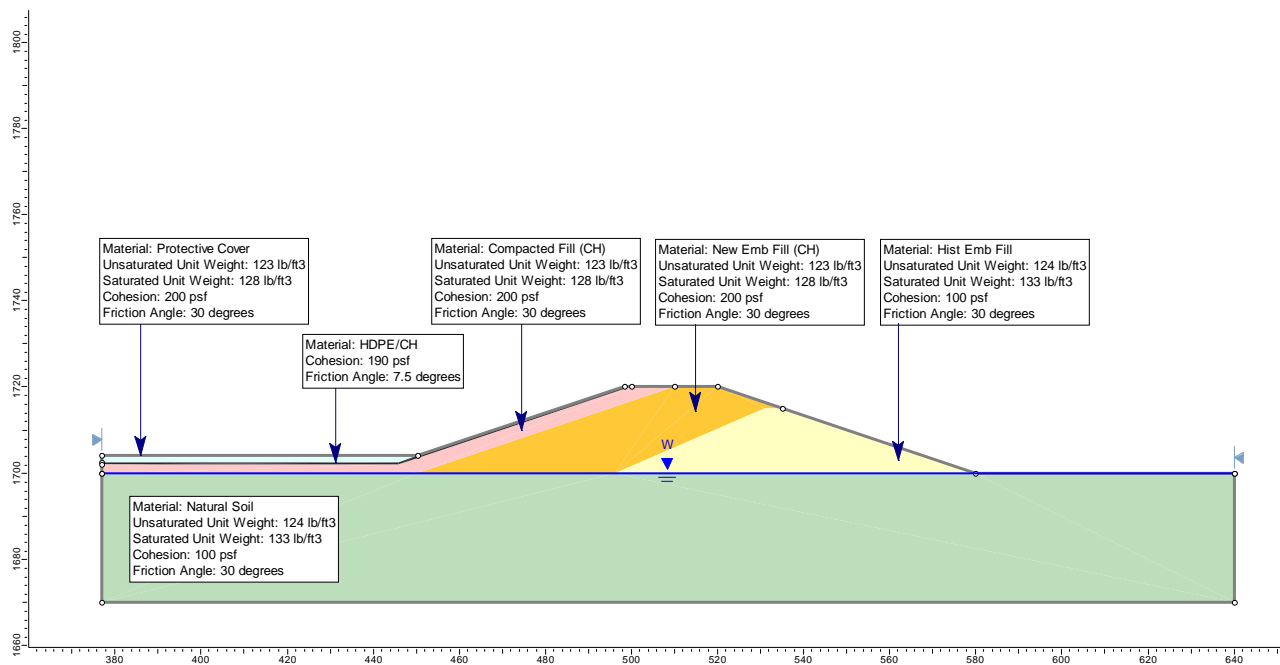
FIGURE 16

The upstream slope has an approximate 3:1 slope from elevation 1720 feet down to elevation 1702 feet. This section geometry was verified with the as-built drawings and grades from the 2001 aerial survey. The cross section for the upstream slope is shown on Figure 16. The analysis of the upstream slope did not look at bottom ash on the smooth geomembrane but focused on the underlying clay liner and berm.

UPSTREAM CROSS SECTION

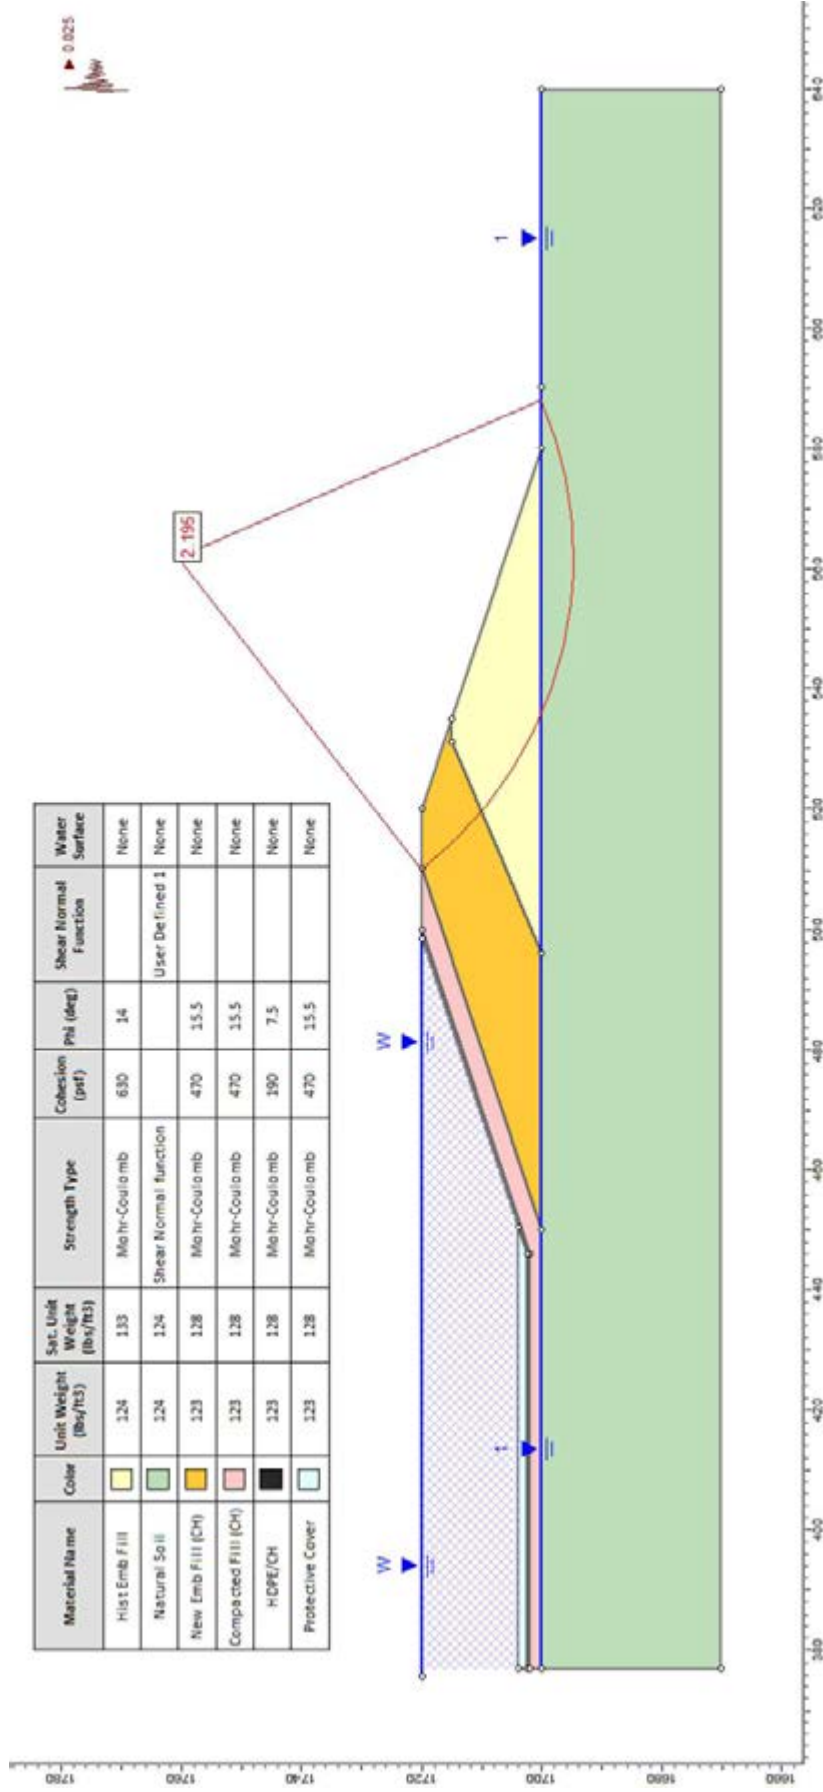
FIGURE 2

NORTH AND SOUTH BERMS
WITH INTACT GEOMEMBRANE
STABILITY ANALYSIS RESULTS

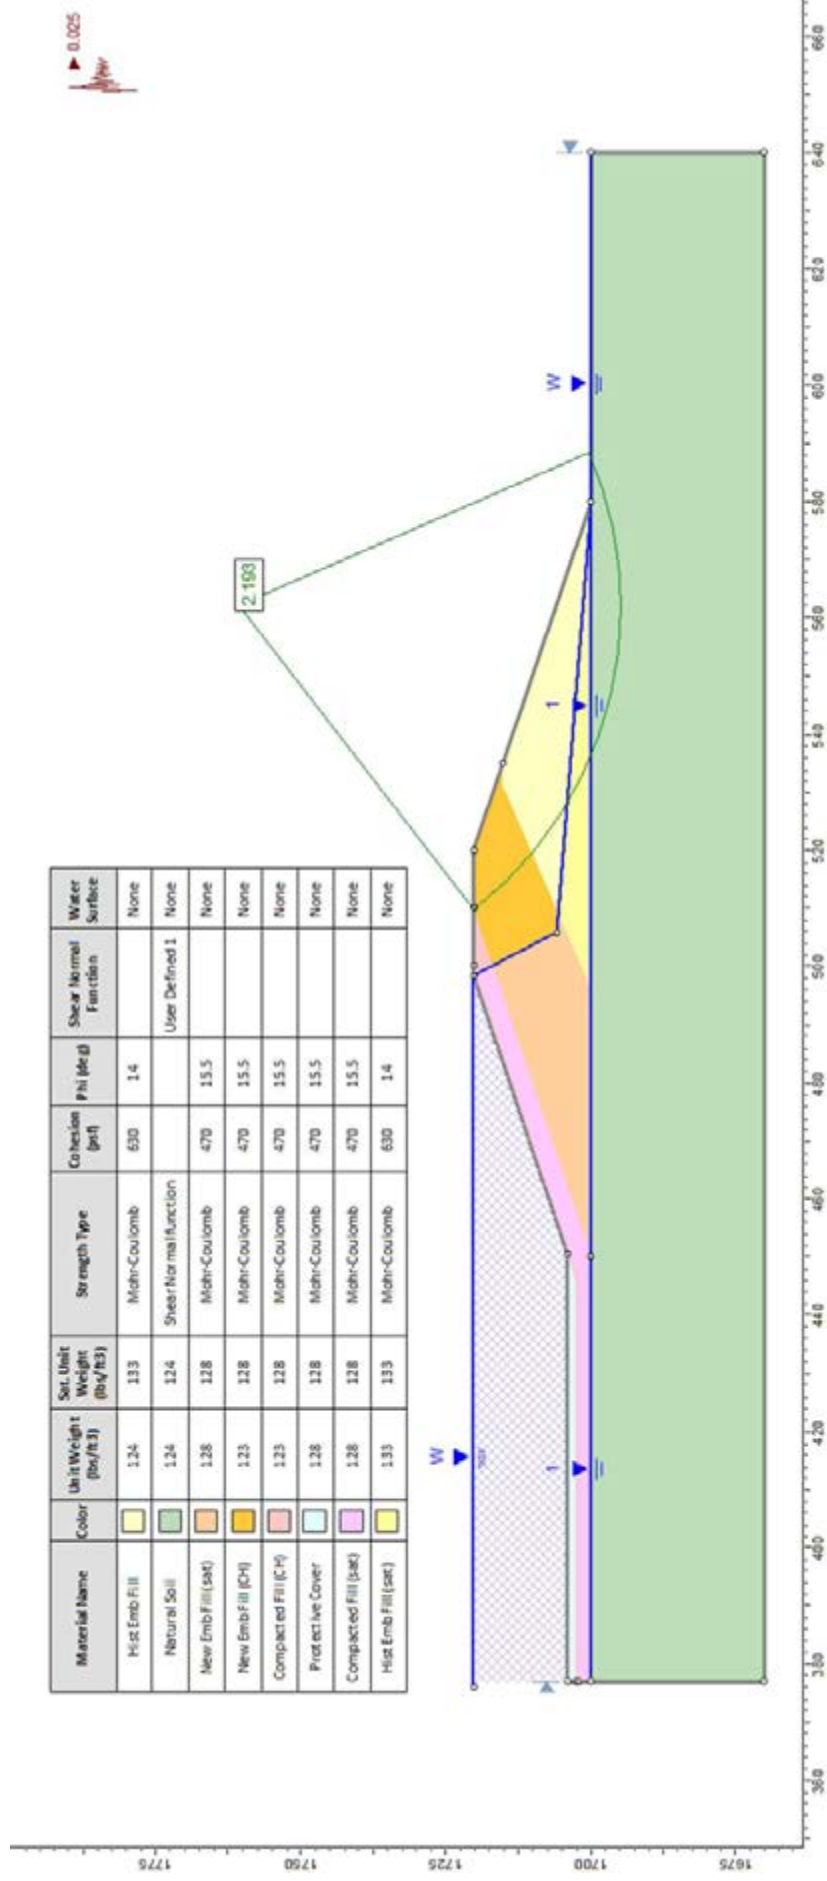
NORTH AND SOUTH BERMS
WITH NO GEOMEMBRANE
STABILITY ANALYSIS RESULTS
FIGURE 3

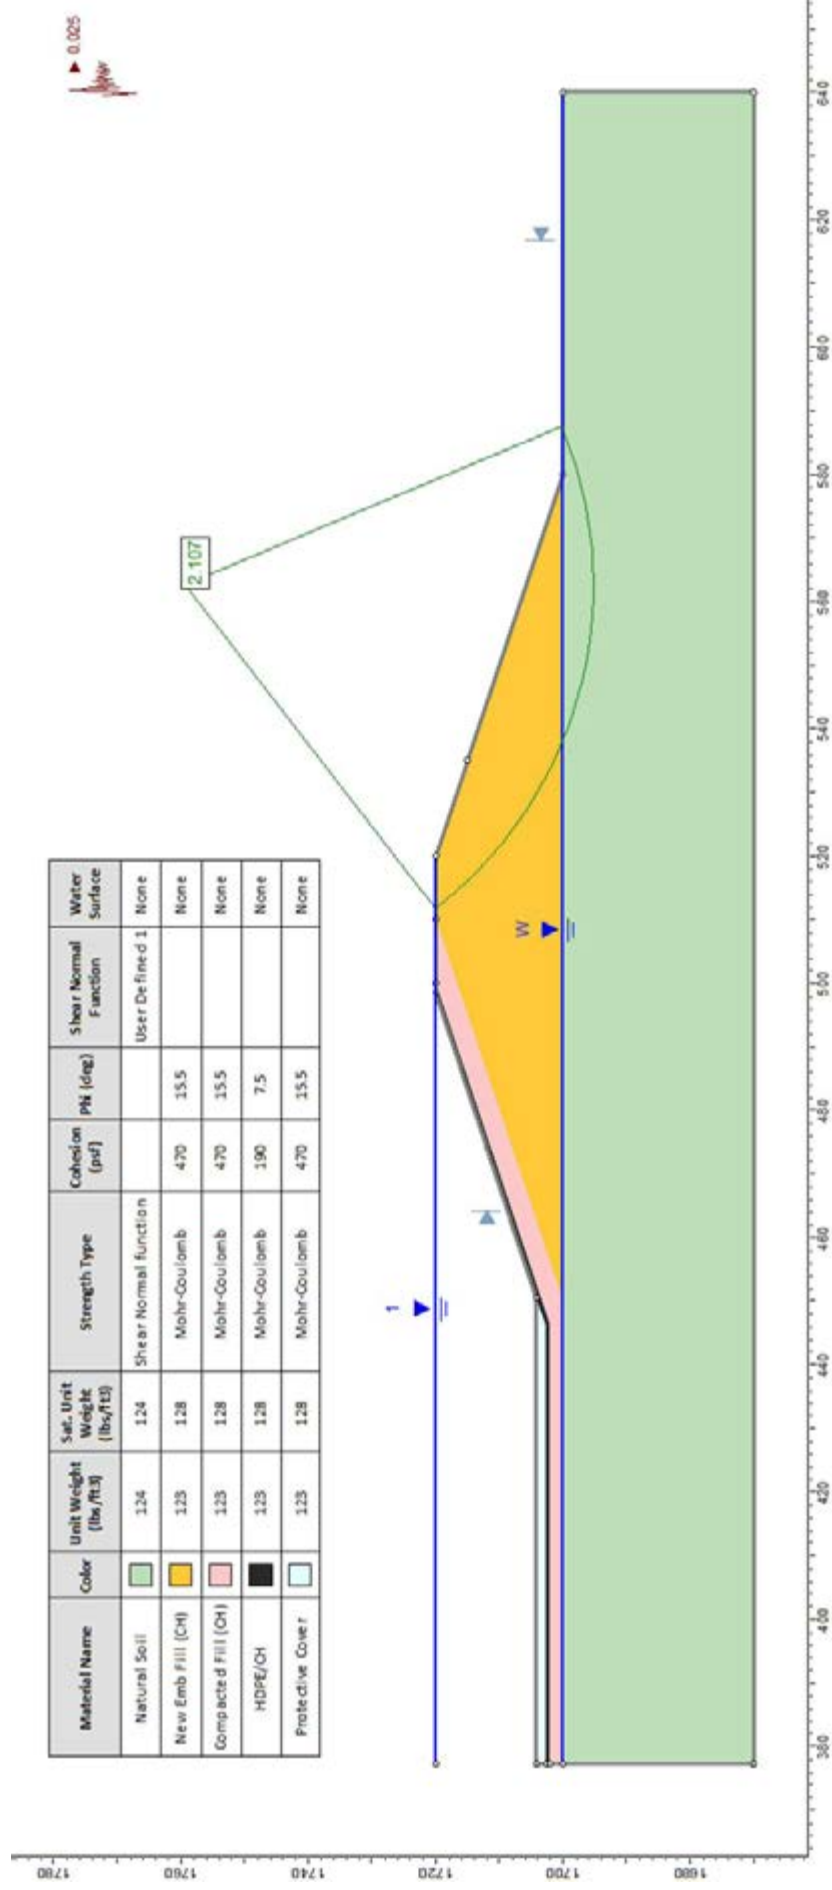
The west downstream slope has a design crest width of 20 feet at an elevation of 1720 feet and extends at an approximate 3:1 slope down to an elevation of approximately 1700 feet. This section geometry was also verified with grades from the 2001 aerial survey. The cross section for the west downstream slope is shown on Figures 4 and 5.

WEST BERMS WITH
INTACT GEOMEMBRANE
STABILITY ANALYSIS RESULTS
FIGURE 4

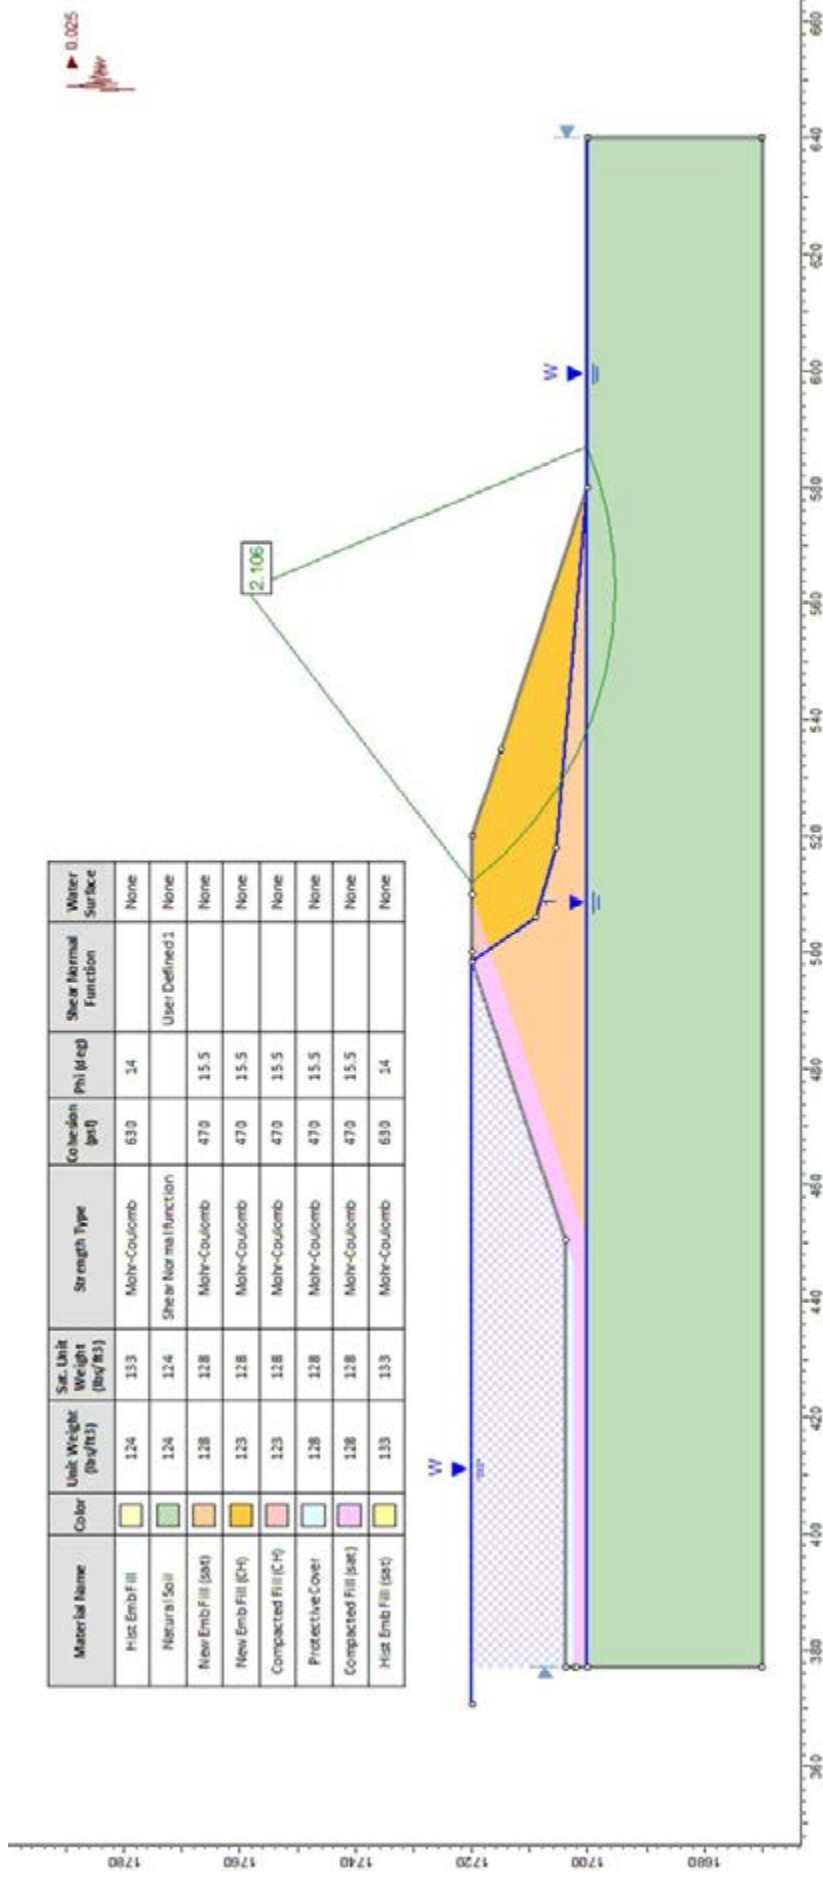
WEST BERMS WITH
NO GEOMEMBRANE
STABILITY ANALYSIS RESULTS
FIGURE 5

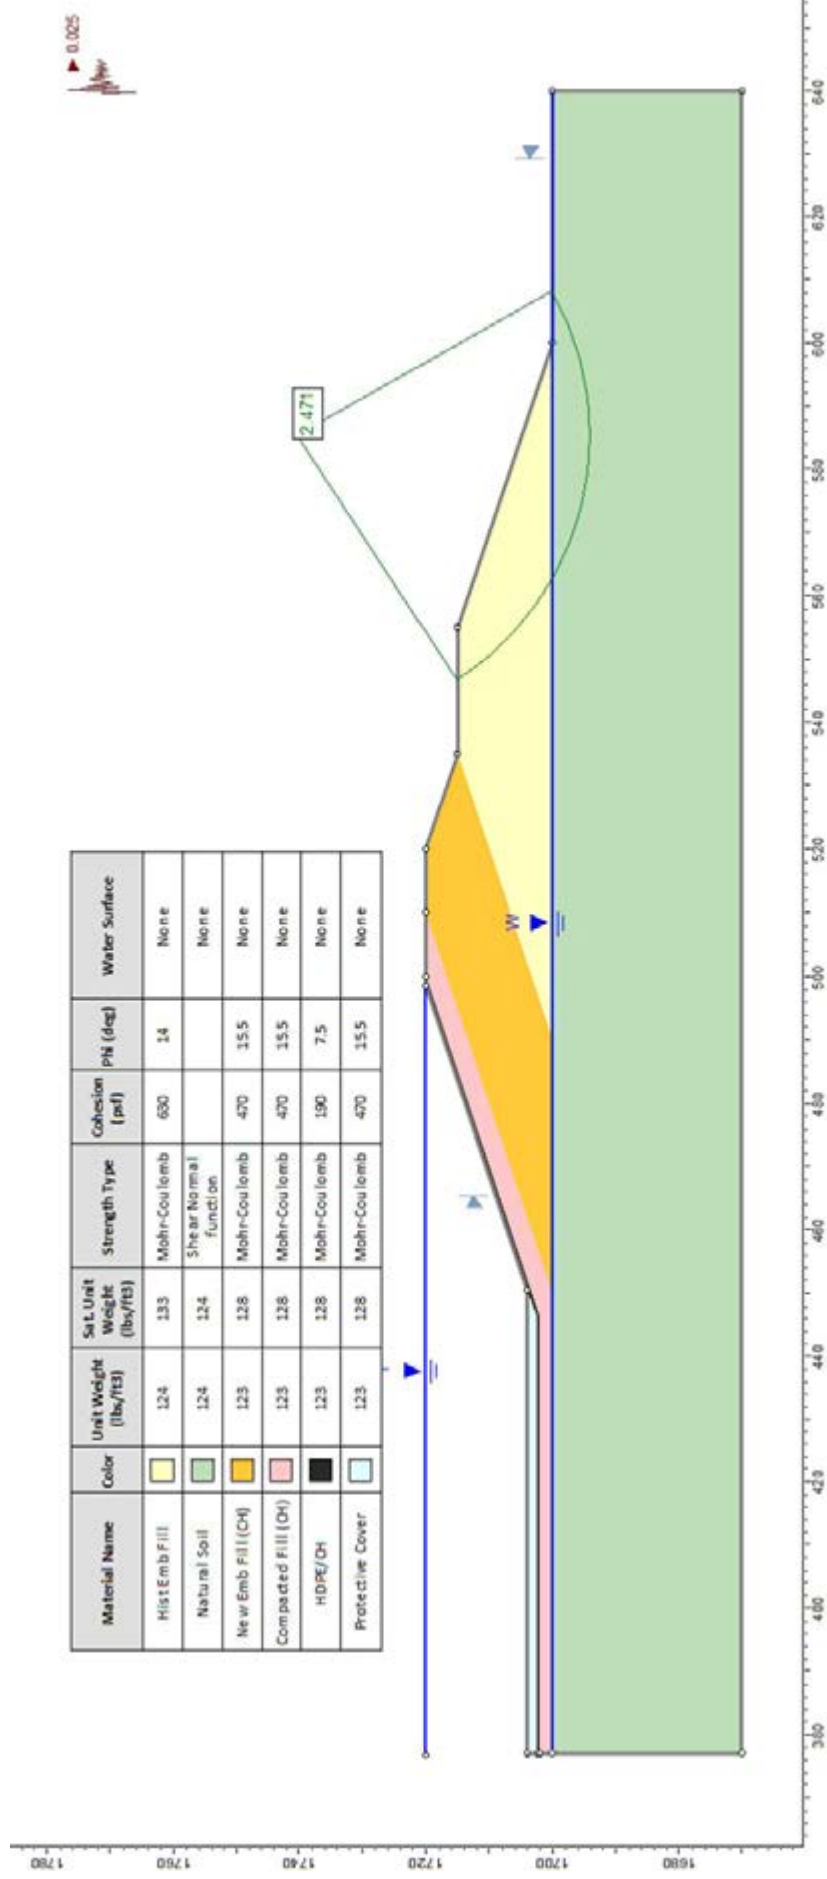
The east downstream slope has a design crest width of 20 feet at an elevation of 1720 feet and extends at an approximate 3:1 slope down to an elevation of 1715 feet. The original design includes a 4-foot wide bench at elevation 1715 then a 3:1 slope down to an elevation of approximately 1700 feet. Site observations, as-built drawings and sections developed using the 2001 aerial survey do not match the design geometry. The bench at elevation 1715 is substantially wider than the design and was modeled as 20 feet. The cross section for the east downstream slope is shown on Figures 6 and 7.

EAST BERMS WITH
INTACT GEOMEMBRANE
STABILITY ANALYSIS RESULTS
FIGURE 6

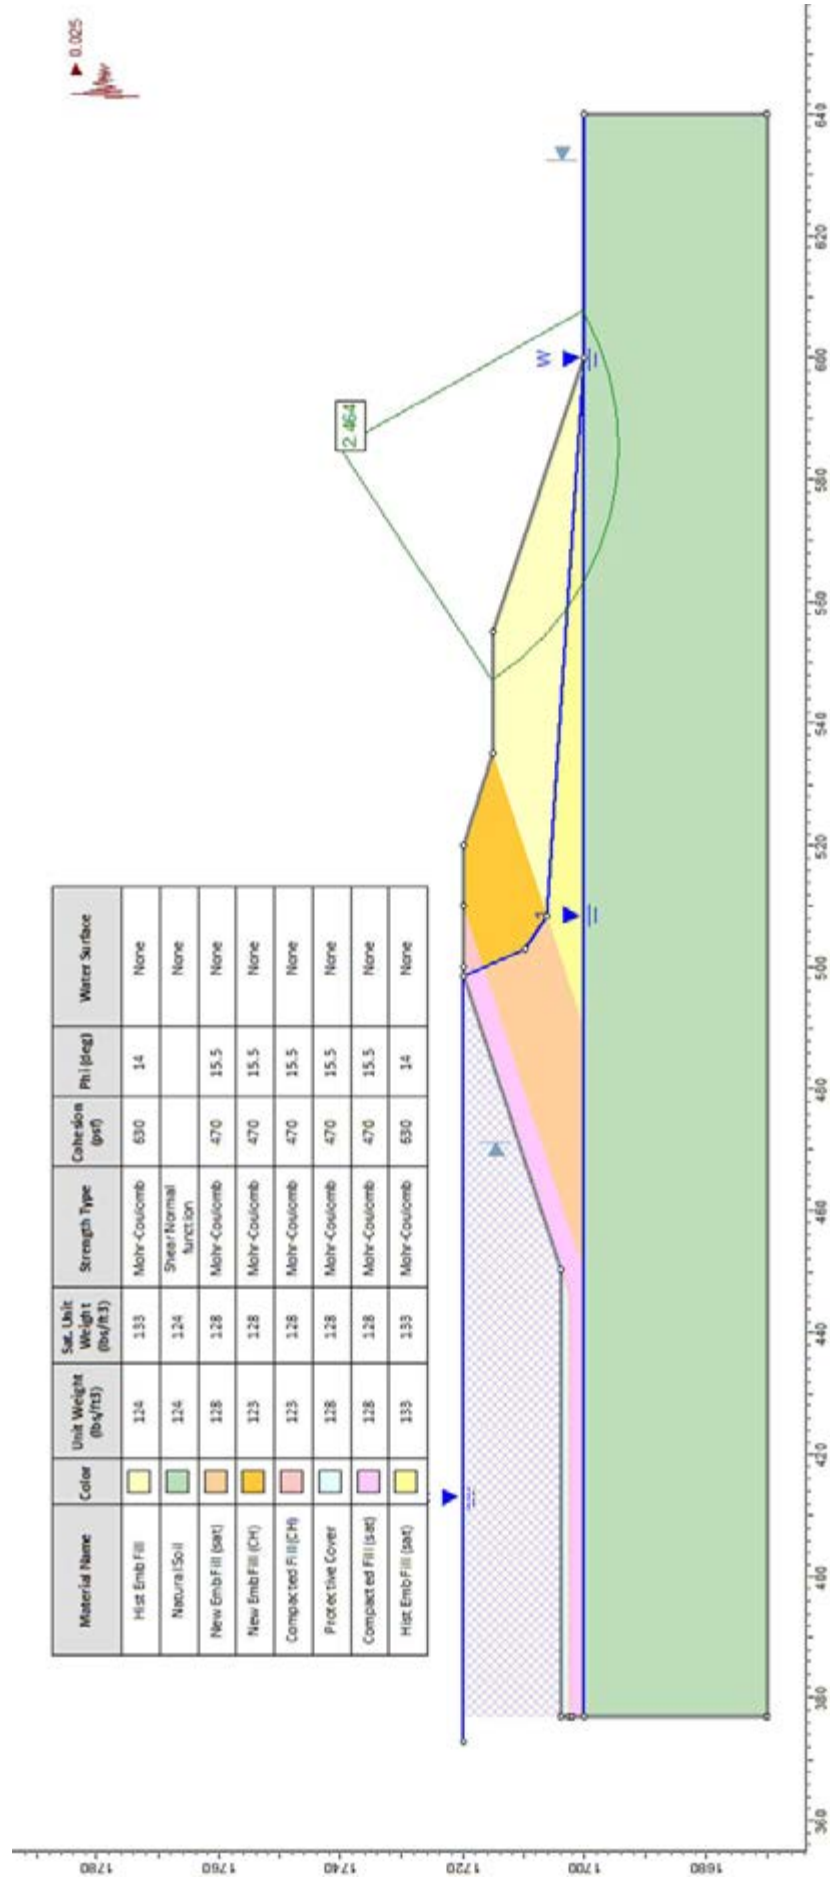
EAST BERMS WITH
NO GEOMEMBRANE
STABILITY ANALYSIS RESULTS
FIGURE 7

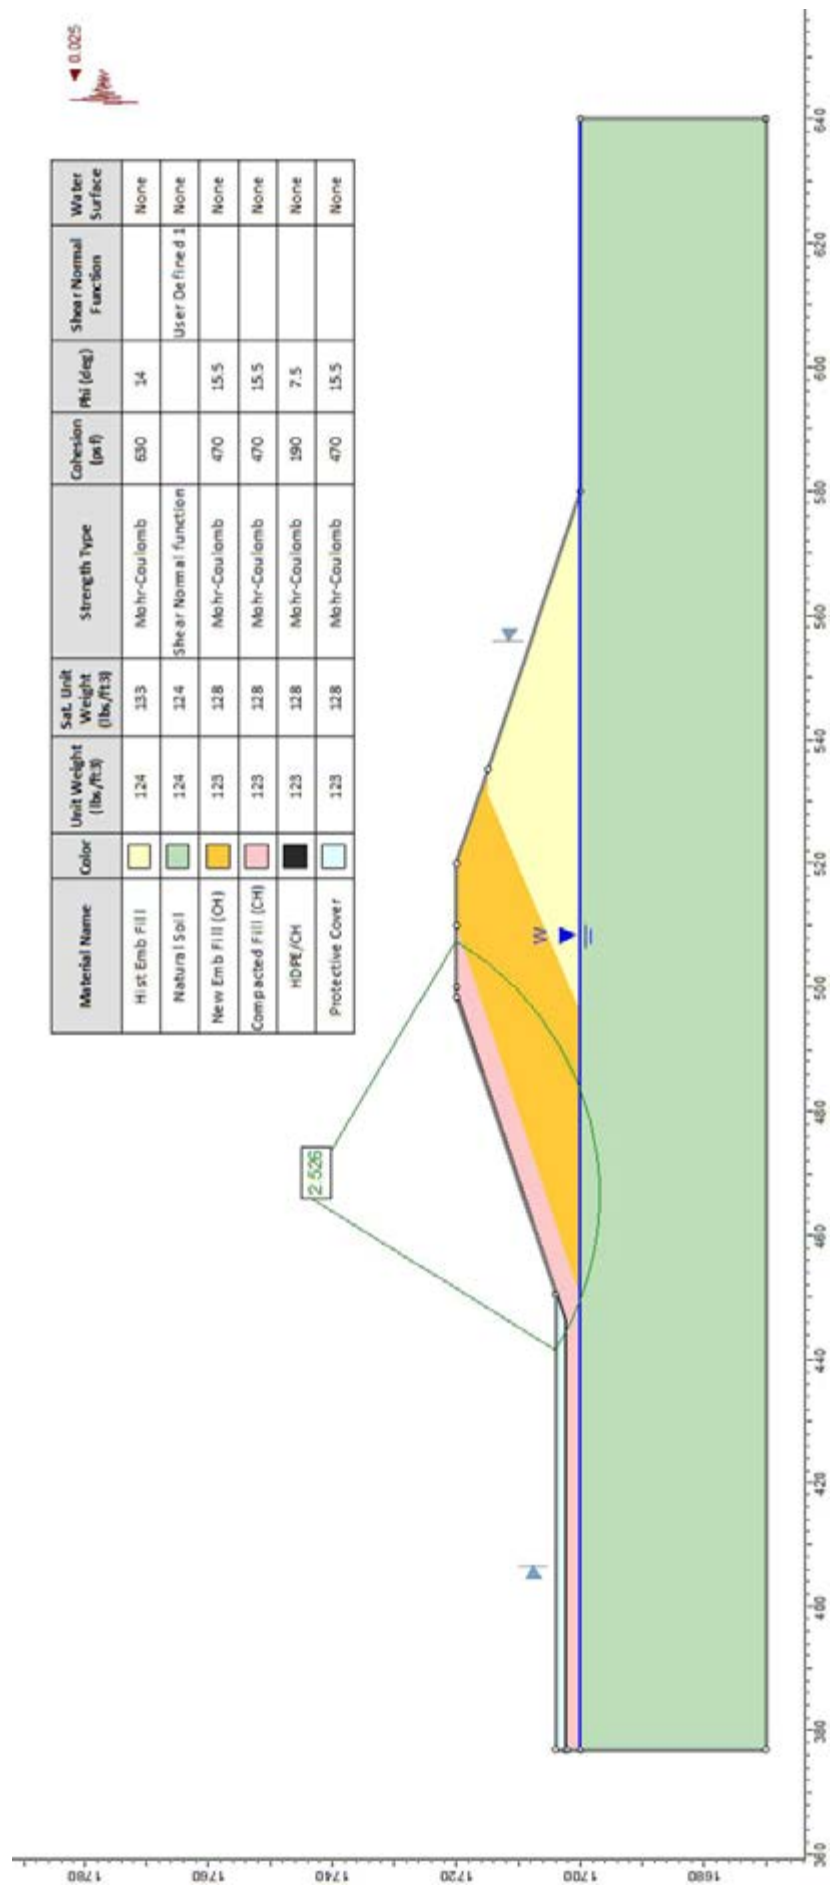
The upstream slope has an approximate 3:1 slope from elevation 1720 feet down to elevation 1702 feet. This section geometry was verified with the as-built drawings and grades from the 2001 aerial survey. The cross section for the upstream slope is shown on Figures 8 and 9. Analysis of the upstream slope did not evaluate bottom ash on the smooth geomembrane, but focused on the underlying clay liner and berm.

UPSTREAM BERMS WITH
EMPTY IMPOUNDMENT
STABILITY ANALYSIS RESULTS
FIGURE 8

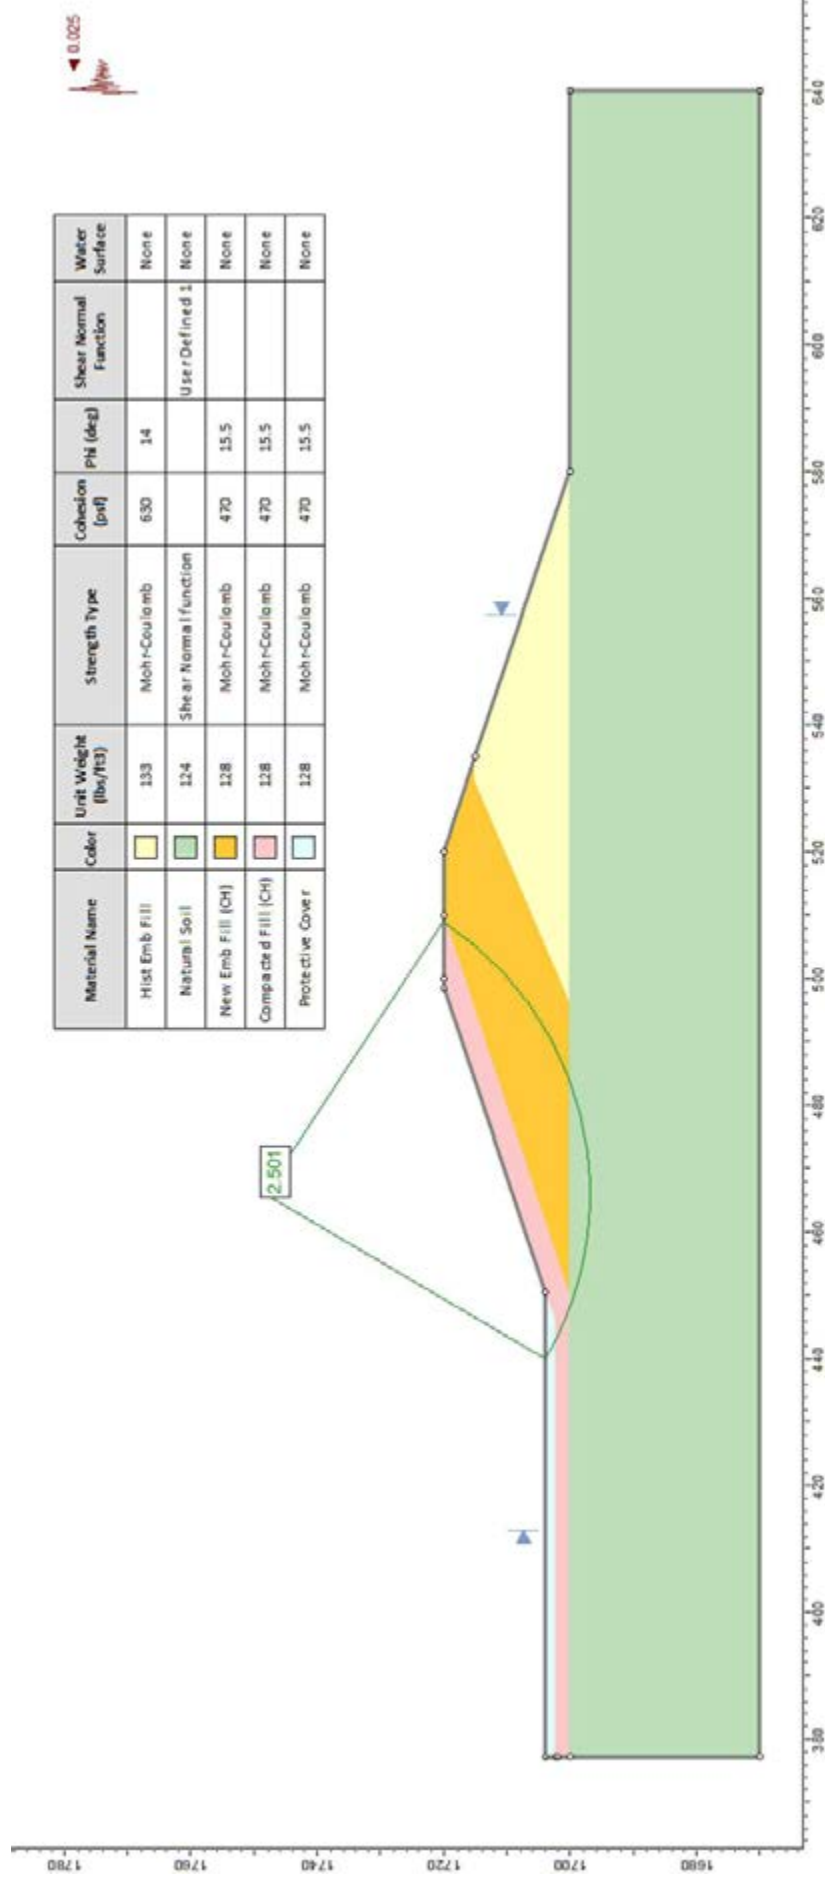
FIGURE 9

UPSTREAM BERMS WITH EMPTY IMPOUNDMENT AND NO GEMOMEMBRANE STABILITY ANALYSIS RESULTS
