# **Assessment of Dam Safety of Coal Combustion Surface Impoundments**

**Indianapolis Power & Light Company**

**Eagle Valley Generating Station**

**June 4, 2010**

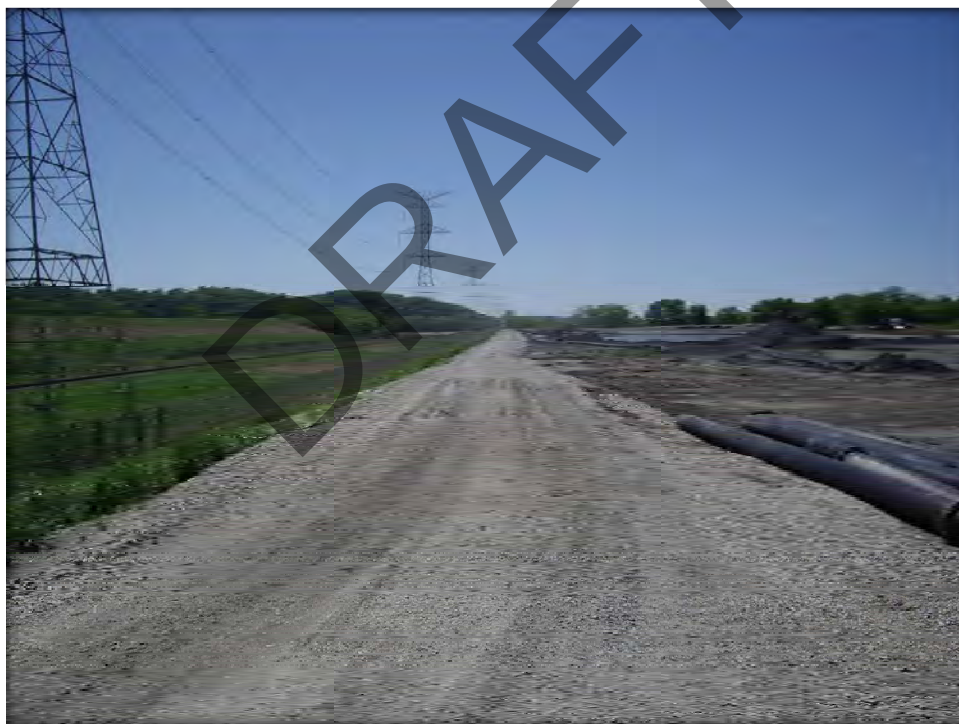
The crest of the Pond A embankments appeared to generally be in fair condition (Photos 2, 8, 14, 16, 19, 22, 24, 27, 30, 34, 43, and 44). The crest was approximately 15 feet wide with exception of the truck turn around area where the crest was significantly wider. The crest consists of a compacted gravel access road around the perimeter. Three low spots were observed in the crest (Photos 2, 14, and 28). Two of the low spots appear to be from recent truck traffic rutting the crest. The low spot on the east embankment observed on 4/28/10 was filled in by IPL personnel by 4/29/10. IPL indicated that the low spot on the divider embankment near the outlet pipes (Photo 28) is an overflow spillway. There are no records in the information provided to CDM to indicate this was a design feature. There were no deficiencies observed in this area.

2. Pond A - East embankment crest looking south.

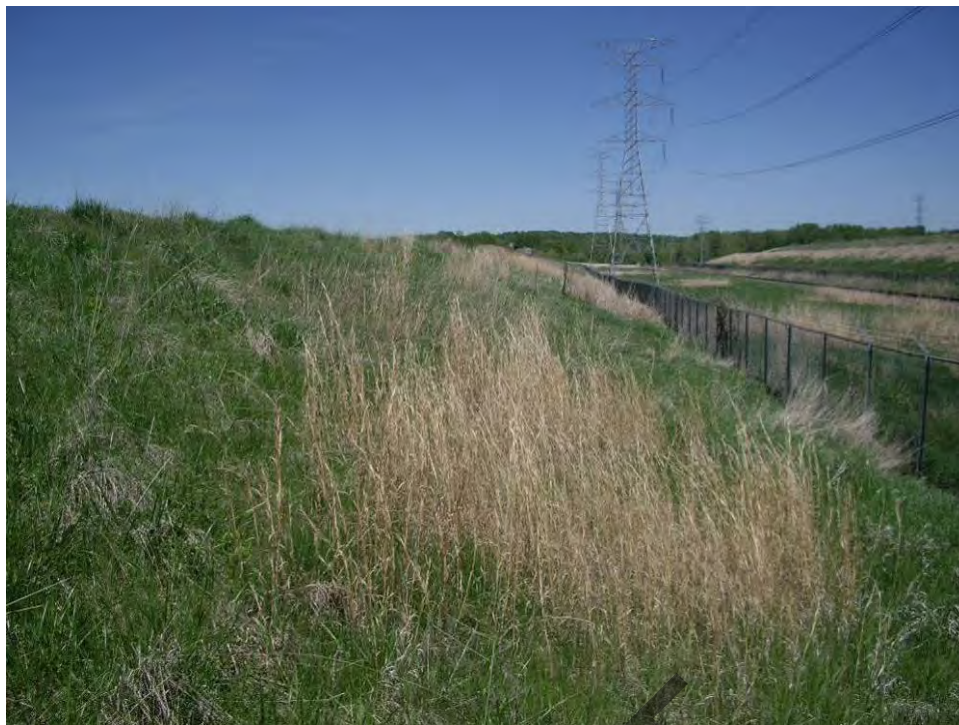
The exterior slopes of the Pond A embankments appear to be in fair condition. The exterior slopes on the north, south, east, and west embankments ranged from approximately 2.5H:1V to 3H:1V (Photos 1, 15, 20, 23, 25, 45, and 46). The exterior slope on the embankment between Pond A and Pond B (divider embankment A/B) and embankment between Pond A and Pond C (divider embankment A/C) ranged from approximately 2H:1V to 3H:1V (Photos 28, 33, 34, 38, 40, and 42).

15. Pond A - East embankment exterior slope looking north.

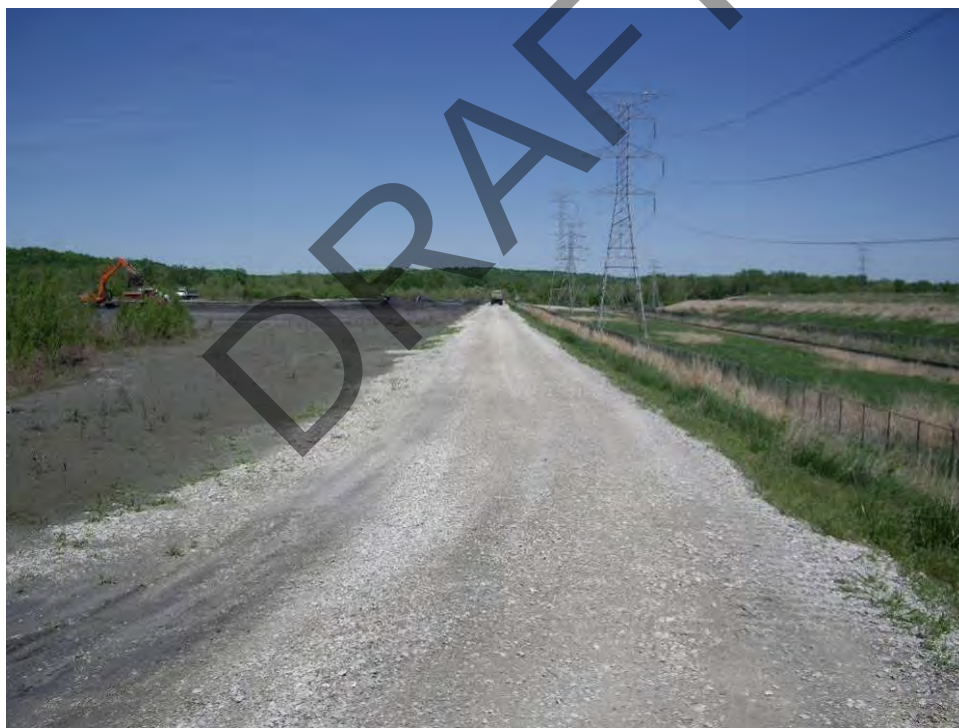
16. Pond A - East crest looking north.

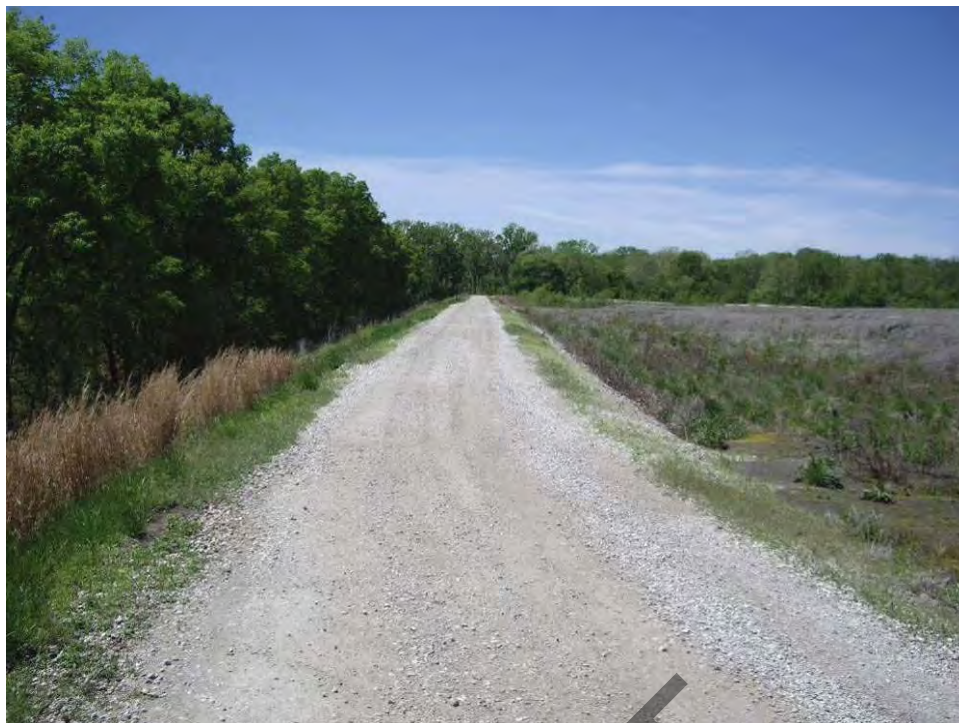
19. Pond A – South embankment crest looking west.

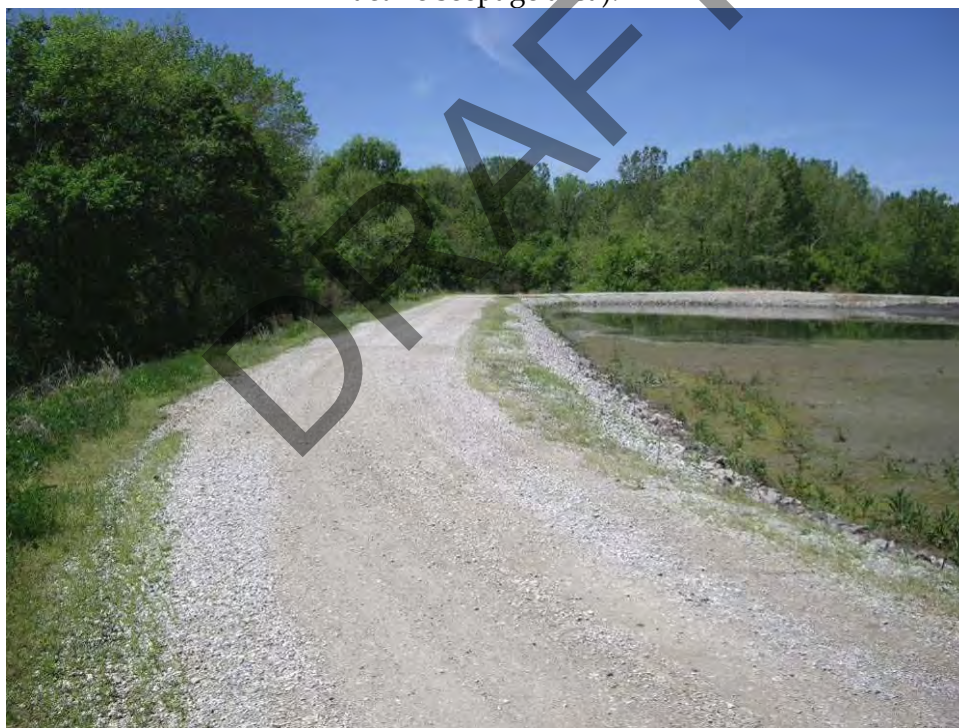
22. Pond A - South embankment crest, looking west.

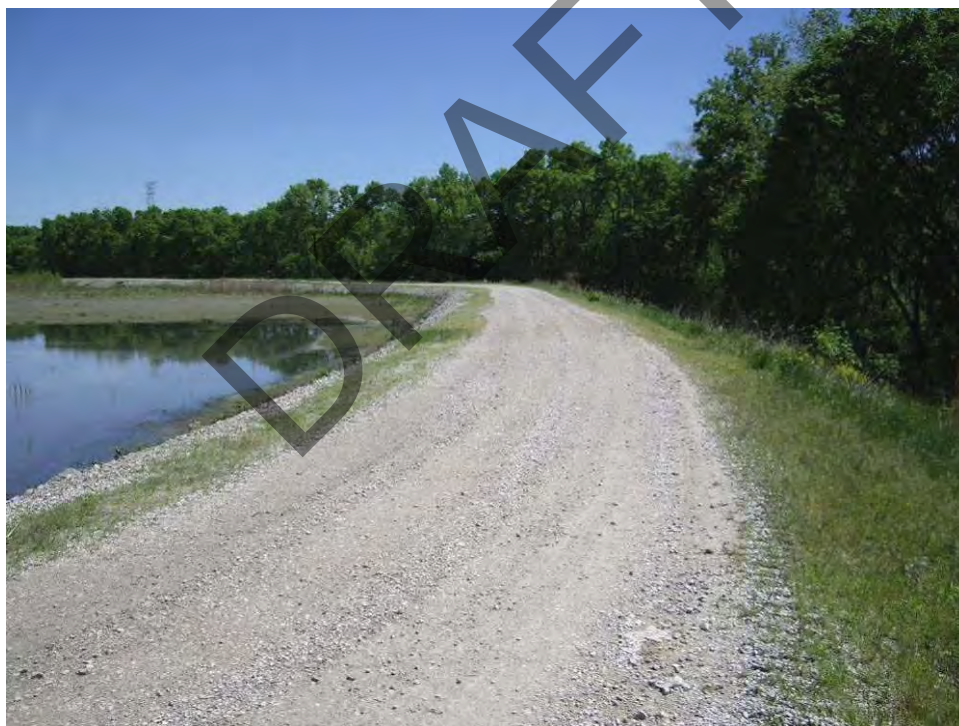
24. Pond A – South embankment crest, looking southeast.

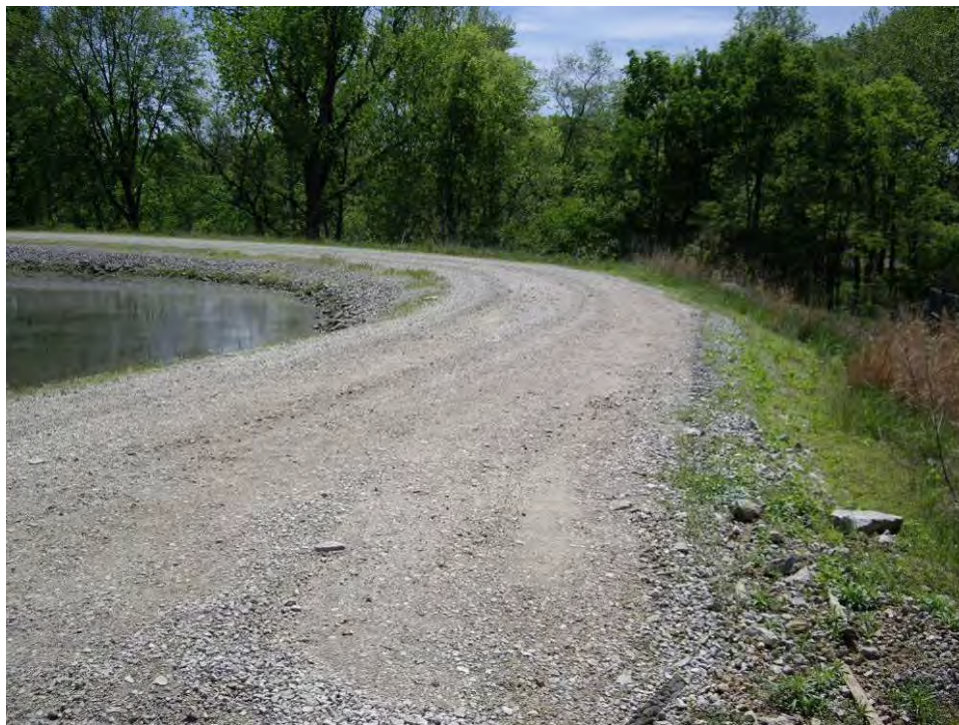
27. Pond A - West embankment crest, looking south.

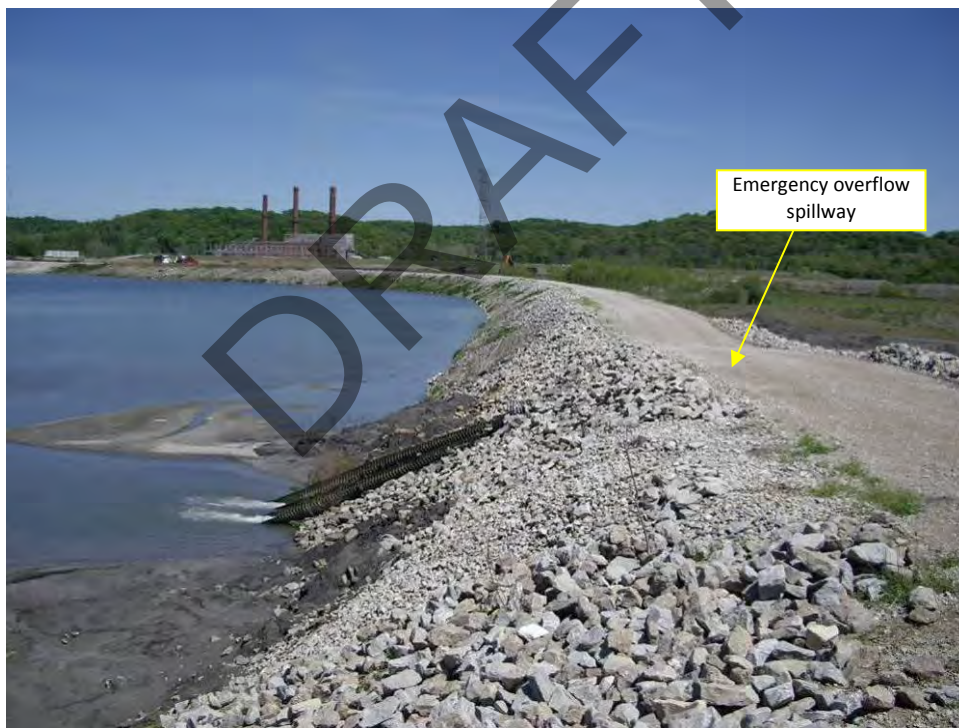
28. Pond A/B - north slope of divider embankment, looking east.

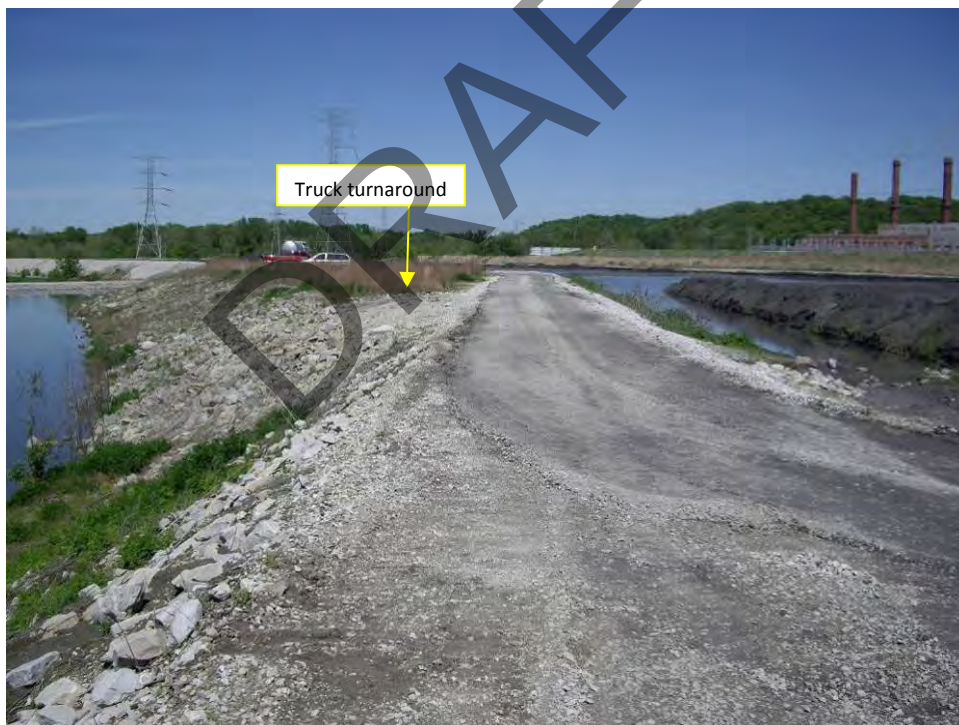
34. Crest of divider embankment A/B, looking northeast.

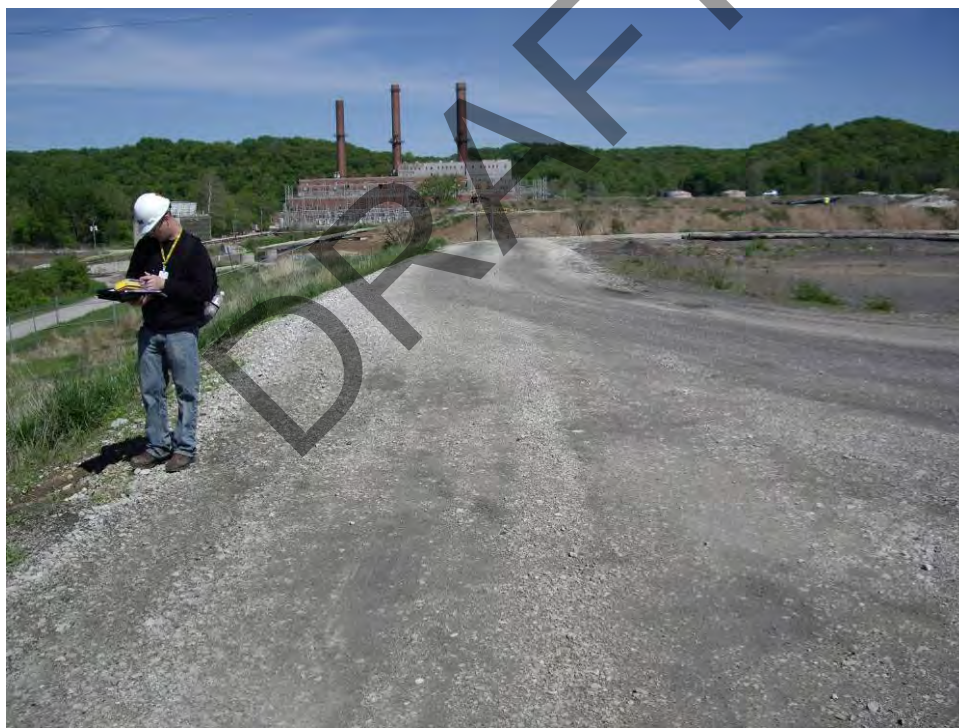
44. Pond A - North embankment crest, looking east.

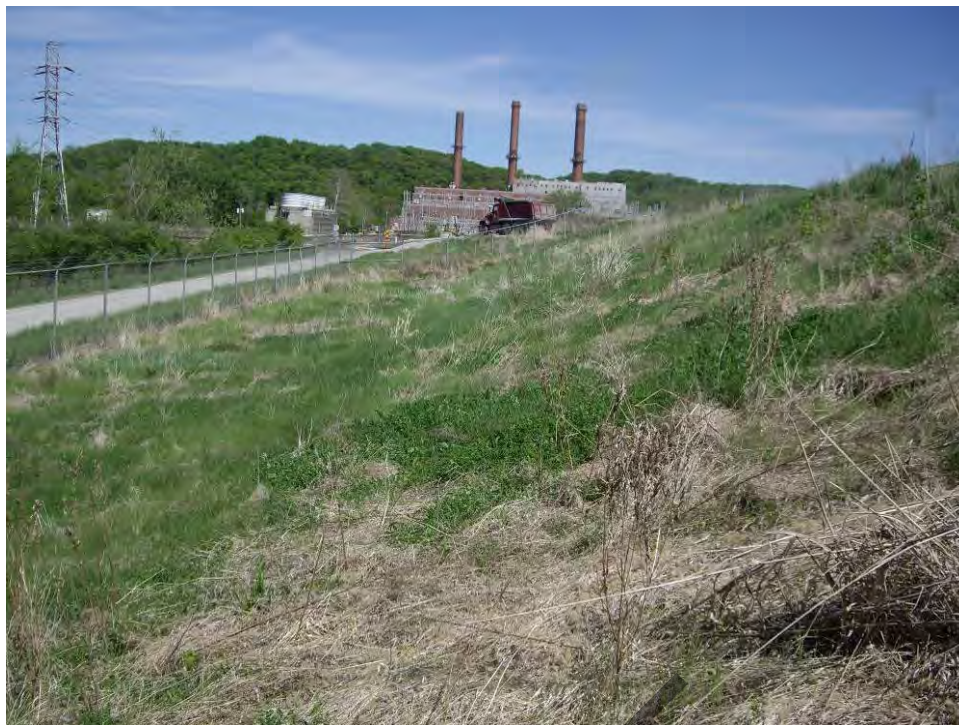
45. Pond A - North embankment exterior slope, looking east.

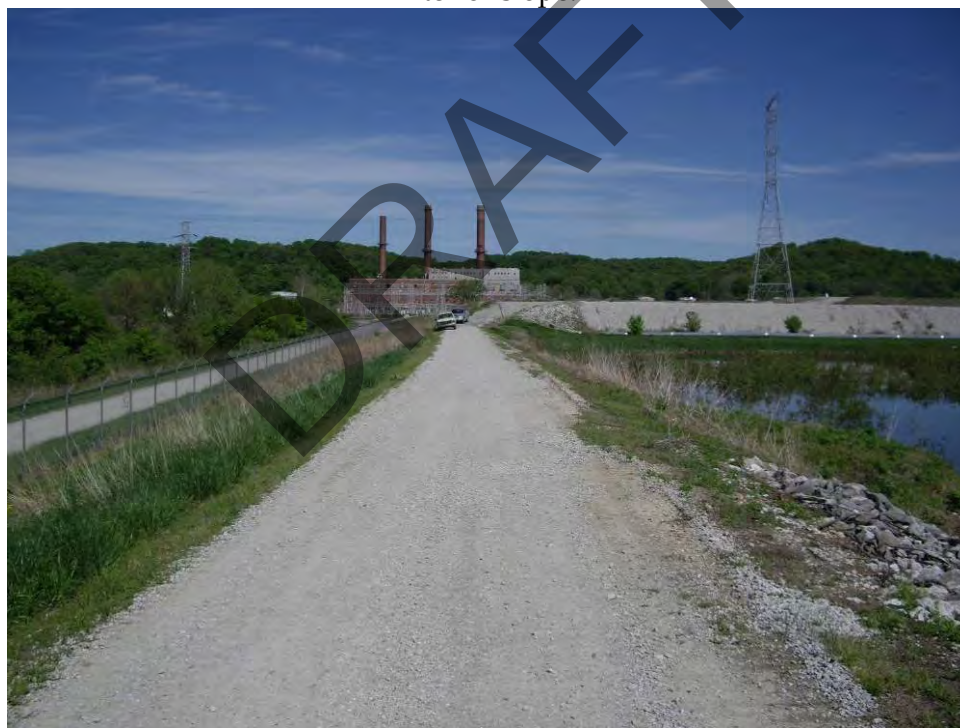
48. Pond C – North embankment crest, looking east.

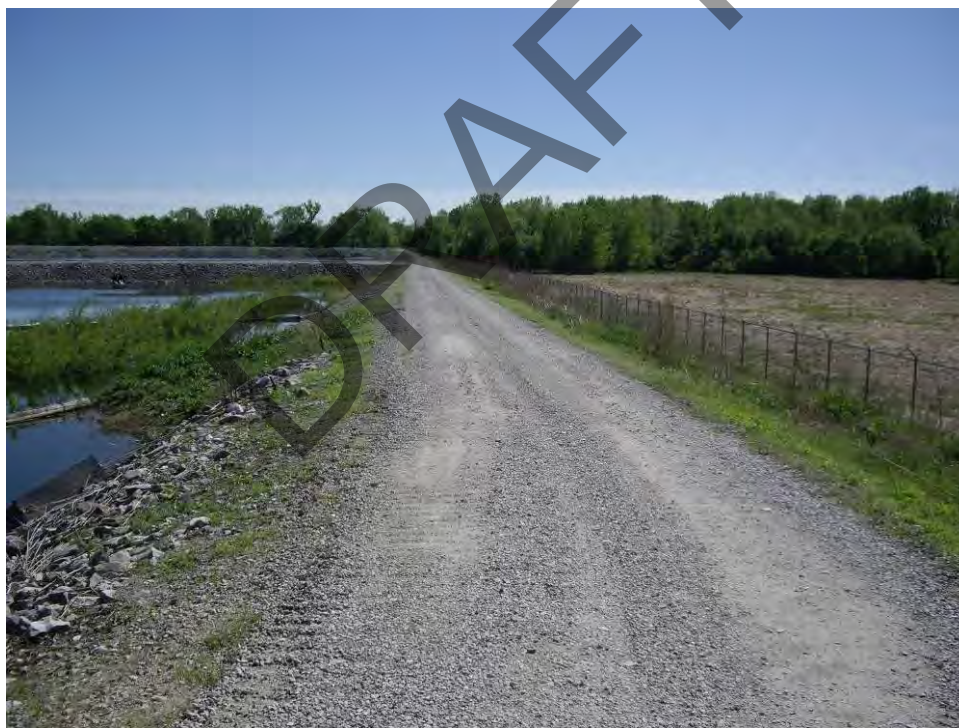
52. Pond C - West embankment crest, looking south.

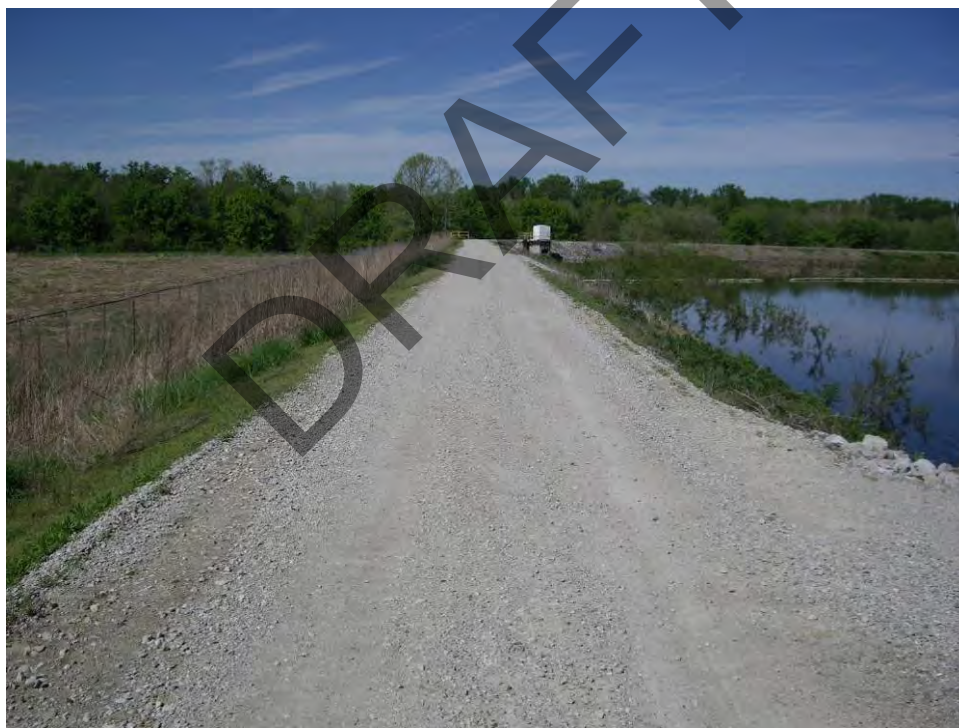
56. Pond C - West embankment crest, looking north

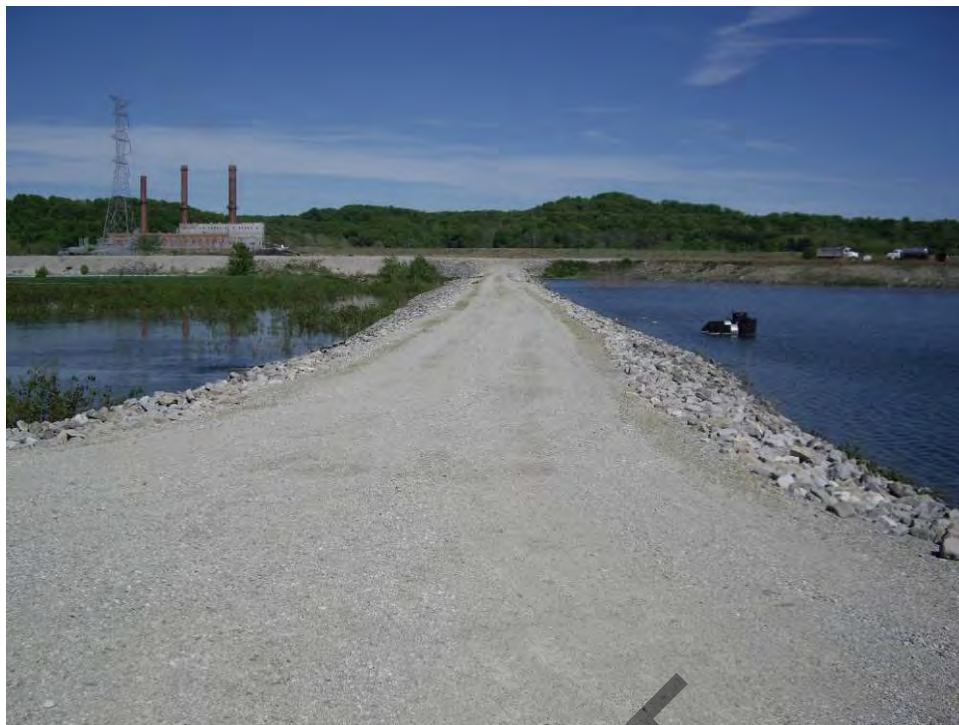
57. Crest of divider embankment B/C, looking east.

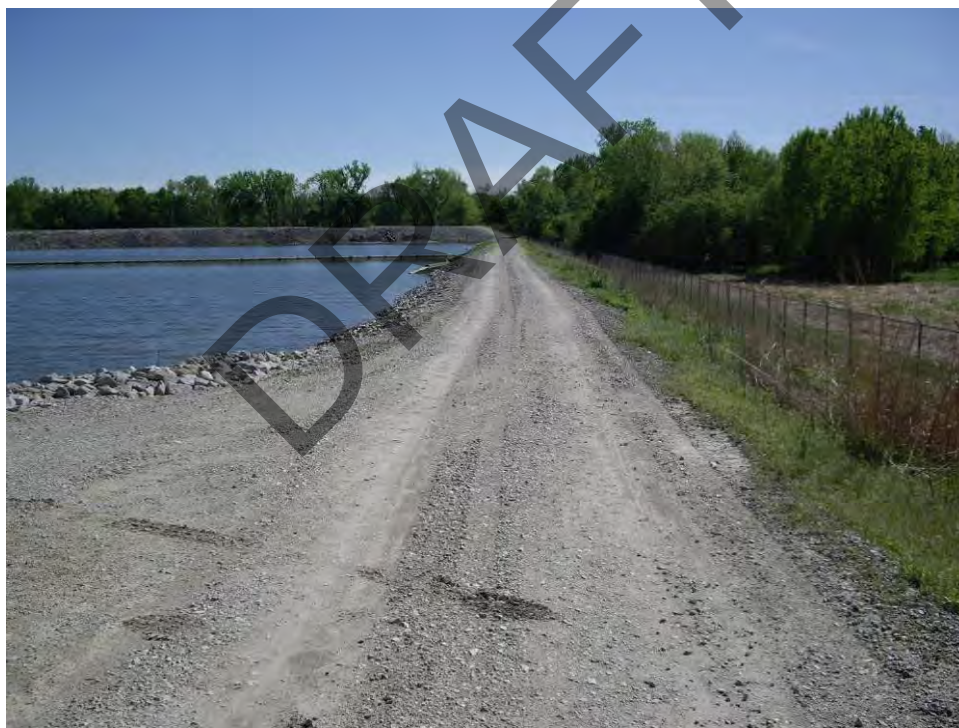
60. Pond B - west embankment crest, looking south.

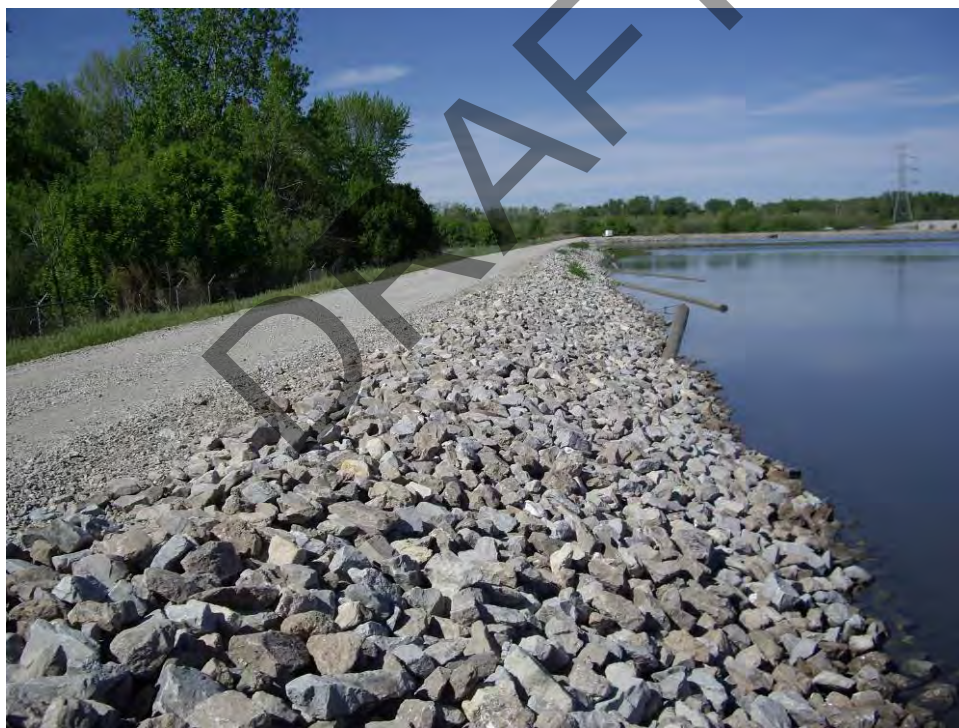
62. Pond B - west embankment interior slope, looking north

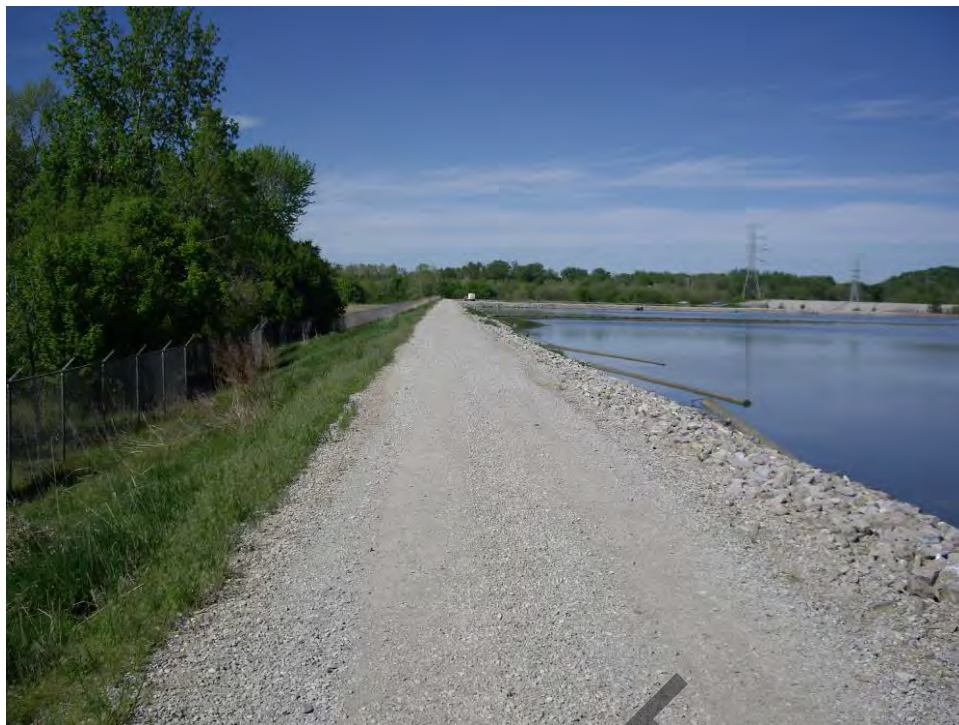
63. Pond B – west embankment crest, looking north

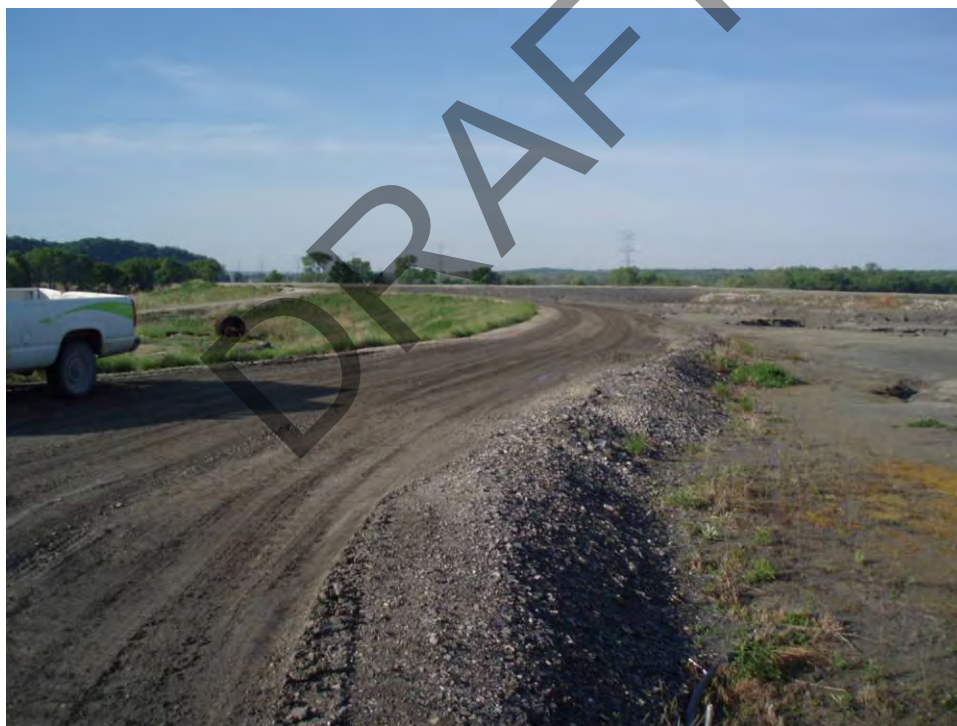
68. Pond D - east embankment crest, looking southwest.

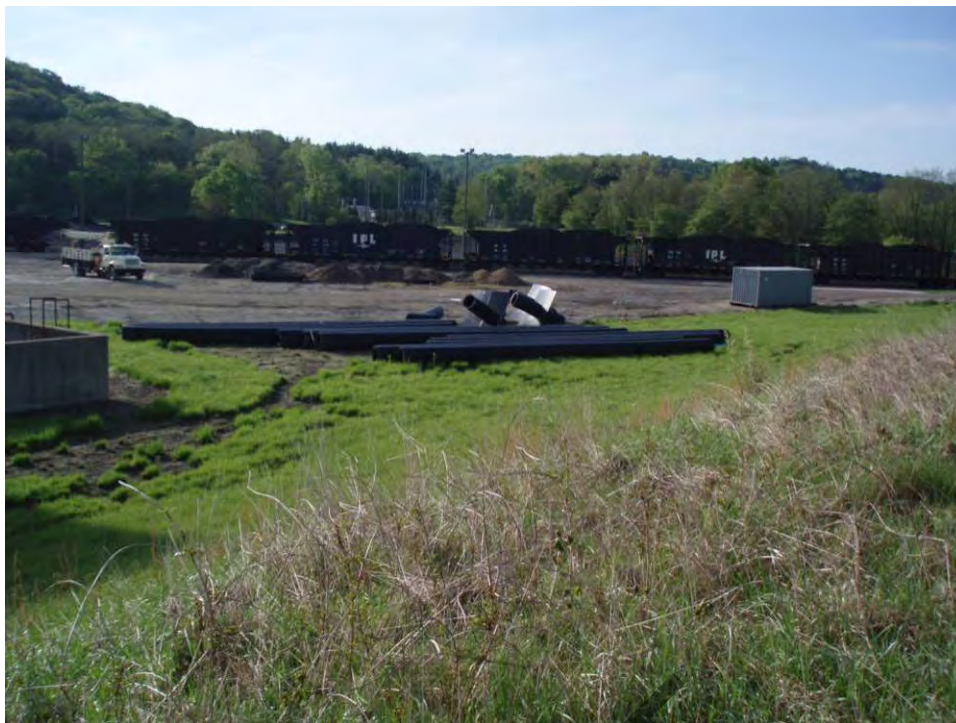
71. Pond D - East embankment downstream area looking southeast. Note new piping for Ponds D & E.

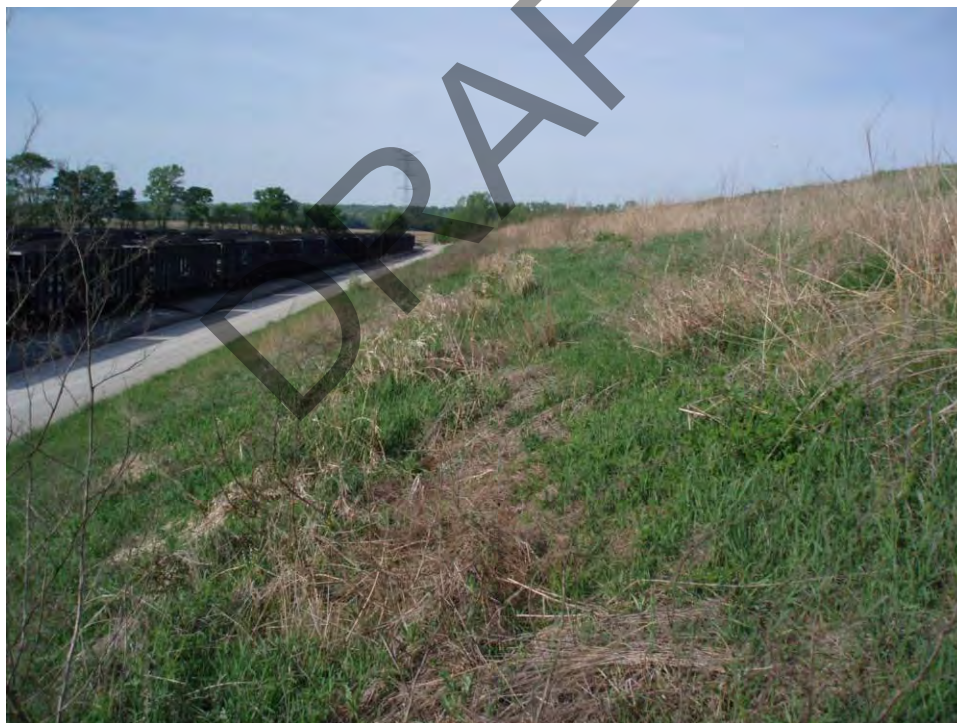
76. Pond D - Southeast embankment exterior slope, looking southwest.

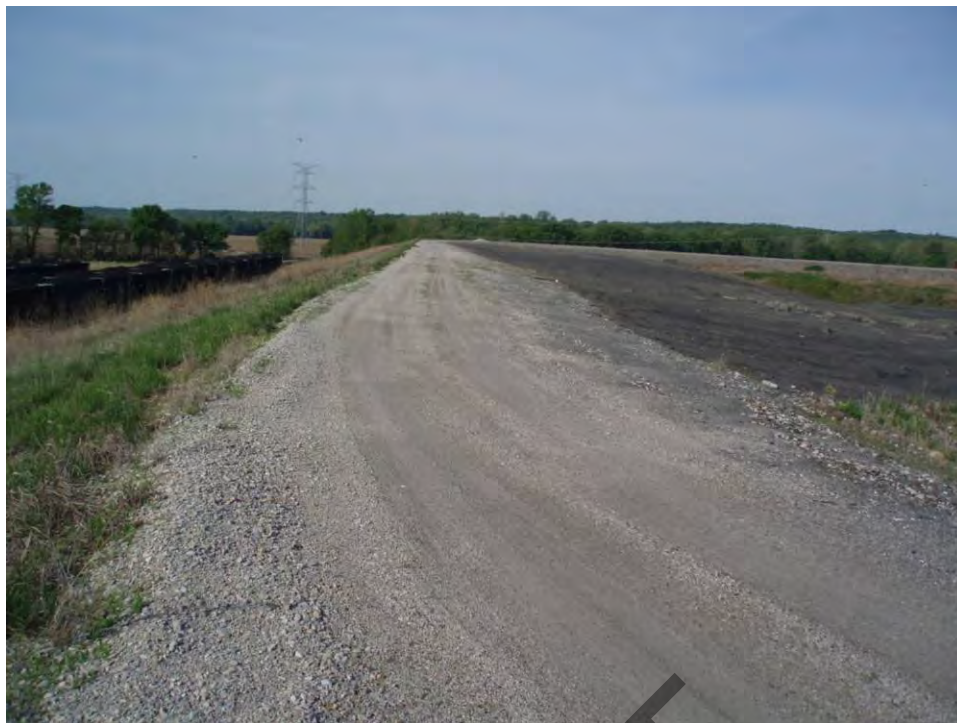
77. Pond D - Southeast embankment crest, looking southwest.

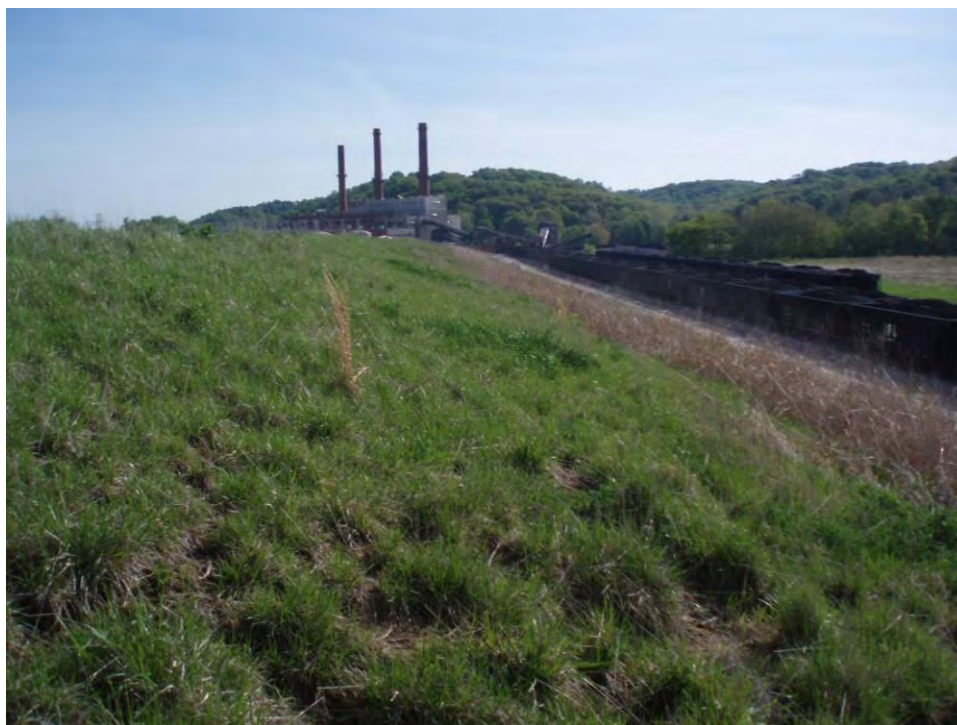
83. Pond D - Southeast embankment exterior slope, looking northeast.

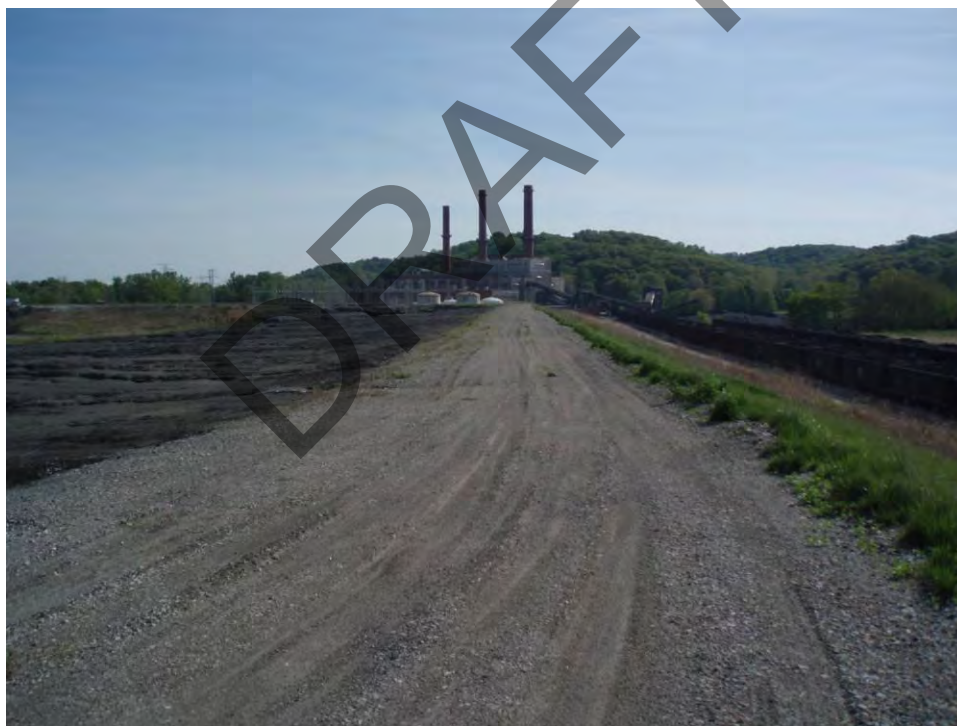
84. Pond D - Southeast embankment crest, looking northeast.

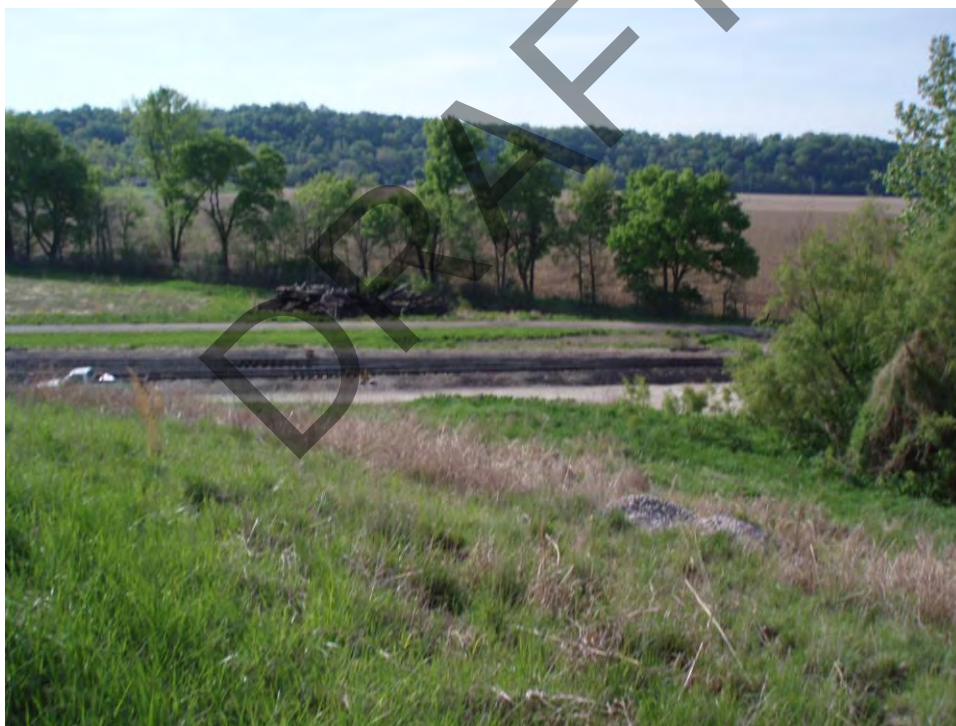
86. Pond D - Southwest corner of southeast embankment exterior slope downstream area, looking southeast.

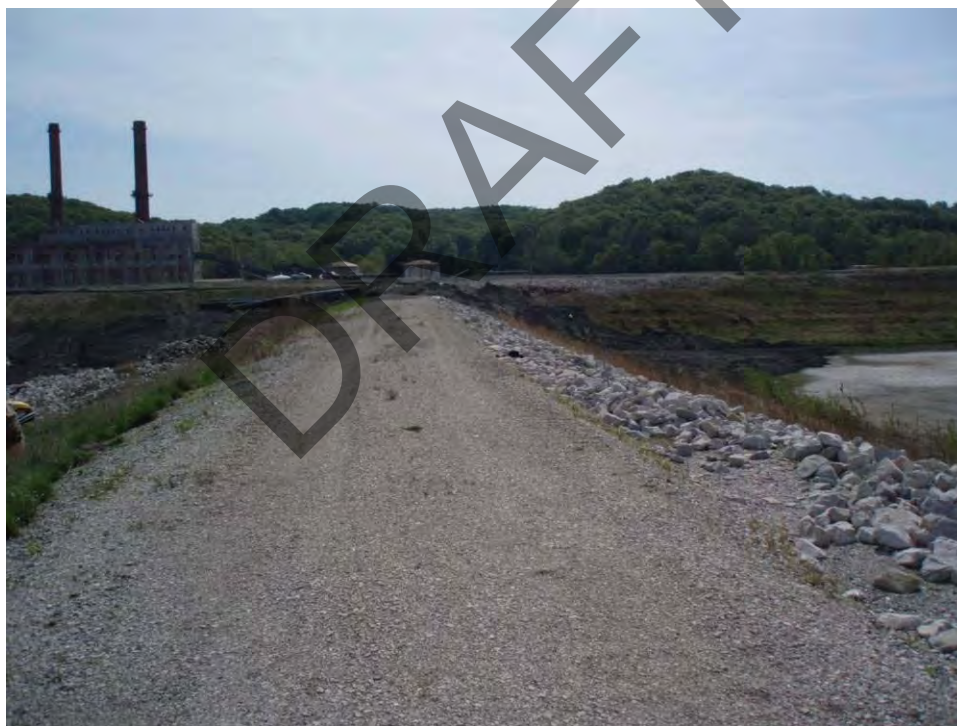
100. Crest of divider embankment D/E, looking east.

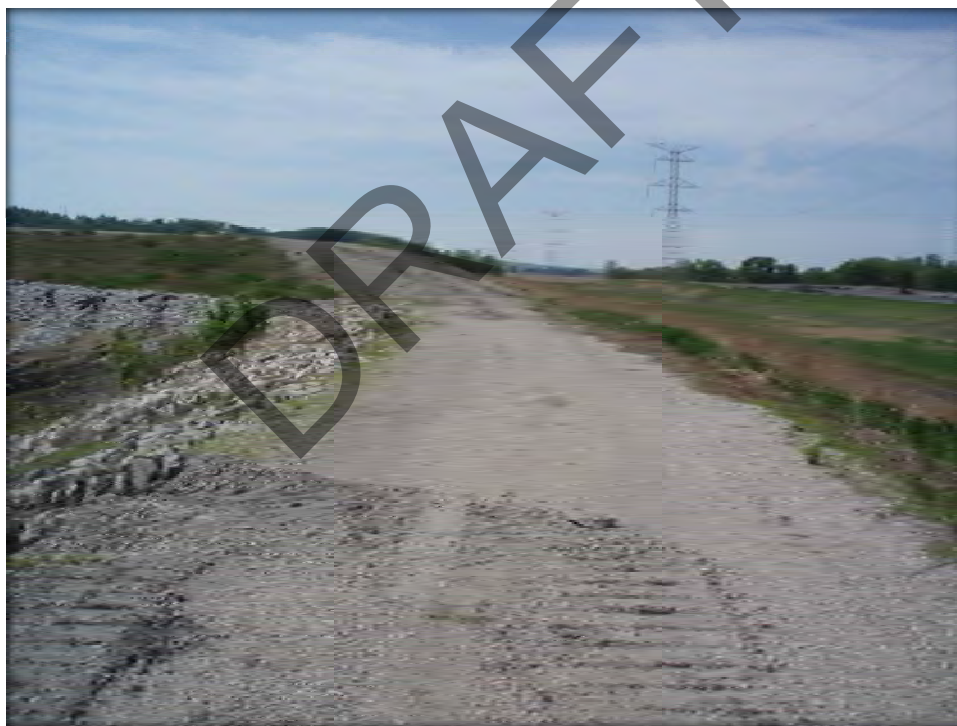
110. Pond E - West embankment crest, looking south.

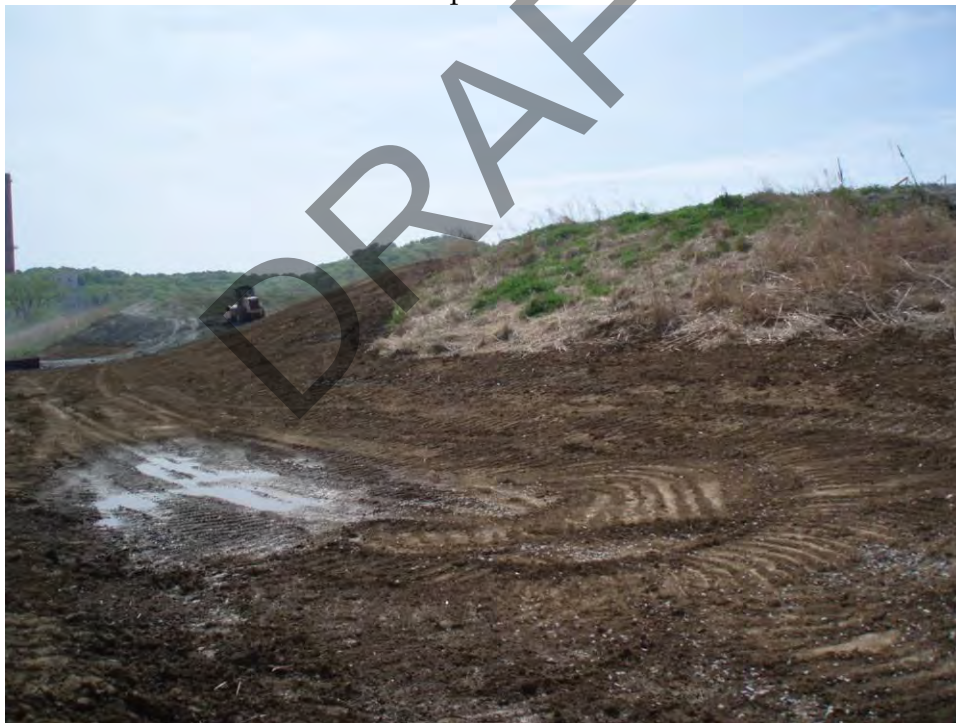
114. Pond E - Downstream area looking south toward failure repair (reconstruction of north embankment).

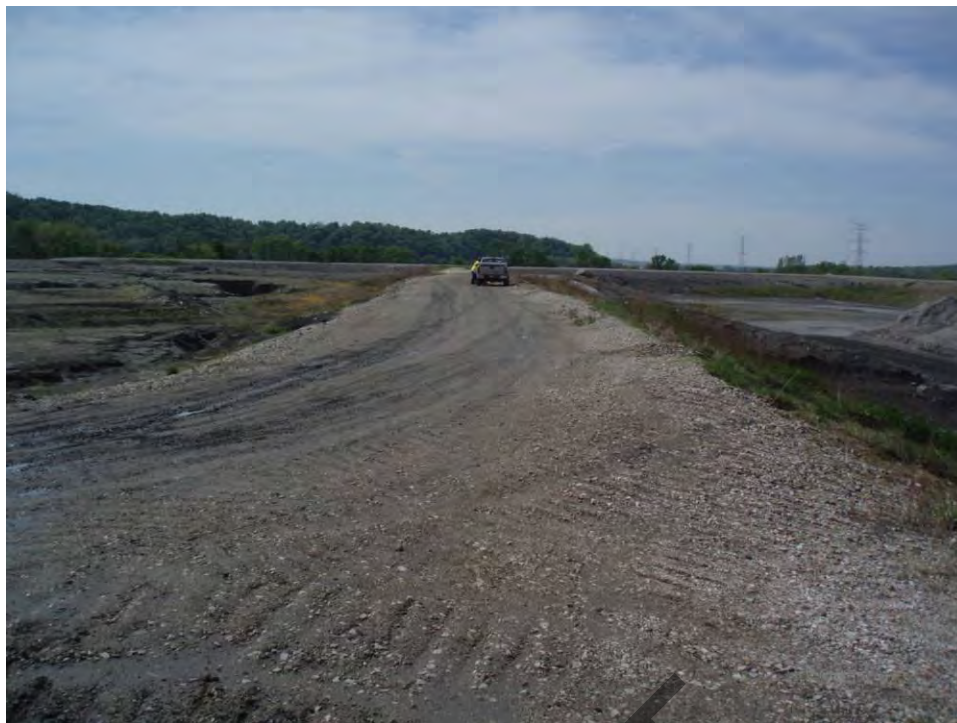
121. Crest of divider embankment D/E, looking south.

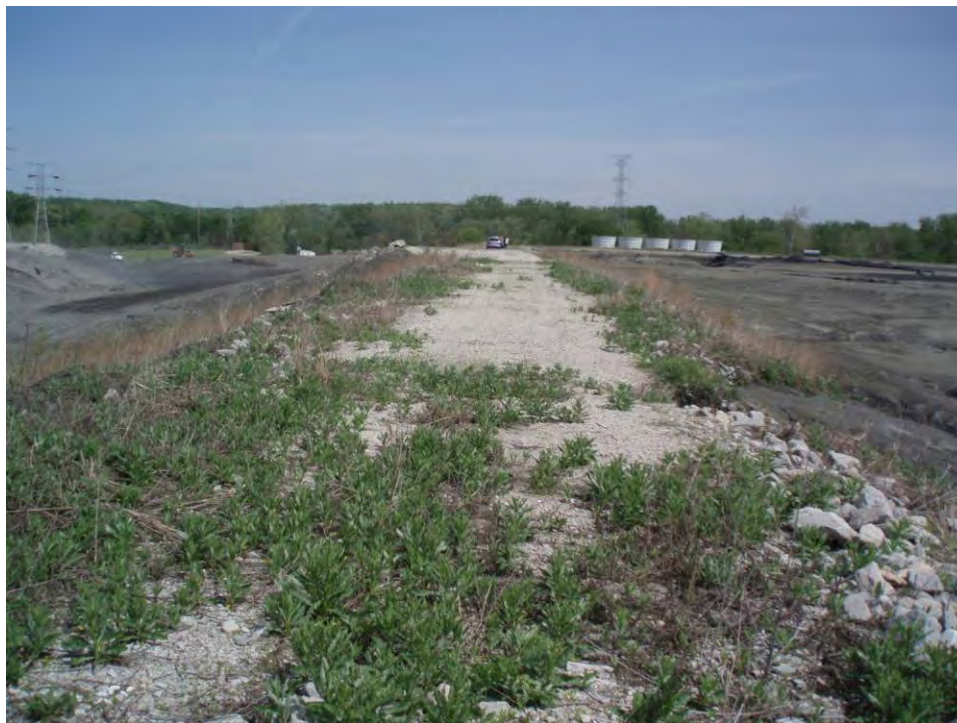
129. Pond D - Crest of diversion embankment, looking north.

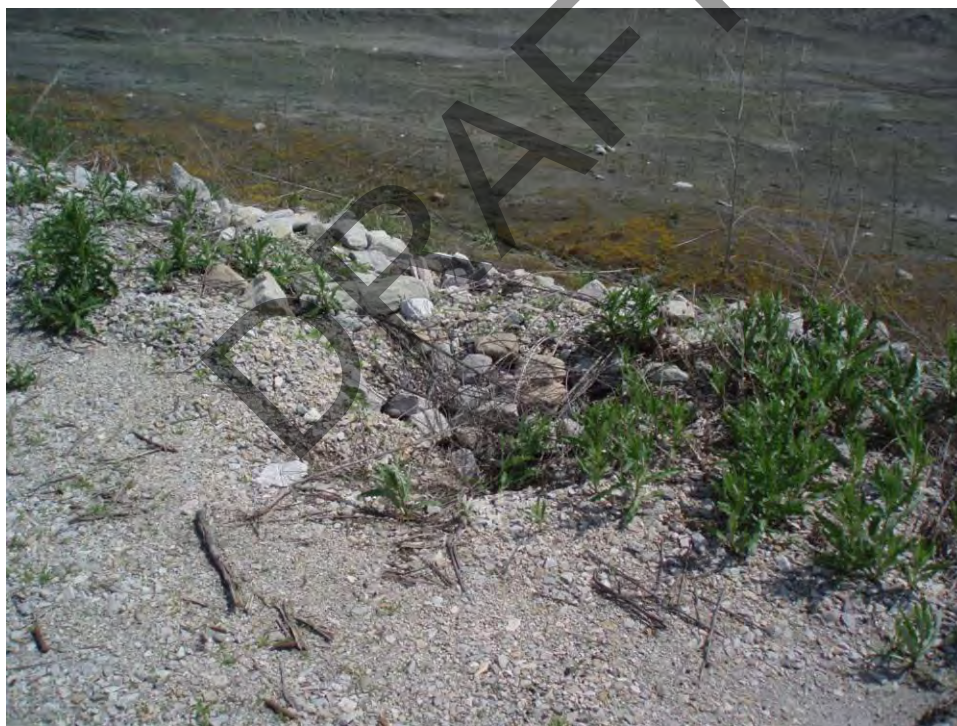
130. Pond D - Depression with piping on east slope of diversion embankment, looking northeast.

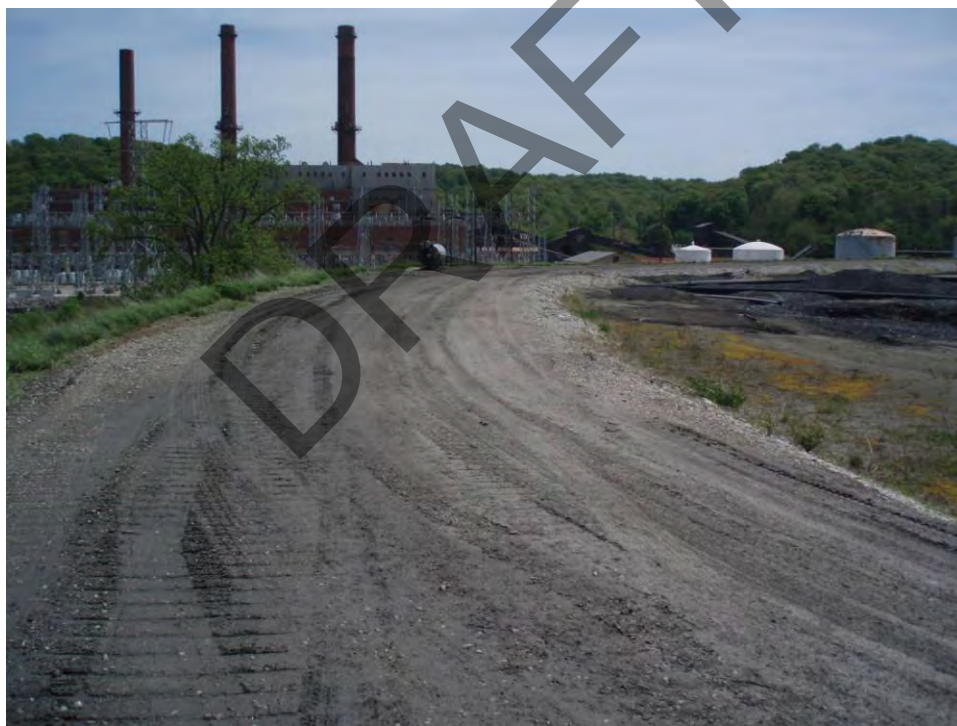
132. Pond D - North embankment crest, looking east.
