# **Assessment of Dam Safety of Coal Combustion Surface Impoundments**

**Indianapolis Power & Light Company**

**Eagle Valley Generating Station**

**June 4, 2010**

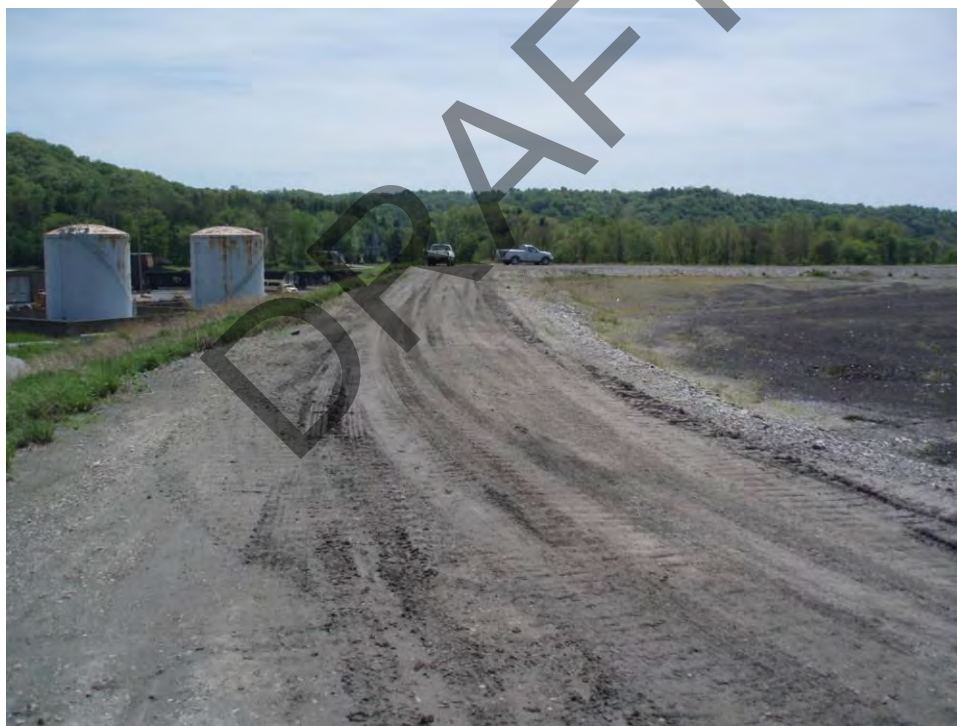
138. Pond D - Northeast embankment crest, looking southeast.

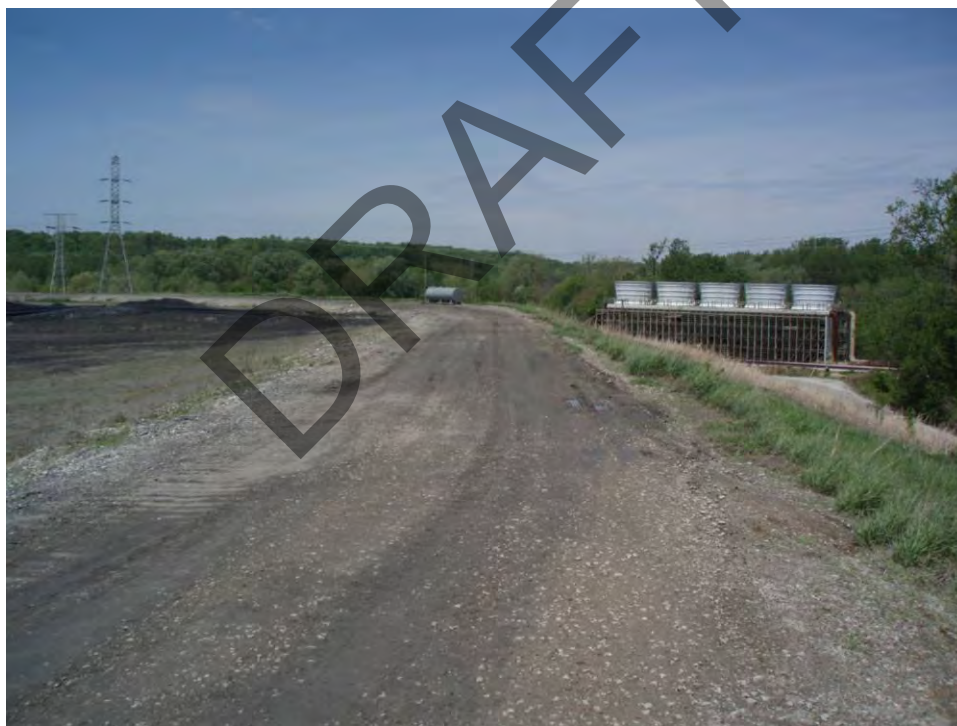
142. Pond D - Northeast embankment crest, looking northwest.
