# **Assessment of Dam Safety of Coal Combustion Surface Impoundments**

**Indianapolis Power & Light Company**

**Eagle Valley Generating Station**

**November 15, 2010**

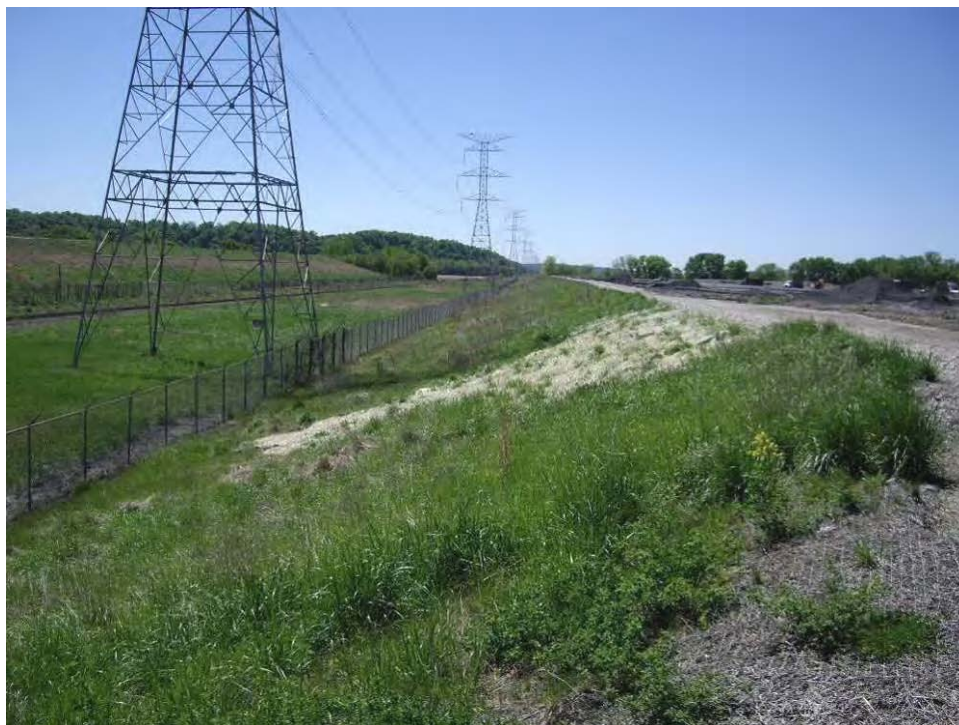
One repair on the northeast corner of the east embankment was observed (Photos 1, 3, and 4). IPL indicated that the repair was needed due to an ash sluice line leak located in the northeast corner of Pond A. The repair consists of an erosion control blanket. The erosion control blanket did not appear to be installed consistent with typical manufacturer's recommendations. Stakes did not appear to be installed properly, and the blankets were not overlapped or keyed into an anchor trench in the slope. Approximately 1- to 3-inch gaps were observed below the blanket.

1. Pond A - East embankment exterior slope looking south.

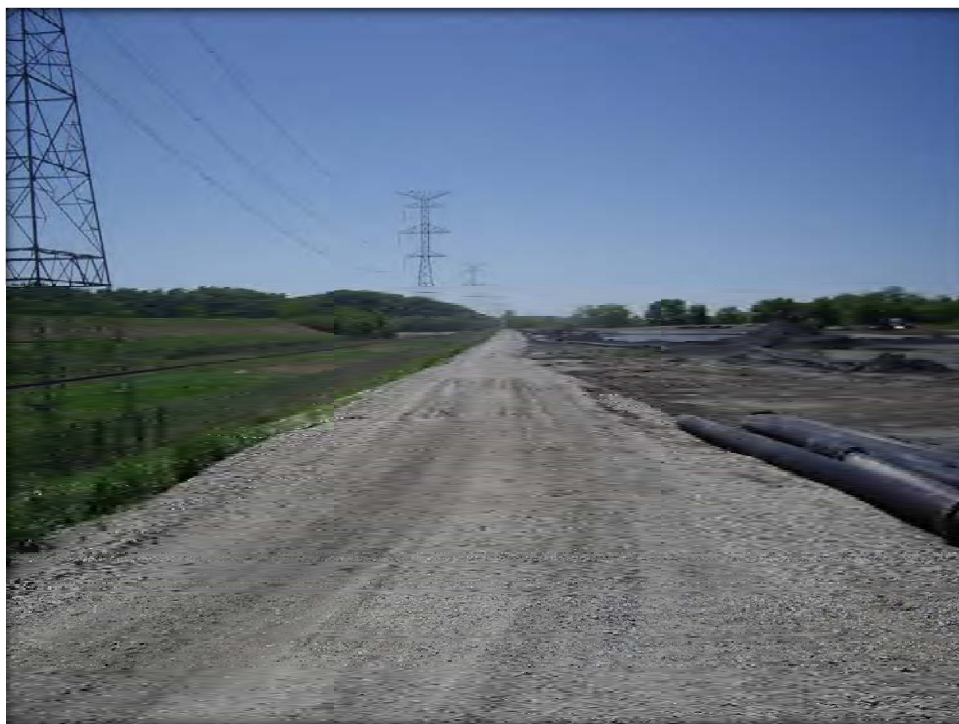
The crest of the Pond A embankments appeared to generally be in fair condition (Photos 2, 8, 14, 16, 19, 22, 24, 27, 30, 34, 43, and 44). The crest was approximately 15 feet wide with exception of the truck turn around area where the crest was significantly wider. The crest consists of a compacted gravel access road around the perimeter. Three low spots were observed in the crest (Photos 2, 14, and 28). Two of the low spots appear to be from recent truck traffic rutting the crest. The low spot on the east embankment observed on 4/28/10 was filled in by an IPL contractor to improve conditions for traffic purposes. IPL indicated that the low spot on the divider embankment near the outlet pipes (Photo 28) is an overflow spillway. There are no records in the information provided to CDM to indicate this was a design feature. There were no deficiencies observed in this area.

2. Pond A - East embankment crest looking south.

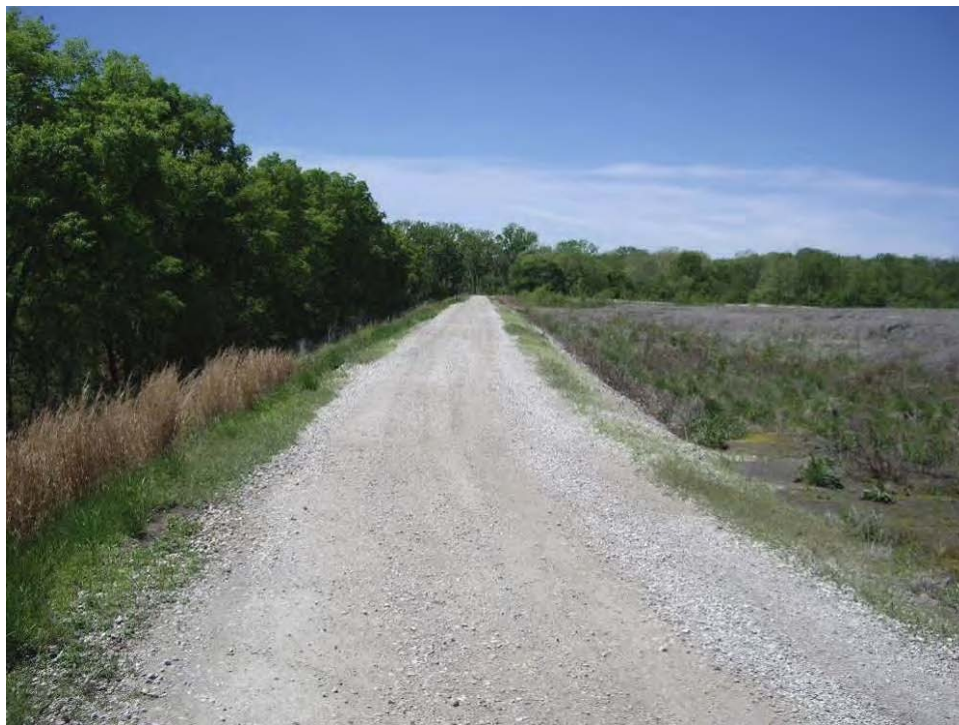
19. Pond A – South embankment crest looking west.

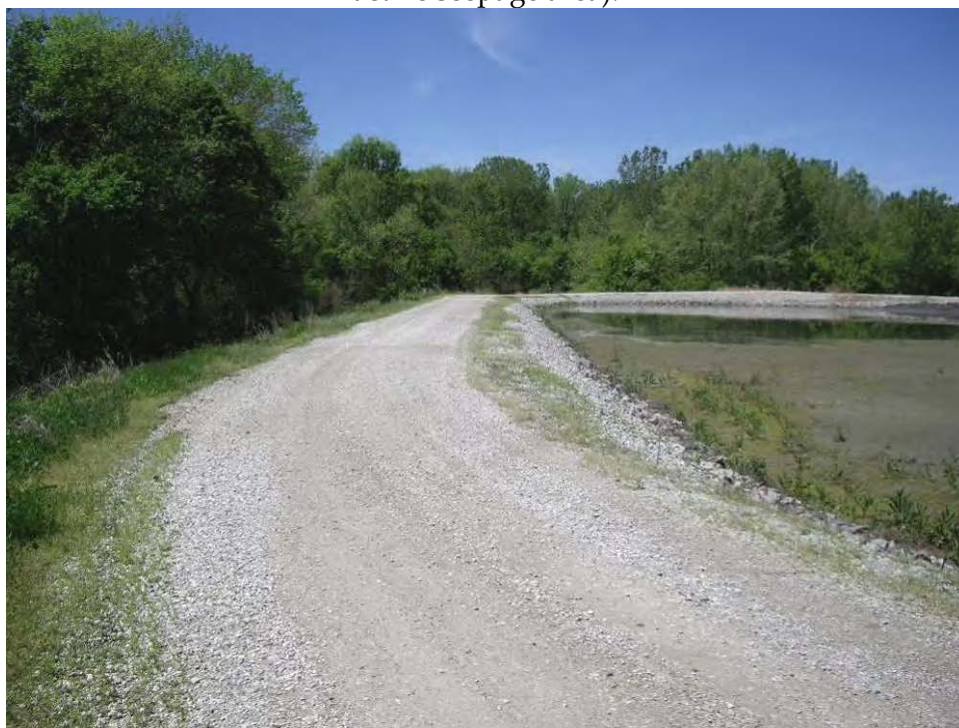
22. Pond A - South embankment crest, looking west.

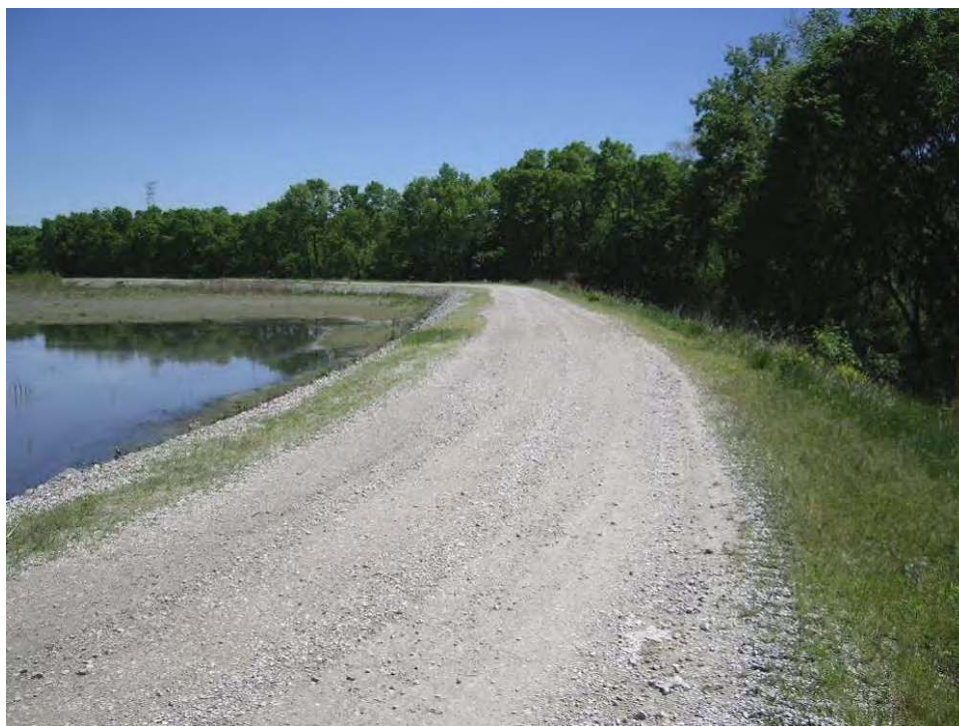
24. Pond A – South embankment crest, looking southeast.

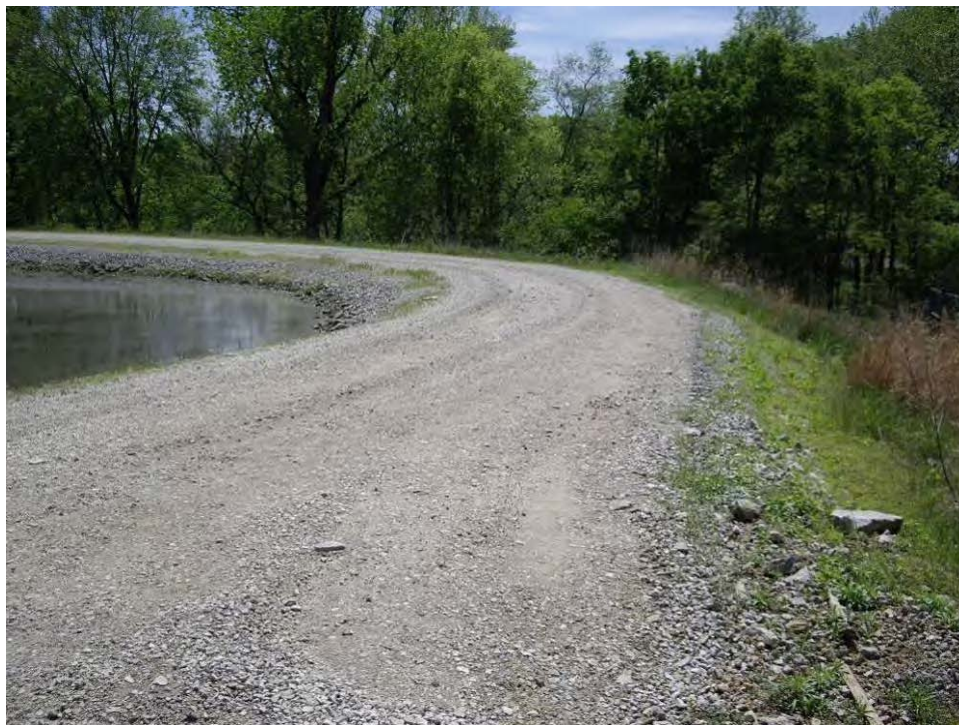
27. Pond A – West embankment crest, looking south.

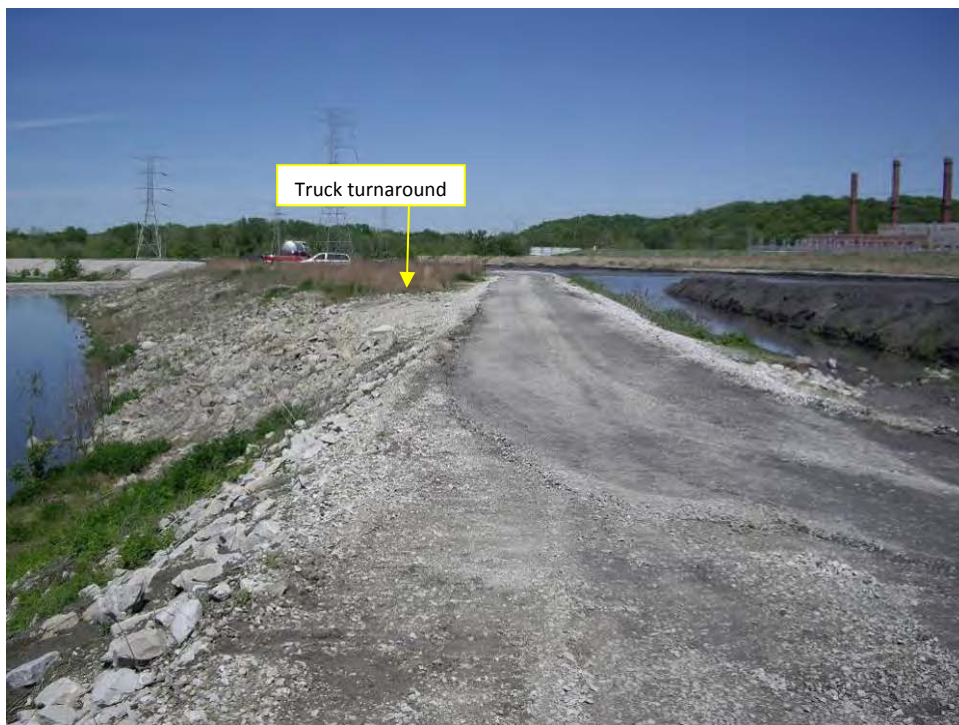
34. Crest of divider embankment A/B, looking northeast.

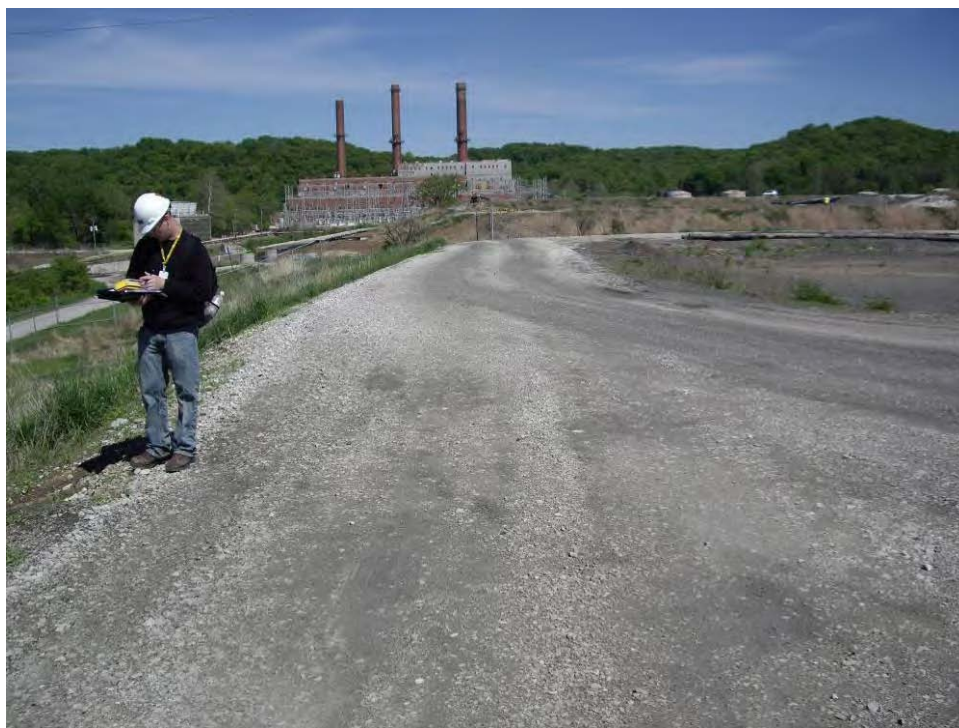
44. Pond A - North embankment crest, looking east.

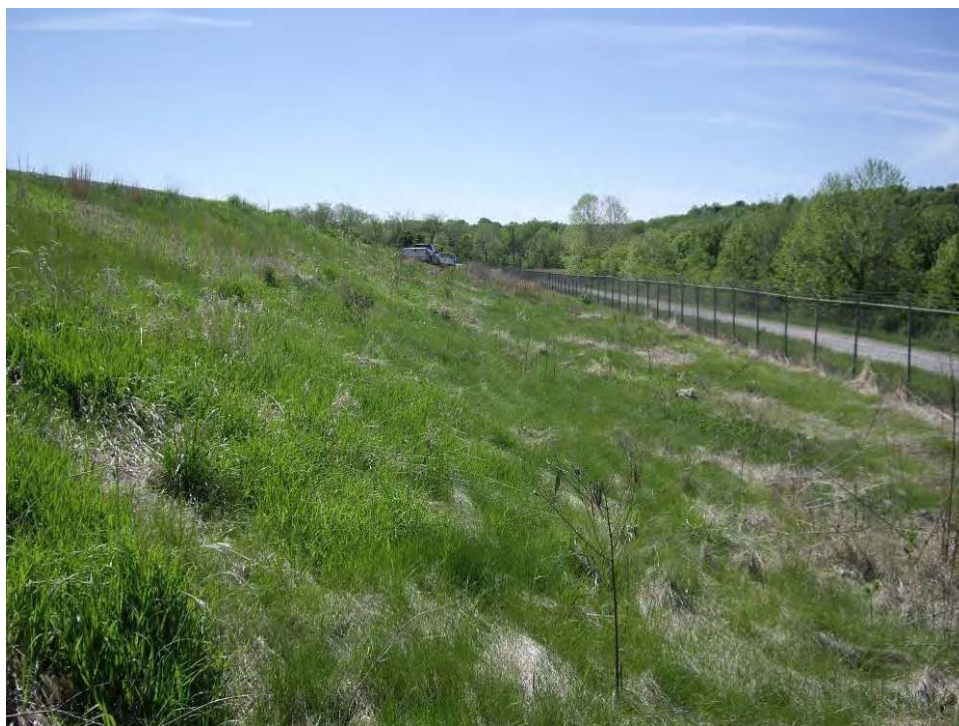
46. Pond C - North embankment exterior slope, looking west.

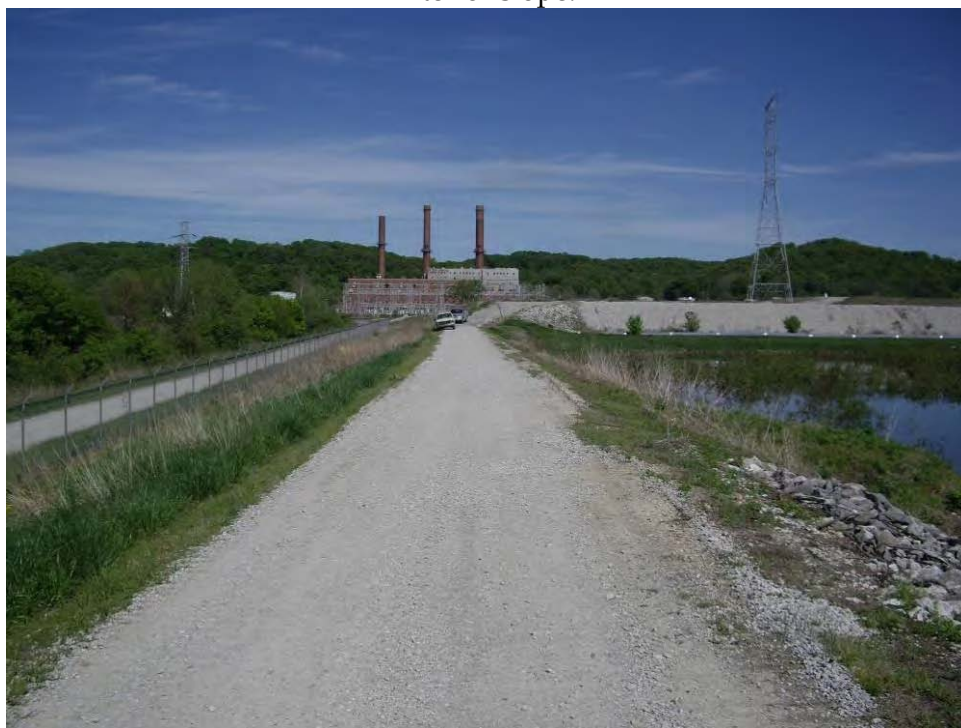
48. Pond C – North embankment crest, looking east.

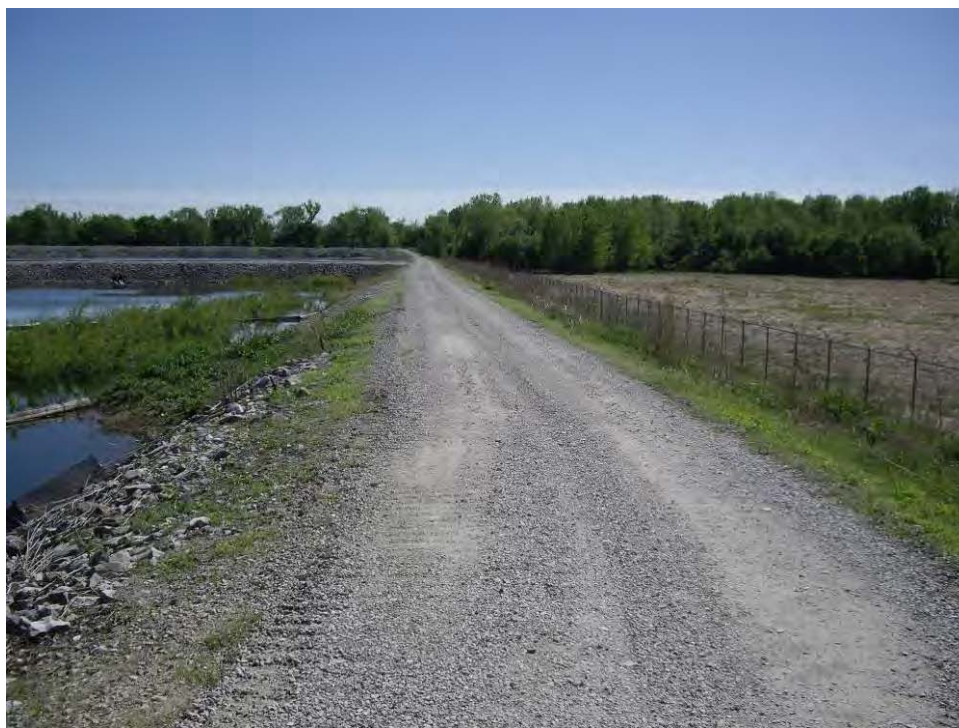
52. Pond C - West embankment crest, looking south.

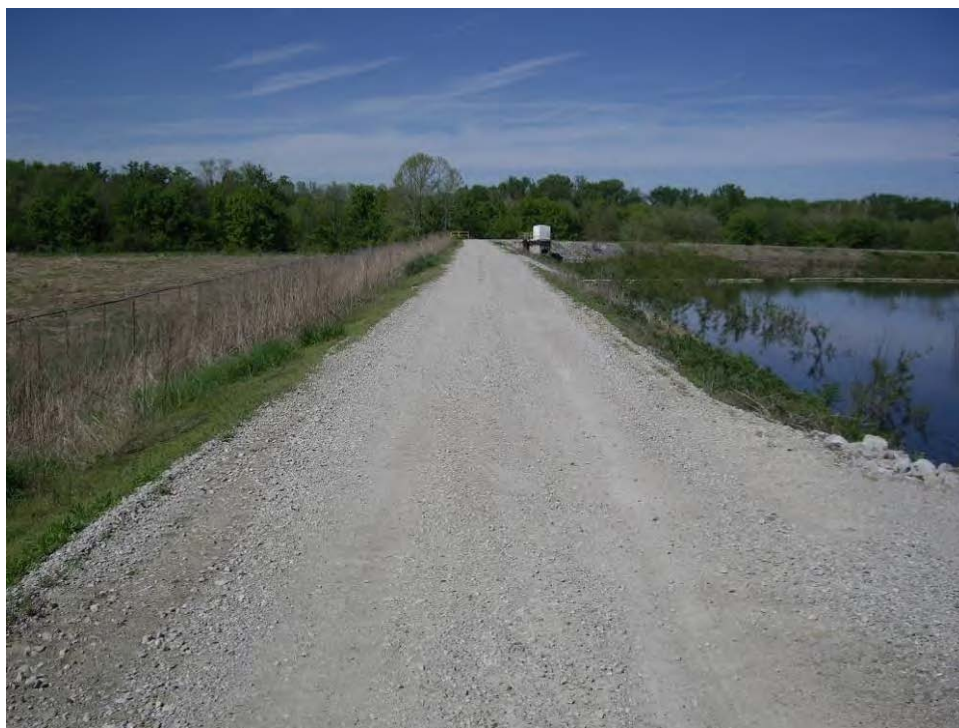
56. Pond C - West embankment crest, looking north

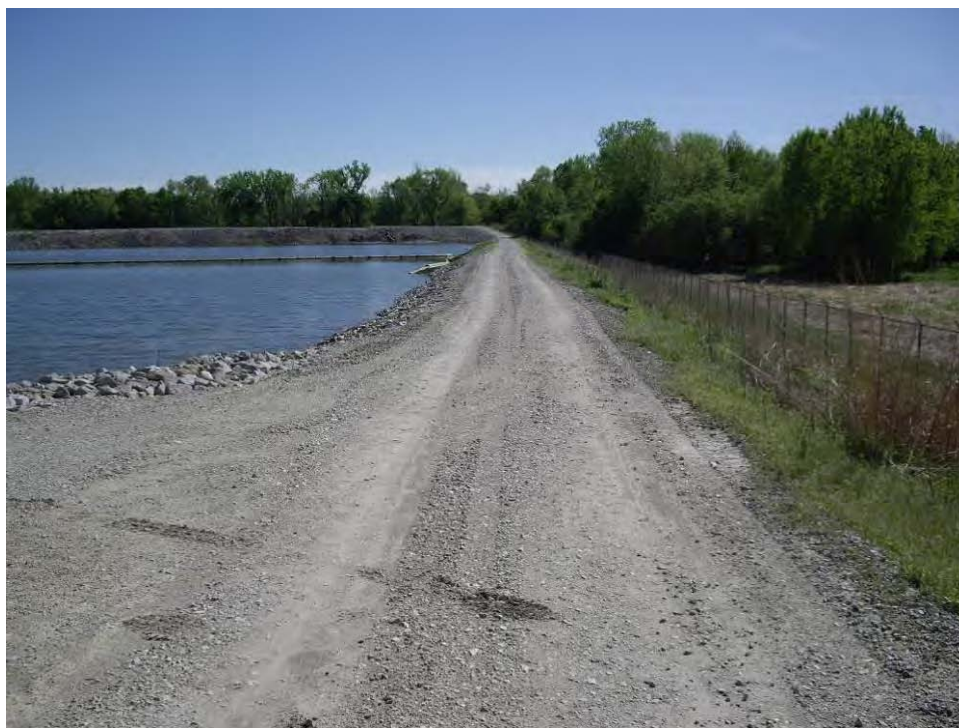
60. Pond B - west embankment crest, looking south.

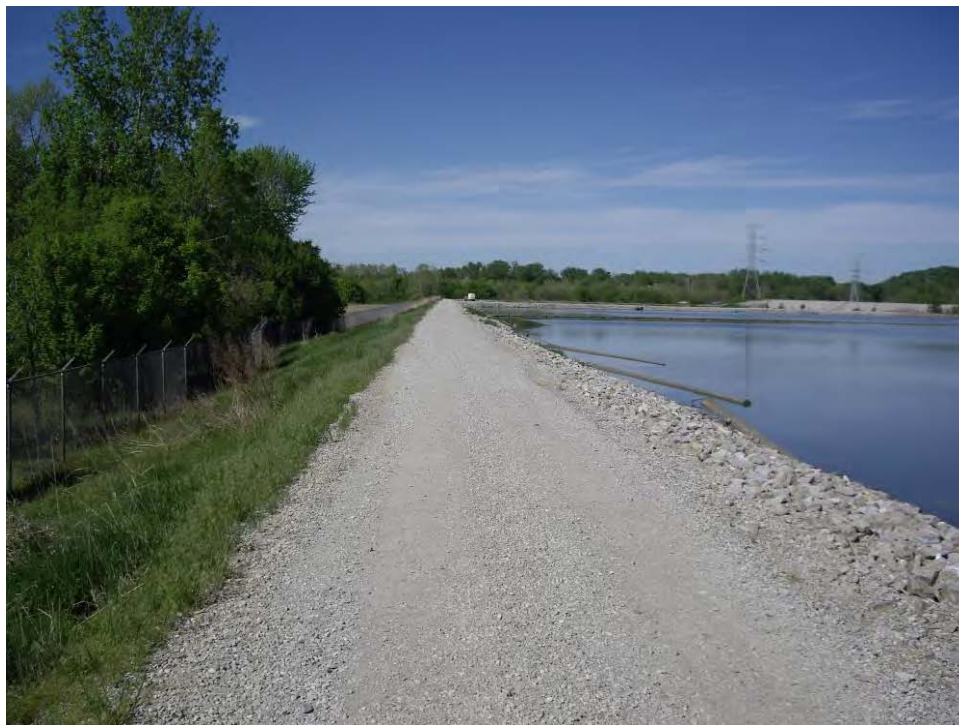
63. Pond B – west embankment crest, looking north

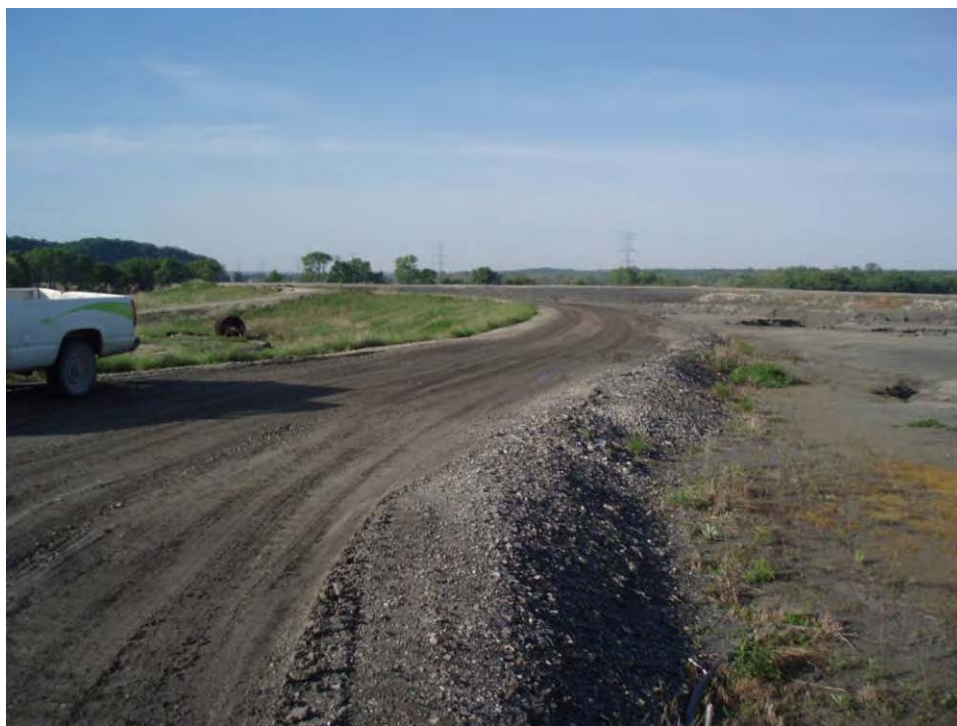
68. Pond D - east embankment crest, looking southwest.

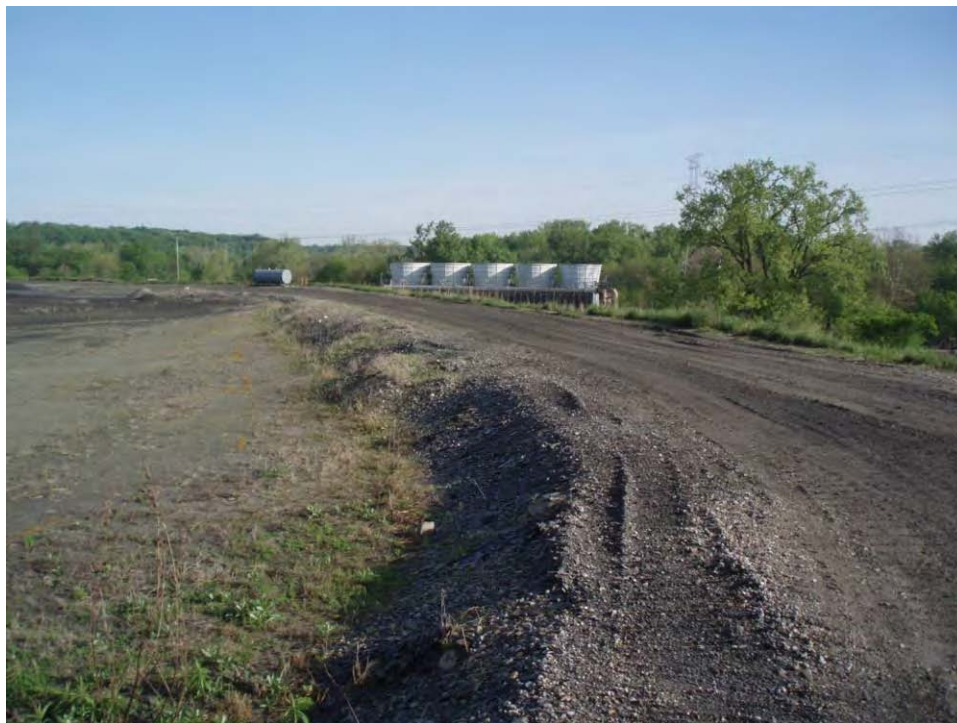
69. Pond D - north embankment crest, looking northwest.

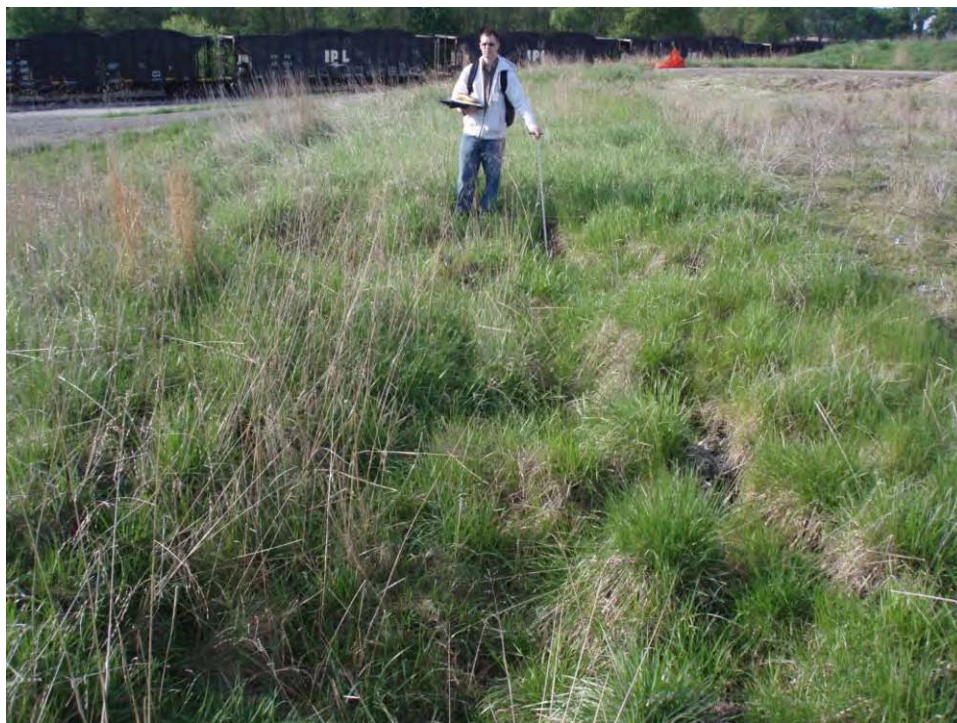
72. Pond D - Erosion rill and depression on east embankment buttress berm, looking south.

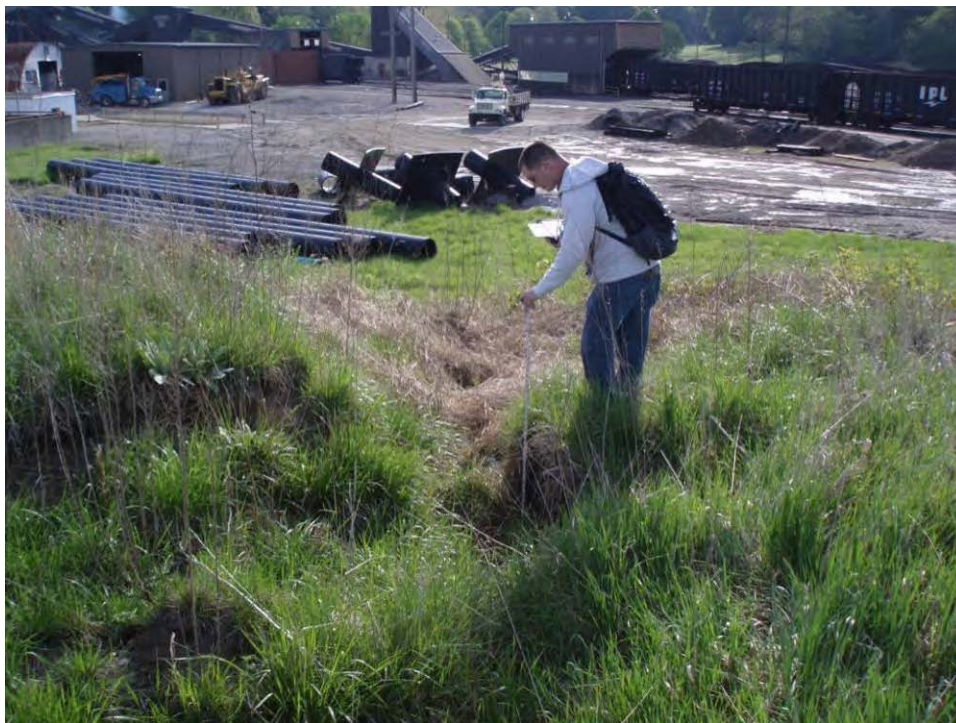
73. Pond D - Erosion rill on east embankment buttress berm, looking northeast

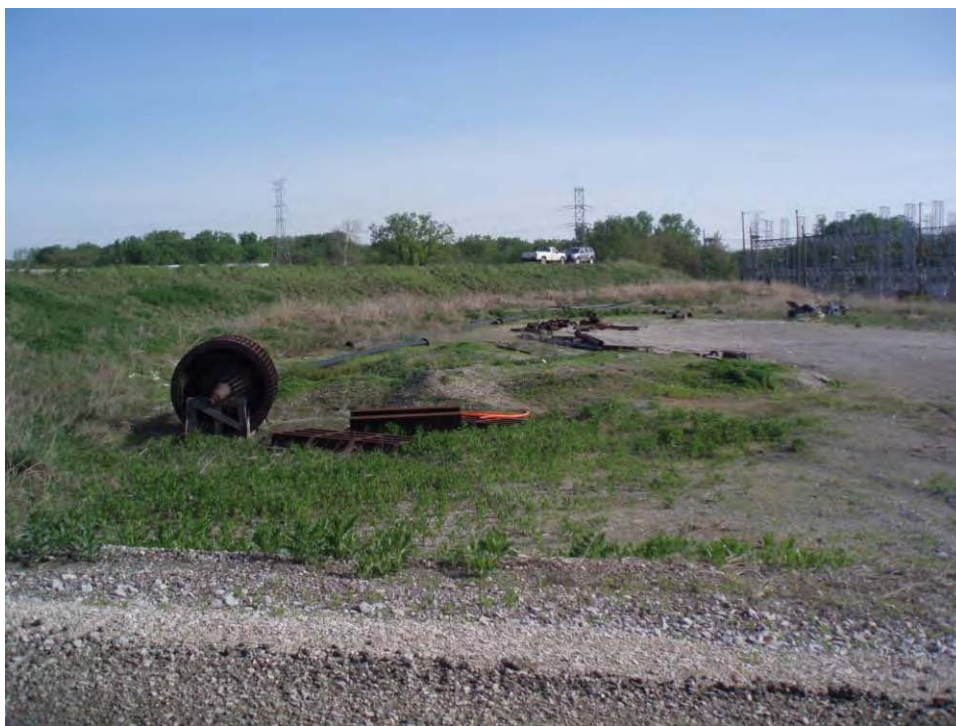
74. Pond D - Crest of east embankment buttress berm, looking north

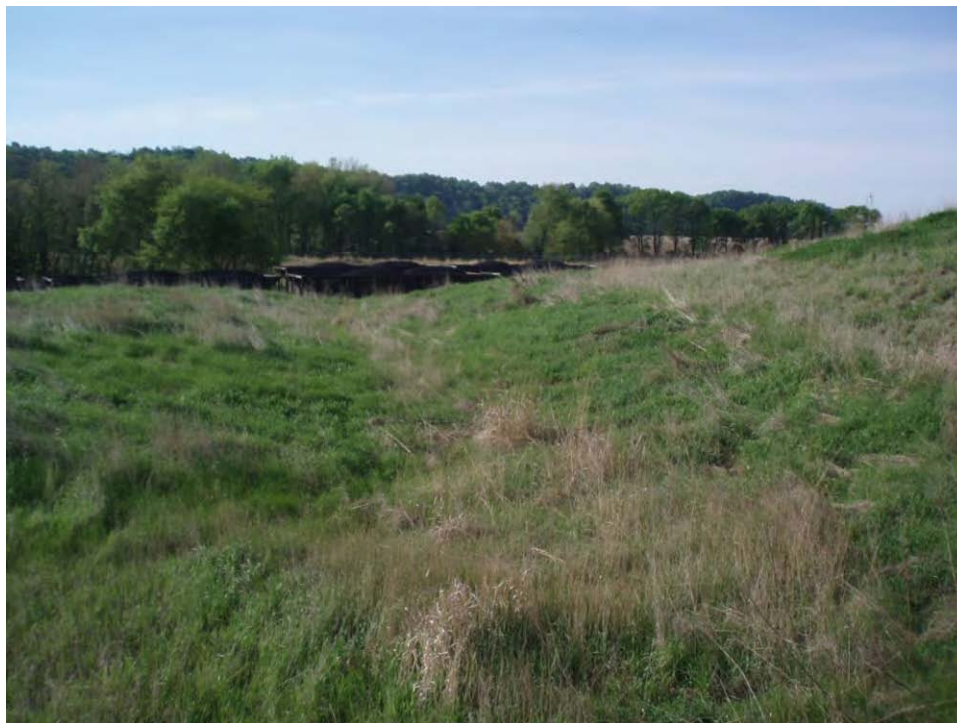
75. Pond D - Crest of east embankment buttress berm, looking south

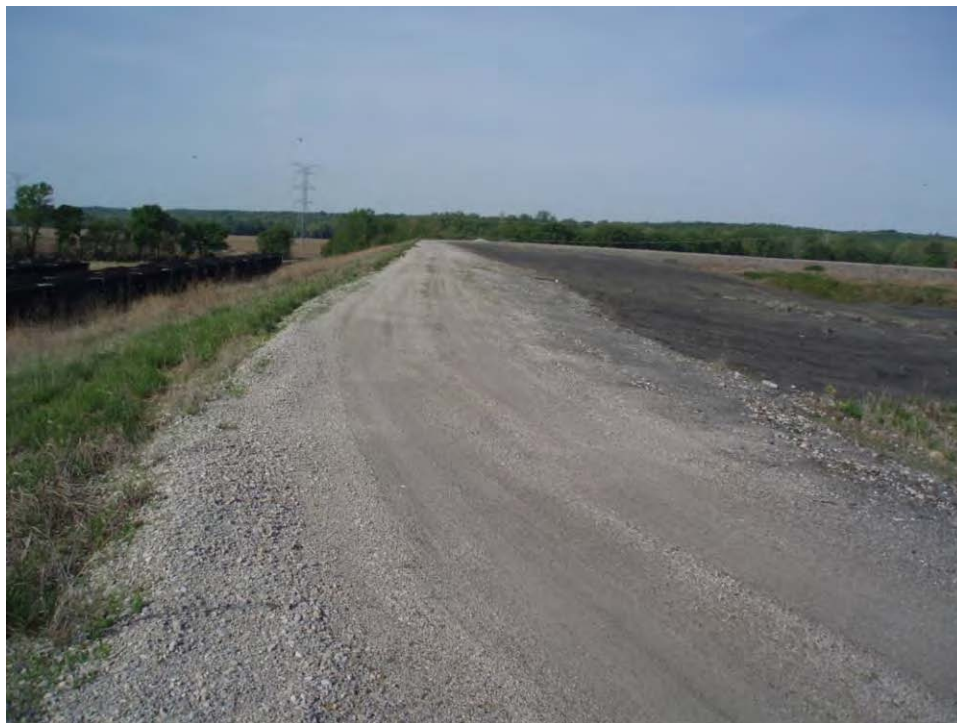
77. Pond D - Southeast embankment crest, looking southwest.

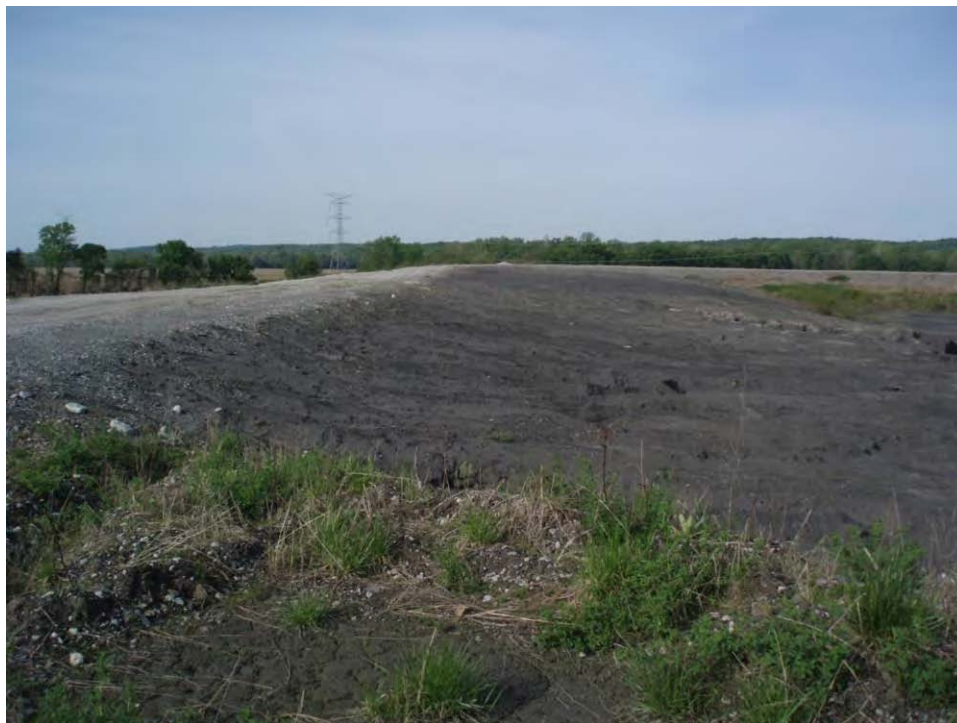
79. Pond D - Southeast embankment interior area, looking southwest

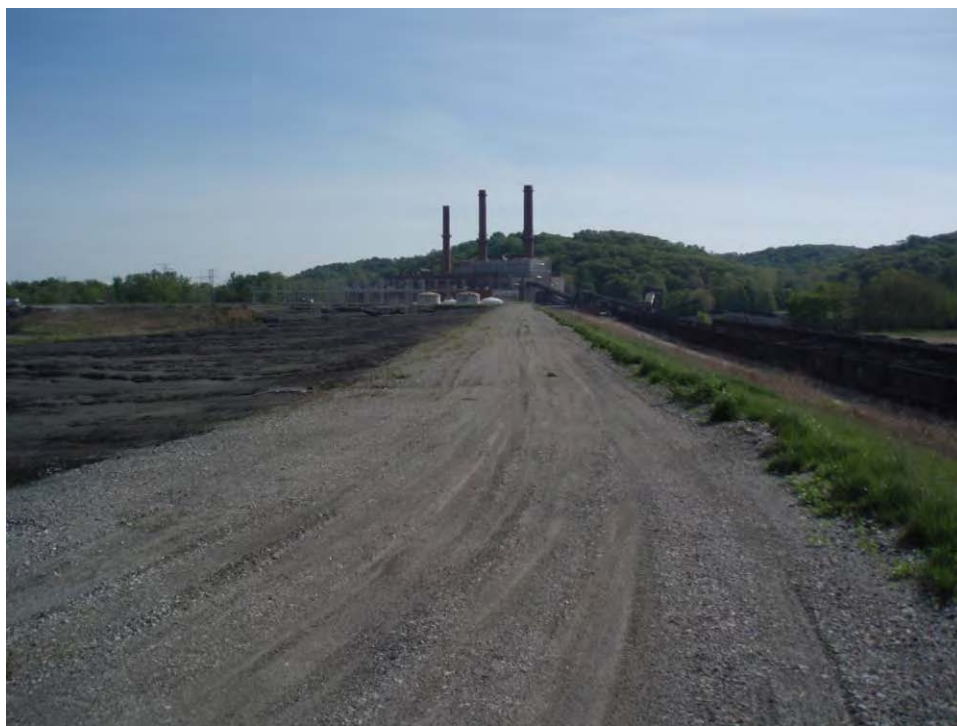
84. Pond D - Southeast embankment crest, looking northeast.

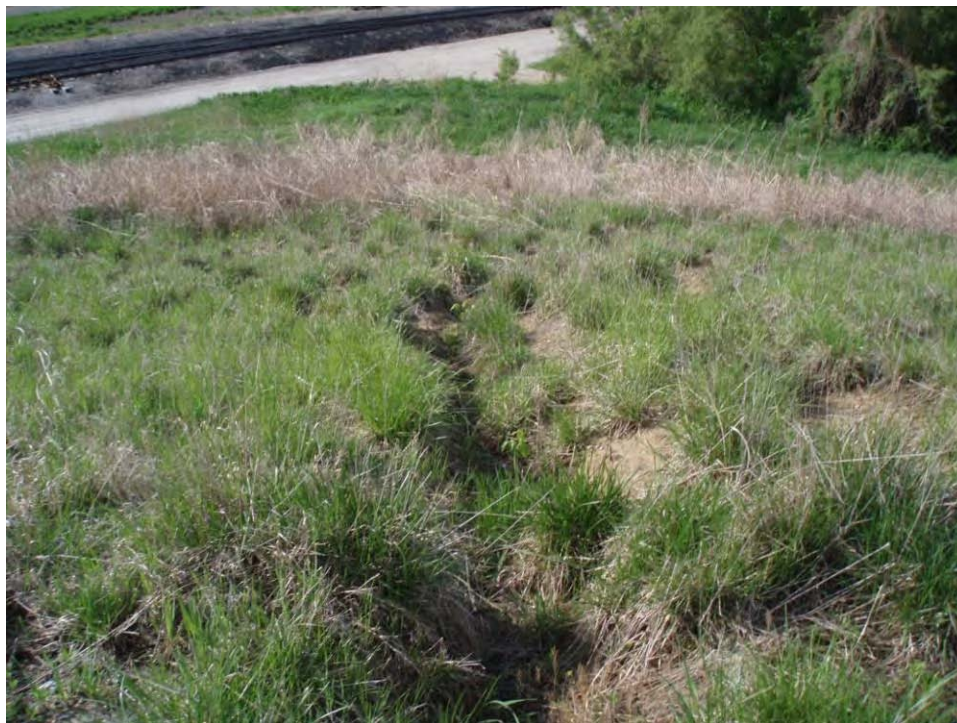
85. Pond D - Erosion rill on southeast embankment exterior slope, looking southeast.

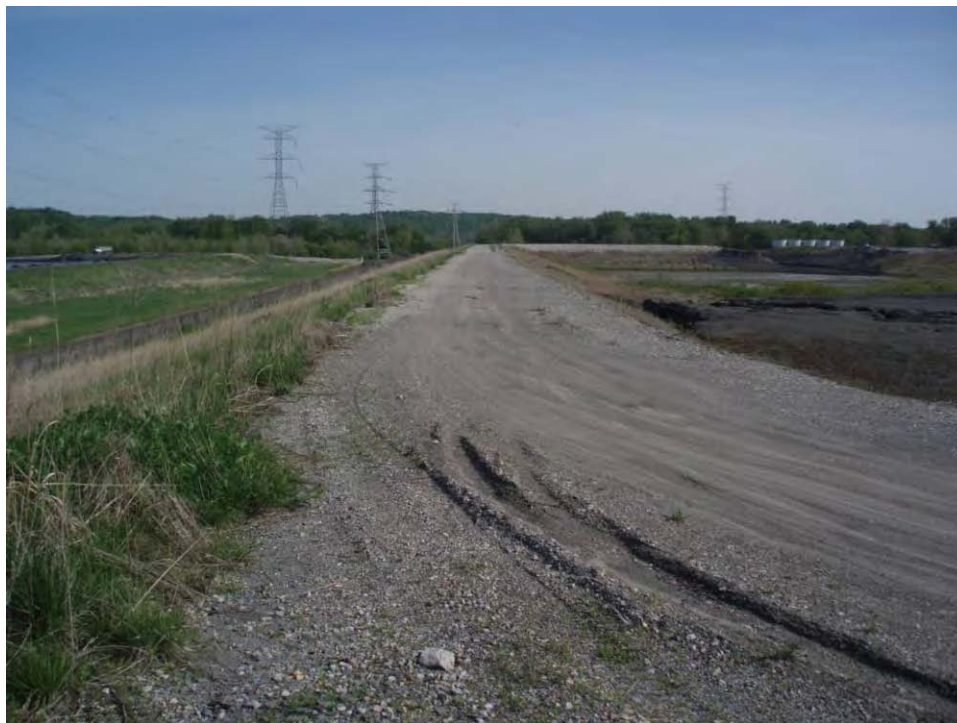
87. Pond D - West embankment crest, looking north

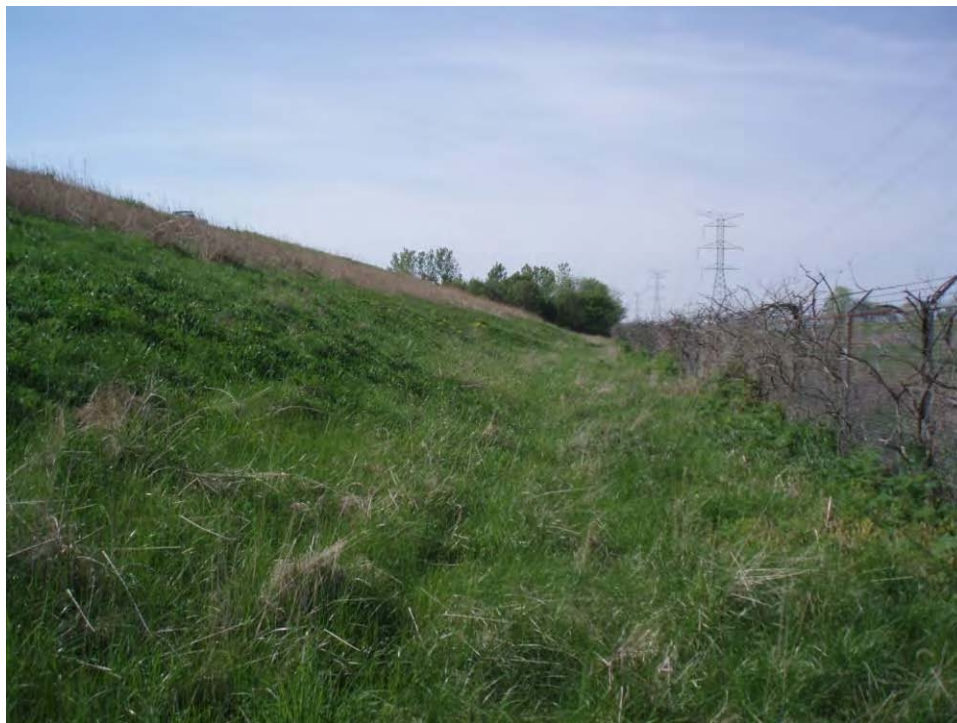
91. Pond D - West embankment exterior slope, looking south.

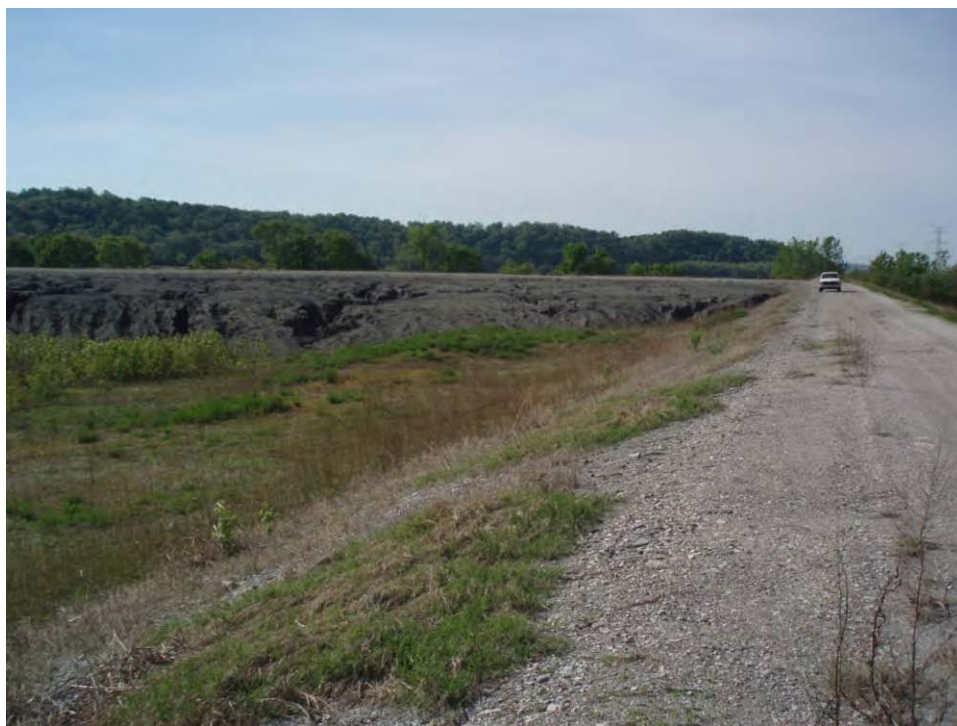
92. Pond D - West embankment interior slope, looking south at edge of ash limit prior to Pond D/E embankment failure.

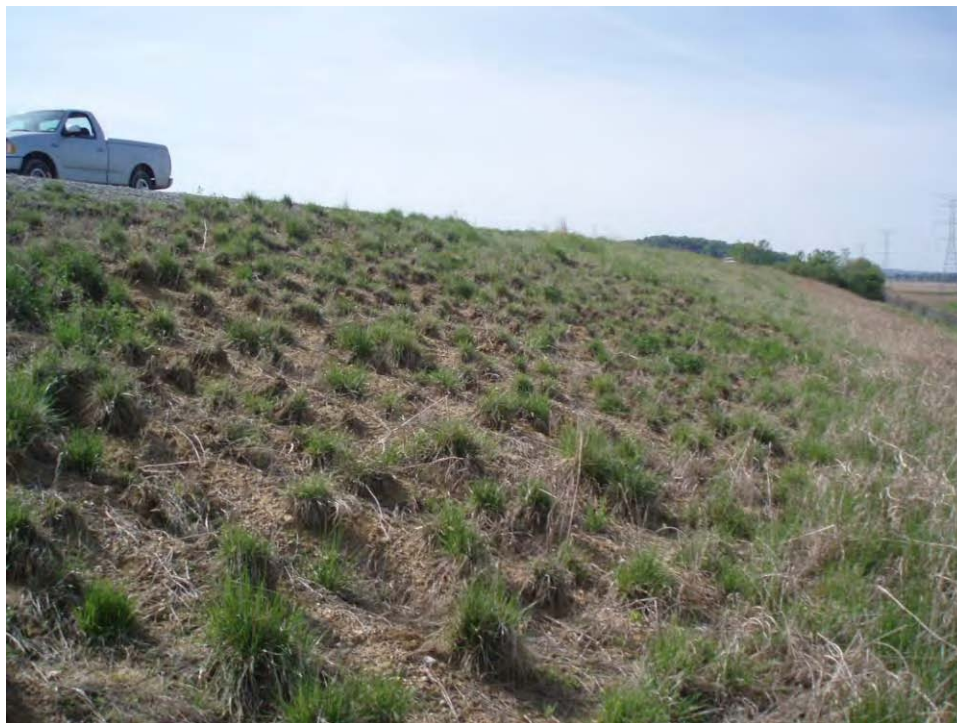
97. Pond D - Typical bare spot and erosion on west embankment exterior slope, looking southeast.

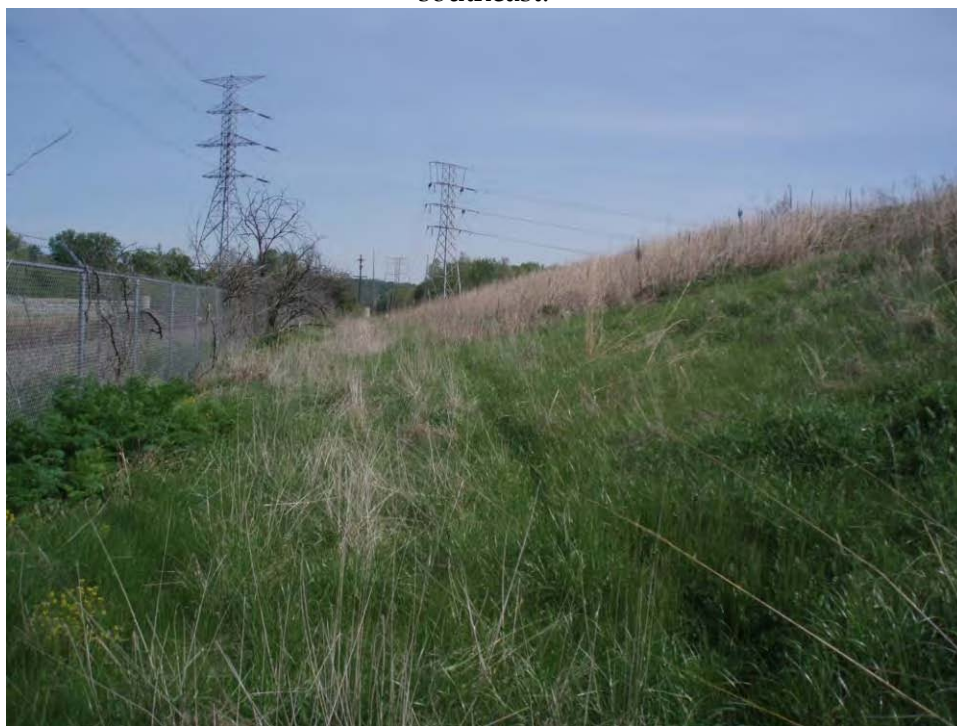
98. Pond D - West embankment exterior slope at toe, looking north.

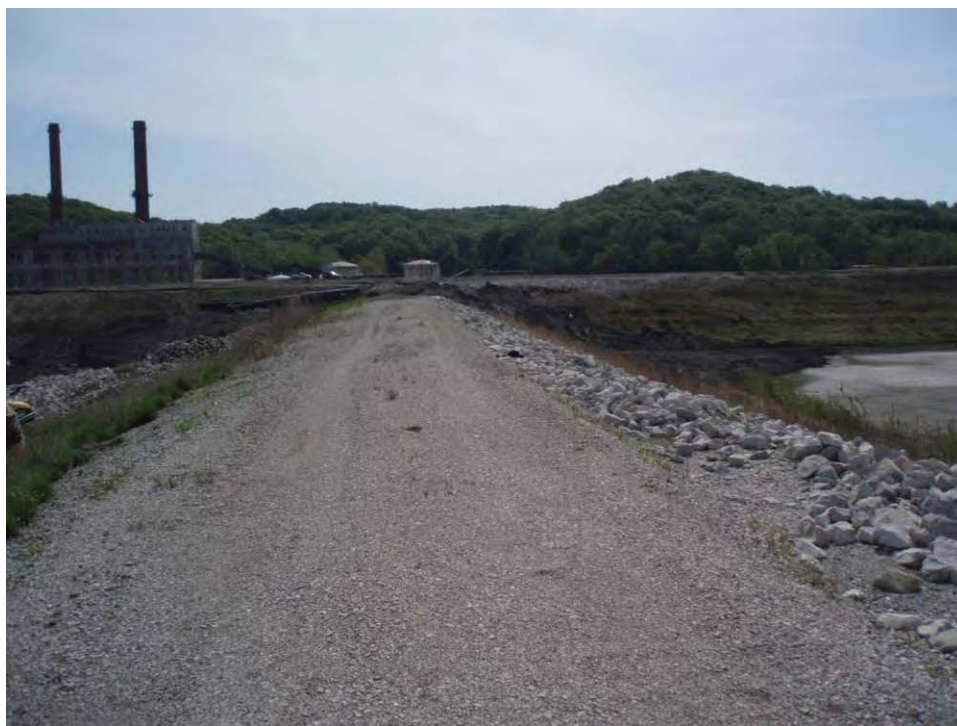
100. Crest of divider embankment D/E, looking east.

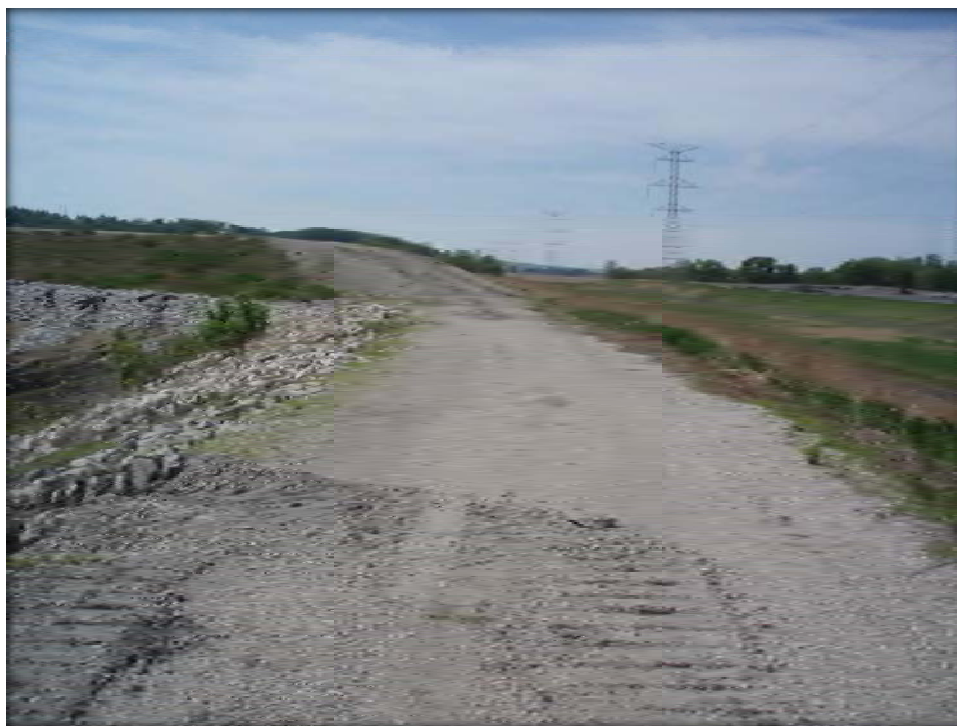
110. Pond E - West embankment crest, looking south.

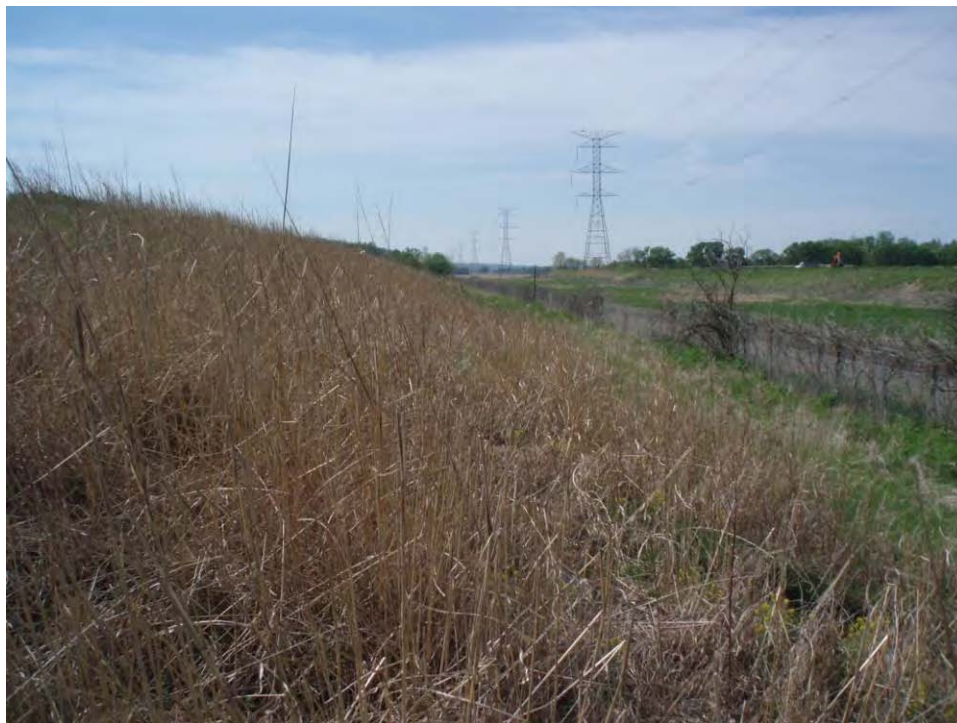
111. Pond E - West embankment exterior slope, looking south.
