# **Assessment of Dam Safety of Coal Combustion Surface Impoundments**

**Indianapolis Power & Light Company**

**Eagle Valley Generating Station**

**November 15, 2010**

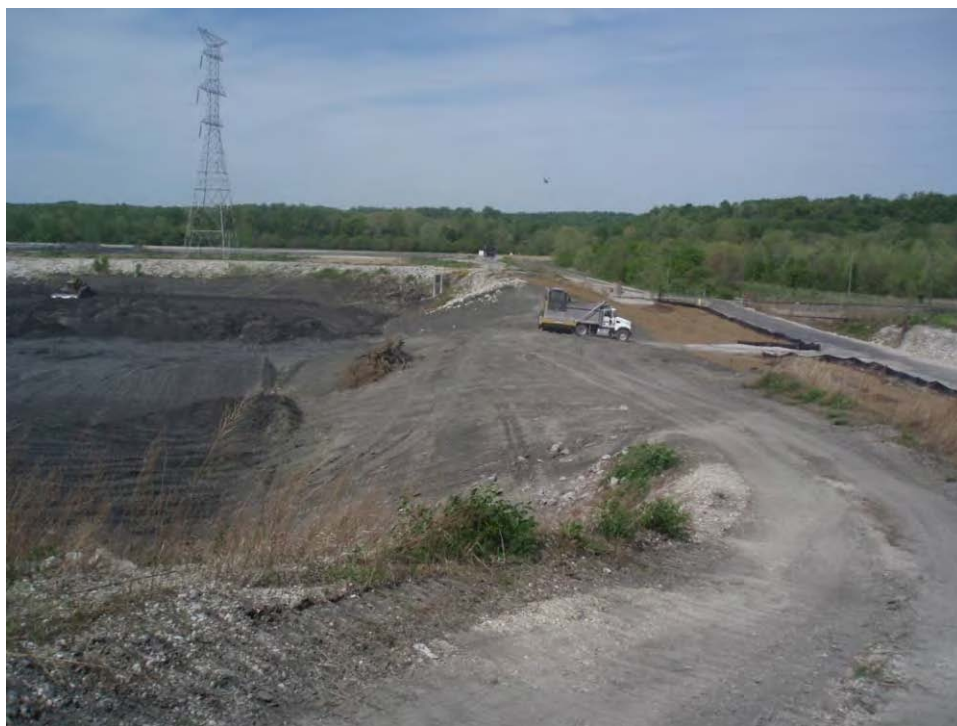
120. Pond E - Overview of north embankment reconstruction, looking west.

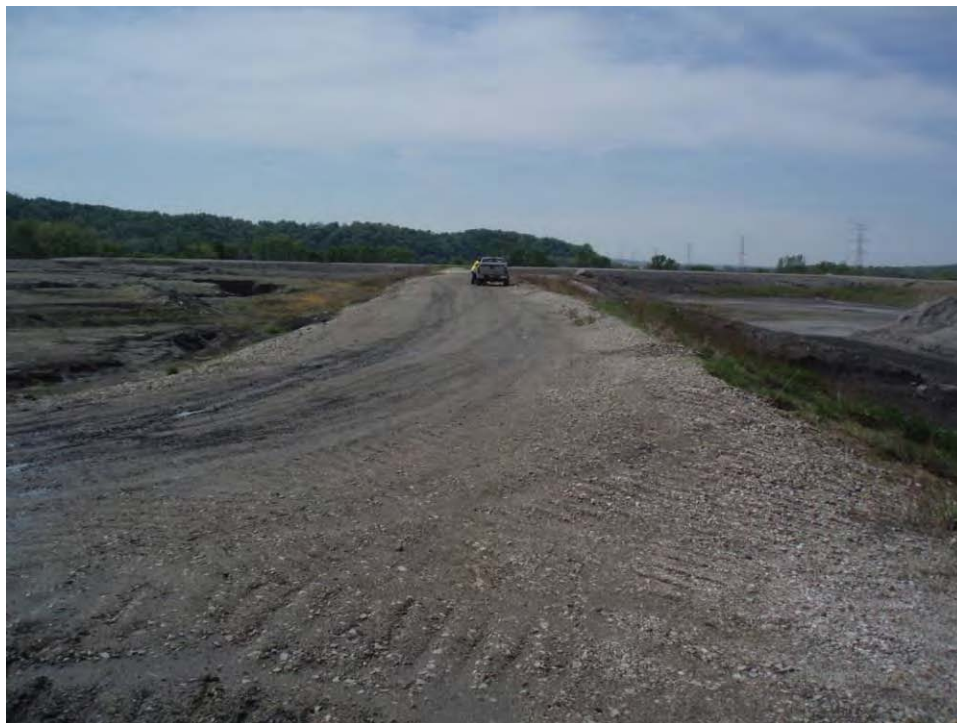
121. Crest of divider embankment D/E, looking south.

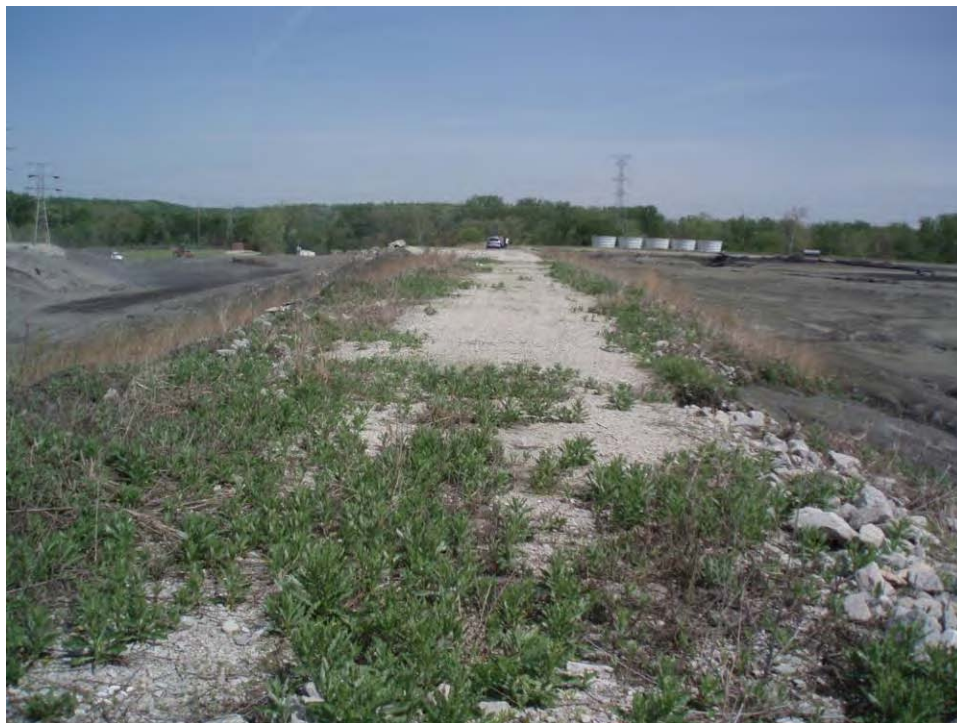
129. Pond D - Crest of divider embankment, looking north.

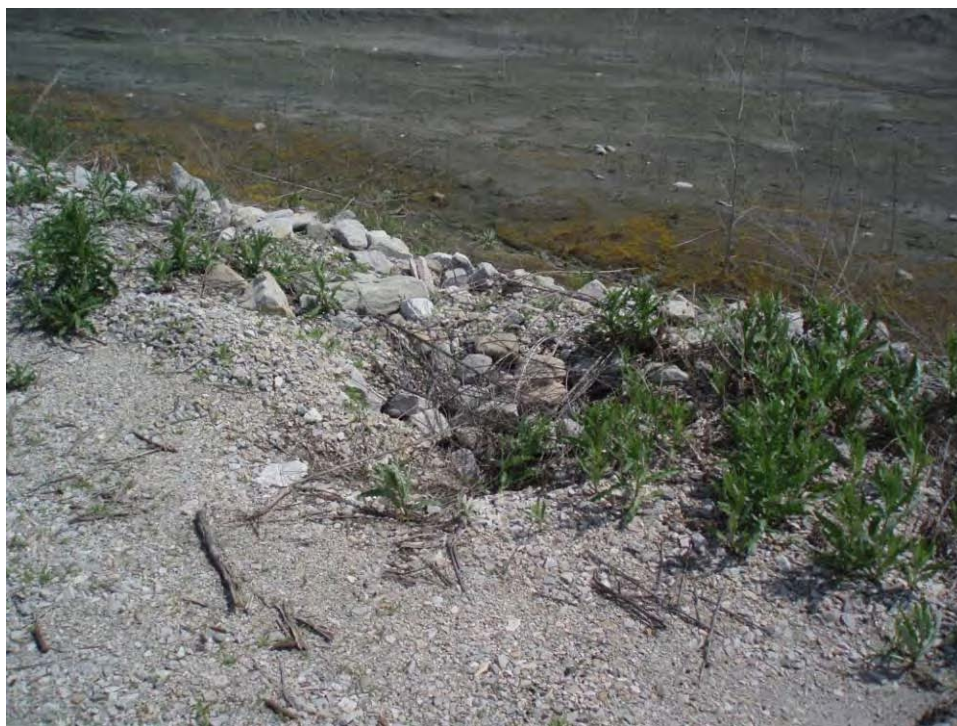
130. Pond D - Depression with piping on east slope of divider embankment, looking northeast.

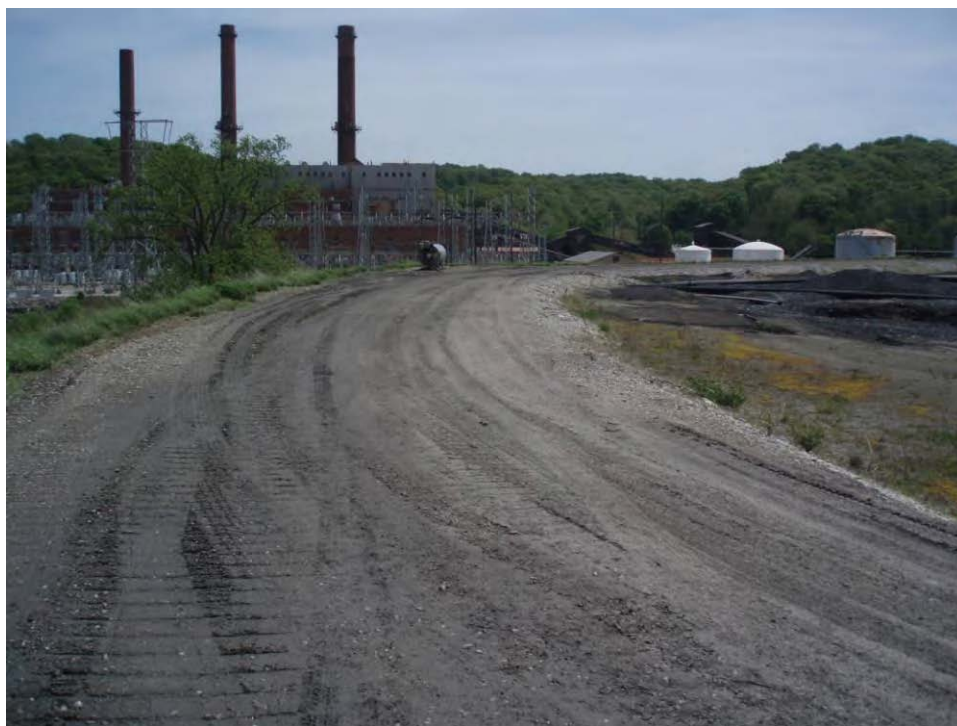
132. Pond D - North embankment crest, looking east.

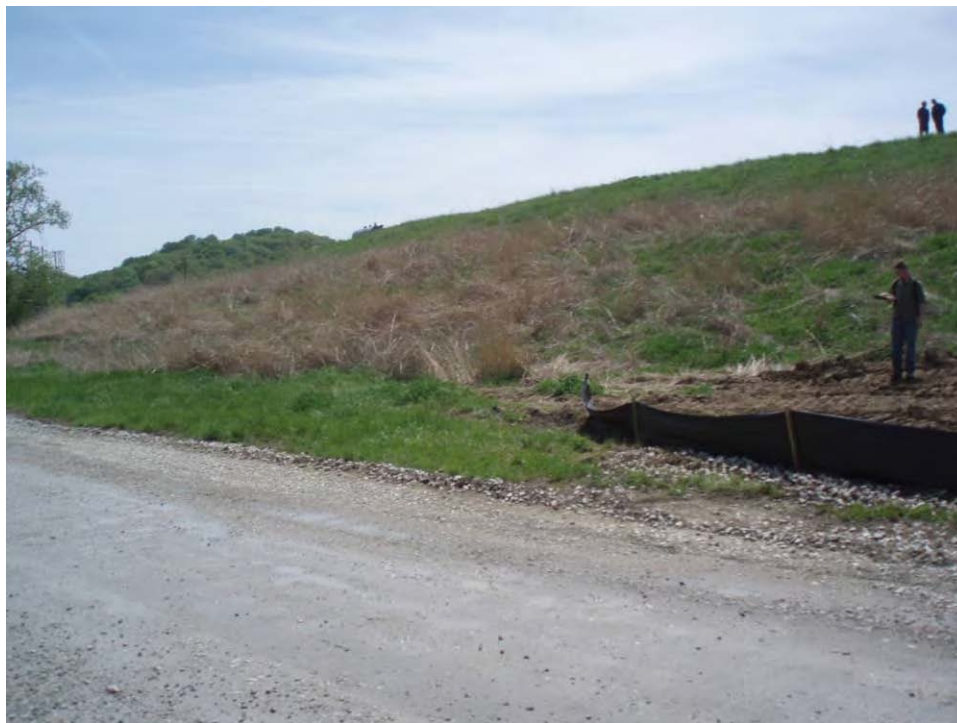
135. Pond D - North embankment exterior slope, looking southeast.

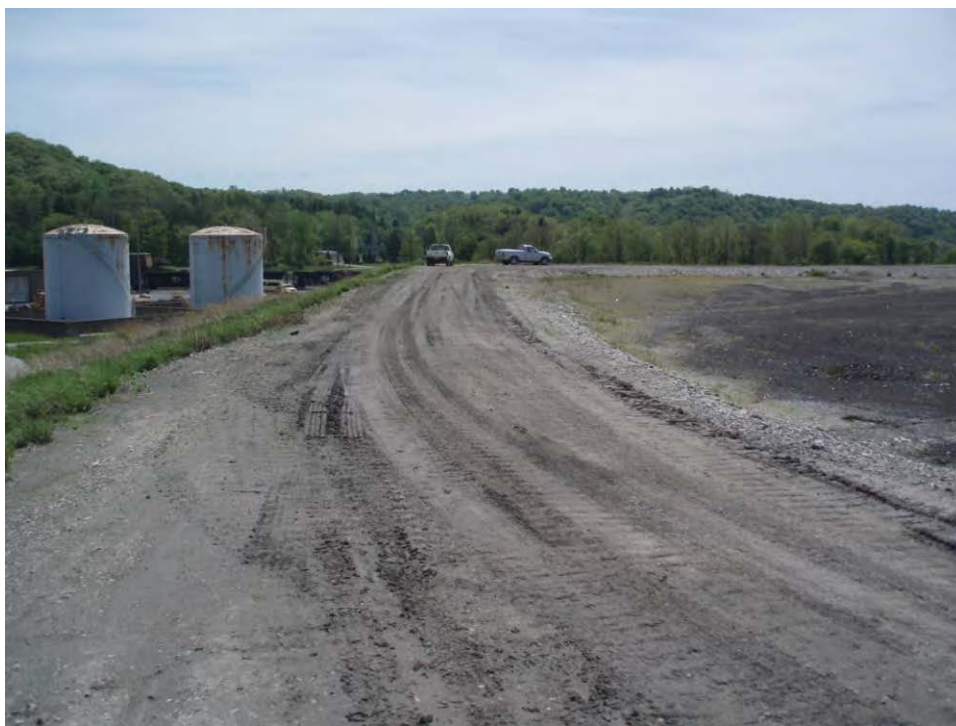
138. Pond D - Northeast embankment crest, looking southeast.

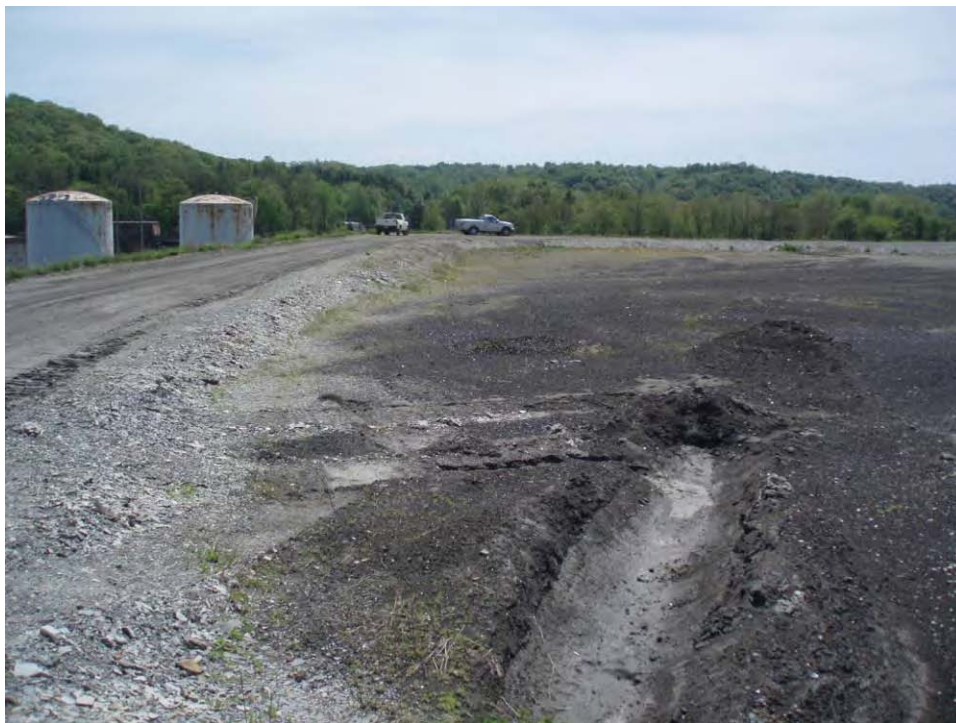
139. Pond D - Northeast embankment interior slope, looking southeast.

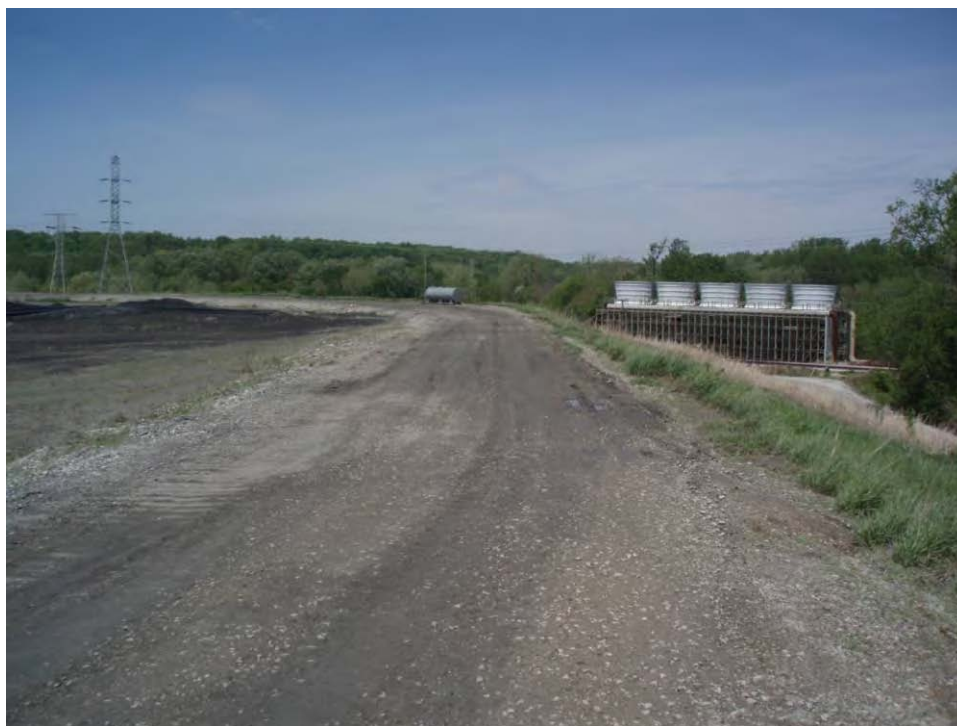
142. Pond D - Northeast embankment crest, looking northwest.
