# **Assessment of Dam Safety of Coal Combustion Surface Impoundments**

**Indianapolis Power & Light Company**

**Petersburg Generating Station**

**November 15, 2010**

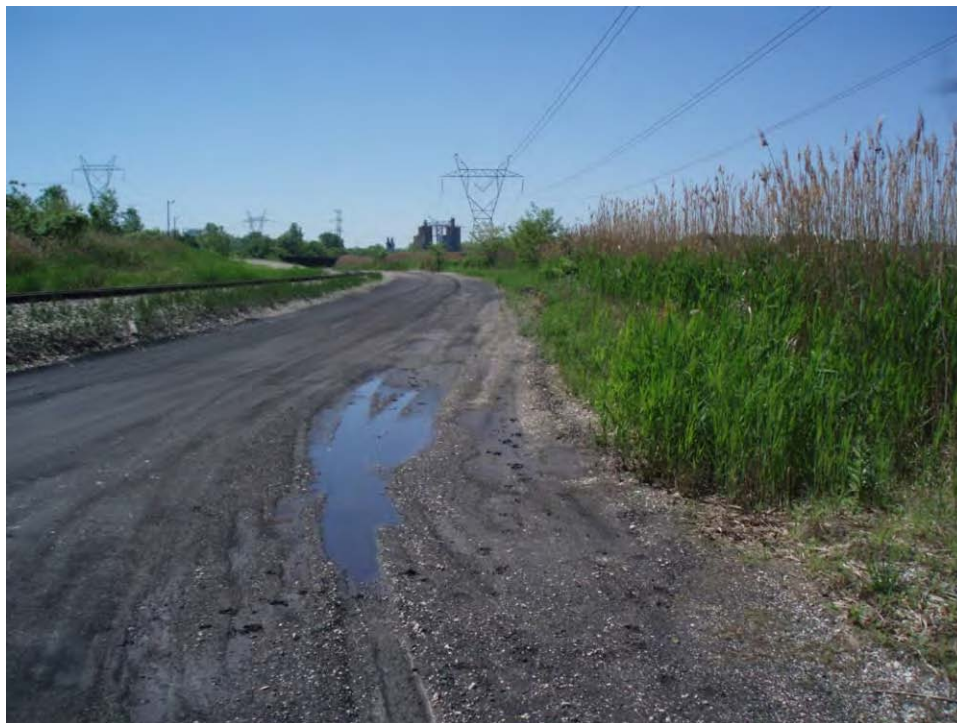
The crest of Pond A generally appeared to be in fair condition (Photos 1, 3, 4, 9, 10, 11, 12, 14, 49, 62, and 64). The crest was approximately 20 feet wide. The crest is surfaced with a compacted gravel access road on the north and east embankments. The crest on the south and west embankments were generally covered with grass approximately 6 to 12 inches tall. The crest around the sluice pipes on the south embankment was covered with ash (Photos 12 and 14). An access ramp excavated into the crest near the sluice pipes on the south embankment was observed (Photo 10 and 12). Track marks from an excavator were observed on the crest of the west embankment (Photos 26, 27, and 29).

1. Pond A - East embankment crest, looking south.

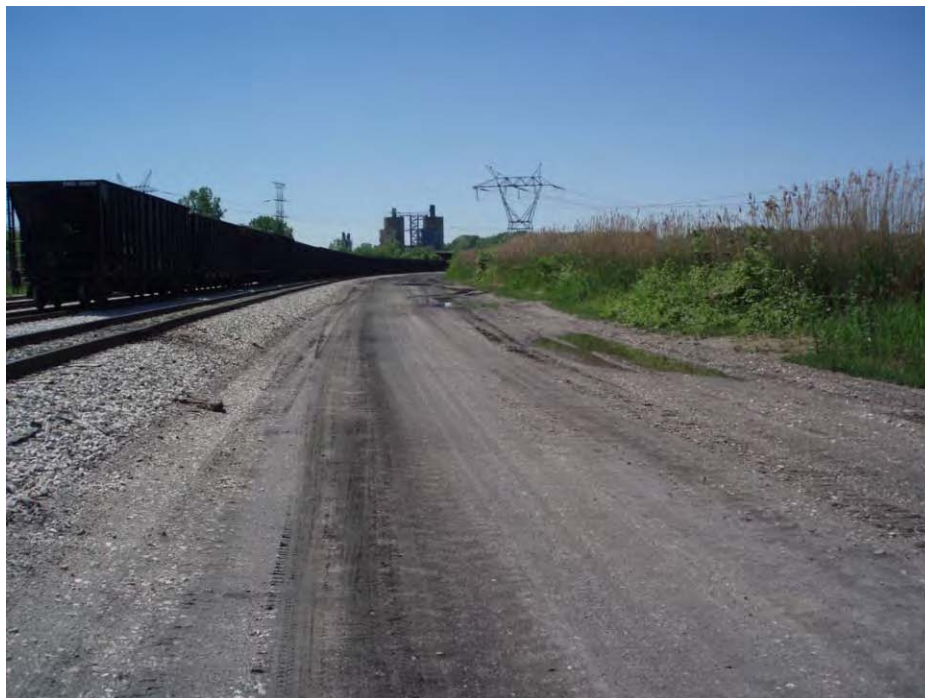
3. Pond A – East embankment crest, looking south.

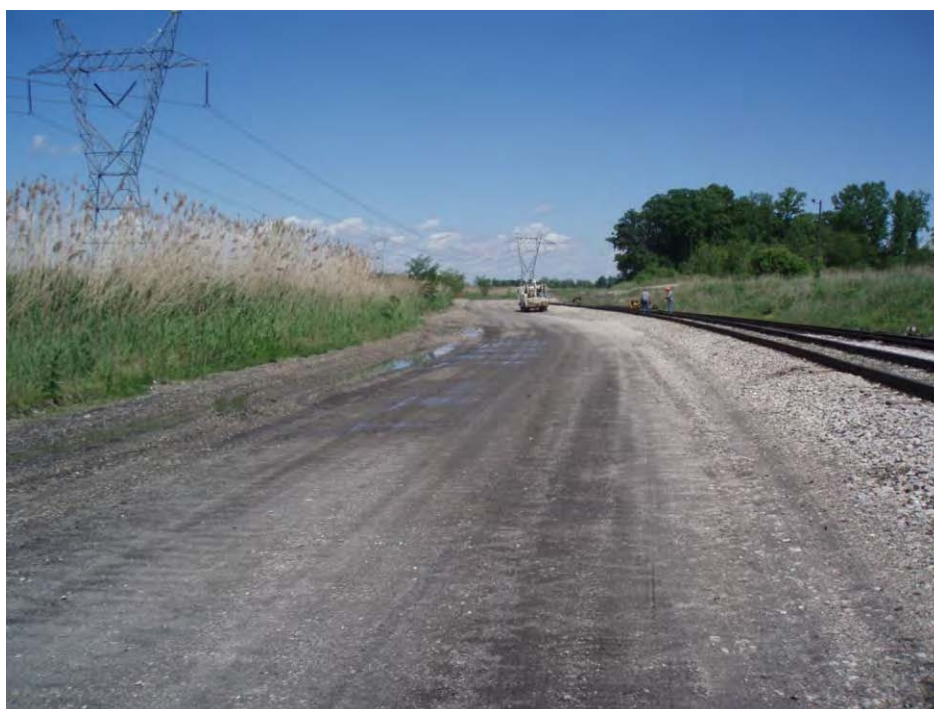
4. Pond A – East embankment crest, looking north

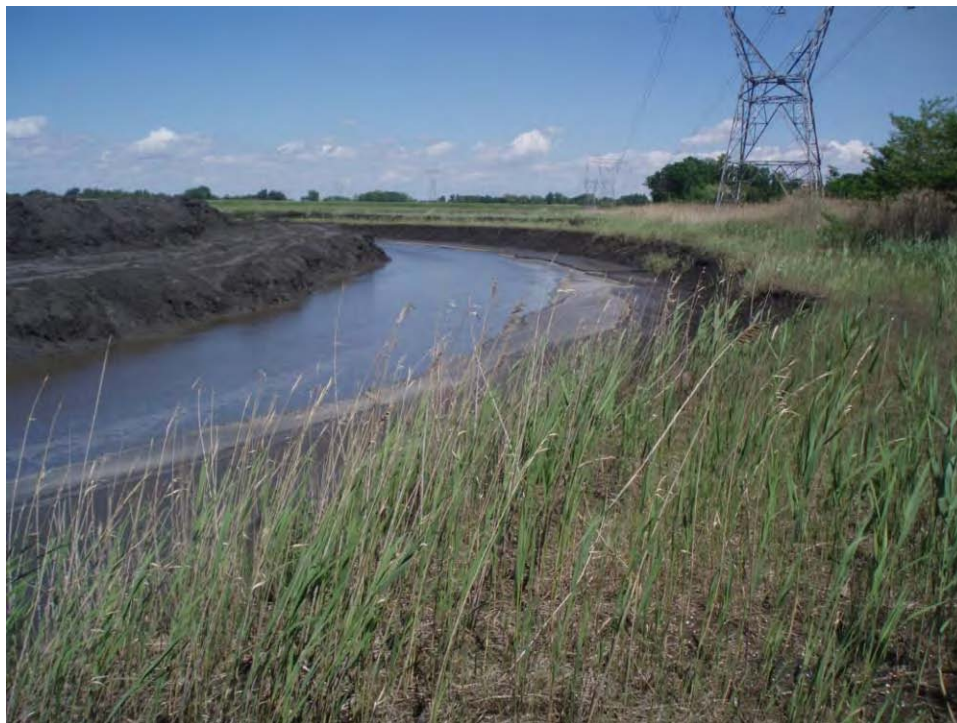
two (2) 36-inch-diameter and five (5) 10-inch-diameter ductile iron (DI) pipes sluice CCW into the impoundment (Photos 7 and 8). A rim ditch (Photos 5, 6, and 7) excavated adjacent to the south and east interior slope diverts flow, increasing the settling time of materials in the impoundment. Along the west embankment one (1) 12-inch-diameter DI and two (2) 8-inch-diameter stainless steel (SS) pipes sluice other liquids into the impoundment (Photo 20). At a headwall located at the western abutment of the divider embankment between Pond A and Pond A – Discharge, two (2) 24-inch-diameter reinforced concrete pipes (RCPs) and one (1) 4-inch-diameter DI pipes sluice other wastes into Pond A (Photo 36). Pond A is connected to Pond A – Discharge through two (2) 36-inch-diameter CMPs (Photo 45). Pond A – Discharge is used as a secondary settling basin prior to water being discharged at the outlet structure or being diverted into the recycling pump station. The outlet structure consists of a box structure with stoplogs and a 24-inch-diameter RCP with an invert elevation of El. 415.9.

5. Pond A rim ditch, looking north.

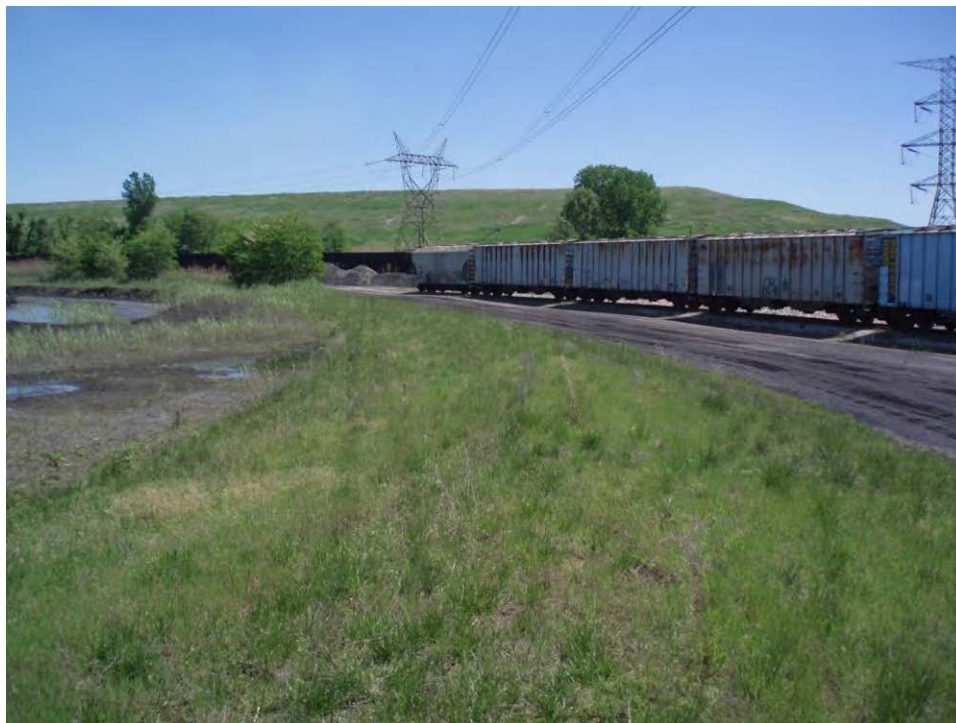
9. Pond A - South embankment crest, looking east.

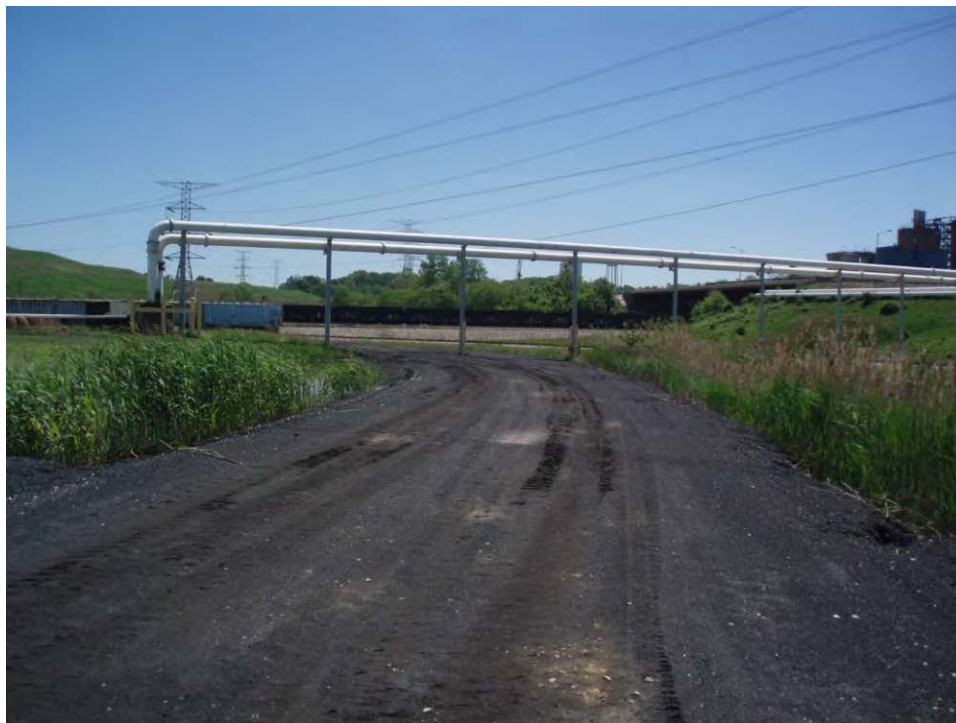
11. Pond A - South embankment looking southeast.

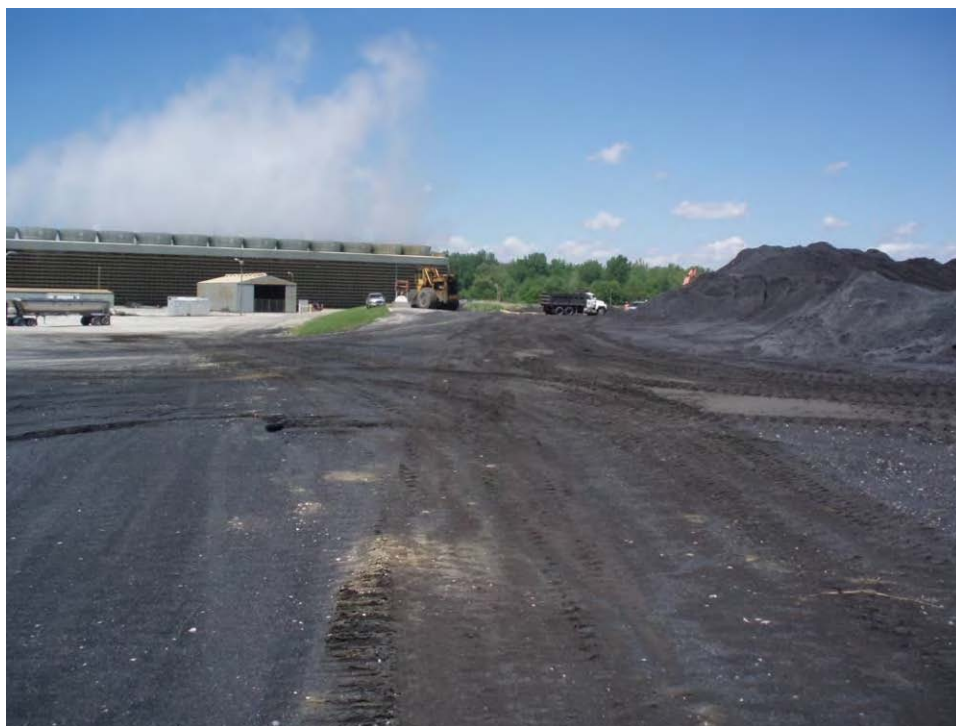
12. Pond A - South embankment crest, looking northwest.

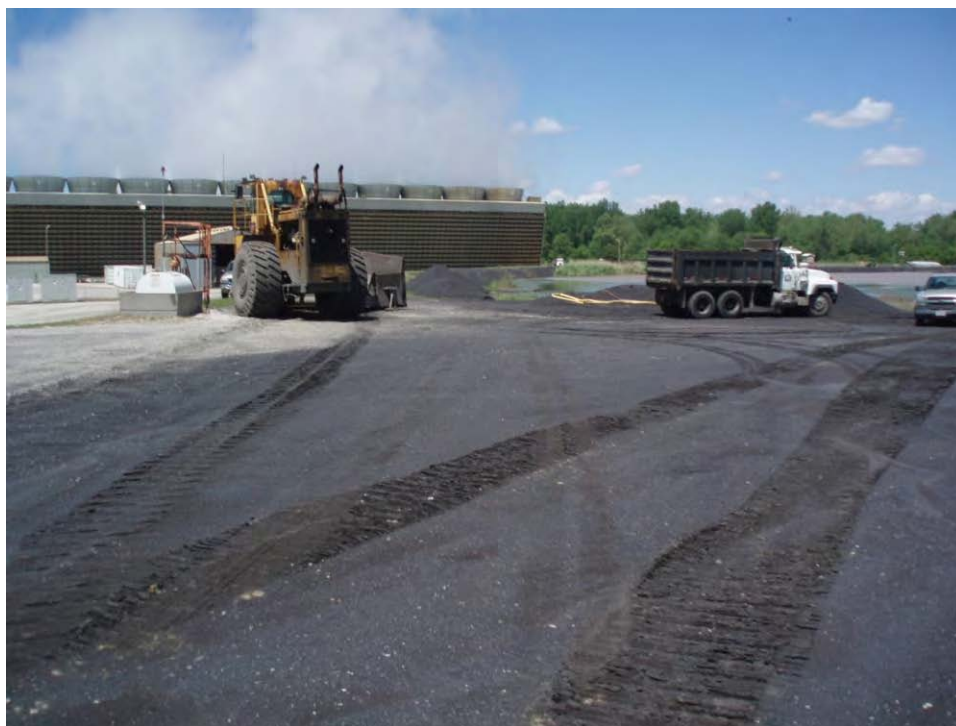
14. Pond A - South embankment crest, looking northwest.

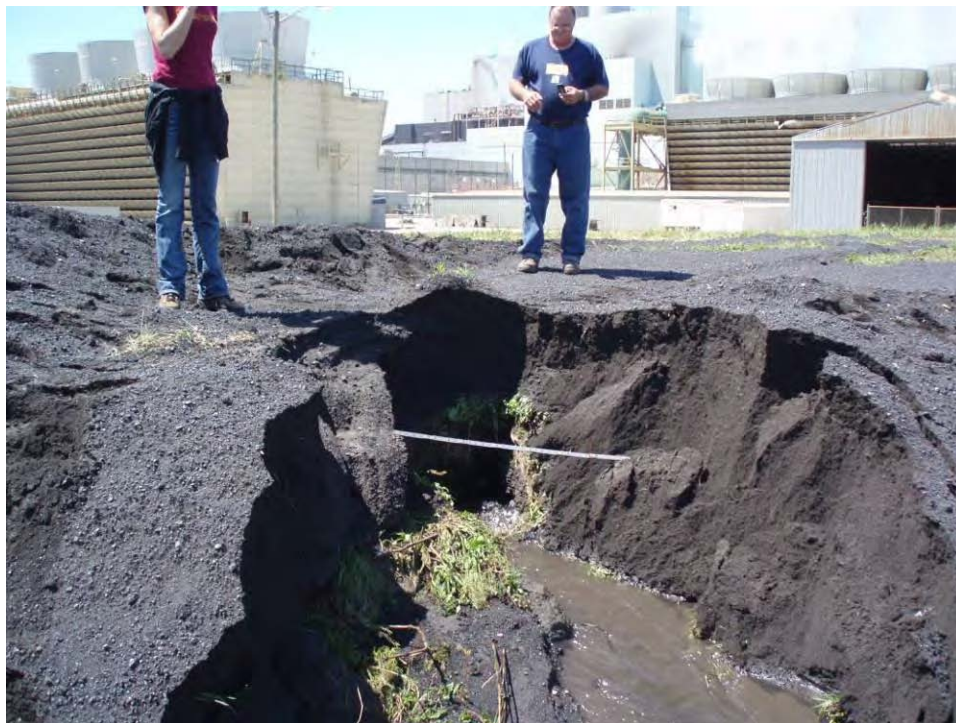
During the site visit, active piping/erosion of the crest was observed (Photo 15). The water had eroded the recently placed ash and formed an erosion cavity in the original embankment. The water was clear and had a constant estimated flow of 10 to 20 gpm. At the time of the site visit, IPL staff did not know the source of the water (i.e., if it was an unmarked pipeline in the embankment). The staff was in the process of identifying the source and addressing the situation. It is our understanding that after CDM's site visit IPL determined that the source of water was Unit #2 cooling tower blow down. It was reported by IPL that the erosion was addressed by placing riprap on the western and southern portions of Pond A's interior slope face, and that these corrective actions were completed on May 14, 2010.

15. Pond A - Active erosion/piping of south embankment interior slope from unknown water source. Water was clear. Eroded area 5'Wx8'Lx3.5'D. IPL personnel were trying to determine source of flow.

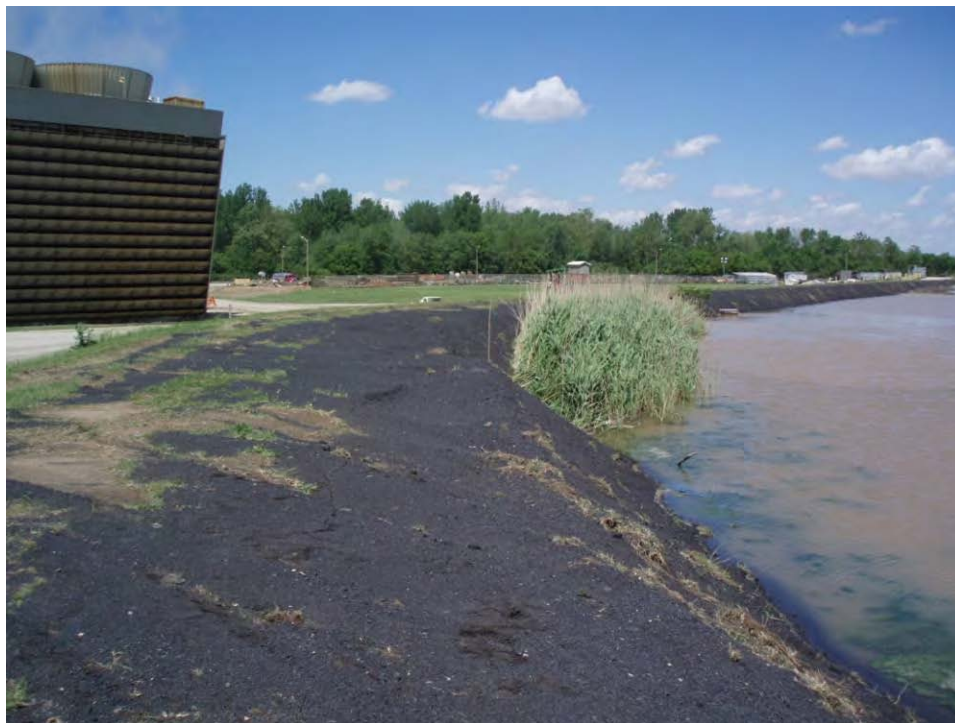
The visible portions of the interior slope generally appeared to be in fair condition (Photos 2, 6, 7, 9, 16, 17, 20, 21, 29, 30, 31, 32, 39, and 48). Tall, thick wetland-type vegetation up to 8 to 10 feet tall obscured the observation of north and east embankment as well as the divider embankment. The north and west interior slope of the divider embankment generally appeared to be armored with a layer of riprap armor.

17. Pond A - South embankment crest, looking northwest at recently placed ash. Note existing embankment was not cleared or grubbed before placing material.

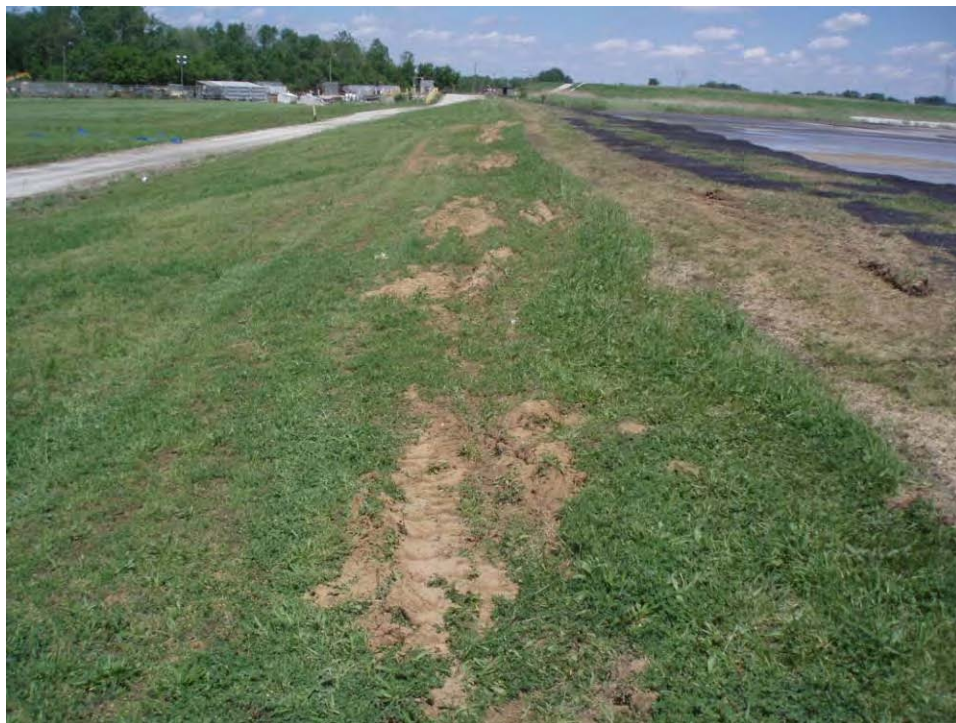
The exterior slopes appear to be in fair condition. The exterior slopes on the south and west embankments were approximately 3H:1V (Photos 13, 19, 22, 23, 24, 26, 27, 28, and 34). The north exterior slope on the divider embankment between Pond A and Pond A – Discharge was approximately 2H:1V (Photos 37 and 47).

23. Pond A - West embankment exterior slope, looking north at tractor ruts.

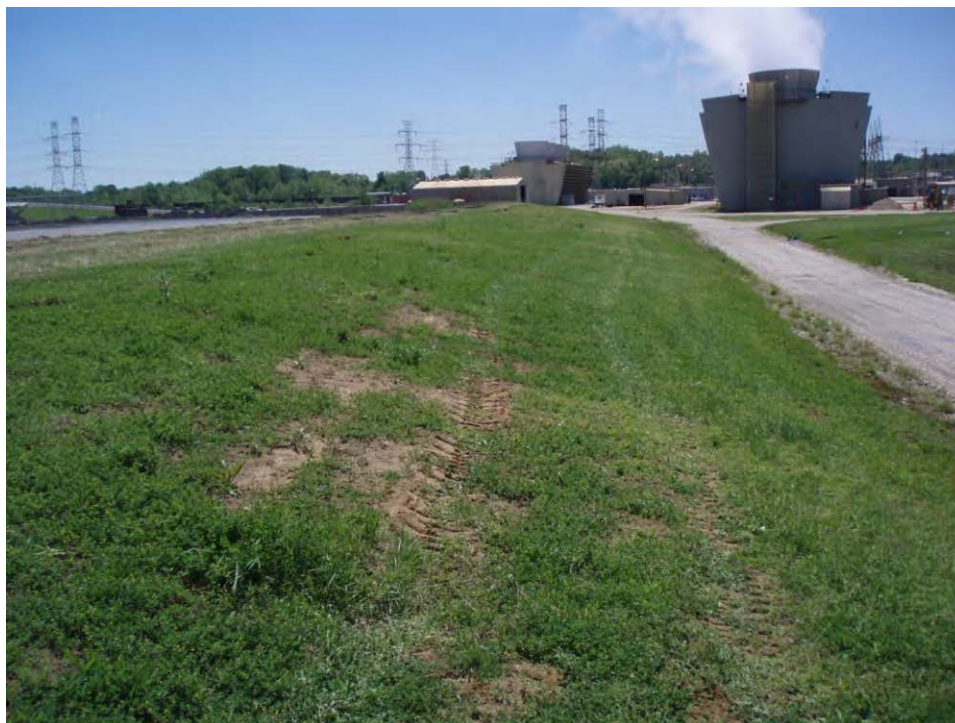
28. Pond A - West embankment exterior slope, looking south.

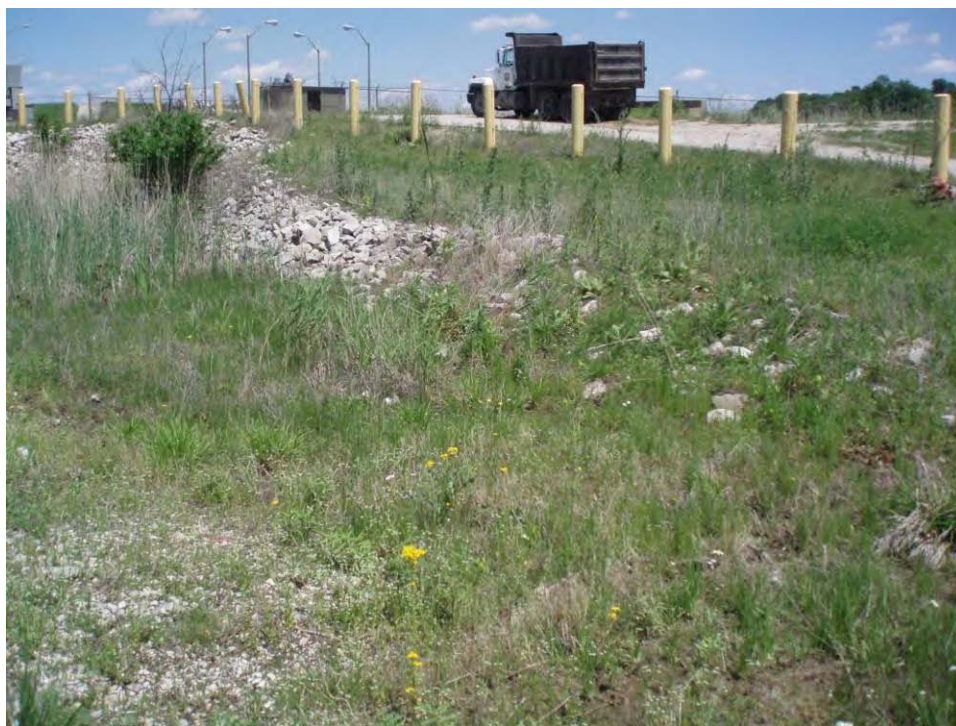
34. Pond A - Former location of Lick Creek at west embankment exterior toe.

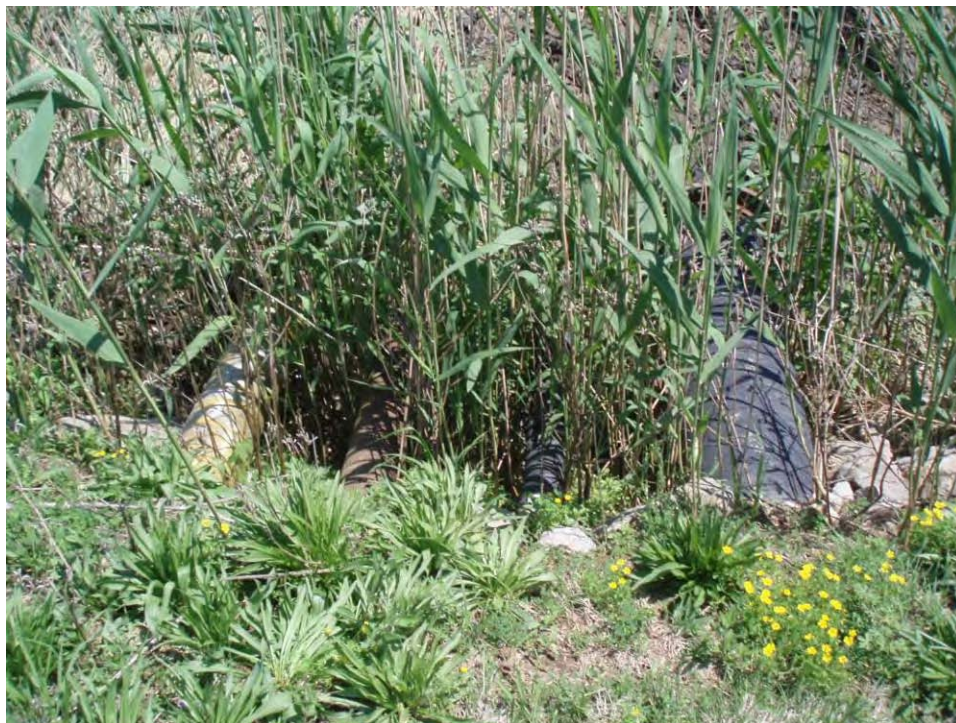
35. Pond A - Looking east at inactive 4-, 6-, 8-, and 15-inch-diameter sluice pipes from unknown origin. Use unknown.

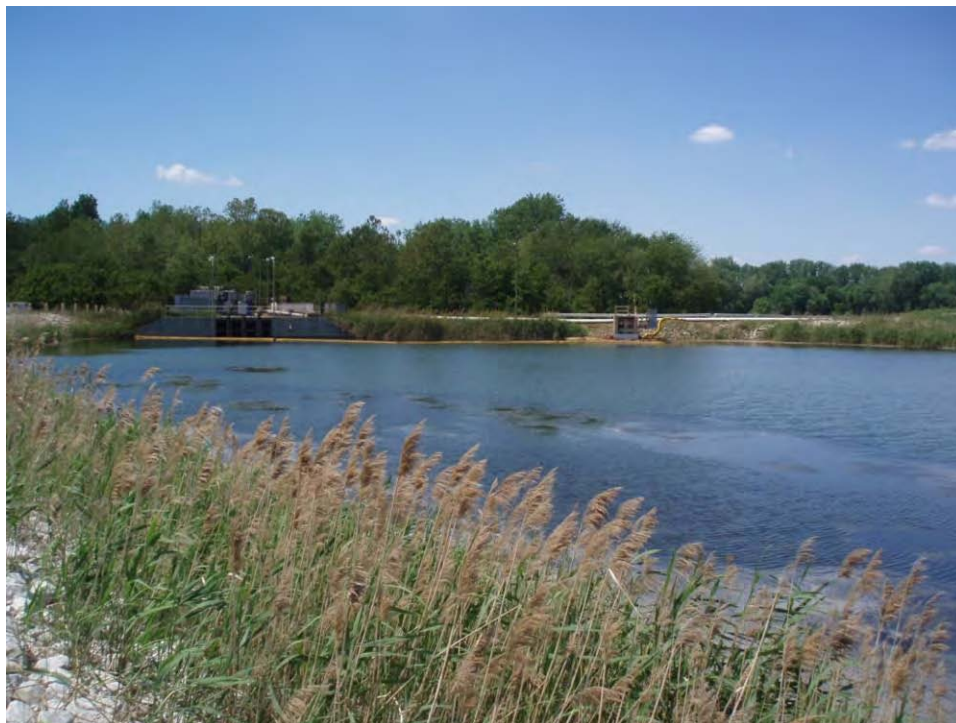
41. Overview of Pond A - Discharge recycle pump station and outlet structure, looking west

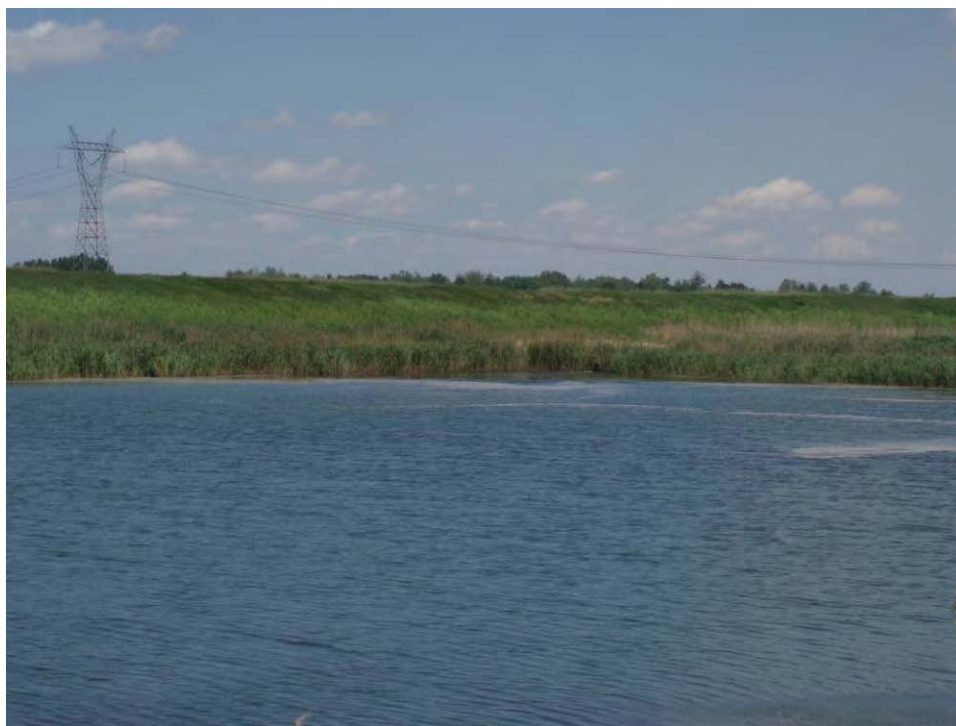
42. Overview of Pond A - Discharge, looking northeast at inlet pipes from Pond A.

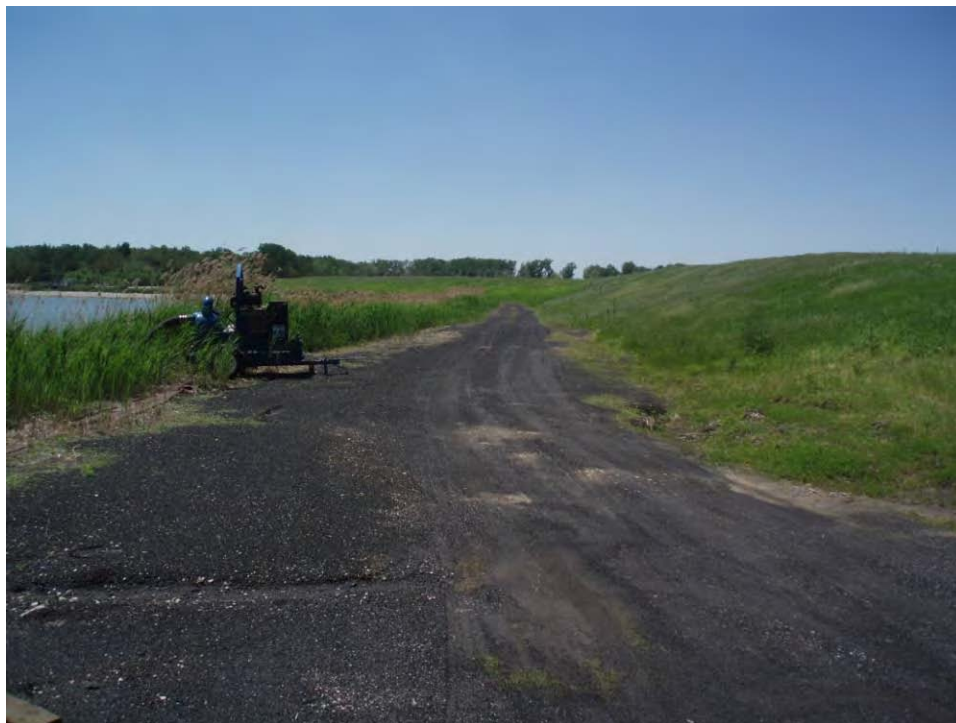
49. Pond A - North embankment crest and Pond B - South embankment exterior slope, looking west.

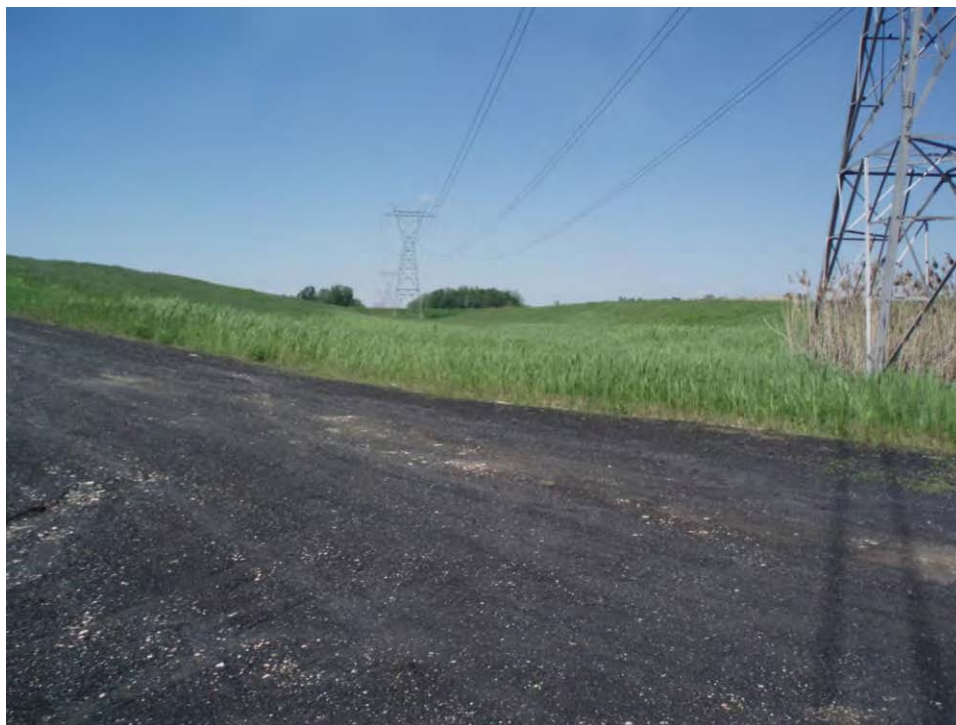
50. Pond B - North embankment exterior slope, looking northwest between Pond B and Pond C.

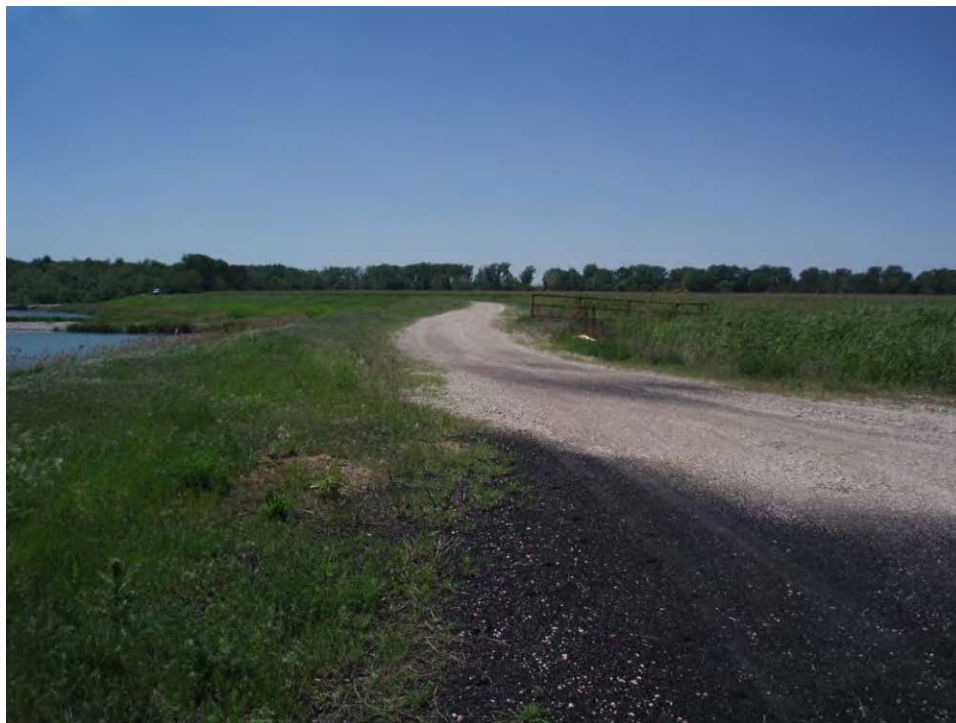
53. Pond B - South embankment crest, looking west.

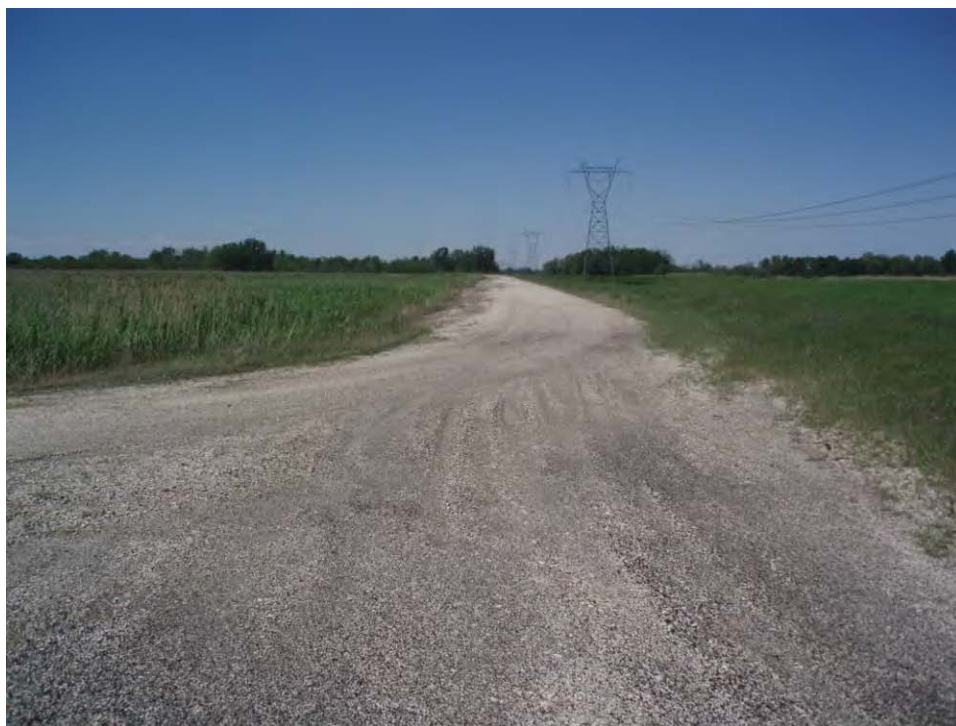
54. Pond B - East embankment crest, looking north.

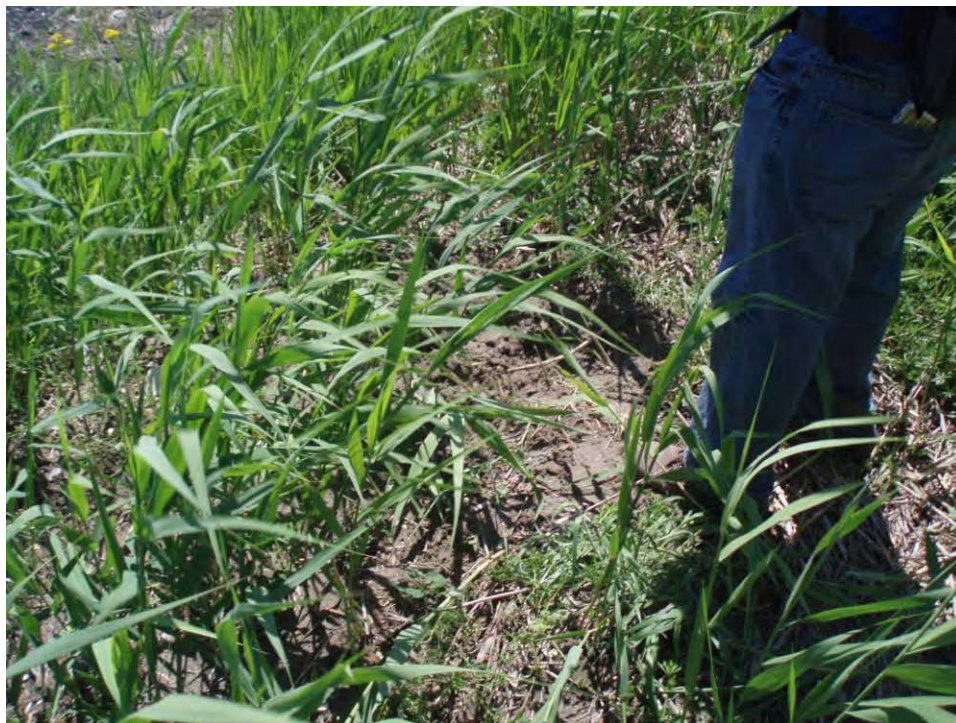
61. Pond B - South embankment exterior slope looking at bare spots of very soft, fine grained stabilized FGD.

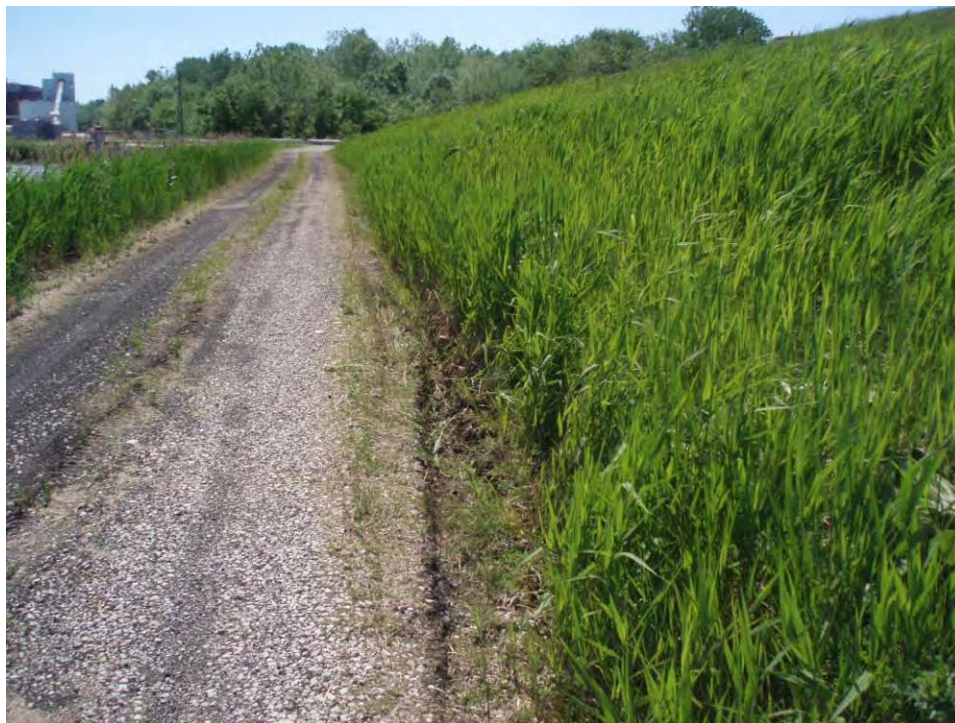
63. Pond B - South embankment exterior slope, looking southwest at possible seepage at toe.

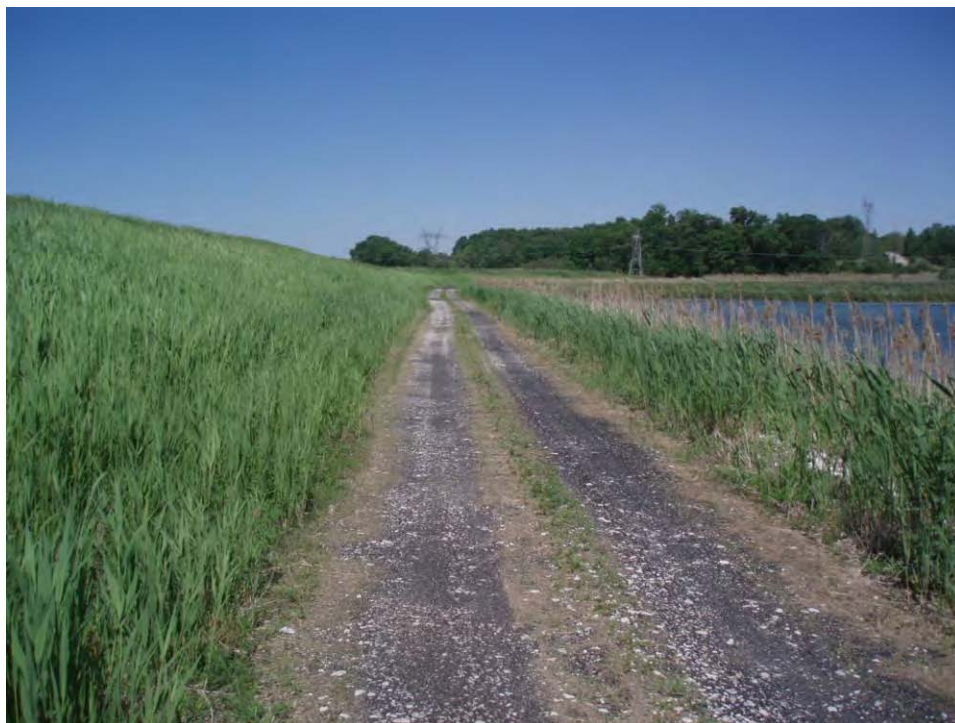
64. Pond A - Discharge north embankment crest and Pond B south embankment toe, looking northeast.

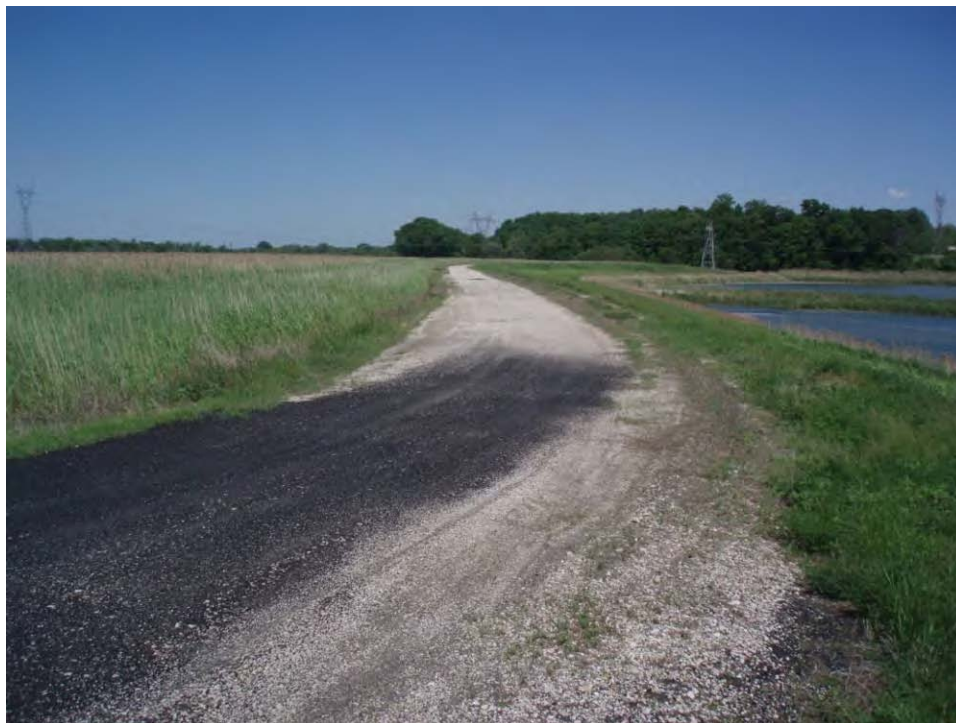
67. Pond B - South embankment crest, looking northeast.

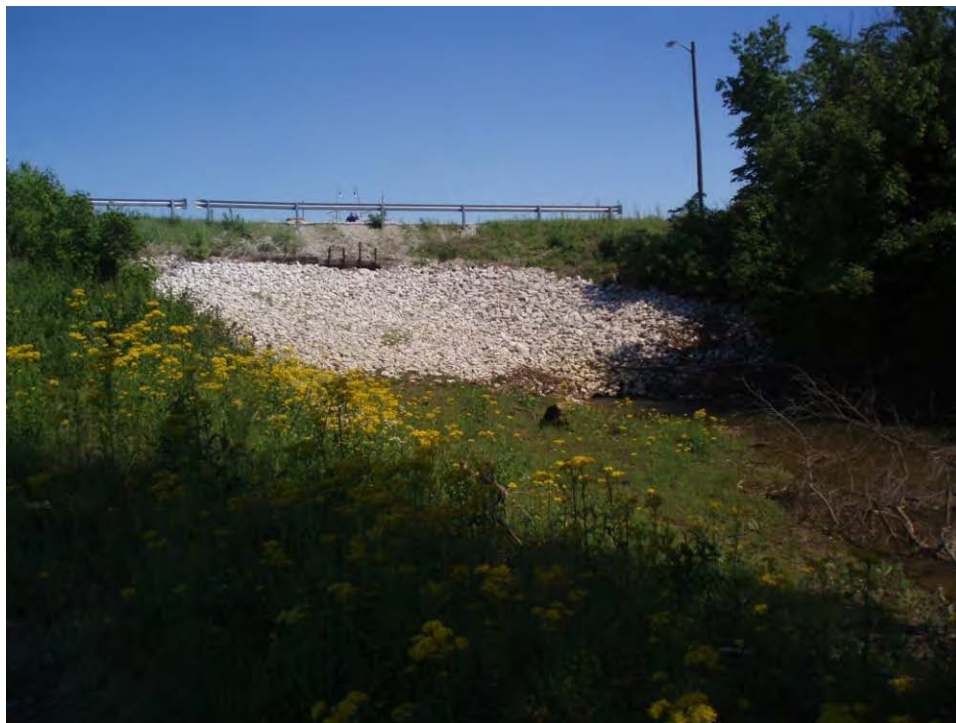
71. Pond A - Discharge, overview of downstream area from outfall.

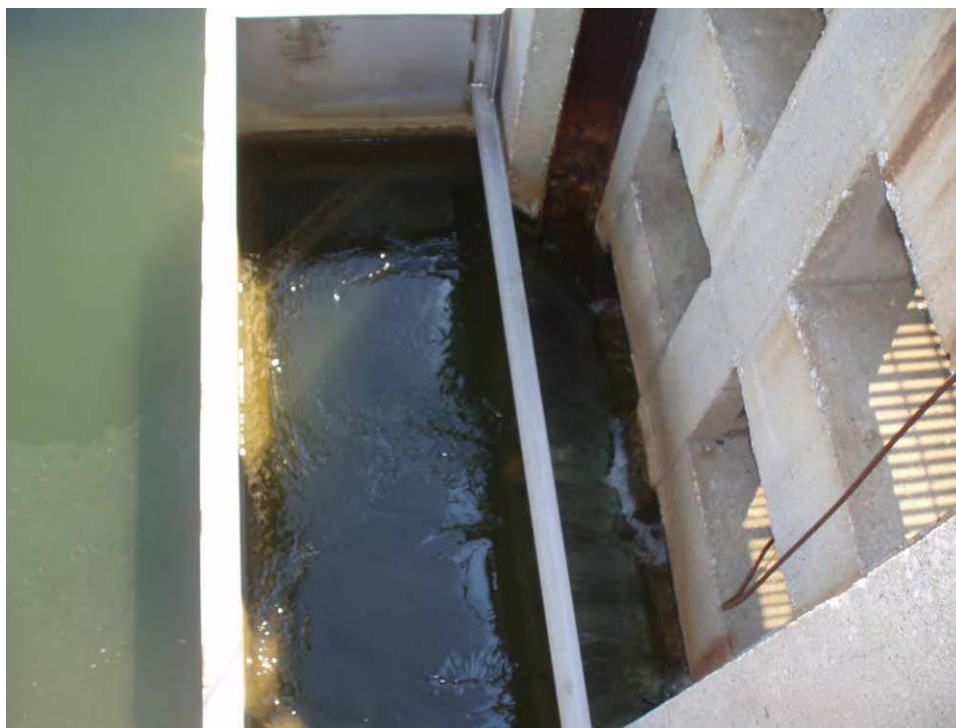
72. Pond A - Discharge, looking south at inlet to outlet control structure.

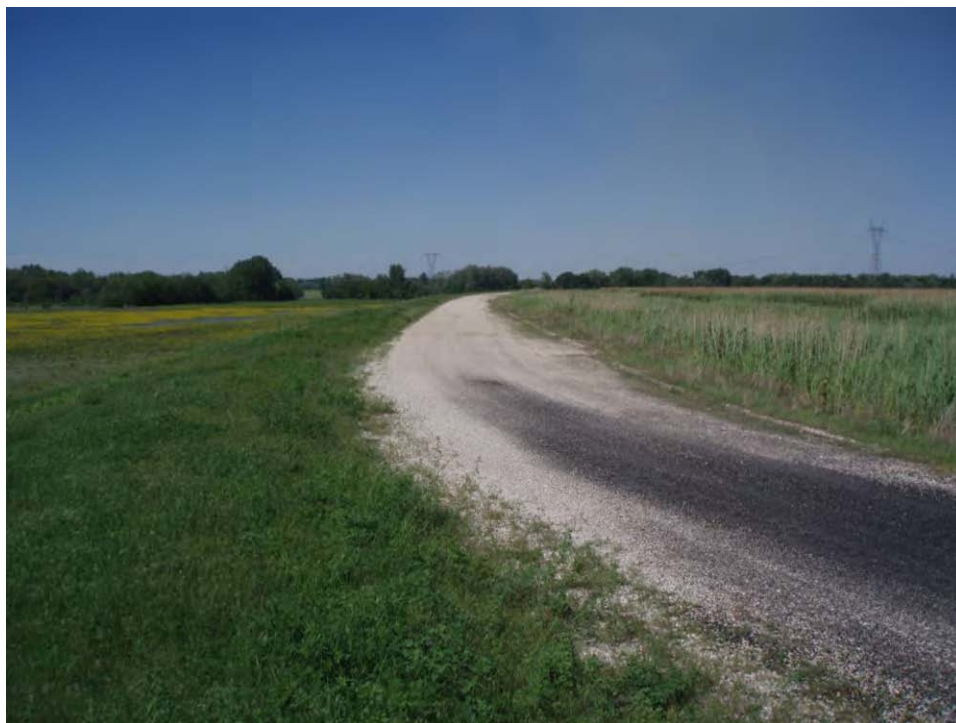
76. Pond B - West embankment crest, looking north.

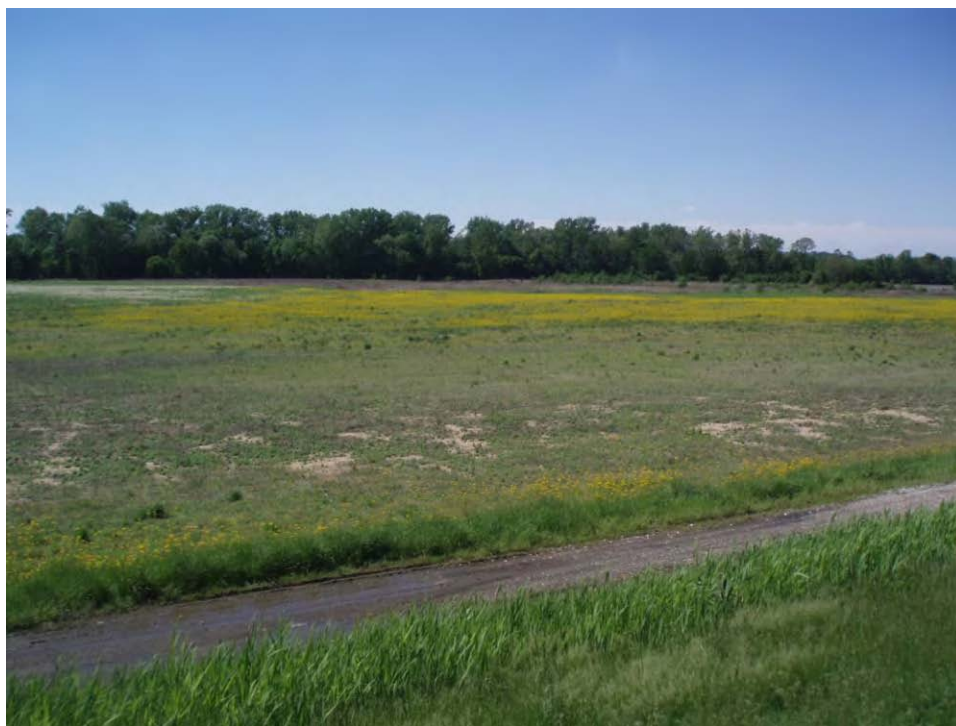
78. Overview of Pond B - West embankment, downstream area, looking west.

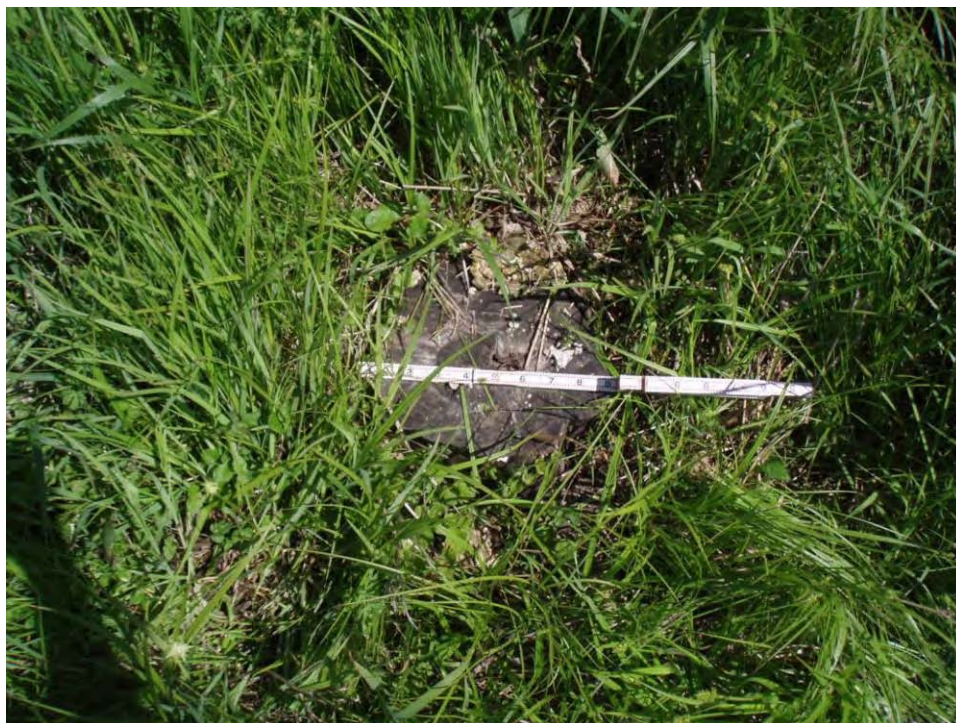
80. Pond B - West embankment lower exterior slope, looking at 0.9-foot-diameter tree stump at toe.

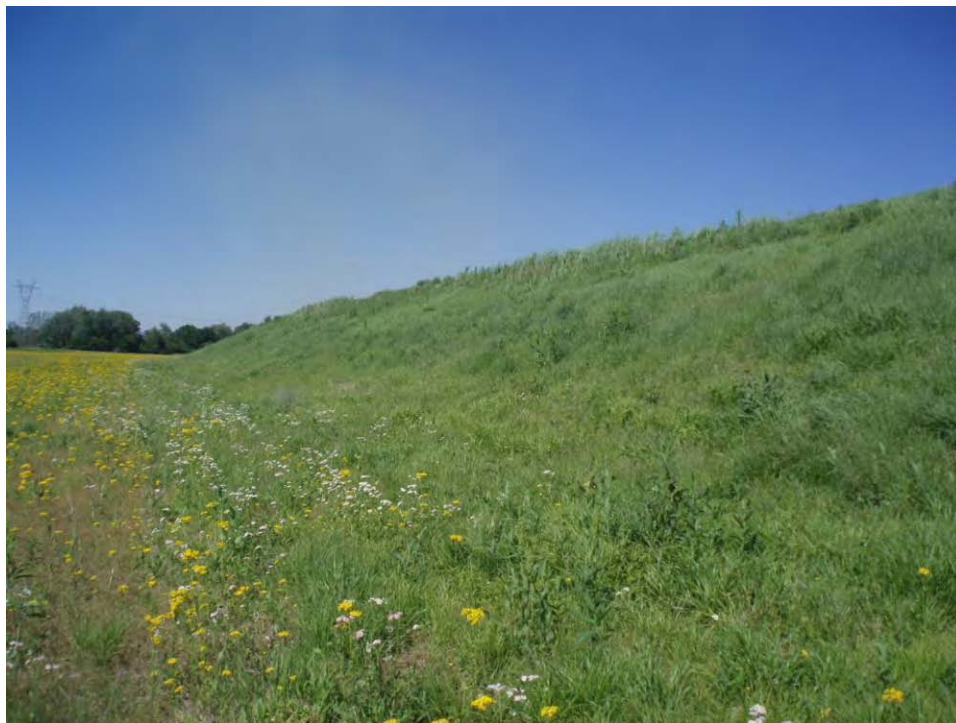
81. Pond B - West embankment lower exterior slope, looking north.

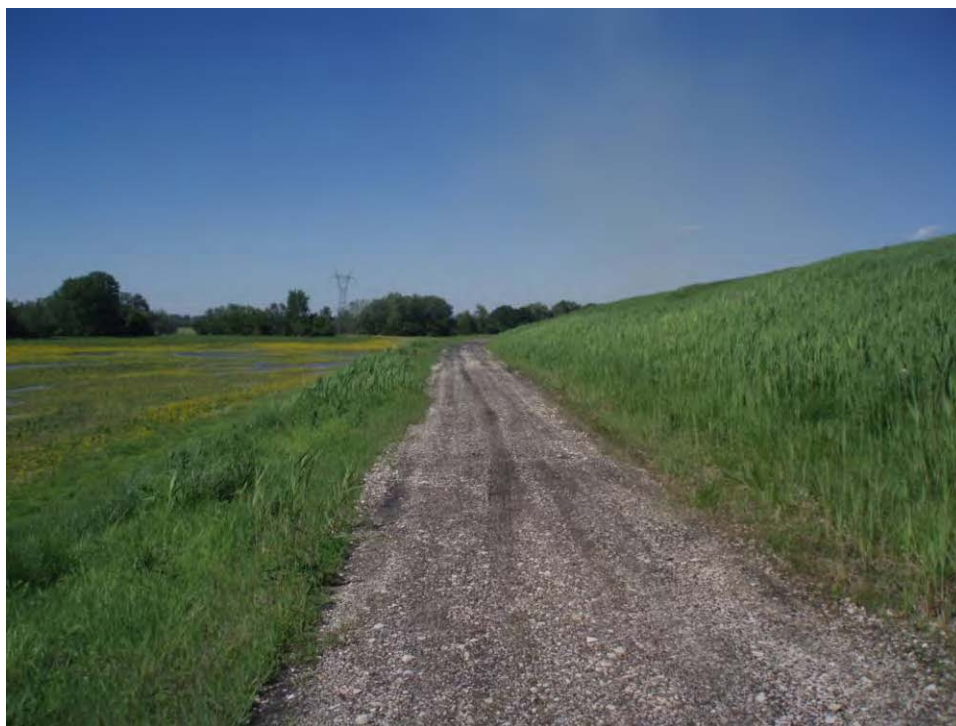
82. Pond B - West embankment bench, looking north.
