# **Assessment of Dam Safety of Coal Combustion Surface Impoundments**

**Indianapolis Power & Light Company**

**Petersburg Generating Station**

**November 15, 2010**

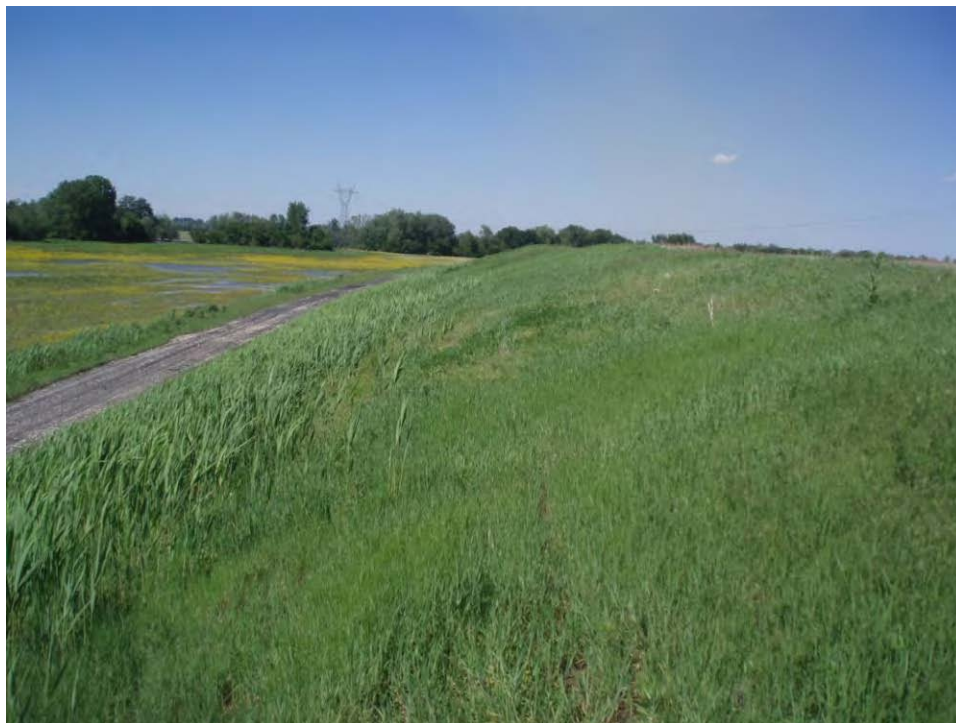
83. Pond B - West embankment upper exterior slope, looking north.

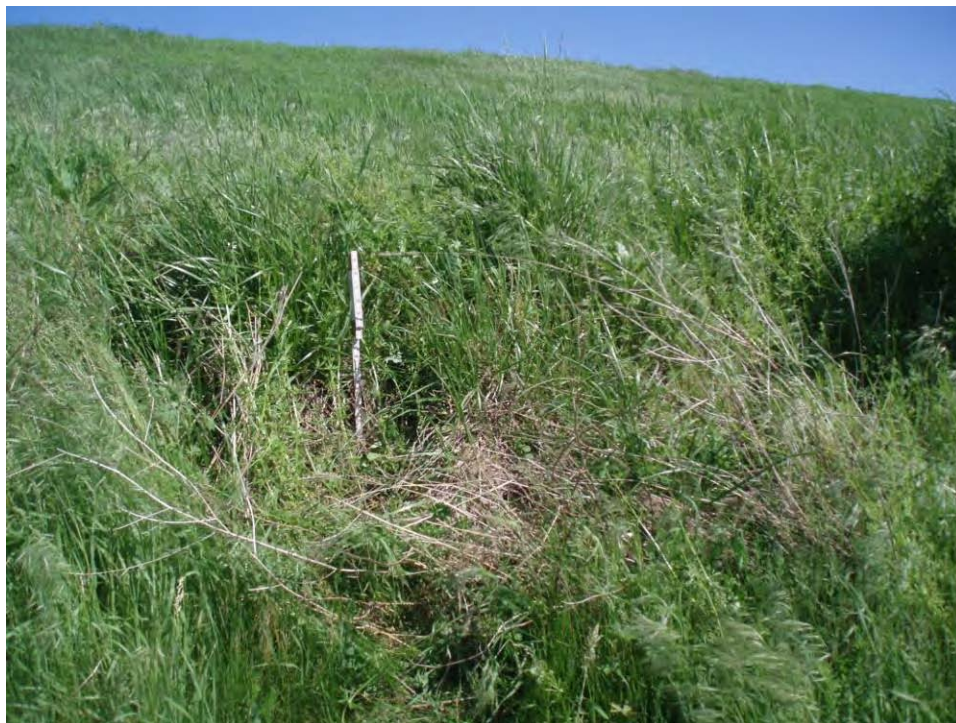
85. Pond B - West embankment lower exterior slope, looking at over-steep area and surficial erosion at bench.

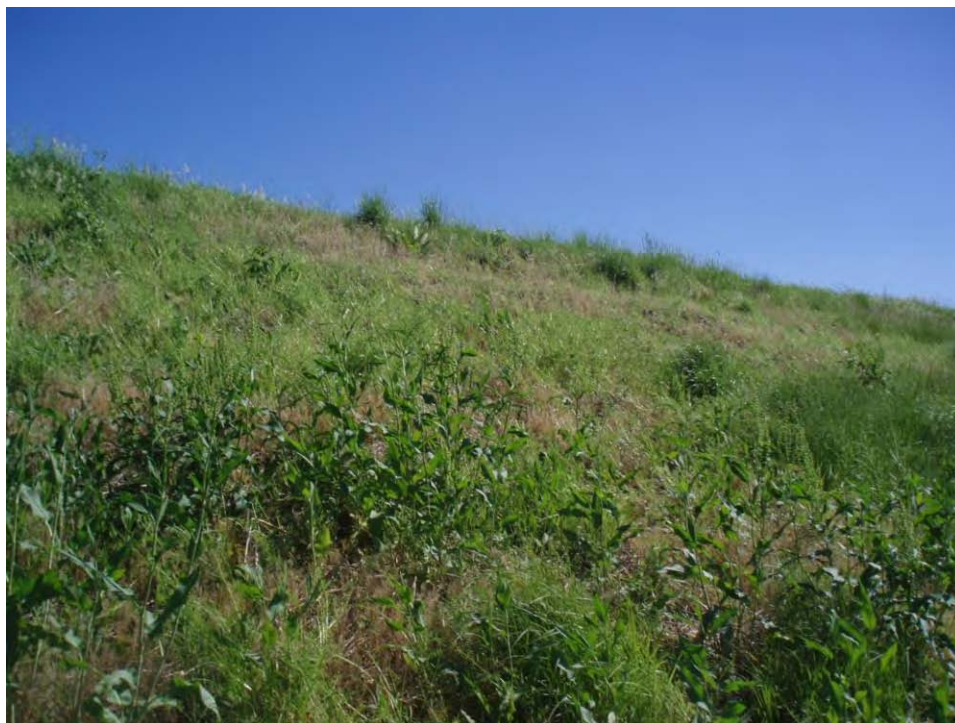
88. Pond B - West embankment lower exterior slope, looking southwest.

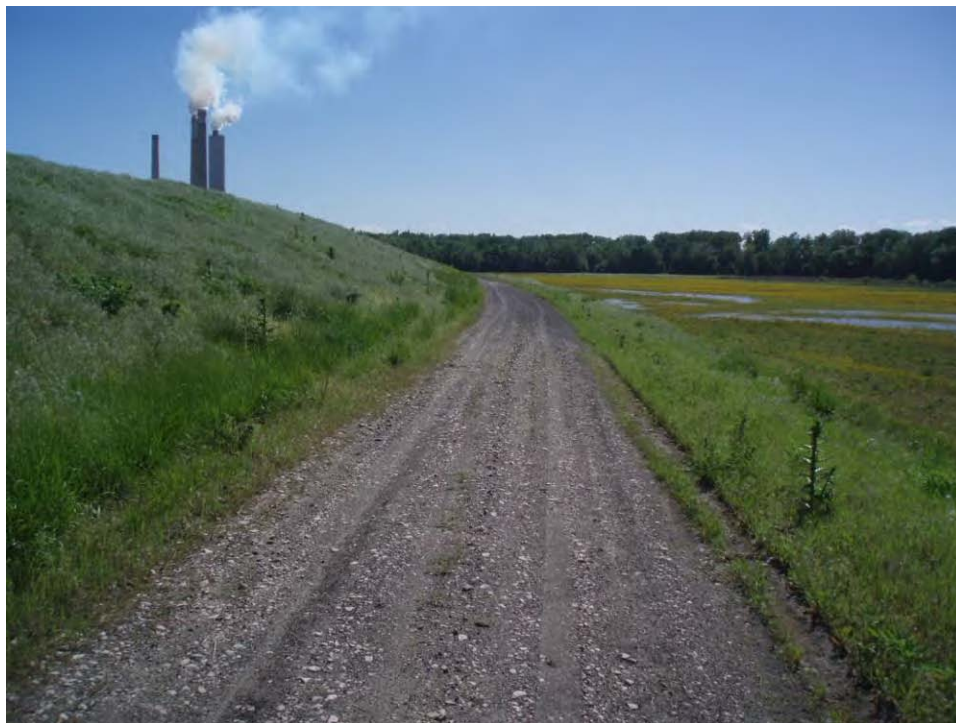
89. Pond B - West embankment bench, looking southwest.

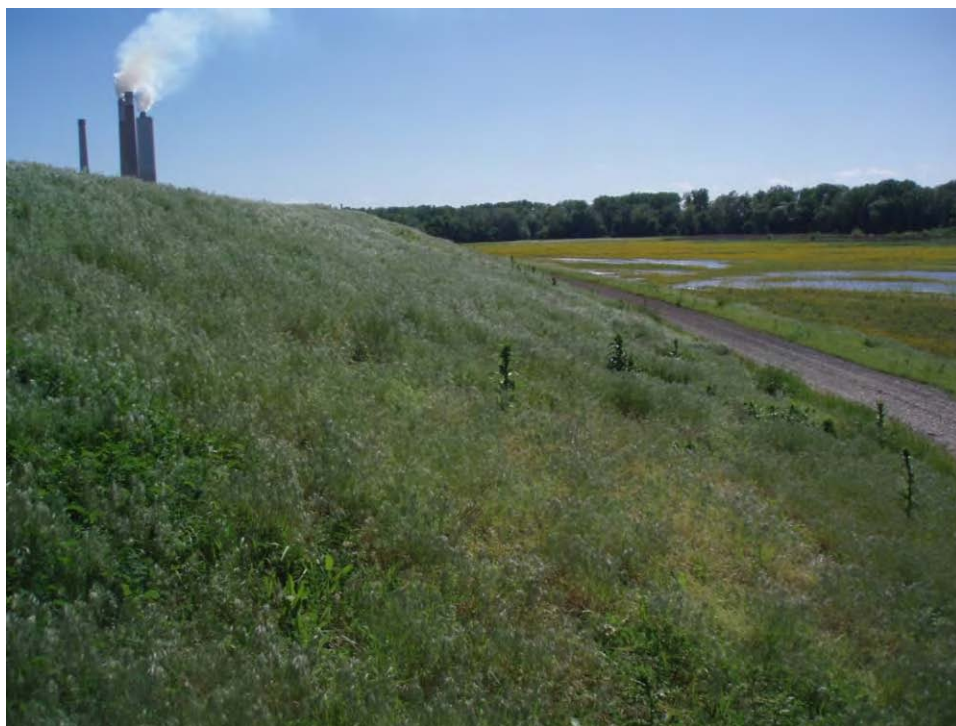
90. Pond B - West embankment upper exterior slope, looking southwest.

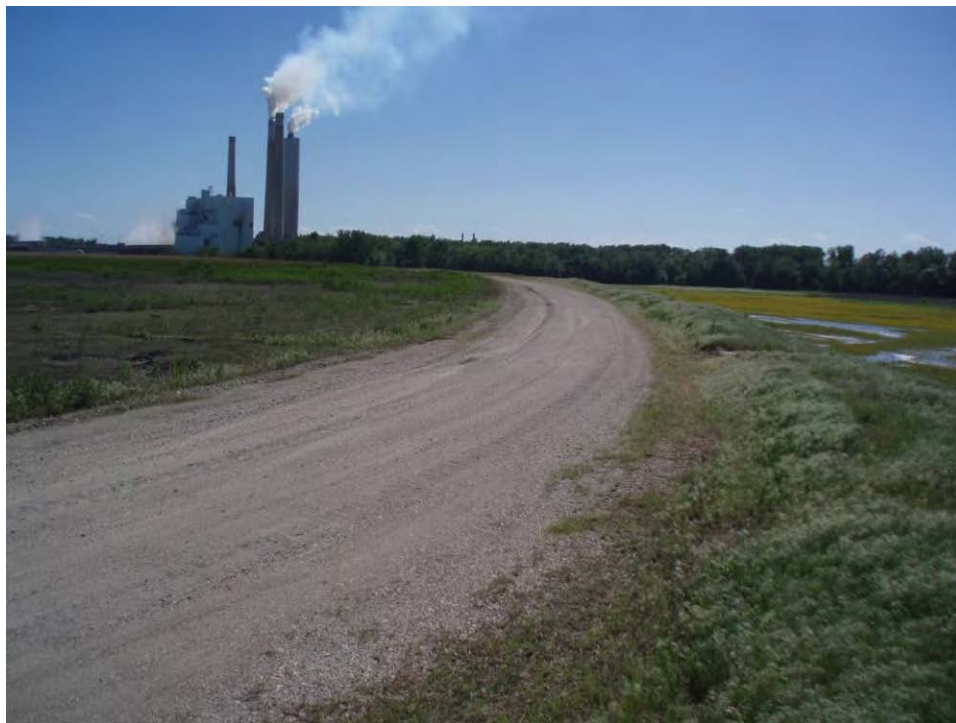
91. Pond B - West embankment crest, looking southwest.

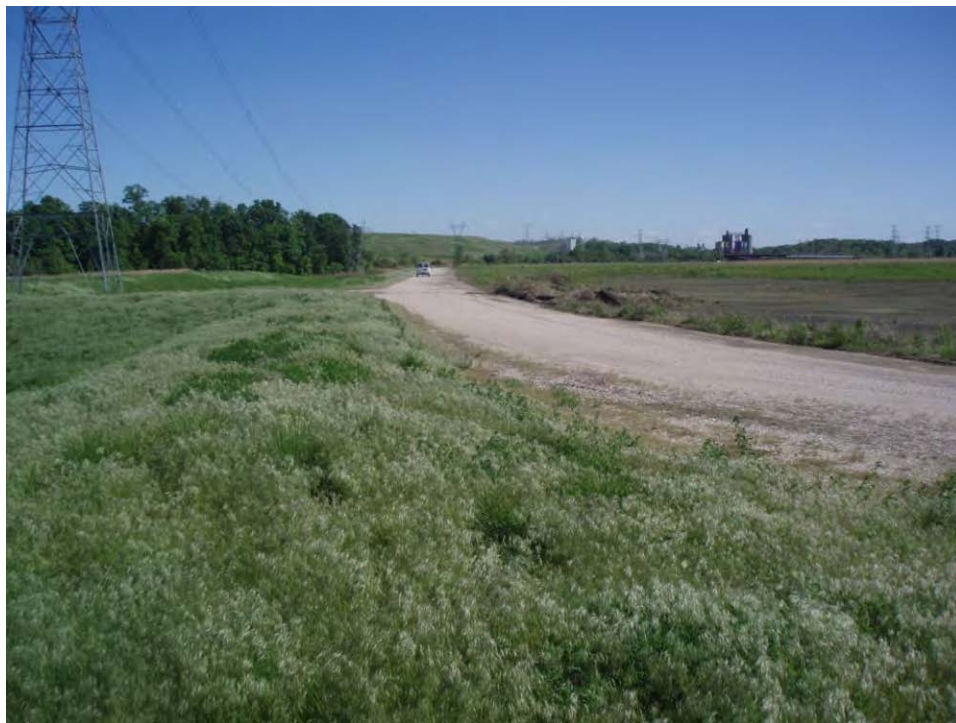
93. Pond B - North embankment crest, looking southeast.

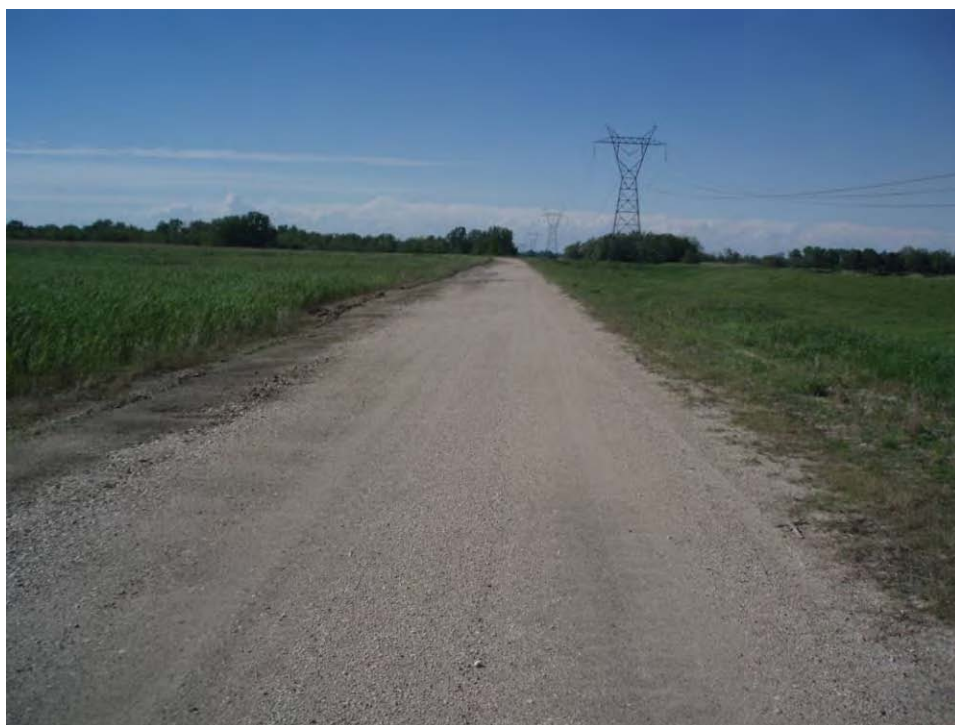
98. Pond B - North embankment crest, looking northwest.

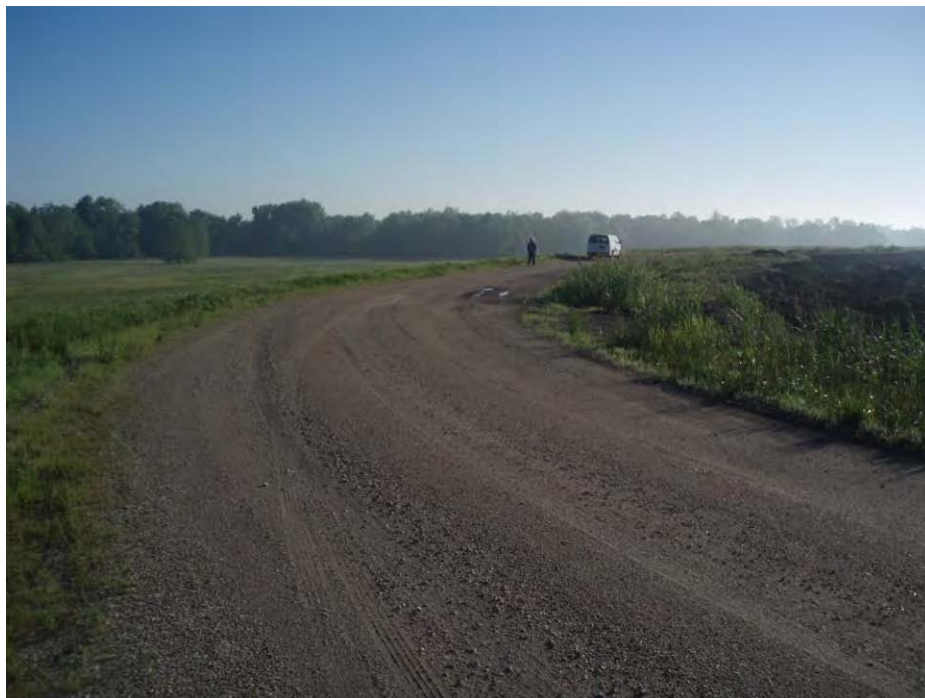
99. Pond C - West embankment crest, looking northeast.

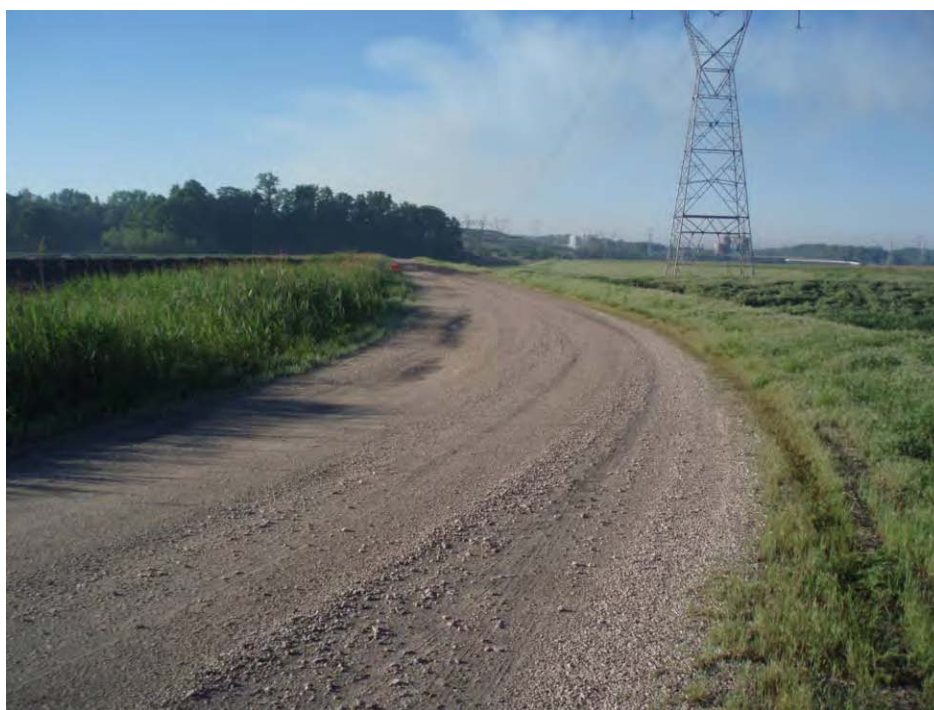
100. Pond C - South embankment crest, looking southeast.

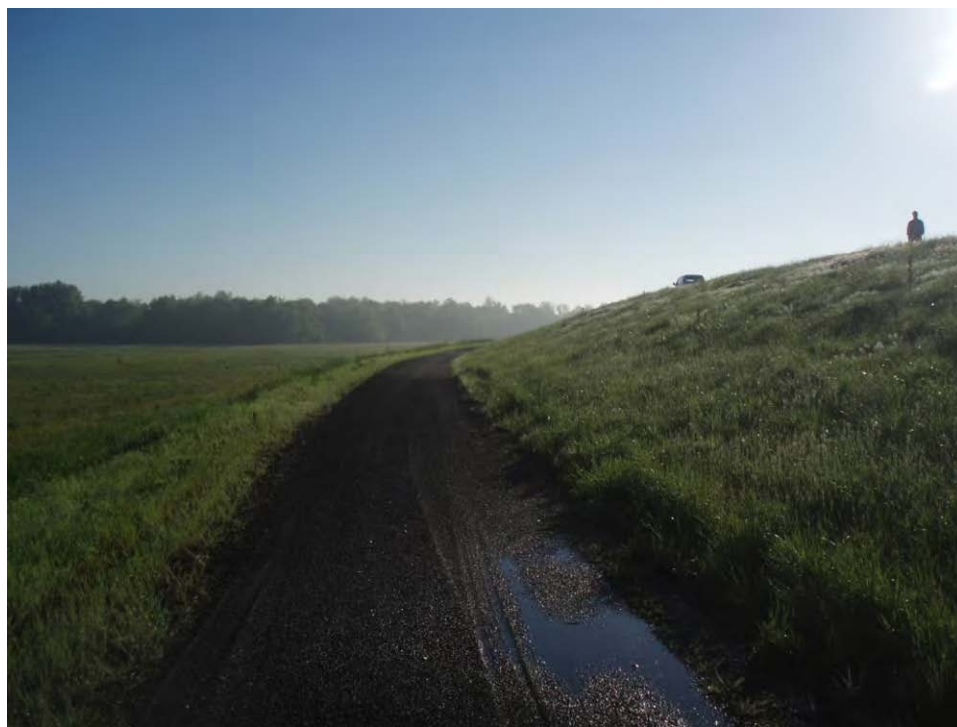
102. Pond C - West embankment bench, looking northeast.

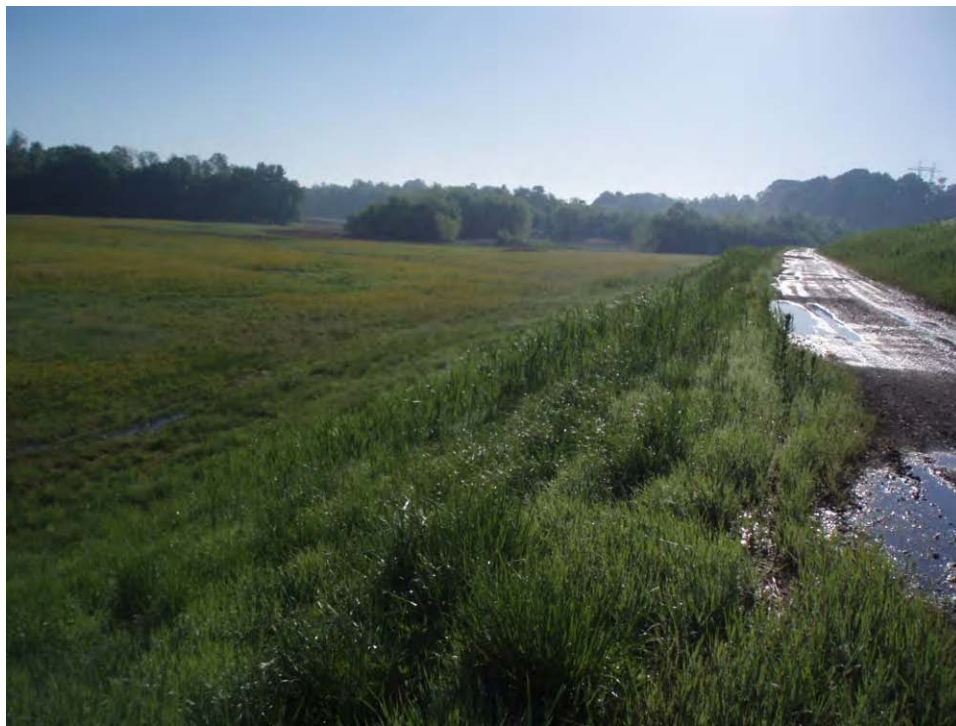
113. Pond C - West embankment bench, looking east.

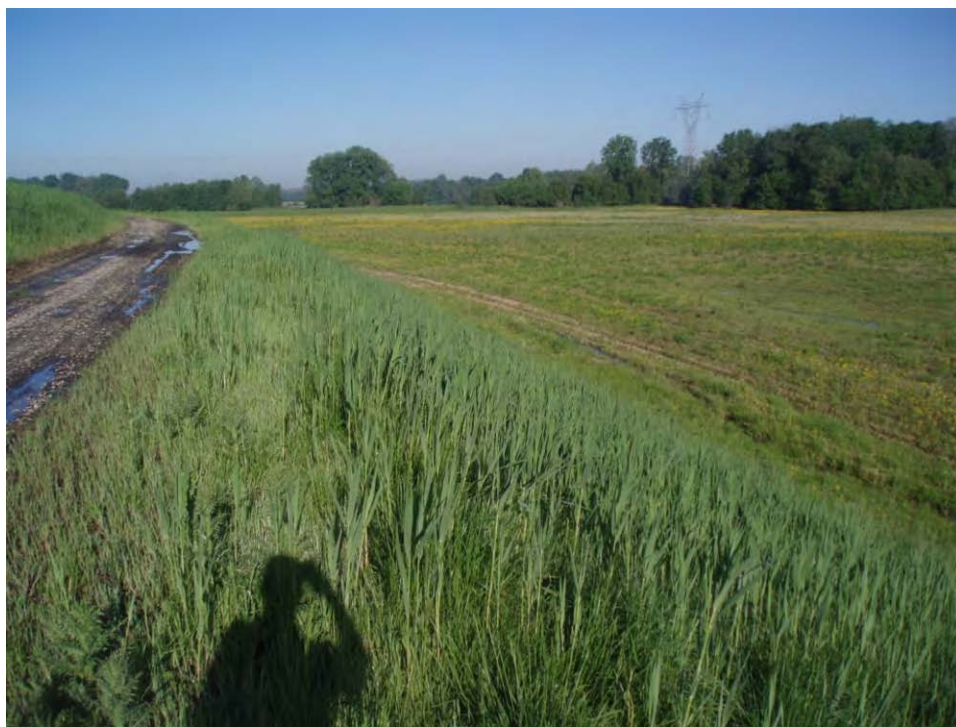
114. Pond C - Wes embankment bench, looking west.

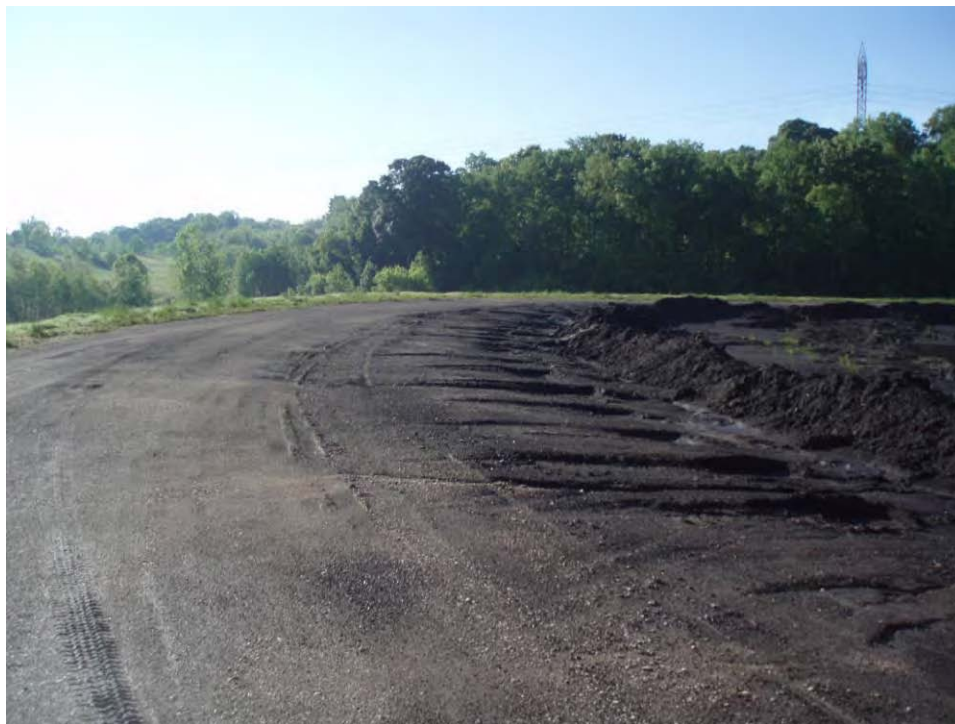
121. Pond C - North embankment crest, looking southeast.

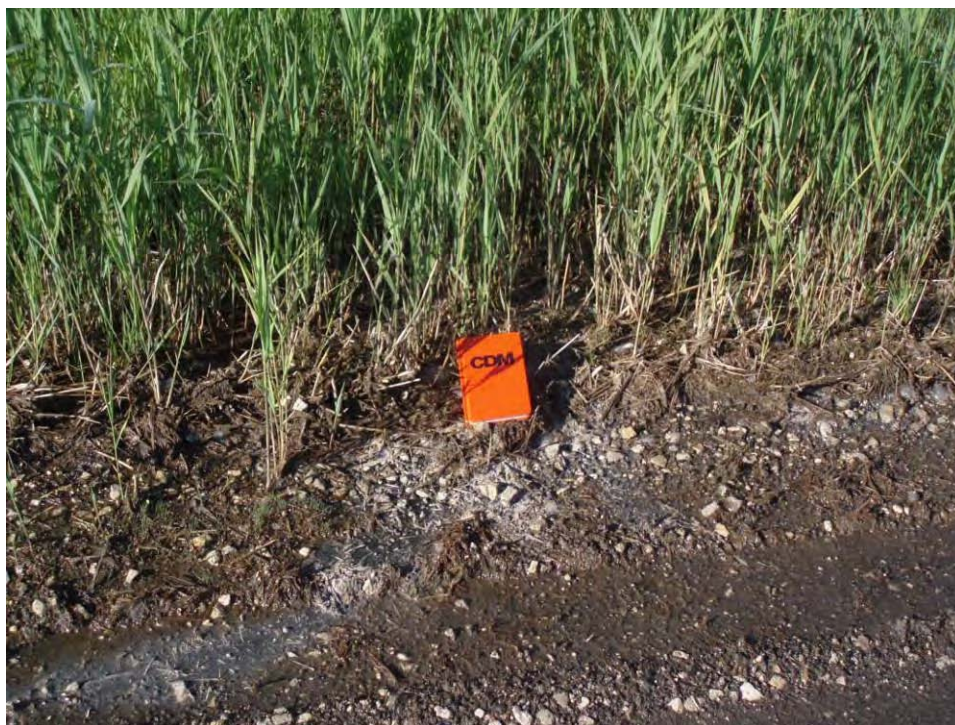
122. Pond C - North embankment bench, looking at active seepage located at toe of upper exterior slope. Note the white sheen in the water.

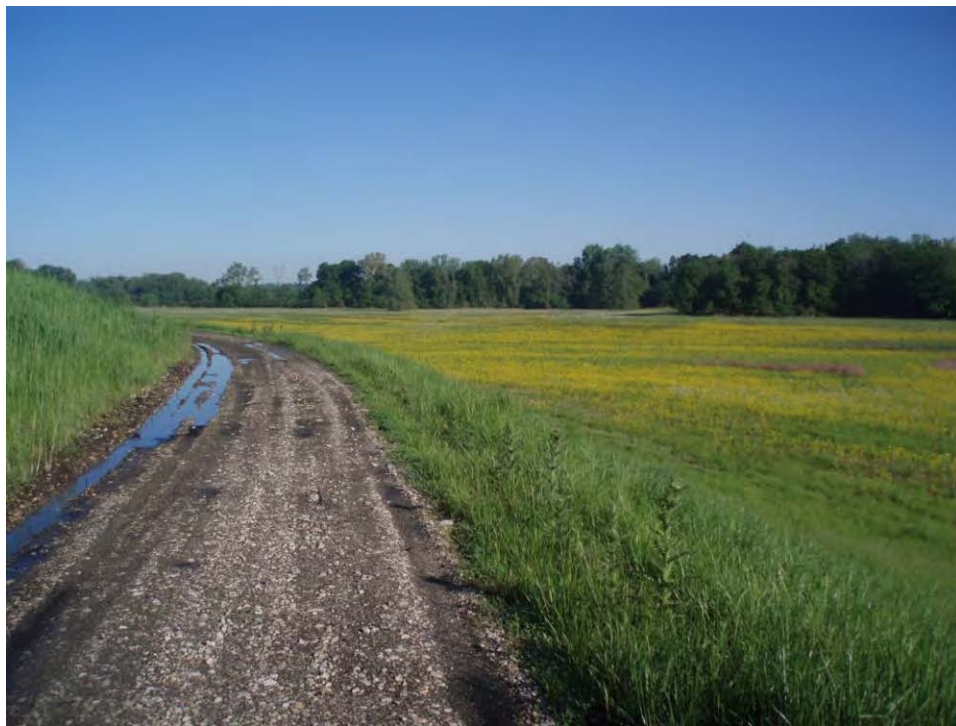
123. Pond C - North embankment bench, looking northwest.

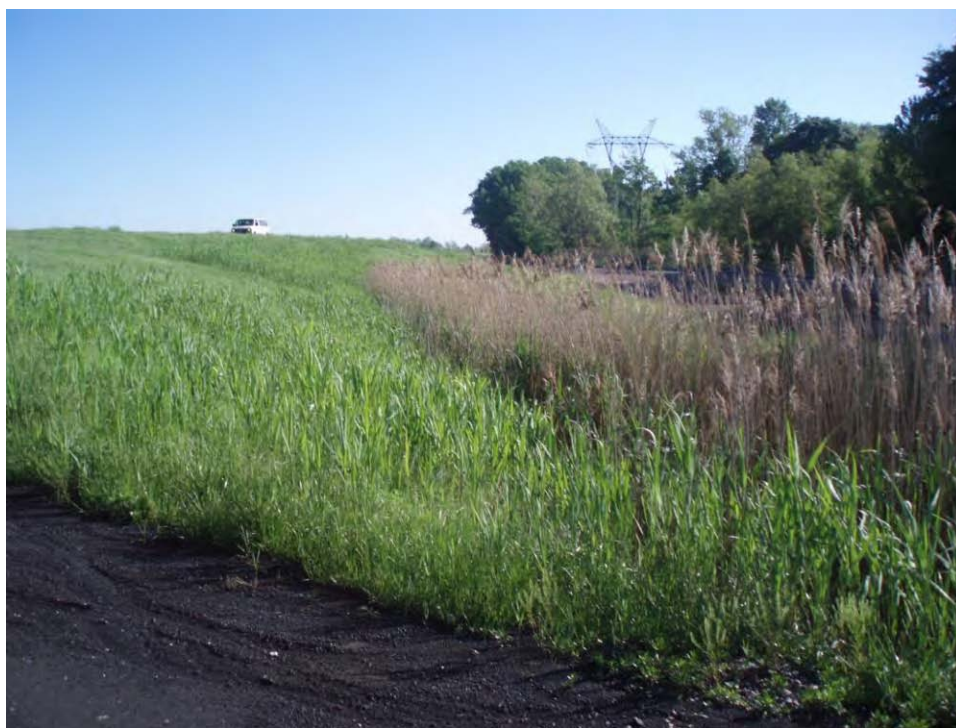
130. Pond C - East embankment exterior slope and drainage ditch, looking northeast.

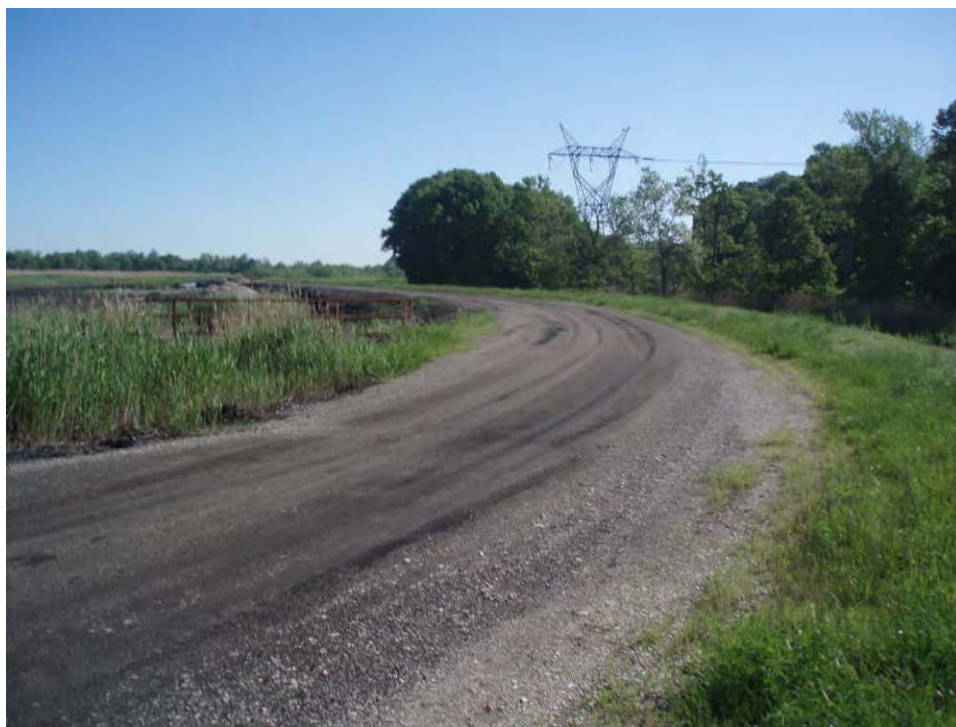
136. Pond C - East embankment crest, looking northeast.

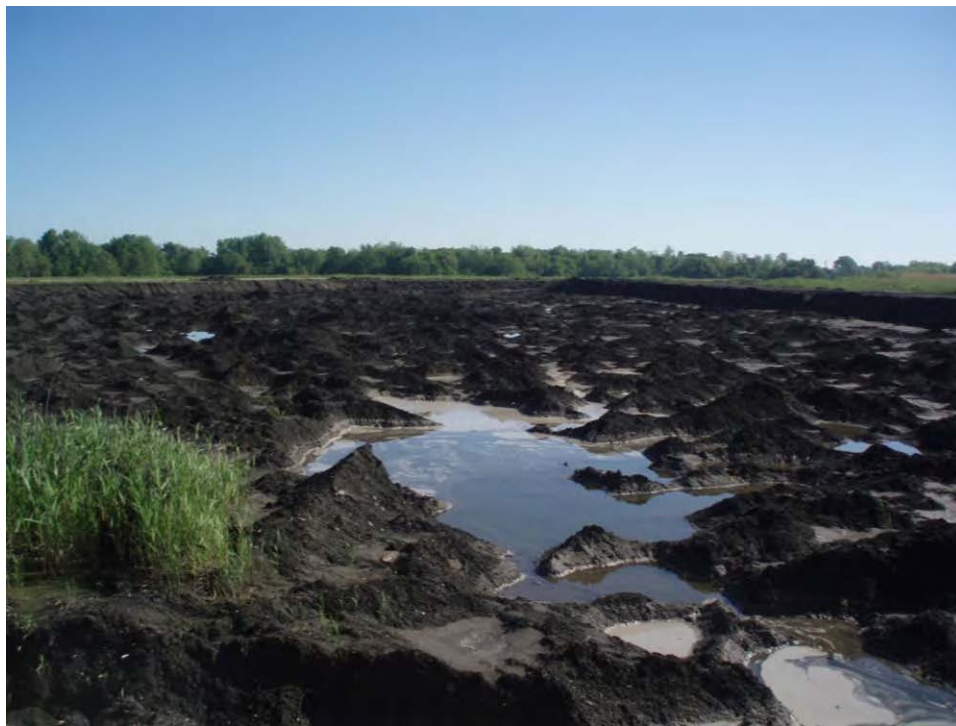
143. Overview of Pond C, looking northeast.
