Subject: EPA Comments on “Draft Coal Combustion Residue Impoundment: Round 12 – Dam Assessment Report – JB Sims Power Plant”

The design of the J. B. Sims Unit 3 project includes a two-cell bottom ash pond. The pond dikes were originally constructed with a sandy material and the pond bottom and interior slopes of the dikes were covered with 1 foot of compacted clay to seal the pond and control seepage. When the pond was initially filled with water, piping was noted around the ash water reclaim structure. Repair of the piping problem proved to be less than satisfactory. Subsequently, it was noted that the pond was leaking along the perimeter.

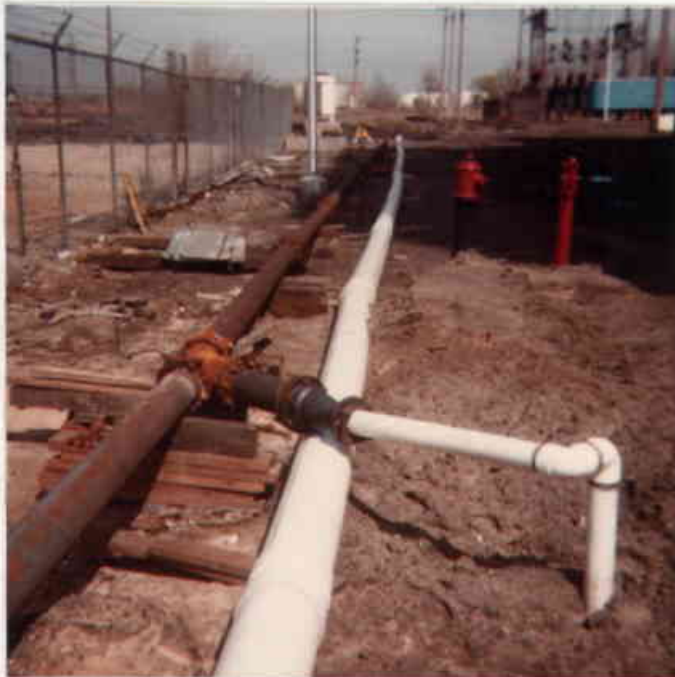
3. Temporary piping leading to Units 1 & 2 ash pond.

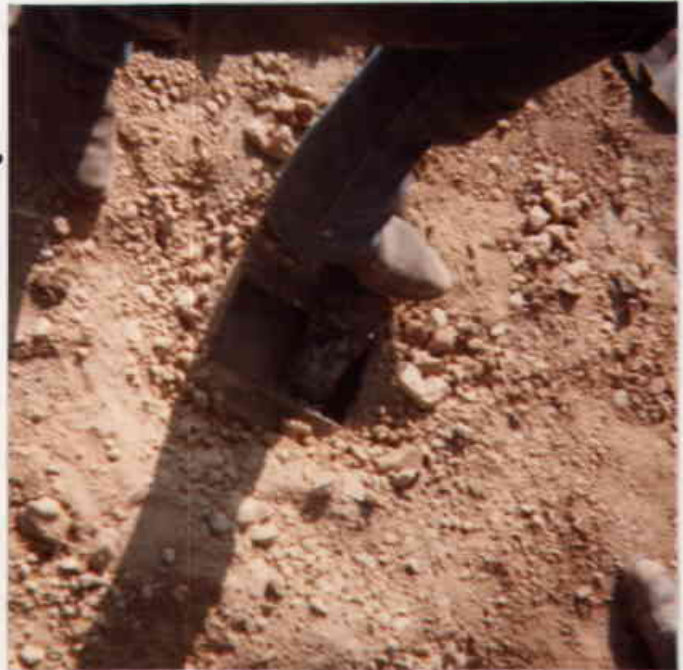
60. Welding the culvert caps after the bentonite slurry was placed.
