ASSESSMENT OF DAM SAFETY OF COAL COMBUSTION SURFACE IMPOUNDMENTS – DRAFT REPORT

**City Utilities of
Springfield**

**John Twitty Energy
Center
Springfield, Missouri**

November, 2012
Revision 1, July 2013

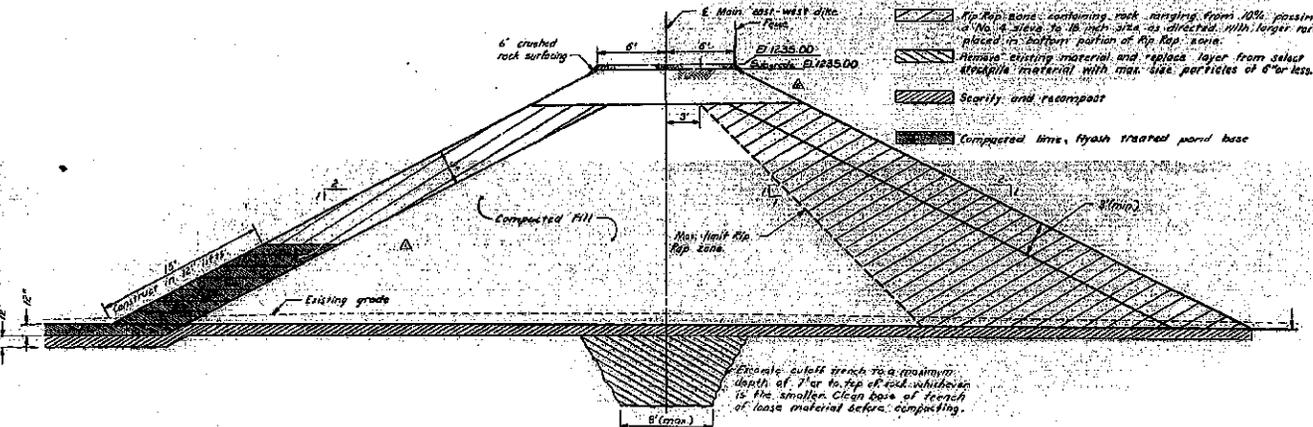
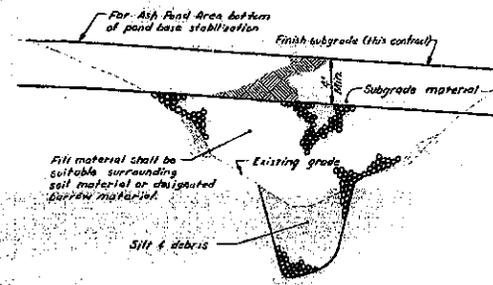
SINKHOLE REPAIR DETAIL
TYPICAL EMBANKMENT AREAS
Not to Scale

NOTES:
1. All unencountered sinkholes shall be cleaned to a min. depth of 4" below proposed grade. Remove all silt & debris prior to filling to a min. depth of 4"
