# DRAFT COAL ASH IMPOUNDMENT SITE ASSESSMENT REPORT

LAKE ROAD GENERATING STATION  
KANSAS CITY POWER & LIGHT  
ST. JOSEPH, MISSOURI

March 2011

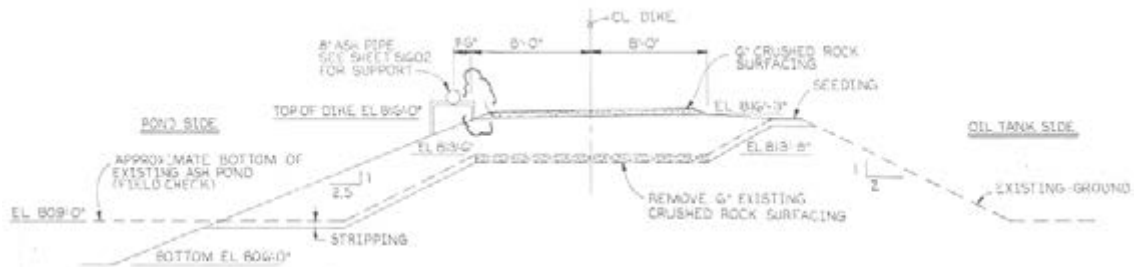
**Figure 1 – Typical Embankment Cross-Section of East Embankment, (Black & Veatch, 1977)**

Settling Basin. The east embankment is a designed structure and was built adjacent to the Existing Oil Tank Berm on the pond side. The embankment foundation does not have an inspection trench and has a wider crest than other sections. A typical embankment cross-section is shown below in Figure 1. The interior embankment to the west is a separator dike constructed of ash mixed with clay to add stability.

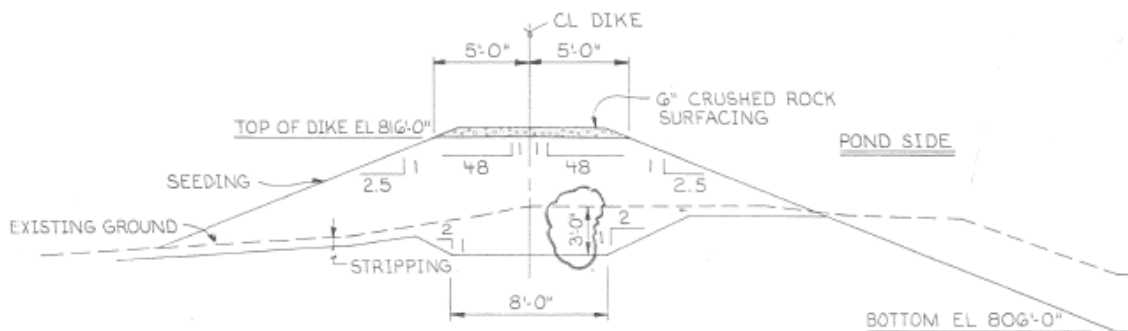
**Figure 2 – Typical Embankment Cross-Section of West Embankment, (Black & Veatch, 1977)**

The Coal Pile Run-off Pool is also a combination incised/diked pool. A sluice pipe transports residual fly ash, sluice water for softening, and concentrate discharge from reverse osmosis to the northeast of the pool. Coal pile run-off water enters through the west embankment. Water is filtered through a 1 ½ to 2-inch clean stone filter dike to the Interim Settling Basin at the south end. A 12-inch CMP overflow pipe accelerates flow to the Final Settling Basin during high water events. The west embankment is a designed embankment with an 8-foot wide inspection trench, a 10-foot crown, and 2.5H:1V slopes. A typical embankment cross-section is shown below in Figure 2.

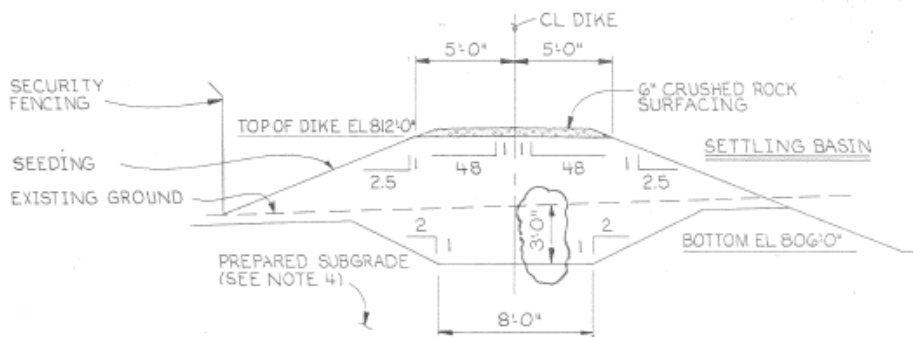
**Figure 3 – Typical Embankment Cross-Section of South Embankment, (Black & Veatch, 1977)**

The Settling Basin is a combination incised/diked pool with a stone filter separator dike between the Interim and Final Settling Basin. Water enters through the stone filter dike from the Ash Pools and exits through the Decant Outlet Works to the southeast. The Decant Outlet Works consists of a 4-foot wide concrete structure with stop-logs that adjust the intake elevation between 806 and 812 feet. The Decant Outlet works flows to a 12-inch RCP conduit which exits at the discharge canal. The landside of the south embankment is part embankment and part excavated canal, and represents the highest section of embankment. The landside of the south embankment (waterside of drainage canal) is reinforced with riprap. The discharge canal flows west and off-site. A typical embankment cross-section is shown below in Figure 3.

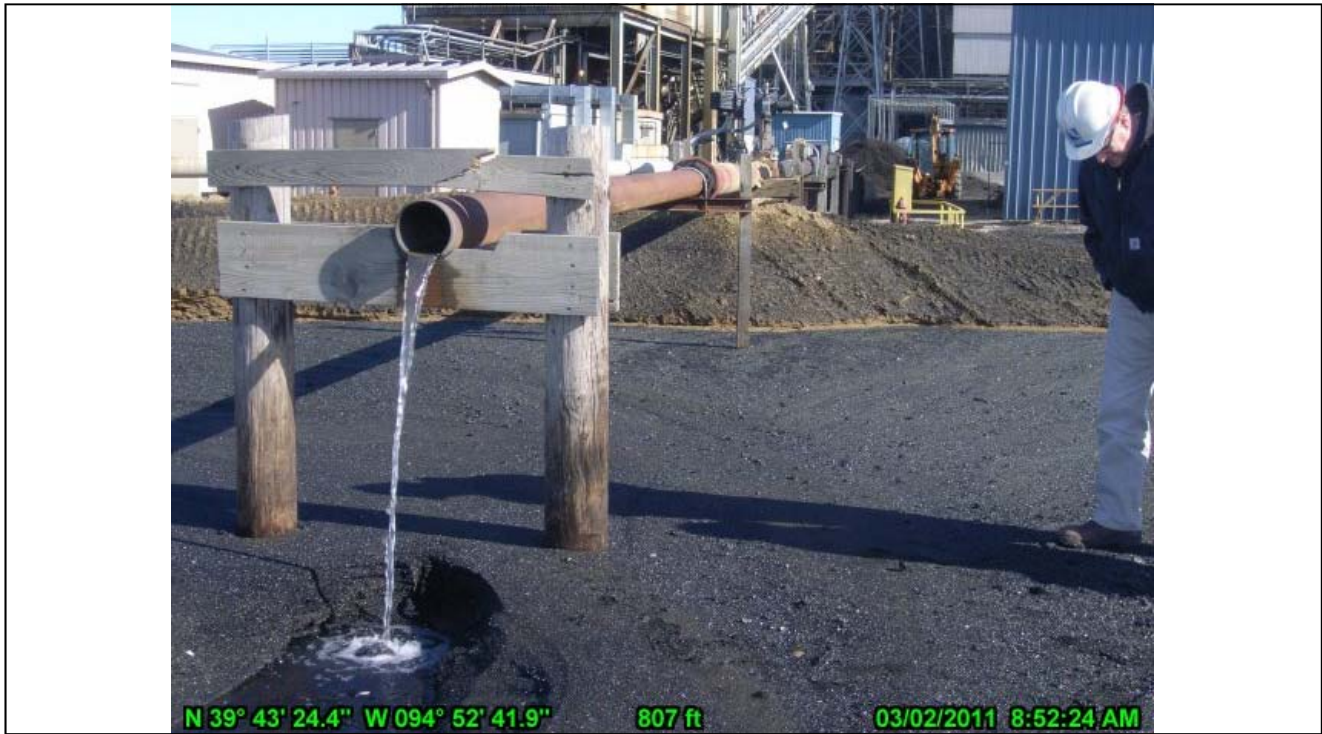
Inflow into the CCB Ash Pond includes metal pipes on the North and Northeast side of the impoundment, as well as coal pile run-off that is pumped into the pond from the west. The Inlet pipes can be seen in Photographs 7 and 27 of Appendix B. Specific observations include:

- The Slag Pool Inlet stretched approximately 30 feet into the pond and did not expose the embankment to erosion. Low flow was observed at the time of inspection.
- The Coal Pile Run-off Pool fly ash inlet was ripped and appeared to be in satisfactory condition. Low flow was observed at the time of inspection.
- The Coal Pile Run-off Pool inlet penetrated the west embankment and appeared in satisfactory condition. High flow was observed at the time of inspection.

7-Slag Inlet Sluice Pipe looking Northeast

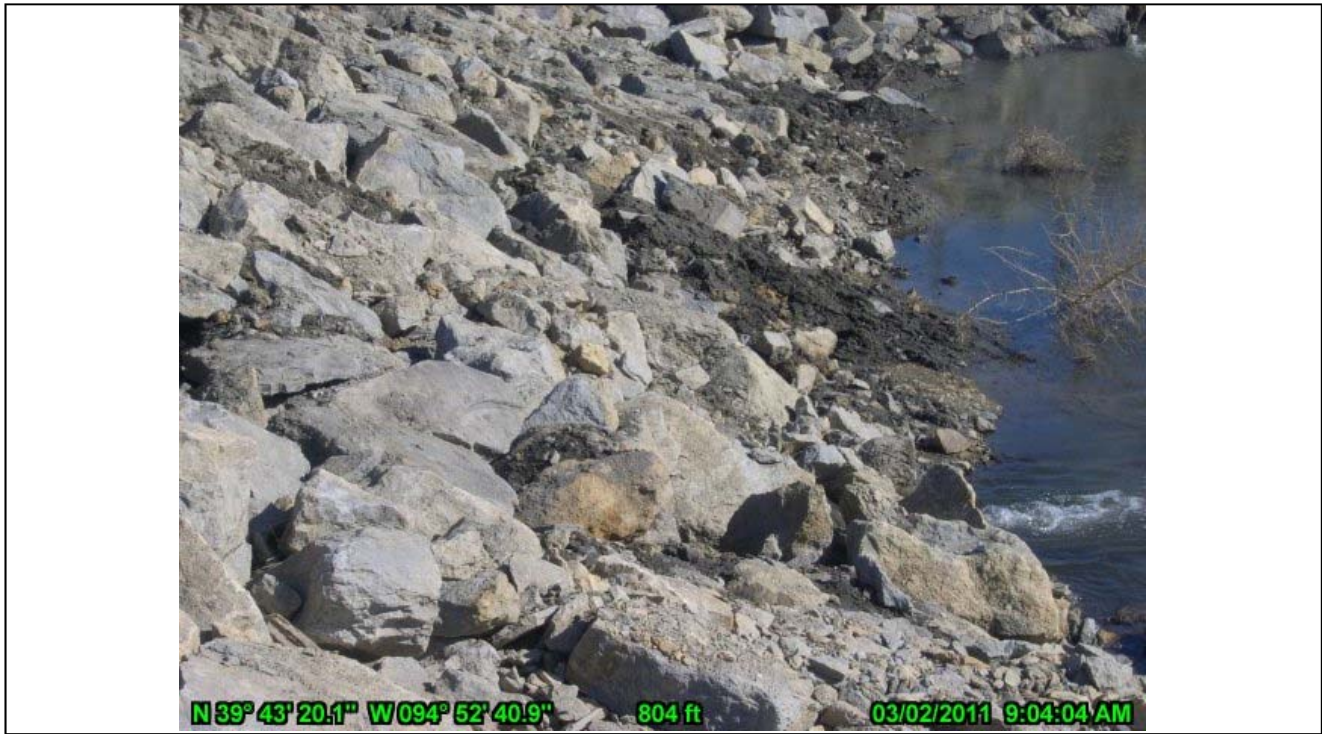
15-Landside of South Embankment/Drainage Canal and Outlet Pipe

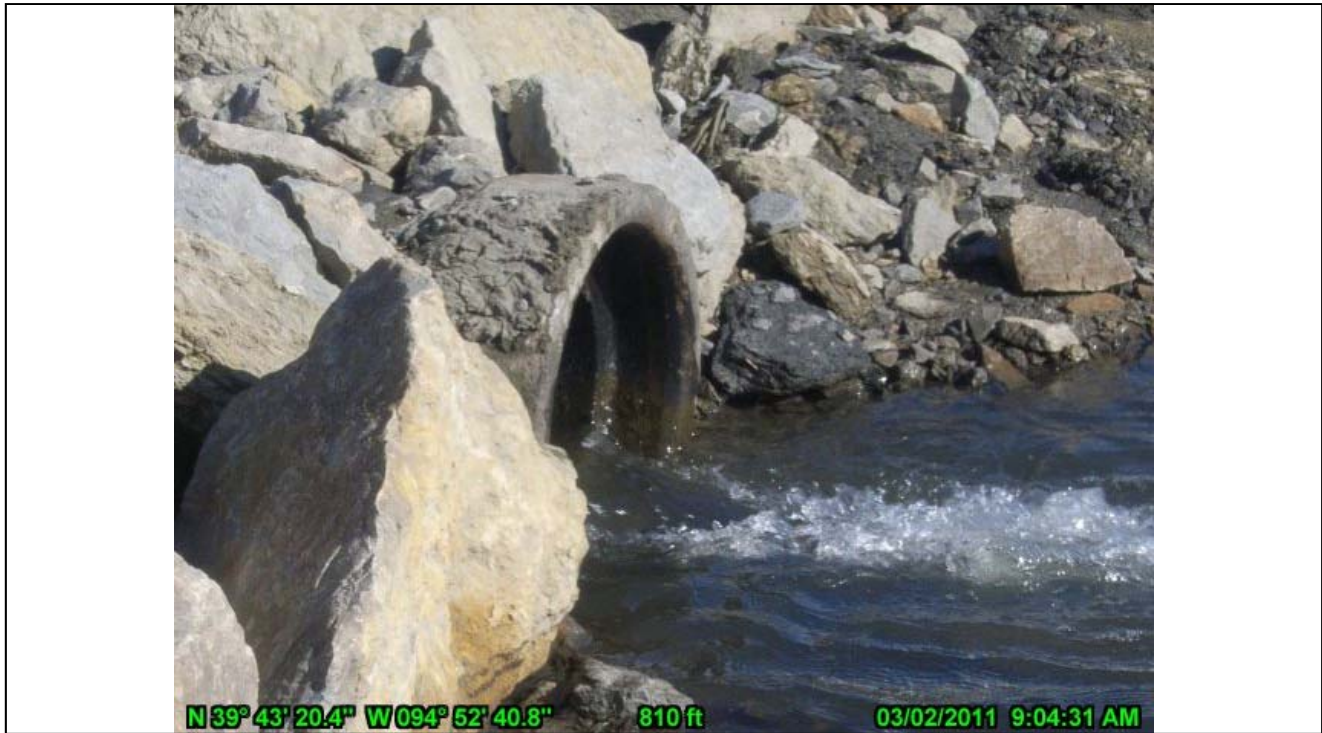
16-Decanter 12" Outlet Pipe

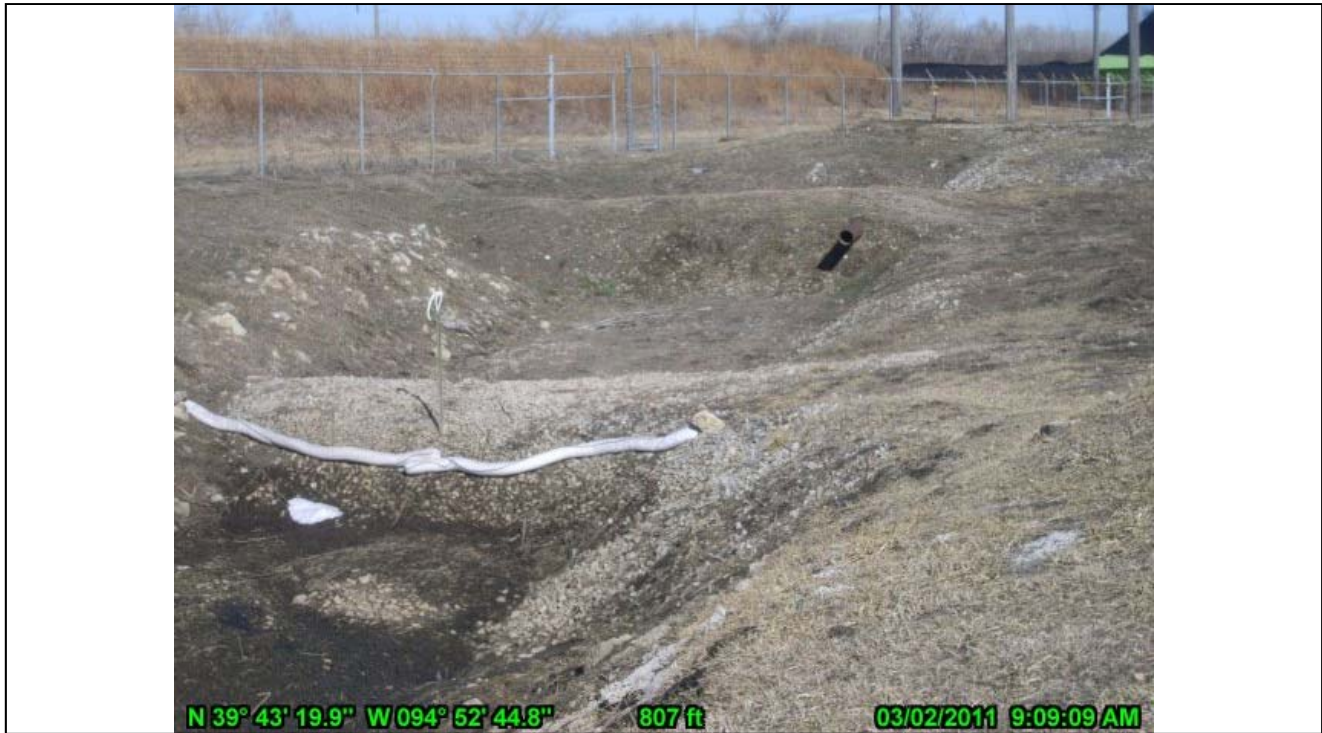
- Erosion and slope steepening was observed on the landside embankment west of Interim Settling Basin. The area is adjacent to a drainage ditch and is likely exposed to more stormwater run-off.
- No internal video inspection of the outlet conduit was available at the time of inspection.

20-Stormwater Erosion Control Channel West of West Embankment Toe

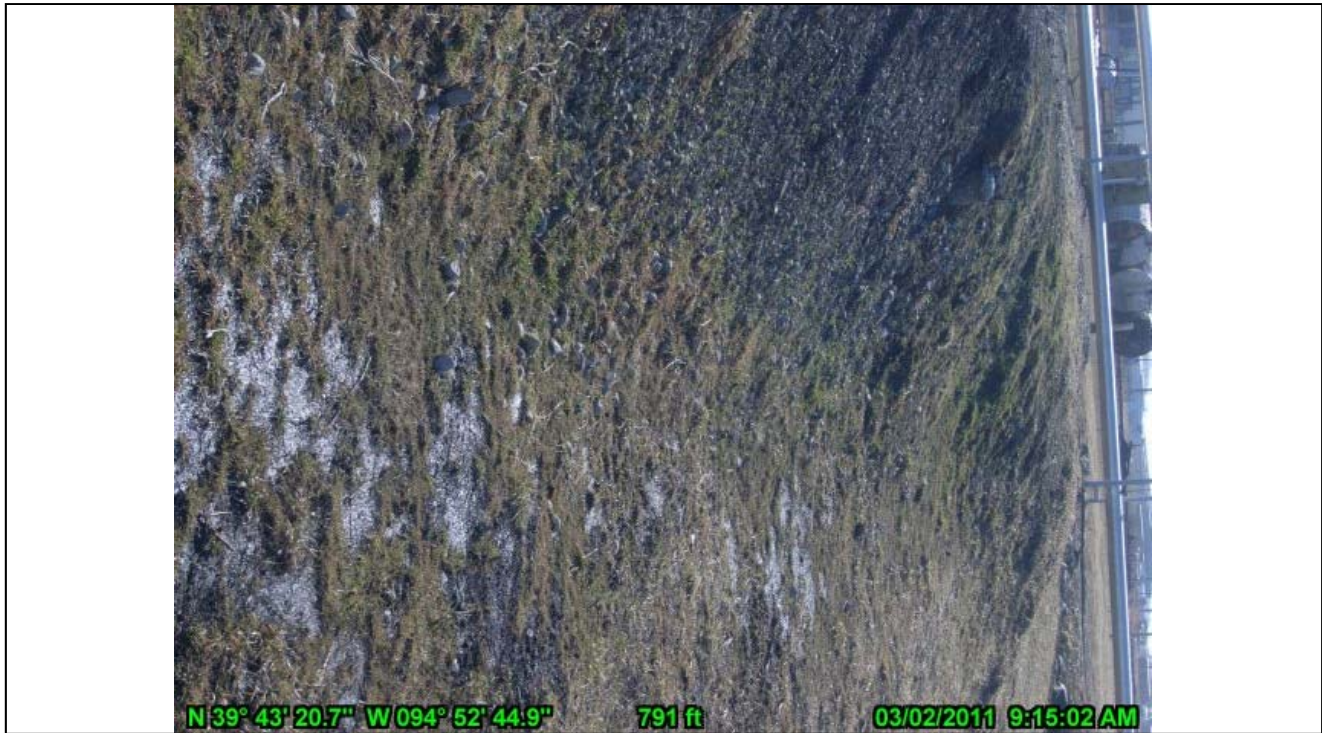
Overall, the landside toe areas were in satisfactory condition. Photographs 6, 24, and 25 in Appendix B show typical conditions of the landside toe. Specific observations include:

- No large trees or hydrophilic vegetation was observed along the embankment toe.
- No ponding water was observed along the embankment toe, with the exception of a coal pile run-off ditch to the northwest and the drainage canal to the south. Both locations appear intended to contain some water.
- Three utility poles were built near the embankment toe.

24-Landside Embankment Toe of Interim Settling Basin Looking South

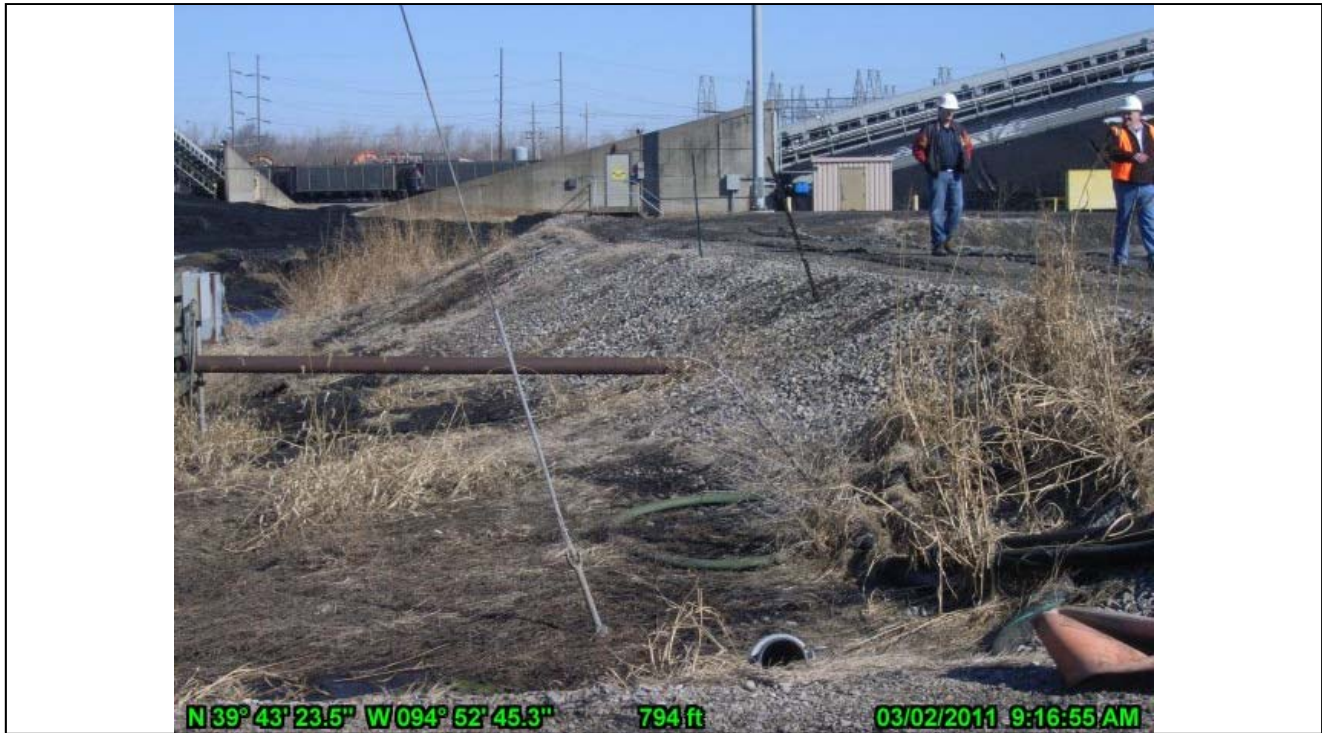
26-Landside Embankment of Coal Pile Run-off Pool Looking North

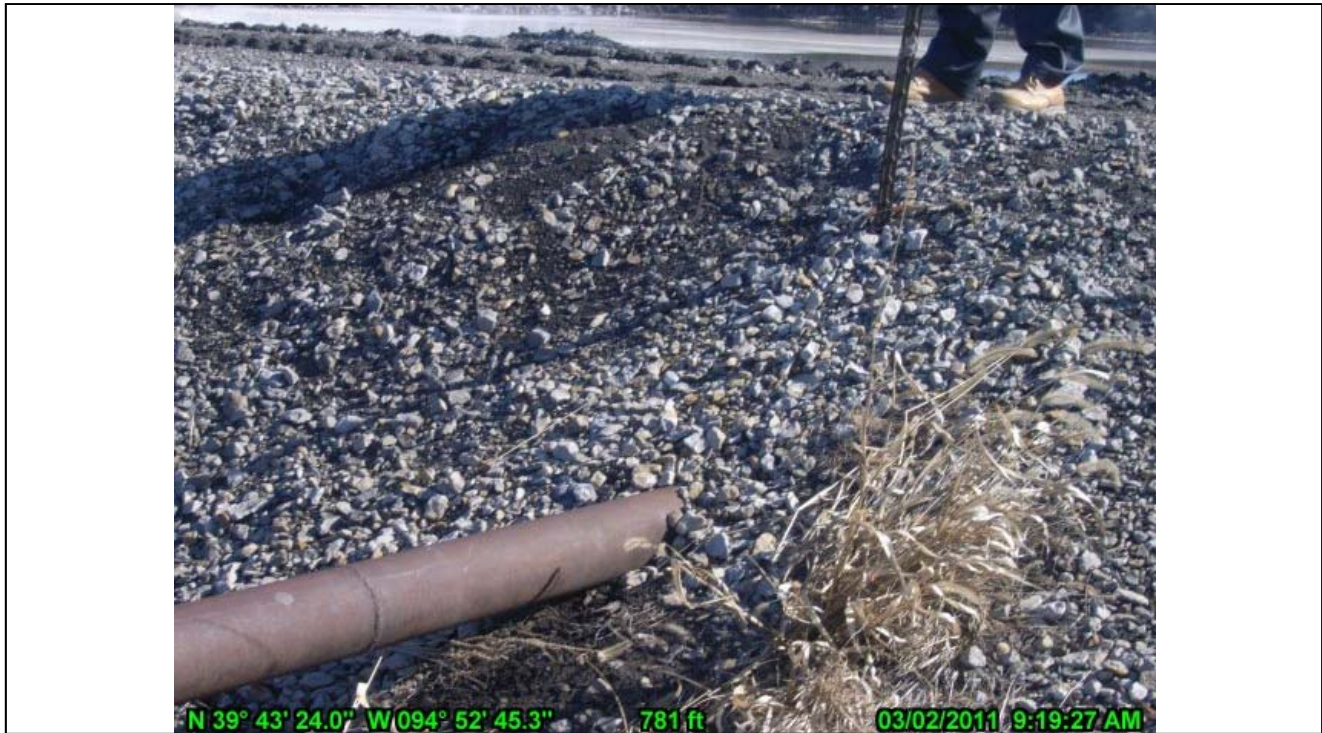
28-Coal Pile Run-off Pipe Landside Penetration

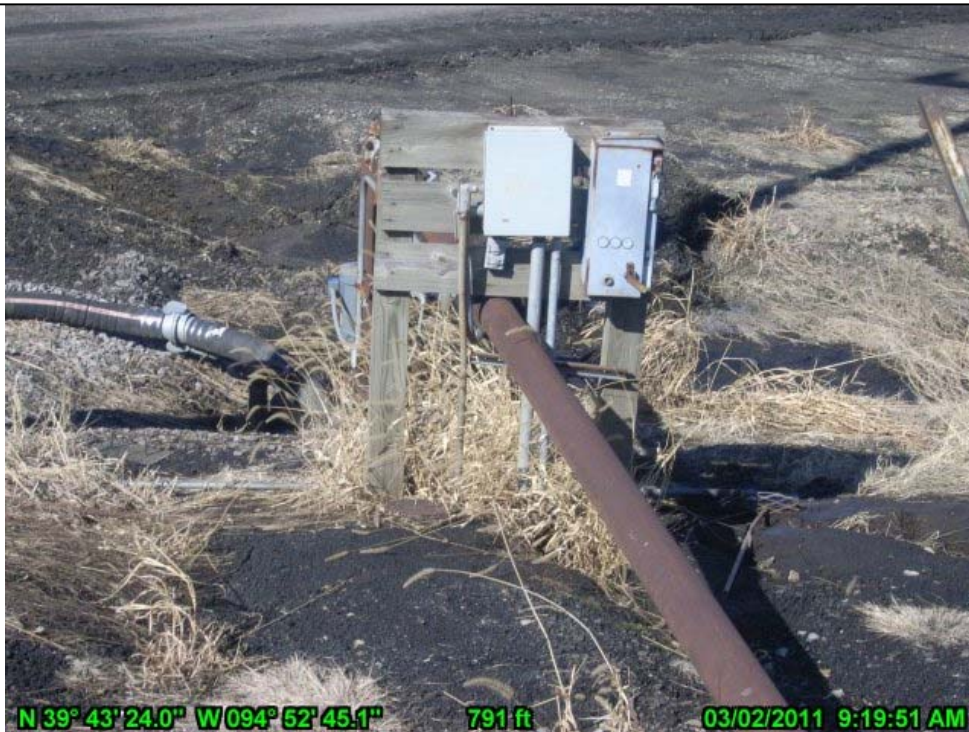
29-Coal Pipe Run-off Pipe and Electric Boxes at Landside Toe

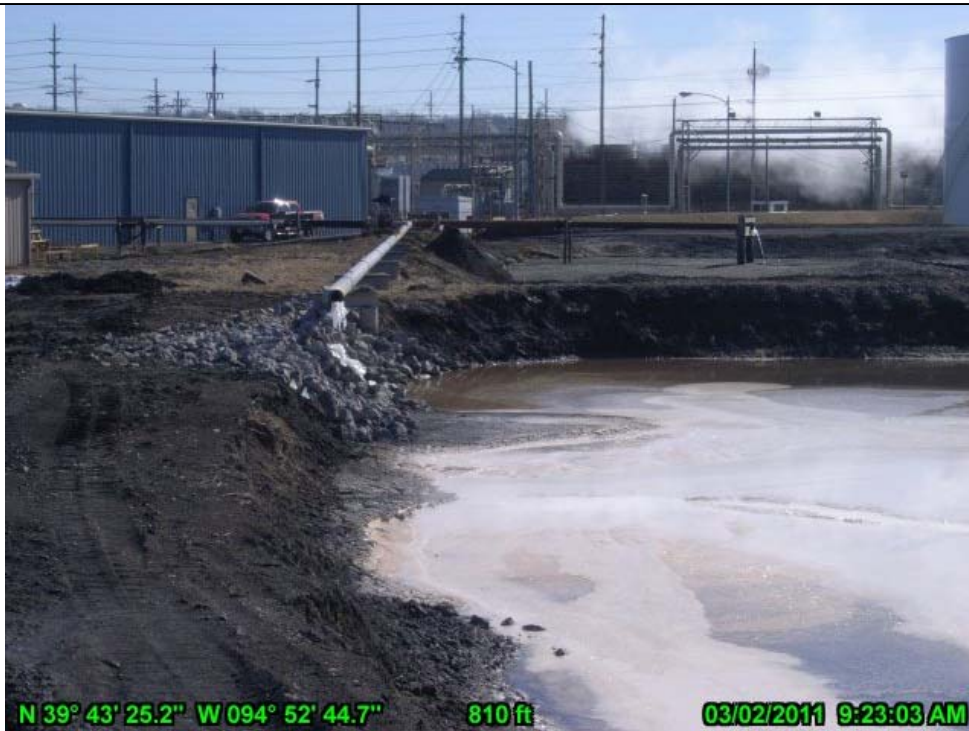
30-Fly Ash Inlet and North Embankment of Coal Pile Run-off Pool Looking East
