Comment on Draft Report – Kentucky Utilities – Tyrone Generating Station

**Re: Kentucky Utilities' Comments for  
*DRAFT Report of Geotechnical Investigation Dam Safety Assessment of Coal Combustion Surface  
Impoundments Kentucky Utilities, a Subsidiary of E.ON U.S. Tyrone Generating Station, Tyrone, Kentucky***

TYRONE ASH POND PHOTOS  
January 7, 2011

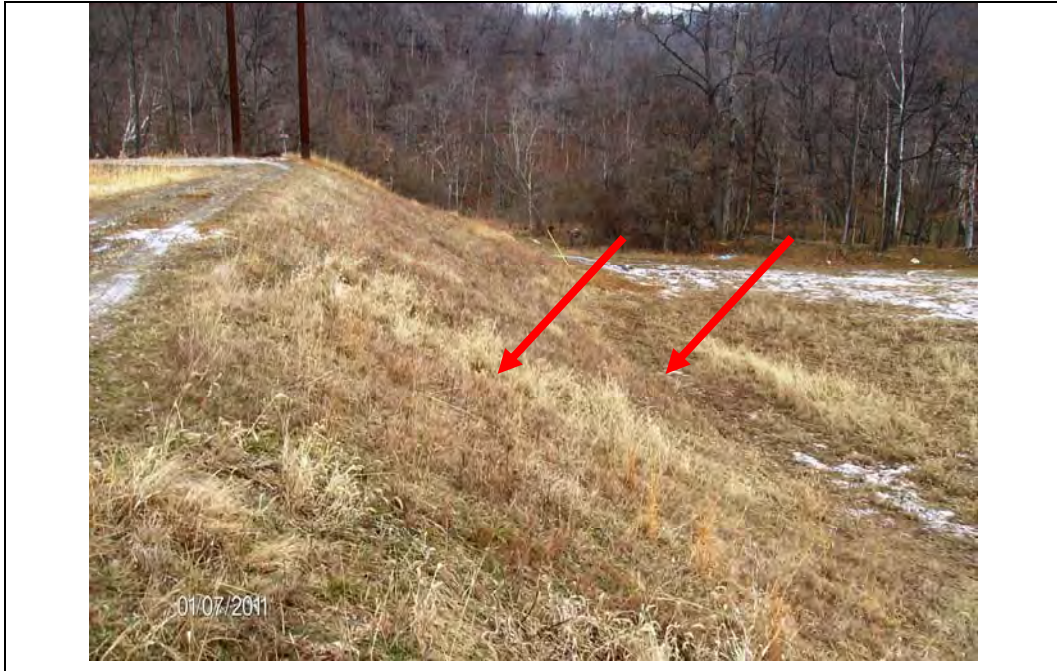
**Photo #3:** North Exterior slope, looking west  
Note: erosion gullies and steep slope at toe

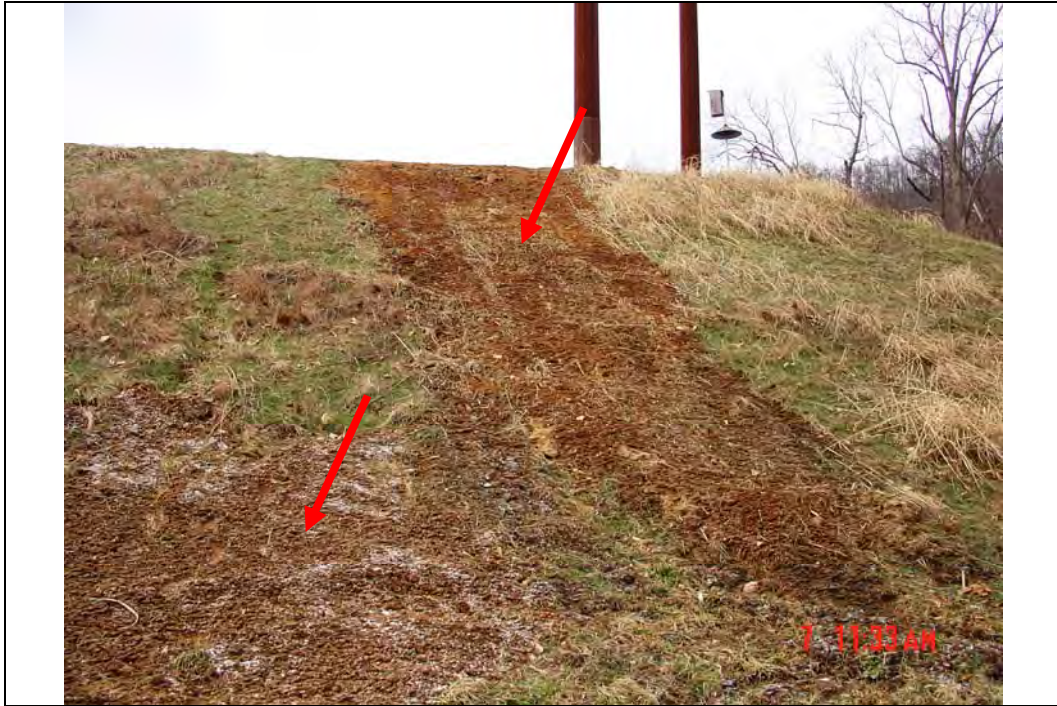
**Photo #4:** Erosion gullies north exterior slope at spillway,  
looking north

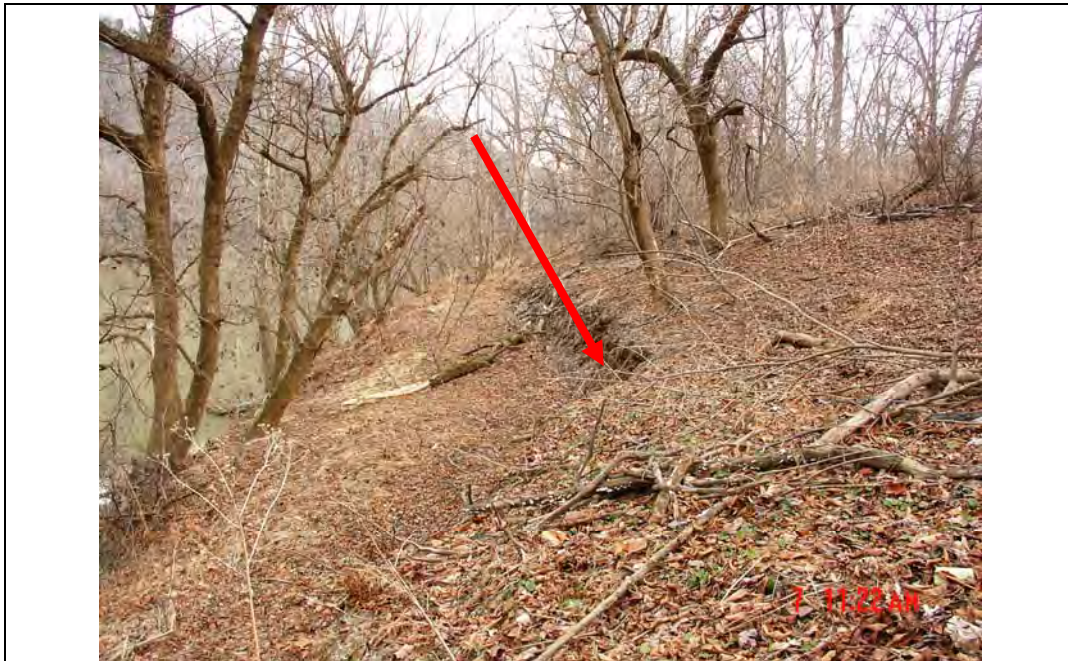
**Photo #7:** Interior slope west embankment, area needs erosion protection, looking north

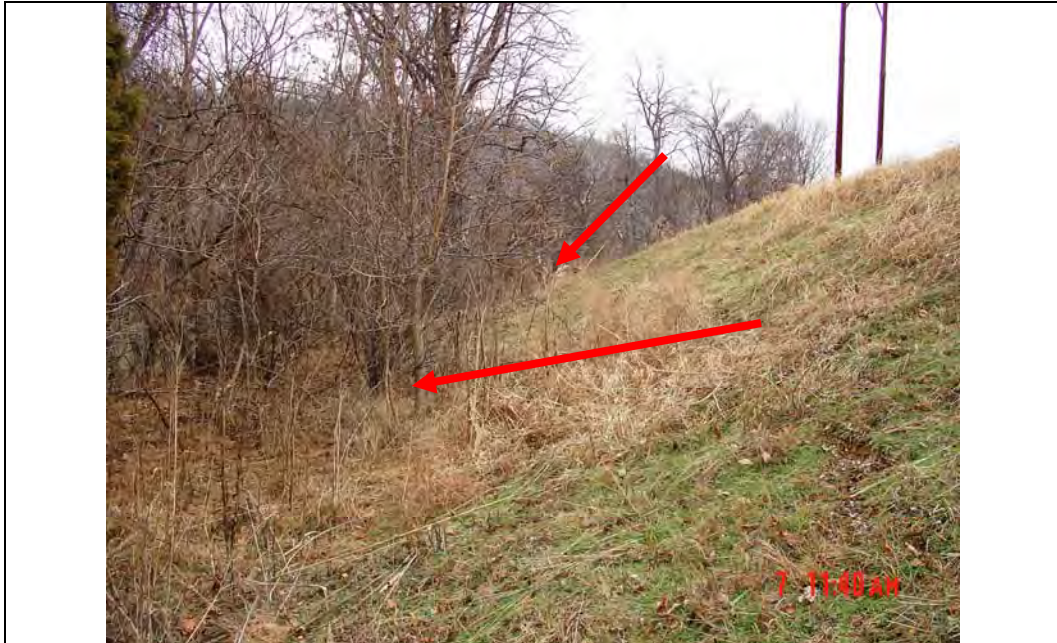
**Photo #8:** Slope scarp above cooling water canal, below toe of pond embankment, looking north

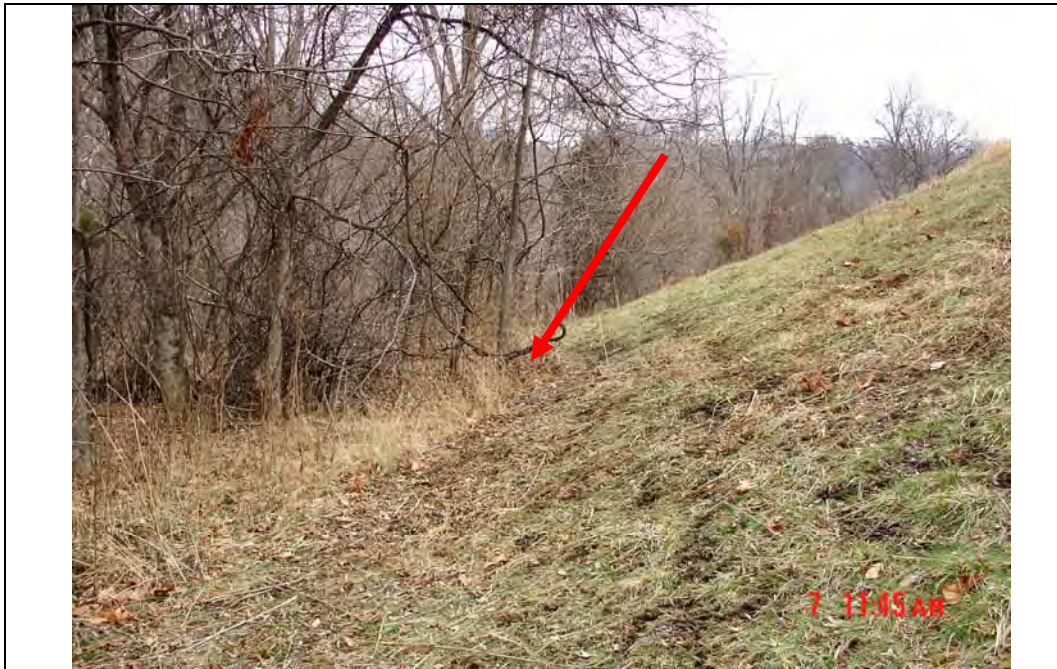
**Photo #9:** Woody vegetation at toe of embankment slope, west exterior slope, looking north

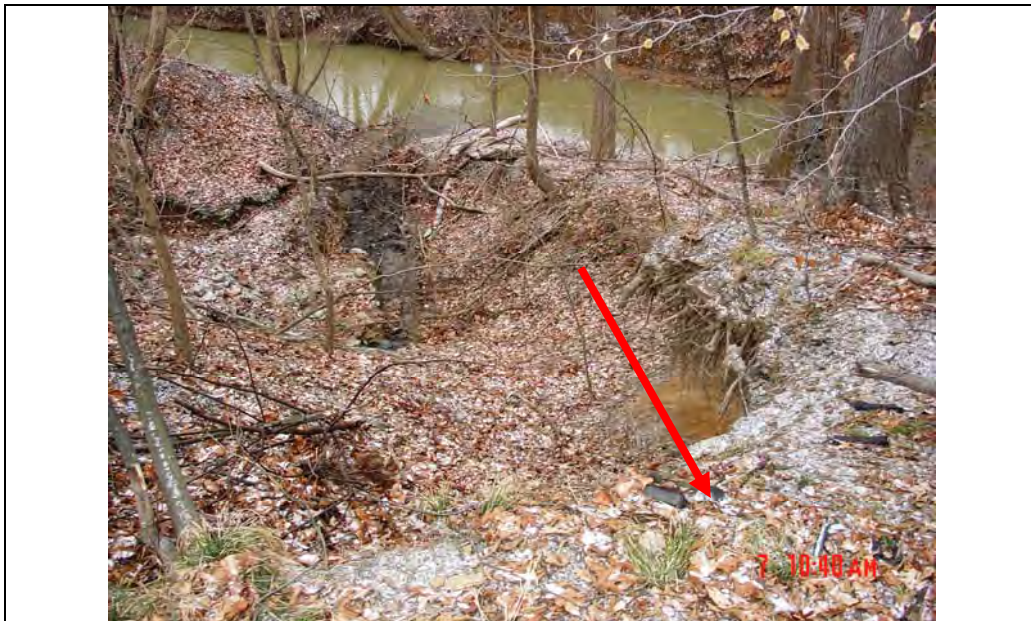
**Photo #11:** New pipe installed at cooling water canal  
Note: Seepage and erosion below pipe, looking south
