Assessment of Dam Safety of Coal Combustion Surface Impoundments

Sam Seymour - Fayette Power Project Station

Lower Colorado River Authority

Draft Report

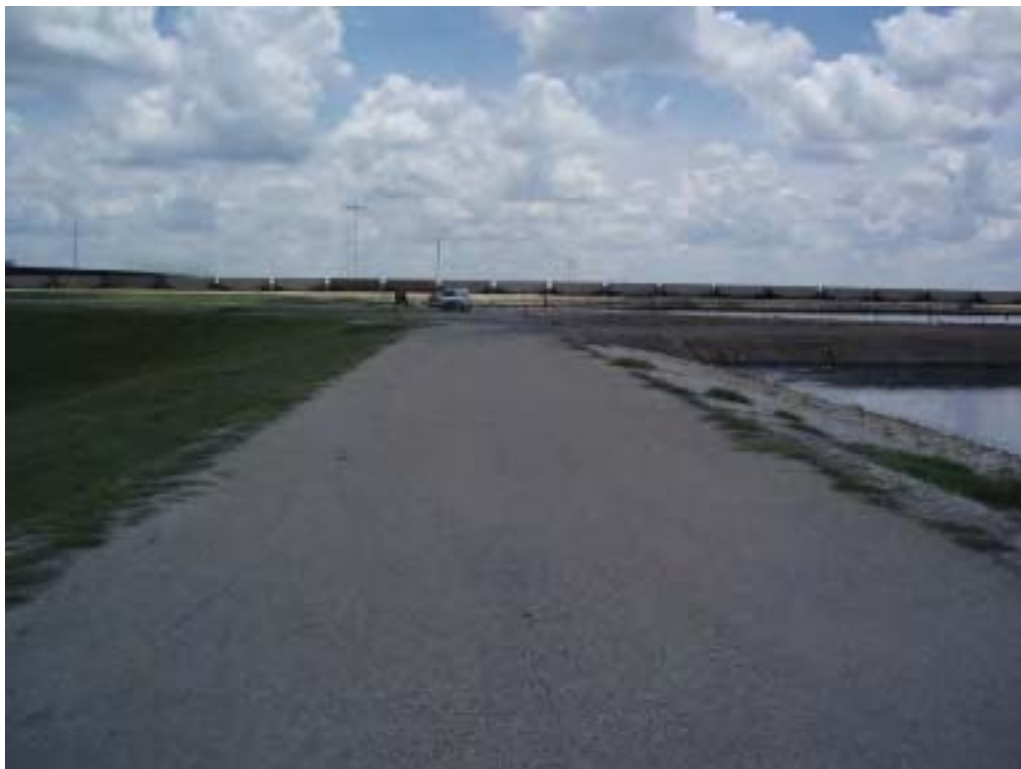
The crest of the Reclaim Pond generally appeared to be in fair condition (Photos 3, 6, 7, 8, 10, 13, 14, 15, 16, 20, 23, 26, 35, 45, and 49). The crest was surfaced with compacted gravel around the perimeter of the impoundment and served as an access road. Some minor rutting was observed on the south and west embankment crest. The railroad spur ballast on the east embankment crest is approximately 2 to 3 feet above the access road. The water level was at approximate El. 366 and there was about four feet of freeboard at the time of the site visit.

Photo No. 3: Reclaim Pond – North embankment crest, looking east

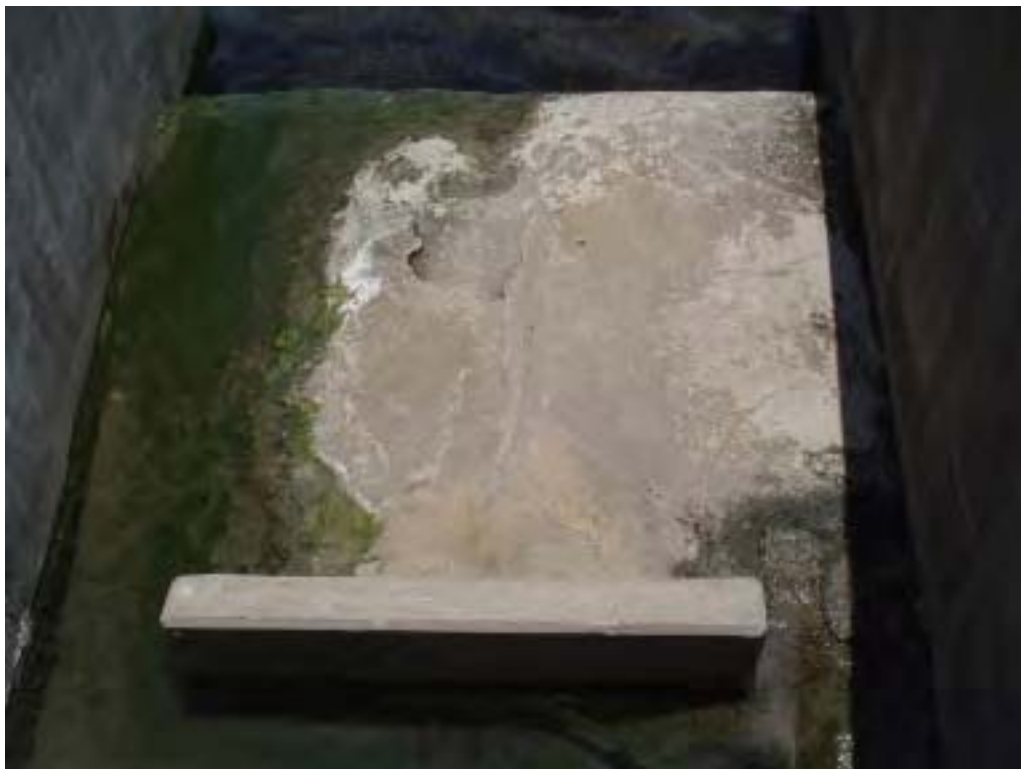
The visible portions of the interior slope generally appeared to be in fair condition (Photos 1, 4, 5, 9, 11, 12, 14, 17, 18, 19, 20, 21, 22, 24, 25, 33, and 36). The interior slope is protected with riprap armor. Some minor brush was growing between the riprap on the east embankment interior slope. On the west and east embankment there were some areas with little or missing riprap and there were areas with sparse vegetation and bare spots near the crest.

Photo No. 9: Reclaim Pond – Overview of stormwater outlet structure on west embankment interior slope. Stormwater is from FGD residue silos and truck wash area.

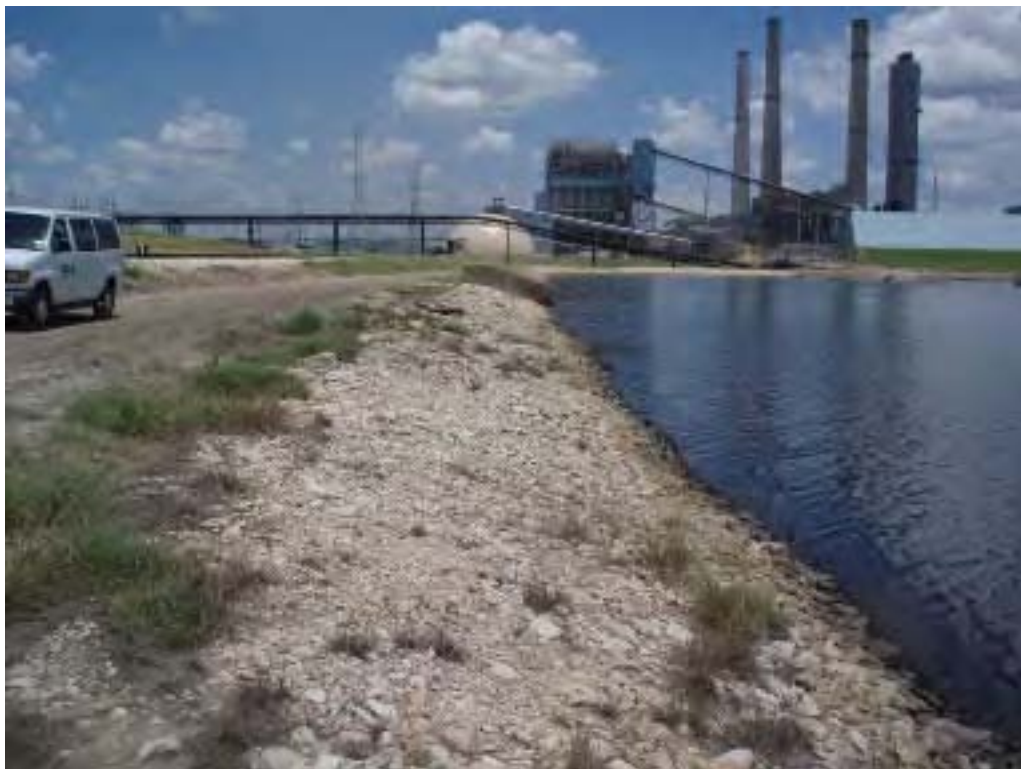
Photo No. 11: Reclaim Pond - West embankment interior slope, looking north.

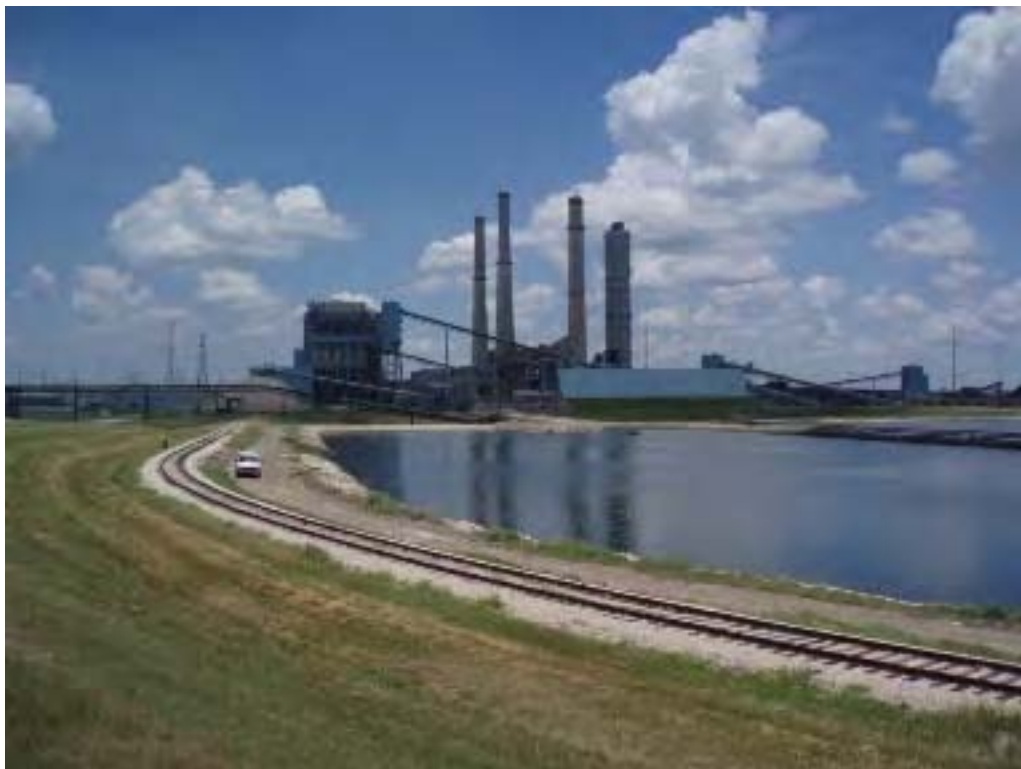
Photo No. 13: Reclaim Pond - Overview of western portion of impoundment, looking north.

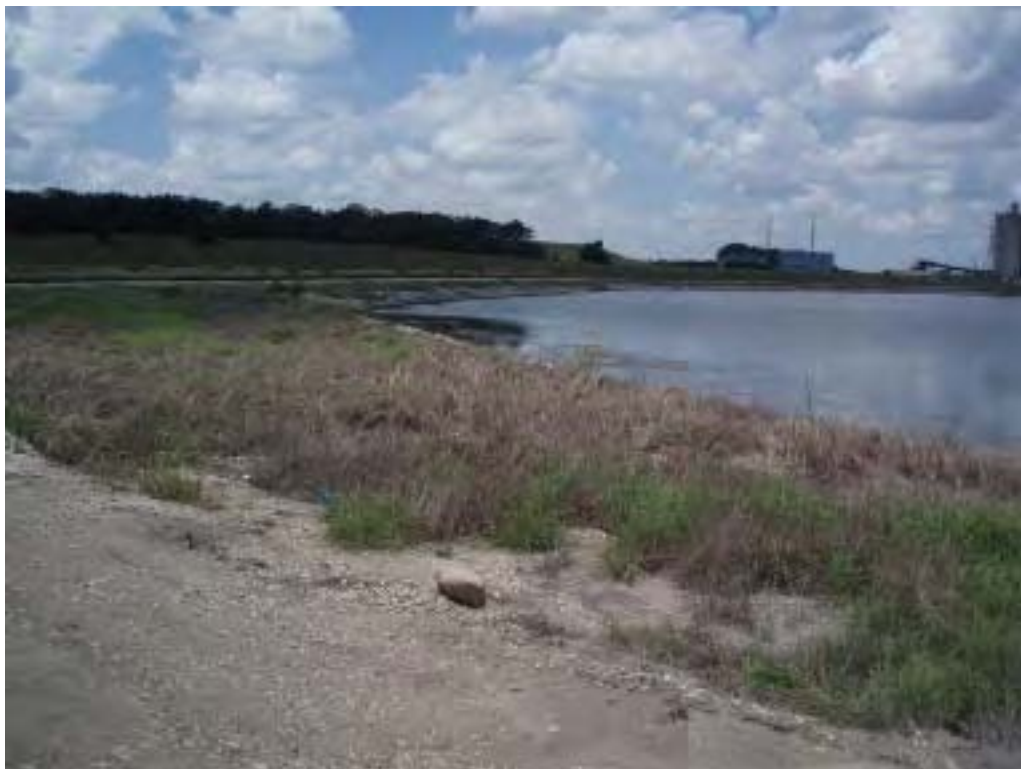
Photo No. 17: Reclaim Pond – Overview of south embankment, looking northwest.

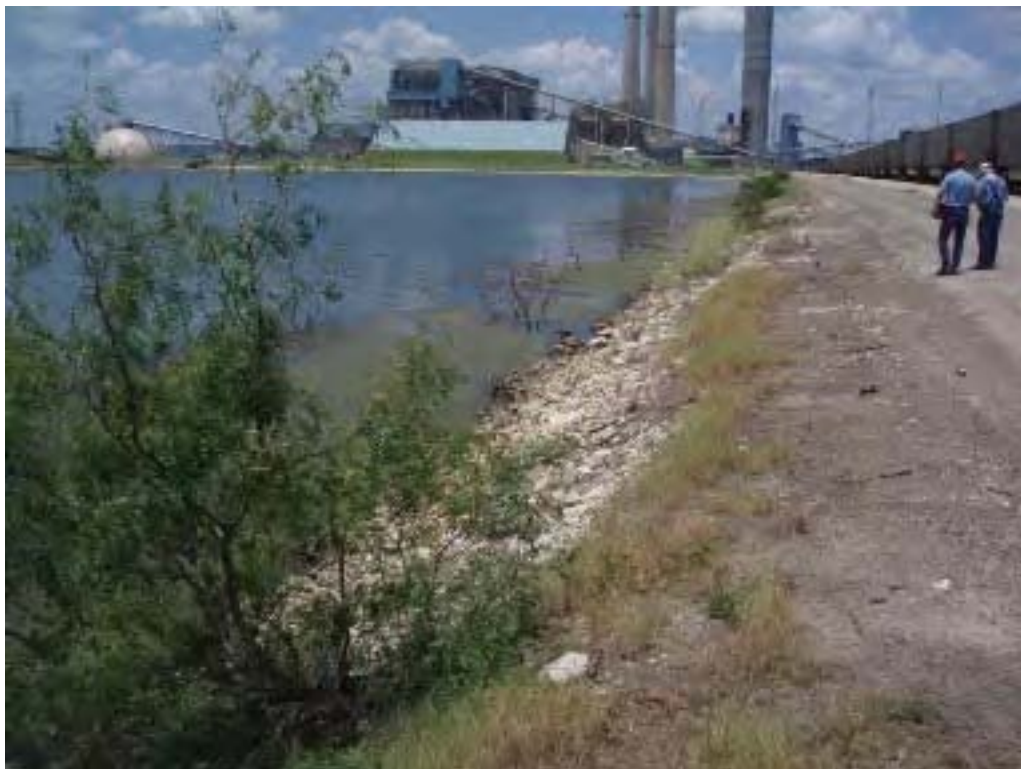
Photo No. 19: Reclaim Pond - East embankment interior slope, looking at a 4-inch-diameter mesquite tree and brush. Note some minor surface erosion near crest.

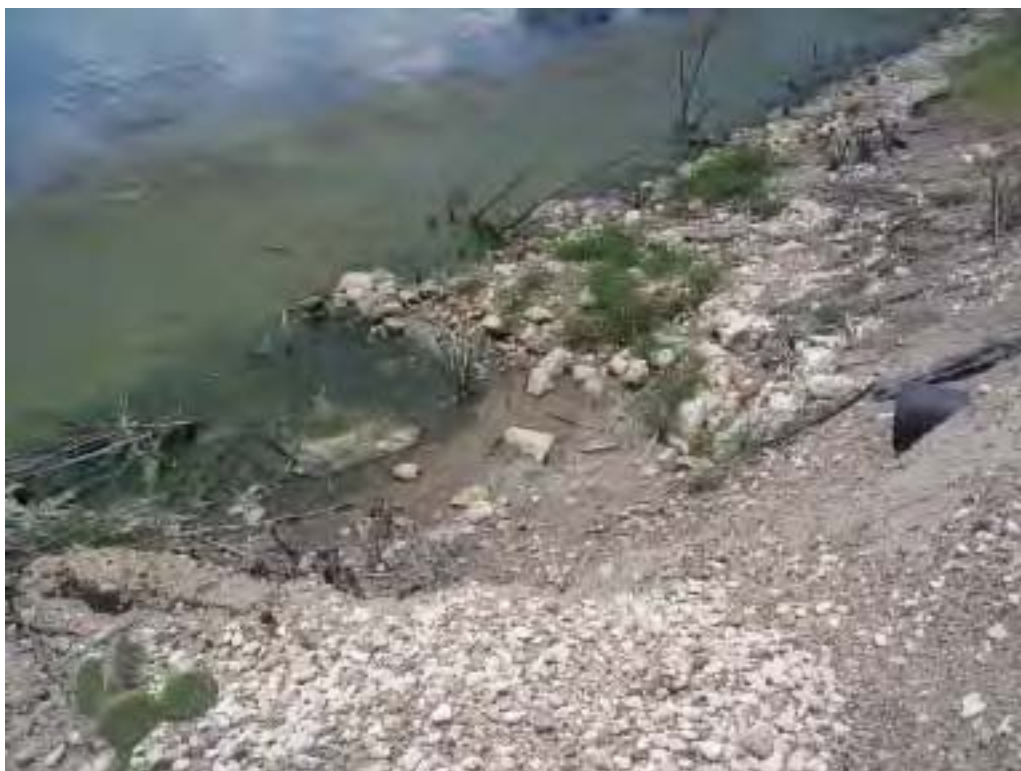
Photo No. 21: Reclaim Pond - East embankment interior slope, looking at abandoned 12-inch-diameter HDPE discharge pipe from the CADP. Note the embankment has been eroded at the discharge pipe.

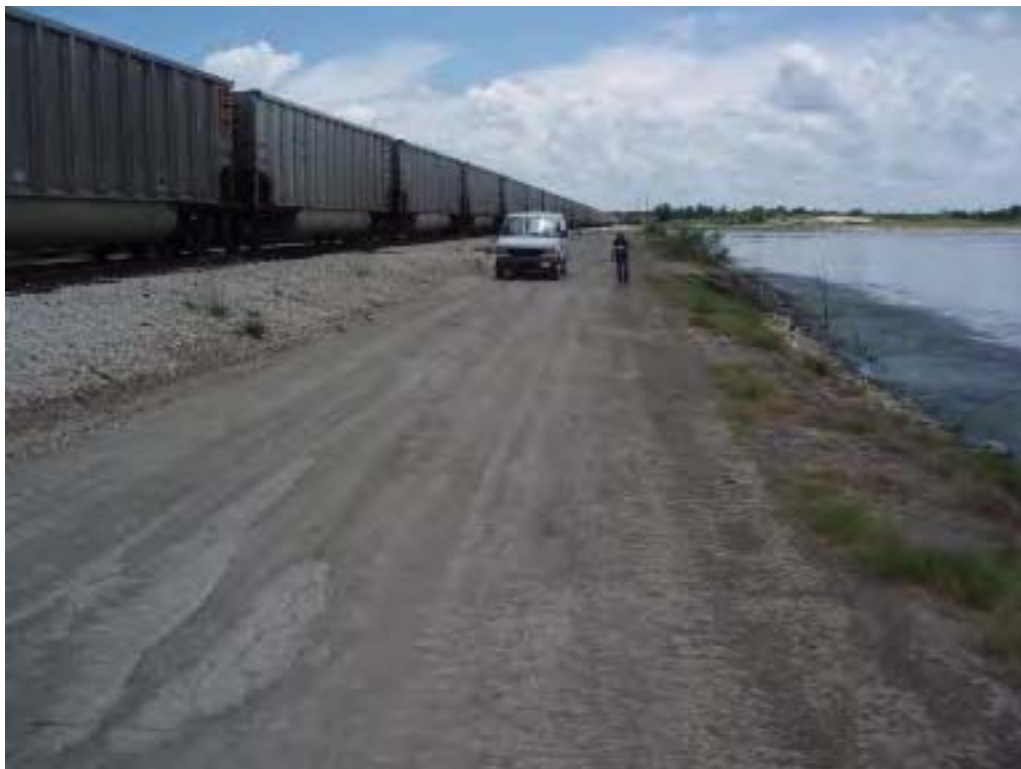
Photo No. 23: Reclaim Pond - East embankment crest, looking south.

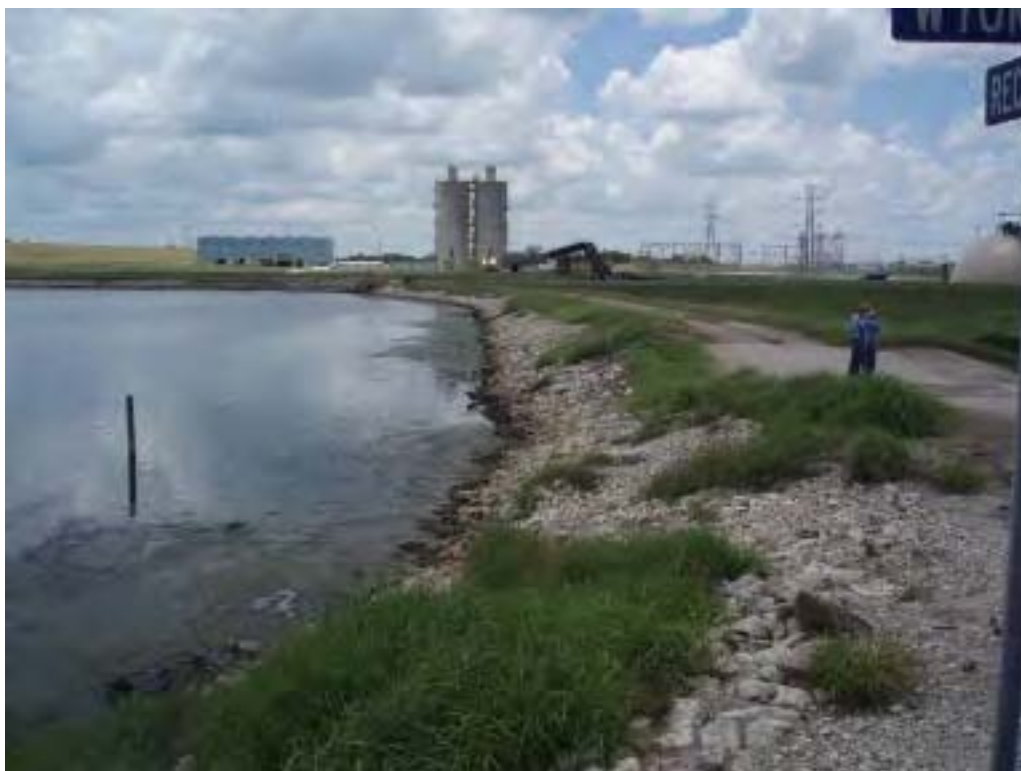
Photo No. 25: Reclaim Pond - North embankment interior slope, looking west.

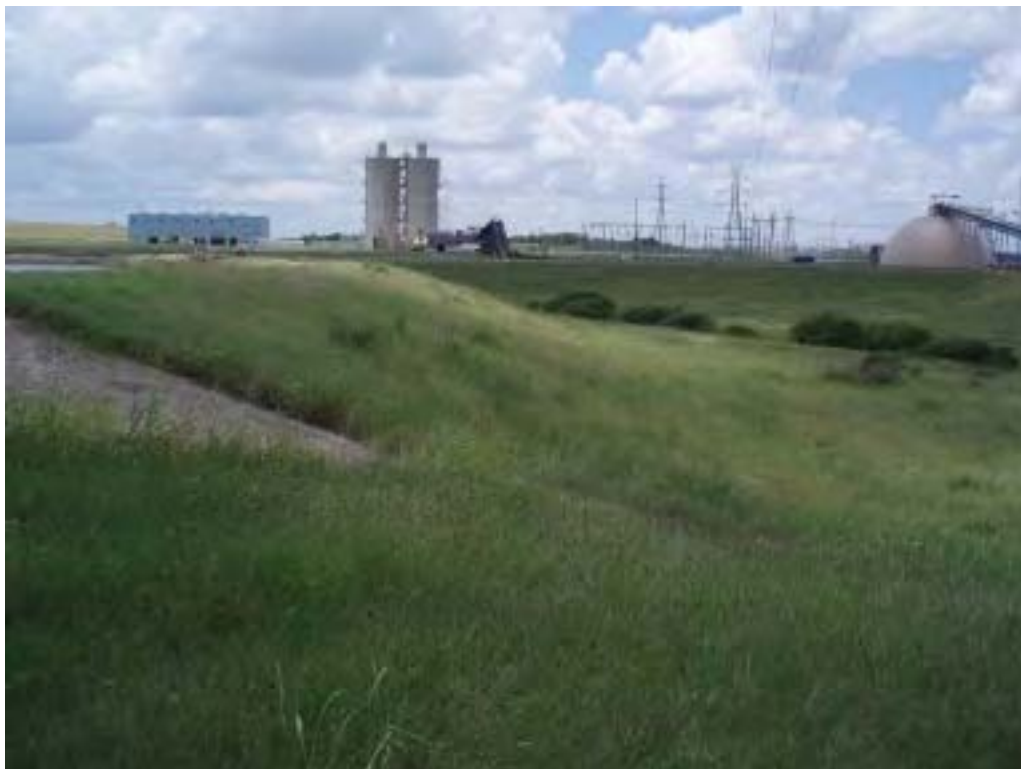
The exterior slope on the north appears to be in fair condition (Photos 2, 27, 34, 37, 38, 39, 40, 41, and 42). The grass on the north embankment ranged from 12 to 36 inches in height. Some minor brush and pricker bushes were observed on the slope. Brush and trees were observed at the toe of the slope in the drainage ditch. Desiccation cracks up to a ½ inch wide and 8 inches deep were observed at various locations on the embankment face.

Photo No. 27: Reclaim Pond - North embankment exterior slope, looking west.

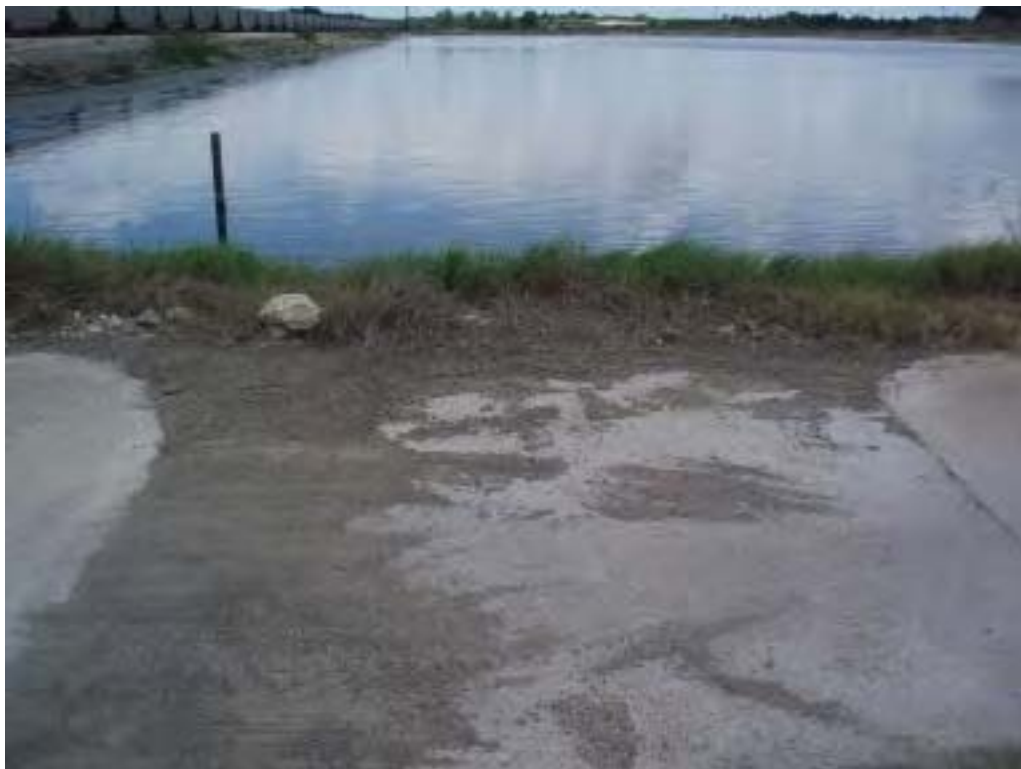
Photo No. 29: Reclaim Pond - North embankment, looking south at spillway channel entrance.

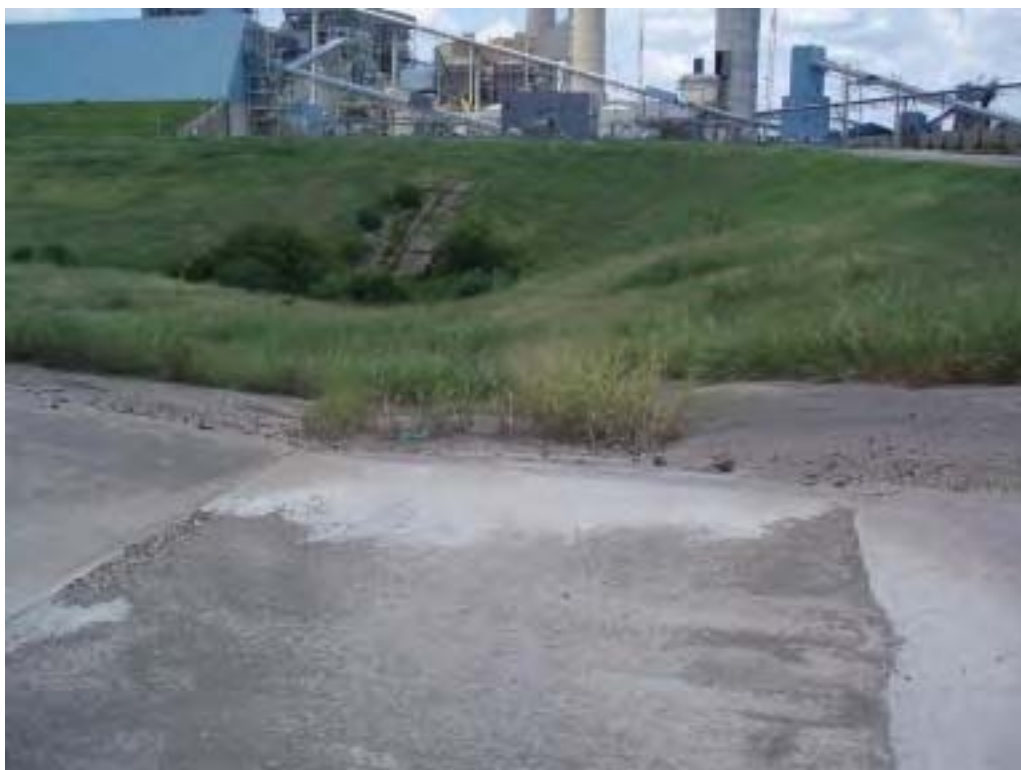
Photo No. 30: Reclaim Pond - North embankment, looking north at spillway discharge channel.

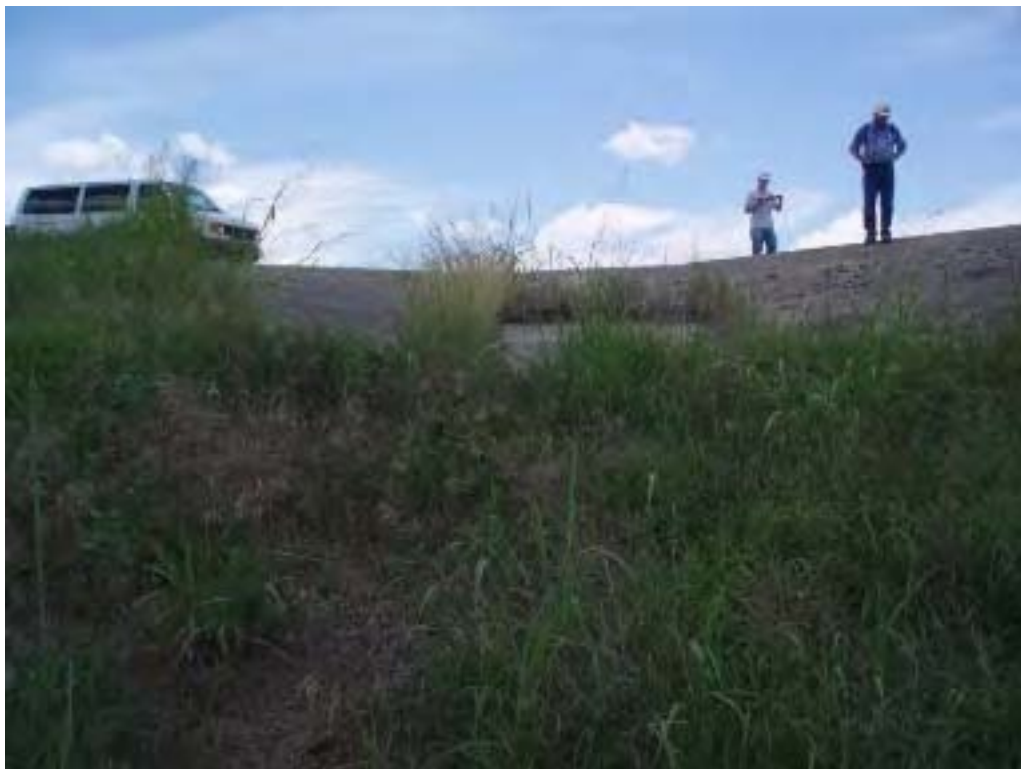
Photo No. 31: Reclaim Pond - North embankment exterior slope, looking south at spillway discharge channel.

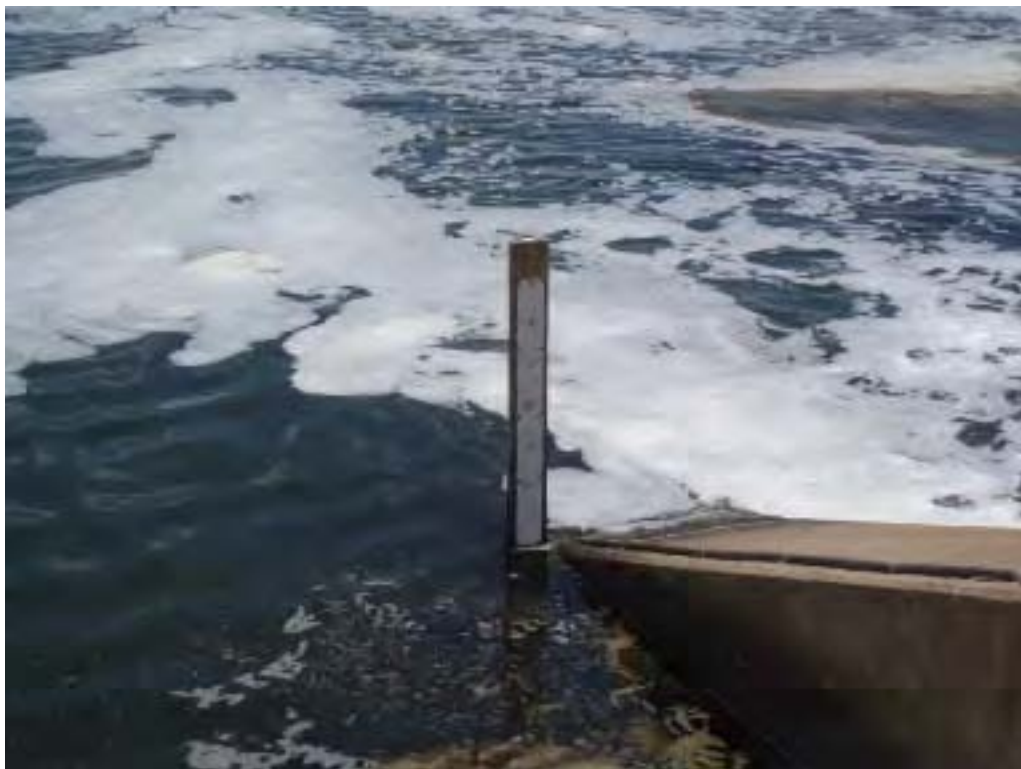
Photo No. 33: Reclaim Pond - North embankment interior slope, looking at staff gage at reclaim pump station

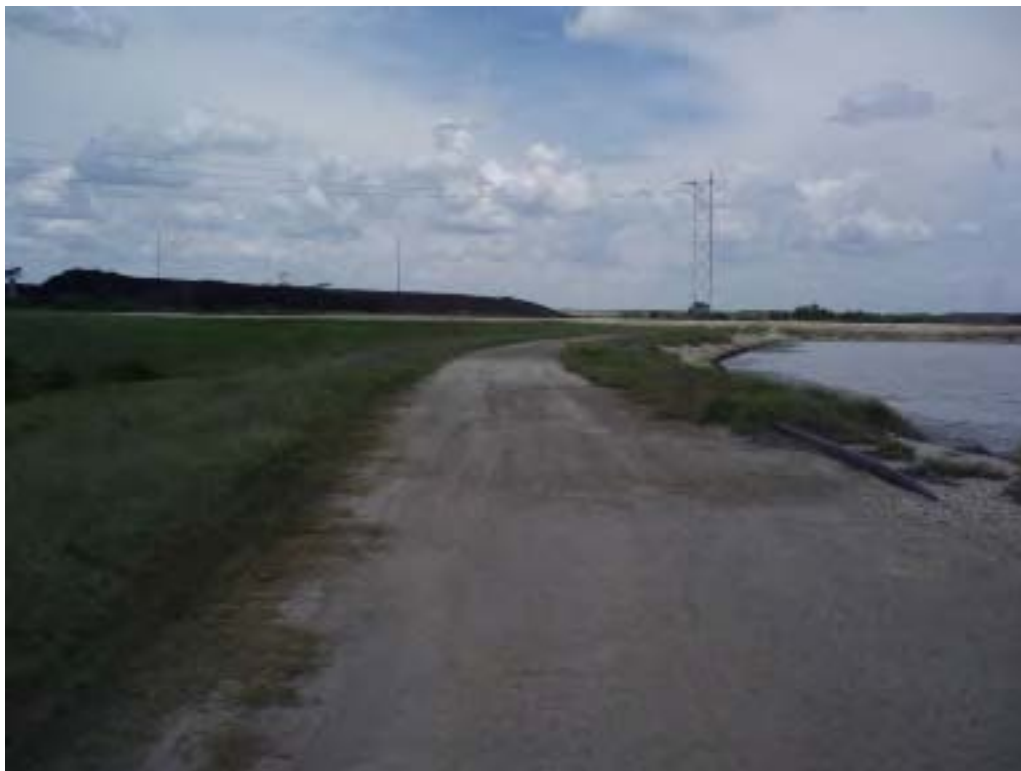
Photo No. 35: Reclaim Pond - North embankment crest, looking east.

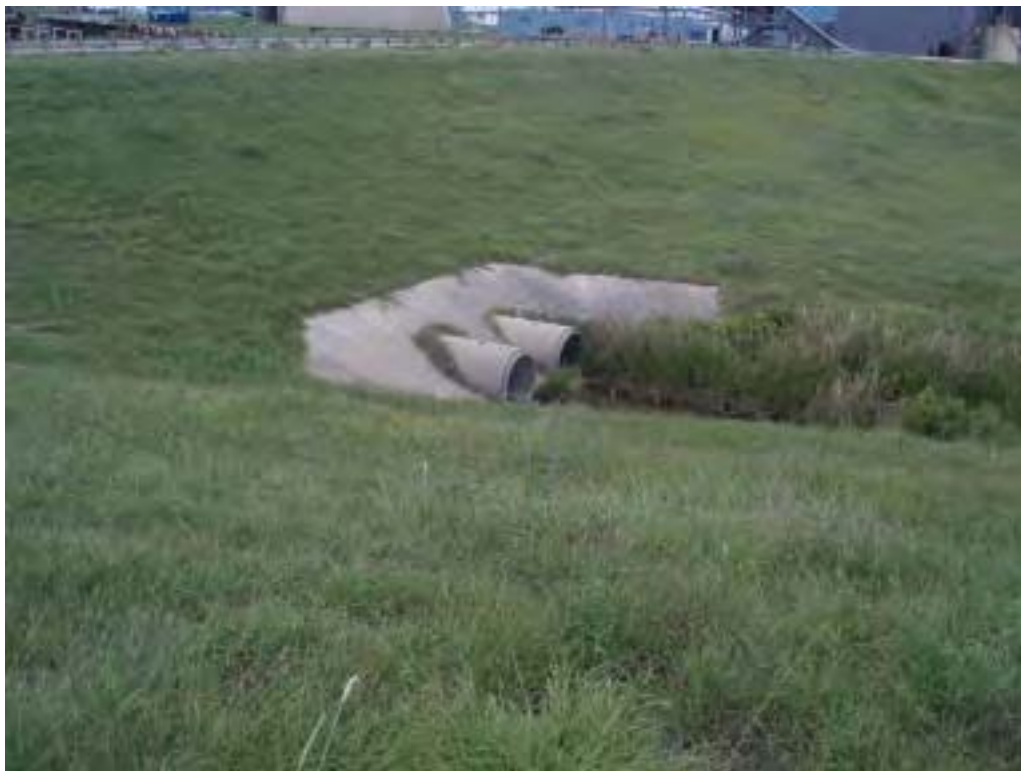
Photo No. 37: Reclaim Pond - North embankment exterior slope, looking north at two 8-foot-diameter drainage pipes at toe of slope.

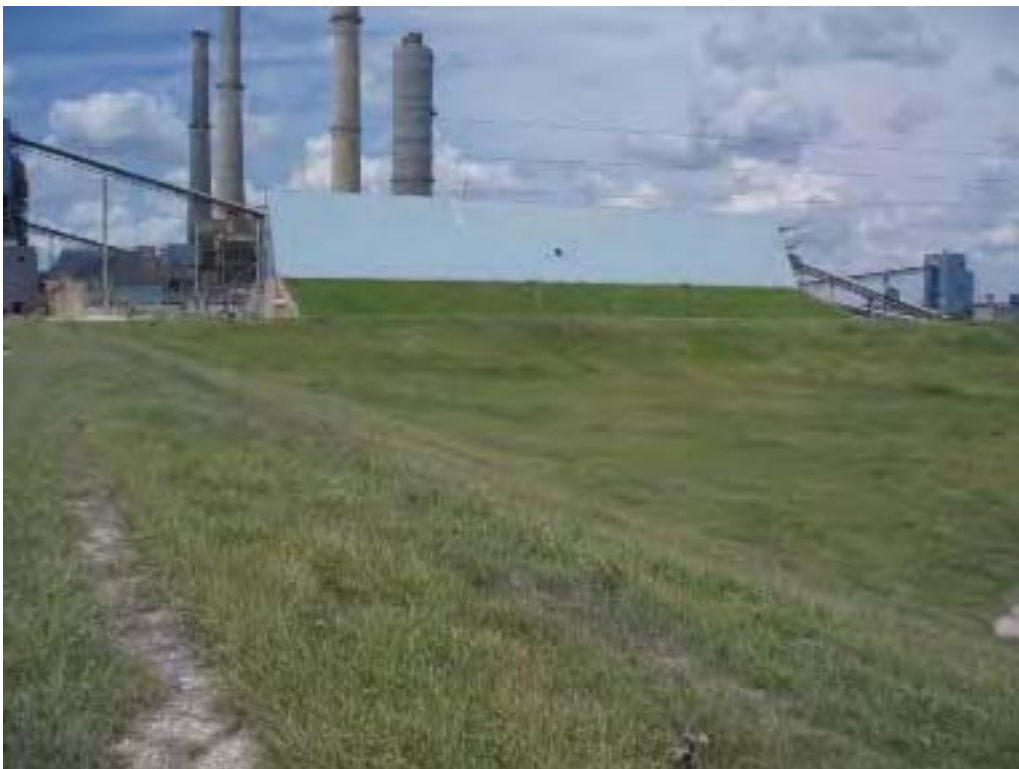
Photo No. 39: Reclaim Pond - Overview of north embankment downstream area, looking north.

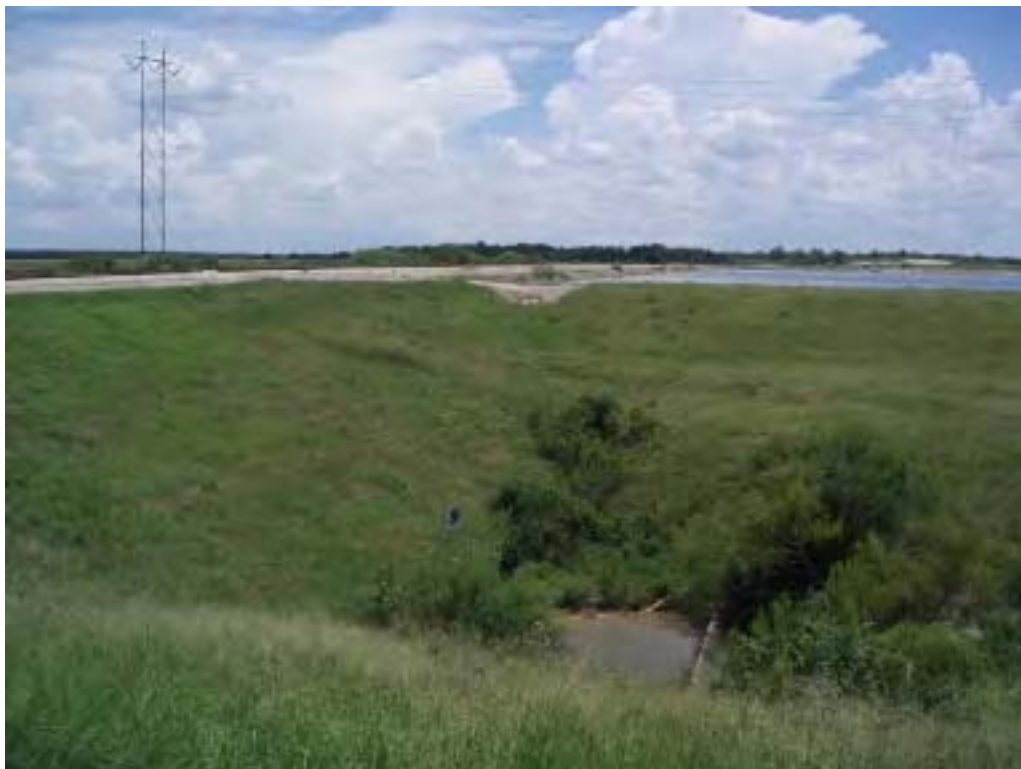
Photo No. 41: Reclaim Pond - Overview of north embankment spillway and railroad embankment, looking south. Note small trees growing at the toe in the drainage ditch.

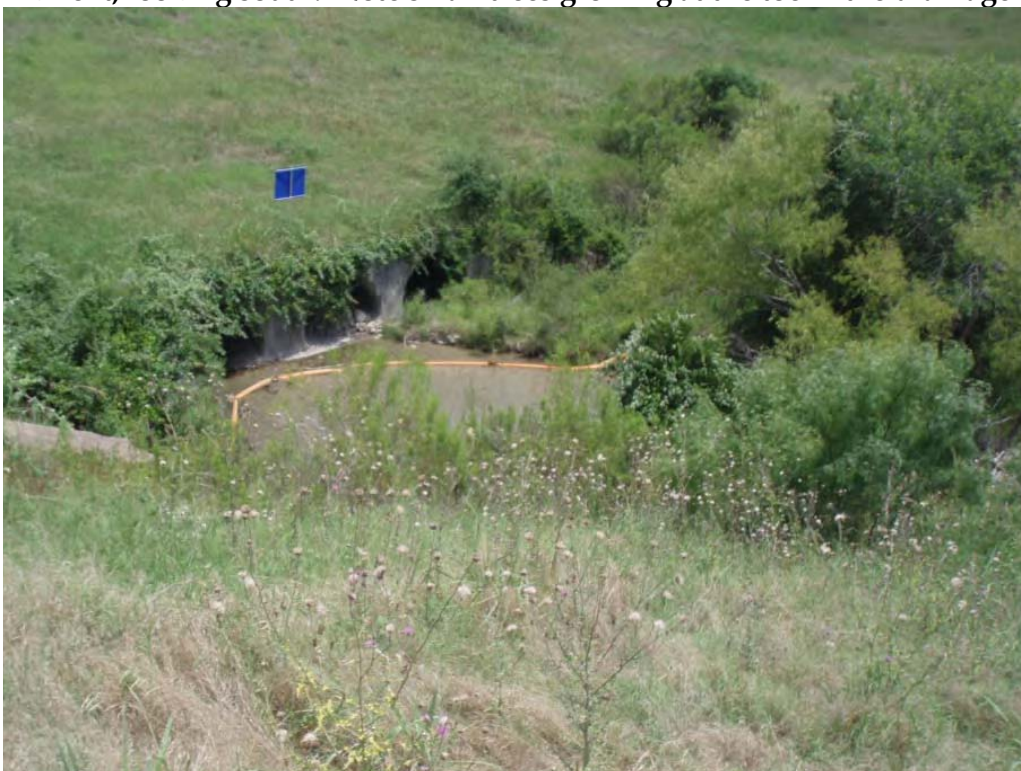
Photo No. 42: Reclaim Pond - Overview of triple arch culverts under railroad embankment. Note small trees and vegetation in the drainage ditch and debris in the arch culverts.

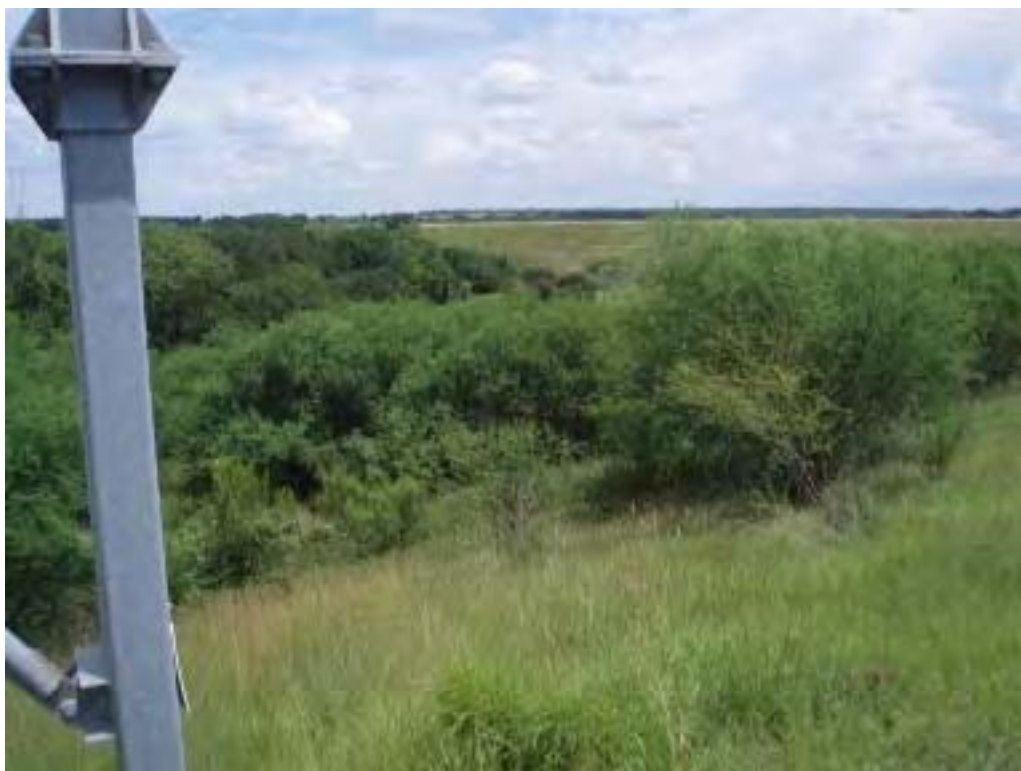
Photo No. 43: Reclaim Pond - East embankment downstream area, looking southeast.

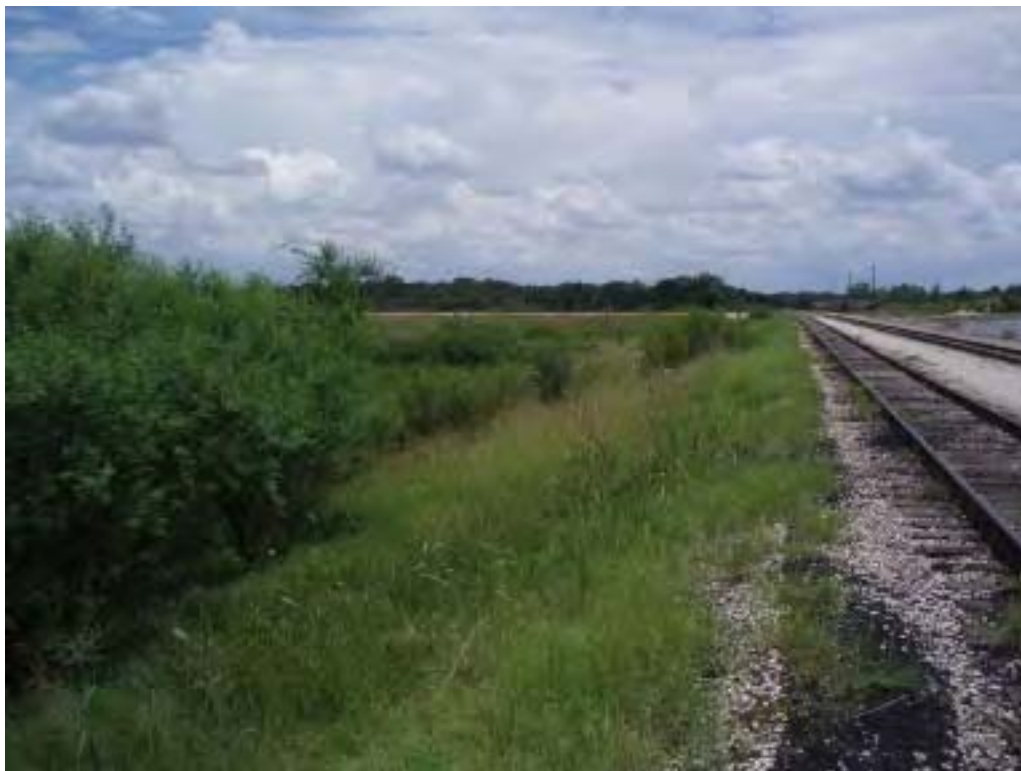
The exterior slope face on the east embankment is generally poor (Photos 43, 44, 46, 47, 48, 50, and 51). The grass on the east embankment ranged from 12 to 36 inches in height. Brush and mesquite trees as large as 30 inches in diameter were observed on the embankment. Desiccation cracks up to a ½ inch wide and 8 inches deep were observed at various locations on the embankment. A flyash surfaced access road was observed on the exterior slope of the embankment (Photos 48 and 50).

Photo No. 47: Reclaim Pond - East embankment exterior slope, looking south.

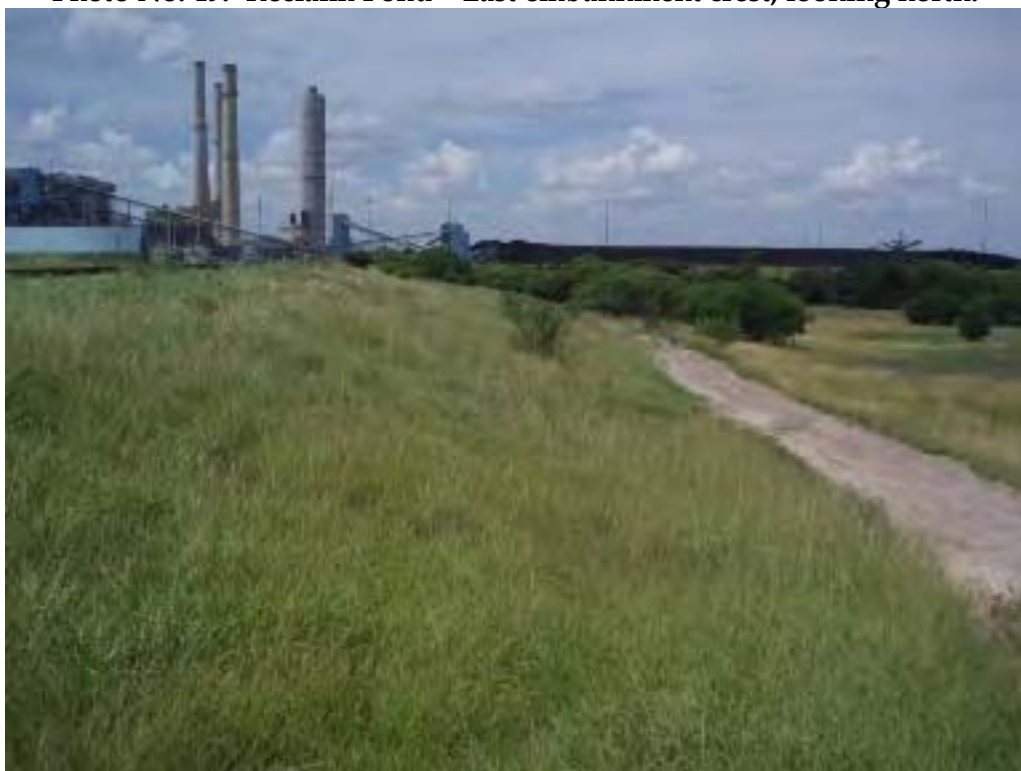
Photo No. 50: Reclaim Pond - East embankment exterior slope, looking north. Note access road to monitoring wells.

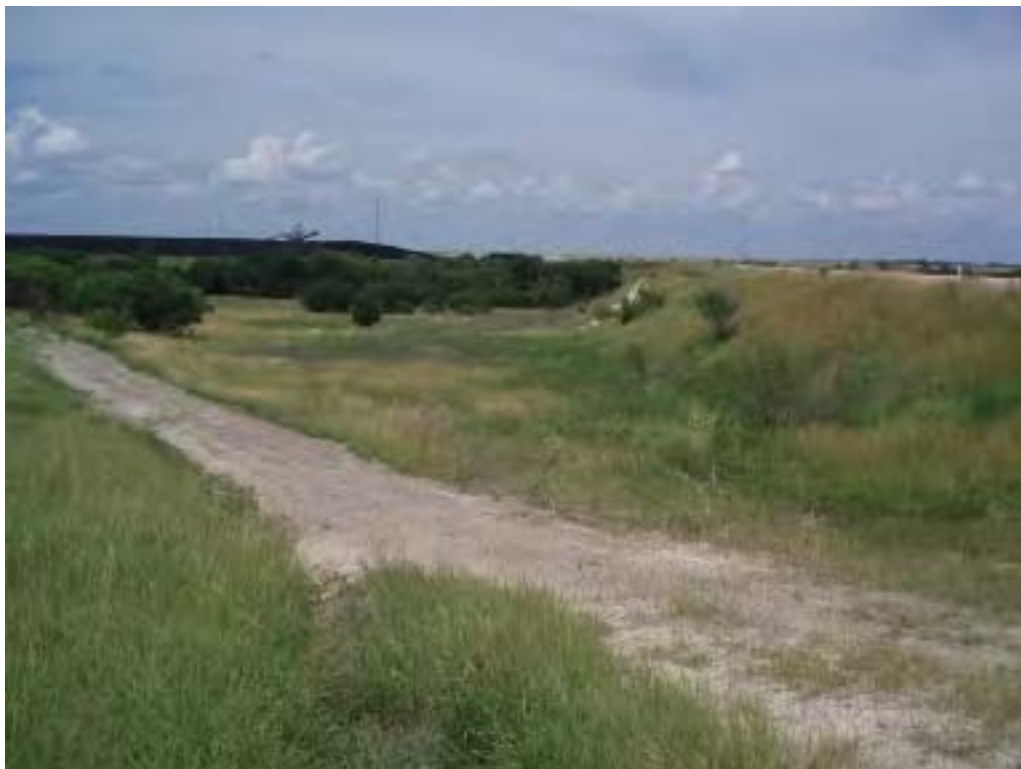
Photo No. 51: Reclaim Pond – Overview of east embankment downstream area. Note railroad embankment to the right side of photo.

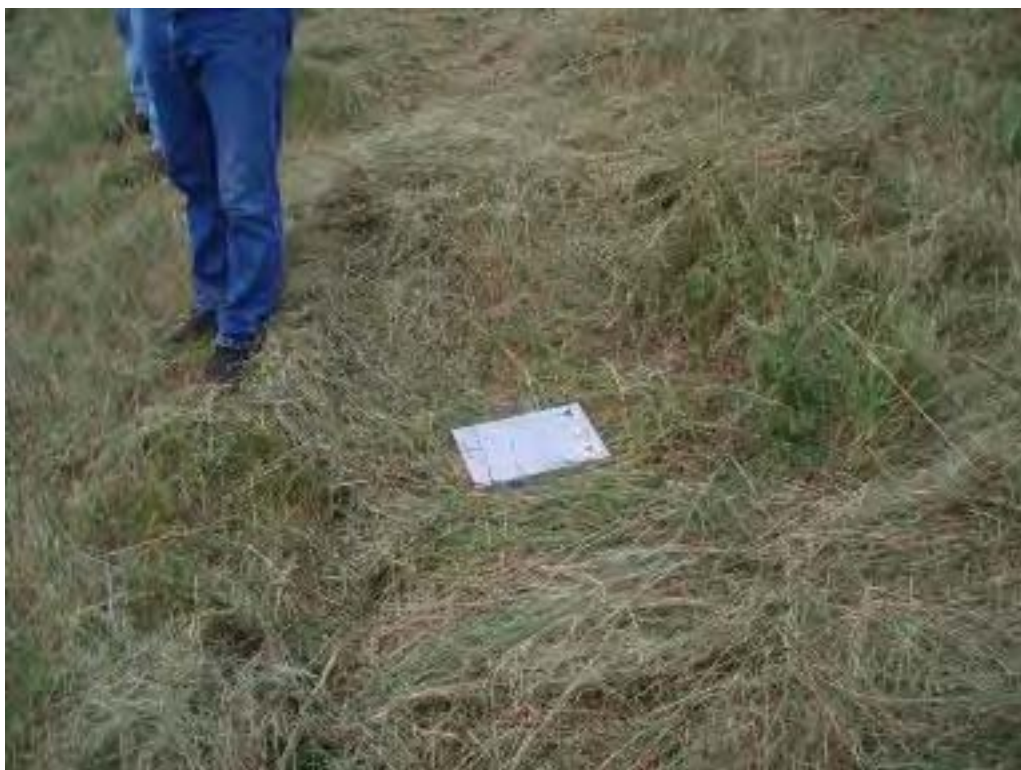
CDM observed 16 rodent holes, reportedly made by armadillo's, on the east embankment exterior slope. The holes ranged in size from 4 to 8 inches in diameter (Photos 63 and 65). There were also multiple surface depressions that were likely rodent holes that collapsed, possibly as a result of mowing operations (Photos 62, 79, 80, and 84).

Photo No. 62: CADP - East embankment exterior slope, looking at 3'Wx3'Lx1'D depression.
Possible collapsed rodent burrow.

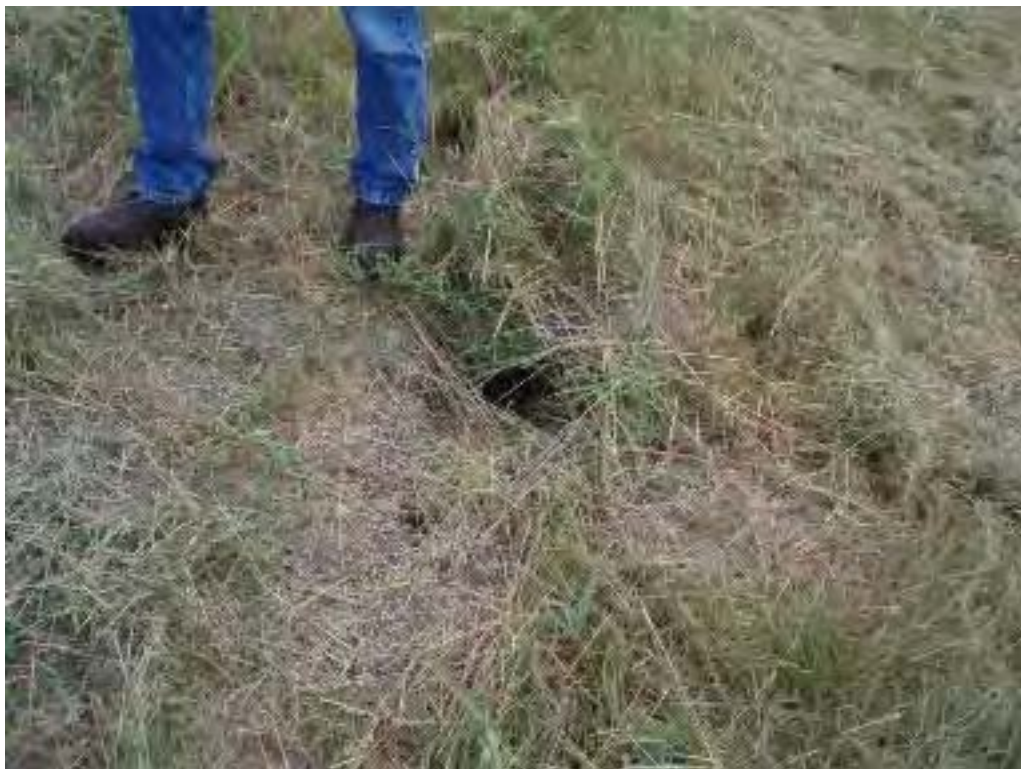
Photo No. 63: CADP - East embankment exterior slope, looking at a 6-inch-diameter rodent hole.

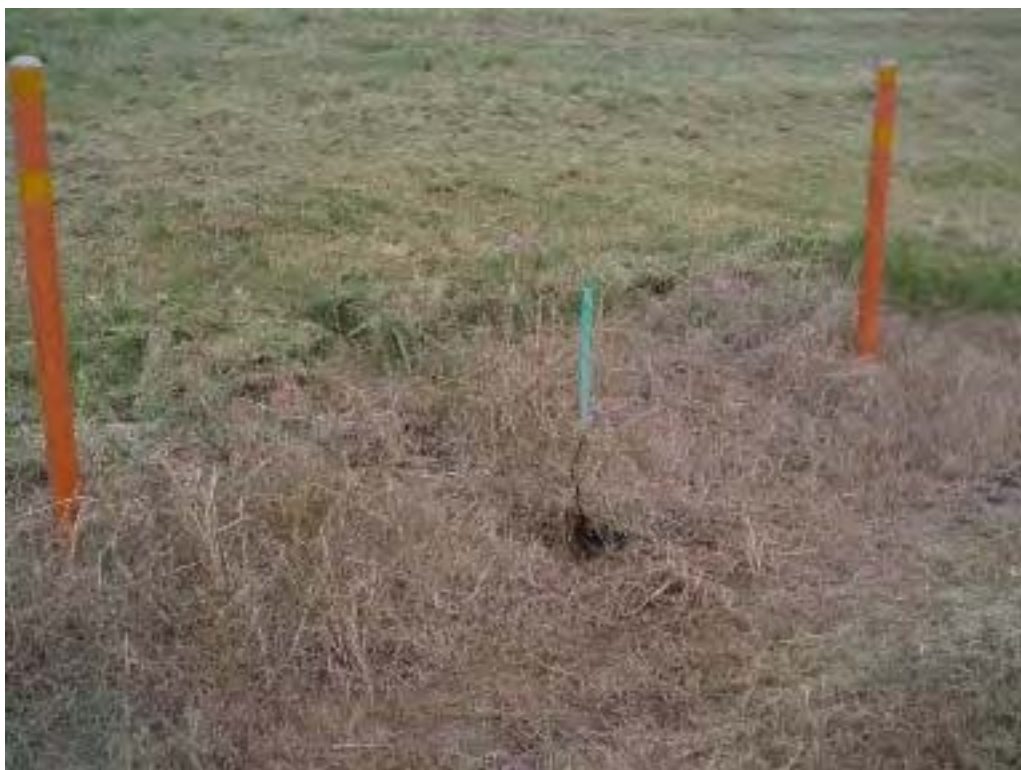
Two of the toe drain outlets from the chimney drain on the east embankment were observed (Photos 64 and 66). One of the toe drain outlets discharges into a seepage collection sump pit. The sump pit pumps water back up into the impoundment.

Photo No. 64: CADP - East embankment exterior slope, looking at toe drain outlet.

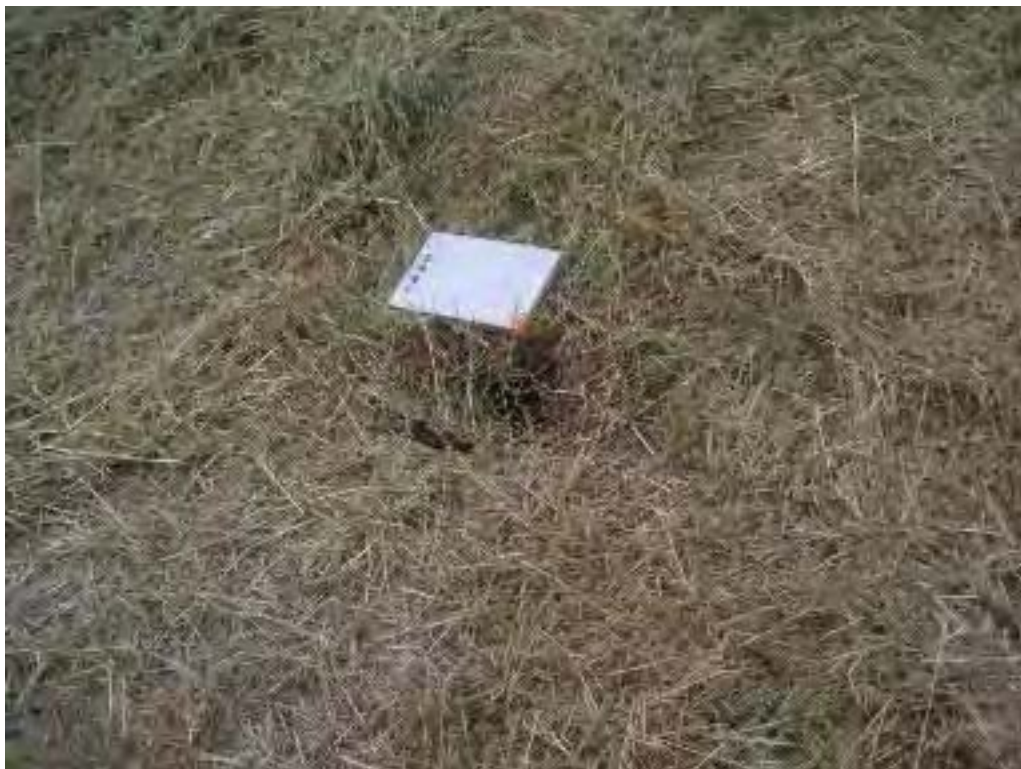
Photo No. 65: CADP - East embankment exterior slope, looking at an 8-inch-diameter rodent hole.
