Assessment of Dam Safety of Coal Combustion Surface Impoundments

Sam Seymour - Fayette Power Project Station

Lower Colorado River Authority

Draft Report

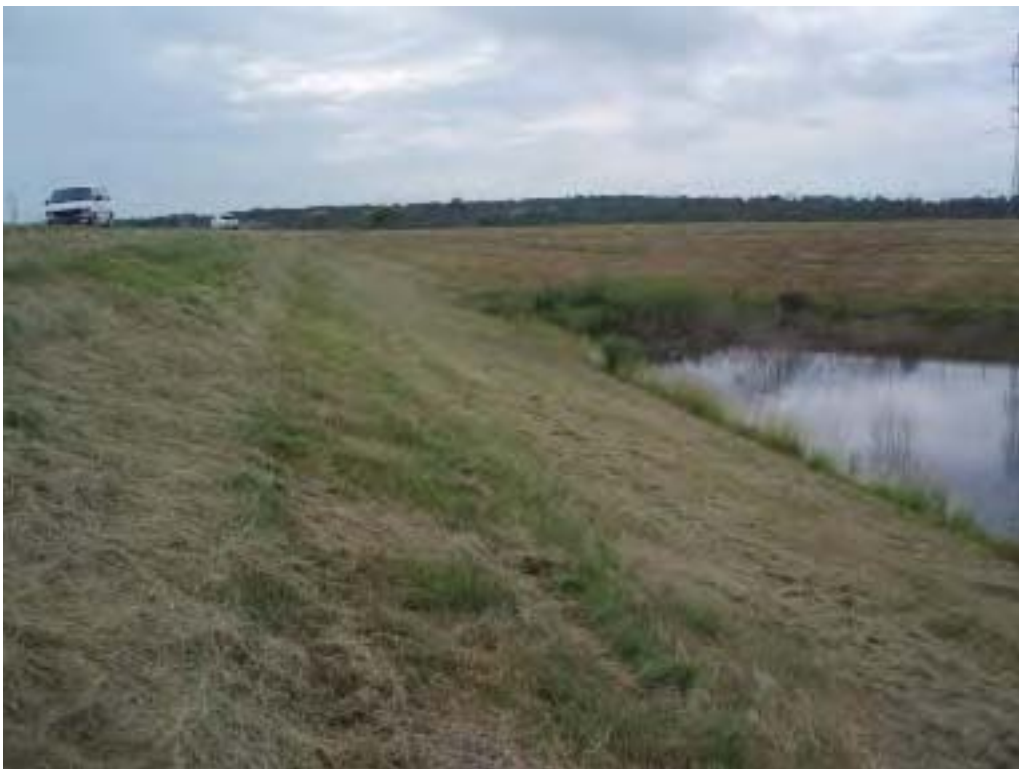
Photo No. 77: CADP - South embankment exterior slope, looking east at groin with Coal Pile Run-off Pond. Note water, brush and small trees at toe of slope.

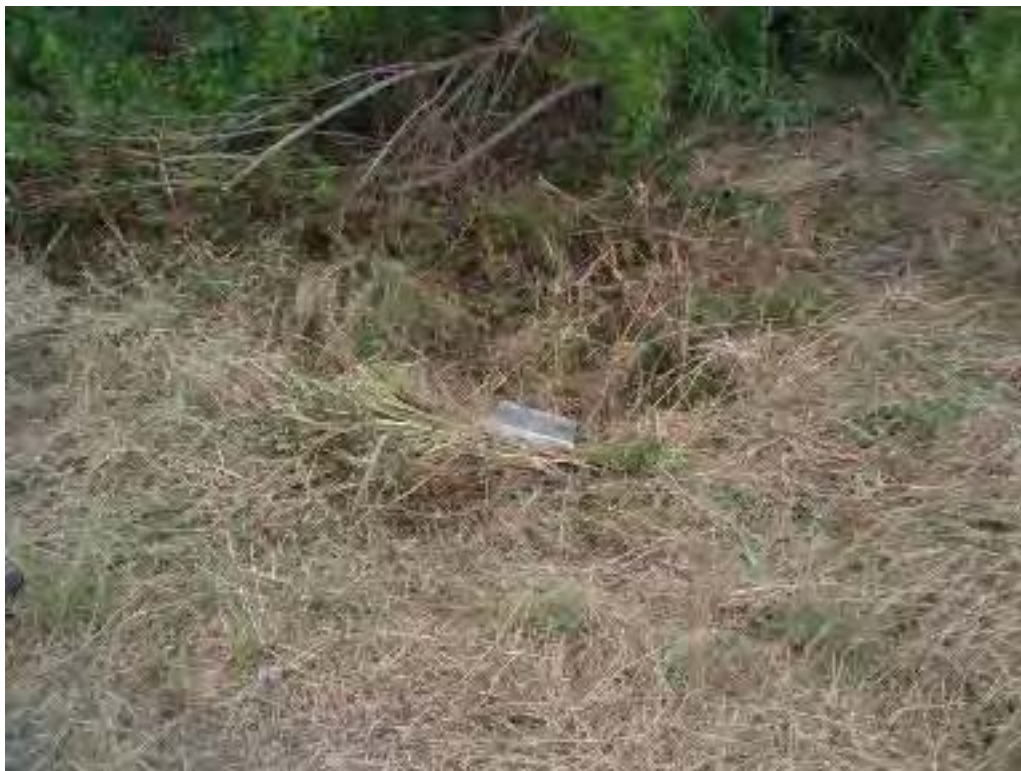
CDM observed 16 rodent holes, reportedly made by armadillo's, on the east embankment exterior slope. The holes ranged in size from 4 to 8 inches in diameter (Photos 63 and 65). There were also multiple surface depressions that were likely rodent holes that collapsed, possibly as a result of mowing operations (Photos 62, 79, 80, and 84).

Photo No. 79: CADP - South embankment exterior slope, looking at 3'Wx4'Lx2'D depression at toe of slope. Possible collapsed rodent burrow

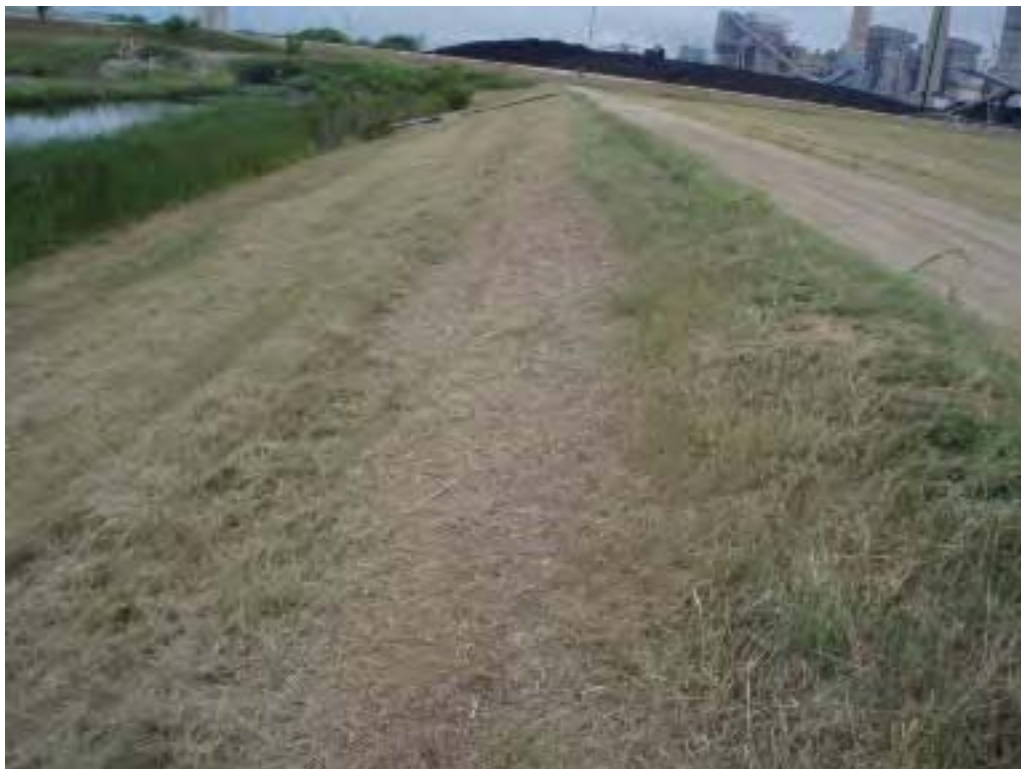
The CADP is incised on the north and west embankments. The south and east exterior slopes appear to be generally in fair condition (Photos 53, 54, 55, 57, 58, 60, 61, 62, 67, 68, 69, 71, 73, 74, 77, 78, and 85). The grass on the embankment was approximately 8 to 12 inches tall and was recently mowed. Trees and brush up to 6 inches in diameter were observed at the toe of the south embankment in the Coal Ash Pile Run-off Pond. There were some bare spots near the middle of the south embankment exterior slope (Photo 81).

Photo No. 81: CADP - South embankment exterior slope, looking west. Note sparse vegetation near crest.

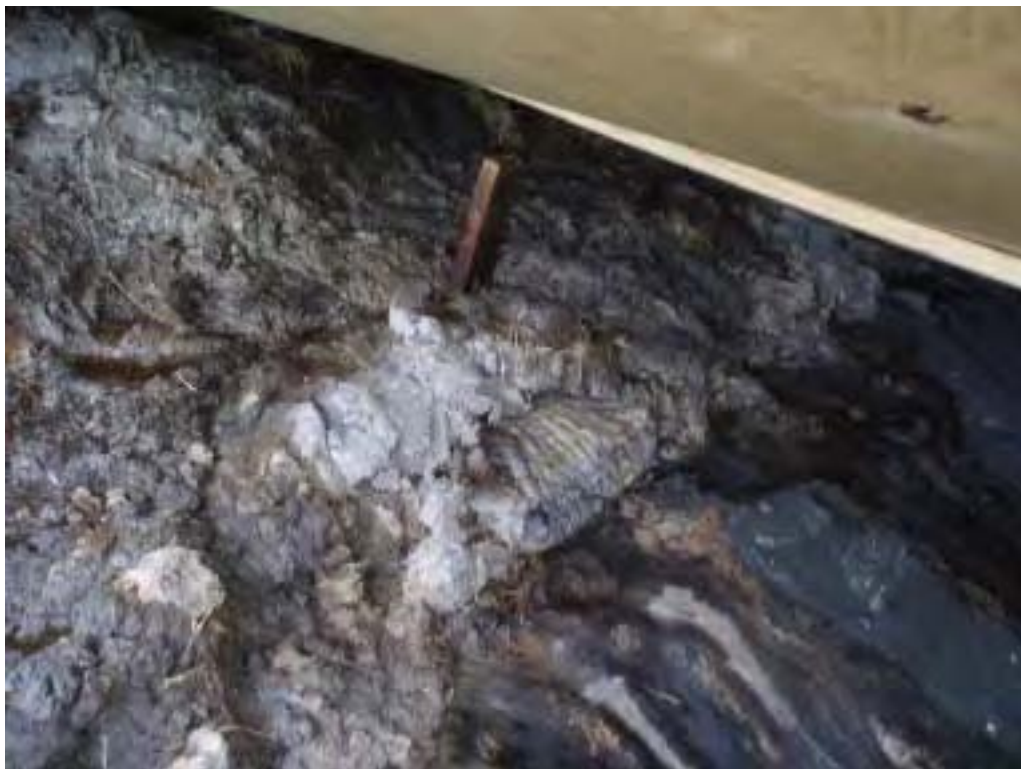
Photo No. 83: CADP - South embankment exterior slope, looking at seep. Note liner down slope of seep to collect water. Flow ~8 gallons per day.

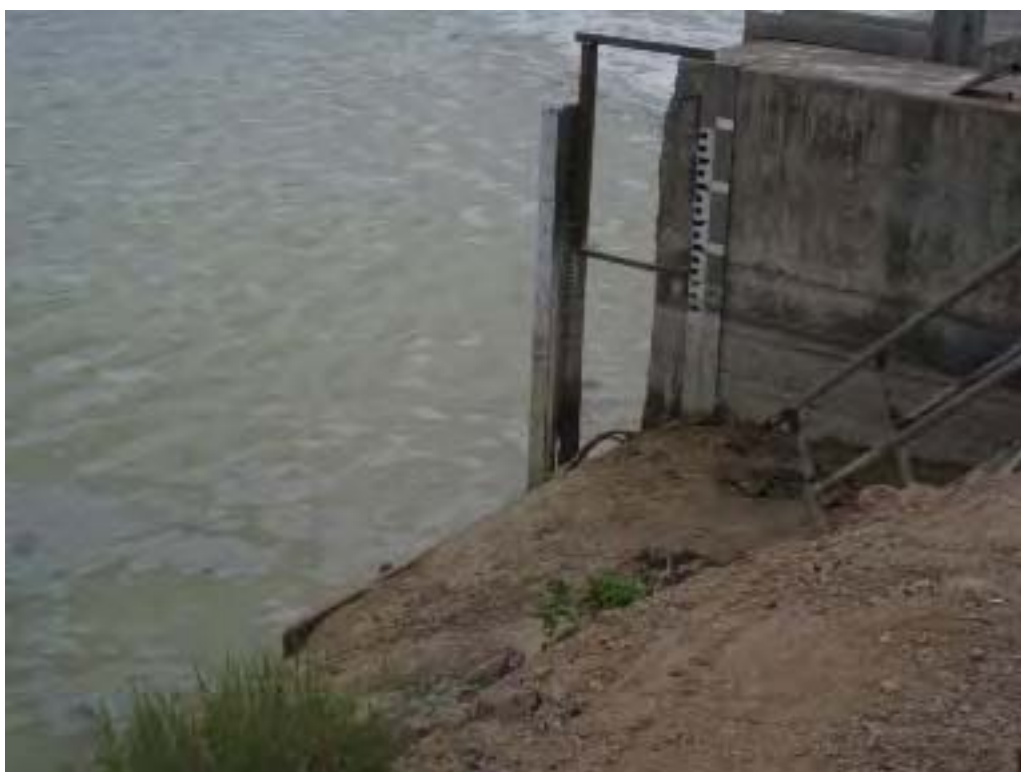
On the northwest corner of the intake structure there are two manual staff gages in the CADP (Photos 92 and 93). The pond water levels are recorded twice a day and reported in a daily status report that is electronically mailed to pertinent staff.

Photo No. 92: CADP - West embankment interior slope, looking at staff gage on intake structure.

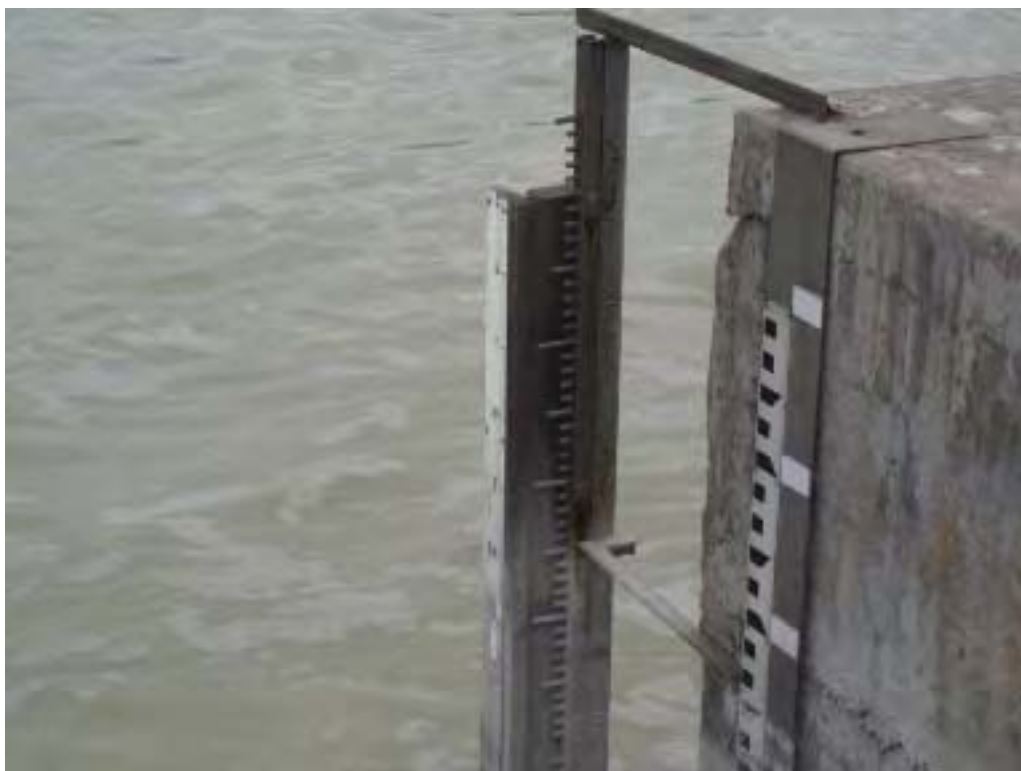
Photo No. 93: CADP - West embankment interior slope, close up of staff gage on intake structure.
