**Coal Combustion Residue Impoundment**

**Round 12 - Dam Assessment Report**

*Martin Lake Steam Electric Plant*

**Tatum, Texas**

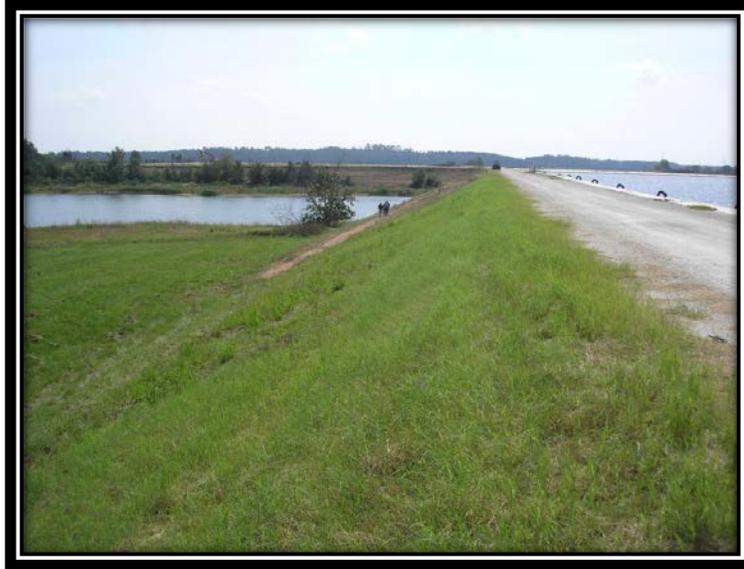
Figure 5.2.1-2 Ash Disposal Pond East cell Dike. Lake Martin is shown to the left of the dike.

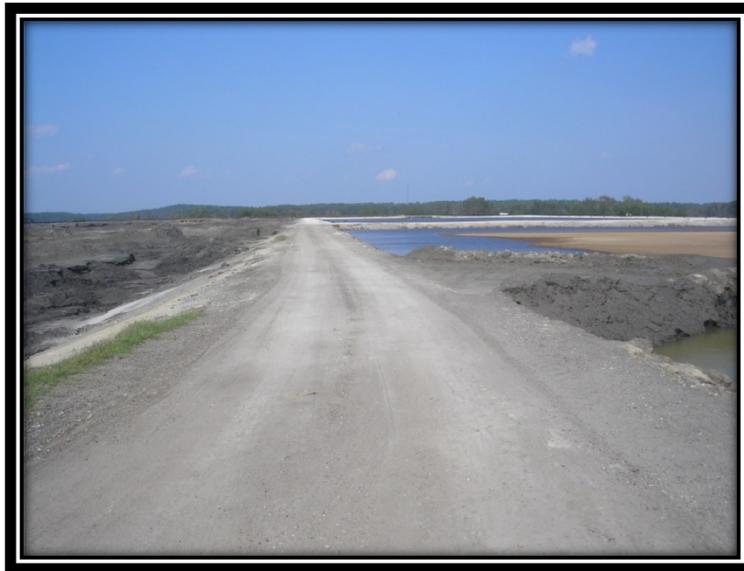
Figure 5.2.1-3 West-East Ash Disposal Pond interior dike.

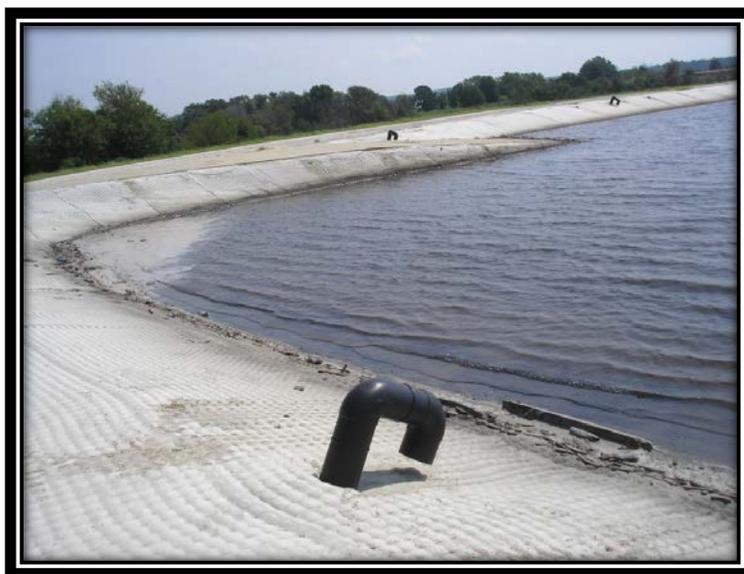
The interior slopes appear stable and maintained. There were no observed scarps, sloughs, bulging, cracks, depressions or other indications of slope instability. Figures 5.2.2-1 and 5.2.2-2 show representative sections of the embankment.

Figure 5.2.2-2 East cell interior slope.

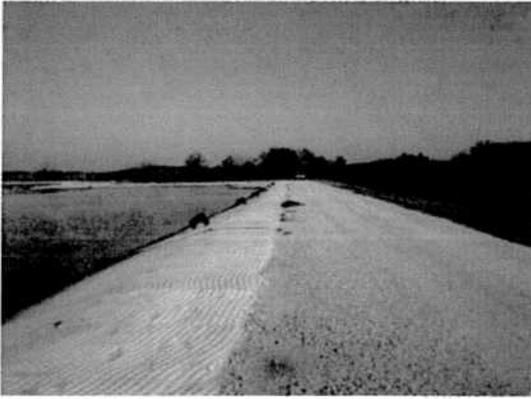
The concrete revetment matting on the interior of the impoundment was in good condition. No cracks, bulges or slides were observed (Figure 3). The crest of the berm was in good condition with occasional patches of minor rutting from vehicular traffic. The exterior side of the berm was well vegetated and there was no evidence of sloughing, major erosion rills or seepage (Figure 4).

**Figure 3: Upstream Slope of Berm and Crest**

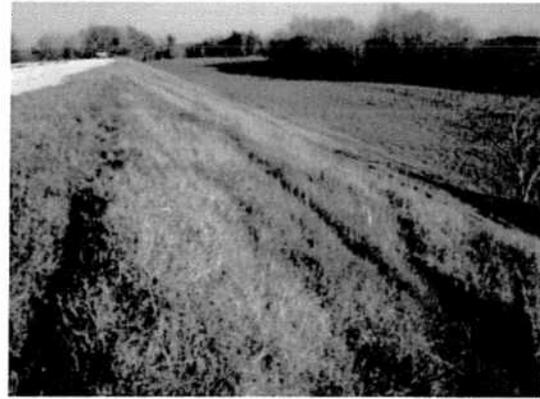
**Figure 4: Downstream Slope of Berm**

Recommendation 1: Continued mowing of grass and vegetation around the downstream side of the impoundment and control of vegetation growing on the crest of the embankment.

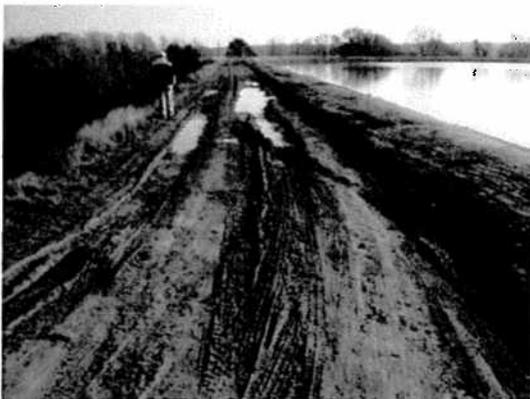
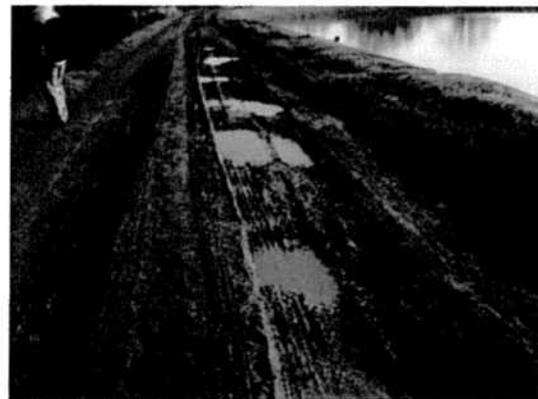
MODERATE ITEM: The crest of the impoundment had areas with rutting from vehicular traffic (Figures 5 and 6) in localized areas around the entire pond.

**Figure 5: Crest Rutting North Side**

**Figure 6: Crest Rutting North Side**

Recommendation 1: Repair damaged areas and grade to drain.

Recommendation 2: Discourage vehicular traffic from driving on impoundment crests after storm events.

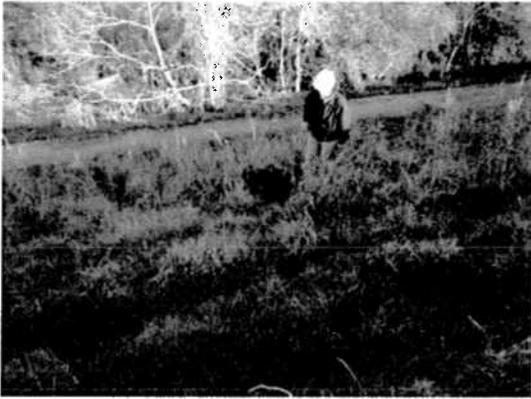
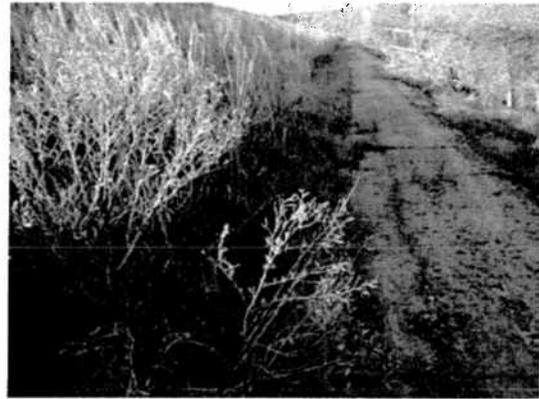
MODERATE ITEM: In general, the downstream side of the impoundment was well vegetated. There were two locations identified with large bushes that should be removed (Figures 8 and 9).

**Figure 8: Bush on Downstream Slope**

**Figure 9: Bush on Downstream Slope**

Recommendation 1: Mow grass to remove bushes.

Recommendation 2: Apply herbicide to bushes.

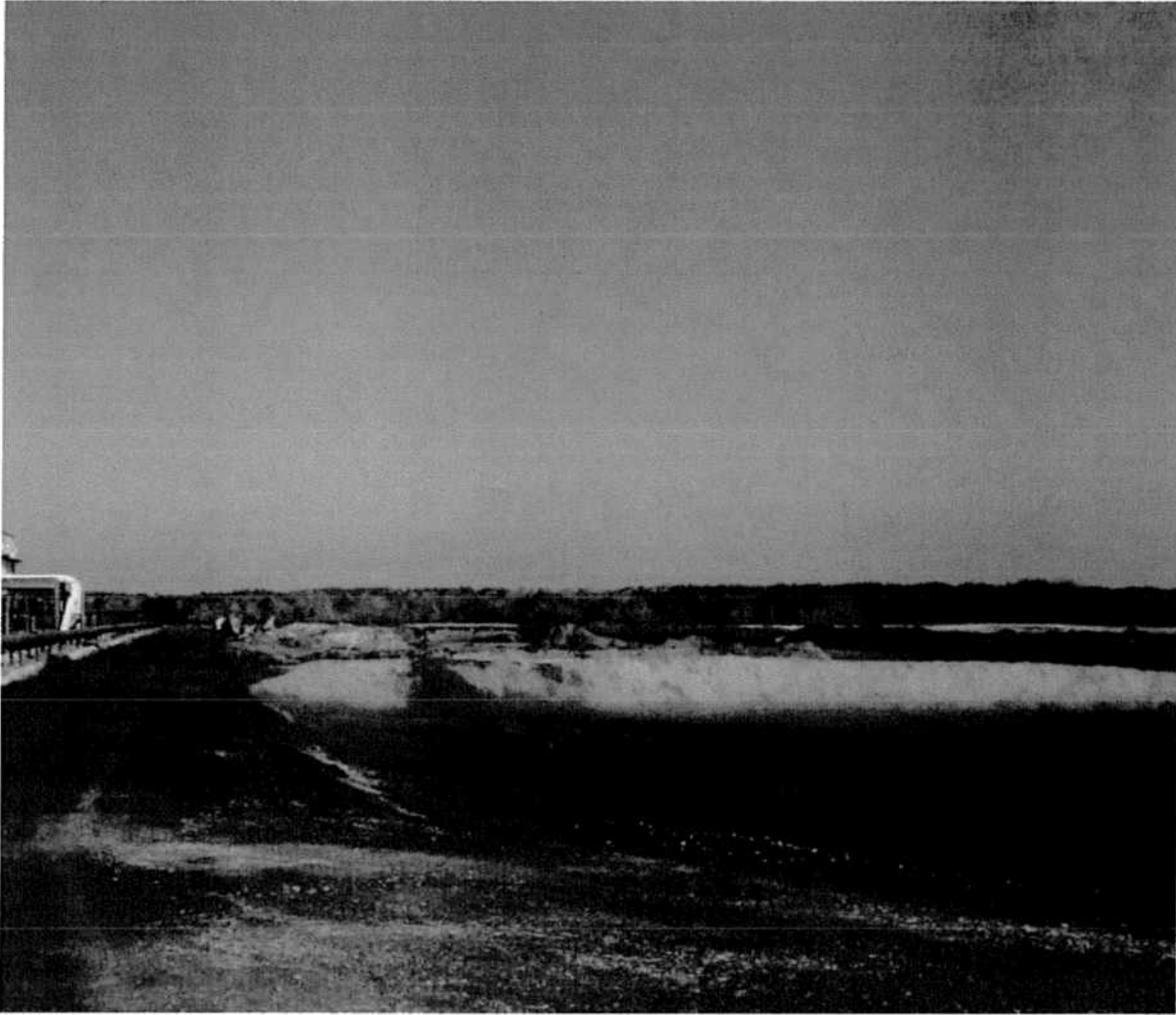
The West Bottom Ash Pond has 14.6 surface acres at full capacity (zero freeboard) of 75.8 million gallons. The elevation of the top of the dike is 330 feet with a freeboard of 2 feet 6 inches. At the time of this inspection, the pond was partially drained and ash material was being excavated from the site (Figure 12).

**Figure 12: Partially Drained and Excavated West Bottom Ash Pond**

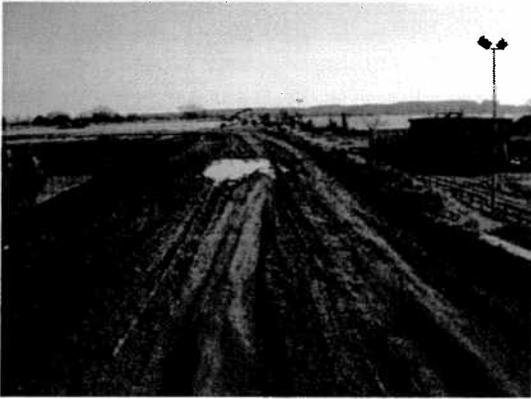
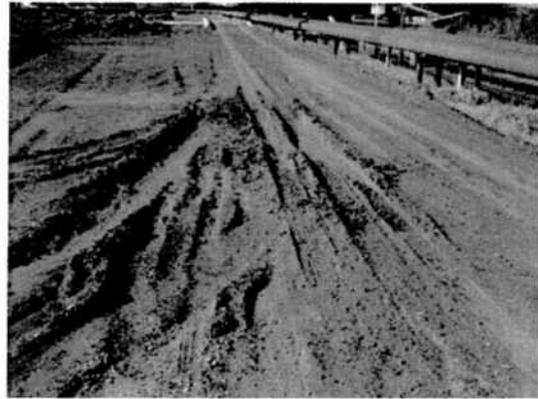
MODERATE ITEM: The crest of the impoundment had areas with moderate rutting from vehicular traffic (Figure 13 and 14) in localized areas around the pond.

**Figure 13: Rutting in Crest from Vehicular Traffic**

**Figure 14: Rutting in Crest**

Recommendation 1: Repair damaged areas and grade to drain.

Recommendation 2: Discourage vehicular traffic from driving on impoundment crests after storm events.

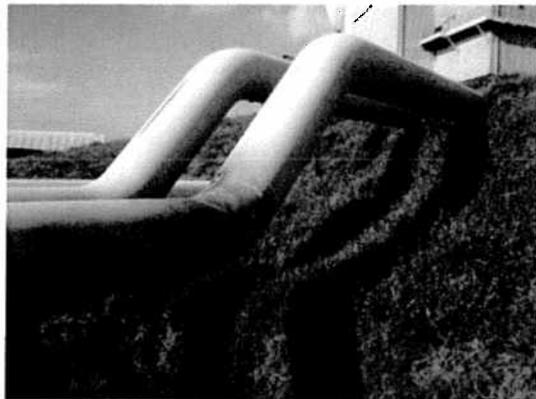
MODERATE ITEM: In general, the downstream side of the impoundment was well vegetated. There was an area at the southwest corner of the pond that appeared to be either a berm slide or erosion washout from the high volume pipes (Figure 15 and 16).

**Figure 15: Possible Erosion or Berm Slide**

**Figure 16: Possible Erosion or Berm Slide**

Recommendation 1: Backfill to original slopes with compacted cohesive soil and reestablish vegetation.

Recommendation 2: Continued monitoring of this area for evidence of berm bulges or seepage at toe of berm.

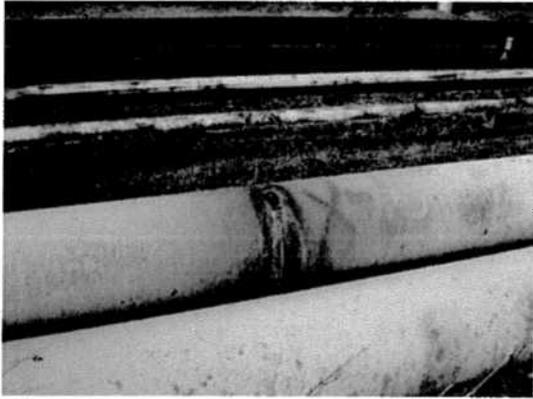
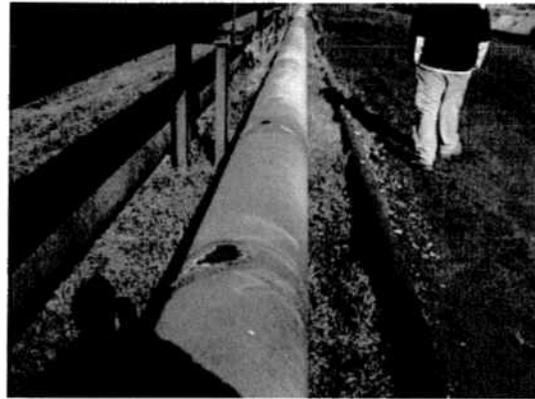
MINOR ITEM: Numerous areas along the eastern outside perimeter of the pond had leaking/seeping pipes (Figures 17 and 18). Each of these leaks has been identified by Martin Lake operations personnel with an alphanumeric code (i.e. X-15) and are being monitored until repairs can be made.

**Figure 17: Typical Pipe Seepage/Leak**

**Figure 18: Typical Pipe Seepage/Leak**

Recommendation 1: Continue monitoring seepage leaks until repairs are complete.

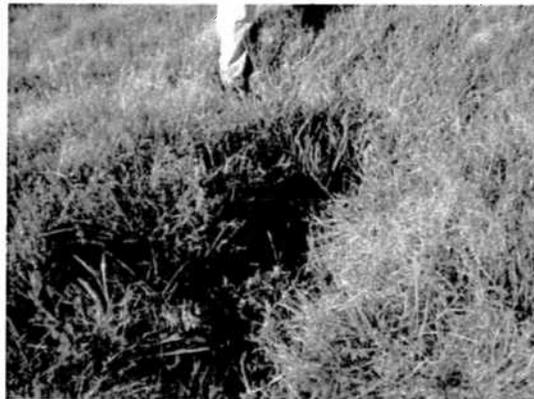
MODERATE ITEM: Evidence of erosion was found along the downstream side of the northern berm (Figures 19 and 20).

**Figure 19: Berm Erosion**

**Figure 20: Berm Erosion**

Recommendation 1: Backfill with compacted cohesive soil and reestablish vegetation.

Recommendation 2: Continue to monitor after repairs are complete.

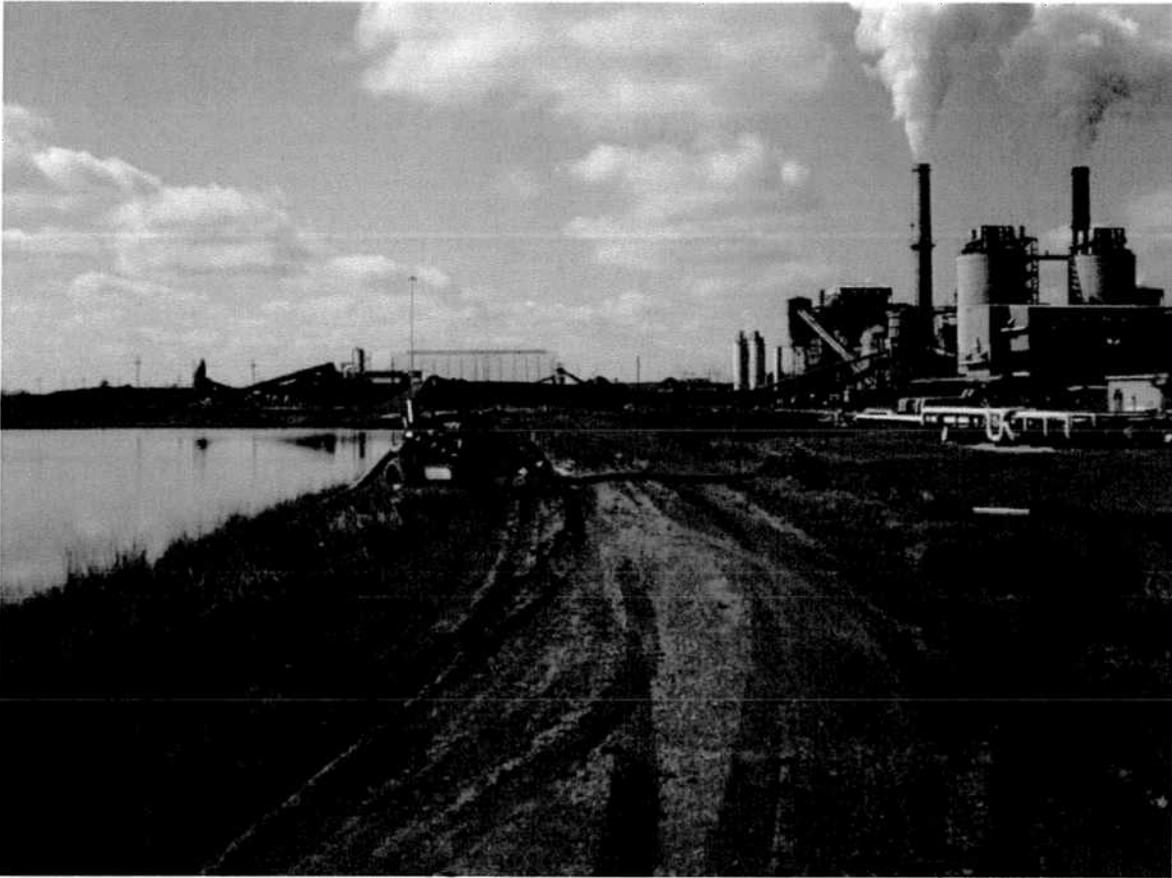
At the time of inspection, the level of the pond was being decreased through the use of a portable pump (Figure 22). The water was being pumped from this pond to one of the storm water catch basins at the base of this pond. Water was then being pumped from the catch basin to the Emergency Sludge Pond.

**Figure 22: Portable Pump Removing Water from Storm Water Pond**

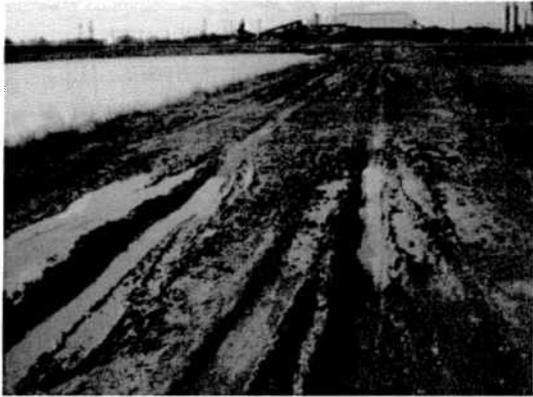
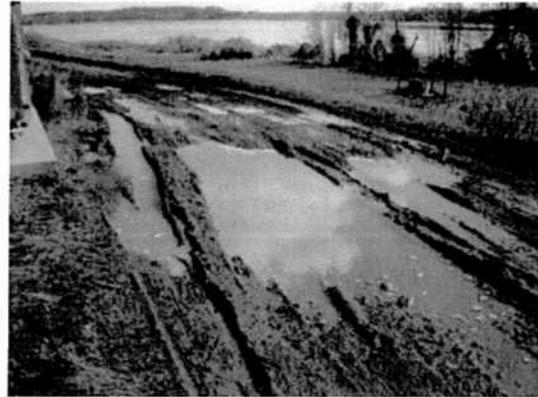
MODERATE ITEM: The crest of the impoundment had areas with moderate rutting from vehicular traffic (Figure 23 and 24) in localized areas around the pond.

**Figure 23: Crest Rutting from Vehicular Traffic**

**Figure 24: Crest Rutting**

Recommendation 1: Repair damaged areas and grade to drain.

Recommendation 2: Discourage vehicular traffic from driving on impoundment crests after storm events.

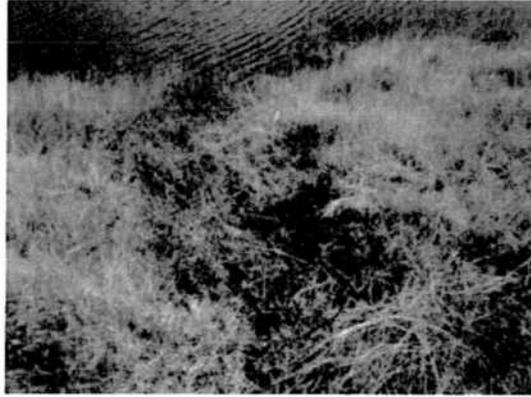
MODERATE ITEM: In general, the upstream side of the impoundment was in good condition and well vegetated. There was an occasional erosion gully (Figure 26) from storm water impacting the protective cover of the pond.

**Figure 26: Upstream Embankment Erosion**

Recommendation 1: Continue to monitor for erosion.

Recommendation 2: Backfill erosion gullies with compacted cohesive soil and reestablish vegetation.

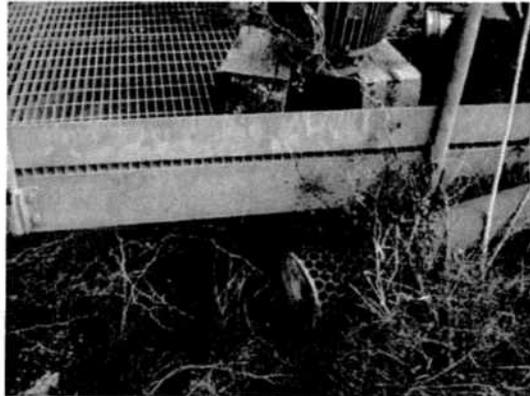
MODERATE ITEM: A discharge line at the pump station located near the southwest corner of the impoundment was eroding the protective cover of the pond (Figure 27).

**Figure 27: Erosion from Discharge Pipe**

Recommendation 1: Extend discharge line into pond to limit erosion to protective cover.

Recommendation 2: Continue to monitor this area for additional erosion to protective cover.

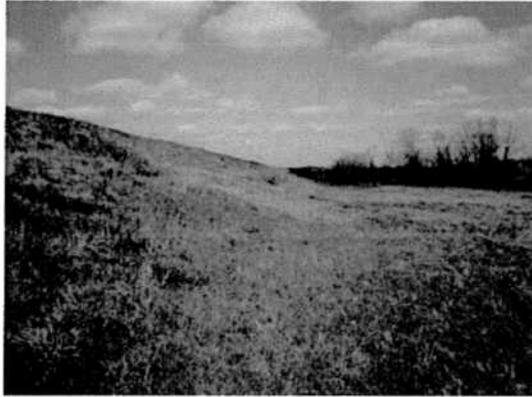
In general, the downstream side of the impoundment was well vegetated (Figure 28).

**Figure 28: Vegetation on Downstream Side of Impoundment**

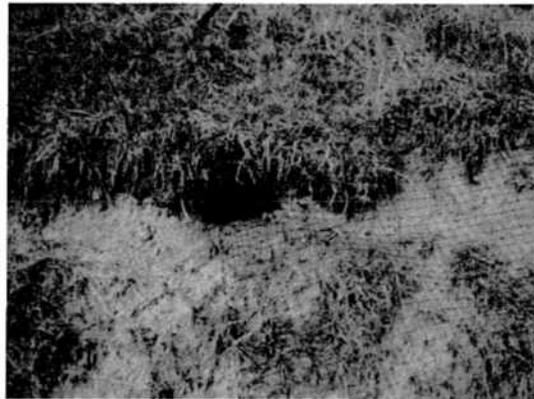
MODERATE ITEM: A few large animal burrows were found on the downstream side of the impoundment (Figures 29 and 30).

**Figure 29: Animal Burrow**

**Figure 30: Animal Burrow**

Recommendation 1: Backfill burrows with compacted cohesive soil and reestablish vegetation.

Recommendation 2: Continue to monitor for burrow reestablishment or erosion to restored areas.

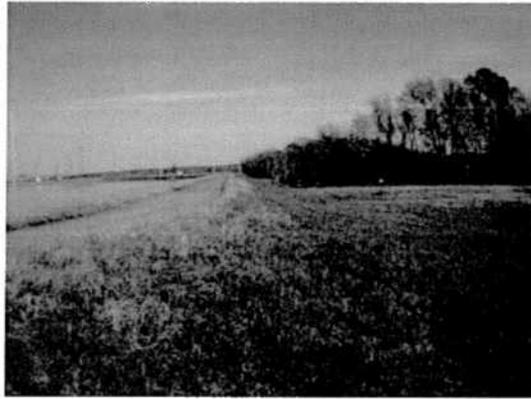
**Figure 54: Downstream Embankment West LARP**

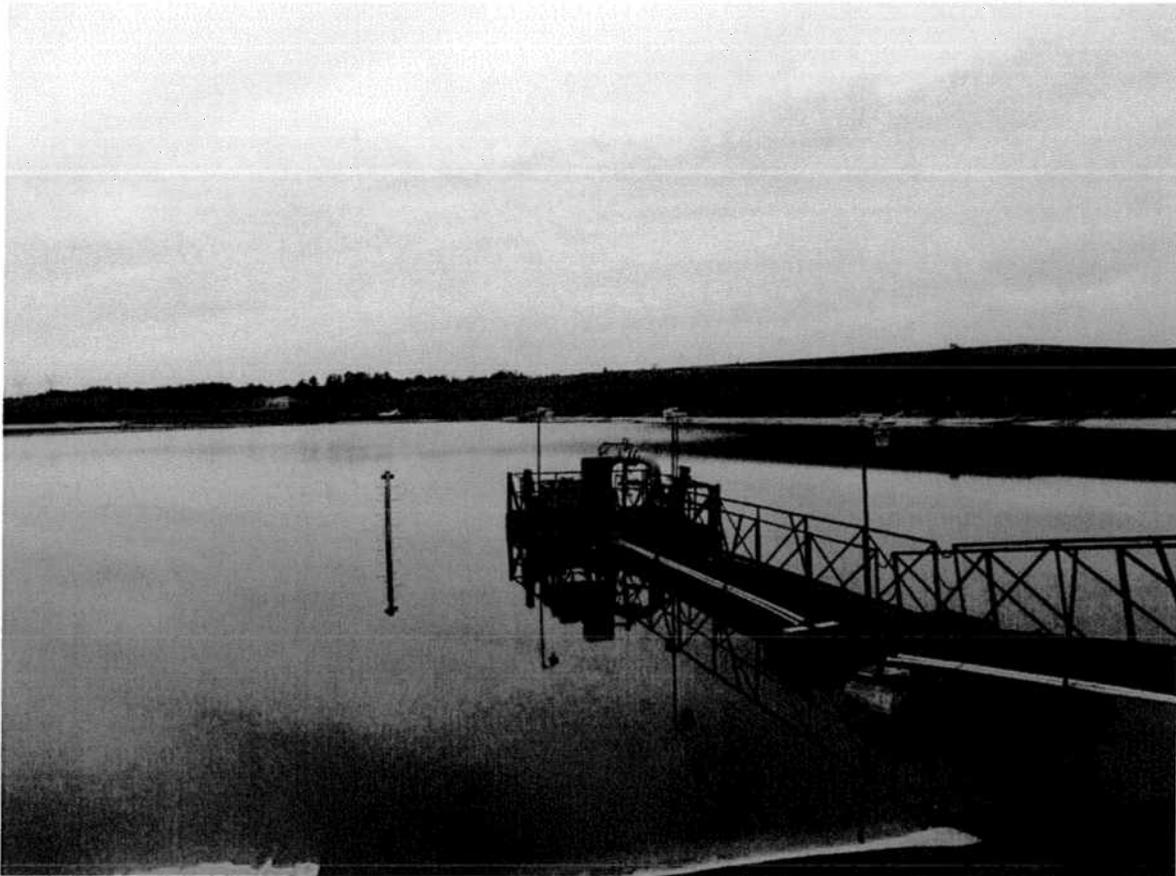
The PDP #4 has 15.34 surface acres with a maximum capacity of 82 million gallons at zero freeboard (Figure 56). The elevation of the top of the dike is 360 feet and the water elevation was 355 feet 11 inches with a freeboard of 4 feet 1 inch.

**Figure 56: PDP #4**

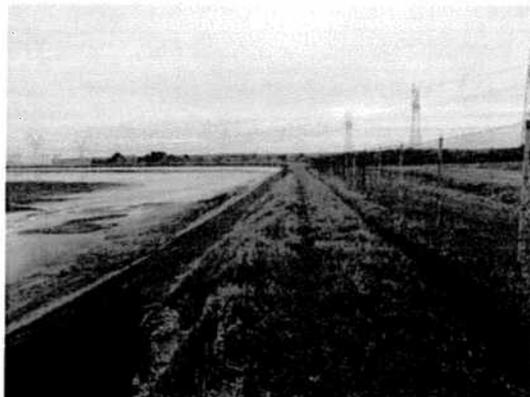
Most of the crest was well vegetation and in good condition (Figure 57).

**Figure 57: Typical Condition of Crest**

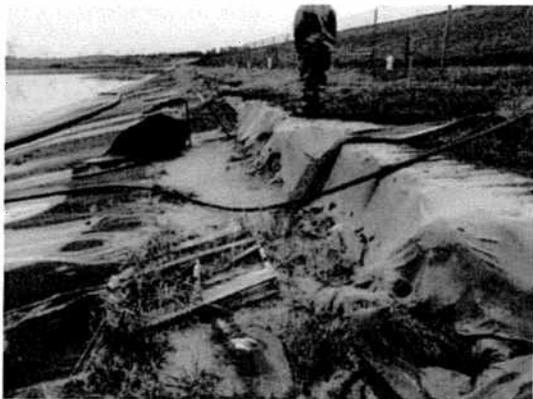
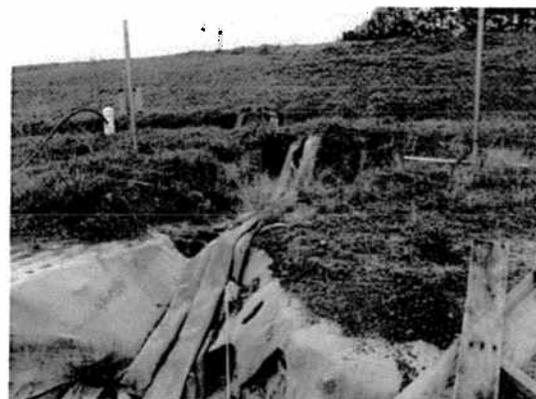
MODERATE ITEM: Along the northern crest, there are areas with severe erosion (Figures 58 and 59). Luminant has installed geotextiles to mitigate the erosion but these efforts are not producing the desired results. This area is above the freeboard elevation of the pond and does not appear to be adversely affecting the pond or the anchor trench for the liner. The primary concern is for the stability of the crest and numerous large rocks and debris scratching and gouging the liner as they are carried by storm water.

**Figure 58: Erosion at Crest of Impoundment**

**Figure 59: Erosion at Crest of Impoundment**

Recommendation 2: Remove large rocks and debris from top of liner.

Recommendation 3: Continue monitoring for additional erosion.

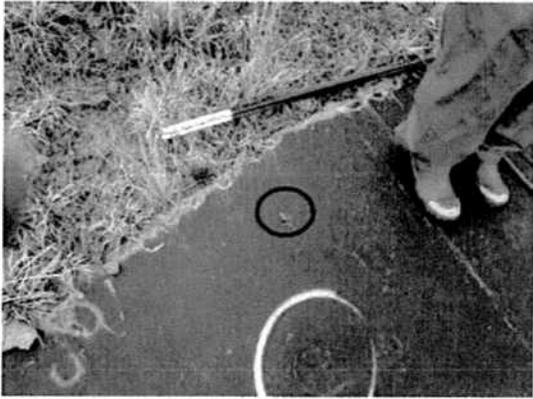
MODERATE ITEM: Metal pickets installed along the crest to anchor pipes leading to the pond have come loose from the aforementioned erosion. These pickets have created minor tears and punctures as they impacted the liner (Figure 60 and 61).

**Figure 60: Minor Tear from Picket**

Recommendation 1: Repair gouges and small tears in liner.

Recommendation 2: If metal pickets must be installed to anchor pipes, set the pickets further back on the crest and away from the liner.

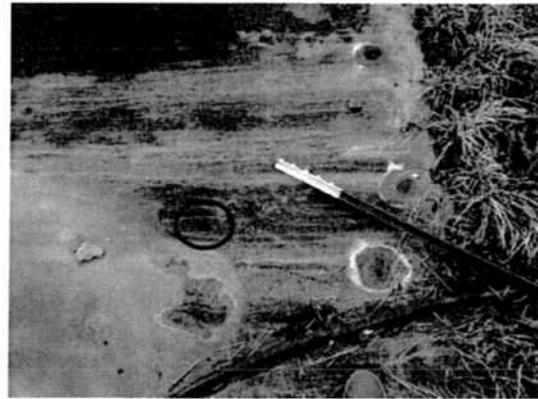
**Figure 61: Minor Tear from Picket**

CR-2012-000183-27	Permanent Disposal Pond #4 (PDP#4)	Holes in the liner caused by the metal pickets used to anchor the pipes.	Moderate	Repair the gouges and small tears in the liner. Set the metal pickets further back on the crest away from the liner.	Annual PM scheduled for November but need to get moved up. The PM has been moved up to October material should be here in mid September to do the work		CI	page 33 photo 60 & 63
CR-2012-000183-28	Permanent Disposal Pond #4 (PDP#4)	Severe erosion along the northern edge.	Moderate	Remove the old geotextile material, regrade the area and backfill the gullies, install an erosion control blanket and reestablish vegetation. Remove large rocks and debris from the liner. Continue to monitor for additional erosion.	This will be addressed in 2013		KM/CI	page 32 photo 58 & 59
CR-2012-000183-29	Permanent Disposal Pond #4 (PDP#4)	Large tear in the liner under the discharge.	Moderate	Repair the liner	Complete	12-May	CI	page 34 photo 62

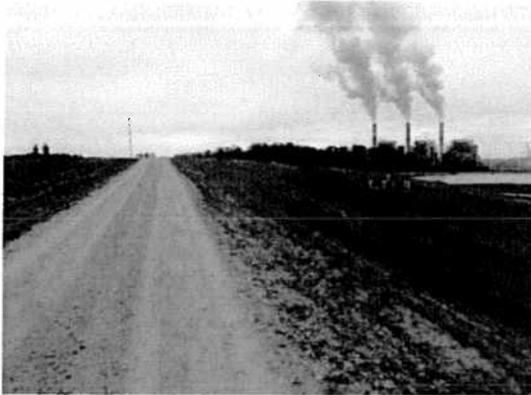
The crest of the impoundment was found to be in good condition around the perimeter of the pond (Figures 63 and 64).

**Figure 63: Crest of Pond**

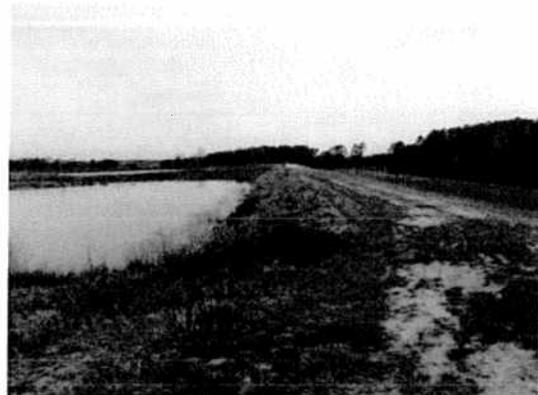
**Figure 64: Crest of Pond**

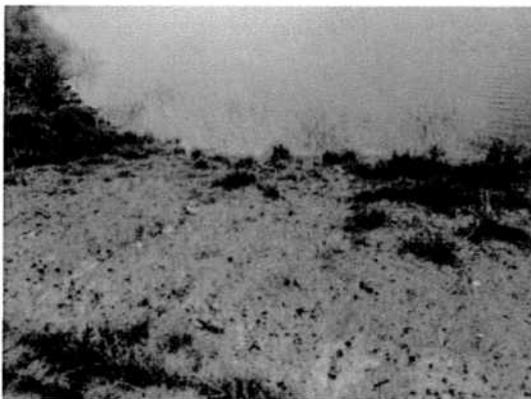
MODERATE ITEM: In general, the upstream embankment was in good condition. Minor to moderate erosion rills were found around the entire interior of the pond (Figures 65 and 66).

**Figure 65: Minor Erosion Rills Upstream Face**

Recommendation 1: Continue to monitor for erosion.

Recommendation 2: Backfill bare erosion gullies with compacted cohesive soil and reestablish vegetation.

Recommendation 3: Raise pond level to minimize erosion to protective cover.

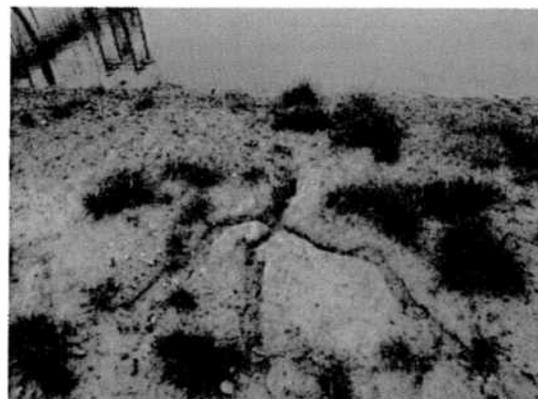
**Figure 66: Moderate Erosion Rills Upstream Face**

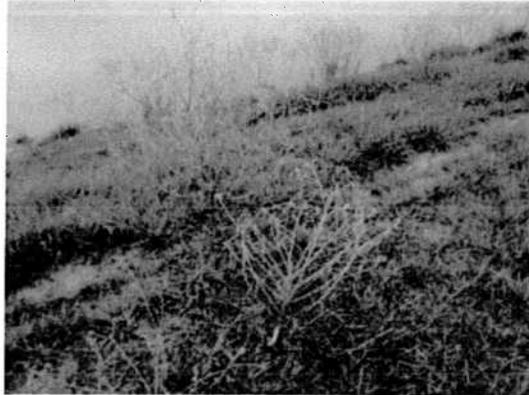
MODERATE ITEM: Small bushes were beginning to grow around the entire interior perimeter of the upstream embankment (Figure 67).

**Figure 67: Bushes Growing on Upstream Embankment**

Recommendation 1: Remove bushes or apply herbicide.

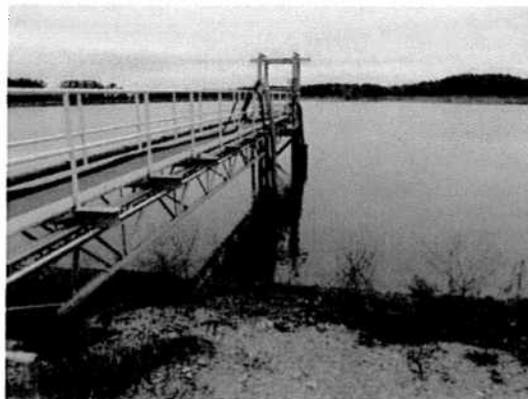
CRITICAL ITEM: A portable submersible pump was placed on the Decant Structure on the south end of the impoundment (Figure 68). This pump was resting on the pond floor potentially impacting the clay liner underneath it.

**Figure 68: Submersible Pump at Decant Structure**

Recommendation 1: Elevate the submersible pump off the pond floor.

Recommendation 2: This structure was designed to accommodate an additional fixed submersible pump off the end of the platform. Provide an additional fixed pump.

CR-2012-000183-30	Permanent Disposal Pond #4 (PDP#4)	The sacrificial liner was installed near the outfall from PDP#5 near the large tear. The outfall exceeds the limits of the sacrificial liner.	Moderate	Install another sacrificial liner beyond the limits of the pipe discharge.	Complete	12-May	CI	page 34 photo 62
CR-2012-000183-31	Permanent Disposal Pond #5 (PDP#5)	Minor to moderate erosion fills around the entire interior of the pond.	Moderate	Continue to monitor for erosion. Backfill the bare erosion gullies and reestablish vegetation. Raise the pond level to minimize the erosion to the protective cover.	Backfilled by Benchmark	8/20/2012	KM	page 35 photo 65 & 66
CR-2012-000183-32	Permanent Disposal Pond #5 (PDP#5)	Small shrubs along the entire upstream embankment.	Moderate	Remove the shrubs.	Complete as per Benchmark	7/27/2012	KM	page 36 photo 67
CR-2012-000183-33	Permanent Disposal Pond #5 (PDP#5)	Portable submersible pump at the decant structure was placed in the water resting on the bottom eroding the liner.	Critical	Elevate the submersible pump off the pond floor. The decant structure was designed to accommodate an additional fixed submersible pump at the end of the platform. Recommended to install an additional fixed pump.	Engineering said this will be done at time of installing permanent installation	8/12/2012	CI JM	page 36 photo 68

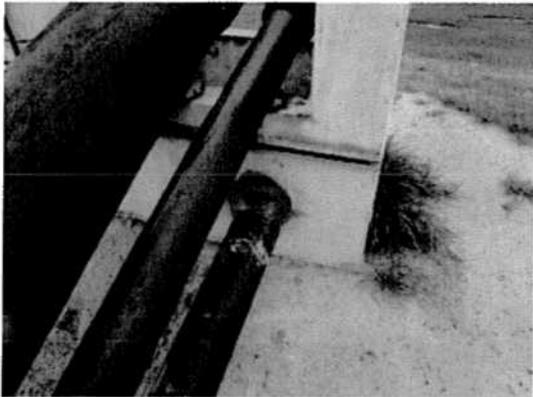
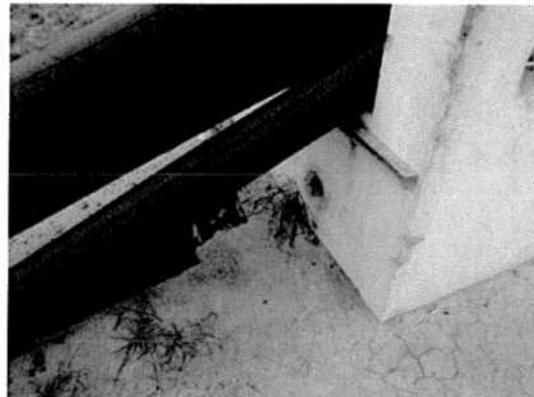
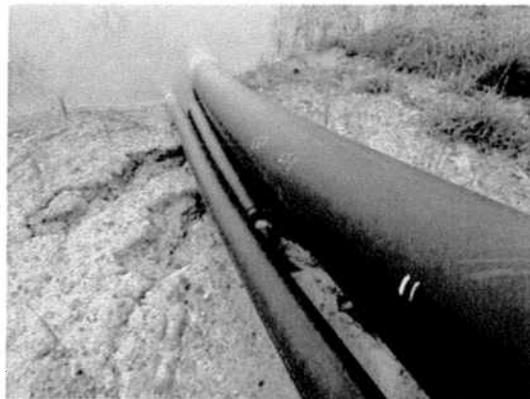
MODERATE ITEM: The overflow return line at the southeast, southwest and northeast sump access structures was separated from the structure (Figures 69, 70 and 71). In the event of an uncontrolled release of water, this pipe returns the water to the pond.

**Figure 69: Return Line Southeast Structure**

**Figure 70: Return Line Southwest Structure**

**Figure 71: Return Line Northeast Structure**

Recommendation 1: Reinstall pipe.

CR-2012-000183-34	Permanent Disposal Pond #5 (PDP#5)	The overflow return lines on the SE, SW and NE sump access structures was separated.	Moderate	Reinstall the pipes.	Work Order 12-142933 has been created	5-Sep	CI	page 37 photo 69, 70, & 71
CR-2012-000183-35	Permanent Disposal Pond #5 (PDP#5)	Bare areas and minor erosion rills in isolated areas along the downstream slope.	Moderate	Reseed and reestablish vegetation in these bare areas and continue to monitor for additional erosion.	minor backfill completed by benchmark. Vegetation to naturally fill	8/20/2012	KM	page 39 photo 75 & 76
CR-2012-000183-36	Permanent Disposal Pond #5 (PDP#5)	Erosion gullies at the southern access ramp, slurry transmission line, northeast sump structure and where PDP#2 cap terminates near the SE corner of the landfill.	Moderate	Backfill the eroded areas and reestablish vegetation. Place rip rap in areas where the water flow is concentrated. Continue to monitor for additional erosions.	Backfilled by benchmark	8/20/2012	KM	page 39 photo 78, 79, & 80

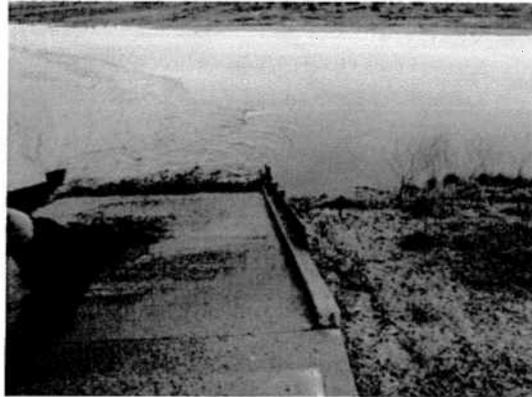
Additional protective rails were installed on the Slurry Channel (Figure 72) in 2011 to prevent erosion to the protective cover from slurry splashing. These appeared to be effective and no slurry splash erosion concerns were noted during this inspection.

**Figure 72: Slurry Channel with Protective Rails**

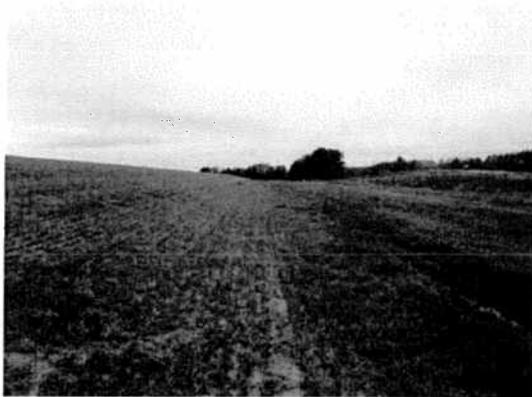
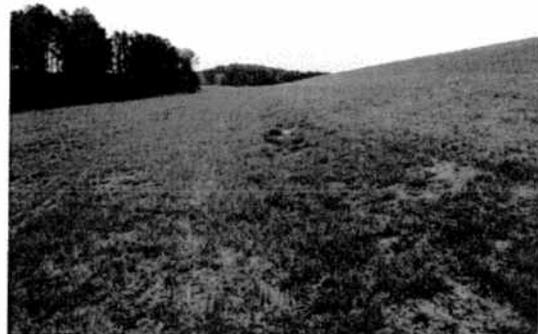
In general, the downstream side of the impoundment was in good condition (Figures 73 and 74). The grass was beginning to take hold and grow after the prolonged drought. At the time of the inspection, the grass was well maintained.

**Figure 73: Downstream Side of Impoundment**

**Figure 74: Downstream Side of Impoundment**

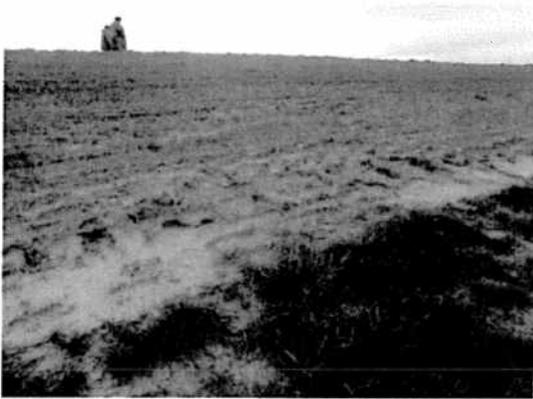
MODERATE ITEM: Bare areas and minor erosion rills were beginning to form in isolated areas around the perimeter of the impoundment (Figures 75 and 76).

**Figure 75: Minor Erosion Rills**

**Figure 76: Minor Erosion Rills**

Recommendation 1: Reseed and reestablish vegetation in these bare areas.

Recommendation 2: Continue to monitor these areas (after vegetation established) for additional erosion.

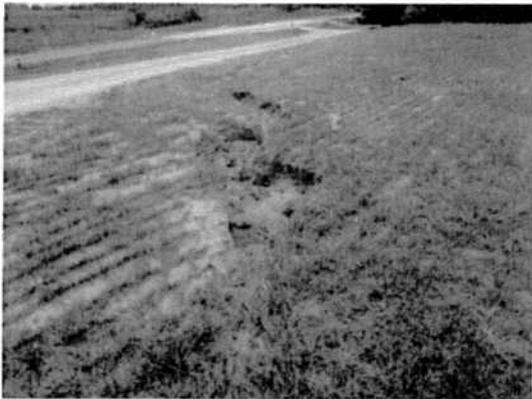
MODERATE ITEM: Erosion gullies were found at the southern access ramp (Figure 77), slurry transmission line (Figure 78), northeast sump access structure (Figure 79) and where the PDP #3 cap terminates near the southeast corner (Figure 80) of the landfill.

**Figure 77: Erosion at South Access Ramp**

Recommendation 1: Backfill bare erosion gullies with compacted cohesive soil and reestablish vegetation.

Recommendation 2: Place riprap in areas of concentrated flow.

Recommendation 3: Continue to monitor areas after repairs for additional erosion.

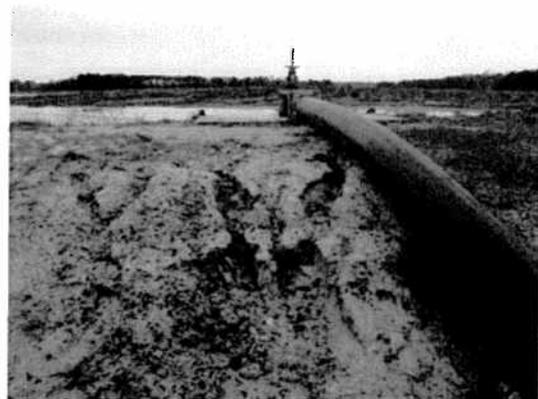
**Figure 78: Erosion at Slurry Transmission Line**

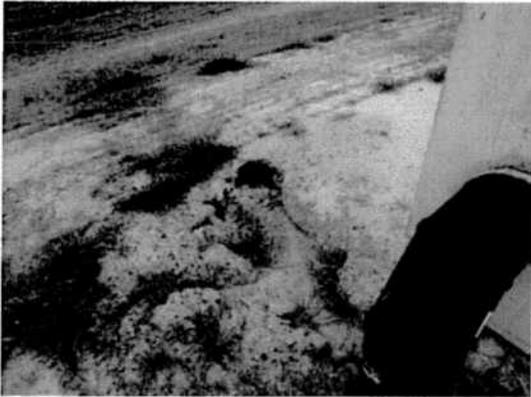
**Figure 79: Erosion at Northeast Access Structure**

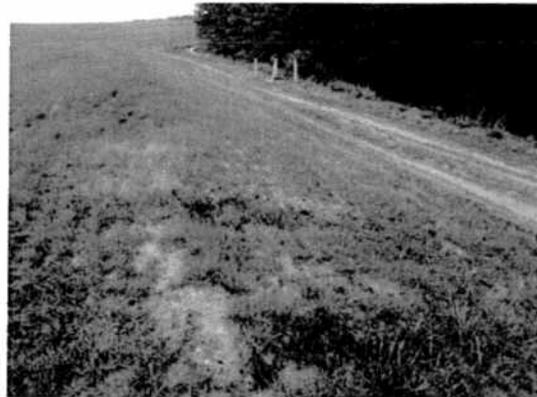
**Figure 80: Erosion at PDP #3 Cap**

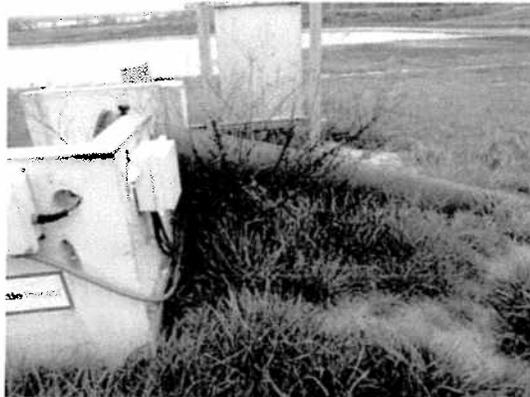
MODERATE ITEM: A large bush is growing near the southeast dewatering access structure (Figure 81)

**Figure 81: Bush near Southeast Dewatering Access Structure**

Recommendation 1: Remove bush and repair disturbed area.

CR-2012-000183-37	Permanent Disposal Pond #5 (PDP#5)	Large shrub near the southeast dewatering structure.	Moderate	Remove the shrub.	Complete as per Benchmark	7/27/2012	KM	page 40 photo 81
CR-2012-000183-38	Permanent Disposal Pond #5 (PDP#5)	Water collecting at the SE corner of the PDP#3 cap.	Minor	It's assumed that this is from recent rains, but continue monitoring especially in dry period to ascertain if it's not seepage from the impoundment. Continue to monitor the toe drain discharge and ensure that the dewatering wells are operational. Backfill this area and grade so that the water does not gather.	No water standing at this location		CI	page 40 photo 82
CR-2012-000183-39	Permanent Disposal Pond #5 (PDP#5)	Exposed corrugated plastic pipes on the north side of PDP#1. no water was draining from the pipes at the time of the inspection.	Minor	Continue to monitor for discharge.	Continue monitoring no changes	12-May	IT KM	page 41 photo 83 & 84

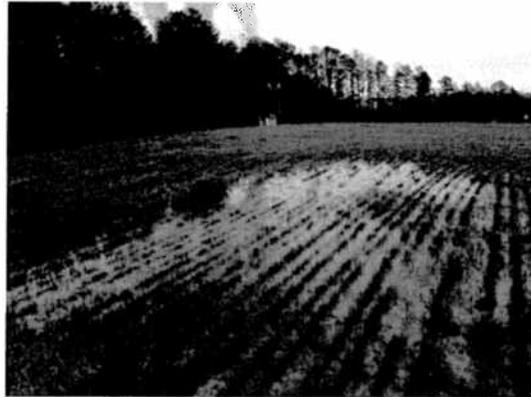
MINOR ITEM: Water is ponding at the southeast corner of the PDP #3 cap (Figure 82). It is assumed the water was from recent storm activities, but this could also represent water migrating from PDP #5.

**Figure 82: Poned Water on PDP #3 Cap**

Recommendation 1: Continue to monitor this area, especially during dry (rain free) periods to determine if this is storm water or water migrating from the pond.

Recommendation 2: Continue to monitor toe drain discharge and ensure dewatering wells are operational.

Recommendation 3: Provide compacted cohesive soil and grade to eliminate the ponding area.

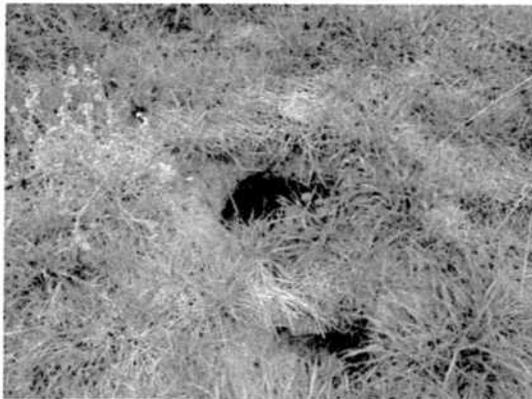
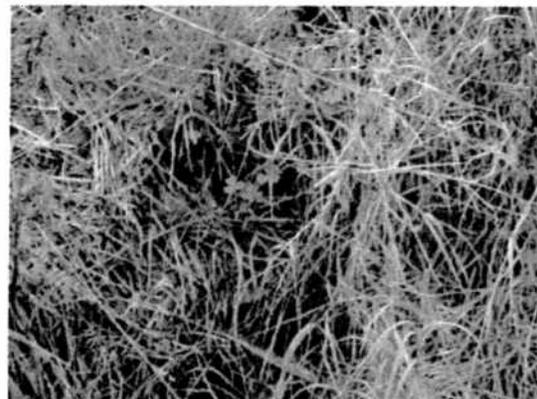
MINOR ITEM: Two large corrugated plastic pipes were located on the north downstream side of PDP #1 (Figures 83 and 84). No water was noticed exiting the pipes during the inspection.

**Figure 83: Corrugated Plastic Pipe**

**Figure 84: Corrugated Plastic Pipe**

Recommendation 1: Continue to monitor these pipes for discharge.

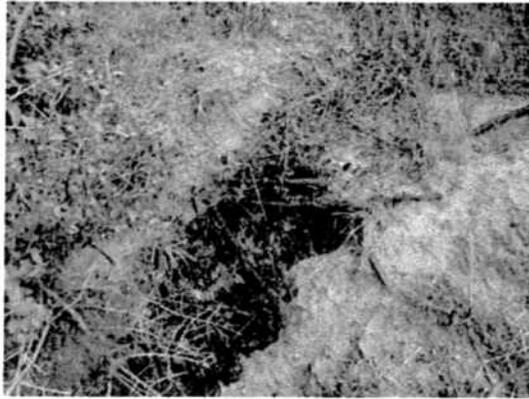
MODERATE ITEM: There was downstream erosion at the PDP #1 embankment (Figure 85) which appeared to initiate from the eastern corrugated pipe.

**Figure 85: Erosion on Downstream Face of PDP #1 Berm**

Recommendation 1: Backfill bare erosion gullies with compacted cohesive soil and reestablish vegetation.

Recommendation 2: Place riprap in areas of concentrated flow.

Recommendation 3: Continue to monitor areas after repairs for additional erosion.

CR-2012-000183-40	Permanent Disposal Pond #5 (PDP#5)	Erosion at the PDP#1 embankment on the north side downstream from the corrugated plastic pipe.	Moderate	Backfill the eroded areas and reestablish vegetation. Place rip rap in areas where the water flow is concentrated. Continue to monitor for additional erosions.	Backfield by benchmark	8/20/2012	KM	page 41, photo 83 & 84
CR-2012-000183-41	Permanent Disposal Pond #5 (PDP#5)	The downstream low of PDP#3 appears to have recently excavated.	Minor	Reestablish the toe with compacted soil and vegetation. Continue to monitor the location for possible slope slides, seepage, unusual movement and abutment problems.	Backfield by benchmark	8/20/2012	KM	page 42, photo 85

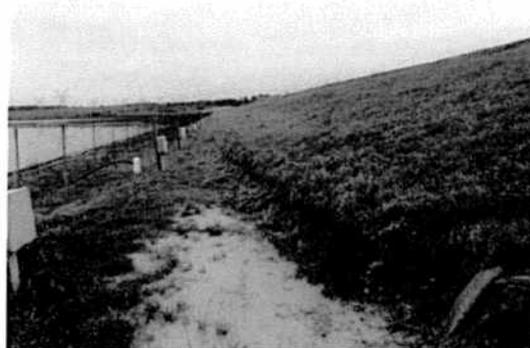
MINOR ITEM: The downstream toe of PDP #3 appeared to have been excavated recently (Figure 86).

**Figure 86: Downstream Toe of PDP #3 Berm**

Recommendation 1: Reestablish toe with compacted cohesive soil and re-vegetate.

Recommendation 2: Continue to monitor this location for possible slope slides, seepage, unusual movement and abutment contact problems.

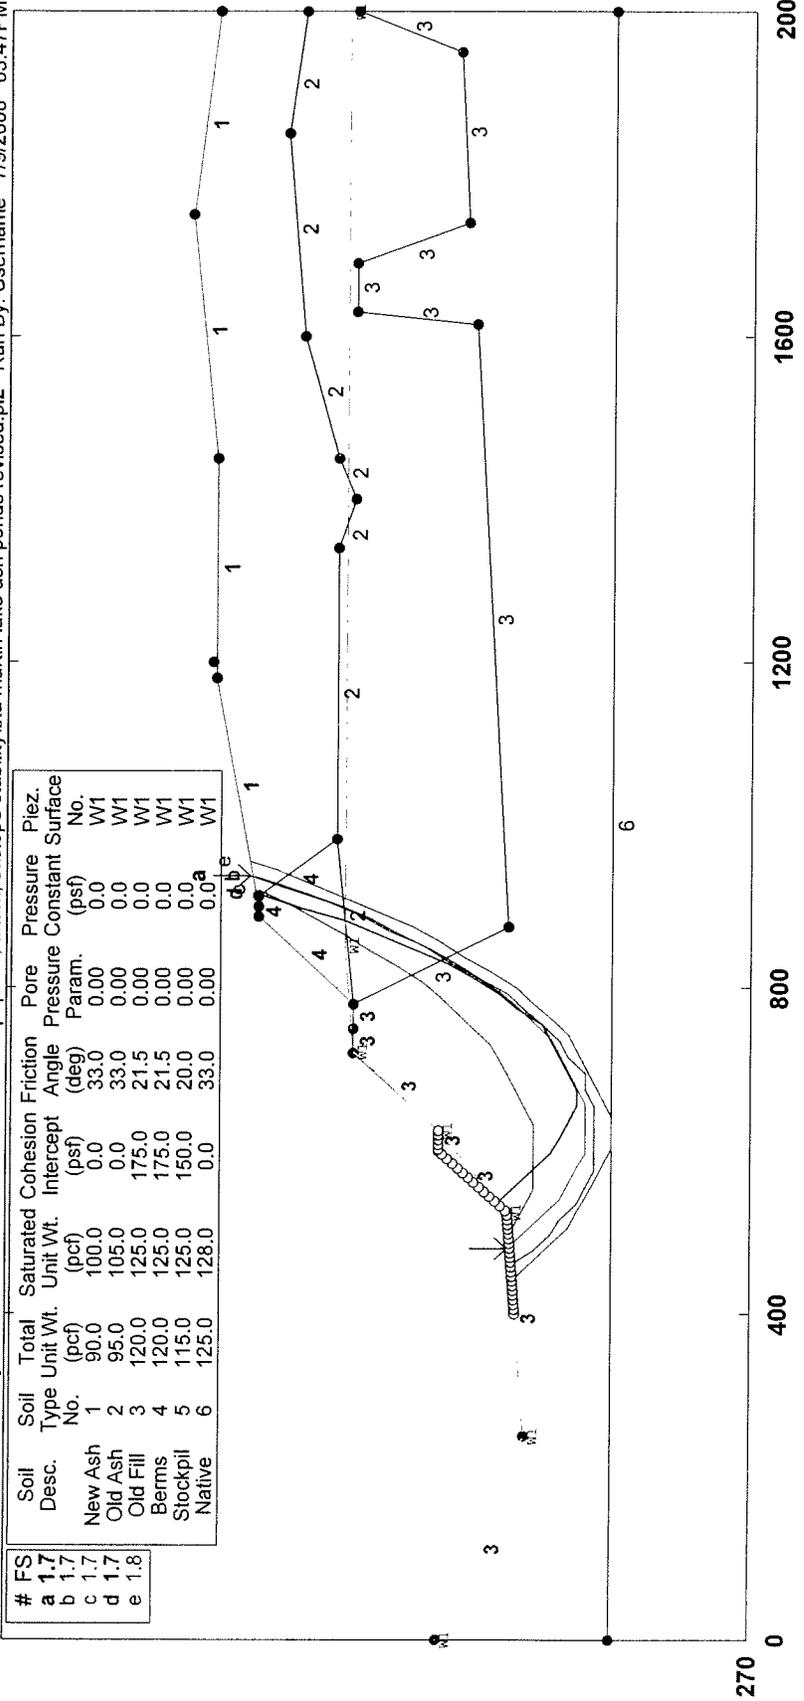
GSTABL7 v.2 FSmin=1.7  
Safety Factors Are Calculated By The Modified Bishop Method

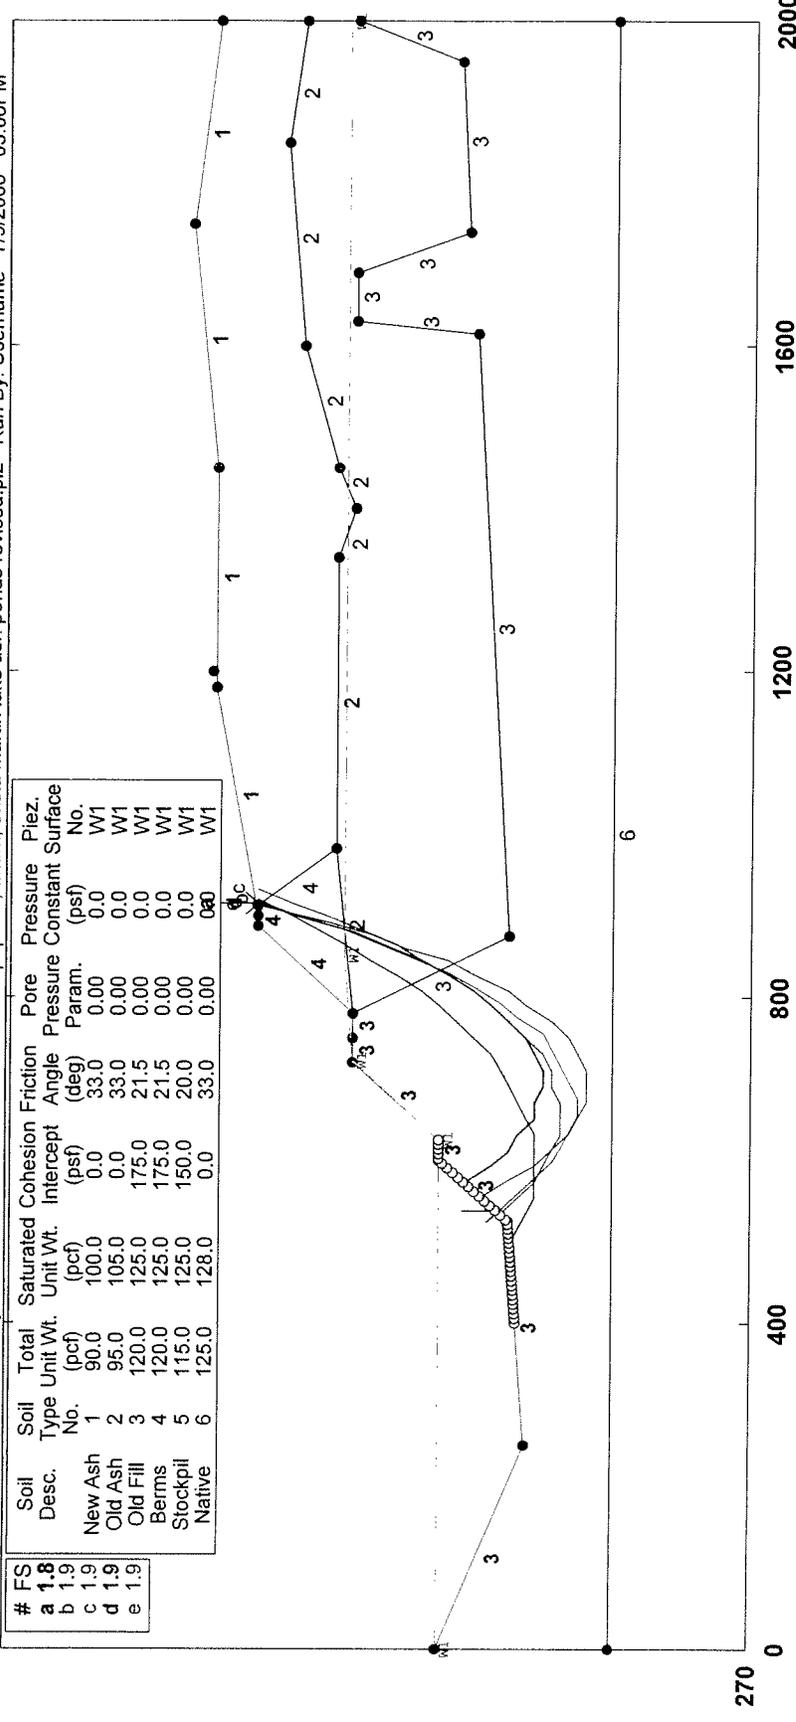
# Luminant Martin Lake PDP Expansion Final Profile - Long Term

GSTABL7 v.2 FSmin=1.8  
Safety Factors Are Calculated By The Modified Bishop Method
