**Coal Combustion Residue Impoundment**

**Round 12 - Dam Assessment Report**

*Martin Lake Steam Electric Plant*

**Tatum, Texas**

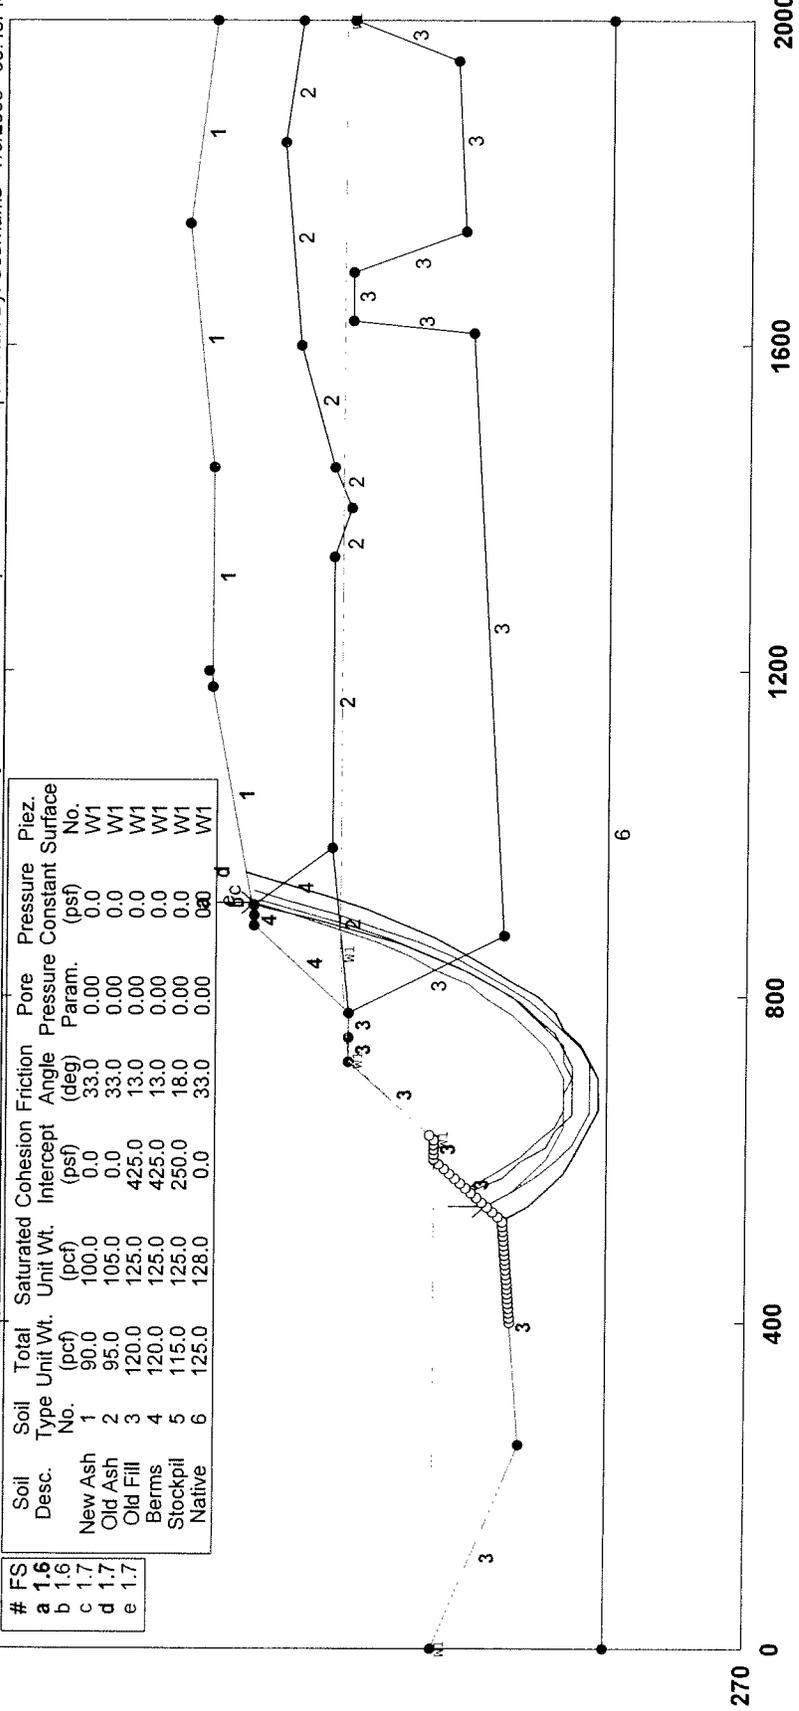
# Luminant Martin Lake PDP Expansion Final Profile - End of Construction

GSTABL7 v.2 FSmin=1.6  
Safety Factors Are Calculated By The Modified Bishop Method

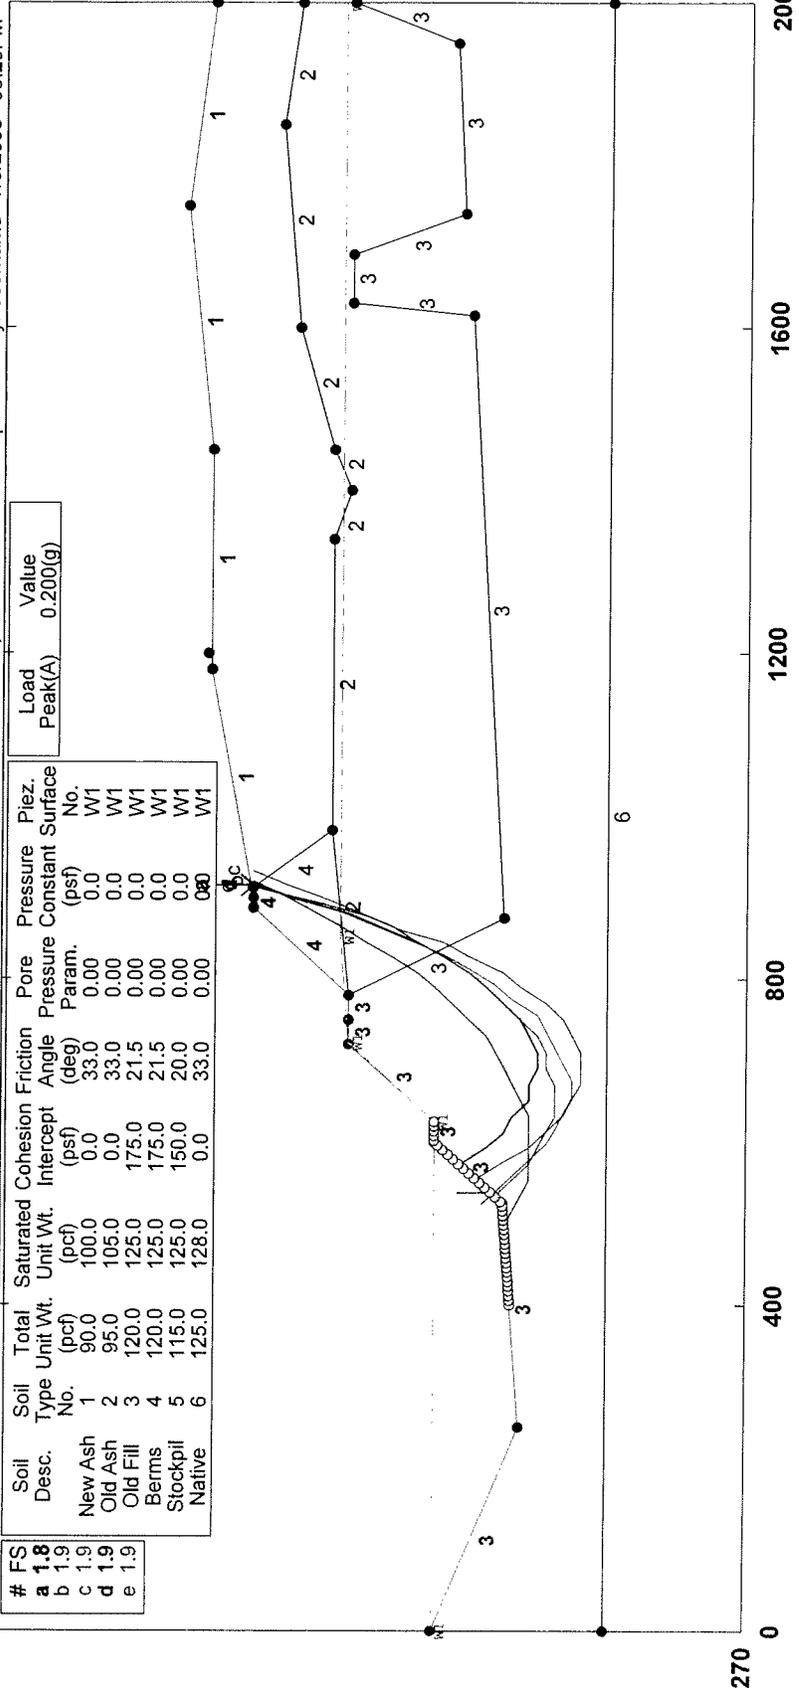
# Luminant Martin Lake PDP Expansion Final Profile - Long Term

GSTABL7 v.2 FSmin=1.8  
Safety Factors Are Calculated By The Modified Bishop Method

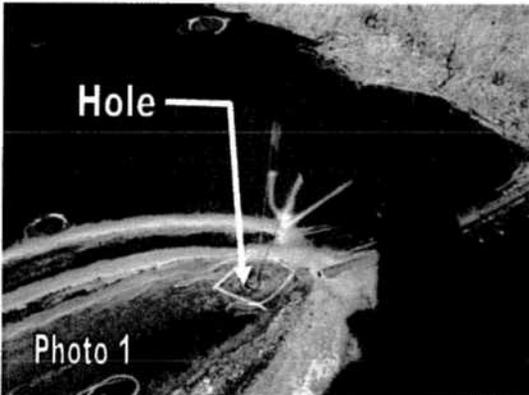
The poly liner was in great condition along the west, south and east side. On the north side there are four small holes (photo 1) and one large tear (Photo 2). See SK-1 for all the hole locations.

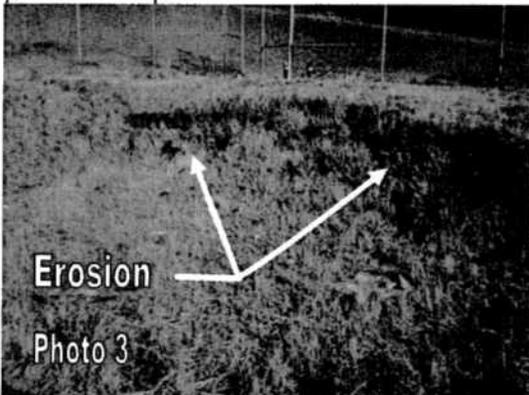
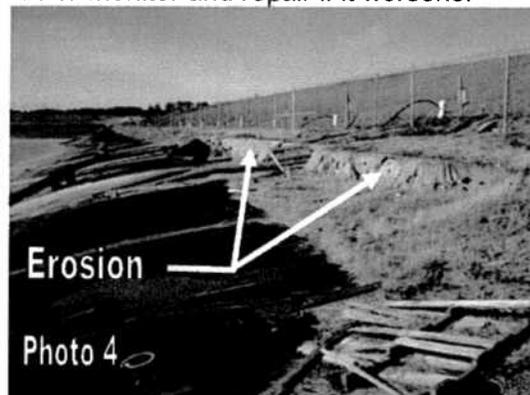
Erosion is present all along the upstream embankment on the northeast side. (Photos 3 & 4) The erosion is believed to be a result of runoff from the construction of PDP5 which is located upstream. The construction of PDP5 is complete and the erosion has not deteriorated since the previous inspection. It is recommended to continue to monitor and repair if it worsens.

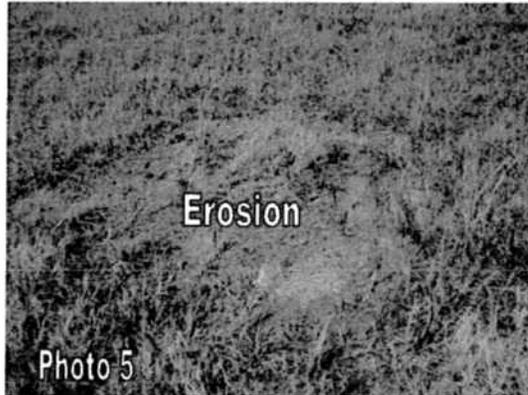
Overall the downstream embankment was in good condition and well vegetated. There was one area near the toe of the embankment on the center of the south side that is bare of vegetation. This needs to be monitored through the winter and ensure that grass fills in this area during the spring growing season (Photo 5). Reseed if the grass is not establish by the end of May.

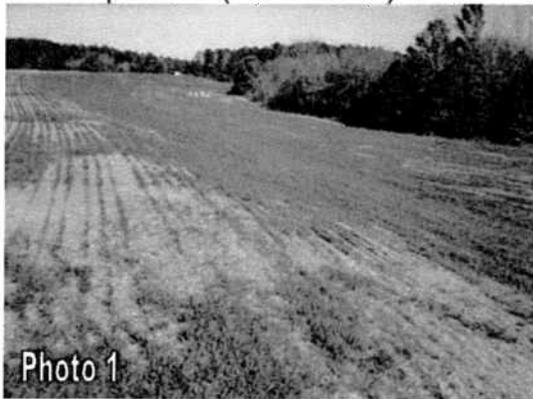
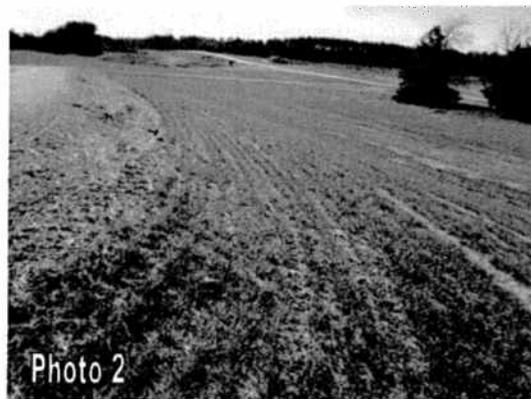
The grass on the downstream slopes is becoming established and there were not any areas of erosion present. (Photos 1 & 2)

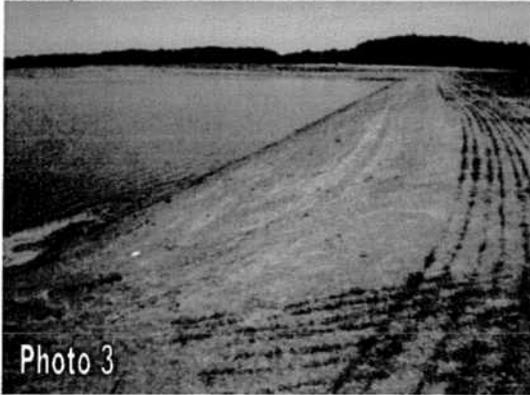
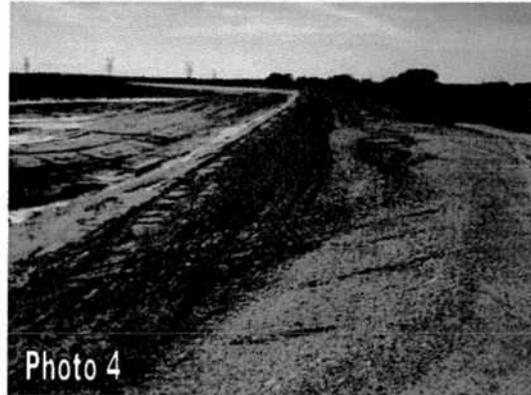
A majority of the upstream slope is not filled in with vegetative cover. This increases the slopes' exposure to erosion and will need to be monitored until the grass becomes established. (Photos 3 & 4)

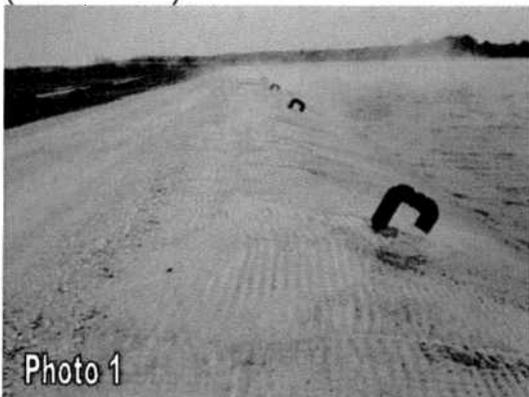
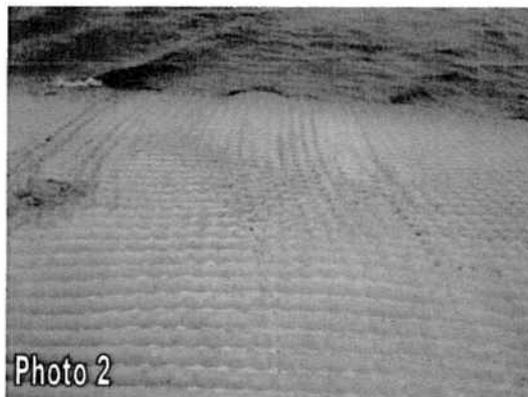
The concrete revetment matting was in good condition. No cracks, bulges or slides were found. (Photos 1 & 2)

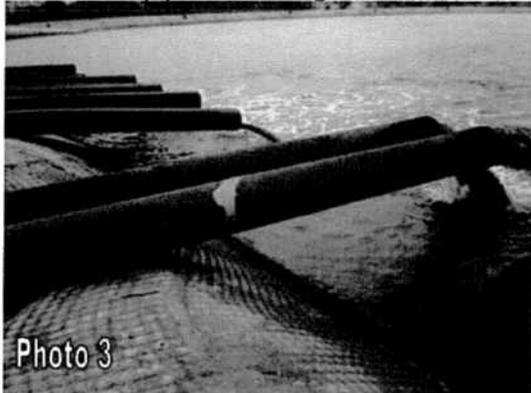
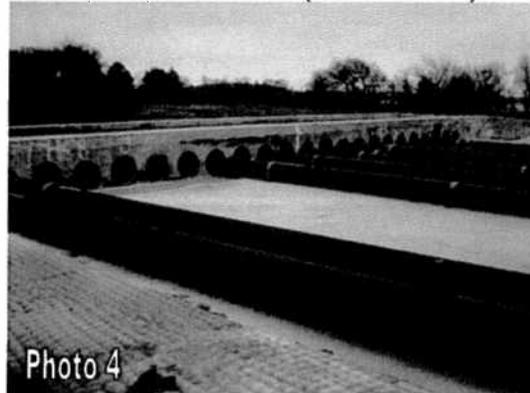
The outfall pipes were in good condition and no leaks were detected. (Photos 3 & 4)

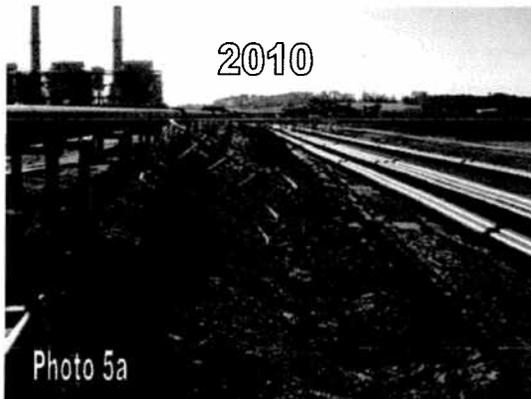
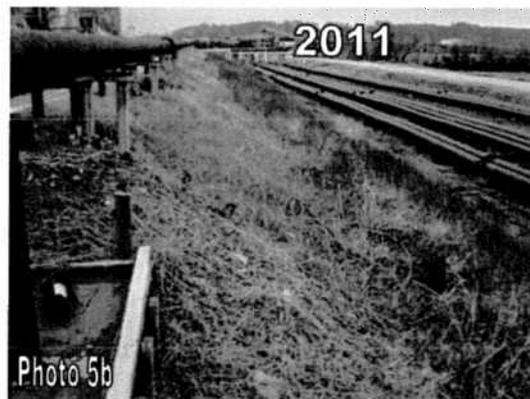
During the construction the downstream embankment on the north side was exposed, but has been revegetated. January 2010 (Photo 5a). January 2011 (Photo 5b).

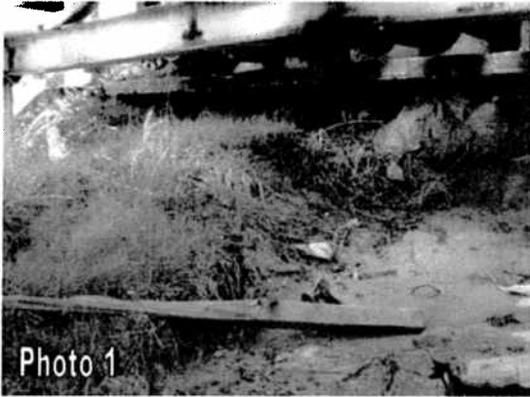
Under the support structure for the pipes on the downstream side on the north side there is significant erosion. This needs to be filled in and vegetation re-established. Monitor closely until repairs are completed. (Photos 1 & 2)

1. Significant erosion is undercutting the crossing structure. This needs to be filled in and vegetated. (Photos 1 and 2)
2. Large gully on the center of the west side. Fill in and reseed. (Photos 3 and 4)

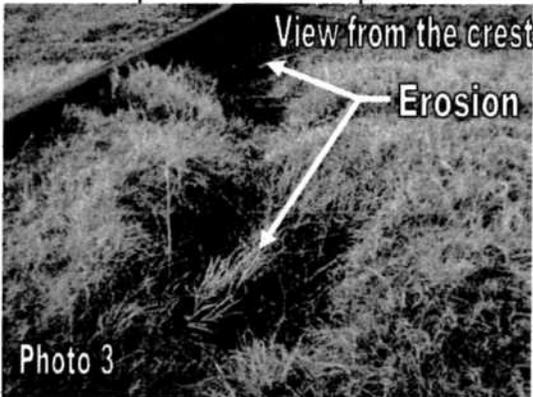
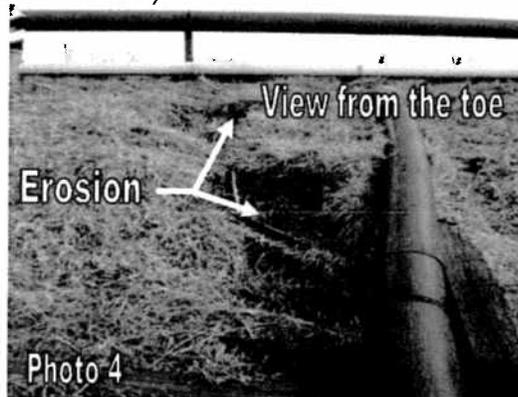
Overall the downstream embankment was in good condition with the exception of a large gully on the center of the west side. This needs to be filled in and re-vegetated. (Photo 3 is the view from the top of the crest and photo 4 is taken from the toe.)

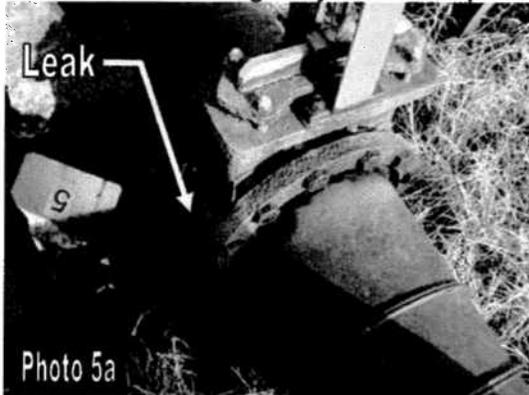
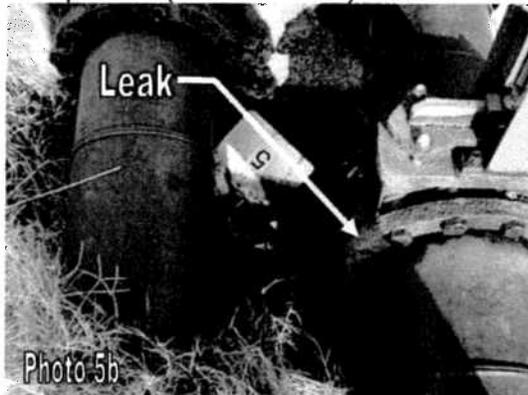
A leak was present on the gate valve on the second (from the west). This needs to be repaired to prevent saturation which could weaken the embankment and possibly result in a slide in this location. Monitor regularly until the repairs are completed. (Photo 5a & 5b)

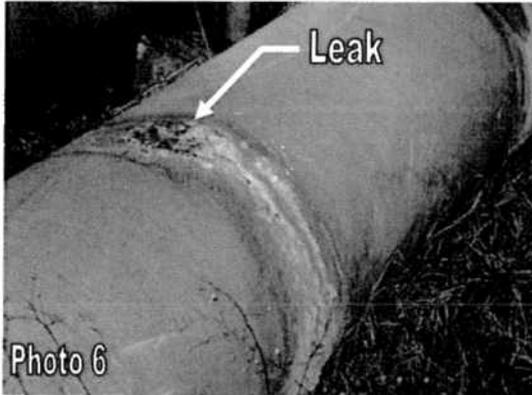
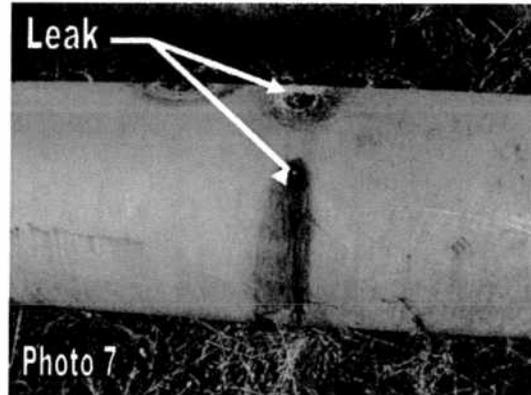
There are steel pipes that are leaking what appears to be sulphur dioxide. These leaks appear to be small and the leaking minimal. Repairs need to be undertaken as soon as possible. (Photo 6 & 7)

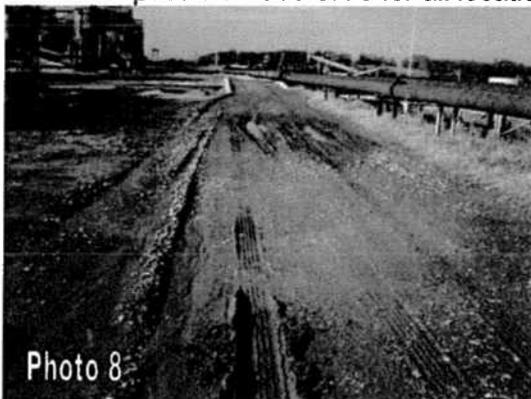
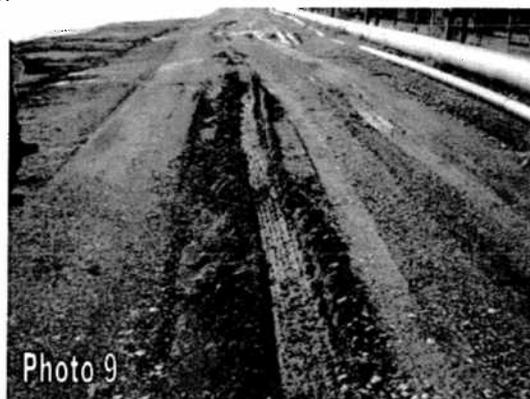
Rutting was present in several locations along the crest (Photos 8 and 9). These need to be repaired to prevent rainfall runoff from collecting and penetrating which can potentially lead to weakening of the embankment. Care should be taken to avoid driving on the crest when it is soft when possible. See SK-3 for all locations.

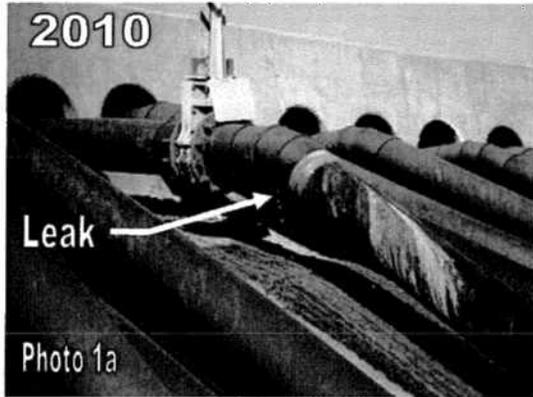
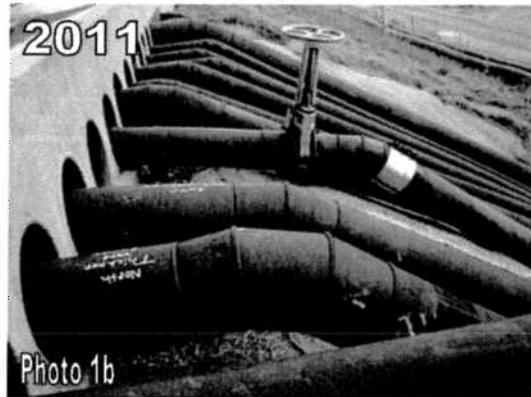
During the 2010 inspection a leak was present in the piping on the south side on the downstream slope. (Photo 1a) This has been corrected. (Photo 1b)

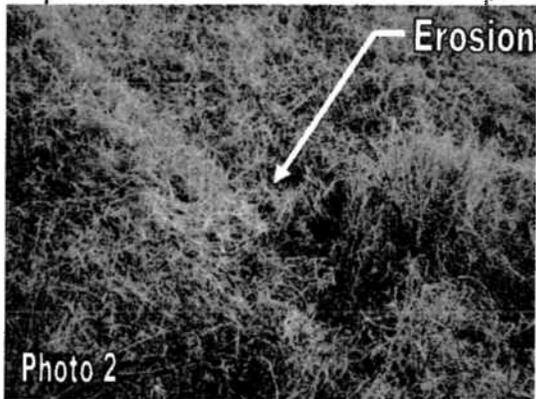
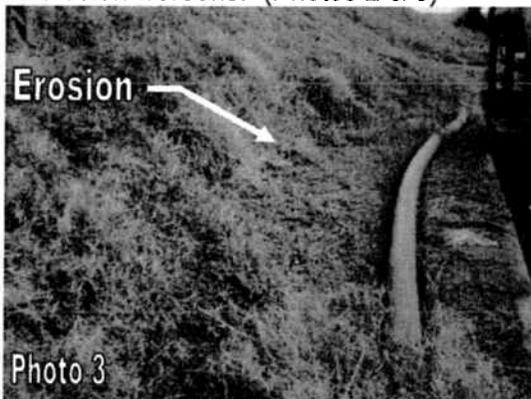
There were two areas on the downstream embankment adjacent to the pump station where erosion has occurred. Both are well vegetated and have not degraded since the previous inspection. Continue to monitor and repair if the erosion worsens. (Photos 2 & 3)

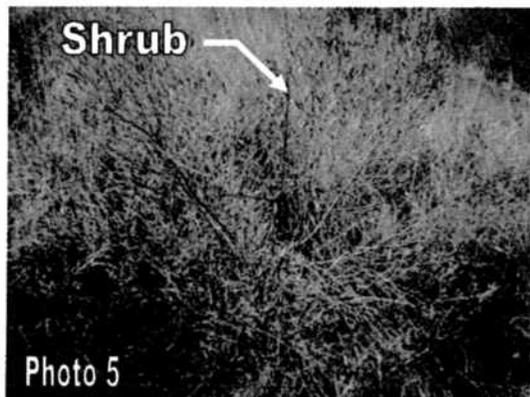
Other action items include filling in the burrow on the north side of the northeast corner (Photo 4) and removing the small shrub on the north side on the downstream slope near where it merges with the East Bottom Ash Pond (Photo 5). There was some rutting on the crest. These need to be repaired to prevent water from collecting and penetrating the embankment. See SK-3 for the locations.

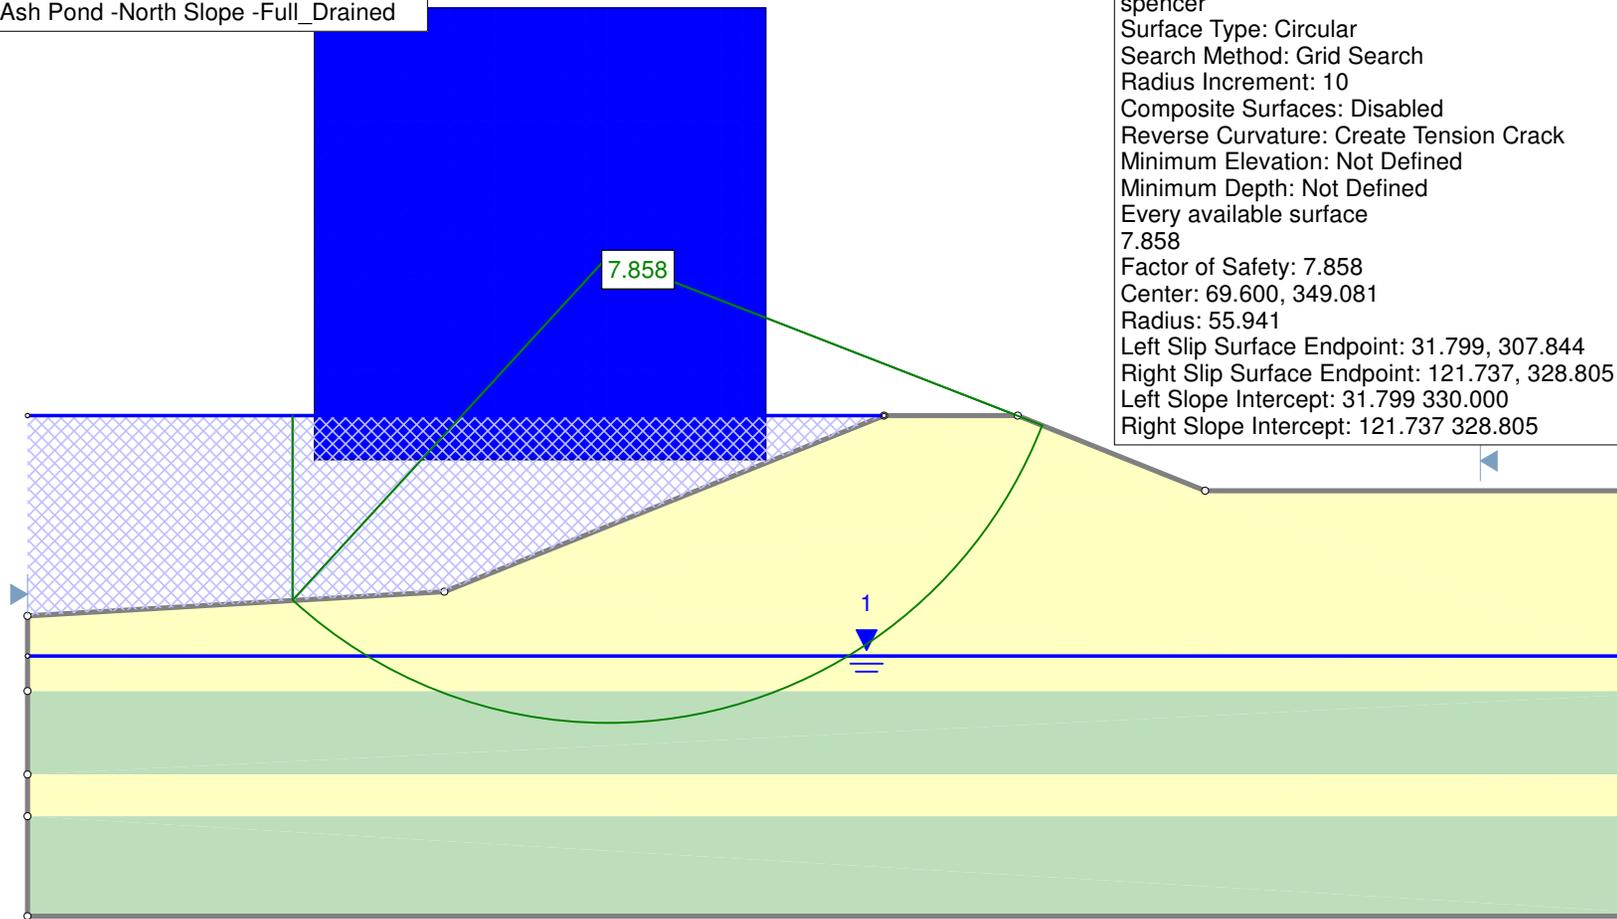
Luminant - Martin Lake Emergency Ash Pond  
West Ash Pond -North Slope -Full\_Drained

Results  
 spencer  
 Surface Type: Circular  
 Search Method: Grid Search  
 Radius Increment: 10  
 Composite Surfaces: Disabled  
 Reverse Curvature: Create Tension Crack  
 Minimum Elevation: Not Defined  
 Minimum Depth: Not Defined  
 Every available surface  
 7.858  
 Factor of Safety: 7.858  
 Center: 69.600, 349.081  
 Radius: 55.941  
 Left Slip Surface Endpoint: 31.799, 307.844  
 Right Slip Surface Endpoint: 121.737, 328.805  
 Left Slope Intercept: 31.799 330.000  
 Right Slope Intercept: 121.737 328.805

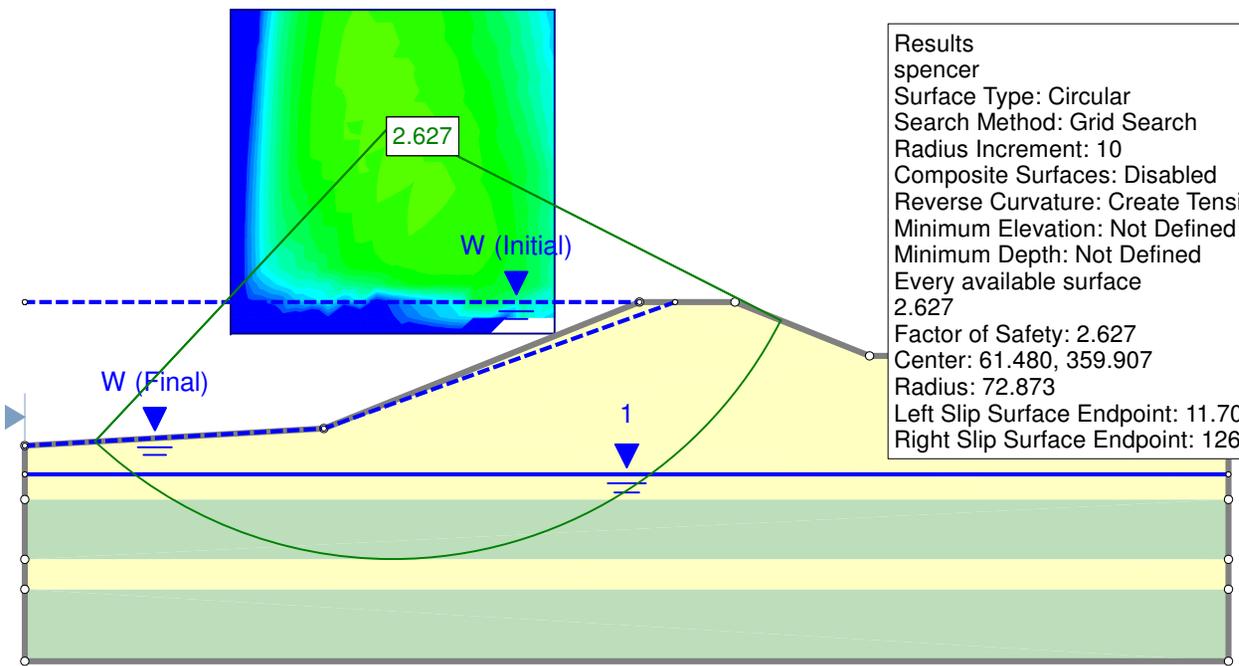
Luminant - Martin Lake Emergency Ash Pond  
West Ash Pond -North Slope -Rapid DD\_drained

Results  
 spencer  
 Surface Type: Circular  
 Search Method: Grid Search  
 Radius Increment: 10  
 Composite Surfaces: Disabled  
 Reverse Curvature: Create Tension Crack  
 Minimum Elevation: Not Defined  
 Minimum Depth: Not Defined  
 Every available surface  
 2.627  
 Factor of Safety: 2.627  
 Center: 61.480, 359.907  
 Radius: 72.873  
 Left Slip Surface Endpoint: 11.709, 306.679  
 Right Slip Surface Endpoint: 126.458, 326.917

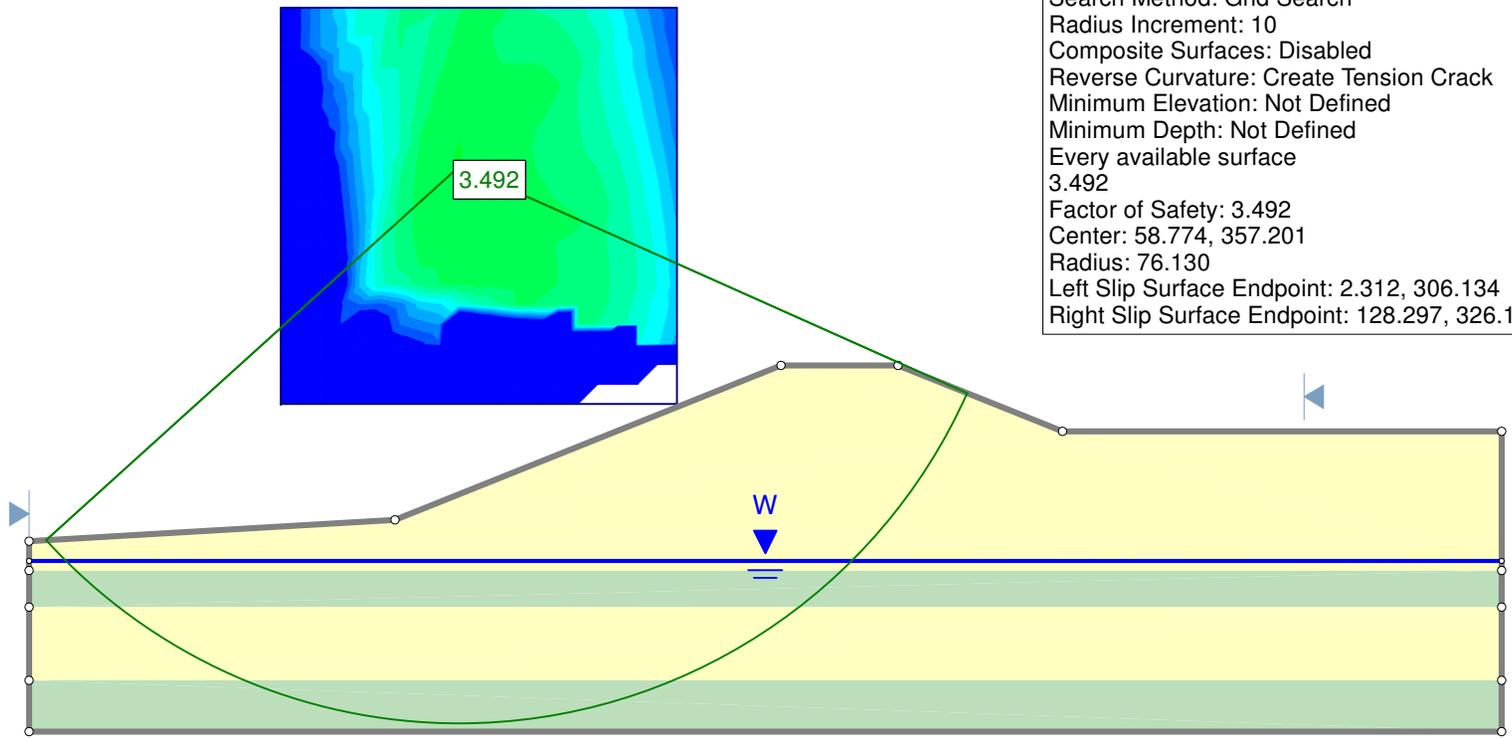
Luminant - Martin Lake Emergency Ash Pond  
West Ash Pond -West Slope -Full\_Undrained

Results  
spencer  
Surface Type: Circular  
Search Method: Grid Search  
Radius Increment: 10  
Composite Surfaces: Disabled  
Reverse Curvature: Create Tension Crack  
Minimum Elevation: Not Defined  
Minimum Depth: Not Defined  
Every available surface  
3.492  
Factor of Safety: 3.492  
Center: 58.774, 357.201  
Radius: 76.130  
Left Slip Surface Endpoint: 2.312, 306.134  
Right Slip Surface Endpoint: 128.297, 326.181

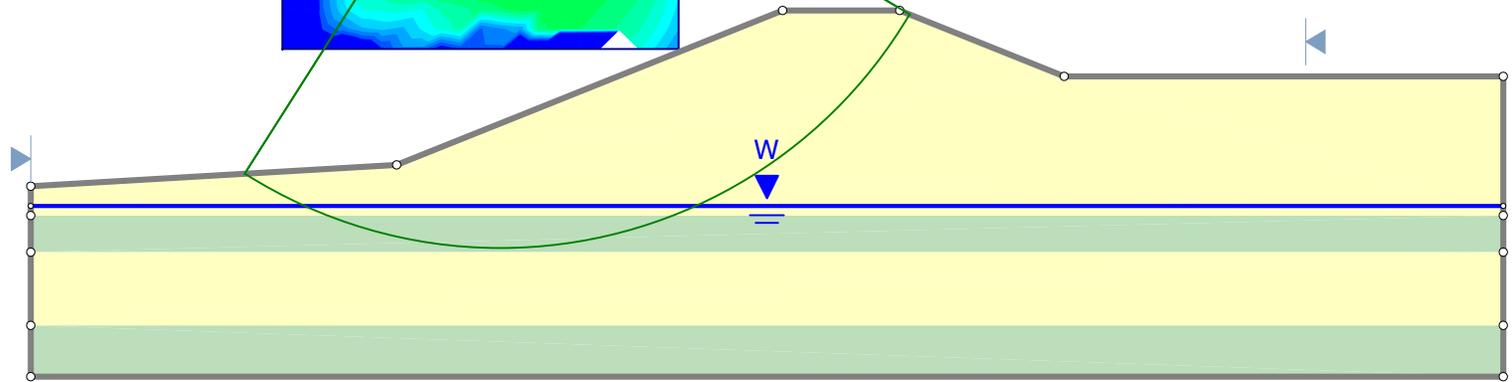
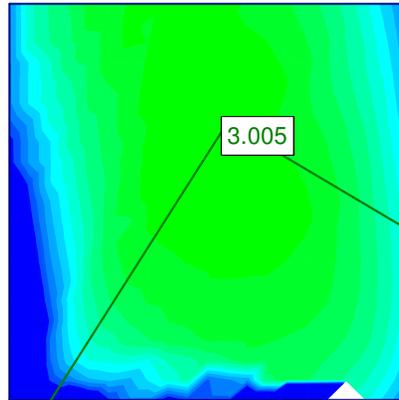
Luminant - Martin Lake Emergency Ash Pond  
West Ash Pond -West Slope -Empty\_drained

Results  
 spencer  
 Surface Type: Circular  
 Search Method: Grid Search  
 Radius Increment: 10  
 Composite Surfaces: Disabled  
 Reverse Curvature: Create Tension Crack  
 Minimum Elevation: Not Defined  
 Minimum Depth: Not Defined  
 Every available surface  
 3.005  
 Factor of Safety: 3.005  
 Center: 64.187, 362.614  
 Radius: 65.095  
 Left Slip Surface Endpoint: 29.239, 307.696  
 Right Slip Surface Endpoint: 120.186, 329.426

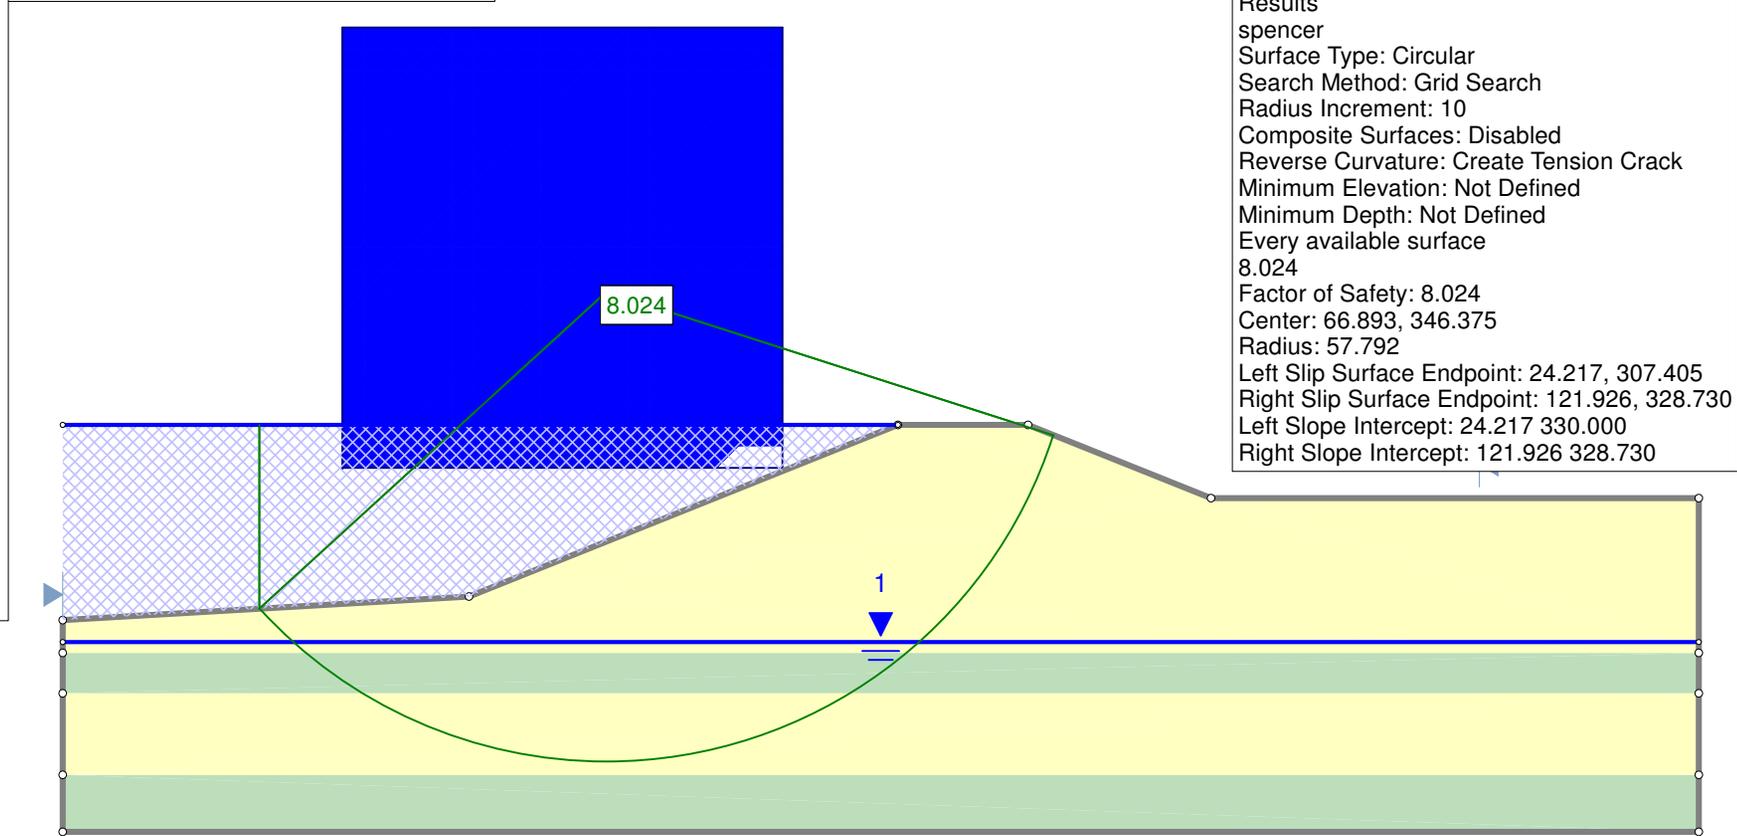
Luminant - Martin Lake Emergency Ash Pond  
West Ash Pond -West Slope -Full\_Undrained

Results  
spencer  
Surface Type: Circular  
Search Method: Grid Search  
Radius Increment: 10  
Composite Surfaces: Disabled  
Reverse Curvature: Create Tension Crack  
Minimum Elevation: Not Defined  
Minimum Depth: Not Defined  
Every available surface  
8.024  
Factor of Safety: 8.024  
Center: 66.893, 346.375  
Radius: 57.792  
Left Slip Surface Endpoint: 24.217, 307.405  
Right Slip Surface Endpoint: 121.926, 328.730  
Left Slope Intercept: 24.217 330.000  
Right Slope Intercept: 121.926 328.730

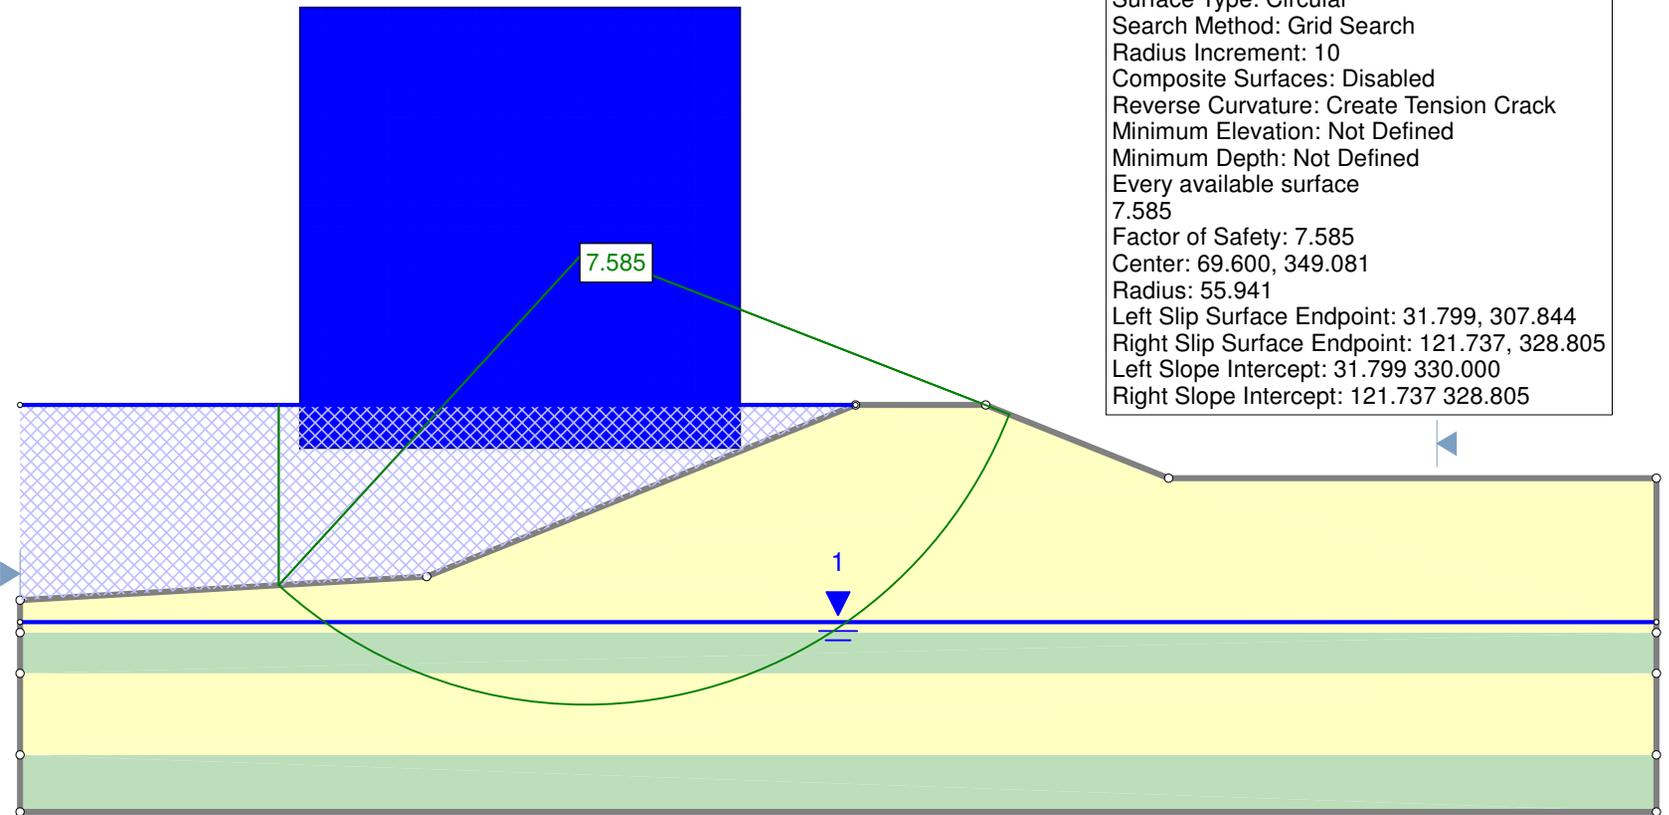
Luminant - Martin Lake Emergency Ash Pond  
West Ash Pond -West Slope -Full\_Drained

Results  
 spencer  
 Surface Type: Circular  
 Search Method: Grid Search  
 Radius Increment: 10  
 Composite Surfaces: Disabled  
 Reverse Curvature: Create Tension Crack  
 Minimum Elevation: Not Defined  
 Minimum Depth: Not Defined  
 Every available surface  
 7.585  
 Factor of Safety: 7.585  
 Center: 69.600, 349.081  
 Radius: 55.941  
 Left Slip Surface Endpoint: 31.799, 307.844  
 Right Slip Surface Endpoint: 121.737, 328.805  
 Left Slope Intercept: 31.799 330.000  
 Right Slope Intercept: 121.737 328.805

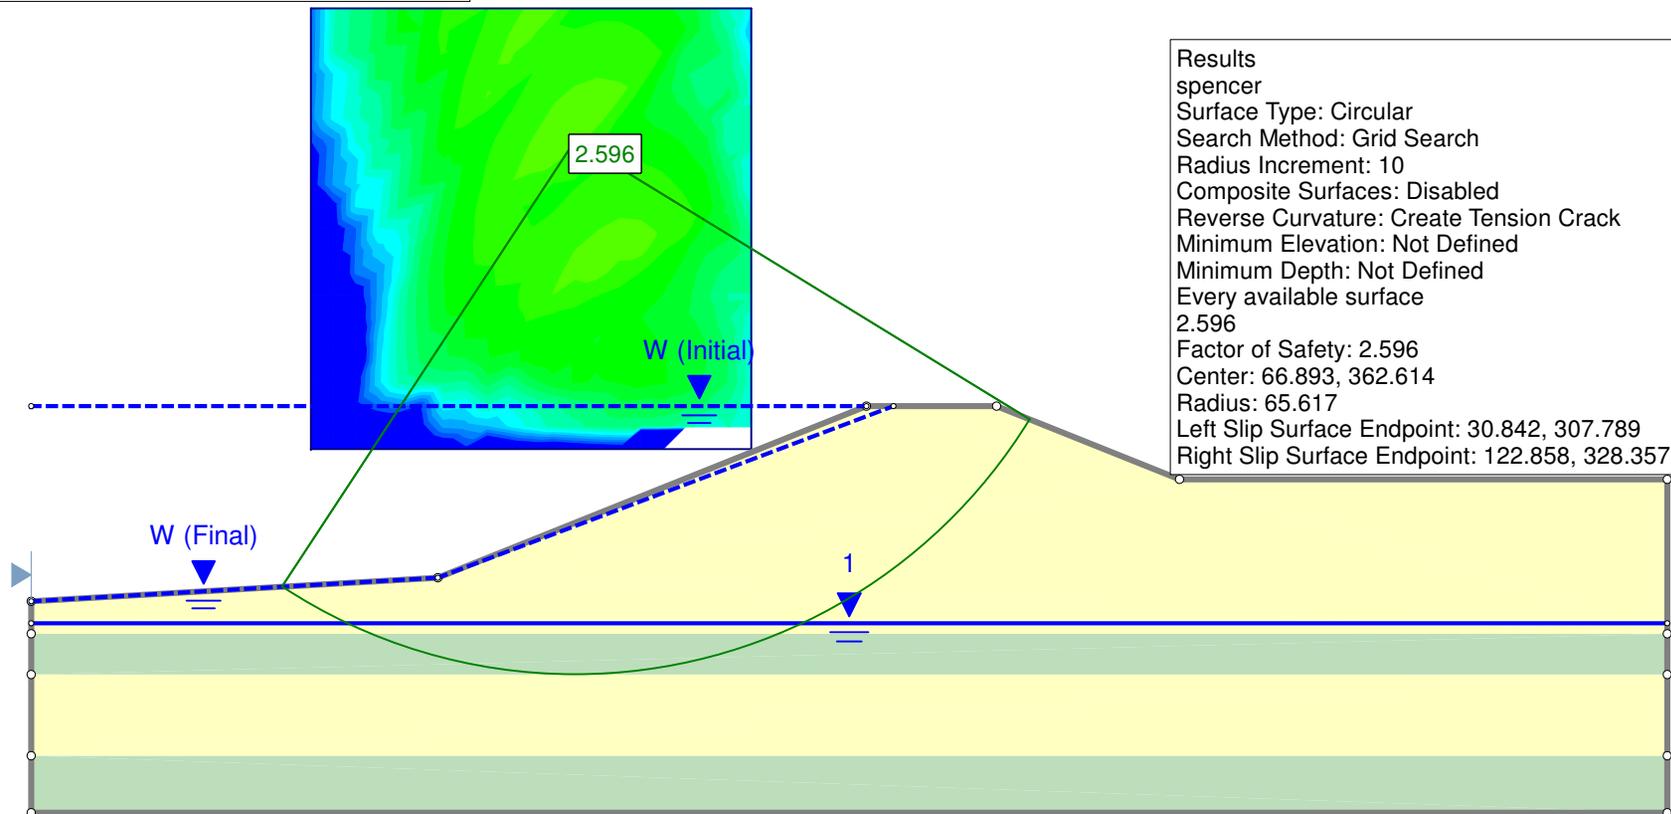
Luminant - Martin Lake Emergency Ash Pond  
West Ash Pond -West Slope -Rapid DD\_Drained

Results  
 spencer  
 Surface Type: Circular  
 Search Method: Grid Search  
 Radius Increment: 10  
 Composite Surfaces: Disabled  
 Reverse Curvature: Create Tension Crack  
 Minimum Elevation: Not Defined  
 Minimum Depth: Not Defined  
 Every available surface  
 2.596  
 Factor of Safety: 2.596  
 Center: 66.893, 362.614  
 Radius: 65.617  
 Left Slip Surface Endpoint: 30.842, 307.789  
 Right Slip Surface Endpoint: 122.858, 328.357

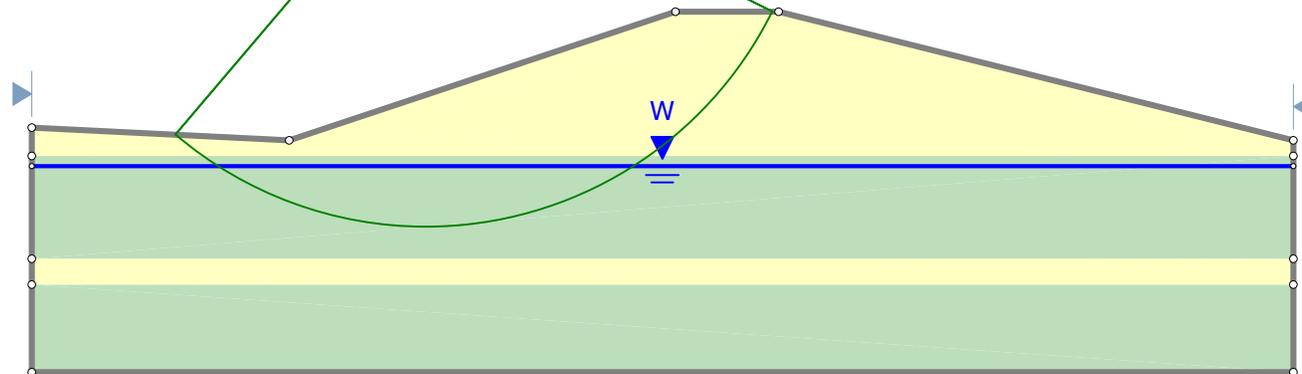
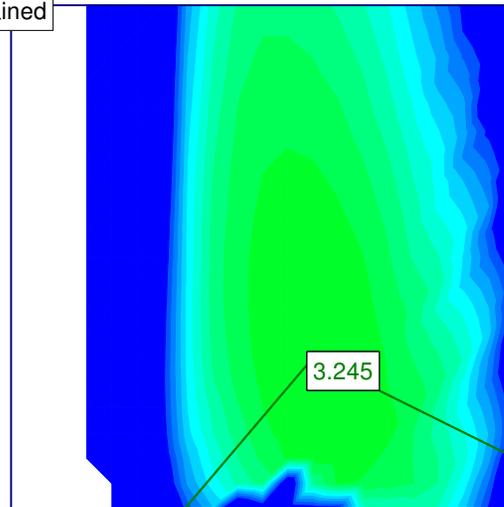
Luminant - Martin Lake Ash Ponds  
PDP4\_ South Slope\_Empty\_Undrained

Results  
 spencer  
 Surface Type: Circular  
 Search Method: Grid Search  
 Radius Increment: 10  
 Composite Surfaces: Disabled  
 Reverse Curvature: Create Tension Crack  
 Minimum Elevation: Not Defined  
 Minimum Depth: Not Defined  
 Every available surface  
 3.245  
 Factor of Safety: 3.245  
 Center: 76.562, 393.356  
 Radius: 75.170  
 Left Slip Surface Endpoint: 27.848, 336.108  
 Right Slip Surface Endpoint: 143.926, 360.000

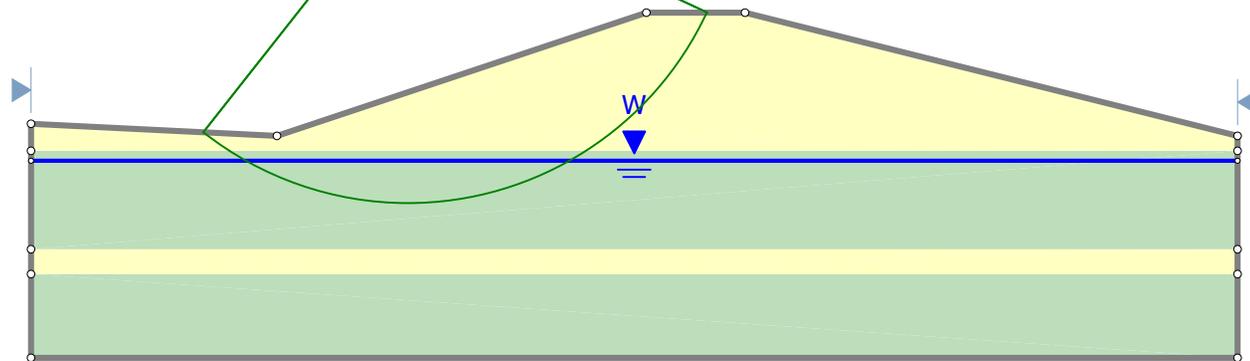
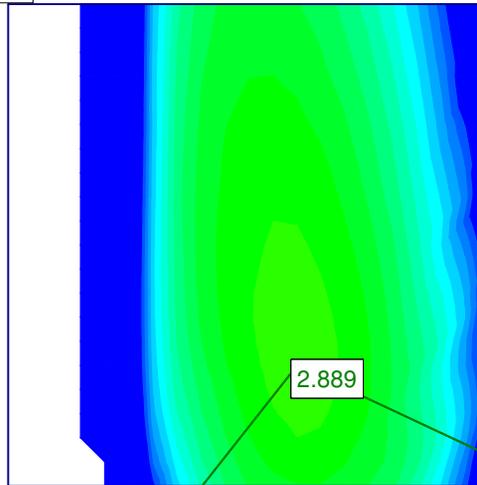
Luminant - Martin Lake Ash Ponds  
PDP4\_ South Slope\_Empty\_Drained

Results  
spencer  
Surface Type: Circular  
Search Method: Grid Search  
Radius Increment: 10  
Composite Surfaces: Disabled  
Reverse Curvature: Create Tension Crack  
Minimum Elevation: Not Defined  
Minimum Depth: Not Defined  
Every available surface  
2.889  
Factor of Safety: 2.889  
Center: 76.562, 388.470  
Radius: 67.152  
Left Slip Surface Endpoint: 34.968, 335.752  
Right Slip Surface Endpoint: 137.380, 360.000

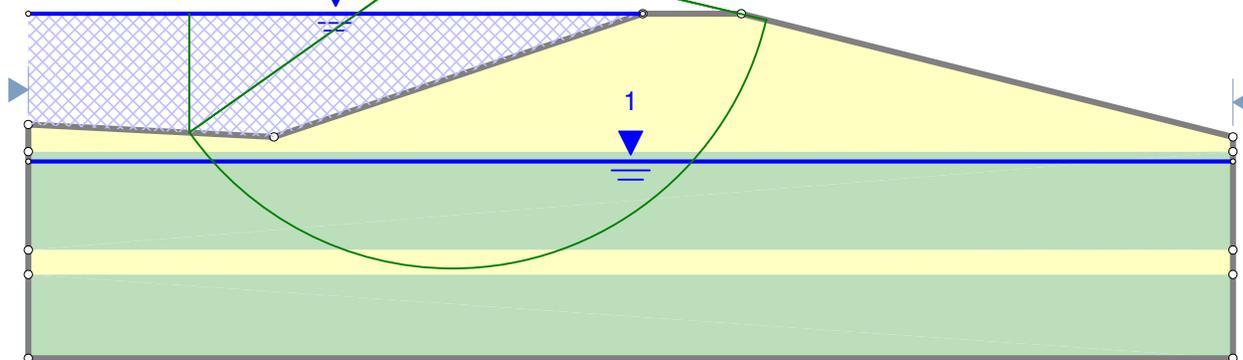
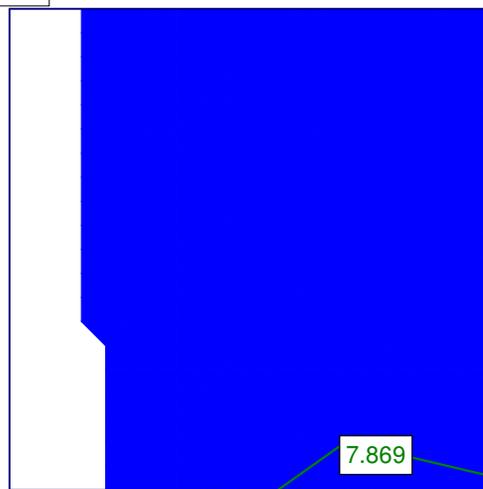
Luminant - Martin Lake Ash Ponds  
PDP4\_ South Slope\_Empty\_Undrained

Results  
 spencer  
 Surface Type: Circular  
 Search Method: Grid Search  
 Radius Increment: 10  
 Composite Surfaces: Disabled  
 Reverse Curvature: Create Tension Crack  
 Minimum Elevation: Not Defined  
 Minimum Depth: Not Defined  
 Every available surface  
 7.869  
 Factor of Safety: 7.869  
 Center: 86.335, 373.811  
 Radius: 65.645  
 Left Slip Surface Endpoint: 32.772, 335.861  
 Right Slip Surface Endpoint: 150.216, 358.696  
 Left Slope Intercept: 32.772 360.000  
 Right Slope Intercept: 150.216 358.696

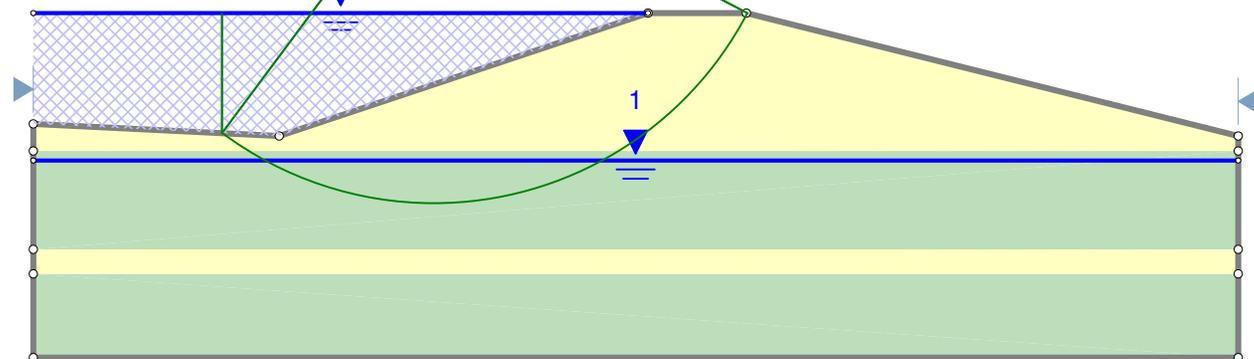
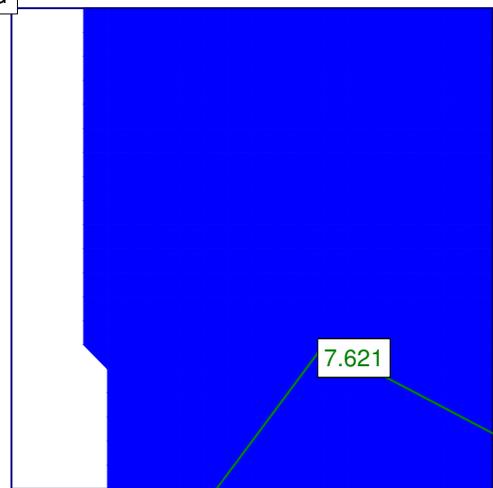
Luminant - Martin Lake Ash Ponds  
PDP4\_ South Slope\_Full\_Drained

Results  
 spencer  
 Surface Type: Circular  
 Search Method: Grid Search  
 Radius Increment: 10  
 Composite Surfaces: Disabled  
 Reverse Curvature: Create Tension Crack  
 Minimum Elevation: Not Defined  
 Minimum Depth: Not Defined  
 Every available surface  
 7.621  
 Factor of Safety: 7.621  
 Center: 81.449, 393.356  
 Radius: 72.089  
 Left Slip Surface Endpoint: 38.331, 335.583  
 Right Slip Surface Endpoint: 145.315, 359.921  
 Left Slope Intercept: 38.331 360.000  
 Right Slope Intercept: 145.315 359.921
