**Coal Combustion Residue Impoundment**

**Round 12 - Dam Assessment Report**

*Martin Lake Steam Electric Plant*

**Tatum, Texas**

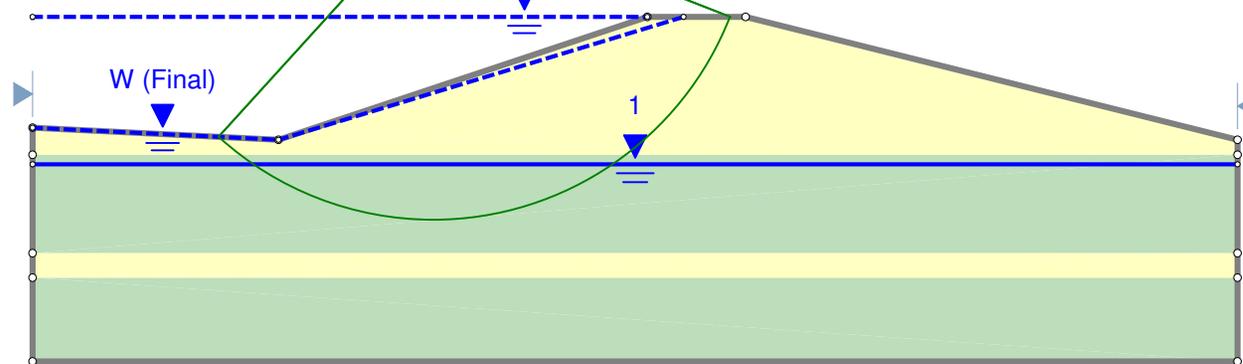
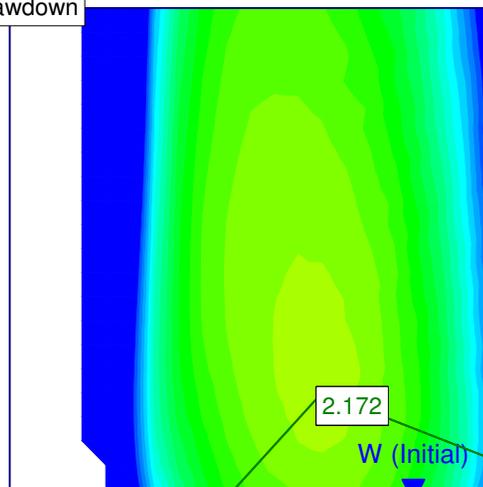
Luminant - Martin Lake Ash Ponds  
PDP4\_ South Slope\_ Rapid Drawdown

Results  
 spencer  
 Surface Type: Circular  
 Search Method: Grid Search  
 Radius Increment: 10  
 Composite Surfaces: Disabled  
 Reverse Curvature: Create Tension Crack  
 Minimum Elevation: Not Defined  
 Minimum Depth: Not Defined  
 Every available surface  
 2.172  
 Factor of Safety: 2.172  
 Center: 81.449, 383.584  
 Radius: 64.864  
 Left Slip Surface Endpoint: 37.792, 335.610  
 Right Slip Surface Endpoint: 141.873, 360.000
