SUBJECT: EPA Comments on "Assessment of Dam Safety of Coal Combustion Surface  
Impoundments: Luminant Generation Co., LLC – Monticello Steam Electric Station,  
Mount Pleasant, TX

DATE: April 7, 2014

US EPA  
 DAM SAFETY ASSESSMENT  
 OF CCW IMPOUNDMENTS  
 LUMINANT ENERGY  
 MONTICELLO STEAM  
 ELECTRIC STATION  
 TITUS COUNTY, TEXAS

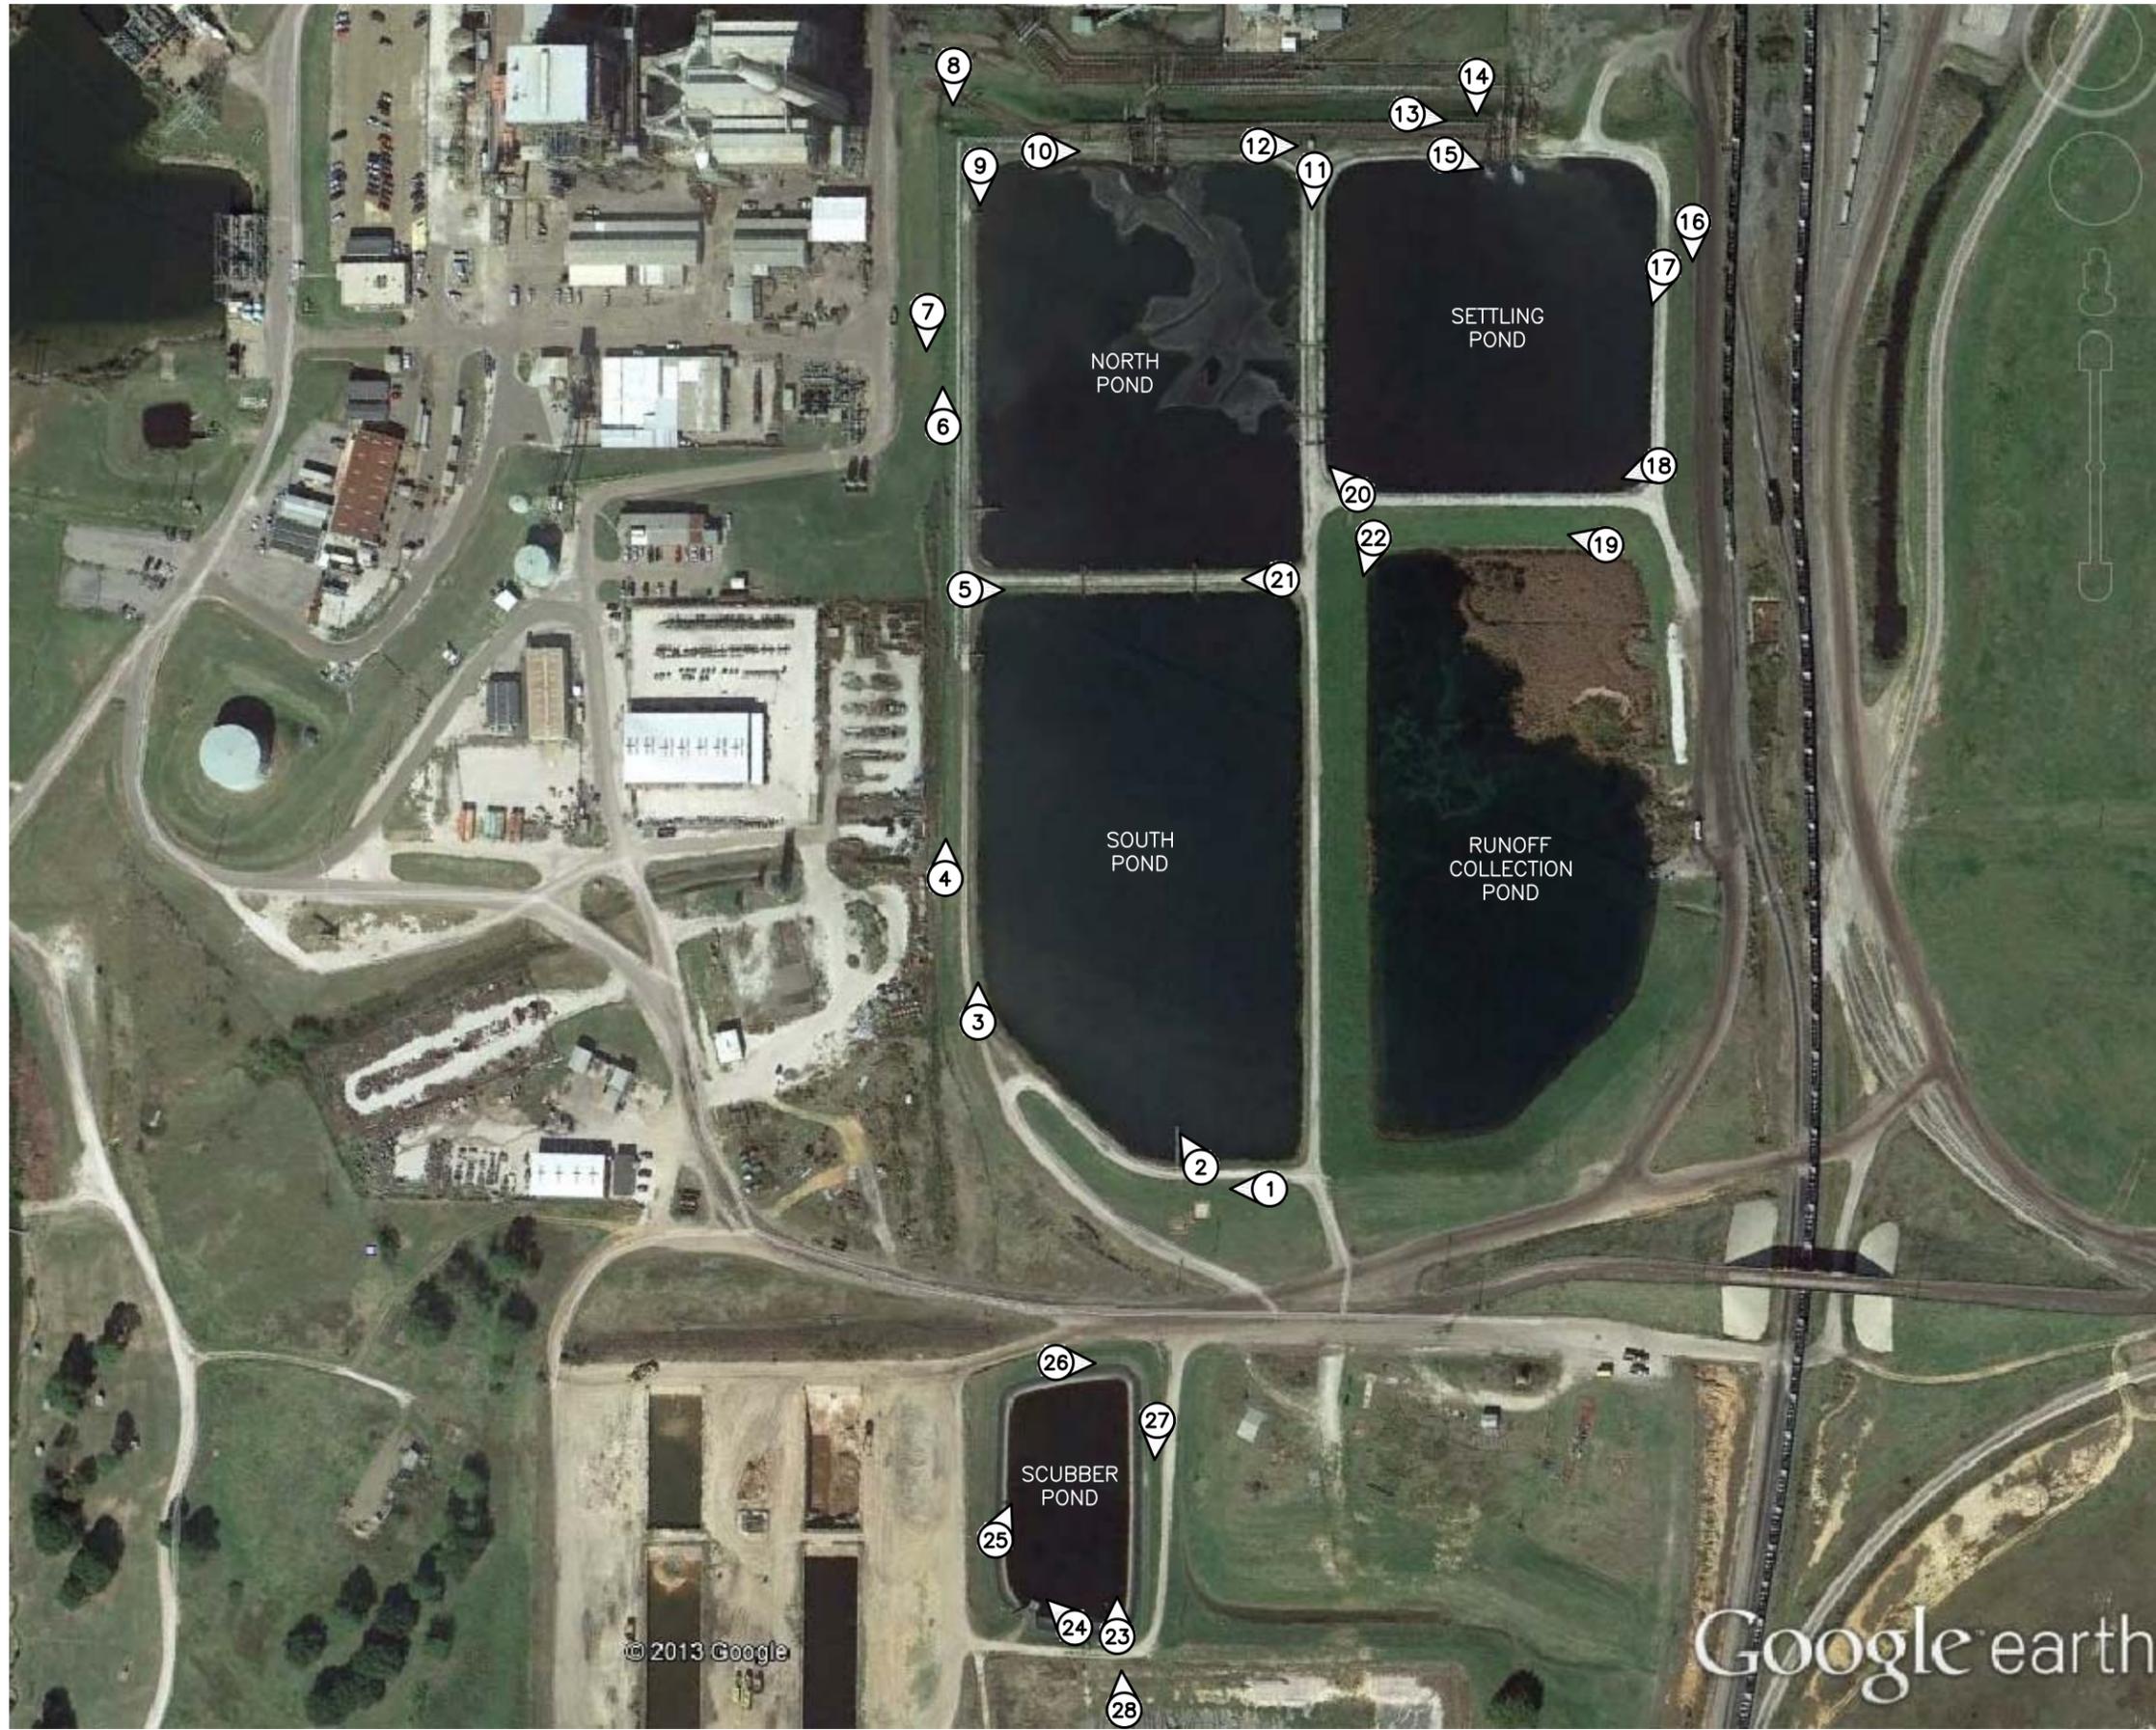
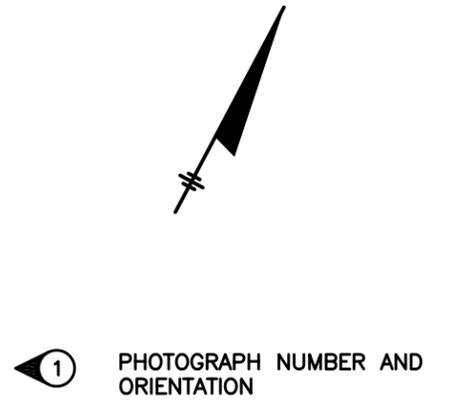
FIGURE 2

**SITE AERIAL PHOTOGRAPH  
 AND PHOTOGRAPH  
 LOCATION MAP**

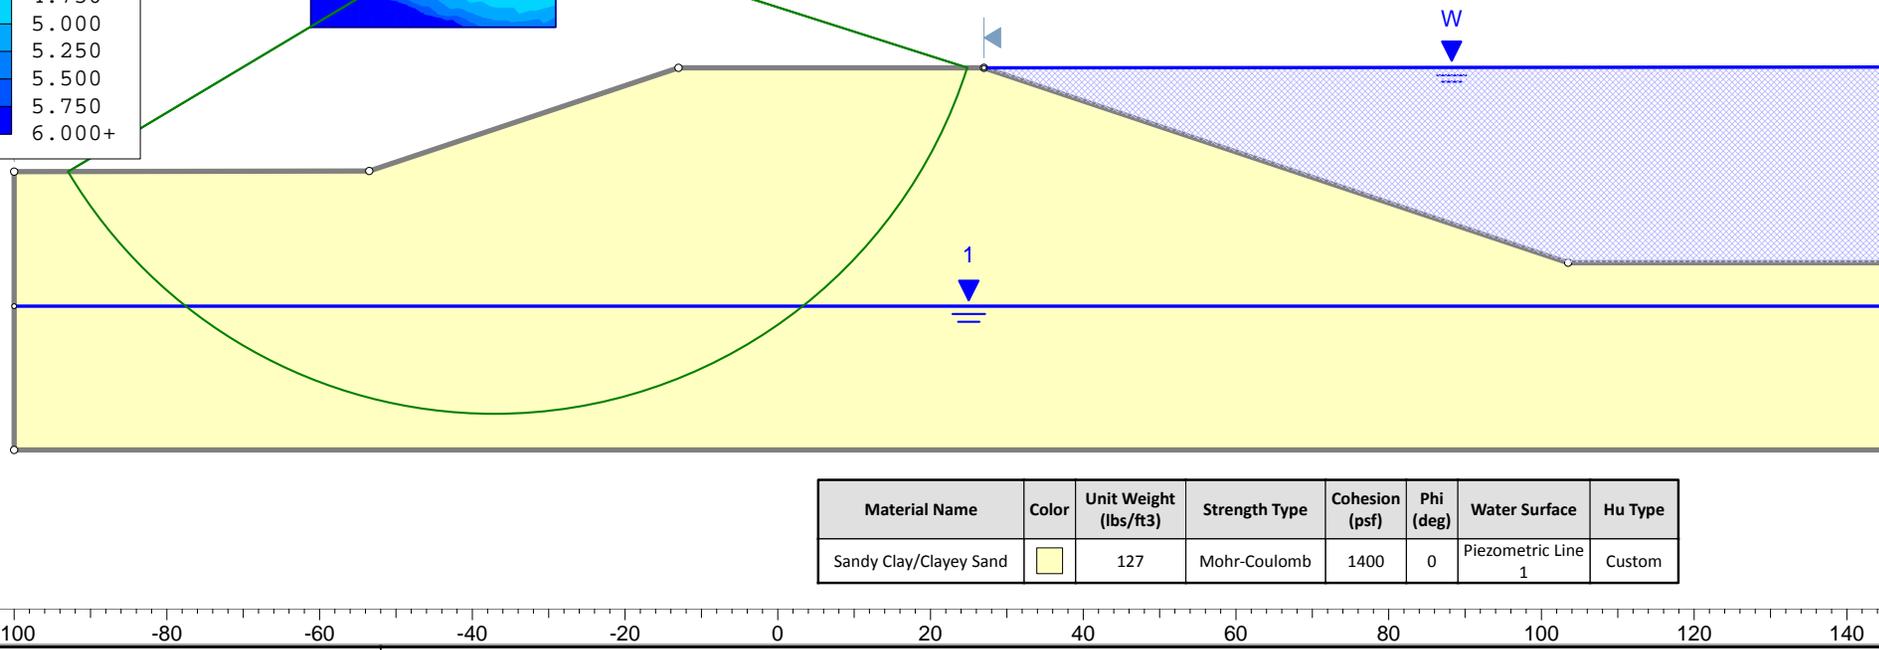
Luminant - Monticello Ash Ponds  
Settling Pond Exterior Slope\_Full\_Undrained

spencer  
 Surface Type: Circular  
 Search Method: Grid Search  
 Radius Increment: 10  
 Composite Surfaces: Disabled  
 Reverse Curvature: Create Tension Crack  
 Minimum Elevation: Not Defined  
 Minimum Depth: Not Defined  
 Every available surface  
 4.710  
 Factor of Safety: 4.710  
 Center: -37.090, 406.238  
 Radius: 65.025  
 Left Slip Surface Endpoint: -92.932, 372.922  
 Right Slip Surface Endpoint: 24.867, 386.500

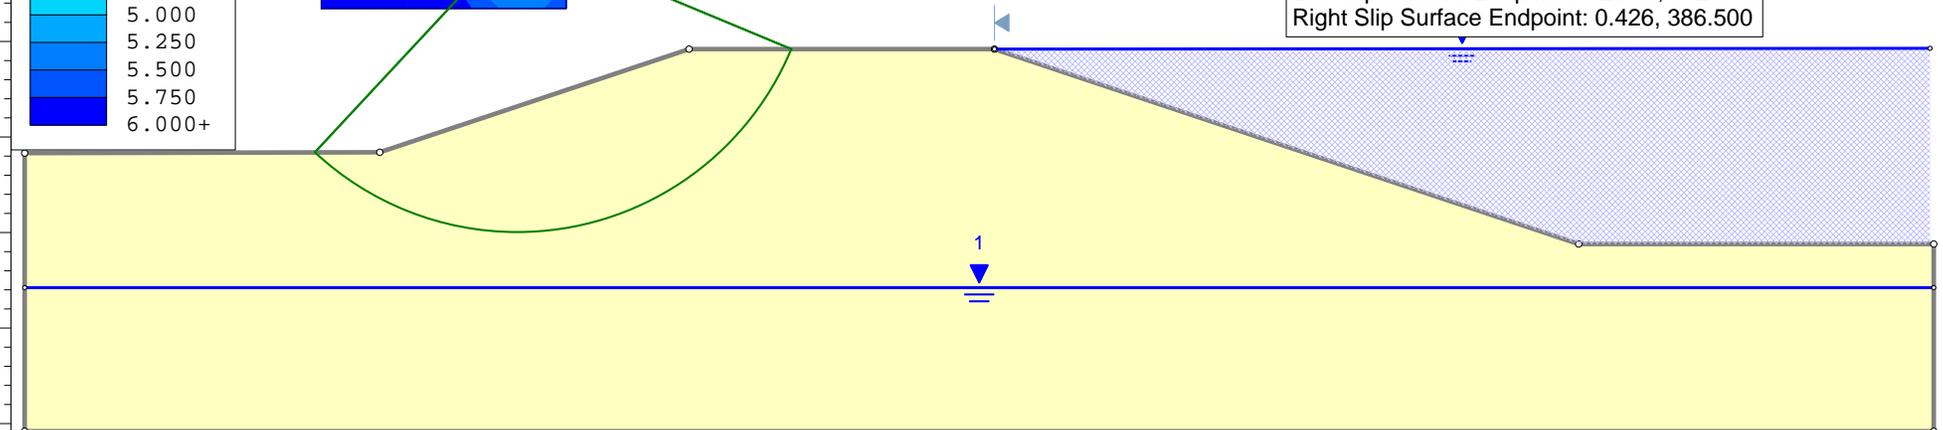
Luminant - Monticello Ash Ponds  
Settling Pond Exterior Slope\_Full\_Drained

Results  
 spencer  
 Surface Type: Circular  
 Search Method: Grid Search  
 Radius Increment: 10  
 Composite Surfaces: Disabled  
 Reverse Curvature: Create Tension Crack  
 Minimum Elevation: Not Defined  
 Minimum Depth: Not Defined  
 Every available surface  
 5.196  
 Factor of Safety: 5.196  
 Center: -35.488, 401.430  
 Radius: 38.893  
 Left Slip Surface Endpoint: -62.011, 372.983  
 Right Slip Surface Endpoint: 0.426, 386.500

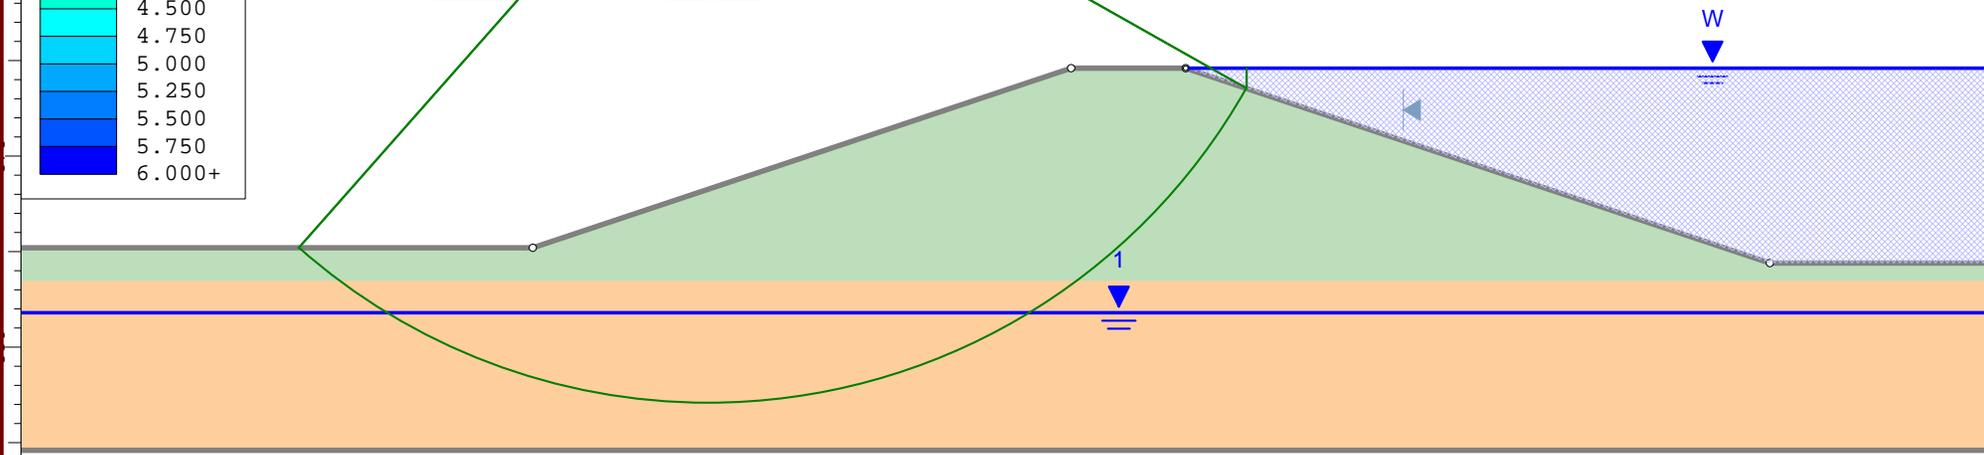
Luminant - Monticello Ash Ponds  
South Pond Exterior Slope \_Full\_Undrained

Results  
 spencer  
 Surface Type: Circular  
 Search Method: Grid Search  
 Radius Increment: 10  
 Composite Surfaces: Disabled  
 Reverse Curvature: Create Tension Crack  
 Minimum Elevation: Not Defined  
 Minimum Depth: Not Defined  
 Every available surface  
 3.552  
 Factor of Safety: 3.552  
 Center: -50.515, 423.648  
 Radius: 80.954  
 Left Slip Surface Endpoint: -104.137, 363.000  
 Right Slip Surface Endpoint: 19.976, 383.841  
 Left Slope Intercept: -104.137 363.000  
 Right Slope Intercept: 19.976 386.500

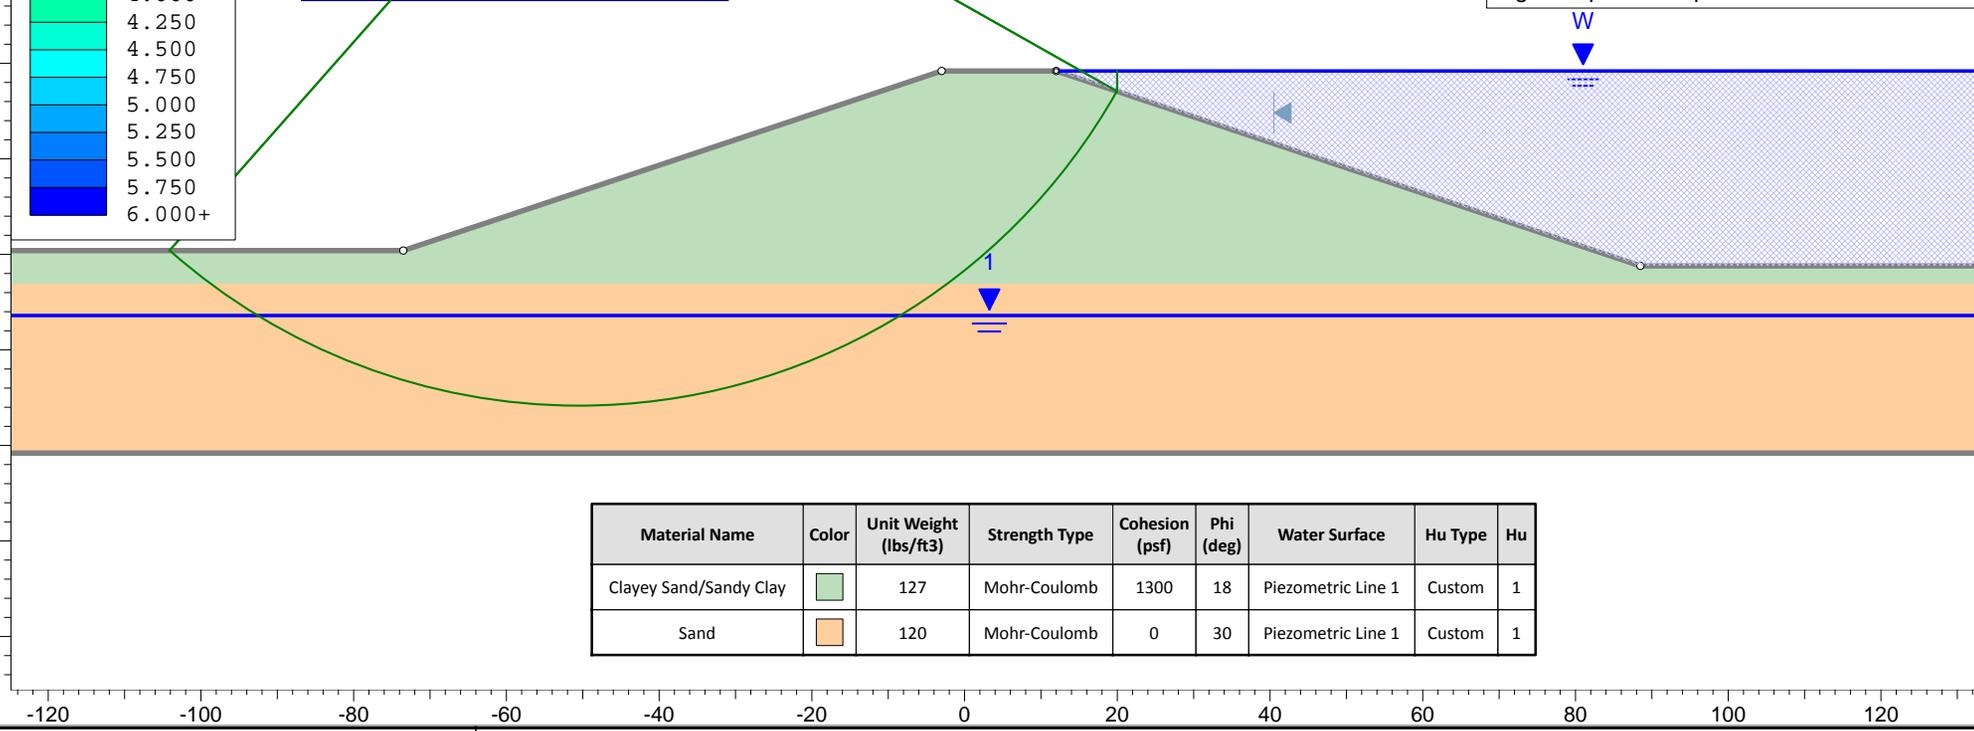
Luminant - Monticello Ash Ponds  
South Pond Exterior Slope \_Full\_Drained

Results  
 spencer  
 Surface Type: Circular  
 Search Method: Grid Search  
 Radius Increment: 10  
 Composite Surfaces: Disabled  
 Reverse Curvature: Create Tension Crack  
 Minimum Elevation: Not Defined  
 Minimum Depth: Not Defined  
 Every available surface  
 3.369  
 Factor of Safety: 3.369  
 Center: -50.515, 423.648  
 Radius: 80.954  
 Left Slip Surface Endpoint: -104.137, 363.000  
 Right Slip Surface Endpoint: 19.976, 383.841  
 Left Slope Intercept: -104.137 363.000  
 Right Slope Intercept: 19.976 386.500
