Dam Safety Assessment of CCW Impoundments

Luminant Generation Co., LLC/MONTICELLO STEAM ELECTRIC STATION

United States Environmental Protection Agency
Washington, DC

June 3, 2014

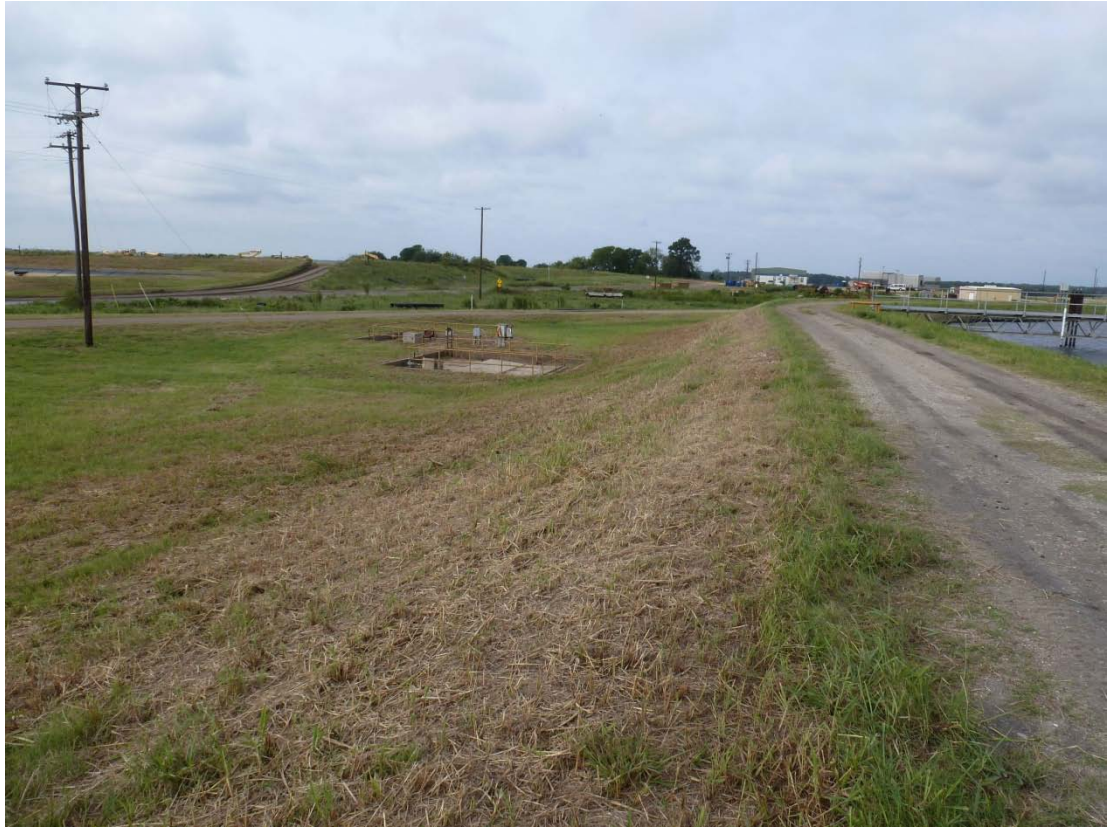
Date:
9/18/12
 Photo Number:
1
 Photographer:
NJA

Orientation:
E
 Description:
Southern
embankment of
the South Pond.

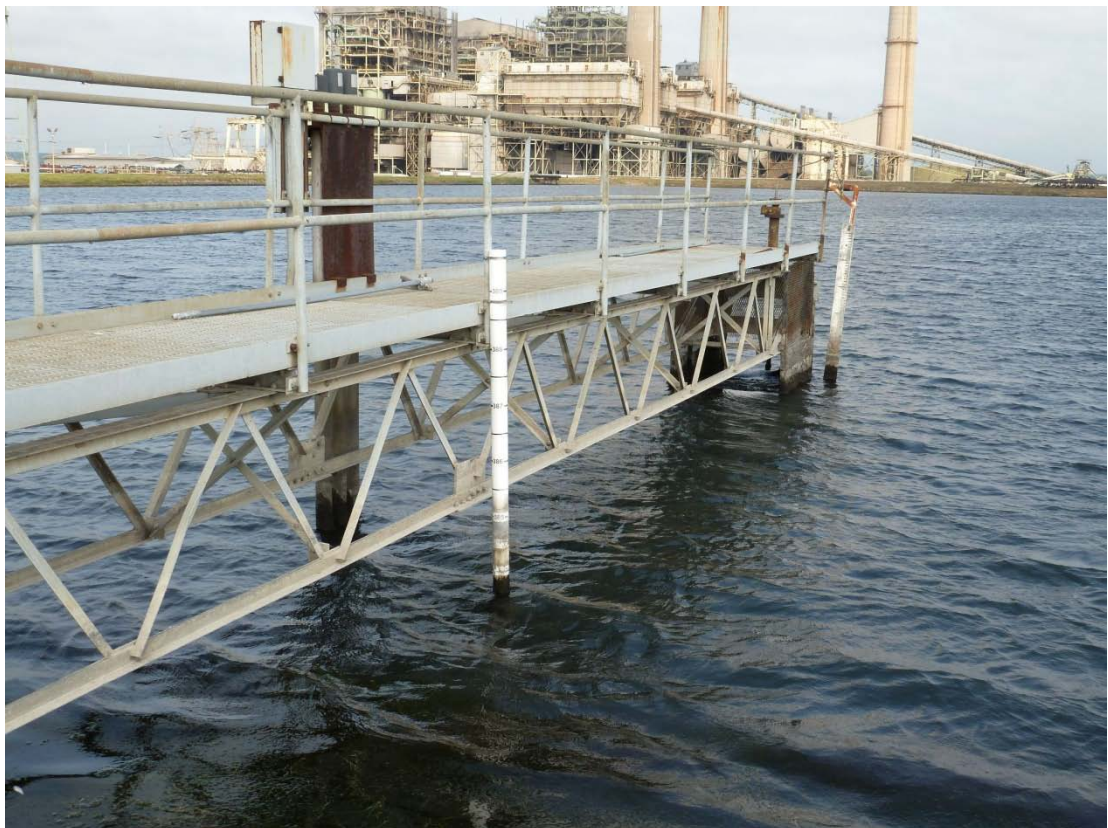
Date:
9/18/12
 Photo Number:
2
 Photographer:
NJA

The Bottom Ash and Scrubber Ponds do not have functioning outlet works. Luminant reported that pumps are used to draw water from the impoundments as needed. A concrete chamber located south of the South Pond was originally installed to allow discharge from the Bottom Ash Pond. Flow into the chamber was designed to be controlled by a valve housed in the South Pond. The valve is accessed via a walkway (see Photo 2). This system has reportedly never been used.

Orientation:
NW
 Description:
Access walkway
to gate
operator in the
South Pond.
Note staff
gages.

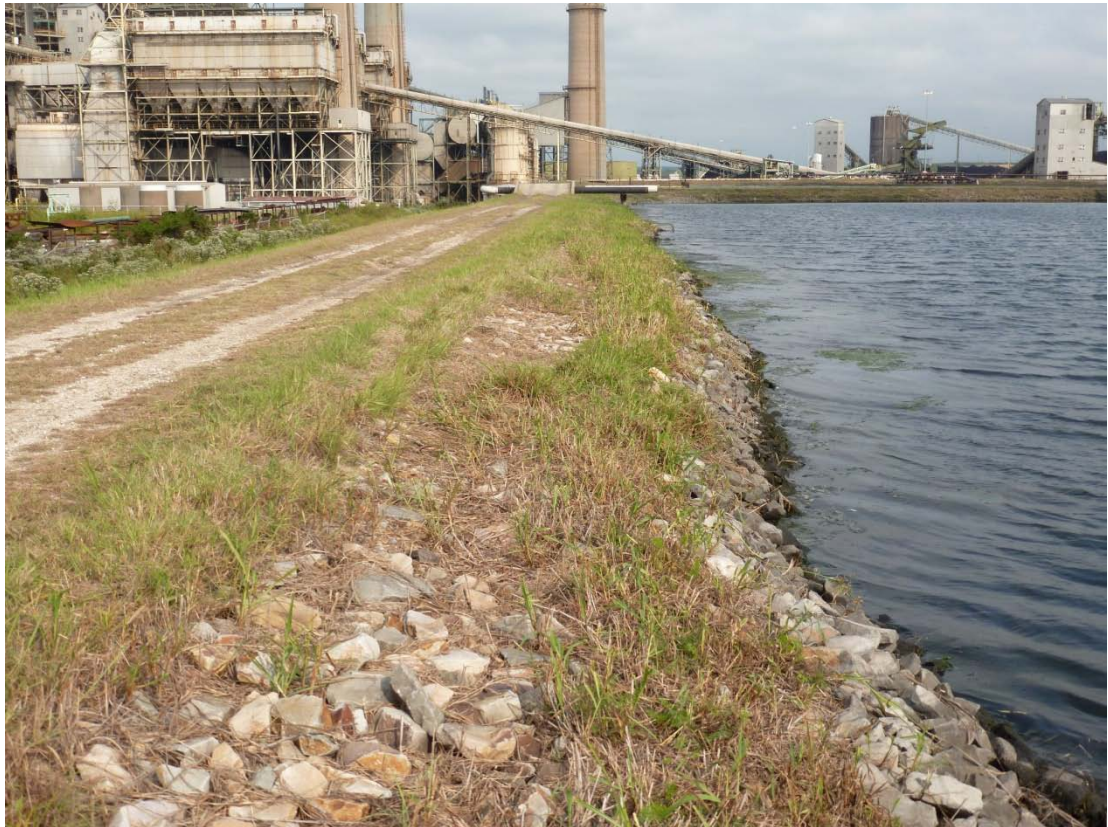
Photo Number:
3

Description:
Inboard face of the eastern embankment of the South Pond. Note riprap facing.

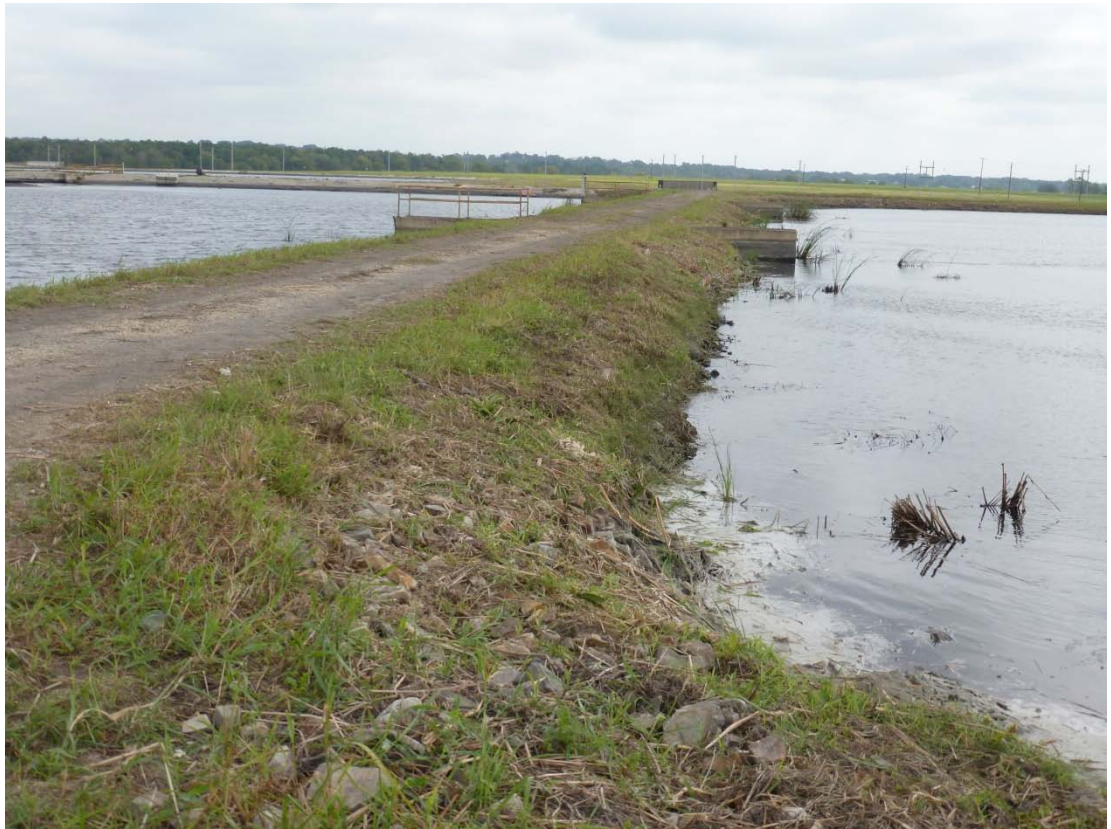
Photo Number:
5

Description:
Dividing dike between the North and South Ponds. Note equalizing channel.

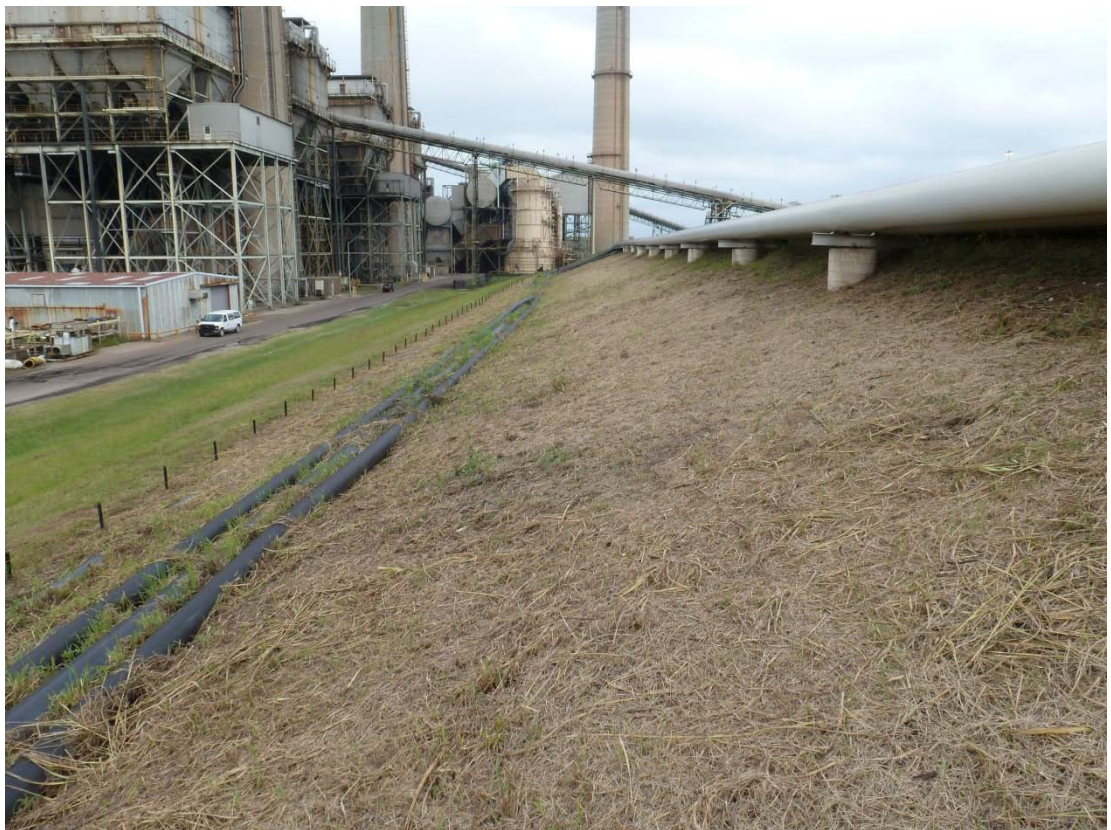
Photo Number:
6

Description:
Western embankment of North Pond

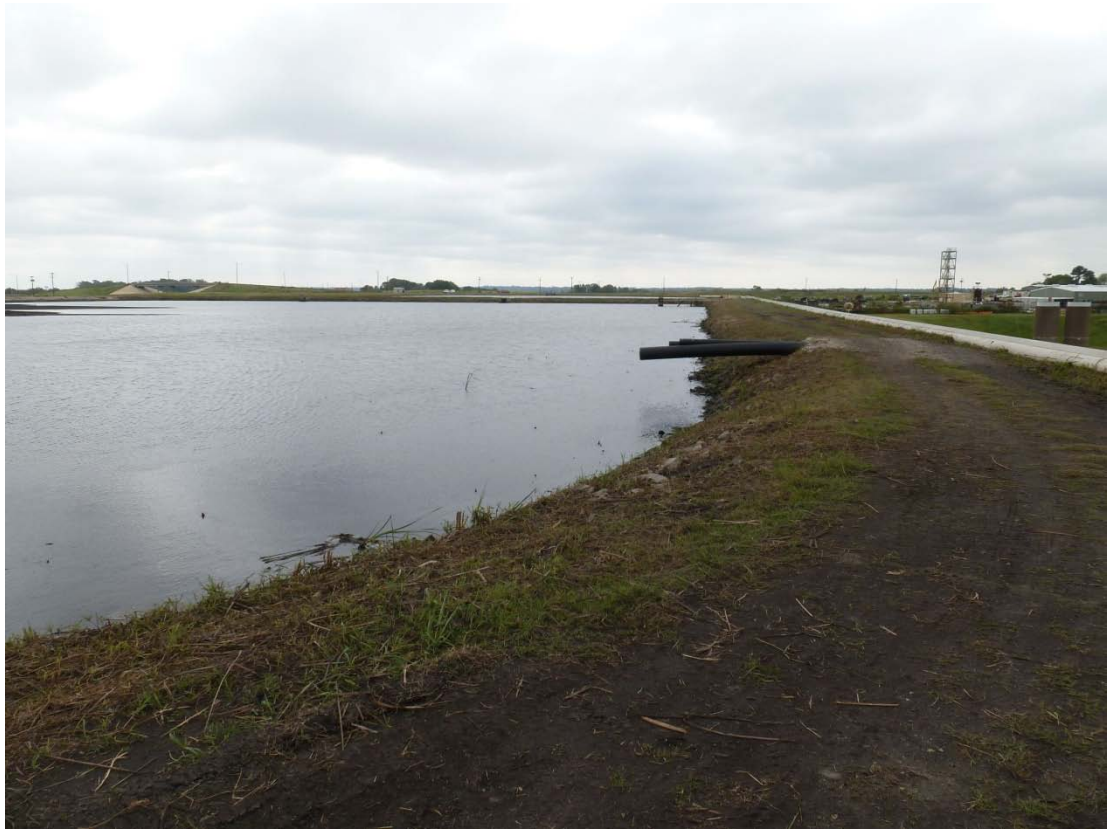
Photo Number:
9

Description:
Interior of North Pond.
Note discharge piping, currently not in use.

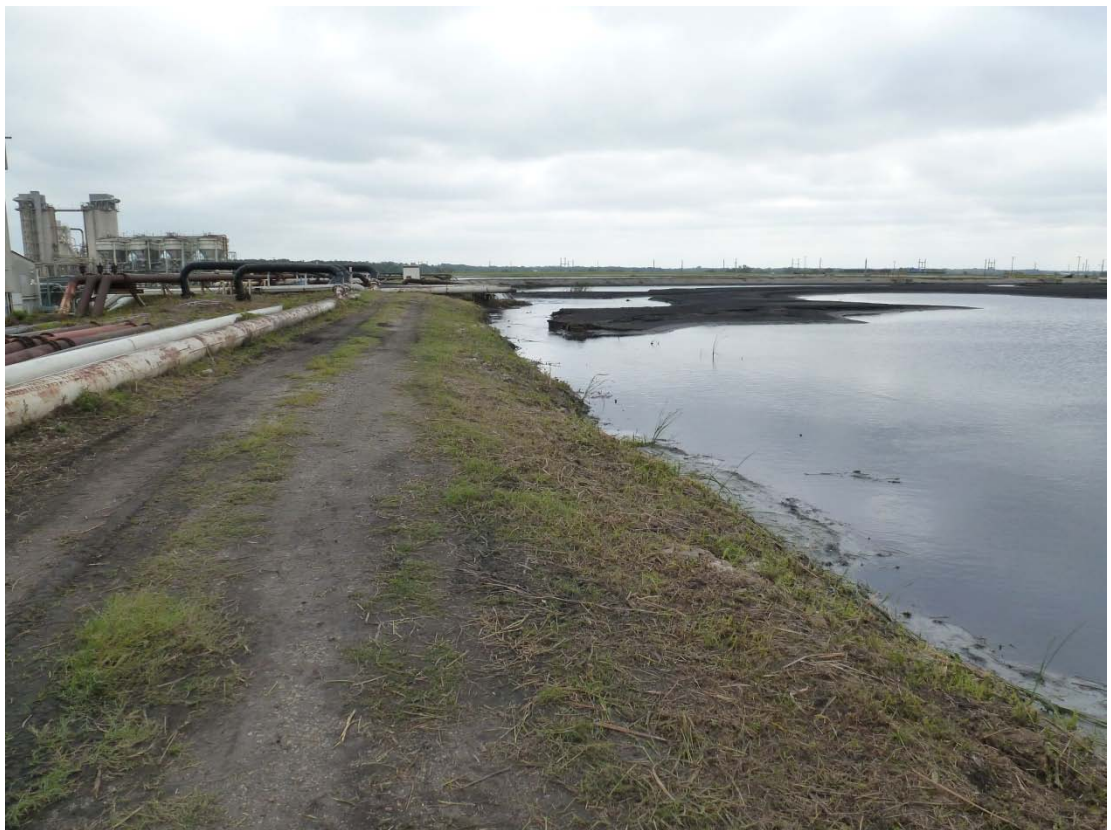
Photo Number:
10

Description:
Crest and interior of the North Pond.

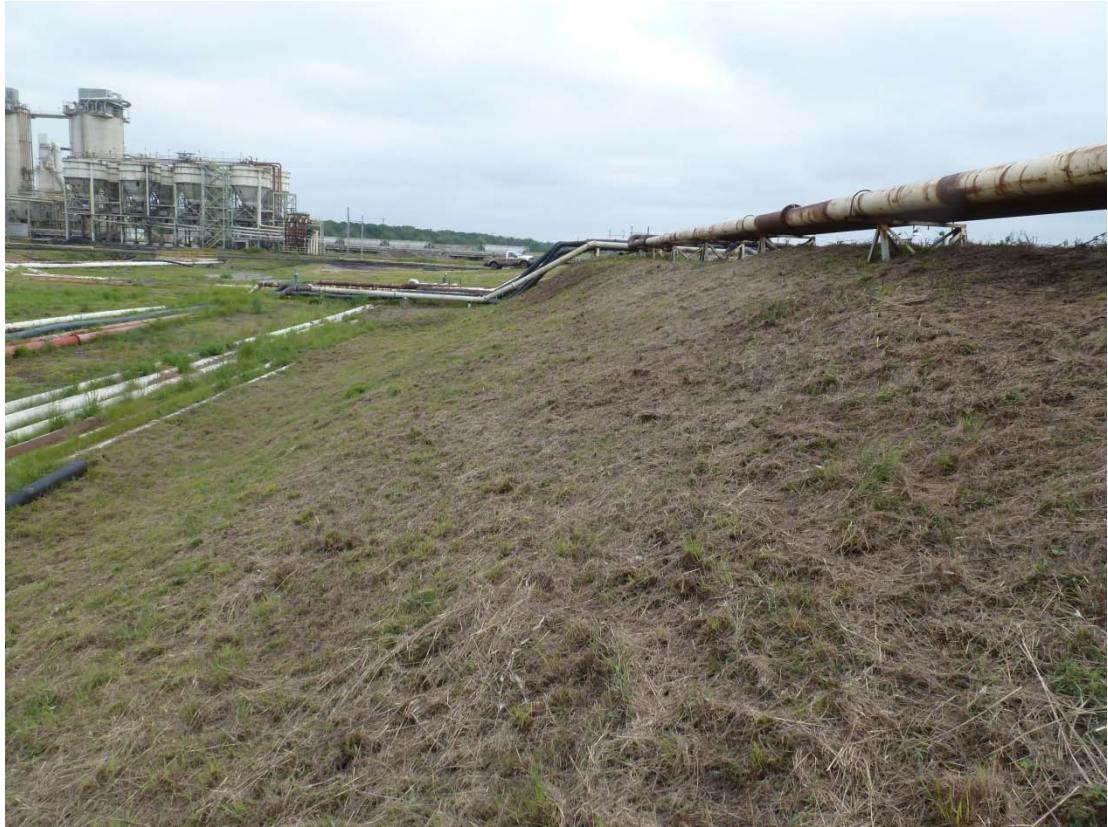
Photo Number:
14

Description:
Small erosion gully at the crest of the Settling Pond.

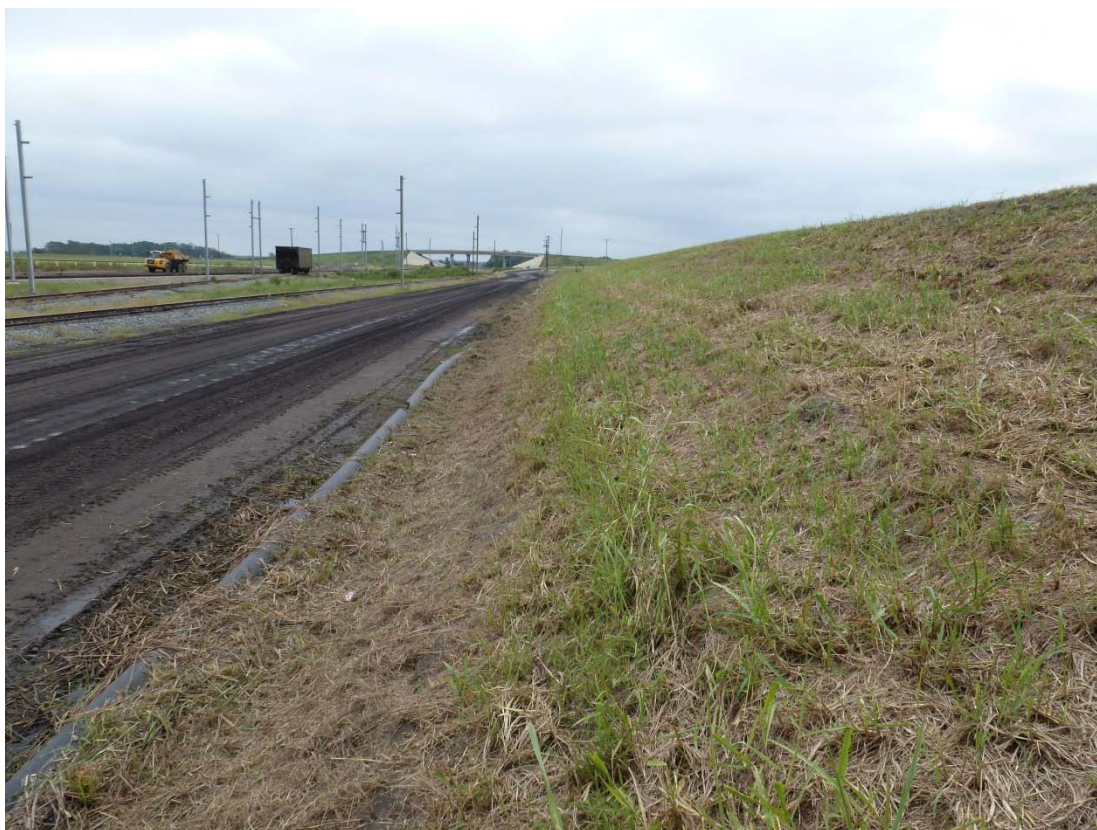
Photo Number:
16

Description:
Outboard face
of the eastern
embankment of
the Settling
Pond.

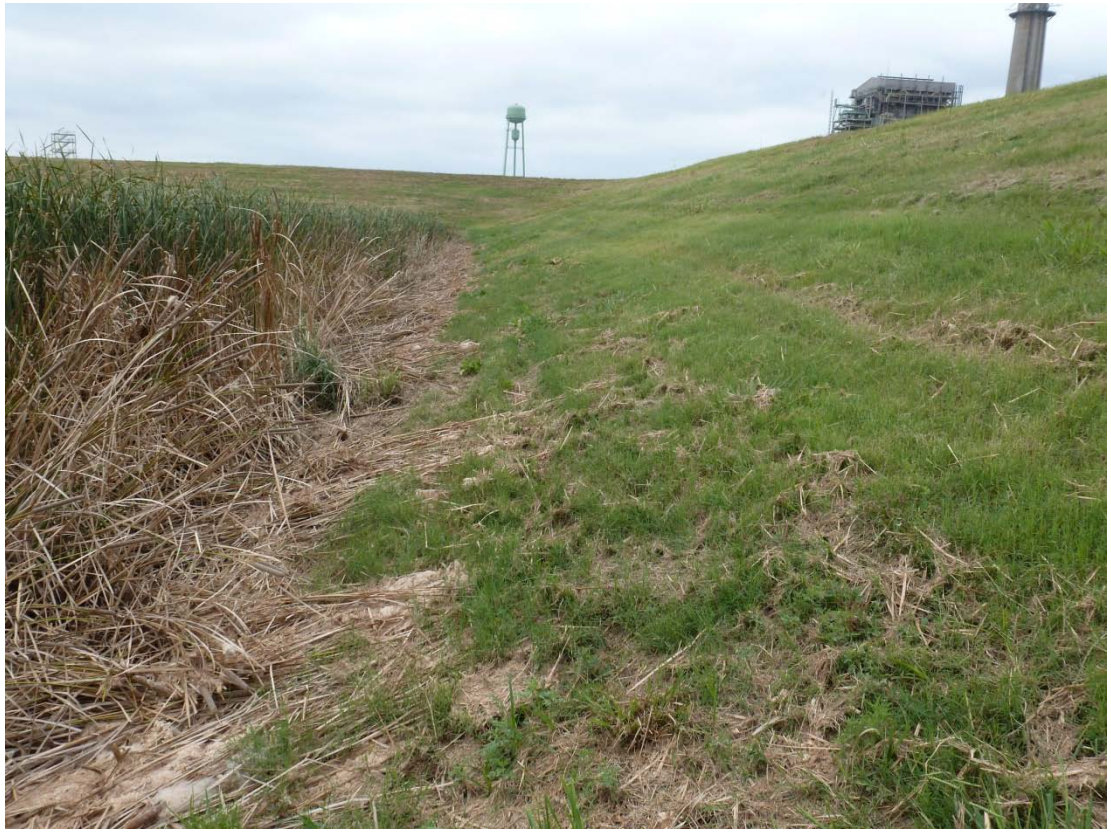
Photo Number:
19

Description:
Outboard face of the southern embankment of the Settling Pond. This embankment serves as the dividing dike between the Settling and Runoff Collection Ponds.

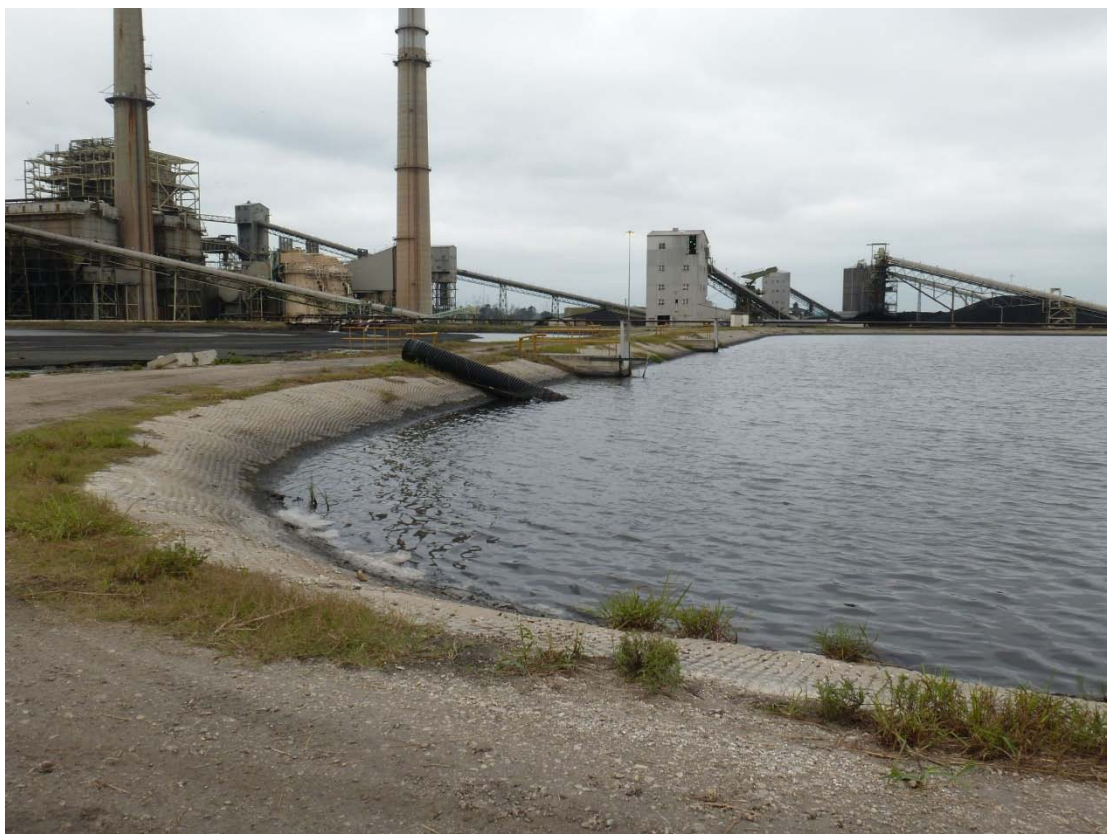
Photo Number:
20

Description:
Southwest corner of the Settling Pond.

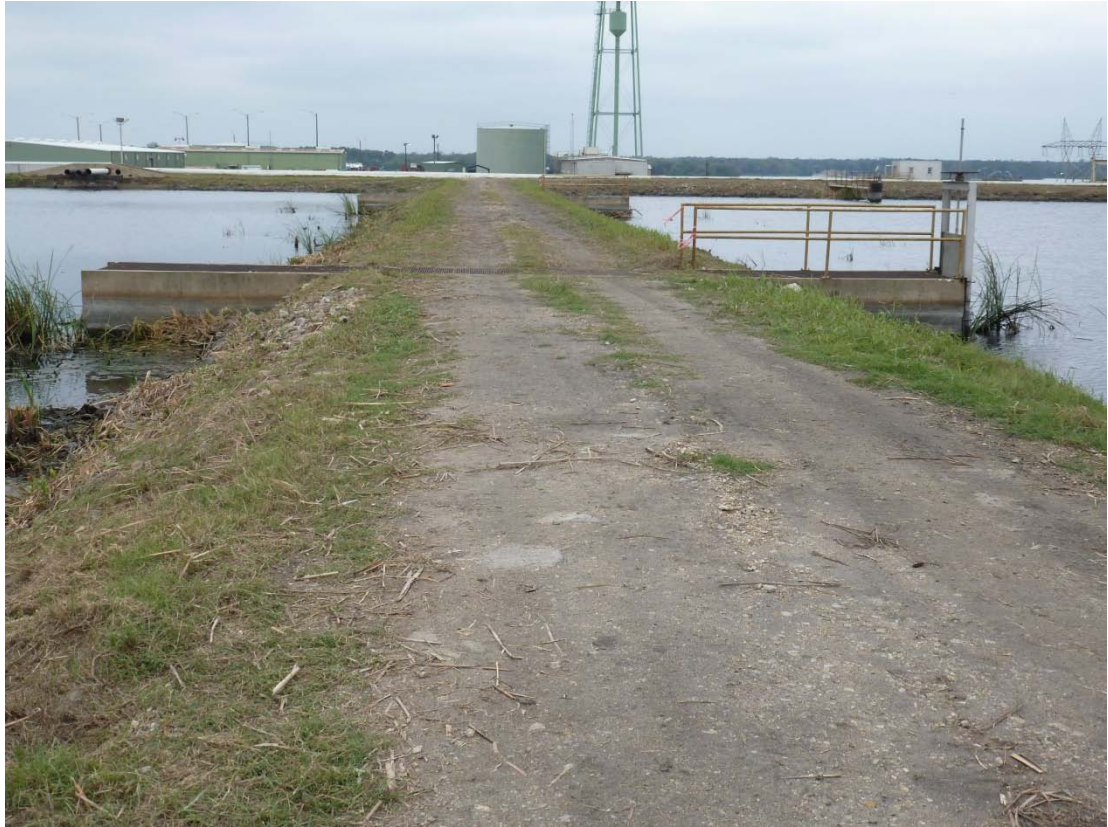
Photo Number:
21

Description:
Dividing dike between the North and South Ponds.

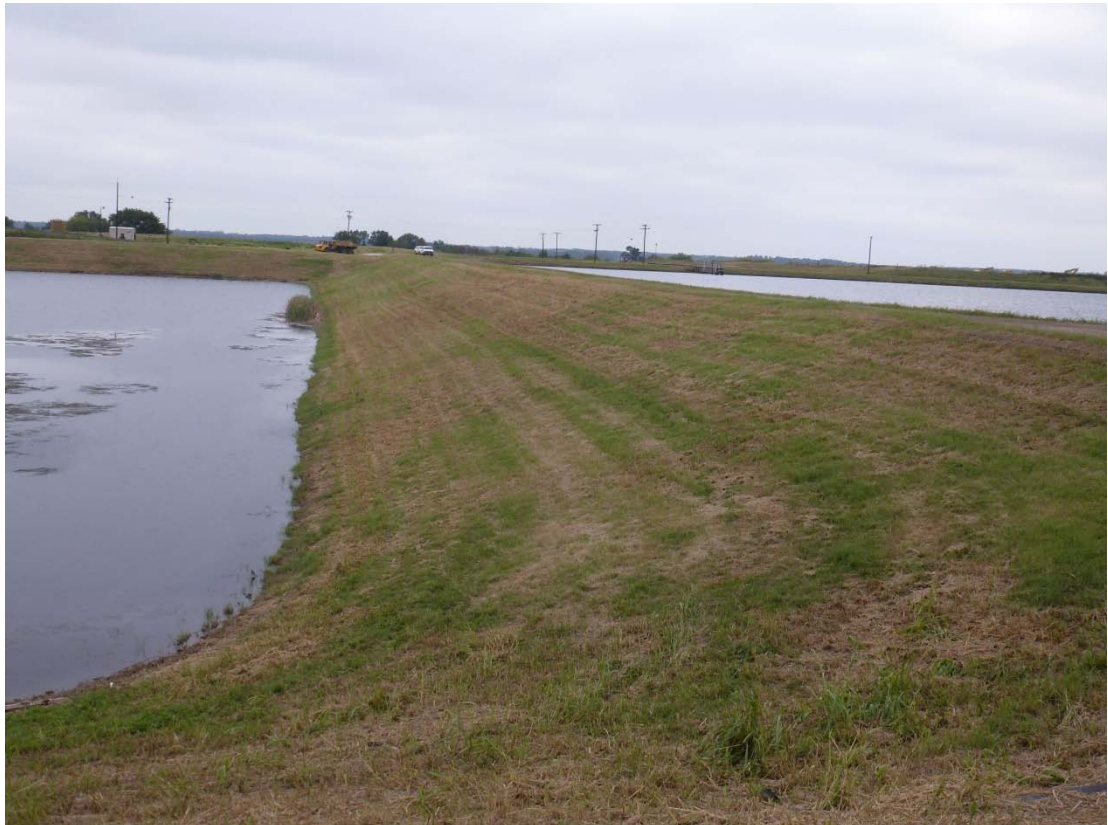
Photo Number:
22

Description:
Outboard face of the eastern embankment of the South Pond and the interior of the Runoff Collection Pond.

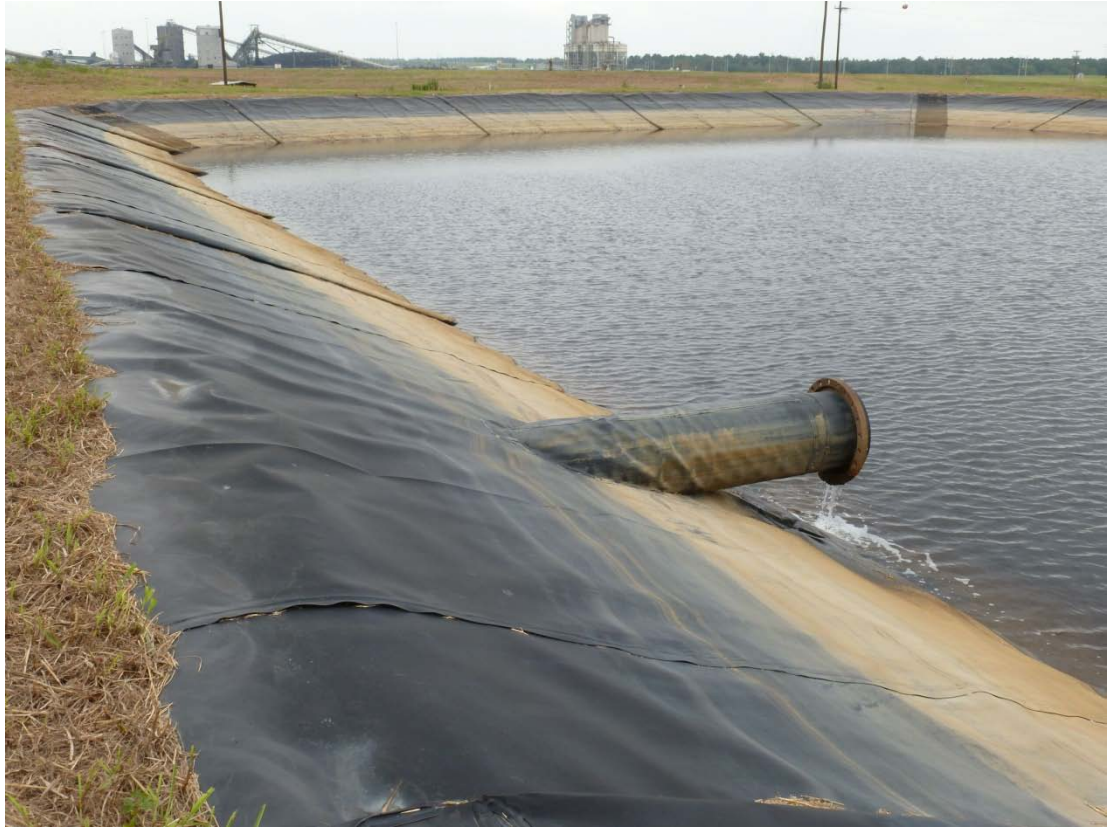
Photo Number:
25

Description:
Eastern inboard face of Scrubber Pond and inflow pipe.

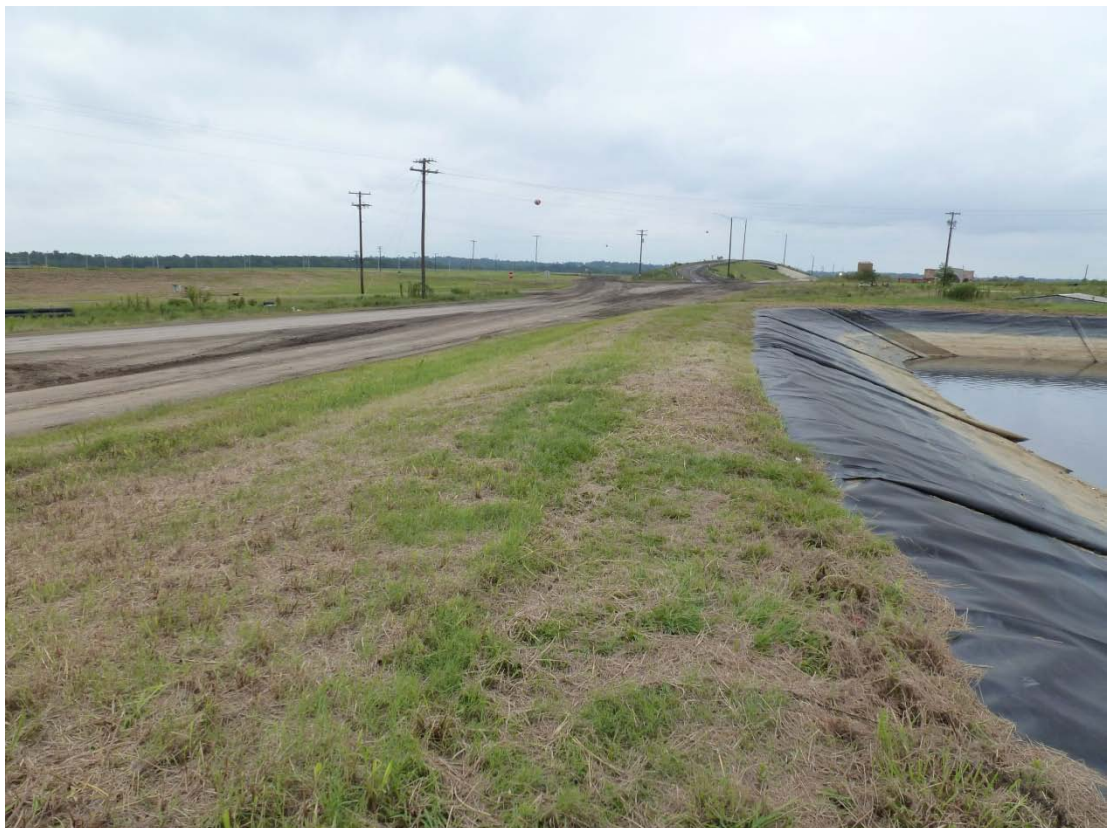
Photo Number:
26

Description:
Northern embankment of the Scrubber Pond.

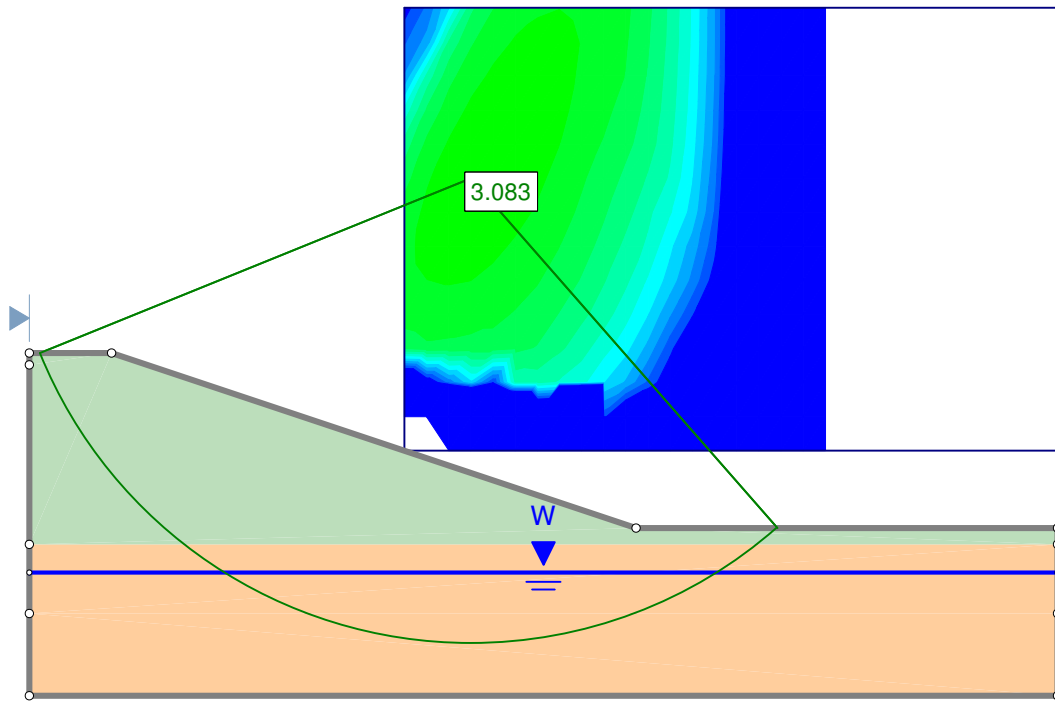
Luminant - Monticello Ash Ponds
South Pond Slope _Empty_Drained

spencer
 Surface Type: Circular
 Search Method: Grid Search
 Radius Increment: 10
 Composite Surfaces: Disabled
 Reverse Curvature: Create Tension Crack
 Minimum Elevation: Not Defined
 Minimum Depth: Not Defined
 Every available surface
 3.083
 Factor of Safety: 3.083
 Center: 64.412, 412.027
 Radius: 67.861
 Left Slip Surface Endpoint: 1.535, 386.500
 Right Slip Surface Endpoint: 109.149, 361.000

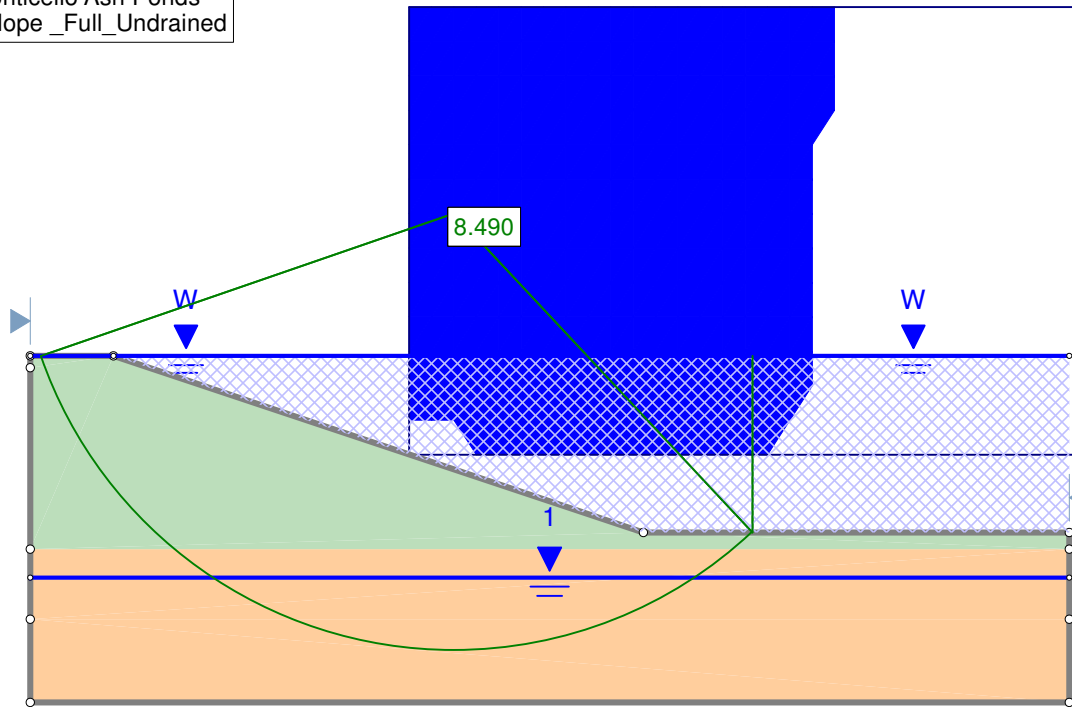
Luminant - Monticello Ash Ponds
South Pond Slope _Full_Undrained

spencer
 Surface Type: Circular
 Search Method: Grid Search
 Radius Increment: 10
 Composite Surfaces: Disabled
 Reverse Curvature: Create Tension Crack
 Minimum Elevation: Not Defined
 Minimum Depth: Not Defined
 Every available surface
 8.490
 Factor of Safety: 8.490
 Center: 61.180, 407.056
 Radius: 63.067
 Left Slip Surface Endpoint: 1.557, 386.500
 Right Slip Surface Endpoint: 104.264, 361.000
 Left Slope Intercept: 1.557 386.500
 Right Slope Intercept: 104.264 386.500

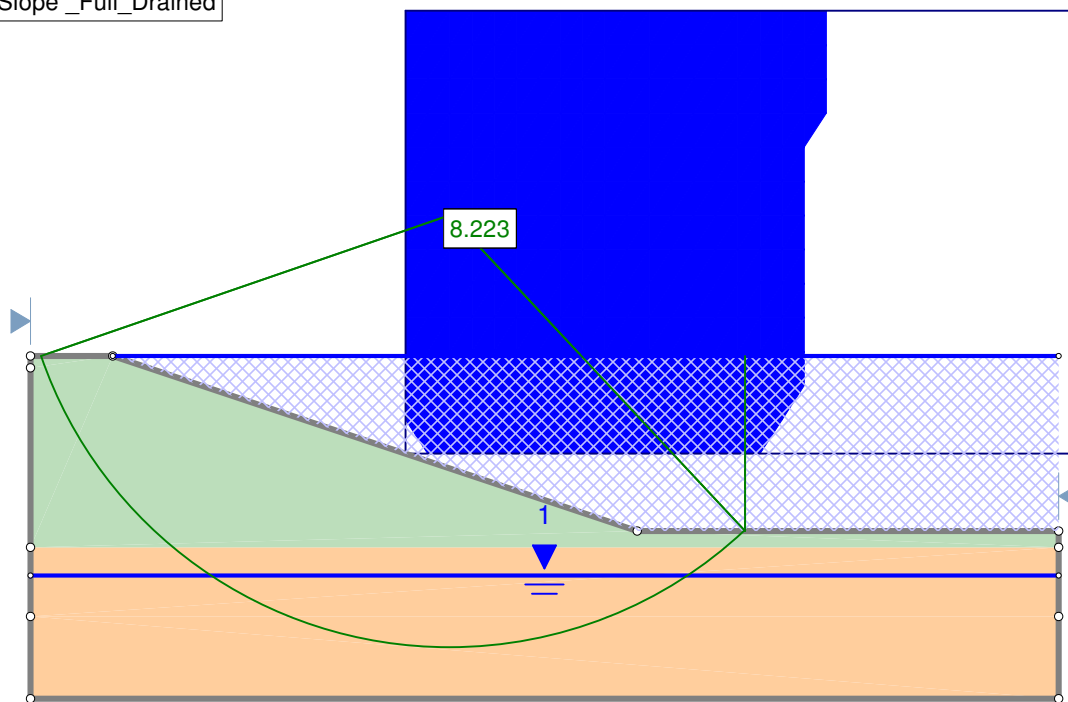
Luminant - Monticello Ash Ponds
South Pond Slope _Full_Drained

Results
spencer
Surface Type: Circular
Search Method: Grid Search
Radius Increment: 10
Composite Surfaces: Disabled
Reverse Curvature: Create Tension Crack
Minimum Elevation: Not Defined
Minimum Depth: Not Defined
Every available surface
8.223
Factor of Safety: 8.223
Center: 61.180, 407.056
Radius: 63.067
Left Slip Surface Endpoint: 1.557, 386.500
Right Slip Surface Endpoint: 104.264, 361.000
Left Slope Intercept: 1.557 386.500
Right Slope Intercept: 104.264 386.500

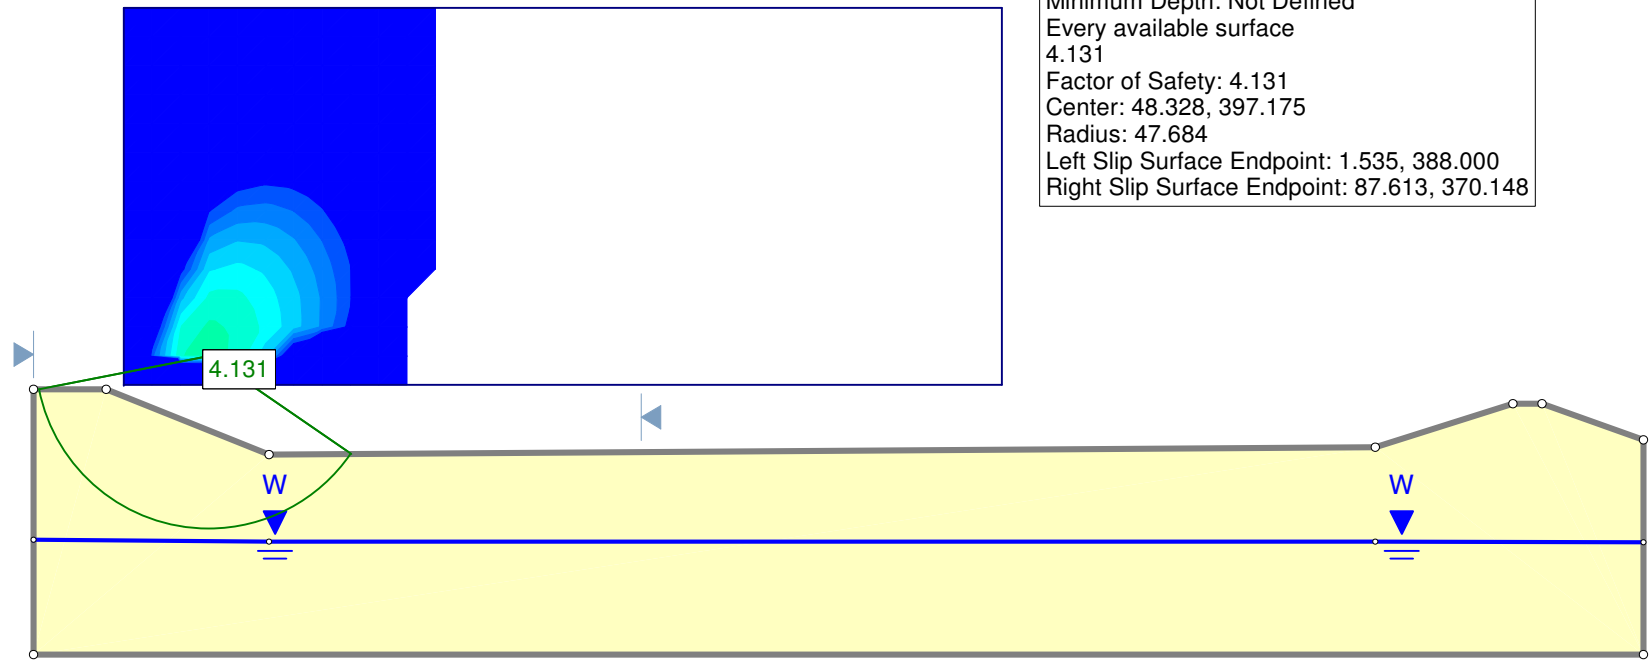
Luminant - Monticello Scrubber Pond
 Scrubber Pond _ Empty_ Undrained

spencer
 Surface Type: Circular
 Search Method: Grid Search
 Radius Increment: 10
 Composite Surfaces: Disabled
 Reverse Curvature: Create Tension Crack
 Minimum Elevation: Not Defined
 Minimum Depth: Not Defined
 Every available surface
 4.131
 Factor of Safety: 4.131
 Center: 48.328, 397.175
 Radius: 47.684
 Left Slip Surface Endpoint: 1.535, 388.000
 Right Slip Surface Endpoint: 87.613, 370.148

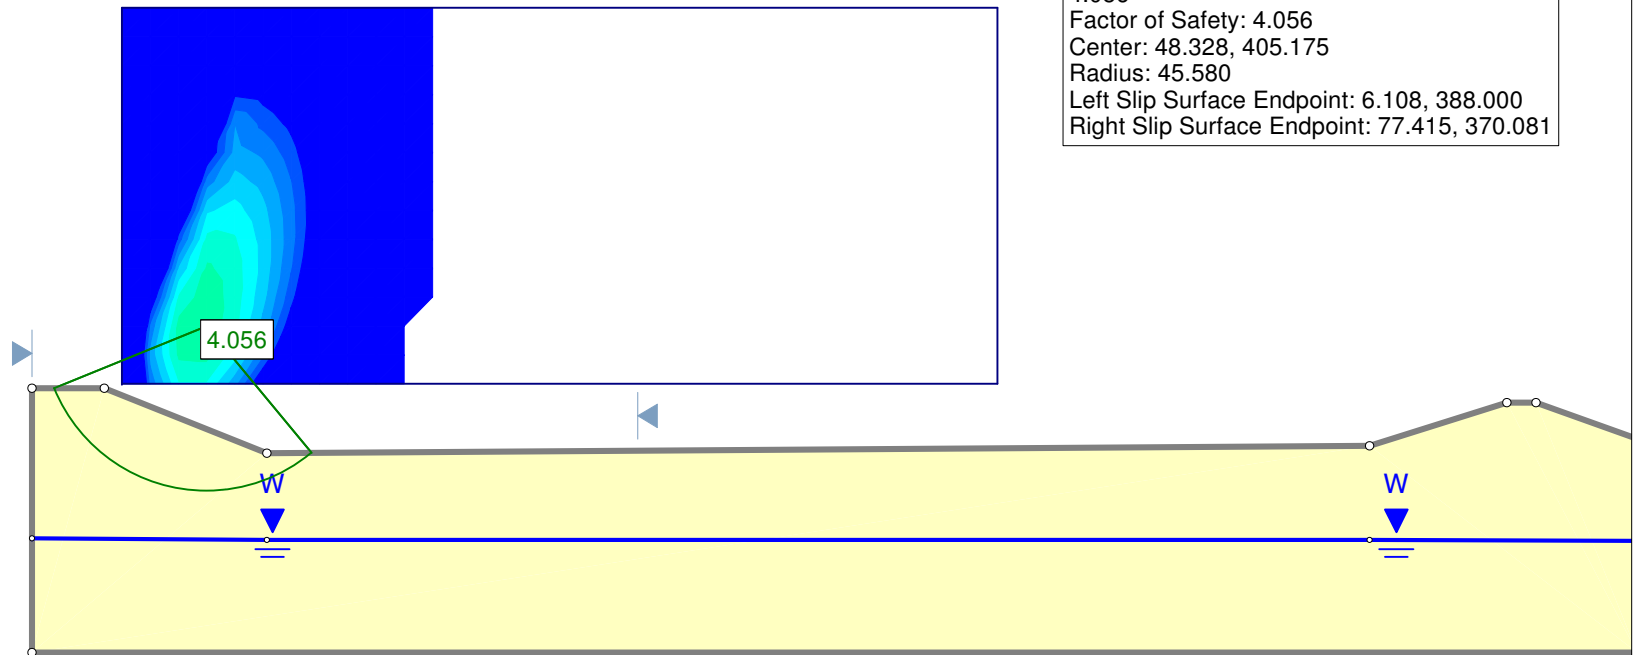
Luminant - Monticello Scrubber Pond
Scrubber Pond _ Empty _ Drained

spencer
 Surface Type: Circular
 Search Method: Grid Search
 Radius Increment: 10
 Composite Surfaces: Disabled
 Reverse Curvature: Create Tension Crack
 Minimum Elevation: Not Defined
 Minimum Depth: Not Defined
 Every available surface
 4.056
 Factor of Safety: 4.056
 Center: 48.328, 405.175
 Radius: 45.580
 Left Slip Surface Endpoint: 6.108, 388.000
 Right Slip Surface Endpoint: 77.415, 370.081

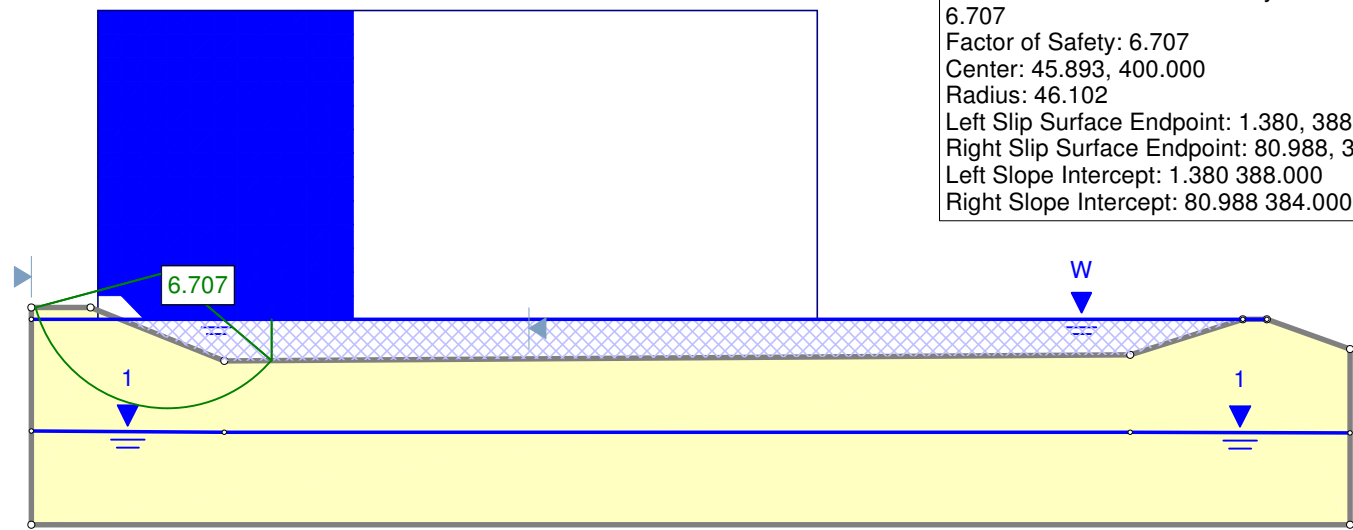
Luminant - Monticello Scrubber Pond
 Scrubber Pond _ Full _ Undrained

bishop simplified
 Surface Type: Circular
 Search Method: Grid Search
 Radius Increment: 10
 Composite Surfaces: Disabled
 Reverse Curvature: Create Tension Crack
 Minimum Elevation: Not Defined
 Minimum Depth: Not Defined
 Surfaces with a factor of safety below 2.000
 6.707
 Factor of Safety: 6.707
 Center: 45.893, 400.000
 Radius: 46.102
 Left Slip Surface Endpoint: 1.380, 388.000
 Right Slip Surface Endpoint: 80.988, 370.105
 Left Slope Intercept: 1.380 388.000
 Right Slope Intercept: 80.988 384.000

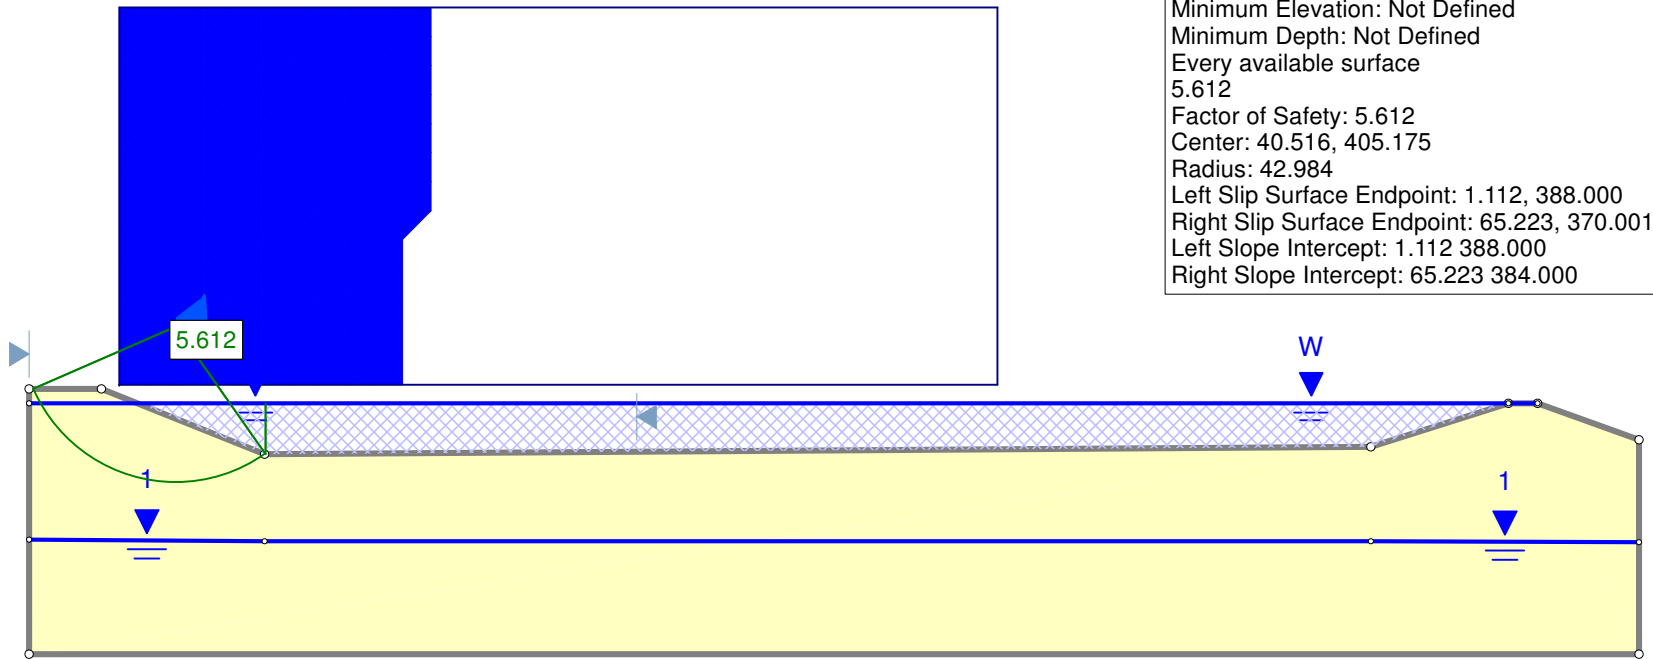
Luminant - Monticello Scrubber Pond
 Scrubber Pond _ Full _ Drained

spencer
 Surface Type: Circular
 Search Method: Grid Search
 Radius Increment: 10
 Composite Surfaces: Disabled
 Reverse Curvature: Create Tension Crack
 Minimum Elevation: Not Defined
 Minimum Depth: Not Defined
 Every available surface
 5.612
 Factor of Safety: 5.612
 Center: 40.516, 405.175
 Radius: 42.984
 Left Slip Surface Endpoint: 1.112, 388.000
 Right Slip Surface Endpoint: 65.223, 370.001
 Left Slope Intercept: 1.112 388.000
 Right Slope Intercept: 65.223 384.000

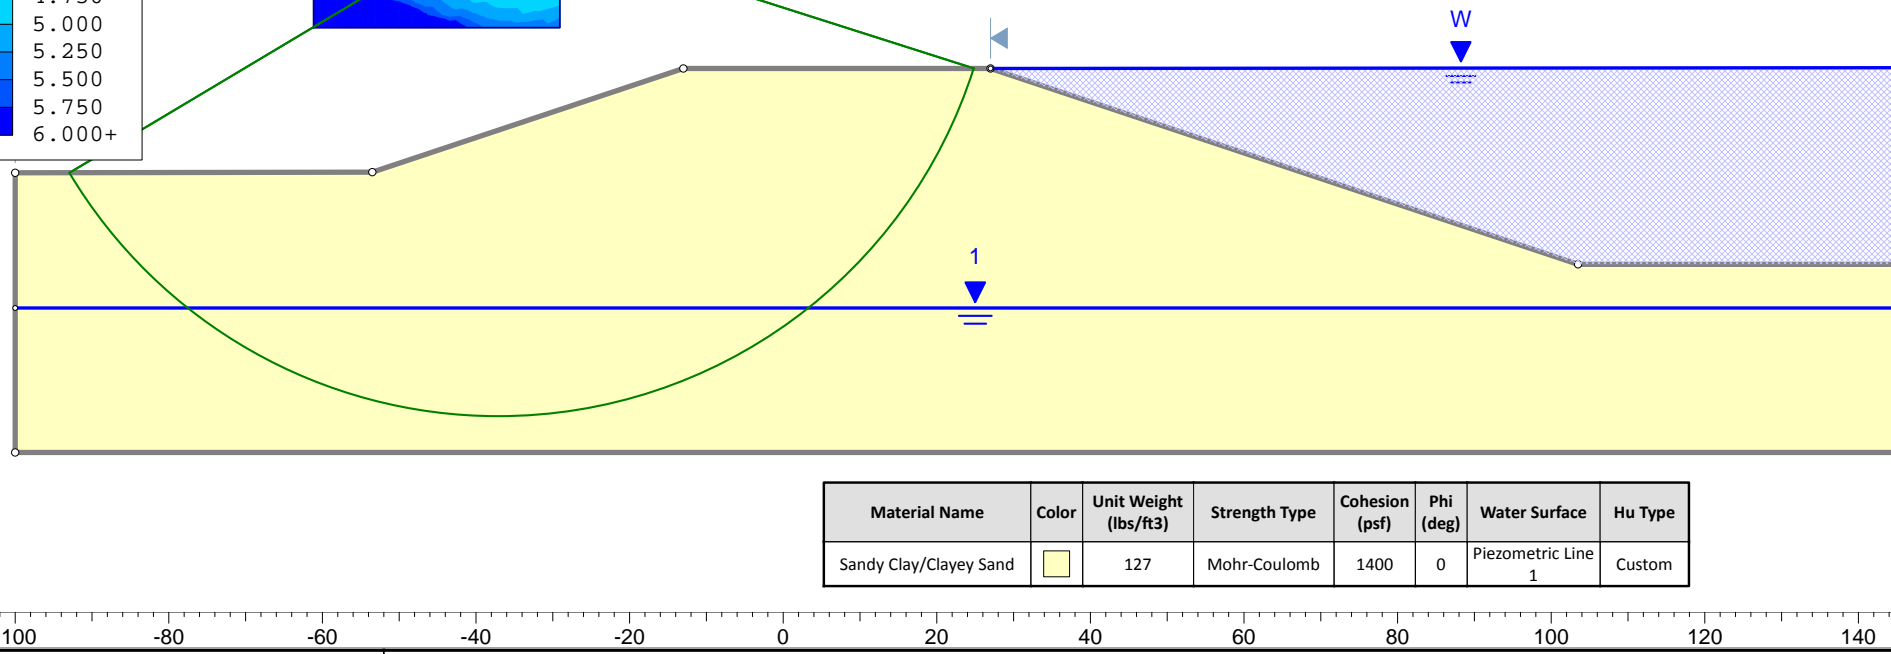
CASE 22

spencer
 Surface Type: Circular
 Search Method: Grid Search
 Radius Increment: 10
 Composite Surfaces: Disabled
 Reverse Curvature: Create Tension Crack
 Minimum Elevation: Not Defined
 Minimum Depth: Not Defined
 Every available surface
 4.710
 Factor of Safety: 4.710
 Center: -37.090, 406.238
 Radius: 65.025
 Left Slip Surface Endpoint: -92.932, 372.922
 Right Slip Surface Endpoint: 24.867, 386.500
