Dam Safety Assessment of CCW Impoundments

Luminant Generation Co., LLC/MONTICELLO STEAM ELECTRIC STATION

United States Environmental Protection Agency
Washington, DC

June 3, 2014

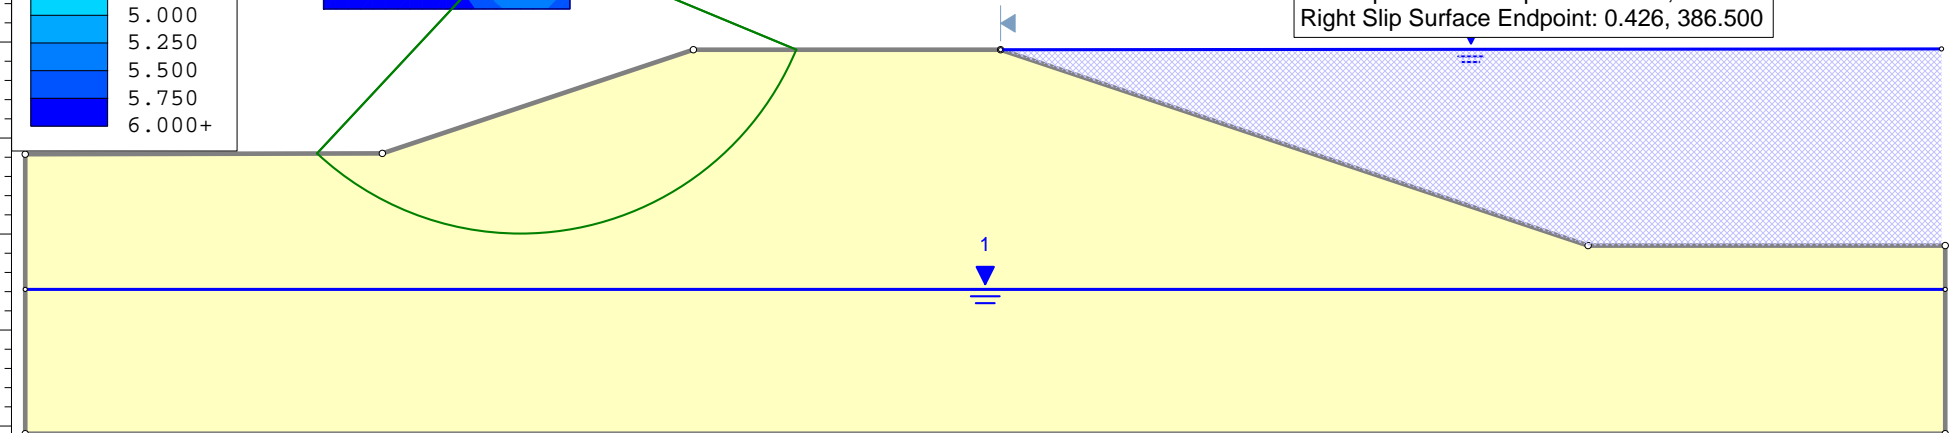
CASE 23

Results
spencer
Surface Type: Circular
Search Method: Grid Search
Radius Increment: 10
Composite Surfaces: Disabled
Reverse Curvature: Create Tension Crack
Minimum Elevation: Not Defined
Minimum Depth: Not Defined
Every available surface
5.196
Factor of Safety: 5.196
Center: -35.488, 401.430
Radius: 38.893
Left Slip Surface Endpoint: -62.011, 372.983
Right Slip Surface Endpoint: 0.426, 386.500

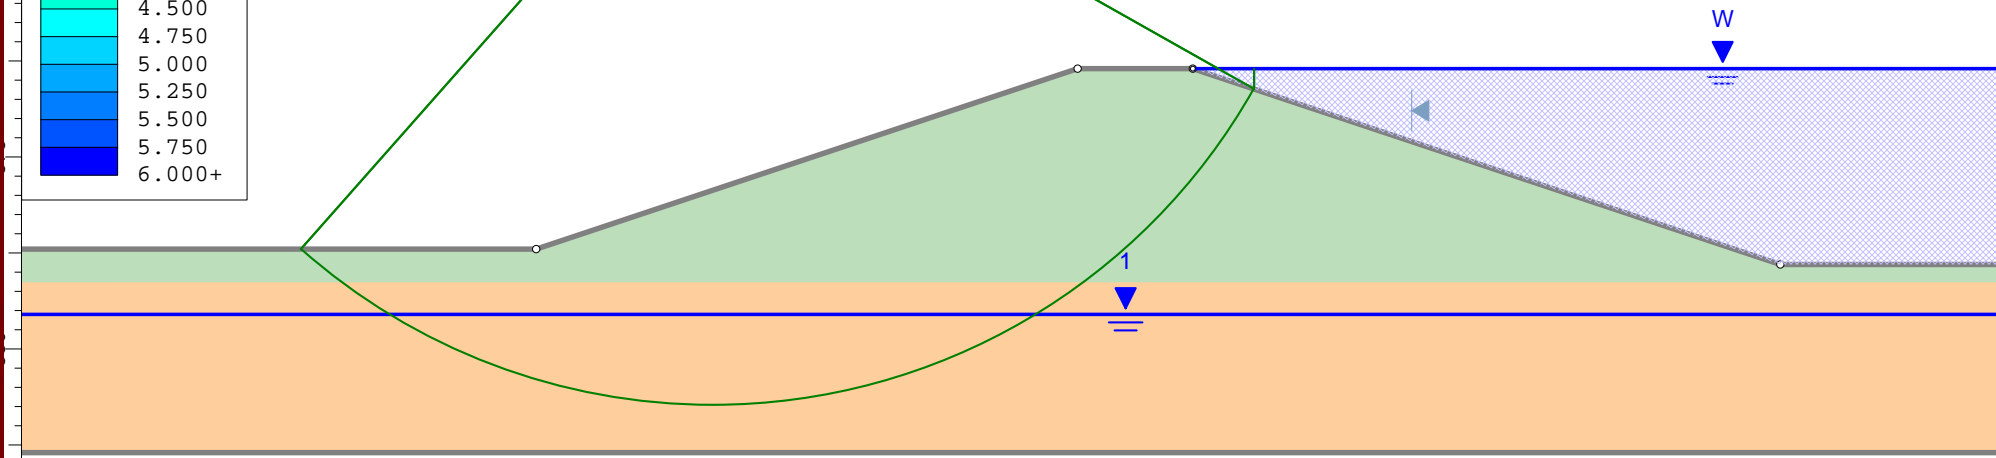
CASE 24

Results
 spencer
 Surface Type: Circular
 Search Method: Grid Search
 Radius Increment: 10
 Composite Surfaces: Disabled
 Reverse Curvature: Create Tension Crack
 Minimum Elevation: Not Defined
 Minimum Depth: Not Defined
 Every available surface
 3.552
 Factor of Safety: 3.552
 Center: -50.515, 423.648
 Radius: 80.954
 Left Slip Surface Endpoint: -104.137, 363.000
 Right Slip Surface Endpoint: 19.976, 383.841
 Left Slope Intercept: -104.137 363.000
 Right Slope Intercept: 19.976 386.500

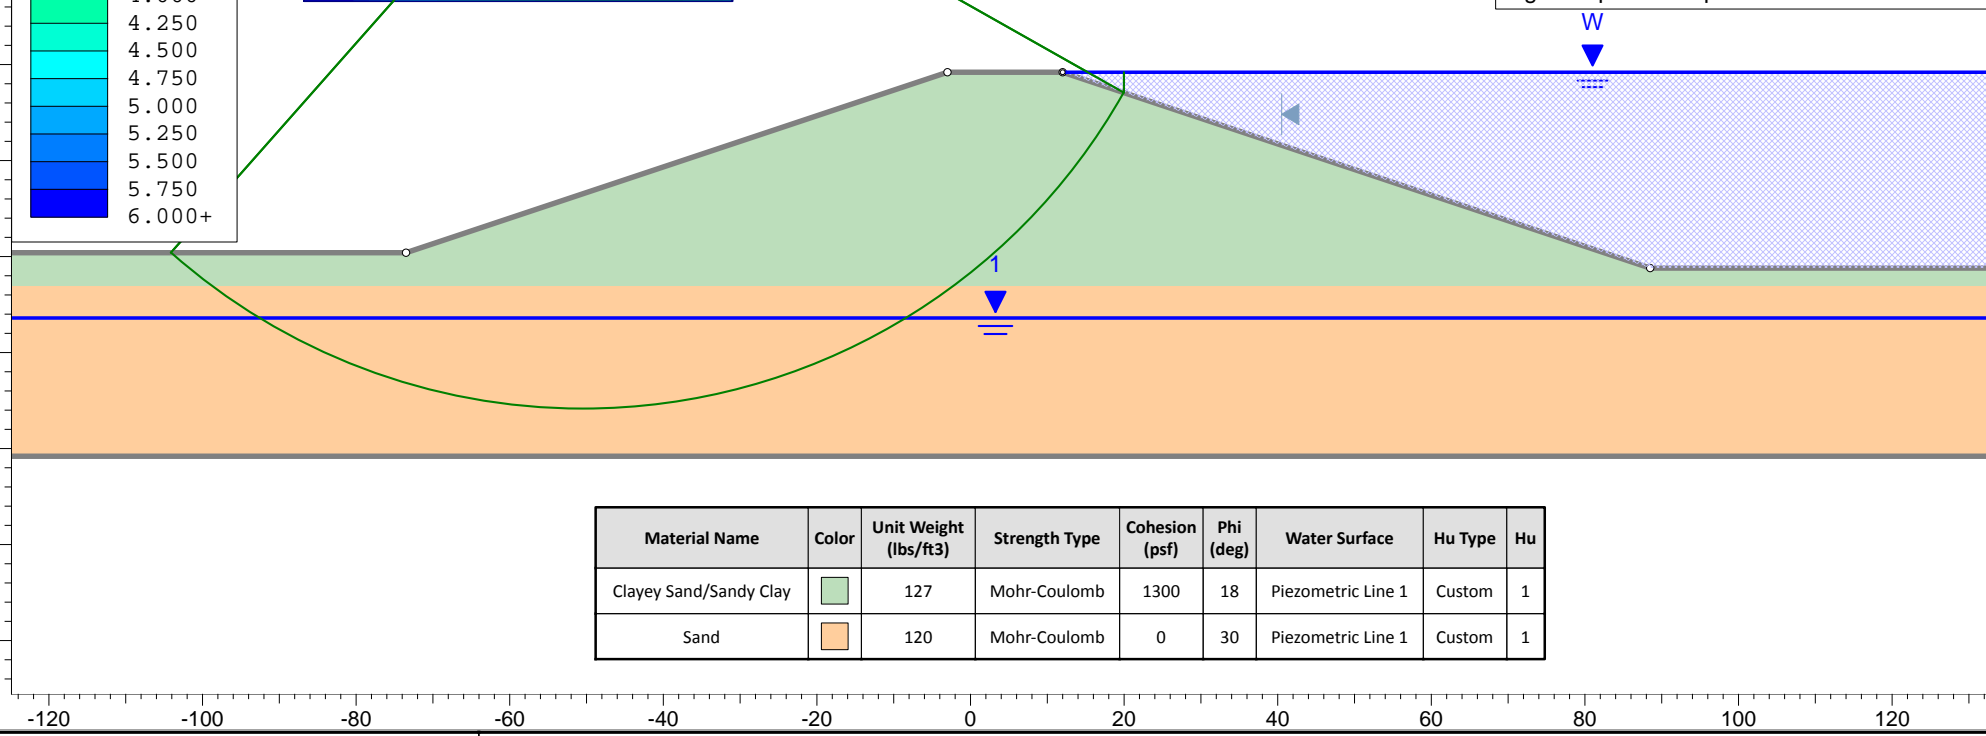
CASE 25

Results
 spencer
 Surface Type: Circular
 Search Method: Grid Search
 Radius Increment: 10
 Composite Surfaces: Disabled
 Reverse Curvature: Create Tension Crack
 Minimum Elevation: Not Defined
 Minimum Depth: Not Defined
 Every available surface
 3.369
 Factor of Safety: 3.369
 Center: -50.515, 423.648
 Radius: 80.954
 Left Slip Surface Endpoint: -104.137, 363.000
 Right Slip Surface Endpoint: 19.976, 383.841
 Left Slope Intercept: -104.137 363.000
 Right Slope Intercept: 19.976 386.500
