SUBJECT: EPA Comments on "Assessment of Dam Safety of Coal Combustion Surface  
Impoundments: Luminant Generation Co., LLC – Oak Grove Steam Electric Station,  
Franklin, TX

DATE: April 7, 2014

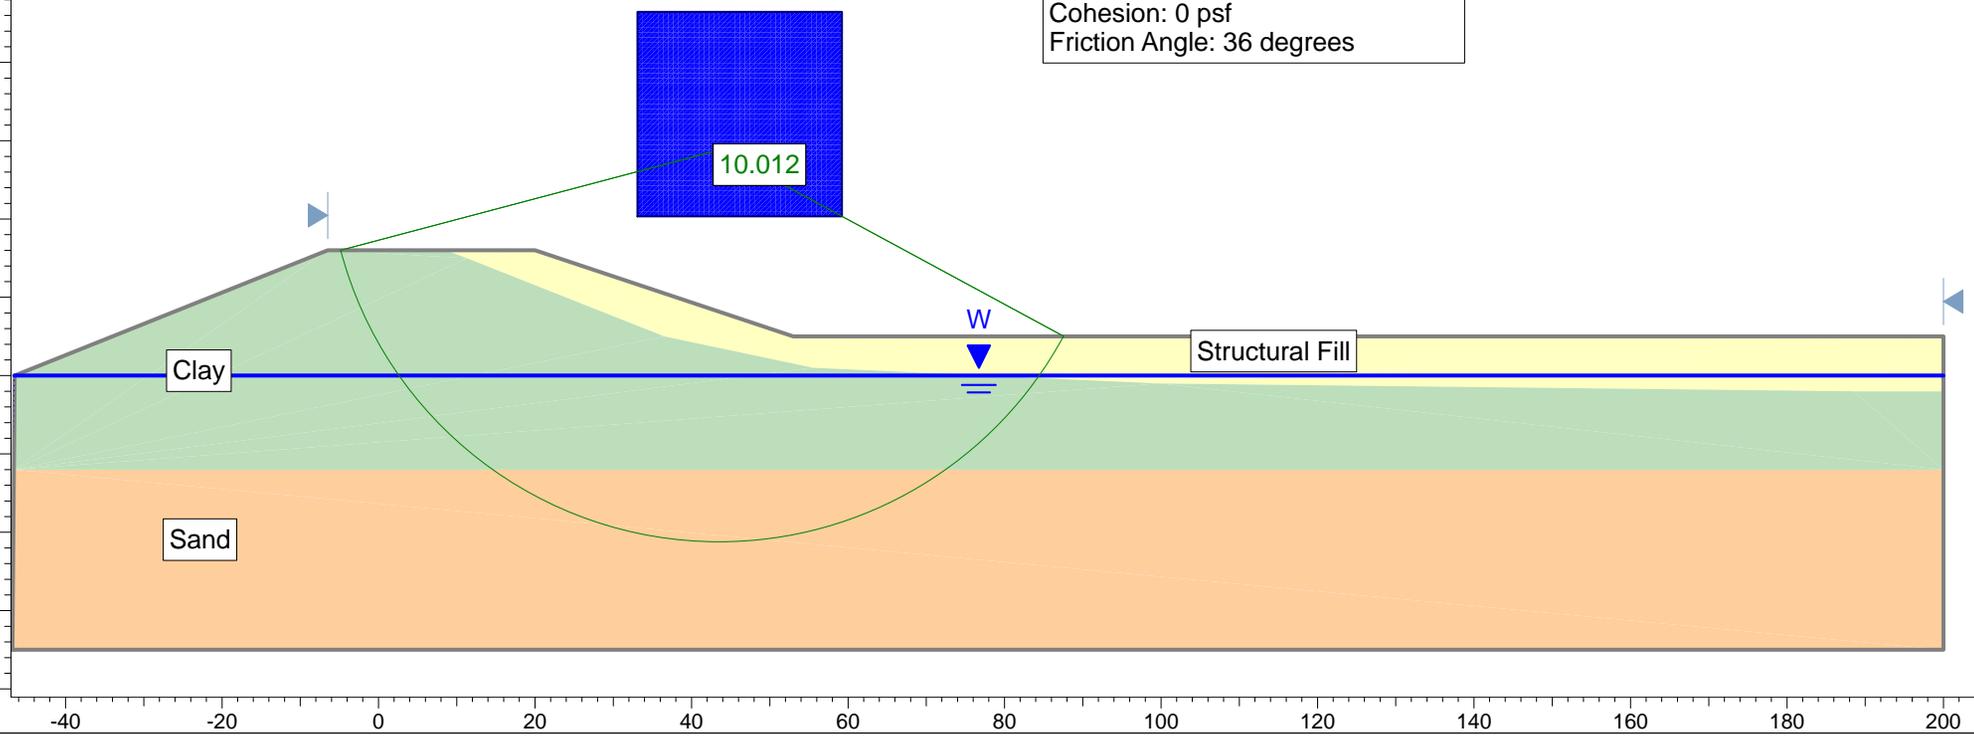
Project Title: FGD-B Pond: Case 1 - West Sideslope (short term)  
Failure Direction: Left to Right  
Units of Measurement: Imperial Units  
Pore Fluid Unit Weight: 62.4 lb/ft<sup>3</sup>  
Groundwater Method: Water Surfaces  
Data Output: Standard  
Calculate Excess Pore Pressure: Off  
Allow Ru with Water Surfaces or Grids: Off  
Random Numbers: Pseudo-random Seed  
Random Number Seed: 10116  
Random Number Generation Method: Park and Miller v.3

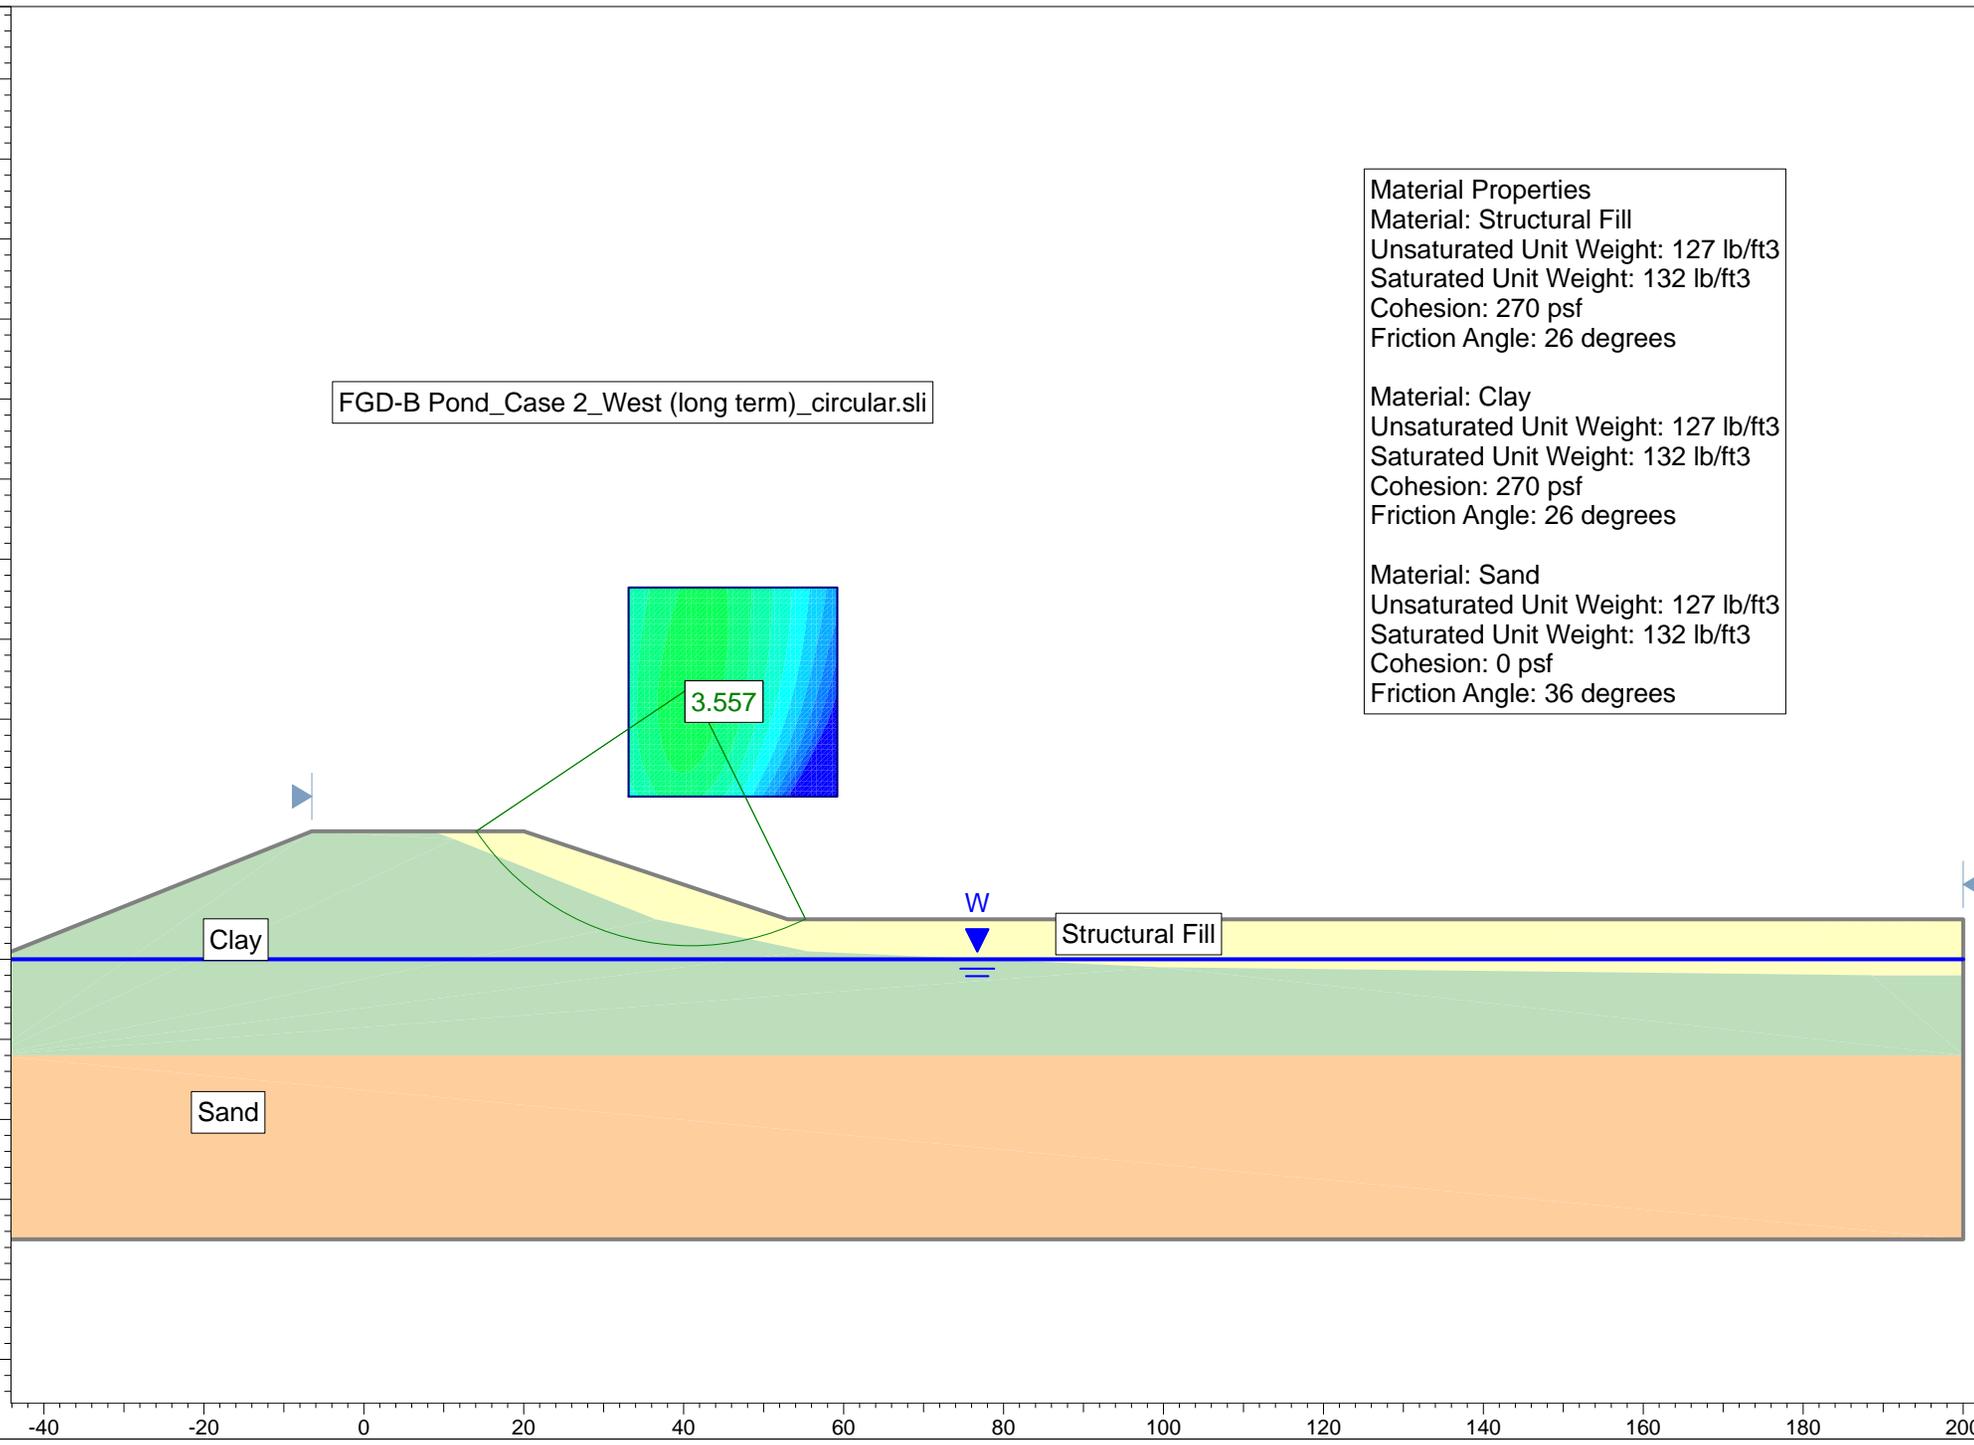
Project Title: FGD-B Pond: Case 2 - West Sideslope (long term)  
Failure Direction: Left to Right  
Units of Measurement: Imperial Units  
Pore Fluid Unit Weight: 62.4 lb/ft<sup>3</sup>  
Groundwater Method: Water Surfaces  
Data Output: Standard  
Calculate Excess Pore Pressure: Off  
Allow Ru with Water Surfaces or Grids: Off  
Random Numbers: Pseudo-random Seed  
Random Number Seed: 10116  
Random Number Generation Method: Park and Miller v.3

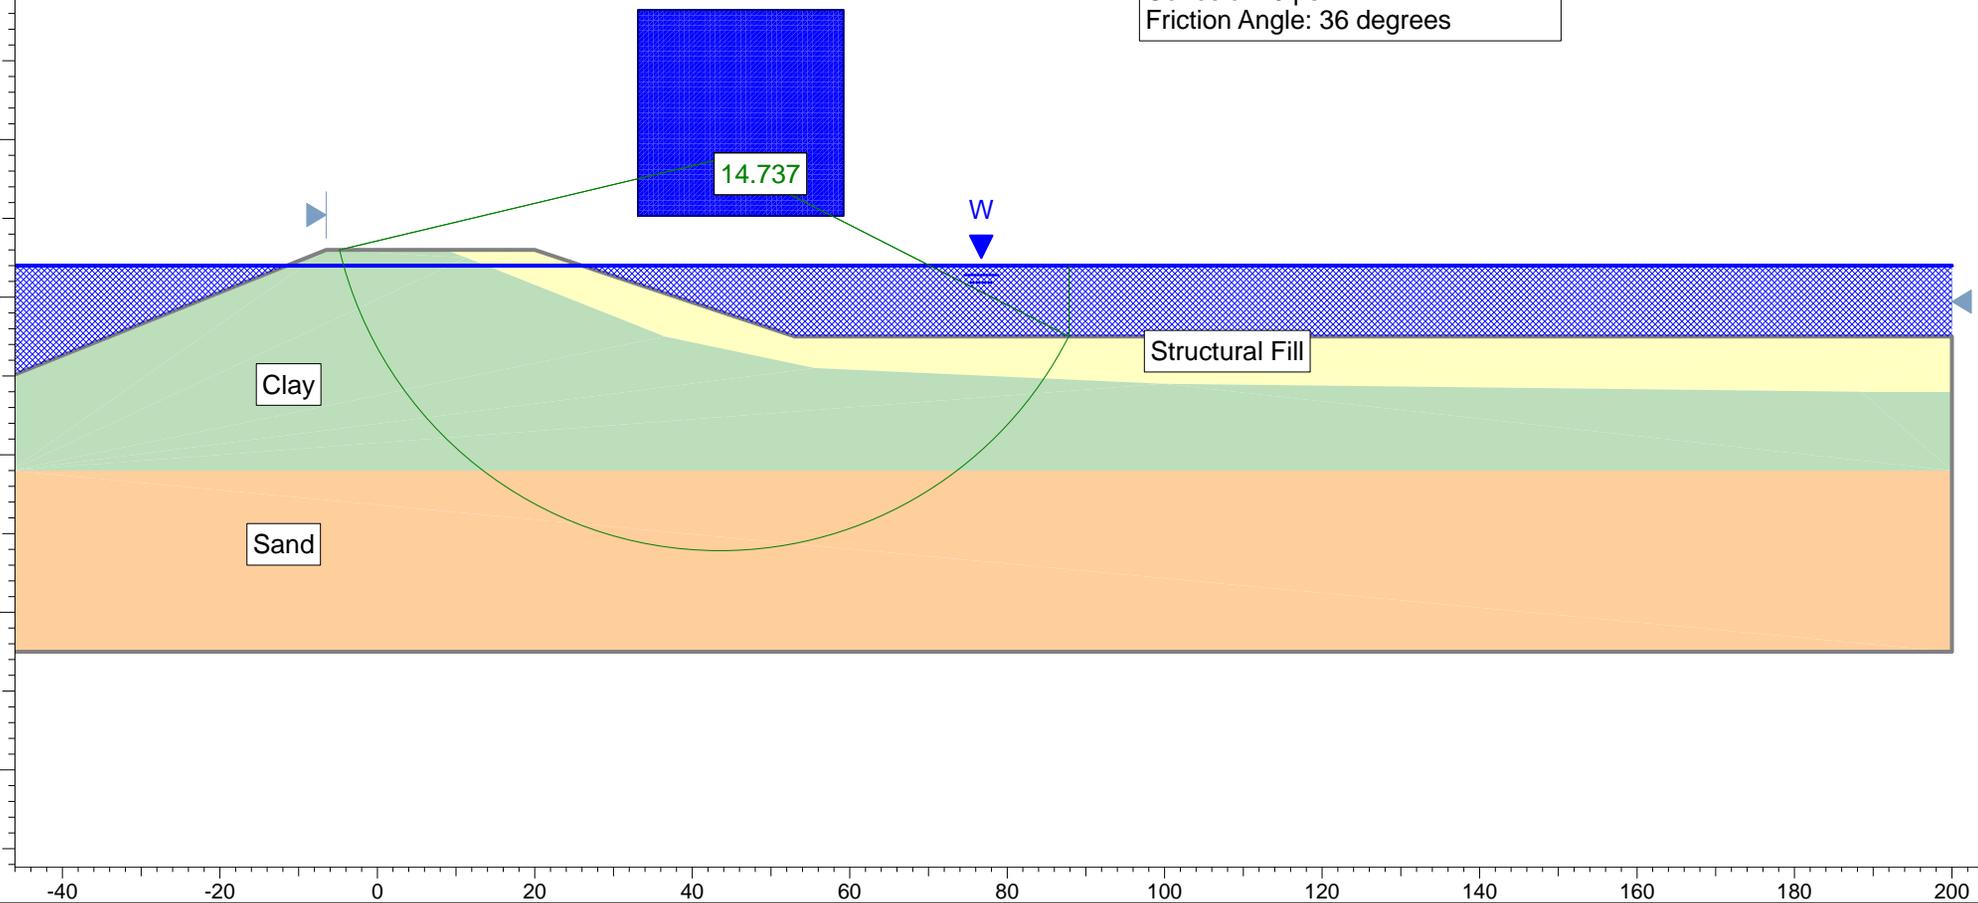
Project Title: FGD-B Pond: Case 3 - West Sideslope - Full Pond (short term)  
Failure Direction: Left to Right  
Units of Measurement: Imperial Units  
Pore Fluid Unit Weight: 62.4 lb/ft<sup>3</sup>  
Groundwater Method: Water Surfaces  
Data Output: Standard  
Calculate Excess Pore Pressure: Off  
Allow Ru with Water Surfaces or Grids: Off  
Random Numbers: Pseudo-random Seed  
Random Number Seed: 10116  
Random Number Generation Method: Park and Miller v.3

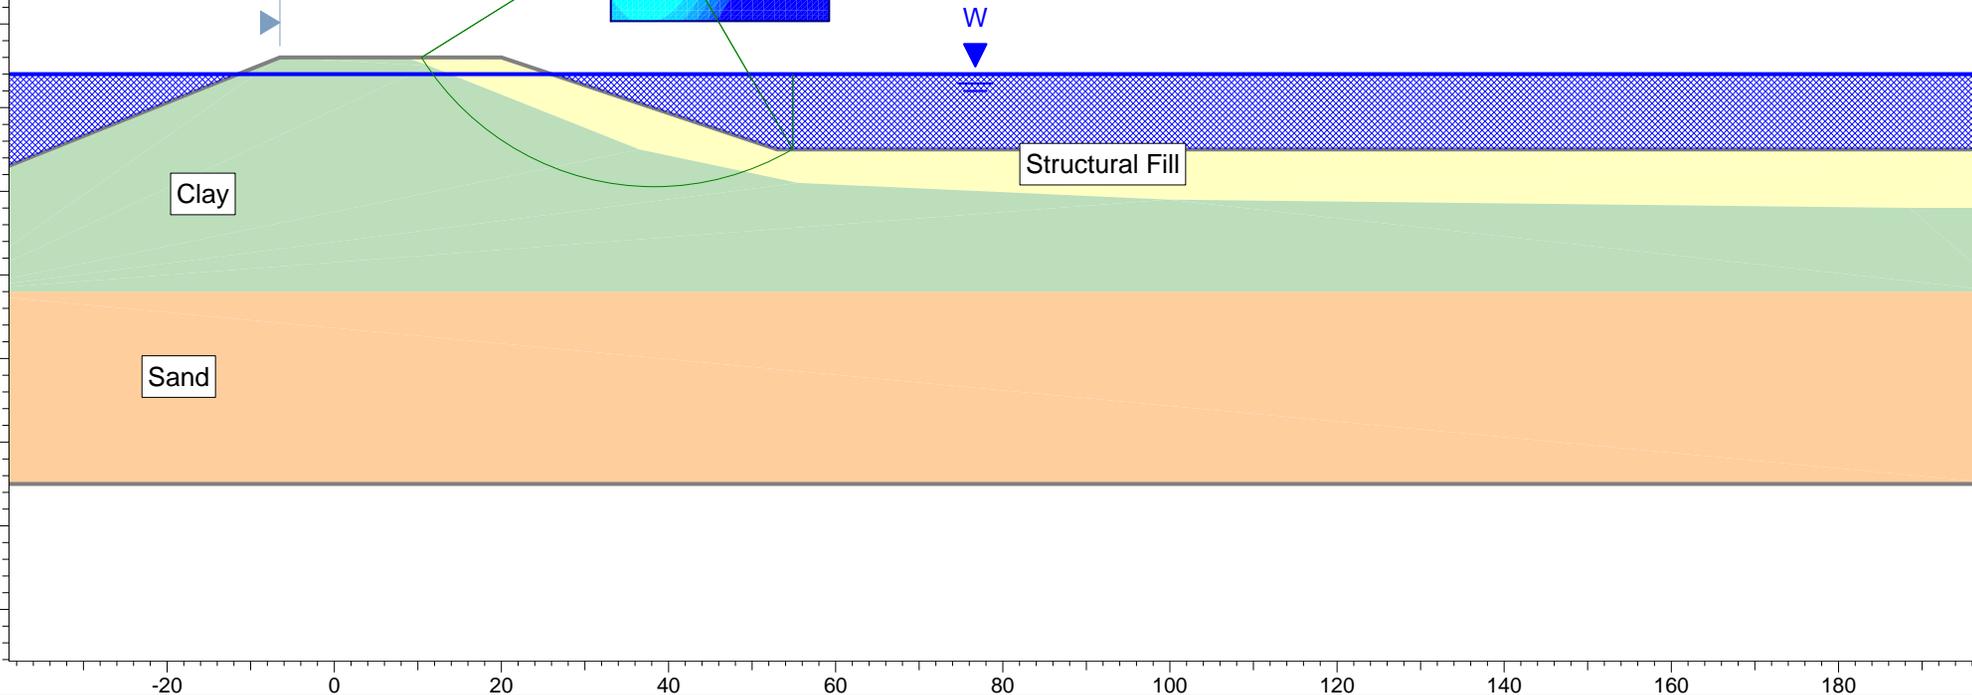
Project Title: FGD-B Pond: Case 4 - West Sideslope - Full Pond (long term)  
Failure Direction: Left to Right  
Units of Measurement: Imperial Units  
Pore Fluid Unit Weight: 62.4 lb/ft<sup>3</sup>  
Groundwater Method: Water Surfaces  
Data Output: Standard  
Calculate Excess Pore Pressure: Off  
Allow Ru with Water Surfaces or Grids: Off  
Random Numbers: Pseudo-random Seed  
Random Number Seed: 10116  
Random Number Generation Method: Park and Miller v.3

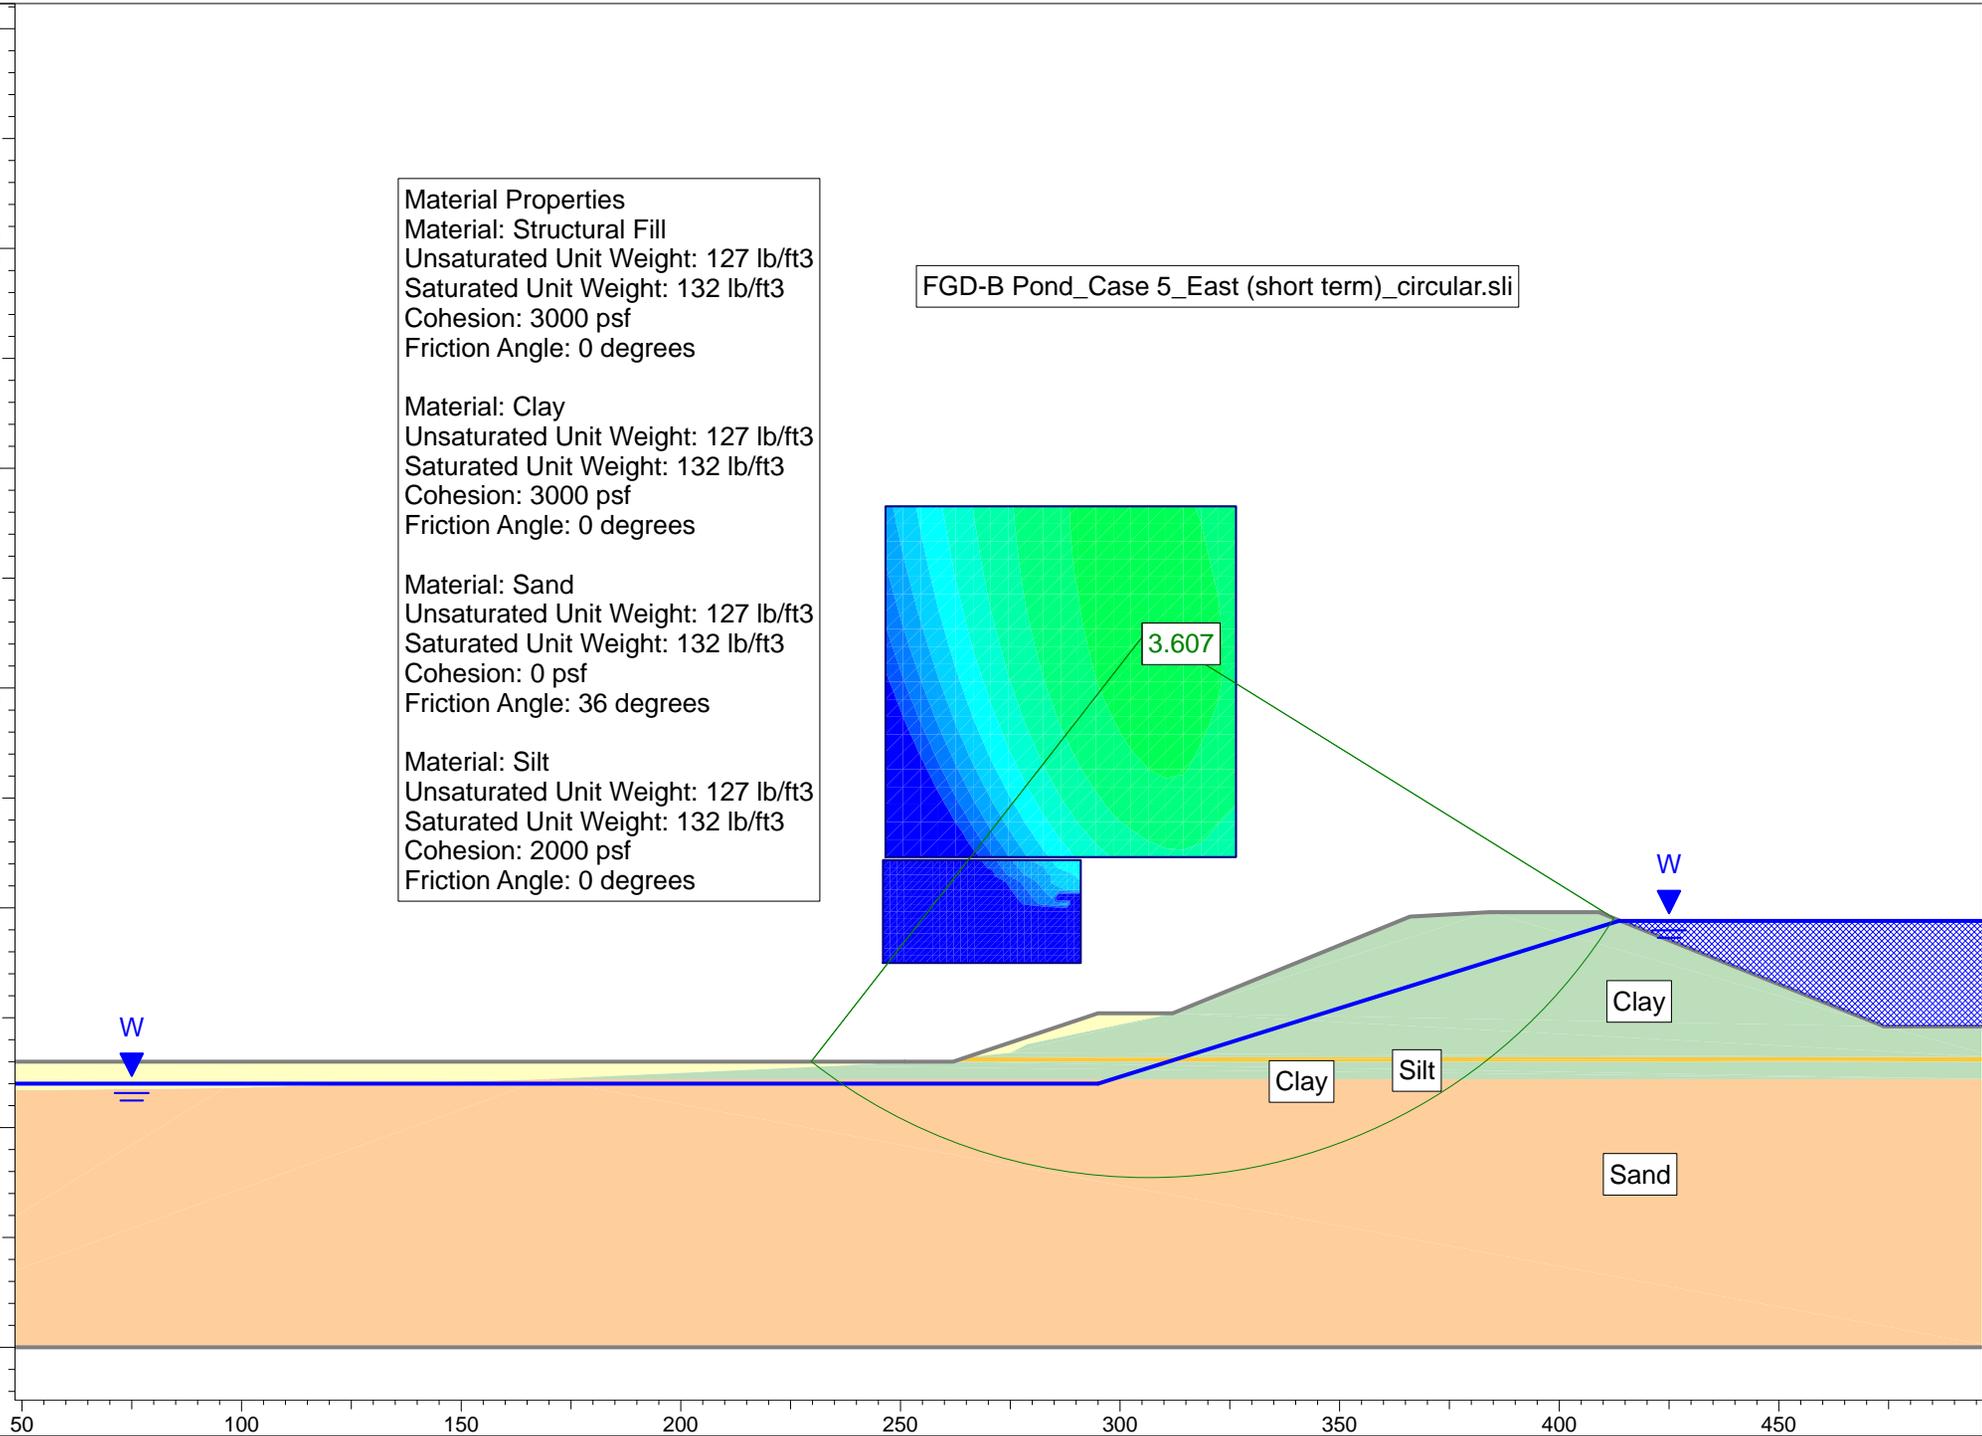
FGD-B Pond\_Case 5\_East (short term)\_circular.sli

Project Title: FGD-B Pond - Case 5 - East Slope (short term)  
Failure Direction: Right to Left  
Units of Measurement: Imperial Units  
Pore Fluid Unit Weight: 62.4 lb/ft<sup>3</sup>  
Groundwater Method: Water Surfaces  
Data Output: Standard  
Calculate Excess Pore Pressure: Off  
Allow Ru with Water Surfaces or Grids: Off  
Random Numbers: Pseudo-random Seed  
Random Number Seed: 10116  
Random Number Generation Method: Park and Miller v.3

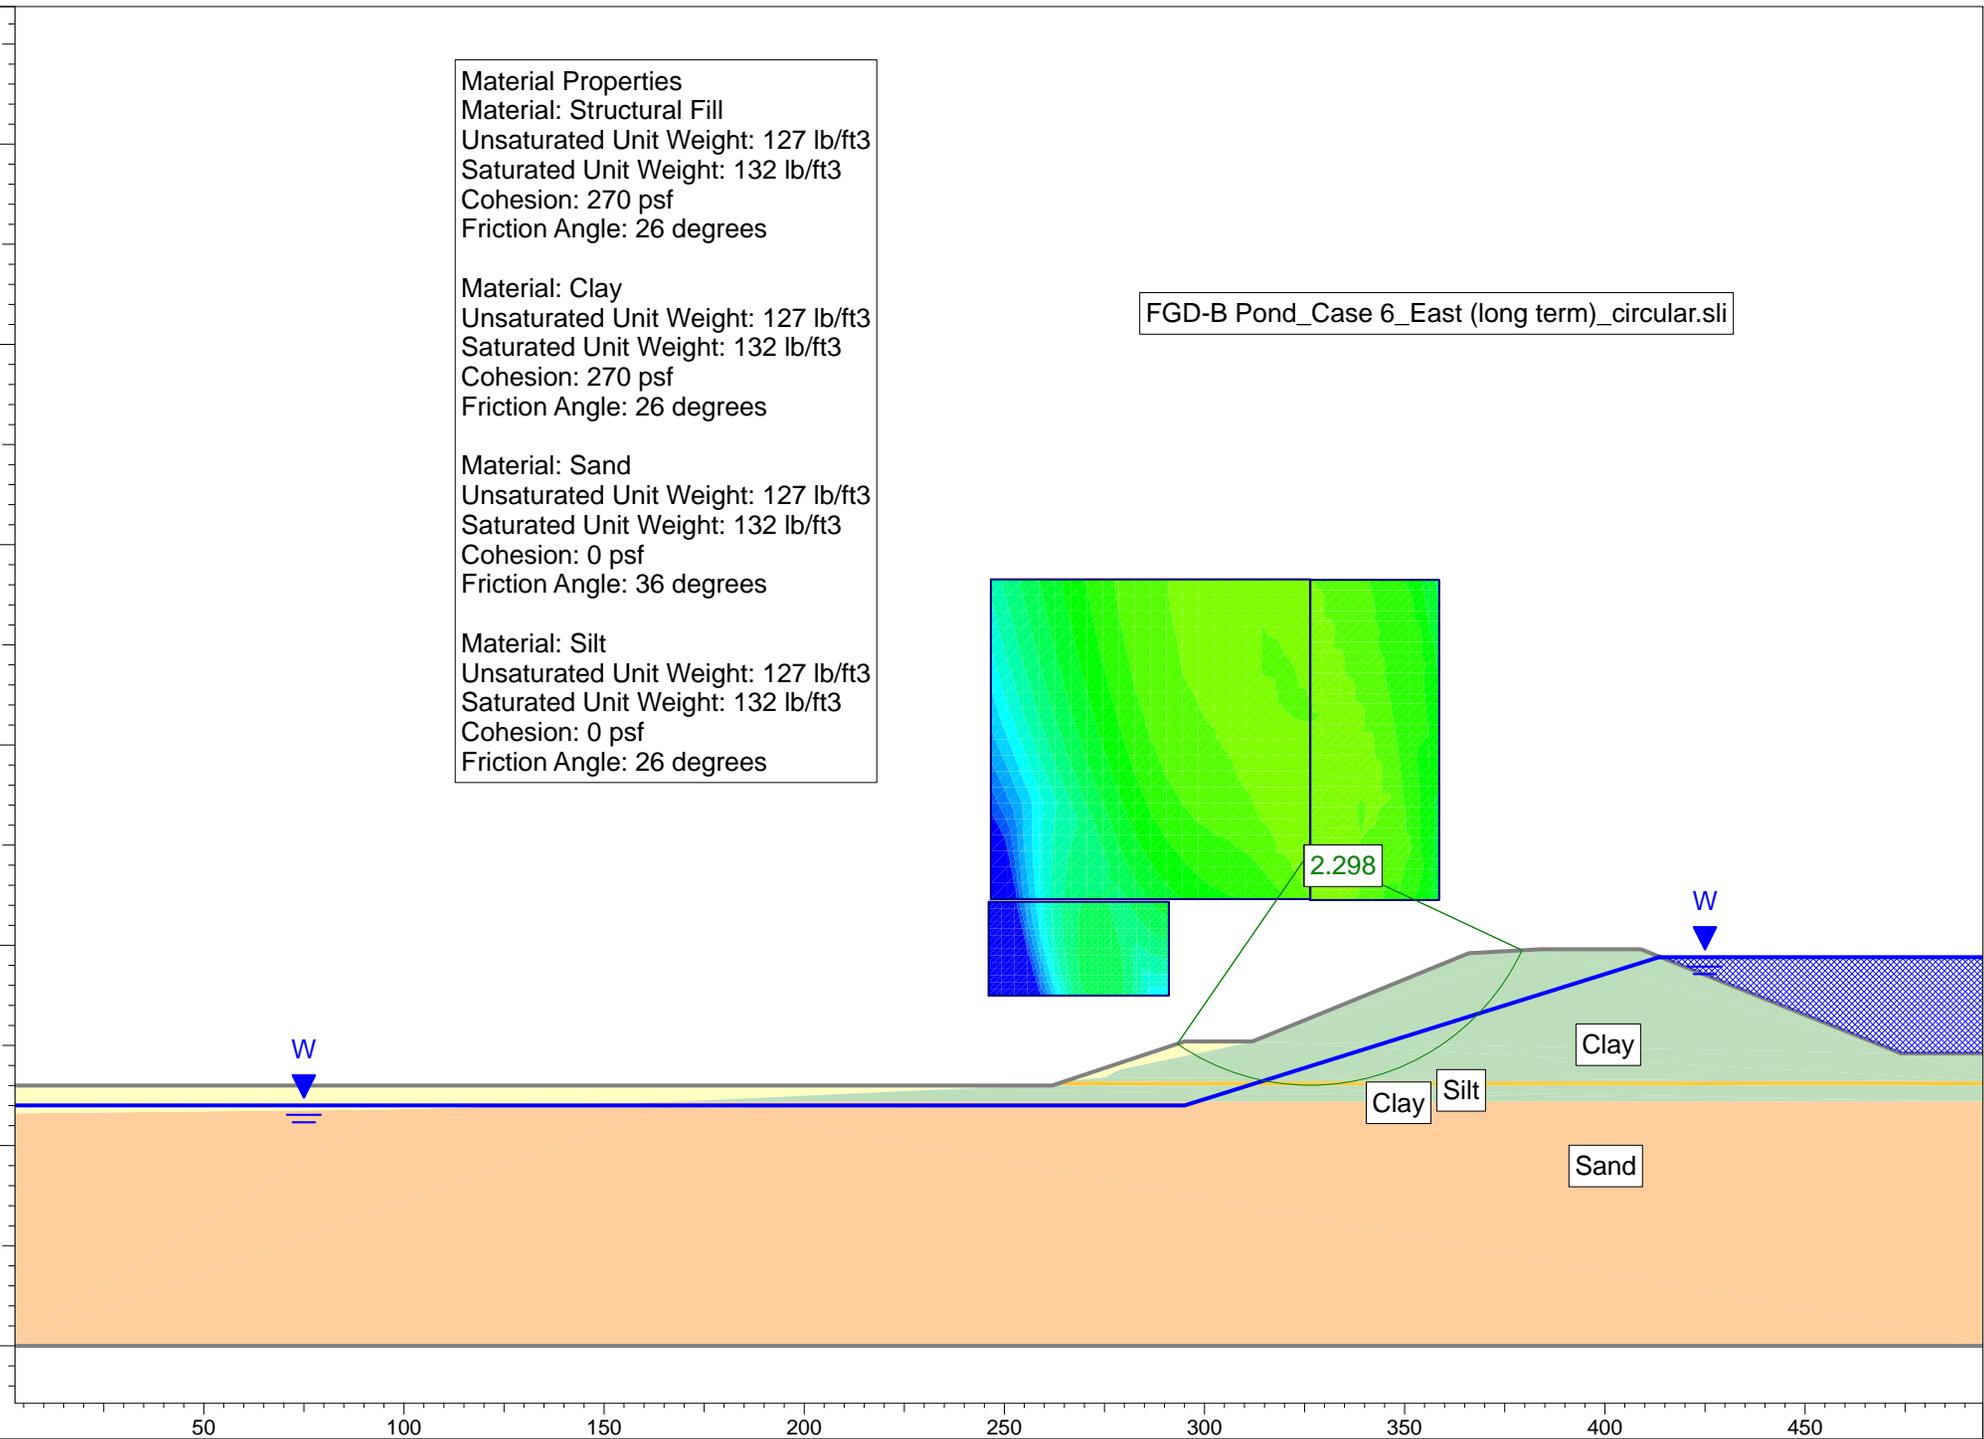
FGD-B Pond\_Case 6\_East (long term)\_circular.sli

Project Title: FGD-B Pond - Case 6 - East Slope (long term)  
Failure Direction: Right to Left  
Units of Measurement: Imperial Units  
Pore Fluid Unit Weight: 62.4 lb/ft<sup>3</sup>  
Groundwater Method: Water Surfaces  
Data Output: Standard  
Calculate Excess Pore Pressure: Off  
Allow Ru with Water Surfaces or Grids: Off  
Random Numbers: Pseudo-random Seed  
Random Number Seed: 10116  
Random Number Generation Method: Park and Miller v.3

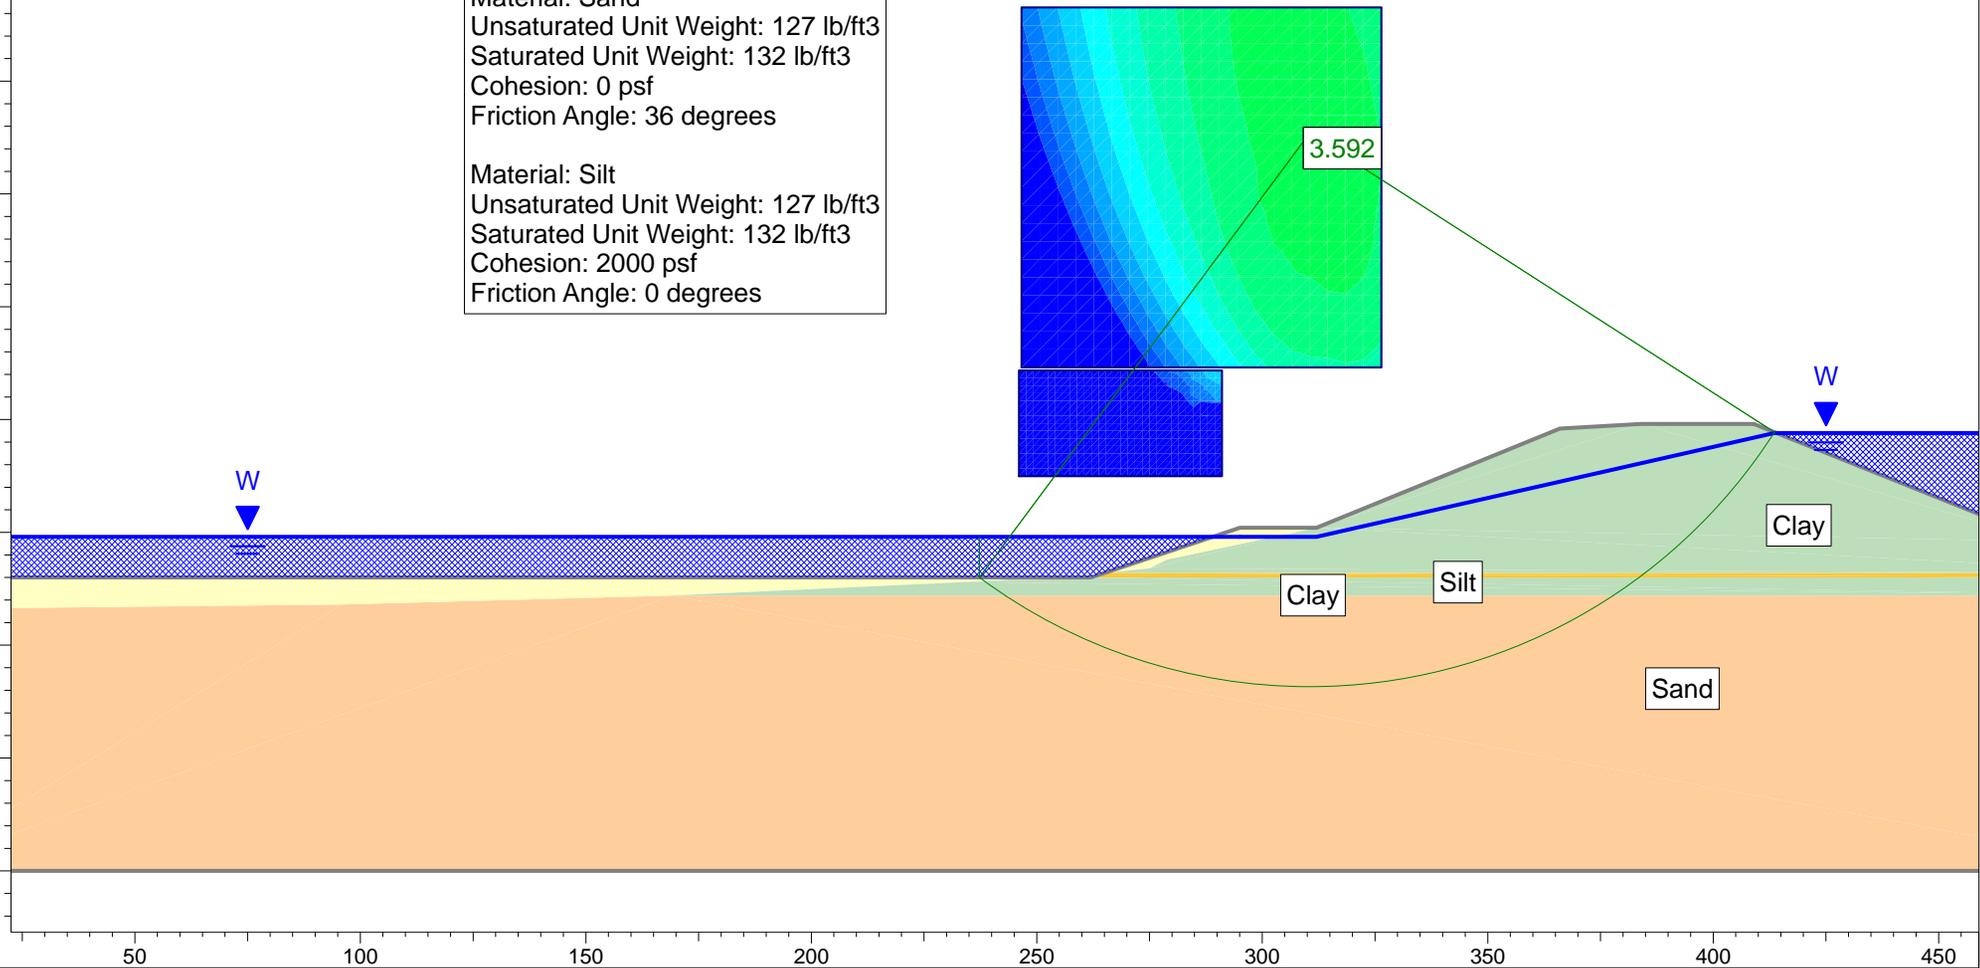
FGD-B Pond\_Case 7\_East\_Full (short term)\_circular.sli

Project Title: FGD-B Pond - Case 7 - East Slope - Full pond (short term)  
Failure Direction: Right to Left  
Units of Measurement: Imperial Units  
Pore Fluid Unit Weight: 62.4 lb/ft<sup>3</sup>  
Groundwater Method: Water Surfaces  
Data Output: Standard  
Calculate Excess Pore Pressure: Off  
Allow Ru with Water Surfaces or Grids: Off  
Random Numbers: Pseudo-random Seed  
Random Number Seed: 10116  
Random Number Generation Method: Park and Miller v.3

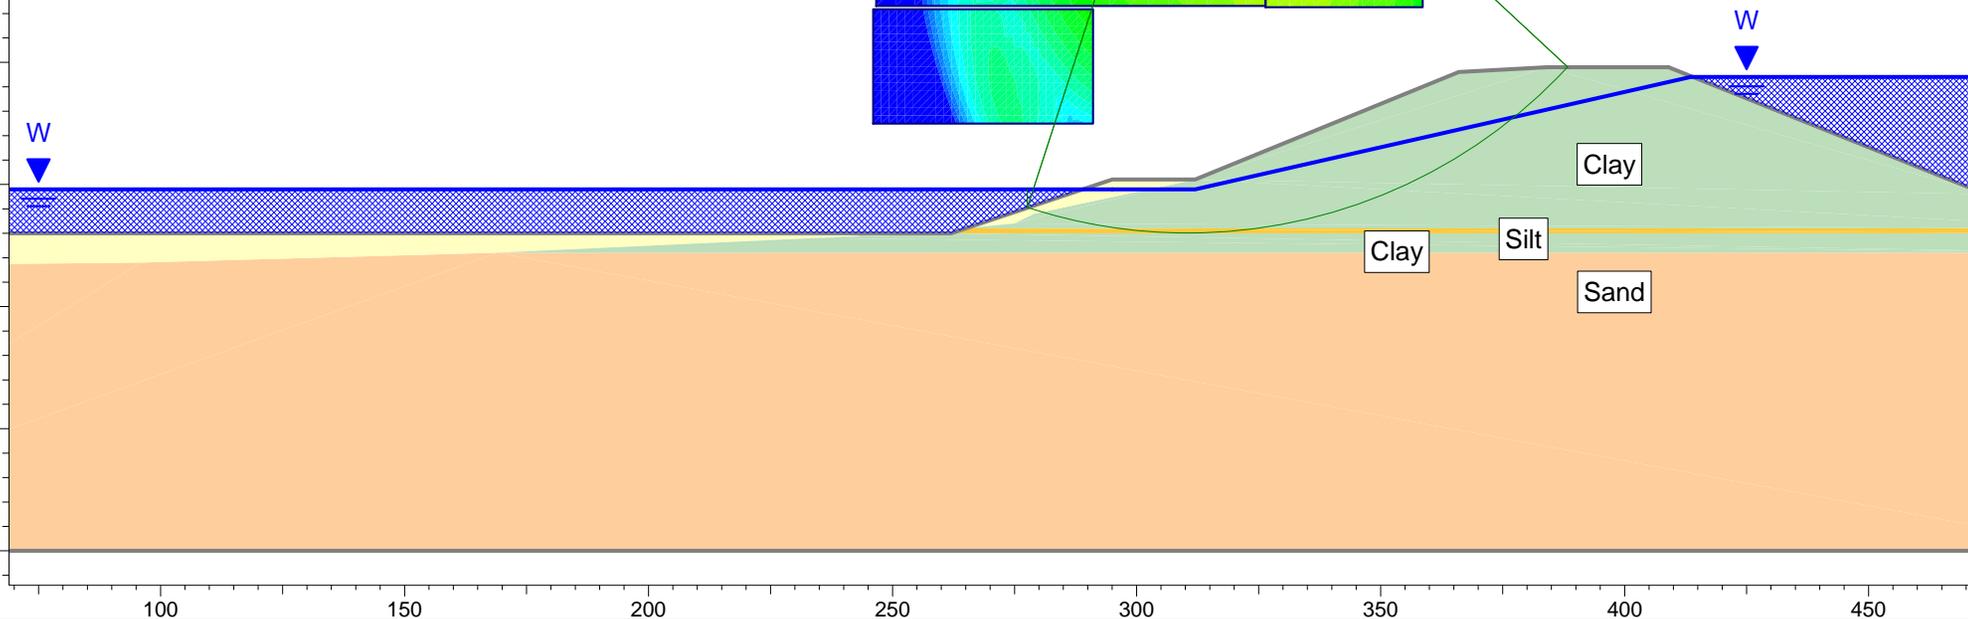
FGD-B Pond\_Case 8\_East\_Full (long term)\_circular.sli

Project Title: FGD-B Pond - Case 8 - East Slope - Full Pond (long term)  
Failure Direction: Right to Left  
Units of Measurement: Imperial Units  
Pore Fluid Unit Weight: 62.4 lb/ft<sup>3</sup>  
Groundwater Method: Water Surfaces  
Data Output: Standard  
Calculate Excess Pore Pressure: Off  
Allow Ru with Water Surfaces or Grids: Off  
Random Numbers: Pseudo-random Seed  
Random Number Seed: 10116  
Random Number Generation Method: Park and Miller v.3

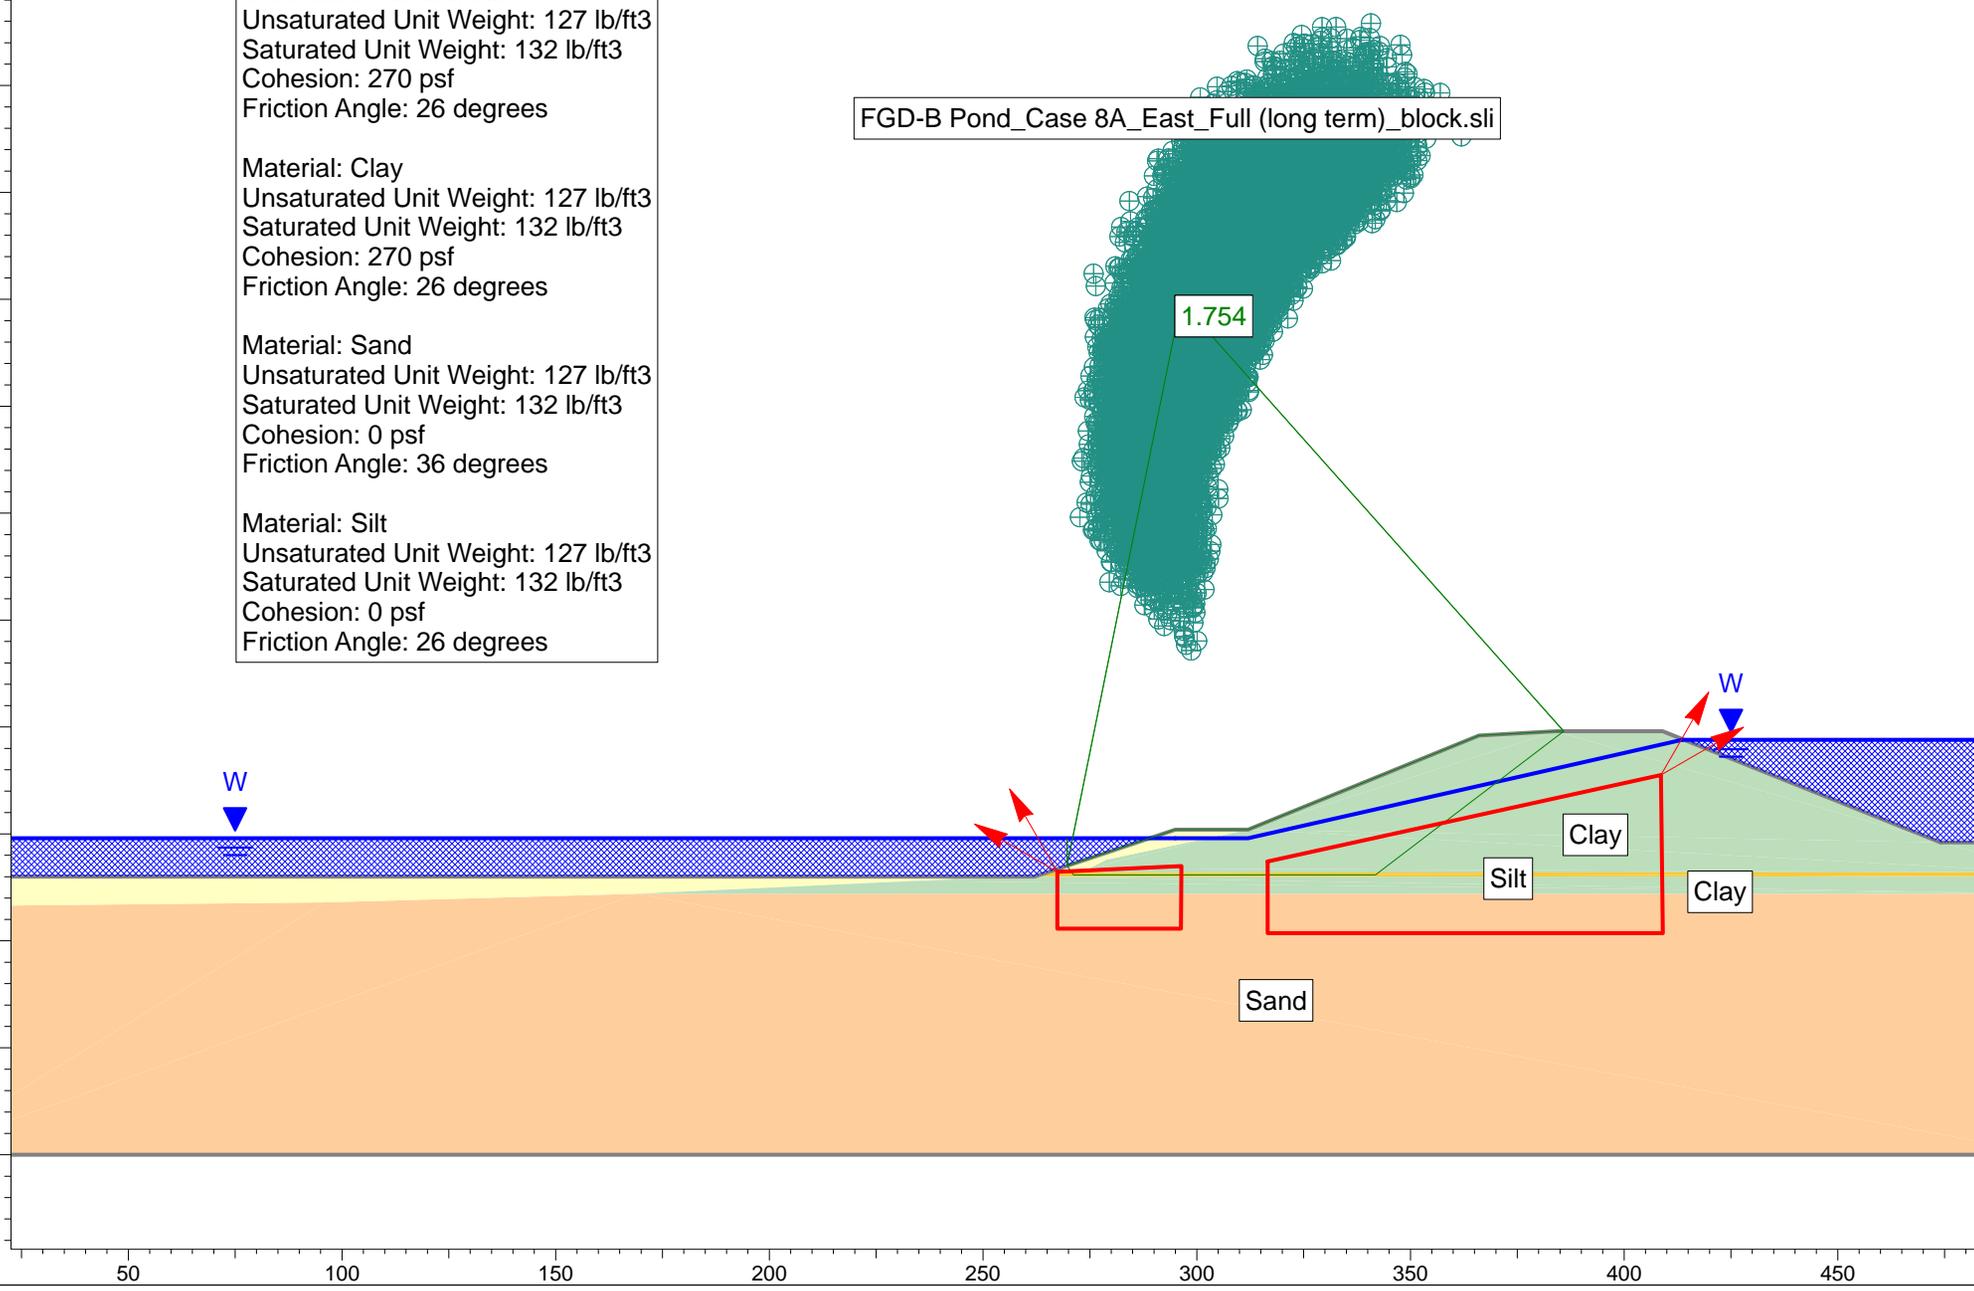
FGD-B Pond\_Case 8A\_East\_Full (long term)\_block.sli

Project Title: FGD-B Pond - Case 8A - East Slope - Full Pond (long term)  
Failure Direction: Right to Left  
Units of Measurement: Imperial Units  
Pore Fluid Unit Weight: 62.4 lb/ft3  
Groundwater Method: Water Surfaces  
Data Output: Standard  
Calculate Excess Pore Pressure: Off  
Allow Ru with Water Surfaces or Grids: Off  
Random Numbers: Pseudo-random Seed  
Random Number Seed: 10116  
Random Number Generation Method: Park and Miller v.3
