Dam Safety Assessment of CCW Impoundments
Luminant/OAK GROVE STEAM ELECTRIC STATION

United States Environmental Protection Agency
Washington, DC

June 3, 2014

Dam Safety Assessment of CCW Impoundments

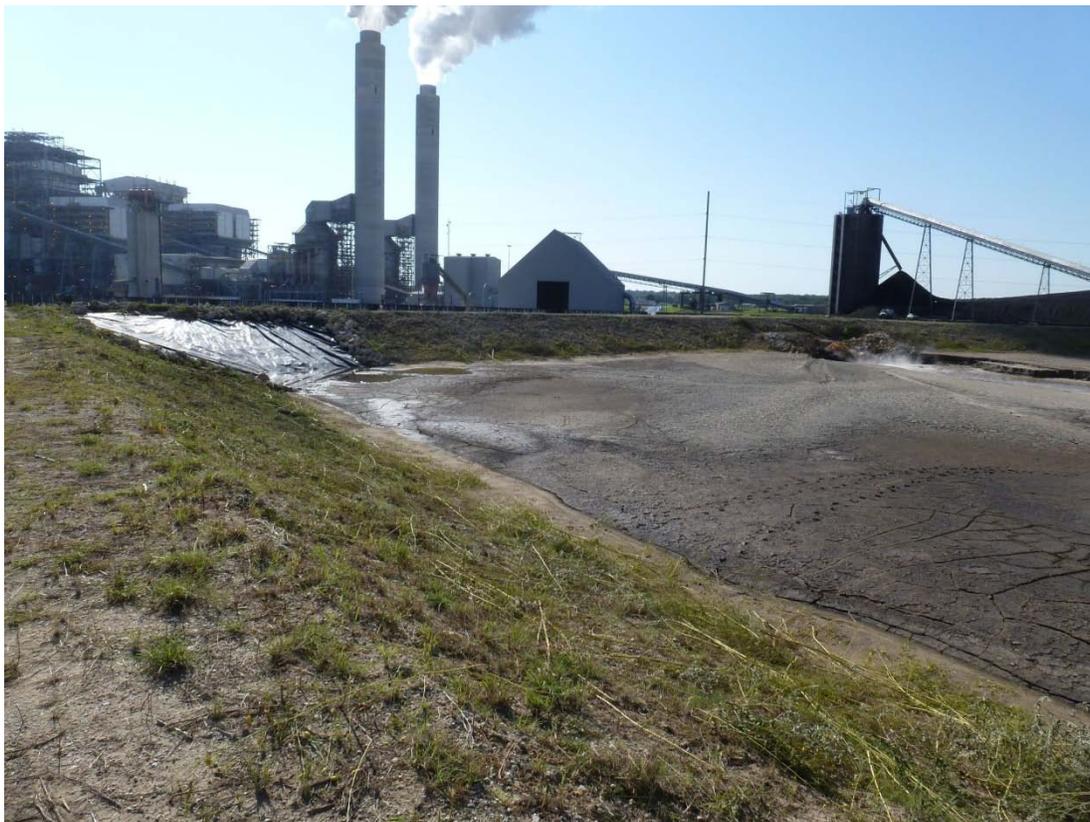
Photo Number:
3

Description:
FGD-A Pond.
Southeast abutment of the "Dividing Dike" and the Pond's Eastern embankment.
Note exposed liner.

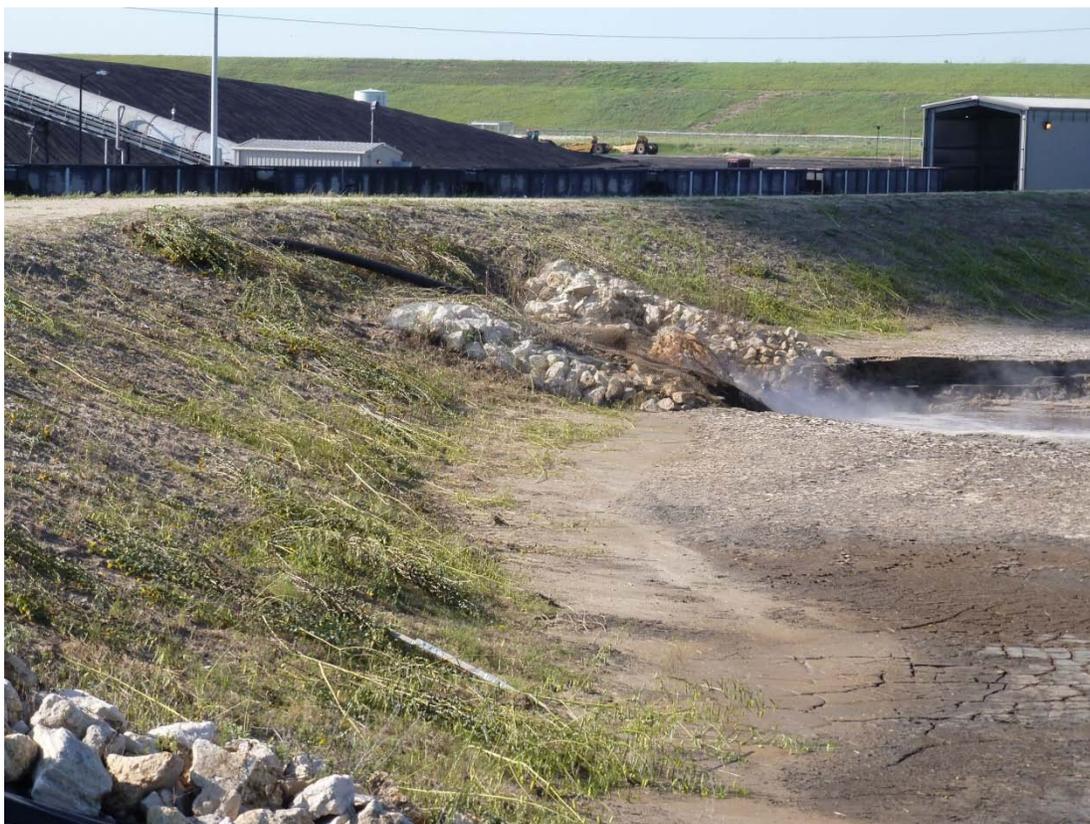
Photo Number:
4

Description:
CCW discharge into FGD-A Pond.

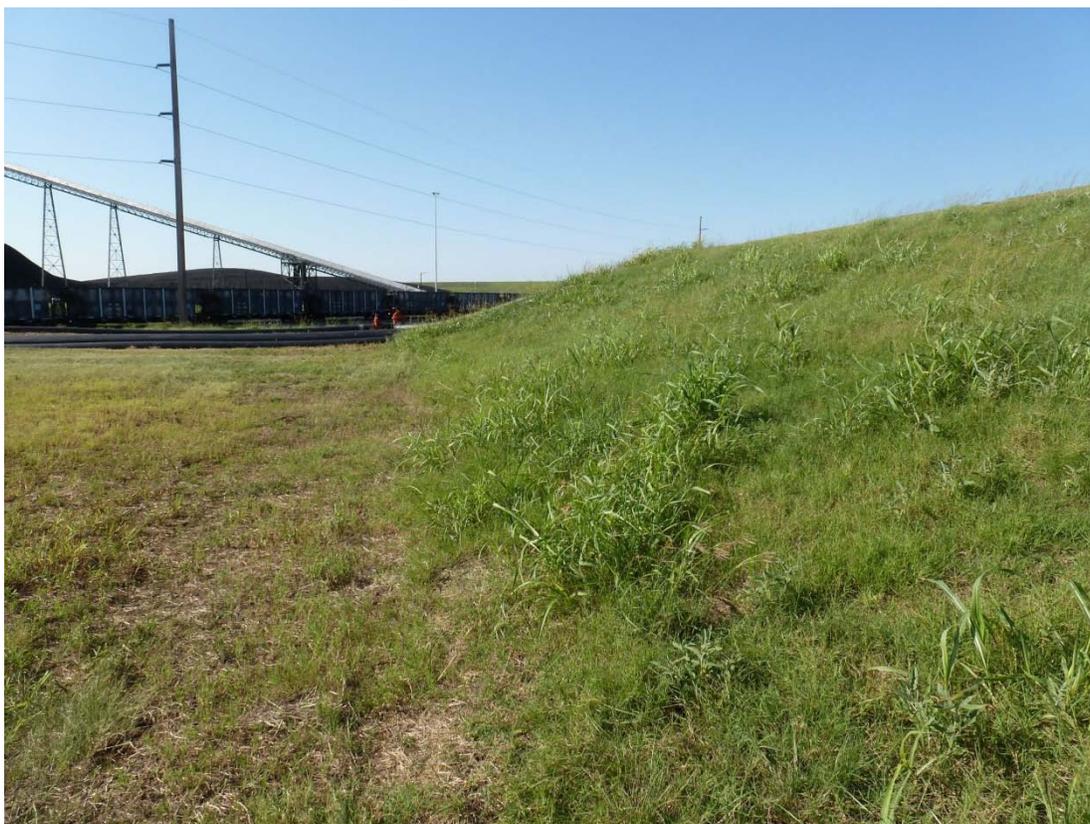
Date: 9/19/12
 Photo Number: 6
 Photographer: RCG

Orientation: S
 Description: FGD-A Pond. Outboard face of Eastern embankment. Photo typical of majority of Eastern, Southern and Northern embankments.

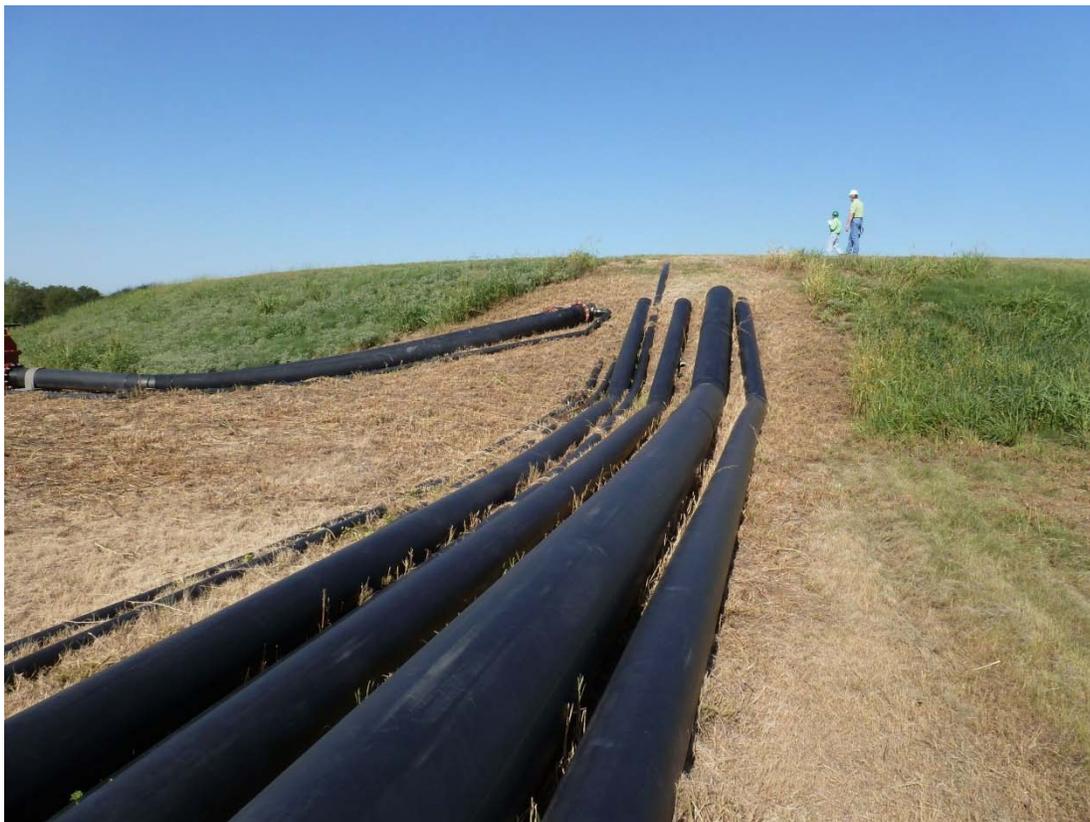
Photo Number:
7

Description:
FGD-A Pond.
Inflow piping.

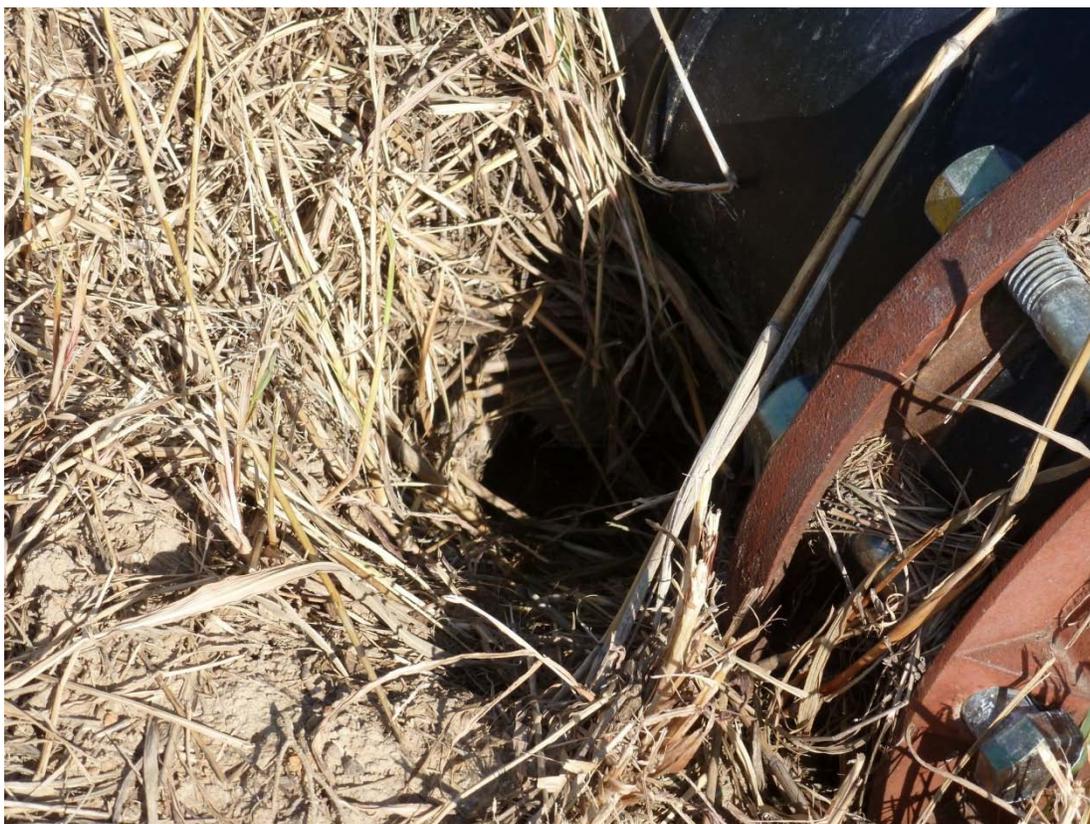
Photo Number:
8

Description:
FGD-A Pond.
Animal burrow
adjacent to
inflow piping.

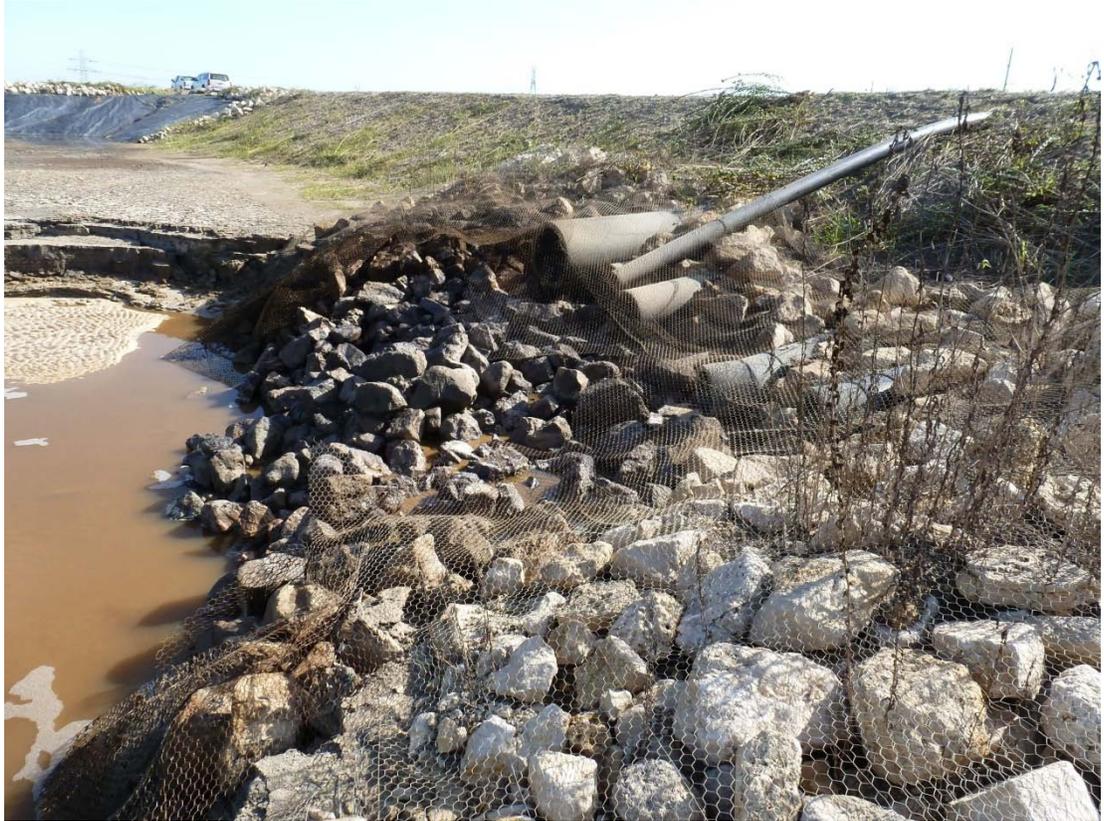
Photo Number:
9

Description:
FGD-A Pond.
Discharge end
of inflow piping.

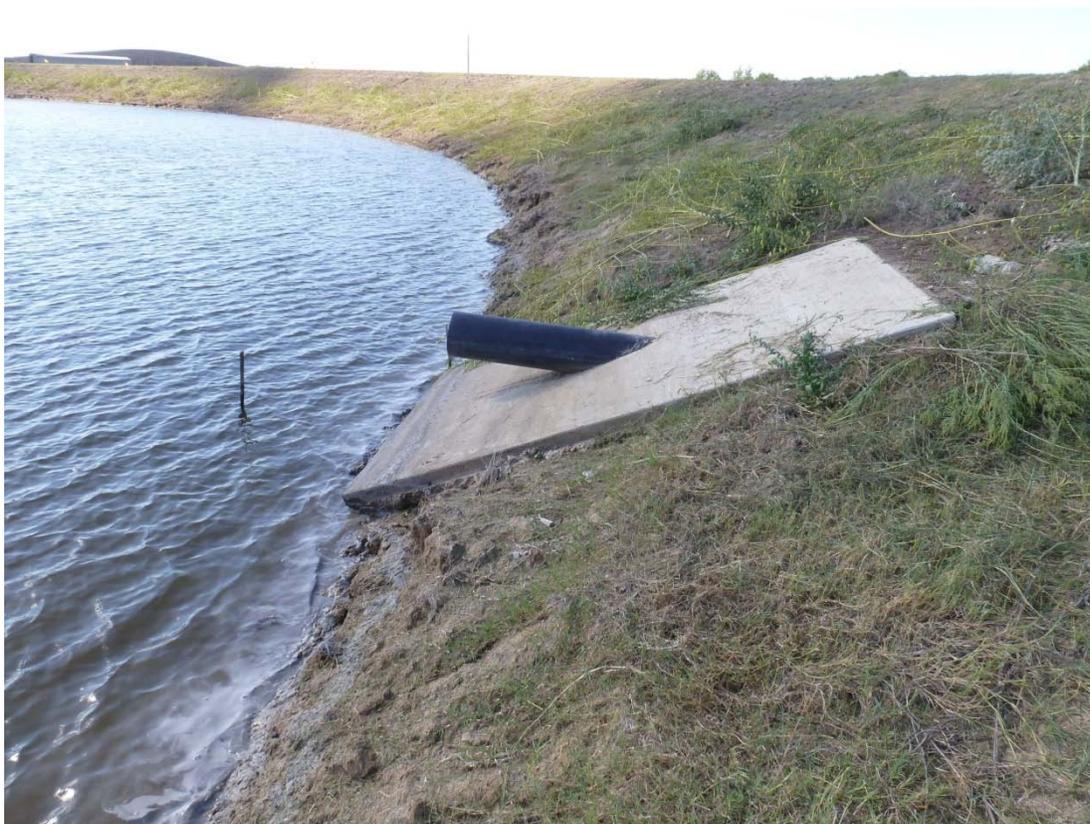
Photo Number:
12

Description:
FGD-A Pond.
Overflow/decant pipe to FGD Pond B.

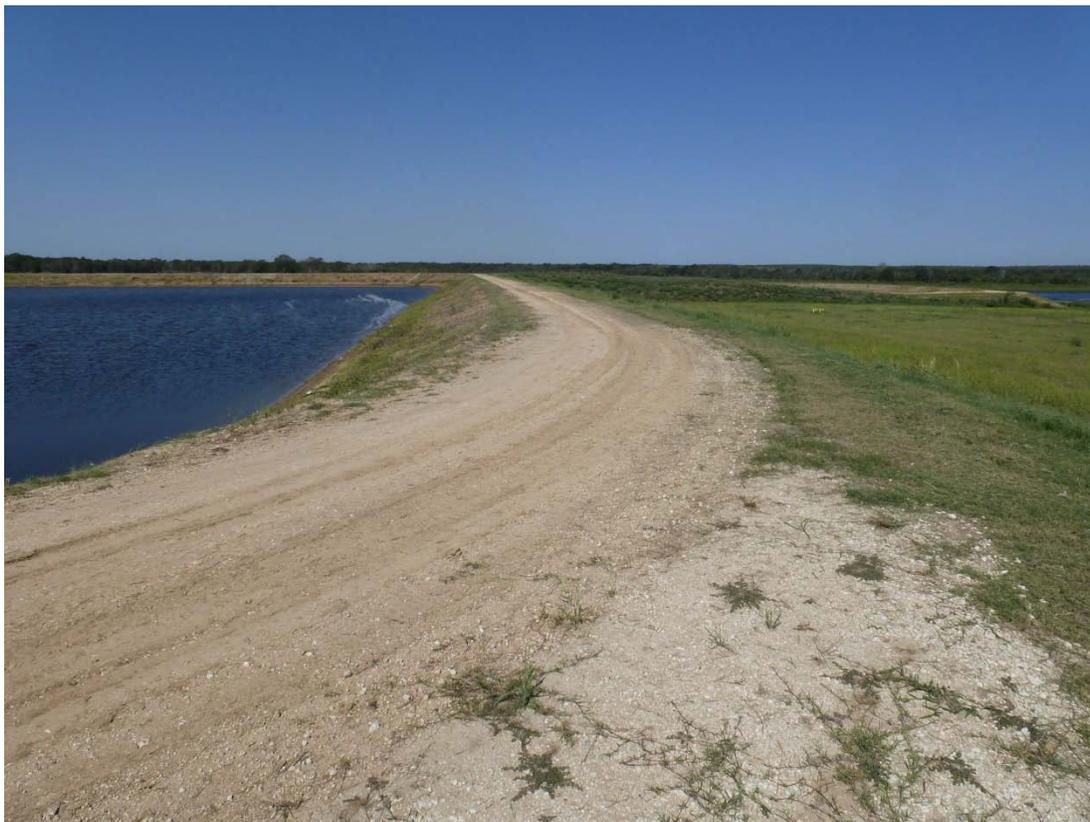
Photo Number:
17

Description:
FGD-A Pond.
Crest of
Northern
embankment.
Condition
shown in photo
is typical of
entire crest.

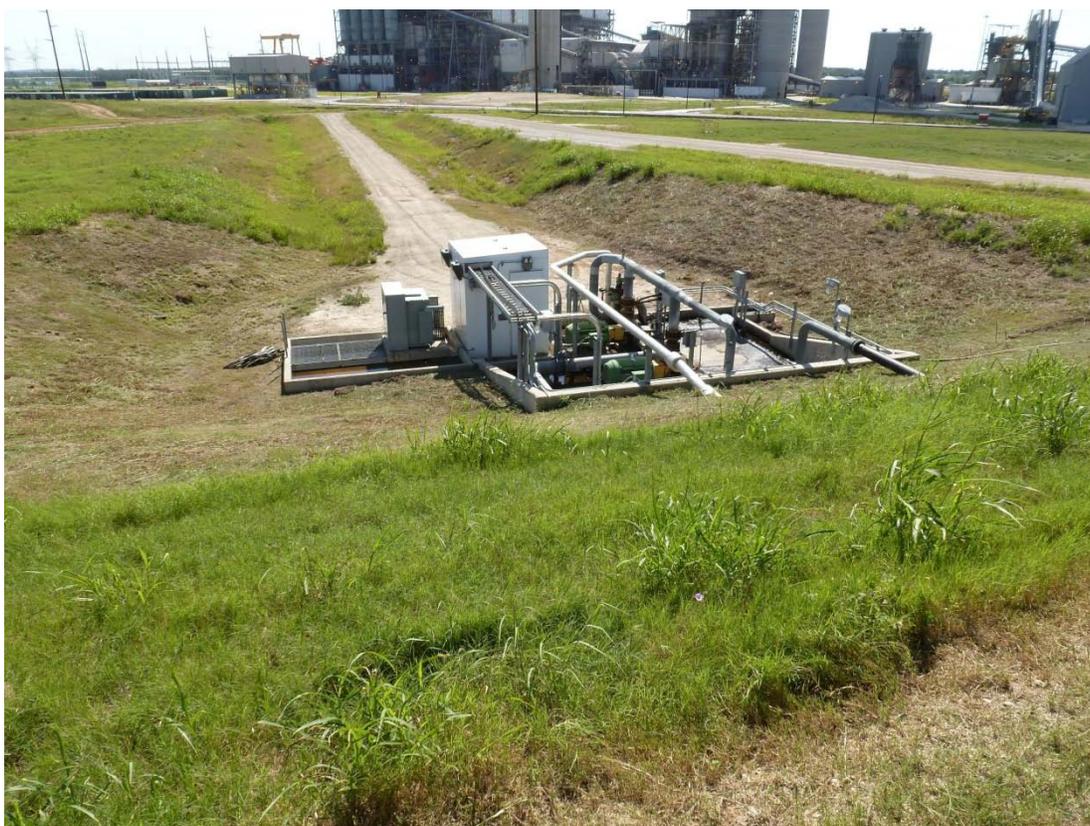
Photo Number:
18

Description:
FGD-A Pond.
Pond pump
station. Used to
pump water
from the pond
to the plant.

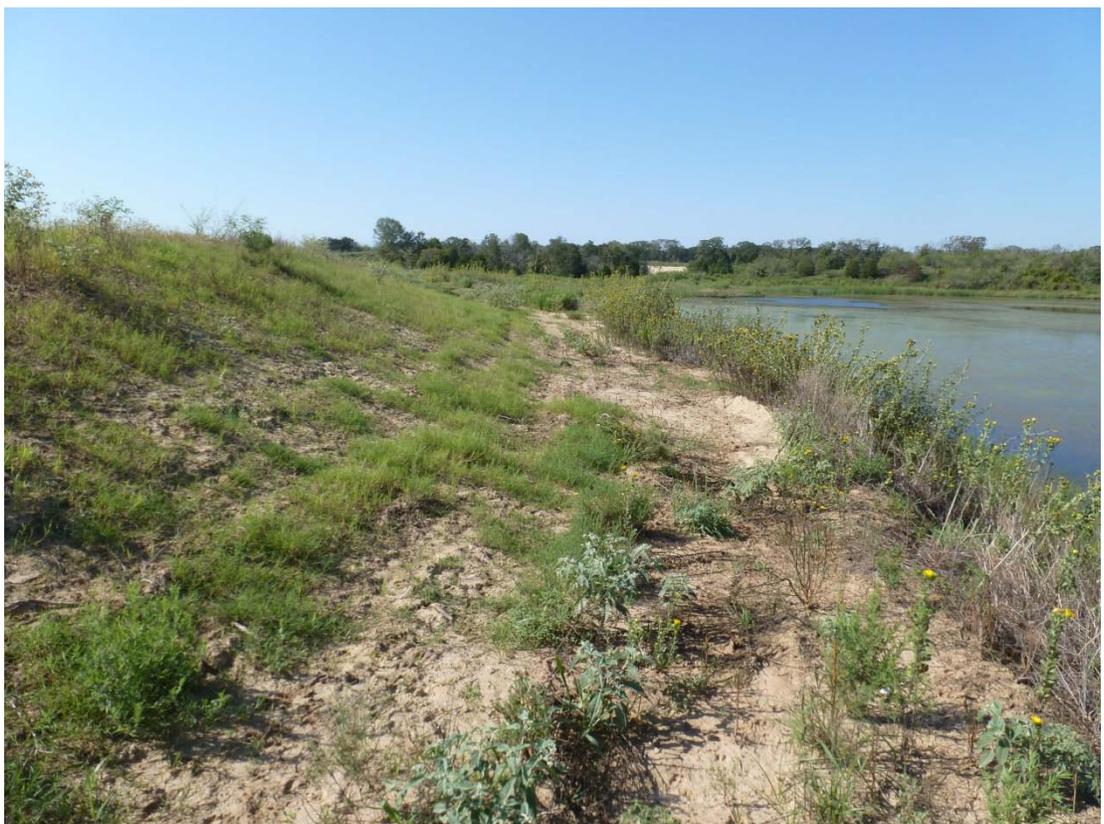
Photo Number:
22

Description:
FGD-B Pond.
Outboard face
of Northern
embankment.
Note reservoir
adjacent to the
impoundment.
The reservoir
does not abut
any
embankment.

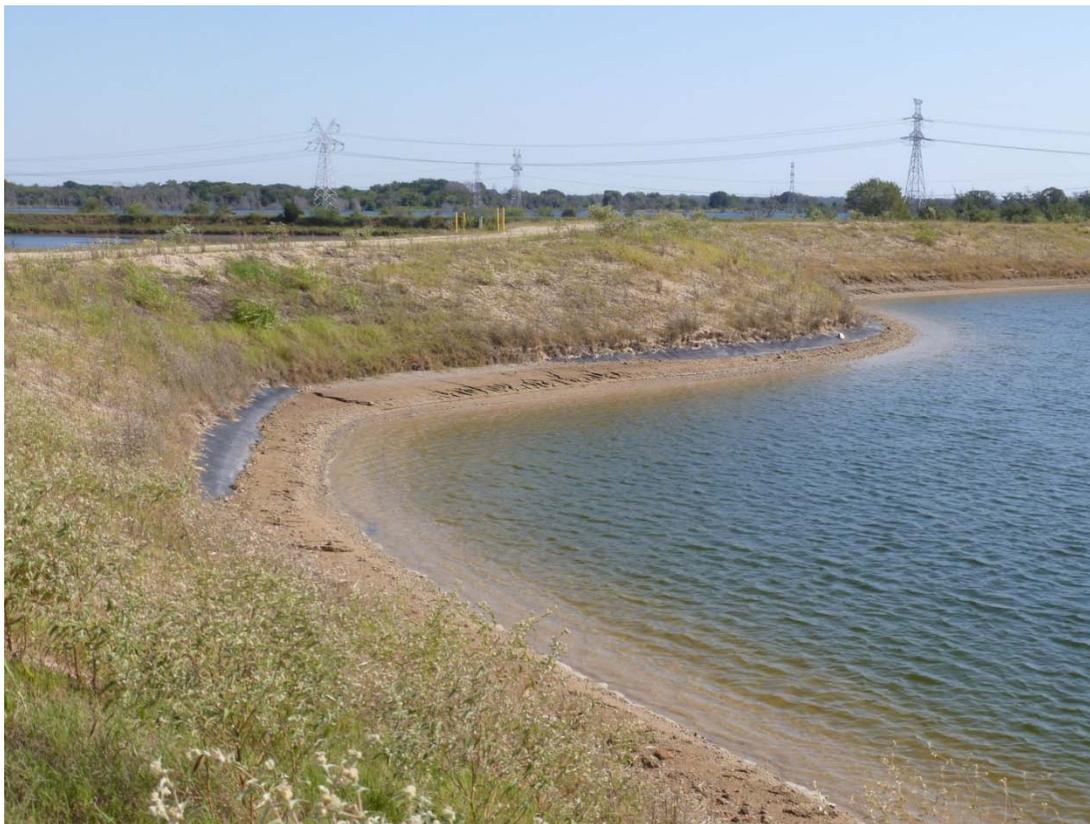
Photo Number:
23

Description:
FGD-B Pond.
Inboard face of
Northern
embankment.
Note exposed
liner.

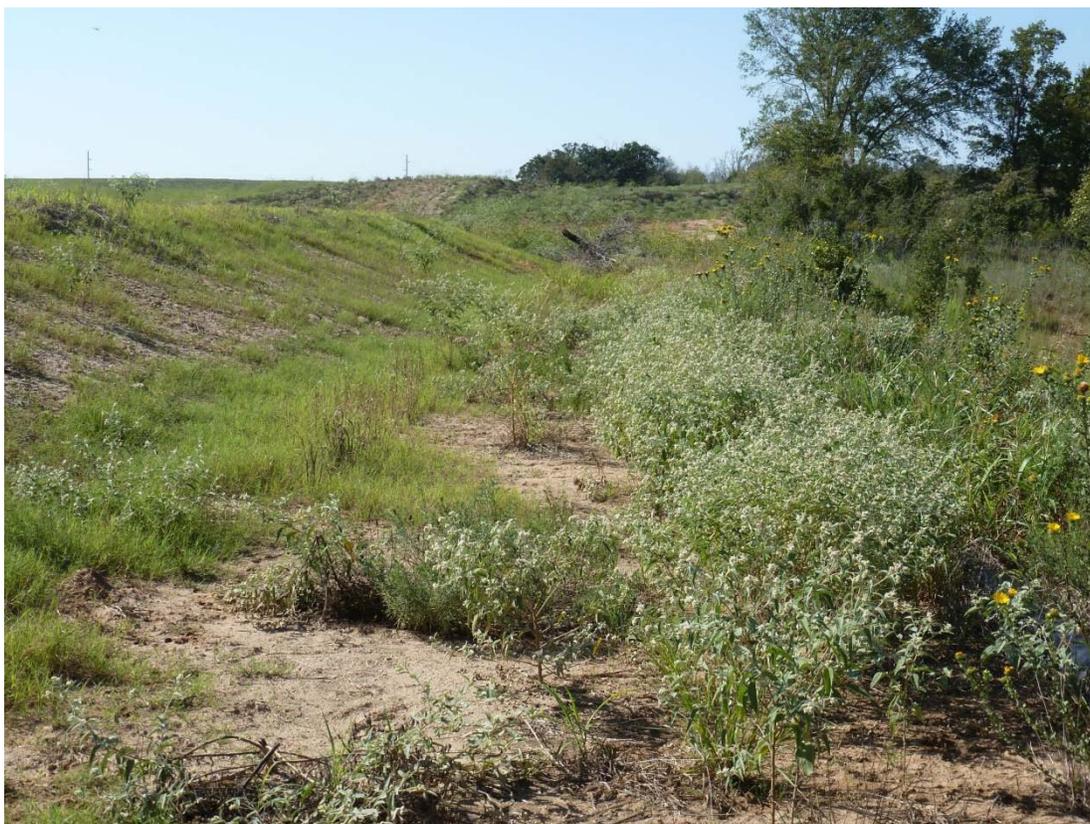
Photo Number:
24

Description:
FGD-B Pond.
Outboard face of
Western
embankment.

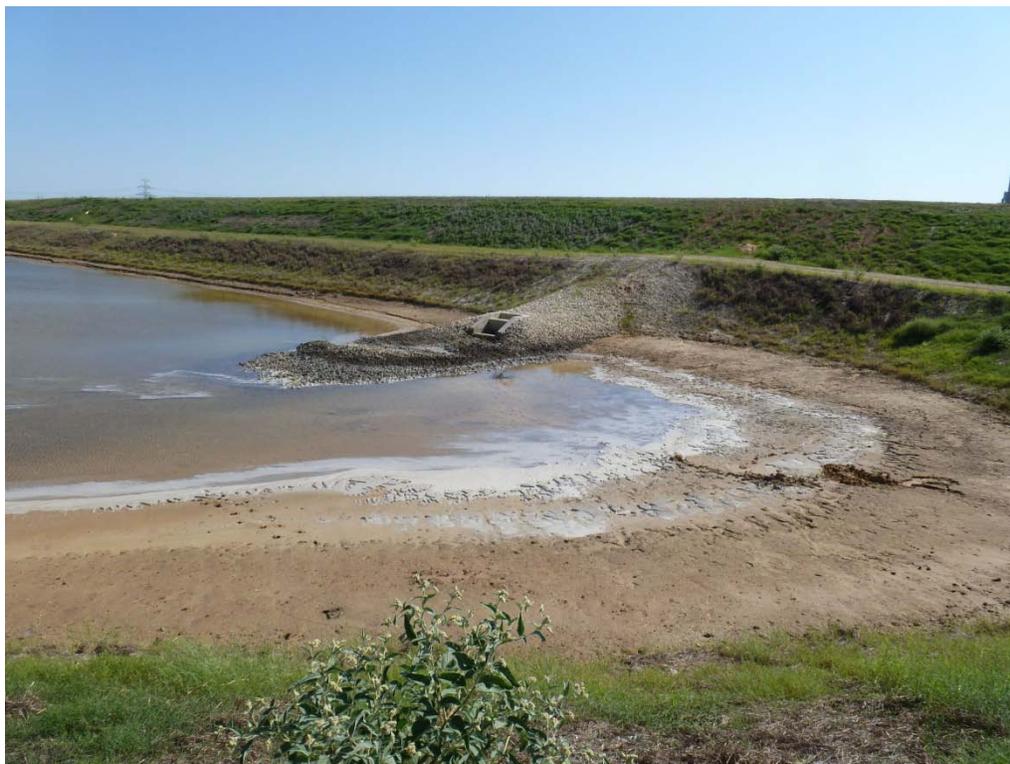
Photo Number:
28

Description:
FGD-B Pond.
Discharge end
of overflow/
decant pipe
from FGD-A
Pond.

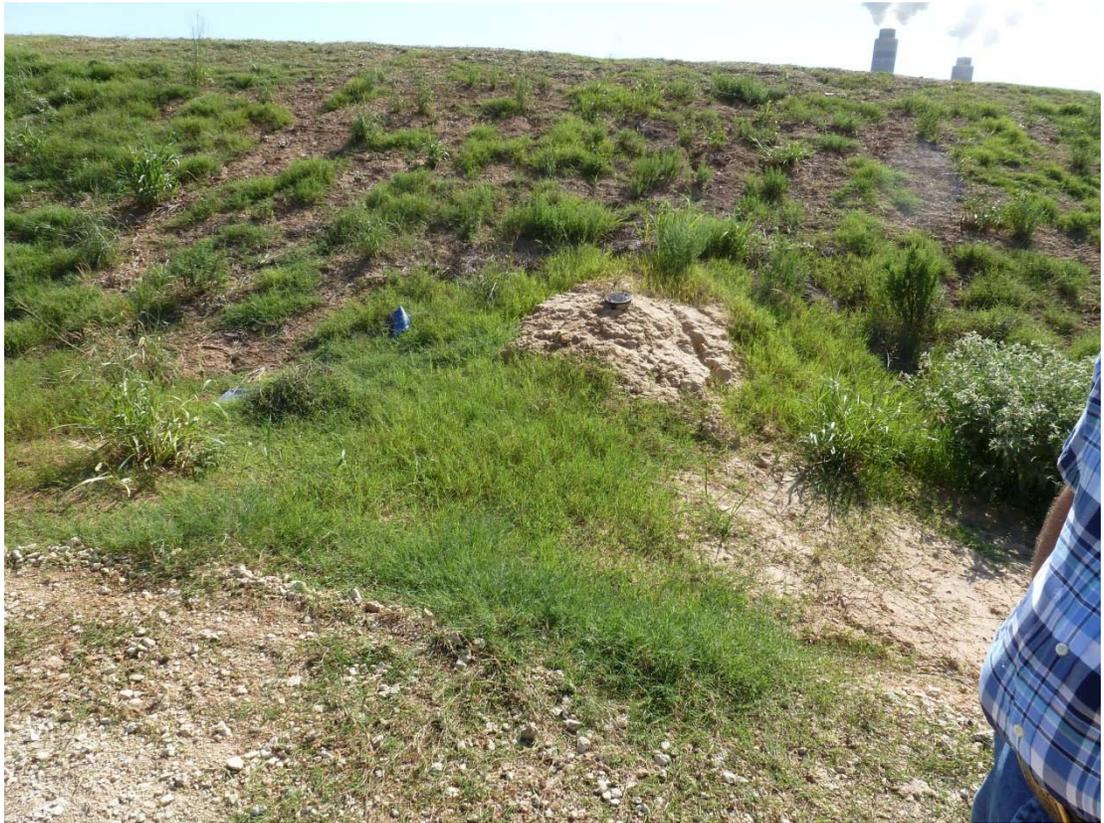
Photo Number:
29

Description:
Outboard face of the Western embankment of FGD-A. Note valve-box for control valve on overflow/decant pipe.

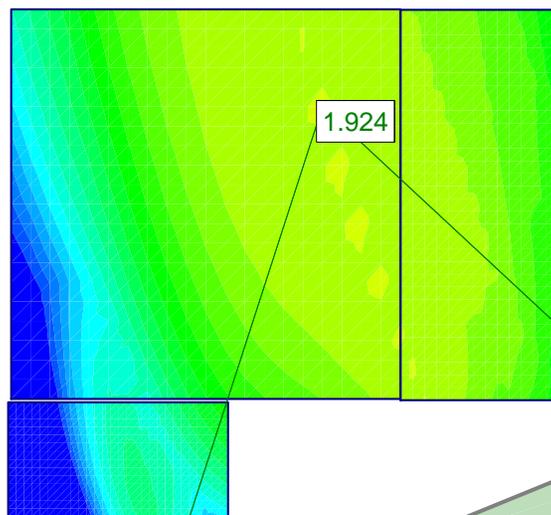
FGD-B Pond_Case 8_East_Full (long term)_circular.sli

Project Title: FGD-B Pond - Case 8 - East Slope - Full Pond (long term)
Failure Direction: Right to Left
Units of Measurement: Imperial Units
Pore Fluid Unit Weight: 62.4 lb/ft³
Groundwater Method: Water Surfaces
Data Output: Standard
Calculate Excess Pore Pressure: Off
Allow Ru with Water Surfaces or Grids: Off
Random Numbers: Pseudo-random Seed
Random Number Seed: 10116
Random Number Generation Method: Park and Miller v.3

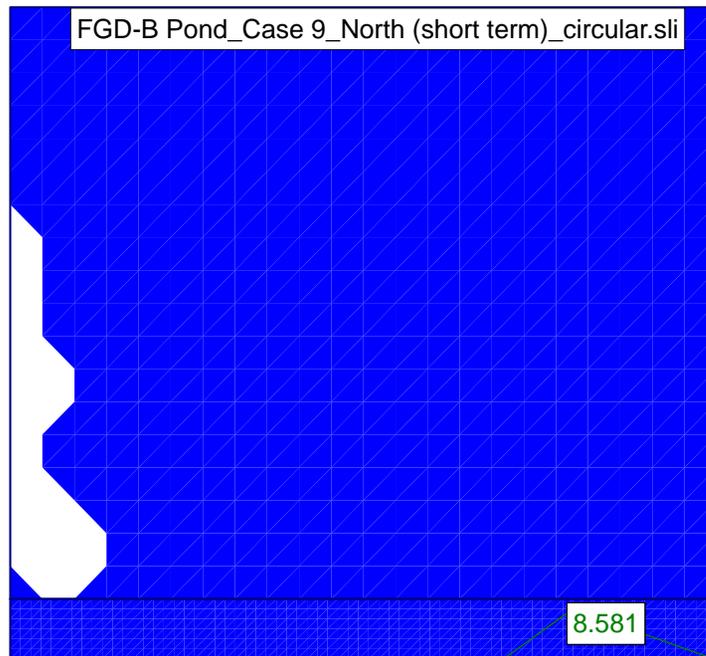
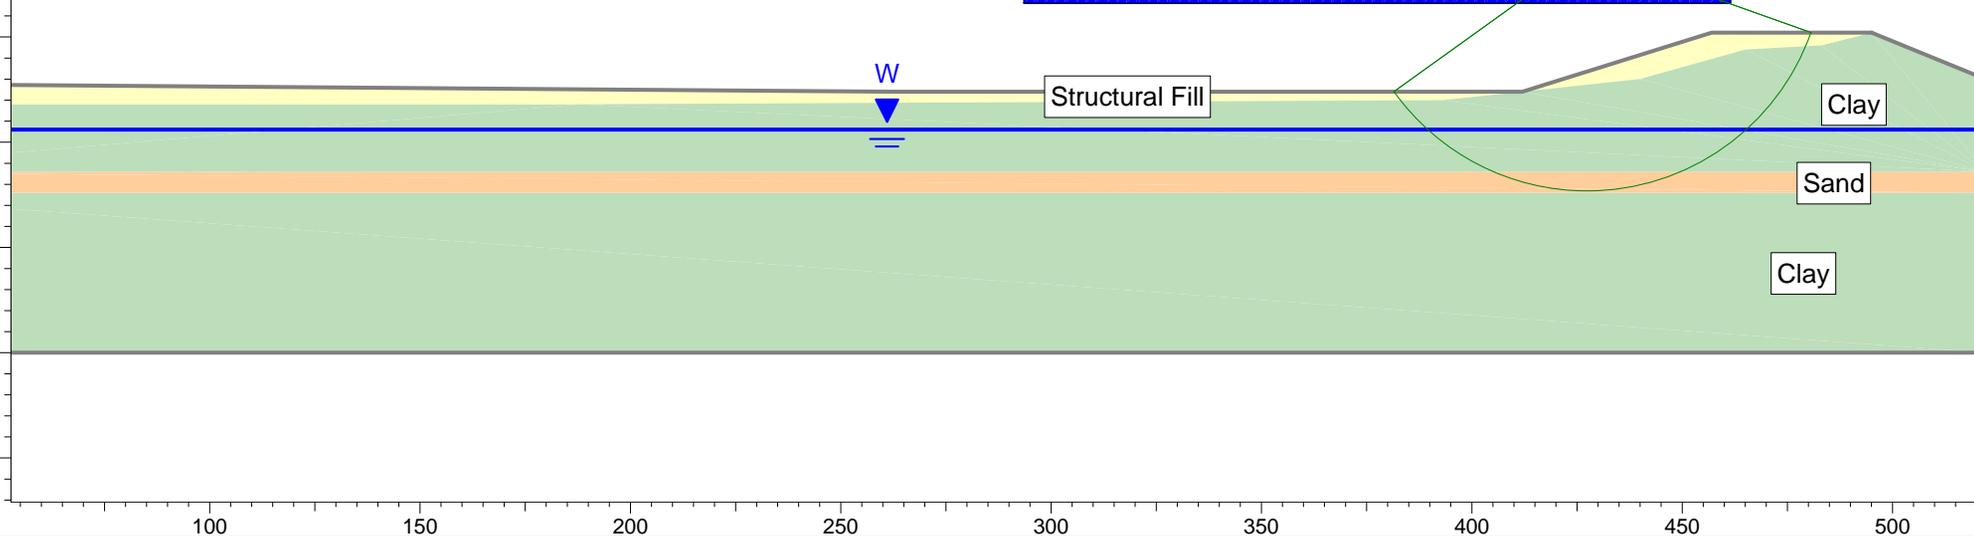
Project Title: FGD-B Pond: Case 9 North Slope (short term)
Failure Direction: Right to Left
Units of Measurement: Imperial Units
Pore Fluid Unit Weight: 62.4 lb/ft³
Groundwater Method: Water Surfaces
Data Output: Standard
Calculate Excess Pore Pressure: Off
Allow Ru with Water Surfaces or Grids: Off
Random Numbers: Pseudo-random Seed
Random Number Seed: 10116
Random Number Generation Method: Park and Miller v.3

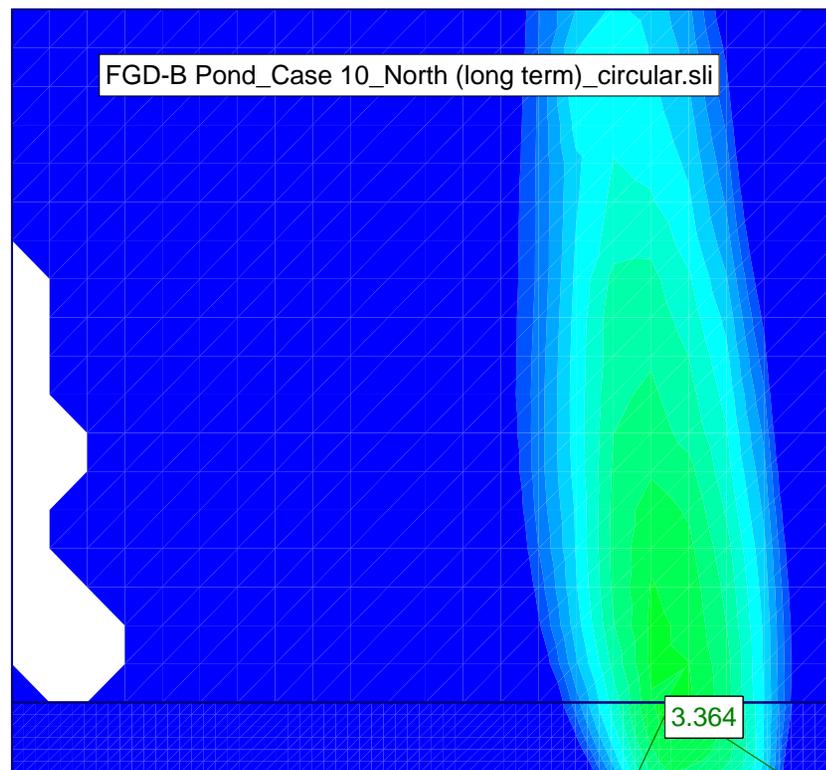
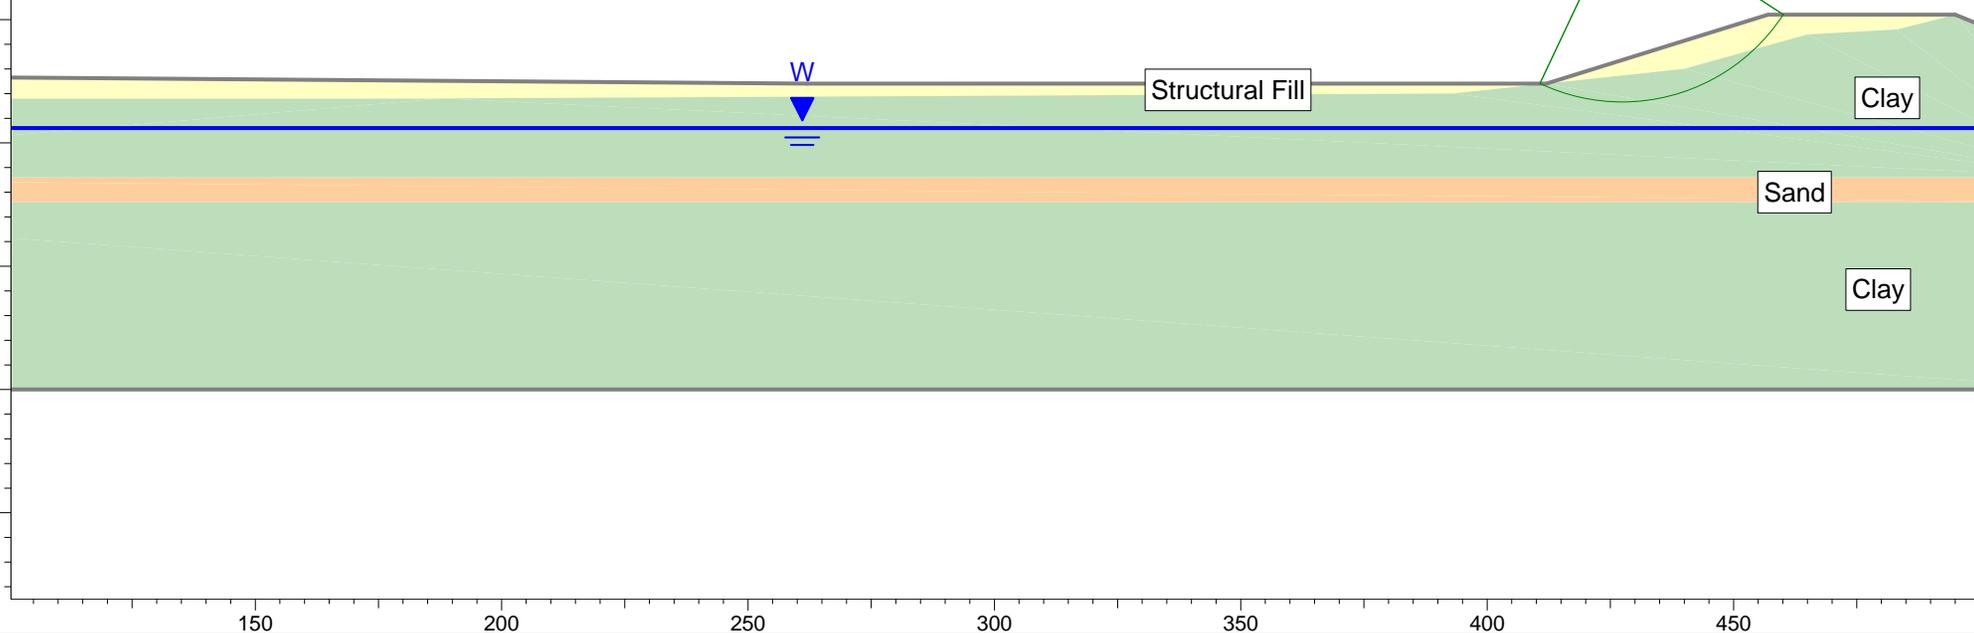
Project Title: FGD-B Pond: Case 10 North Slope (long term)
Failure Direction: Right to Left
Units of Measurement: Imperial Units
Pore Fluid Unit Weight: 62.4 lb/ft³
Groundwater Method: Water Surfaces
Data Output: Standard
Calculate Excess Pore Pressure: Off
Allow Ru with Water Surfaces or Grids: Off
Random Numbers: Pseudo-random Seed
Random Number Seed: 10116
Random Number Generation Method: Park and Miller v.3

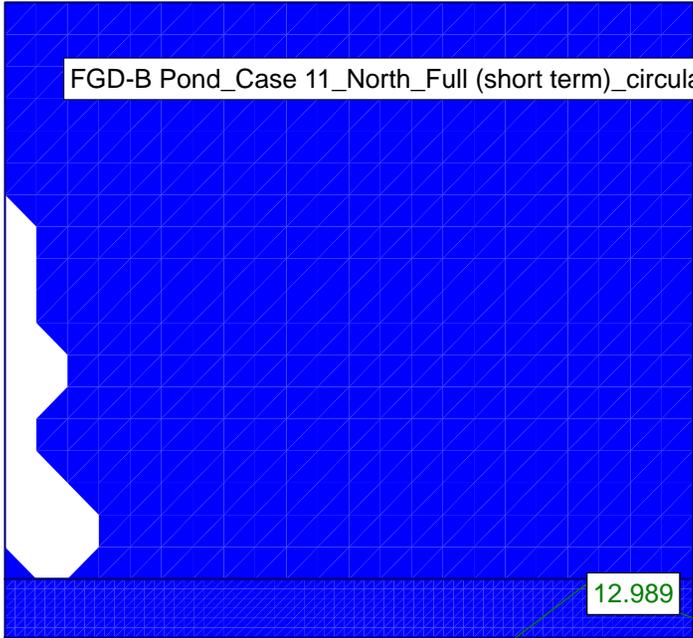
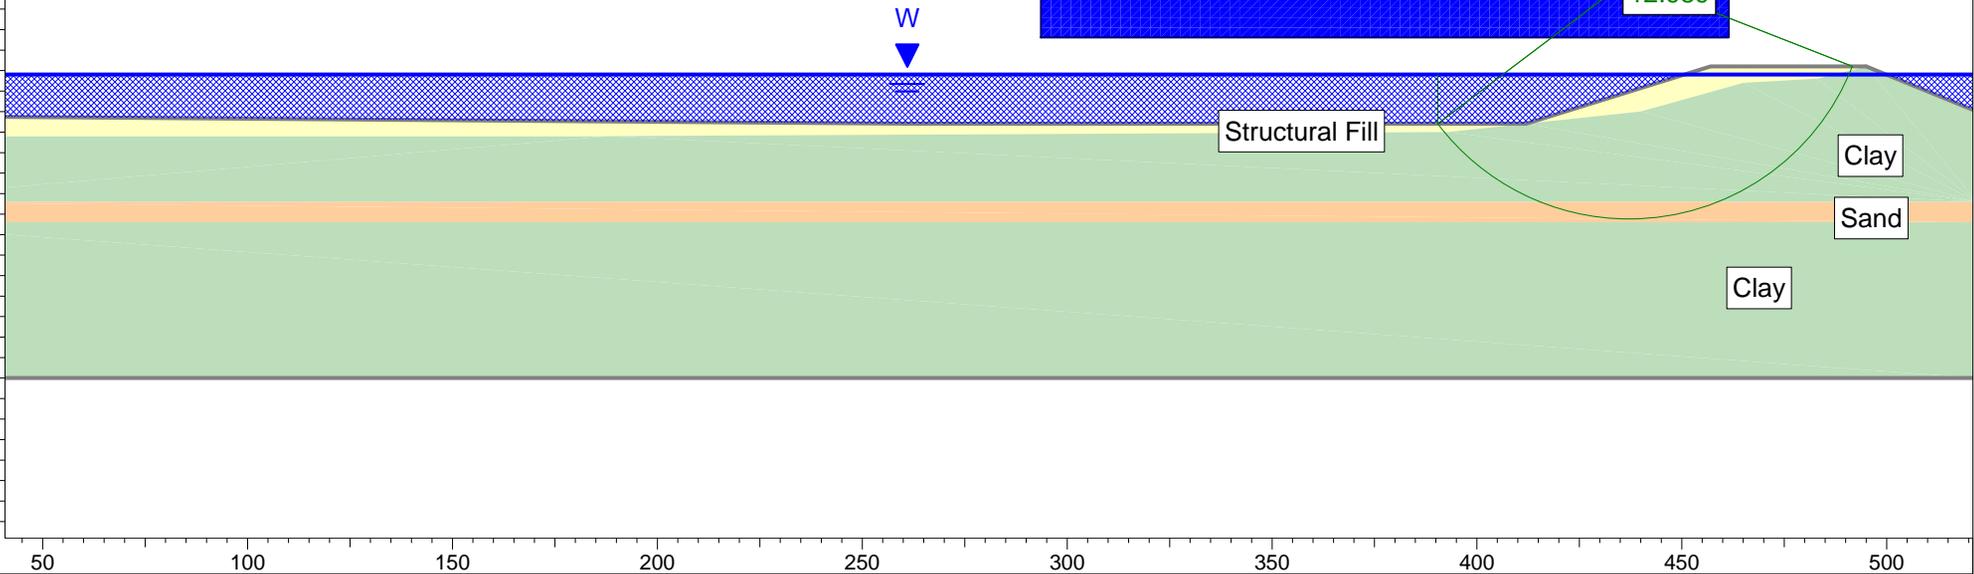
Project Title: FGD-B Pond: Case 11 North Slope - Full (short term)
Failure Direction: Right to Left
Units of Measurement: Imperial Units
Pore Fluid Unit Weight: 62.4 lb/ft3
Groundwater Method: Water Surfaces
Data Output: Standard
Calculate Excess Pore Pressure: Off
Allow Ru with Water Surfaces or Grids: Off
Random Numbers: Pseudo-random Seed
Random Number Seed: 10116
Random Number Generation Method: Park and Miller v.3

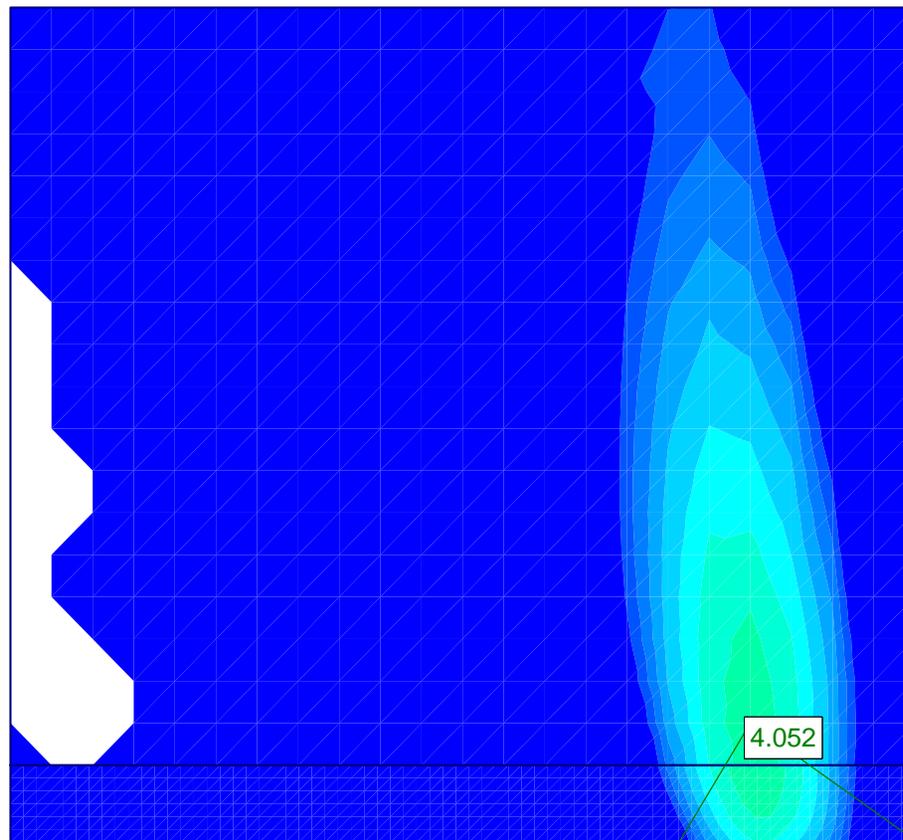
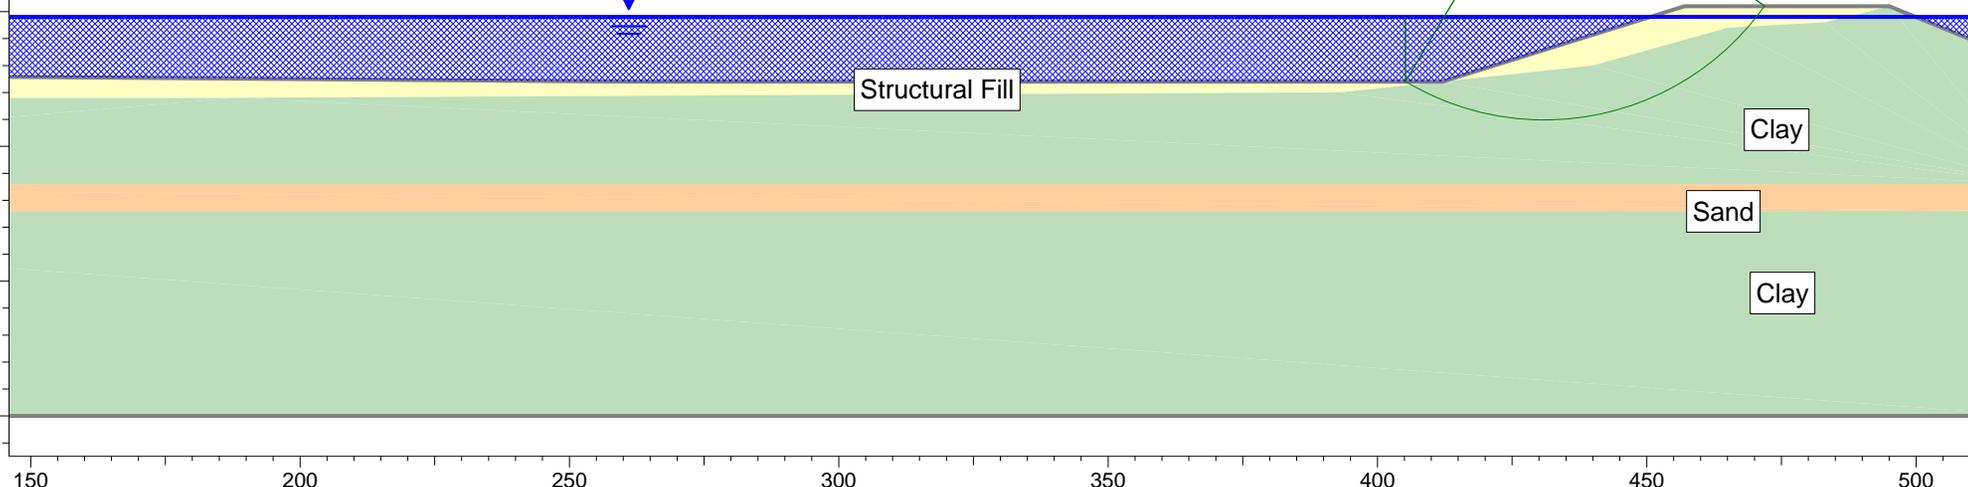
Project Title: FGD-B Pond: Case 12 North Slope - Full (long term)
Failure Direction: Right to Left
Units of Measurement: Imperial Units
Pore Fluid Unit Weight: 62.4 lb/ft³
Groundwater Method: Water Surfaces
Data Output: Standard
Calculate Excess Pore Pressure: Off
Allow Ru with Water Surfaces or Grids: Off
Random Numbers: Pseudo-random Seed
Random Number Seed: 10116
Random Number Generation Method: Park and Miller v.3
