Coal Combustion Waste Impoundment

Round 7 - Dam Assessment Report

George Neal North Energy Center

MidAmerican Energy
Sergeant Bluff, Iowa

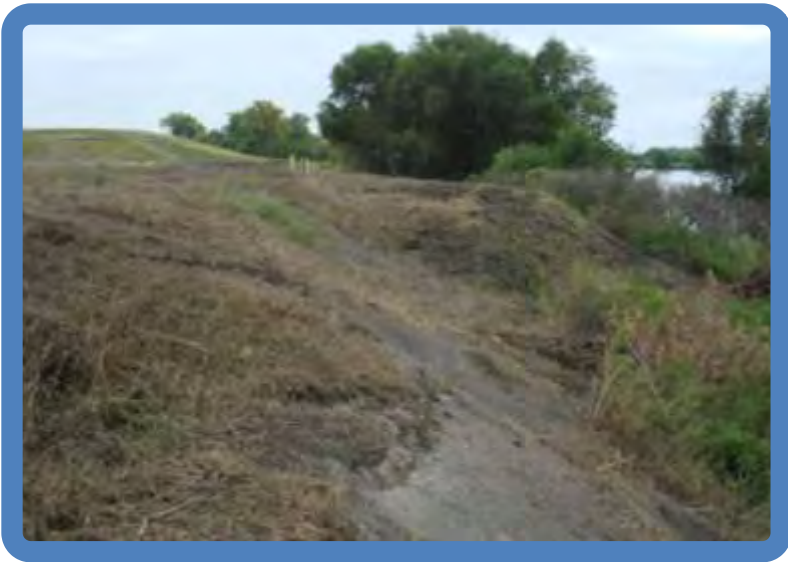
Photo 1.4

Pond 1 dike inside slope (SW side viewed SE)
-mounded ash is in area of former erosion

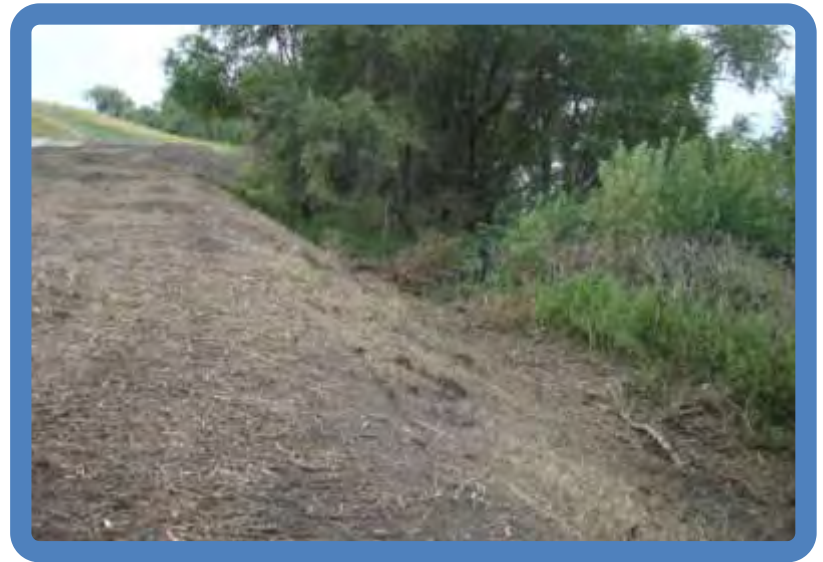
Photo 1.5
Pond 1 dike outside slope (SW side viewed SE)-note berm

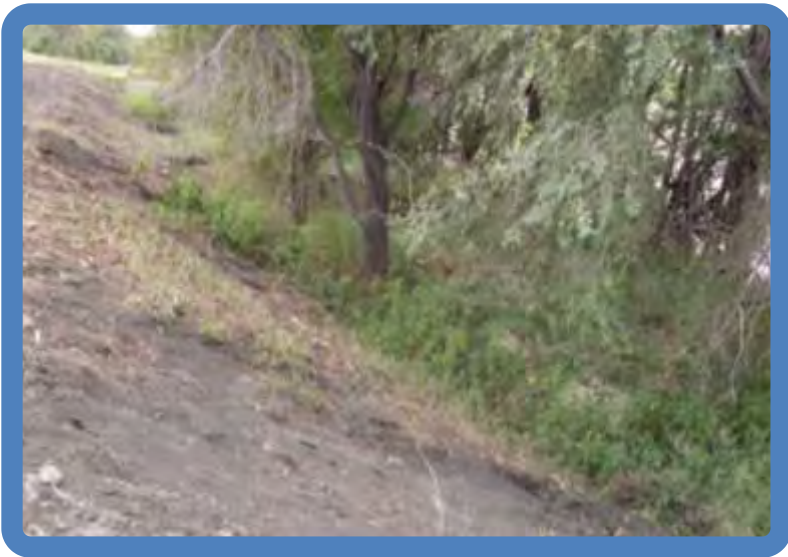
Photo 1.6
Pond 1 dike outside slope (SW side viewed SE)-note berm

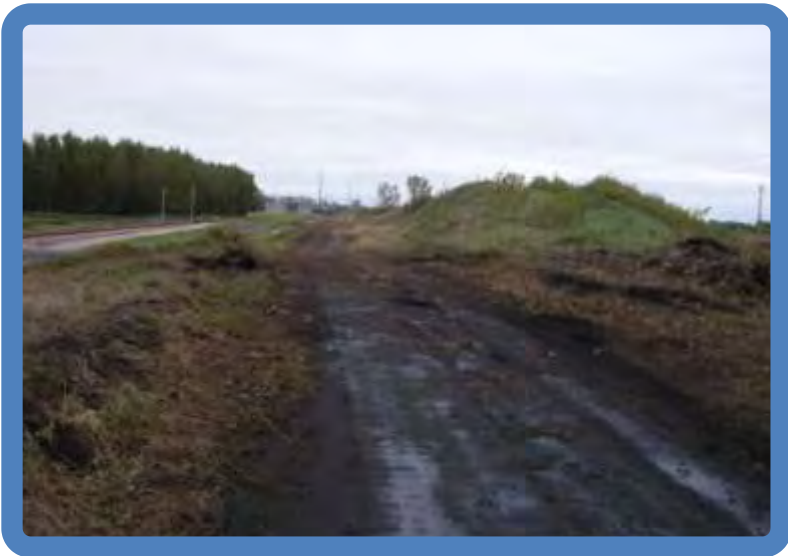
Ash material was observed to have been piled up along the inside edge of the crest on the northwest side of Pond 2 (and Pond 3) giving the appearance of a higher berm (see Photo 2.3).

Photo 2.3
Pond 2 dike crest (NW side viewed NE)

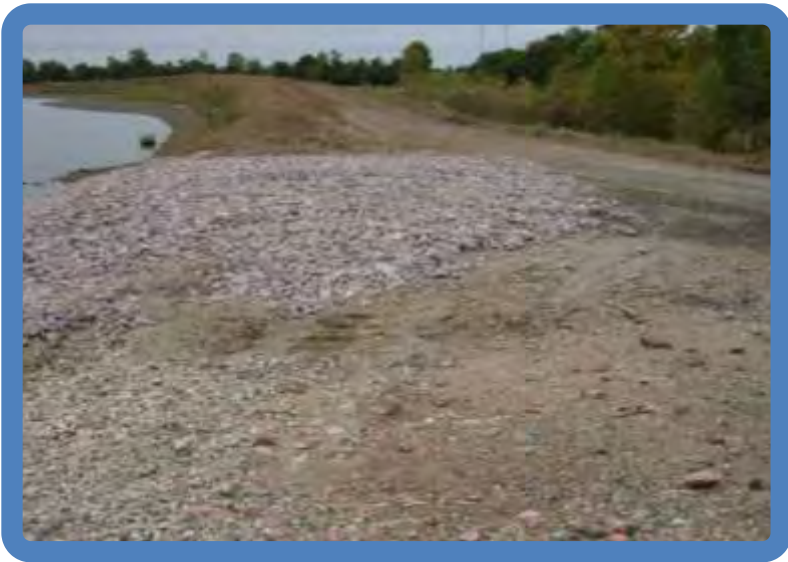
No major tension cracks or other signs of soil shear value were observed. However, a noticeable low section of the crest was observed along the south perimeter dike section (see Photo 3.5) and extending around to the northeast side.

Photo 3.5
Pond 3B South dike inside slope (S side viewed NE) -low crest

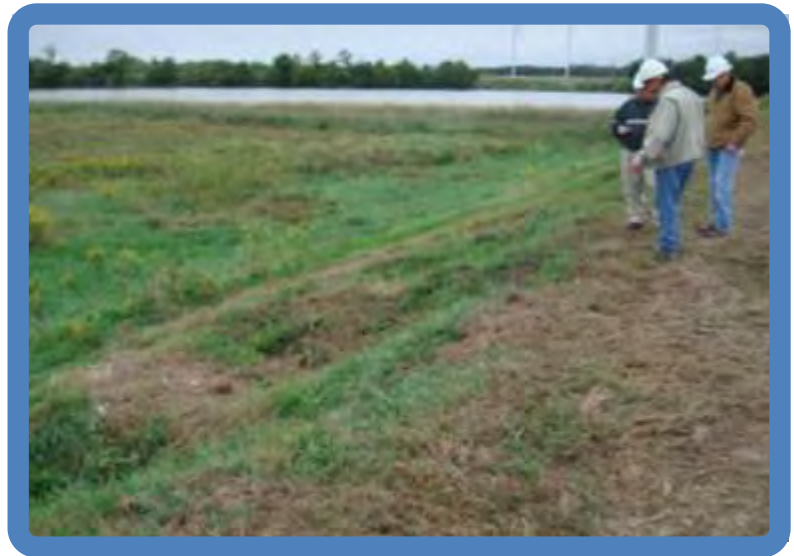
No obvious signs of slumps, slides, bulges, tension cracks, or animal holes were observed in the outside slope. However, holes were observed in the outside slope surface several feet (vertically) below the crest in the area of suspected seepage erosion through the northeast-side perimeter dike (see Photo 3.8). An animal hole was noted in the ash mound above crest level on the northwest side. No major surface erosion was observed.

Pond 3B North is the northerly half of Pond 3 B. The southwest part (less than half) of Pond 3B North currently receives sluiced ash from Boiler Unit 3; the sluice water ponds at the lower, southeast end and the ash builds up at the northwest end, where ash is discharged into the pond (see Photo 3.18). The northeast part of Pond 3B North is currently diked off and in the process of being excavated to restore storage volume; the southeast end of this part has been excavated, and vegetation is becoming established on the bottom (see Photo 3.11). A buffer of 50 or 60 feet has been maintained between the excavation and the perimeter dike where apparent seepage erosion holes were observed in the outside slope.

Photo 3.8
Pond 3B North dike outside slope (NE side viewed SE)
-note erosion holes

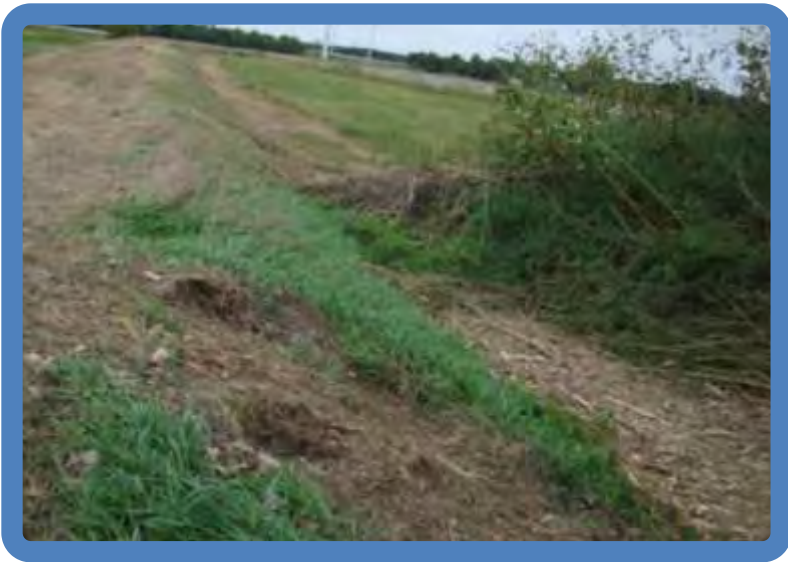
In the visible parts of the inside slopes above ash level no obvious signs of slumps, slides, bulges, tension cracks, or animal holes were observed (see Photos 3.10 through 3.13). No significant erosion was observed.

Photo 3.13
Pond 3B North dike inside slope (NE side viewed SE)

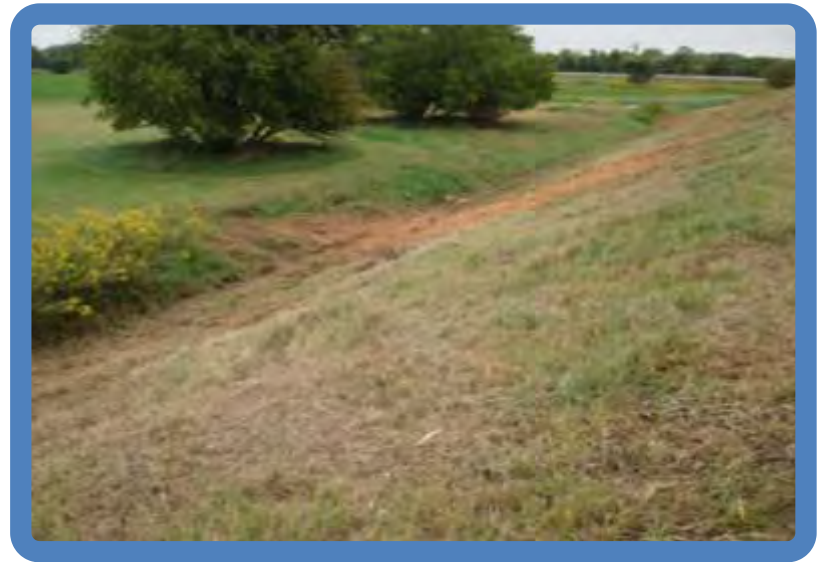
The outside slope and toe area along the northwest-side and northeast-side perimeter dike was observed to have a well-maintained grass cover (see Photos 3.14 through 3.16).

Photo 3.14
Pond 3B North dike outside slope (NE side viewed SE)

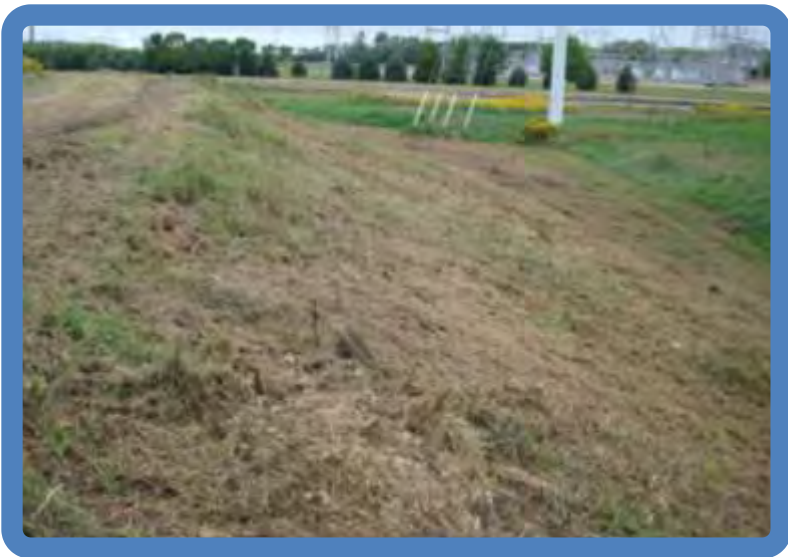
Photo 3.15
Pond 3B North dike outside slope (NE side viewed NW)

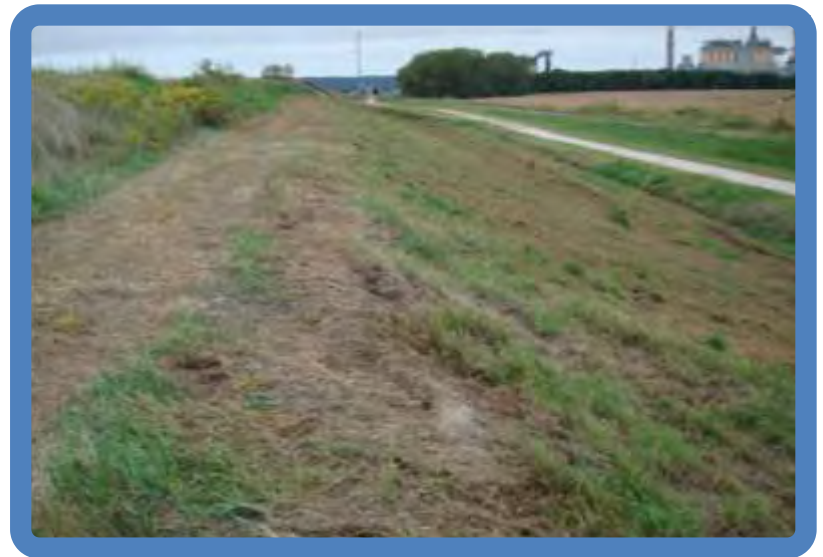
The perimeter dike inside slope is generally buried with ash deposits, except along the southeast part of the perimeter dike on the northeast side, which is partially exposed above ash level in the pond. There is a linear mound of ash material up to 10 feet high above the dike crest elevation along the inside edge of the perimeter dike crest on the northwest side (see Photos 3.16 and 3.19) and partly on the northeast side, northwest end.

Photo 3.16
Pond 3B North dike outside slope (NW side viewed SW)

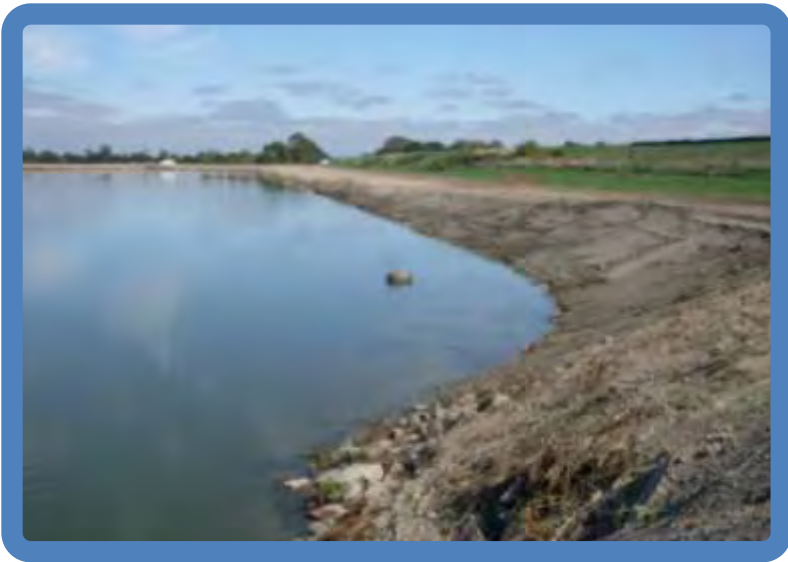
Pond 3A was observed to have the largest pool of water of all the ash ponds at NNEC. The pool of water occupies most of the basin area (see Photos 3.24 and 3.30), except in the northwest part where ash deposits have accumulated and where ash formerly was mounded along the inside edge of the northwest-side crest above the crest elevation (see Photos 3.19 through 3.22). Thus, the inside slopes of Pond 3A are generally covered with water or buried with ash deposits. The ash deposits were observed to contain some C-stone fragments (see Photo 3.31). In addition to the sluiced discharge received from Pond 2, Pond 3A occasionally receives discharge from an ash sluice pipe located over the northwest side (see Photo 3.32), near juncture with northeast part of Pond 2. The exposed upper part of the inside slope above water level on the south side was observed to have been recently graded and was generally bare with no vegetative cover at the time of the site visit (see Photo 3.25).

Photo 3.25
Pond 3A dike inside slope (S side viewed E)

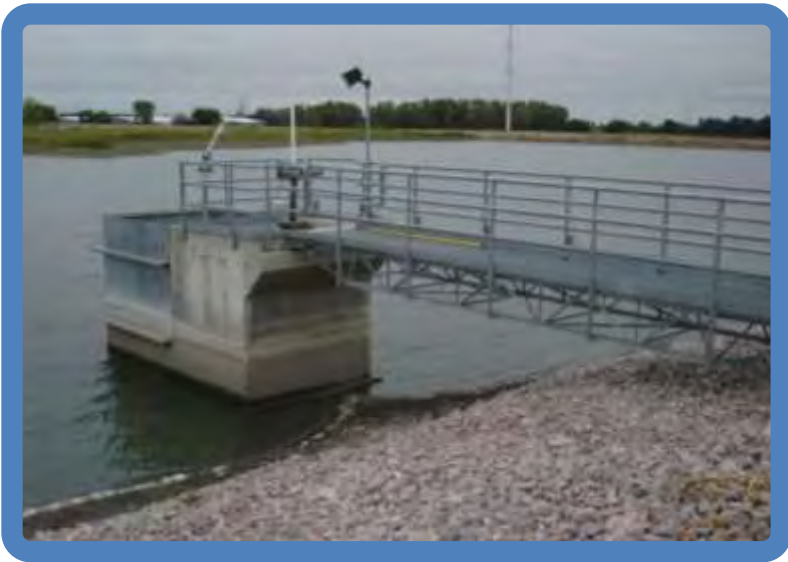
The outfall path from Pond 3B South starts at the new stop-log structure shown in Photo 4.1. A skimmer box surrounds the overflow section and is fitted with a staff gauge (see Photo 4.2). From an adjustable 4-foot wide stop-log weir (see Photo 4.3) flow enters the structure and discharges through a 24-inch RCP pipe in the bottom of the structure to a wet well (see Photo 4.4, interior view) at the crest of the dike.

The overflow structure is the new stop-log structure located at the southwest corner of Pond 3B South (see Photos 4.1 through 4.3); the overflow structure and access bridge were observed to be in very good visual condition and appeared sound and serviceable. The wet well located at the south-side perimeter dike crest was in good visual condition (see Photo 4.4). MidAmerican staff explained that CO₂ is added to the discharge water at the wet well to maintain a pH value near 8.0.

Photo 4.1
Pond 3B South Stop-log Structure

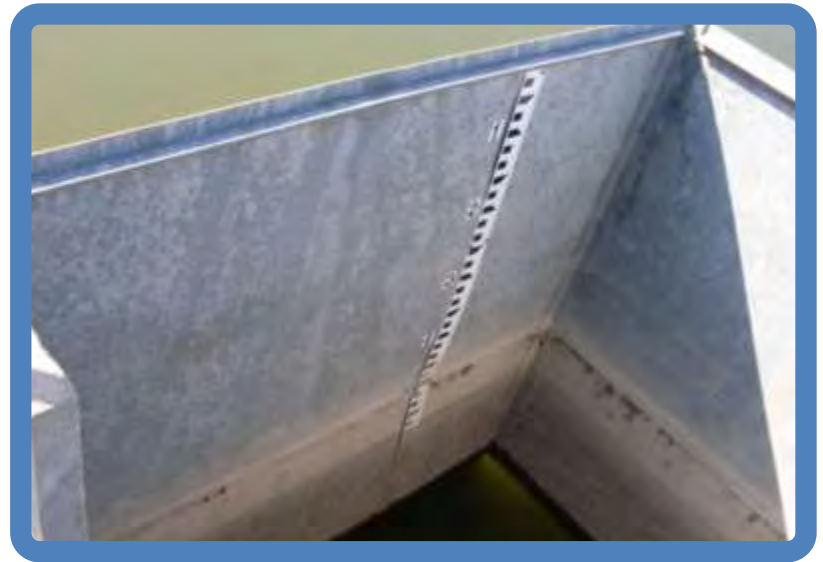
Photo 4.2
Pond 3B South Skimmer Box with staff gauge

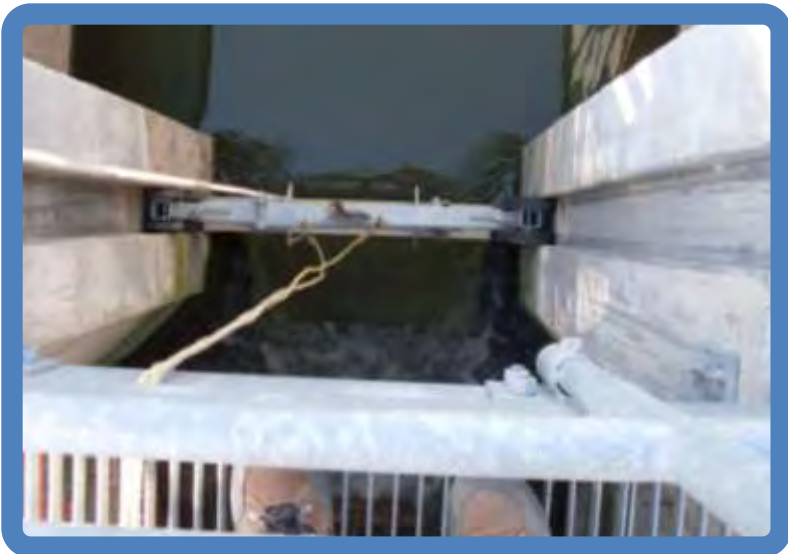
Photo 4.3
Pond 3B South Stop-log Structure adjustable weir

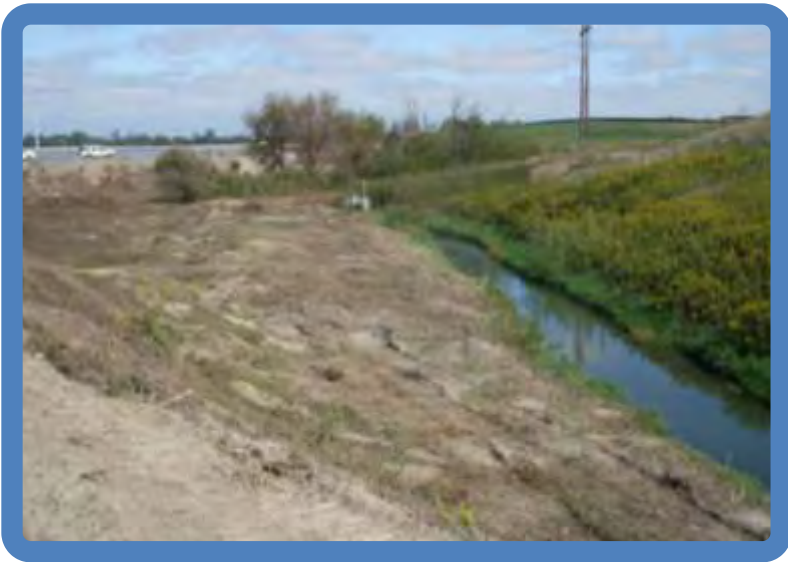
The outside slope and toe area along the northwest-side perimeter dike was observed to have a relatively well-maintained vegetative cover of grass and weeds. There is no actual slope on the south side of Pond 3A; this area is occupied by a drainage swale between Pond 3A and the adjacent landfill slope that extends up to the southeast; it was observed that the swale area had been recently graded and a new cover of grass was being established, as part of the landfill capping project recently completed. The 48-inch diameter culvert to the outlet channel from the outlet at Pond 3B South is buried under the swale area. The outside slope and toe area along the short southwest-side offset segment of the perimeter dike was observed to have sparse vegetation, apparently due to recent construction operations (see Photo 2.10). The southwest-side perimeter dike segment outside toe area is at the head of the outlet channel, where the 48-inch diameter culvert discharges into the channel (see Photo 4.9).

Photo 4.9
Outlet End of 48" RCP Culvert adjacent to landfill
