Re: Responses to Recommendations in Final Coal Combustion Waste Impoundment
Round 7 - Dam Assessment Report for Riverside Generating Station

Riverside Generating Station Recommendations

Re: Interim Report - Results of Global Stability Analyses Revisions
South Ash Containment Pond Embankments
Riverside Generating Station
Bettendorf, Iowa
Terracon Project No. 07105081/02105081G

Re: Geotechnical Report Addendum No. 2
Revised Global Stability Analyses
South Ash Containment Pond Embankments
Riverside Generating Station
Bettendorf, Iowa
Terracon Project No. 07105081/02105081G

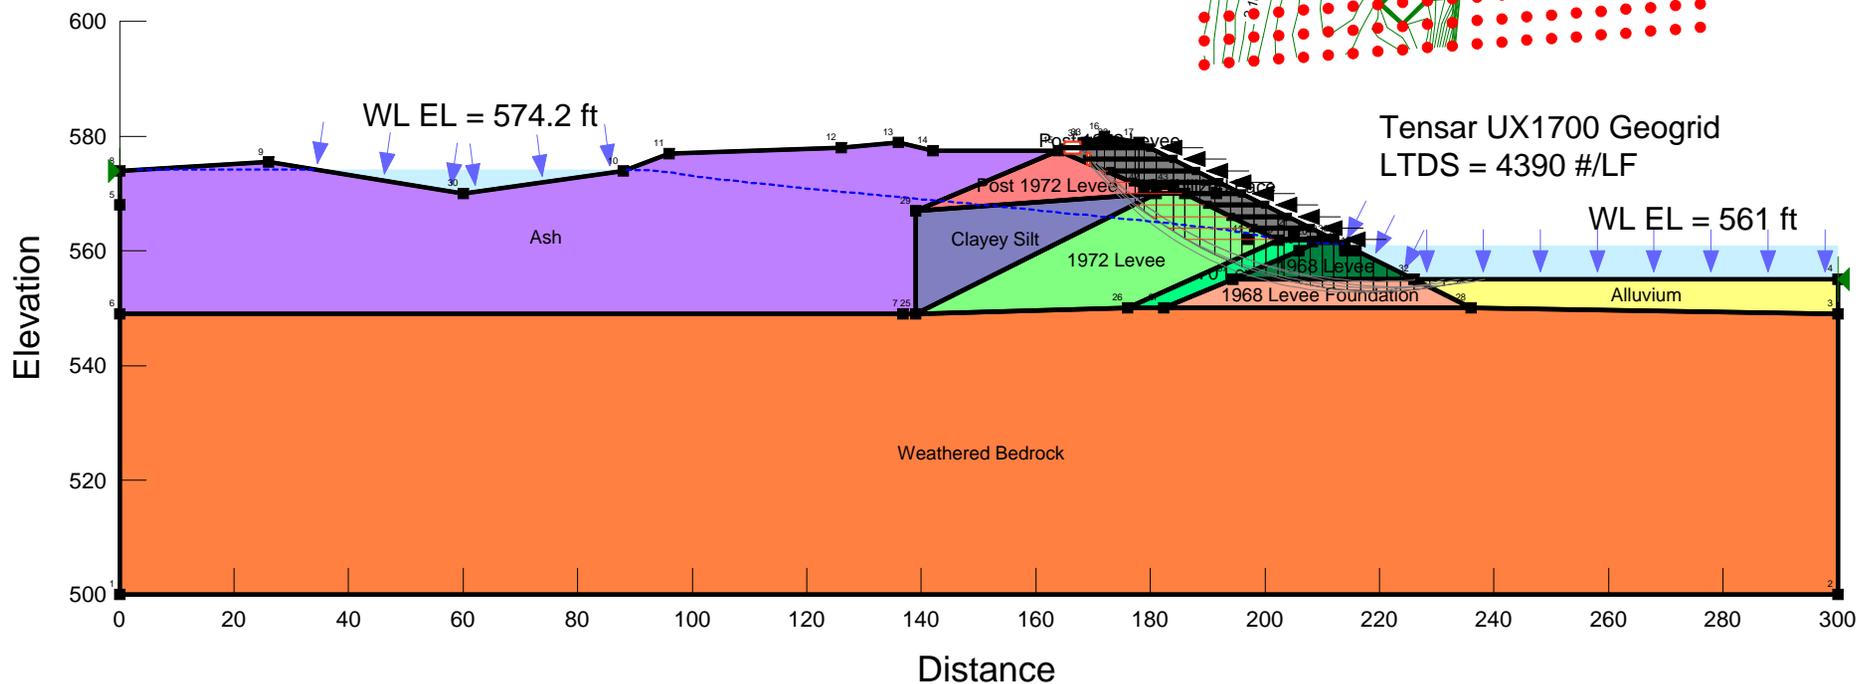
Title: 10-ft Stabilized Face - Steady State Seepage

File Name: SECT B 10-ft Stabilized w 15-ft top (Steady State) REV MSE Sep 2011.gsz

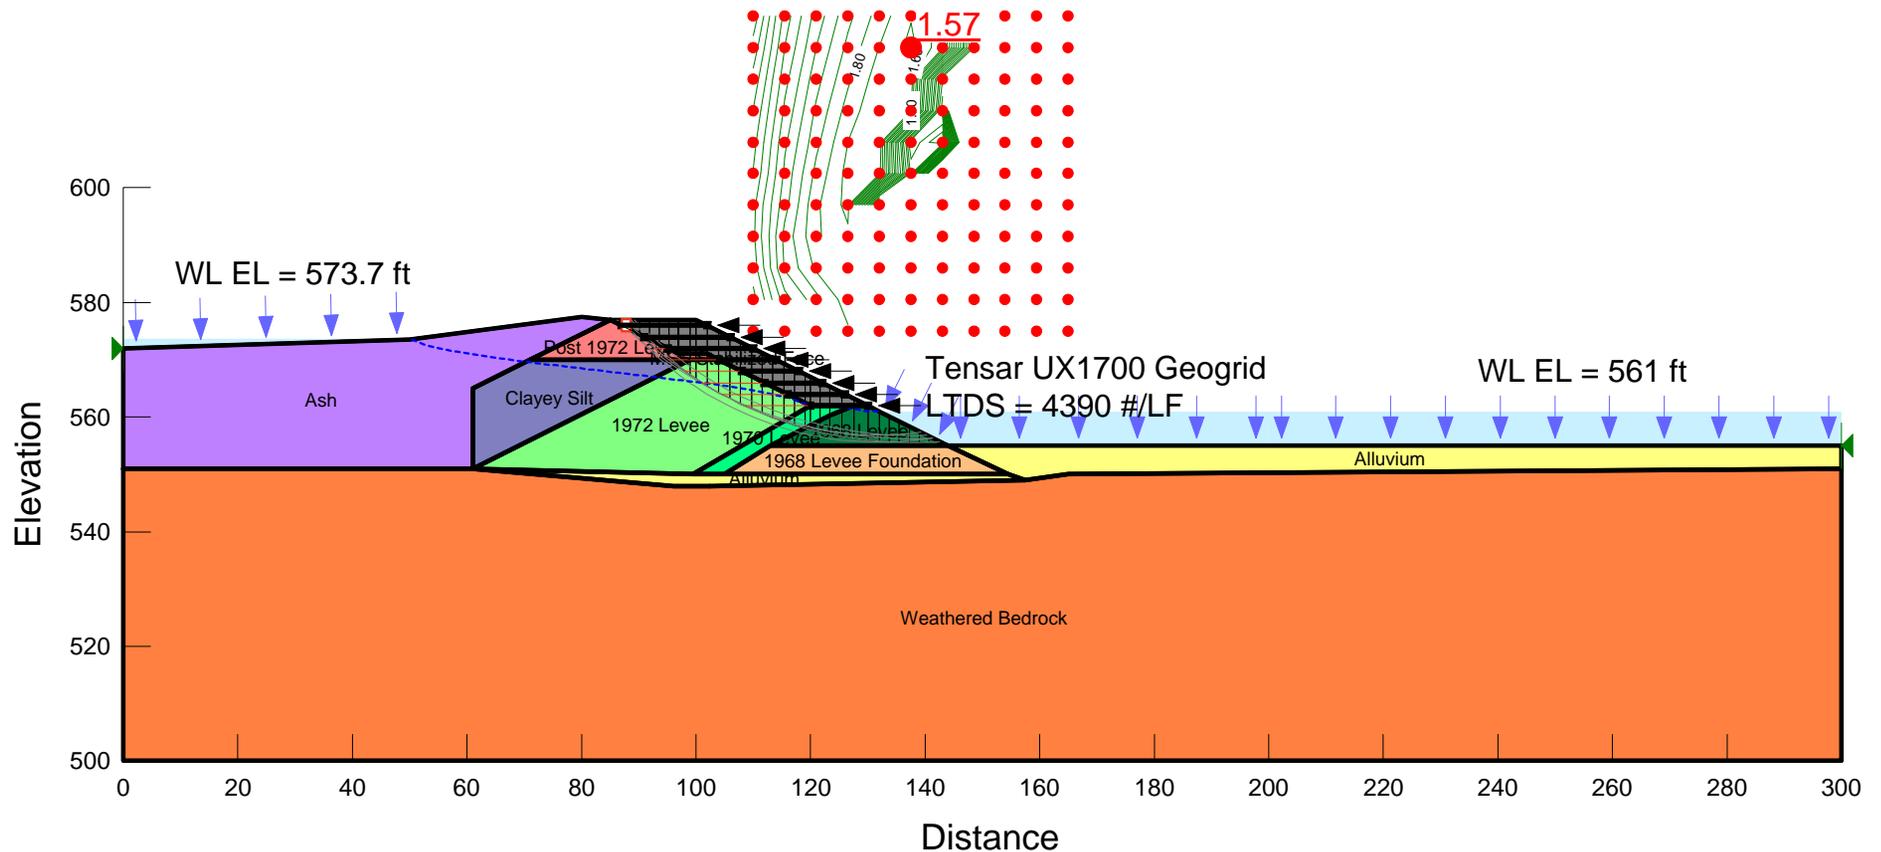
Title: 10-ft Stabilized Face - Steady State Seepage

File Name: SECT C 10-ft Stabilized w 15-ft top (Steady State) REV MSE Sep 2011.gsz

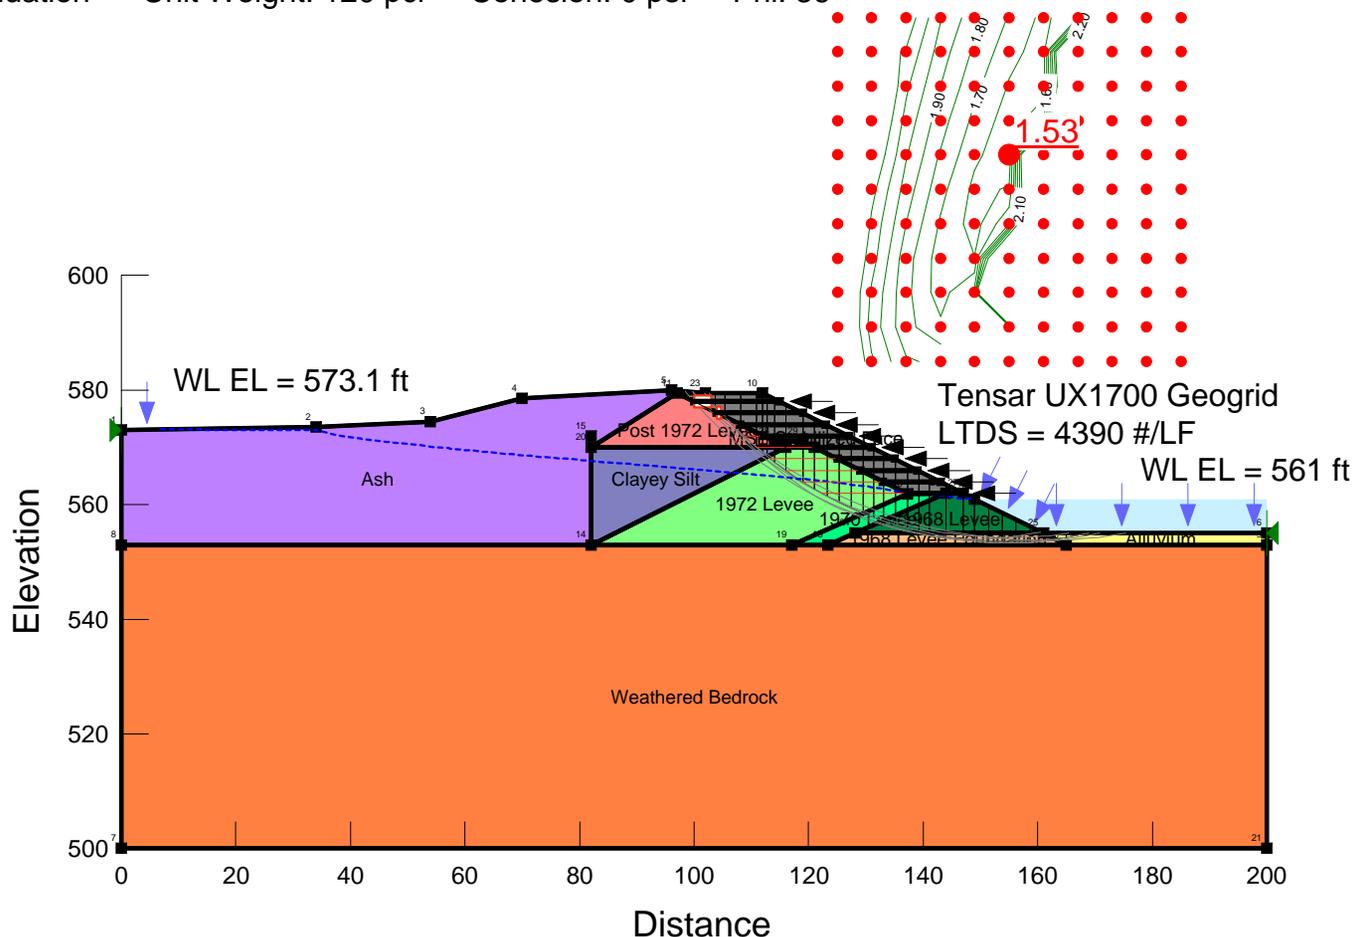
Title: 10-ft Stabilized Face - Steady State Seepage

File Name: SECT D 10-ft Stabilized w 15ft top (Steady State) REV MSE Sep 2011.gsz

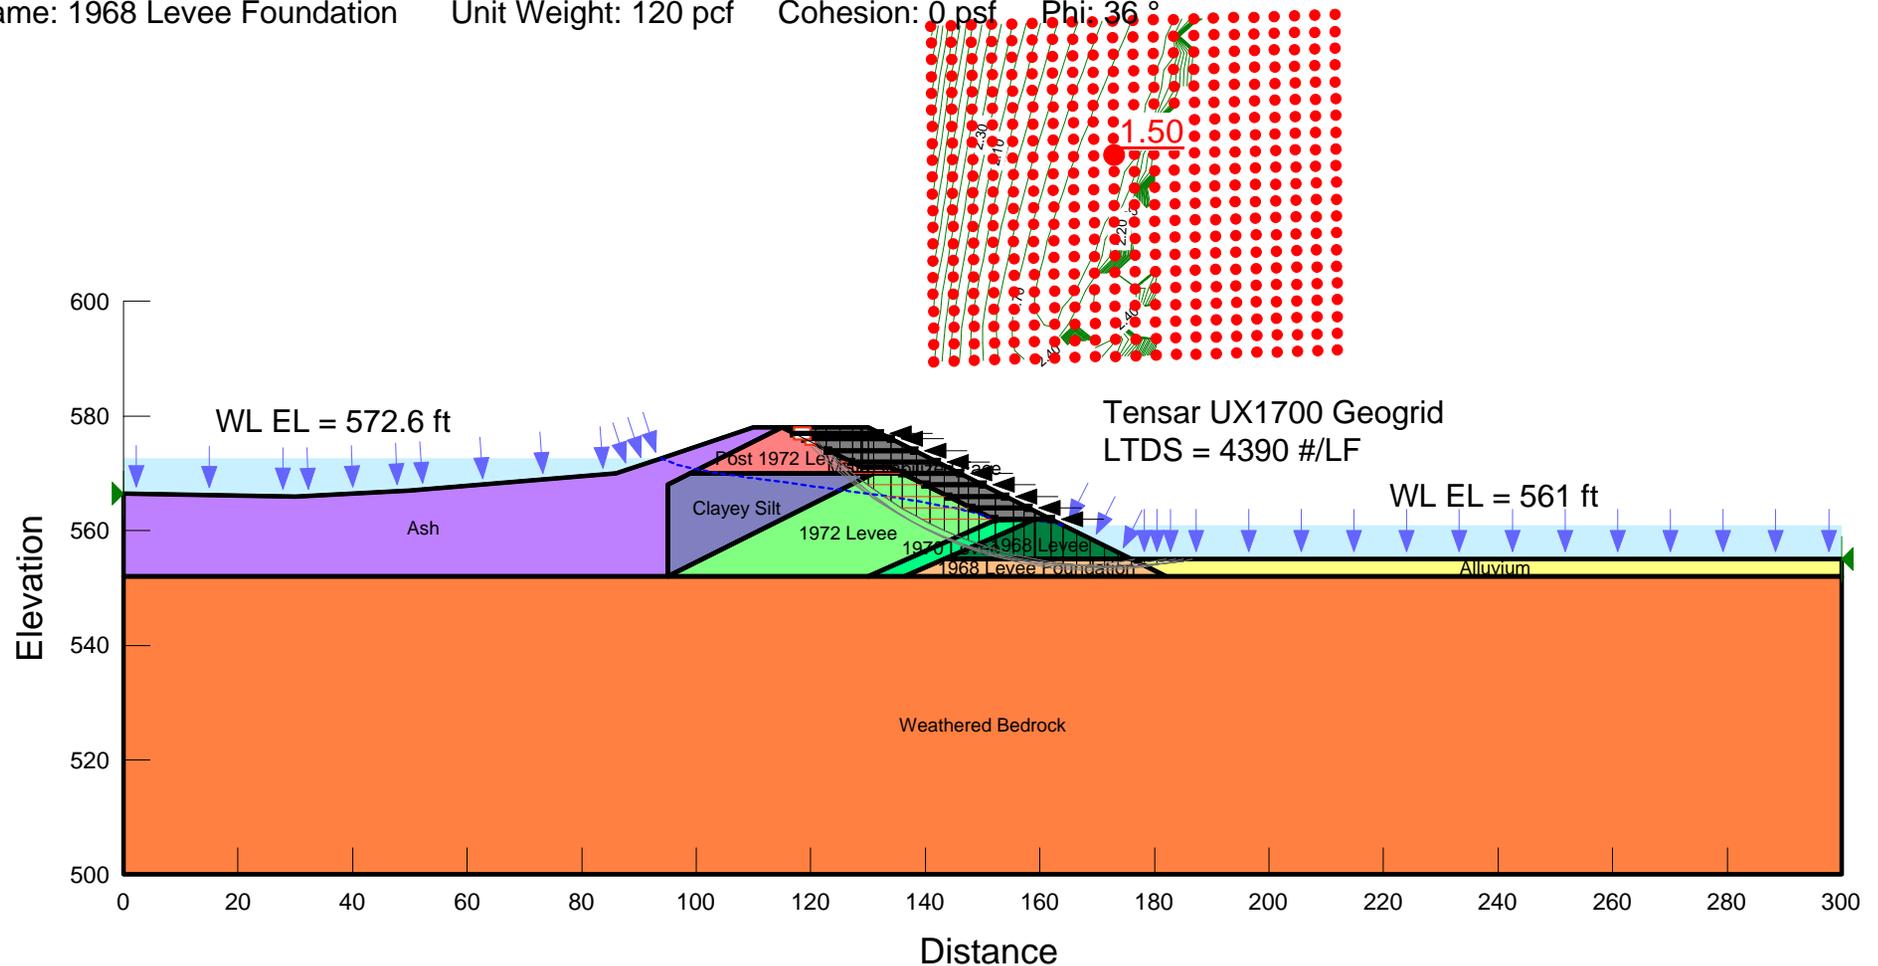
Title: 10-ft Stabilized Face - Steady State Seepage

File Name: SECT E 10-ft Stabilized w15 ft top (Steady State) REV MSE Sep 2011.gsz
