Subject: EPA Comments on MidAmerican Energy Co, Walter Scott Junior Energy Center,  
Council Bluffs, IA  
Round 7 Draft Assessment Report

Re: Comments to Draft Coal Combustion Waste Impoundment Round 7 Dam Assessment Reports for Neal North Energy Center (Site #13), Walter Scott Energy Center (Site #14), Riverside Generating Station (Site #15 ), and Louisa Generating Station (Site #16)

#### **Walter Scott Energy Center Draft Report Comments**

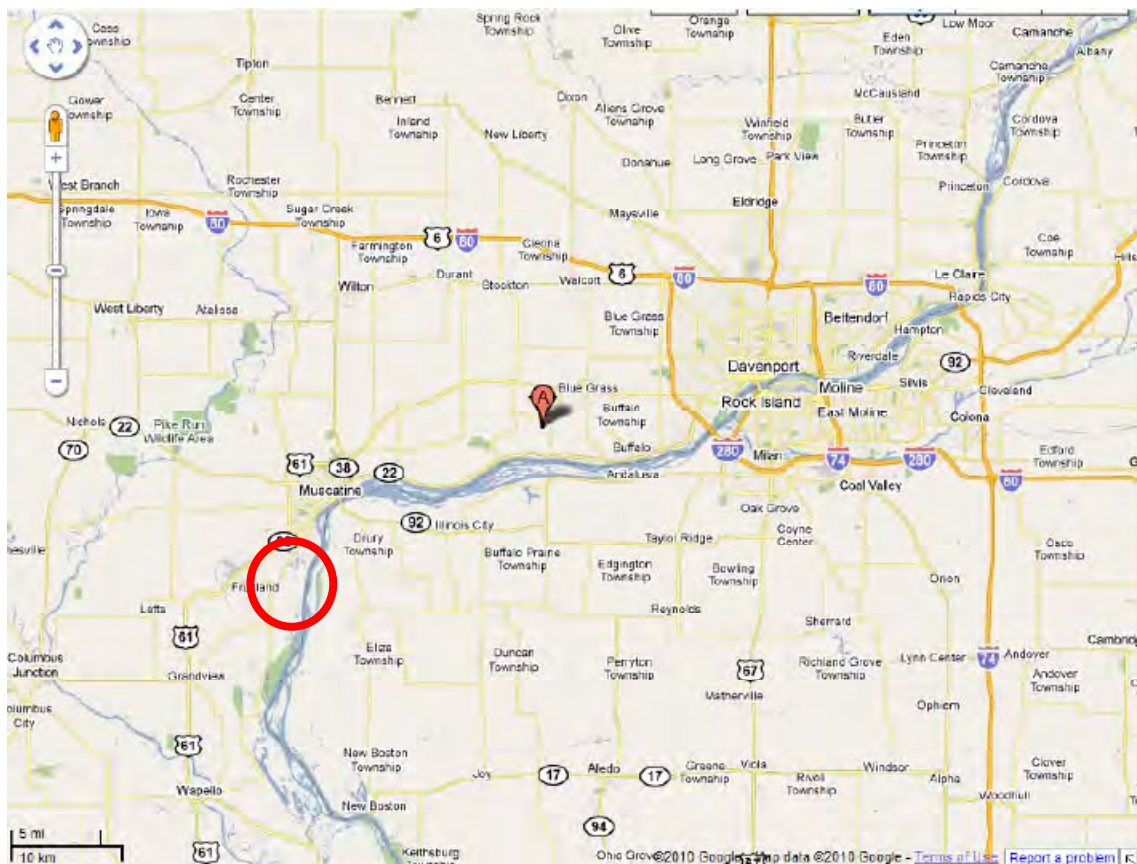
**Section 2.1:** The general description and figures 2.1a and 2.1b relate to IPSCO Steel, not Louisa. The Louisa Generating Station is further southwest near Fruitland, Iowa, as shown in the red circle on the map below.
