**CAROLINA POWER & LIGHT  
MAYO ELECTRIC GENERATING PLANT**

**MAYO CREEK DAM  
ASH POND DAM  
PERSON COUNTY, NORTH CAROLINA**

**FIVE-YEAR INDEPENDENT CONSULTANT INSPECTION  
AS REQUIRED BY  
NORTH CAROLINA UTILITIES COMMISSION**

**December 22, 1999**

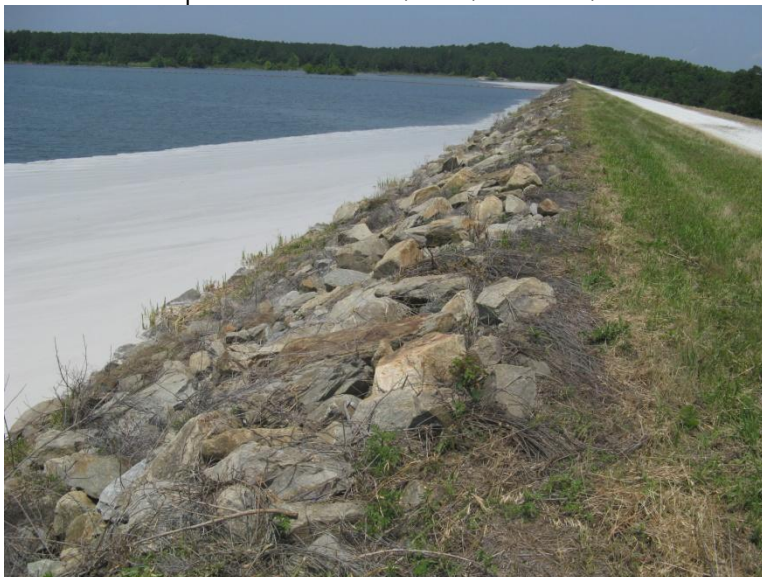
Photo 1: Upstream Embankment, Crest, Photo: 042, 6/3/09

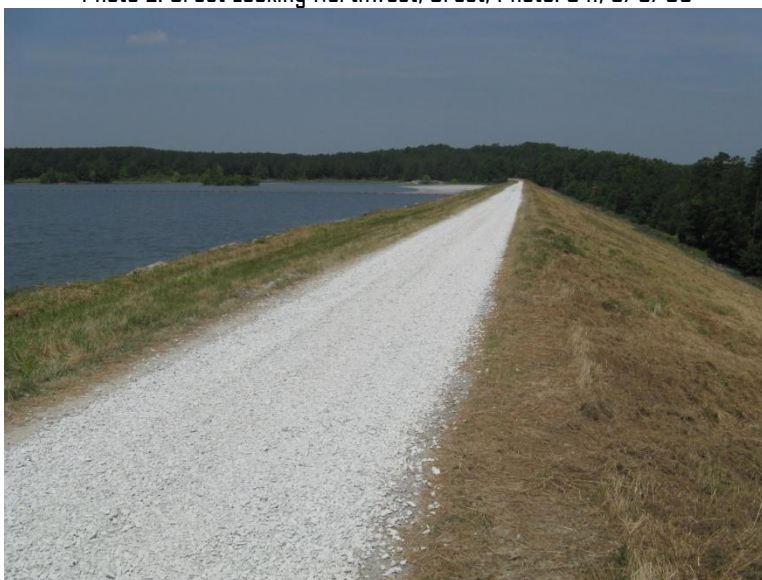
Photo 2: Crest Looking Northwest, Crest, Photo: 041, 6/3/09

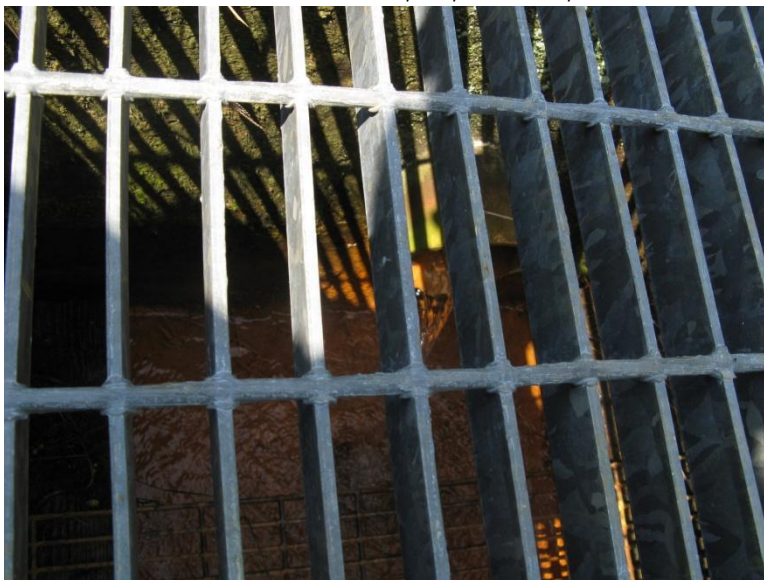
Photo 7: Internal Drain Outlet, Toe, Photo: 019, 6/3/09

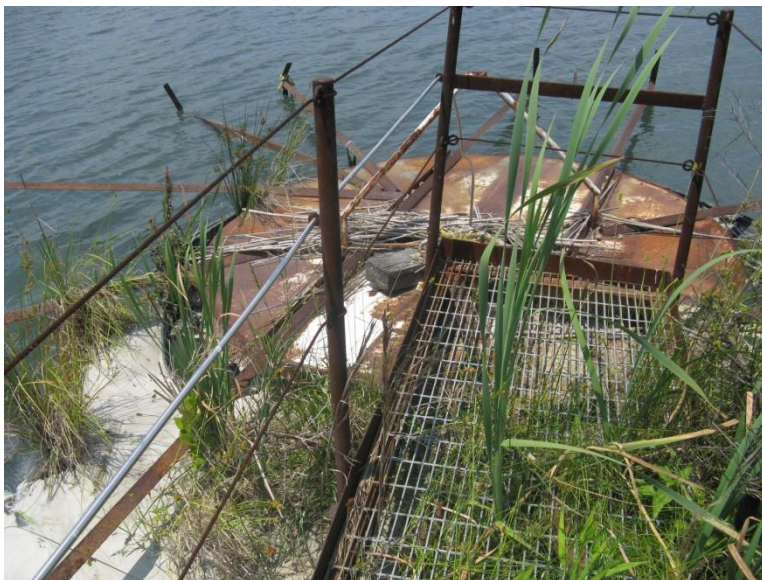
Photo 9: riser and skimmer at stilling pool, Photo: 079, 6/3/09

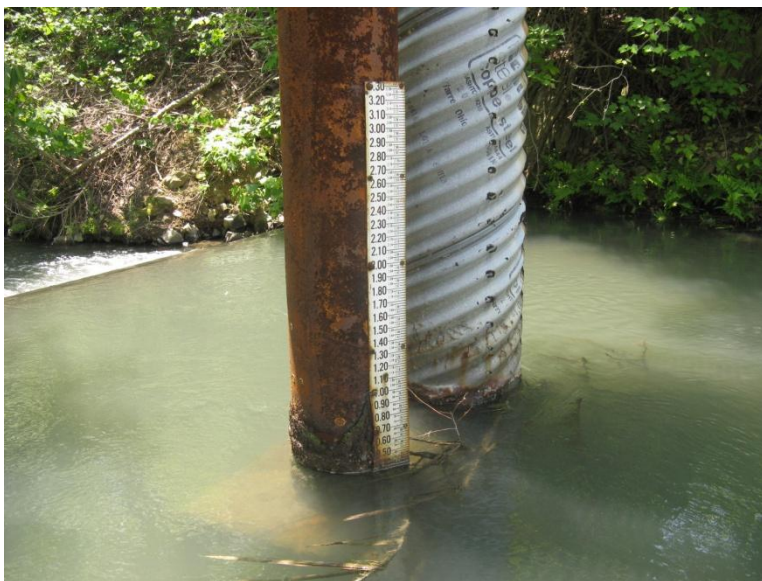
Photo 10: stilling pool staff gauge near spillway, Photo: 072, 6/3/09

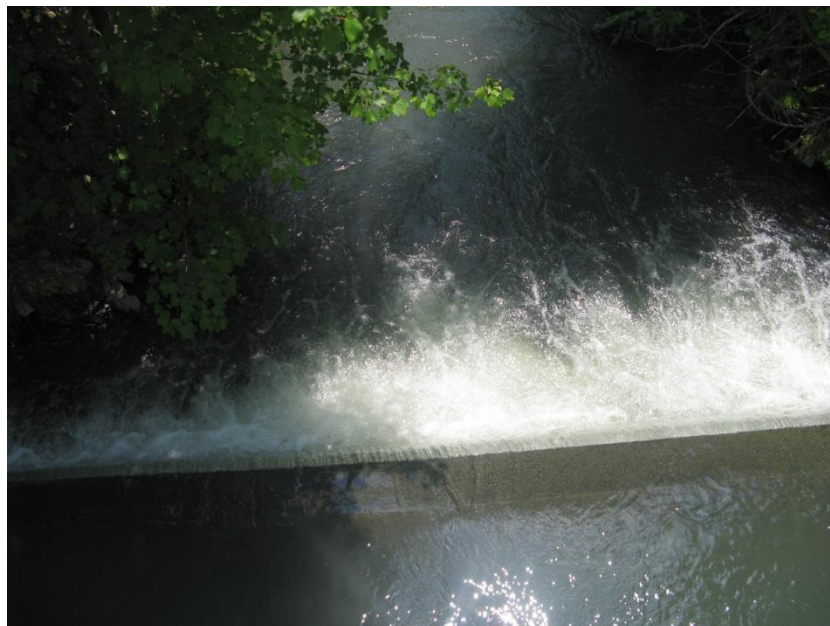
Photo 11 concrete overflow weir spillway, Photo: 068, 6/3/09
