DRAFT
Specific Site Assessment for
Coal Combustion Waste
Impoundments at Minnkota
Power Cooperative
Milton R. Young Station

Center, North Dakota

December 2010
Project 092884

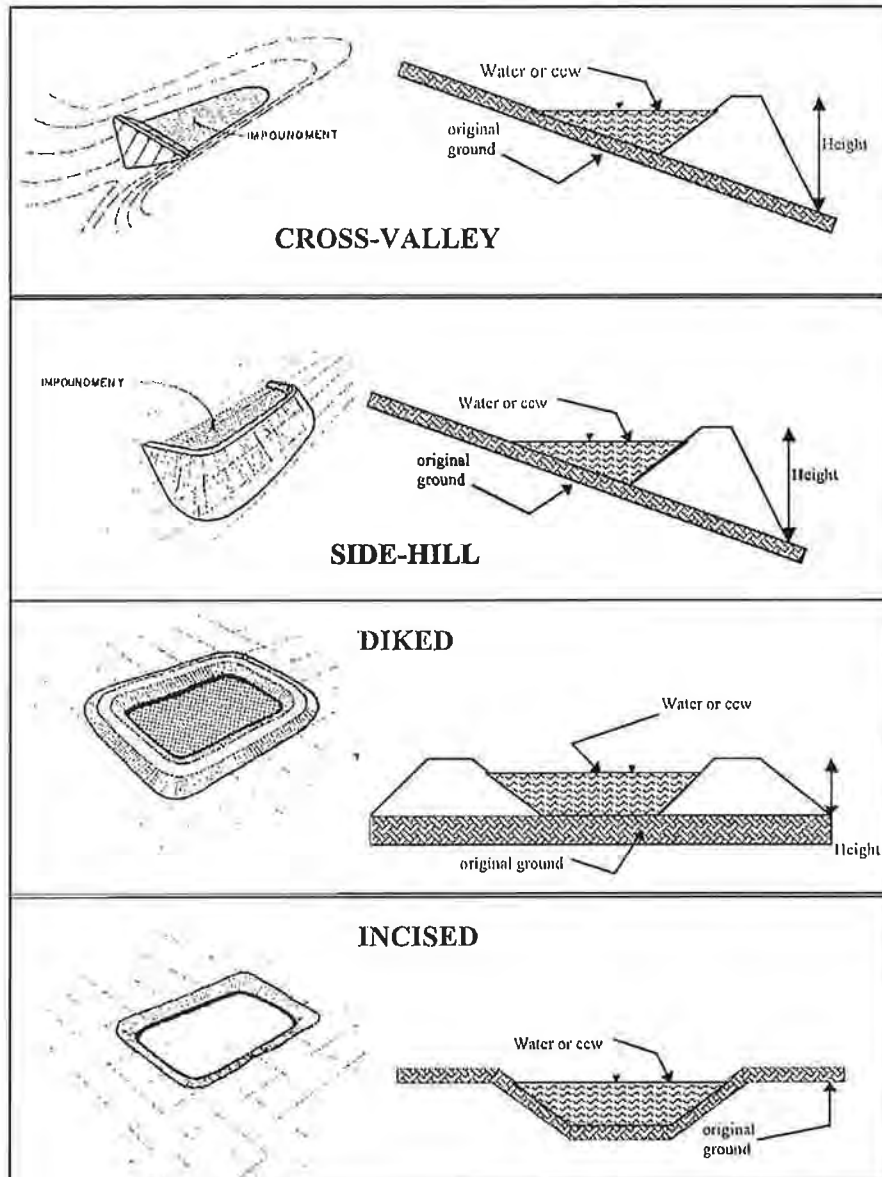
A failure of the embankments of the Alternate Bottom Ash Pond would result in coal combustion ash being released into the cooling water canal and Lake Nelson. Coal combustion ash could also flood plant roads located south of the pond. Loss of life is not anticipated; however, there would be environmental impacts. Since Minnkota Power Cooperative owns Nelson Lake losses would most likely be limited to the Owner's property.

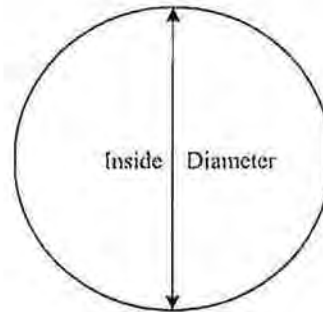
Is water flowing through the outlet? YES X NO _____

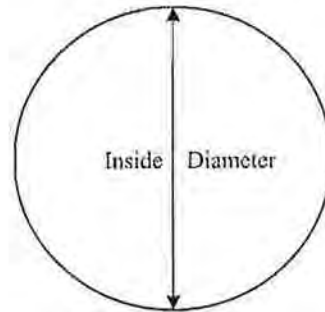
Is water flowing through the outlet? YES _____ NO X

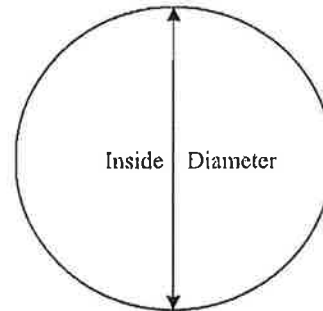
Is water flowing through the outlet? YES _____ NO **X***

***At the time of the inspection, the plant was shutdown for maintenance. Water was not being returned to the plant because the power units were not being run.**
