SUBJECT: AEP NRG Energy, Limestone Electric Station, Response to Comments

**Coal Combustion Residue Impoundment
Round 9 - Dam Assessment Report**

***Limestone Generating Station
DSDA & ST-18 Ponds***

***NRG Texas Power LLC
Jewett, Texas***

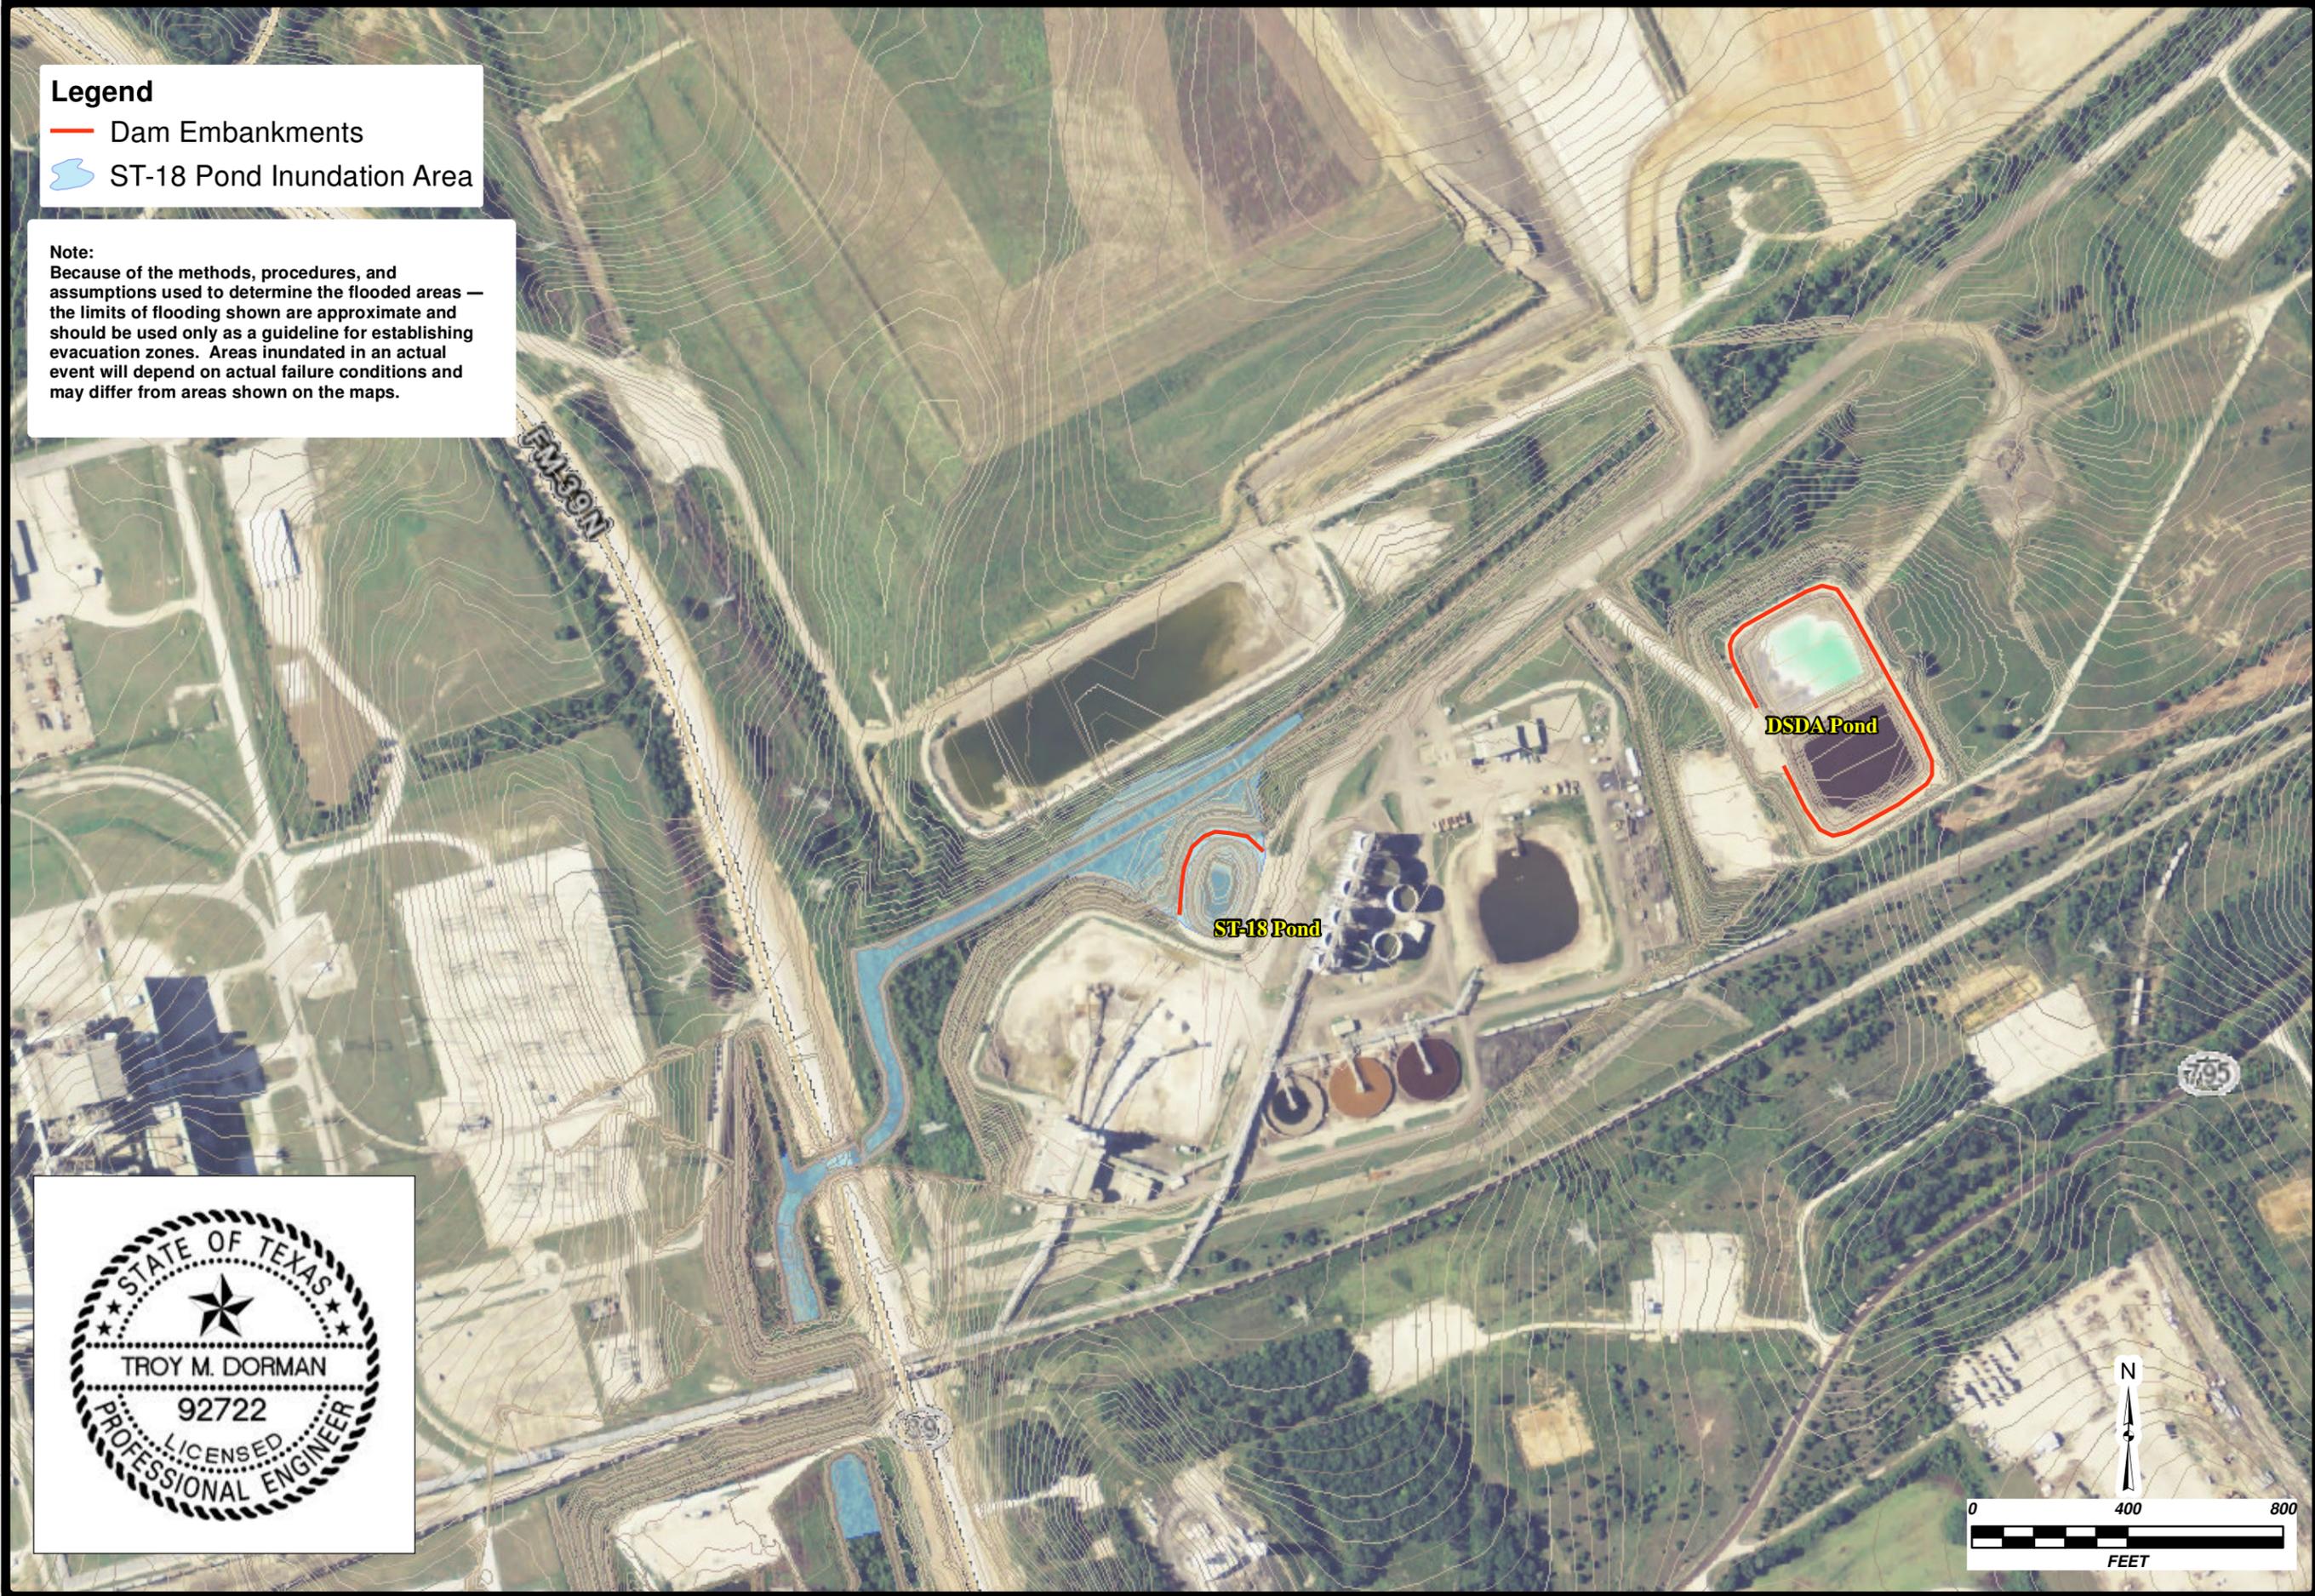
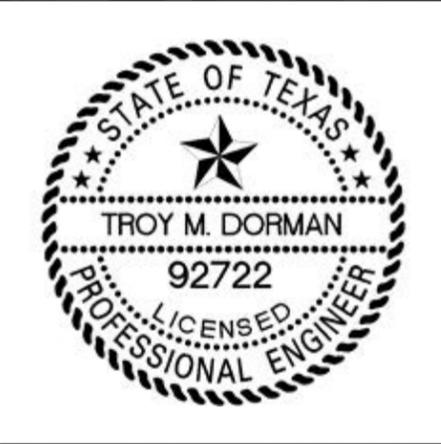
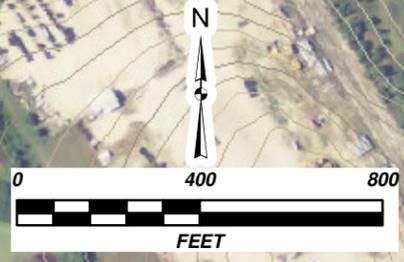
**ST-18 Pond
 Dam Breach
 Inundation Map**

- Dam Embankments
- ST-18 Pond Inundation Area

Note:
 Because of the methods, procedures, and assumptions used to determine the flooded areas — the limits of flooding shown are approximate and should be used only as a guideline for establishing evacuation zones. Areas inundated in an actual event will depend on actual failure conditions and may differ from areas shown on the maps.
