# Dam Safety Assessment of CCW Impoundments

GenOn Energy – New Castle Plant  
West Pittsburg, Lawrence County, Pennsylvania

November 30, 2012

GenOn Energy – New Castle Plant

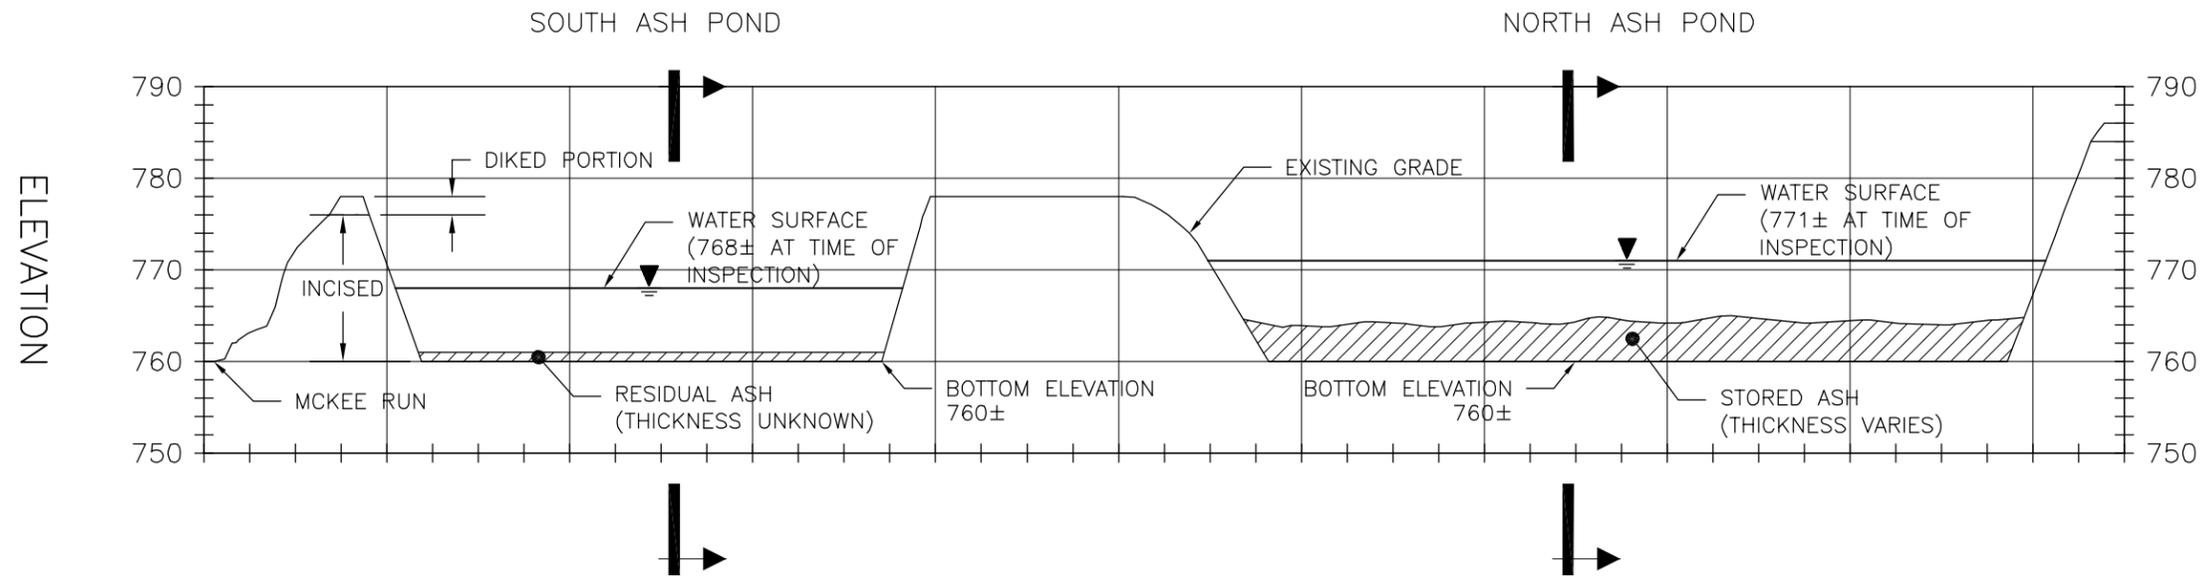
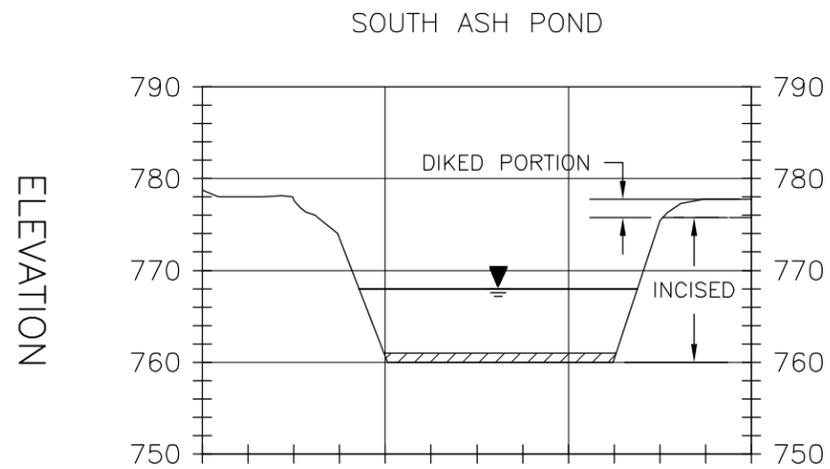
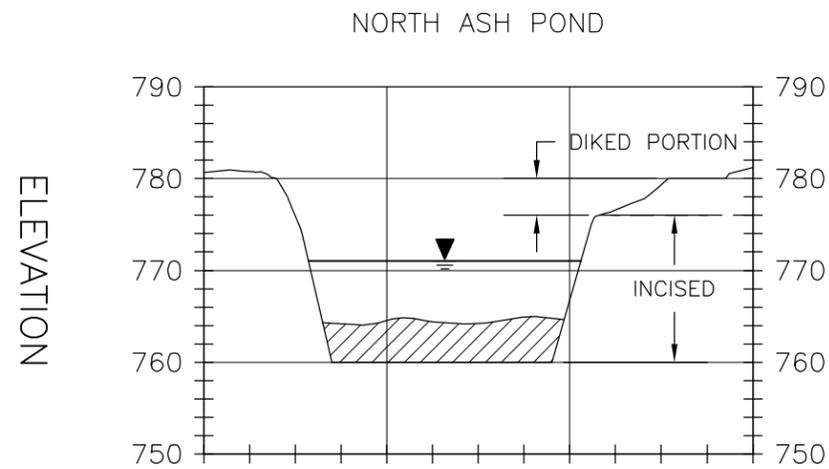
FIGURE 3

The following sections summarize the structural components and basic operations of the North Ash Pond and the South Ash Pond. The location of these impoundments on the plant grounds and their relevant features are provided on Figure 2. Typical cross-sections of the impoundments are provided as Figure 3. It should be noted that the site plans shown in Figure 2 and the topographic detail shown in Figure 3 are adapted from publicly available data and may not depict all current features. Design plans and documents are not available for these impoundments, and feature locations and dimensions are primarily from plant records and site measurements. Additionally, photos taken during the visual inspection are incorporated in a Photographic Log provided as Appendix B.
