SUBJECT: EPA Comments on "Assessment of Dam Safety of Coal Combustion Surface Impoundments: GenOn Energy – Shawville Generating Station, Shawville, PA"

DATE: September 9, 2013

22 November 2013

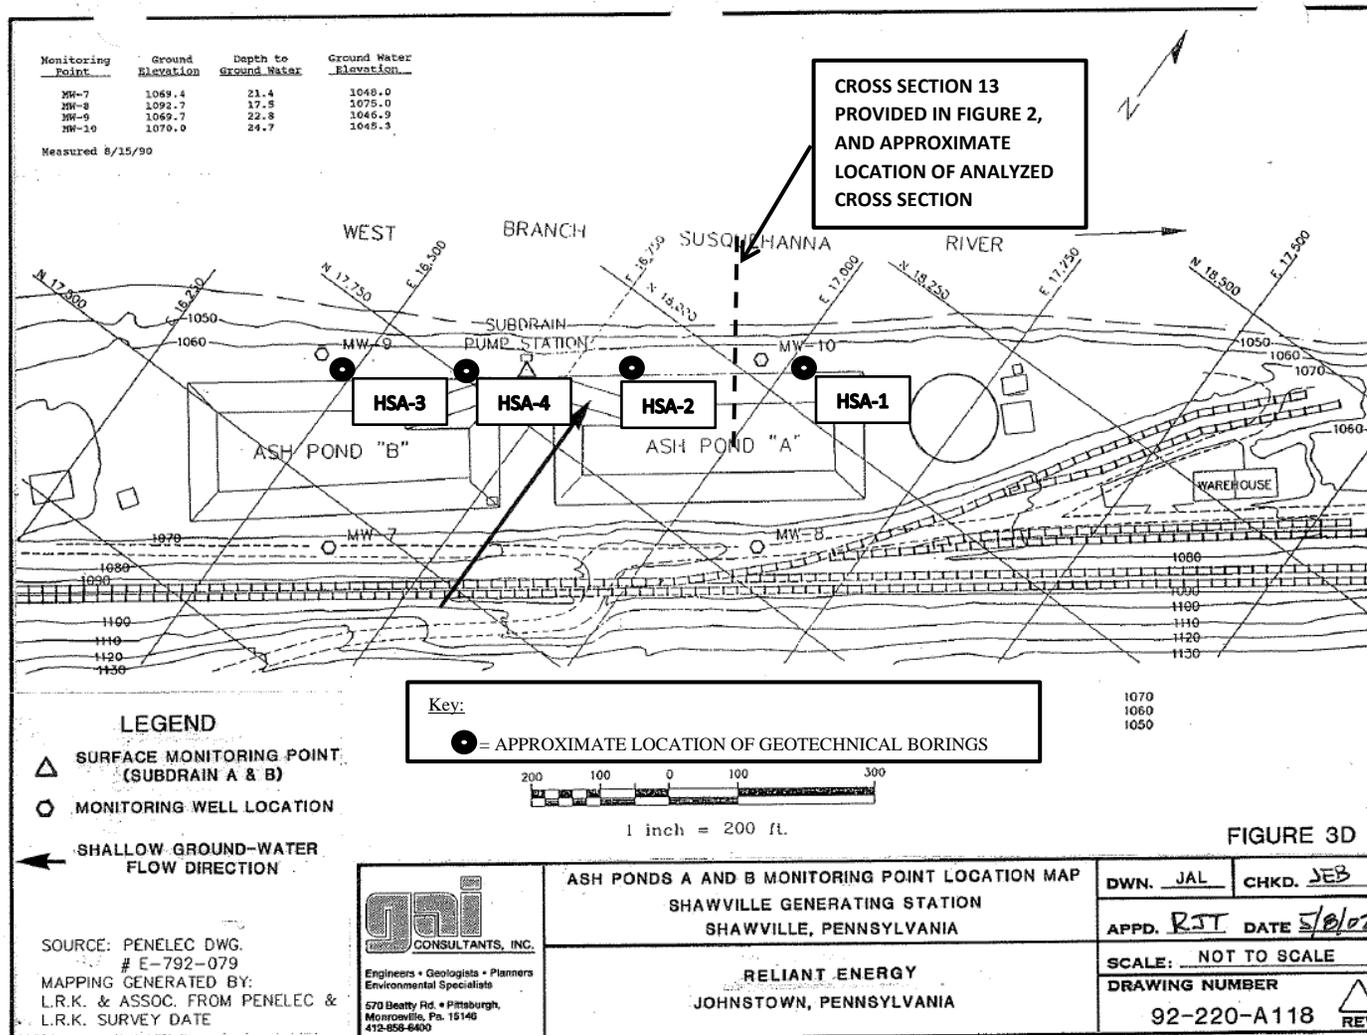
Figure 1 - Geotechnical Boring Locations

The main purpose of this report is to document the subsurface geotechnical condition and evaluate the embankment stability for both ponds. One of the review comments in EPA's draft report is the lack of stability analyses and as-built geotechnical information. Thus, the stability analysis and geotechnical information presented in this report supplement the EPA report. This report also provides additional information to address the comments and recommendations in EPA's draft report. This report complements Geosyntec's previous report dated 21 February 2013.

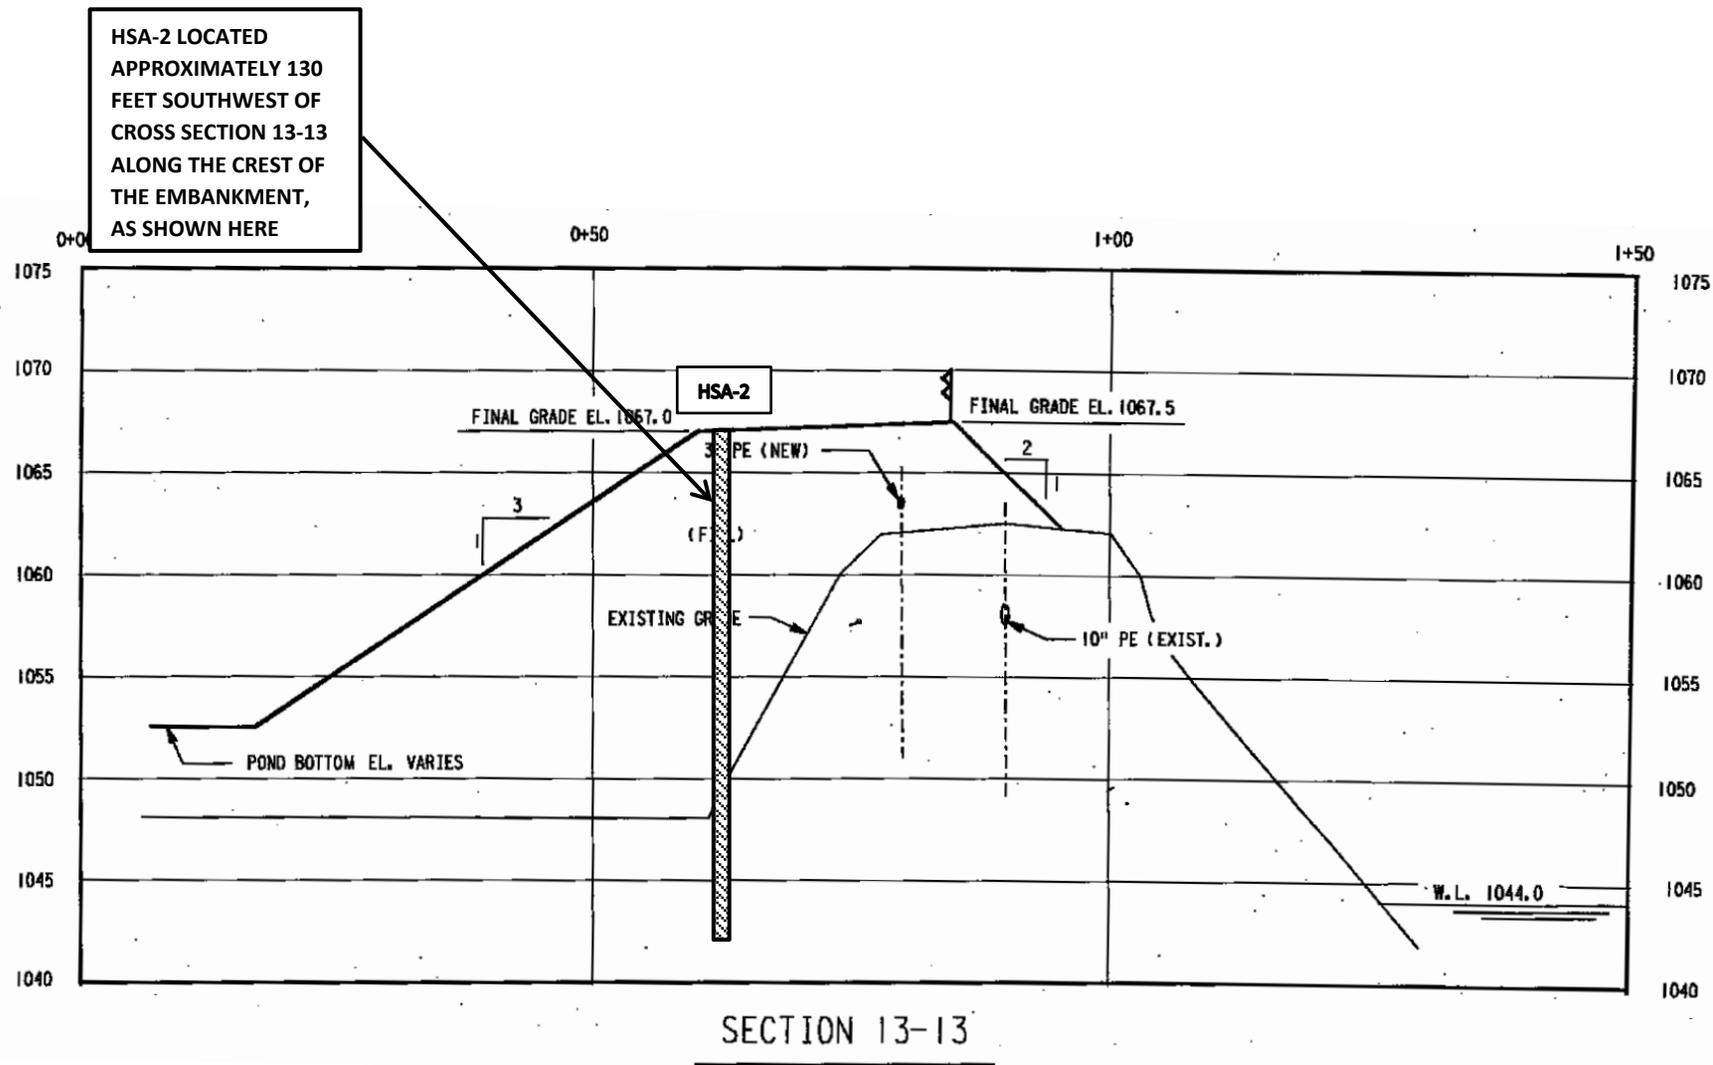
Figure 2 – Cross Section 13-13 of the Northwest Berm of Ash Pond A

The Shawville Power Station has two bottom ash ponds (BAPs) (i.e., Ash Pond A and Ash Pond B) that are part of the site's bottom ash water recycle system. Both ponds have an engineered liner system consisting of a PVC liner with geotextile cushion fabric. The ponds were constructed using a combination of diked and incised construction methods, with the embankments for the diked portion of the ponds running parallel to the west branch Susquehanna River (river). The current configuration of Ash Ponds A and B has been in service since 1989. The locations of the BAPs are shown in Figure 1, which also illustrates the orientation of the ponds in relation to the river. A typical cross section of the northwest embankment, depicting the spatial relationship of the pre-1989 embankment to the 1989 vertical expansion of the embankment, is provided in Figure 2.

Due to the alignment of the pre-existing embankment and the location of the utilities, it is unclear whether soil data from the pre-existing embankment in Ash Pond A was obtained. The cross section provided in Figure 2 depicts the typical location of the borings in relation to pre-existing embankment and the underground power lines that are located within the embankments. As shown in this cross section, the borings may have missed the inside toe of the pre-existing berm, but likely encountered the native material that formed the bottom of the unlined ash pond that later became Ash Pond A. Because the pond was constructed as a combination diked/incised pond, it is assumed that the pre-existing embankment was constructed using the material removed from the excavation of the pond. Based on the boring logs for HSA-1 and HSA-2, the native material is likely to be either a sandy clay (CL) or low-plasticity silt (ML). Hence, Geosyntec considered two different soil properties for the pre-existing soil berm in the analyses:

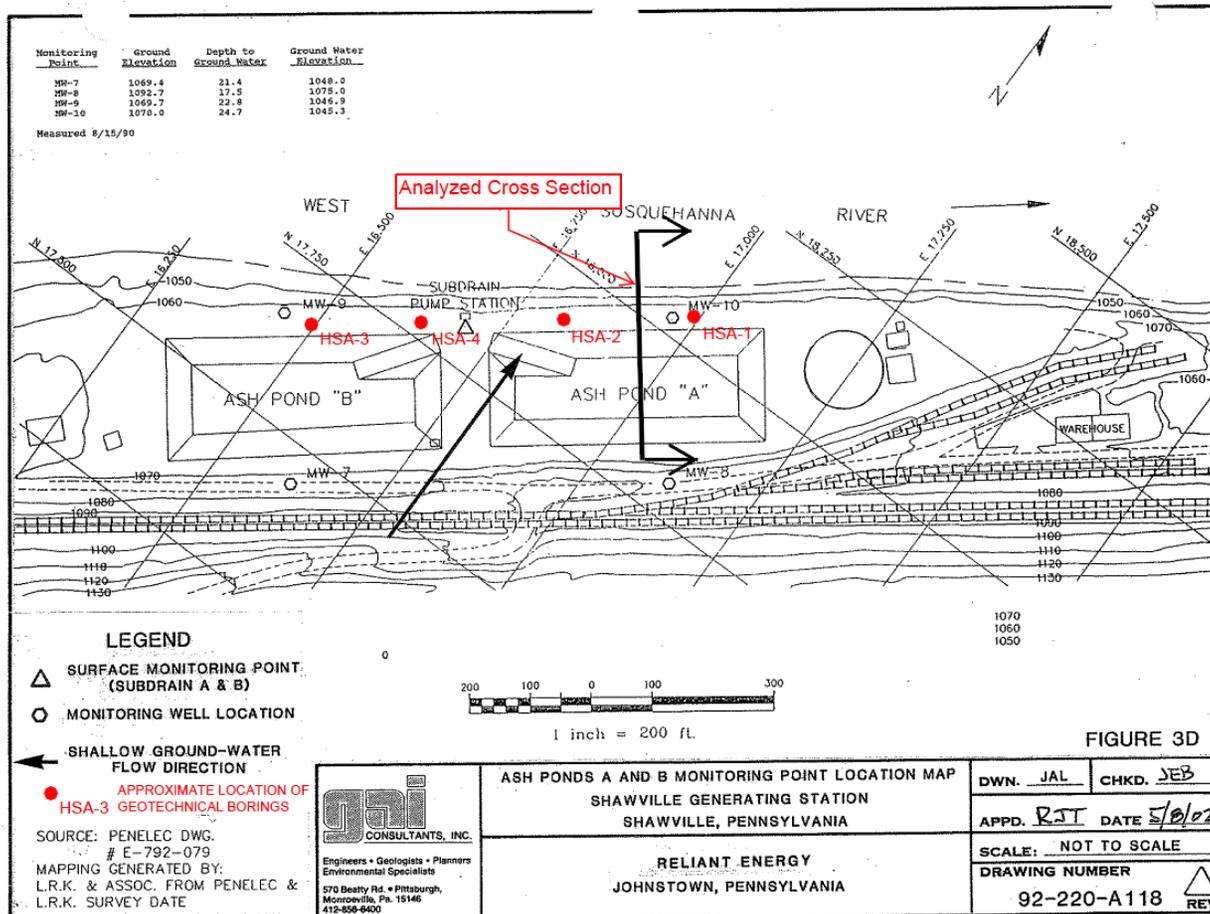
Figure 1. Location of Geotechnical Borings and Analyzed Cross Section

One critical cross section was selected for the analysis based on review of subsurface condition and pond geometry. The location of the selected cross section is at the approximate mid-point of the northern embankment of Ash Pond A, as shown in Figure 1.

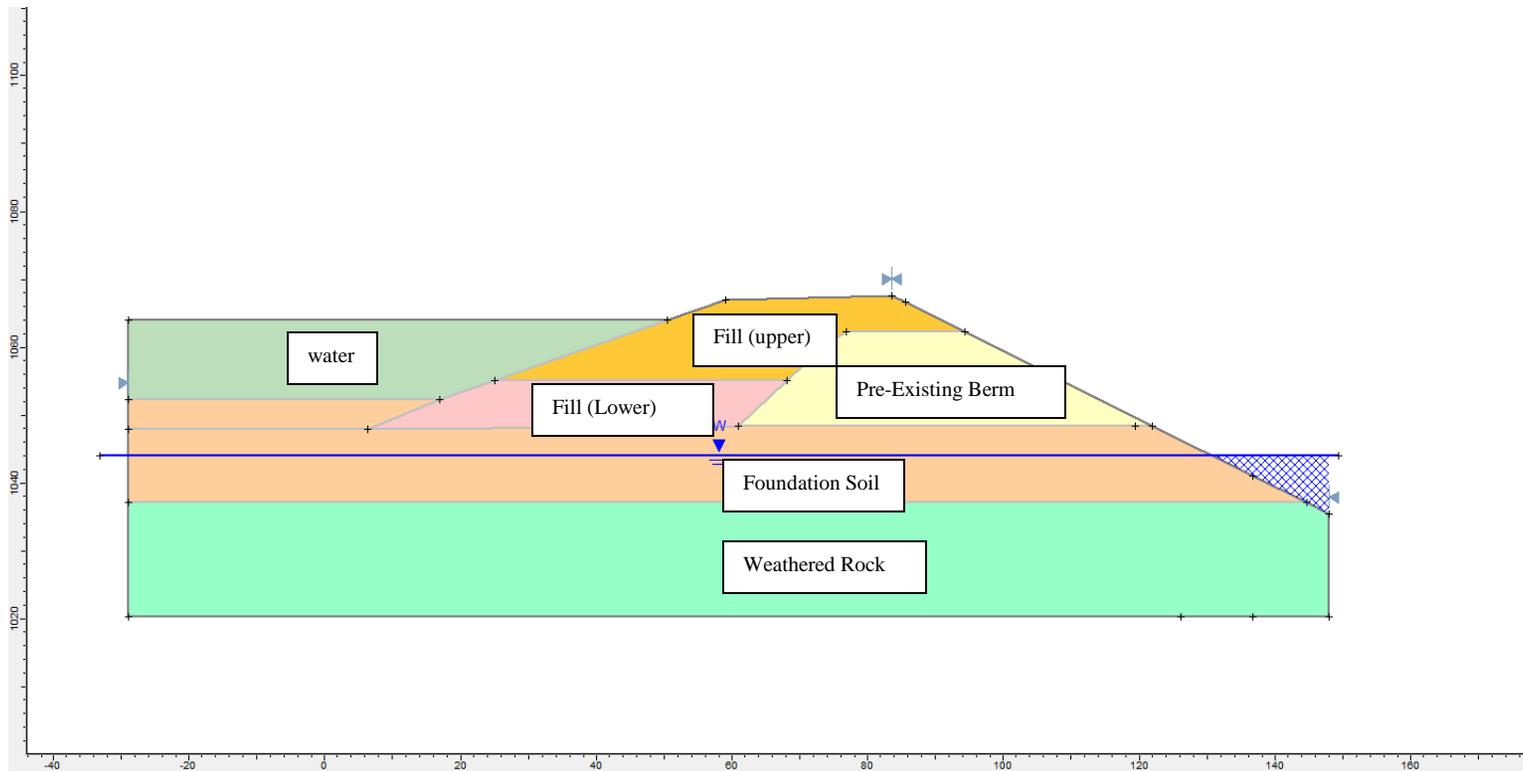
Figure 8. Analyzed Cross Section

Table 1 summaries the material properties used in the slope stability analysis. The analyzed cross section is shown in Figure 8.
