PRELIMINARY REPORT

Dam Safety Assessment of CCW Impoundments

GenOn Energy – Shawville Generating Station Shawville, Clearfield County, Pennsylvania

December 17, 2012

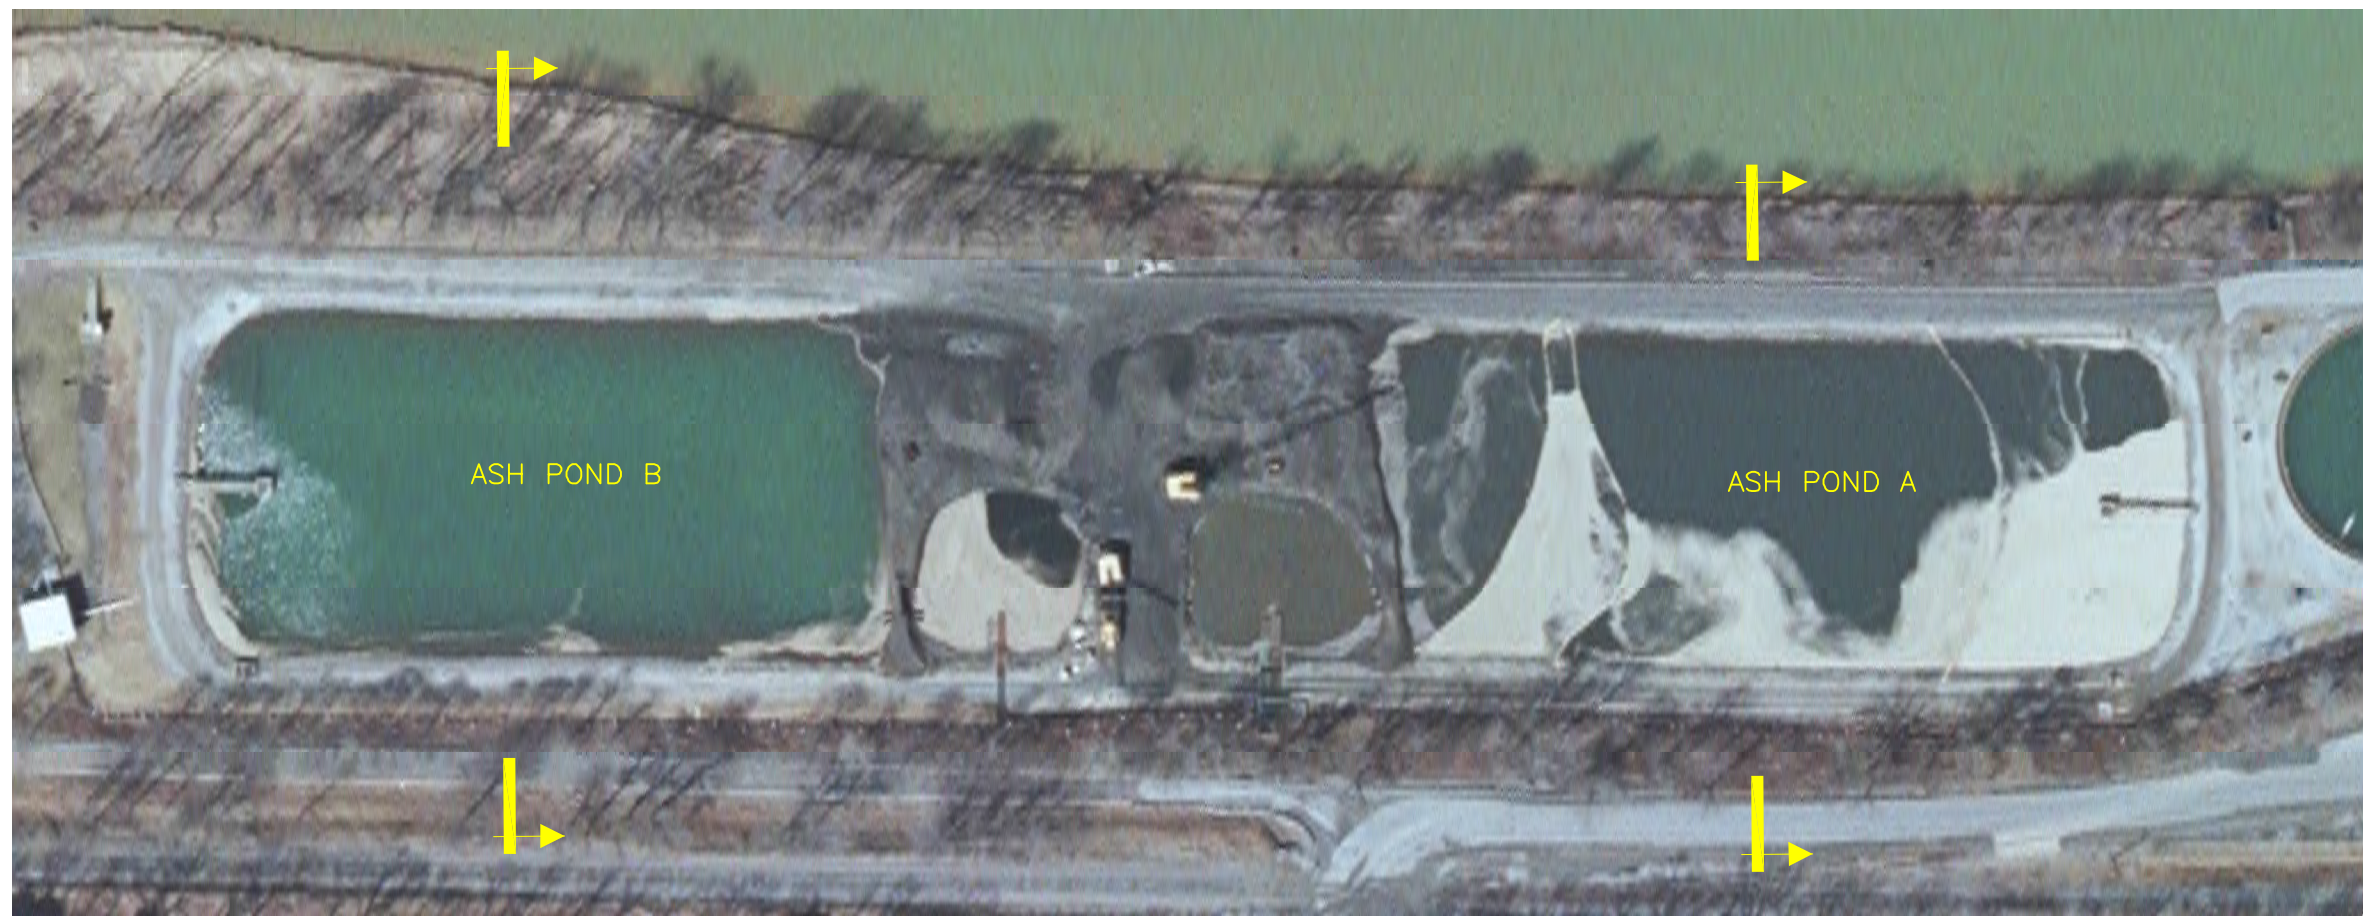
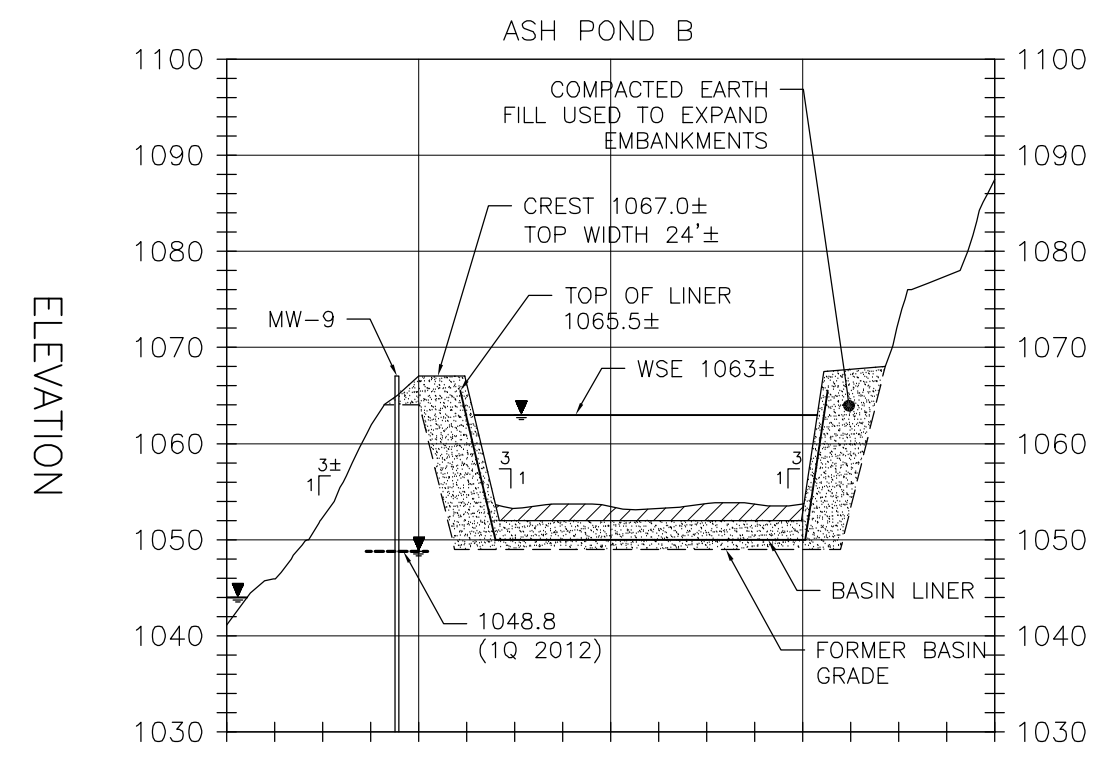
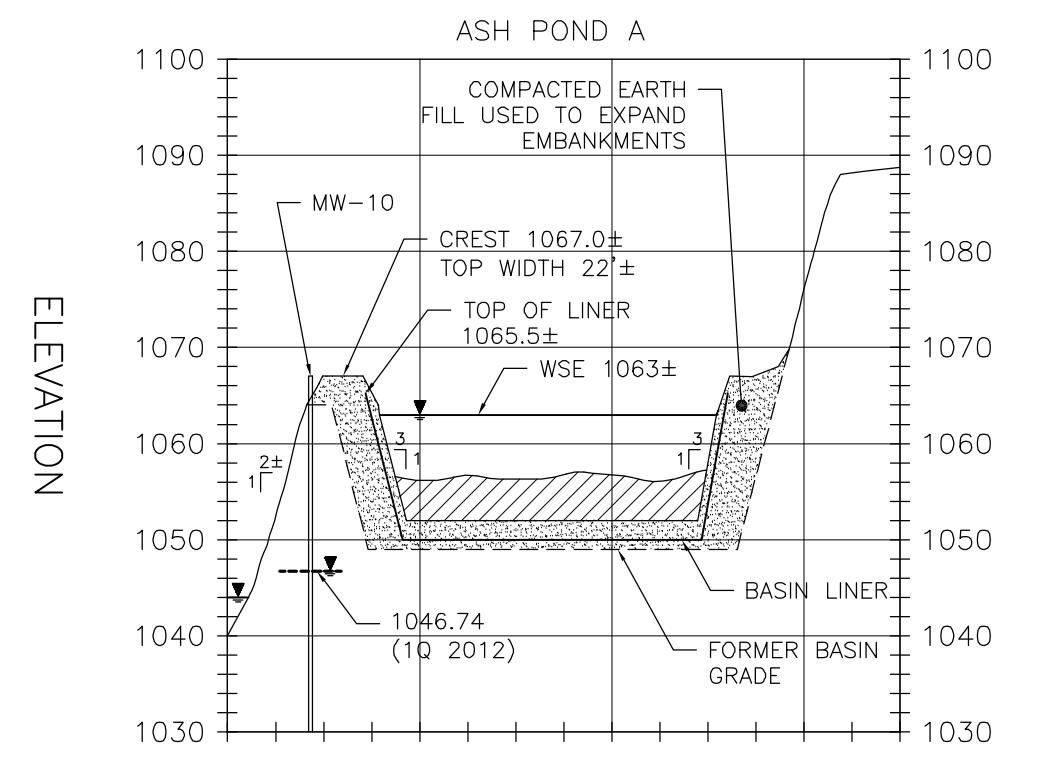
FIGURE 3

In addition to the physical deficiencies, we also noted that no geotechnical data or associated slope stability analyses are on record for the impoundment. Typical cross-sections of the impoundment are provided in Figures 3 and 4. The embankments are generally broad-crested with typical crest widths varying between 18 and 24 feet with relatively flat side slopes (3:1 or flatter). The presence of a constructed liner significantly reduces the risk of developing a phreatic surface within the diked embankment. The data provided for Monitoring Wells MW-9 and MW-10 indicate that the groundwater elevation within the northwestern embankment adjacent to the West Branch of the Susquehanna River is typically below the bottom elevation of the Ash Ponds, indicative that the liner system is serving to prevent the development of a phreatic surface within this embankment. Given the nature of this impoundment as primarily incised with a constructed impermeable liner system, there do not appear to be any critical slopes requiring a stability analysis in the immediate future. Completion of a slope stability analysis should be considered if modifications to the impoundment structure or significant alterations in the normal water level are proposed in the future.
