Dam Safety Assessment of CCW Impoundments

**NRG REMA LLC – Shawville Generating Station
Shawville, Clearfield County, Pennsylvania**

**United States Environmental Protection Agency
Washington, DC**

December 16, 2013

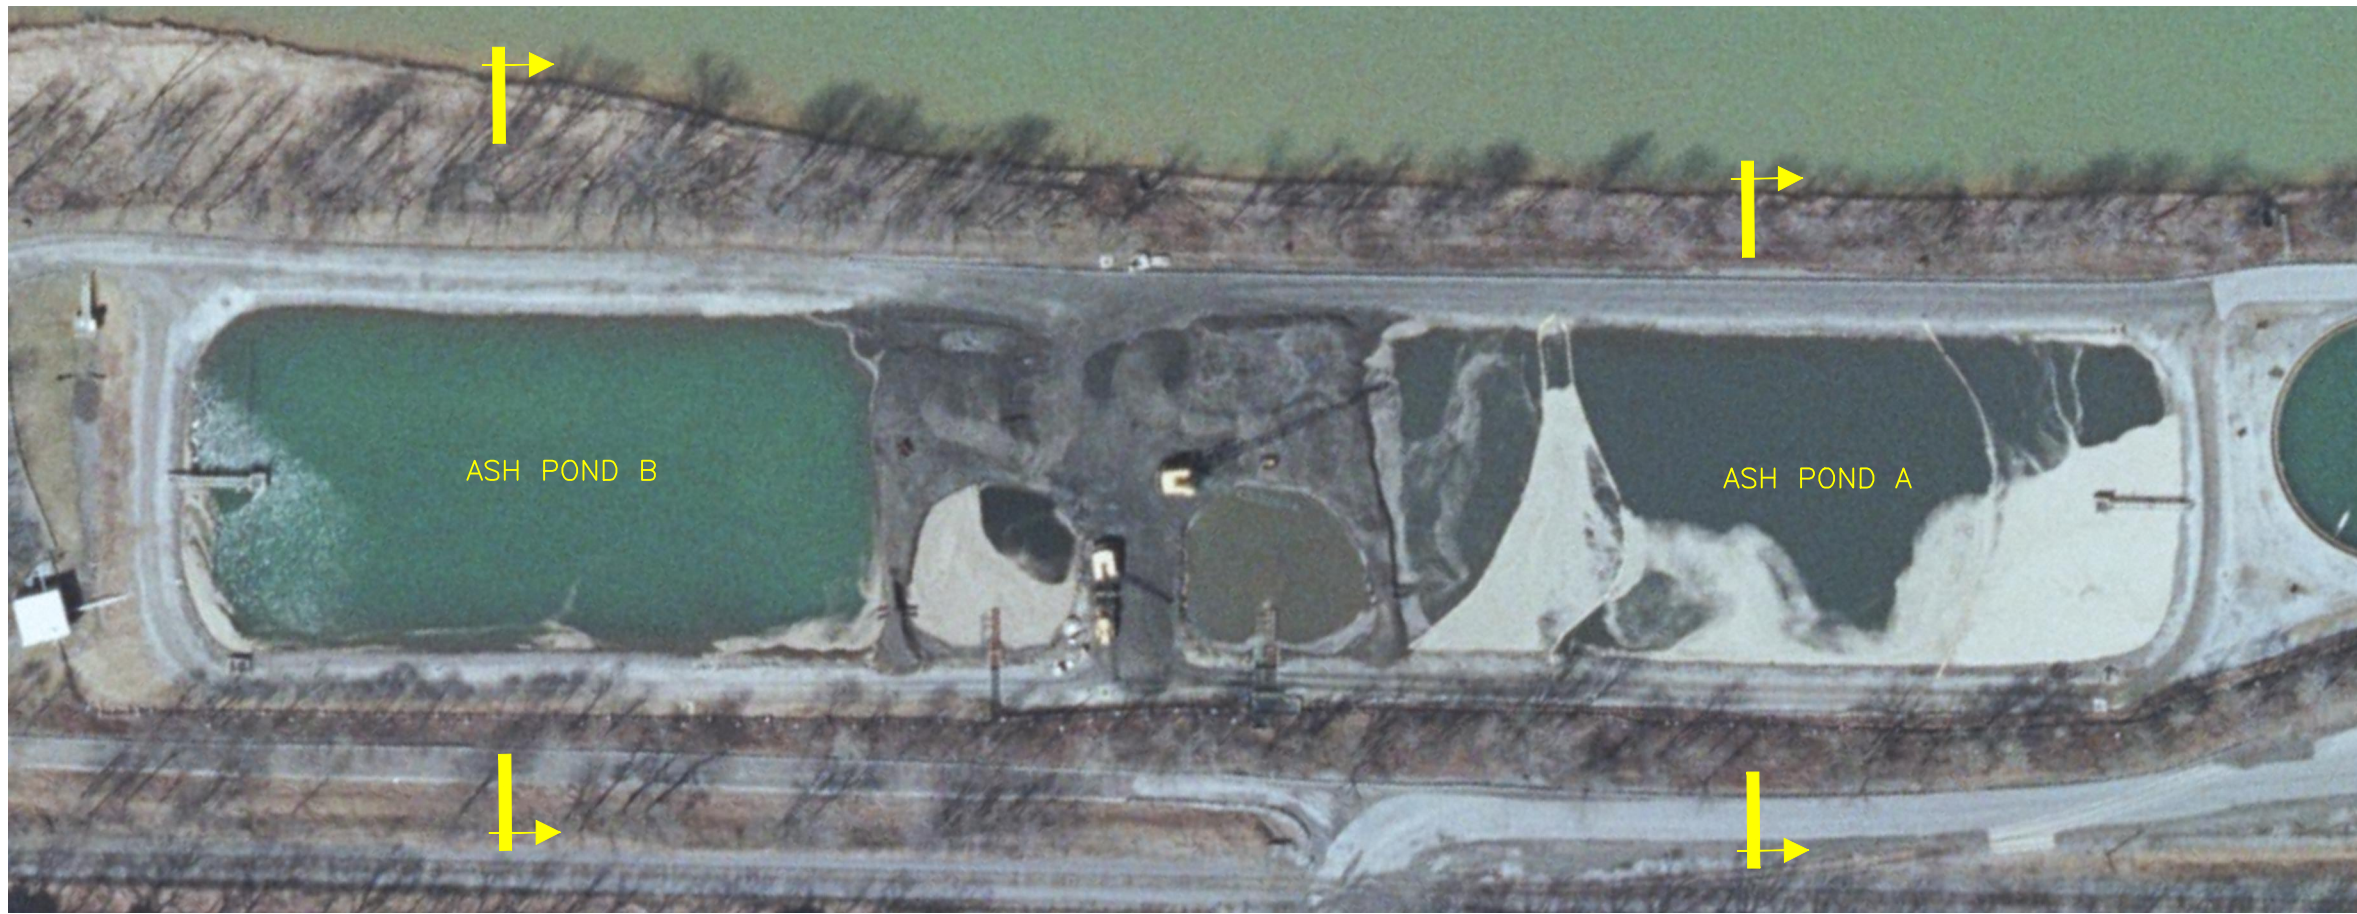
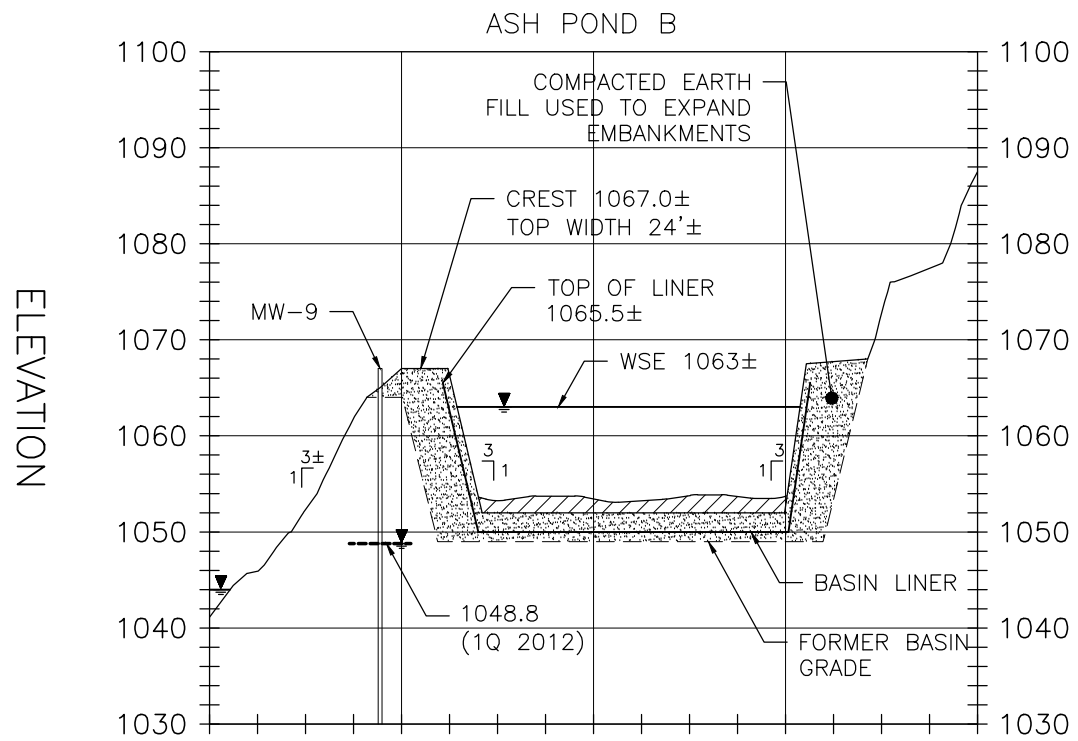
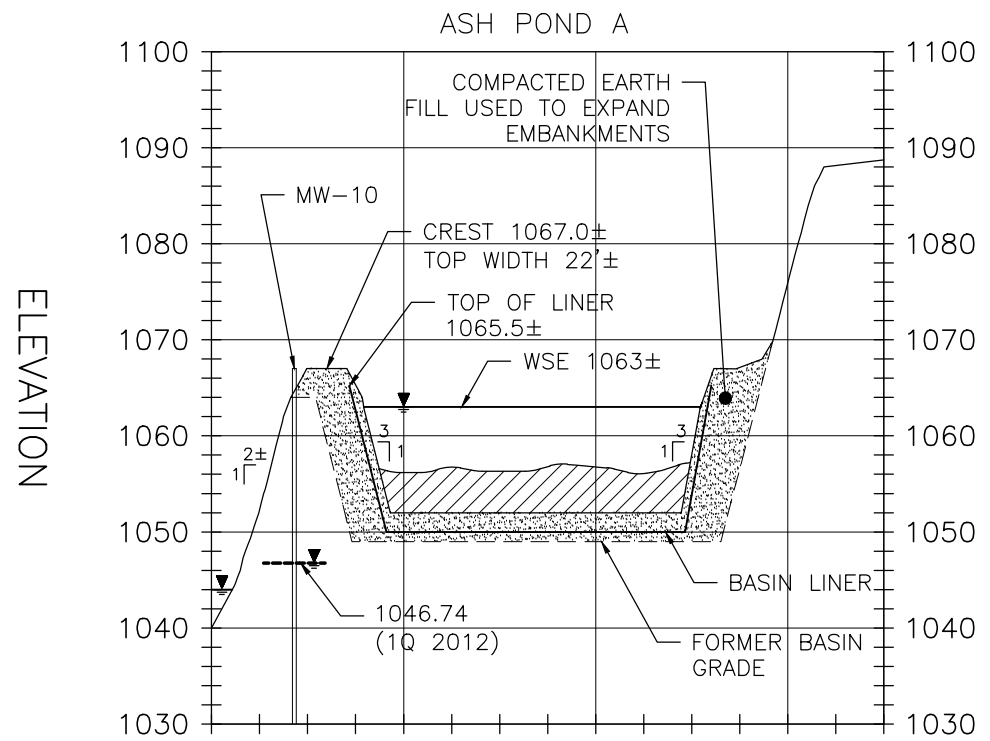
FIGURE 3

Does the configuration of the embankment, specifically as seen in elevation views from Figure 3 in the attachments of the report, present a concern in a flood condition in the West Branch of the Susquehanna River, i.e., elevated phreatic surface and potential subsequent downstream rapid drawdown condition in the downstream(outboard) slope? Additionally, would it be overly-conservative to analyze the downstream embankment based on its configuration and subsequent lack of lateral soil pressure buffering the embankment?

Given the close proximity to the West Branch of the Susquehanna River and the lack of any setbacks, benches, etc. on the slope, a recommendation to perform geotechnical slope stability analyses of these slopes would not be perceived as overly conservative in our opinion; however, we considered the following during preparation of our report recommendations:

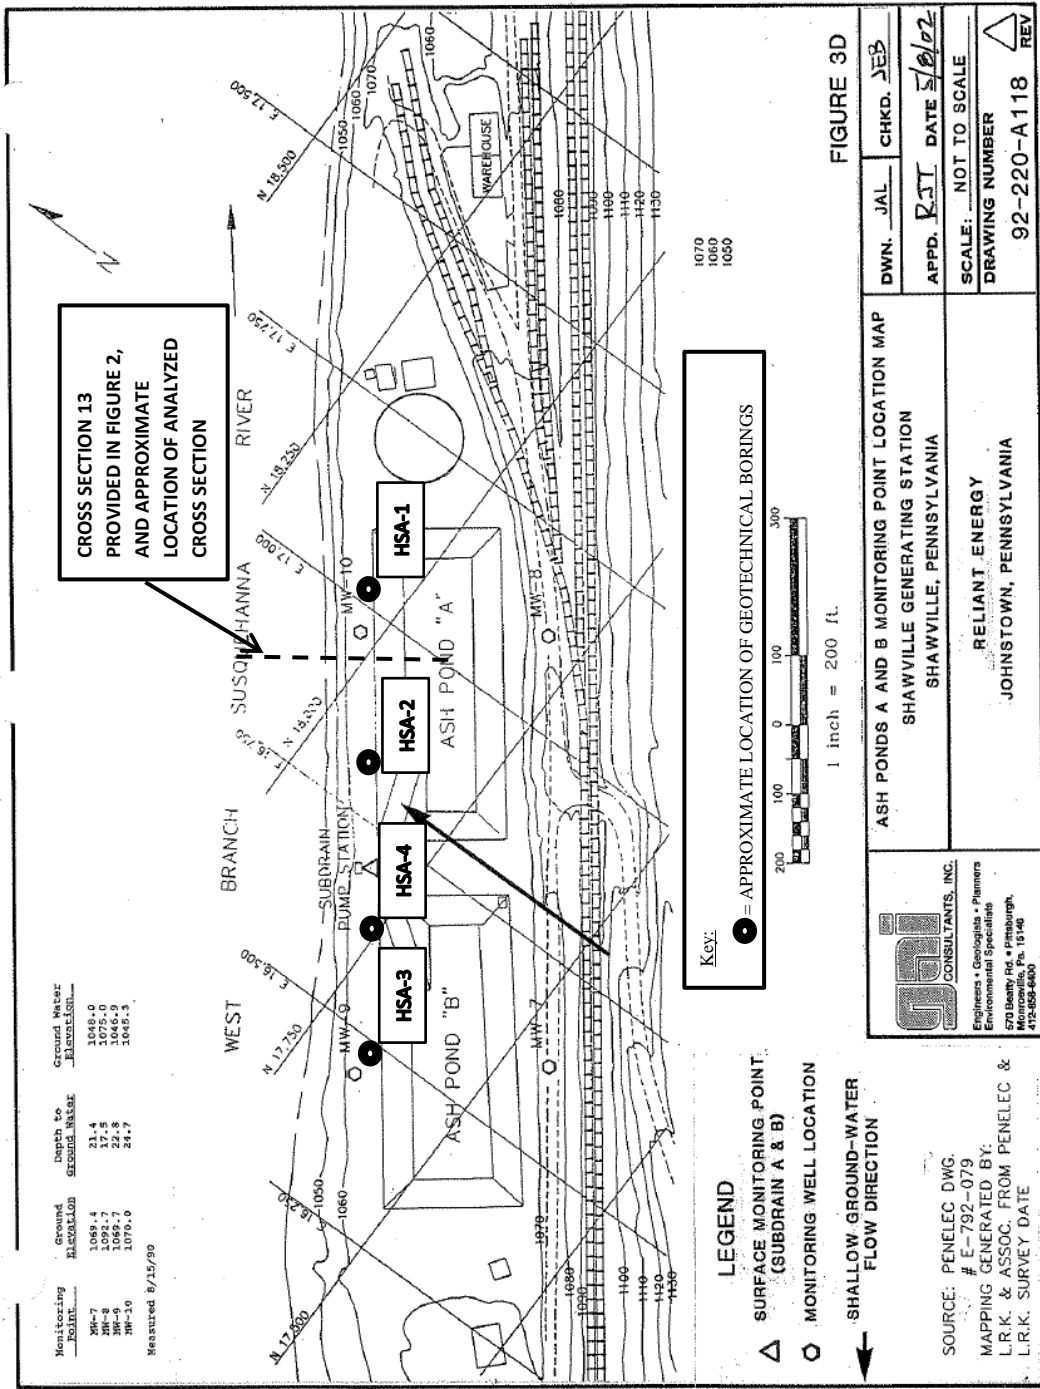
Figure 1 - Geotechnical Boring Locations

On 18 December 2012, Geosyntec conducted a geotechnical field investigation to collect data for assessing the stability of the BAP embankments. The geotechnical field investigation consisted of drilling four test borings, identified as HSA-1 through HSA-4, at the locations shown in Figure 1. Two borings were advanced along the inside crest of the northwest embankment for each BAP, which are the highest portions of the BAP embankments (i.e., approximately 24 feet high). Three borings were drilled to an approximate depth of 25 feet below the existing ground surface (ft-bgs); one boring (HSA-4) was drilled to a depth of approximately 30 ft-bgs.

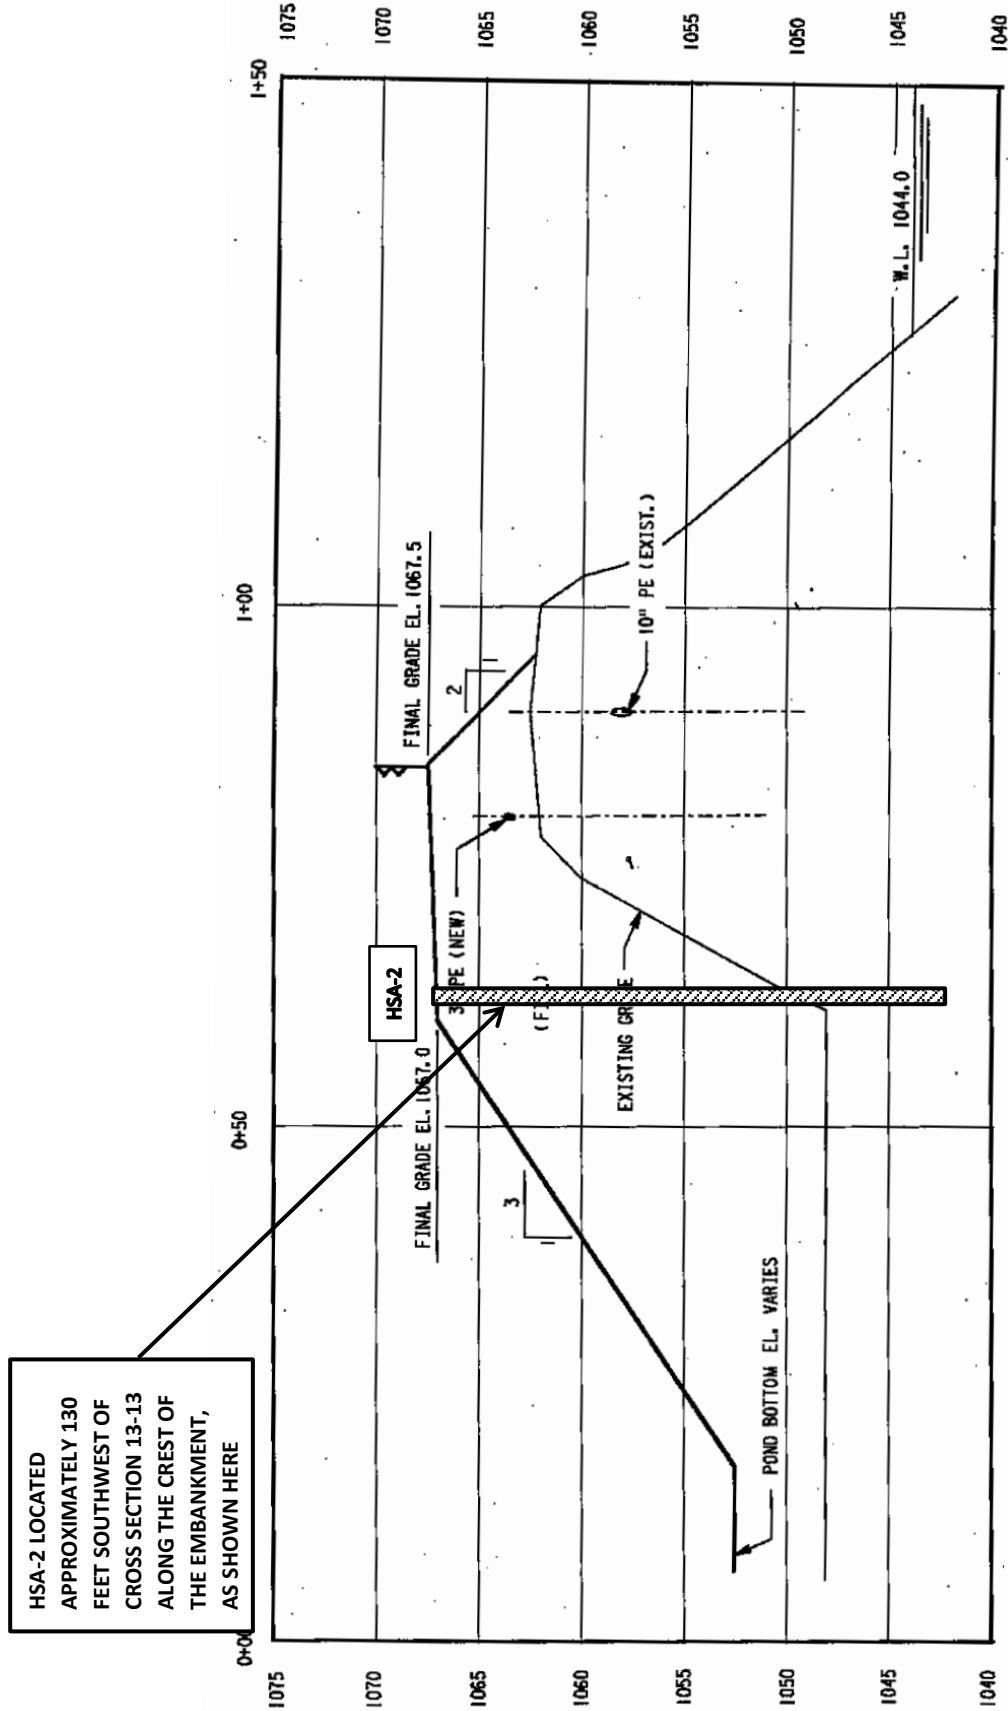
Figure 2 – Cross Section 13-13 of the Northwest Berm of Ash Pond A

The Shawville Power Station has two bottom ash ponds (BAPs) (i.e., Ash Pond A and Ash Pond B) that are part of the site's bottom ash water recycle system. Both ponds have an engineered liner system consisting of a PVC liner with geotextile cushion fabric. The ponds were constructed using a combination of diked and incised construction methods, with the embankments for the diked portion of the ponds running parallel to the west branch Susquehanna River (river). The current configuration of Ash Ponds A and B has been in service since 1989. The locations of the BAPs are shown in Figure 1, which also illustrates the orientation of the ponds in relation to the river. A typical cross section of the northwest embankment, depicting the spatial relationship of the pre-1989 embankment to the 1989 vertical expansion of the embankment, is provided in Figure 2.

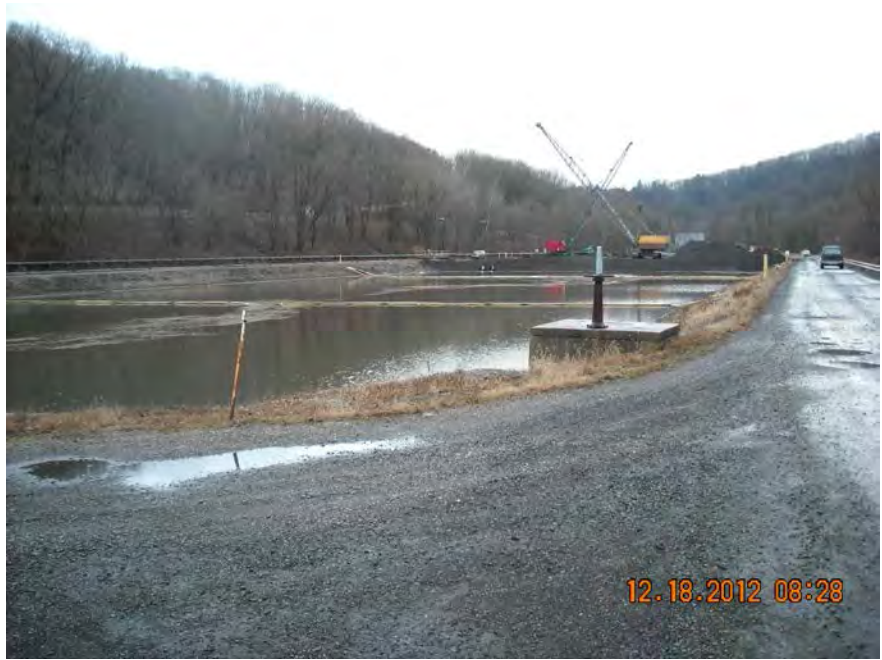
Photograph 2

View of the northeast berm of Ash Pond A. Walkway on the right leads to the decant structure. The water treatment facility appears on the left side of the photo.

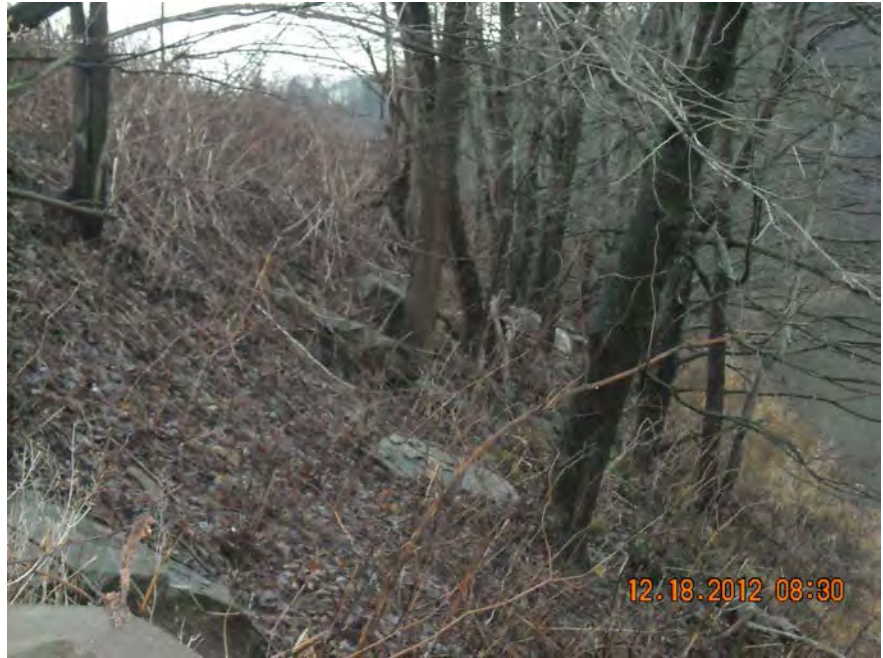
Photograph 5

Outer slope (i.e. northwest slope) of Ash Pond A, looking southwest along the bank of the West Branch Susquehanna River. Large boulders, trees, and grass line the slopes.

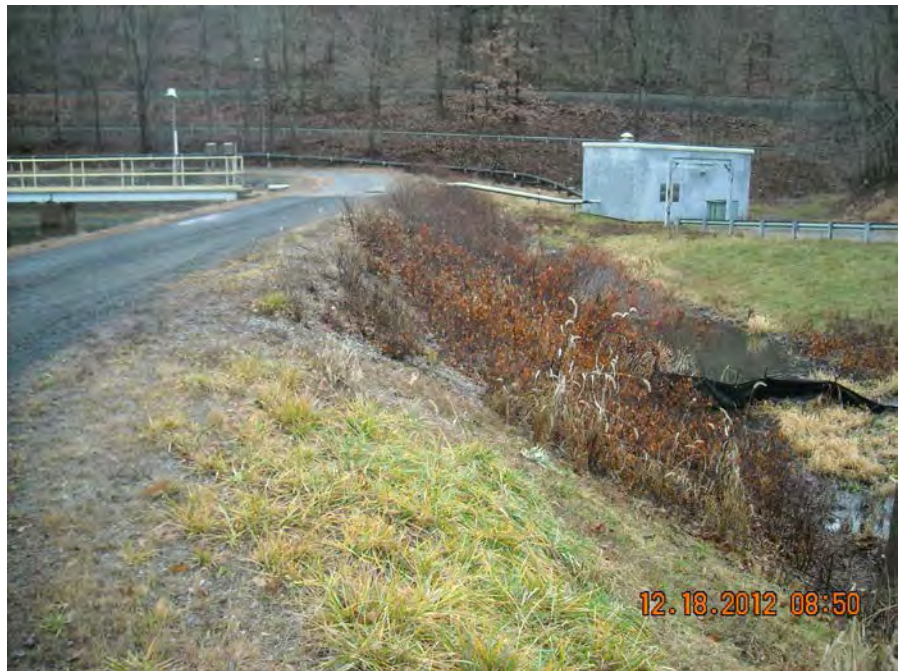
Photograph 6

View of the southwest slope of Ash Pond B, looking southeast. Berm is relatively short (less than ten feet high), and a natural counterweight exists to the other side of the incised ditch shown here.

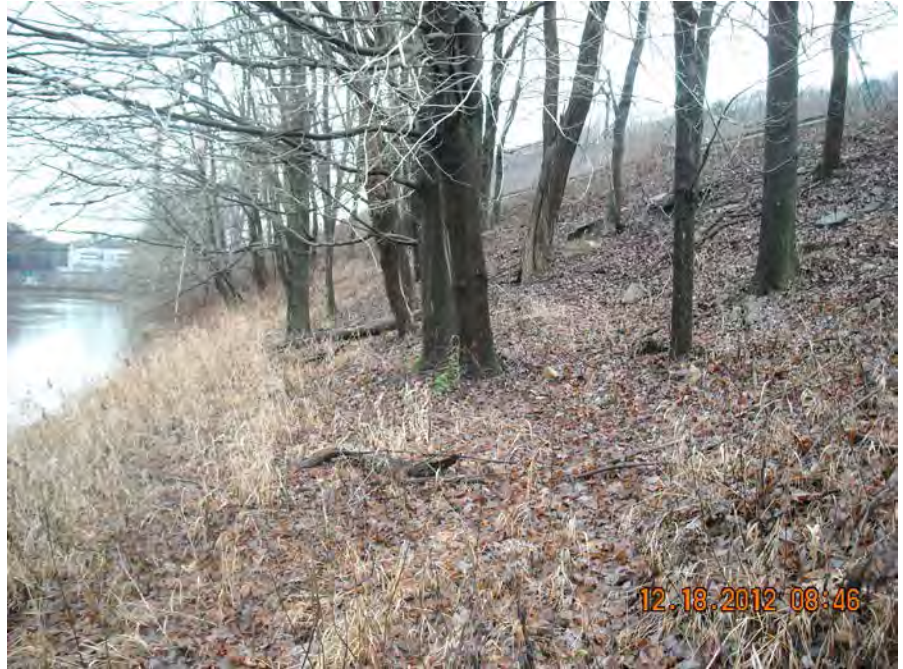
Photograph 5

Outer slope (i.e. northwest slope) of Ash Pond B, looking northeast along the bank of the West Branch Susquehanna River. Boulders, trees, and grass line the slopes.

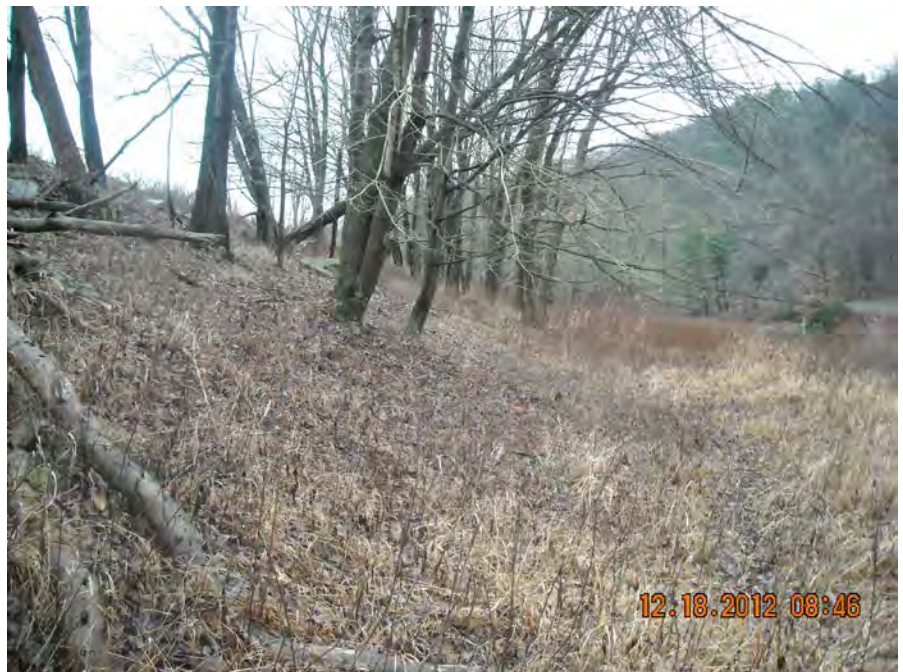
Photograph 6

Outer slope (i.e. northwest slope) of Ash Pond B, looking southwest along the bank of the West Branch Susquehanna River. Large boulders, trees, and grass line the slopes.

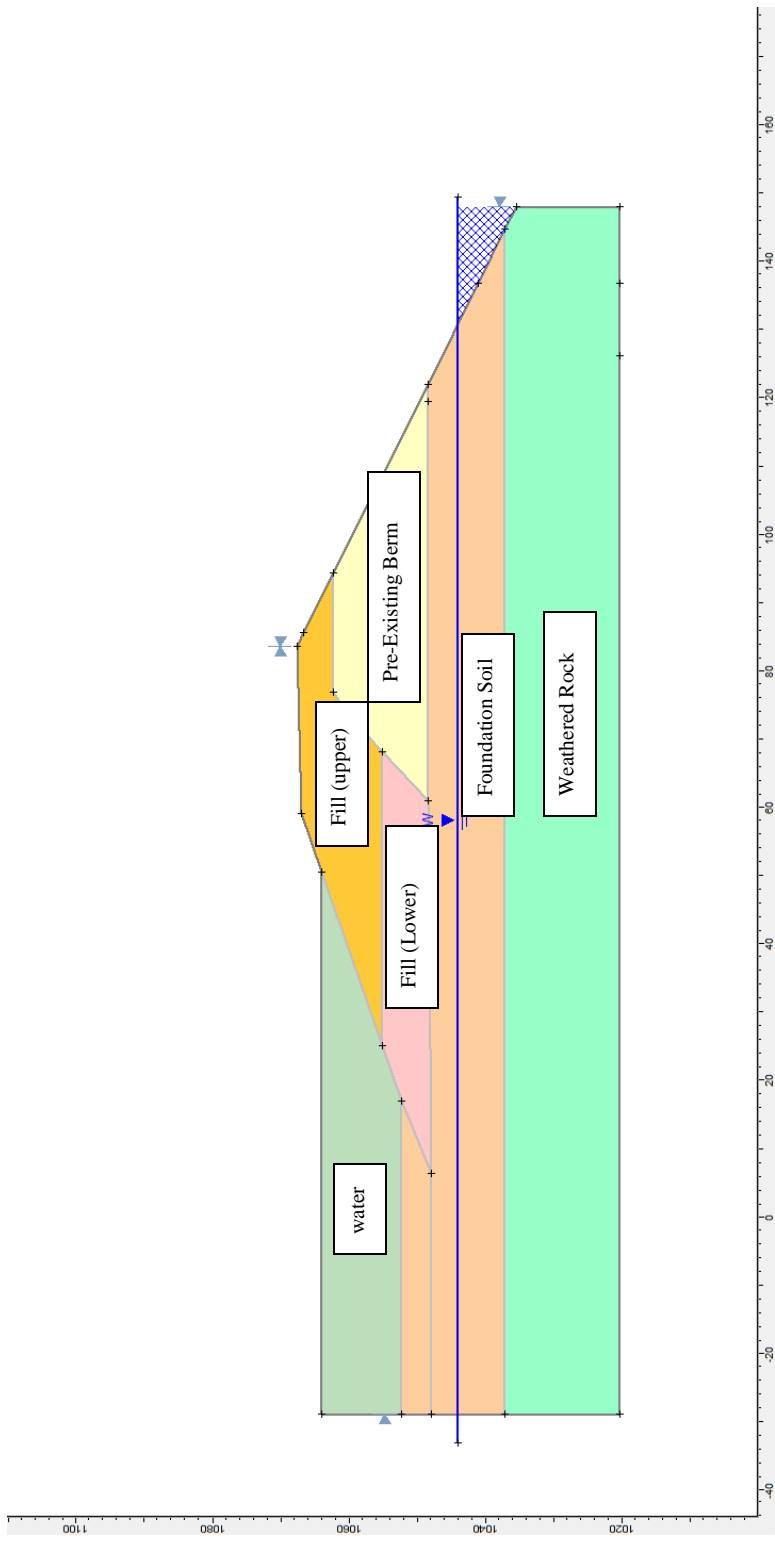
Figure 8. Analyzed Cross Section

Table 1 summaries the material properties used in the slope stability analysis. The analyzed cross section is shown in Figure 8.
