February 27, 2012

RE: NV Energy Response to Recommendations in EPA Letter Dated January 12, 2012

**RE: Liquefaction Analysis – Coal Combustion Waste Impoundments  
Reid Gardner Generating Station**

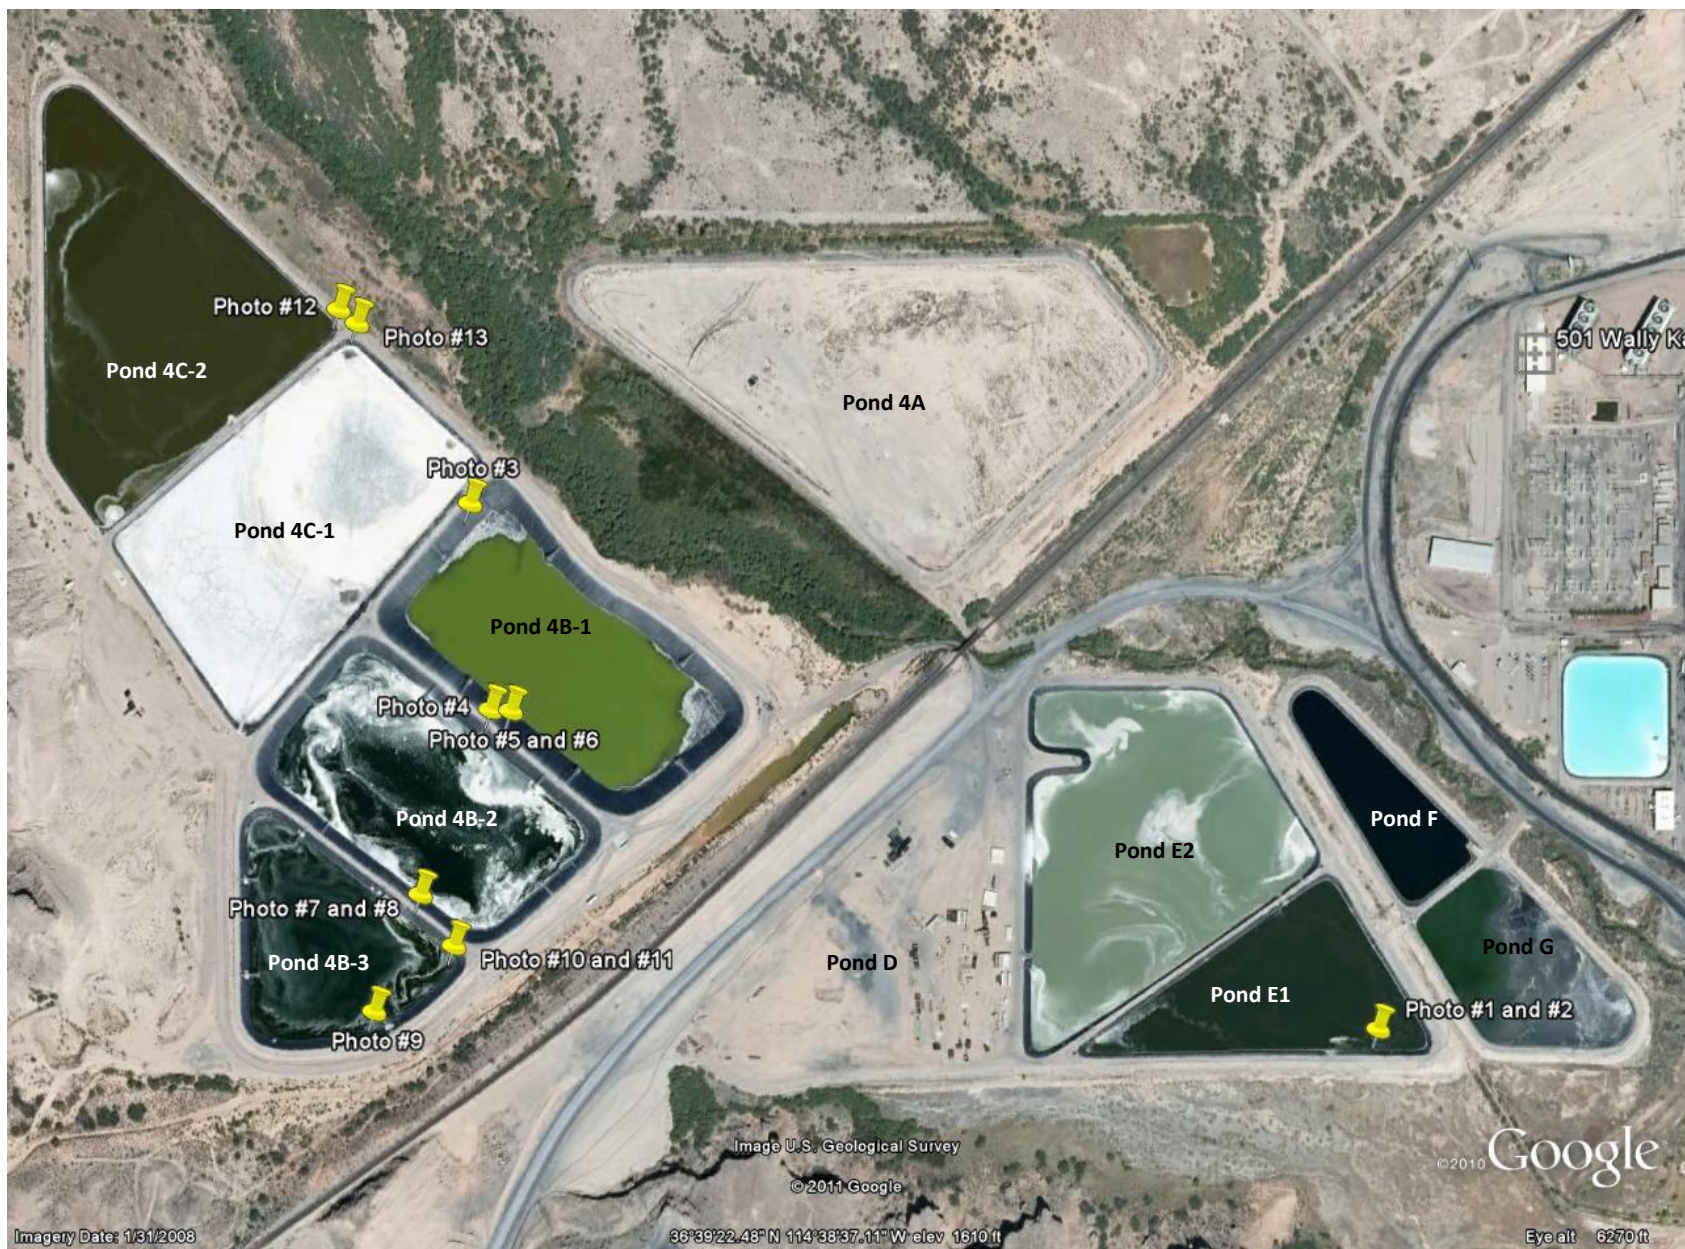
## Photo Location #1

# Reid Gardner – Pond E1

NV Energy (NVE) is pleased to inform your office that we have completed repairs to the interstitial leak detection system outlet boots noted in your July 19, 2011 letter.
