Coal Combustion Residue Impoundment

Round 9 - Dam Assessment Report

L.V. Sutton Steam Electric Plant

Ash Ponds

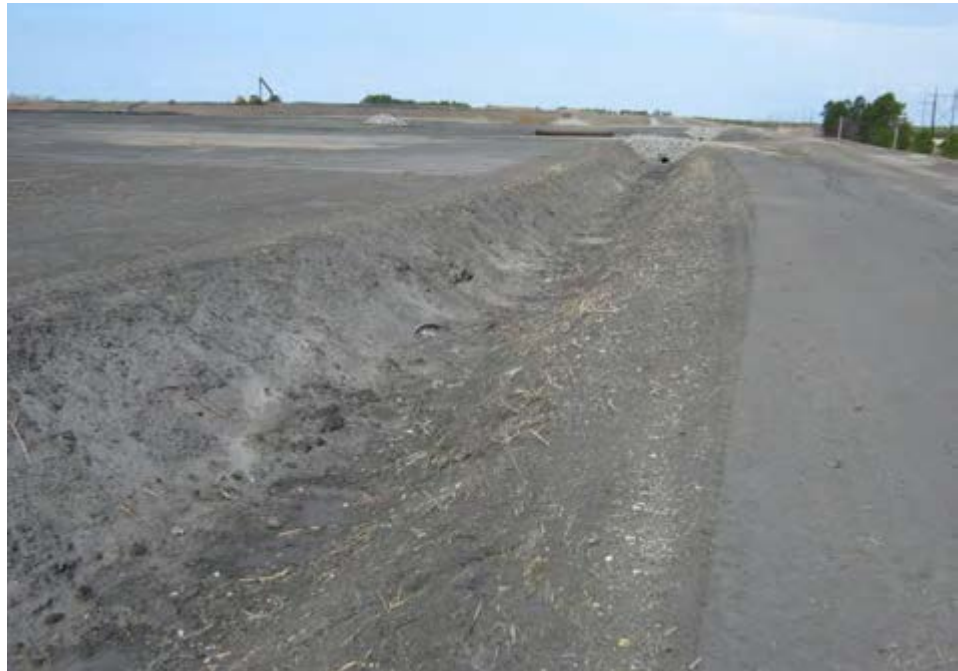
The upstream/inside slopes were not vegetated in many areas. Progress Energy had performed some work within the pond and stated they would be seeding when the weather was appropriate.

Upstream slopes to be vegetated, Spring 2011

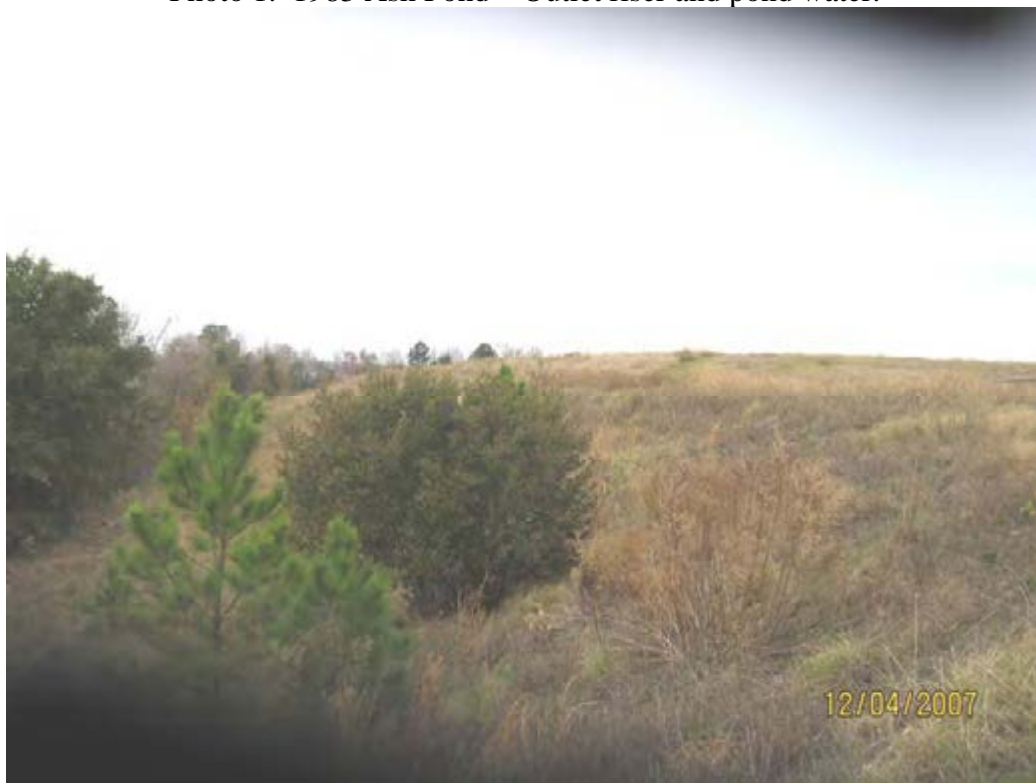
Photo 2. 1984 Ash Pond – Exterior Slope looking northwest.

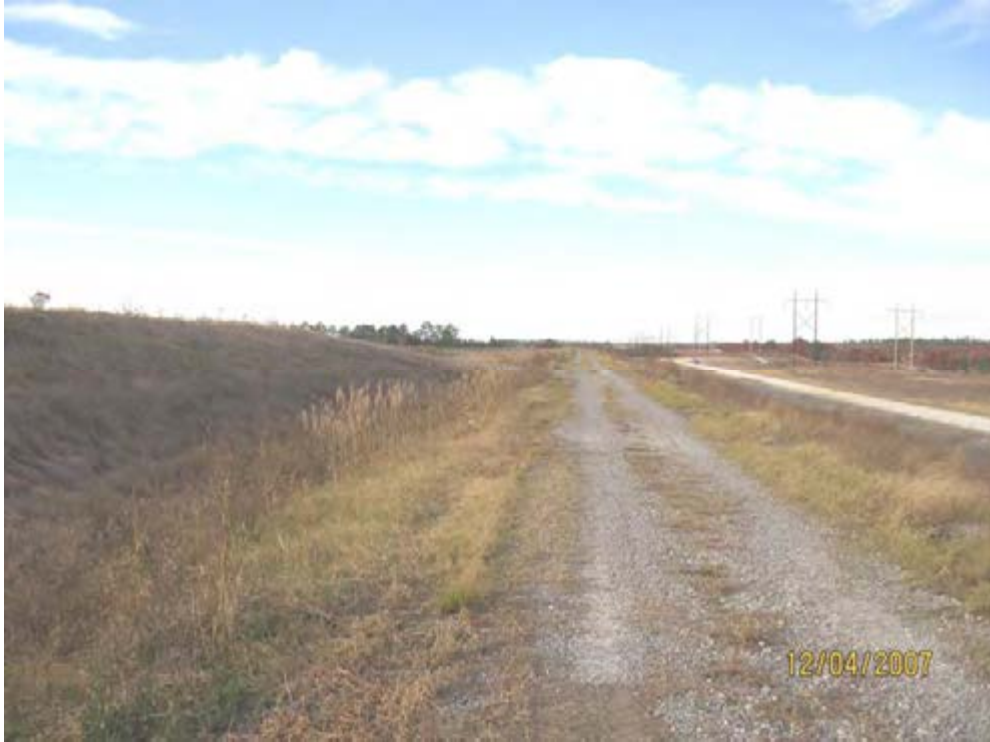
The exterior slope has exposed fly ash with sparse to good grass cover (Photographs 3 and 10). Erosion control netting is present on the slope. MACTEC observed several areas along the top of the stability berm on the north dike where circular depressions about one to four inches deep and about one to three feet in diameter were present (Photograph 11). Discussions with Mr. Alderman indicate these areas are the result of filling in erosion rills that developed in the fly ash slope. These areas are filled by Progress Energy as they are noted. We recommend such areas be checked during each monthly inspection and their positions marked with flags so they can continue to be filled. We interpret these depressions as due to infiltration of surface water and not due to subsurface piping. Also, along the toe of the stability berm slope in the general vicinity of the discharge structure, several local slumps with minor seepage or wet areas were observed (Photograph 12). Due to the width of the stability berm and the gentle slope, these local slumps do not represent an immediate concern. They should be marked and observed during monthly inspections for signs of increasing size or seepage flow.

Photo 3. 1984 Ash Pond – Crest of 1984 dike and exterior slope of 2006 dike.

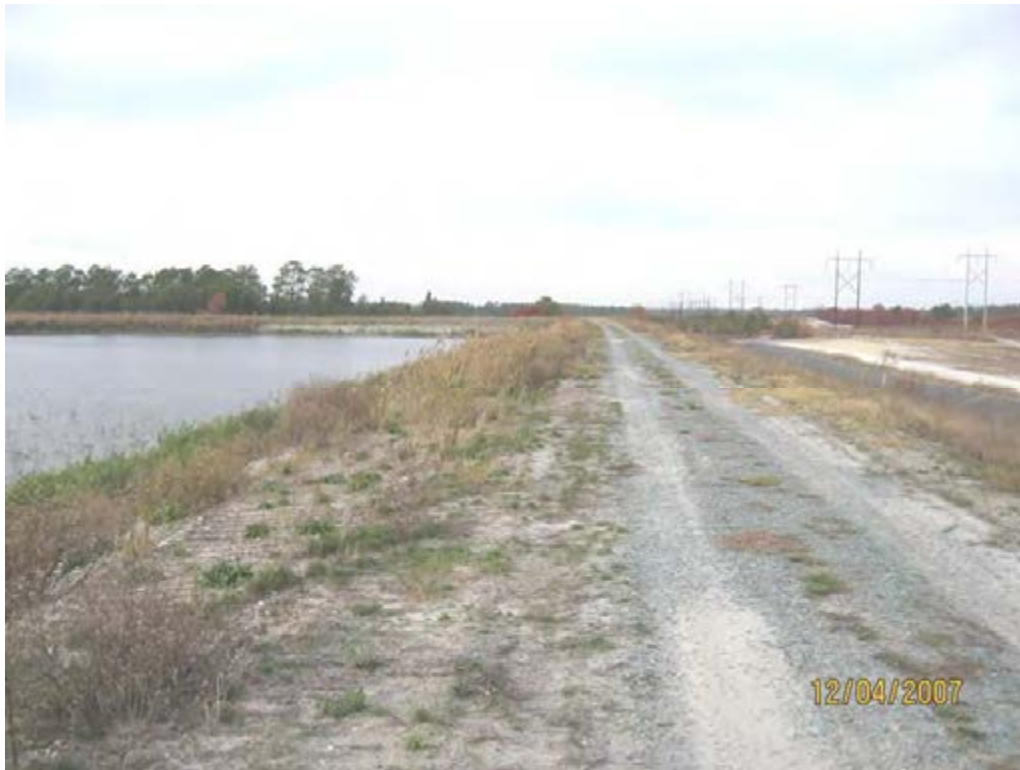
Photo 4. 1984 Ash Pond – Crest and interior slope looking north.

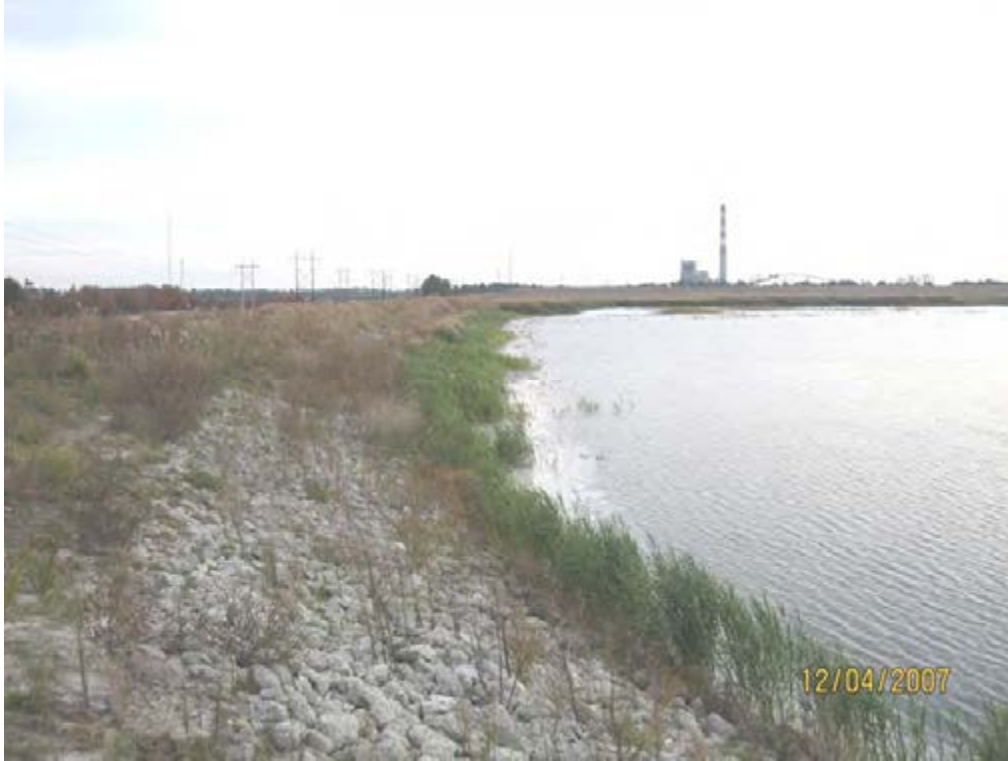
Photo 5. 1984 Ash Pond – Typical interior slope looking south. Note minor grass growth.

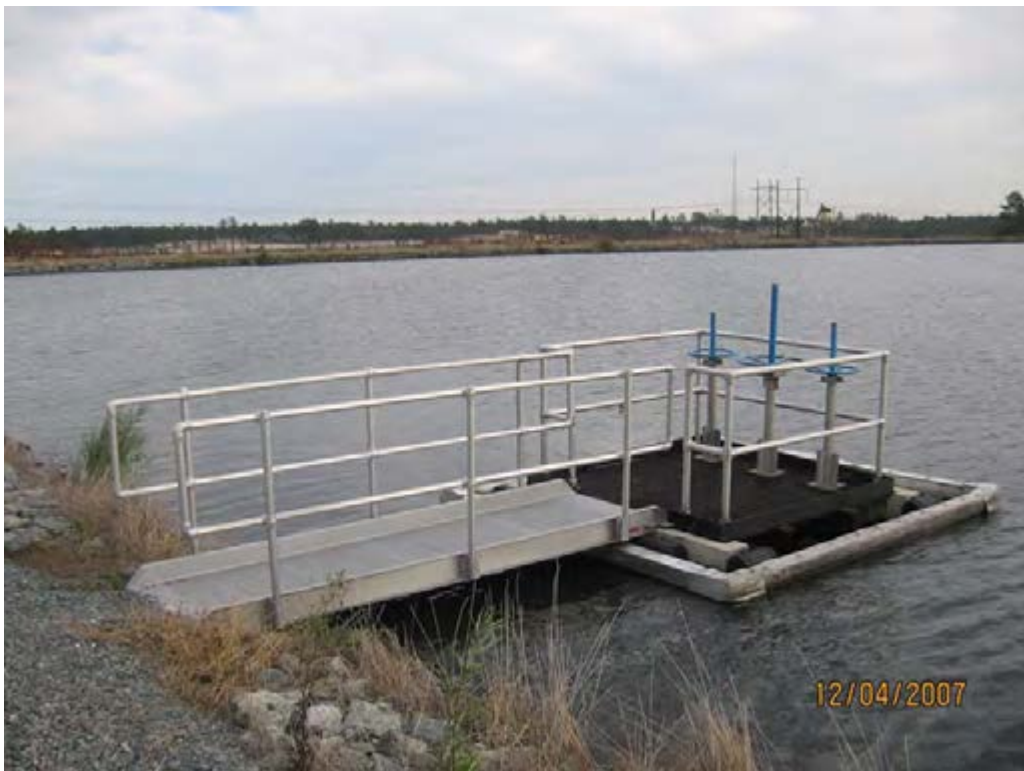
At the time of our inspections, the water level in the interior storage area was slightly above elevation 40.0 feet MSL, and was flowing over the top of the riser (Photograph 8) and out into the 1984 ash pond (Photograph 9). A slight discharge of seepage water from the seepage drain pipe alongside the discharge pipe was observed on the west side of the pipe.

Photo 8. 2006 Interior Ash Pond Inlet looking east.

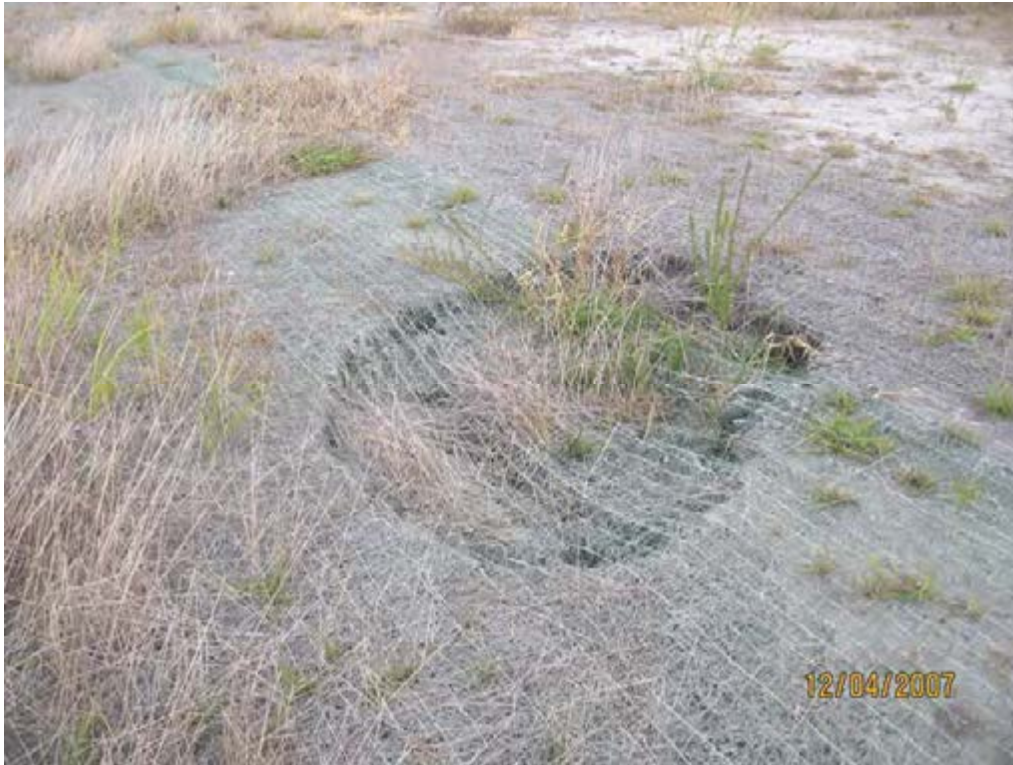
Photo 11. 2006 interior Ash Dike –Exterior Slope looking a sink hole.

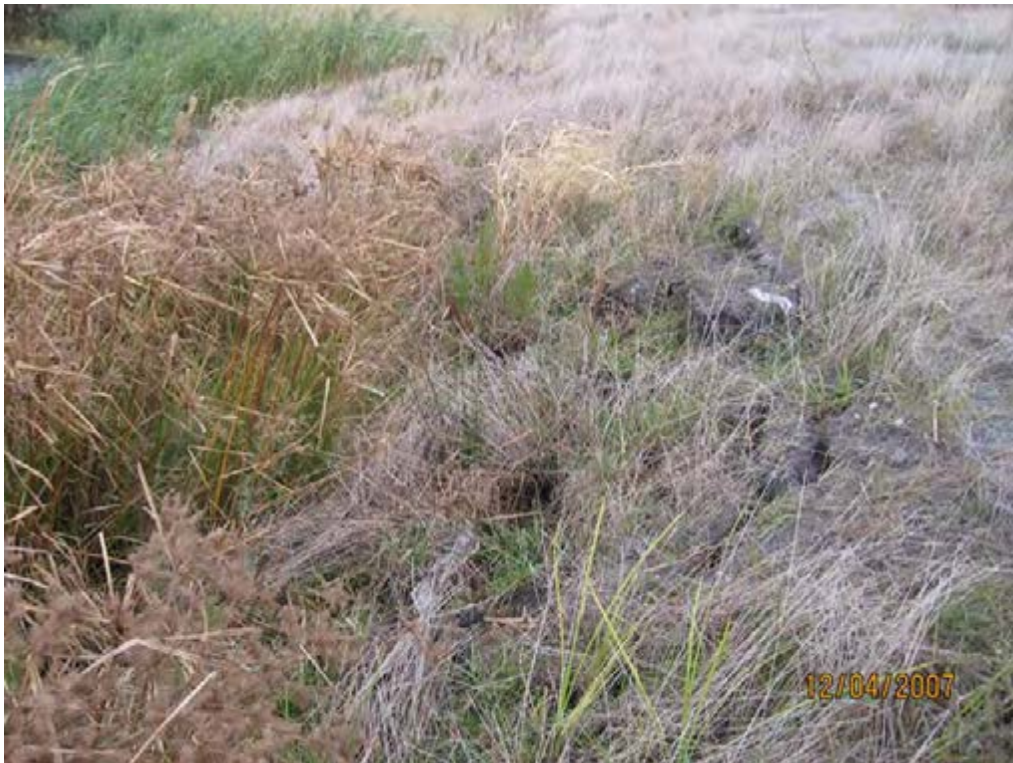
Photo 12. 2006 interior Ash Dike – Area of erosion of ash along exterior slope of dike.

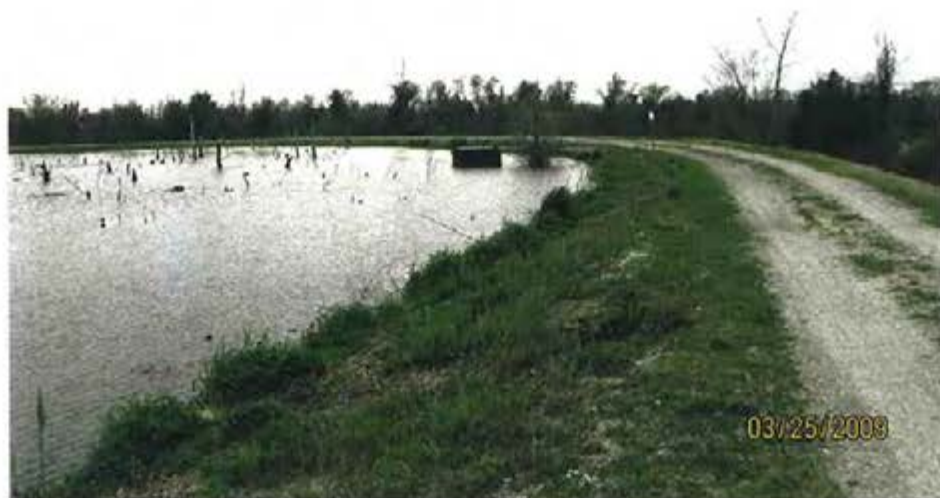
1. 1983 Ash Pond – View of interior slope, outlet riser and standing water near riser.

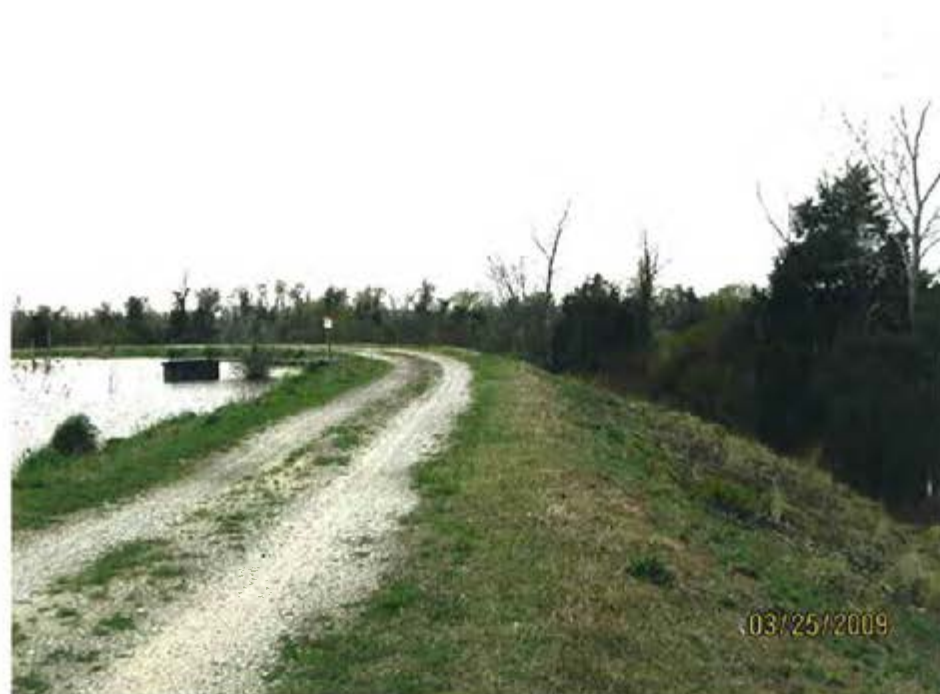
2. 1983 Ash Pond - View of dike exterior slope near outlet riser

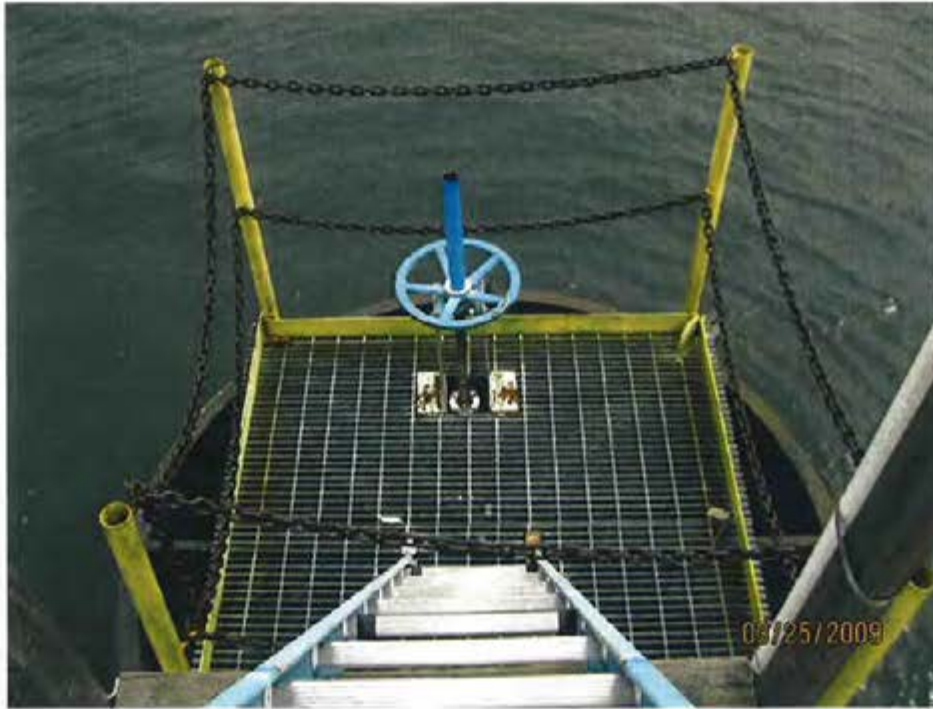
The vertical riser for the discharge structure was observed from the access platform. The skimmer structure and interior surfaces appeared to be in good visual condition (Photograph 11). The downstream outlet structure appeared to be structurally sound with no obvious signs of leakage or displacement (Photograph 12). The discharge from the structure appeared to be free flowing at the time of inspection. Representative photographs of the dike slopes looking toward the discharge structure are included with Appendix B (Photographs 9 and 10).

11. 1984 Ash Pond – View of top for discharge riser.

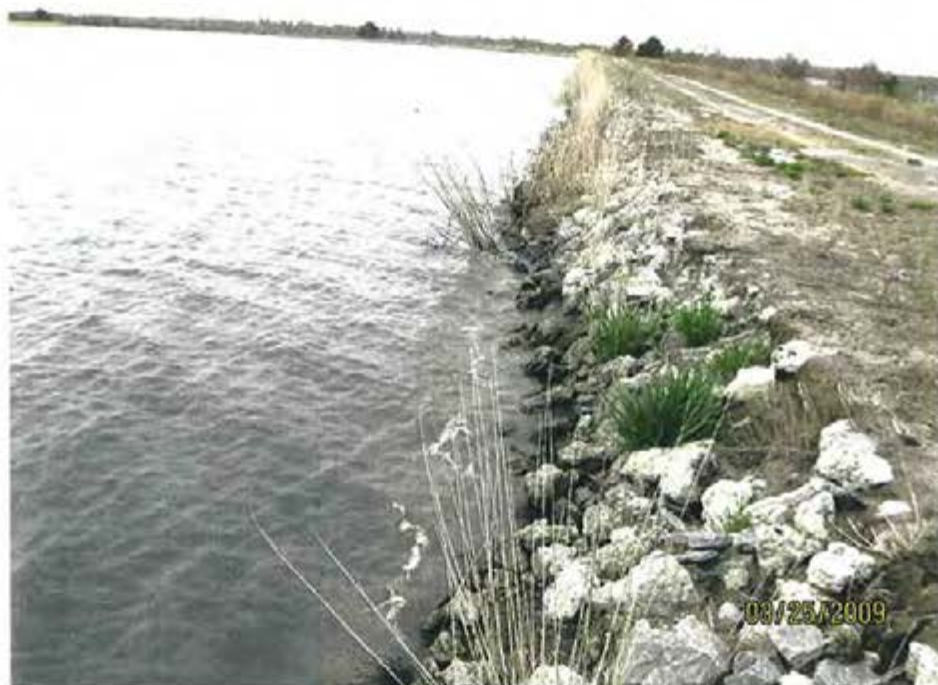
- (AP-2009-1) 2006 Interior Storage Area - Riprap material on the inside slope was observed to have slipped down the slope on the north side of the dike near the discharge structure. This appears to be a localized conditions affecting about 15-20 linear feet along slope. There was no significant slope damage observed at the time of inspection. We recommend routinely checking this area for slope damage and providing riprap repairs as soon as possible.

The interior slope has rip rap placed for erosion protection above the water level which generally appeared to be intact. However, riprap material on the inside slope was observed to have slipped down the slope on the north side of the dike near the discharge structure. This appears to be a localized conditions affecting about 15-20 linear feet along slope. There was no significant slope damage observed at the time of inspection. We recommend routinely checking this area for slope damage and providing riprap repairs as soon as possible. (Photograph 17)

17. 1984 Ash Pond (Interior Storage Area) – View of riprap along interior slope on north side of pond.

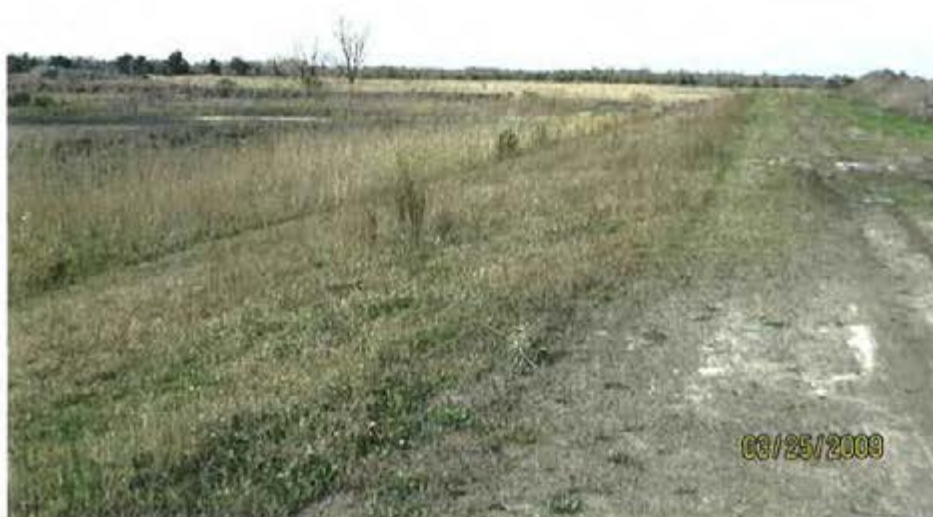
The exterior slopes generally appeared to be stable. However, the vegetation on the exterior slopes continued to appear sparse and should be routinely checked for erosion. The toe of slope along the east and west sides appeared to be dry at the time of inspection. Previous inspections have noted depressions and erosion for the stability berm on the north side of the ash storage area. Repairs to the toe berm appear to have been effective. Progress Energy should continue to monitor the toe area for erosion and provide repairs. (Photograph 18)

18. 1984 Ash Pond (Interior Storage Area) – View of exterior slope on south side of pond.

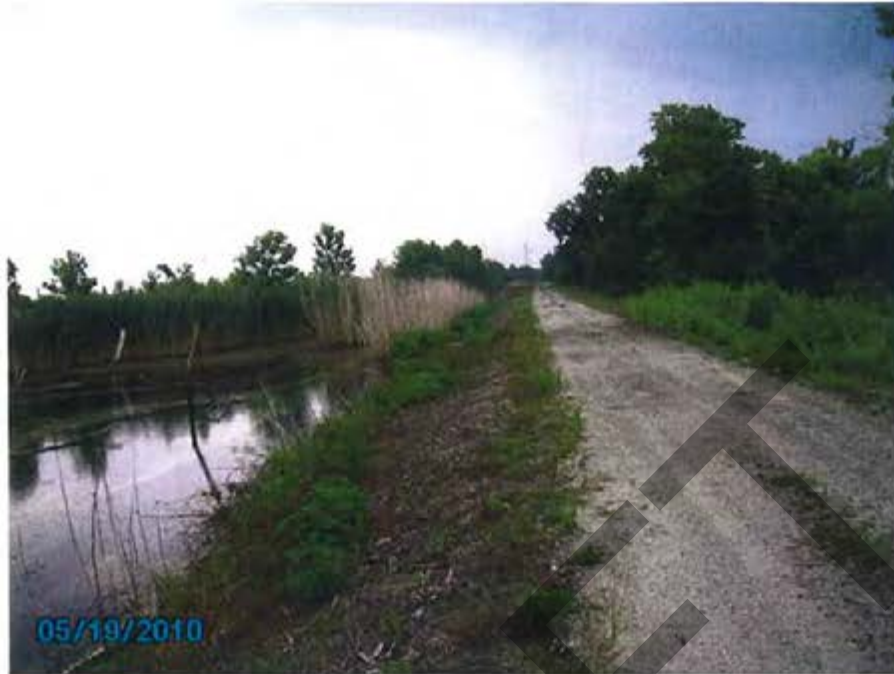
3. 1983/1971 Ash Pond – View of interior slope for south dike.

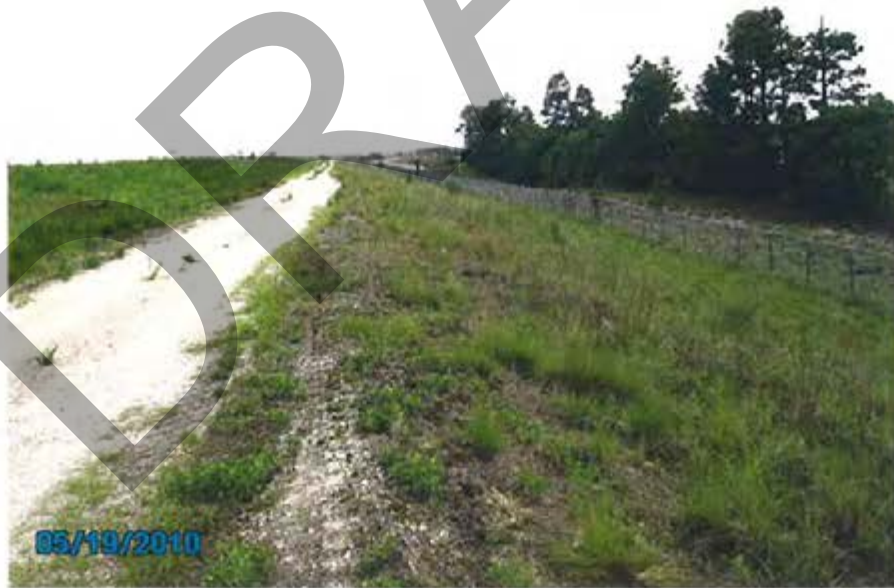
6. 1984 Ash Pond - View of exterior slope for east dike looking north.

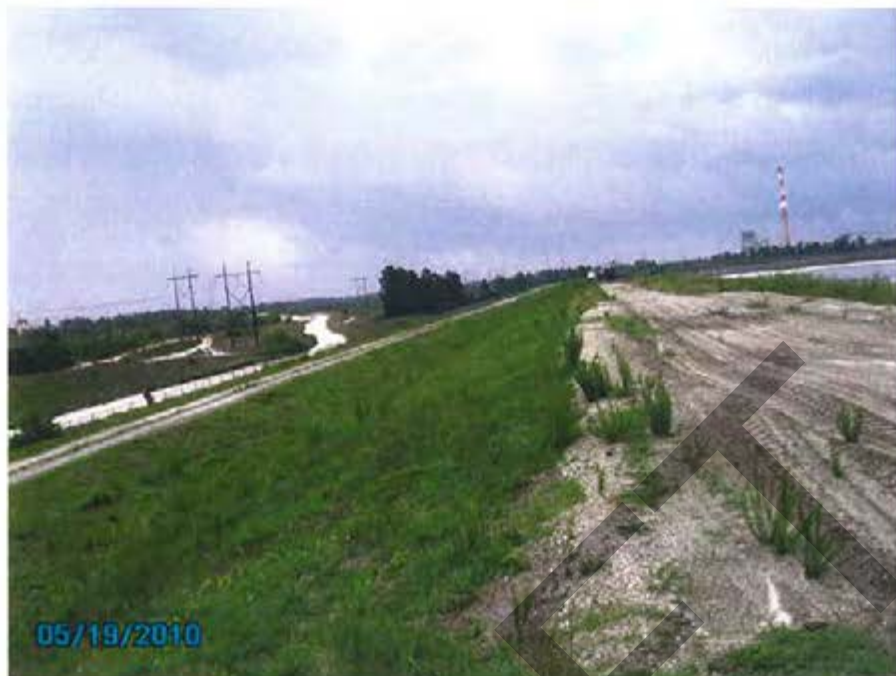
7. 1984 Ash Pond – View of exterior slope for east dike looking south (at northeast corner).

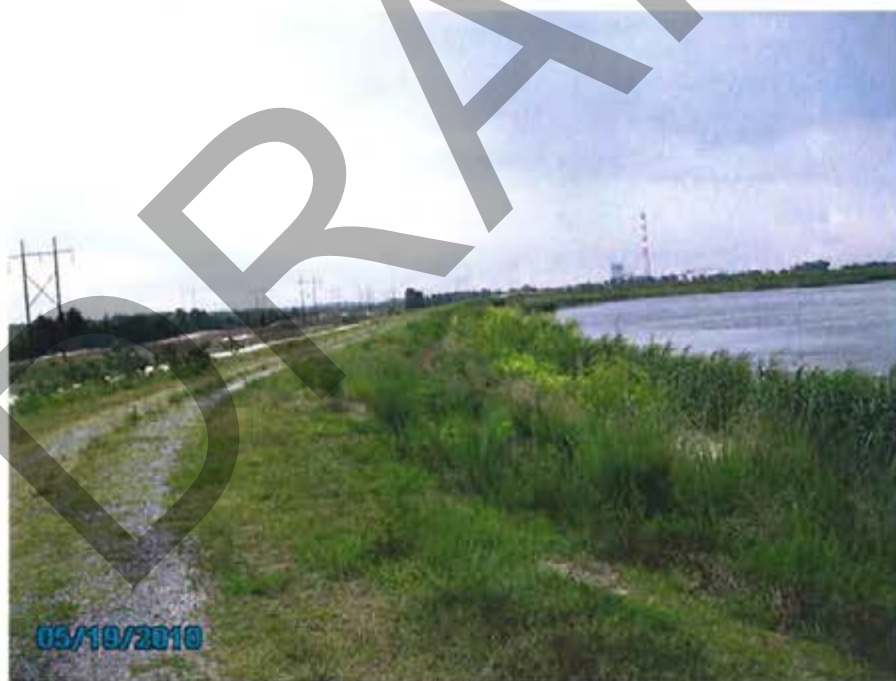
8. 1984 Ash Pond – View of interior slope for east dike looking south (at northeast corner).

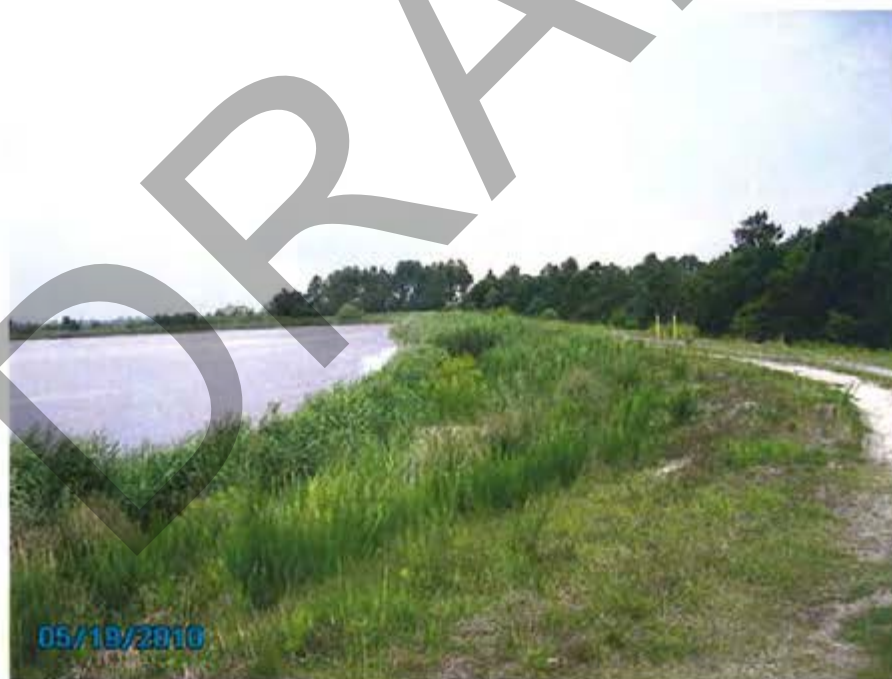
10. 1984 Ash Pond – View of interior slope for south dike looking west (at northeast corner).

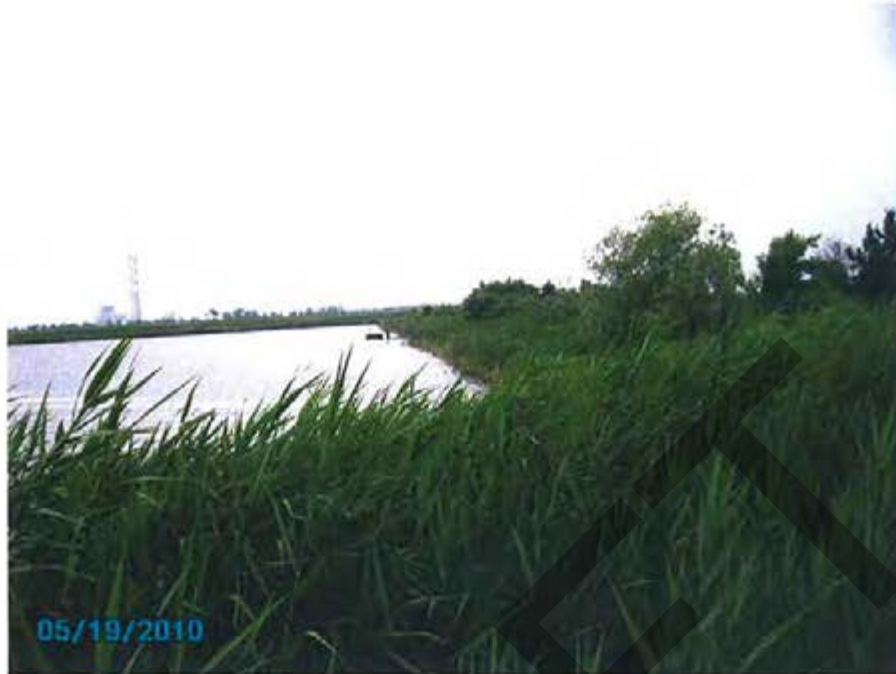
13. 1984 Ash Pond – View of interior slope for west dike looking toward discharge structure.

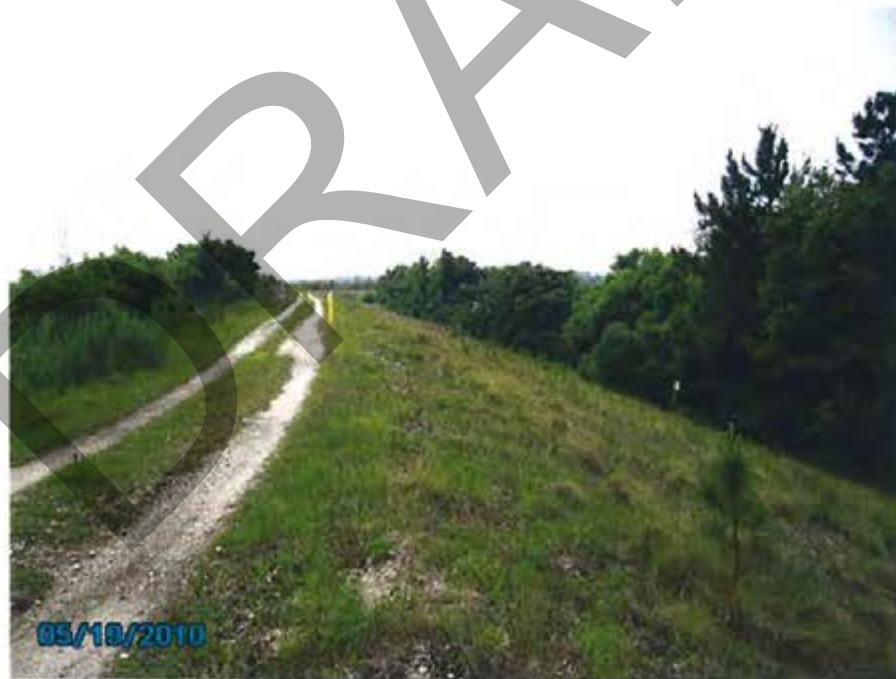
14. 1984 Ash Pond – View of exterior slope for west dike looking toward discharge structure.

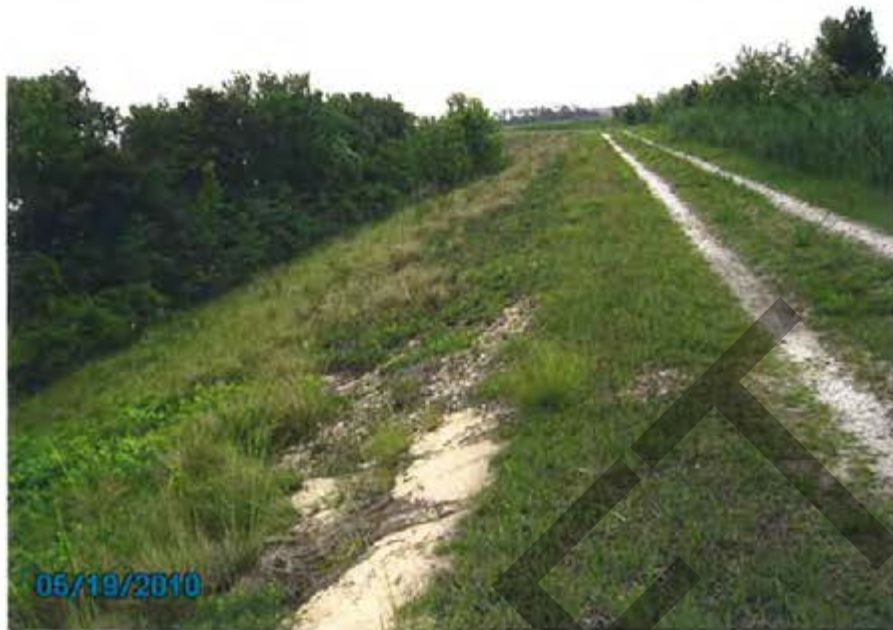
15. 1984 Ash Pond – View of exterior slope for west dike looking north.

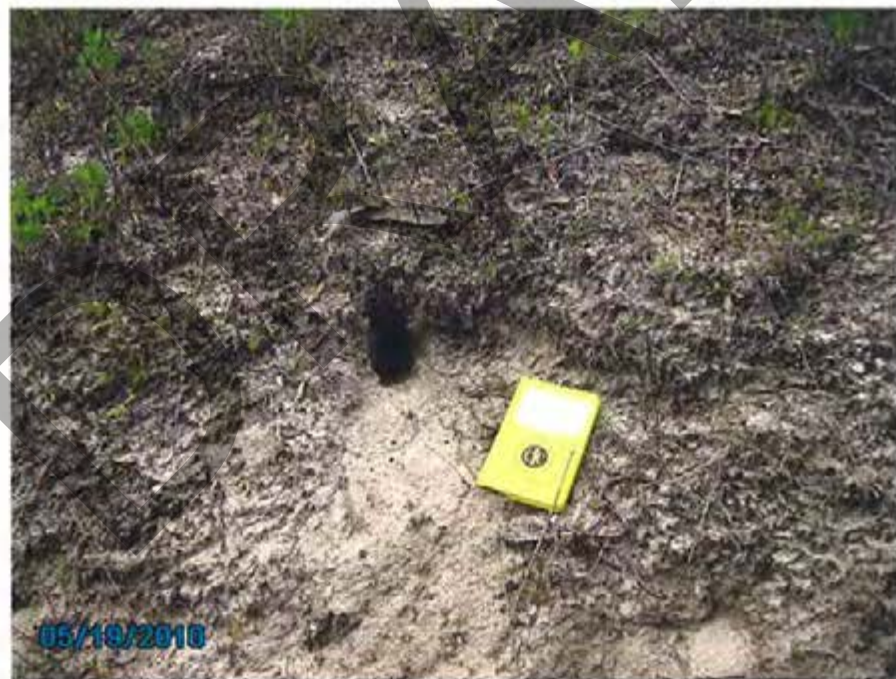
18. 1984 Ash Pond – View of animal burrow on the exterior slope for north dike (4" x 7" field book shown for scale).

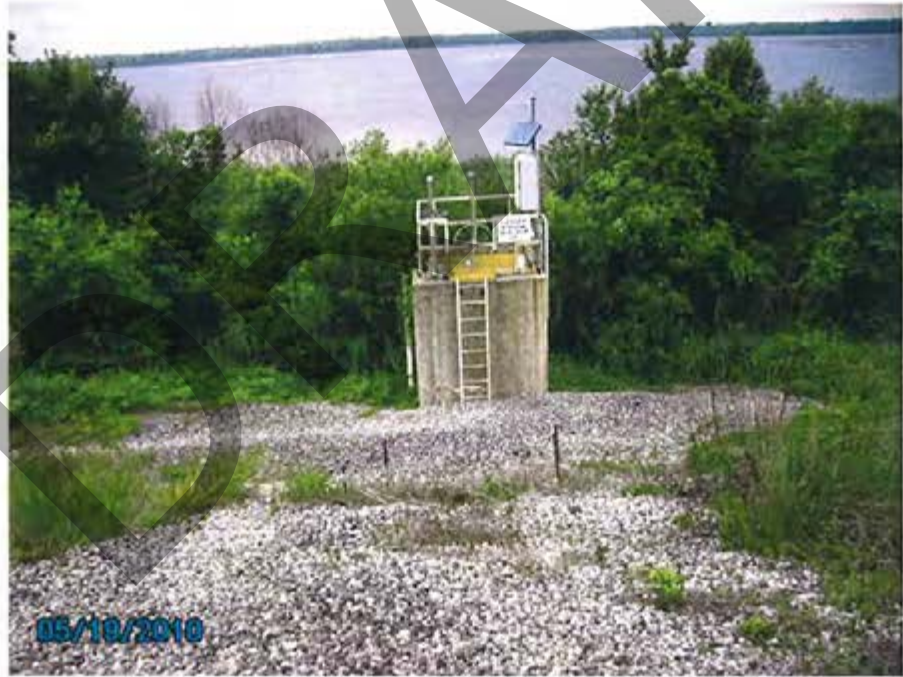
20. 1984 Ash Pond – View of discharge diversion structure at toe of west dike.

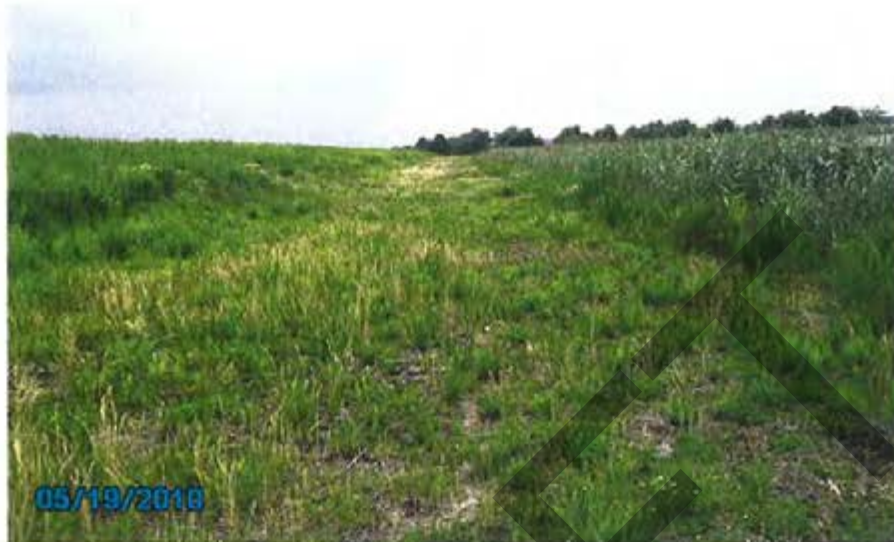
23. 1984 Ash Pond/Interior Storage – View of stability berm for containment dike looking west.

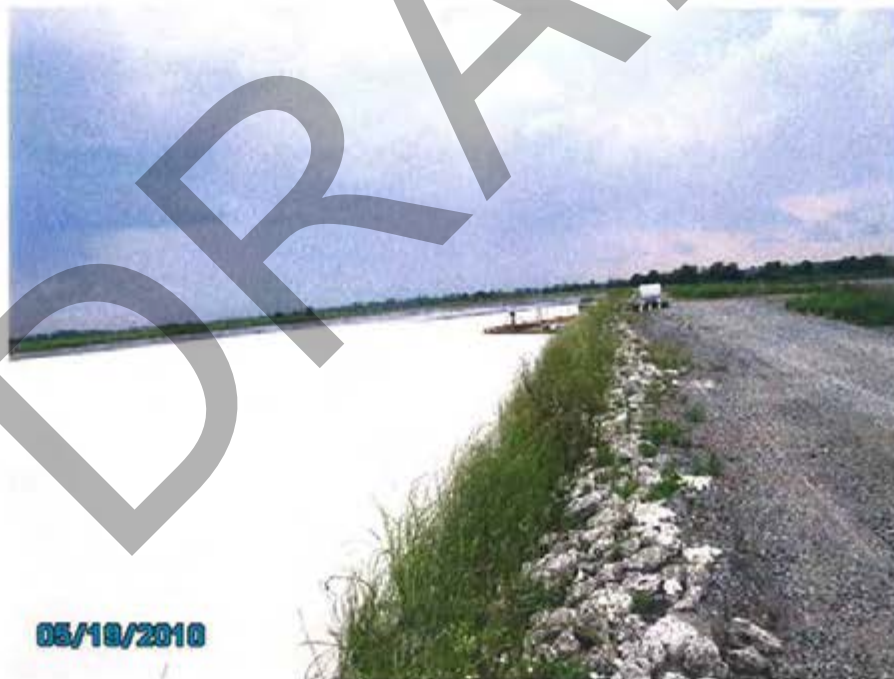
24. 1984 Ash Pond/Interior Storage – View of interior slope for containment dike and discharge structure looking west.

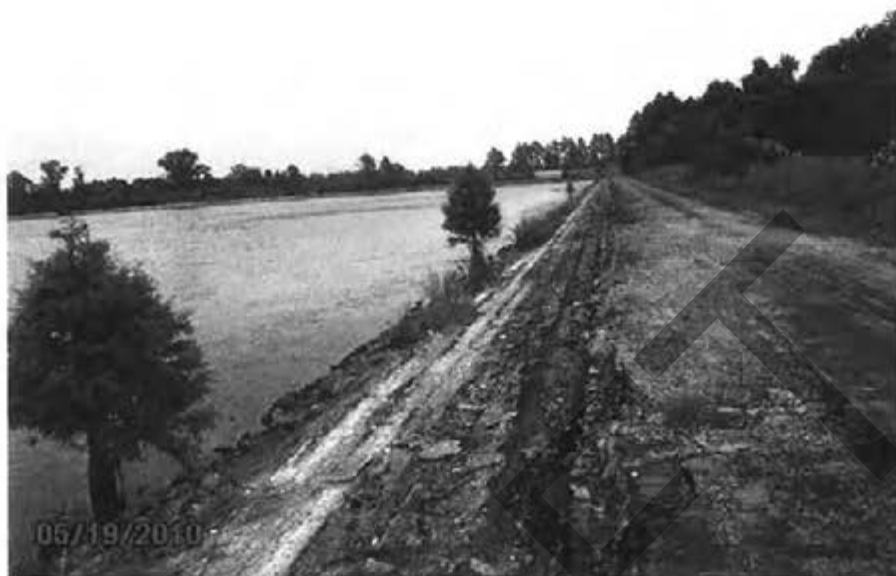
26. Cooling Pond – (Bay #1) View of crest and interior slope showing small trees growing at toe.

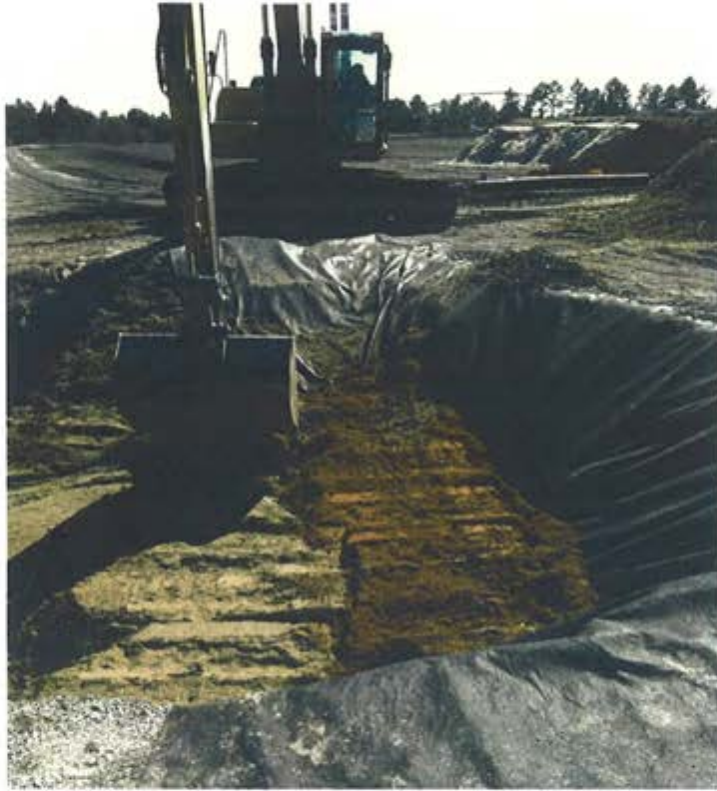
Photo 3. Sand and clay fill nearing top of repair zone.
