US EPA ARCHIVE DOCUMENT

| Site Name: <u>Progress Energy Asheville</u> | Date: <u>29 MAY 2009</u> |
| Unit Name: <u>1964 POND</u> | Operator's Name: <u>PROGRESS ENERGY</u> |

PHOTOGRAPH LOCATION PLAN  
ASH PONDS - PROGRESS ENERGY  
ASHEVILLE STEAM ELECTRIC PLANT  
SKYLAND, NORTH CAROLINA

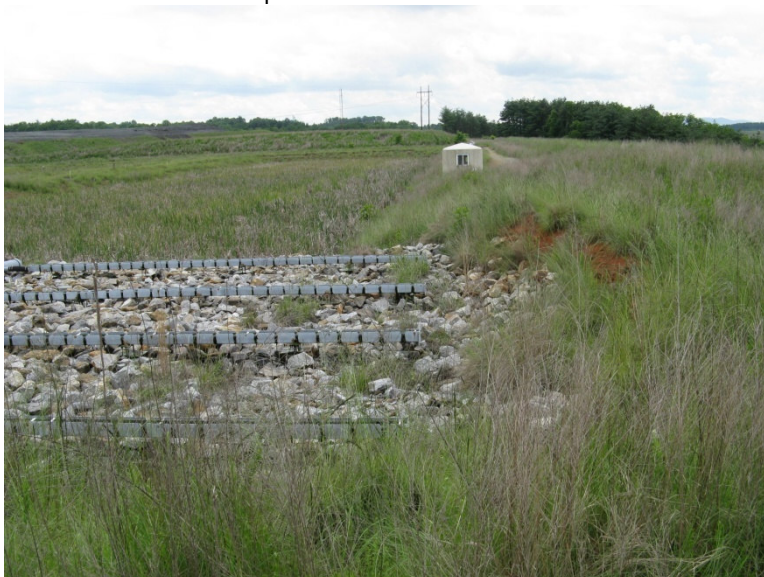
Photo 2: 1964 Dam - Upstream Wetland, Crest, Photo: 053, 5/29/09

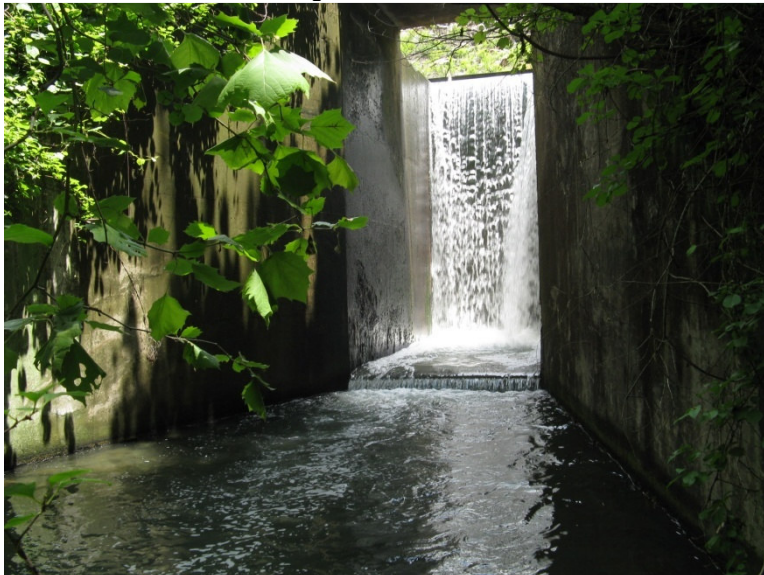
Photo 8: 1964 Dam - 60" CMP Underneath I-26, Toe, Photo: 087, 5/29/09

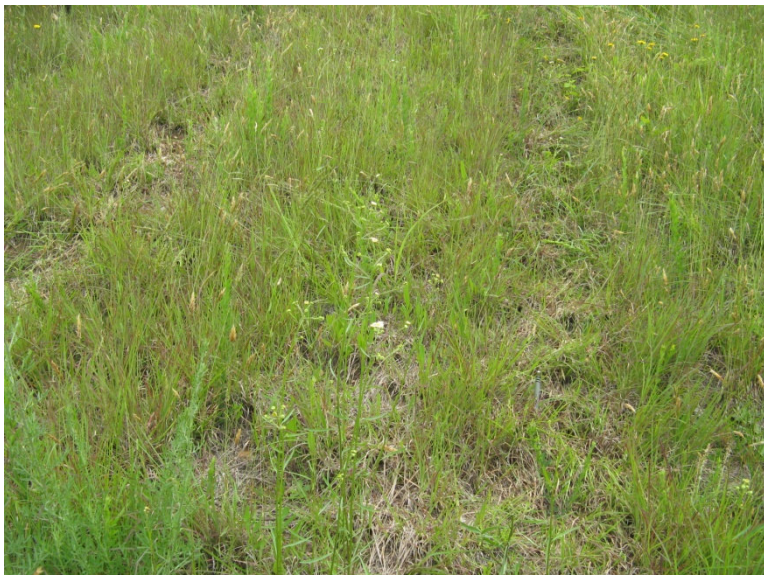
Photo 18: 1982 Dam – Minor Rill Erosion, Downstream Embankment, Photo: 033, 5/29/09
