# Assessment of Dam Safety Coal Combustion Surface Impoundments Draft Report

Progress Energy  
Carolinas  
Cape Fear Plant

Moncure, North Carolina

July 17, 2009

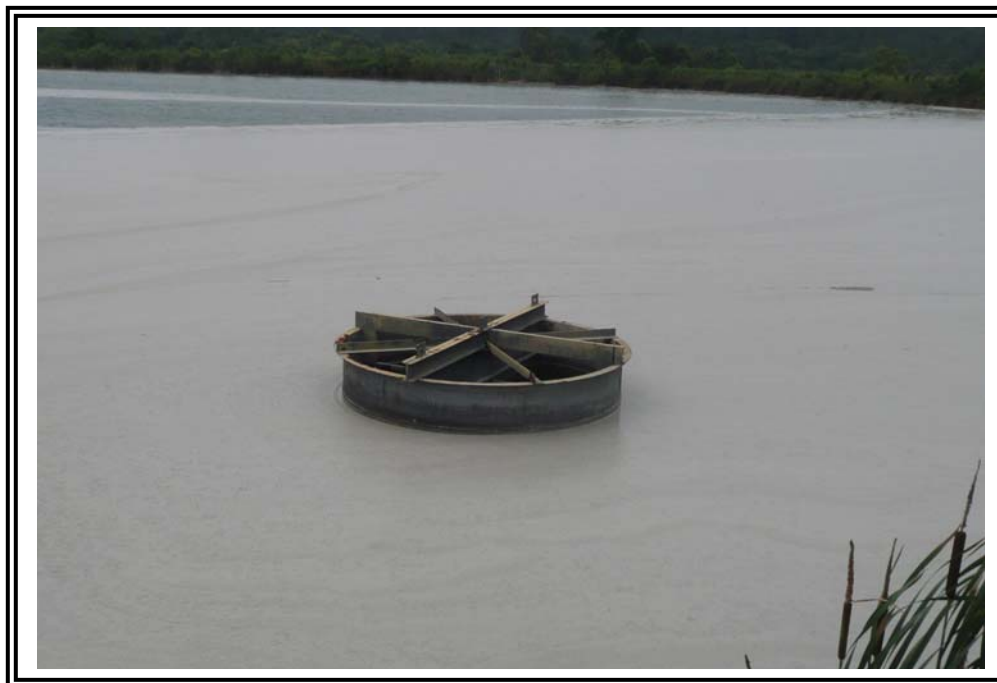
30

Outlet structure in the 1985 Ash Pond.

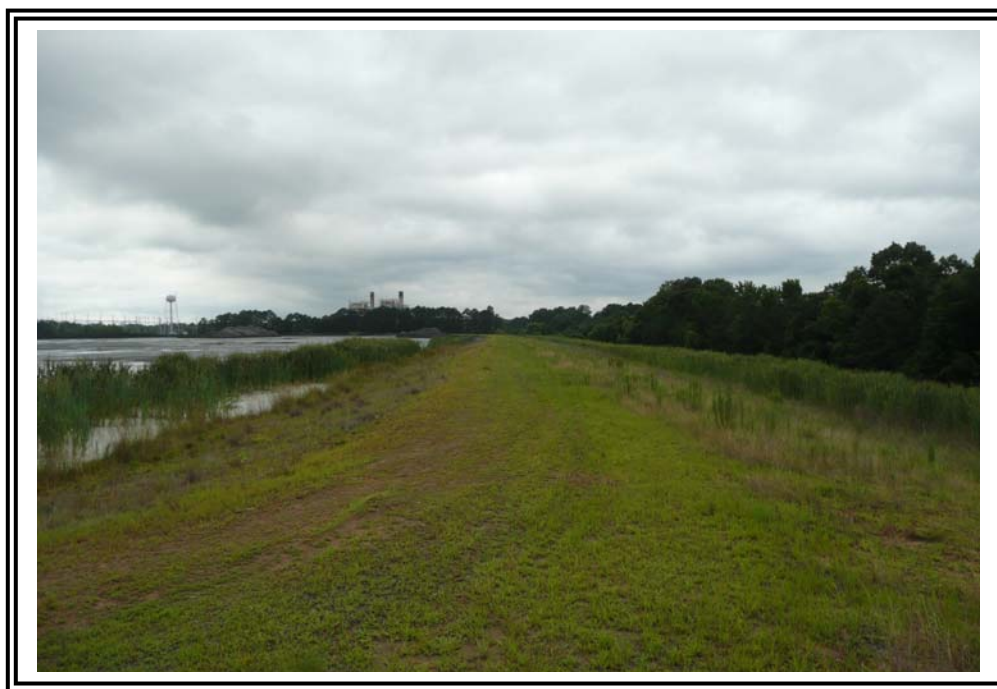
39

North Dike of "Pond within a pond" crest. Notice ash stockpiles within the pond.

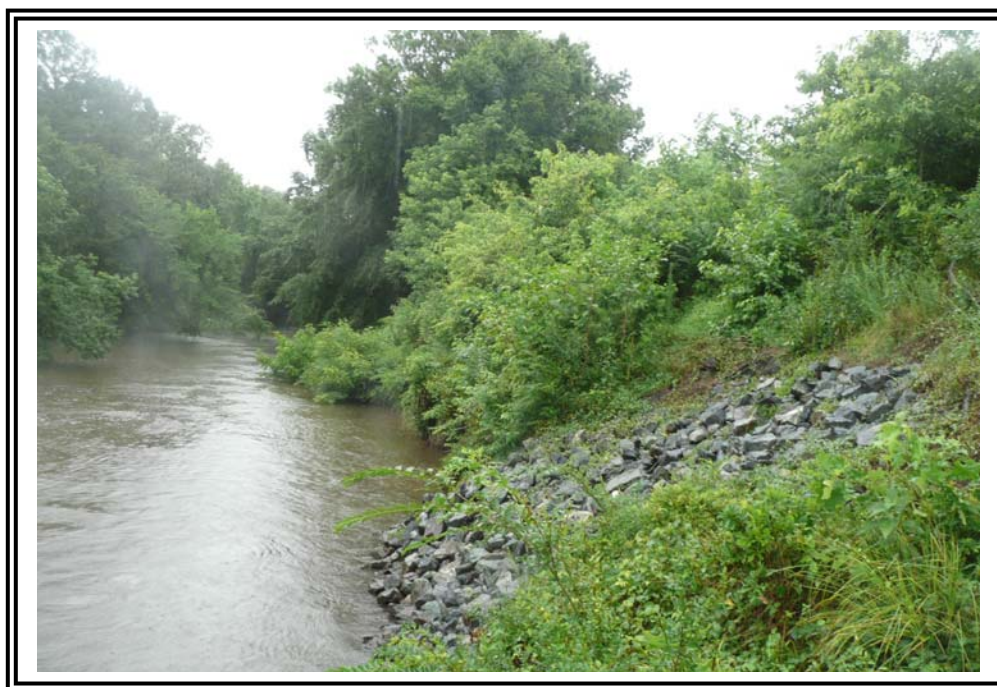
47

Rip Rap fill at the toe of the 1978 Ash Pond Dike along the discharge canal.

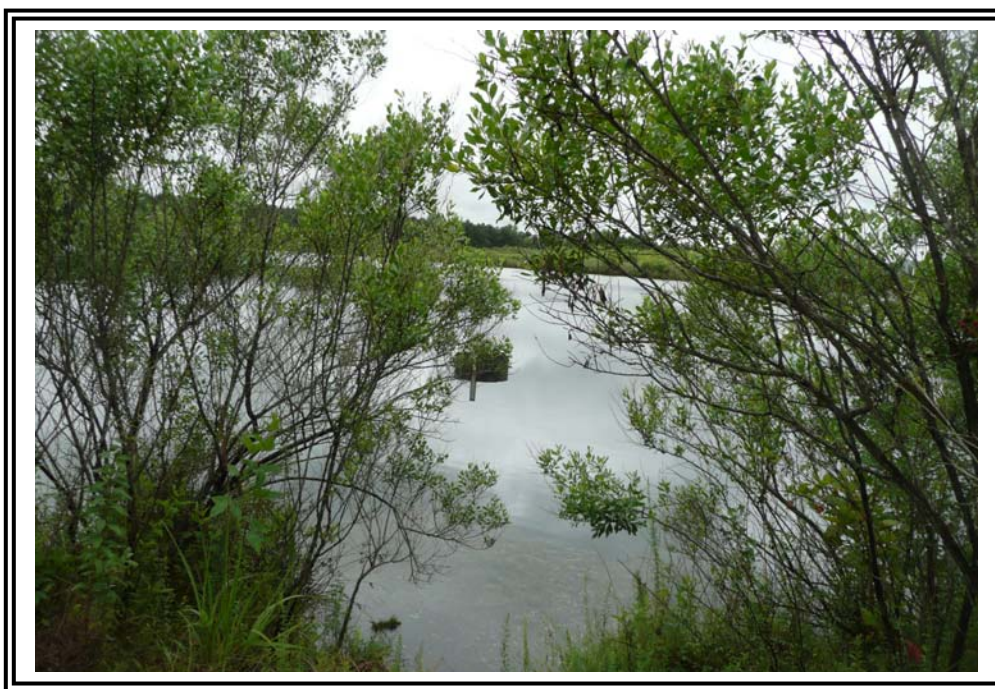
57

Outlet structure in 1978 Ash Pond.

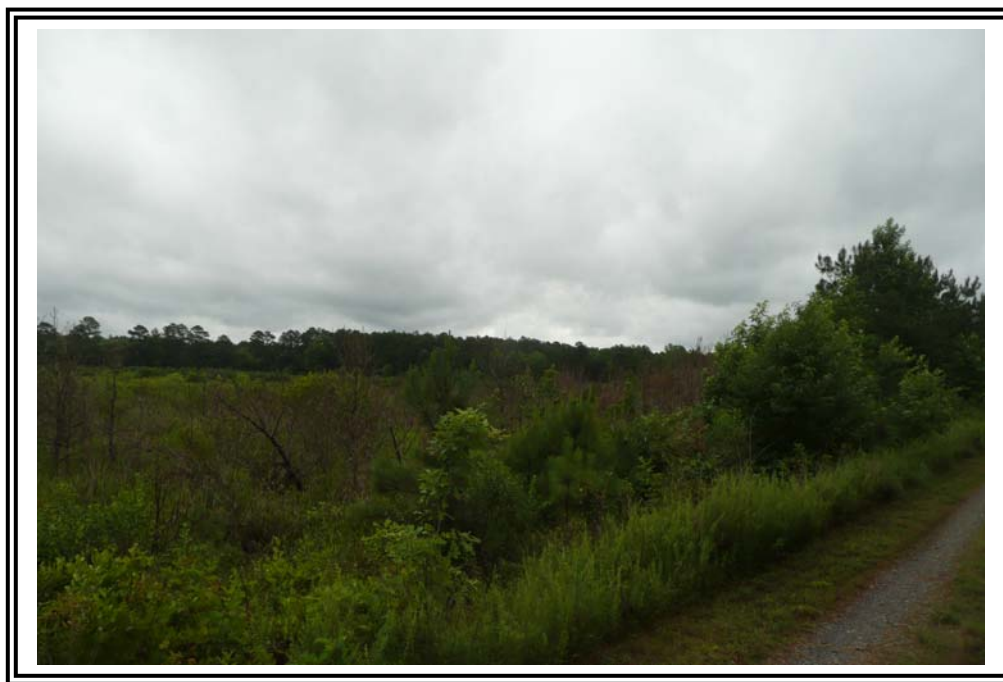
66

1978 Ash Pond From west dike looking southeast.

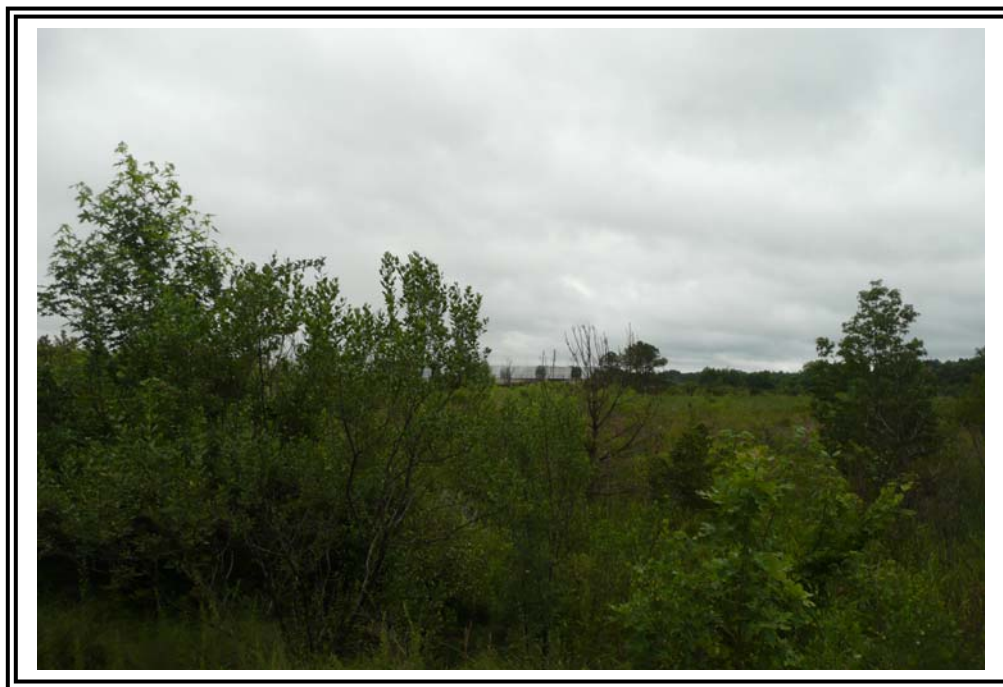
67

1978 Ash Pond from west dike looking east.

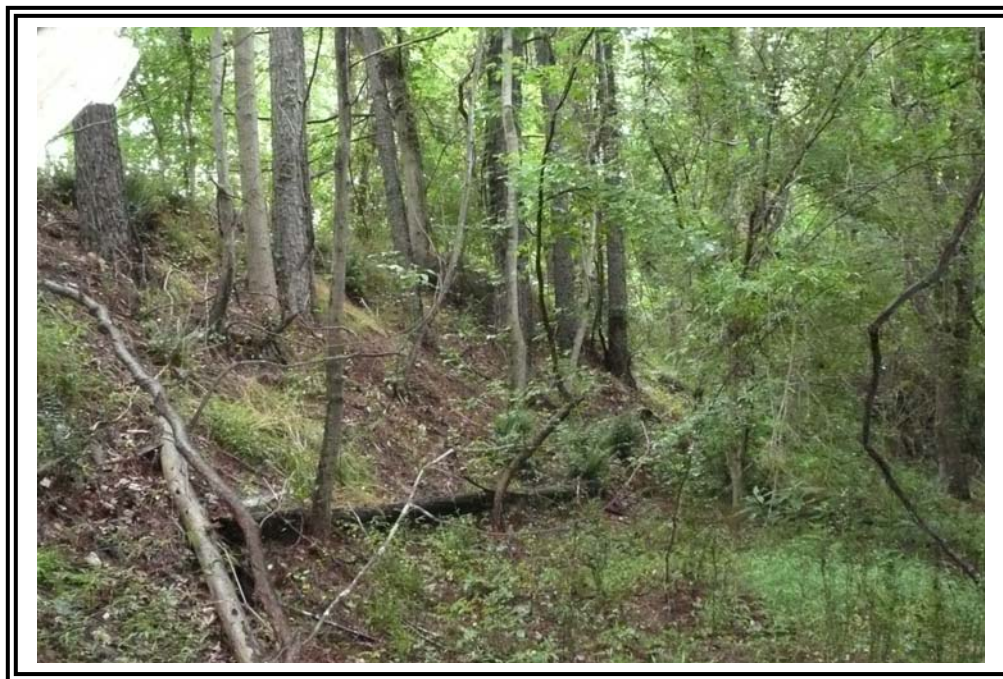
76

1970 Ash Pond downstream slope near southwest corner.

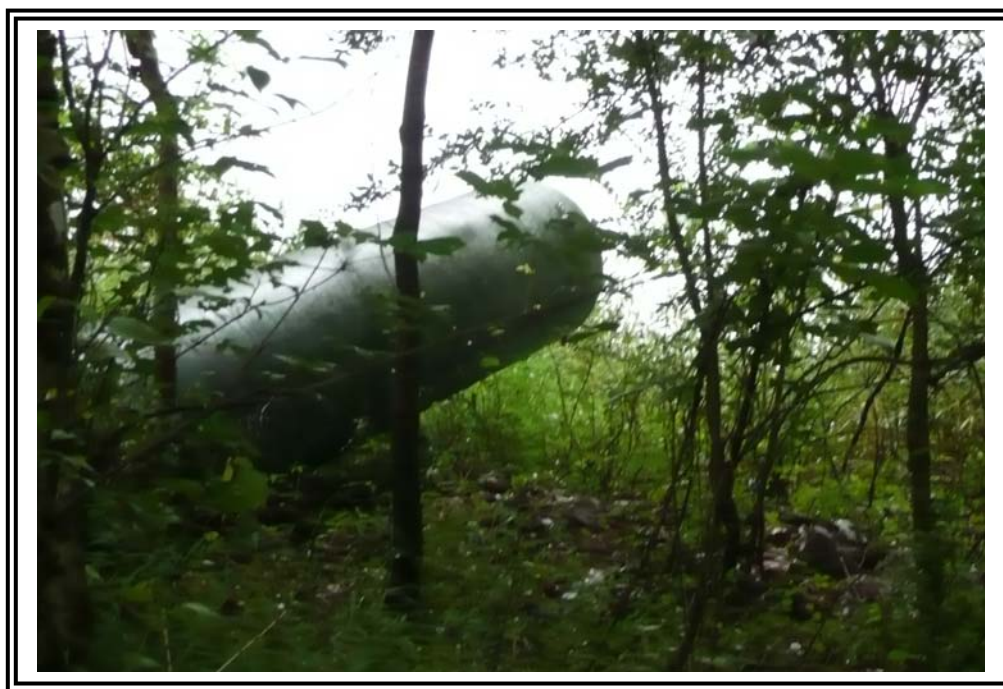
79

Downstream end of 1970 Ash Pond outlet.

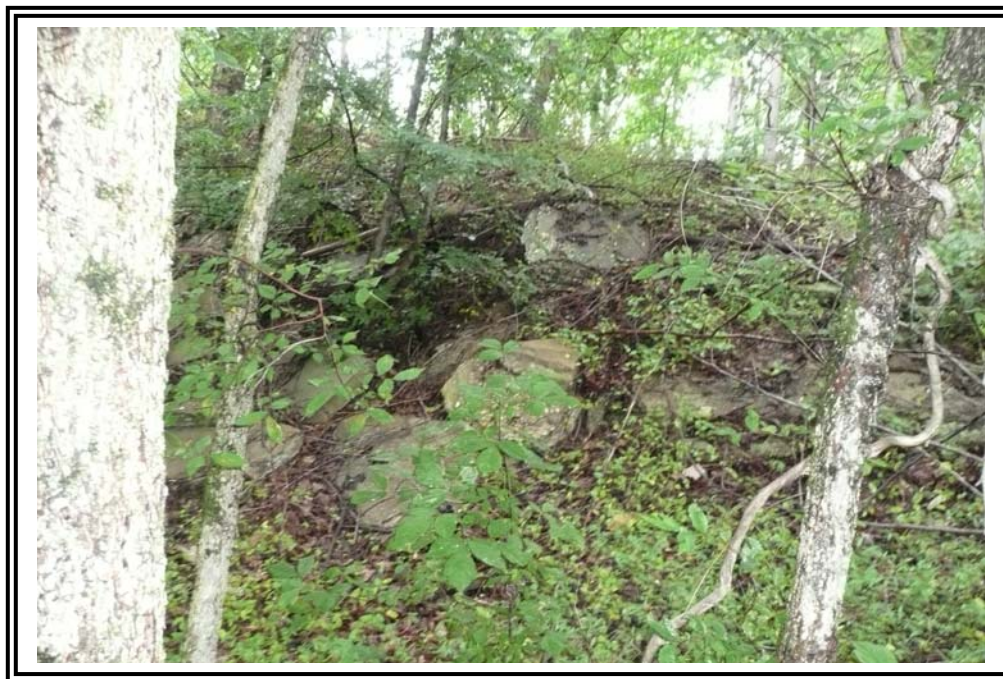
80

1970 Ash Pond downstream slope near outlet structure..

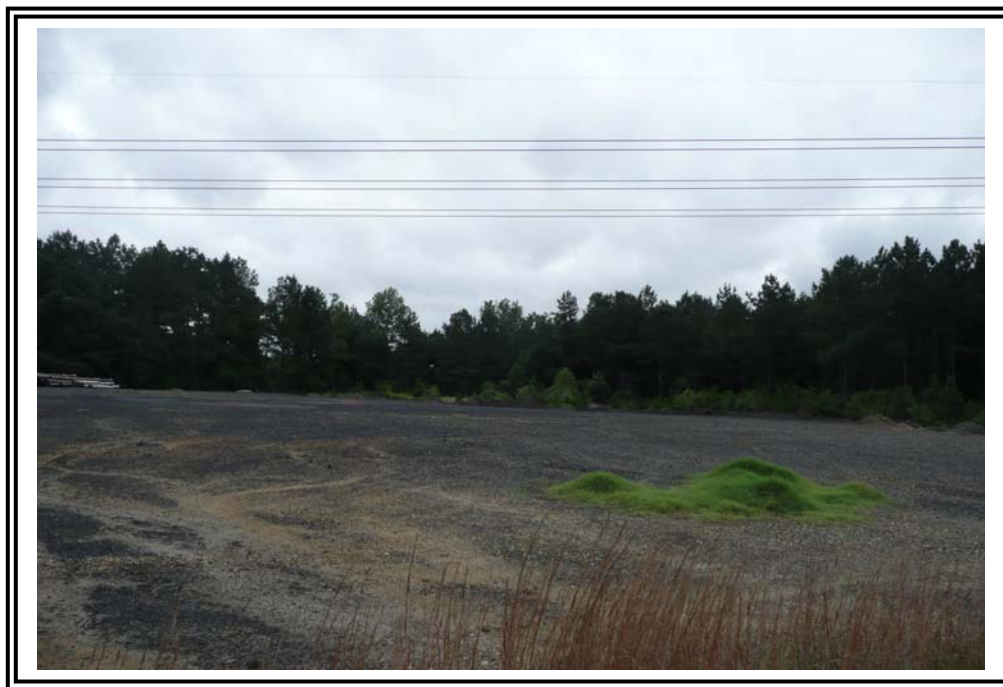
91

North end of 1963 Ash Pond.

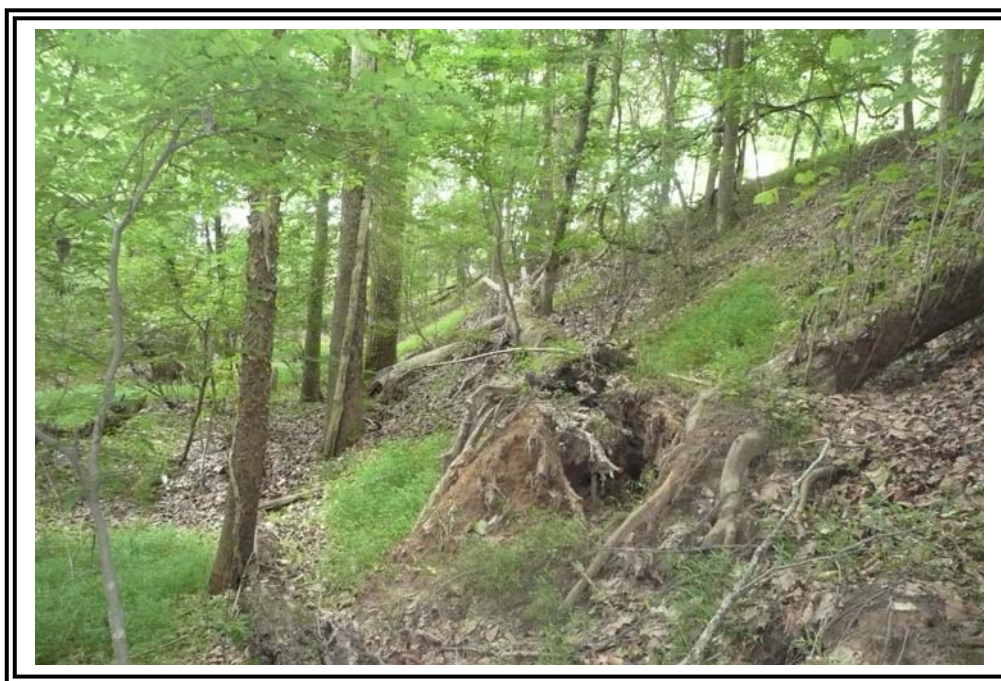
101

Uprooted tree on the 1956 Ash Pond Dike.

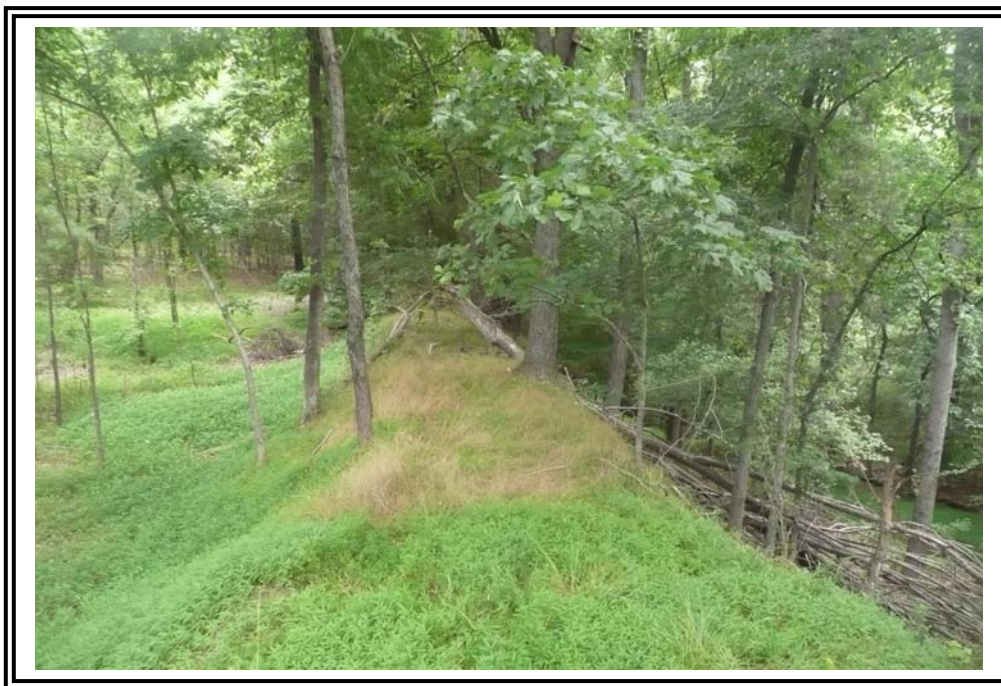
104

Crest of the 1956 Ash Pond Dike.

Note: Some areas the ash surface inside the pond was approximately equal to the top of the Dike.
