Coal Combustion Residue Impoundment

Round 9 - Dam Assessment Report

L.V. Sutton Steam Electric Plant

Ash Ponds

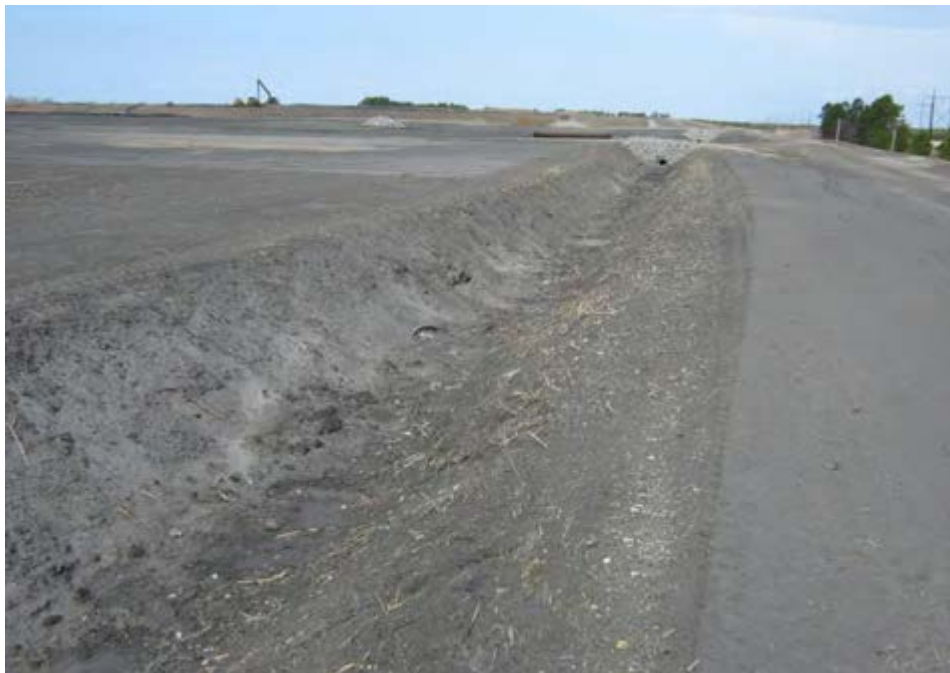
The upstream/inside slopes were not vegetated in many areas. Progress Energy had performed some work within the pond and stated they would be seeding when the weather was appropriate.

Upstream slopes to be vegetated, Spring 2011

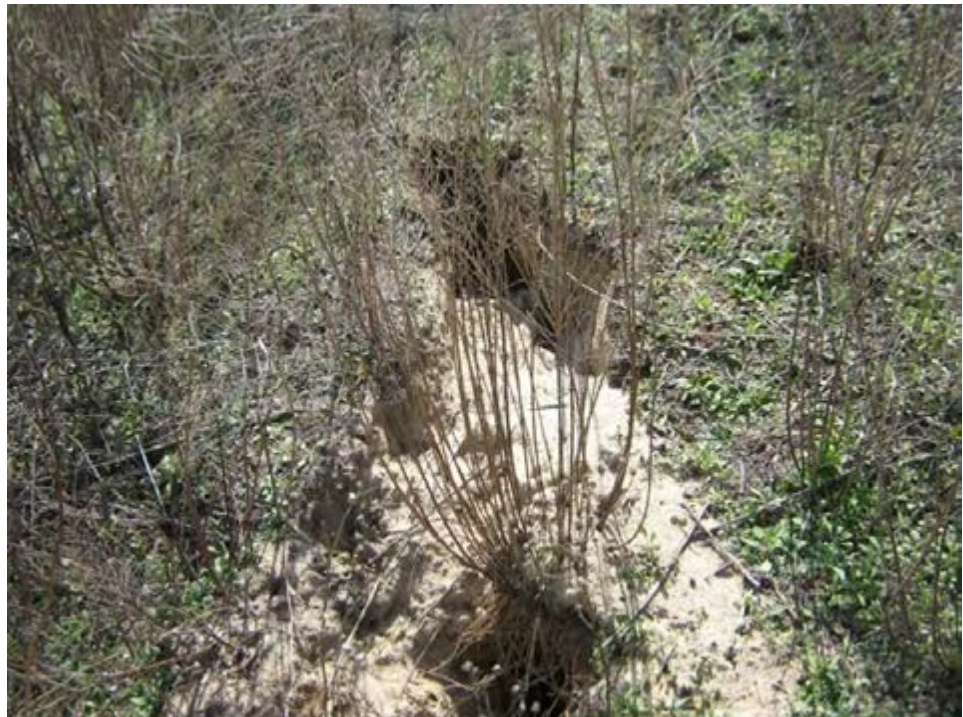
There were no signs of surficial sloughing along the downstream slope. Rill erosion and animal burrows were found in multiple places along the embankment. There were also areas that were bare and need to be seeded.

Animal burrows along downstream slope, 1984 Ash Pond

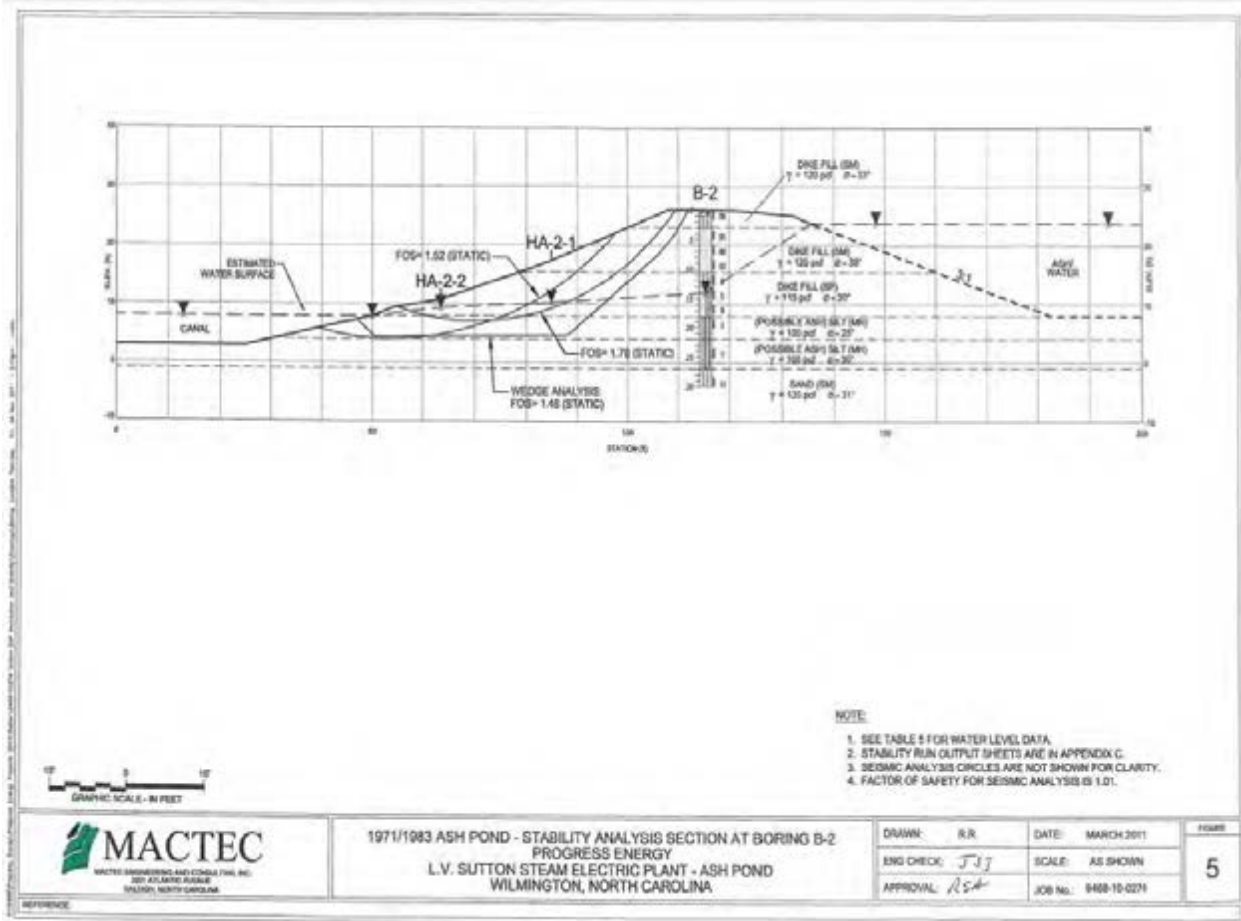
Figure 7.1.2a: 1971 Ash Pond – Typical Stability Analysis Section (B-2)

Structural stability documentation is adequate; however, we would recommend further evaluating 1971 Pond - Section B-2 and developing a plan of action to increase factors of safety to meet or exceed minimum applicable standards.

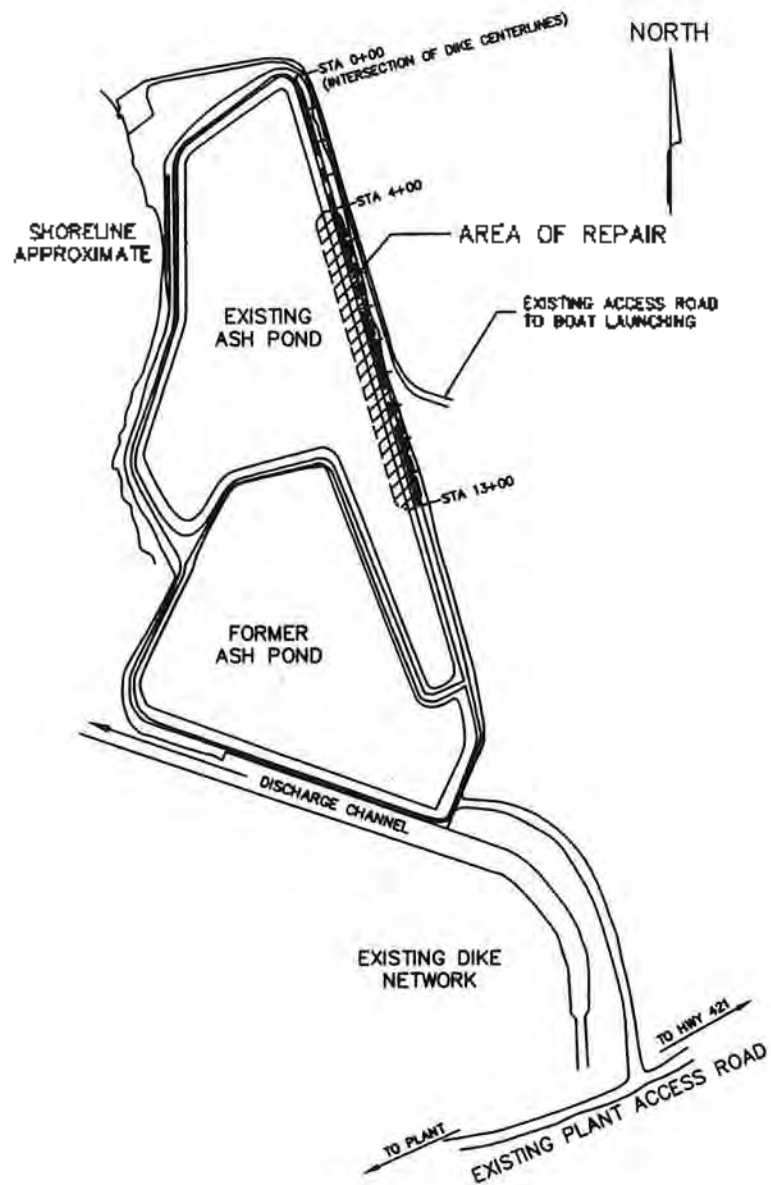
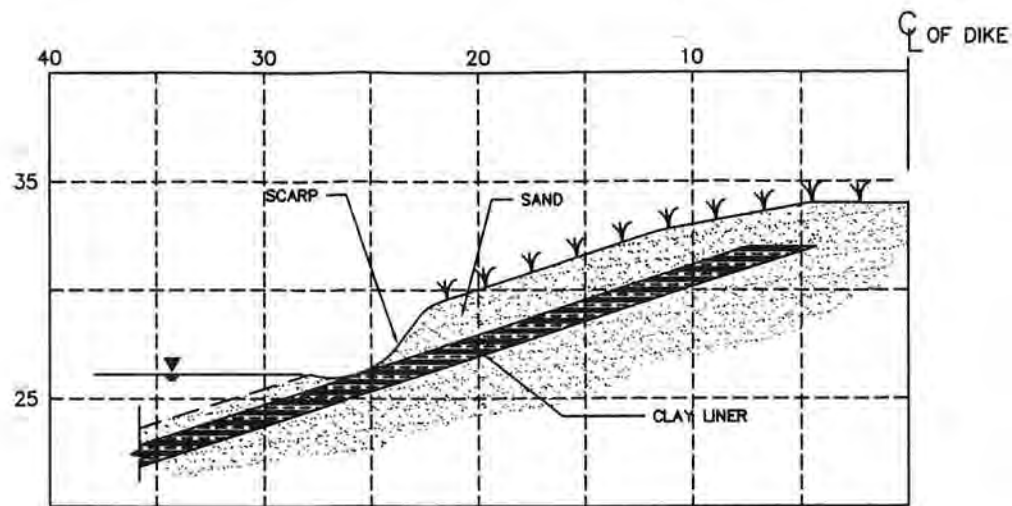
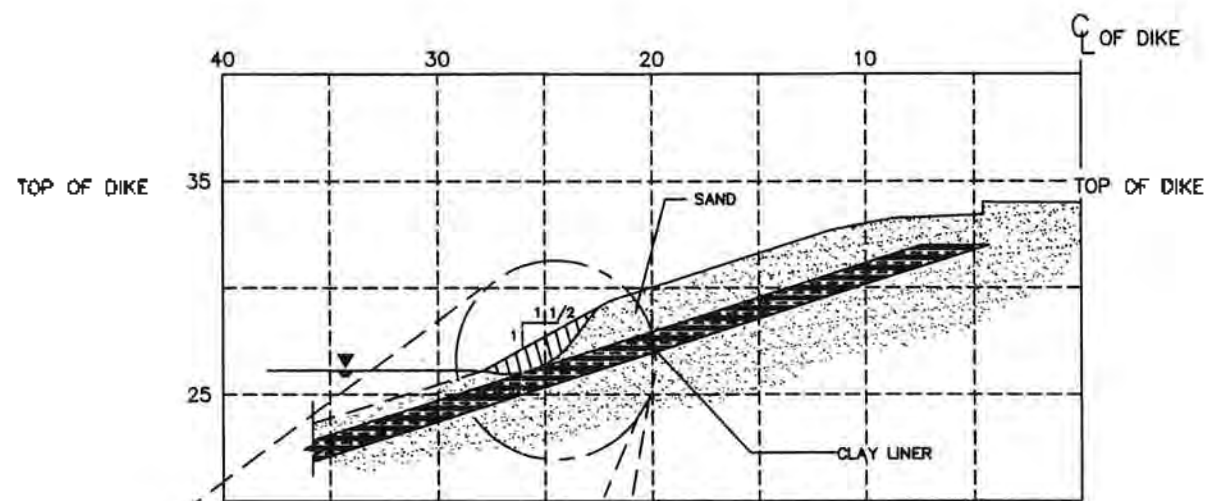
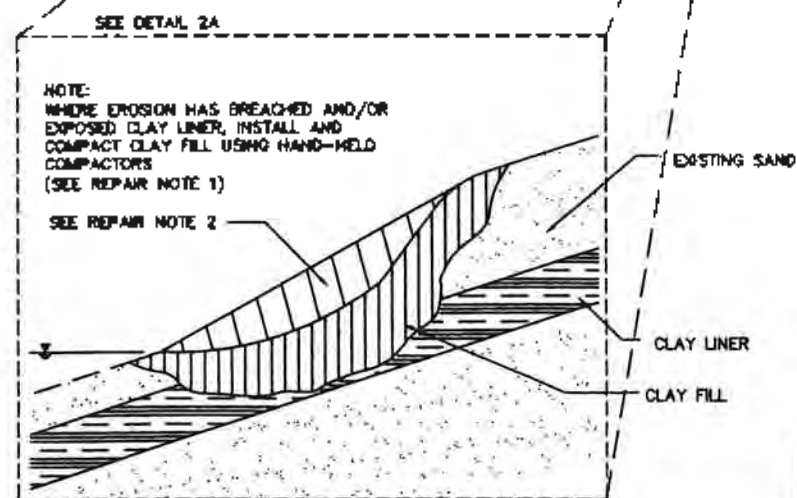
CLAY LINER REPAIR PLAN
ASH POND DIKE INTERIOR SLOPE
SUTTON PLANT - CP&L
WILMINGTON, NORTH CAROLINA

REPAIR LOCATIONS TABLE	
STATION	
5+45 TO 5+90	
6+30* TO 11+10*	
11+35 TO 11+70

Scope of work consists of preparation for and spot repairs to clay liner erosion of the west face of the east dike in the area shown.

- 1) Repair clay liner at locations where erosion has exposed clay. Scarify existing clay material and compact additional clay soil (USCS classification CL or CH) using hand-held compactors to at least 83 percent of standard Proctor maximum dry density, to achieve a minimum thickness of 12 inches (measured perpendicular to slope).
- 2) Use additional compacted clay to restore approximate original slope in repair areas.
- 3) Seeding of upper part of slope and repaired areas will be done by others after repairs are completed.

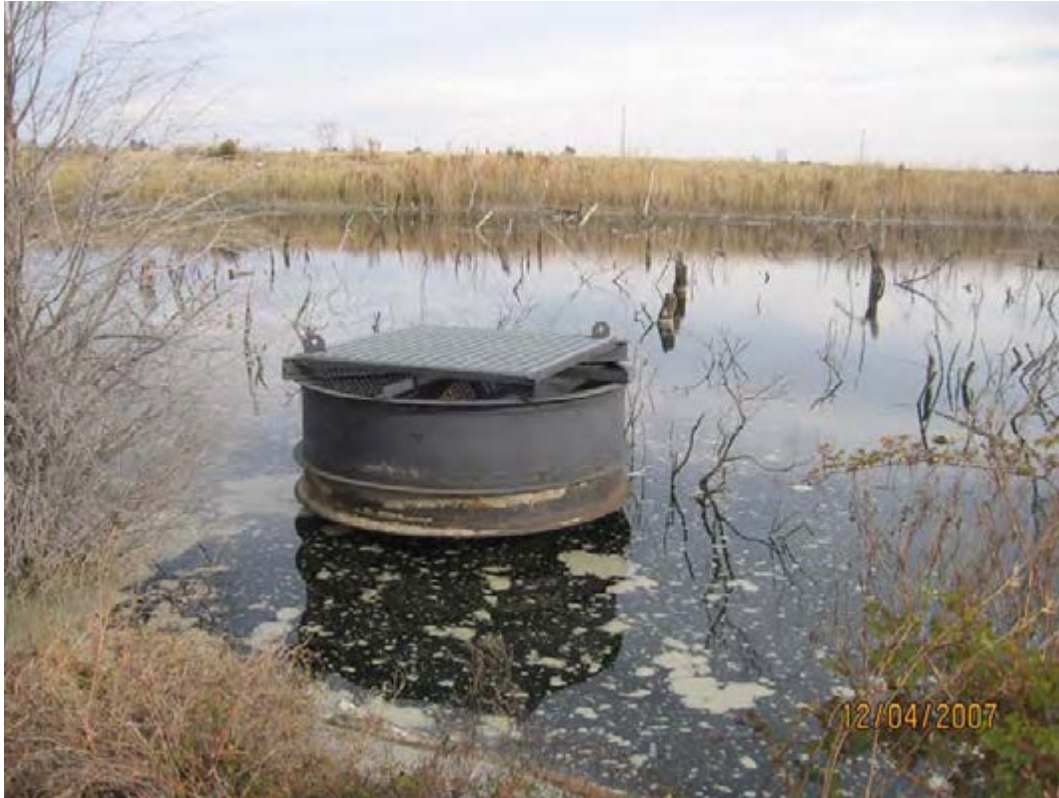
Photo 1. 1983 Ash Pond – Outlet riser and pond water.

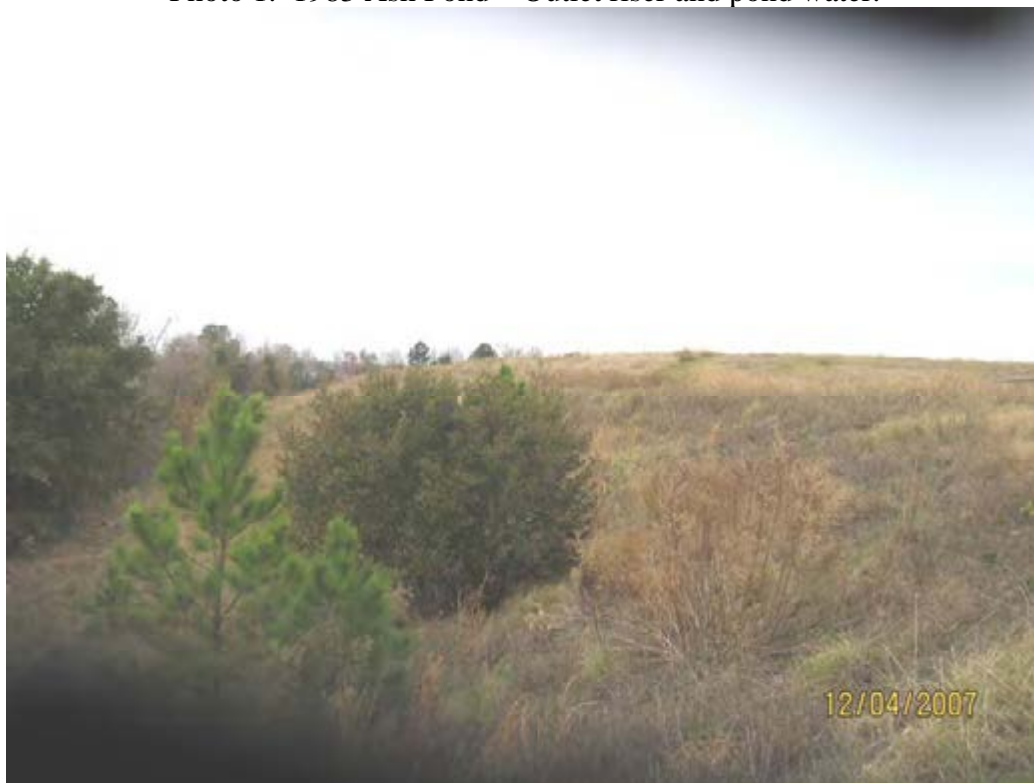
Photo 2. 1984 Ash Pond – Exterior Slope looking northwest.

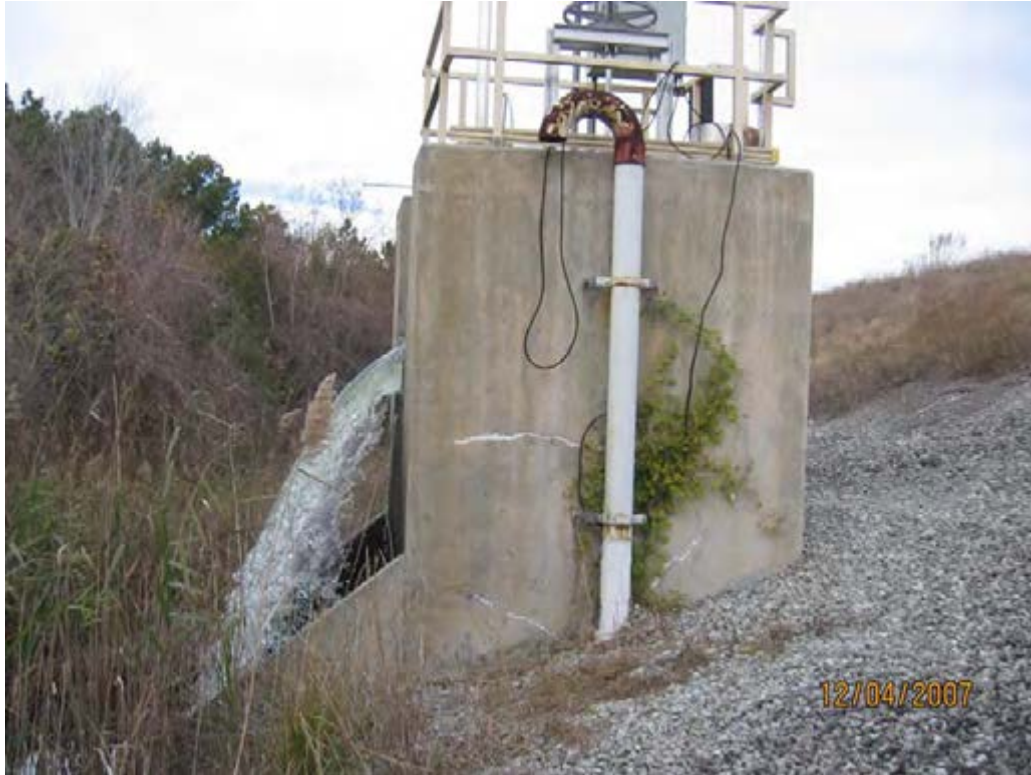
cracks were seen on the west side of this structure, near the base, with minor efflorescence (Photograph 7). These have been observed previously, are not unusual and pose no concern.

Photo 7. Ash Pond – Outlet drainage Structure looking northwest.

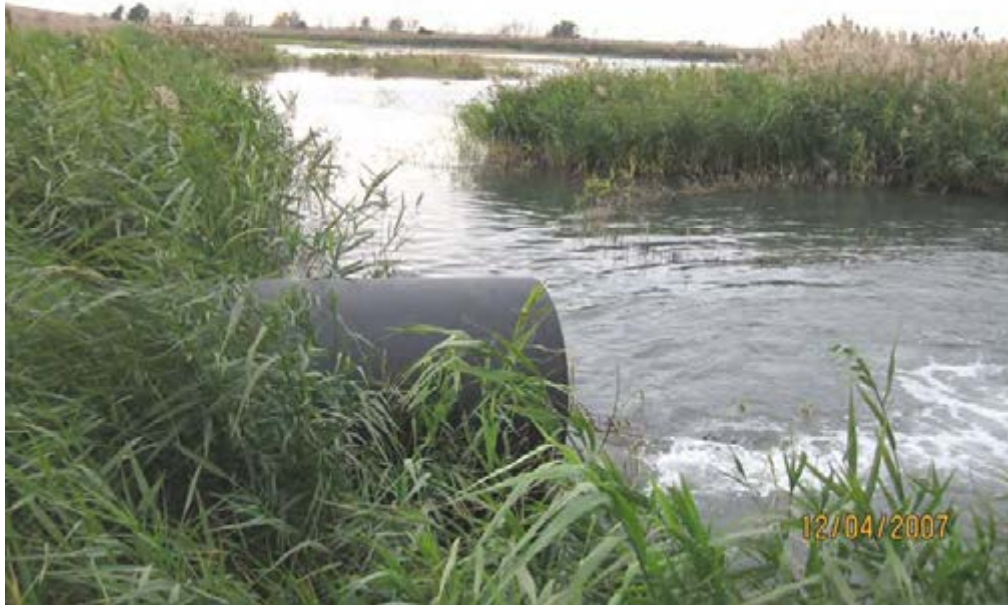
Photo 9. 2006 Outlet Pipe draining into 1984 pond.

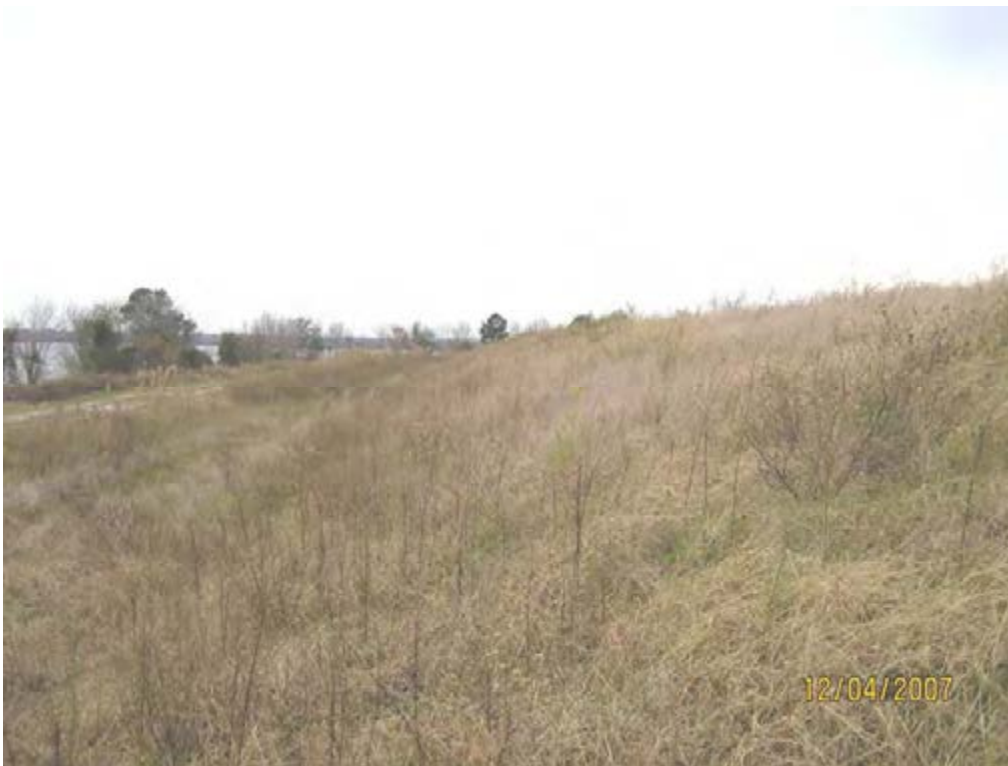
The exterior slope has exposed fly ash with sparse to good grass cover (Photographs 3 and 10). Erosion control netting is present on the slope. MACTEC observed several areas along the top of the stability berm on the north dike where circular depressions about one to four inches deep and about one to three feet in diameter were present (Photograph 11). Discussions with Mr. Alderman indicate these areas are the result of filling in erosion rills that developed in the fly ash slope. These areas are filled by Progress Energy as they are noted. We recommend such areas be checked during each monthly inspection and their positions marked with flags so they can continue to be filled. We interpret these depressions as due to infiltration of surface water and not due to subsurface piping. Also, along the toe of the stability berm slope in the general vicinity of the discharge structure, several local slumps with minor seepage or wet areas were observed (Photograph 12). Due to the width of the stability berm and the gentle slope, these local slumps do not represent an immediate concern. They should be marked and observed during monthly inspections for signs of increasing size or seepage flow.

Photo 10. Ash Pond –Typical exterior slopes of 2006 dike.

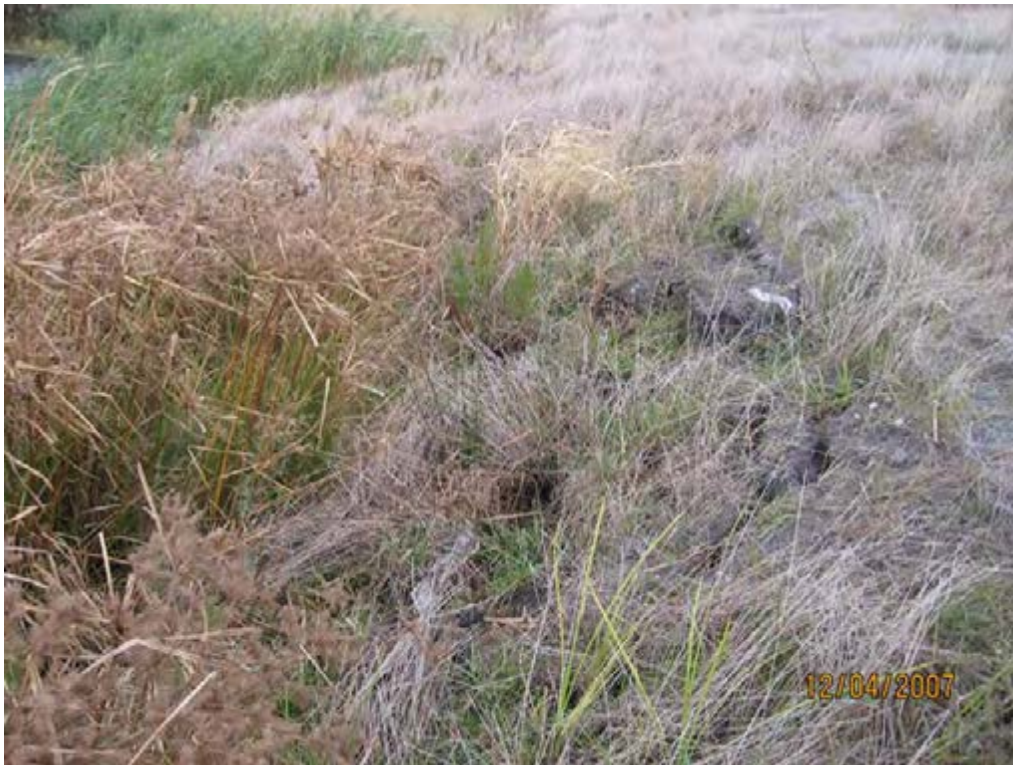
Photo 12. 2006 interior Ash Dike – Area of erosion of ash along exterior slope of dike.

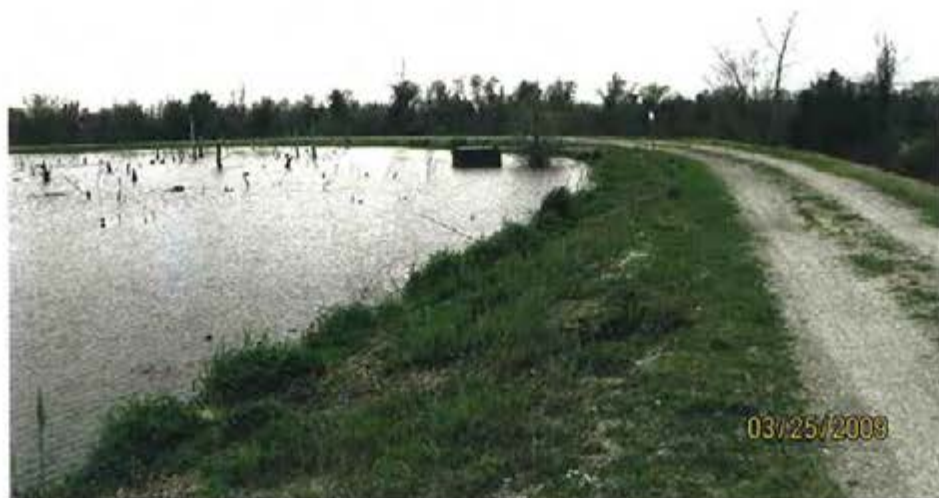
1. 1983 Ash Pond – View of interior slope, outlet riser and standing water near riser.

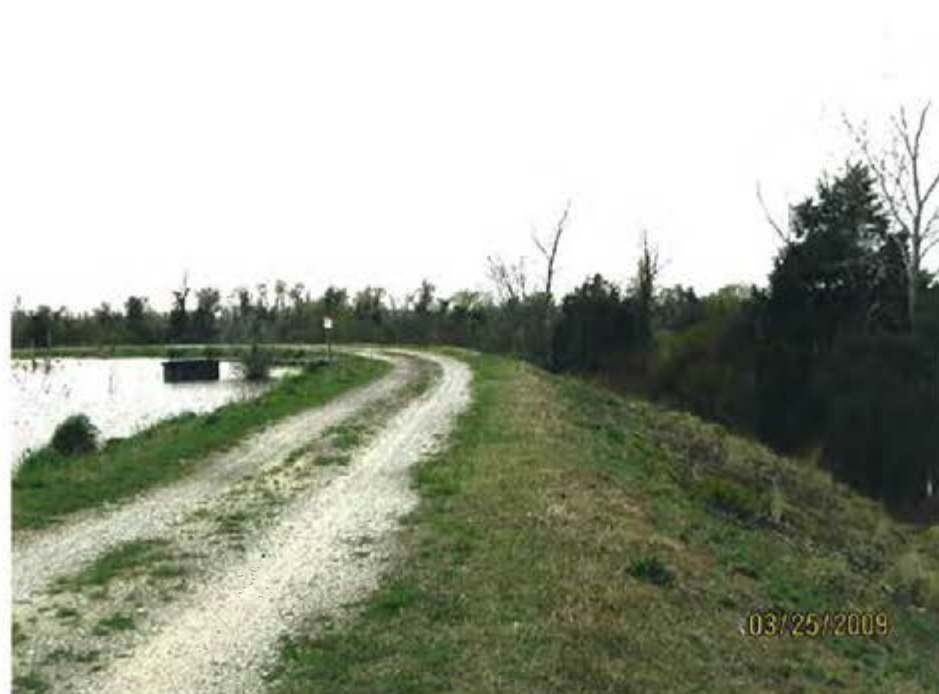
2. 1983 Ash Pond - View of dike exterior slope near outlet riser

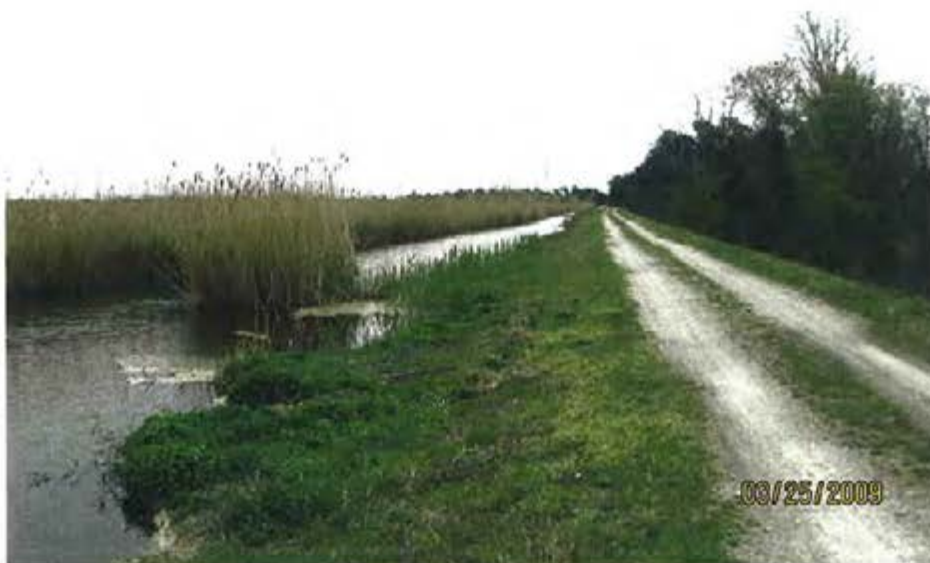
3. 1983 Ash Pond – View of crest, interior slope and standing water adjacent to discharge canal.

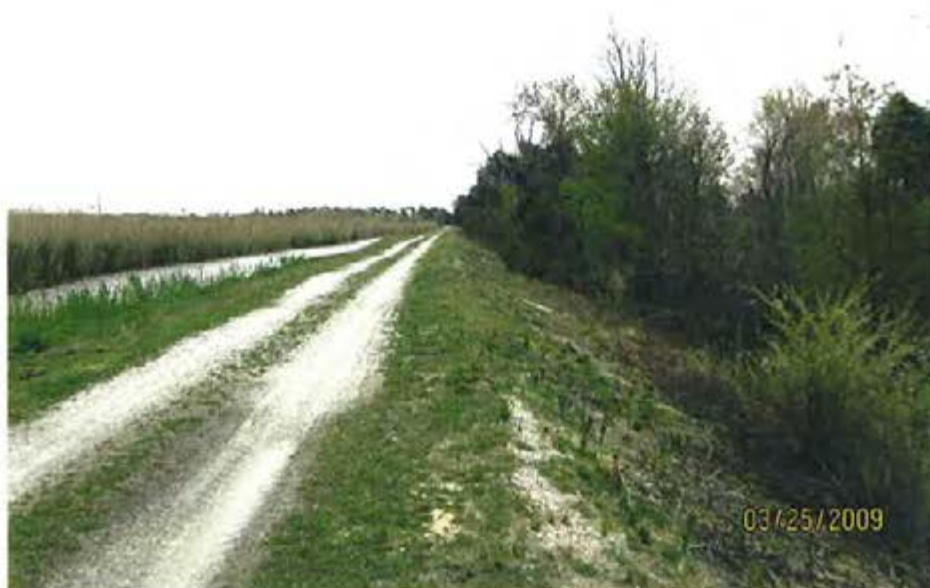
4. 1983 Ash Pond – View of crest and exterior slope adjacent to discharge canal.

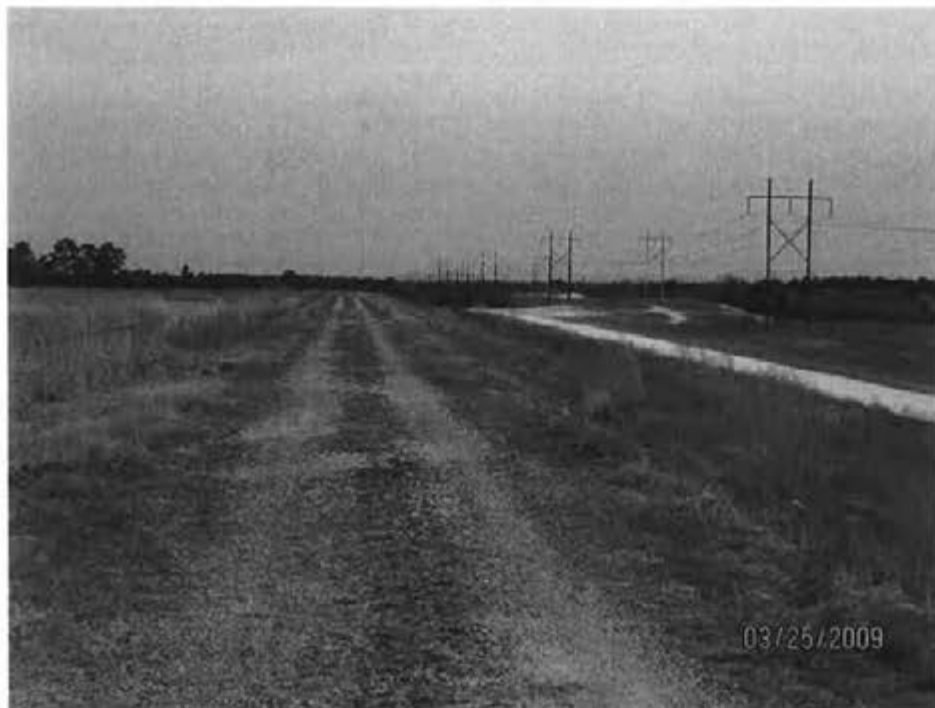
The dike crest appeared to generally be good condition with no signs of unusual settlement or displacement. (Photographs 5 and 6)

5. 1984 Ash Pond – View of dike crest and exterior slope east side of pond

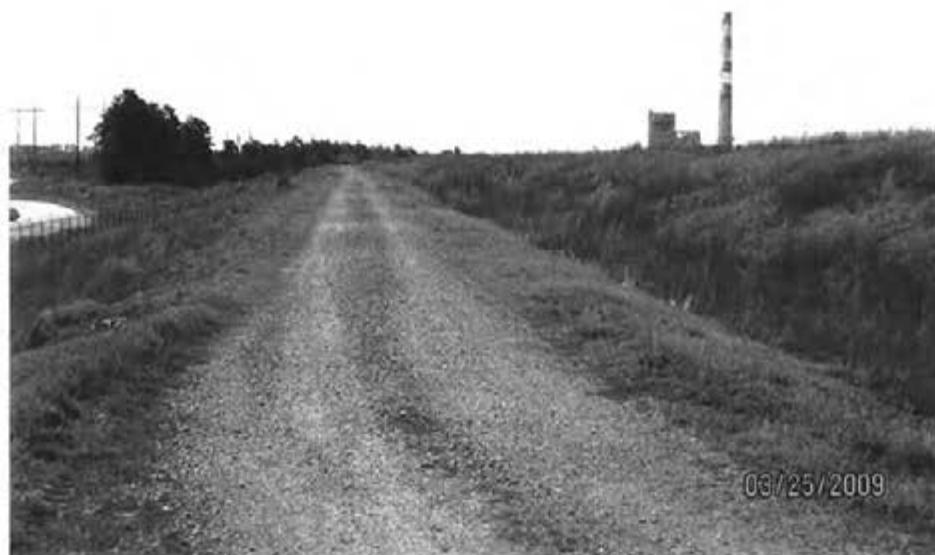
6. 1984 Ash Pond -- View of dike crest and exterior slope on east side of pond

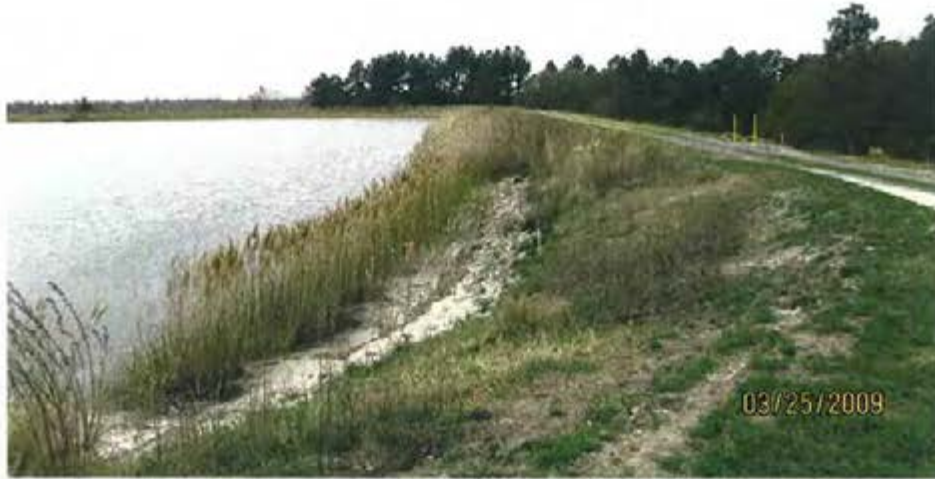
The interior slopes were heavily overgrown with tall grass along with patches of briars which limited inspection. Grass and briars are also becoming established in the riprap slope protection on the interior slope along the east side of the pond area (Photograph 7).

7. 1984 Ash Pond - View of riprap placed for interior slope on north side of pond.

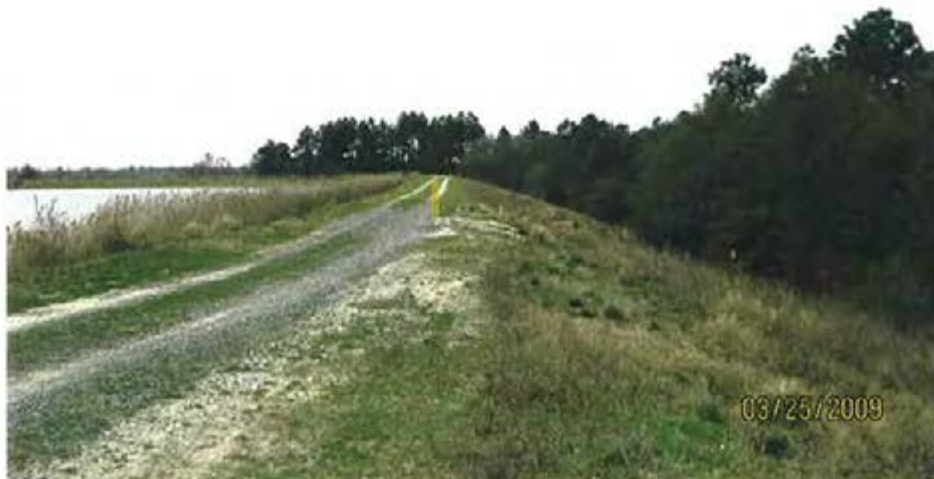
The exterior slopes of the dikes are moderately to well vegetated with grass along with some briars and small bushes (Photograph 8). For this inspection, most of the toe area was checked for seepage. All locations inspected along the toe appeared to be dry with no indication of seepage or slope stability problems. The upper portion of the dike slope near the crest appeared to have been mowed prior to the inspection.

8. 1984 Ash Pond – View of exterior slope on north side of pond.

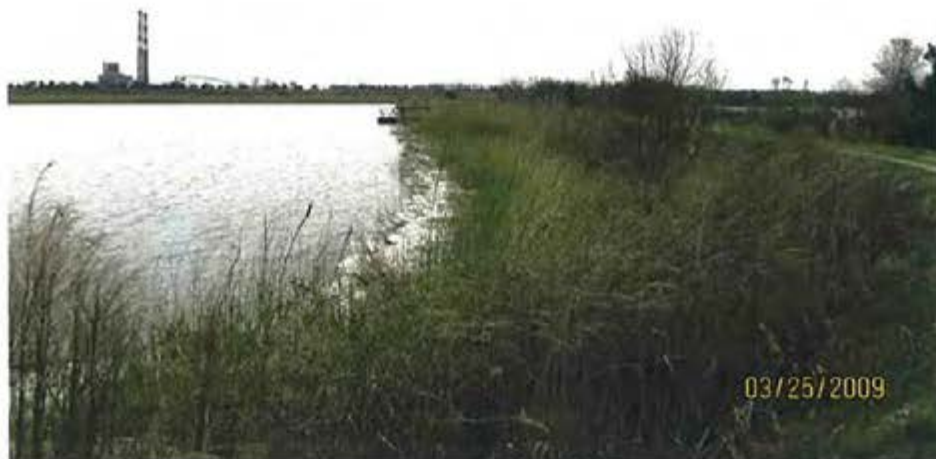
9. 1984 Ash Pond – View of interior slope of dike on west side of pond looking toward discharge riser.

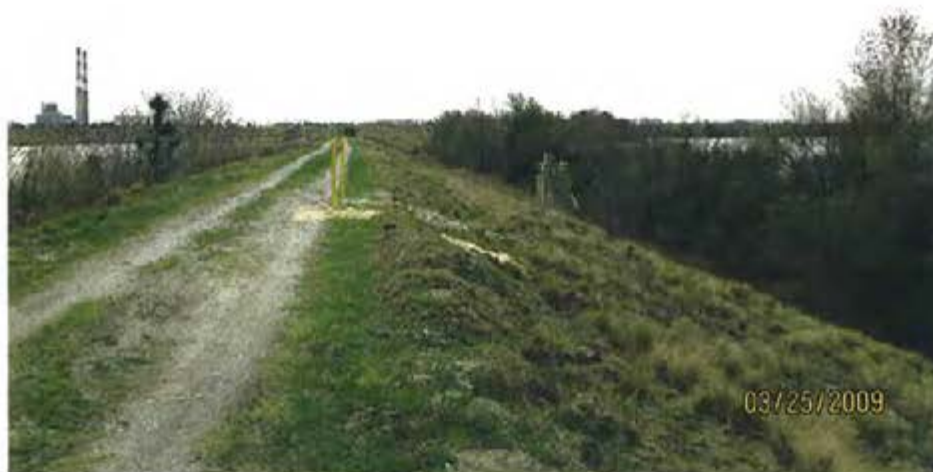
10. 1984 Ash Pond – View of exterior slope of dike on west side of pond looking toward outlet structure.

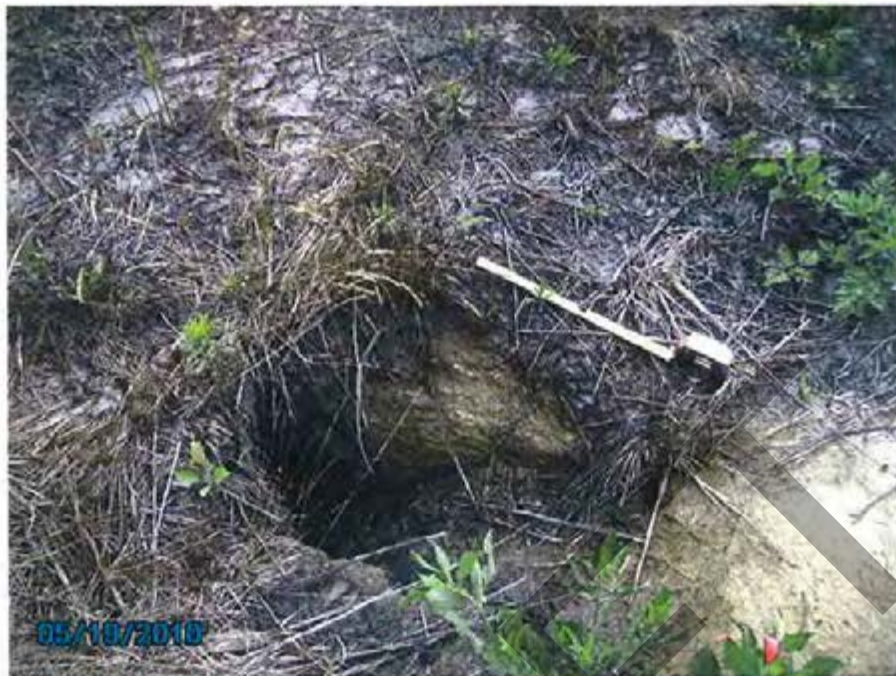
17. 1984 Ash Pond – View of animal burrow on the exterior slope for east dike (12 inch tape extension shown for scale).

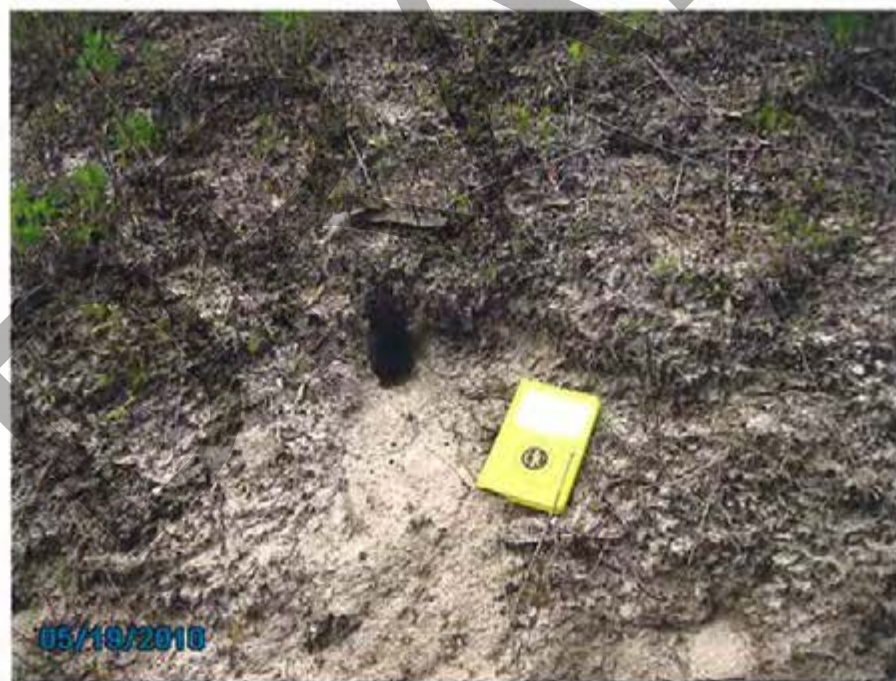
18. 1984 Ash Pond – View of animal burrow on the exterior slope for north dike (4" x 7" field book shown for scale).

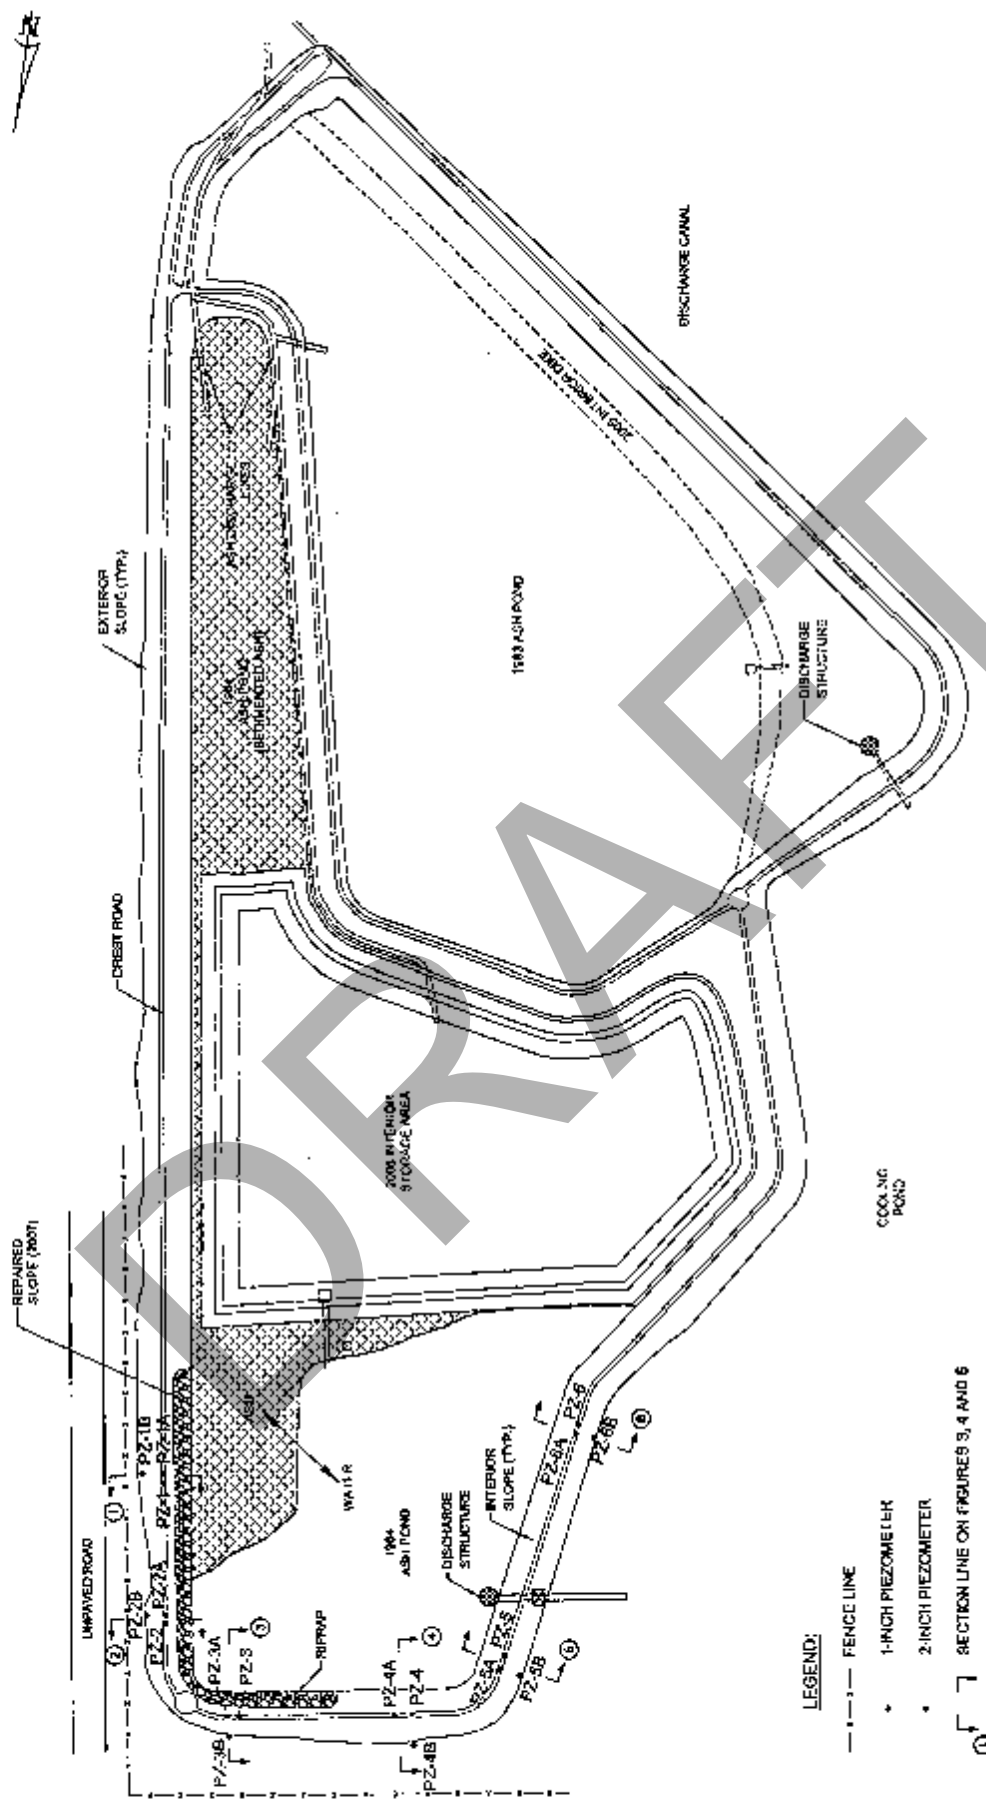
The field reconnaissance work did not find evidence of seepage emerging from the dike slopes and areas adjacent to the dike toe. MACTEC recommended that piezometers be installed to provide a means of checking for conditions at greater depths than could be reached with hand augers and a means of checking water level changes over time as related to pond level changes. The field exploration consisted of six penetrometer soundings along the crest of the dike with soil samples obtained using a lined tube sampler, six hand auger borings near the base of the dike, installation of six pairs of piezometers on the crest and six piezometers along the base at the boring locations. Two exploration points were located on each of the north, east and western portions of the dike. The boring locations were located in the field by MACTEC. Figure 1 in the Appendix shows the approximate boring and piezometer locations.

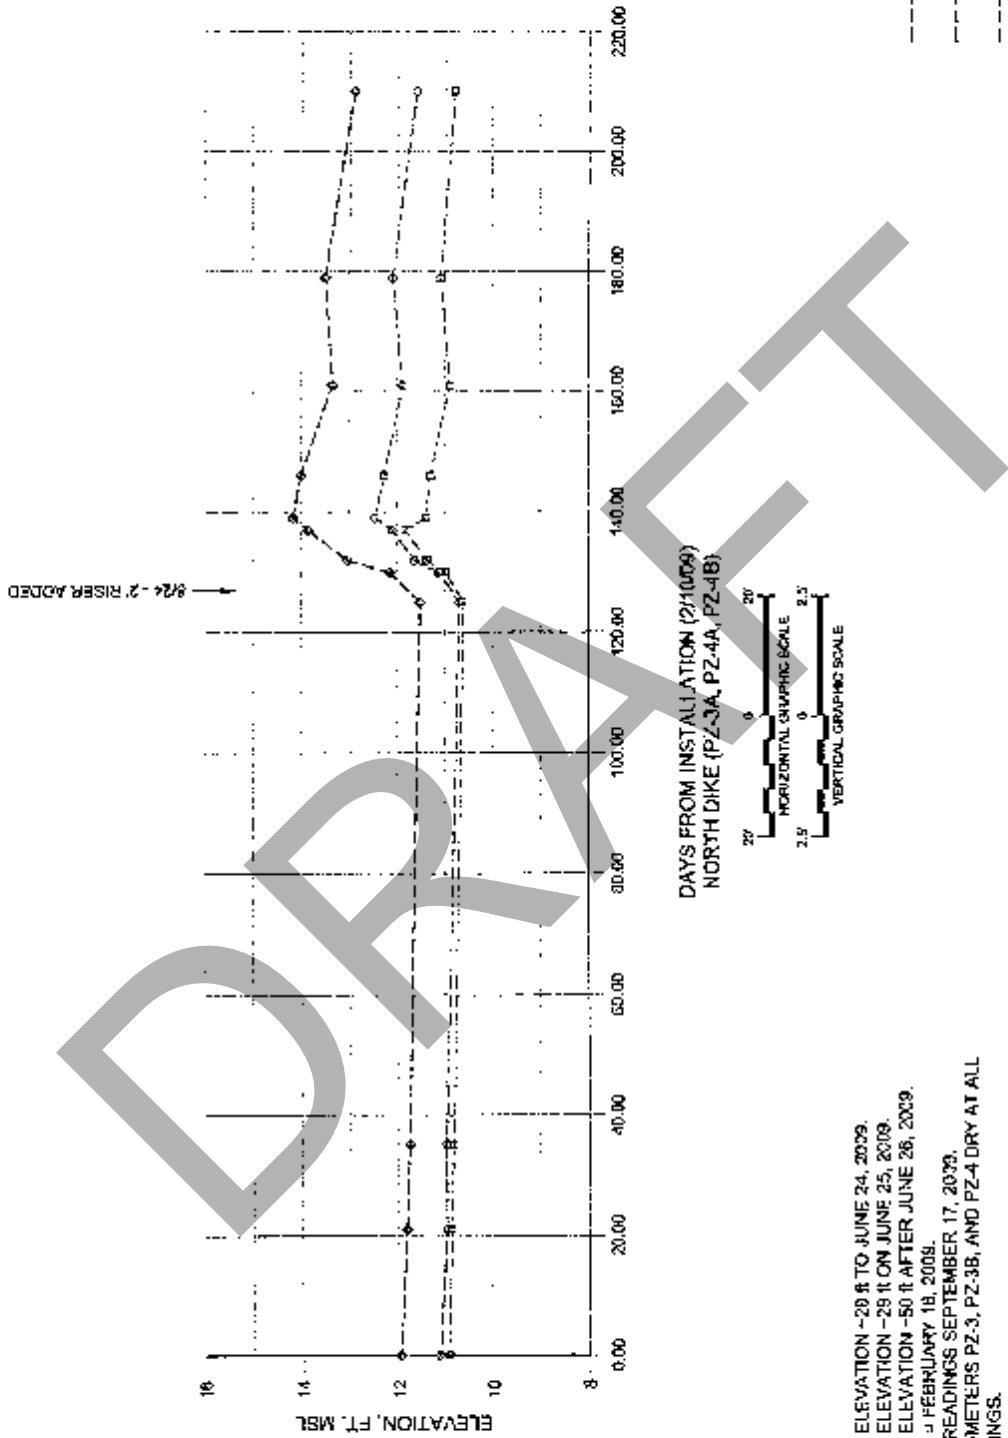
PIEZOMETER READINGS - NORTH DIKE
 1984 ASH POND DIKE
 L.V. SUTTON STEAM ELECTRIC PLANT
 WILMINGTON, NORTH CAROLINA

Figures 6, 7 and 8 show changes in the water level elevations over time. The piezometers were installed and initial readings taken about 25 days after the pond water level had been lowered from elevation 30 feet to elevation 28 feet, too late to observe changes related to the water lowering. Water levels observed in piezometers between February 18, 2009 through June 24, 2009, with the pond level at elevation 28 feet, showed a slight declining trend. During this time frame, the outflows from the upper pond and the outflows from the 1985 pond (clear pond) were similar. No water was found in the shallower piezometers installed on the dike crest. All but one of the piezometers installed at the dike toe had no measureable water. The single piezometer at the dike toe where water was found (on the north dike) was installed at a lower elevation than all other toe piezometers. The water level in that piezometer was below the ground surface elevation.

MACTEC interprets the changes in piezometer water levels as indicating a pressure connection between the water in the pond and the groundwater below the clay liner in the pond bottom. A pressure connection indicates that the clay liner is saturated, as would be expected due to its long period of submergence. The increase in pond water level causes a pressure increase at the top of the clay liner that is transmitted to the water below the liner. The natural soils below the clay liner are sands and these are continuous under the dikes. The sands have a relatively high permeability and can transmit the pressure increase out to the piezometer locations in the dike, causing their water levels to rise. The pressure increase does not indicate leakage in the clay liner, and the decrease in piezometer water levels over time indicates an adjustment of natural groundwater levels as the local pressure increase under the pond is dissipated out into the surrounding groundwater system.

MACTEC recommends that the piezometers be checked for water levels during regular dam safety inspections by independent inspectors. Additional readings should be made by plant personnel if unusual inflow/outflow patterns are seen or if the pond water level drops for no apparent reasons. If the level of the pond is to be changed by adding or removing a section of the discharge riser pipe, we recommend that piezometer readings be made at least twice in the week prior to the height change, daily for a week after the height change and monthly for three months. A similar pattern of water level changes in the piezometers as observed during the past water level increase would be expected.
