Coal Combustion Residue Impoundment

Round 9 - Dam Assessment Report

L.V. Sutton Steam Electric Plant

Ash Ponds

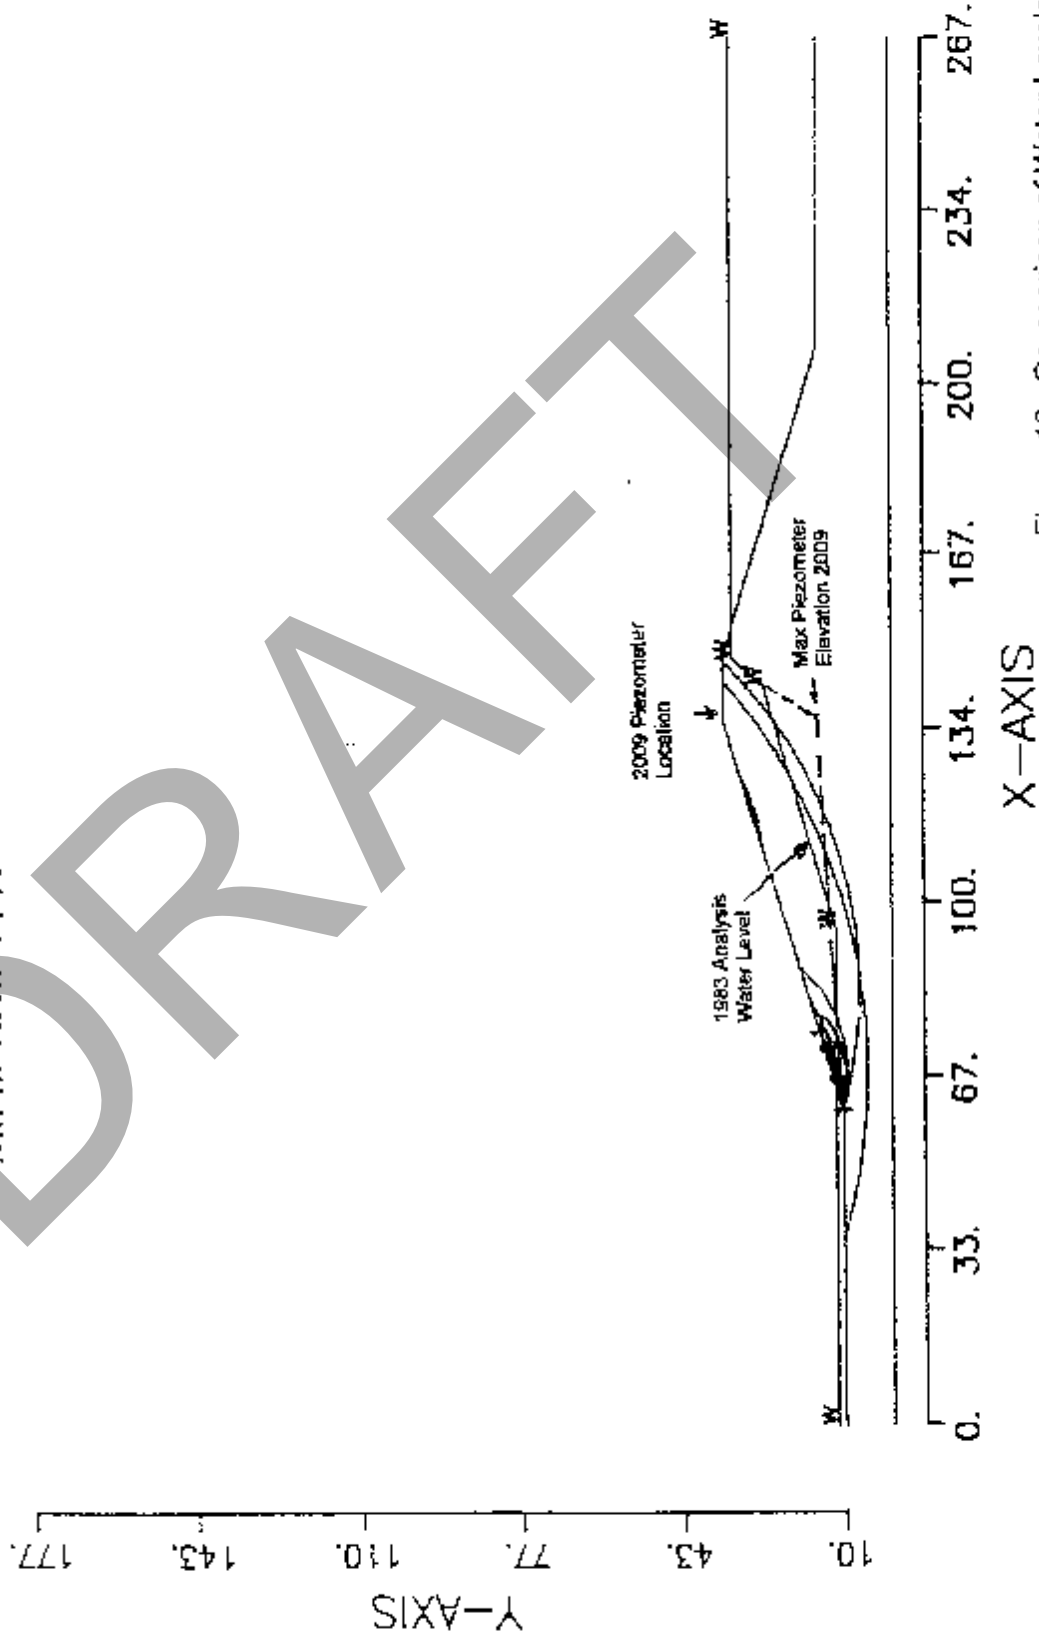
Figure 10. Comparison of Water Levels with Stability Analysis

Figure 10 shows a slope stability analysis cross section from the original dike design report. The water surface through the dike is shown. The maximum water level elevations from the piezometers were used to draw a current water surface through the dike (red line on Figure 10). The piezometer data show that the water level within the dike is lower than the water level used when the dike stability analyses were performed during the dike design. No seepage out of the dike at the toe or from the natural ground adjacent to the toe was indicated by the piezometers or by visual reconnaissance on several site visits. The recorded water levels, therefore, do not indicate that possible leakage through the clay liner on the dike slopes or through the clay liner on the pond bottom, if any, is causing a reduction in the dike stability.

100 SURFACES HAVE BEEN GENERATED
10 MOST CRITICAL OF SURFACES GENERATED
MINIMUM FACTOR OF SAFETY = 1.583

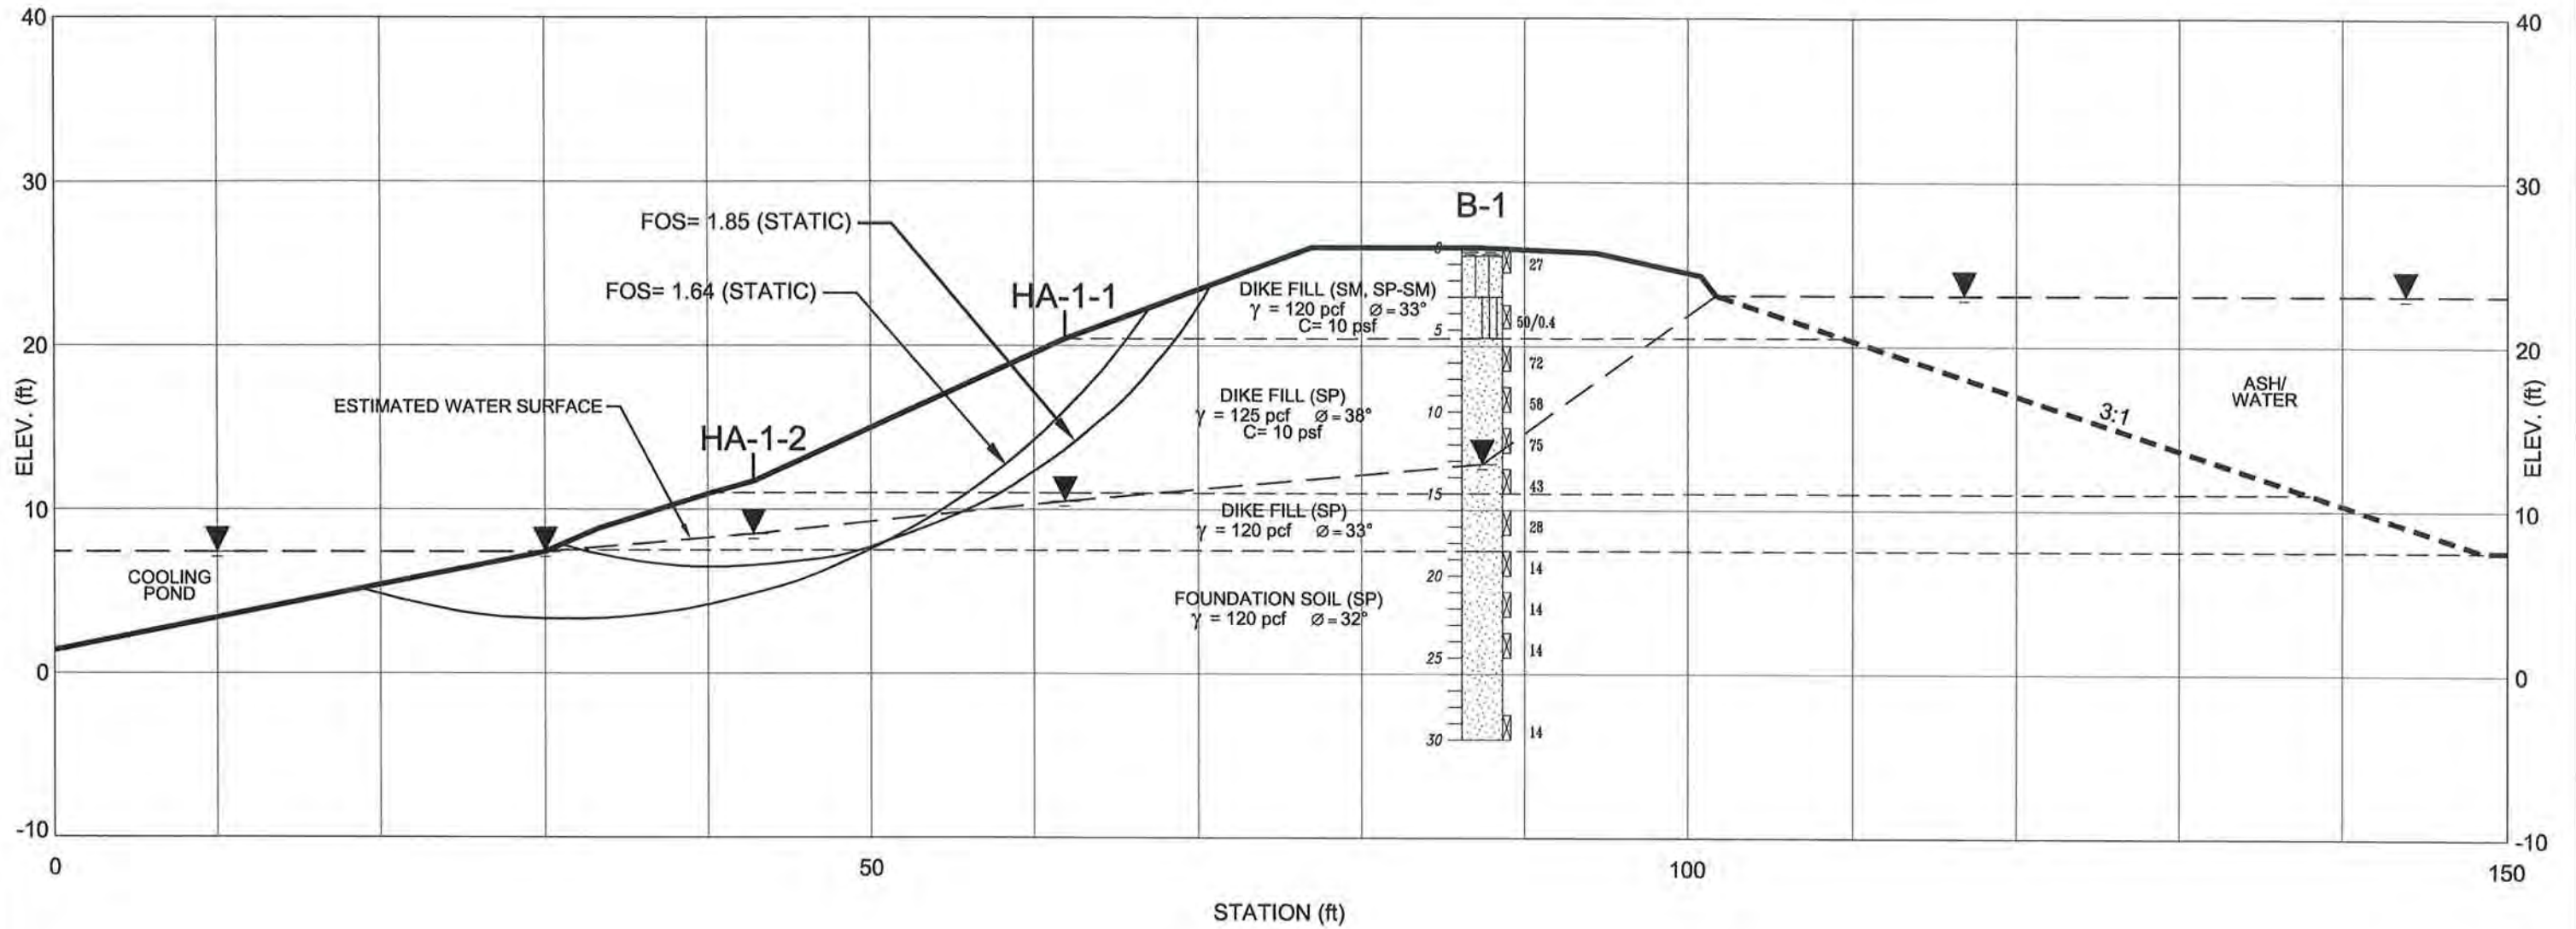
- NOTE:**
1. SEE TABLE 5 FOR WATER LEVEL DATA.
 2. STABILITY RUN OUTPUT SHEETS ARE IN APPENDIX C.
 3. SEISMIC ANALYSIS CIRCLES ARE NOT SHOWN FOR CLARITY.
 4. FACTOR OF SAFETY FOR SEISMIC ANALYSIS IS 1.18.

1971/1983 ASH POND - STABILITY ANALYSIS SECTION AT BORING B-1
 PROGRESS ENERGY
 L.V. SUTTON STEAM ELECTRIC PLANT - ASH POND
 WILMINGTON, NORTH CAROLINA

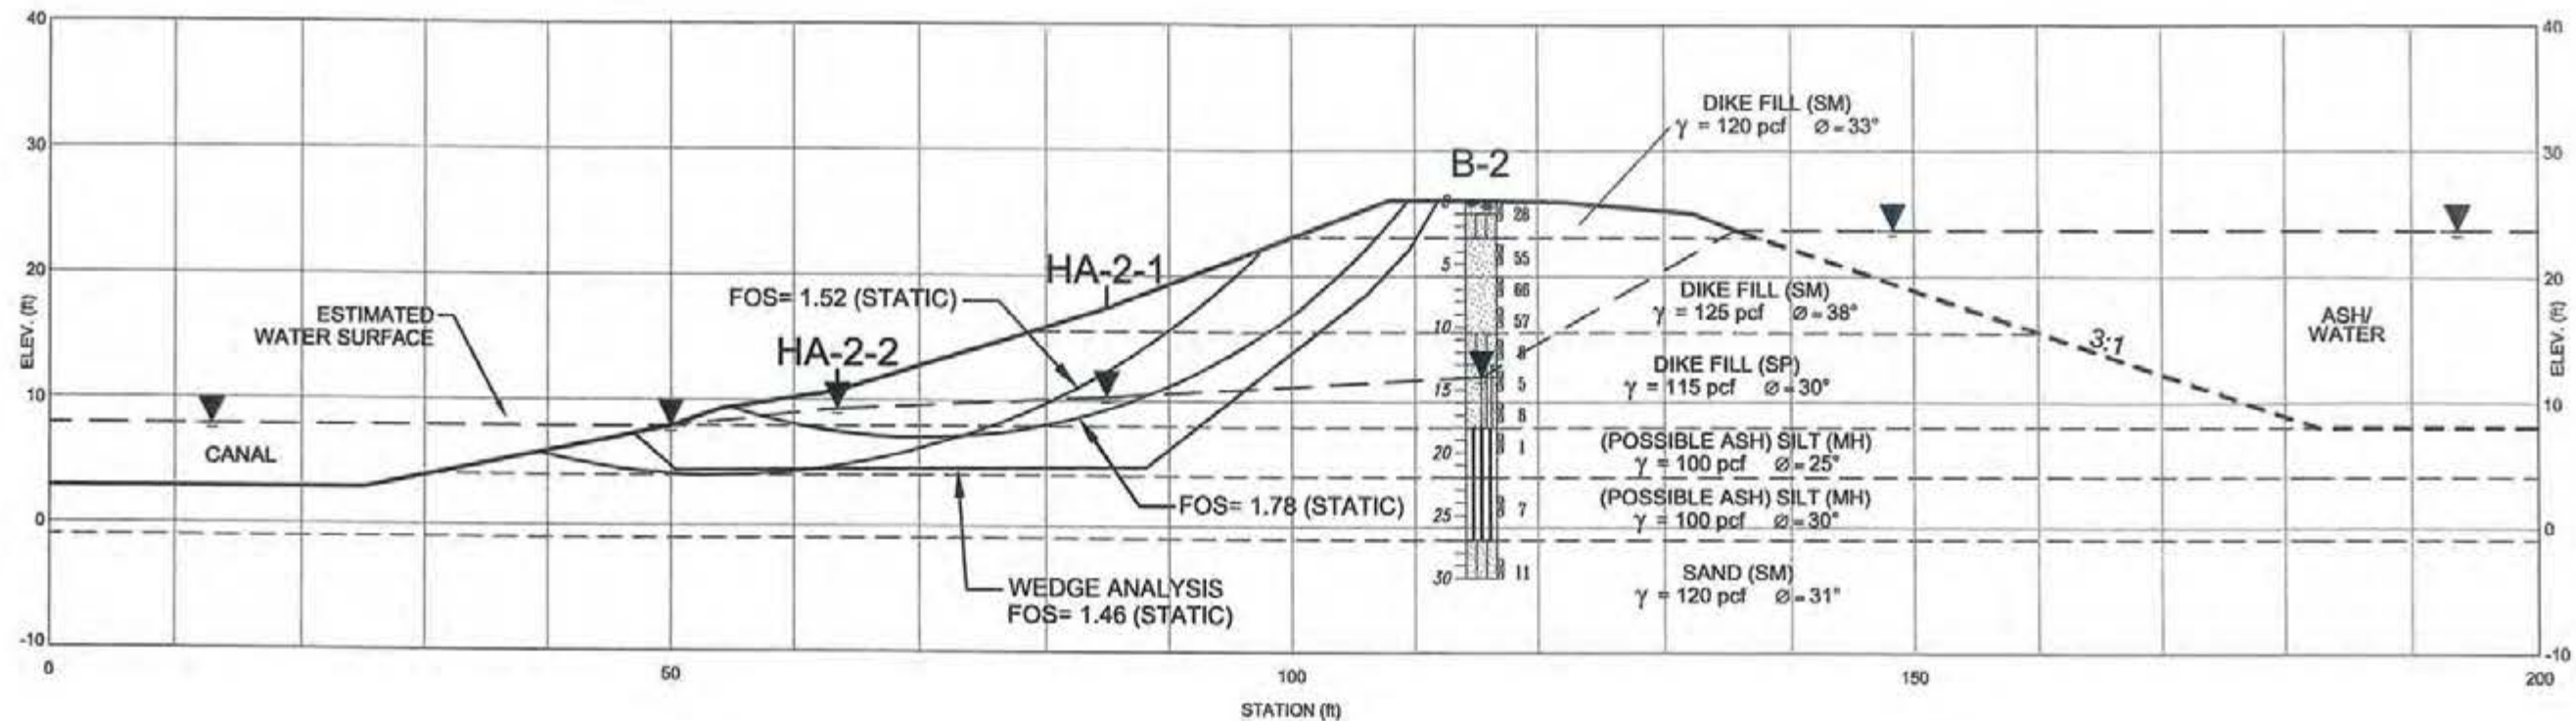
1. SEE TABLE 5 FOR WATER LEVEL DATA.
2. STABILITY RUN OUTPUT SHEETS ARE IN APPENDIX C.
3. SEISMIC ANALYSIS CIRCLES ARE NOT SHOWN FOR CLARITY.
4. FACTOR OF SAFETY FOR SEISMIC ANALYSIS IS 1.01.

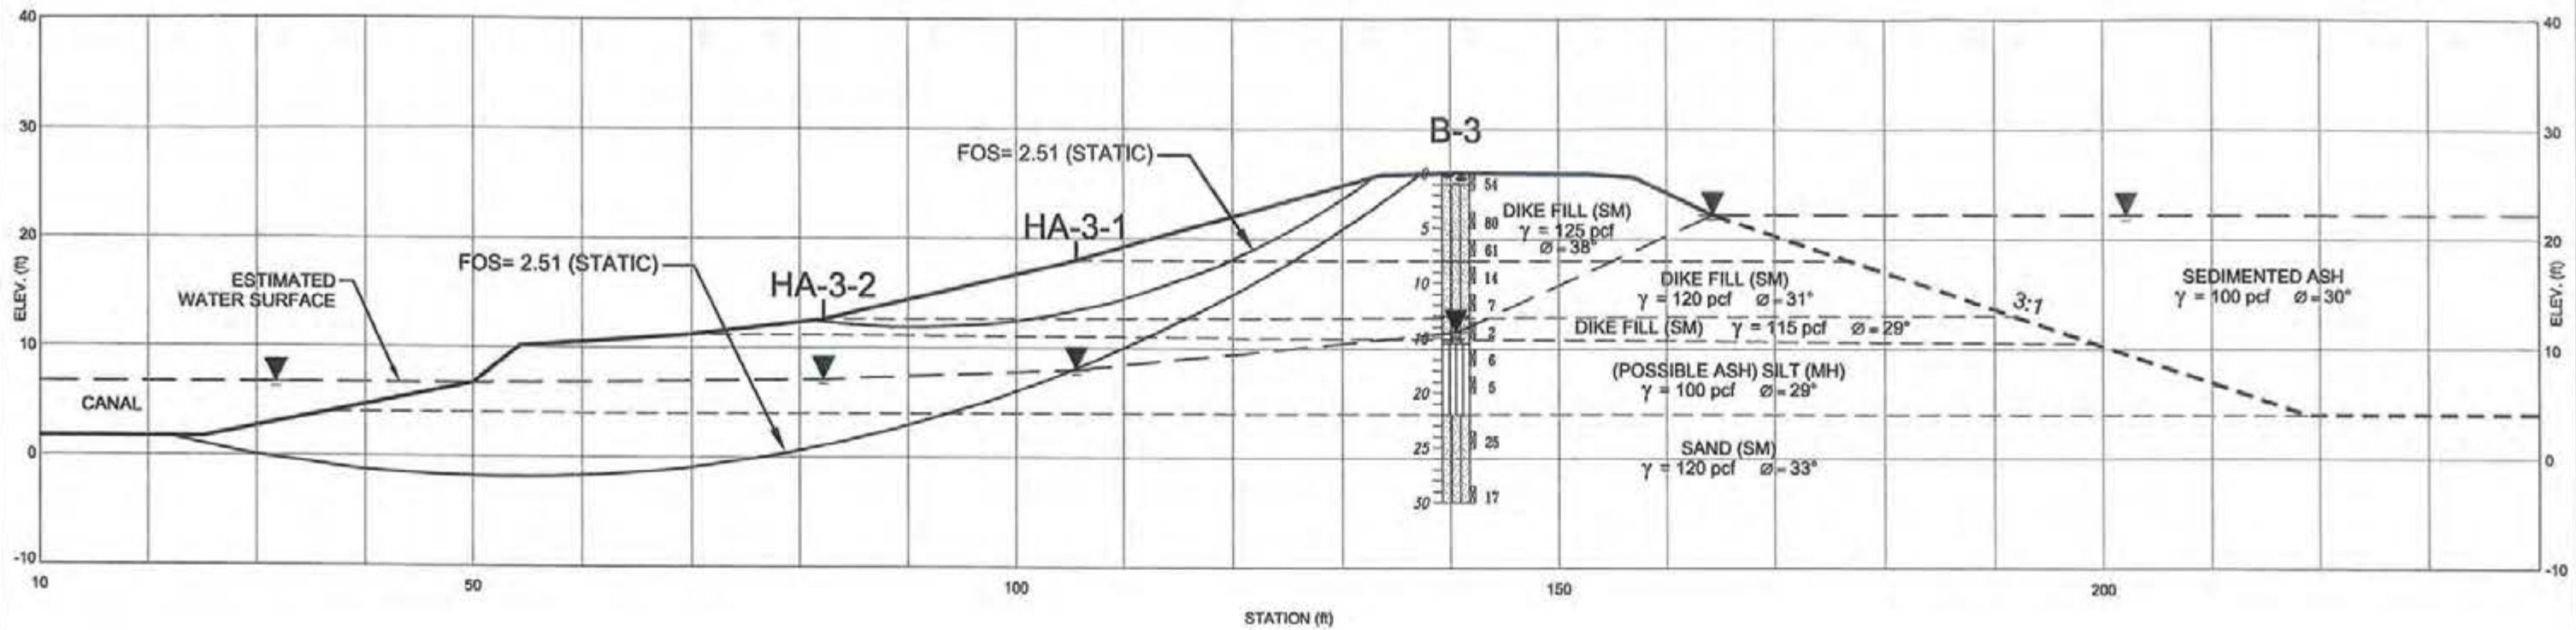
1. SEE TABLE 5 FOR WATER LEVEL DATA.
2. STABILITY RUN OUTPUT SHEETS ARE IN APPENDIX C.
3. SEISMIC ANALYSIS CIRCLES ARE NOT SHOWN FOR CLARITY.
4. FACTOR OF SAFETY FOR SEISMIC ANALYSIS IS 1.56.

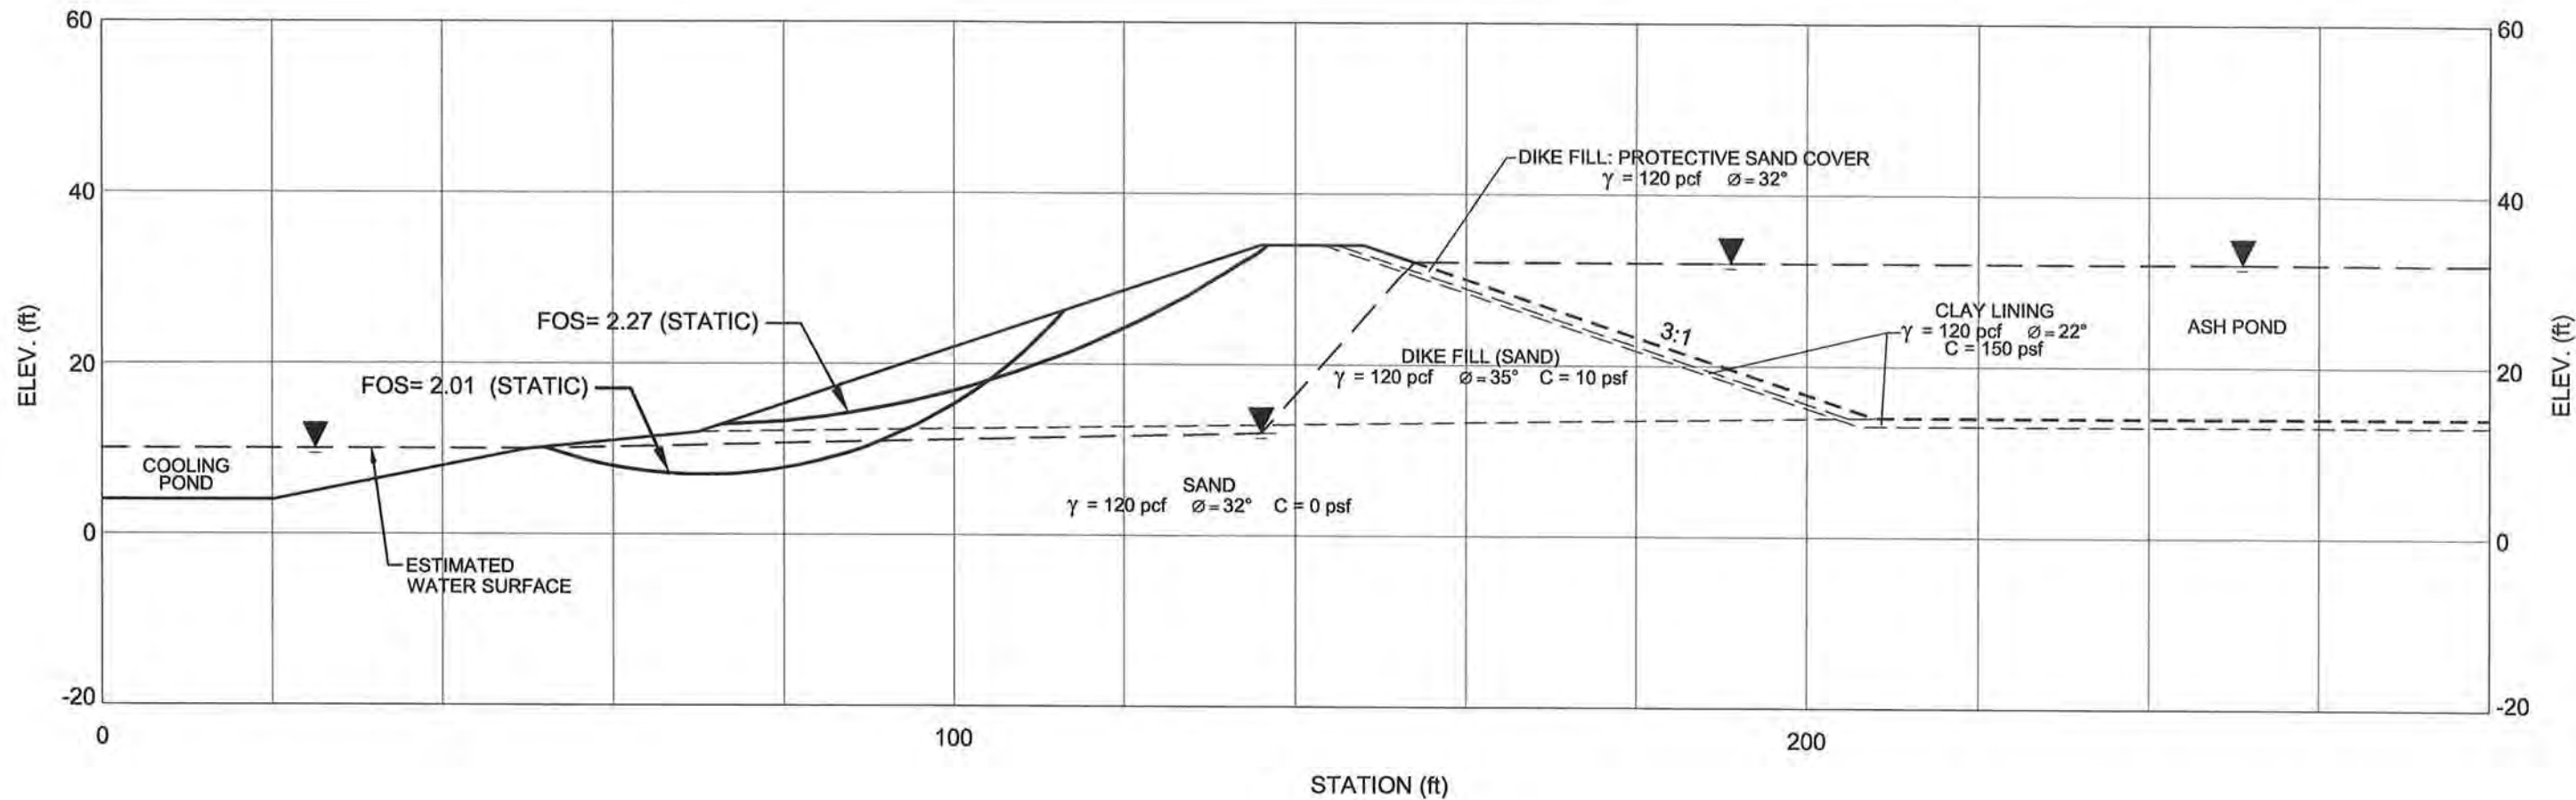
1. SEE APPENDIX G FOR WATER LEVEL DATA.
2. STABILITY RUN OUTPUT SHEETS ARE IN APPENDIX D.
3. SEISMIC ANALYSIS CIRCLES ARE NOT SHOWN FOR CLARITY.
4. FACTOR OF SAFETY FOR SEISMIC ANALYSIS IS 1.36.

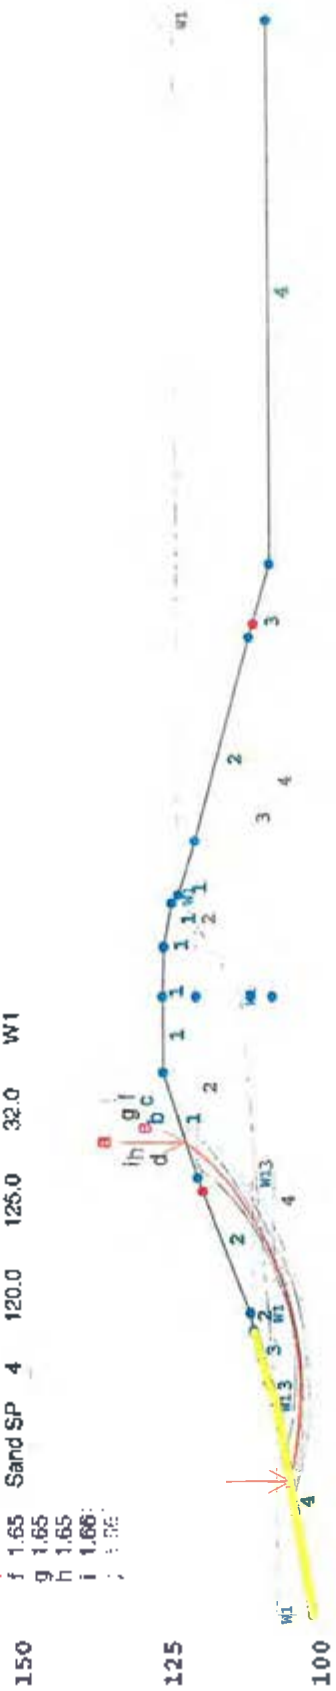
#	FS	Soil Desc.	Soil Type No.	Total Unit Wt. (pcf)	Saturated Unit Wt. (pcf)	Friction Angle (deg)	cohesion (pcf)	Piez. Surface No.
a	1.64	Dike SM	1	120.0	125.0	33.0	0	W1
b	1.64	Dike SP	2	125.0	130.0	38.0	0	W1
c	1.64	Dike SP	3	120.0	125.0	33.0	0	W1
d	1.65	Sand SP	4	120.0	125.0	32.0	0	W1
e	1.65							
f	1.65							
g	1.65							
h	1.65							
i	1.66							
j	1.66

PCSTABL5M/si FSmin=1.64

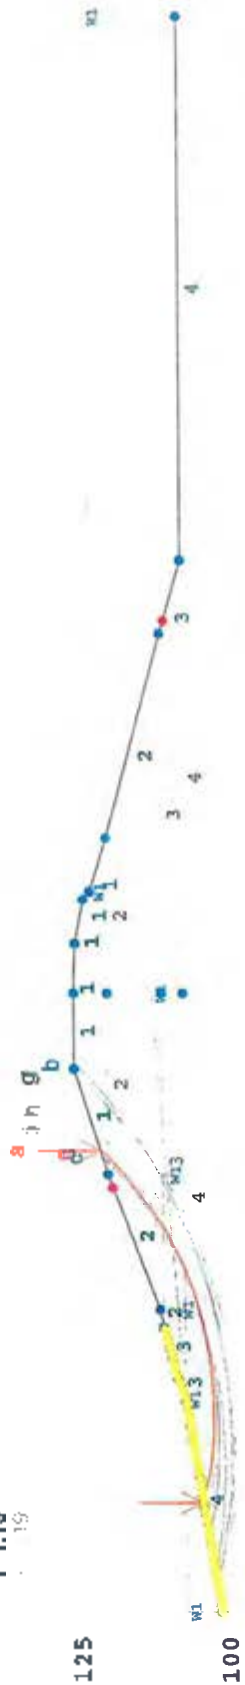
#	FS	Soil Desc.	Soil Type No.	Total Unit Wt (pcf)	Saturated Unit Wt (pcf)	Friction Angle (deg)	Piez. Surface No.	Load Horiz Eqk	Value
a	1.18								0.110 g<
b	1.18	Dike SM	1	120.0	125.0	33.0	W1		
c	1.18	Dike SP	2	125.0	130.0	38.0	W1		
d	1.18	Dike SP	3	120.0	125.0	33.0	W1		
e	1.18	Sand SP	4	120.0	125.0	32.0	W1		
f	1.19								
g	1.19								
h	1.19								
i	1.19								
j	1.19

PCSTABL5M/si FSmin=1.18
Safety Factors Are Calculated By The Modified Bishop Method

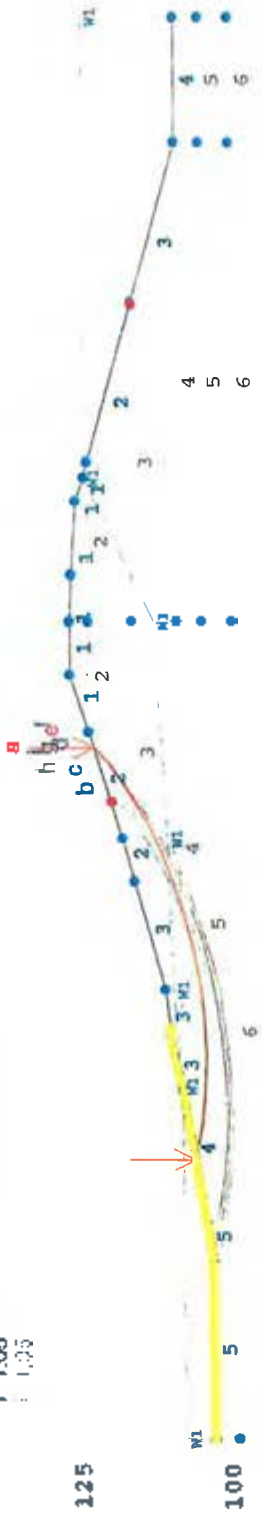
#	FS	Soil Desc.	Soil Type No.	Total Unit Wt. (pcf)	Saturated Unit Wt. (pcf)	Friction Angle (deg)	Piez. Surface No.	Load Horiz Eqk	Value
a	1.03	Fill	1	120.0	125.0	33.0	W1		0.110 g<
b	1.04	Fill	2	125.0	130.0	38.0	W1		
c	1.05	Fill	3	115.0	120.0	30.0	W1		
d	1.05	Silt	4	100.0	105.0	25.0	W1		
e	1.05	Silt	5	100.0	105.0	30.0	W1		
f	1.05	Sand	6	120.0	125.0	31.0	W1		
g	1.05								
h	1.05								
i	1.05

PCSTABL5W/s1 FSmin=1.03

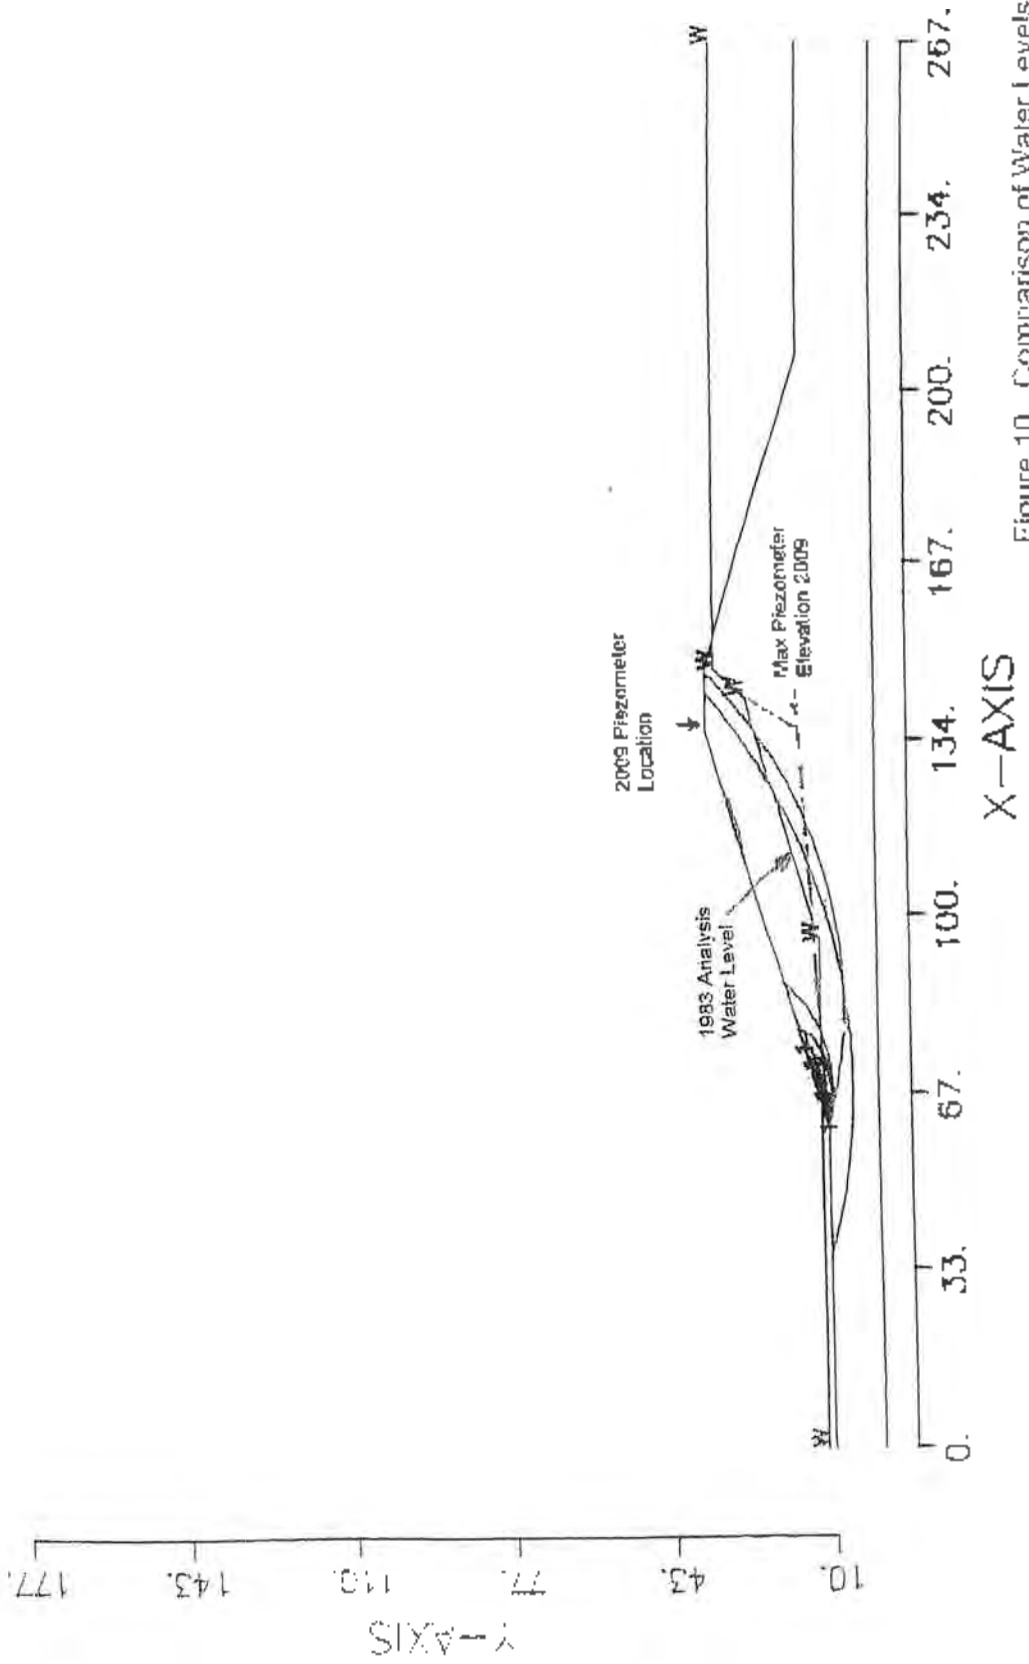
Figure 10. Comparison of Water Levels with Stability Analysis

100 SURFACES HAVE BEEN GENERATED
10 MOST CRITICAL OF SURFACES GENERATED
MINIMUM FACTOR OF SAFETY = 1.583

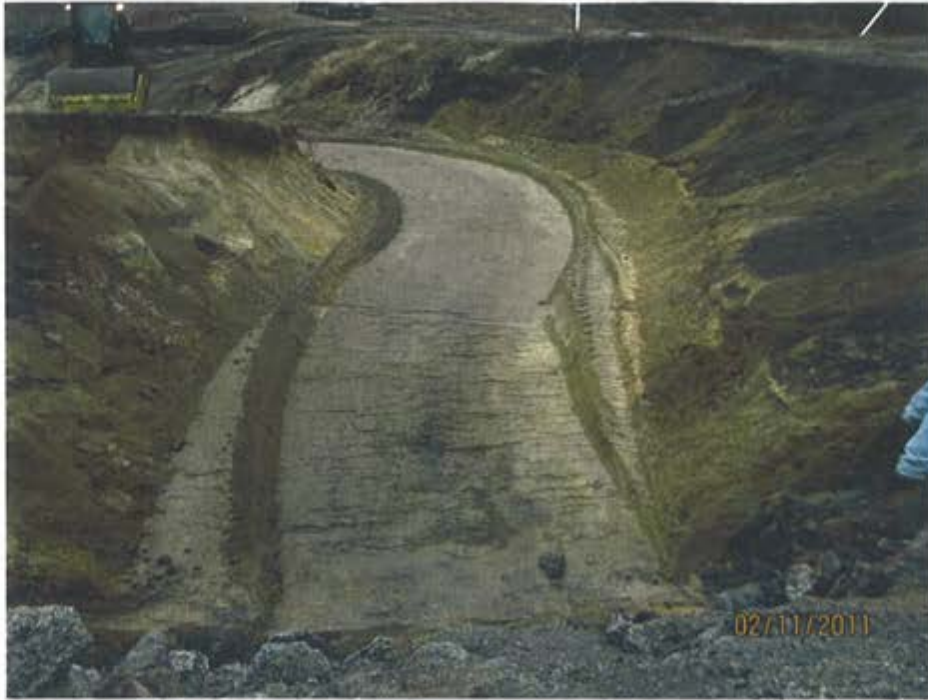
Photo 1. Breach bottom area after initial preparation.

MACTEC Engineering and Consulting, Inc. (MACTEC) has provided engineering observation and construction testing services related to implementation of repairs to the small breach area in the 1985 Ash Pond Dike at the Sutton Plant. Emergency repairs in the breach area were made immediately after the breach, in September, 2010. Plans for a permanent repair were prepared by MACTEC under the engineering supervision of J. Allan Tice, P. E. and approved by the North Carolina Department of Environment and Natural Resources, Division of Land Resources (DLR) by letter dated January 21, 2011. This Completion Report summarizes construction activities and MACTEC's observations and testing results. Appendices contain results of laboratory and field tests. Two sets of Record Drawings and a Certificate of Completion are attached. This Completion Report and its attachments is to be submitted to DLR by Progress Energy.

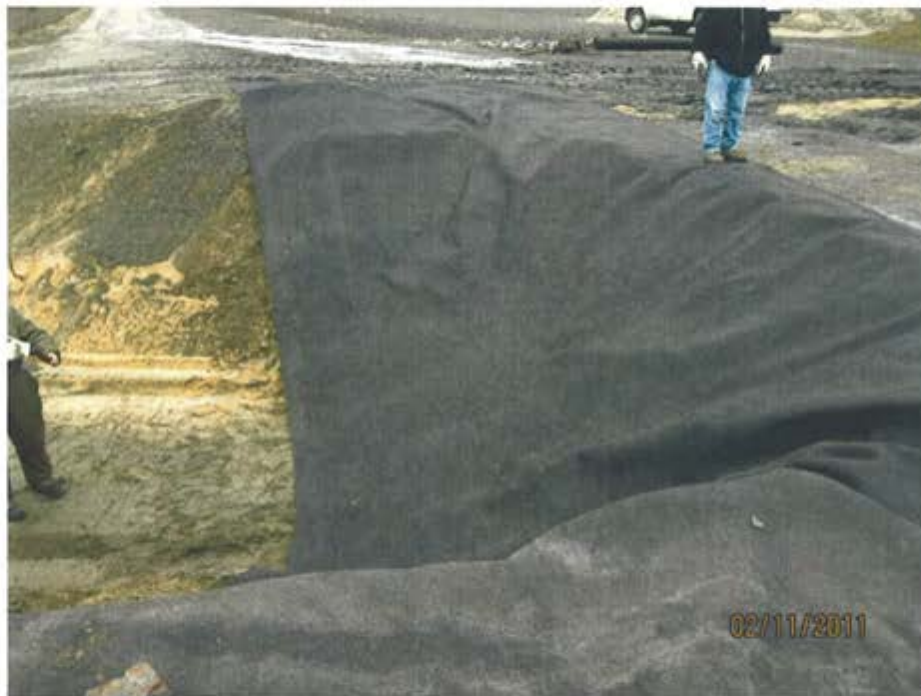
Photo 2. Placing geotextile across riprap face of emergency plug.

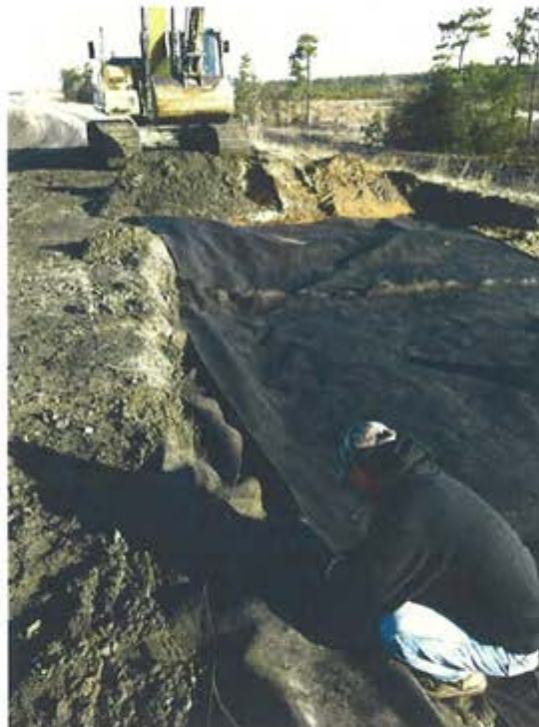
Photo 4. Placing geotextile in preparation for crest gravel.

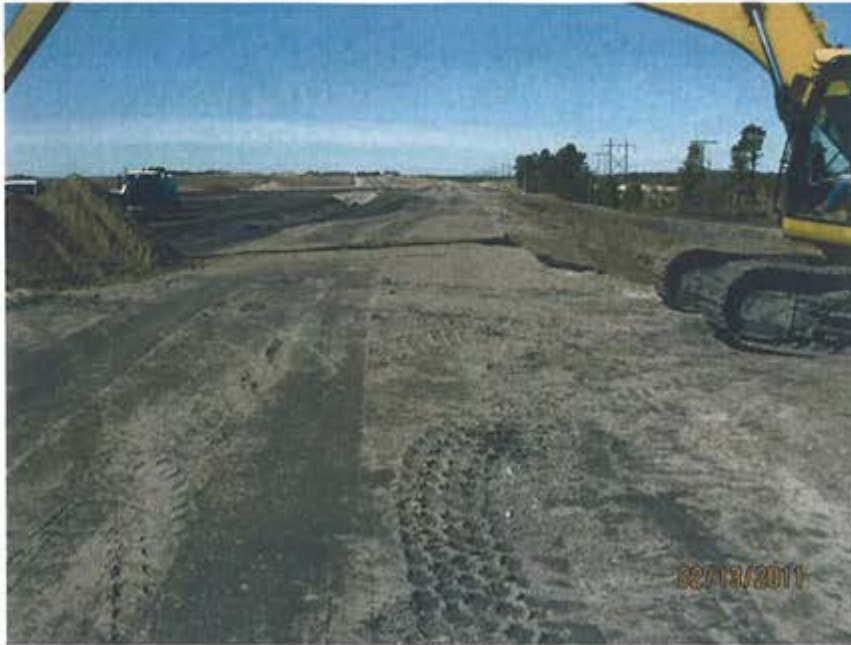
Photo 5. Crest at final grade.

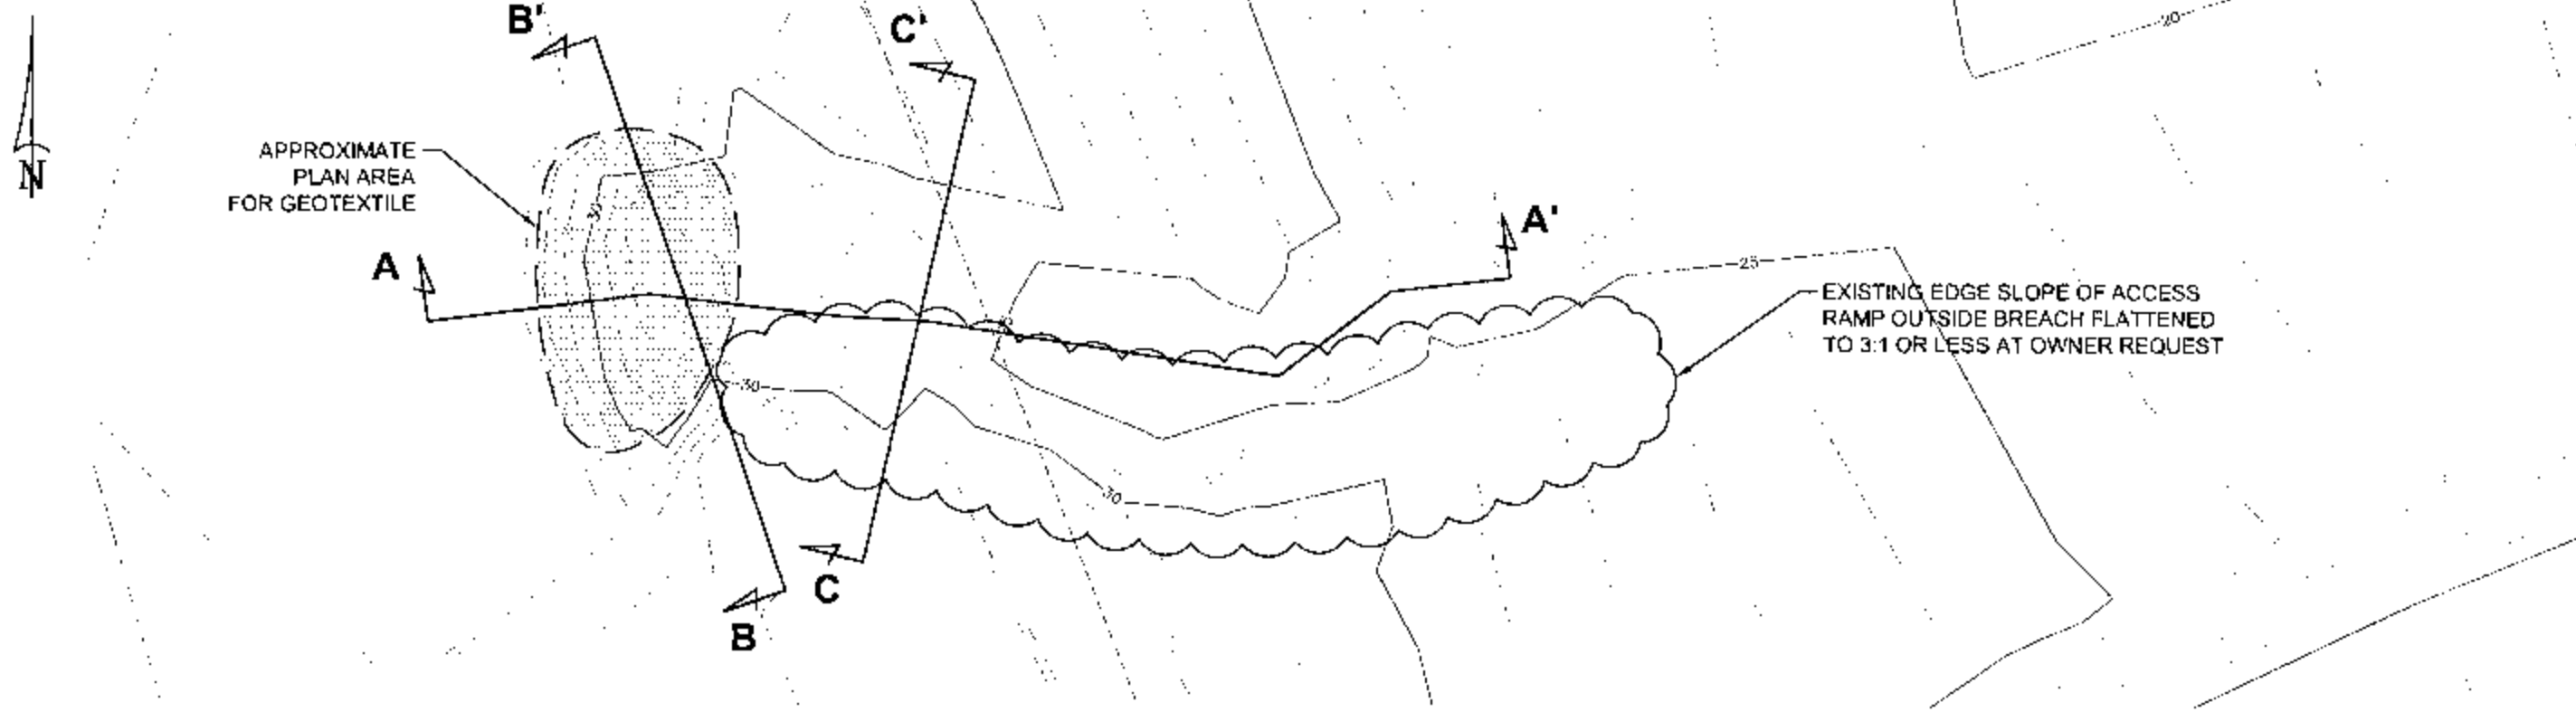
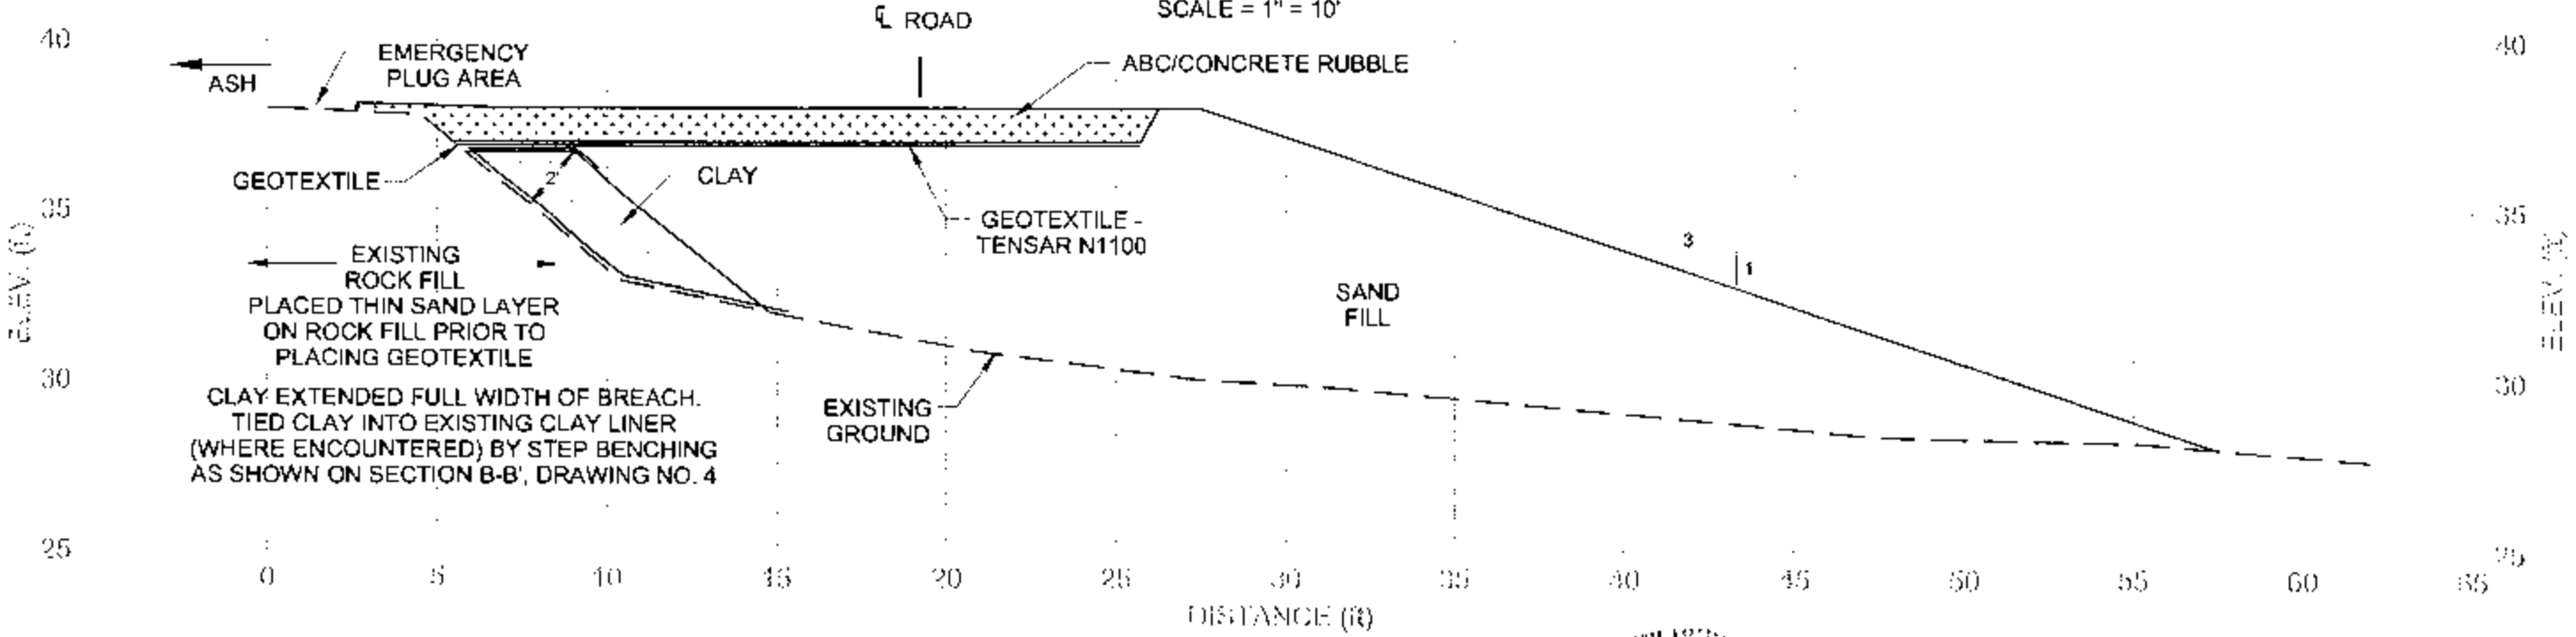
DRAWING
3

BREACH PLAN AND PROFILE
 1984 ASH POND DIKE (NEWHA-005)
 SUTTON PLANT
 WILMINGTON, NORTH CAROLINA
