Coal Combustion Residue Impoundment

Round 9 - Dam Assessment Report

Weatherspoon Steam Electric Plant

Ash Pond Embankment

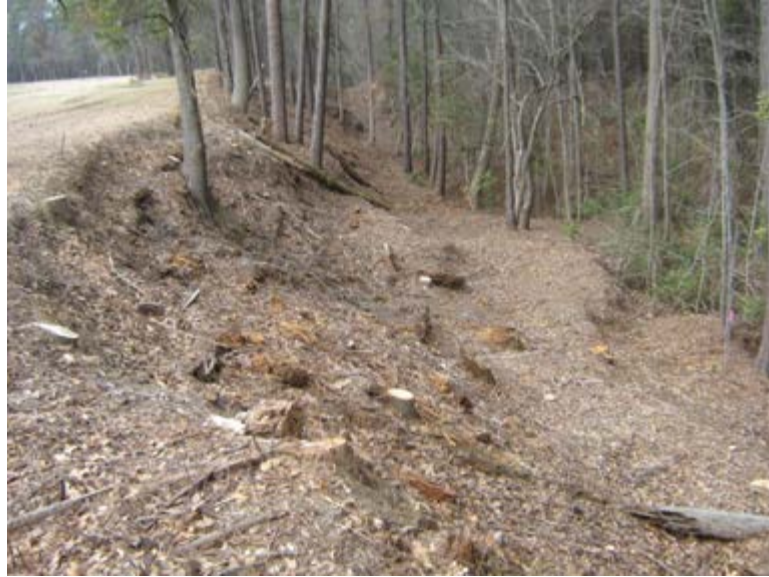
Downstream slope – Northern Ash Area

Areas of the downstream slope were eroding, in disrepair and had large trees established within the embankment. This area needs to be remediated. We were made aware by Progress Energy that a plan is already in place and they are awaiting approval from NCDENR to begin the repairs.

Based on the assessments of this report, maintenance procedures appear to be inadequate. Trees and other vegetation has established on the northern embankment. Multiple areas along the northern embankment showed signs of erosion and slope failure.

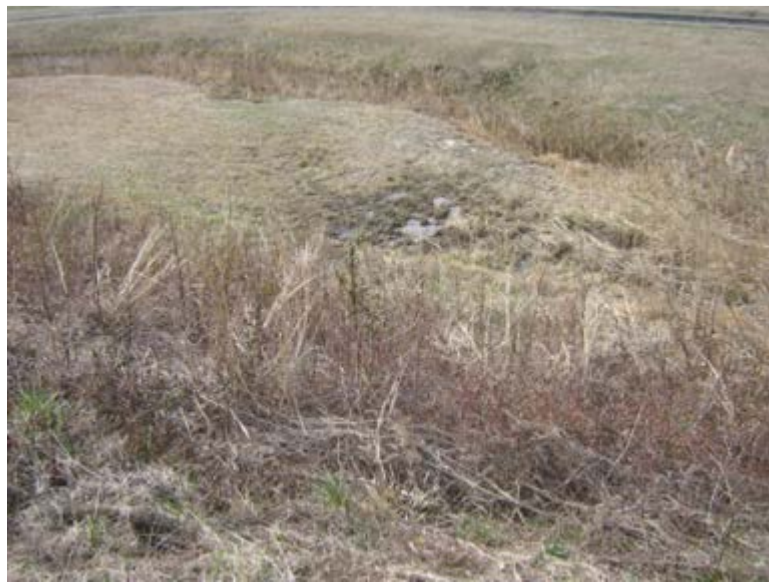
No scarps, sloughs, depressions, bulging or other indications of slope instability or signs of erosion were observed. It is recommend the power plant install animal guards for the toe drains. Seepage was observed at a few locations and this needs to be monitored.

Potential seepage along downstream toe – Southern Ash Area

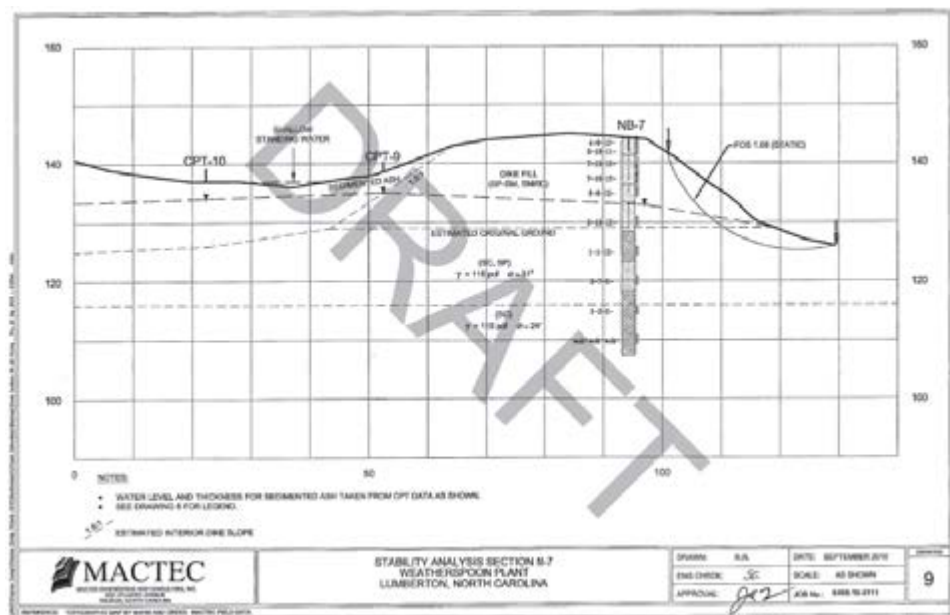
Figure 7.1.2a: Stability Analysis (Section NB-7)

Test results showing the strength parameters of the embankments are presented below. There are multiple sections analyzed in the report and only a portion of those analyzed are shown below. The ones shown below are sections that did not meet the minimum factors of safety.

Stability analysis of the northern ash area has shown in a few locations factors of safety below the 1.5 NCDENR and United States of America Corp of Engineers (USACOE) thresholds. The MACTEC 2010 report concludes that the factors of safety below the threshold are acceptable because the dikes have been in place for 40 to 50 years, no failures have been noted, currently the dikes do not have water impounded against them, and exploration found water levels within the dikes at low levels.

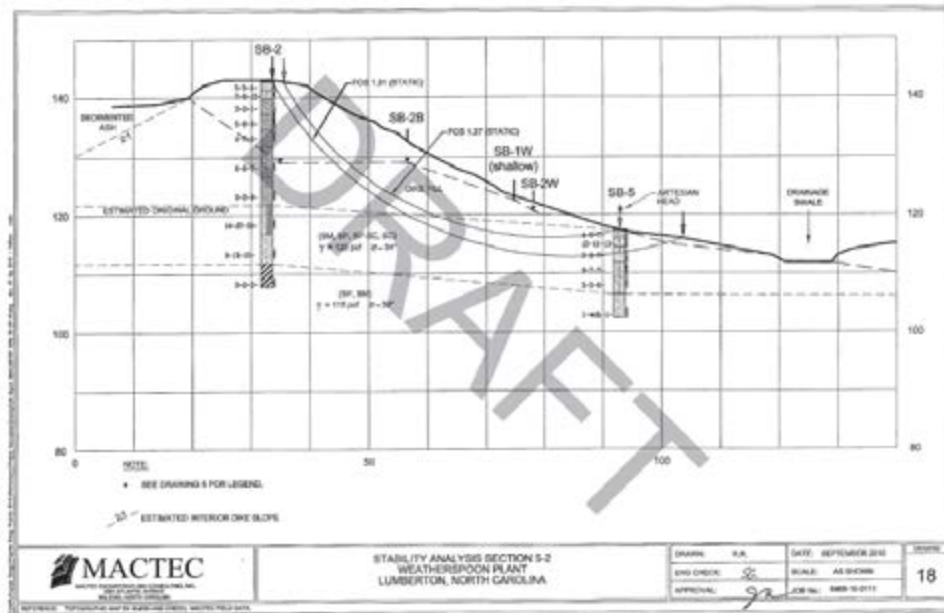
Figure 7.1.2b: Stability Analysis (Section SB-7)

Stability analysis of the southern ash area also showed a factor of safety in one area below the threshold. There was seepage occurring in this area, so it was recommended to place a “riprap blanket on the slope and toe berm/road.” (Appendix A: Doc 03 – Seepage and Stability Analysis)

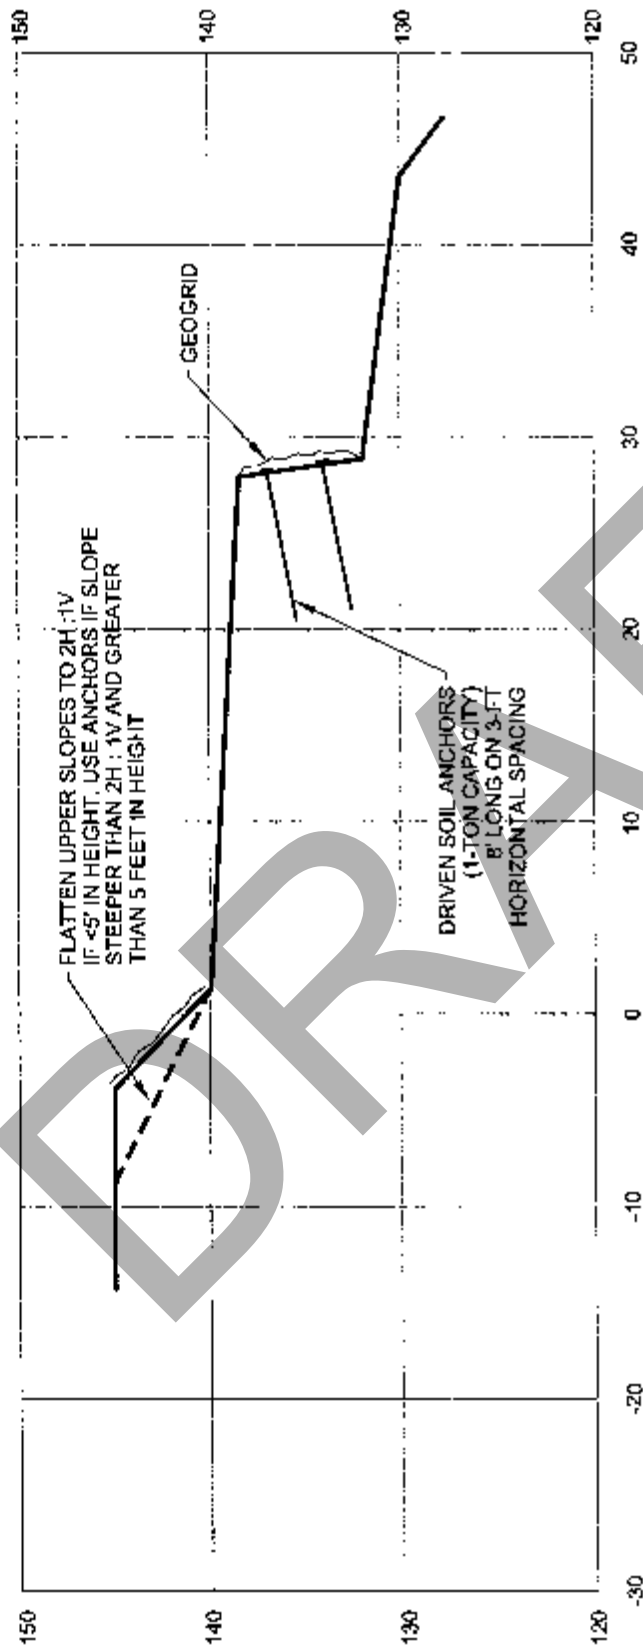
NOTE:
SECTION REPRESENTS TYPICAL LOCAL AREAS WHERE EITHER SURFICIAL SLIDES OR EROSION HAVE OCCURRED. HEIGHT OF AREAS VARIES. AREAS ARE MORE COMMON BETWEEN BORINGS NB-1 AND NB-5.

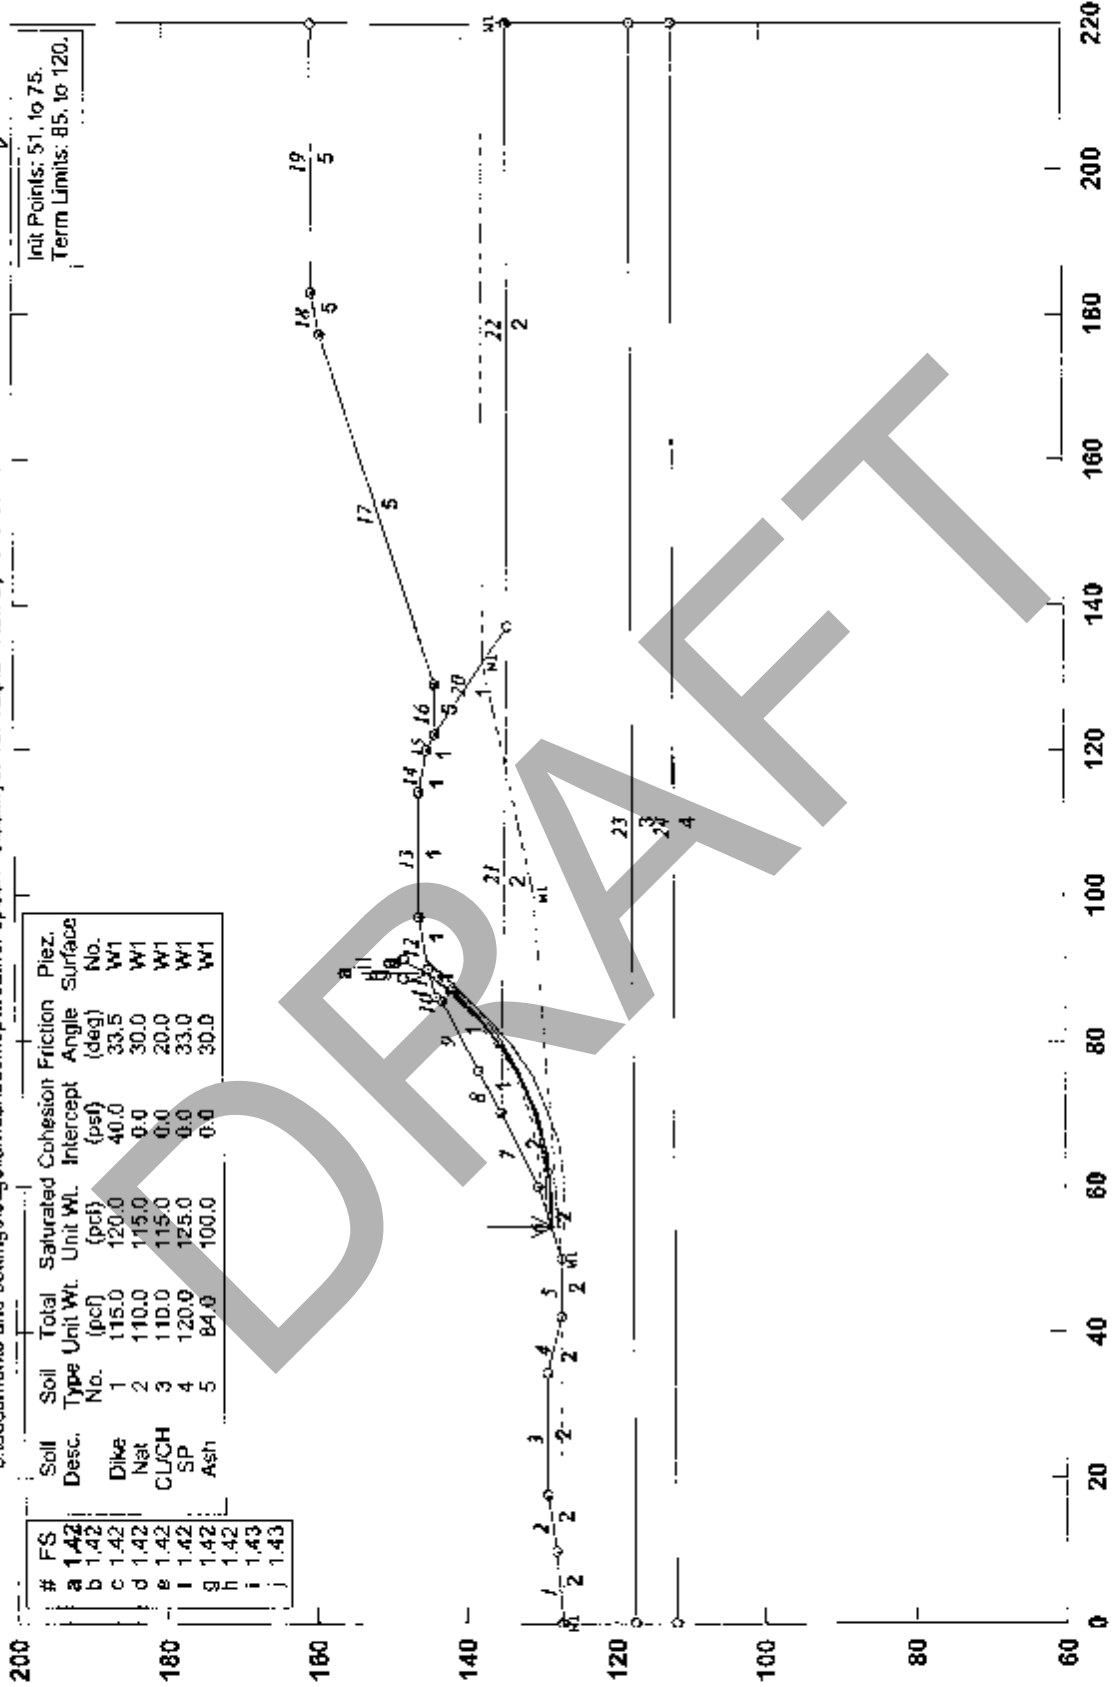
#	FS	Soil Desc.	Soil Type No.	Total Unit Wt. (pcf)	Saturated Unit Wt. (pcf)	Cohesion (psf)	Friction Angle (deg)	Intercept (psf)	Piez. Surface No.
a	1.42	Dike	1	115.0	120.0	40.0	33.5	0.0	W1
b	1.42	Net	2	110.0	115.0	0.0	30.0	0.0	W1
c	1.42	CLCH	3	110.0	115.0	0.0	20.0	0.0	W1
d	1.42	SP	4	120.0	125.0	0.0	33.0	0.0	W1
e	1.42	Ash	5	84.0	100.0	0.0	30.0	0.0	W1

PCSTABL5M/sj FSmin=1.42

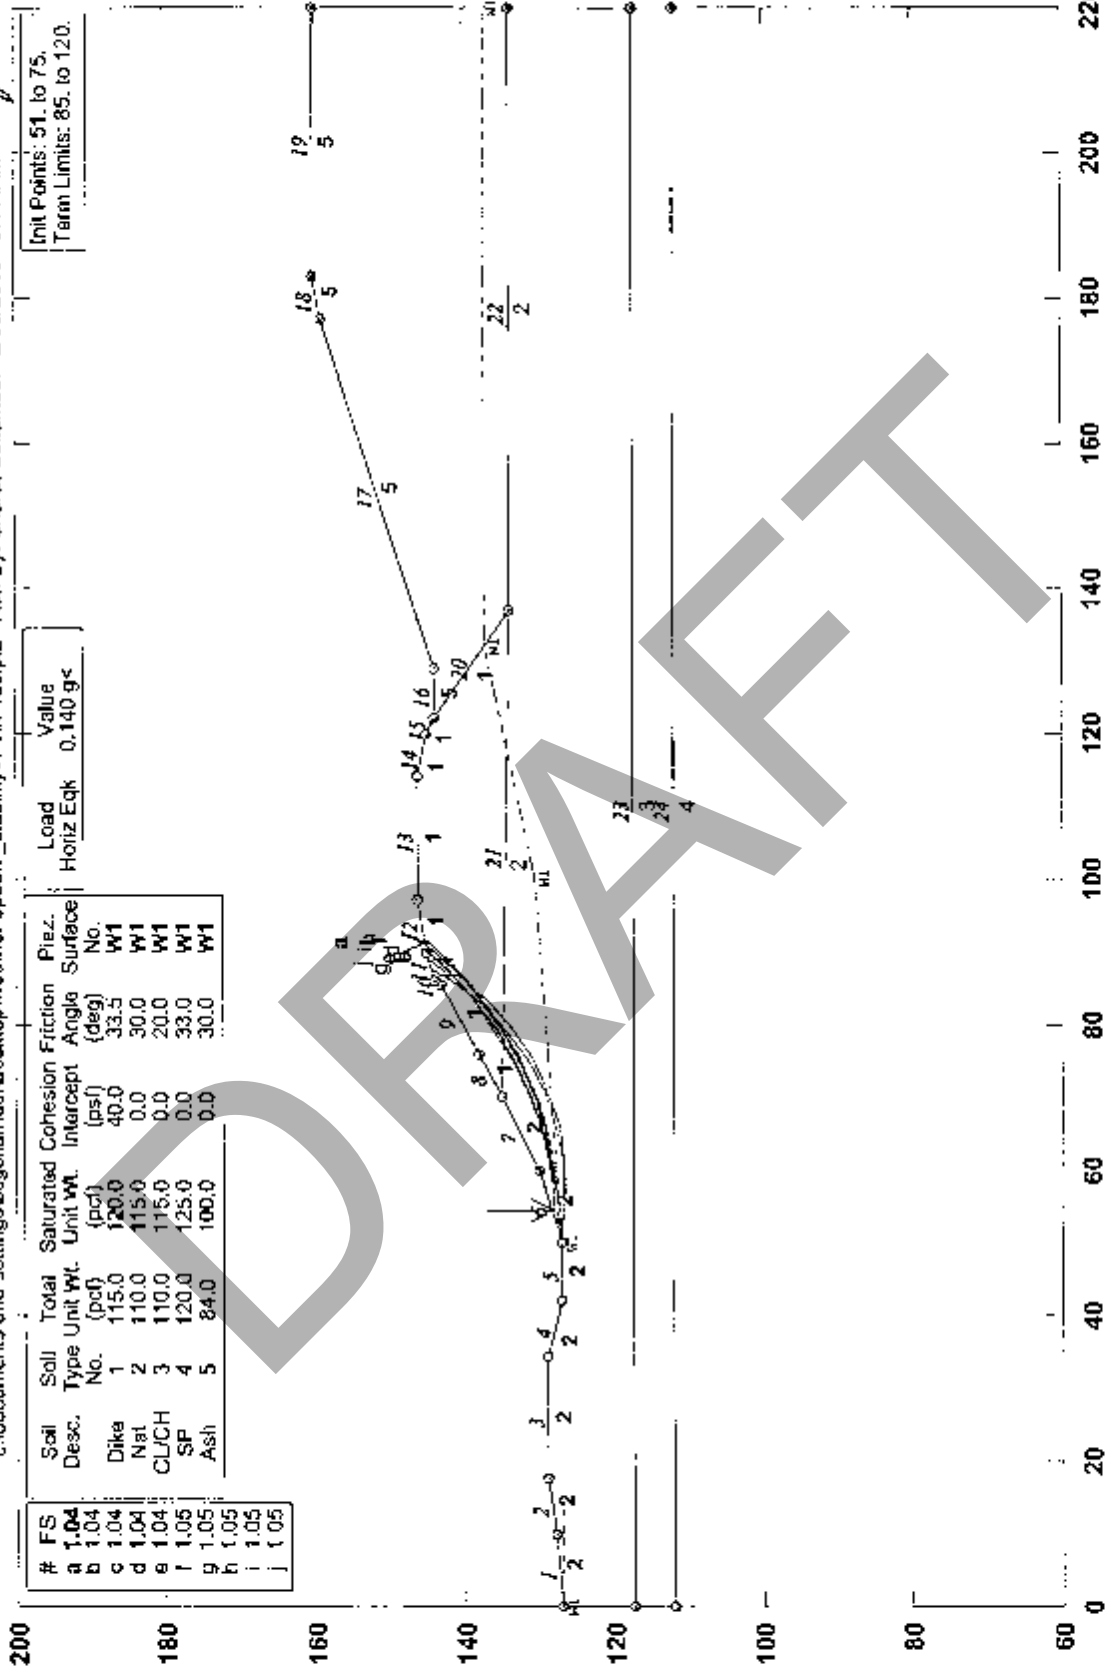
#	FS	Soil Desc.	Type No.	Total Unit Wt. (pcf)	Saturated Unit Wt. (pcf)	Interc. (psf)	Friction Angle (deg)	Piez. Surface No.
a	1.04	Dike	1	115.0	120.0	40.0	33.5	W1
b	1.04	Nat	2	110.0	115.0	0.0	30.0	W1
c	1.04	CLCH	3	110.0	115.0	0.0	20.0	W1
d	1.04	SP	4	120.0	125.0	0.0	33.0	W1
e	1.05	Ash	5	84.0	100.0	0.0	30.0	W1
f	1.05							
g	1.05							
h	1.05							
i	1.05							
j	1.05

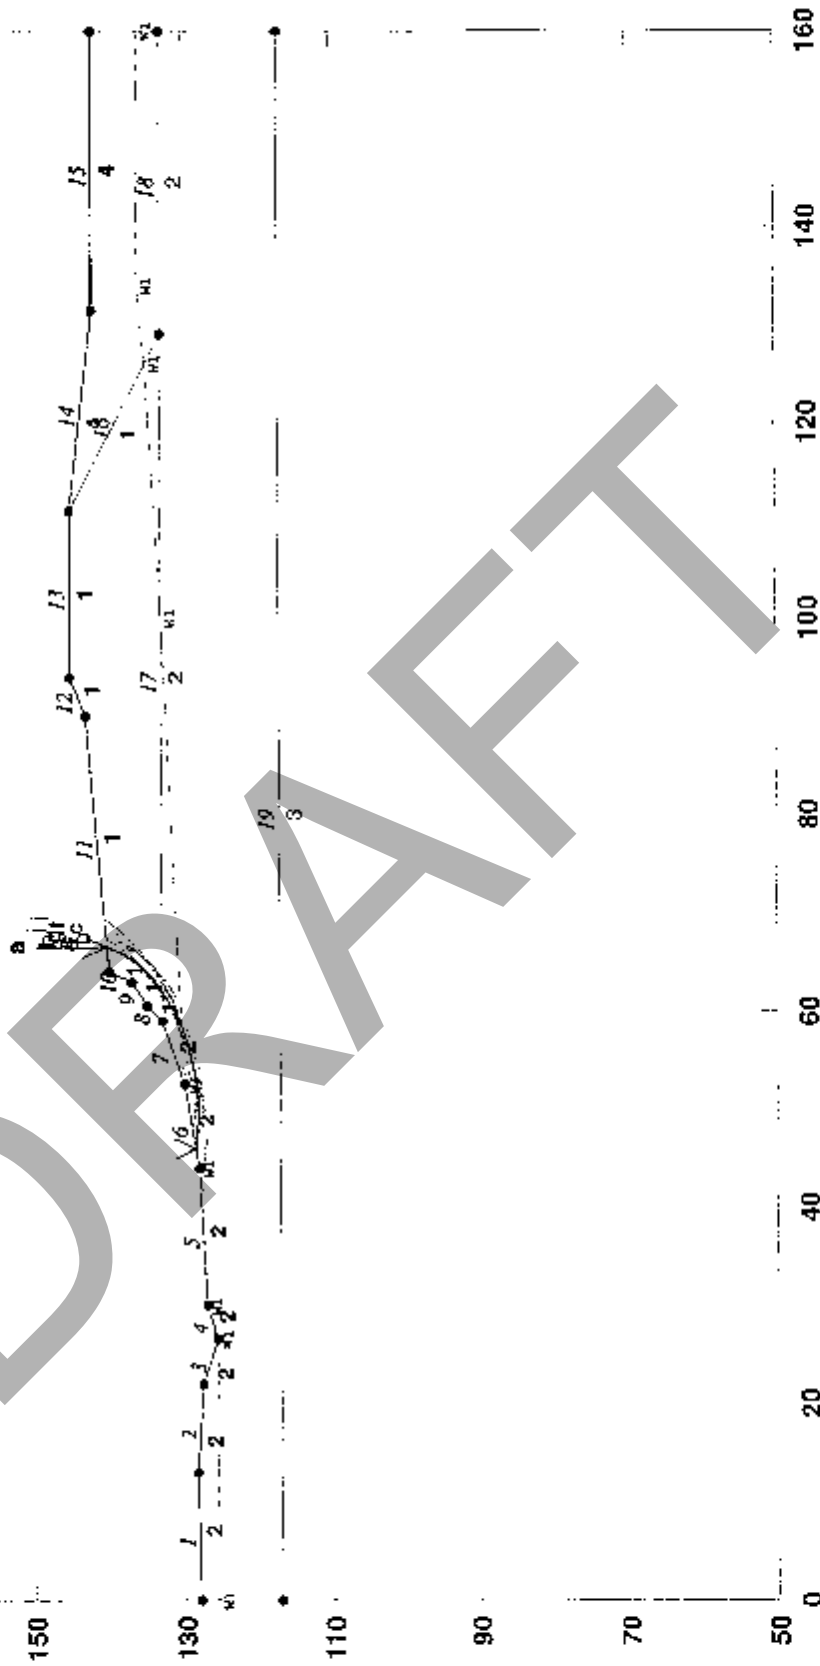
#	FS	Soil Desc.	Type No.	Total Unit Wt. (pcf)	Saturated Unit Wt. (pcf)	Cohesion (psf)	Friction Angle (deg)	PIez. Surface No.
a	1.07	Dike	1	115.0	120.0	40.0	33.5	W1
b	1.08	Dike	2	115.0	120.0	0.0	32.0	W1
c	1.09	Na11	3	110.0	115.0	0.0	30.0	W1
d	1.10	Na12	4	84.0	100.0	0.0	30.0	W1
e	1.10	Ash						
f	1.10							
g	1.10							
h	1.10							
i	1.10							
j	1.10

PCSTABL5M/si FSmin=1.07

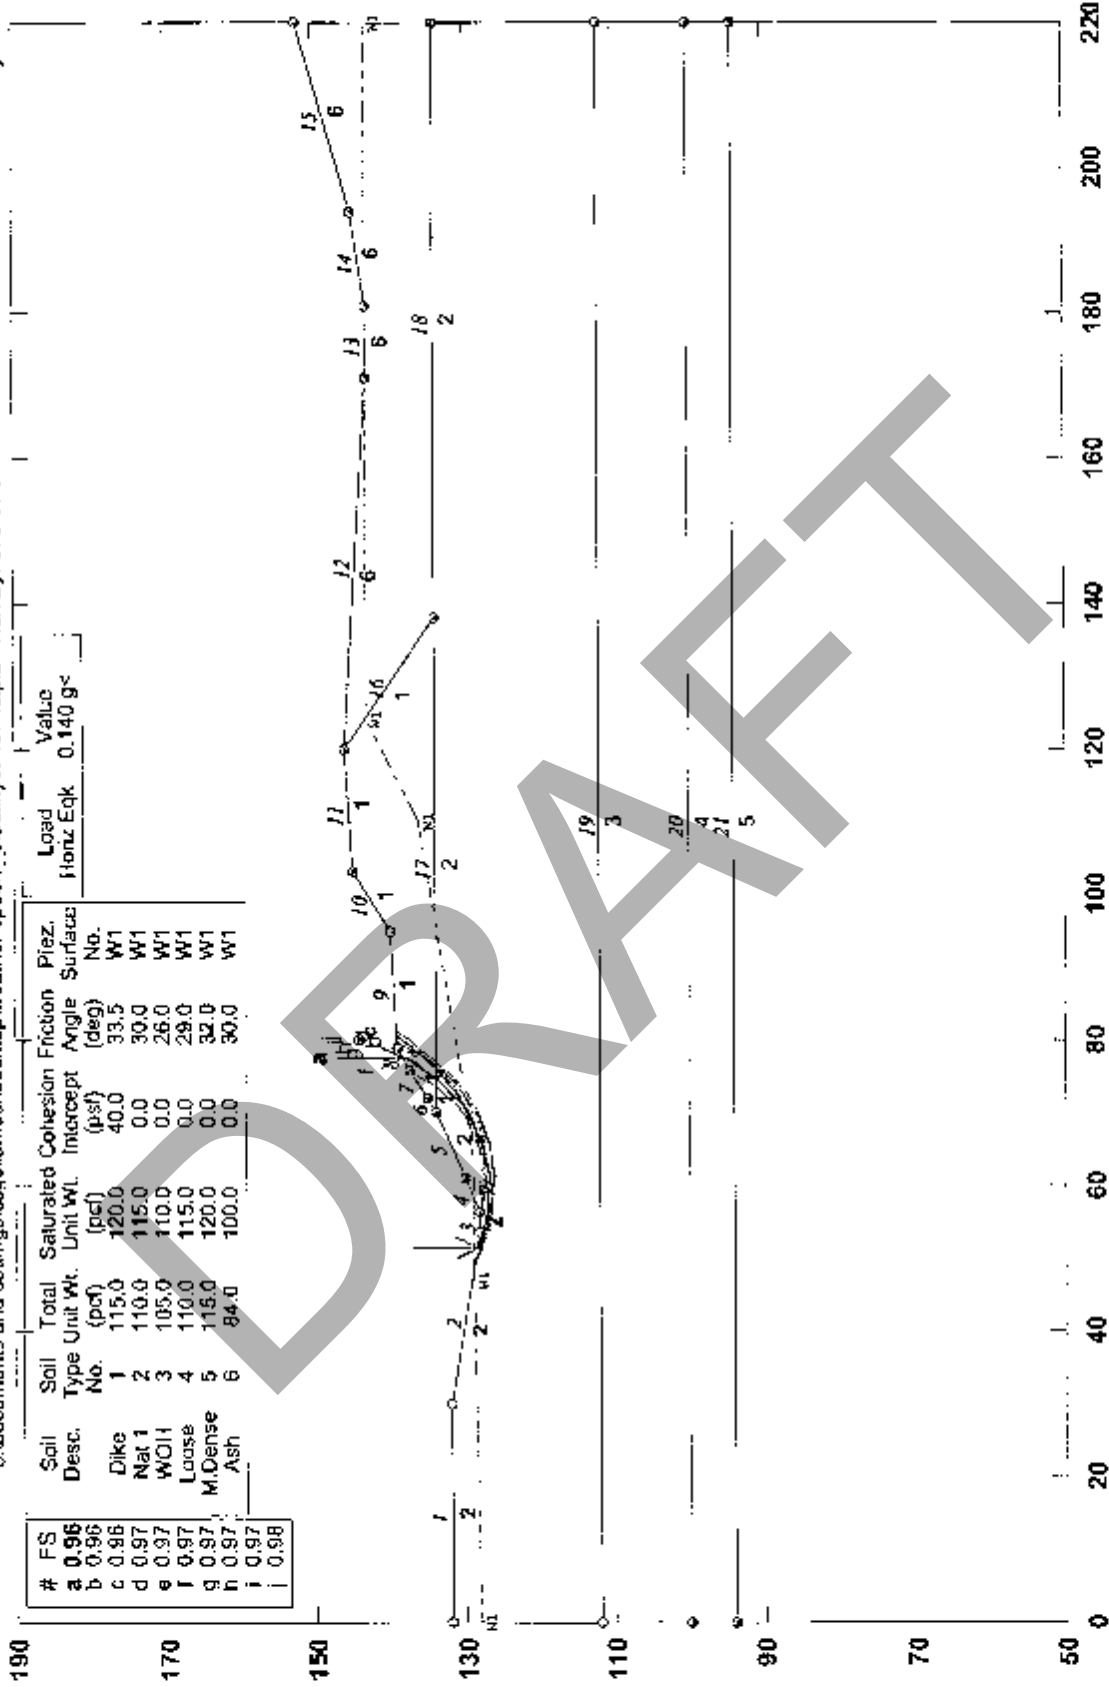
Progress Energy - Weatherspoon Ash Pond-North Dike Sec# 4_Failure thru Crest

#	FS	Soil Desc.	Type No.	Total Unit Wt. (pcf)	Saturated Unit Wt. (pcf)	Cohesion (psf)	Friction Angle (deg)	Piez. Surface No.	Load Horiz. Eqk	Value
a	0.96	Dike	1	115.0	120.0	40.0	33.5	W1	0.140	g<
b	0.96	Nat 1	2	110.0	115.0	0.0	30.0	W1		
c	0.96	WCH	3	105.0	110.0	0.0	26.0	W1		
d	0.97	Loose	4	110.0	115.0	0.0	29.0	W1		
e	0.97	M.Dense	5	115.0	120.0	0.0	32.0	W1		
f	0.97	Ash	6	84.0	100.0	0.0	30.0	W1		
g	0.97									
h	0.97									
i	0.98

PCSTABL5M/si FSmin=0.96

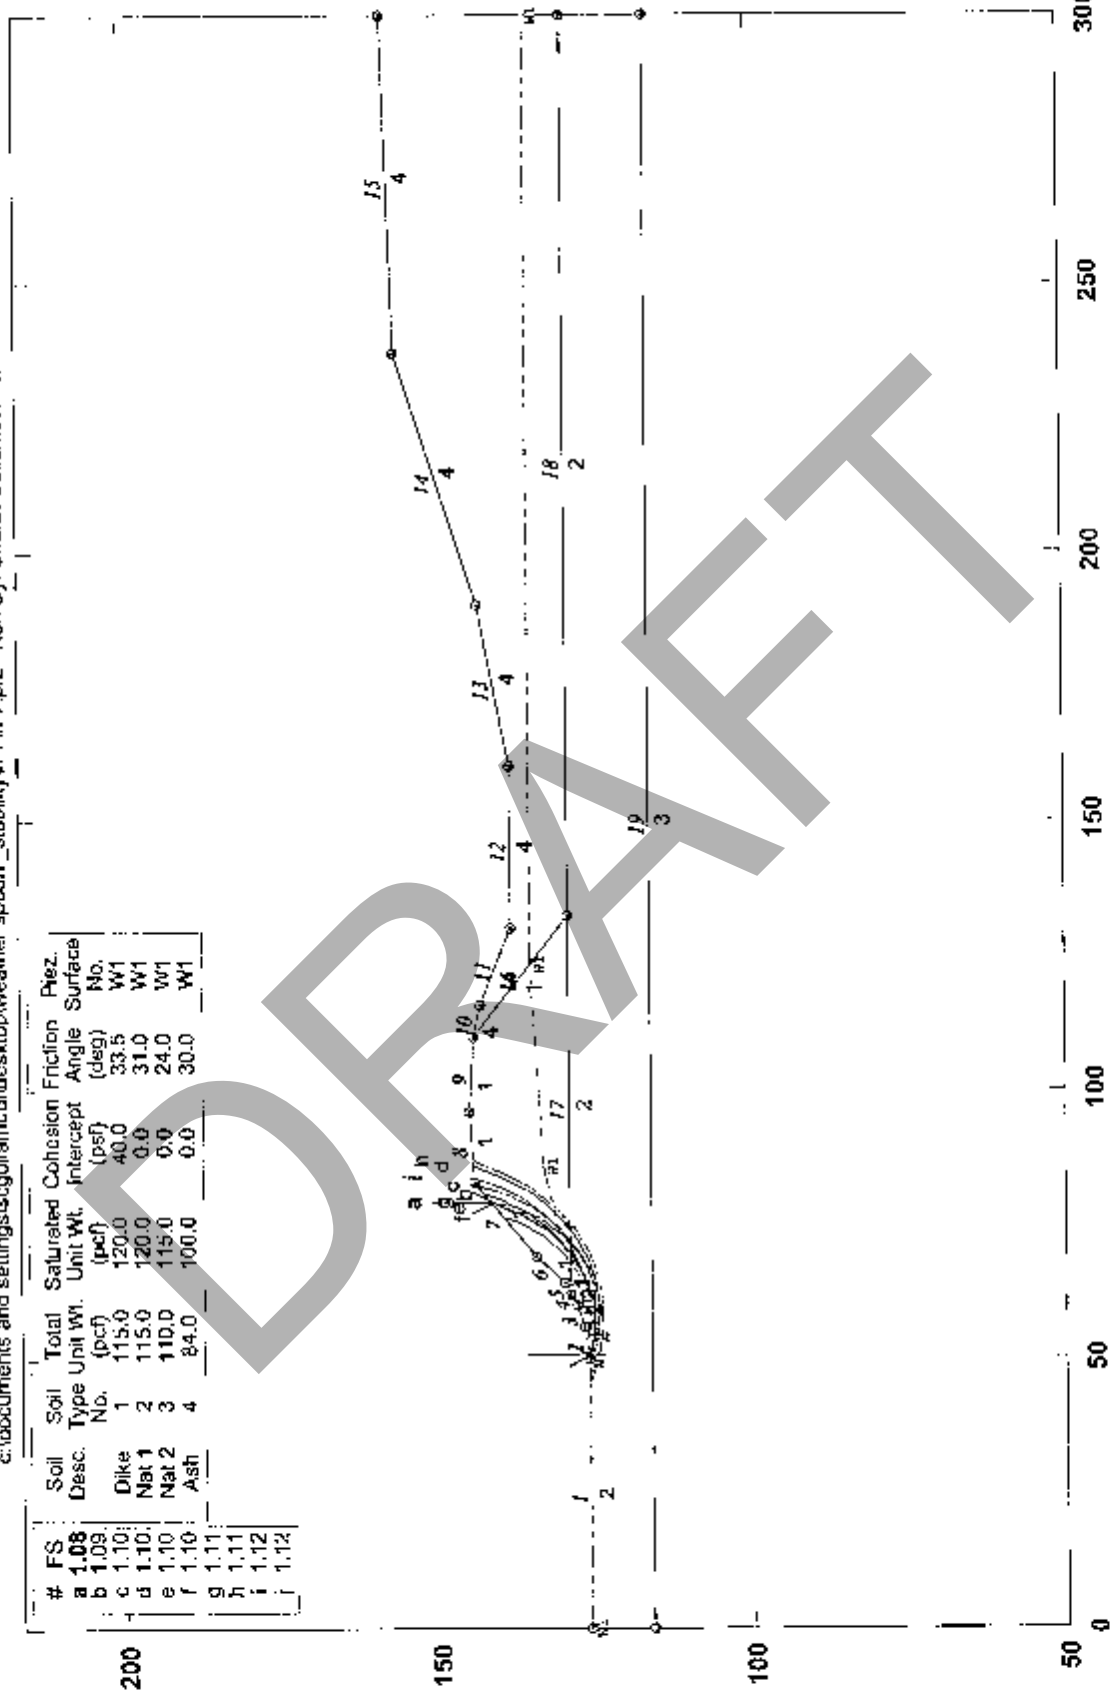
#	FS	Soil Desc.	Soil Type No.	Total Unit Wt. (pcf)	Saturated Unit Wt. (pcf)	Cohesion (psf)	Friction Angle (deg)	Piez. Surface No.
a	1.08	Dike	1	115.0	120.0	40.0	33.5	W1
b	1.09	Nat 1	2	115.0	120.0	0.0	31.0	W1
c	1.10	Nat 2	3	110.0	115.0	0.0	24.0	W1
d	1.10	Ash	4	84.0	100.0	0.0	30.0	W1

PCSTABL5M/si FSmin=1.08

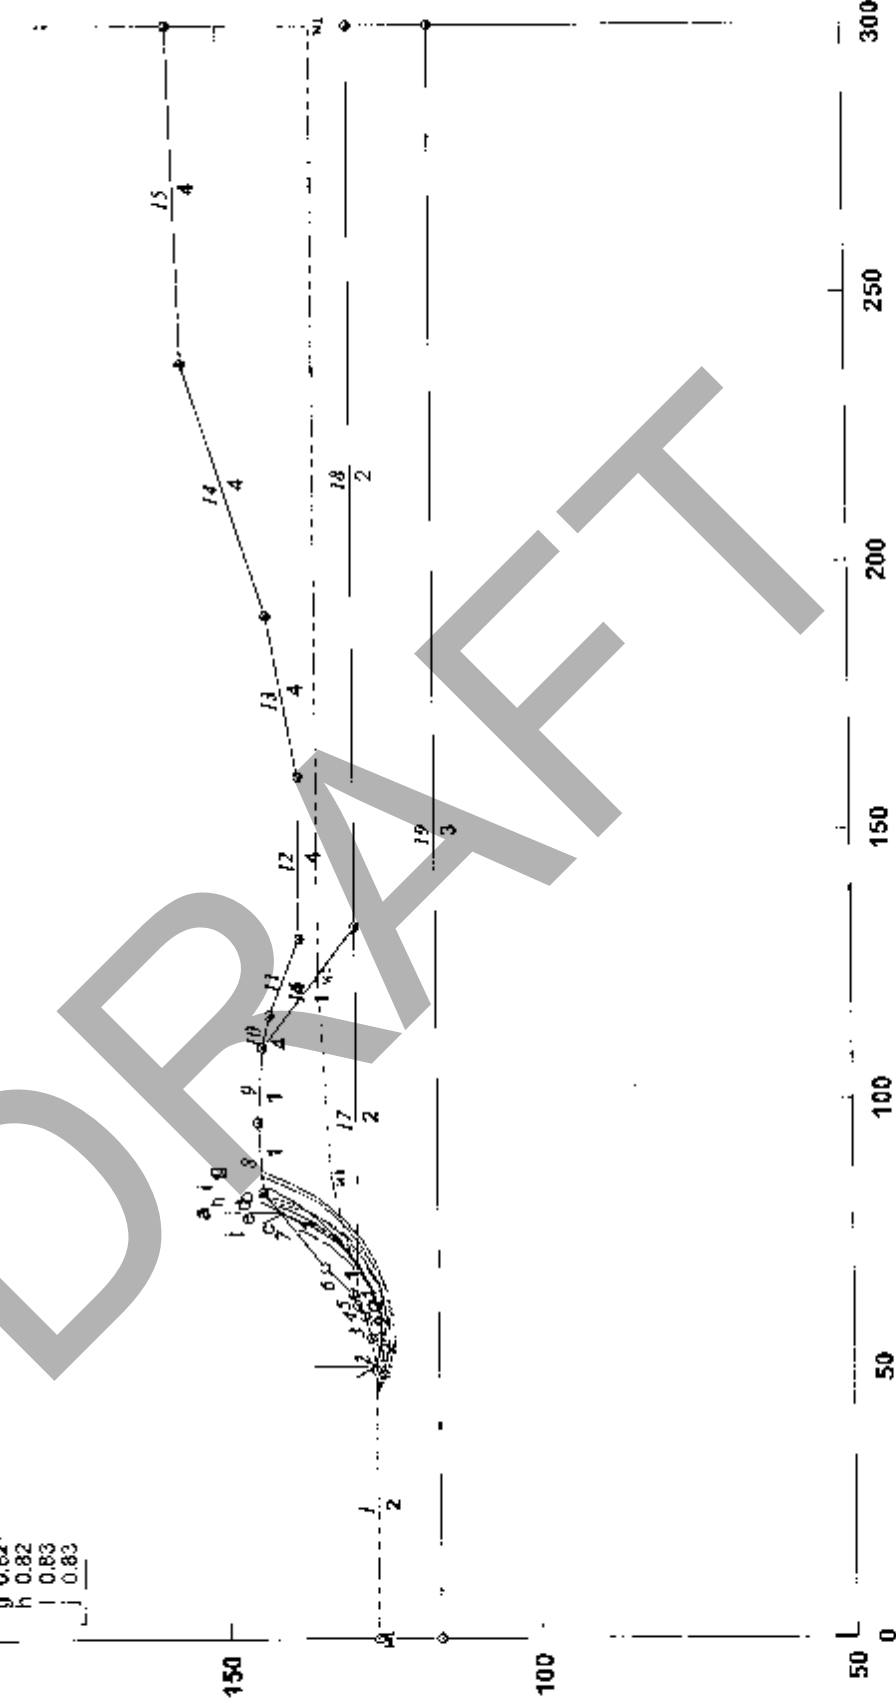
#	FS	Soil Desc.	Soil Type No.	Total Unit Wt. (pcf)	Saturated Unit Wt. (pcf)	Cohesion Intercept (pcf)	Friction Angle (deg)	Piez. Surfaco No.	Load Horiz Eqk	Value
a	0.80	Dike	1	115.0	120.0	40.0	33.5	W1		
b	0.81	Nat1	2	115.0	120.0	0.0	31.0	W1		
c	0.82	Nat2	3	110.0	115.0	0.0	24.0	W1		
d	0.82	Ash	4	84.0	100.0	0.0	30.0	W1		
e	0.82									
f	0.82									
g	0.82									
h	0.82									
i	0.83									
j	0.83

PCSTABL5M/si FSmin=0.80
Safety Factors Are Calculated By The Modified Bishop Method

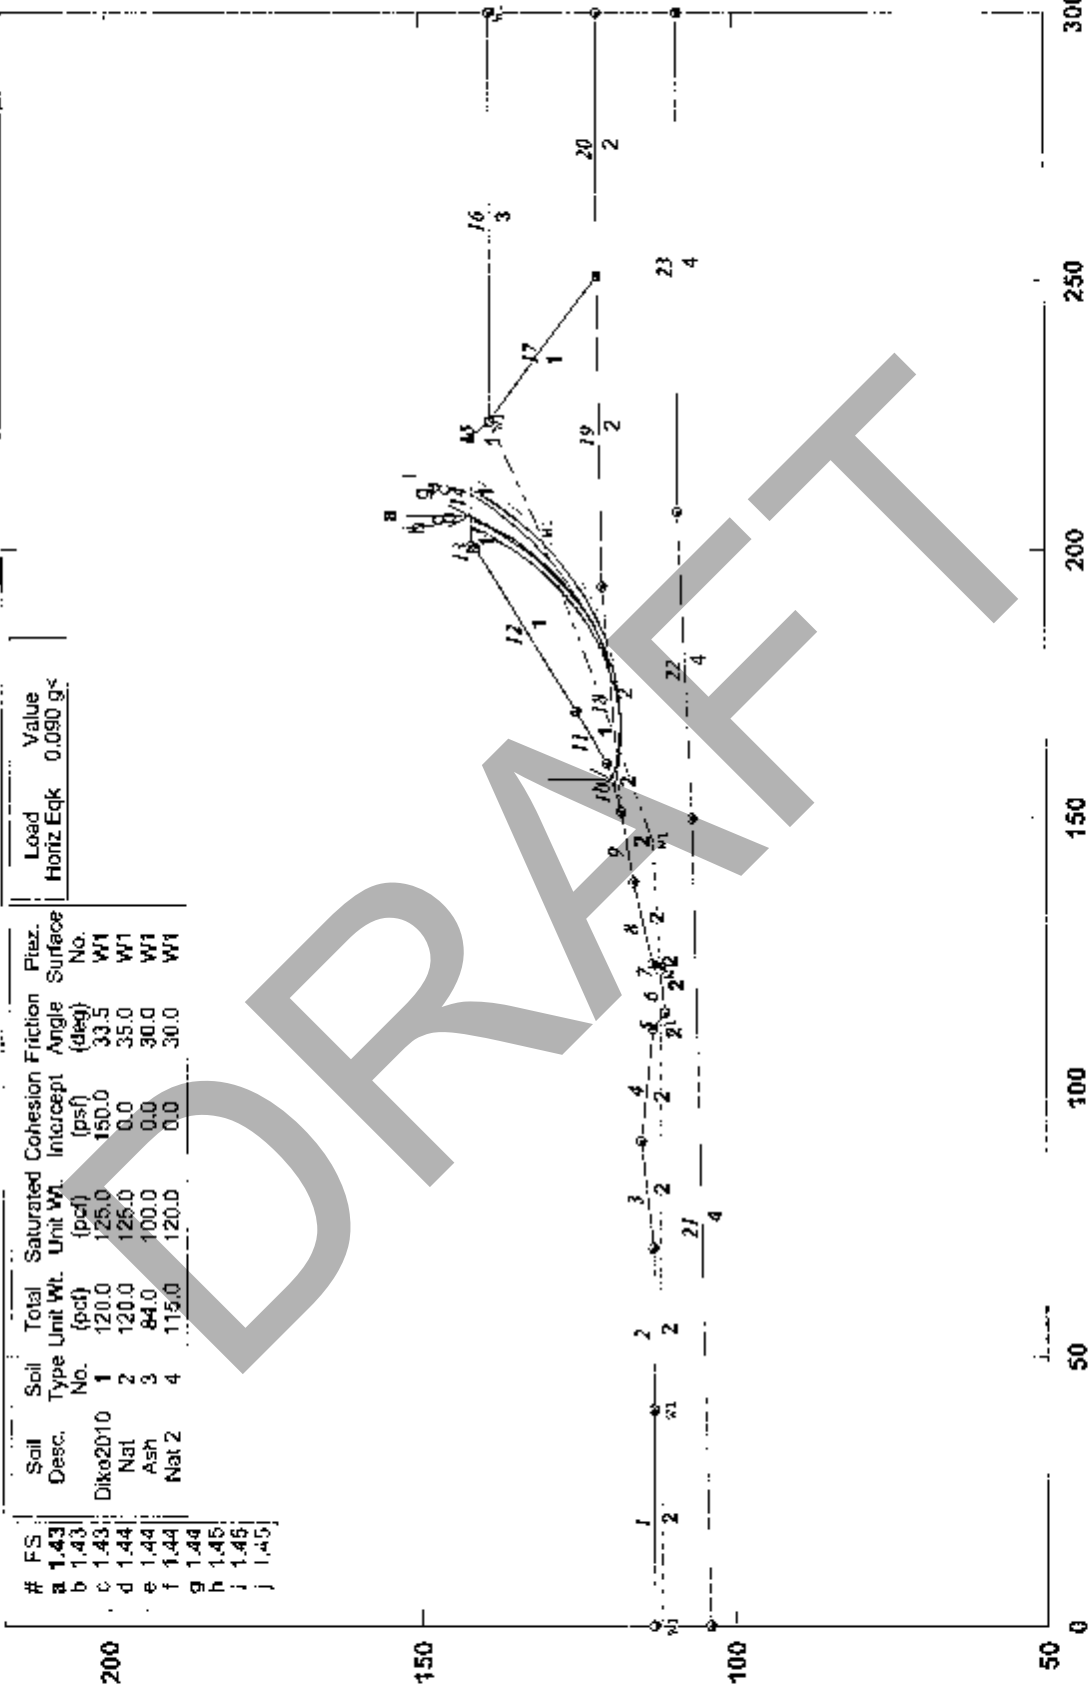
PCSTABL5M/si FSmin=1.43

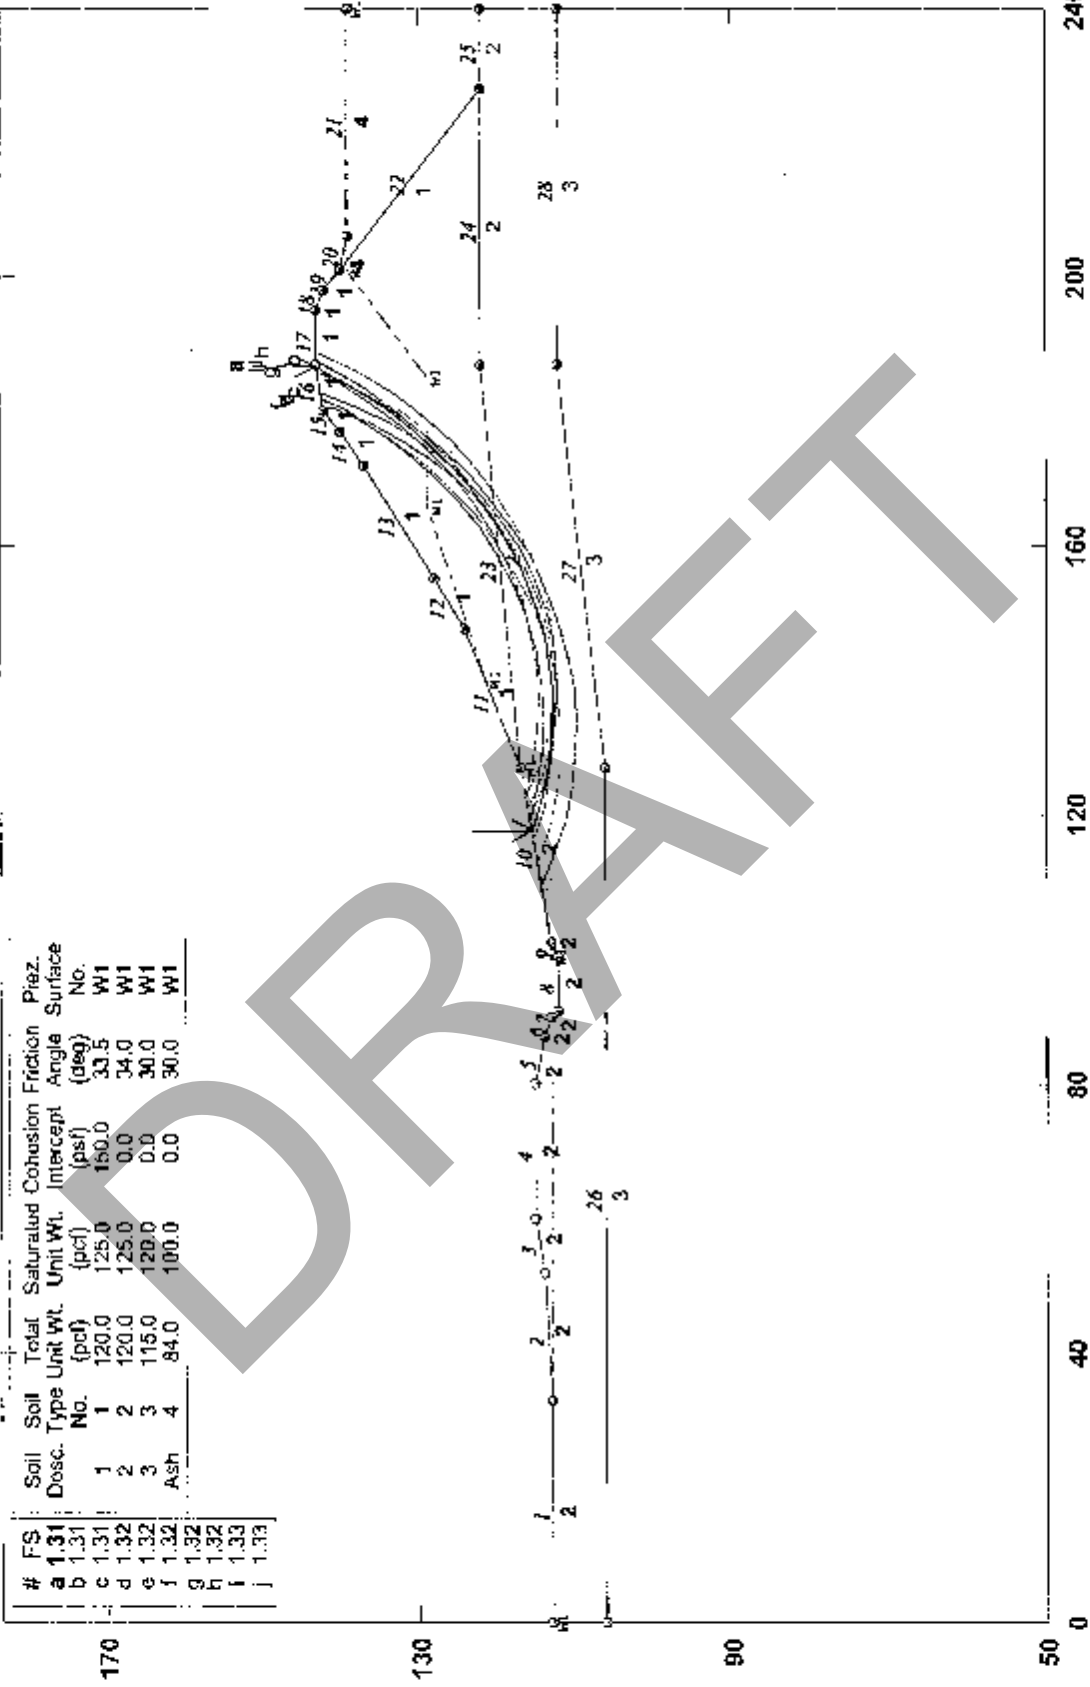
Progress Energy -Weatherspoon Ash Pond- South Sec# 2 Failure thru Foundation

PCSTABL5M/psi FSmin=1.31
Safety Factors Are Calculated By The Modified Bishop Method

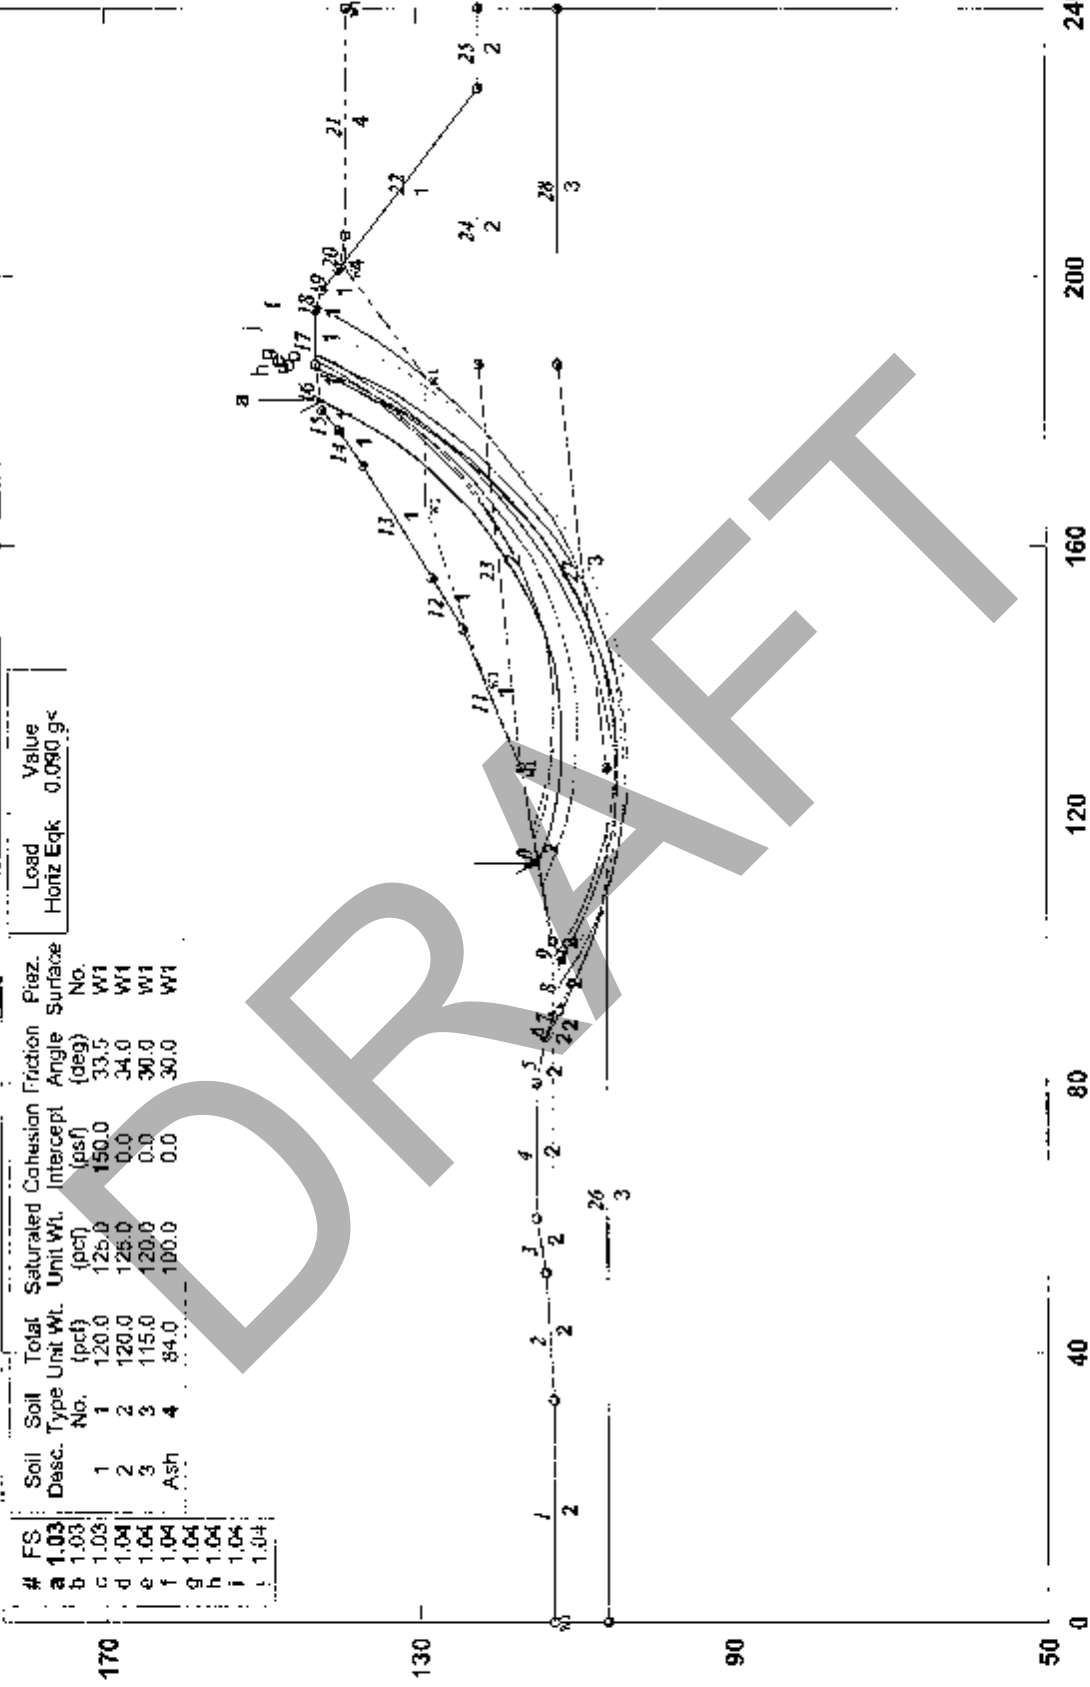
Progress Energy - Weatherspoon Ash Pond - South Sect# 2 Fail - Foundation Seismic

PCSTABL5M/psi FSmin=1.03

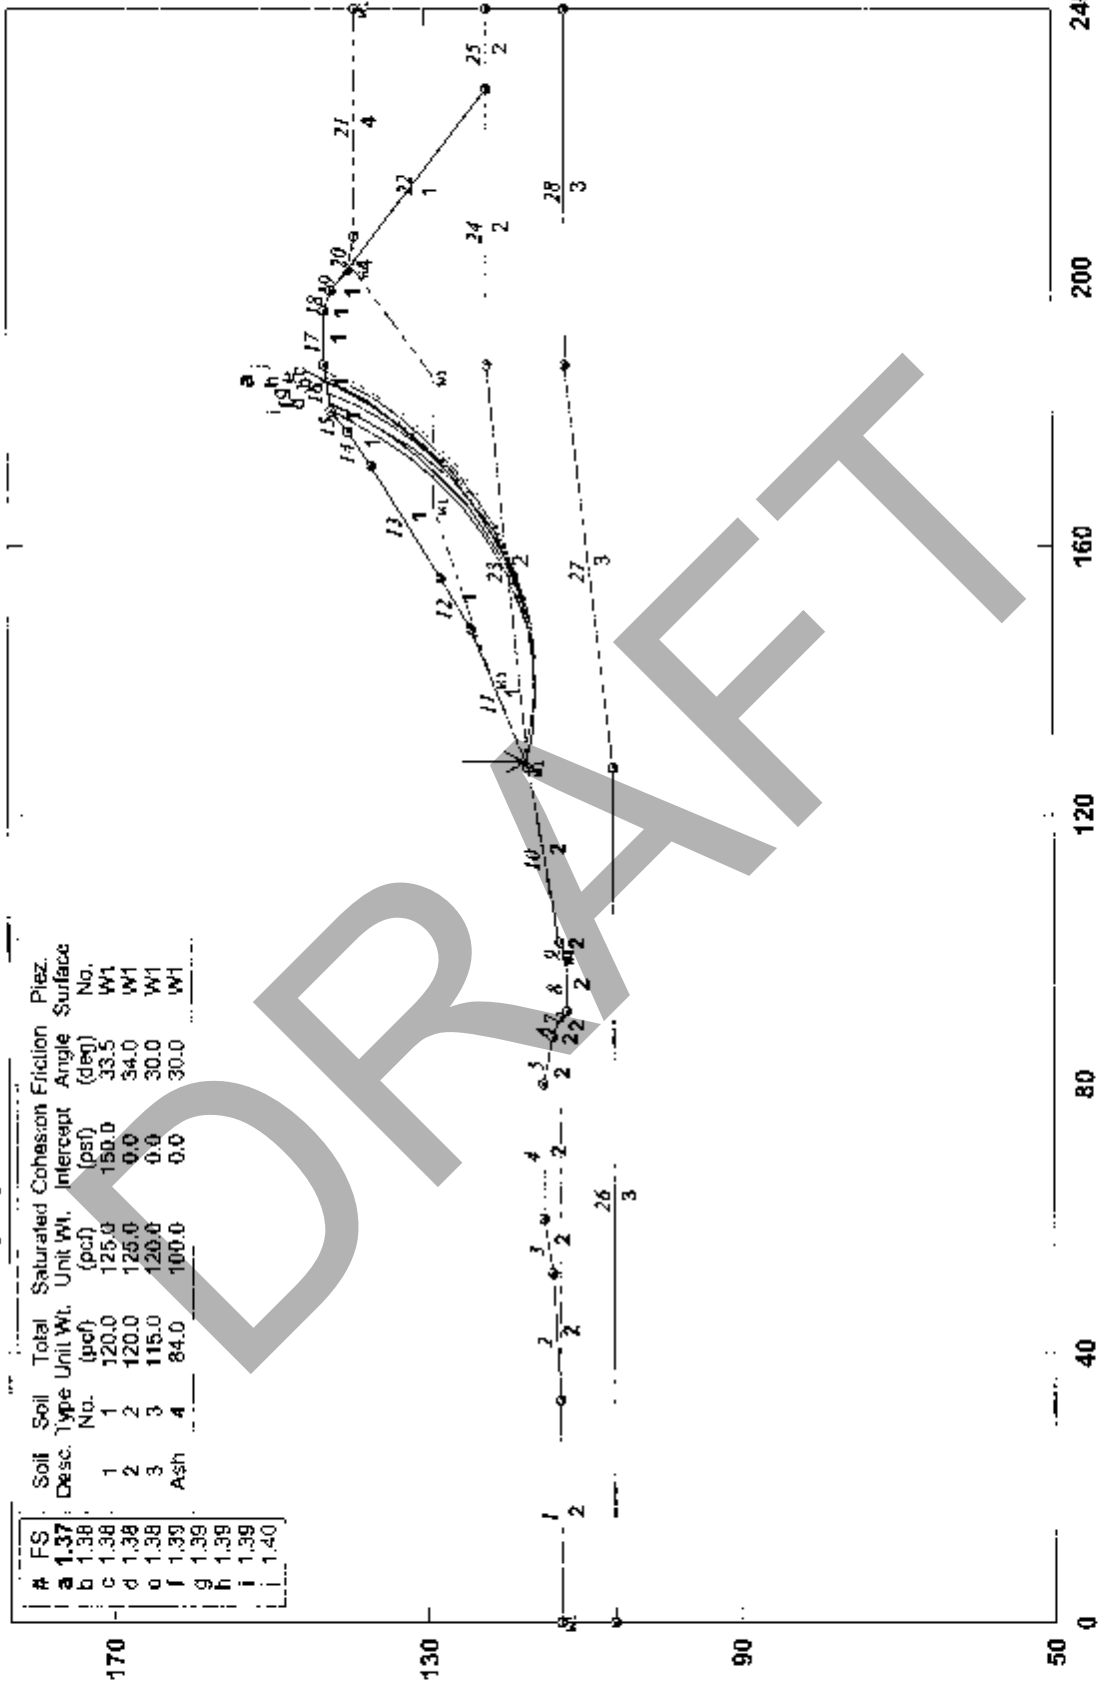
Progress Energy -Weatherspoon Ash Pond- South Dike - Section 2- within dike

PCSTABL5M/si FSmin=1.37
Safety Factors Are Calculated By The Modified Bishop Method
