Coal Combustion Residue Impoundment

Round 9 - Dam Assessment Report

Weatherspoon Steam Electric Plant

Ash Pond Embankment

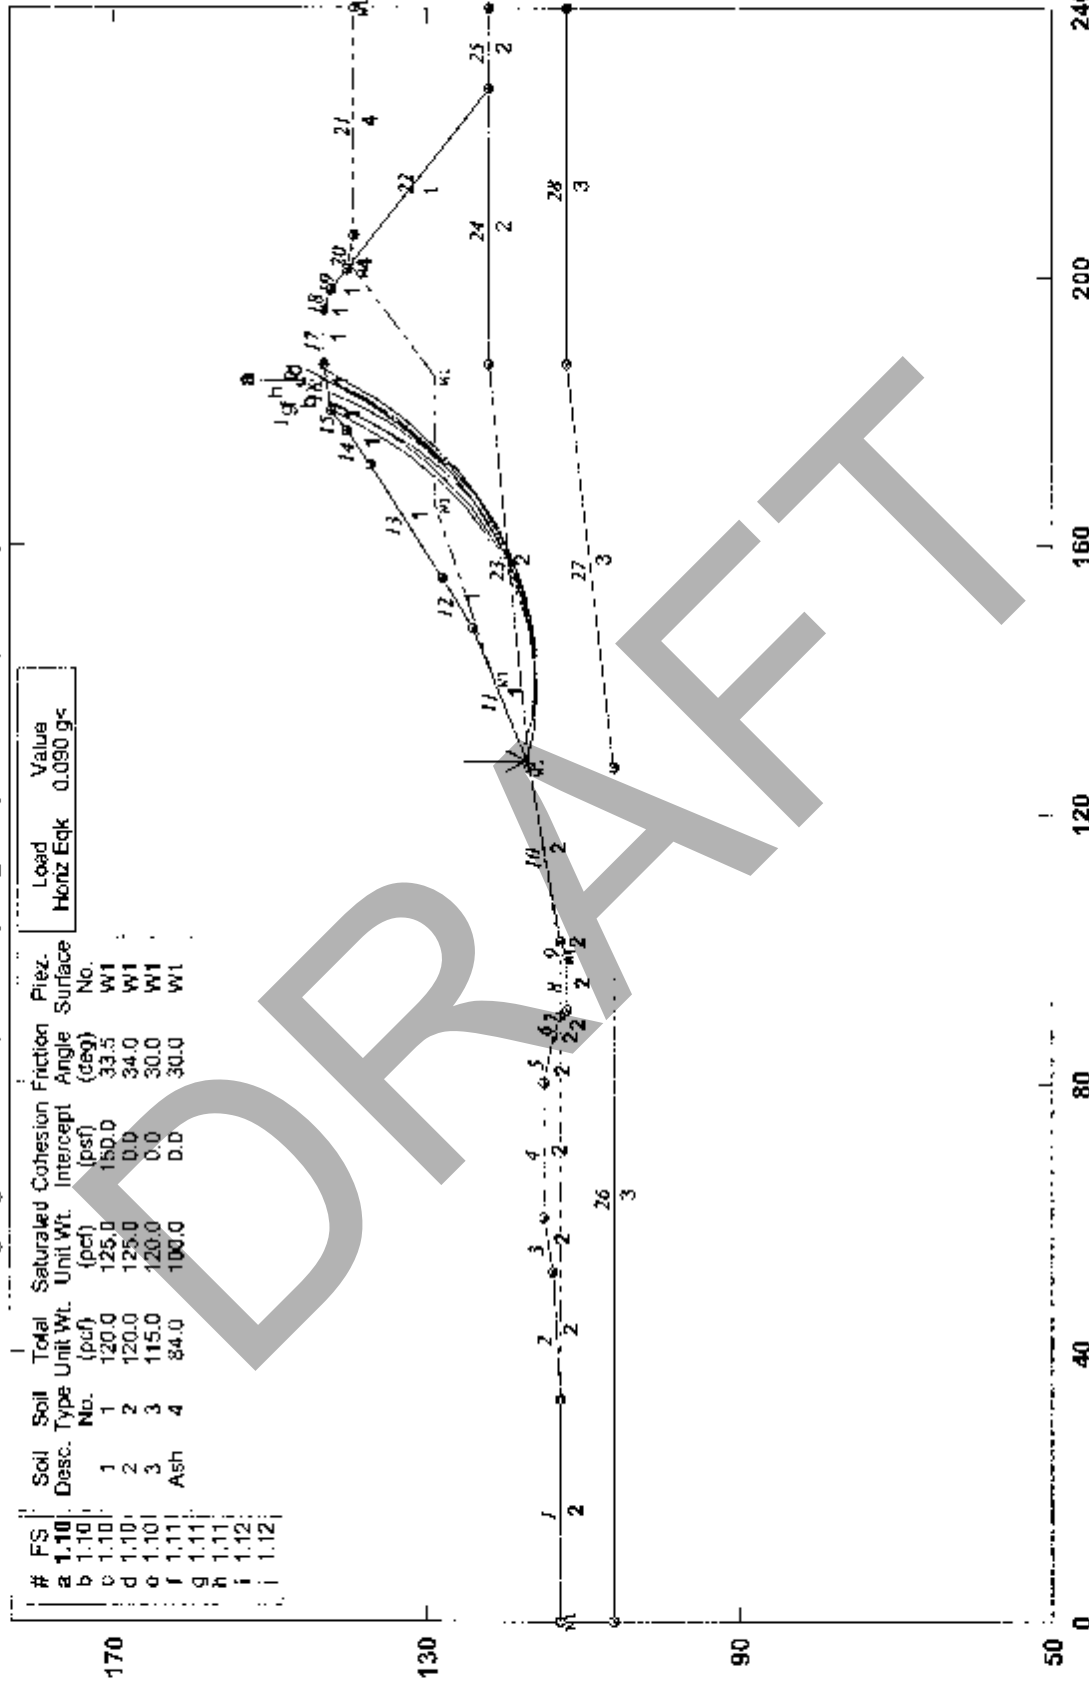
Progress Energy -Weatherspoon Ash Pond- South - Section 2- within dike -Seismic

PCSTABL5M/si FSmin=1.10
Safety Factors Are Calculated By The Modified Bishop Method

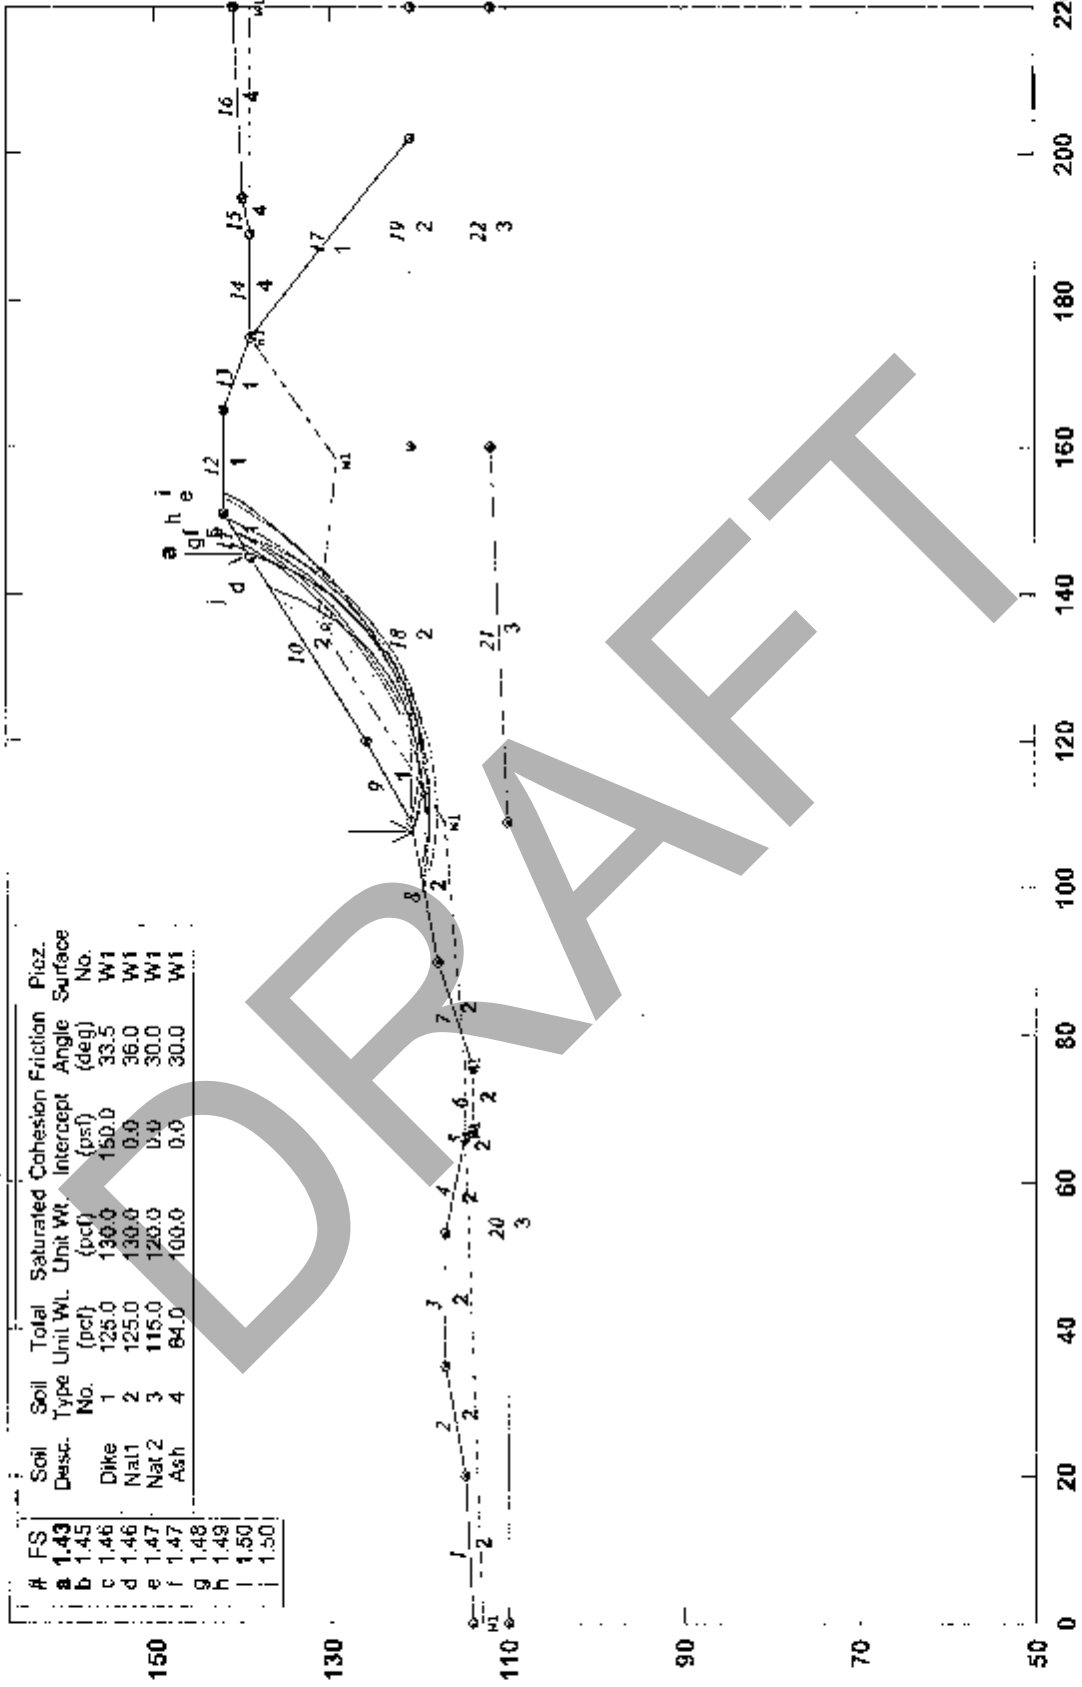
Progress Energy - Weatherspoon South Dike - Section 3

#	FS
a	1.43
b	1.45
c	1.46
d	1.46
e	1.47
f	1.47
g	1.48
h	1.48
i	1.50
j	1.50

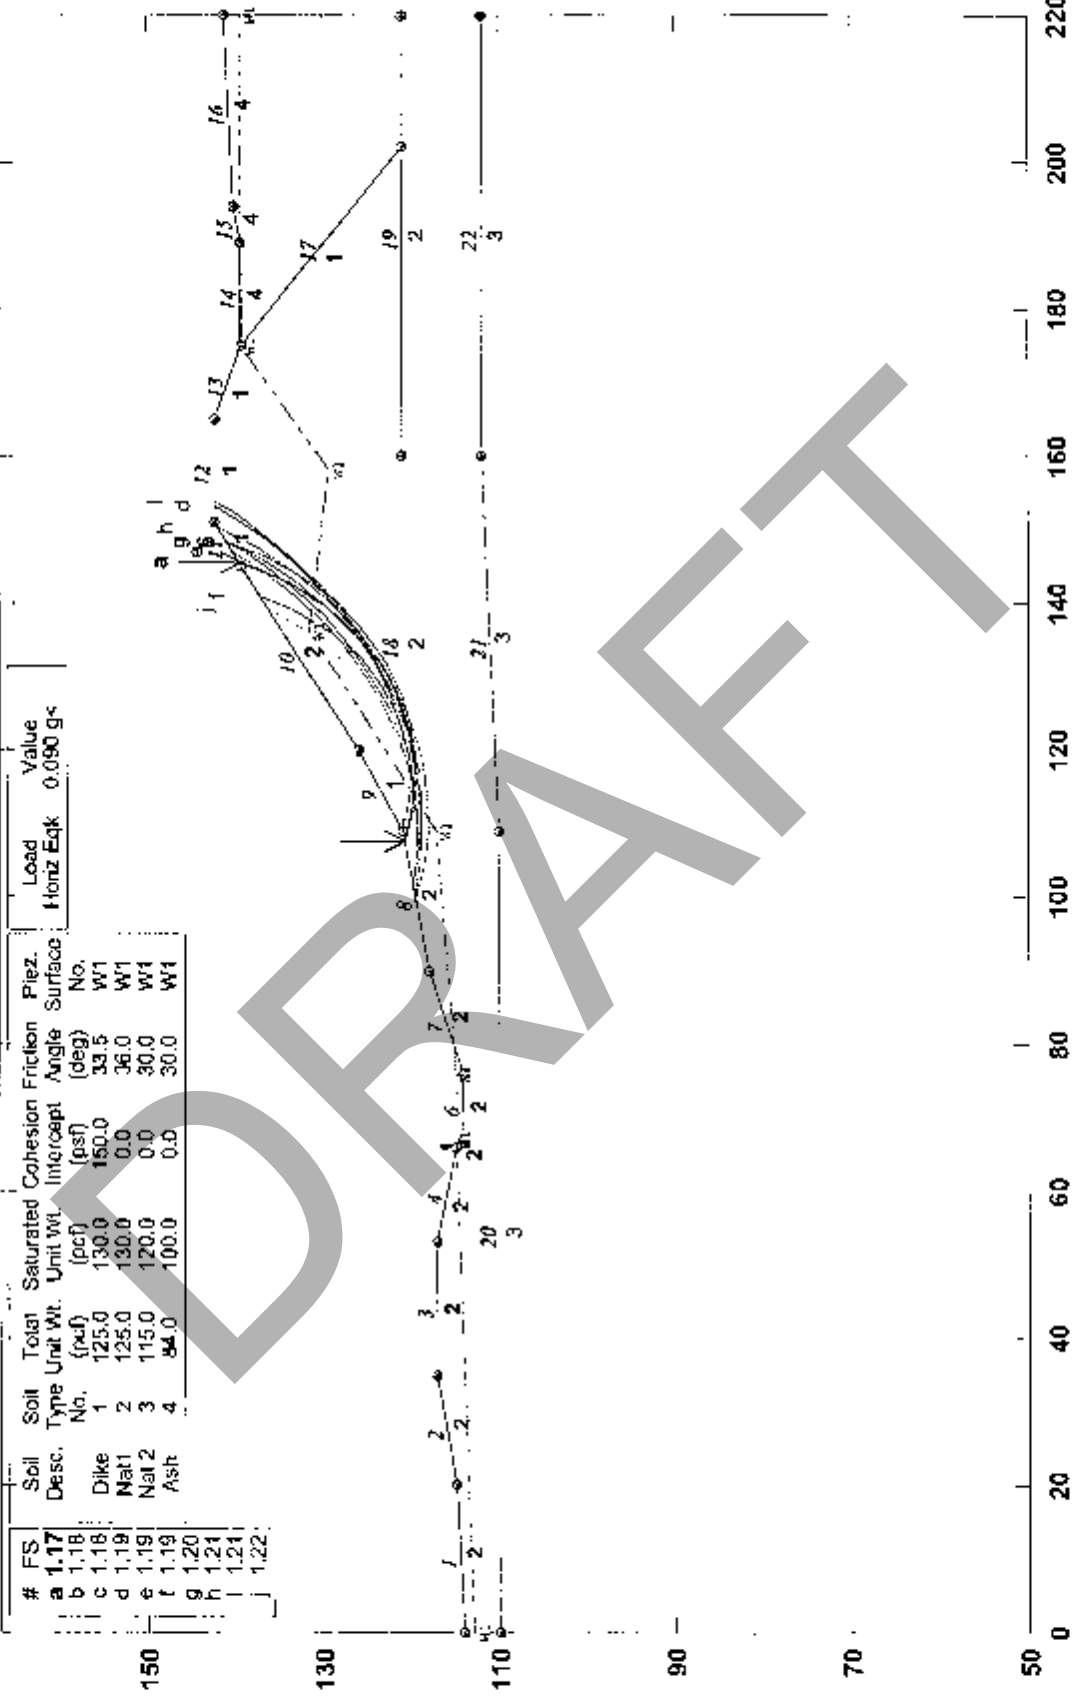
Progress Energy - Weatherspoon South Dike - Section 3 - Seismic

PCSTABL5M/si FSmin=1.17

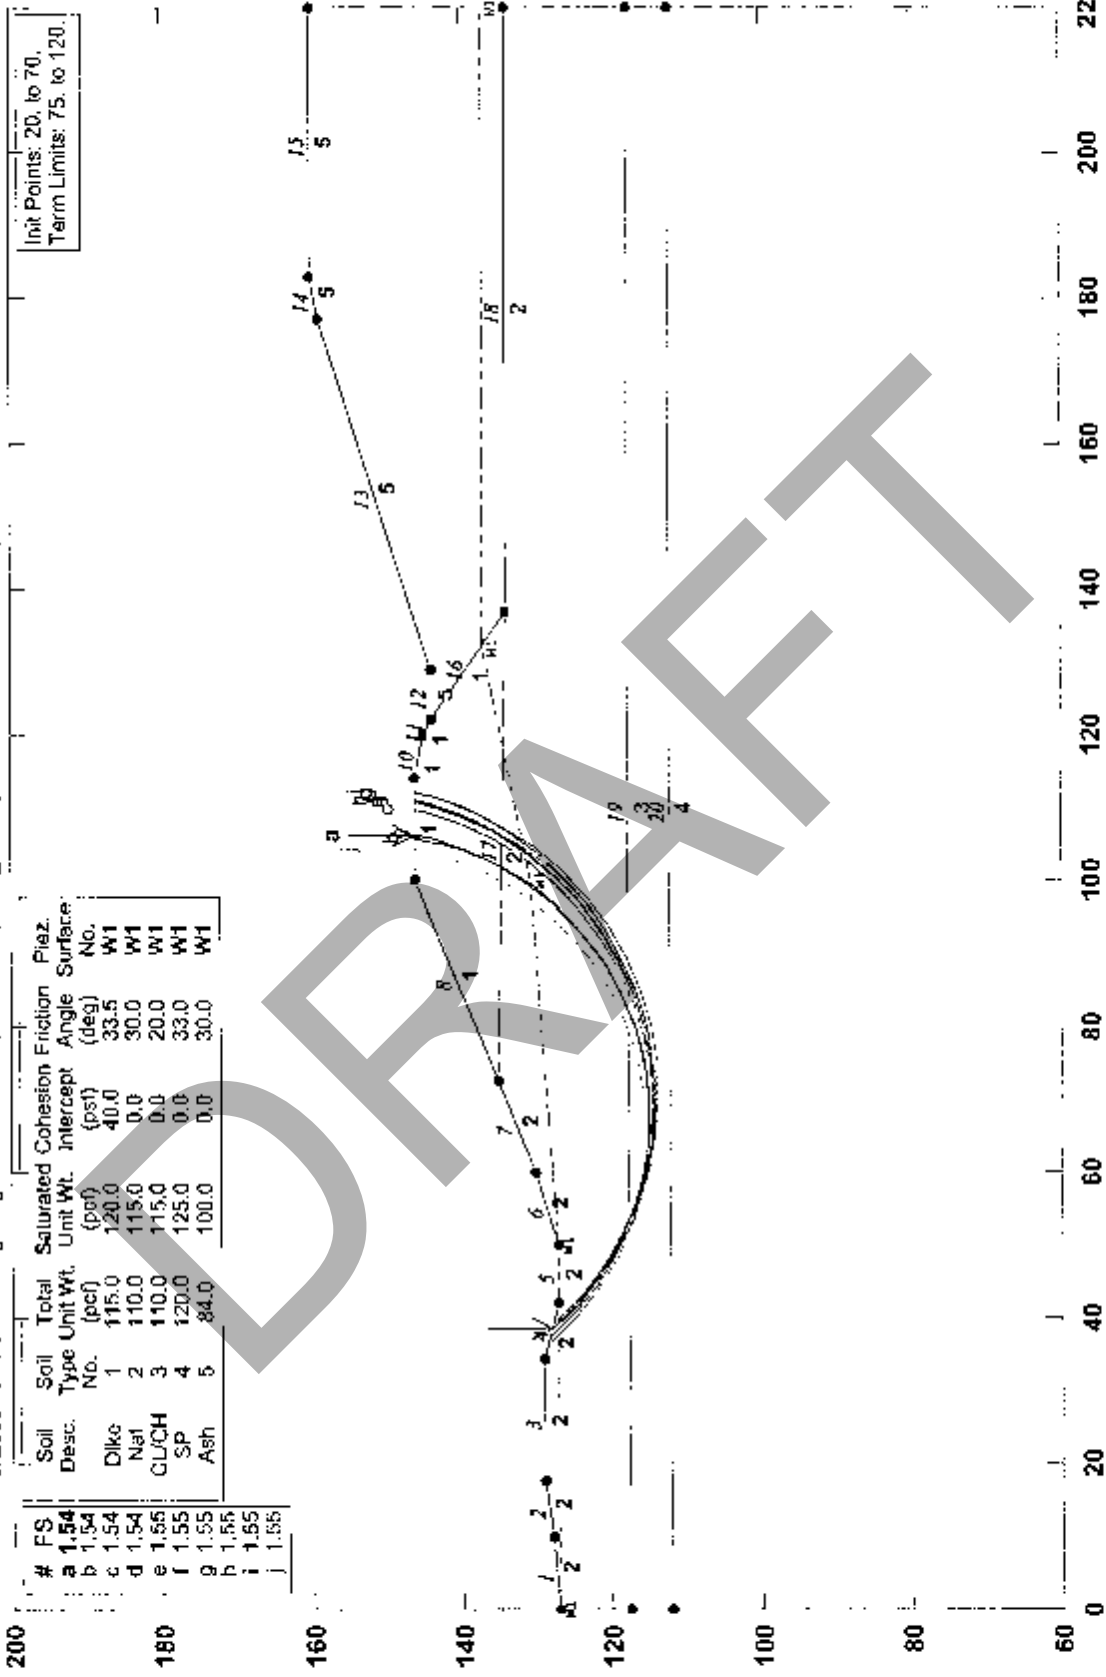
Progress Energy -Weather Spoon Ash Pond North Dike - Section 1 - Slope 2.5H:1V

PCSTABL5M/si FSmin=1.54

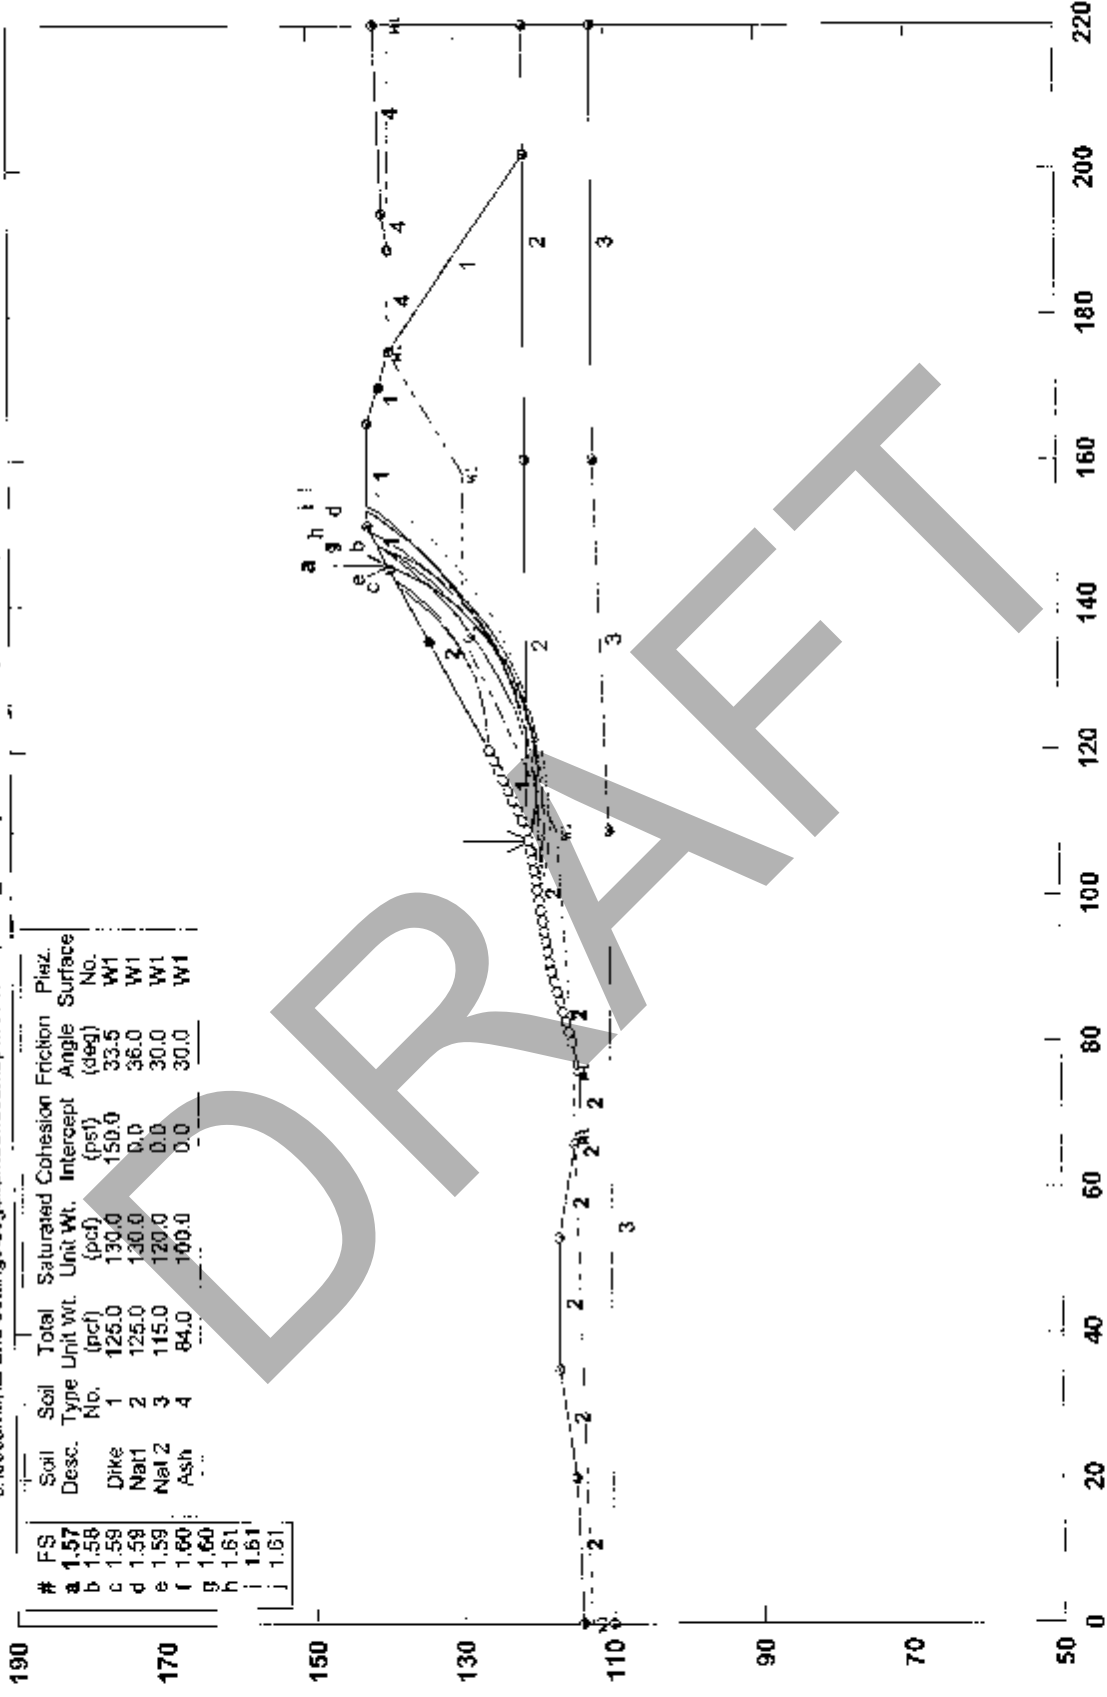
Progress Energy - Weatherspoon South Dike_Sec#3_lower_H2o by 2'

PCSTABLEM/si FSmin=1.57

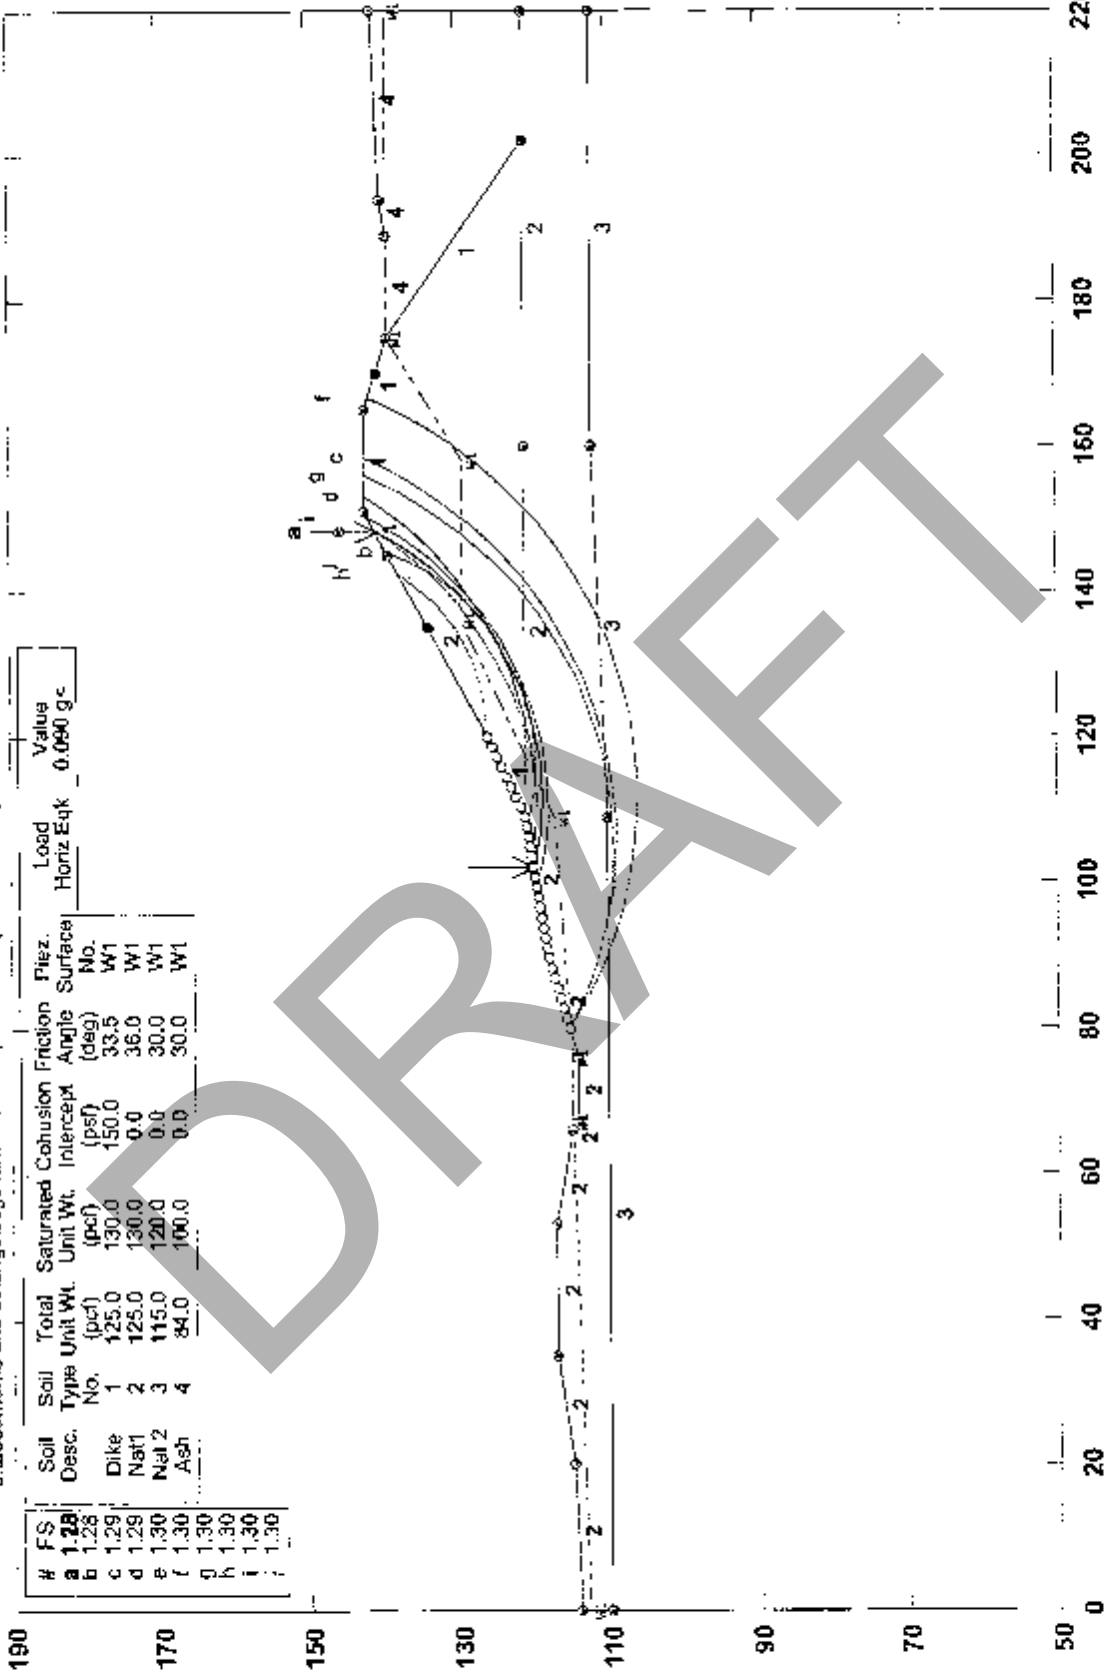
Progress Energy - Weatherspoon South Dike_Sec#3_lower_H2o by 2'-Seism

PCSTABL5M/si FSmin=1.28
Safety Factors Are Calculated By The Modified Bishop Method

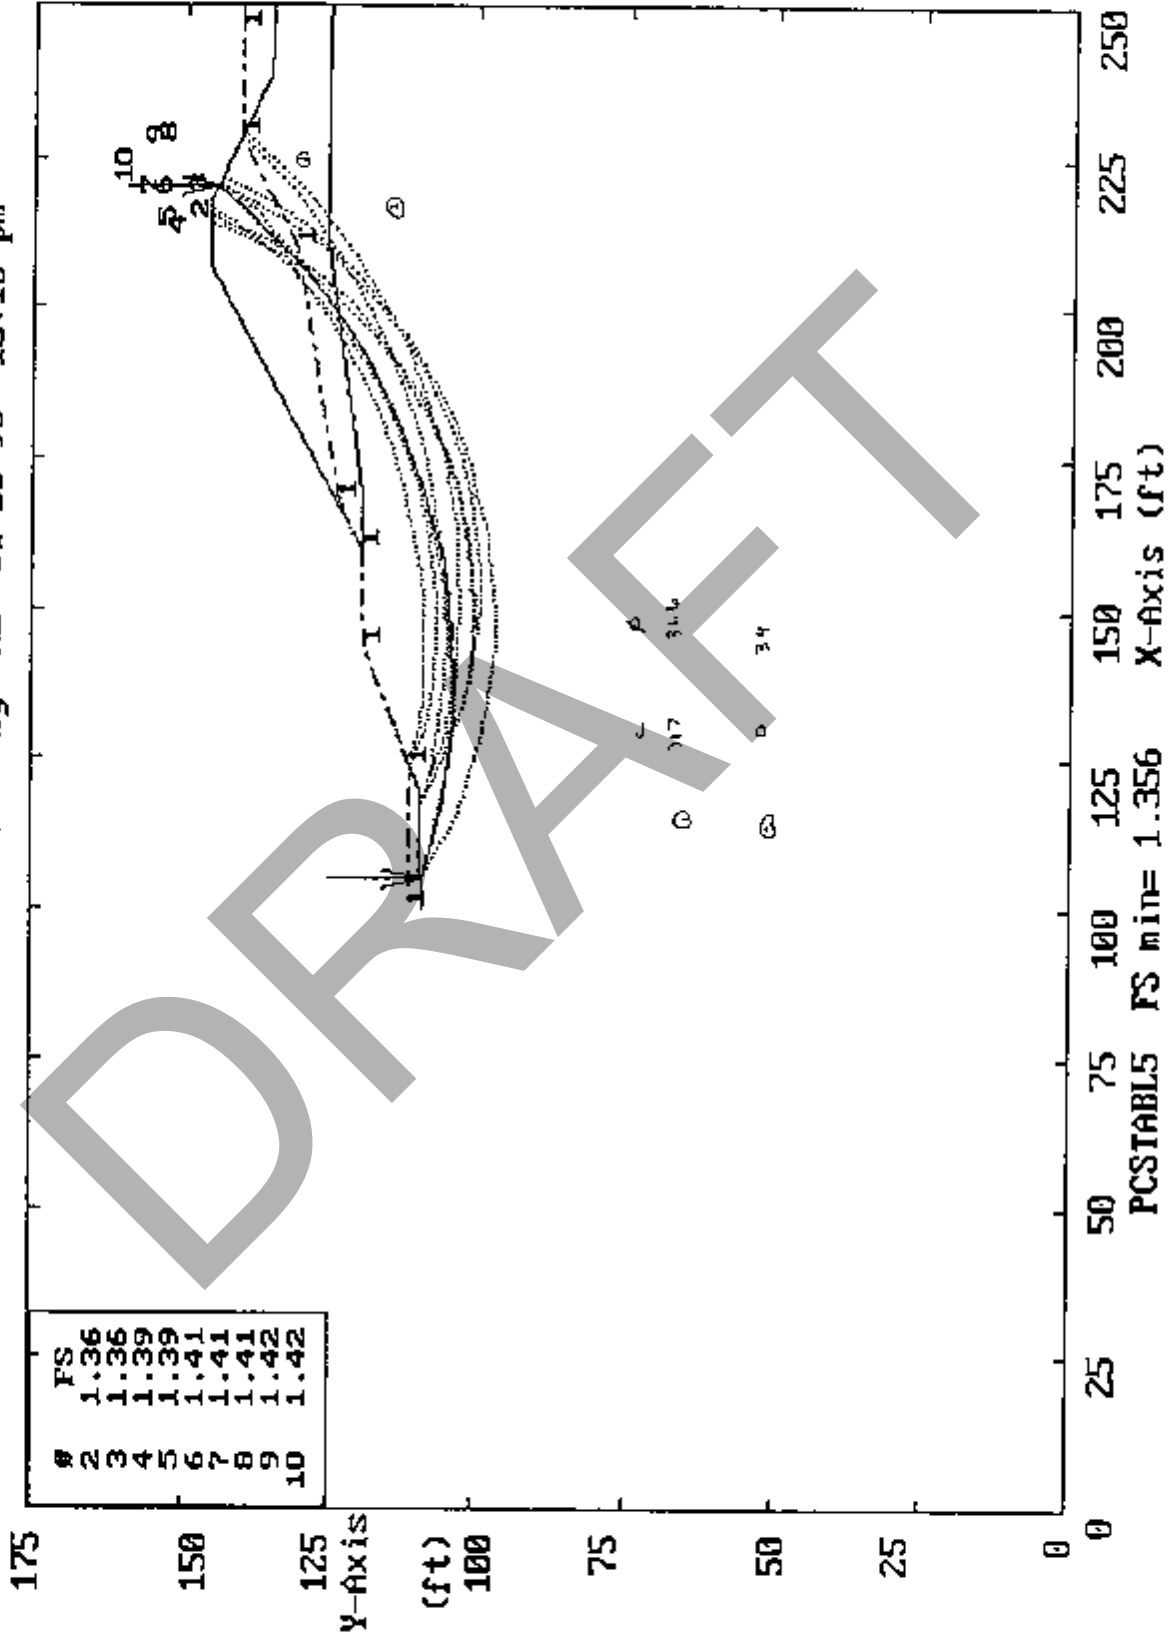
CP&L WEATHERSPOON ASH POND DIKE SEEPAGE SECTION 3A-3C 1/12/93
 Ten Most Critical. D:\WSP3D.PLT By: ML 01-20-93 12:13 pm

Several computer modeled slope stability analyses were performed for the worse case dike section. The dike section at our well set, 3A to 3C, was used because it was the steepest section. Strength values were estimated from average SPT values and soil types obtained in the borings. The triaxial test results were used for comparison. Based on our stability analyses, again varying input parameters, we obtained the following results with respect to factor of safety against a deep circular failure:

RUN #	SOIL #1 PARAMETERS **			SOIL #2 PARAMETERS **			FS AGAINST CIRCULAR FAILURE*
	γ	ϕ	c	γ	ϕ	c	
WSP3D	115	31.6	317	115	34	0	1.35
WSP3E	115	31.6	317	115	34	50	1.46
WSP3F	115	30	400	115	34	0	1.38
WSP3G	115	30	400	115	34	0	1.42***

Based on these results and our observations of the saturated zone in the deeper crest borings, we believe that the dike profile is more likely to mimic a lower phreatic condition thereby providing a FS against circular failure of approximately 1.4.

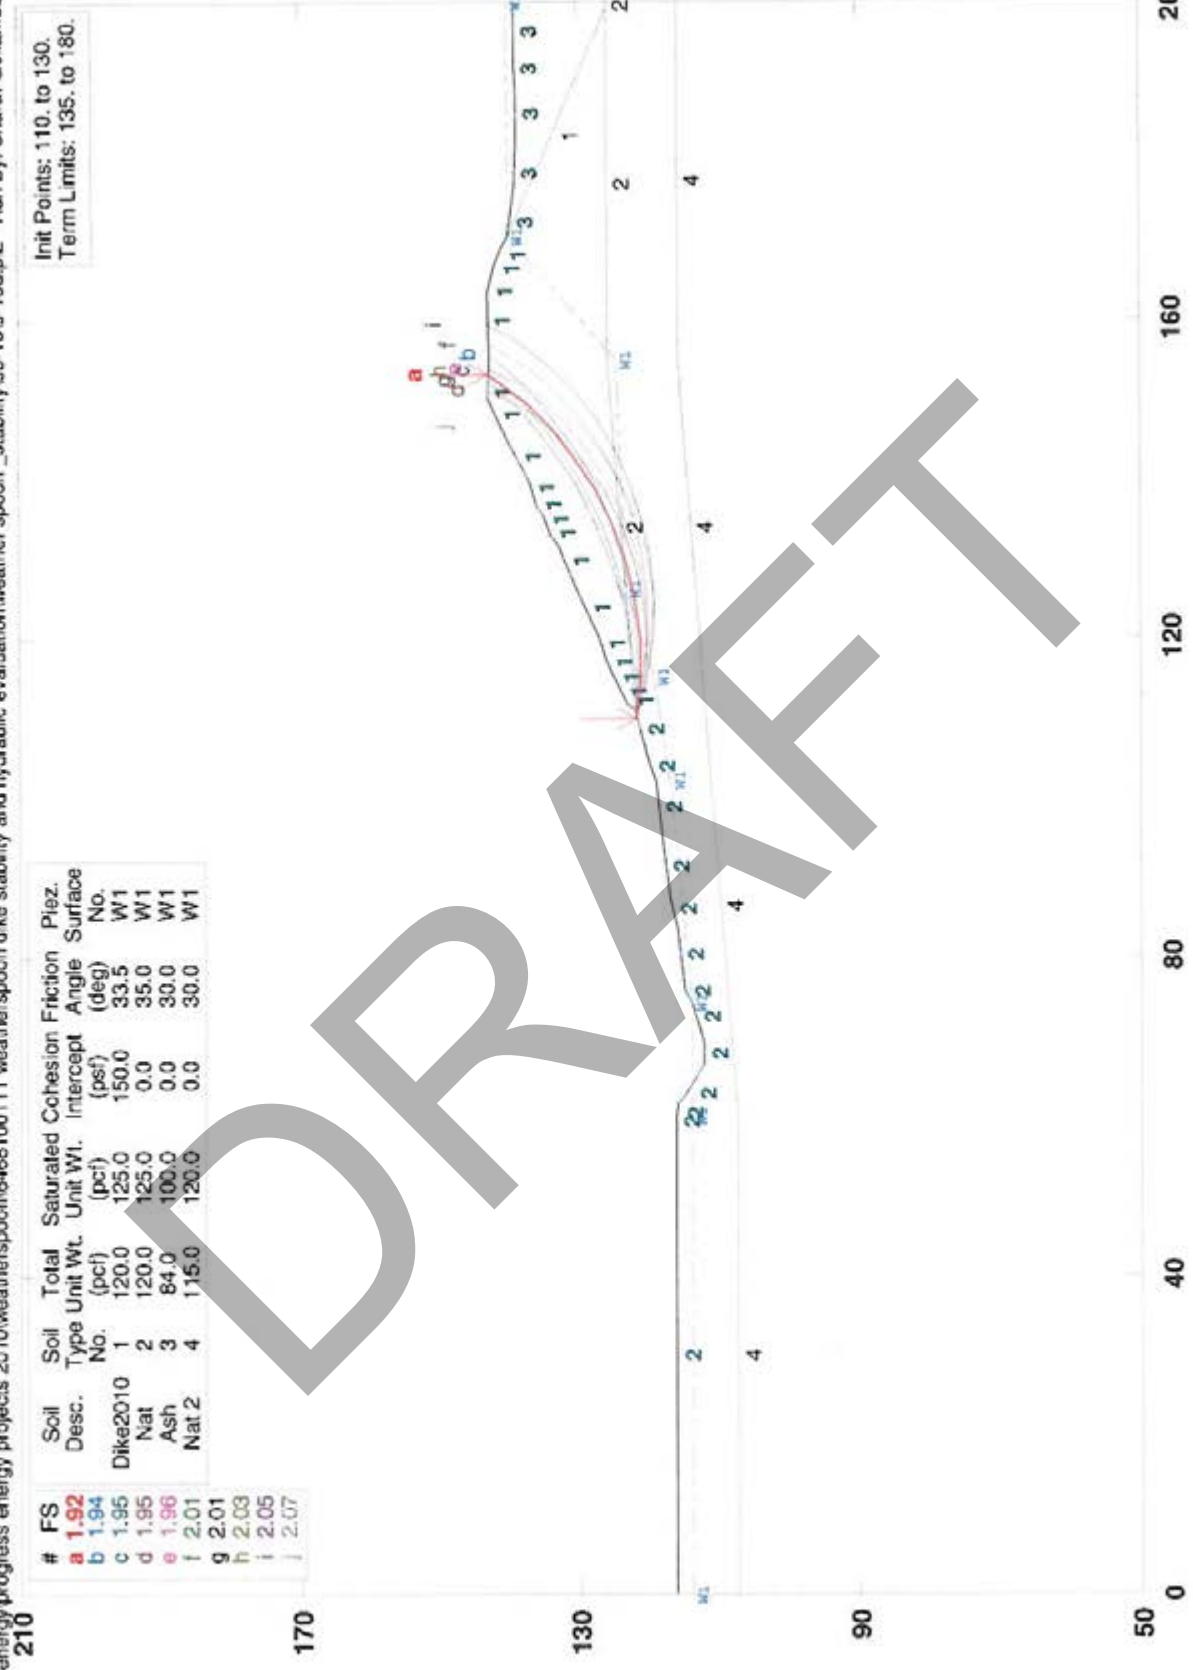
Progress Energy - Weatherspoon Ash Pond South Dike - Section 10 - within Dike

#	FS	Soil Desc.	Soil Type No.	Total Unit Wt. (pcf)	Saturated Unit Wt. (pcf)	Cohesion (psf)	Friction Angle (deg)	Piez. Surface No.
a	1.92	Dike2010	1	120.0	125.0	150.0	33.5	W1
b	1.94	Nat	2	120.0	125.0	0.0	35.0	W1
c	1.95	Ash	3	84.0	100.0	0.0	30.0	W1
d	1.96	Nat 2	4	115.0	120.0	0.0	30.0	W1
e	2.01							
f	2.01							
g	2.01							
h	2.03							
i	2.05							
j	2.07

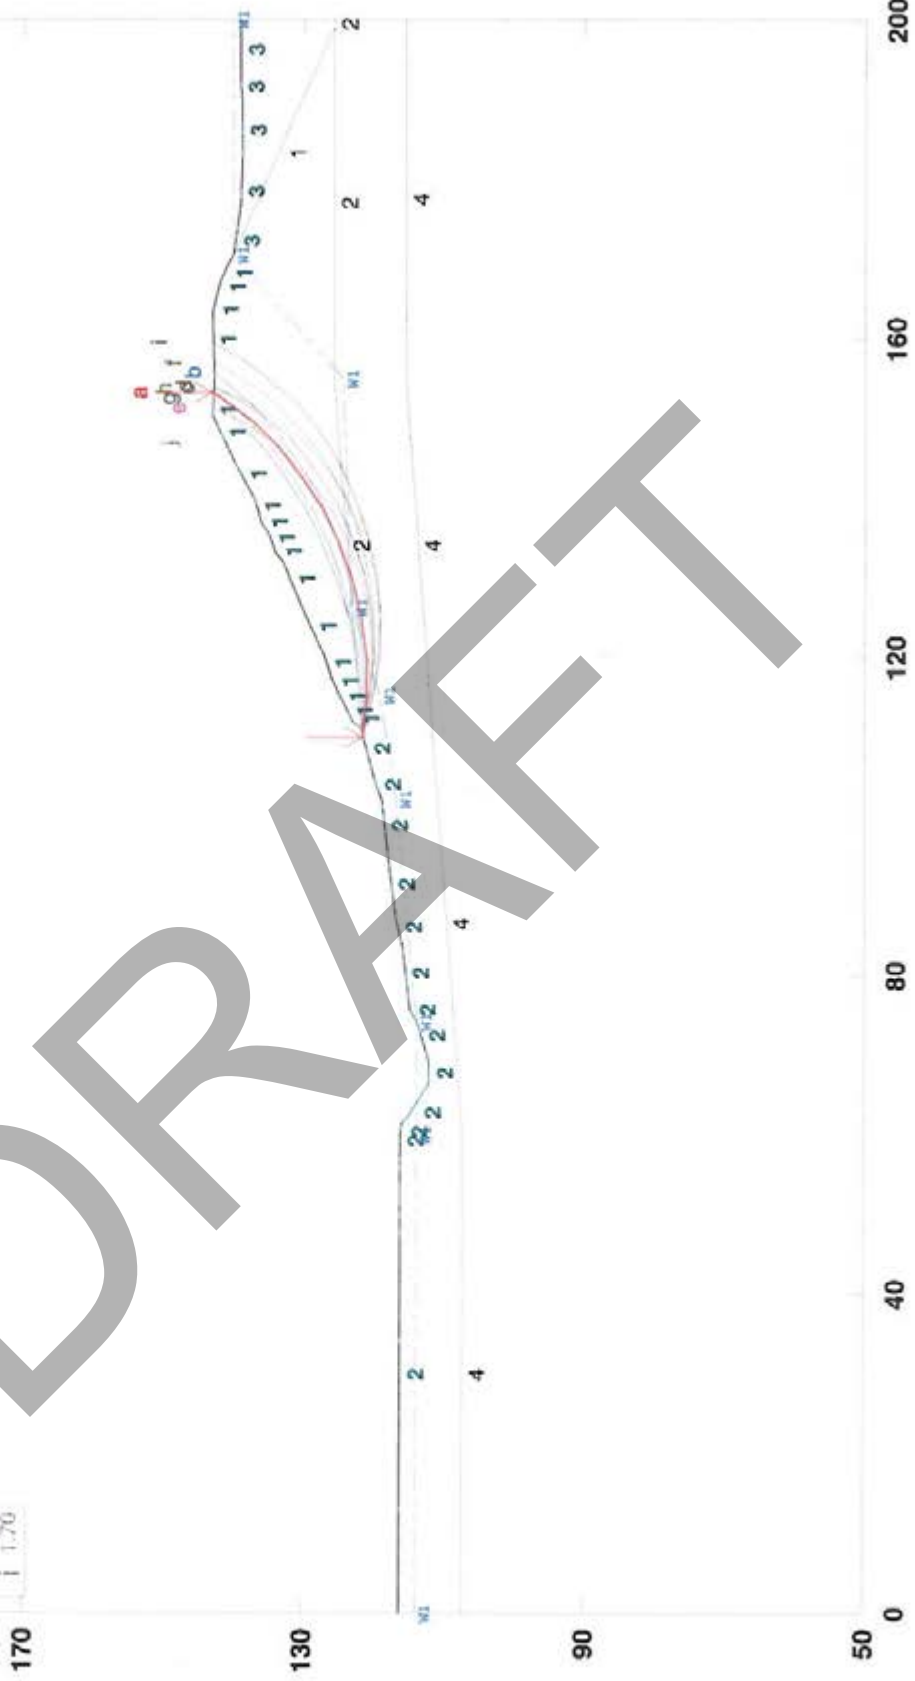
#	FS	Soil Desc.	Soil Type No.	Total Unit Wt. (pcf)	Saturated Unit Wt. (pcf)	Cohesion (psf)	Friction Angle (deg)	Piez. Surface No.	Load Horiz Eqk	Value
a	1.58	Dike2010	1	120.0	125.0	150.0	33.5	W1		
b	1.59	Nat	2	120.0	125.0	0.0	35.0	W1		
c	1.61	Ash	3	84.0	100.0	0.0	30.0	W1		
d	1.61	Nat 2	4	115.0	120.0	0.0	30.0	W1		
e	1.64									
f	1.64									
g	1.66									
h	1.67									
i	1.67									
j	1.70

PCSTABL5M/si FSmin=1.58
Safety Factors Are Calculated By The Modified Bishop Method

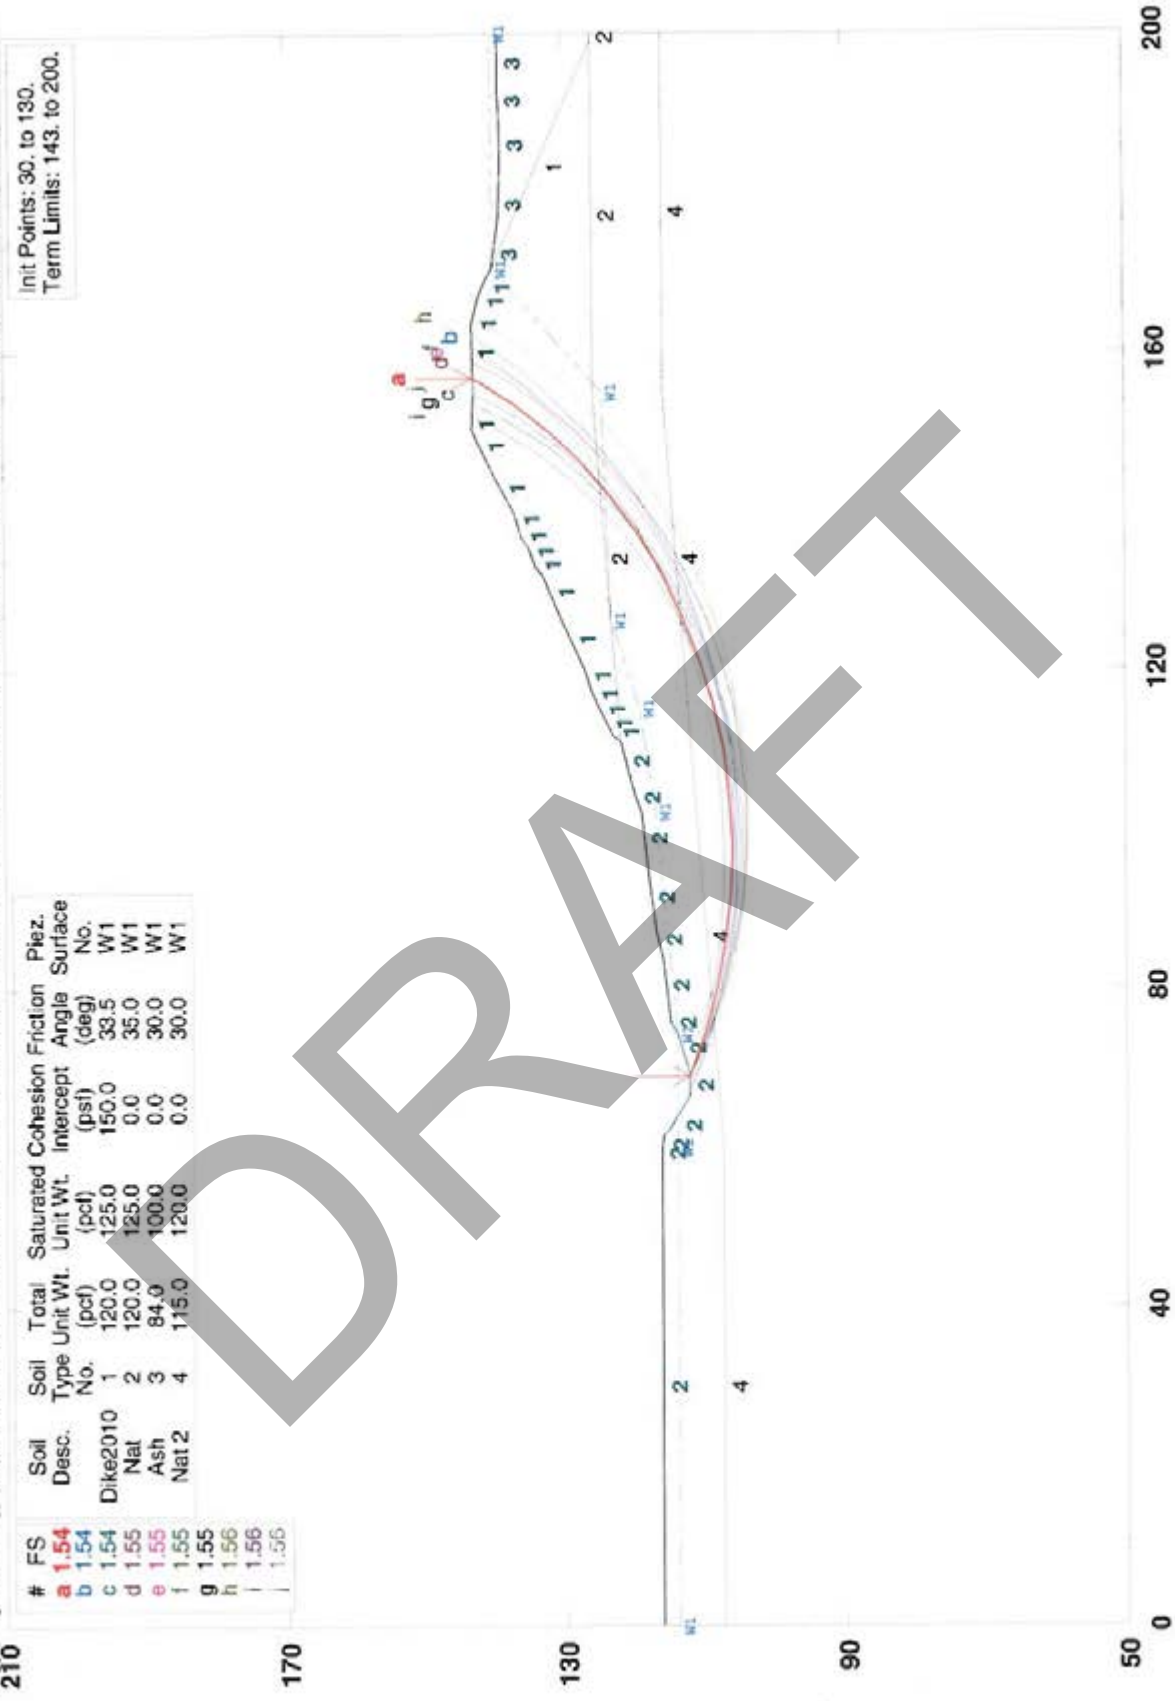
Progress Energy - Weatherspoon Ash Pond South Dike - Section 10 - Deep Failure

PCSTABL5M/si FSmin=1.54
Safety Factors Are Calculated By The Modified Bishop Method

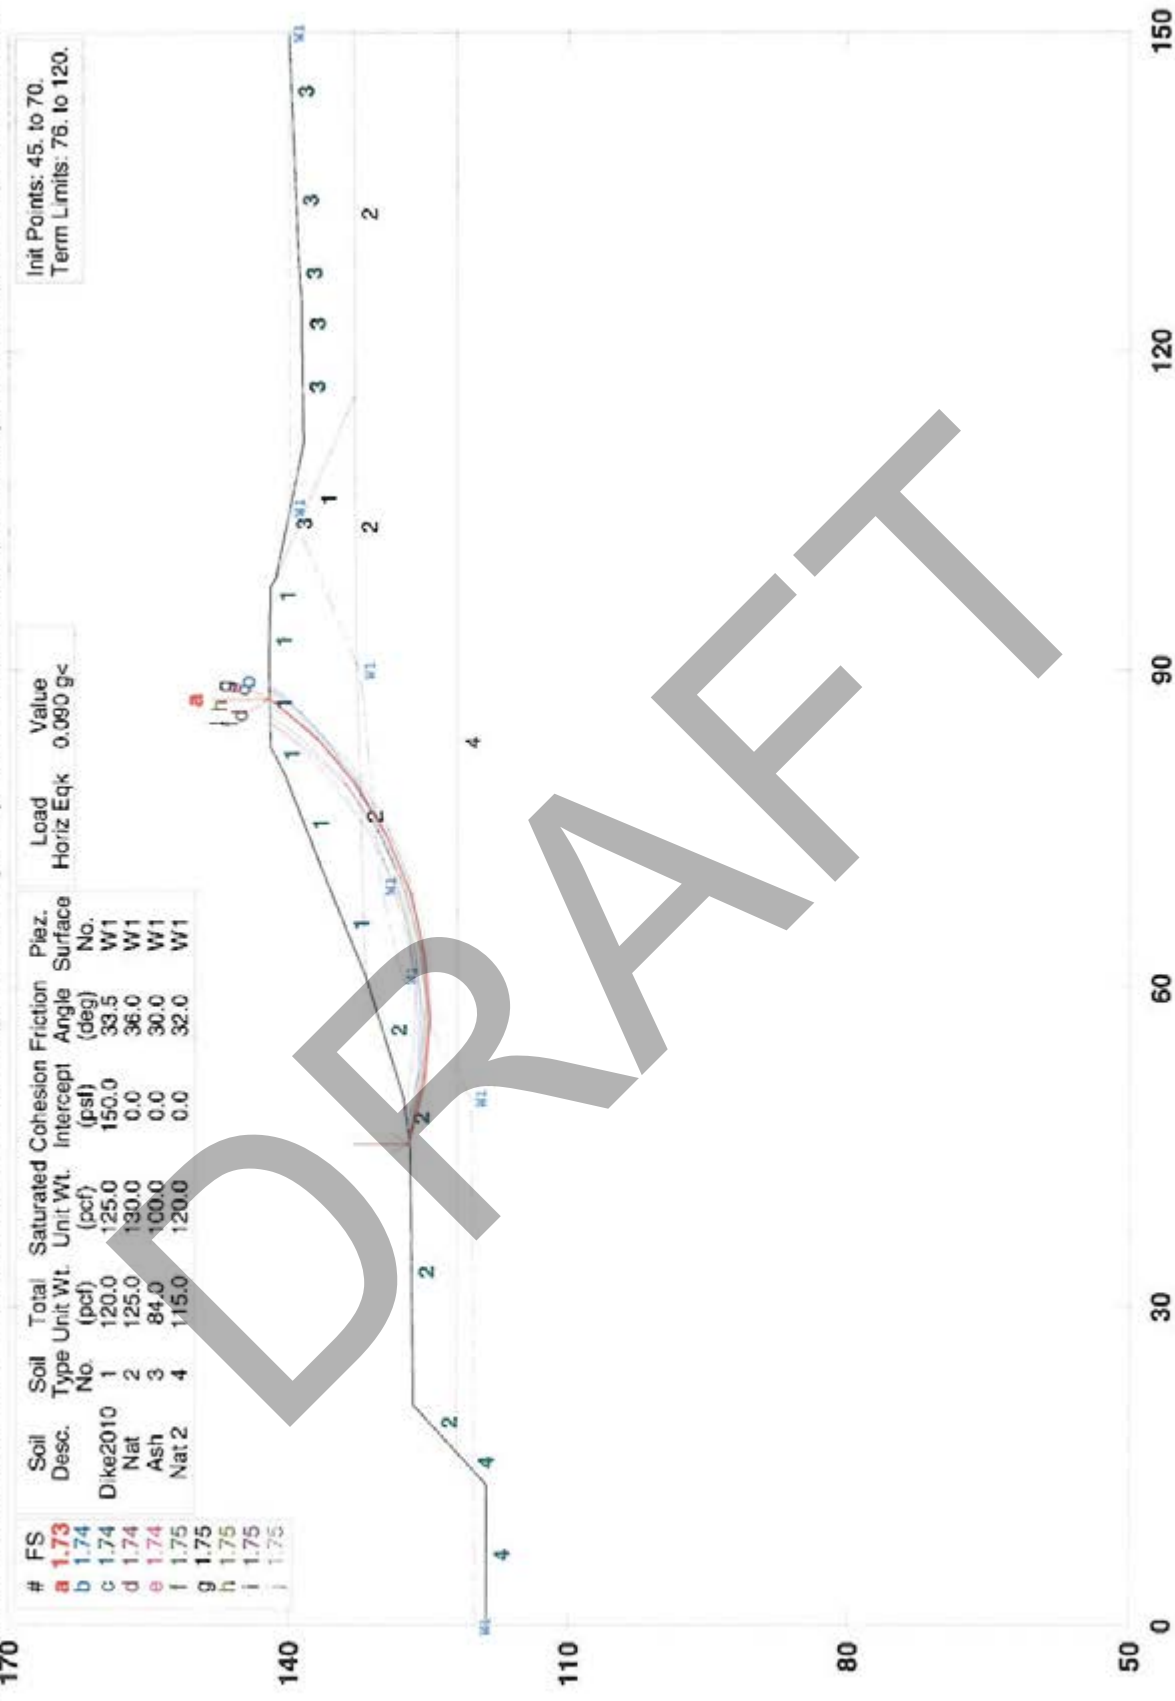
Progress Energy - Weatherspoon Ash Pond South - Sec#12 - within slope (Seismic)

PCSTABL5M/si FSmin=1.73
Safety Factors Are Calculated By The Modified Bishop Method
