Coal Combustion Residue Impoundment

Round 9 - Dam Assessment Report

Weatherspoon Steam Electric Plant

Ash Pond Embankment

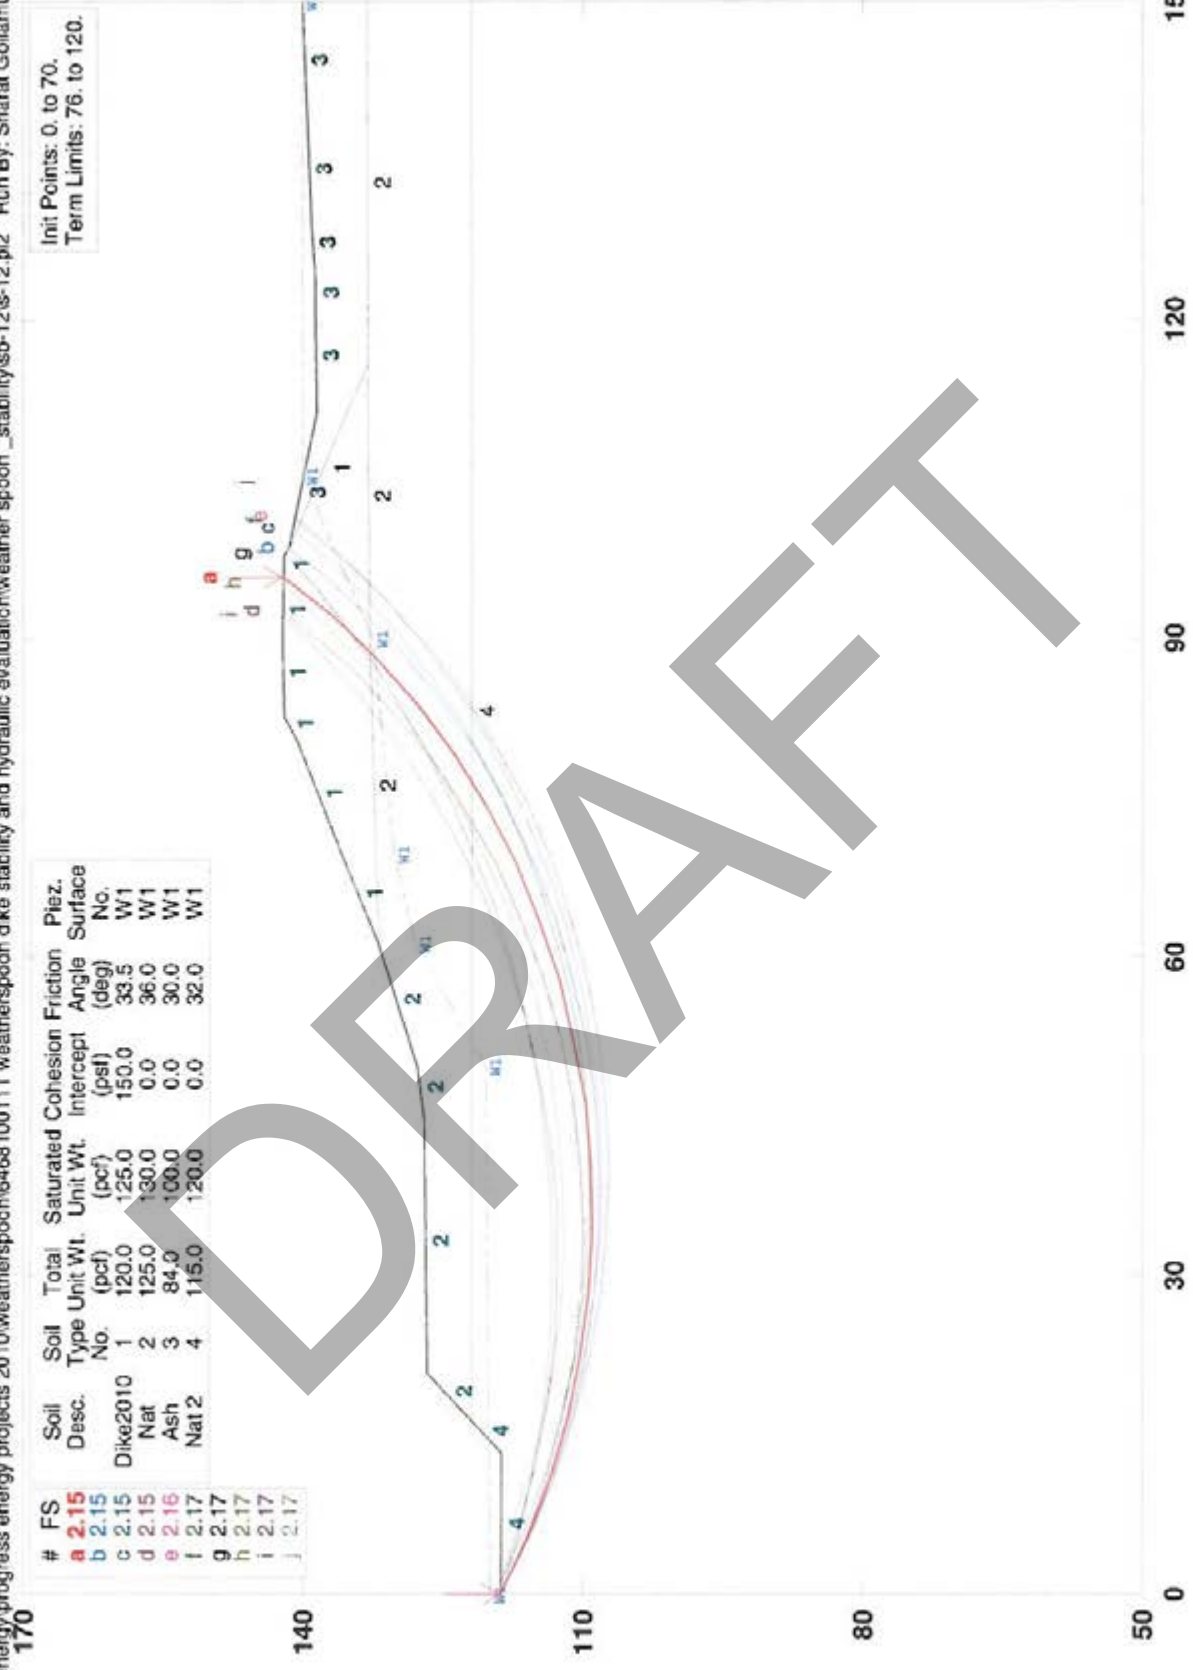
Progress Energy - Weatherspoon Ash Pond South Dike - Section 12 - Deep Failure

PCSTABL5M/si FSmin=2.15
Safety Factors Are Calculated By The Modified Bishop Method

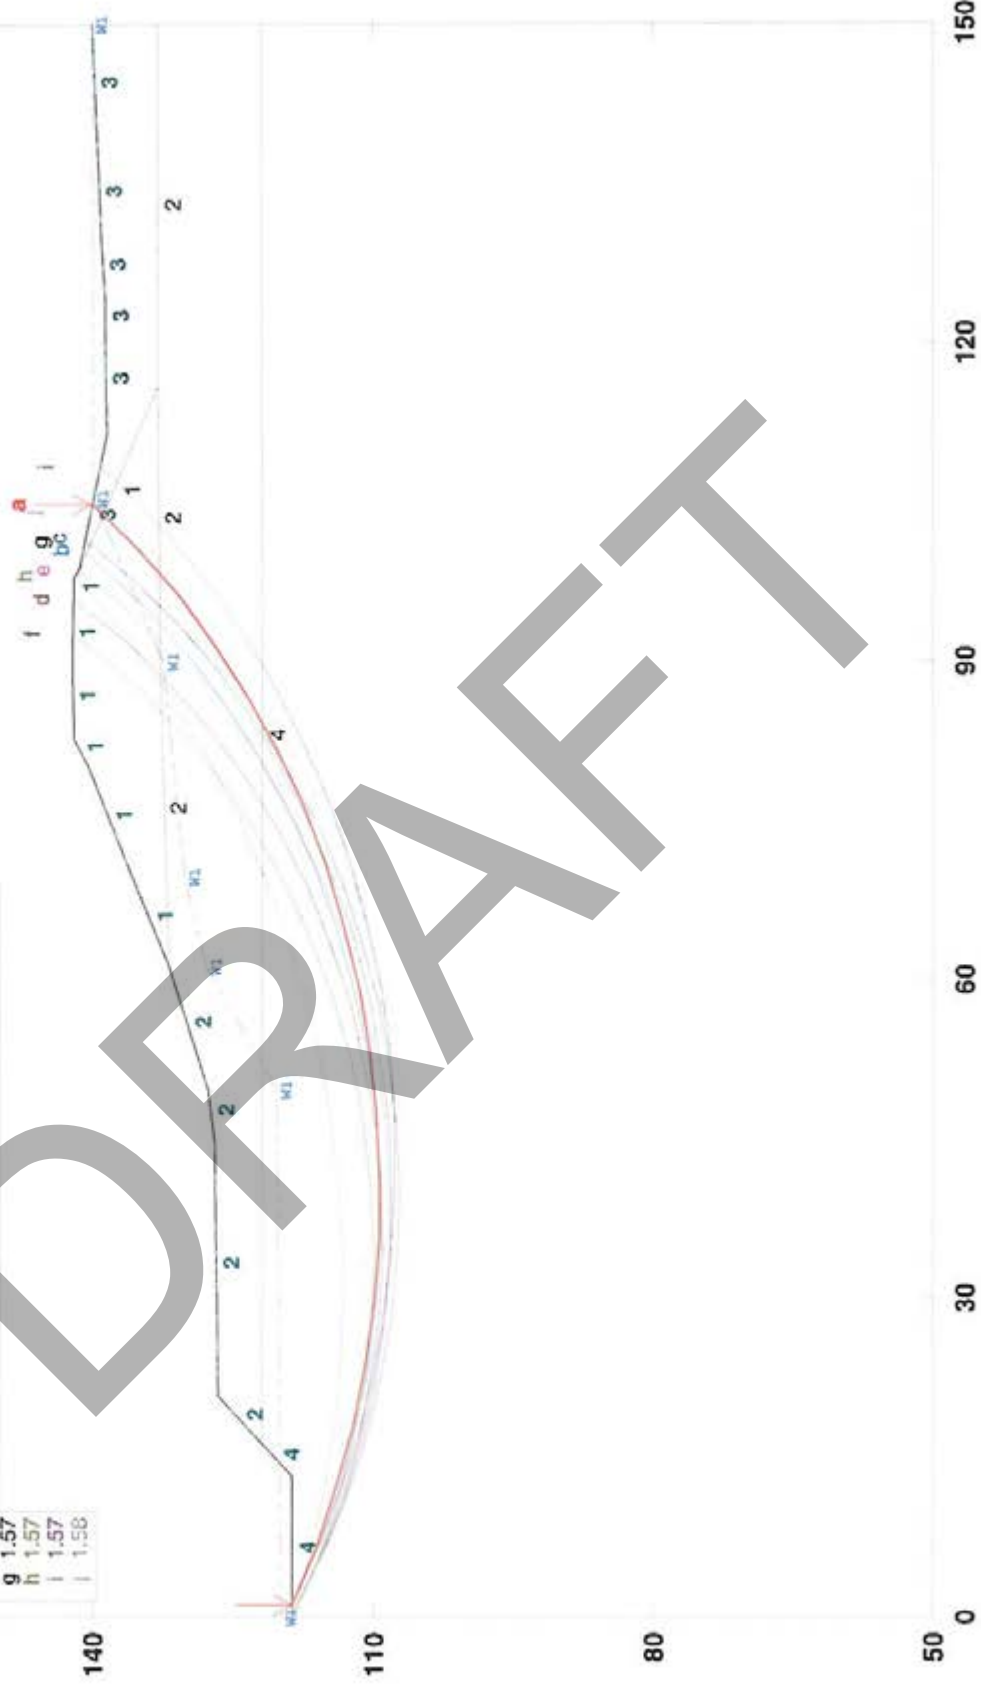
Progress Energy - Weatherspoon Ash Pond South - Sec#12 - Deep Failure (Seismic)

#	FS	Soil Desc.	Soil Type No.	Total Unit Wt. (pcf)	Saturated Unit Wt. (pcf)	Cohesion (psf)	Friction Angle (deg)	Piez. Surface No.	Load Horiz Eqk	Value
a	1.56	Dike2010	1	120.0	125.0	150.0	33.5	W1		0.090 g<
b	1.56	Nat	2	125.0	130.0	0.0	36.0	W1		
c	1.56	Ash	3	84.0	100.0	0.0	30.0	W1		
d	1.56	Nat 2	4	115.0	120.0	0.0	32.0	W1		
e	1.57									
f	1.57									
g	1.57									
h	1.57									
i	1.57									
j	1.58

PCSTABL5M/si FSmin=1.56
Safety Factors Are Calculated By The Modified Bishop Method

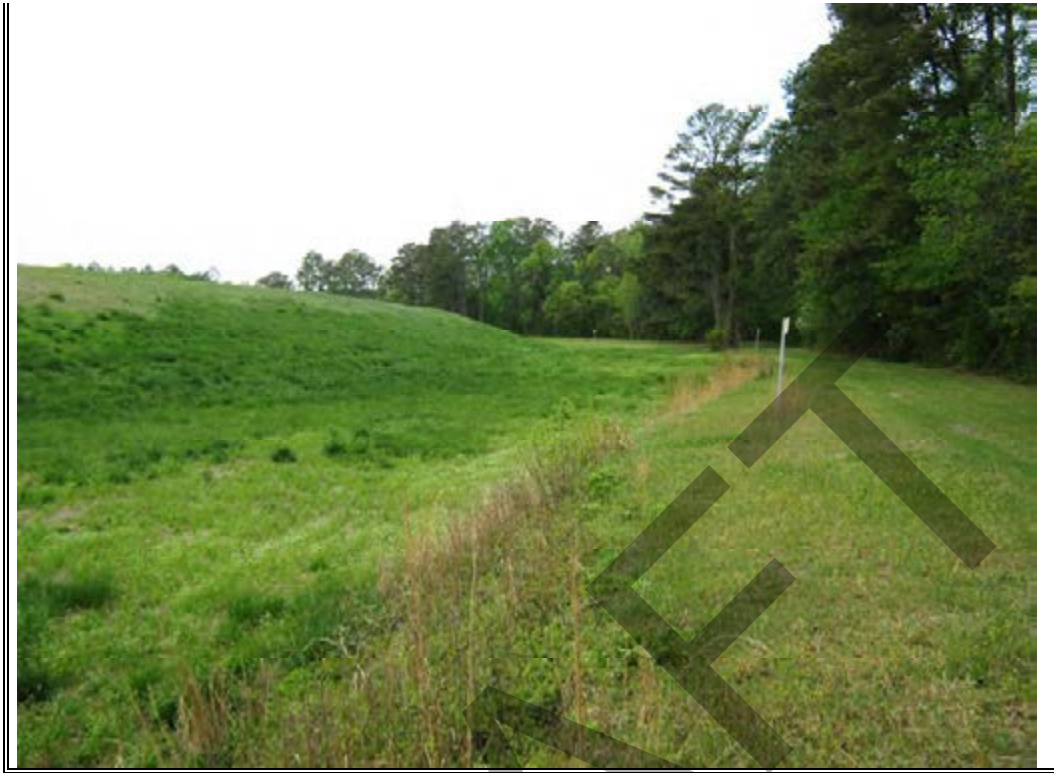
No areas of concern were noted on the crest of the dike. The crest is relatively level and has a thin, but adequate, grass cover with some gravel (Photographs 1 and 2).

The interior slopes are mostly covered by dry sedimented ash that has a good grass cover (Photographs 1, 3 and 4). A few old trees are present along the edge of the dike crest in one area (Photograph 4); these trees present no concerns for dike stability. The sedimented ash extends approximately 80 to 100 feet south to the toe of one of the interior containment dikes. Grading has been conducted to create a drainage swale to guide rainfall east to a low area where it is allowed to infiltrate (Photograph 3). Where interior slopes are exposed around the lower area at the northeast corner, they are covered with grass, reeds and small brush (Photograph 5). No indications of slope stability concerns were observed on these exposed segments of the interior slope.

Photograph 1: Crest and interior area – Northern Ash Area, north dike.

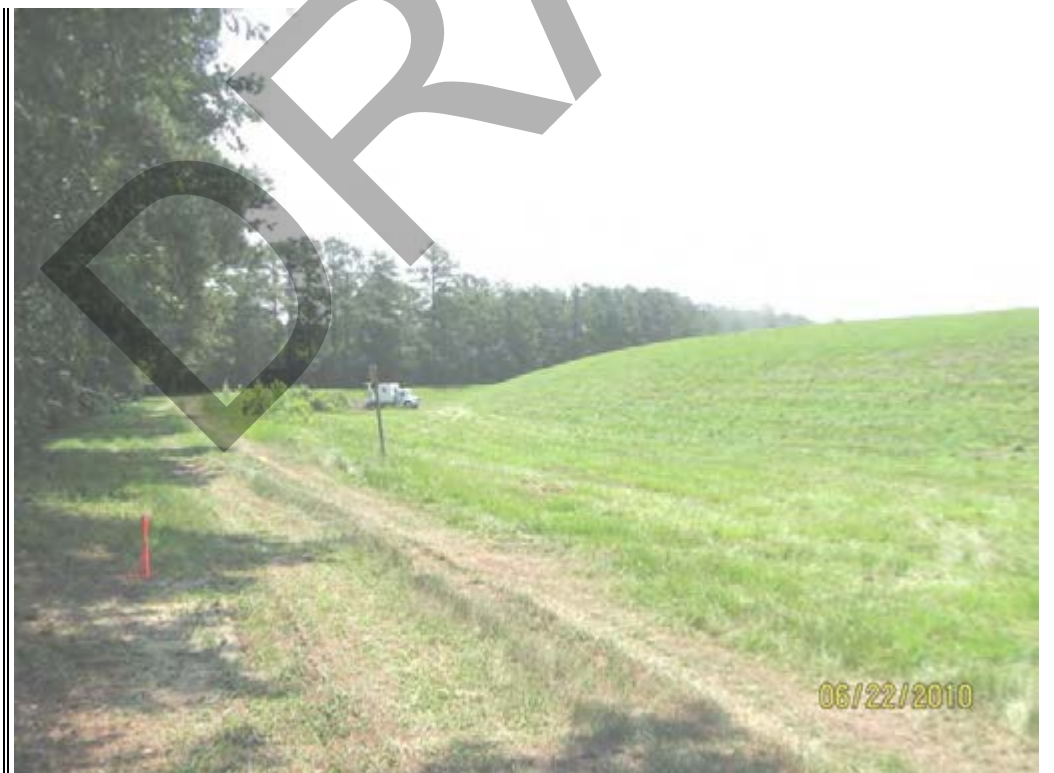
Photograph 2: Crest and interior area – Northern Ash Area, north dike.

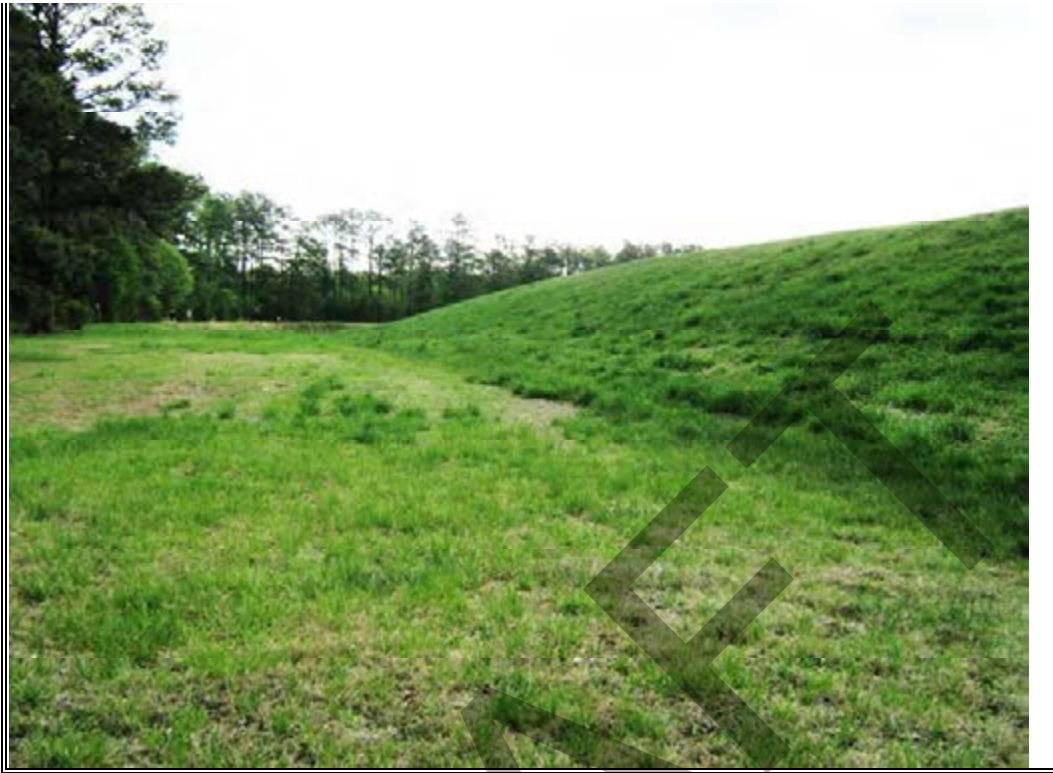
Photograph 3: Interior drainage swale – Northern Ash Area, north dike.

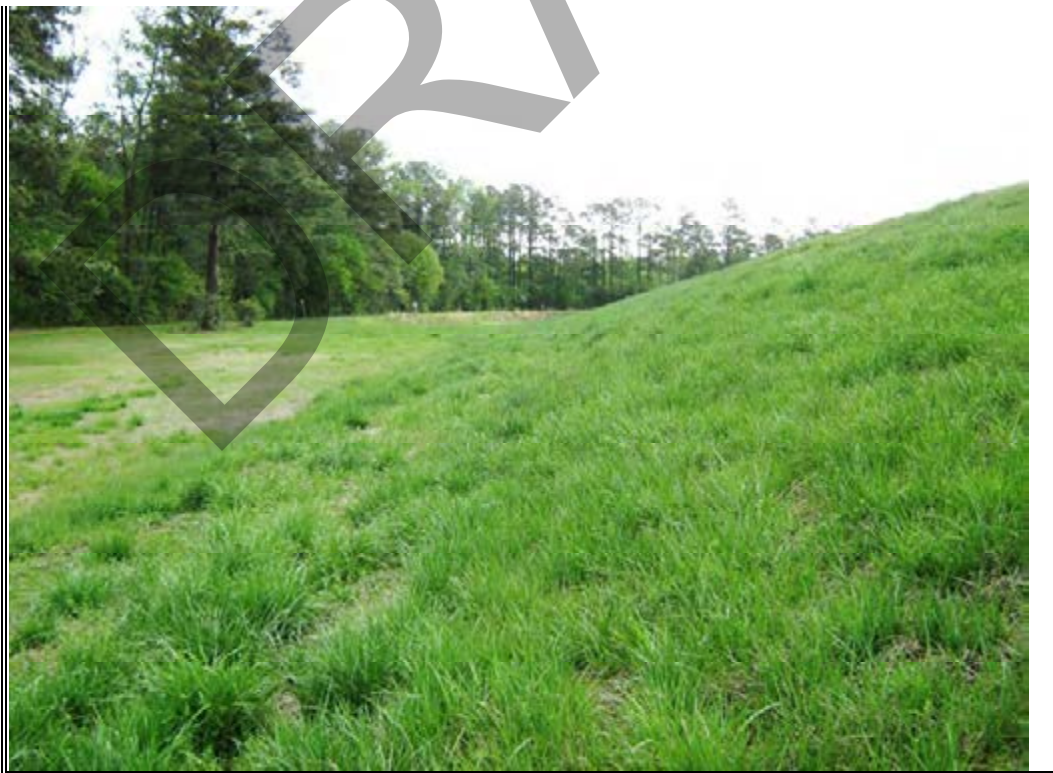
Photograph 4: Interior area, local tree presence – Northern Ash Area, north dike.

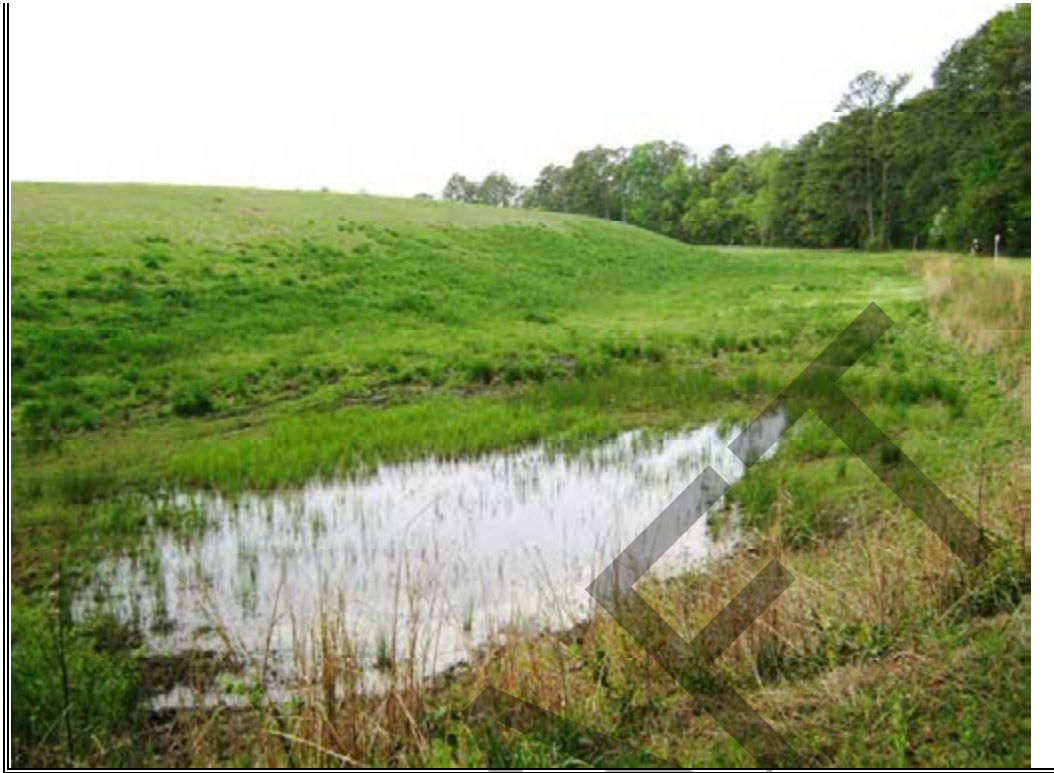
Photograph 5: Local standing water near old pond discharge – Northern Ash Area.

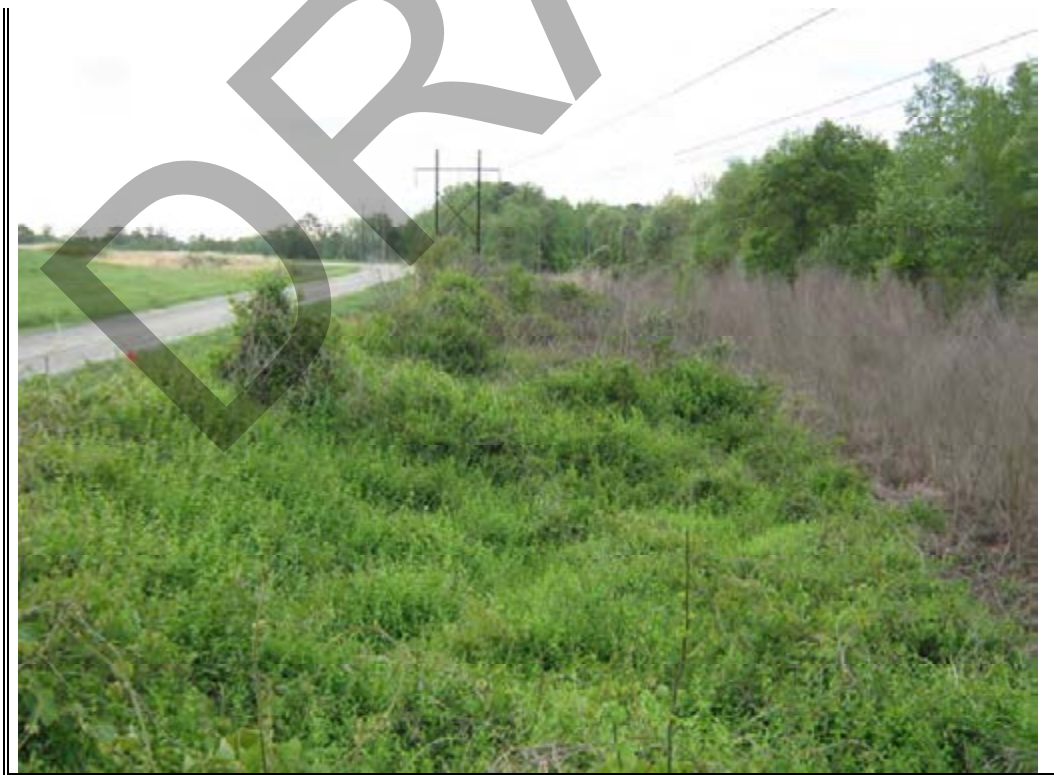
The exterior slopes from the plant road access ramp on the west side to the start of the north dike are generally covered with small brush and kudzu (Photograph 6). There is one section approximately 125 feet in length where near vertical slopes are present (Photograph 7). The dike height in this area is low (< 10 feet), and there are no indications of active or recent slumping. The area at the toe of the west side dike is topographically low, and some standing water can be seen during periods of rain. There is old sedimented ash adjacent to the dike crest and level with the crest on the interior. Even if a regressive slumping occurred, its effect would be to reduce the travel path width on the dike crest and not cause a breach or release of ash. MACTEC recommends a plan be developed to address the near vertical slope area by either moving the dike crest travel area to the west (out onto the sedimented ash), by using soil anchors to provide stabilization, or by placing a rip rap berm along the toe.

Photograph 6: Exterior slope – Northern Ash Area, west dike. Note vegetation.

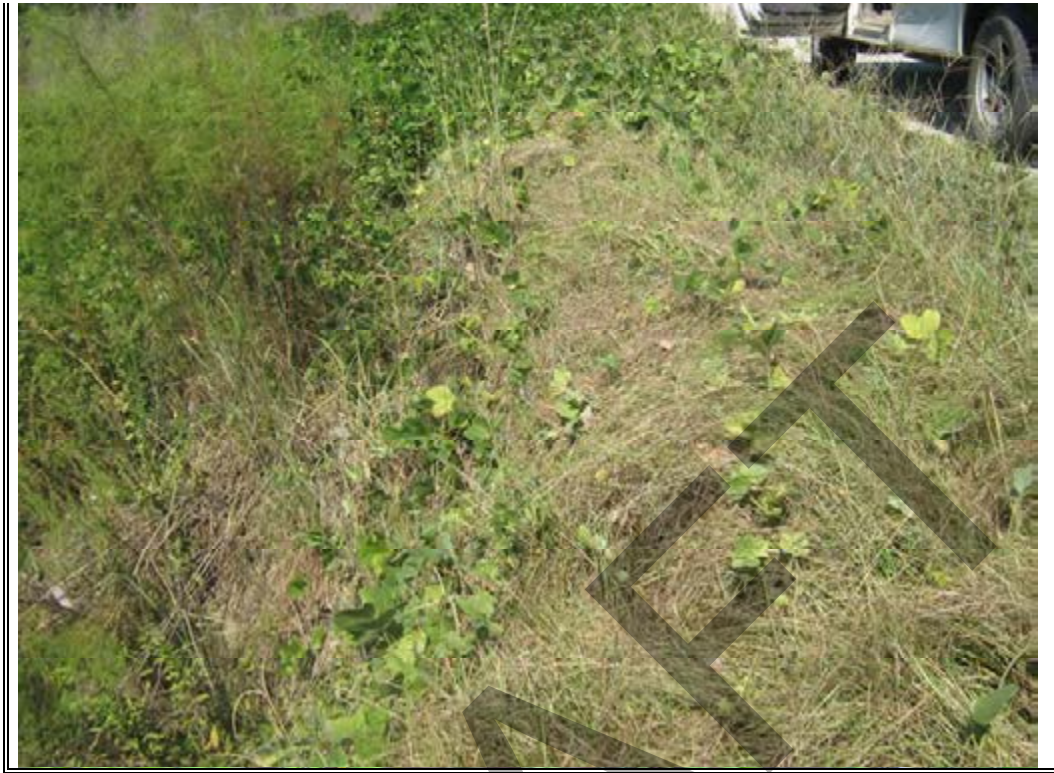
Photograph 7: Local steep scarp on exterior slope – Northern Ash Area, west dike.

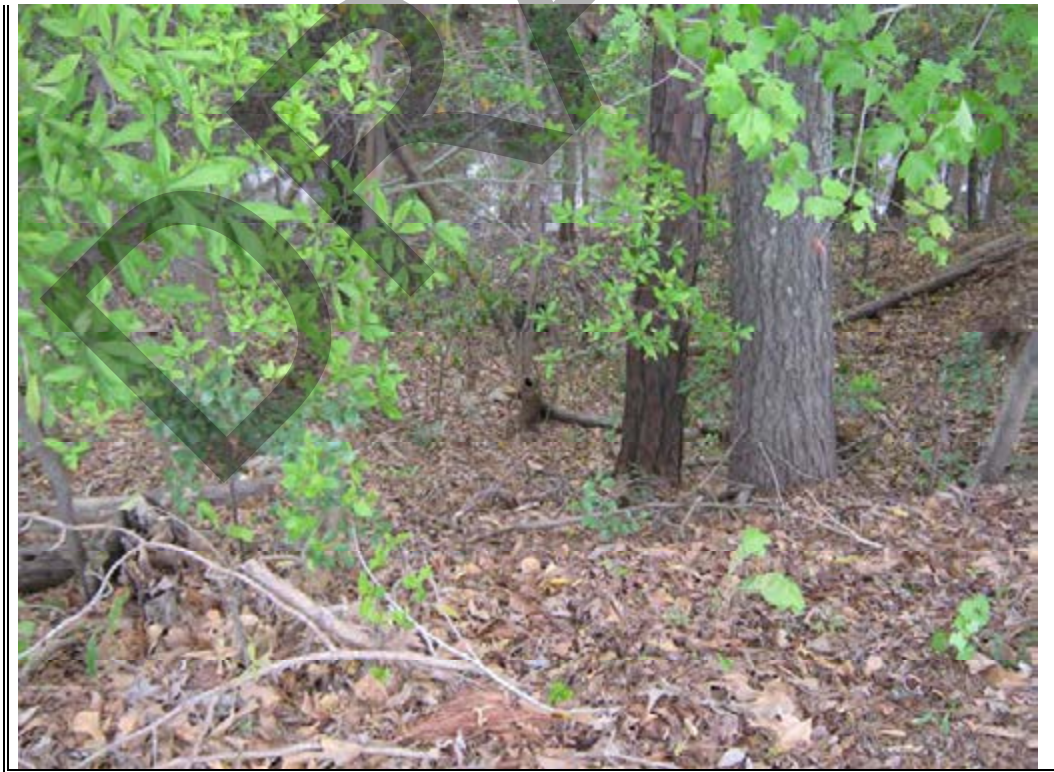
The exterior slope along the northern and eastern dike has moderate to thick growth of brush and trees. Some trees are 8 to 12 inches in diameter. The slope has segments with signs of old slumping or erosion, leaving steep slopes (Photographs 8 and 9). A notable area is at the former discharge pipe (Photograph 10). None of the areas show signs of recent activity. The slope angle outside the irregular areas is typically 2(H) : 1(V).

Photograph 8: Tree growth on exterior slope – Northern Ash Area, north dike.

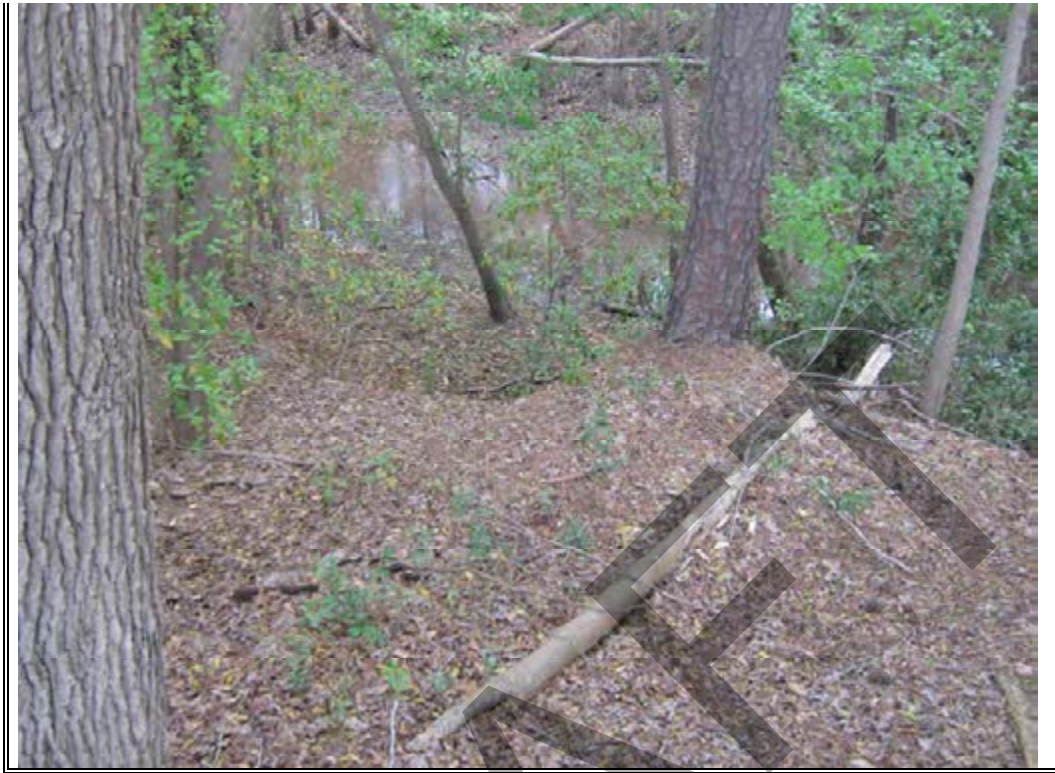
Photograph 9: Typical bench and tree growth – Northern Ash Area, west end north dike.

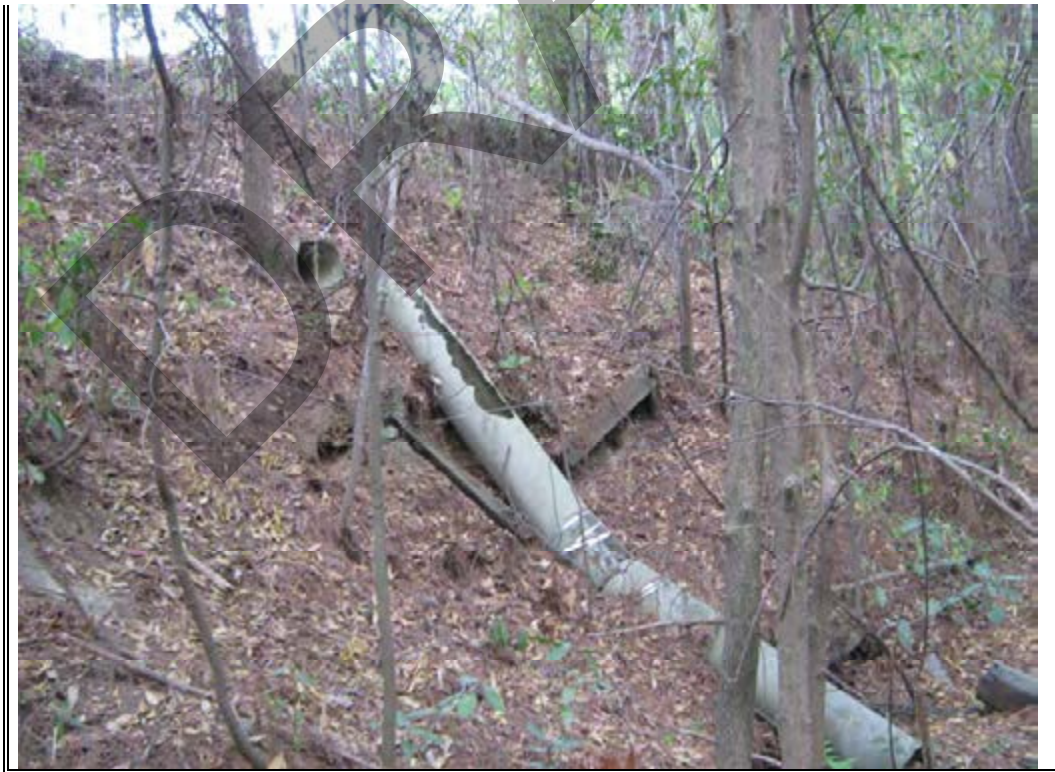
Photograph 10: Remnants of old pond discharge pipe – Northern Ash Area, east dike.

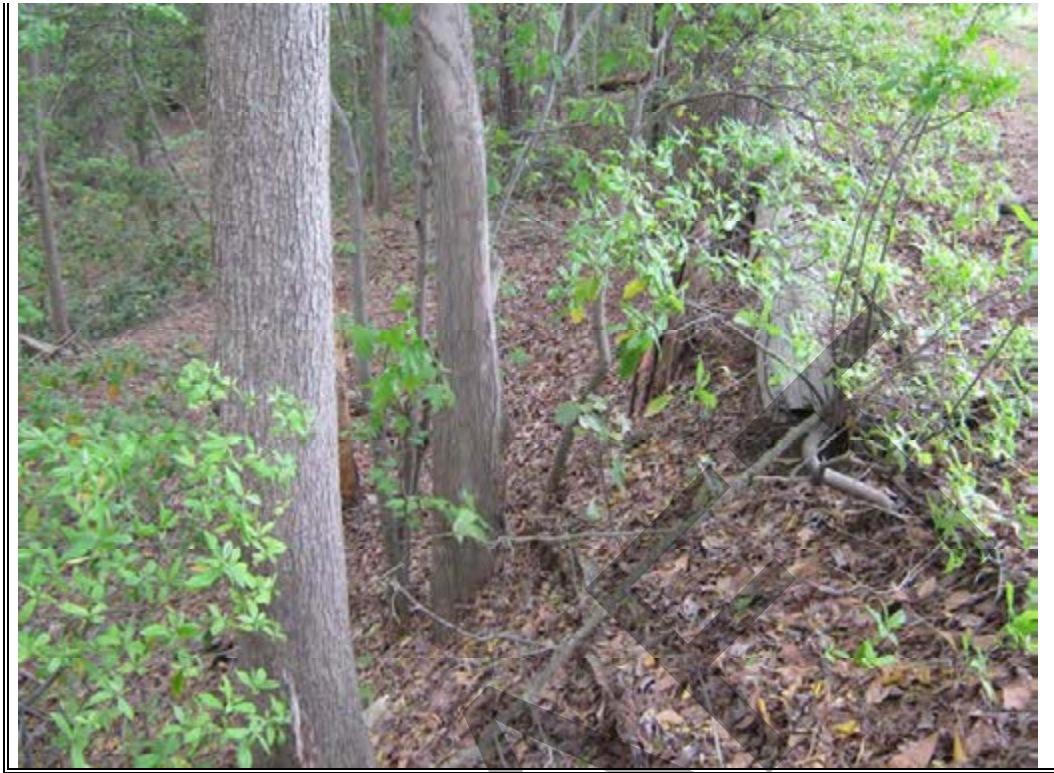
(Photograph 11). These areas are also associated with locally steep upper slope conditions that may represent old shallow slumps. These areas did not show signs of recent activity.

Photograph 11: Local timber restraint at crest level – Northern Ash Area, north dike.

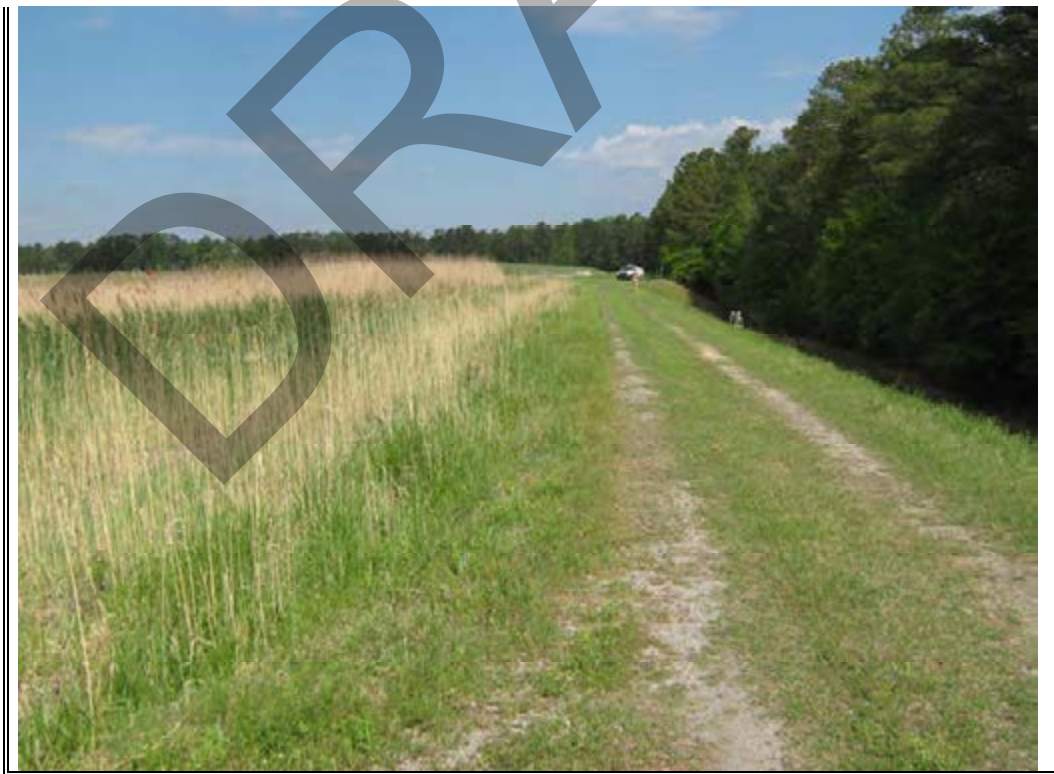
No areas of concern were noted on the crest of the dike. The crest is relatively level and has a thin, but adequate, grass cover (Photographs 12, 13 and 14). An area of the separating dike between the pond and the settling basin was repaired in 1990 when seepage was observed as the pond level was being raised. The repaired area appears as a slight “hump” in the dike. There were no indications of seepage seen in this area during our inspection.

Photograph 12: Crest and interior slope – Southern Ash Area, east dike.

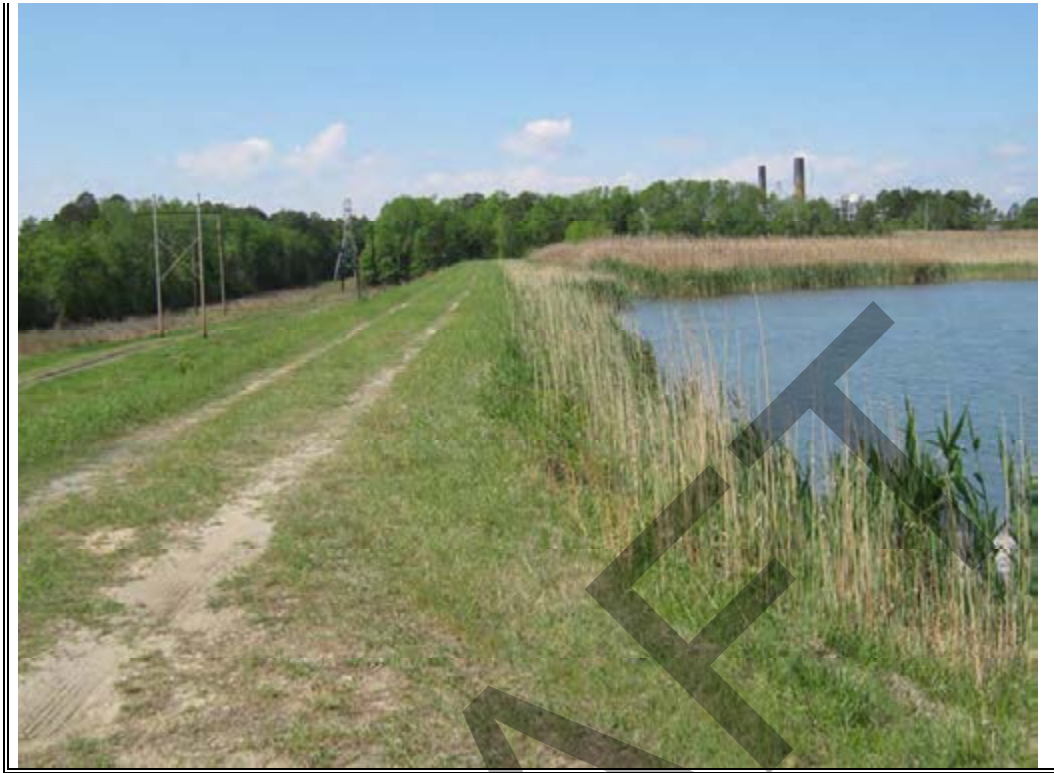
The interior slopes are well vegetated and the vegetation is well maintained (Photographs 13, 15, 16 and 17). Previous inspections have noted beaching erosion along some portions of the south dike. The beaching erosion areas appear inactive and grown over with reeds and grass (Photograph 18). The pond-side slope of the separating dike and the interior slope on the southern portion of the east dike also show some effects of past wave erosion with local sections of near vertical slopes for 1 to 2 feet above the water line. These dike sections appear to be down wind of the prevailing wind direction.

Photograph 13: Crest and interior slope – Southern Ash Area, south dike.

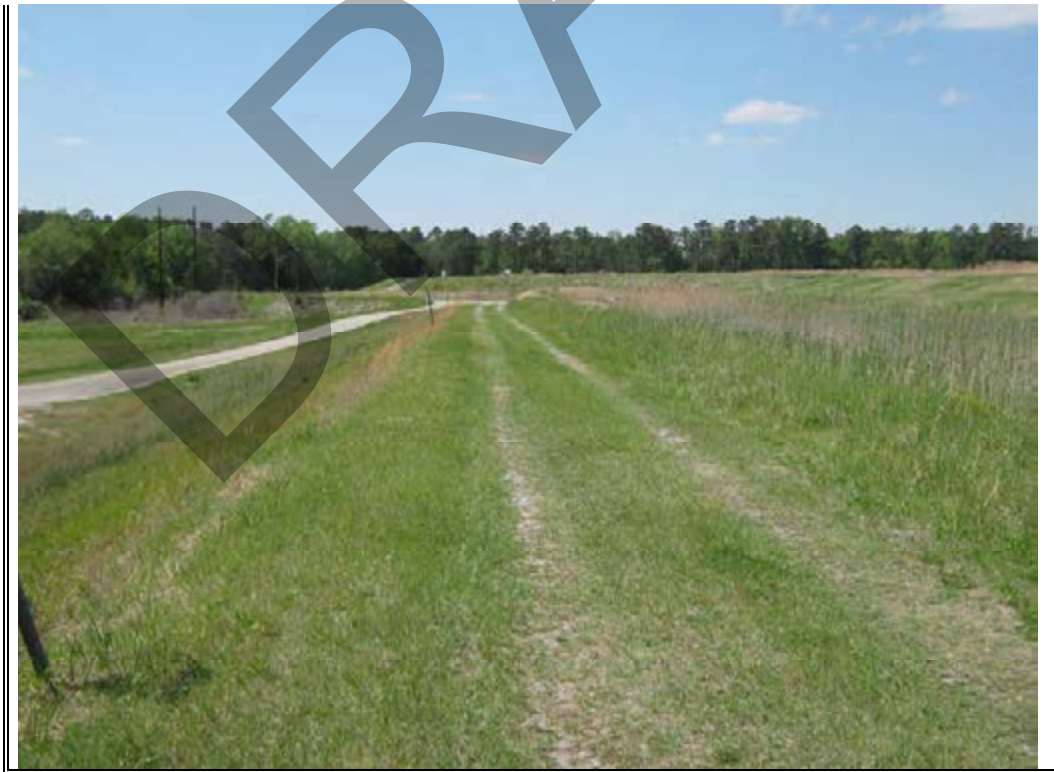
Photograph 14: Crest of west dike, Southern Ash Area.

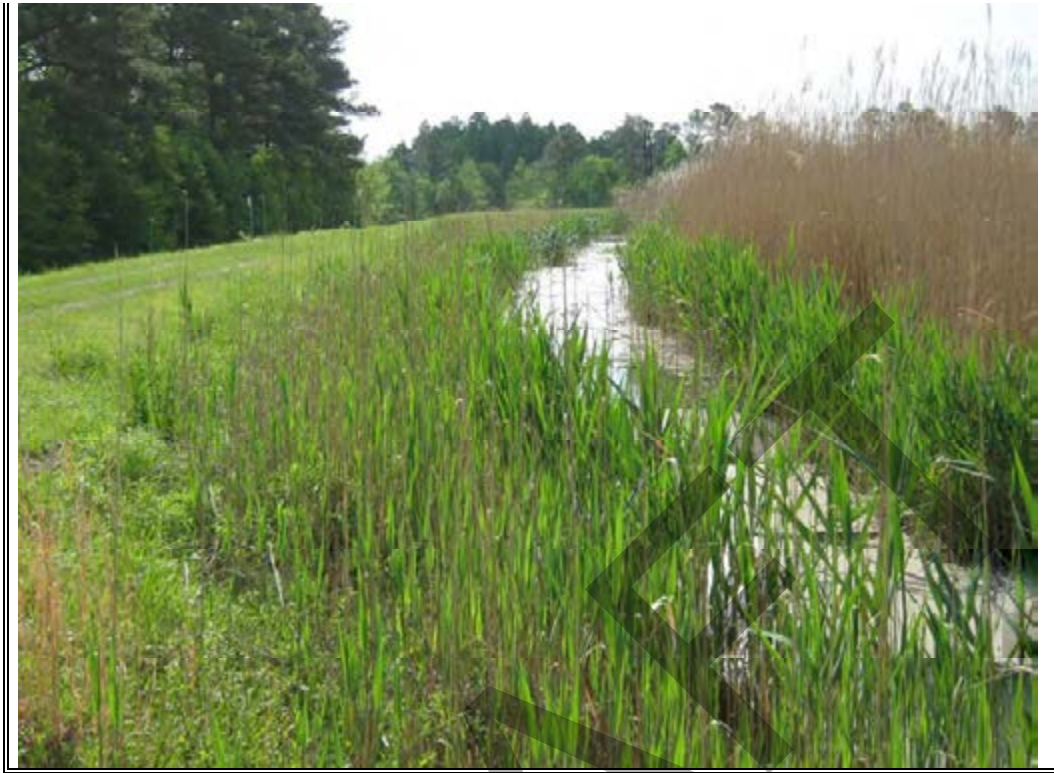
Photograph 15: Interior slope and ash/water channel – Southern Ash Area, east dike.

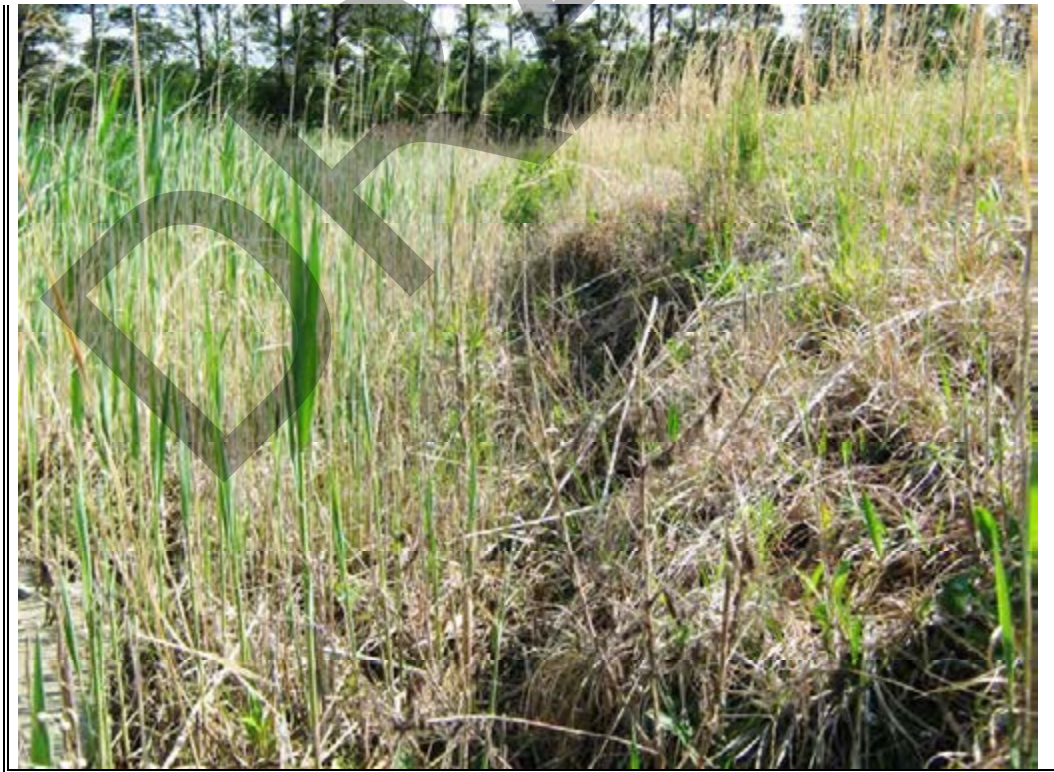
Photograph 18: Old beaching erosion on south dike – Southern Ash Area.

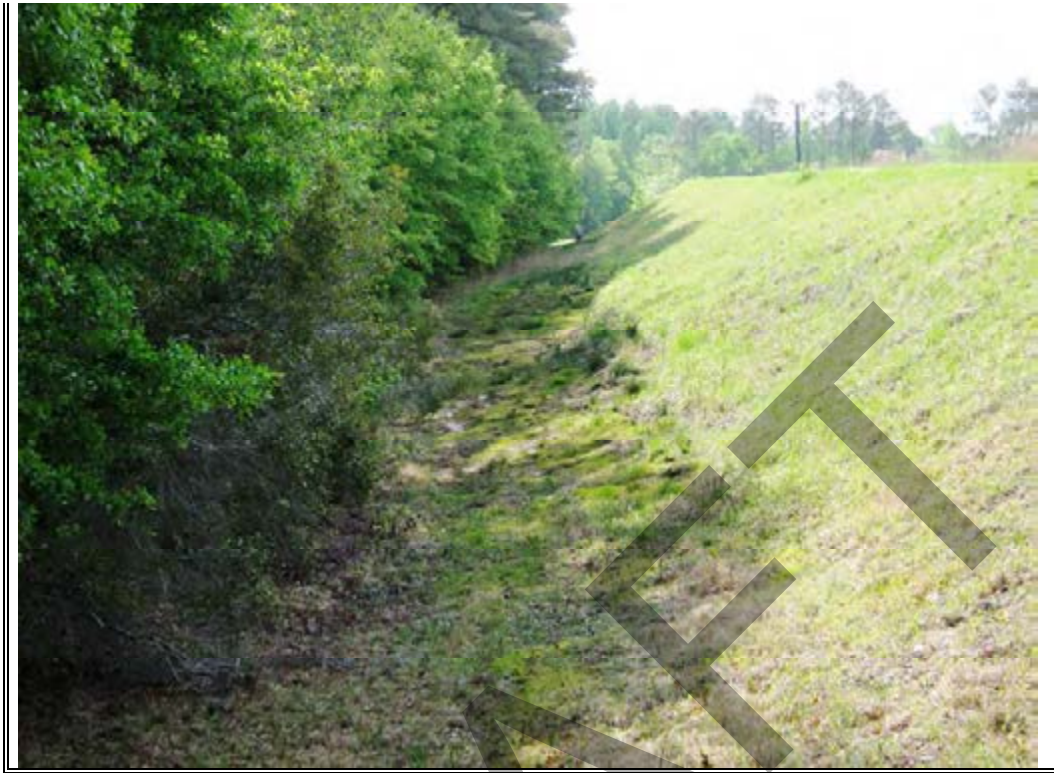
Photograph 19: Exterior slope and toe wet area – Southern Ash Area, east dike.

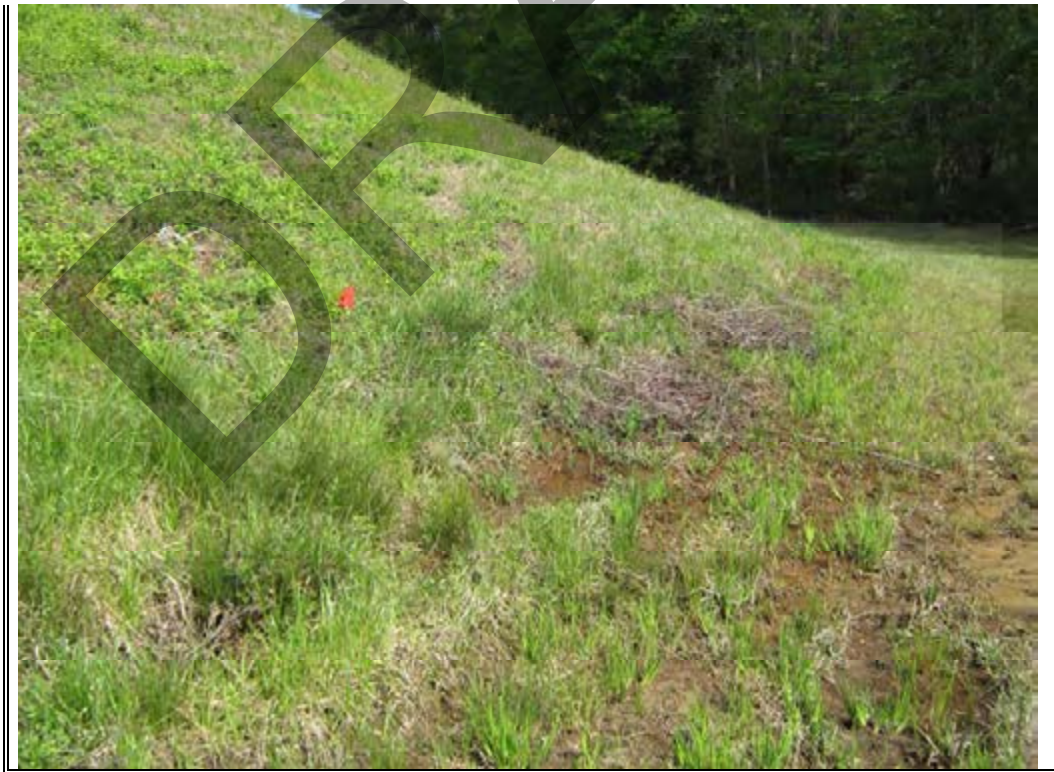
Photograph 22: Local wet areas and slight seepage – Southern Ash Area, southeast corner at settling basin dike.

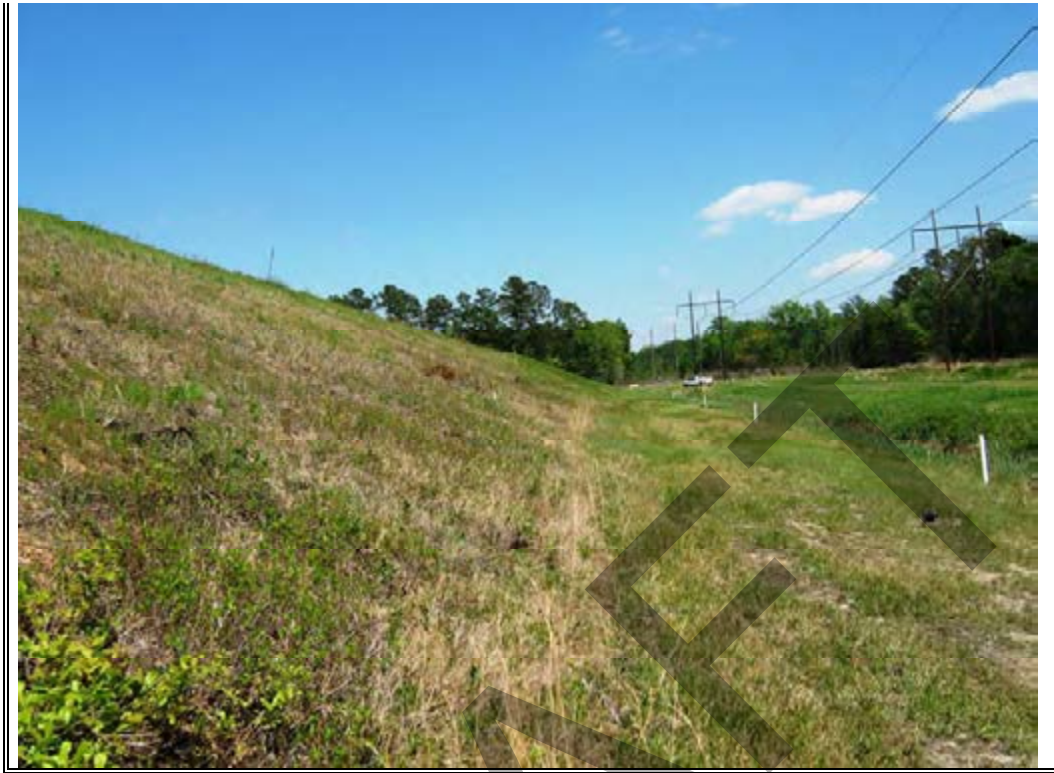
Conditions on the south exterior slope were generally similar to those seen in past visits (Photograph 23), but wet areas appeared to be expanded from the last inspection. In past inspections, an area of slightly increased wetness and minor seepage was noted in the lower third of the slope, near the middle row of the old water level casings. This area appeared similar to the previous observations (Photograph 24). Seasonal variation in amount of seepage has been noted by Progress Energy personnel and by MACTEC during past inspections. Progress Energy personnel had placed some sand fill over one wet slope area since the last inspection visit in 2009. This area had sparse grass cover, but no signs of surface erosion (Photograph 25).

Photograph23: Toe of south dike – Southern Ash Area.

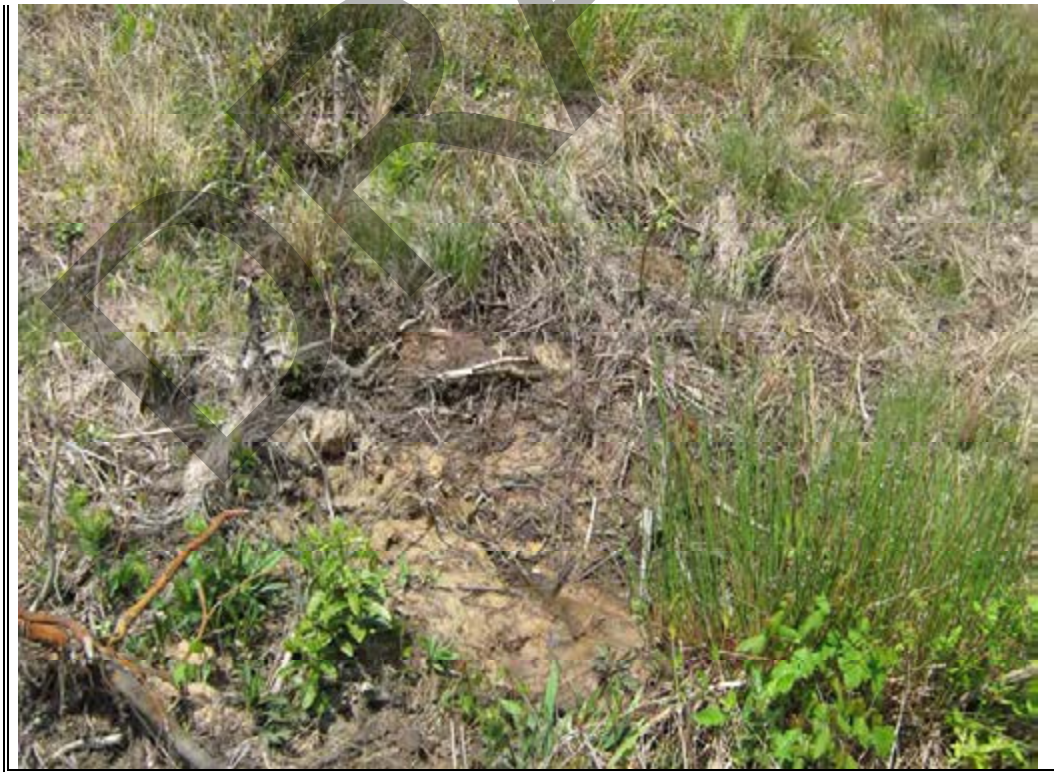
Photograph 24: Seepage spot on dike toe – Southern Ash Area, south dike.

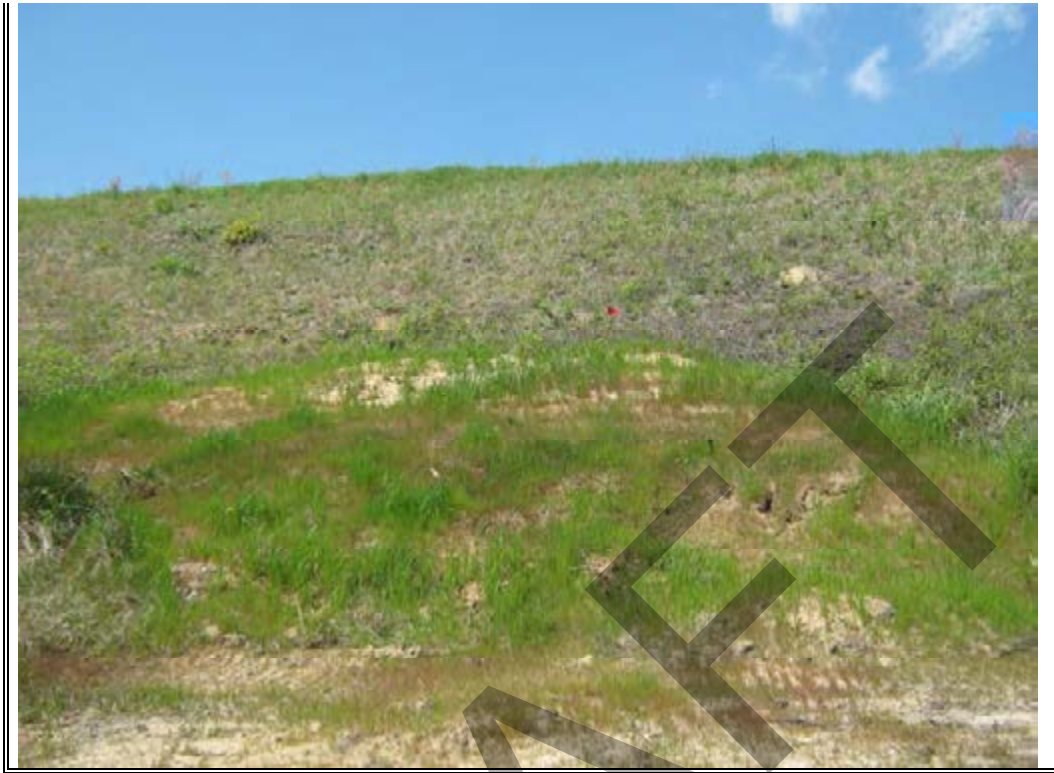
Photograph 25: Sand fill placed on seepage area – Southern Ash Area, south dike.
