Coal Combustion Residue Impoundment

Round 9 - Dam Assessment Report

Weatherspoon Steam Electric Plant

Ash Pond Embankment

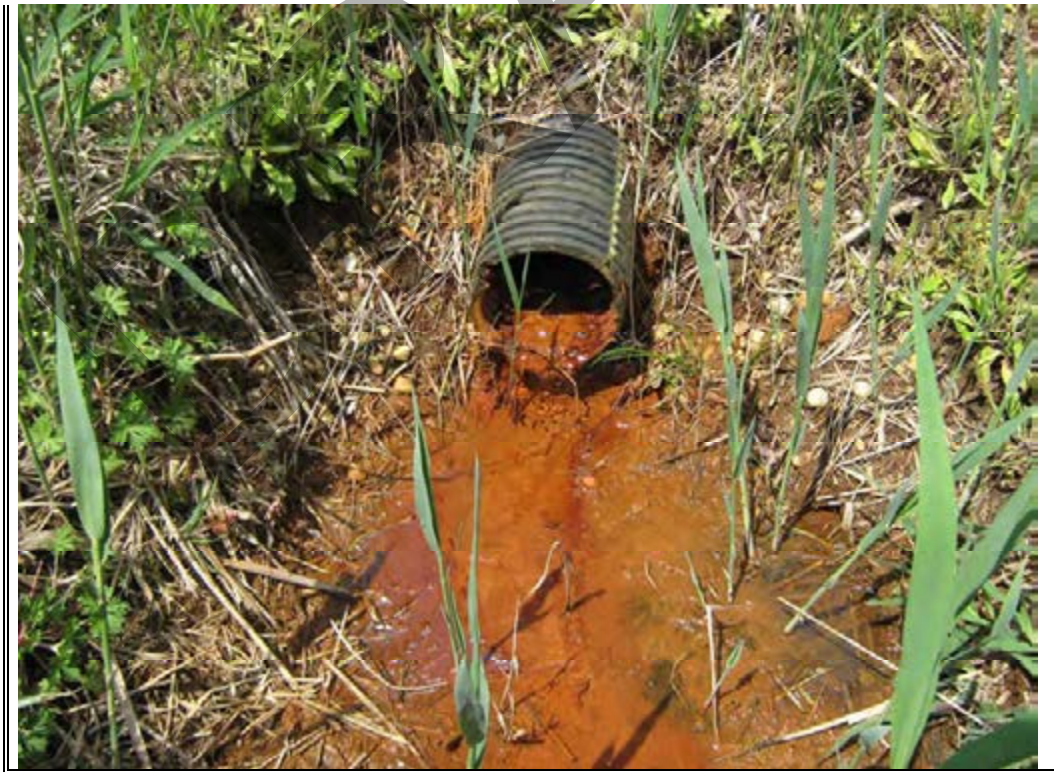
Photograph 26: Toe drain outlet pipe after cleaning – Southern Ash Area, south dike.

Photograph 26 shows the outlet after soil removal. We recommend that all of the outlet pipes be cleaned out.

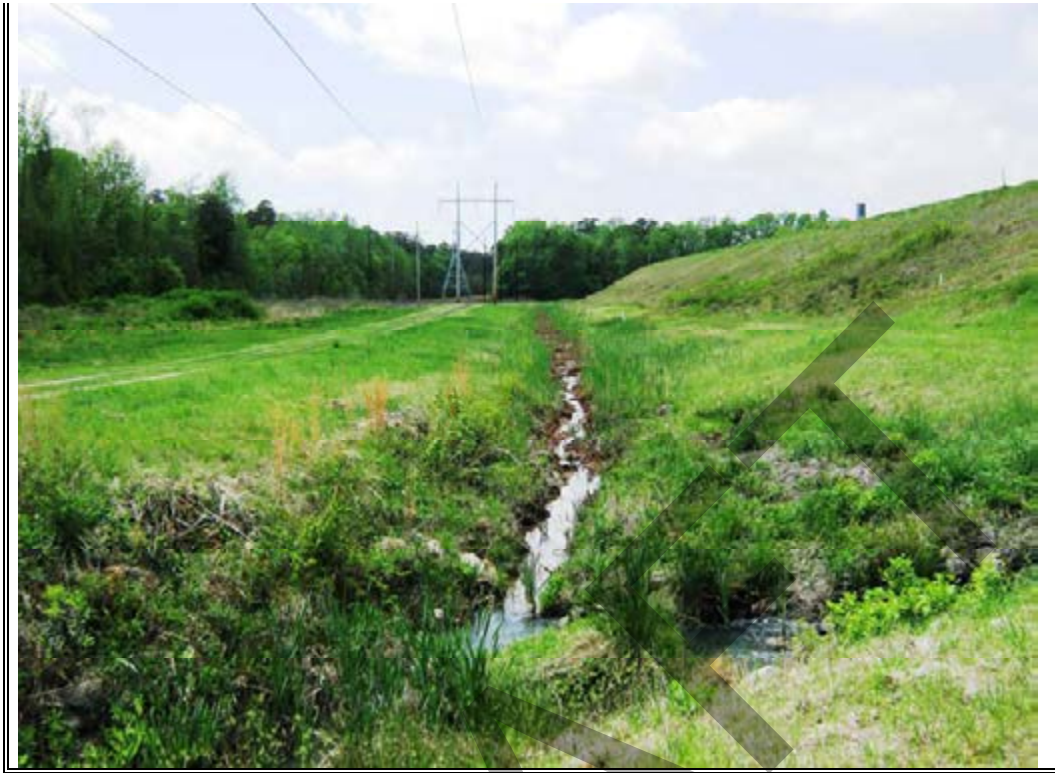
The ditch that carries the flow from the toe drain outlets and surface runoff was sufficiently clear of potential vegetation that would block flow into the outfall ditch (Photograph 27).

Photograph 27: Drainage swale along toe or south dike – Southern Ash Area.

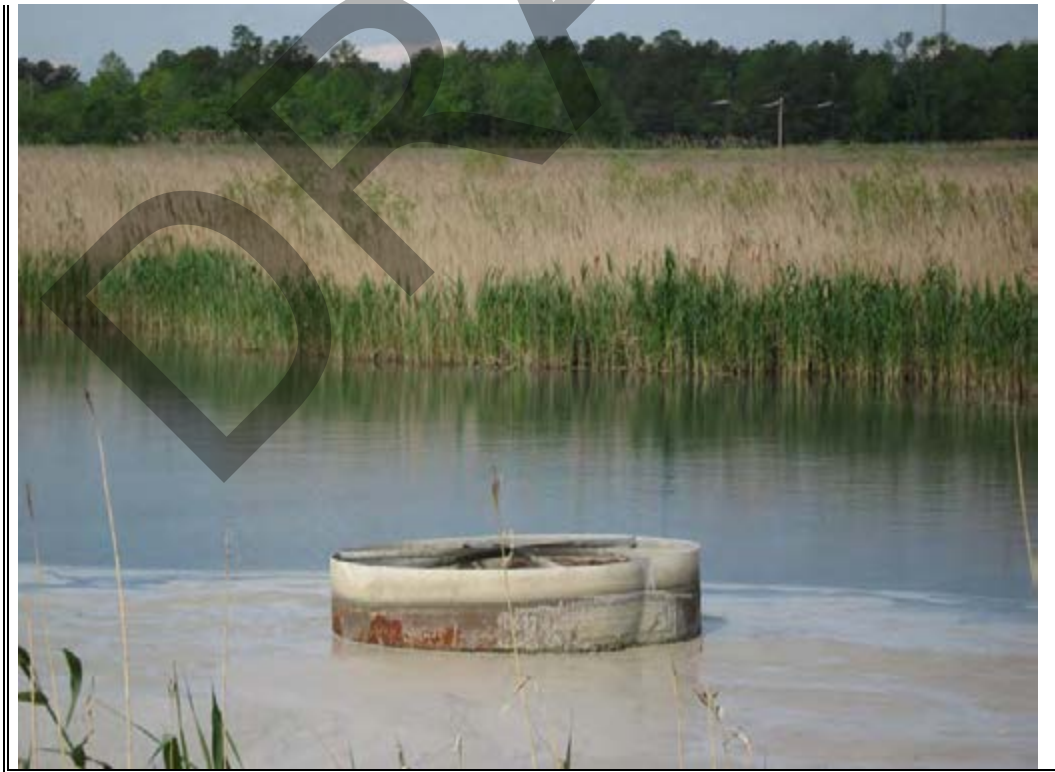
The pond water flows through a skimmer discharge structure to a settling pond. Water from the settling pond flows into a skimmer type inlet and discharges through a 24-inch diameter concrete pipe. Both skimmer structures are in good condition (Photographs 28 and 17). The skimmer for the main pond is slightly tilted as a result of a slight mis-alignment during recent removal in anticipation of a hurricane in 2009 and replacement. The mis-alignment does not impact the function of the vertical riser. The outflow pipe from the settling basin is in good condition at the outlet end (Photograph 29) and no signs of water flowing around the exterior of the pipe were seen.

Photograph 28: Skimmer structure for Southern Ash Area.

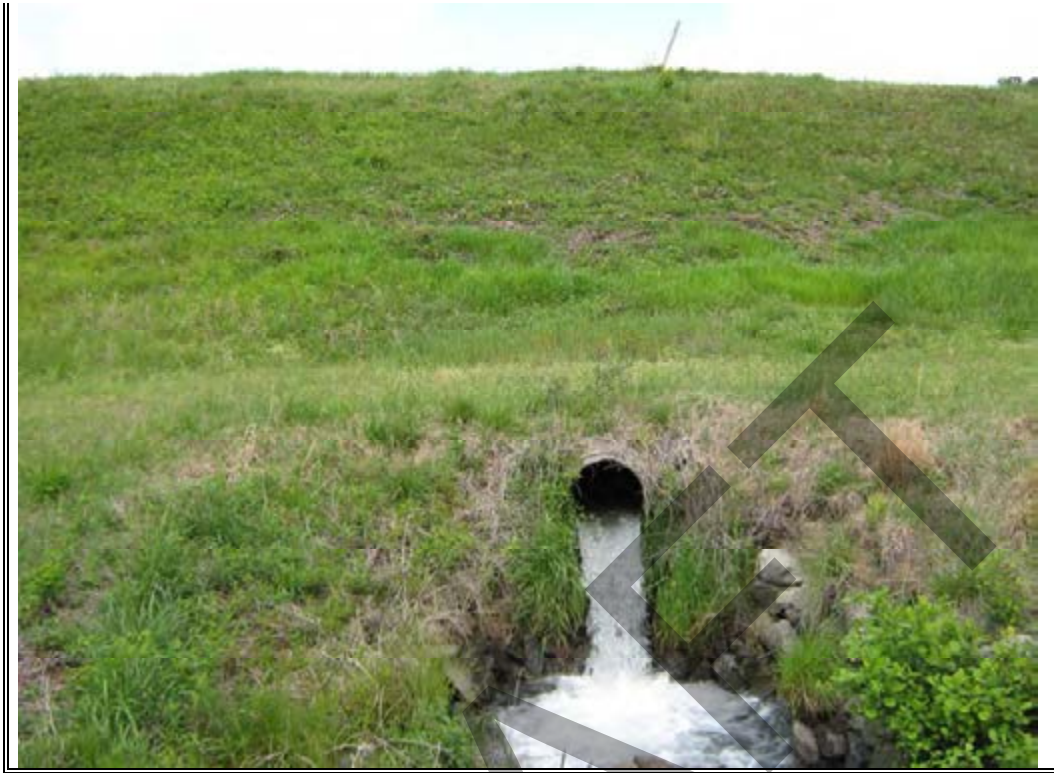
Photograph 29: Discharge pipe outlet from Settling Basin – Southern Ash Area.

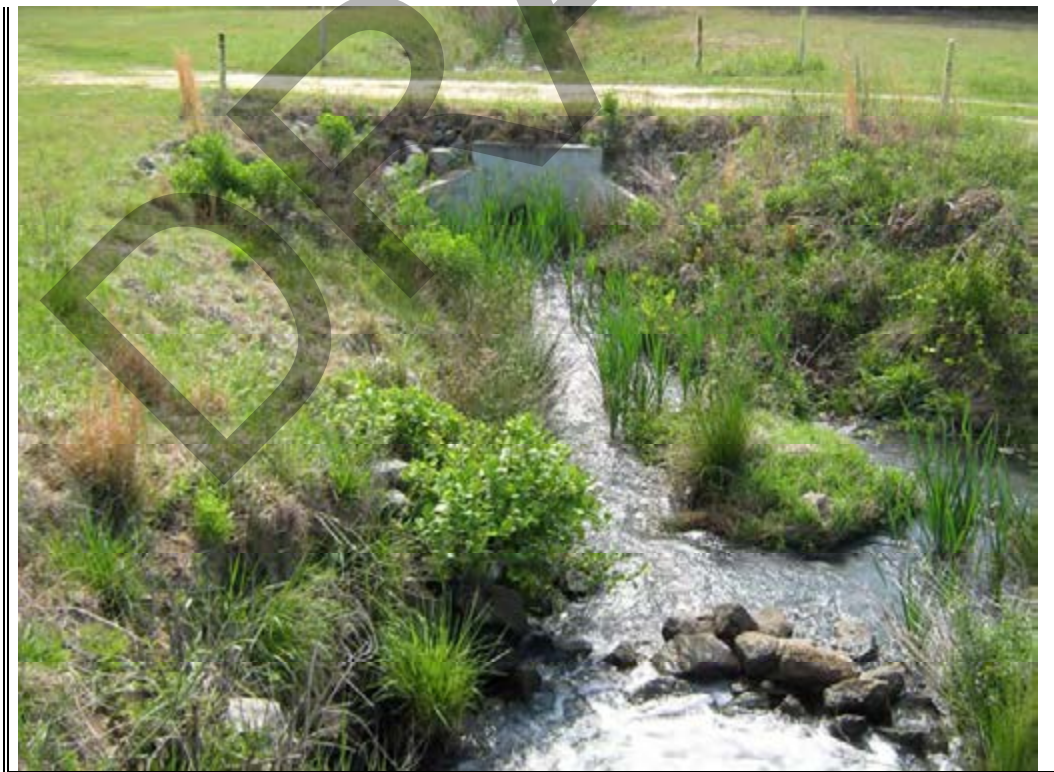
The outflow from the discharge pipe flows in a channel which has rip rap and vegetation, and then through a culvert under the access road to the Cooling Lake (Photograph 30). The timber headwalls for this culvert were replaced by concrete walls since the 2005 inspection.

Photograph 30: Outflow channel toward Cooling Lake – Southern Ash Area.

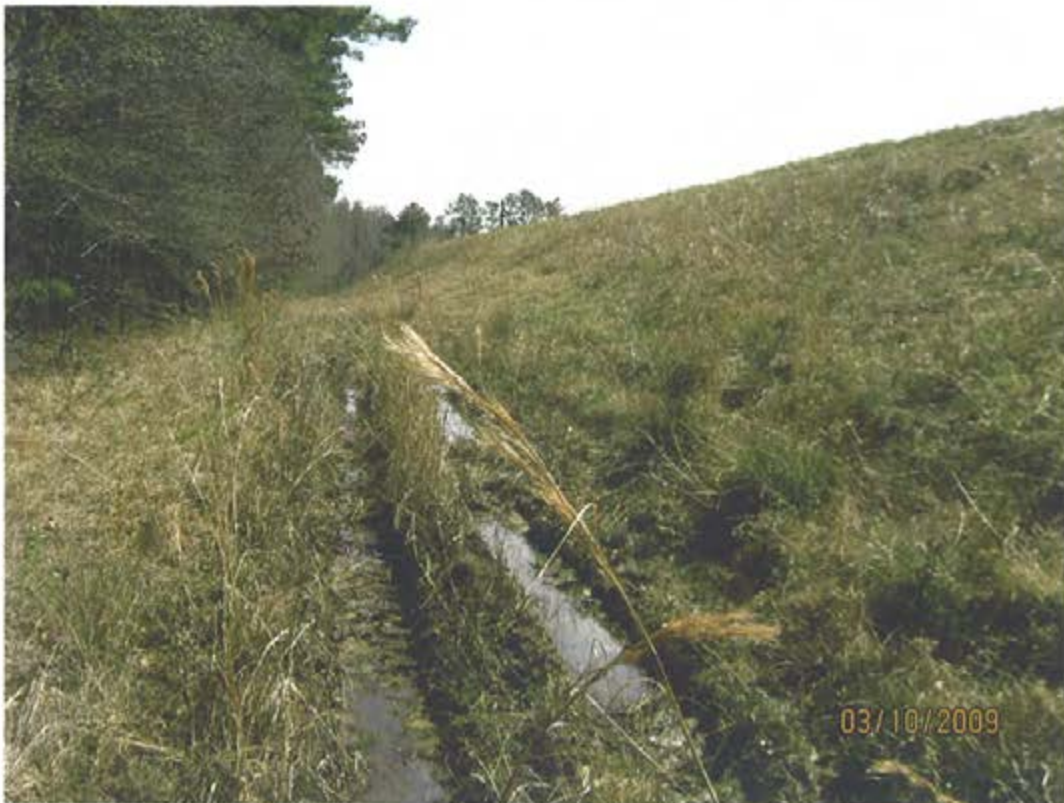
10. Ash Pond – East Dike looking south-Wet area at toe of slope

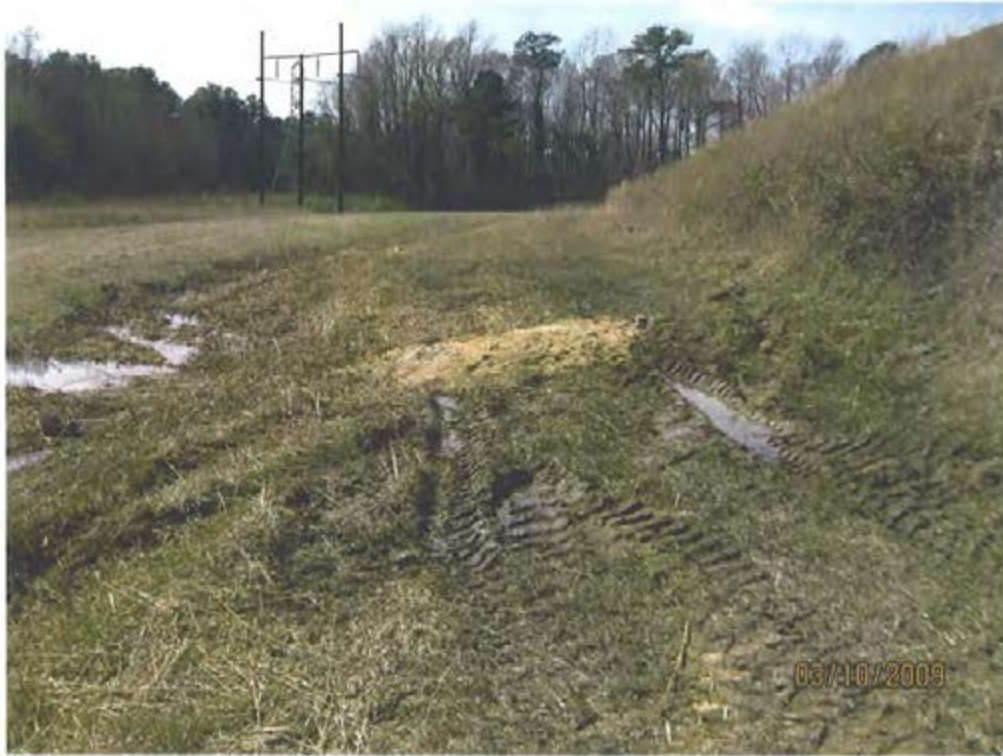
11. Ash Pond – South Dike-West end with ruts from mowing

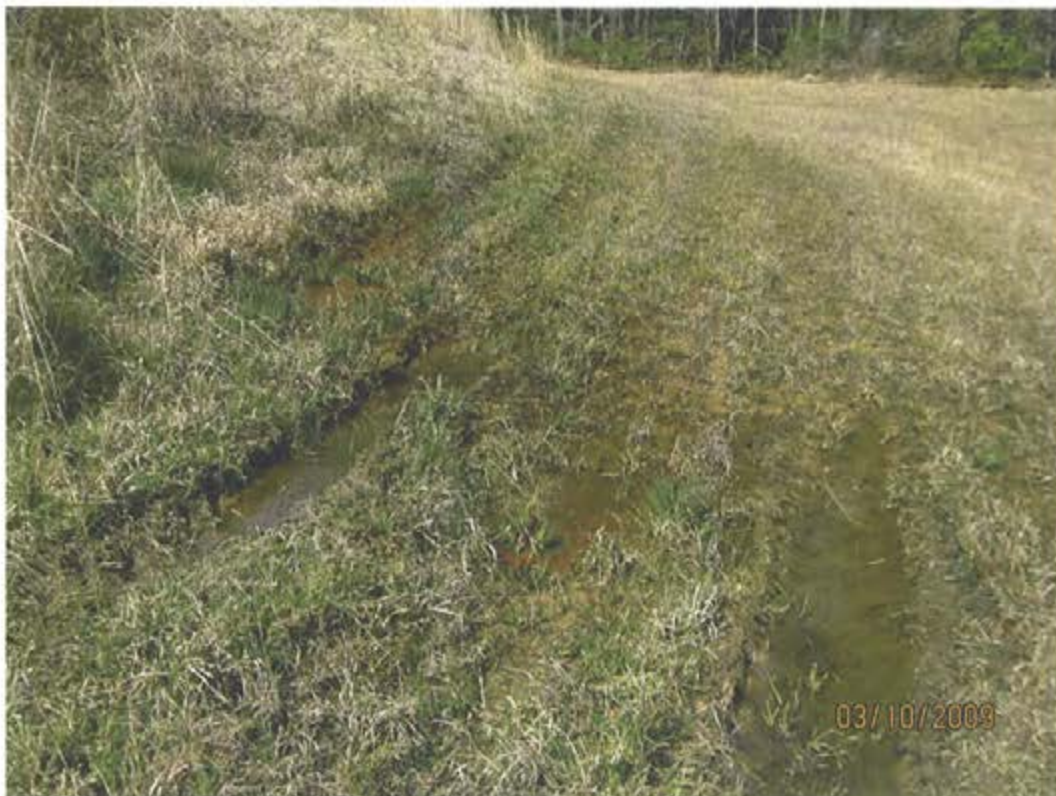
12. Ash Pond – Southeast corner-wet area (normally seen)

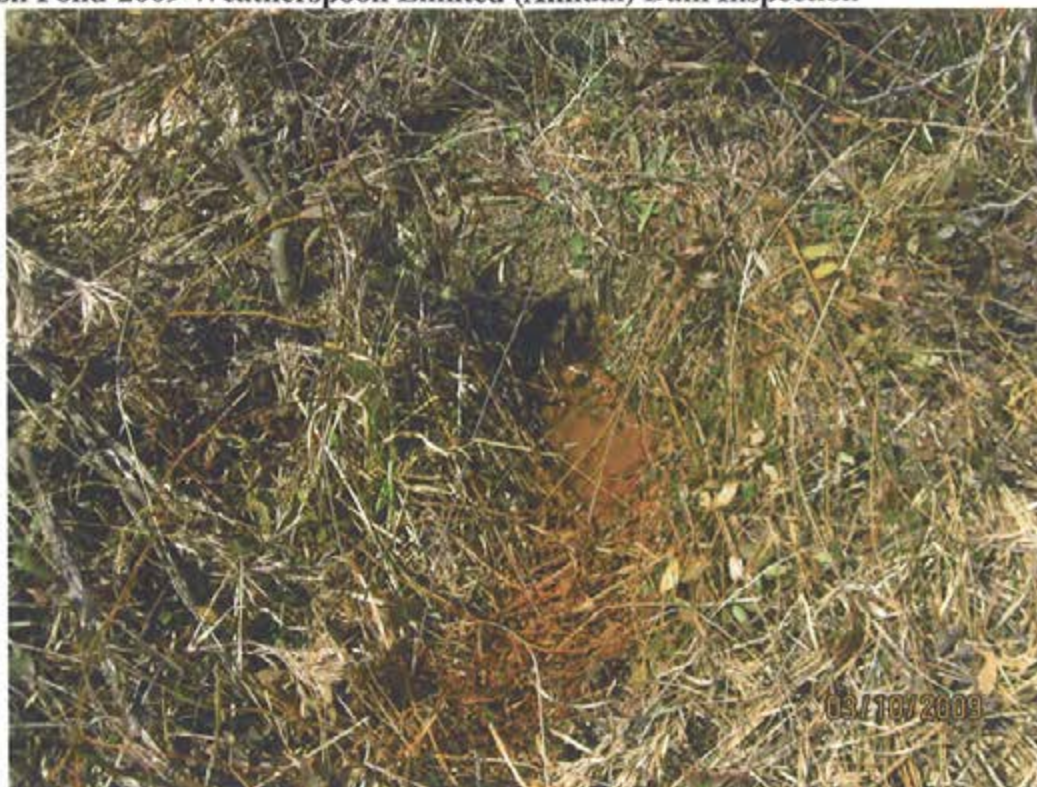
The exterior slope of the south dike also has a history of wet ground conditions possibly associated with seepage. In 2003, an area of slightly increased wetness and minor seepage was noted in the lower third of the slope, near the middle row of old water level casings. Similar observations of wet conditions and evidence of seepage were made during the current inspection. These areas were small and appeared to be adequately stabilized by vegetation with no signs of significant surface erosion (Photograph 13).

13. Ash Pond – Localized seep on south slope dike

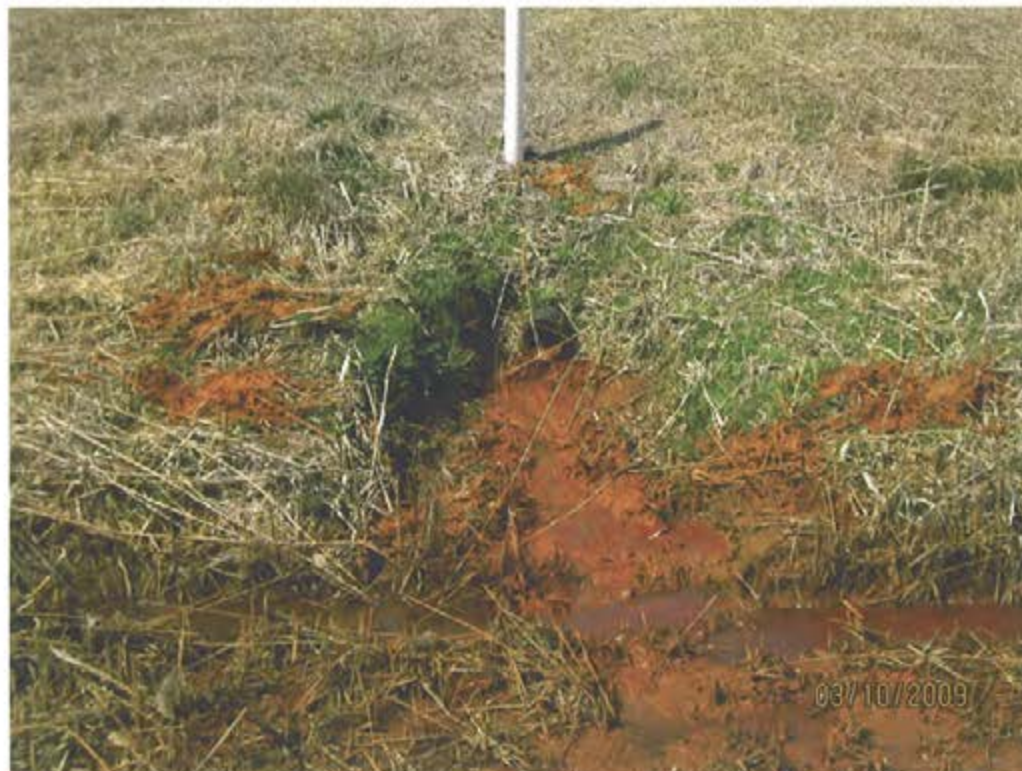
A toe drain along the south dike was installed in 1994 to reduce wet conditions in the toe road. The toe drain is provided with outlet pipes to discharge flow into the drainage ditch along the adjacent access road. The vegetation around the drain pipes and in the drainage ditch had recently been cut. The outlets are well maintained, with signs that sediment accumulations are being removed. Flow from the drain outlets was slight, ranging from a trickle to about ½ gpm (Photograph 14).

14. Ash Pond – South Dike-outlet from toe drain (typical)

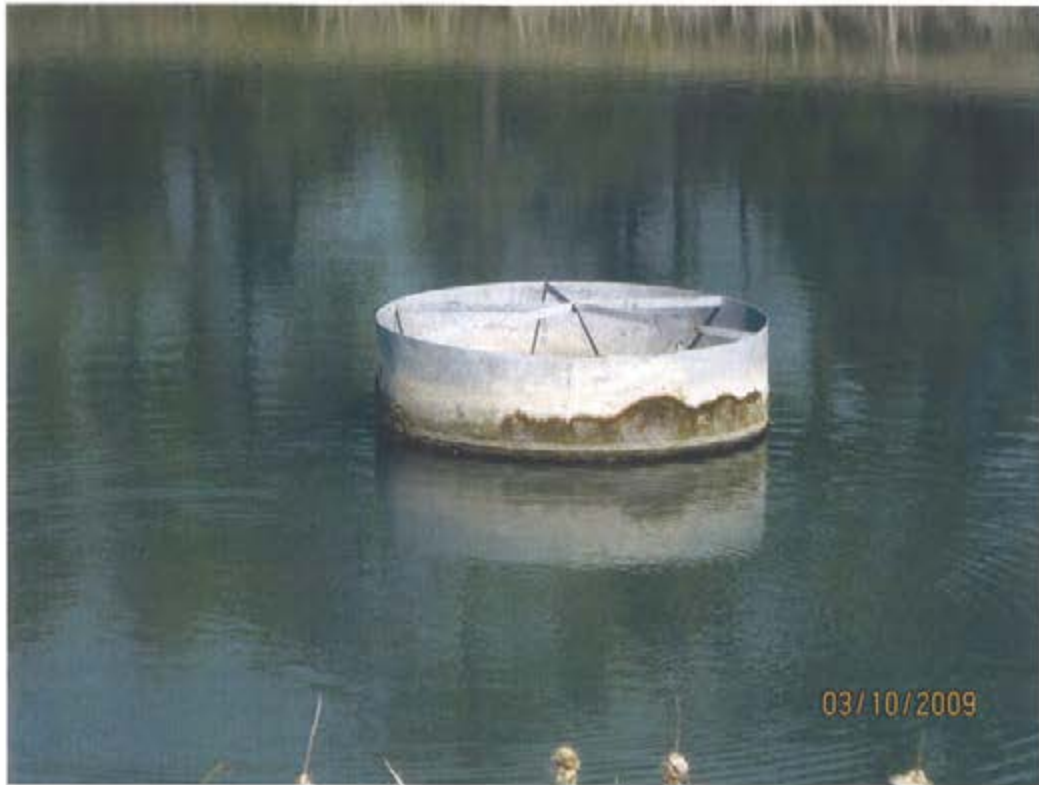
Structures: The skimmer structures on the vertical risers in the ash pond and in the secondary settling basin appeared to be in good condition (Photographs 15 and 16). The discharge pipe from the secondary settling basin was free flowing with no visible underseepage (Photograph 17). The flow from the discharge pipe follows a channel that passes under the access road then through a culvert that ultimately discharges into the Cooling Lake. The discharge channel appears to be free flowing with minor vegetation (Photograph 18). The vegetation is maintained on a regular basis according to Progress Energy plant personnel.

15. Ash Pond – Secondary Settlement Pond Skimmer on Riser

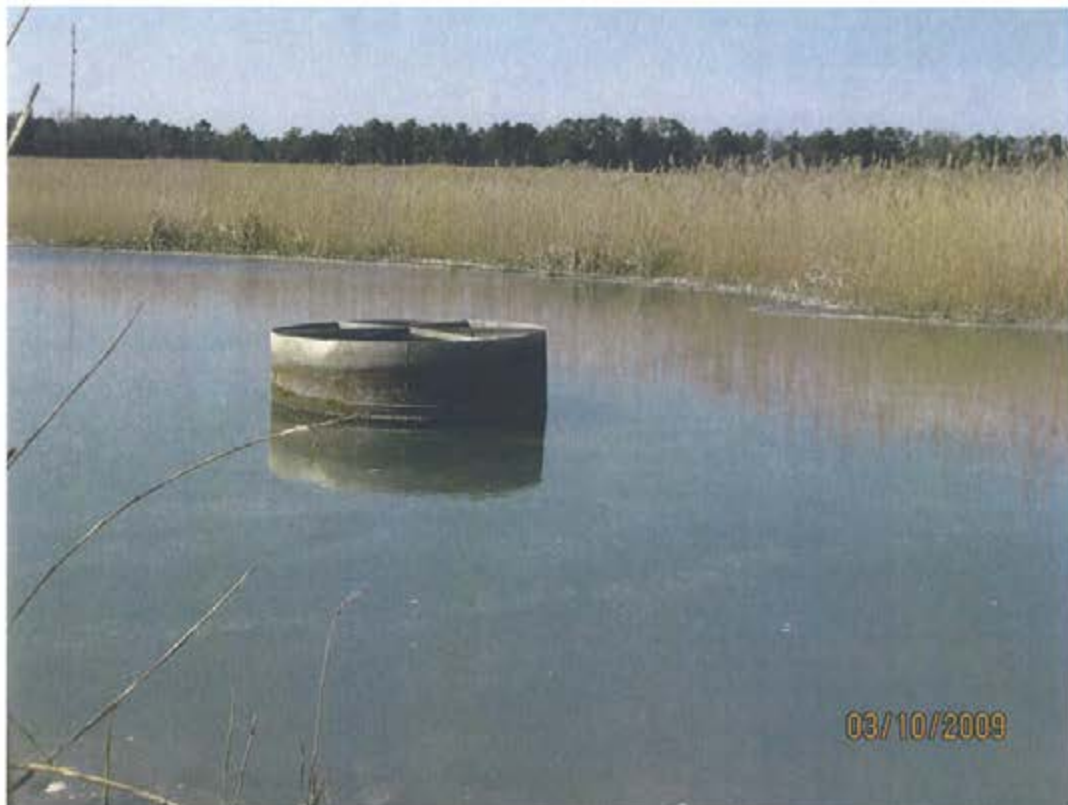
16. Ash Pond –Main Pond Skimmer on Riser

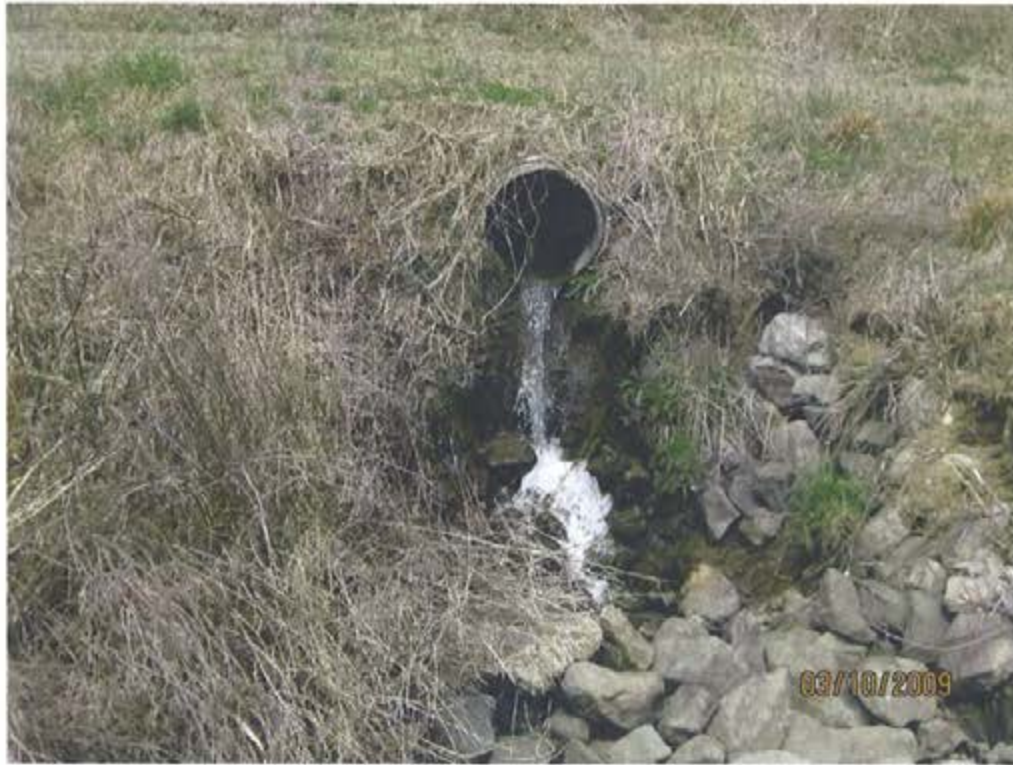
17. Ash Pond – Discharge from secondary settling basin

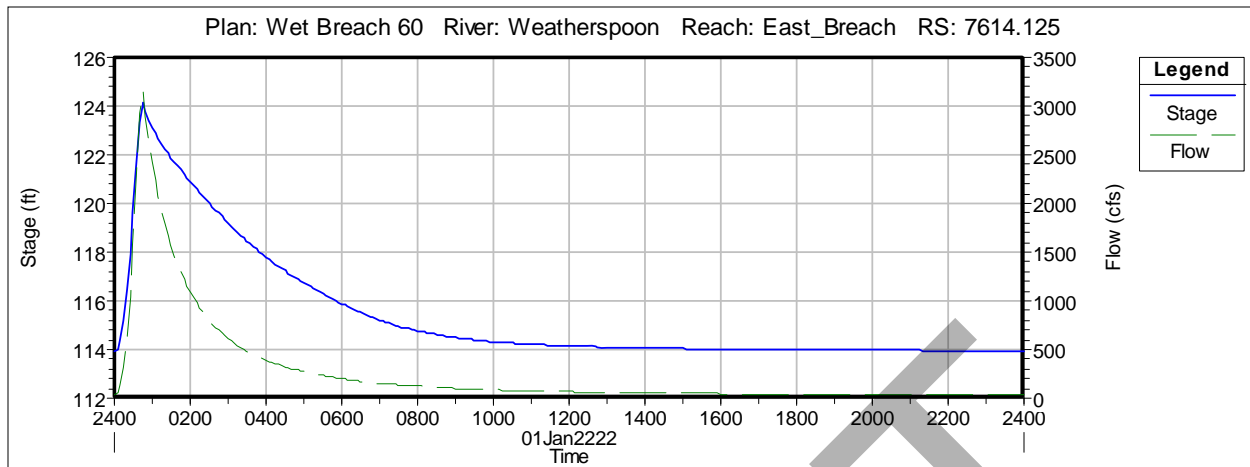
Figure 3. Discharge and Stage Hydrographs at embankment, Wet Weather Breach

Due to conveyance capacity and storage volume of Lumber River relative to the breach flood wave after passing through the drainage canal, minimal inundation is observed for both breach scenarios. As a result, the ash pond breach produced no water level increase in the Lumber River of more than 1.0 foot compared to the no breach condition. Discharge and stage hydrographs in the discharge canal are presented for the dry weather condition and the wet weather condition in Figures 2 and 3, respectively. In the dry weather condition, the initial breach flood wave of ten feet attenuates to one foot by the time it reaches the Lumber River. In the wet weather condition, the initial breach flood wave of 11 feet attenuates to two feet by the time it reaches the Lumber River.

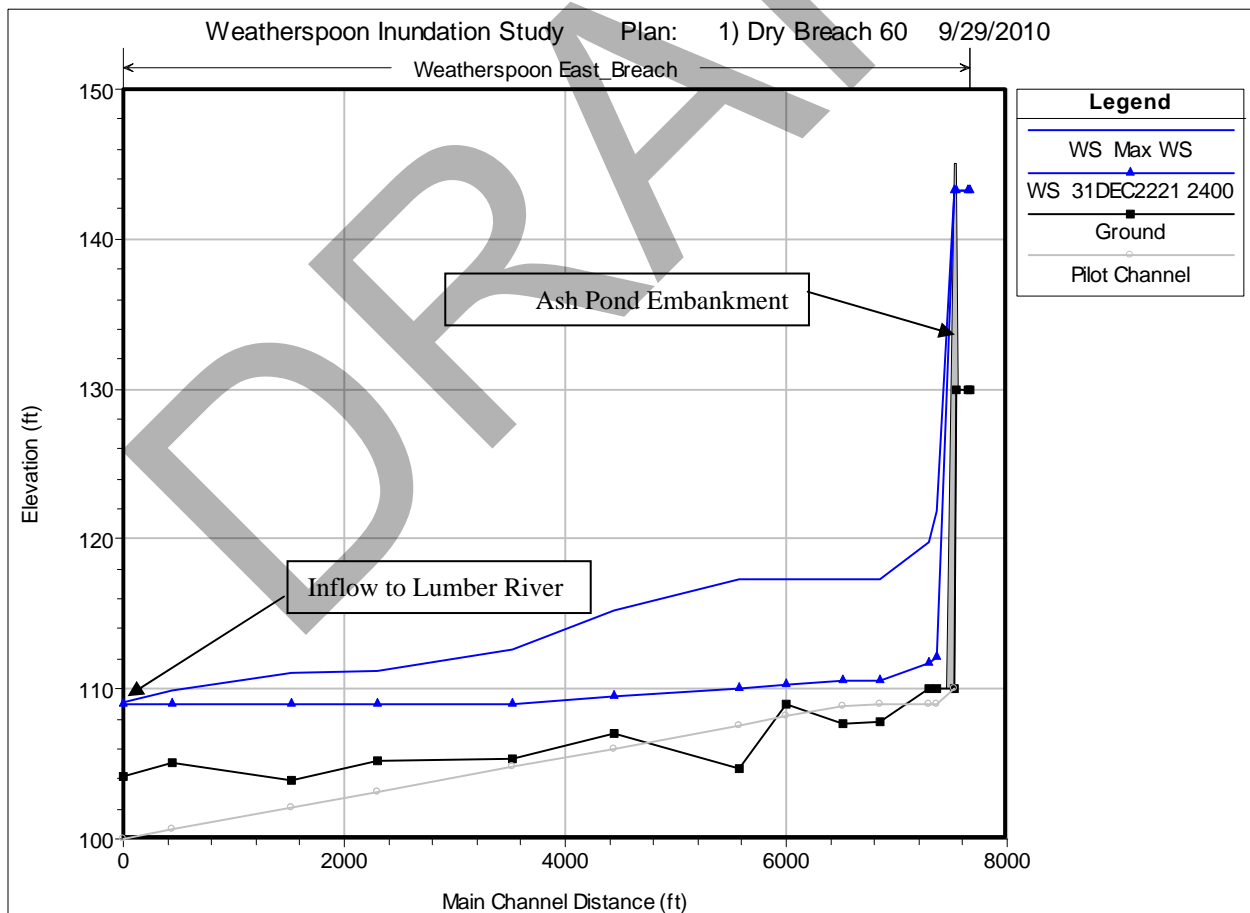
Figure 4. Breach Profile along Discharge Canal, Dry Weather Breach

Stream profiles depicting the effects to the Lumber River from the embankment breach for the dry and wet weather scenarios are provided in Figures 4 and 5. The baseline stream profile is shown as well.

The breach analyses indicate that the breach of the Weatherspoon Ash Pond into the discharge canal is not likely to cause a water level increase of greater than 1 foot in the Lumber River. The majority of flood attenuation occurs along the drainage canal. A breach of Ash Pond to the Cooling Pond will result in an increase storage volume with the Cooling Pond. However, at the current operating conditions, the Cooling Pond has sufficient capacity to store the breach. Based on these model results, it appears that a breach of the Ash Pond will not pose a significant risk to public safety.
