FINAL
Coal Ash Impoundment –
Specific Site Assessment Report
PPL Montana
Colstrip Power Plant

Submitted by:
GEI Consultants, Inc.
6950 South Potomac Street, Suite 300
Centennial, CO 80112

September 2009
Project 091330

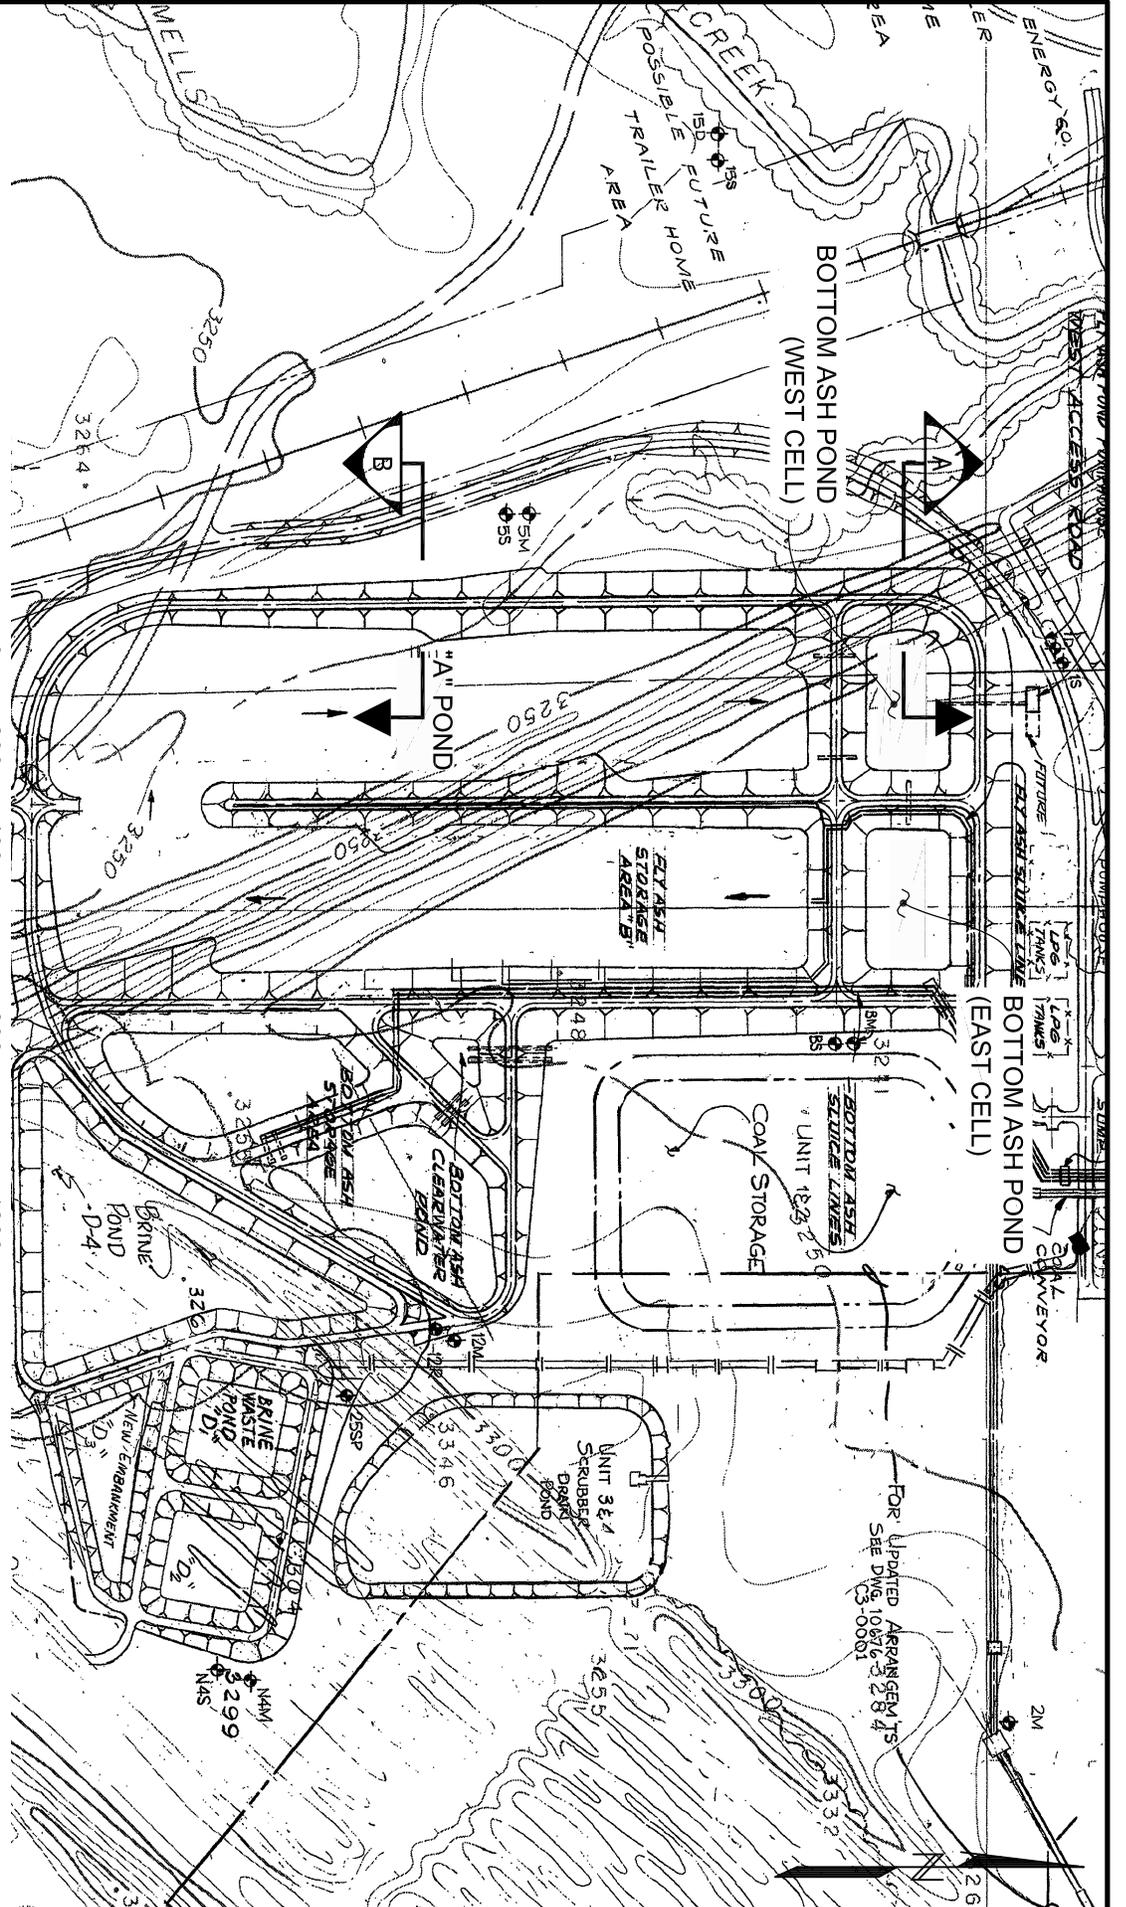
UNITS 1 & 2
 BOTTOM ASH AND
 "A" POND-PLAN
 Project 091330
 September 2009
 Figure 6

We based the embankment geometry for the slope stability analyses on the cross sections shown in Figures 6 and 7. We analyzed Sections A and B as representative of the west embankment, which impounds the Units 1 & 2 Bottom Ash Ponds and Pond "A". Soil parameters were assumed to be the same as those used for design of the STEP Dam (Bechtel, 1979). Bedrock depth was estimated from the Portage, 2005 report on design of the "B" Bottom Ash Pond and was assumed to be at El. 3,217. Piezometric surfaces were estimated using conservative assumptions. The soil material properties adapted from the STEP design are listed in Table 3.

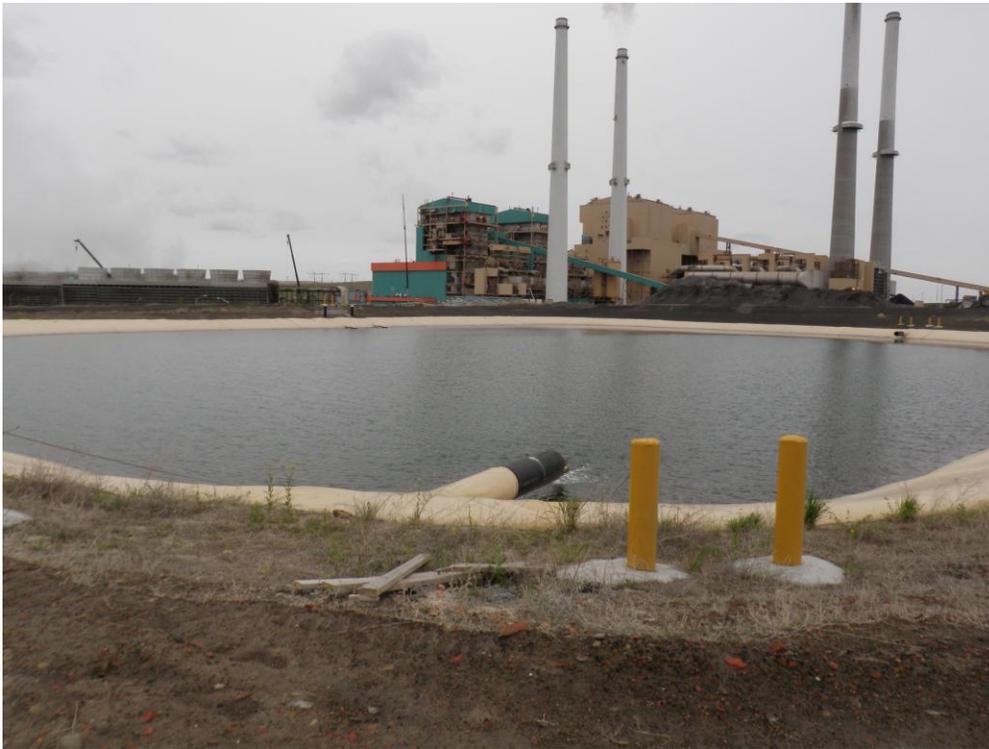
Photo 1: Units 1 & 2 Bottom Ash Ponds: west cell, general view looking northeast from southwest corner of pond.

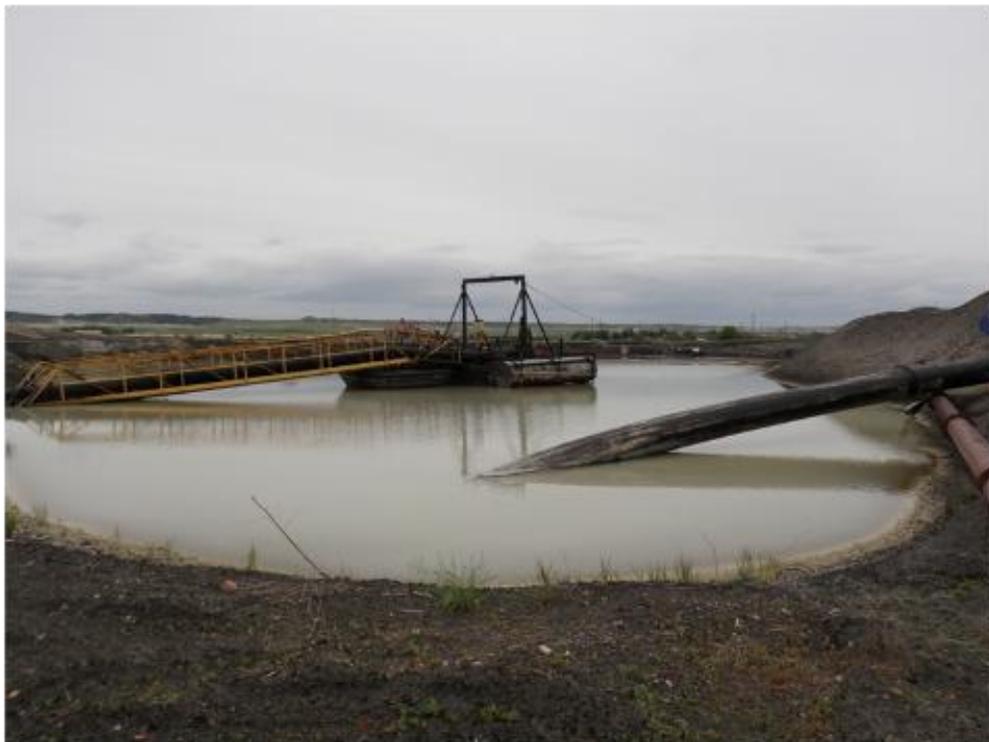
Photo 2: Units 1 & 2 Bottom Ash Ponds: east cell, looking west. The east cell has a clay lining. Note the out-of-service pump barge and associated pipes.

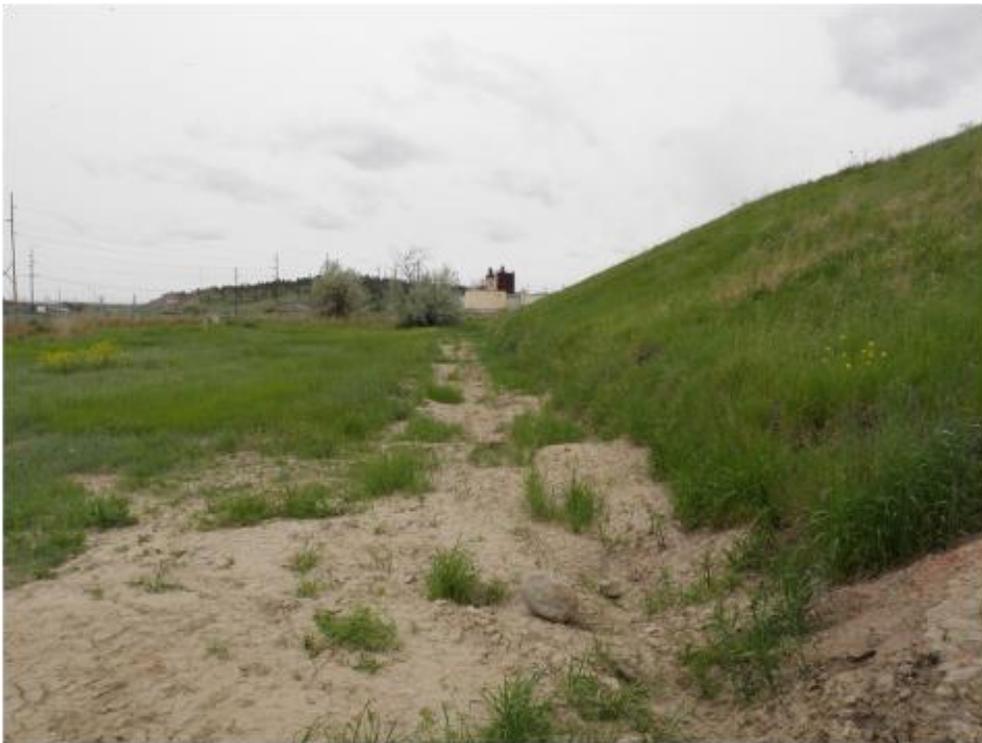
Photo 8: Units 1 & 2 Bottom Ash Ponds: east cell, looking north along downstream toe from near the southwest corner of east cell. Note disturbed soil at toe along recent pipe trench.

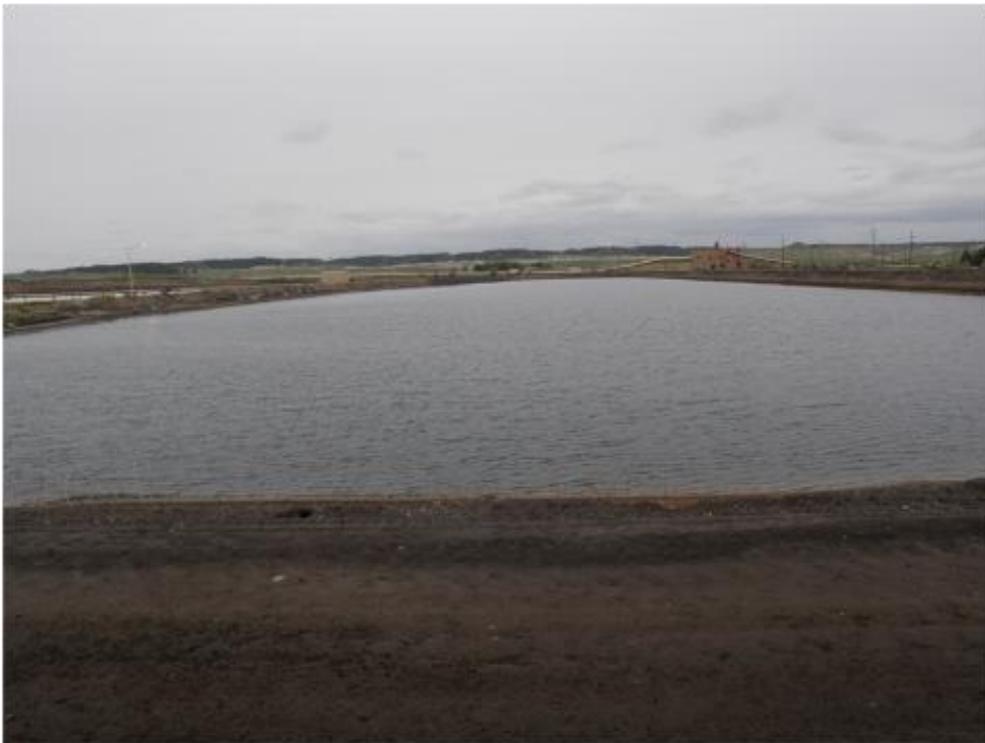
Photo 14: Units 1 & 2 "A" Pond: General view of pond from north embankment, looking south.

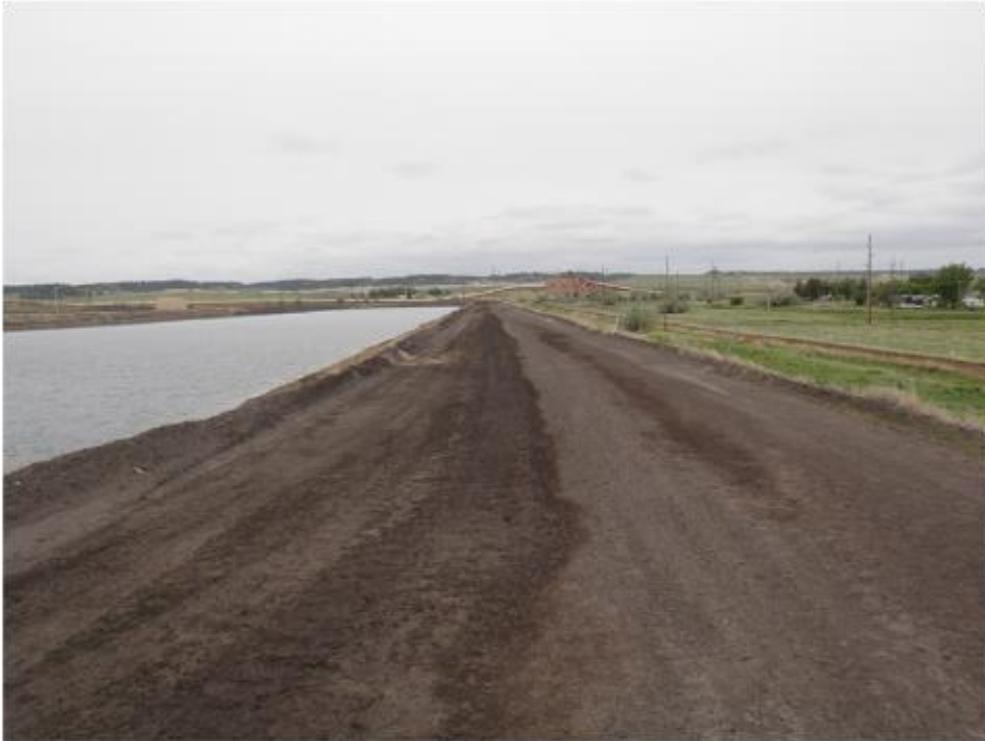
The embankment crest appeared to be in good condition. No signs of cracking or settlement were observed during the assessment. No vegetation was observed on the dam crest (Photo 15).

Photo 15: Units 1 & 2 "A" Pond: View from northwest corner, looking south at upstream slope and crest of clay lined pond.

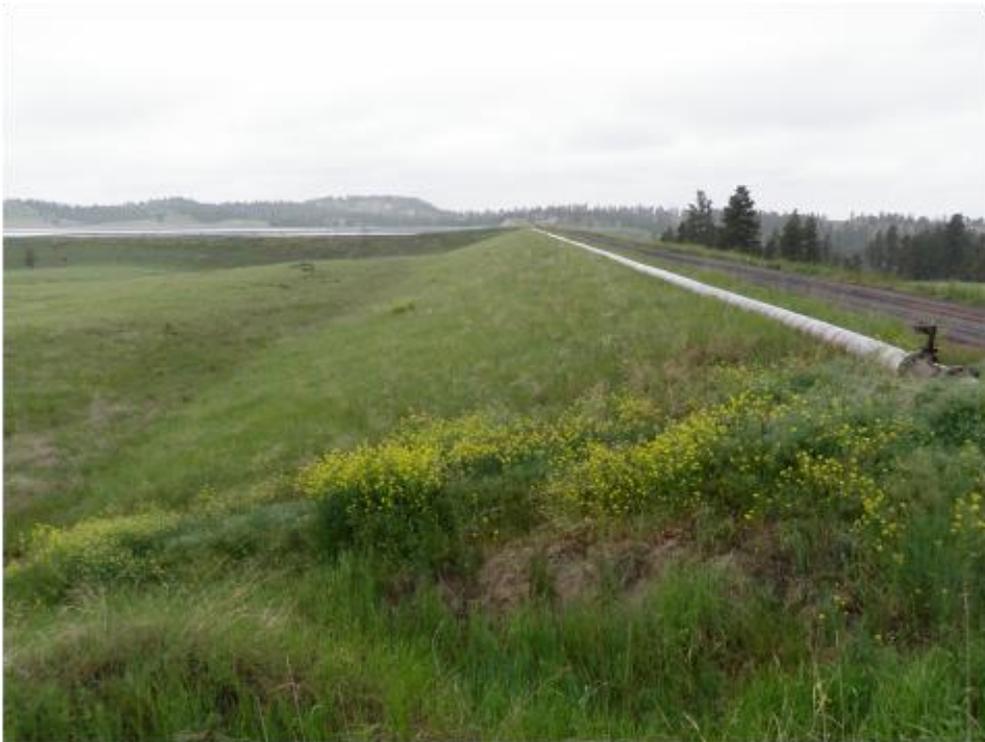
Photo 18: Units 1 & 2 STEP Dam: looking along upstream slope from near the right abutment. Note cell D has not been put in service. At right abutment looking northwest – upstream slope

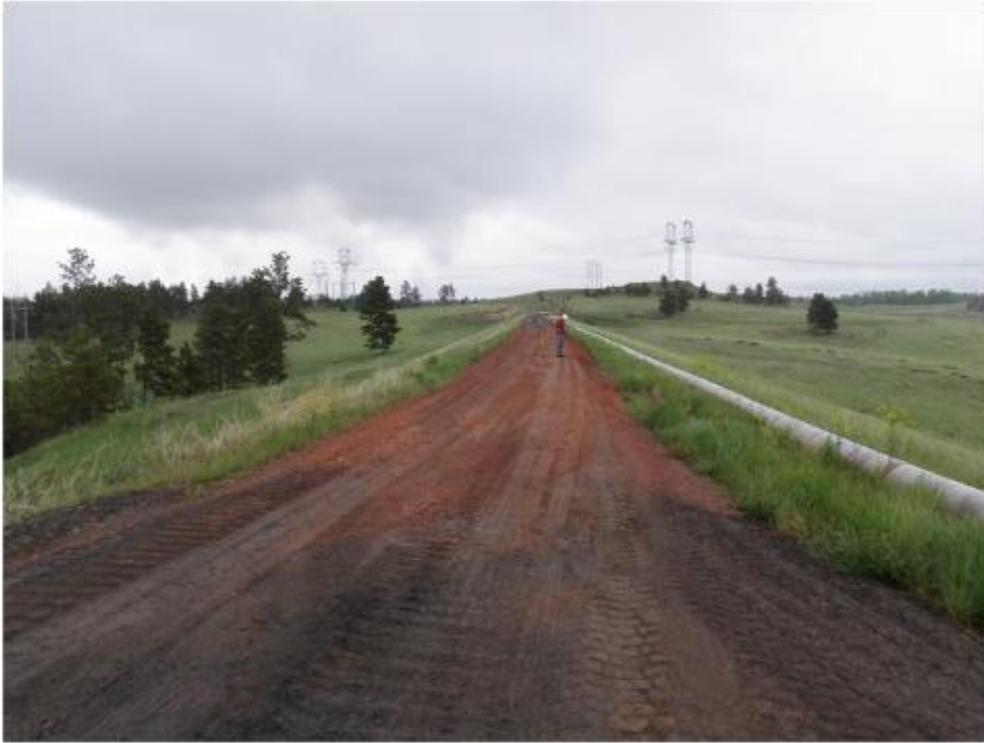
Photo 19: Units 1 & 2 STEP Dam – looking to right (southeast) at dam crest. Note the upstream cell at right (cell D) has not been put in service.

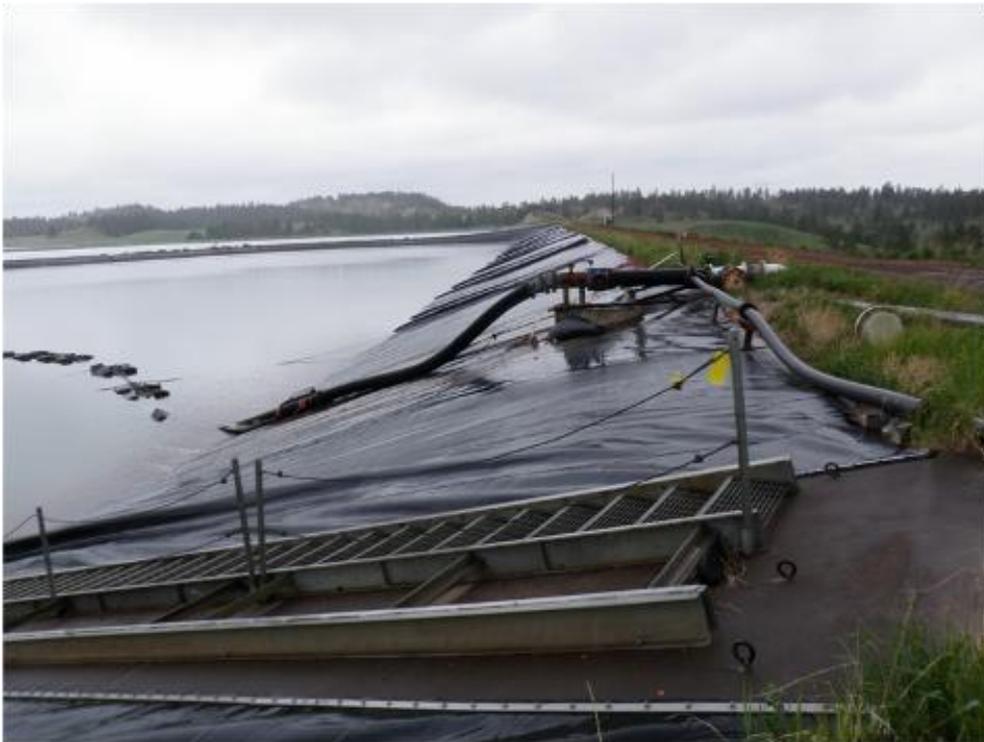
Photo 20: Units 1 & 2 STEP Dam – upstream slope at clearwell, looking to left. Note RFP liner.

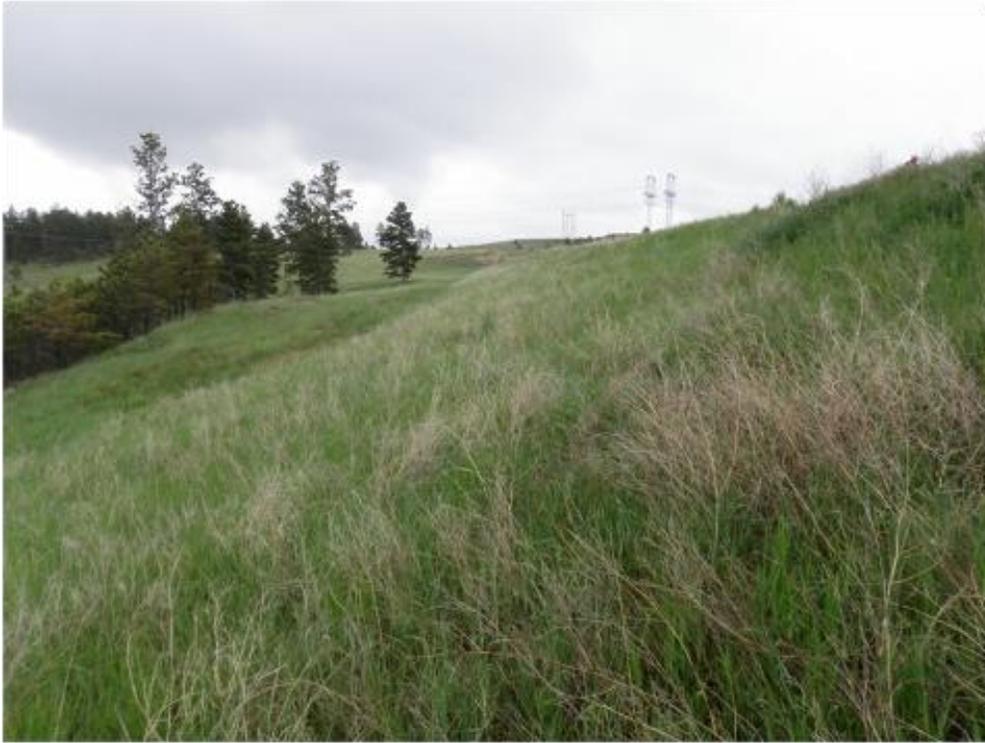
The downstream slope of the embankment is well-vegetated, which provides some erosion protection (Photos 23-24). No signs of major instability were observed along the downstream slope. Some erosion rills caused by surface water were observed in the groin near the right abutment (Photo 25). Stormwater flows across the downstream area near the right side of the dam toe due to runoff from a contributing drainage area located southeast of the dam.

Photo 23: Units 1 & 2 STEP Dam: downstream slope, looking to the right from mid-height near the center of the dam.

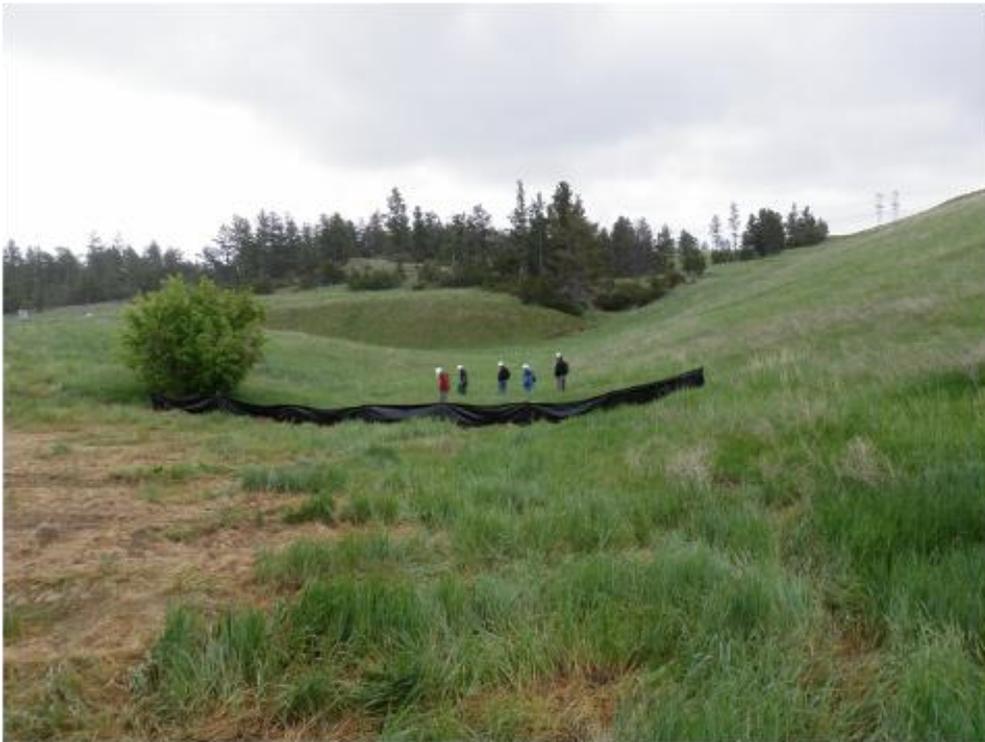
Photo 24: Units 1 & 2 STEP Dam: downstream toe, looking to the right from near the center of the dam.

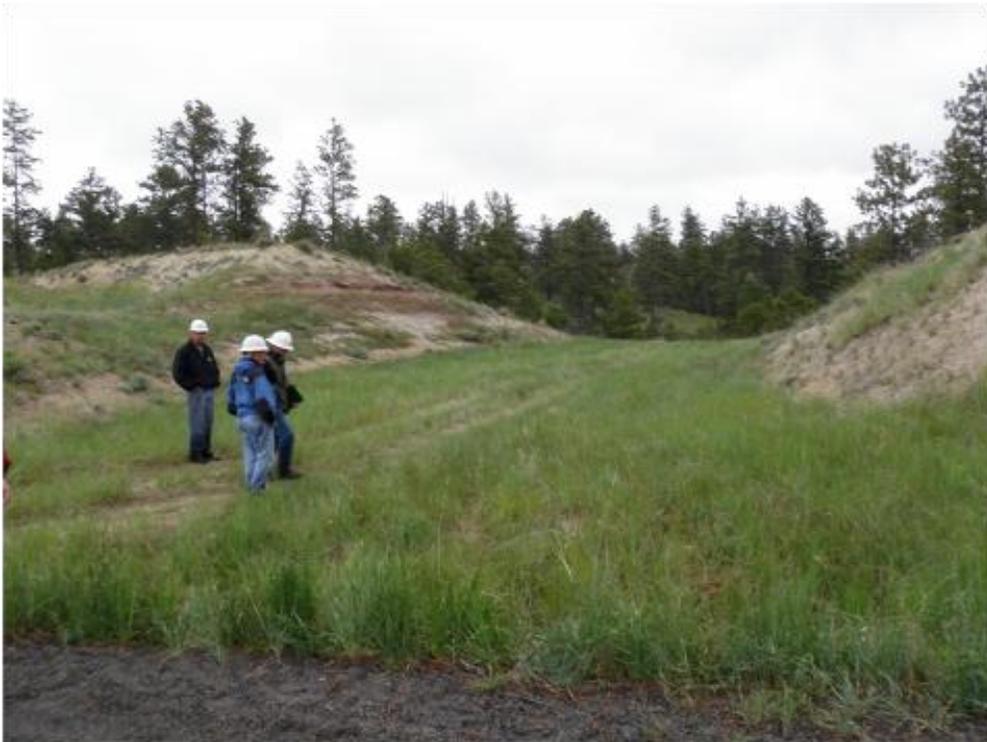
The emergency spillway beyond the left abutment of the dam appeared to be in good condition, with no visible deterioration (Photo 26). No pond discharges have ever flowed through the spillway.

Photo 26: Units 1 & 2 STEP Dam: Emergency spillway, looking downstream.

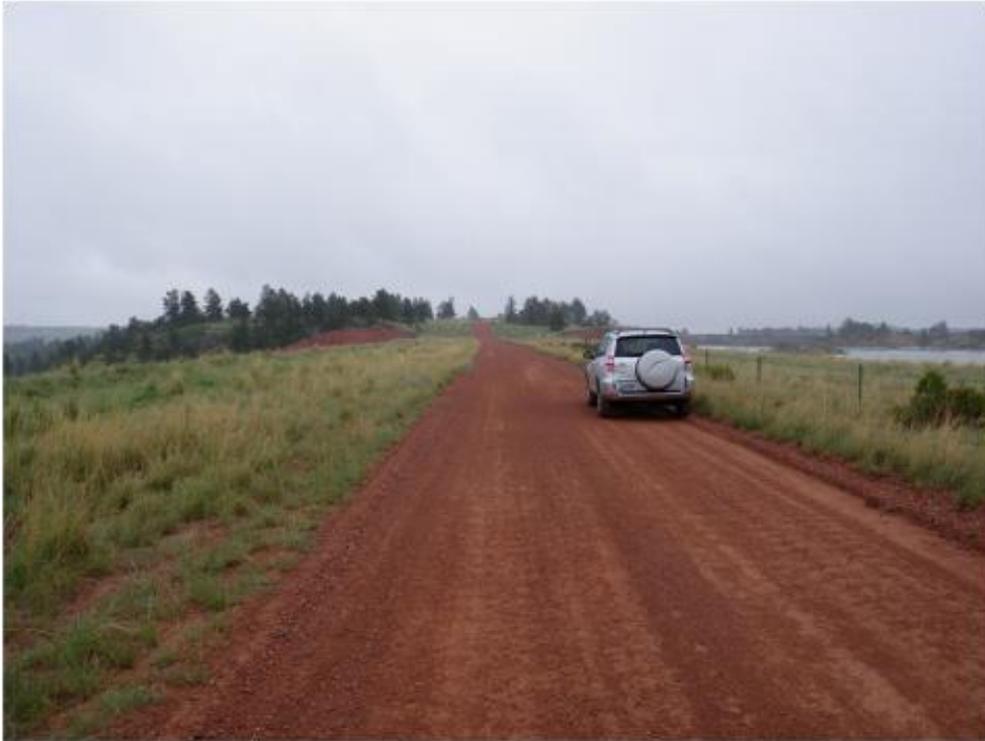
Photo 27: Units 3 & 4 EHP Main Dam: View of very wide dam crest from left abutment, looking to the right. The Old Clearwell cell is on the upstream side.

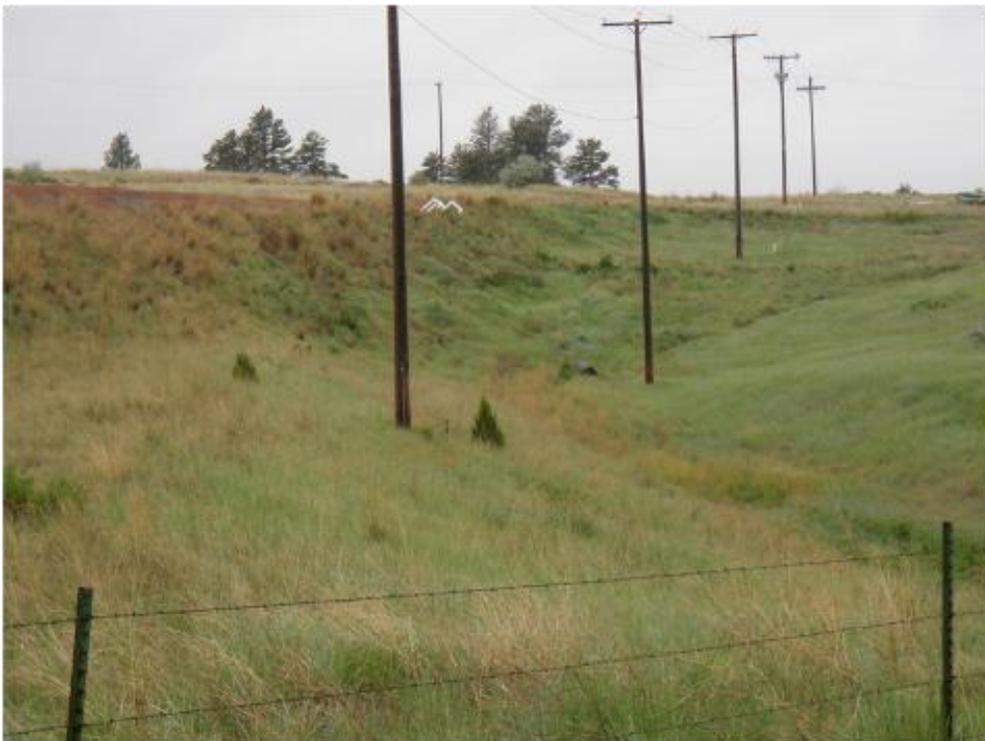
The embankment crest appeared to be in good condition. No signs of cracking or settlement were observed during the assessment. Because the dam will be raised in the future, the crest is currently much wider than its proposed 20 feet. The crest is vegetated with grass and has a dirt road near the centerline of the dam (Photo 27). The dam crest appears to have a length of fill located in a small saddle about 500 feet to the left of the left abutment (Photo 28). This fill should also be considered part of the dam until conditions are documented that indicate it does not serve as part of the dam structure.

Photo 28: Units 3 & 4 Main Dam: Fill in topographic low area (saddle) located about 500 feet to the left of left abutment. This fill may constitute part of the Main Dam, but has not been documented as such.

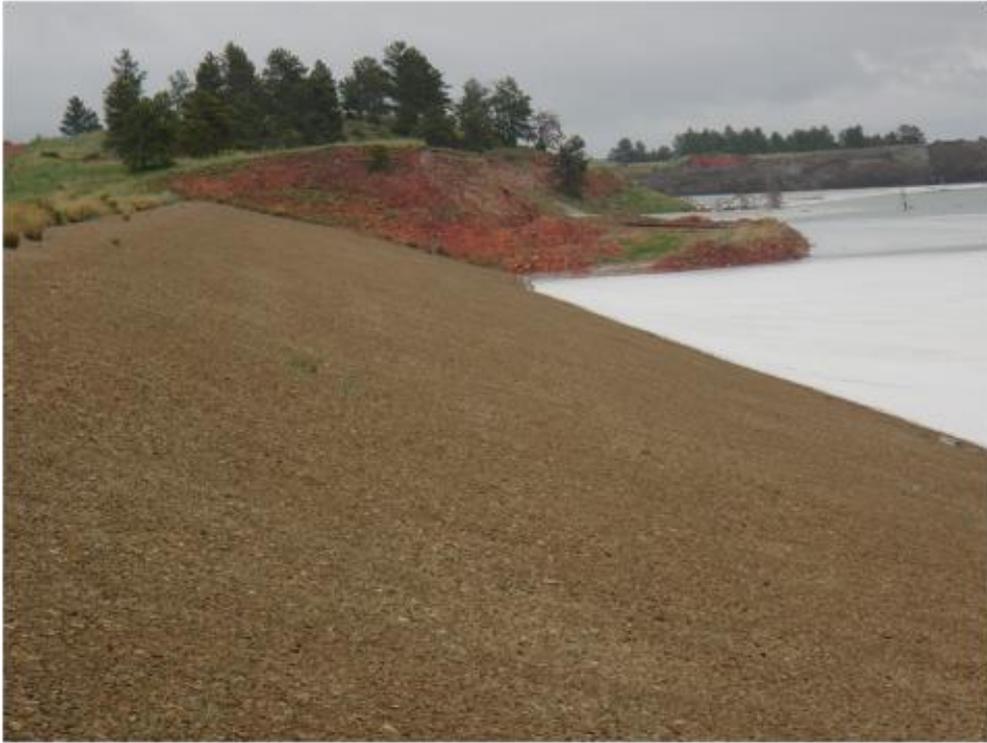
The upstream slope of the Main Dam is protected by soil cement and appeared to be generally in satisfactory condition (Photo 29 and 30). Some seepage and erosion was observed at the left abutment groin on the upstream slope. The seepage was located more than 10 feet above the reservoir water level. Ray Womack of Womack Consulting indicated that the seepage originates from perched groundwater within the dam abutment and the adjacent divider dike due to the recent rain (Photo 31). This seepage location was also acknowledged in Womack's 2009 report. The report indicates that the seepage originates due to surface water collecting in the baked shale and has no effect on the stability of the dam.

Photo 29: Units 3 & 4 Main Dam: Looking to right from the left abutment – upstream slope with soil cement protection that impounds the Old Clearwell.

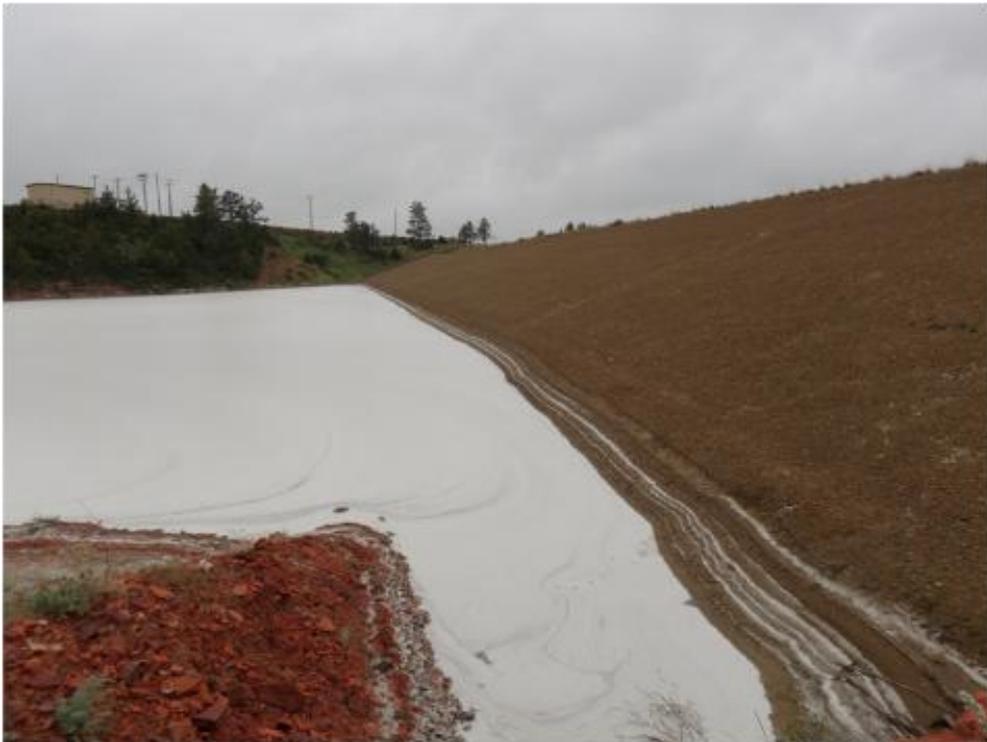
Photo 30: Units 1 & 4 Main Dam: Looking to left from the right abutment – upstream slope with soil-cement.

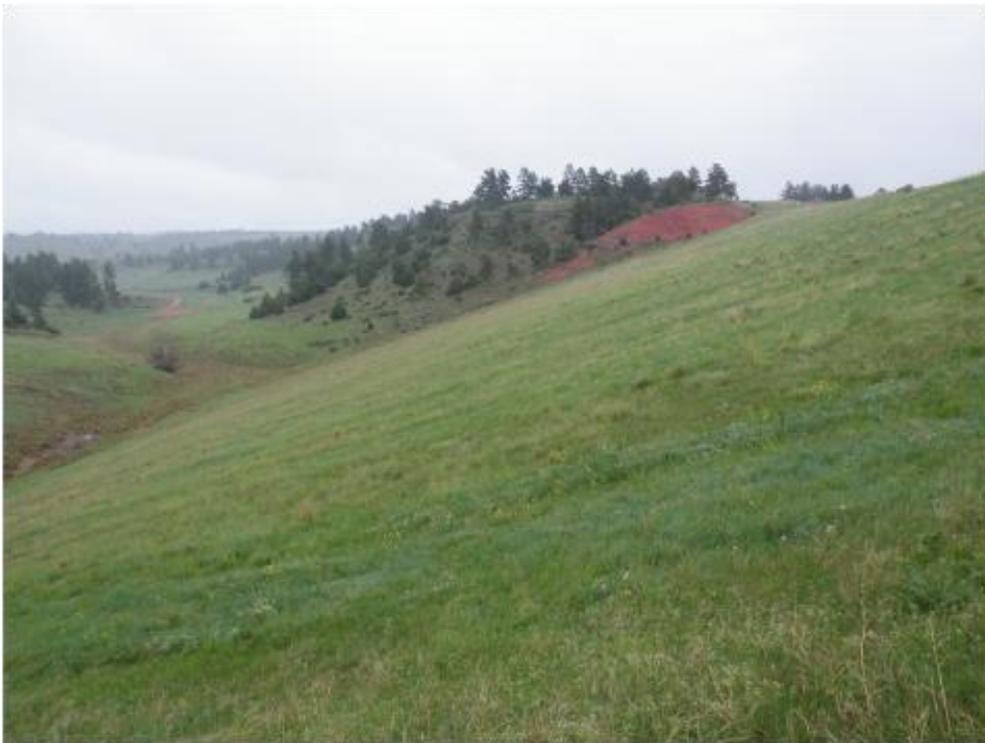
The downstream slope of the embankment is well-vegetated, which provides some erosion protection (Photos 32 and 33). No signs of major instability were observed along the downstream slope. Some animal burrows, including one excavated into the drainage sand at the right downstream groin, and minor erosion rills caused by surface water were observed (Photos 34 and 35). Seepage has been observed in the natural ground a short distance downstream of the Main Dam since 2000 (Womack 2009) and studies have shown the flow

Photo 32: Units 3 & 4 Main Dam: Looking to right at the downstream slope from left abutment.

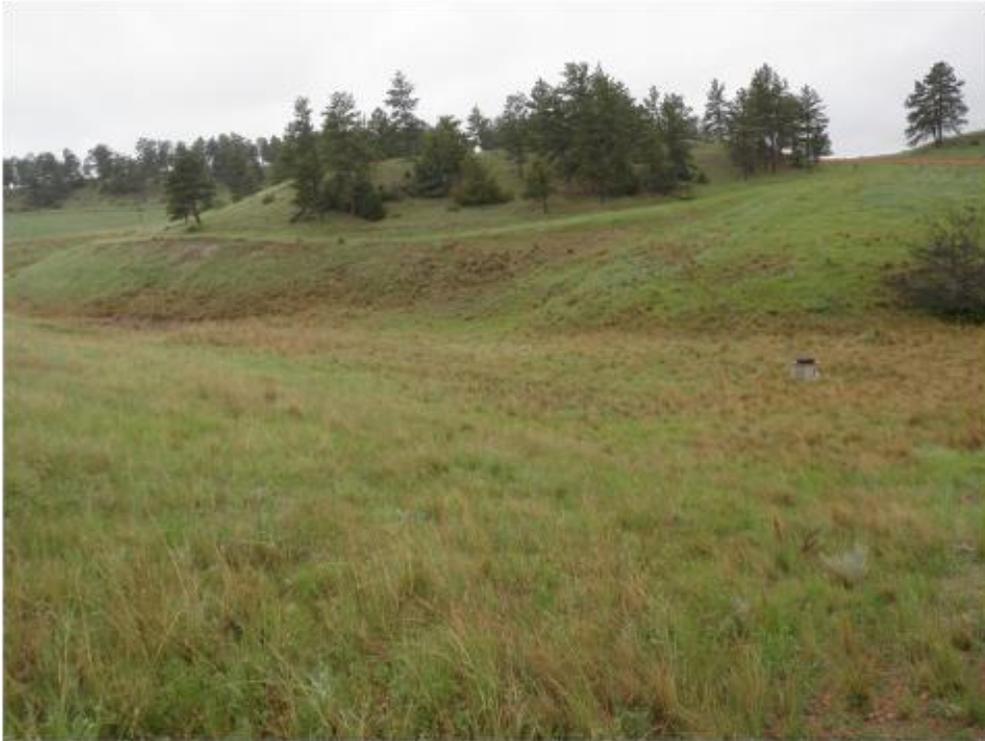
Photo 33: Units 3 & 4 Main Dam: Looking to left at downstream slope and toe from the right groin area.

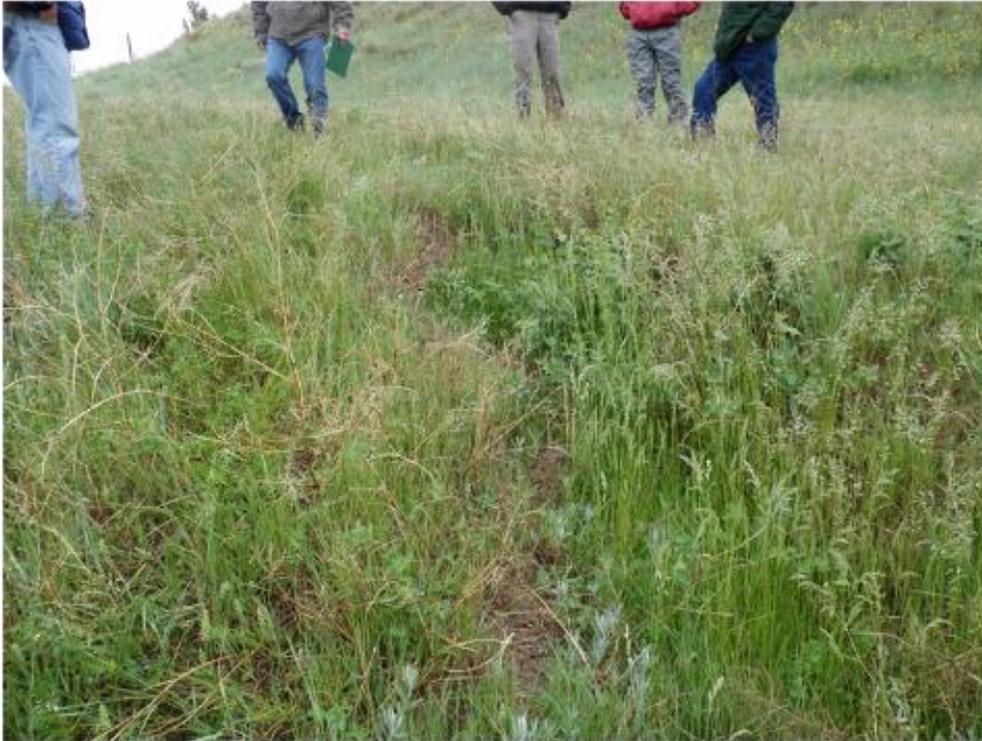
Photo 35: Units 3 & 4 Main dam: Minor surface erosion at about mid-height on downstream slope near left groin.

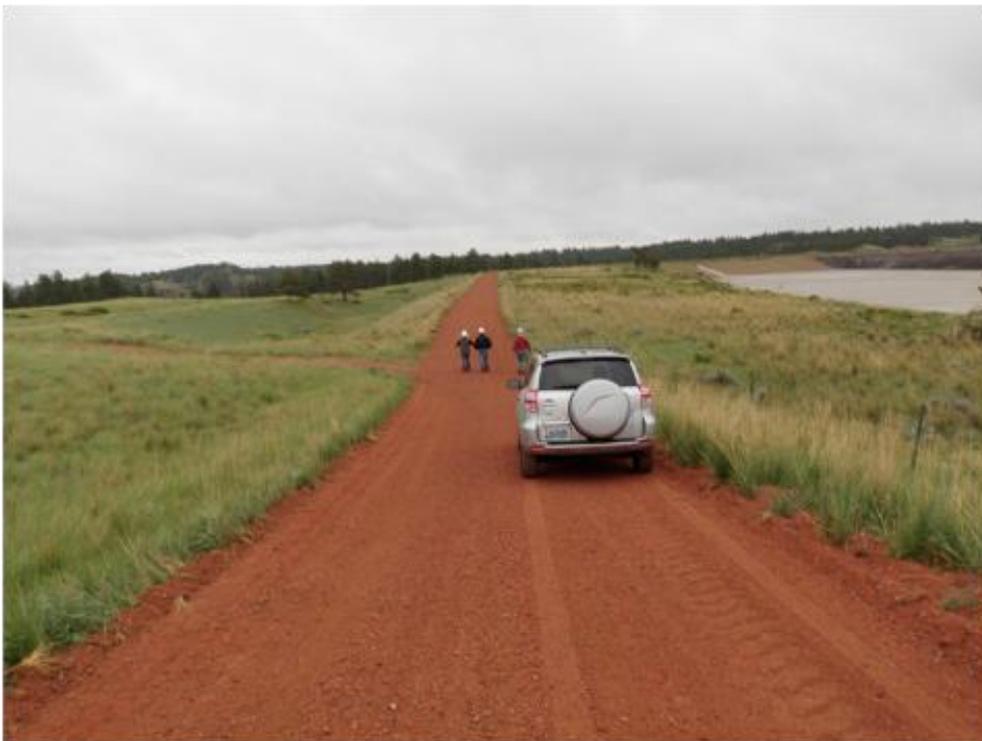
The embankment crest appeared to be in fair condition. Because the dam will be raised in the future, the crest is currently wider than its proposed 20 feet. There is a dirt road along the downstream side of the crest, (Photo 36) while the upstream side is vegetated with a thick stand of sage brush and grass (Photo 37). PPL Montana personnel pointed out healed cracks in areas where cracking and settlement occurred associated with the 1999 seepage event (Photos 38 and 39). Cracks up to about 1 foot wide and several feet deep were originally observed during the inspection by Maxim Technologies in 1999 (Maxim, 2005) and have since been repaired. No new damage was observed beyond that documented in the past.

Photo 36: Units 3 & 4 Saddle Dam: View of very wide dam crest from the left abutment, looking to the right. Cell "G" is impounded to the right.

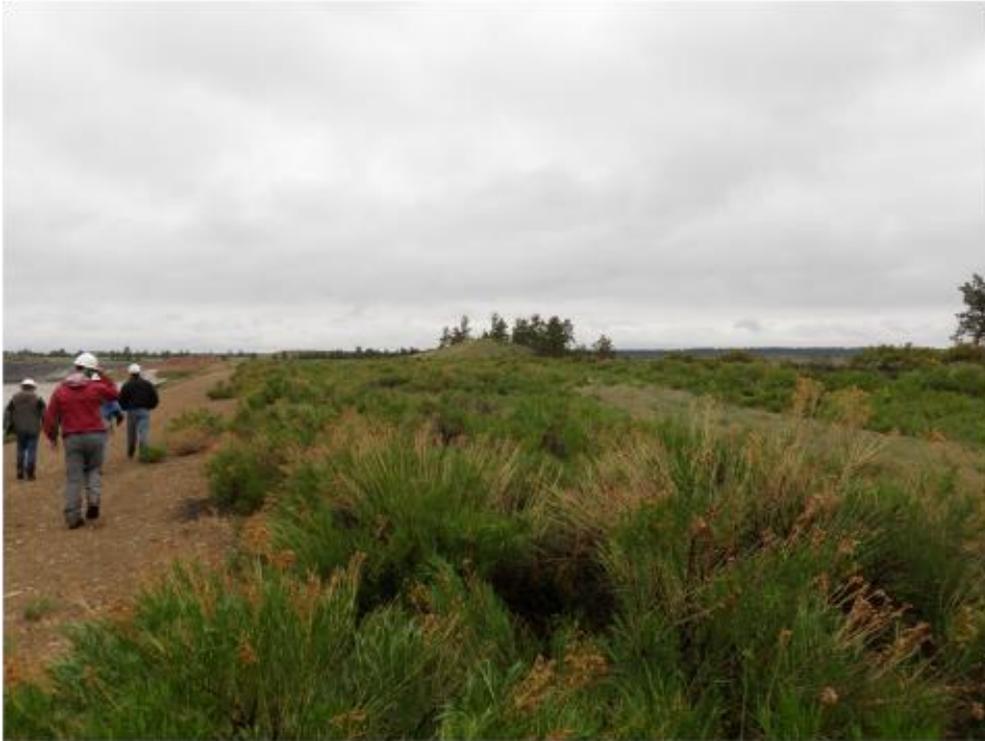
Photo 37: Units 3 & 4 Saddle Dam: Upstream side of upstream crest at right abutment. Note heavy sage brush vegetation.

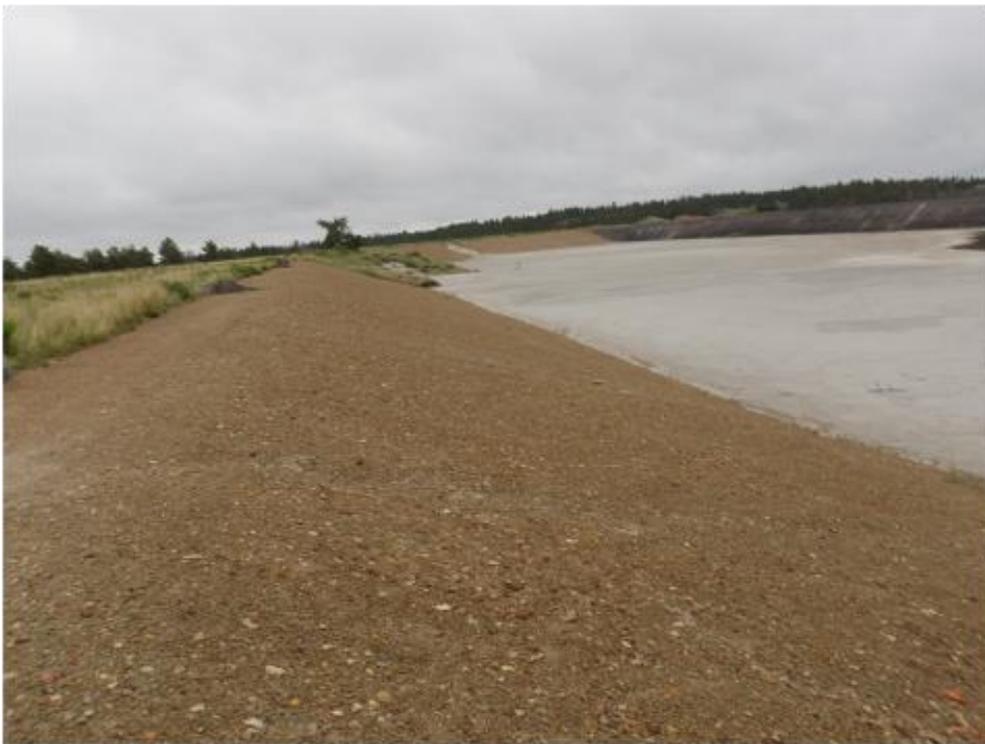
The upstream slope of the dam is protected by soil cement and appeared to be in good condition (Photo 40). Minor vegetation was becoming established on the soil cement in some areas (Photo 41).

Photo 40: Units 3 & 4 Saddle Dam: View of upstream slope from near the left abutment. Note soil-cement erosion protection.

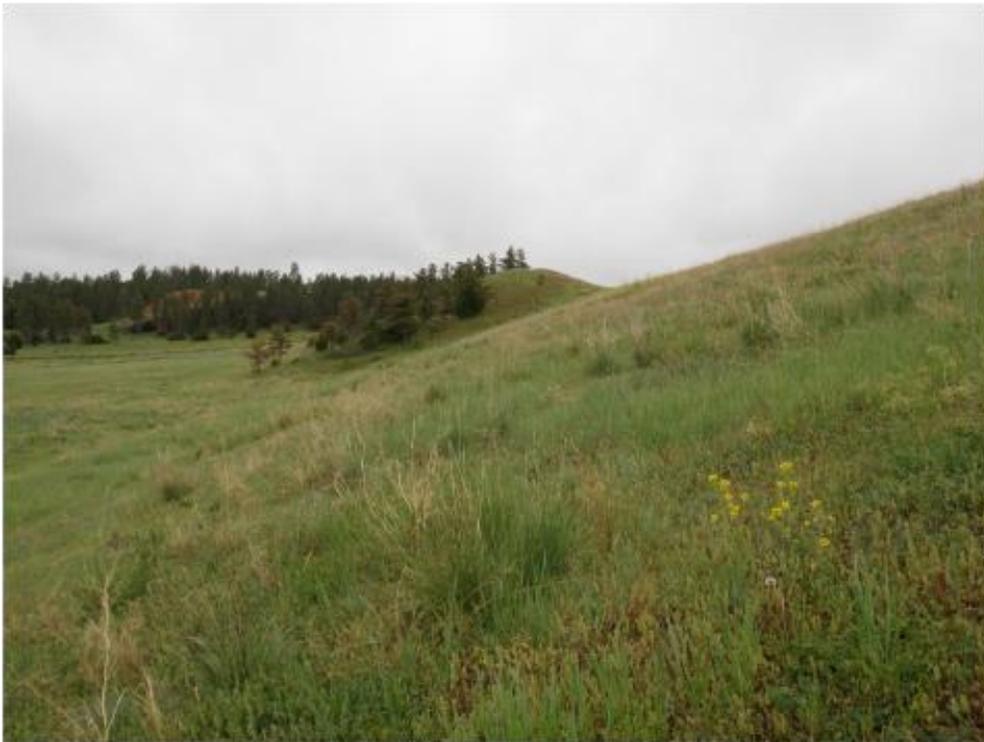
The downstream slope of the embankment is well-vegetated, which provides some erosion protection (Photos 42 and 43). Several issues were noted during the field assessment of the downstream slope. Near the center of the dam at the downstream toe was an open test pit (Photo 44) that was excavated about 10 years ago to observe the toe drain during the 1999 seepage event. The drain sand and a broken toe drain pipe were visible in the test pit

Photo 42: Units 3 & 4 Saddle Dam: View of downstream slope looking to the right.

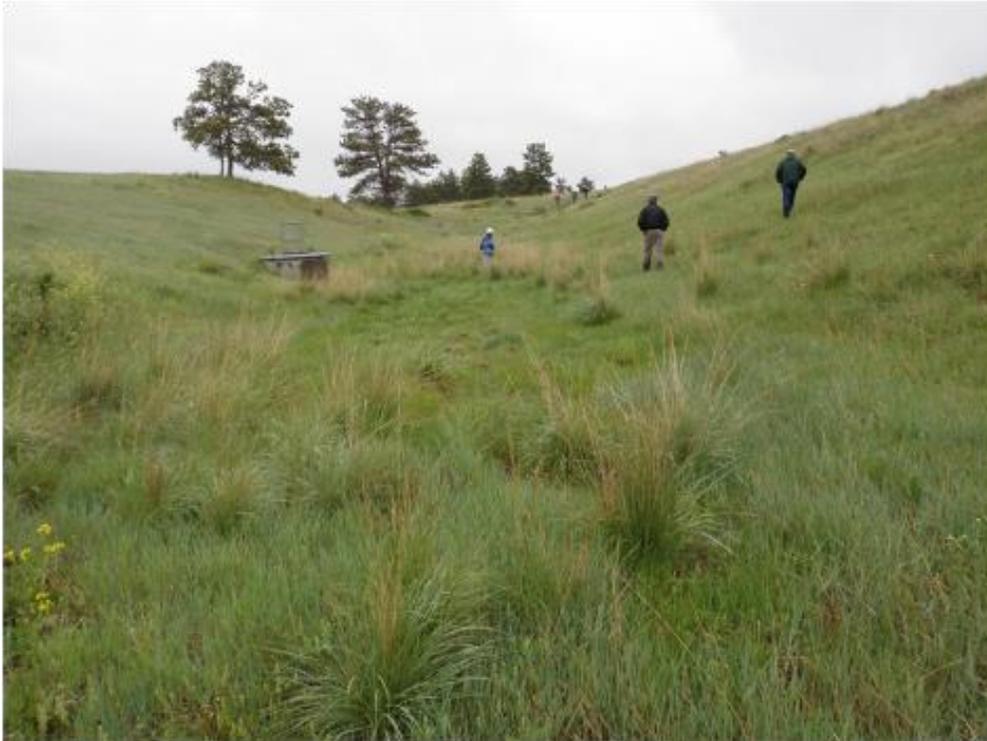
Photo 43: Units 3 & 4 Saddle Dam: Downstream toe near left abutment.

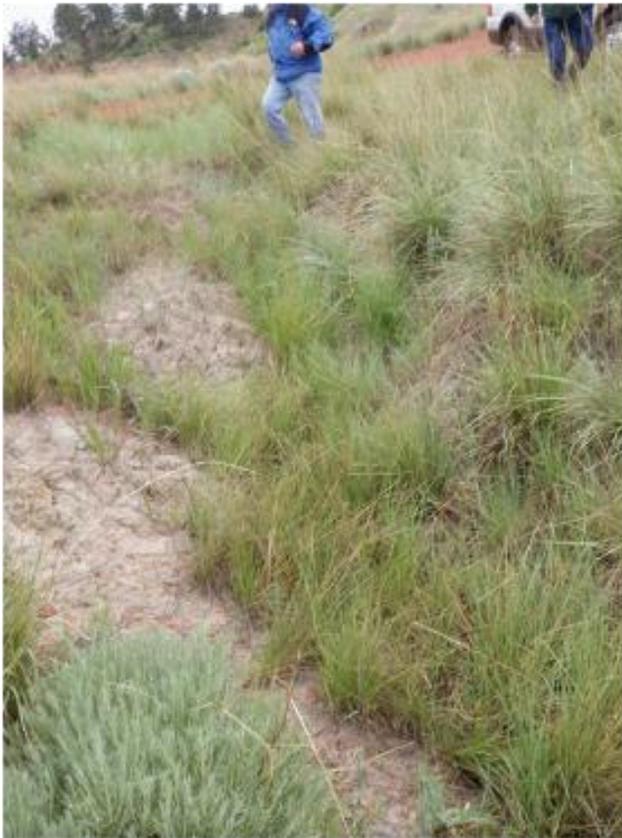
(Photo 45). PPL operates the adjacent cell “G” with a restricted water level below El. 3,237 to prevent recurrence of the seepage issue. Some minor surface erosion was also observed along the downstream slope (Photo 46).

Photo 46: Units 3 & 4 Saddle Dam: Surface erosion near crest at left abutment/downstream groin.
