Martins Creek Power Plant Regional Map Showing the Management Unit(s) in Relationship to Critical Infrastructure (Photo Locations of Documents A1.3-A1.10)

***DEP comment # 6: PPL asserts that certain portions of the basin are susceptible to leaching dissolved selenium when ash remains saturated for a period of time. Please provide estimates of the amount of continuous precipitation that could result in the saturation of fly ash within the basin and the increase in water level within the aquifer beneath the basin such that it contacts the ash and affects groundwater.***

**Martins Creek SES Ash Basin #4 Release**  
Martins Creek SES Site Layout

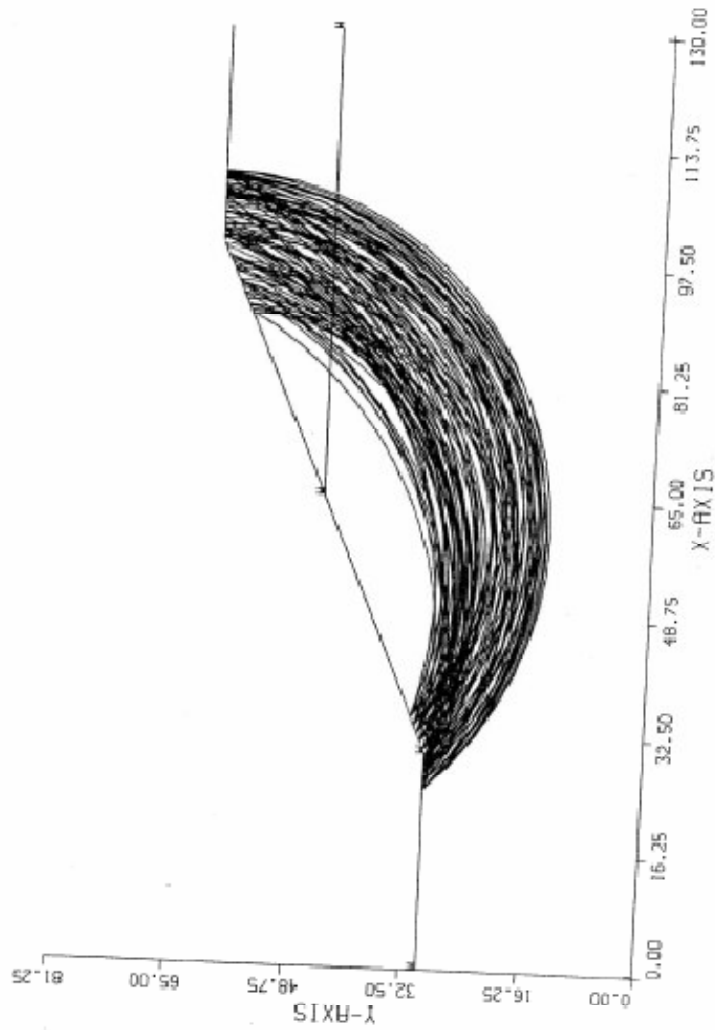
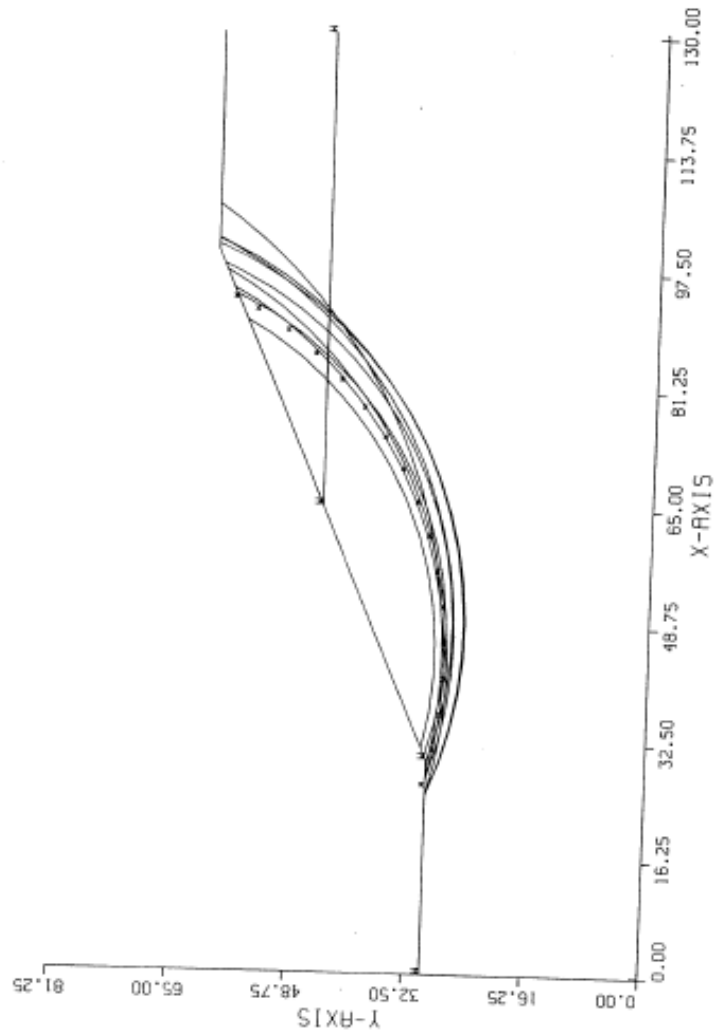
10 MOST CRITICAL OF SURFACES GENERATED  
 MINIMUM FACTOR OF SAFETY = 1.401

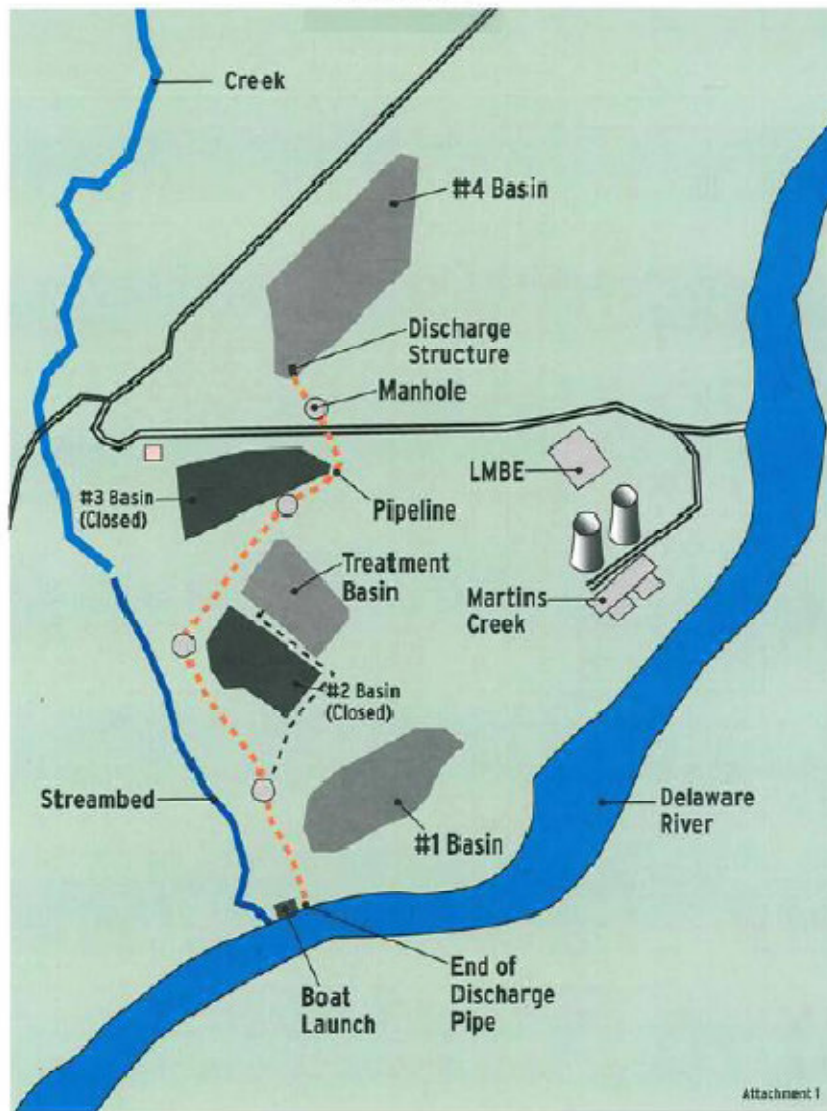
FIGURE 1

The discharge structure at Ash Basin #4 is a 45-foot high concrete tower that is divided into two chambers. At the time of the incident, water entered the first chamber and was held back by a wall consisting of wooden stop logs stacked on top of each other, each about 9 inches high, 7 inches wide and 7 ½ feet long. Figure 2 shows the flow-through arrangement of the discharge structure (prior to any modifications). The stop logs were fitted into a steel reinforced channel in the concrete tower discharge structure and held in place by the structure. The stop logs were treated with creosote to prevent underwater deterioration. The design of the stop log wall allowed operators to add or remove stop logs to adjust the water level in the basin. This ensured that the fly ash deposited in the basin remained submerged to prevent dusting and to allow for proper settling of the sluiced ash. There was also the occasional need to adjust the level of the basin to allow maintenance on the basin liner. Under normal operation, as water and ash were pumped into the basin, the water flowed under a metal skimmer plate (used to block any floating material), then over the stop log wall into the second chamber of the discharge structure. There it entered the pipe that discharges to the Delaware River.

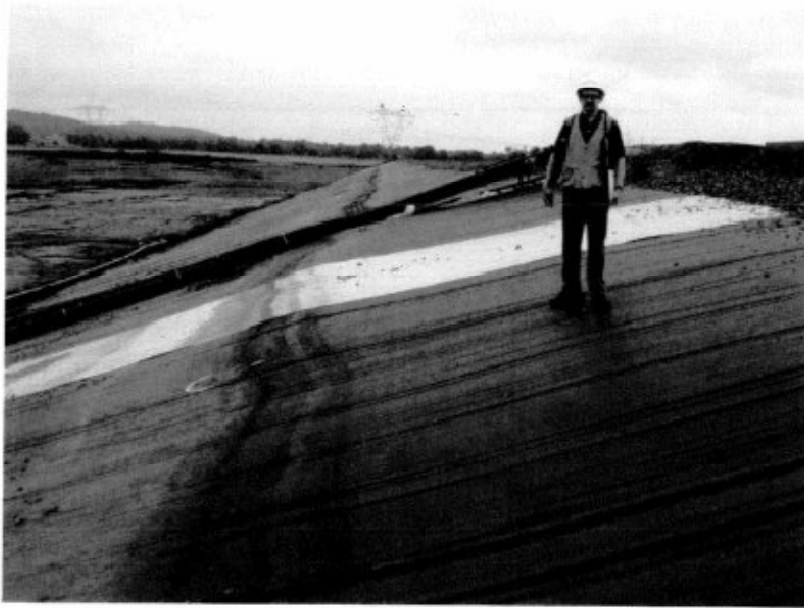
The upstream slope is graded at approximately 3H:1V and was observed to be in good condition, as seen in Photo 4. Approximately 450 feet north of the outlet structure, a 25-foot-long bulge was observed in the liner at the water line, as seen in Photo 5, which is indicative of a shallow slough in the underlying embankment soils. Between Stations 8+00 and 12+00 a bulge up to 2 feet high was observed in the upstream slope under the liner, as seen in Photos 6 and 7. The cause of these slumps was not obvious, but they did cause the liner to be suspended above ground and in tension. Since the observed slumps were above the planned water level, they do not have any impact on future liner performance, provided that fill is not

Photo 5 - Bulge in liner along upstream slope of east embankment, looking north from Sta 4+30.

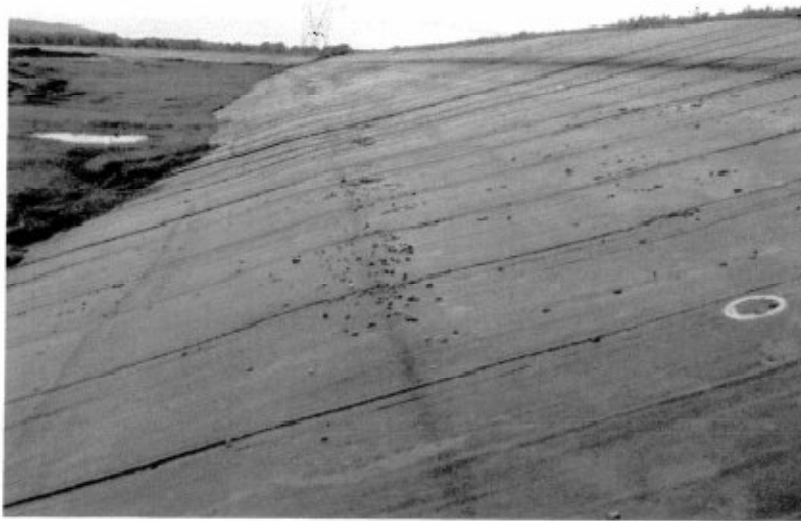
Photo 6 - Bulge in liner north of Station 8+00, looking north.

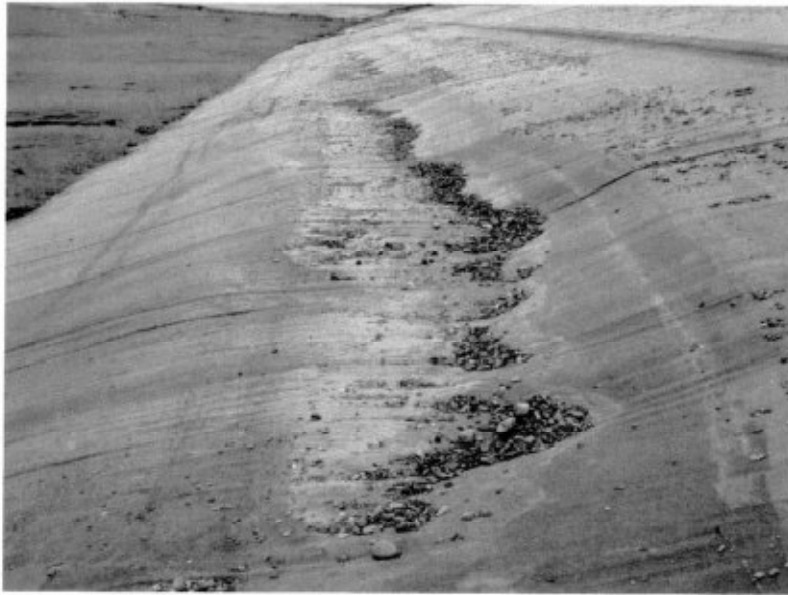
Photo 7 - Bulge in liner at Sta 9+75, looking north.

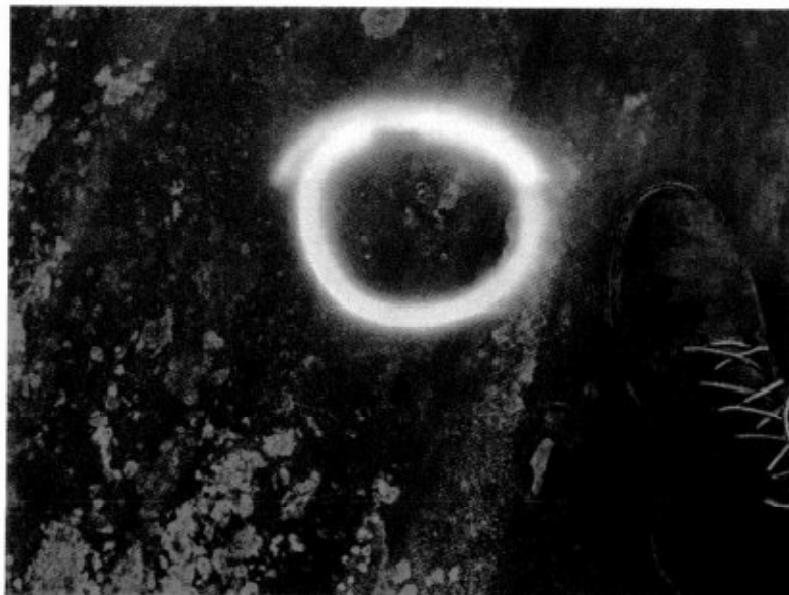
Photo 8 - Weathered section of liner with small hole.

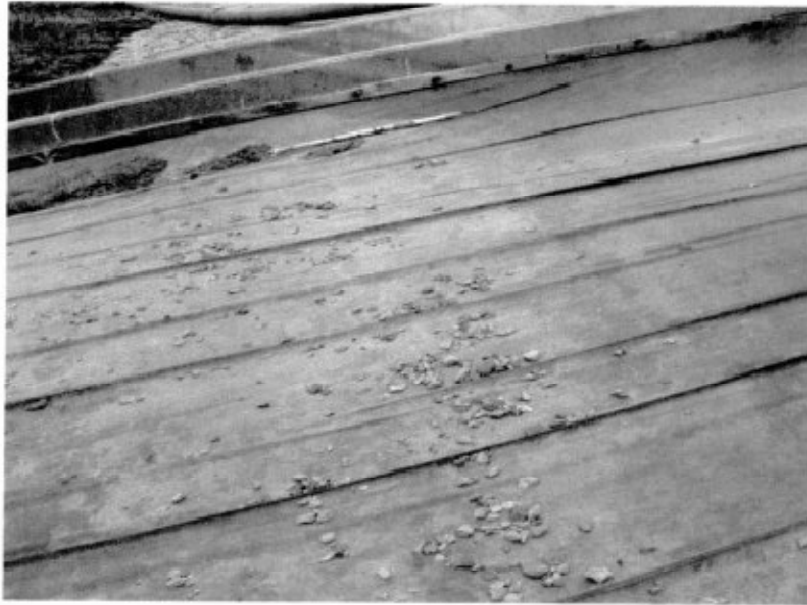
Photo 9 - Wrinkling of the upstream liner near the concrete loading ramp, Sta 13+50.

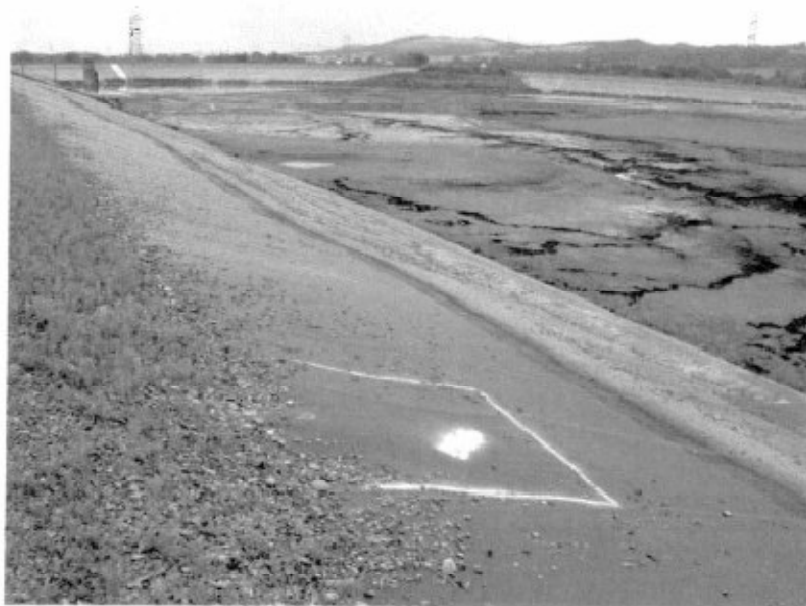
The crest of the embankment is approximately 15 feet wide and consists of gravelly soil. No evidence of movement, settlement, cracking, or other distress was observed. The road base includes sharp pieces of shale which have washed onto the liner in places, as seen in Photo 10, which has the potential to puncture the liner.

Photo 10 - Roadway gravel on top of liner.

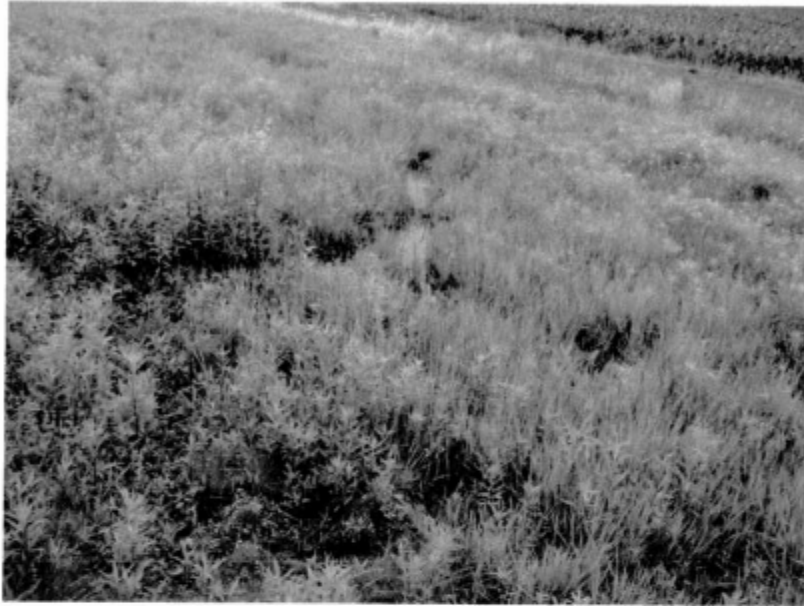
Photo 13 - Standing water and wet areas along the toe of the northeast embankment between Sta 14+50 and 17+50.

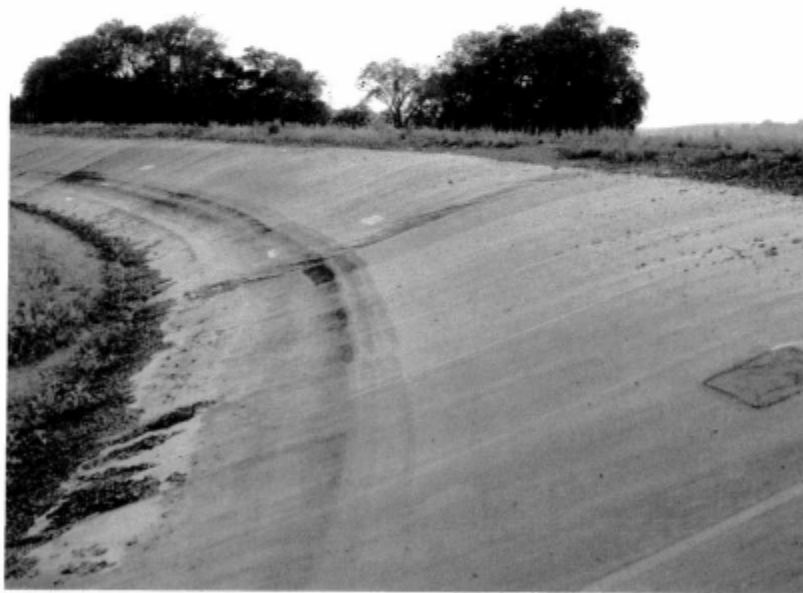
The upstream slope and liner were in generally good condition over this section of embankment. As the embankment makes the sharp bend near the northwest end, near the intersection with the west embankment, wrinkling and tension in the fabric was observed as seen in Photo 14, which tended to increase the number of fabric tears that were observed. At the north end of the embankment, the impoundment fill was within 10 feet of the crest.

Photo 14 - Fabric wrinkle at northwest end of northeast embankment Sta 27+00.

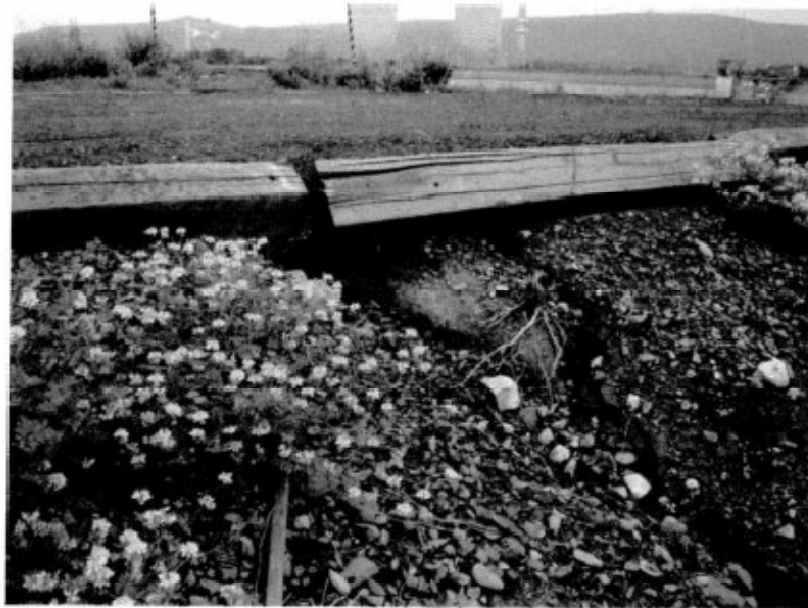
Photo 20 - Crest erosion near truck turnaround area on the southwest embankment.

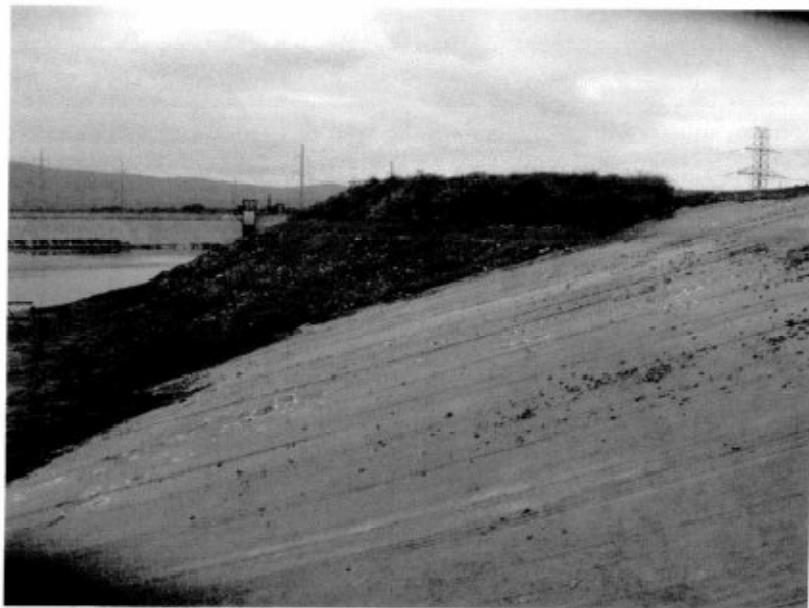
Photo 22 - Weathering and concentrated holes in liner north of truck turnaround on southwest embankment.

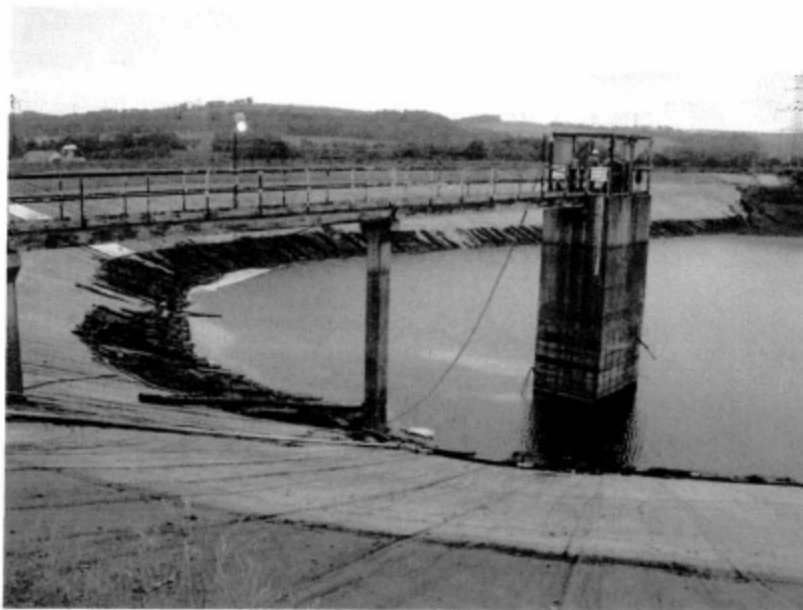
The discharge structure concrete, grating, and gate/stoplog support and lift structure were all in good condition. The access footbridge was in good condition, although the paint was beginning to deteriorate. The bridge supporting piers were in good condition. The outlet structure can be seen in Photo 25. PPL typically performs an interior inspection of the structure annually. Dave – has this been done?

Photo 24 - The discharge tower and bridge, looking west.

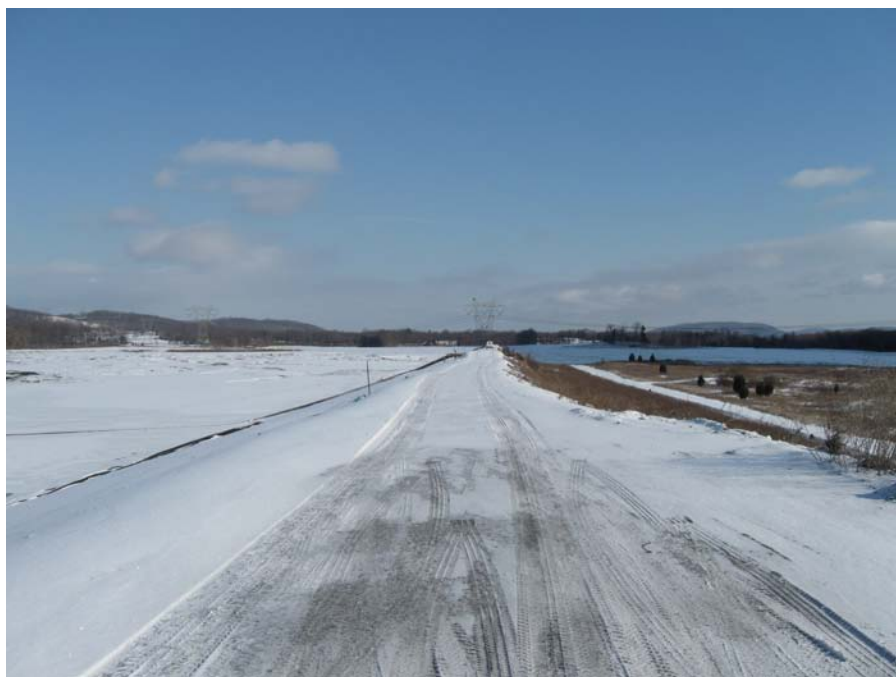
Crest – Left Side

**Crest:** The crest of the dam has a circular, horizontal alignment with a level appearance. The crest is covered with snow. The crest is in good condition.

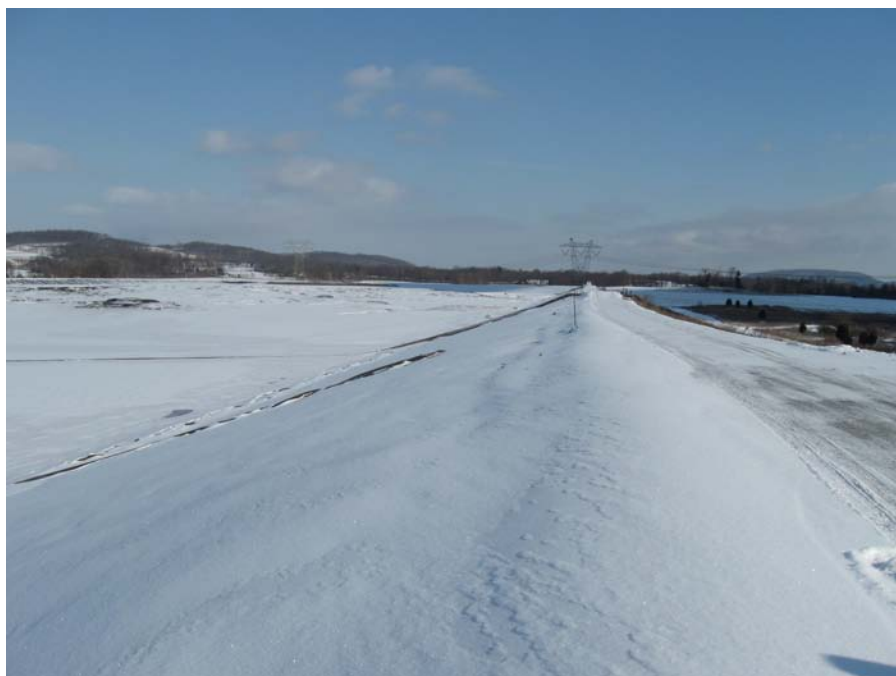
Crest/Upstream Face

**Upstream Face:** The majority of the upstream face consists of a PVC liner which extends throughout the entire basin area. The liner is covered with snow and not visible. The face is in good condition.

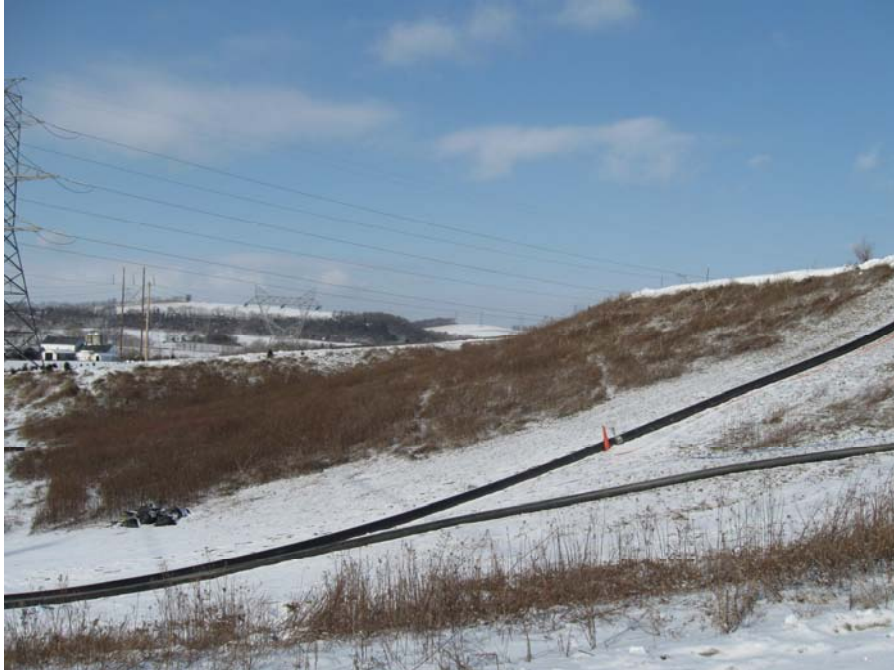
D48-149      Downstream Face – Dam Center – Looking Right      01/15/2009

**Downstream Face:** The downstream face consists of an approximate 2H:1V slope with a moderate, dense vegetative cover consisting mostly of crown vetch. The dense cover hindered a close inspection of the face. The face is in fair condition.

**Comments:** The dam is in good condition. The owner should consider establishment of a maintenance program which includes the routine cutting of vegetation on the downstream face and along the toe. The goal should be the establishment of a controlled grass cover in these areas.

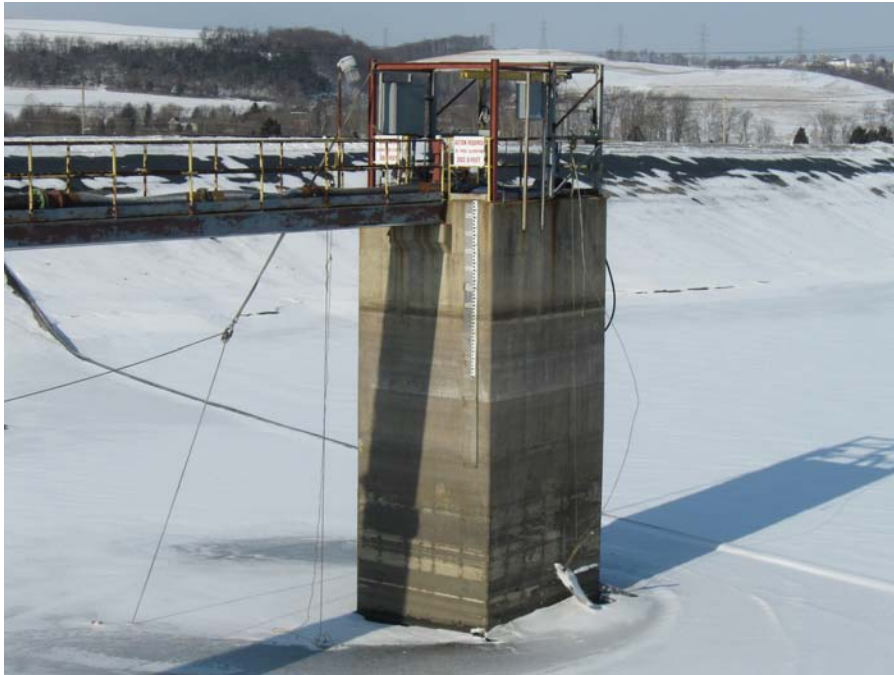
Riser Structure

**Drawdown Facilities:** The drawdown facilities consist of a stop log structure housed within a concrete structure within the reservoir. There are three closure structures associated with the facilities. The stop log structure itself and two valve structures. The control structures were rehabilitated and are in good condition. No flow was discharging from the spillway. The valve was completely closed. The flow exiting the outlet pipe, which is located several thousand feet downstream, originates at the IWTB. Flow discharges the CMP outlet to a grouted riprap channel. The outlet structure and channel are in good condition.

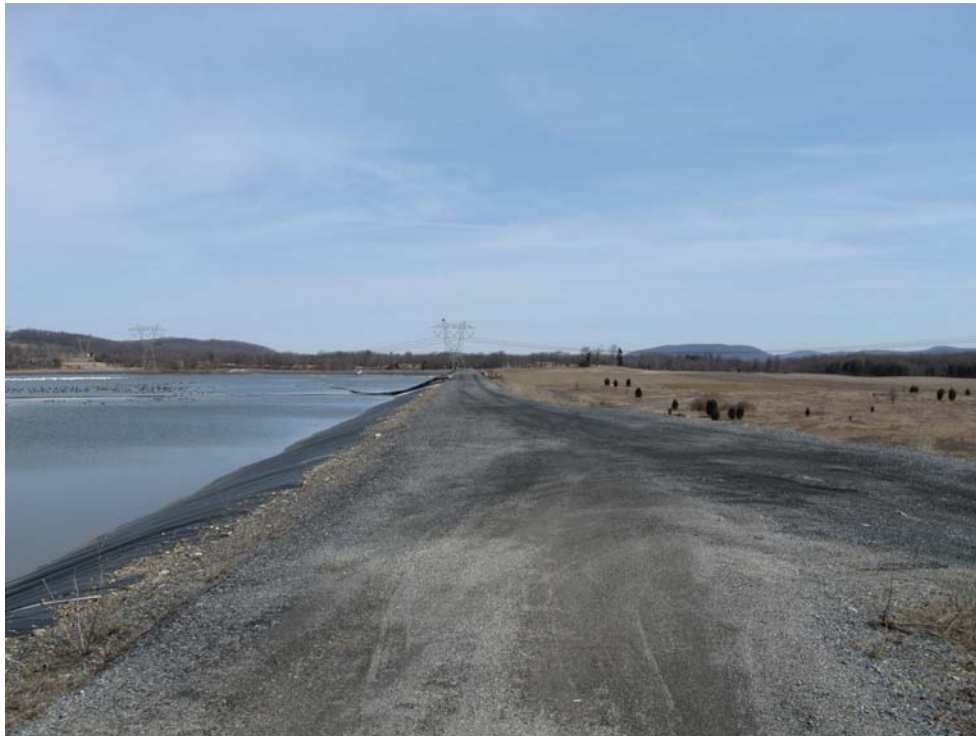
Crest- Left Side

**Crest:** The crest of the dam has a circular, horizontal alignment with a level appearance. The crest consists of a gravel maintenance road which encircles the entire dam. The crest is in good condition.

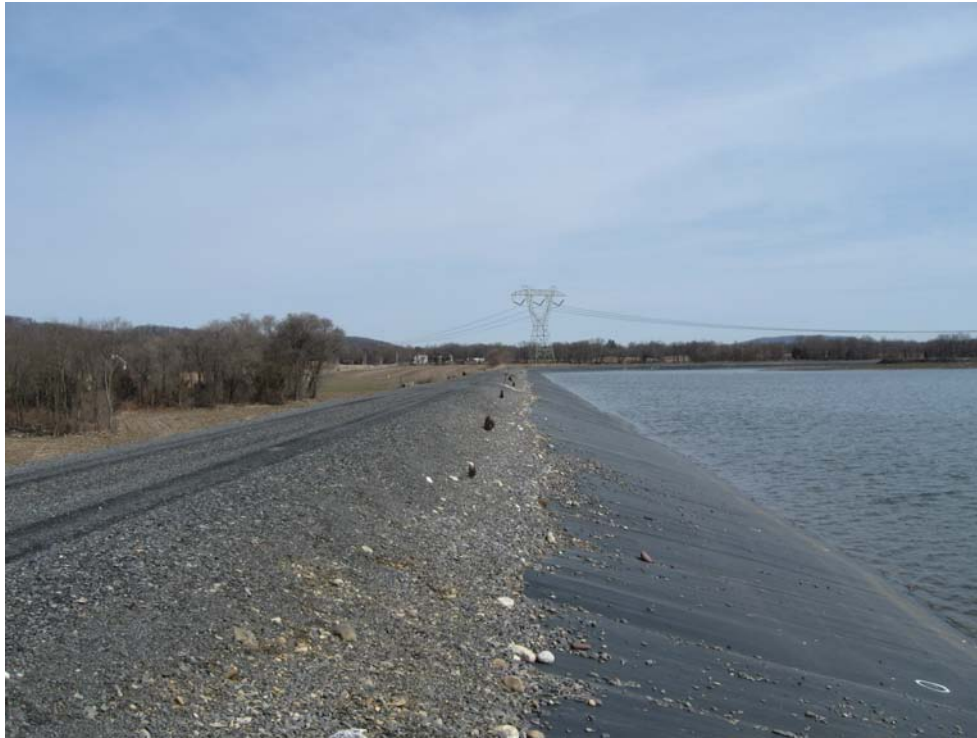
D48-149

Crest/ Upstream Face- Left Side

**Upstream Face:** The majority of the upstream face consists of a PVC liner which extends throughout the entire basin area. The liner is in good condition. Above the liner, the face consists of a gravel cover. Overall, the face is in good condition. The face has an approximate 2H:1V slope.

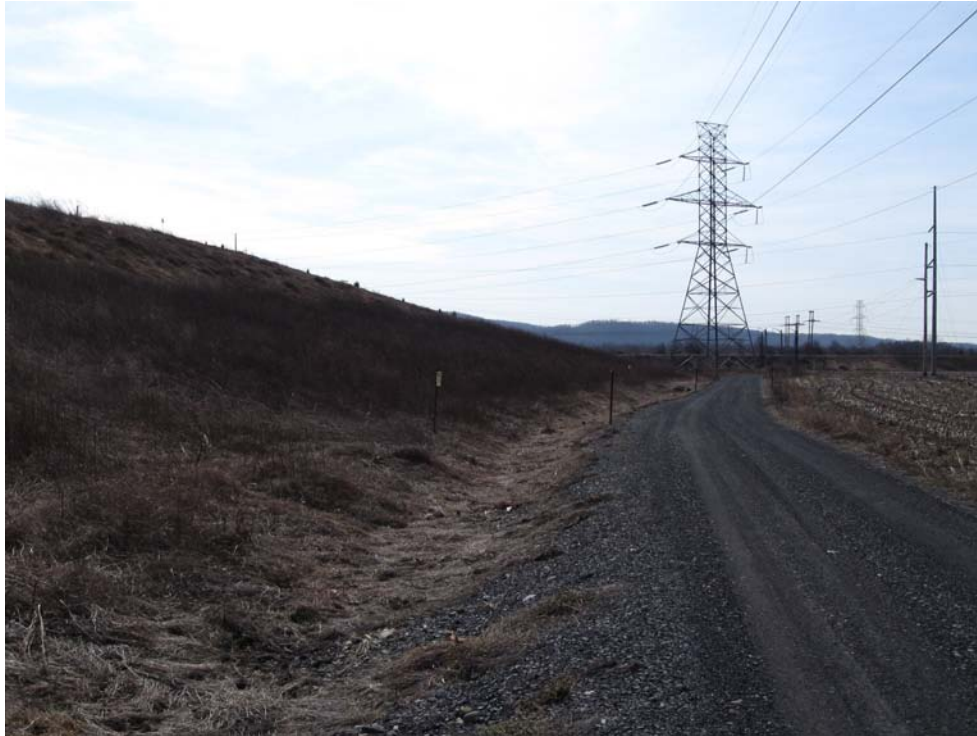
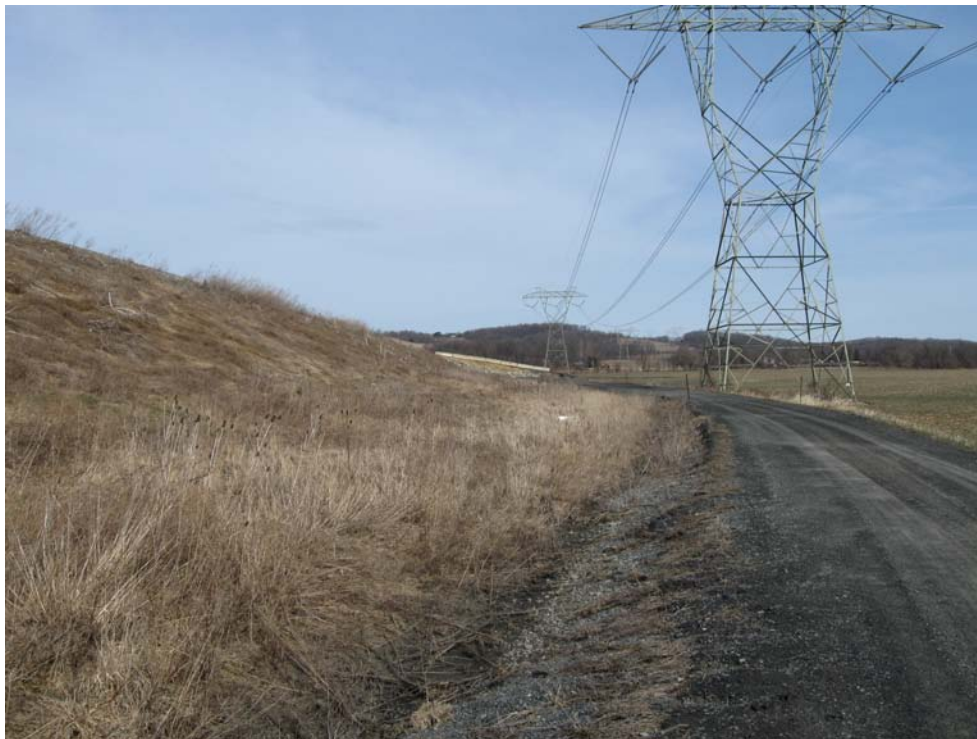
D48-149

Downstream Face/ Toe Area- Right Side

**Downstream Face:** The downstream face consists of an approximate 2H:1V slope with a dense vegetative cover consisting mostly of crown vetch and golden rod. There are a couple of small areas on the face which were recently seeded with a low grass cover establishing. Adjacent to these two areas, near the crest, the face has two small bare areas which appear from recent construction. The dense cover hindered a close inspection of the face. Over the face is in fair condition.

**Comments:** Overall, the dam is in good condition. The owner should consider establishment of a maintenance program which includes the routine cutting of vegetation on the downstream face and along the toe. The ultimate goal should be the establishment of a controlled grass cover in these areas. The two small bare areas on the downstream face should be seeded and mulched. There is no low flow release required at this dam. This facility is a storage facility for fly ash.

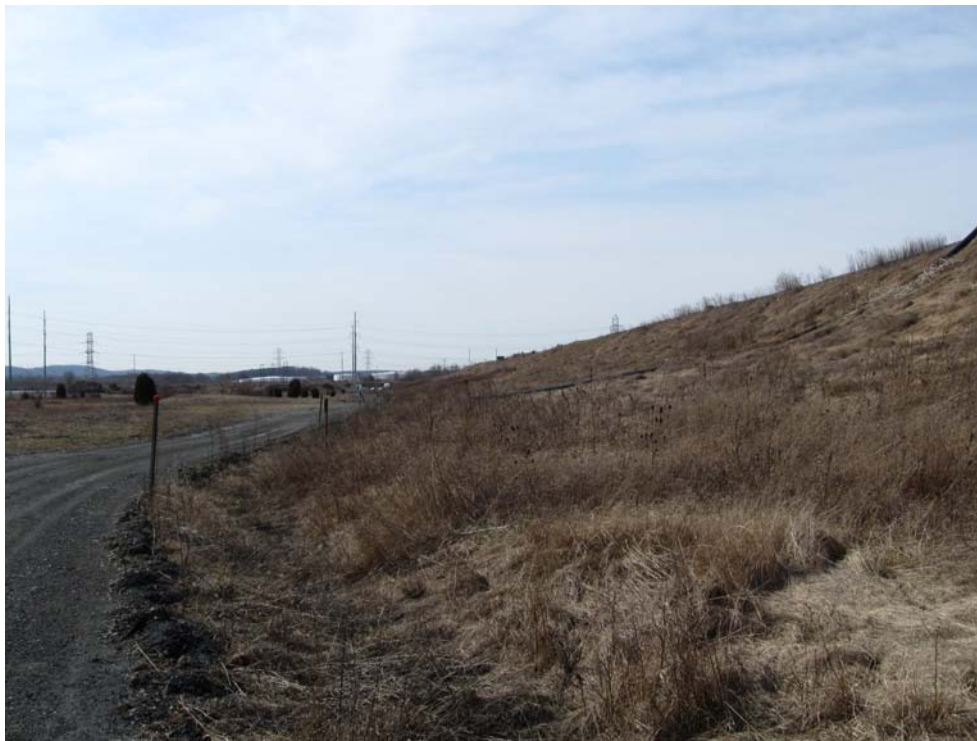
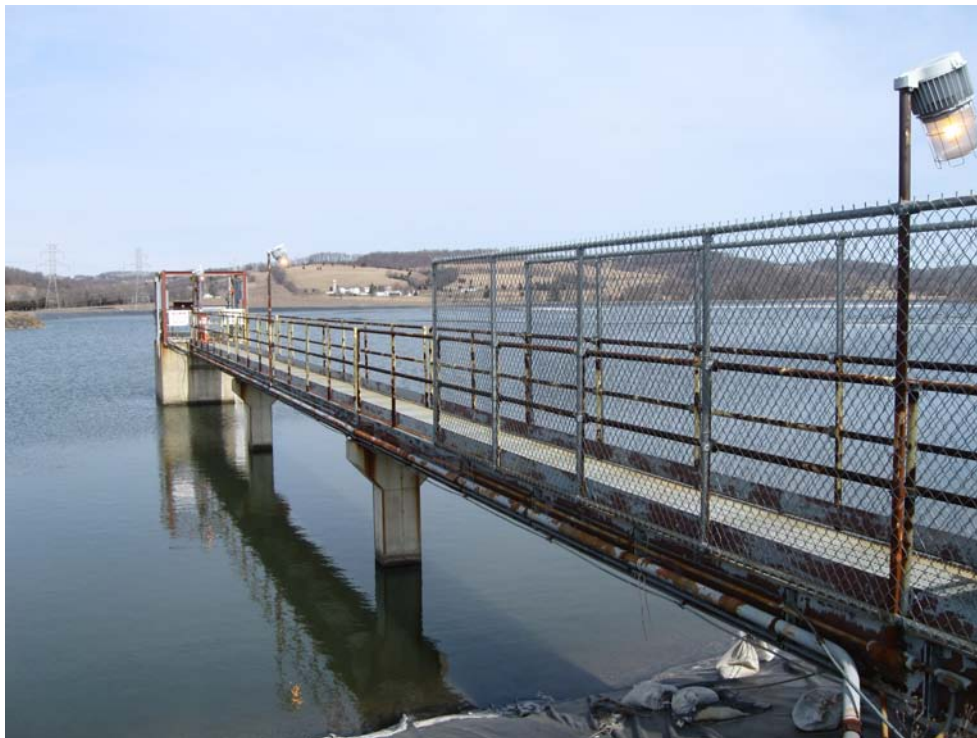
D48-149

Downstream Face/ Toe Area- Left Side

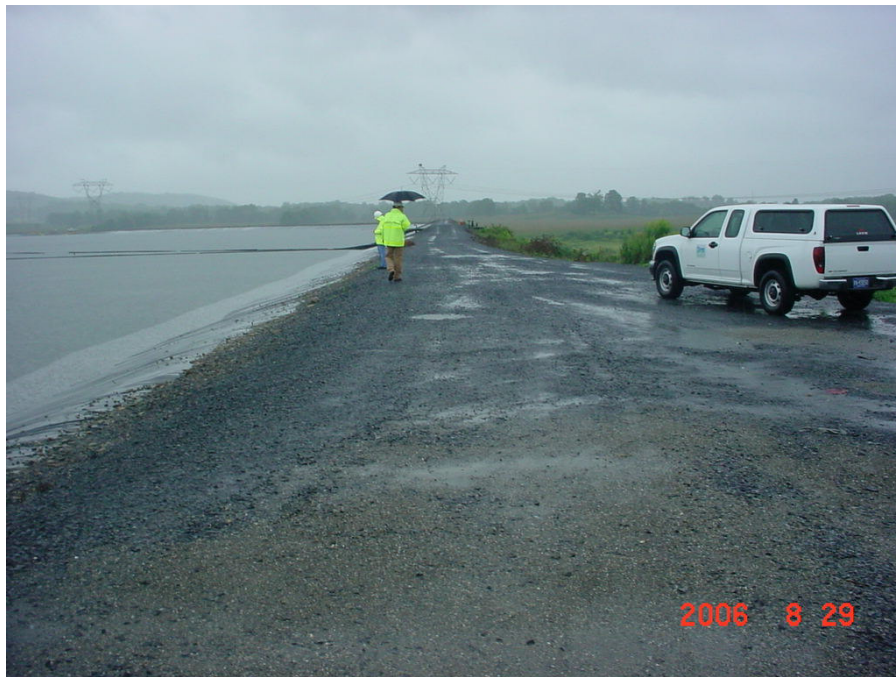
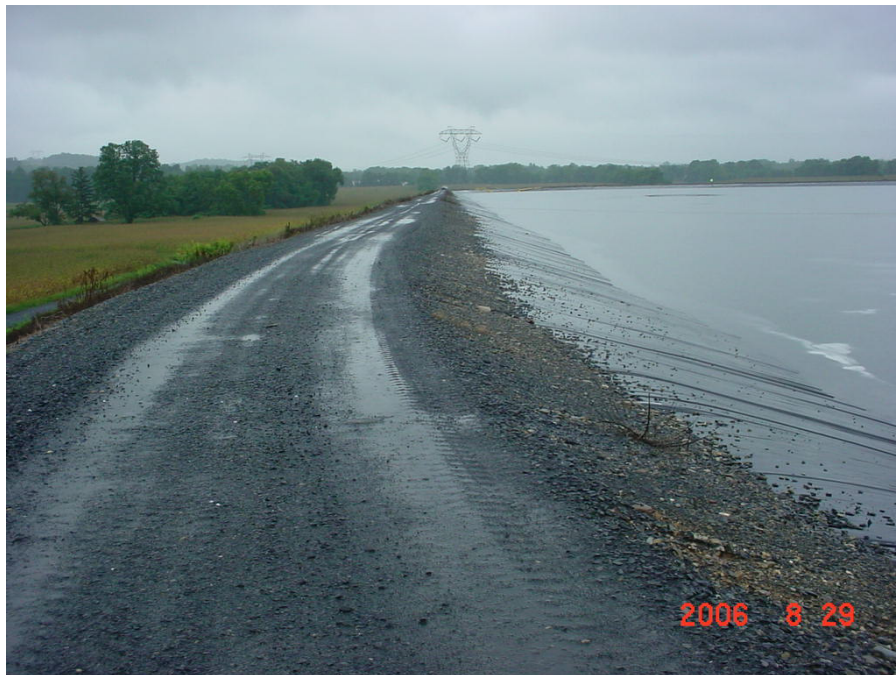
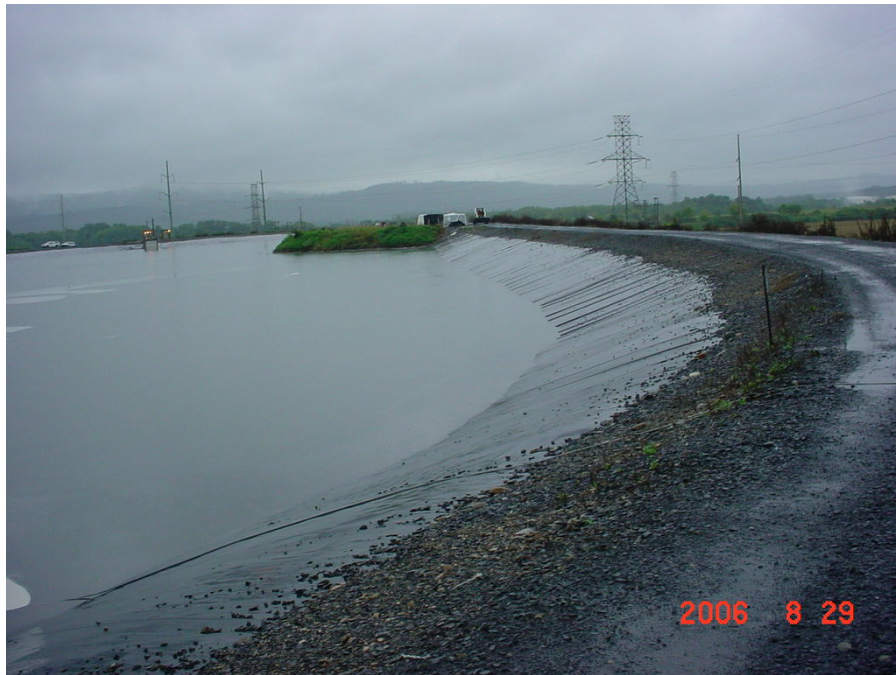
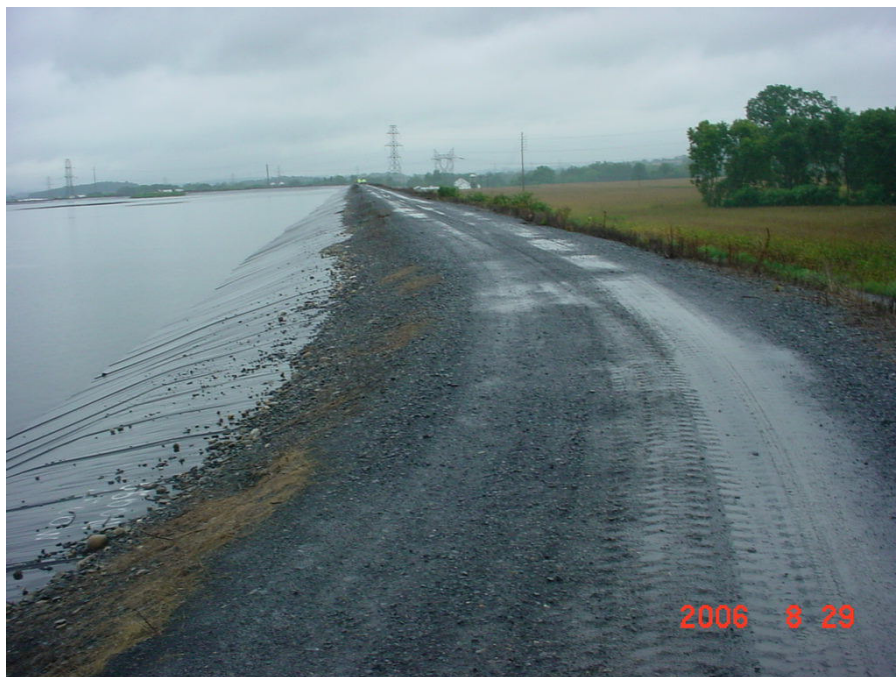
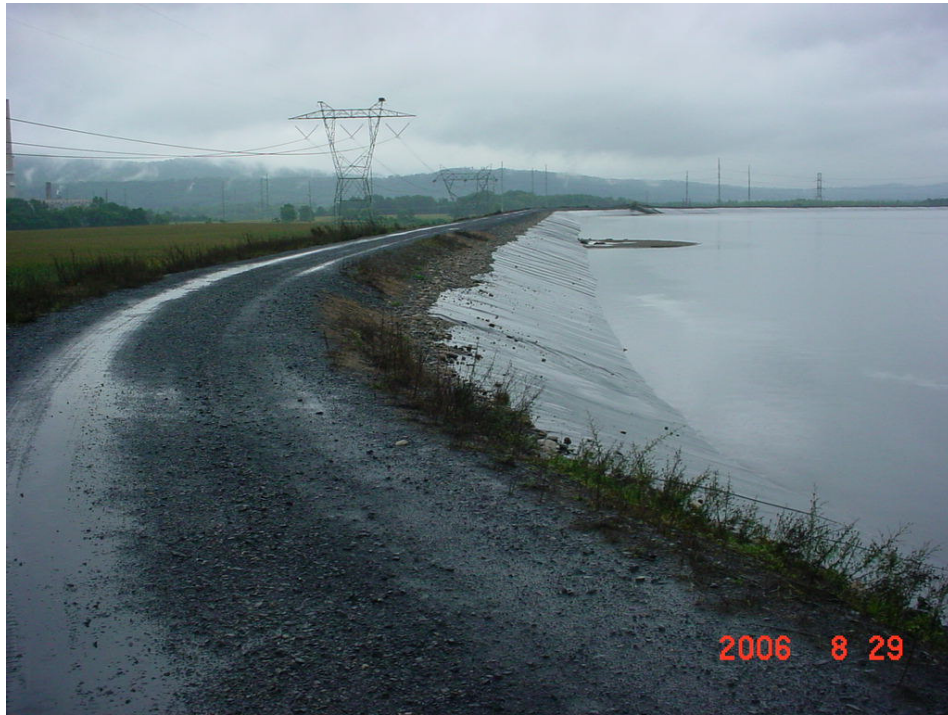
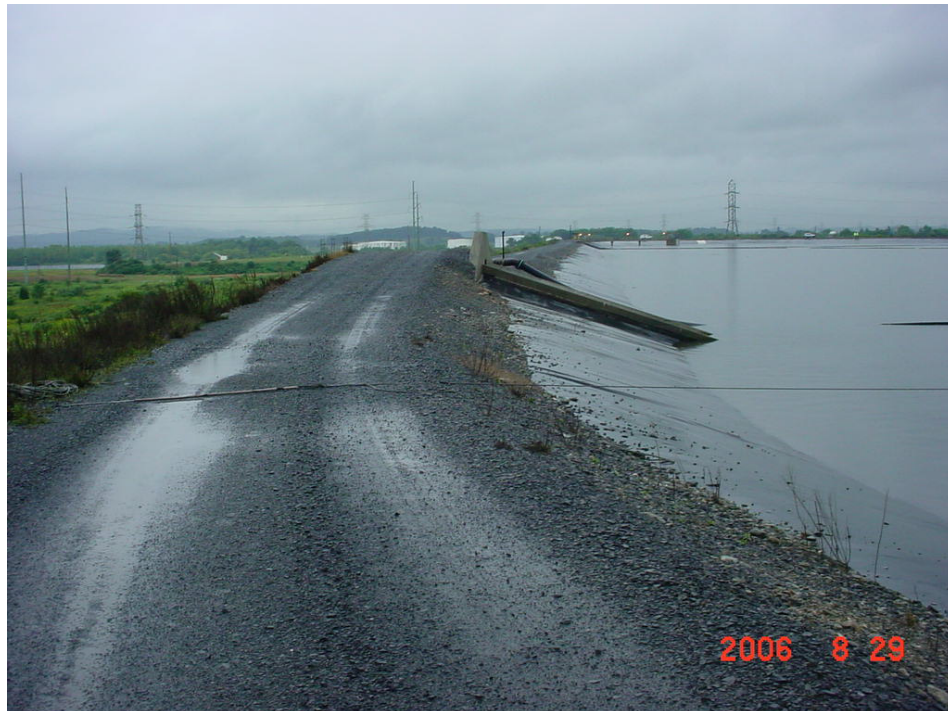
Crest/Upstream Face

**Upstream Face:** The majority of the upstream face consists of a PVC liner which extends throughout the entire basin area. The liner is in good condition. Above the liner, the face consists of a gravel cover. The face is in good condition.
